October 9, 2014

# Post-Reclamation Geotechnical Inspection

## FORMER POLARIS MINE, NUNAVUT

**Report Number:** 1408454

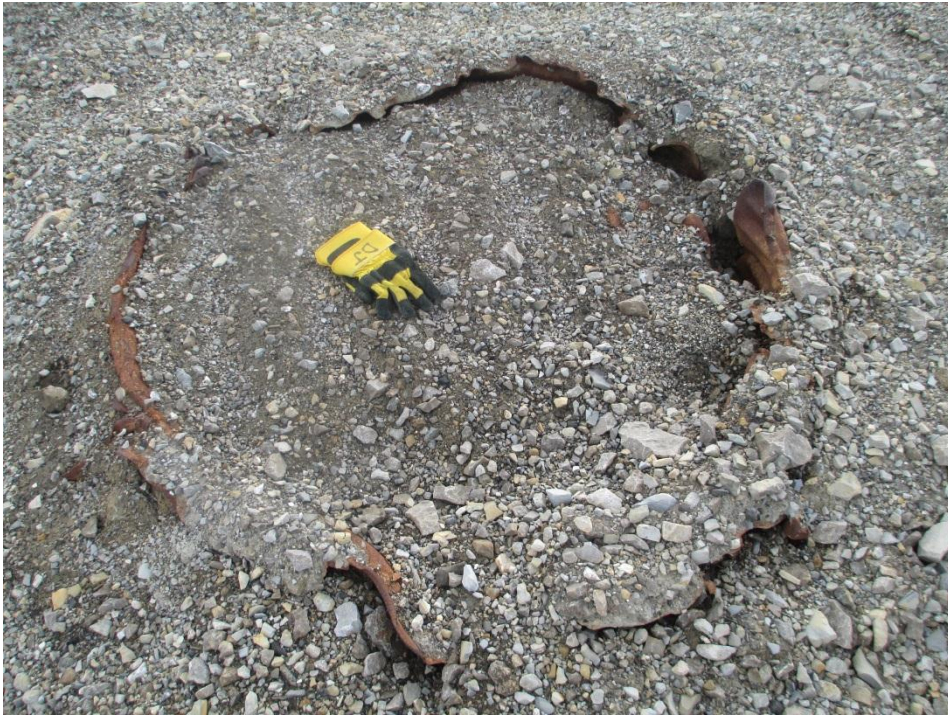
Photo 41, Subsidence Area, Vent/Backfill Raise (WP#35)

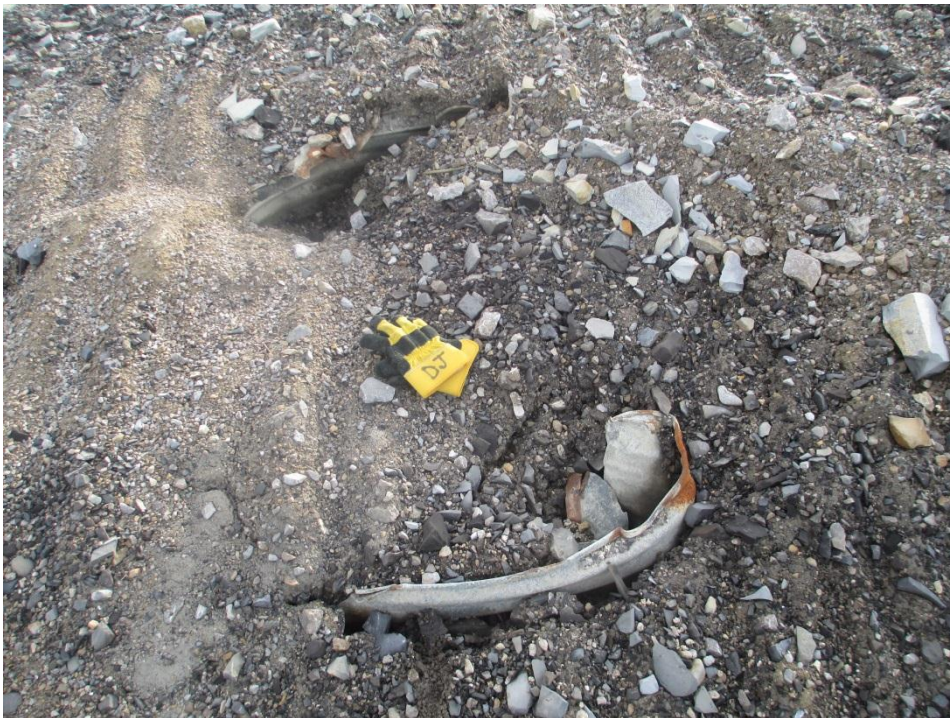
Photo 42, Subsidence Area, Vent/Backfill Raise (WP#36)

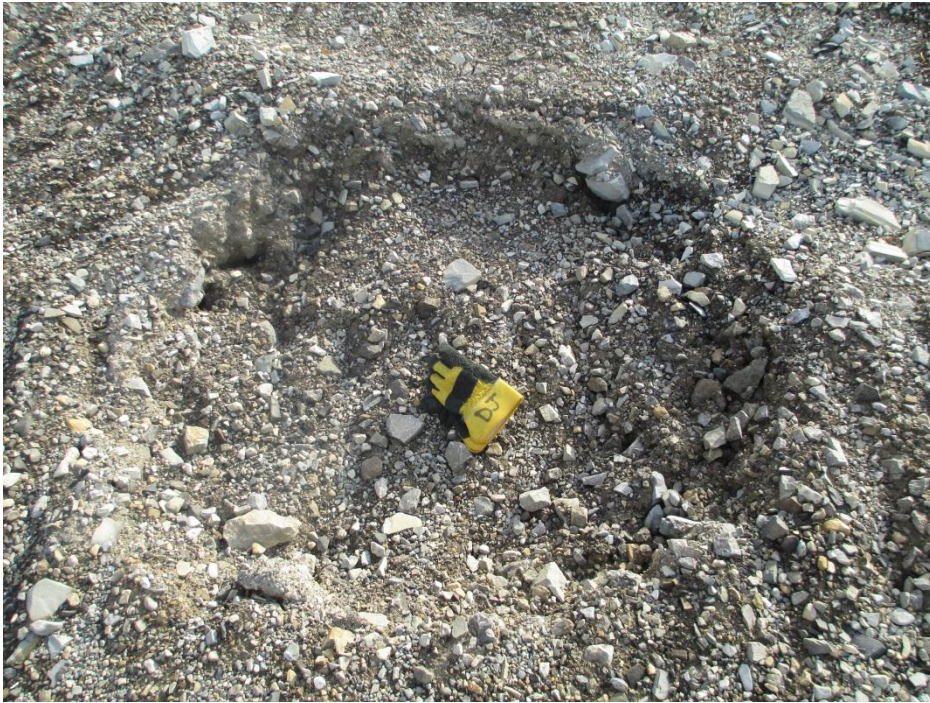
Photo 43, Subsidence Area, Vent/Backfill Raise (WP#37/51)

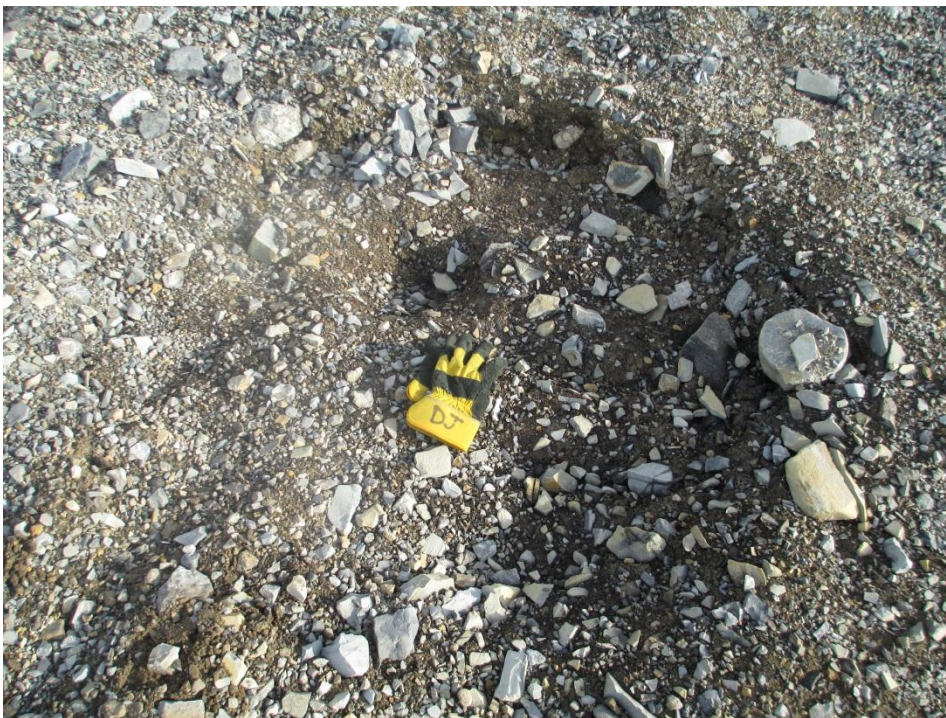
Photo 44, Subsidence Area, Vent/Backfill Raise (WP#38/50)

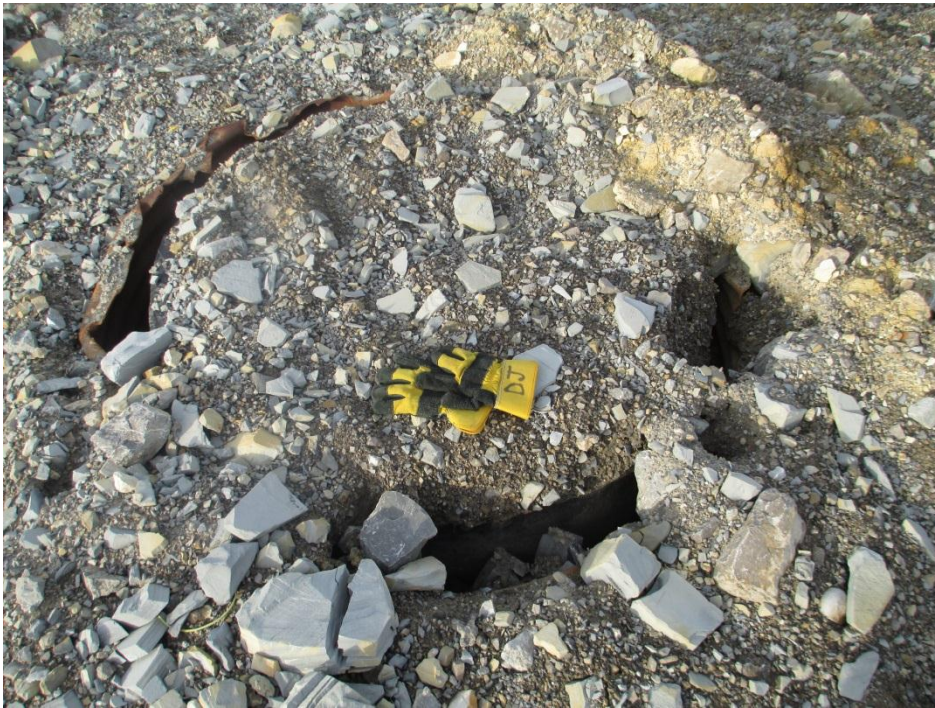
Photo 45, Subsidence Area, Vent/Backfill Raise with internal HPDE liner (WP#39)

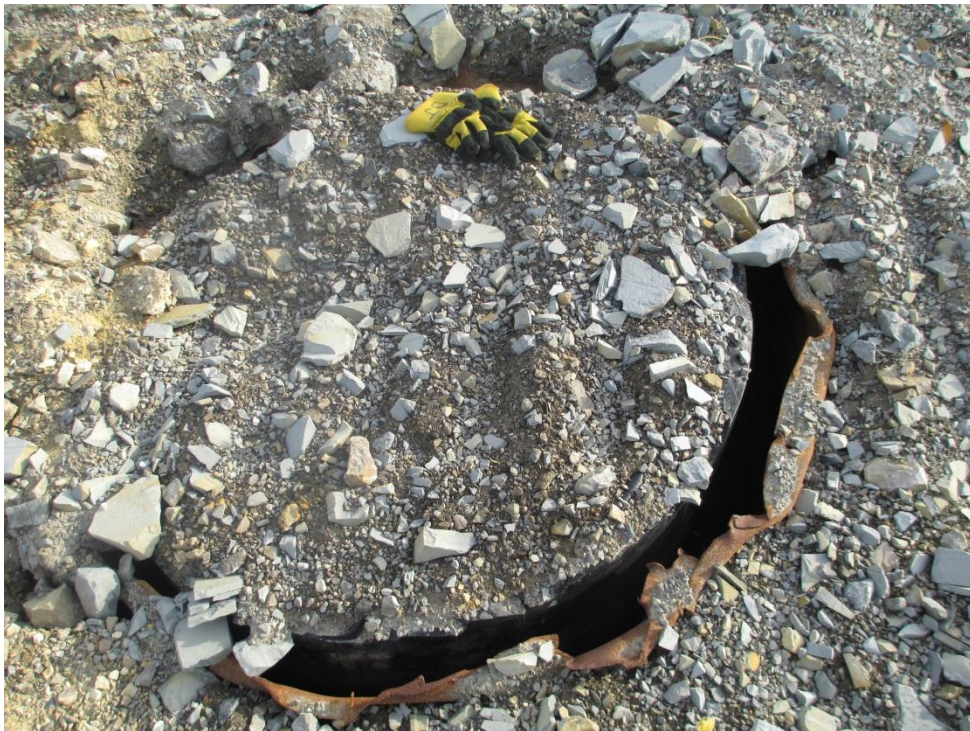
Photo 46, Subsidence Area, Vent/Backfill Raise with internal HPDE liner (WP#39)

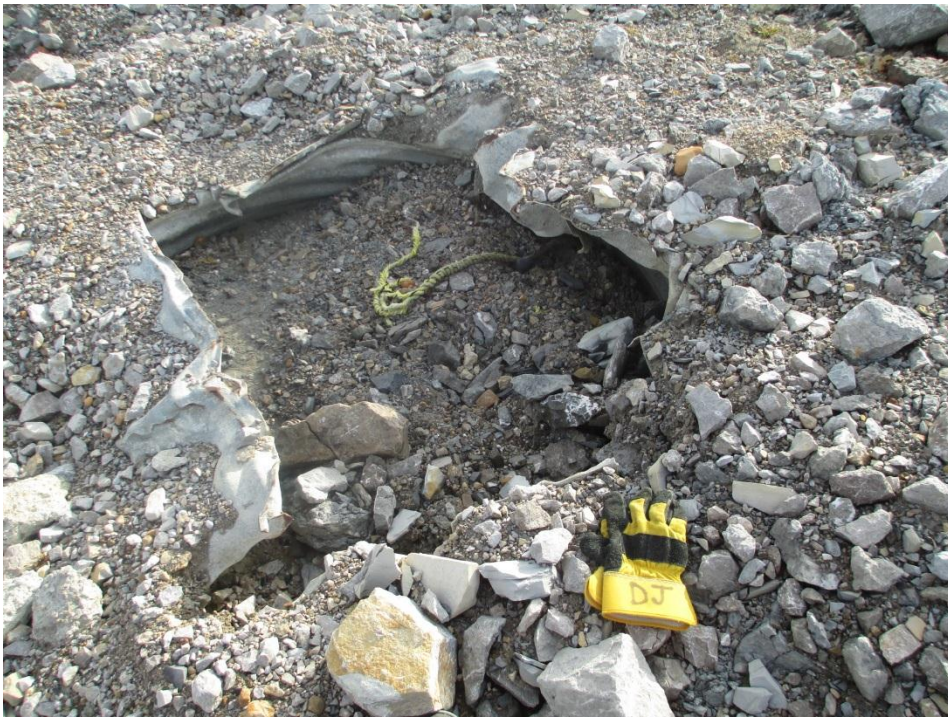
Photo 47, Subsidence Area, Vent/Backfill Raise (WP#40)

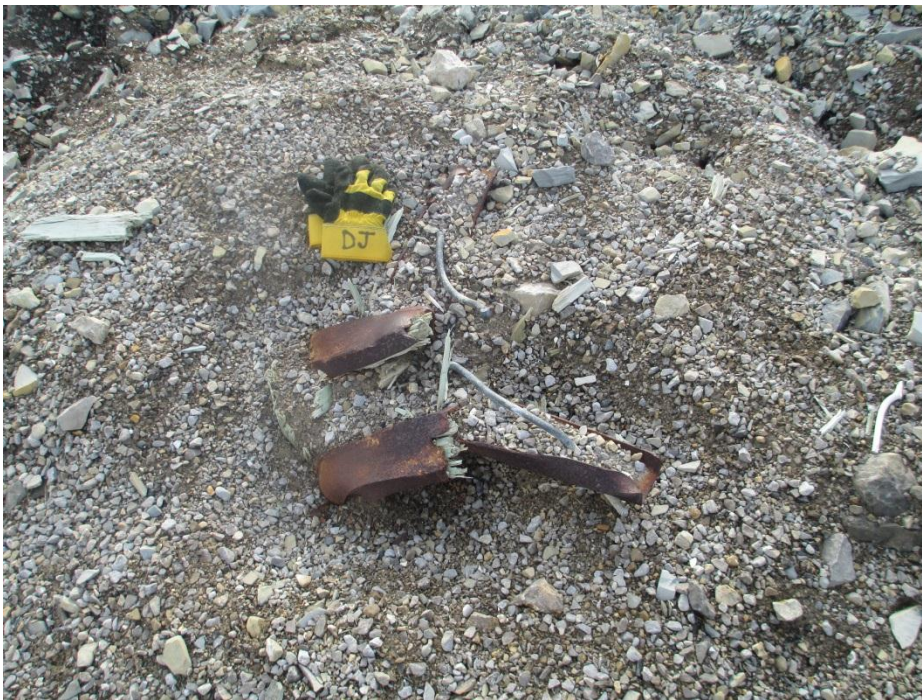
Photo 48, Subsidence Area, Pole Anchor (WP#41)

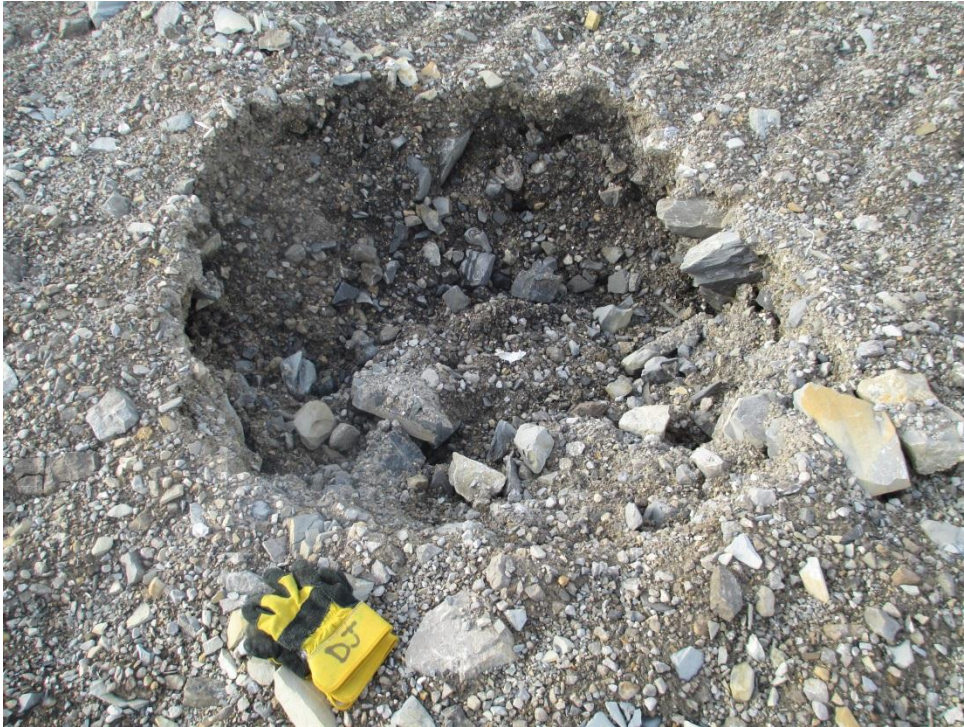
Photo 49, Subsidence Area, Vent/Backfill Raise (WP#42)

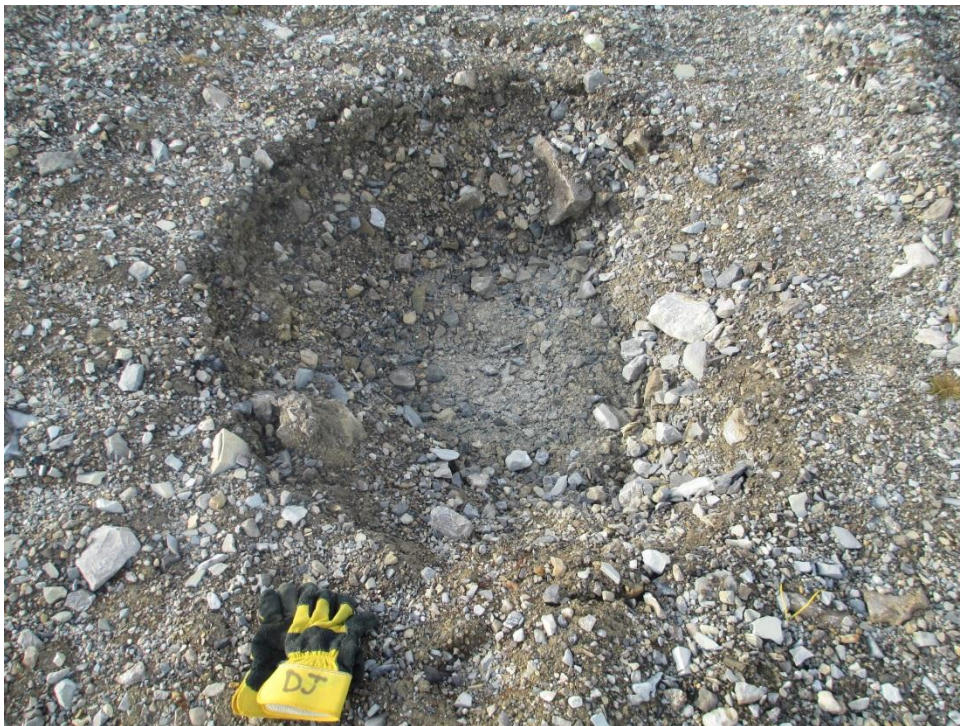
Photo 50, Subsidence Area, Vent/Backfill Raise (WP#43)

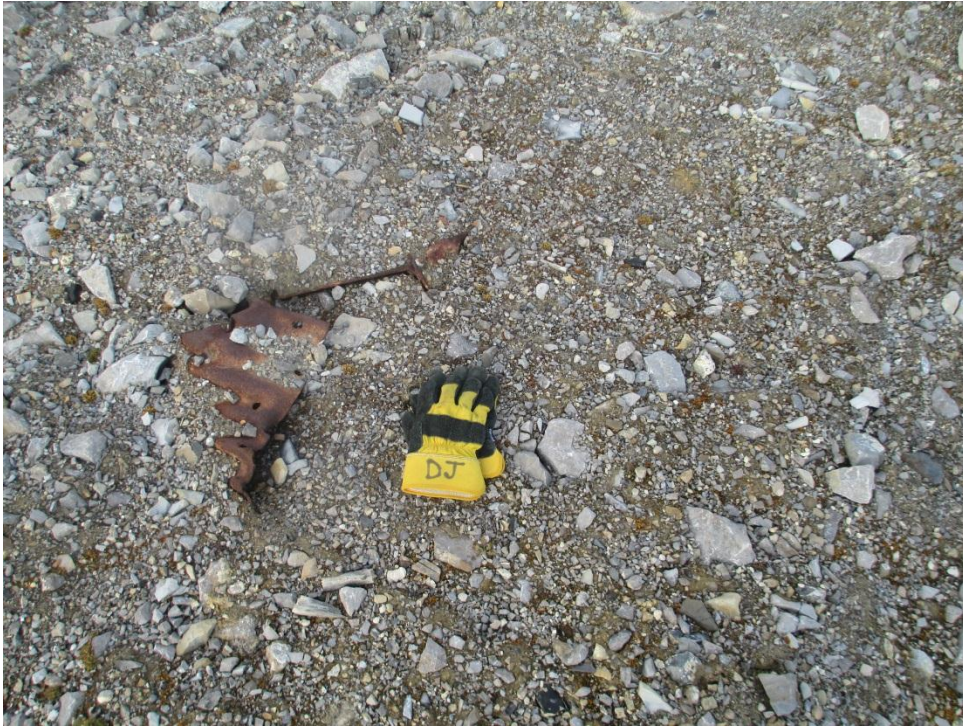
Photo 51, Subsidence Area, Vent/Backfill Raise (WP#44)

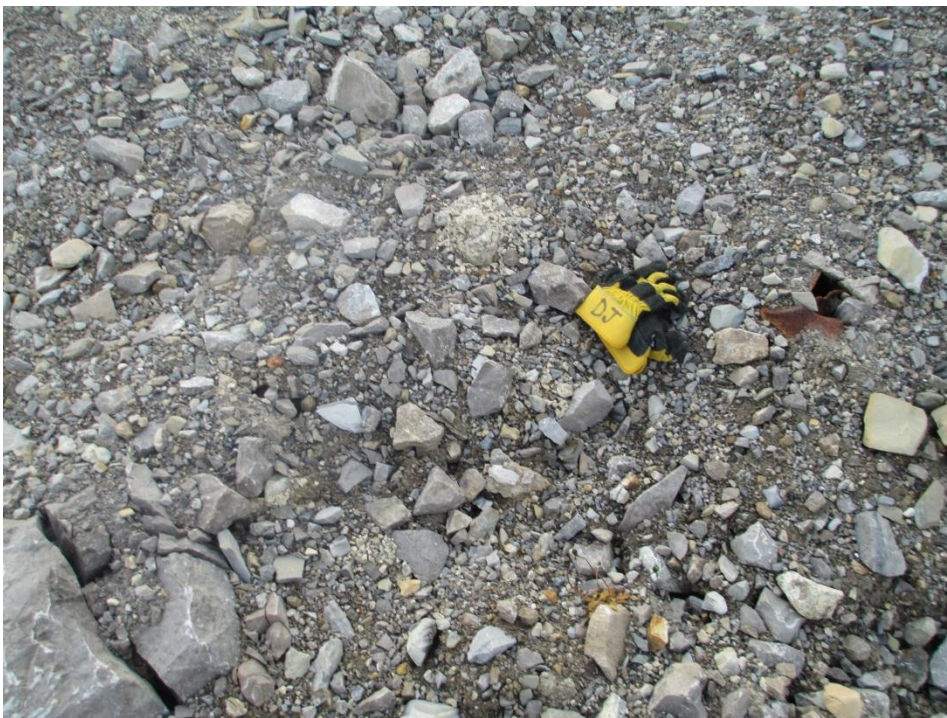
Photo 52, Subsidence Area, Vent/Backfill Raise (WP#45)

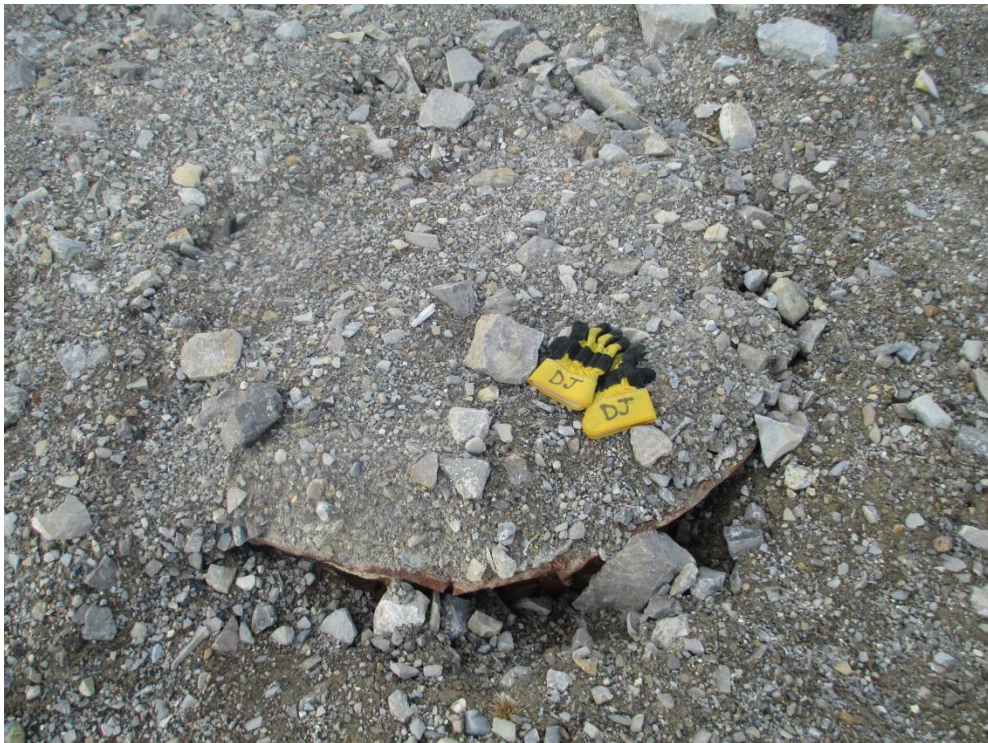
Photo 54, Subsidence Area, Vent/Backfill Raise (WP#47)

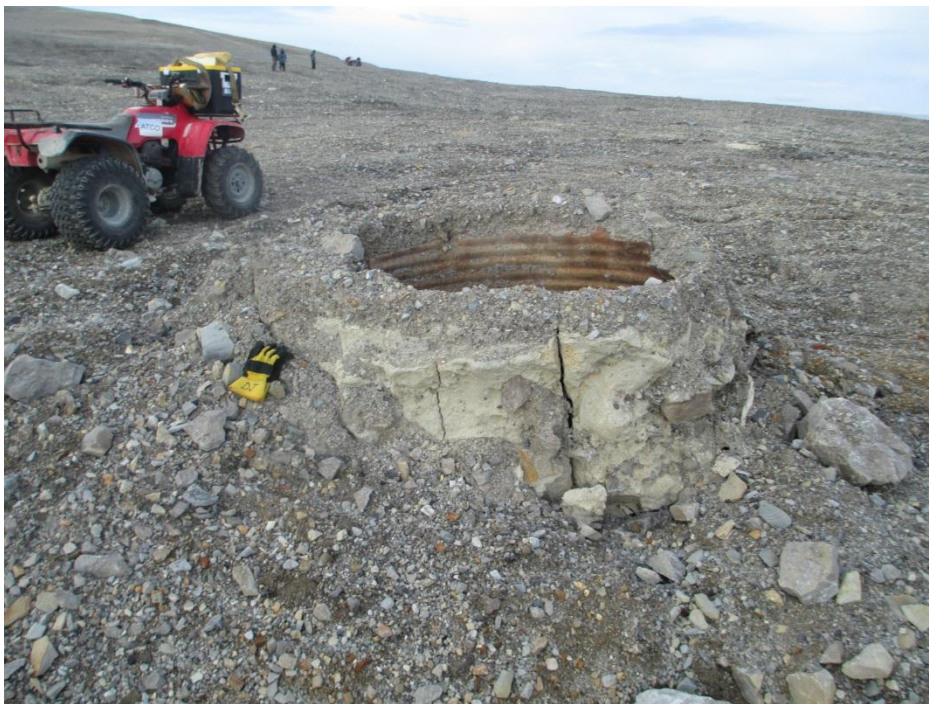
Photo 56, Subsidence Area, Vent/Backfill Raise (WP#48)

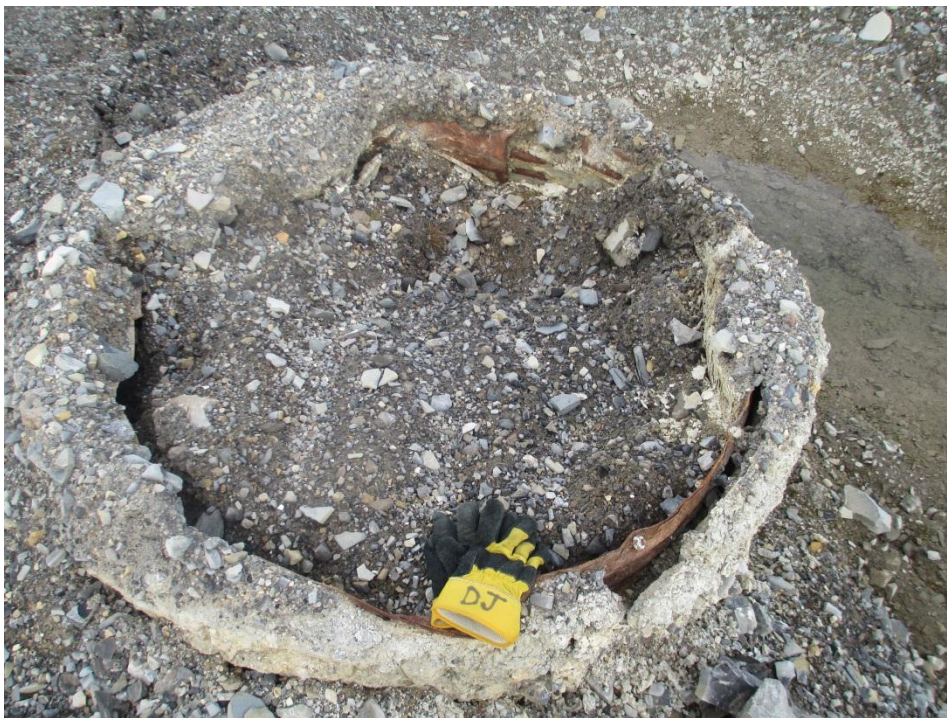
Photo 58, Subsidence Area, Vent/Backfill Raise (WP#49)

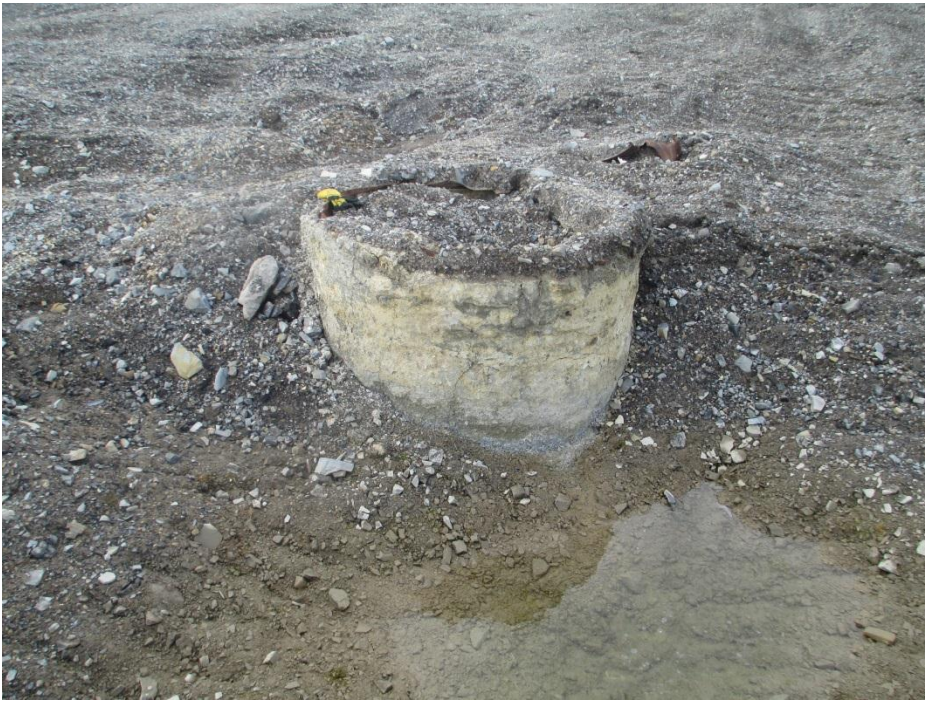
Photo 59, Subsidence Area, Vent/Backfill Raise sideview (WP#49)

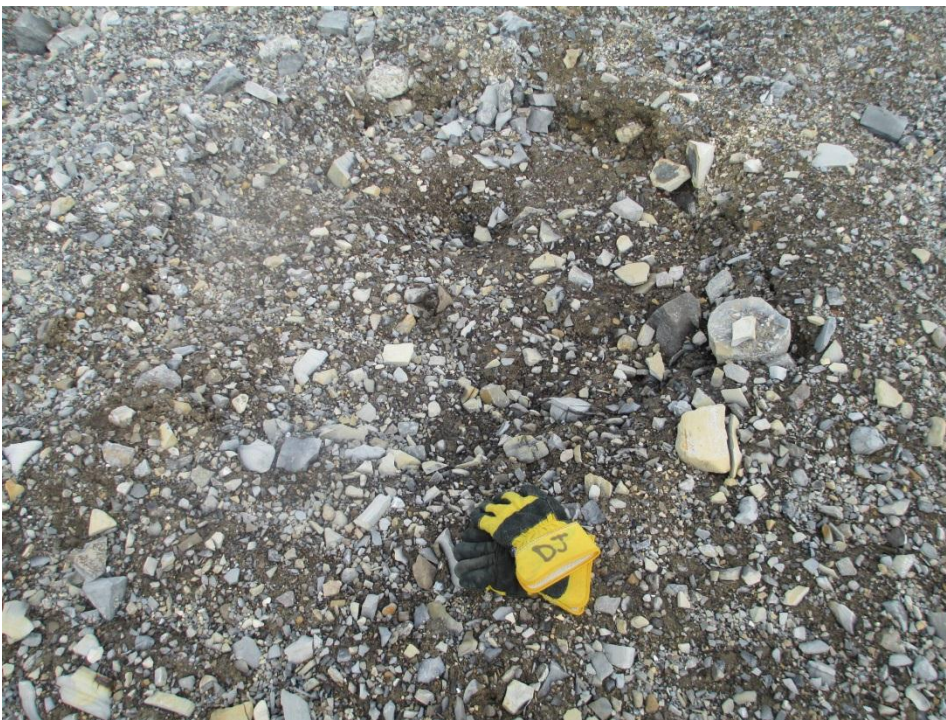
Photo 60, Subsidence Area, Vent/Backfill Raise (WP#38/50)

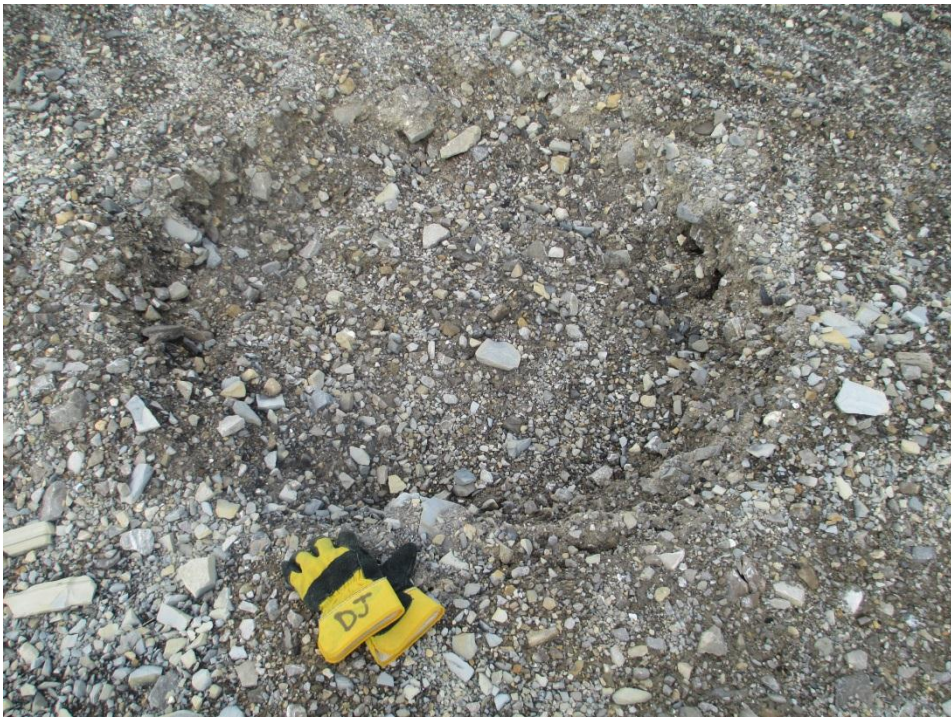
Photo 61, Subsidence Area, Vent/Backfill Raise (WP#37/51)

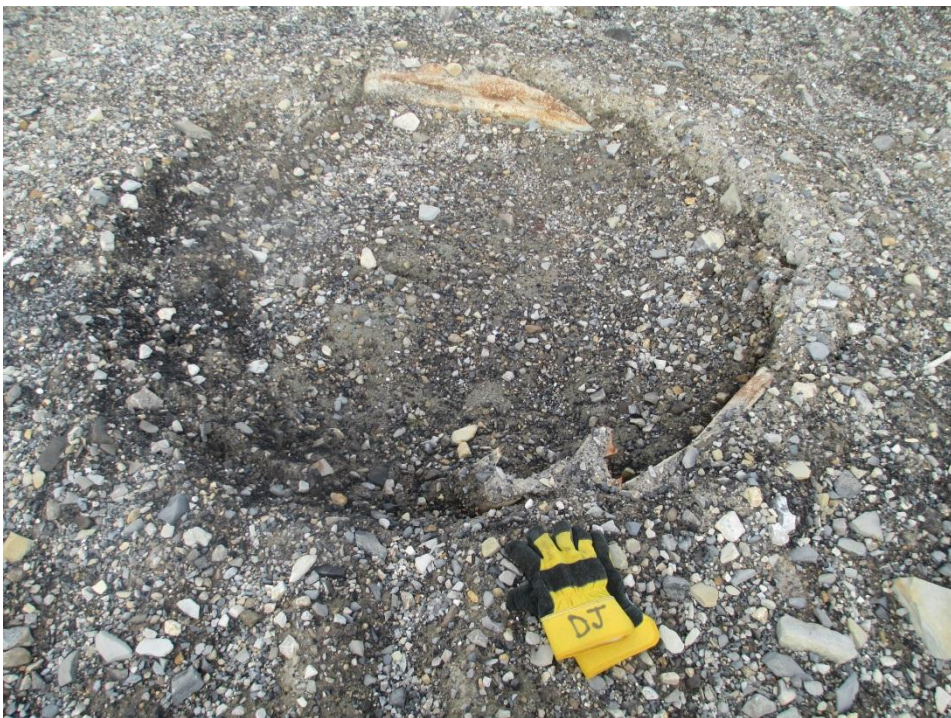
Photo 62, Subsidence Area, Vent/Backfill Raise (WP#52)

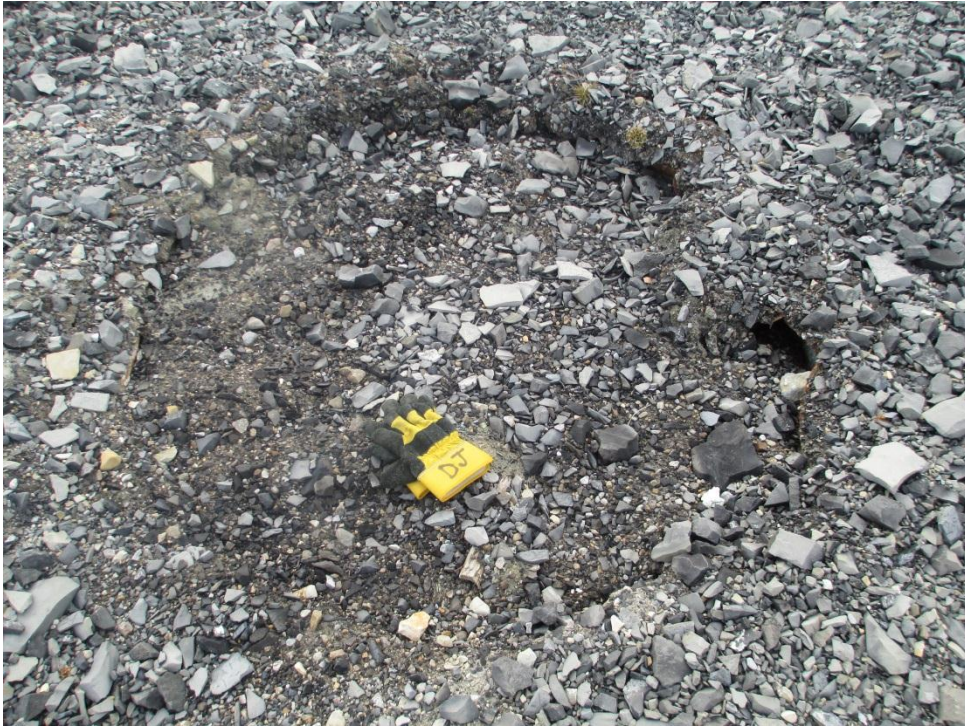
Photo 63, Subsidence Area, Vent/Backfill Raise (WP#53)

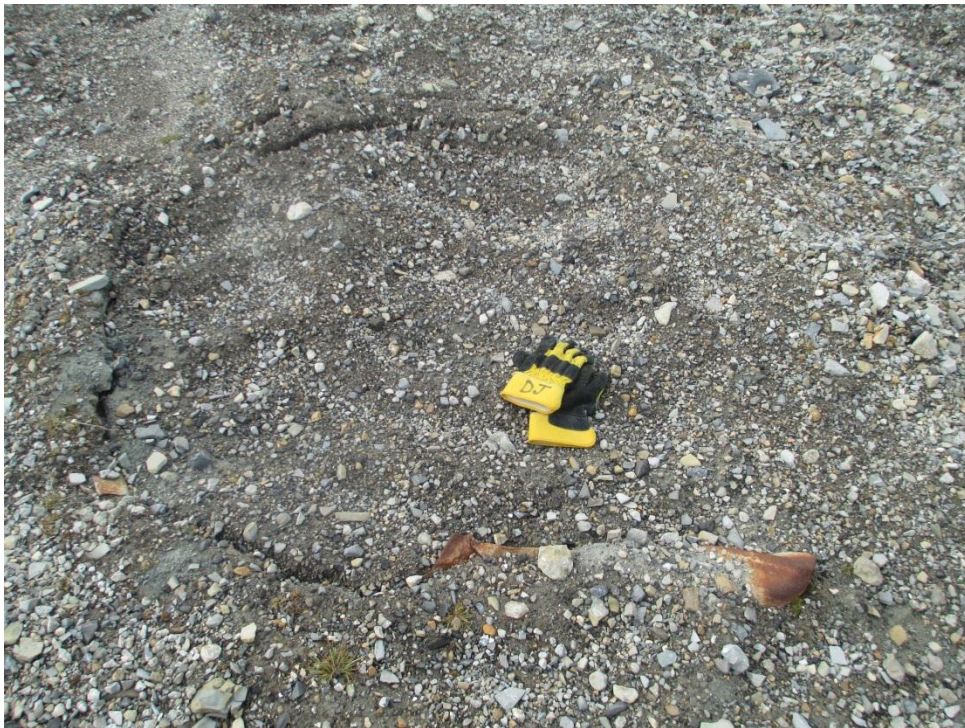
Photo 64, Subsidence Area, Vent/Backfill Raise (WP#54)

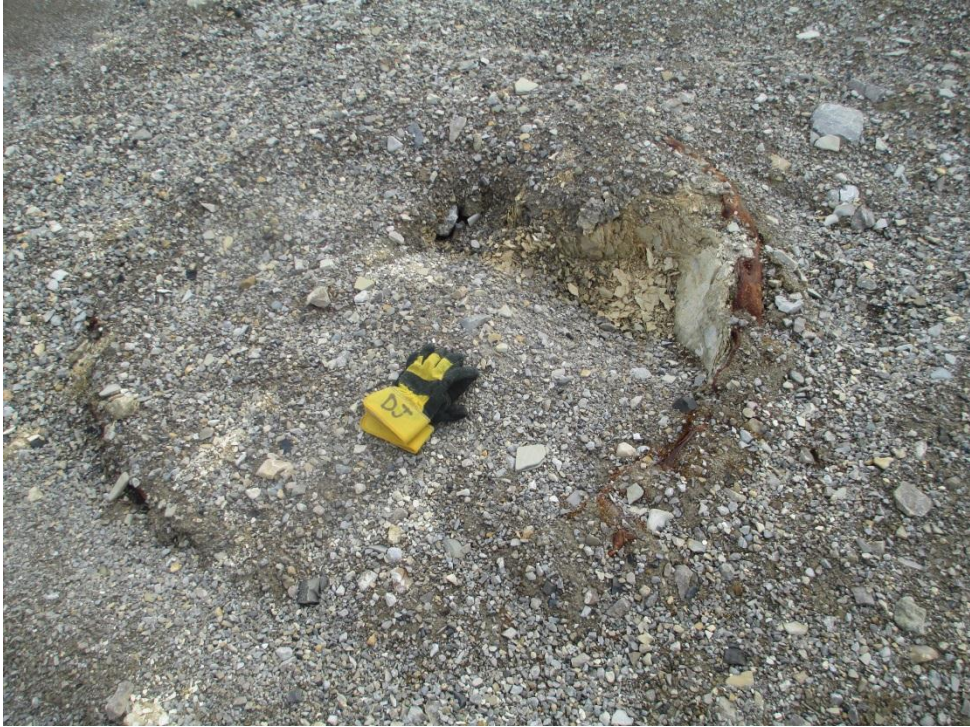
Photo 65, Subsidence Area, Vent/Backfill Raise (WP#55)

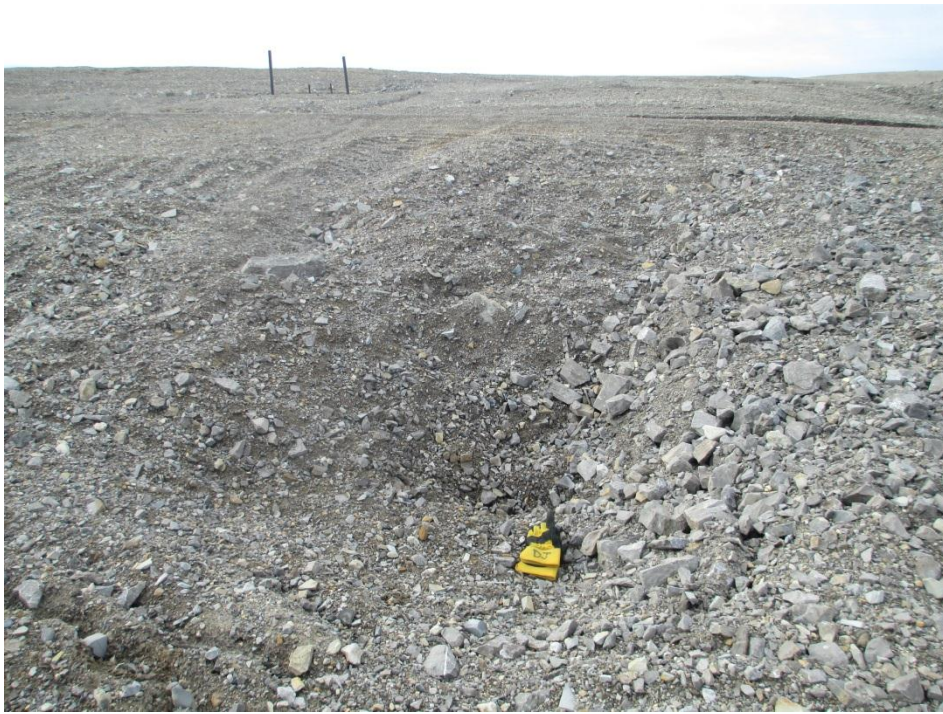
Photo 67, Subsidence Area, thaw settlement (WP#57)

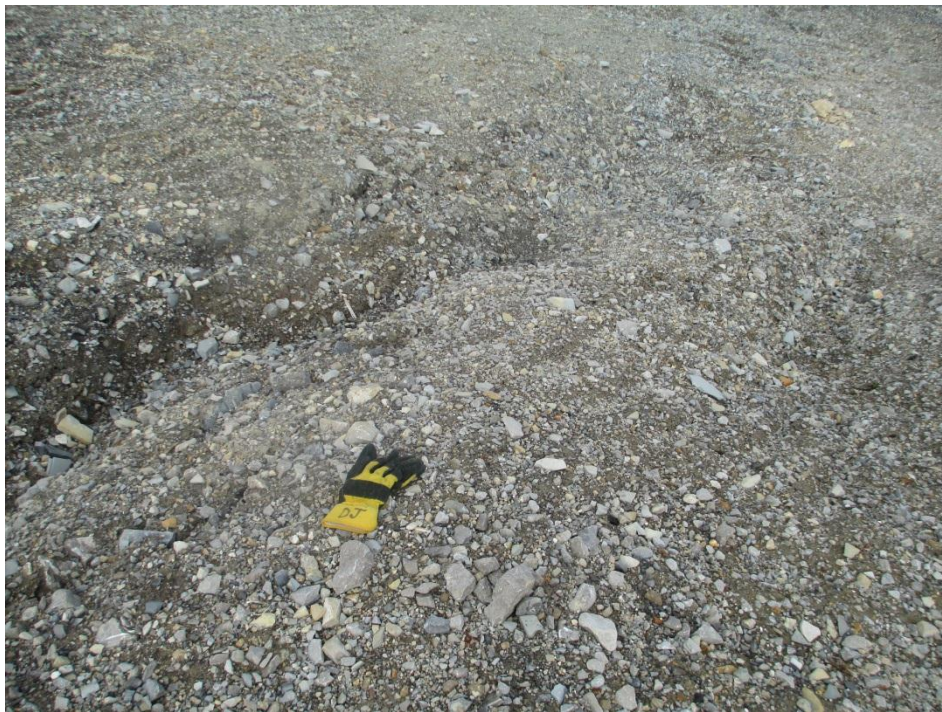
Photo 68, Subsidence Area, thaw settlement (WP#58)

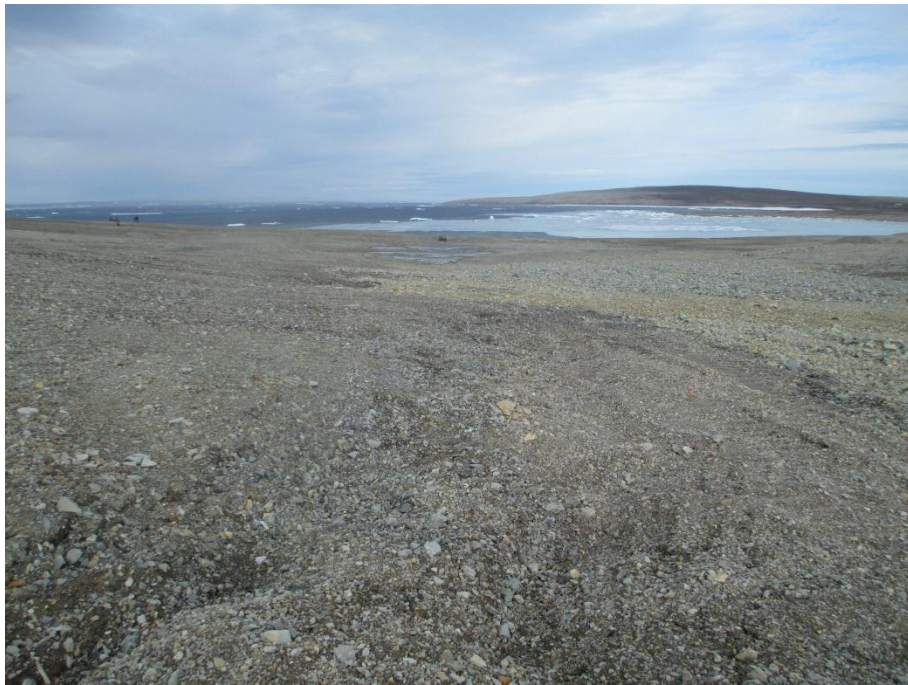
Photo 69, Subsidence Area, facing Northeast from WP#58

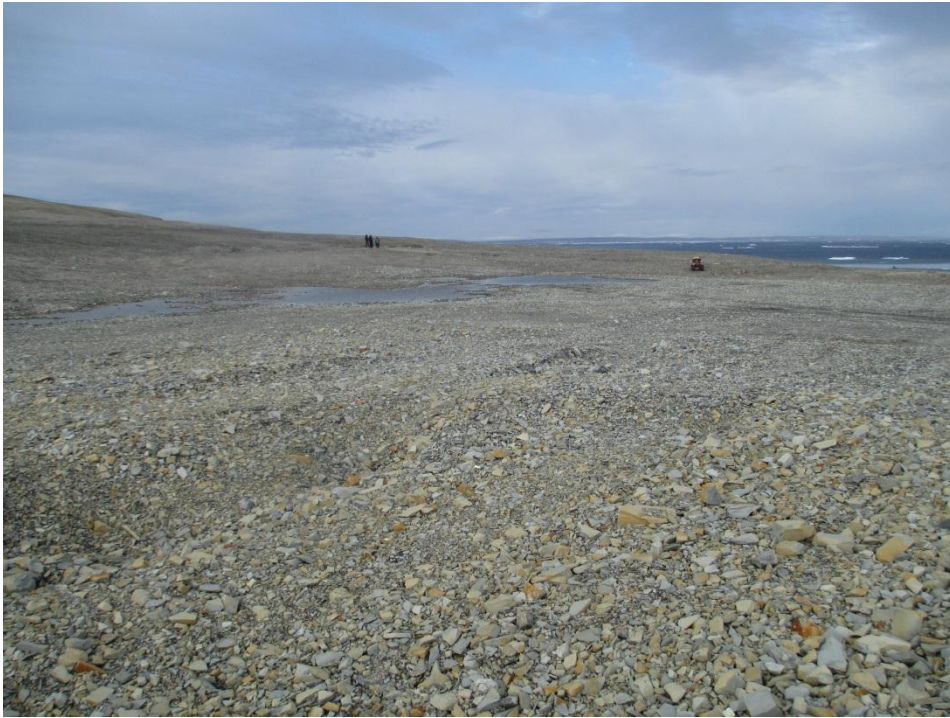
Photo 73, Subsidence Area, facing Northwest from WP#61

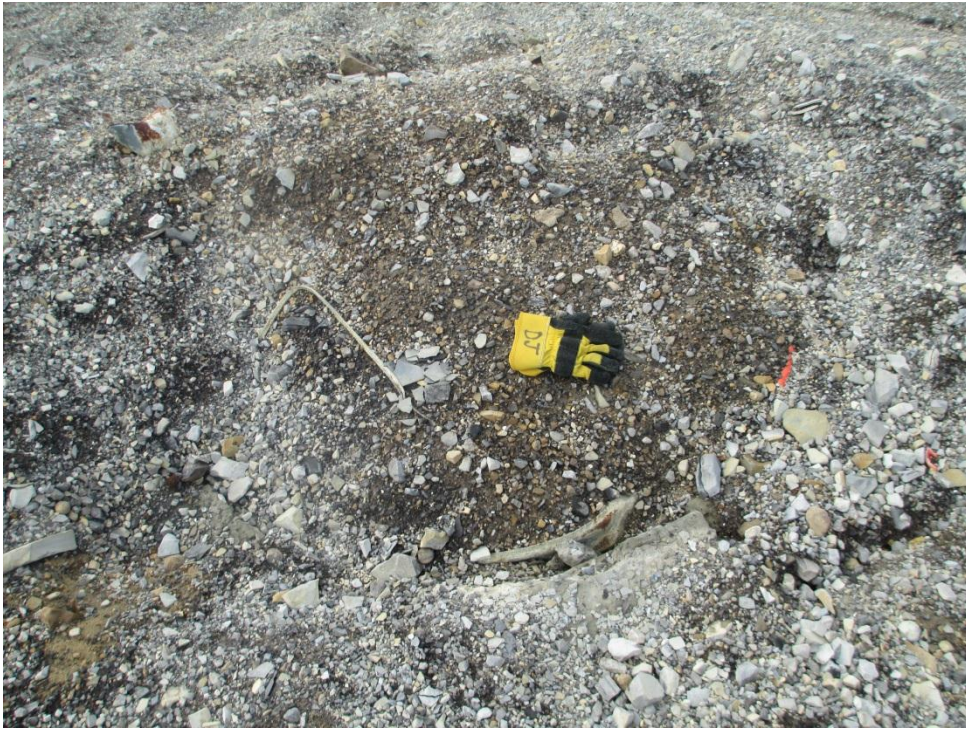
Photo 79, Subsidence Area, Vent/Backfill Raise (WP#66)

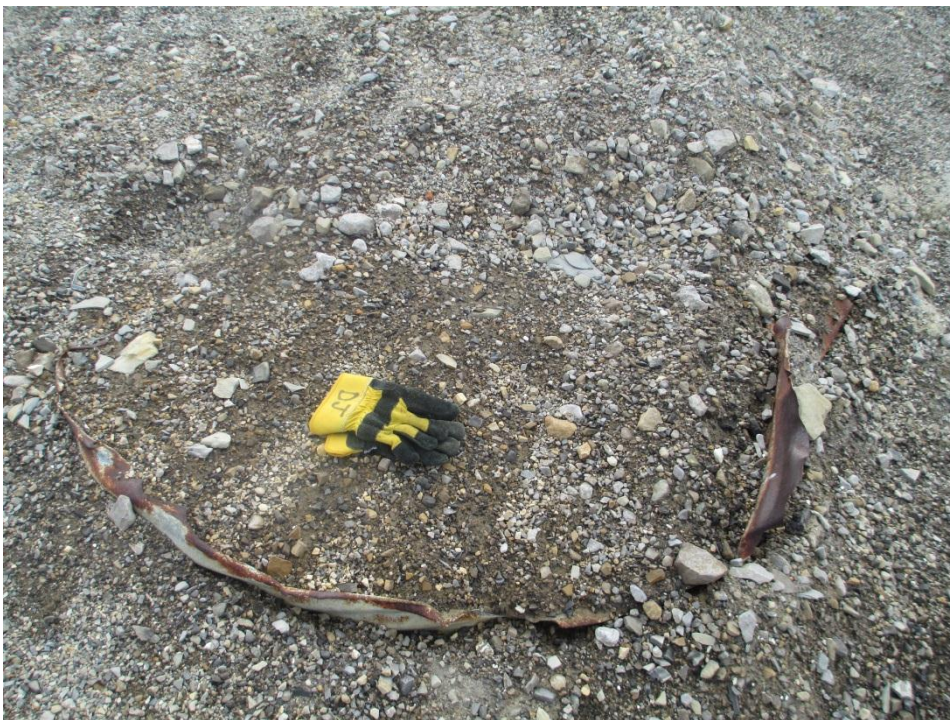
Photo 80, Subsidence Area, Vent/Backfill Raise (WP#67)
