October 9, 2014

# Post-Reclamation Geotechnical Inspection

## FORMER POLARIS MINE, NUNAVUT

**Report Number:** 1408454

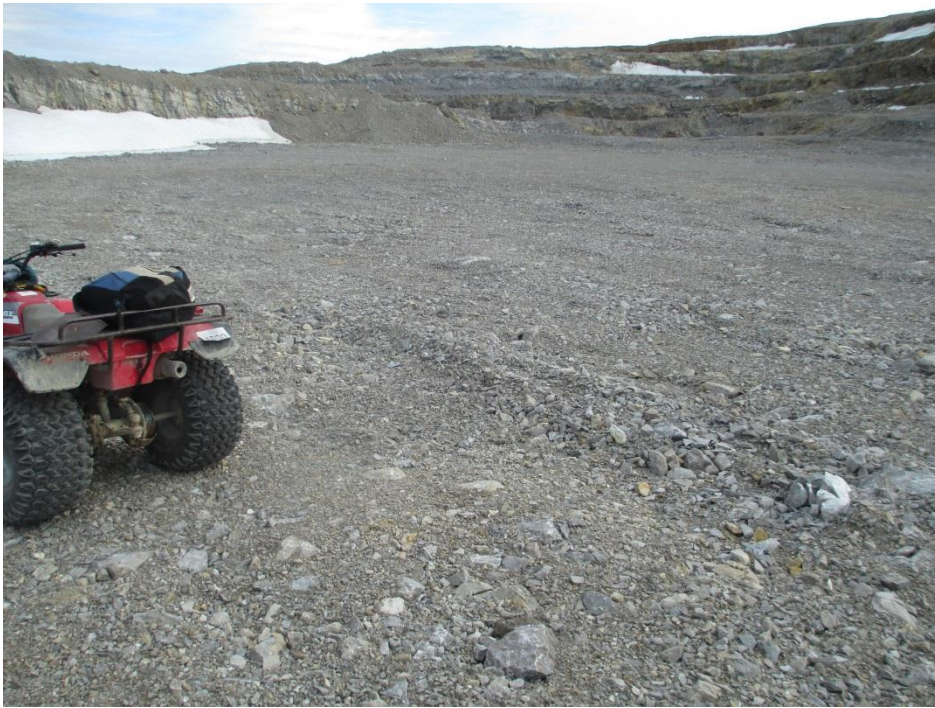
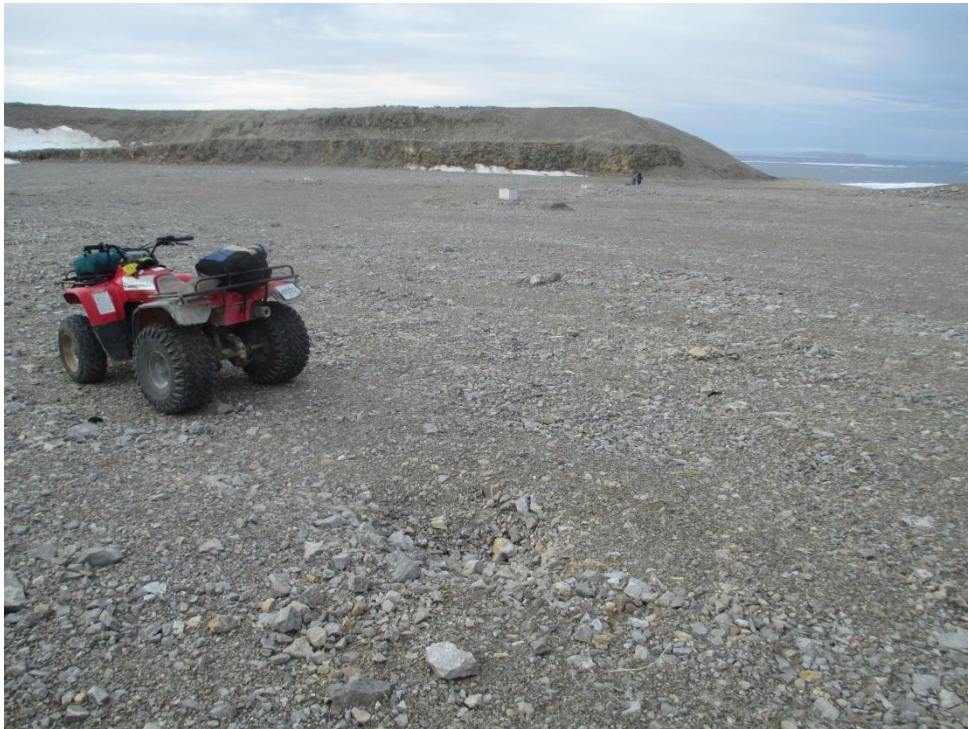
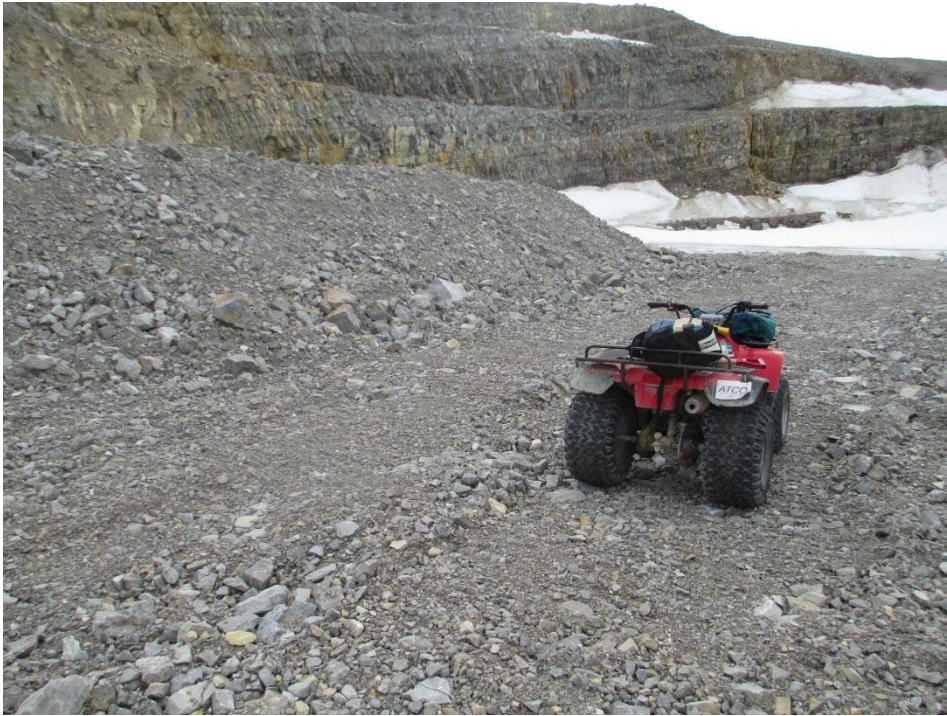
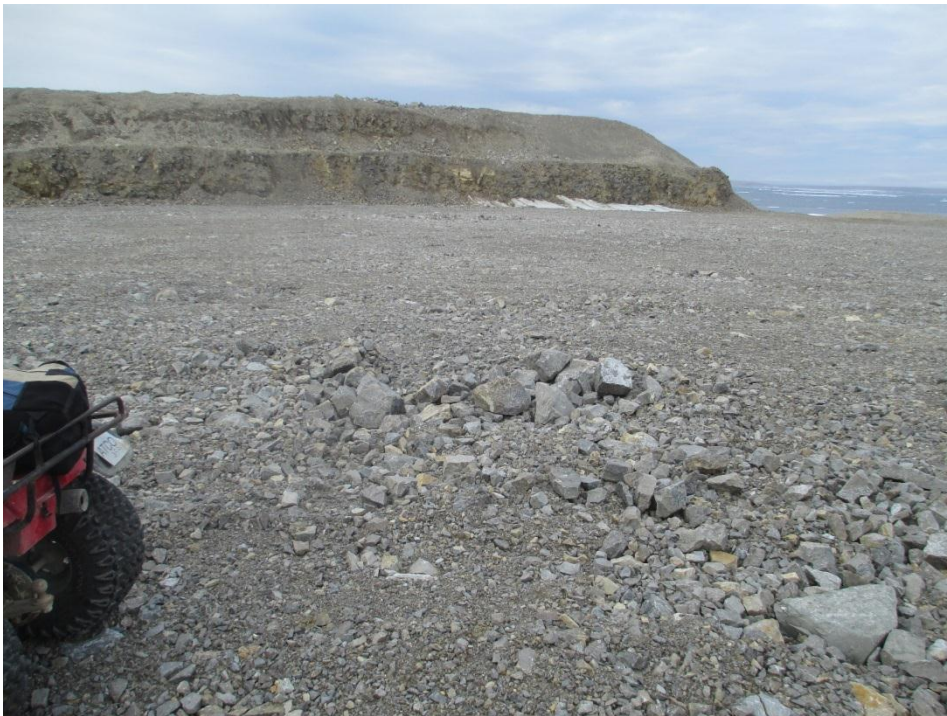
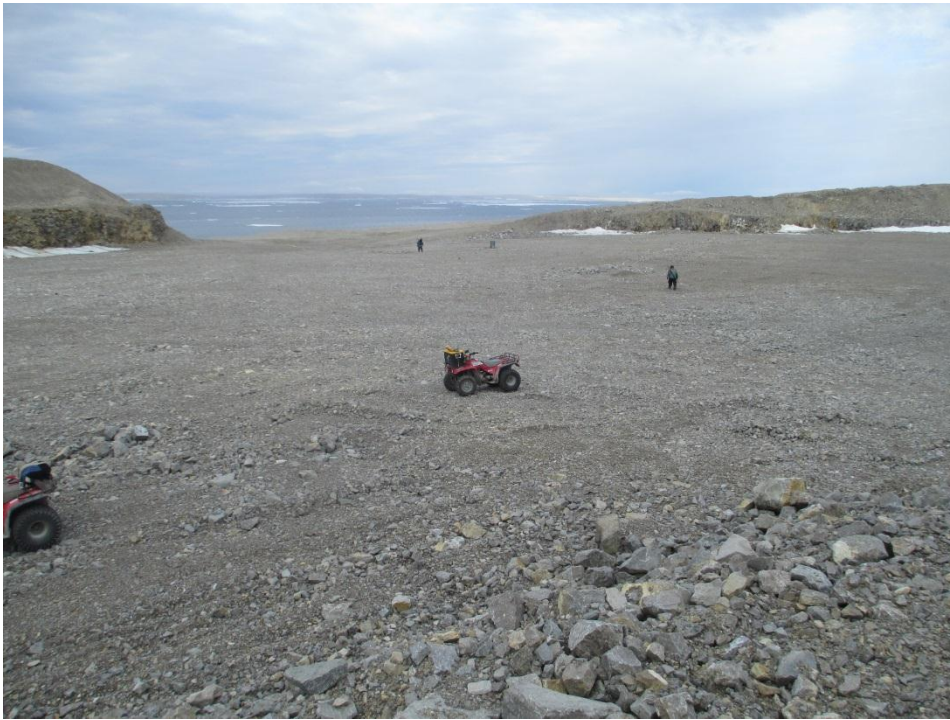
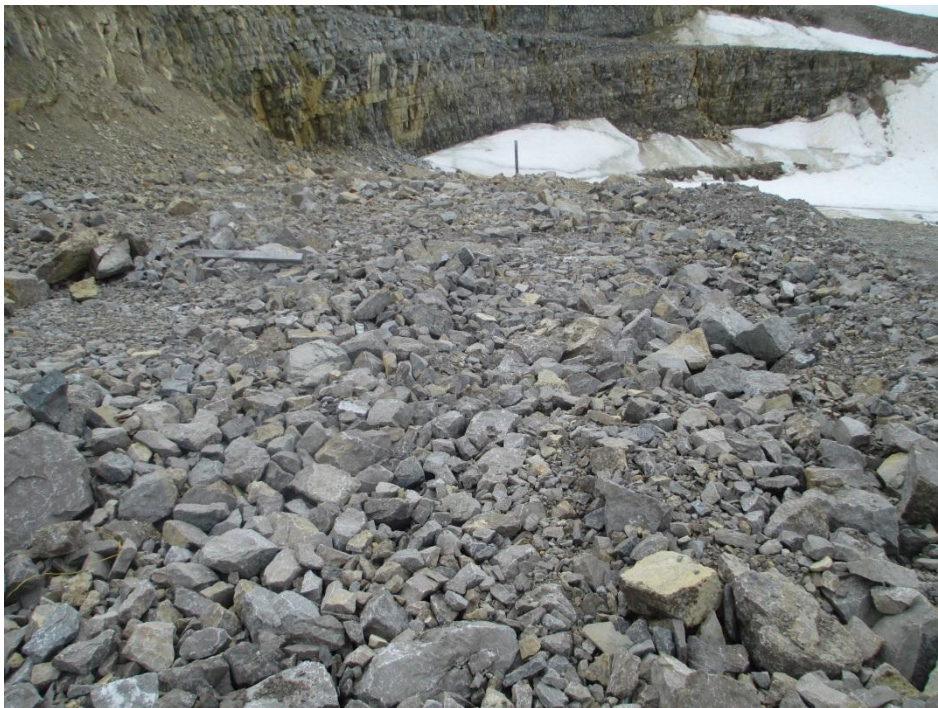
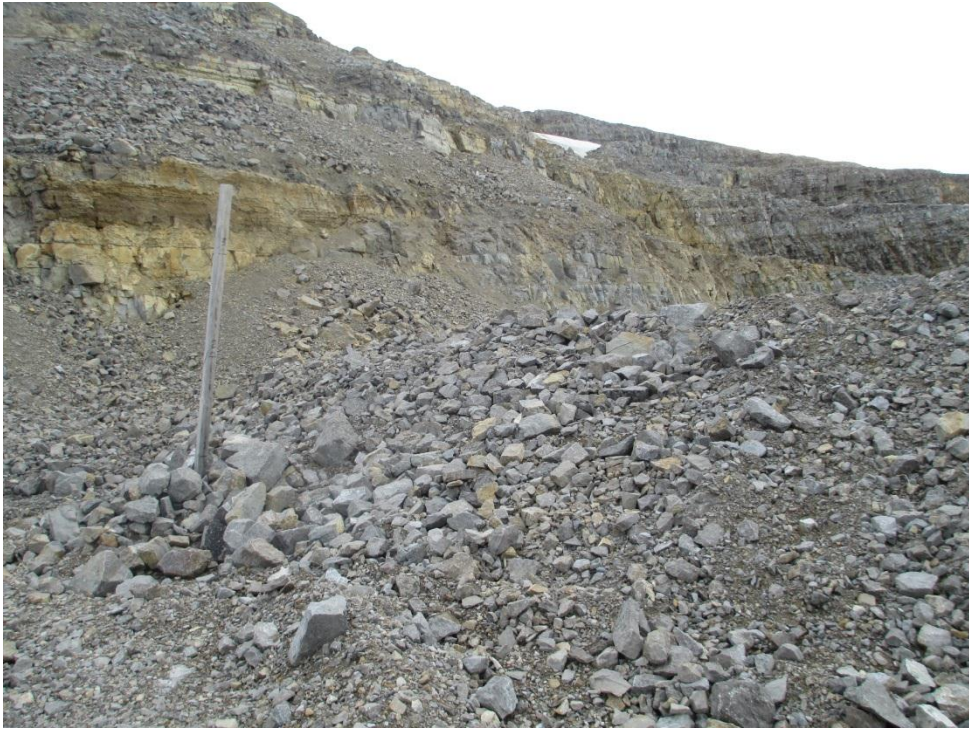
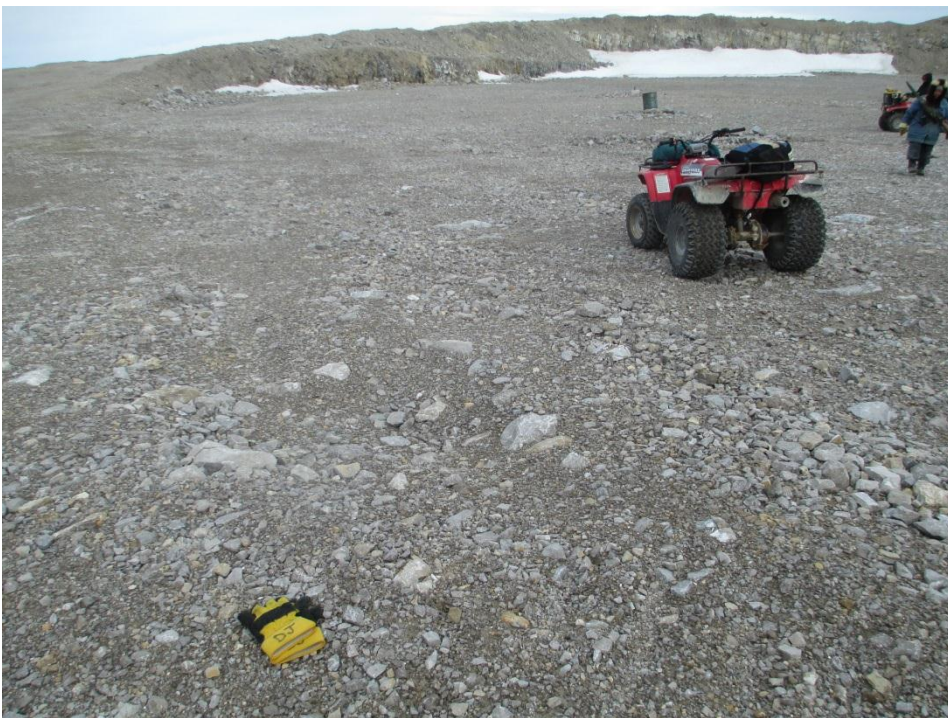
No protruding waste, tension cracks or settlement depressions were observed on the Little Red Dog Quarry Landfill cover during the September 2014 inspection. Photographs 81 through 88 document the condition of the Little Red Dog Quarry Landfill cover during the September 2014 inspection.

No protruding waste, erosion, slope instability or significant settlement was observed at either the Operational Landfill or the Little Red Dog Quarry Landfill during the September 2014 inspection. The batteries in the landfill thermistor dataloggers had not been changed since 2011 and therefore were not downloaded during the September 2014 inspection. Ground temperature data measured from 2006 through 2011 at the Little Red Dog Quarry Landfill and Operational Landfill previously indicated that permafrost had extended up through the waste into the overlying rockfill cover effectively encapsulating waste materials as designed. Observed conditions at the two landfills do not present a safety risk to either humans or wildlife.

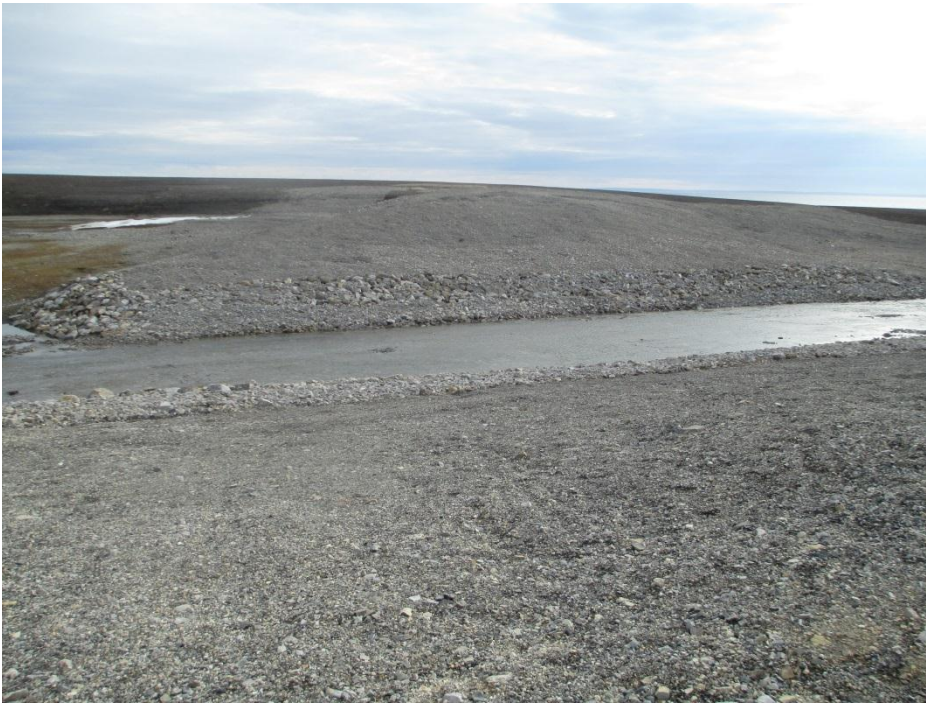
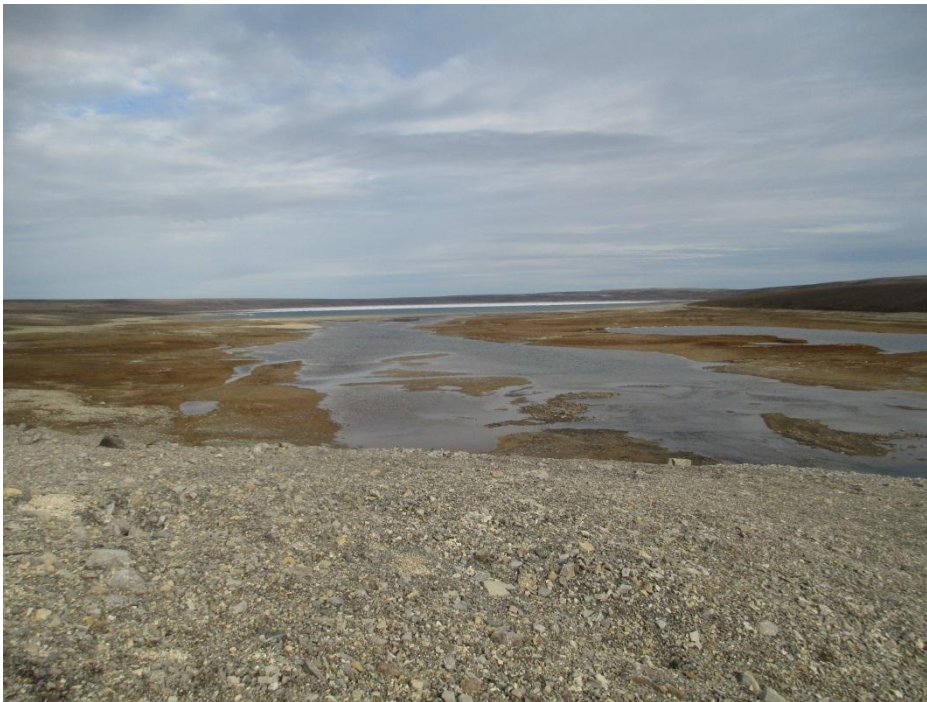
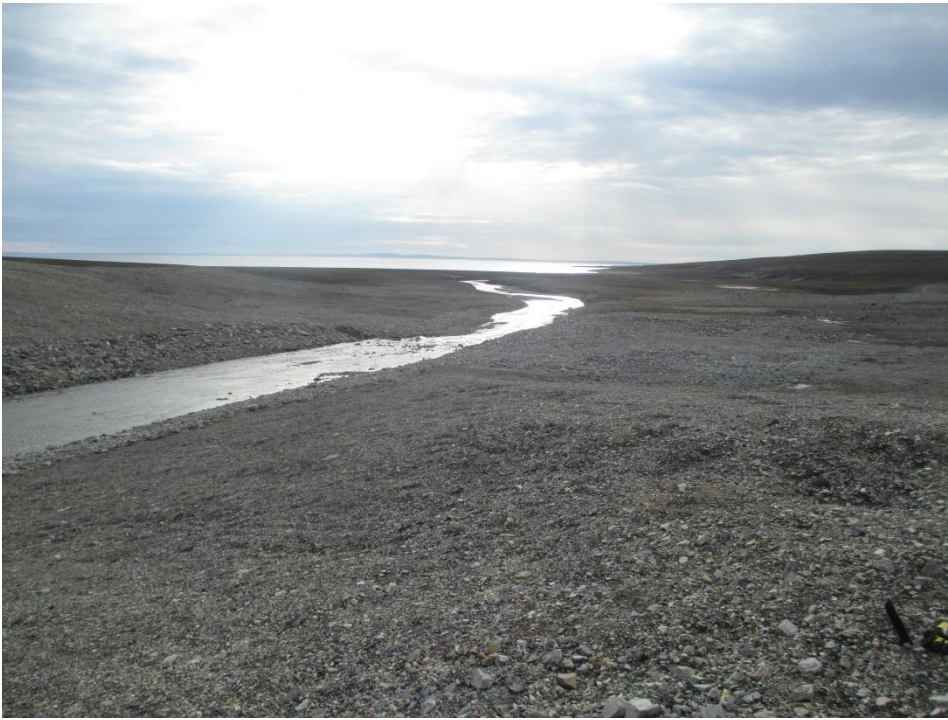
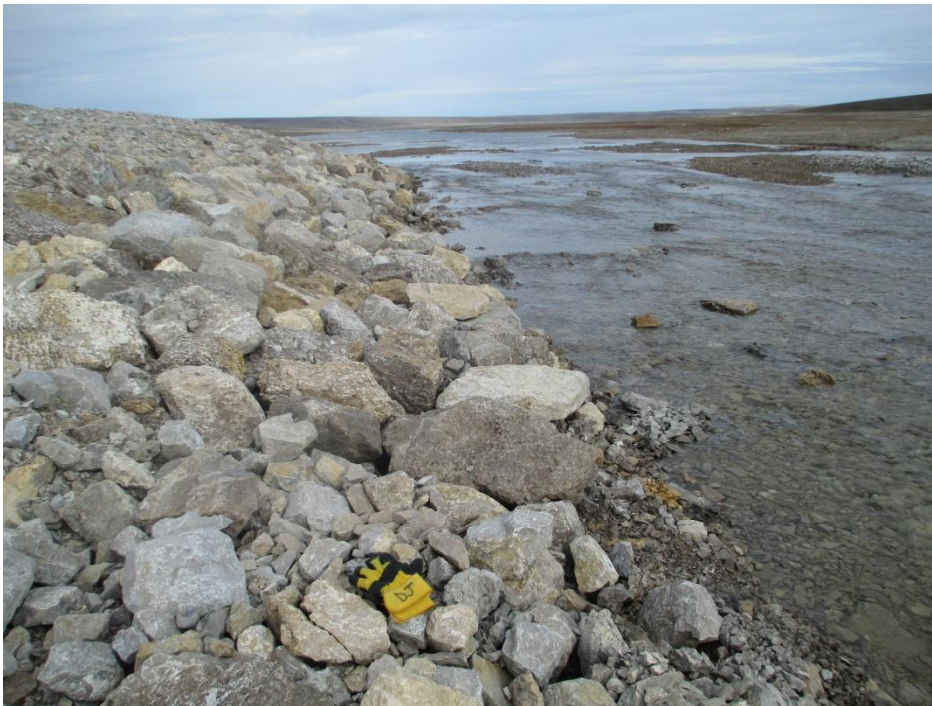
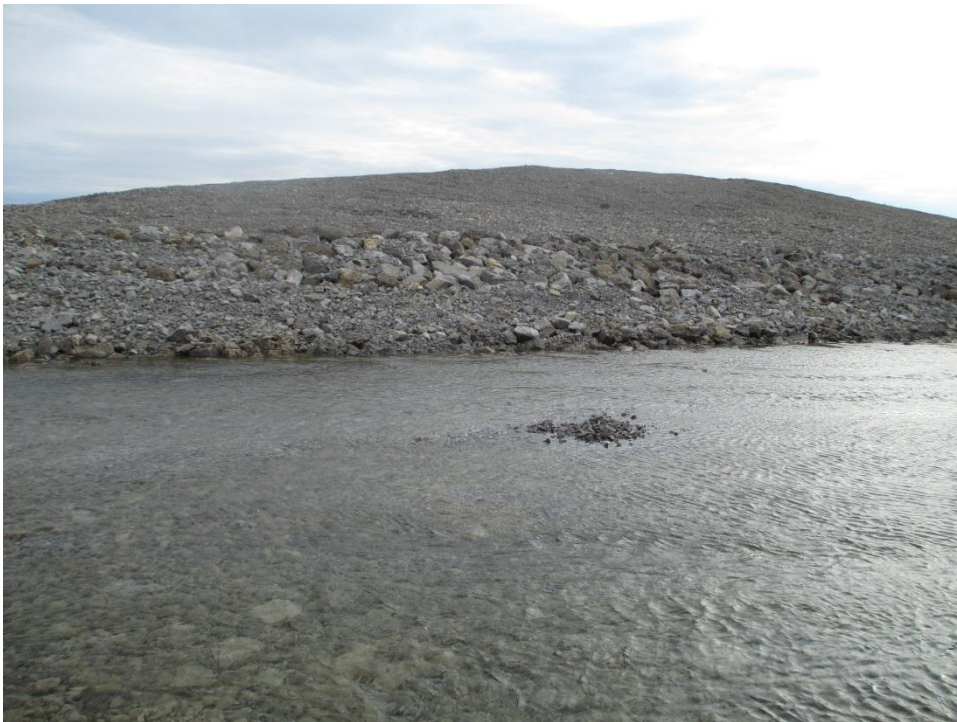
Photographs 89 through 94 illustrate the condition of the breached Garrow Lake Dam and creek channel. Minor thaw settlement on the dam breach slopes appear to be unchanged during post-reclamation geotechnical inspections. Rip-rap at the base of the breach slopes appears to be in good condition and is effectively protecting the breach slopes from channel erosion.

The breached Garrow Lake Dam and creek channel were unchanged from previous post-reclamation geotechnical inspections. Rip-rap at the base of the breach slopes appears to be in good condition and is effectively protecting the breach slopes from channel erosion. Observed conditions at the breached dam and creek channel do not present a safety risk to either humans or wildlife.

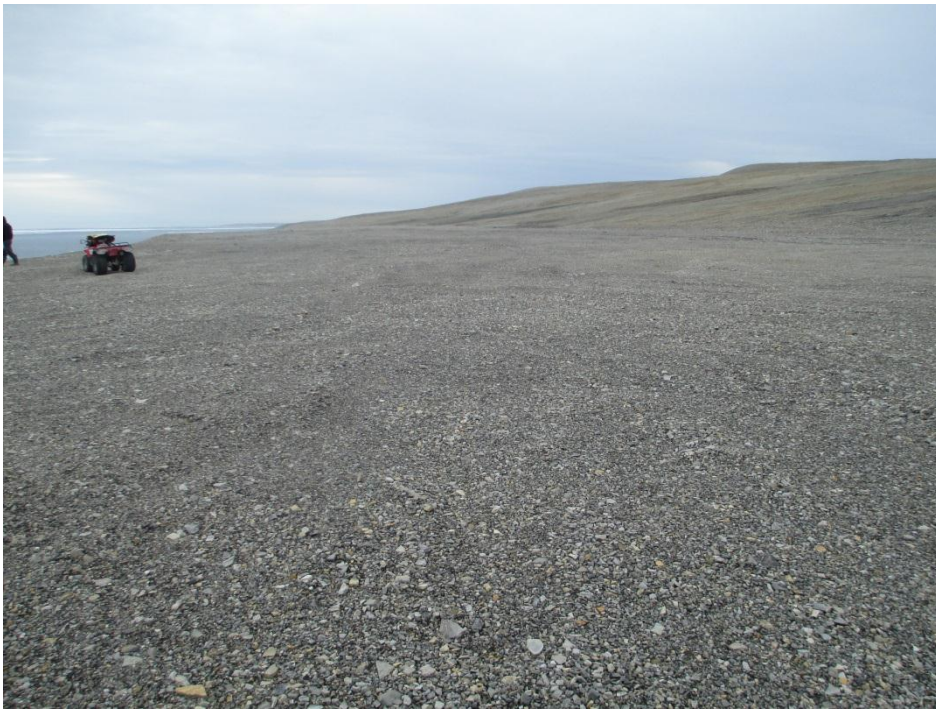
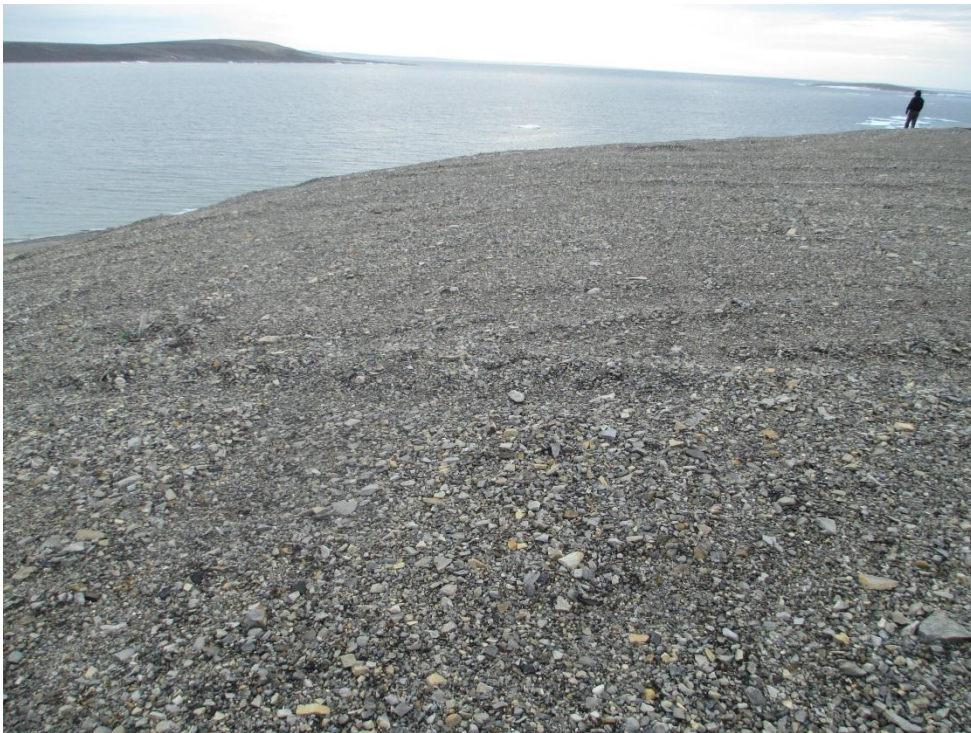
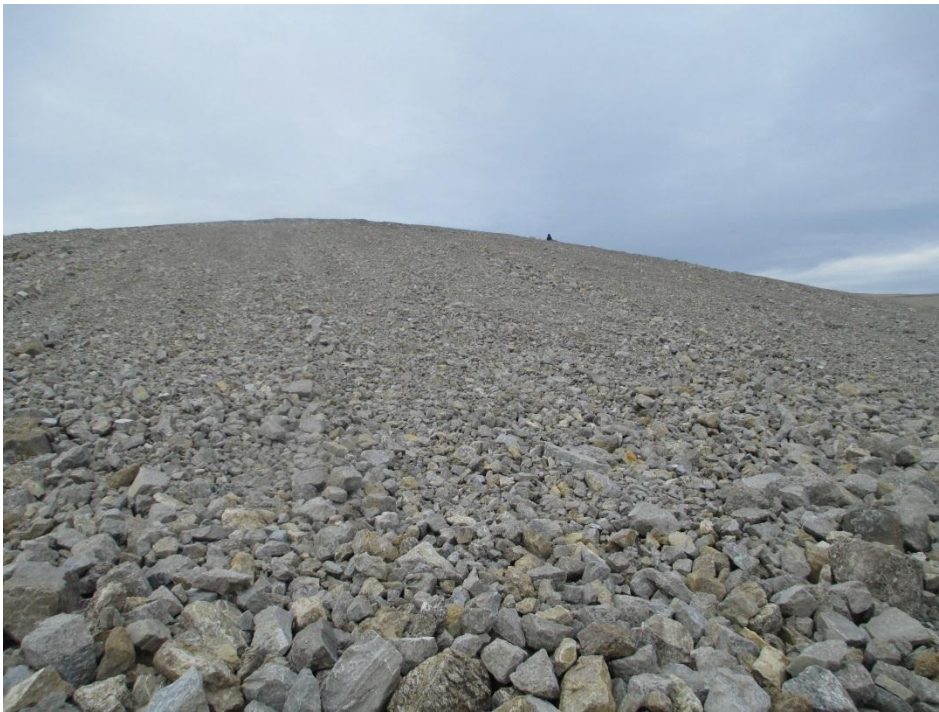
Photographs 95 through 108 illustrate conditions observed at the Operational Landfill during the September 2014 inspection. No indications of slope instability or exposed waste were observed. No tension cracks or settlement depressions were observed on the landfill crest. No indications of erosion or slope instability were observed on the landfill slopes.

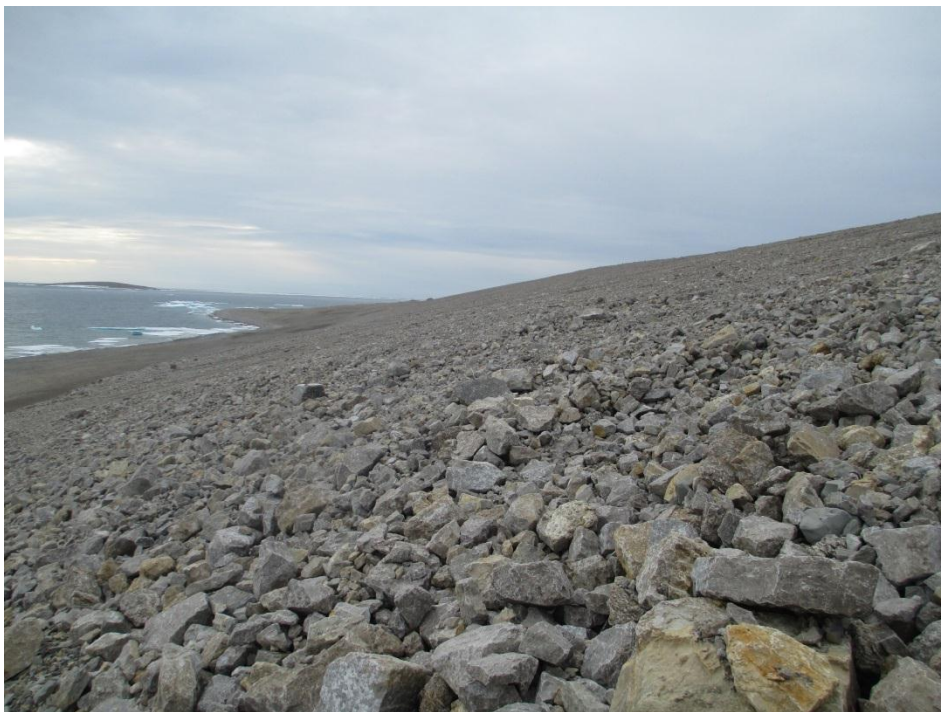
Photo 98, Operational Landfill, facing across slope at North end (WP#74)

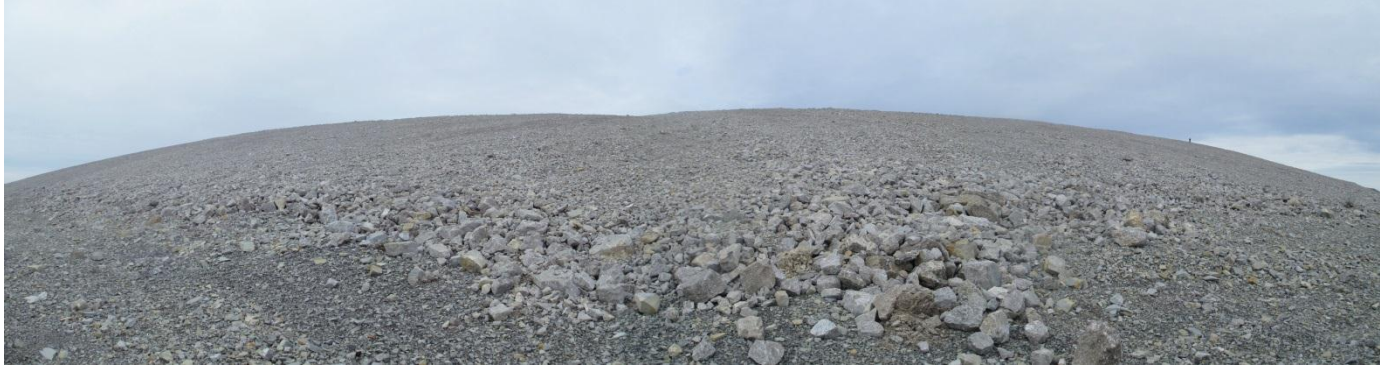
Photo 99, Operational Landfill, Panorama from toe of slope (WP#75)

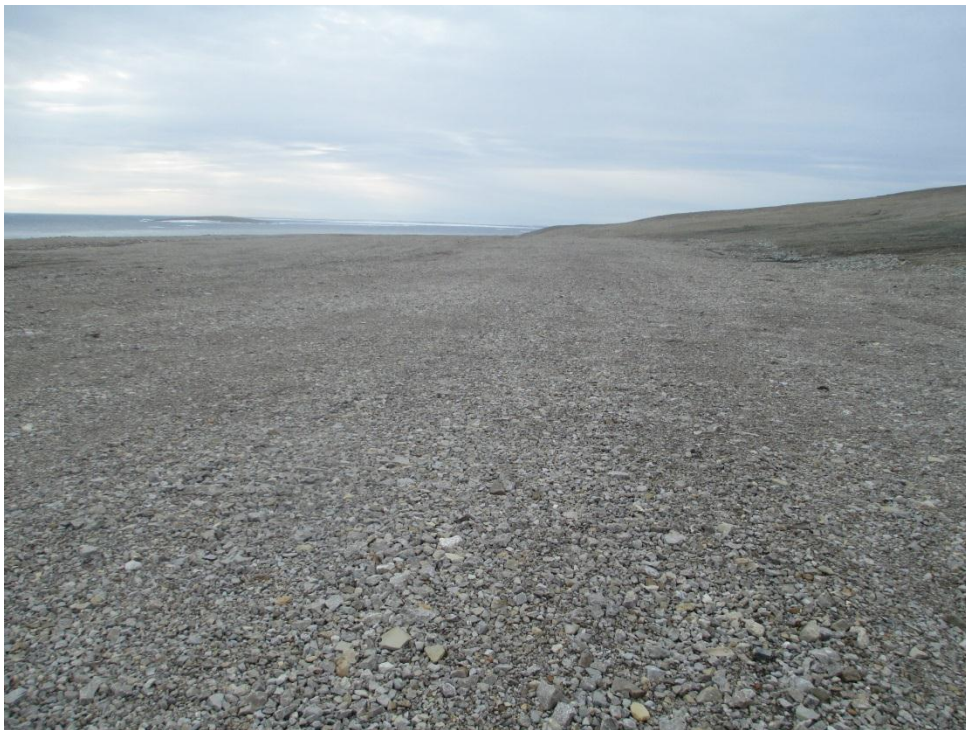
Photo 100, Operational Landfill, Back of central crest (WP#76)

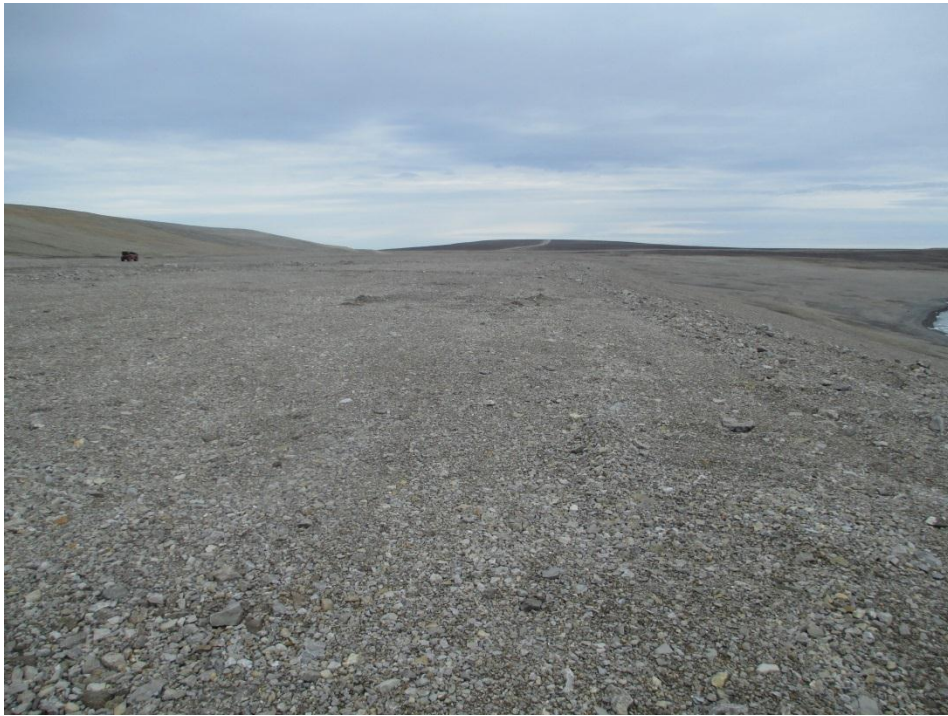
Photo 101, Operational Landfill, South central crest facing North (WP#77)

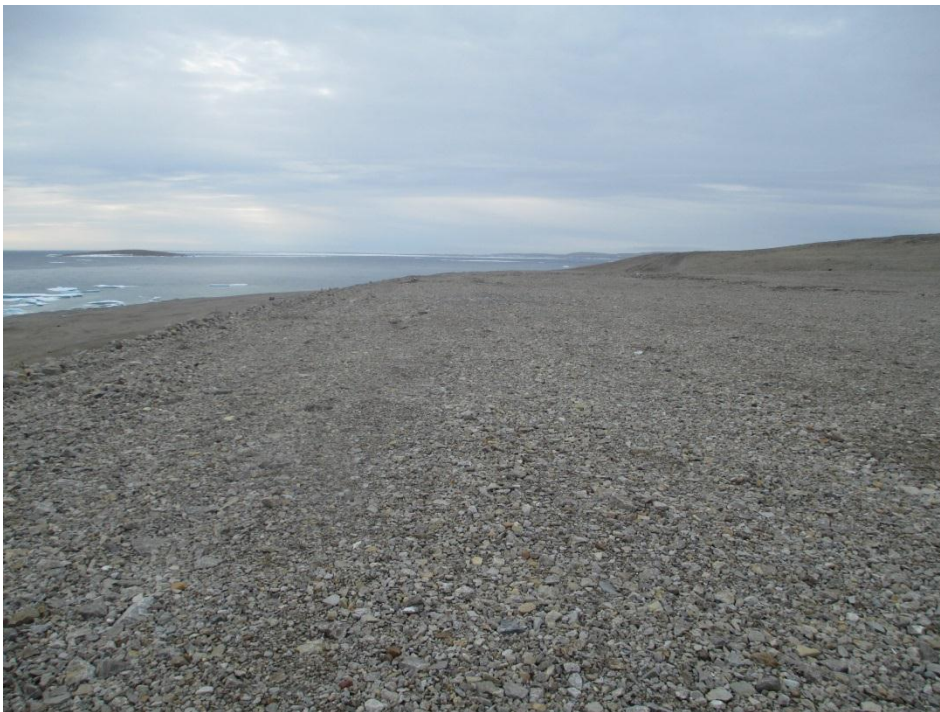
Photo 102, Operational Landfill, South central crest facing South (WP#77)

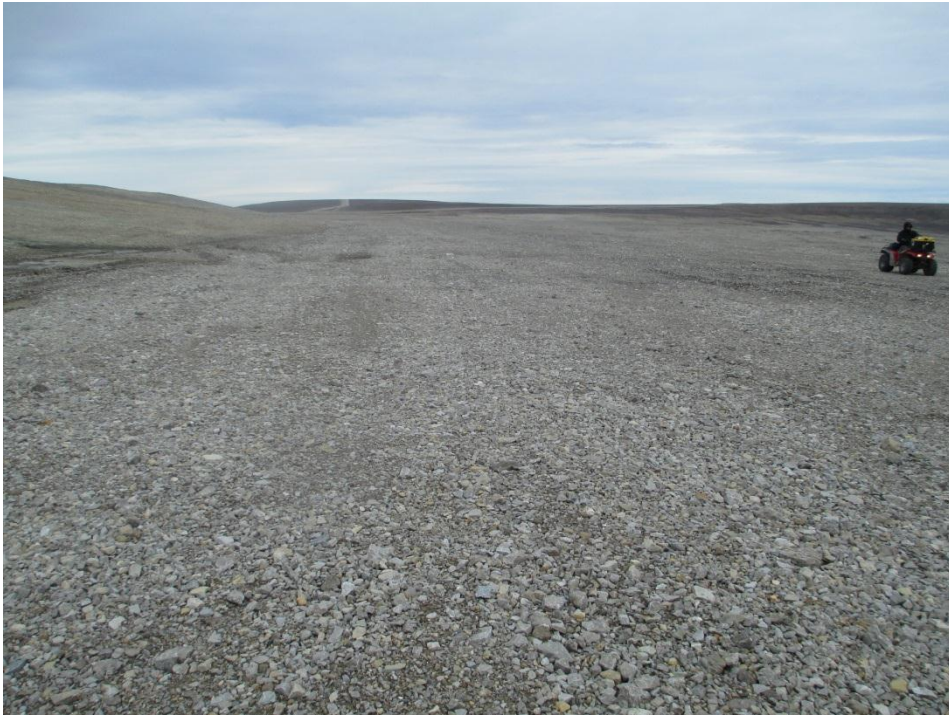
Photo 103, Operational Landfill, Back of crest at South end (WP#78)

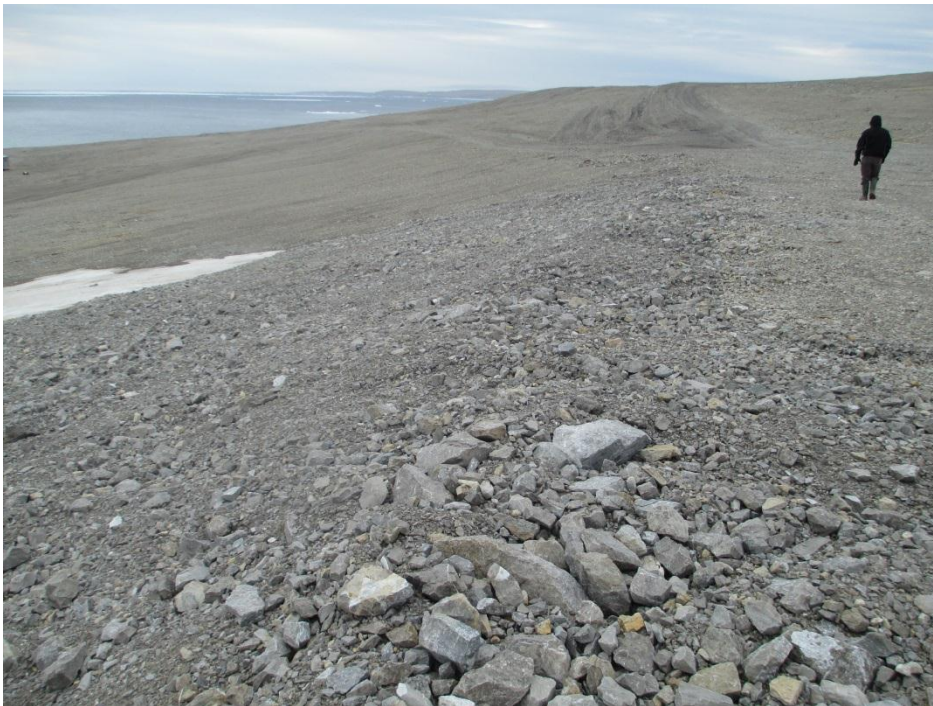
Photo 104, Operational Landfill, crest edge at South end (WP#78)

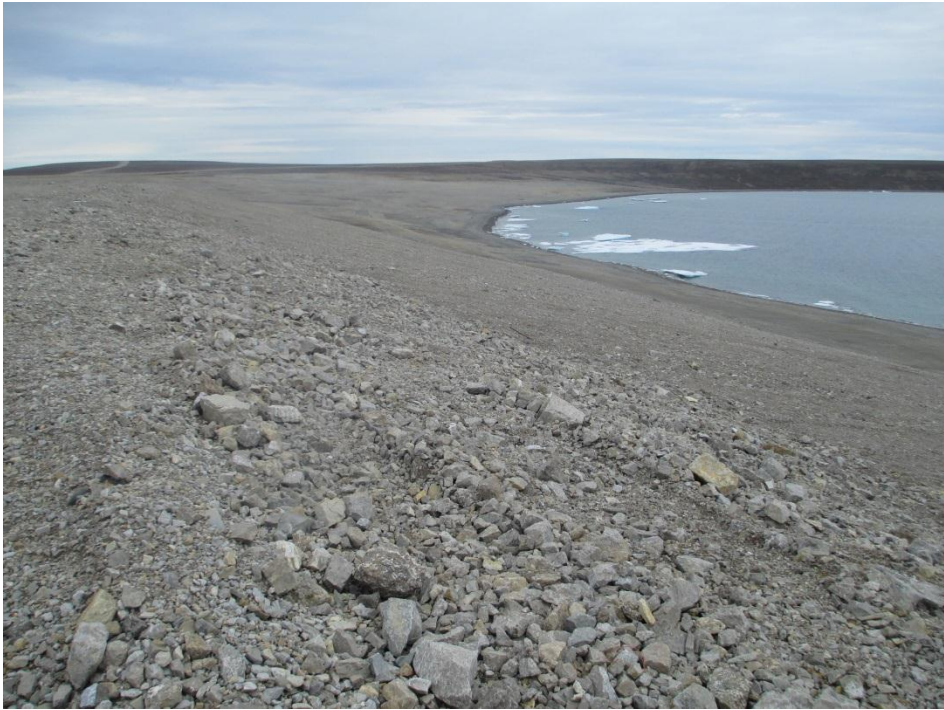
Photo 105, Operational Landfill, South end facing down slope (WP#78)

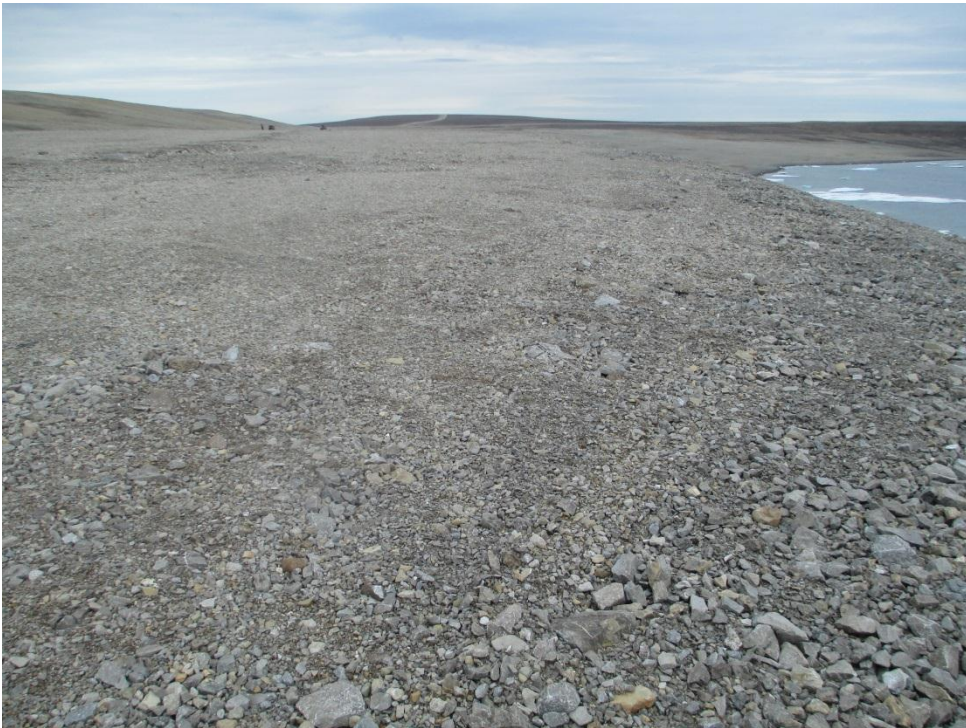
Photo 106, Operational Landfill, South end slope (WP#79)

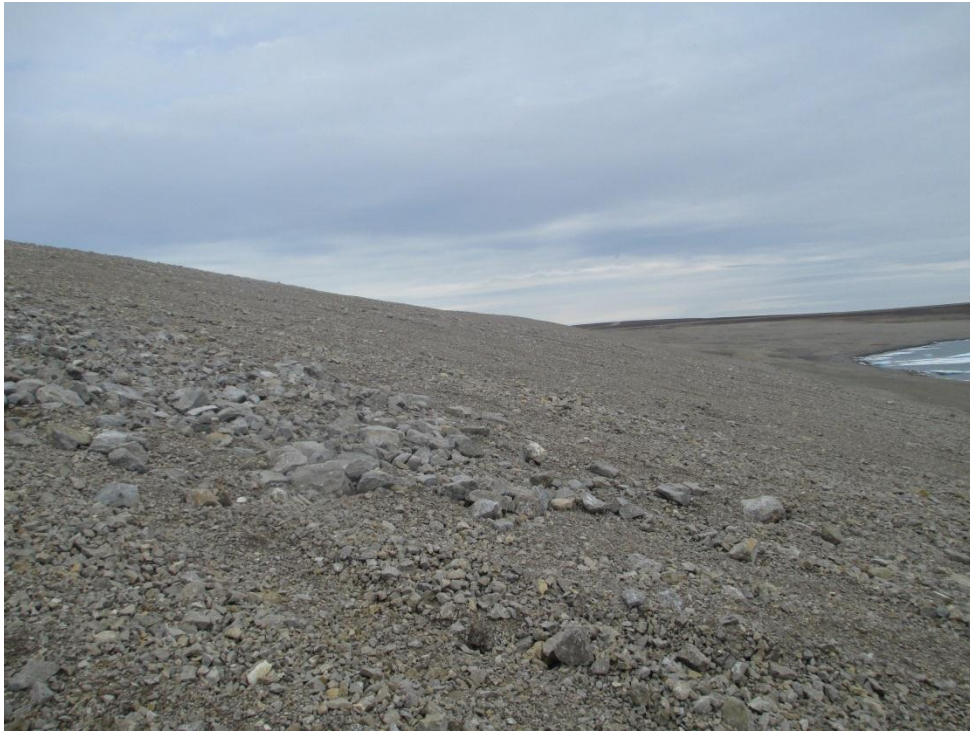
Photo 107, Operational Landfill, slope from toe at South end (WP#79)

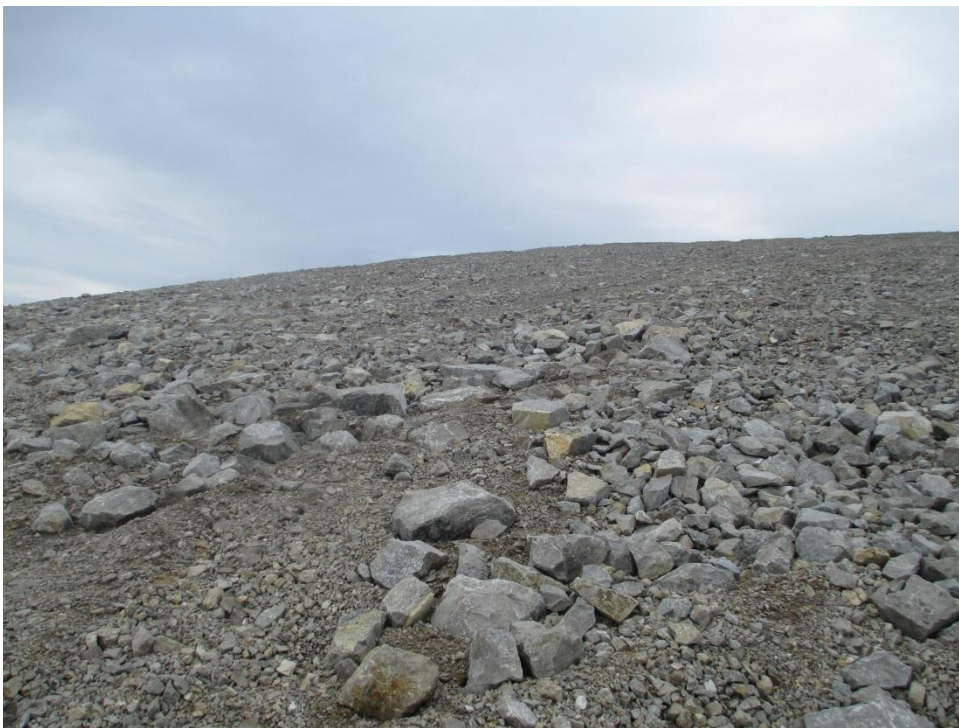
Photo 108, Operational Landfill, slope from toe at South end (WP#79)

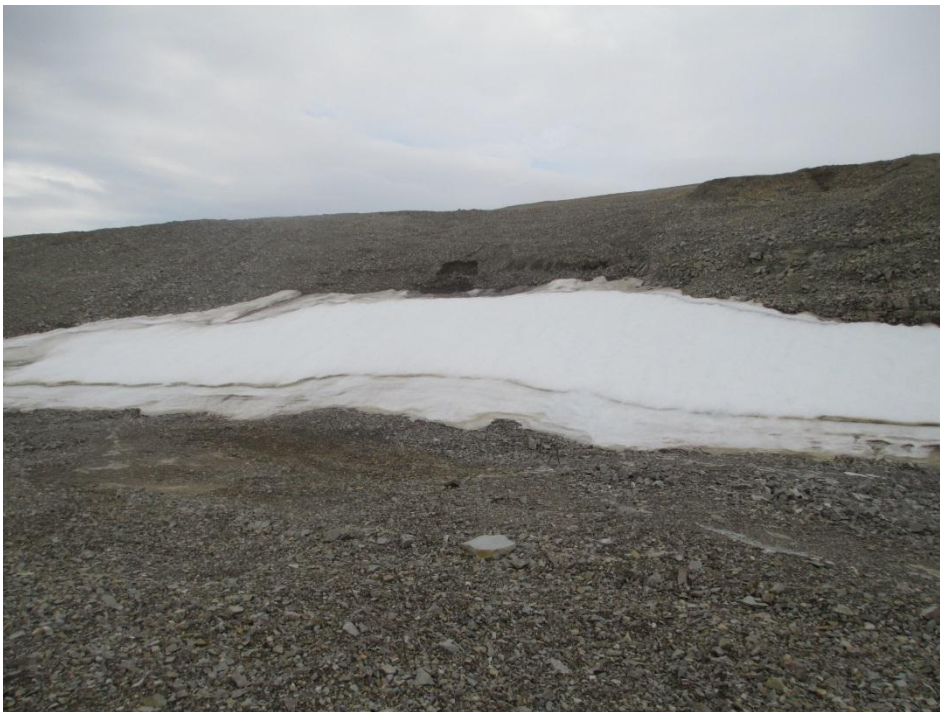
The Conveyor Portal slope was observed to be in good condition during the September 2014 inspection (see Photograph 111). Most of the backfilled slope in front of the Main Portal was snow covered during the September 2014 inspection (see Photograph 112). The slope in front of the Main Portal had been regraded and flattened in 2009 to repair a slope failure. Photograph 113 is a close-up of some new minor slumping above the Main Portal slope.

Photo 112, Main Portal, snow covered slope (WP#82)

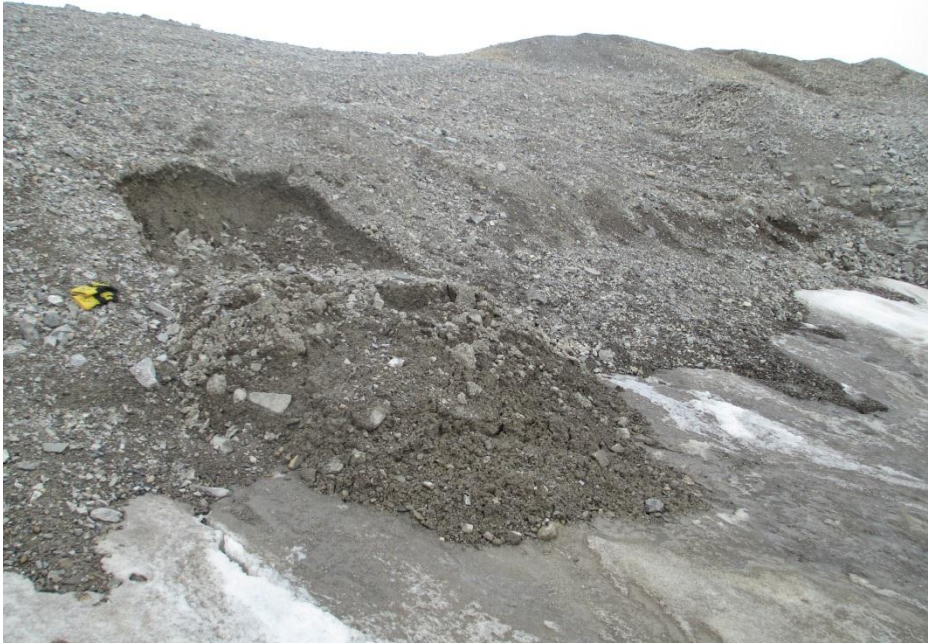
Photo 113, Main Portal, minor slumping of slope above portal (WP#82)

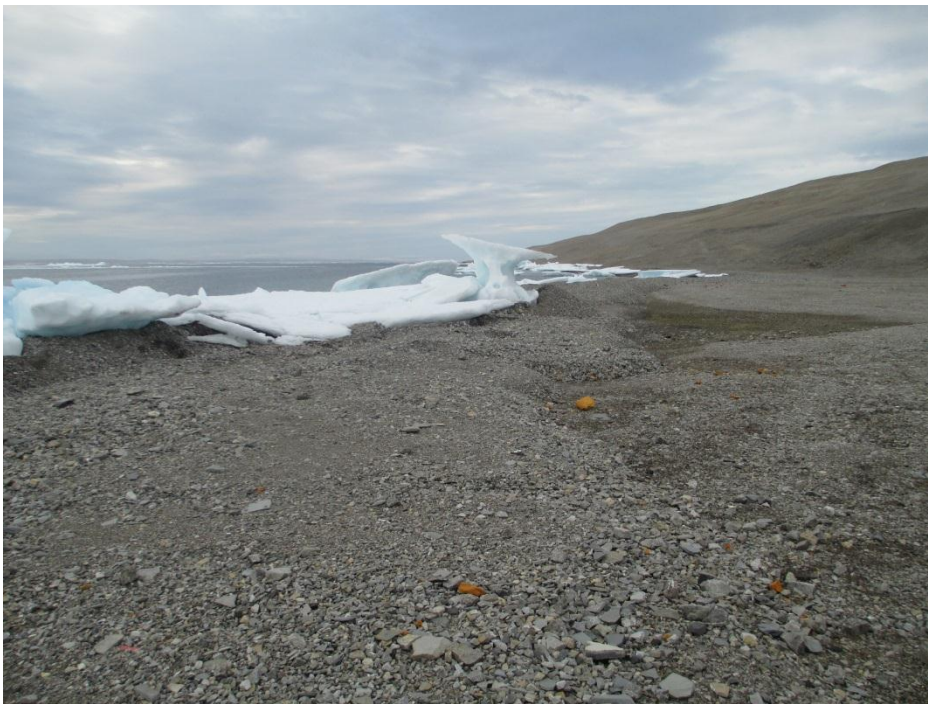
Photo 114, Marine Foreshore, gravel berm deposition from waves and ice (WP#83)
