INDIAN AND NORTHERN AFFAIRS CANADA

POLARIS MINE ABANDONMENT AND RECLAMATION

AUGUST 24, 2008 SITE VISIT AND INSPECTION

PROJECT NO.: 0131-013-06
DATE: NOVEMBER 6, 2008

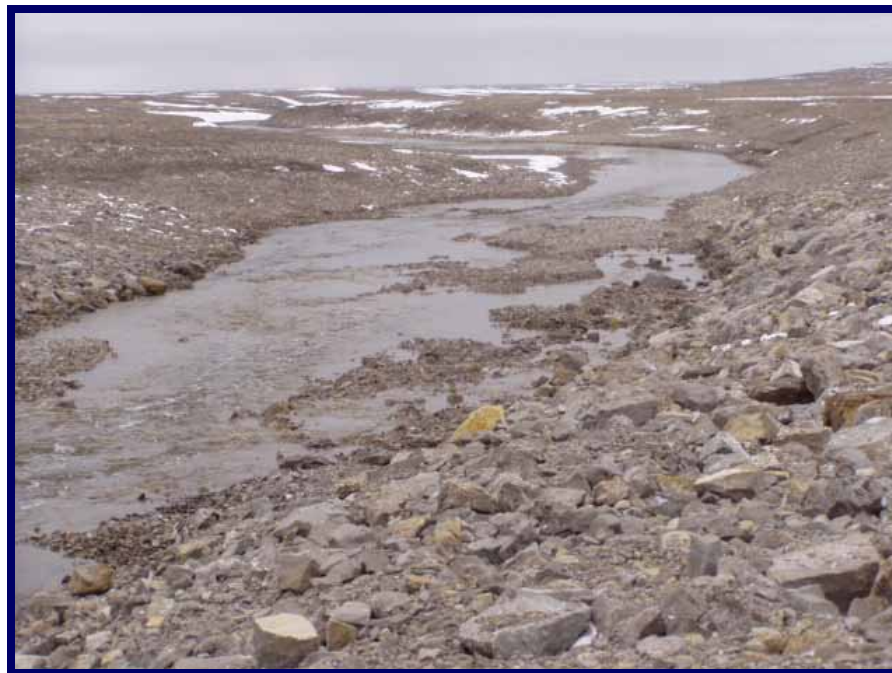
Photo 34: Garrow Creek downstream of dam, looking downstream. Note riprap on channel sides extends across top of bank on right, as shown in next photo.

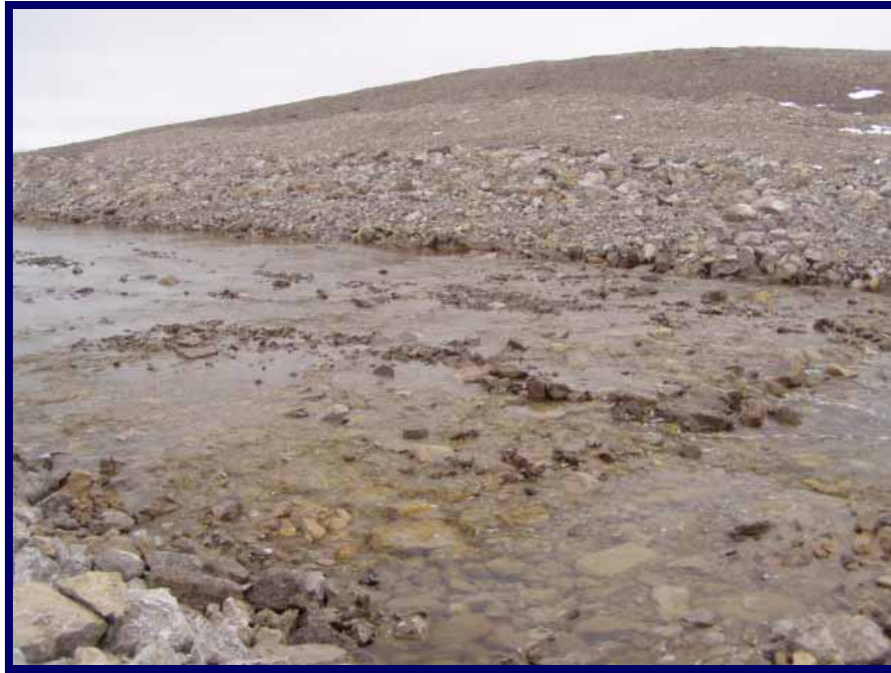
Photo 36: Looking across channel carrying Garrow Creek flow towards left bank side of dam breach.

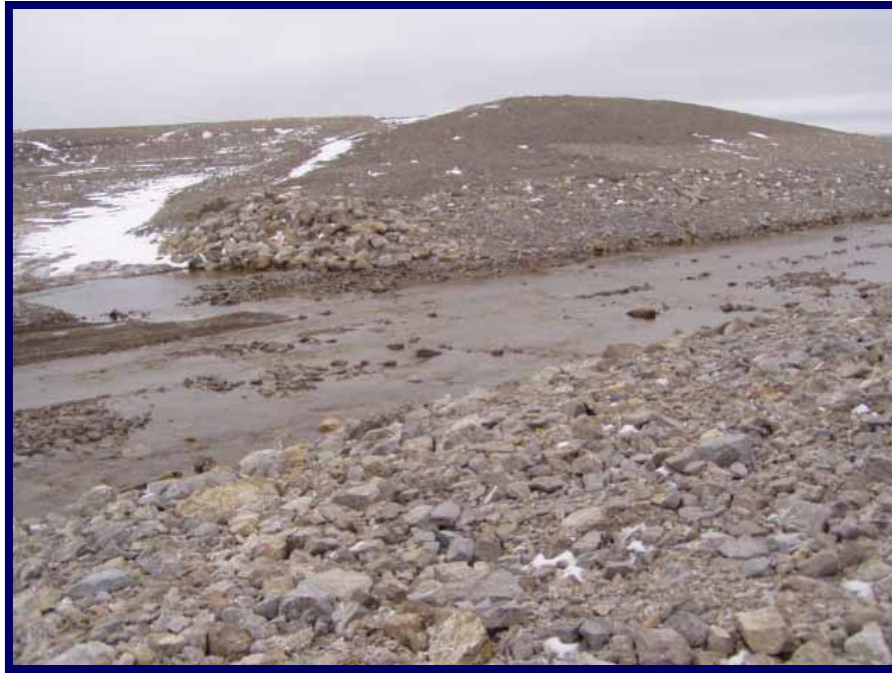
Photo 38: View across breached dam to left bank side, along upstream slope of dam.

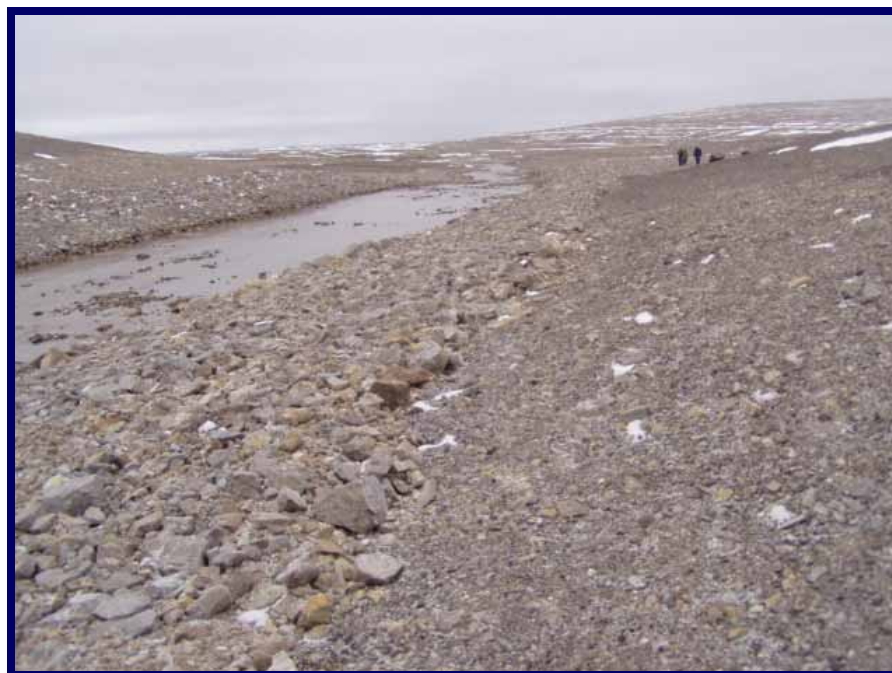
Photo 39: Looking downstream along right bank of Garrow Creek through breach in dam.

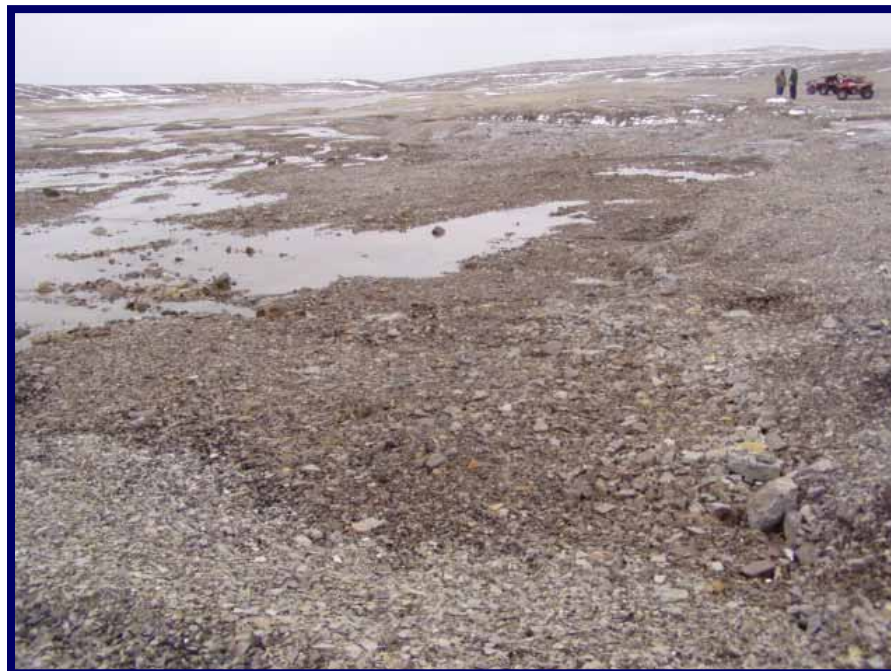
Photo Photo 42: Looking downstream from location of previous photo. Garrow Lake Dam is in distant background. Water is entirely from seepage through the natural berm or under seepage through the pervious former lakebed gravels. Surface disturbance of gravels is due to previous episode of flow when natural berm was breached by overtopping. Berm has since re-healed itself.

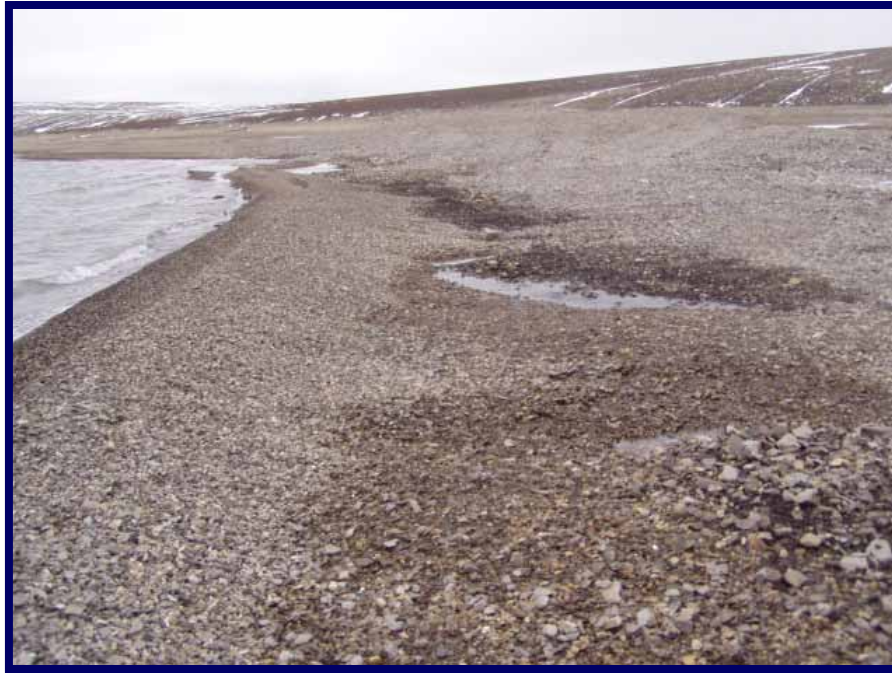
Photo 43: Looking east along downstream side of natural gravel bar across south end of Garrow Lake. Material to right is foundation footprint of former wave break structure. Note seepage exiting along toe of berm. Berm is at maximum height at this point, about 1.2 m (see

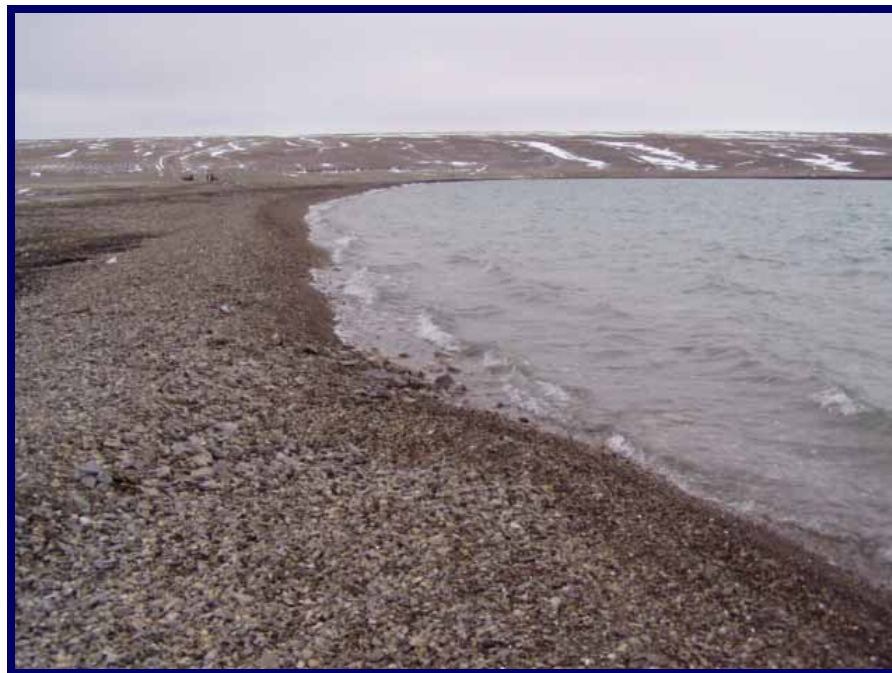
Photo 44: View of natural berm along crest from close to the east abutment side.

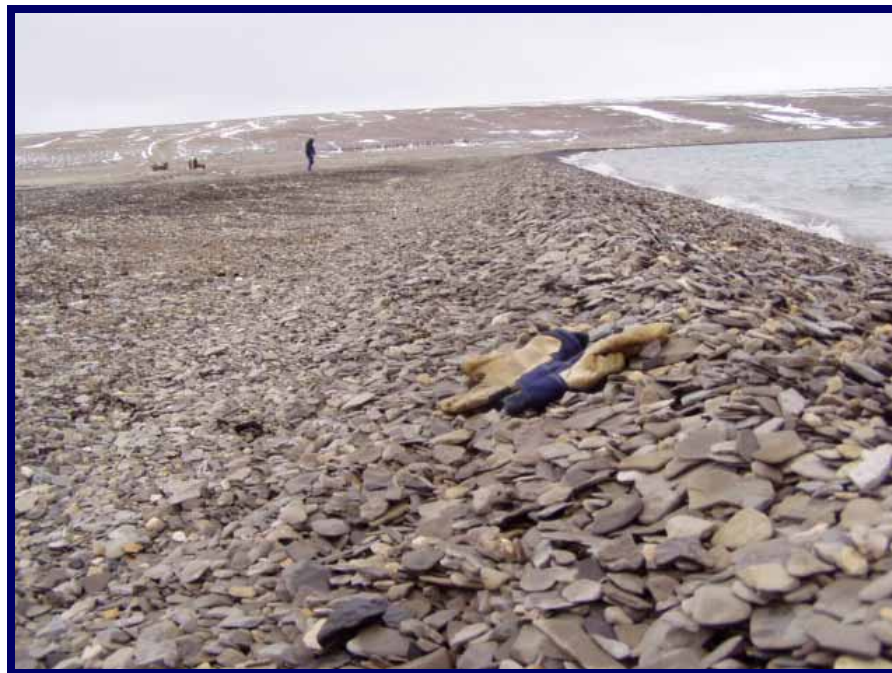
Photo 48: Ground level view of natural berm downstream slope at same location as previous photos (use gloves as reference). Berm is less than 30 cm high at this point.

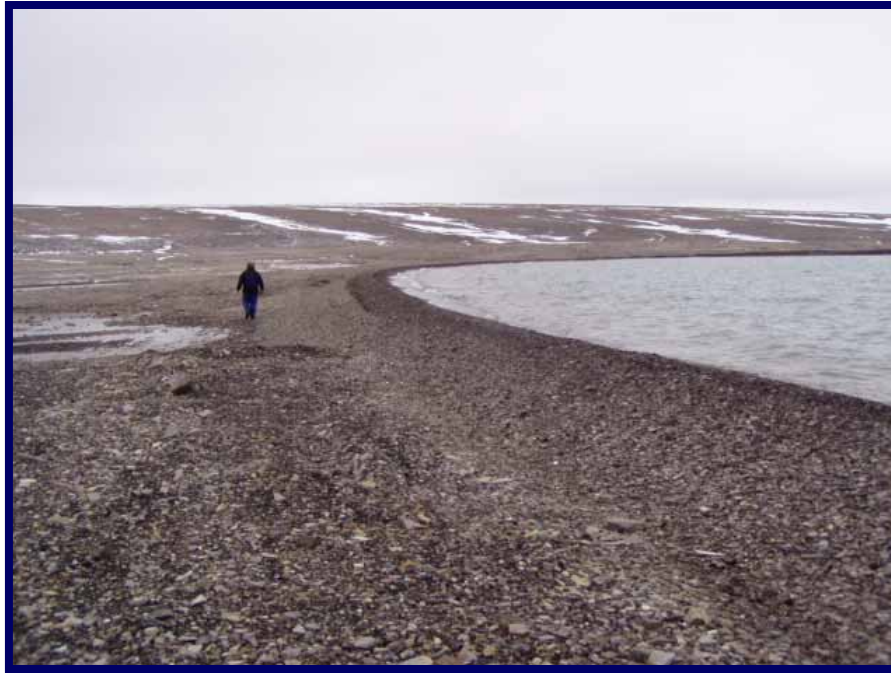
Photo 49: Maximum section of berm near west end, approximately waist height on individual in photo.

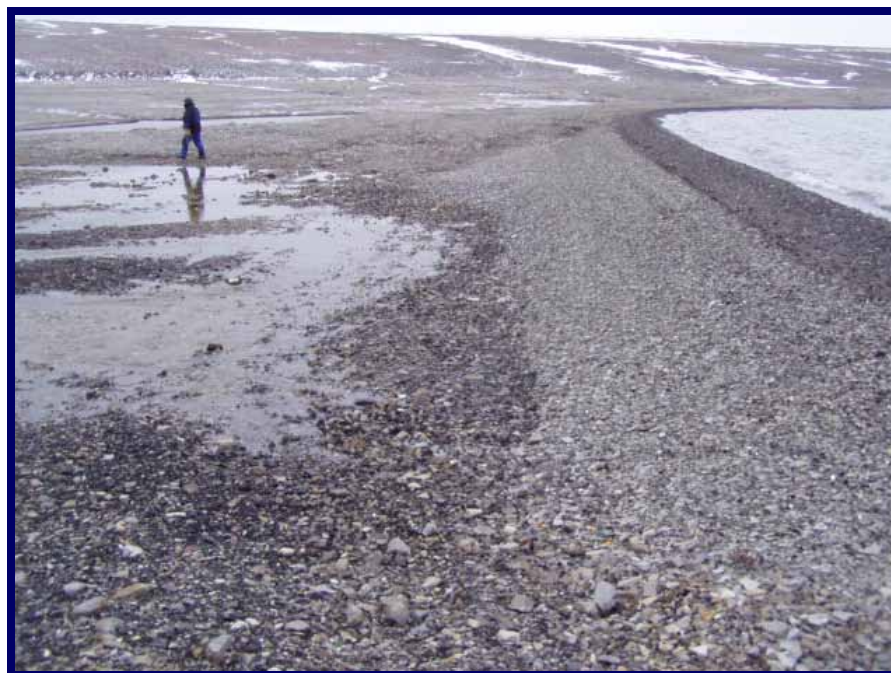
Photo 50: Seepage along downstream toe at point of maximum height.

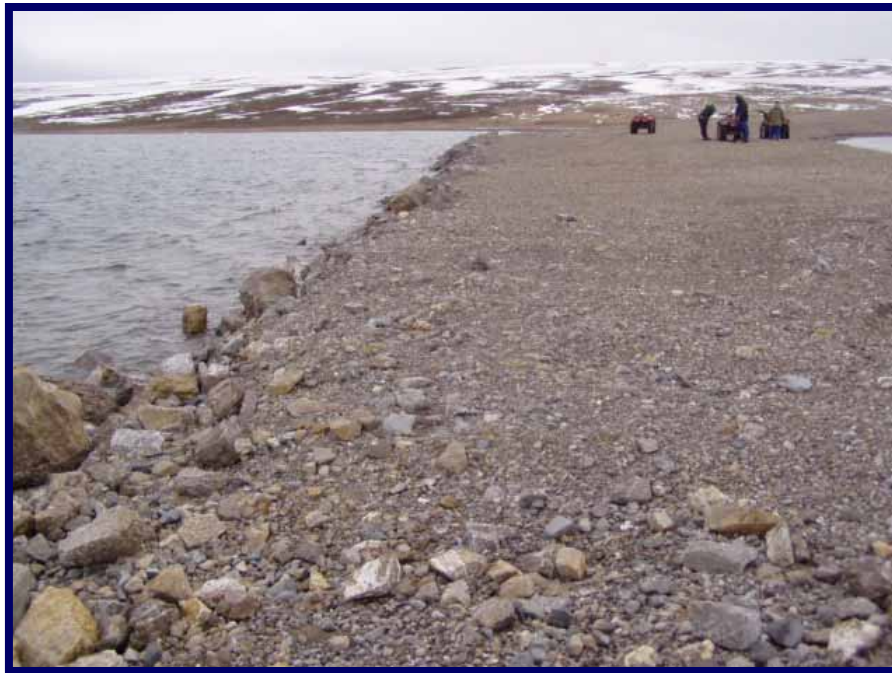
The windward slopes of the causeway have become armoured with larger rock fragments, whereas little or no erosion was noted on the leeward side. Since decommissioning, there has been relatively limited degradation of the causeway. The water surrounding the structure is clear, even with waves acting against the sides.

Photo 51: Wave washed windward (north) side of causeway.

Current water licence requirements call for a water quality sample and inspection of this structure. The original concern was that erosion of the causeway would release excessive amounts of suspended sediment into the water. If this occurred, Teck Cominco was required to take mitigative action. This monitoring requires access down the decommissioned road to the causeway. As noted above, vehicle traffic has diverted around the rougher sections of the water bars onto the adjacent tundra and is beginning to show some minor damage to the ground surface. BGC recommends that this sampling and monitoring requirement be removed as there is no longer a concern about suspended sediment resulting from degradation of this structure.

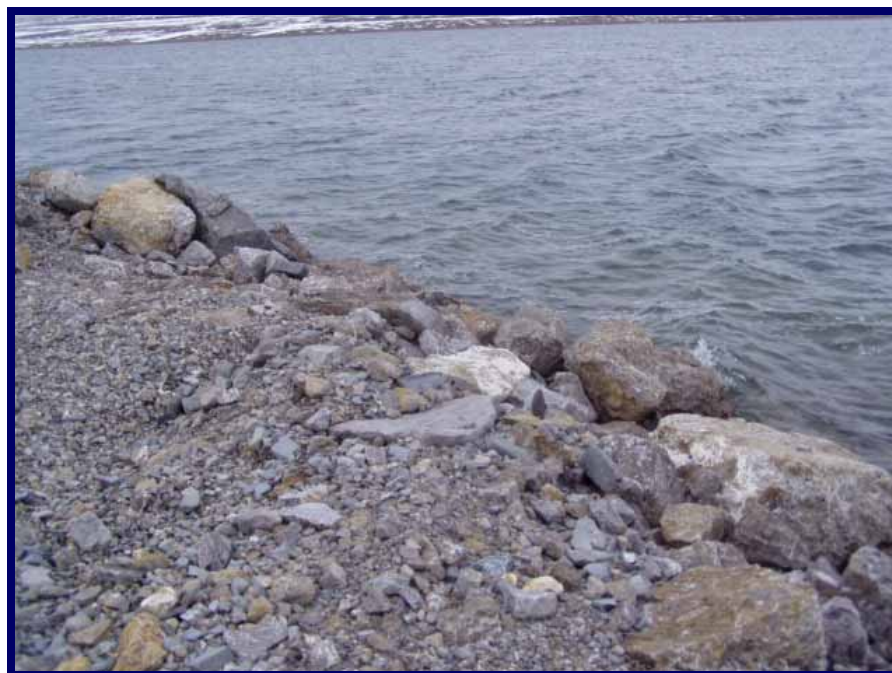
Photo 53: End of causeway, larger riprap still intact.

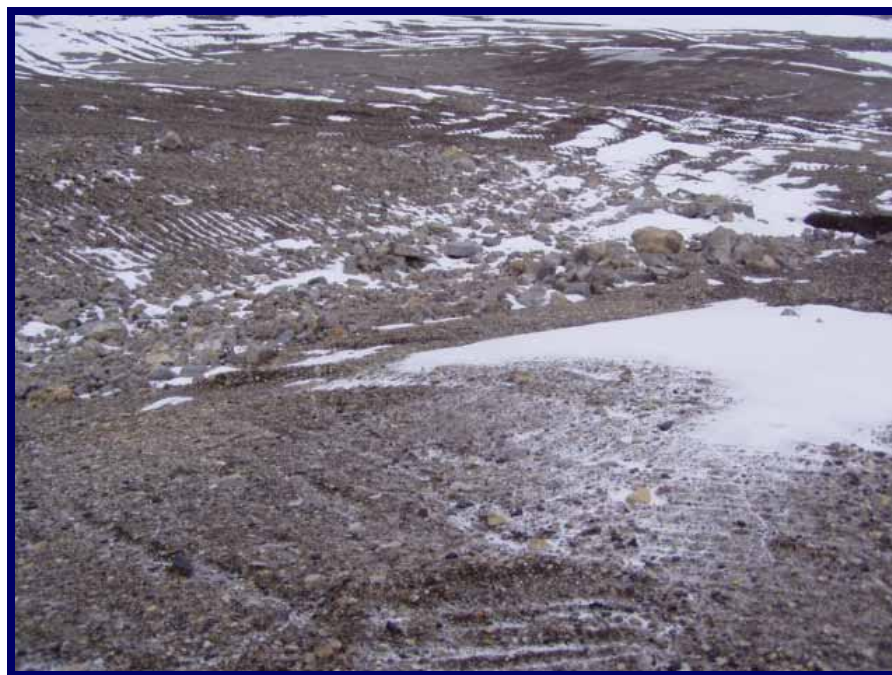
During the 2006 site inspection, BGC noted several erosional gullies that had developed around the perimeter slopes of the New Quarry. Notably, two deep gullies had incised across the fill of the decommissioned haul road along the southwest side of the quarry. These gullies formed as a result of runoff from existing drainage courses further upslope, including the outlet of Loon Lake. Debris fans of material were washed onto the floor of the quarry. In 2006, Teck Cominco completed remedial work on these areas has flattened the gully slopes and armoured the channels with riprap. No water was flowing in either channel at the time of the inspection, however the channel sides appeared to be stabilized and have shown no deterioration over the last 2 years of service.

Photo 57: View of riprap in stream channel along slope on west side of New Quarry.

Further monitoring of these gullies is recommended for the remainder of the licence period. The channels appear to have become stabilized, however minor repairs may be necessary if the flow regime in the drainage course is increased by an intense rainfall event or rapid snowmelt.

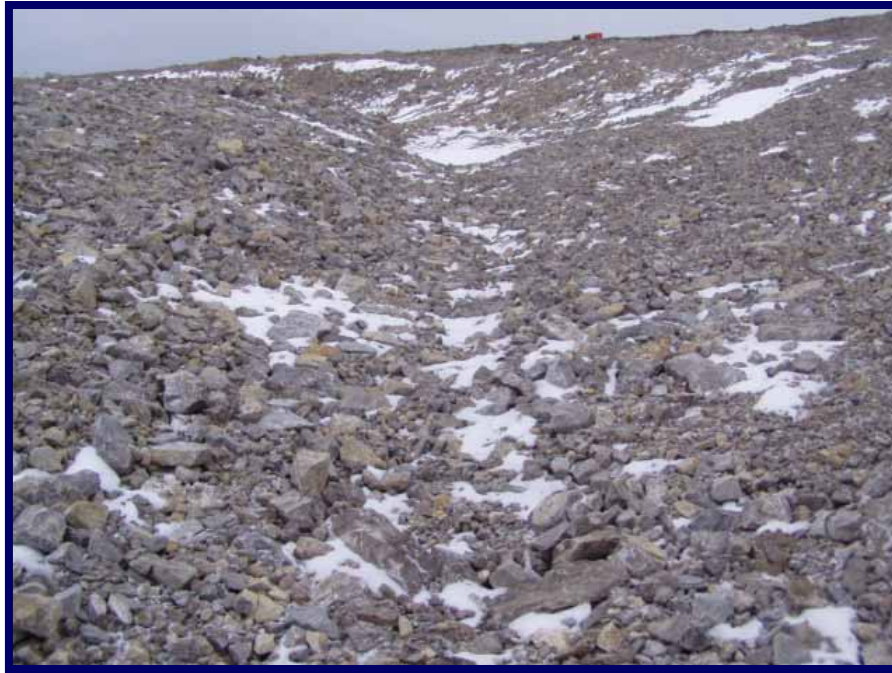
Photo 58: View looking upstream along riprap lined channel.

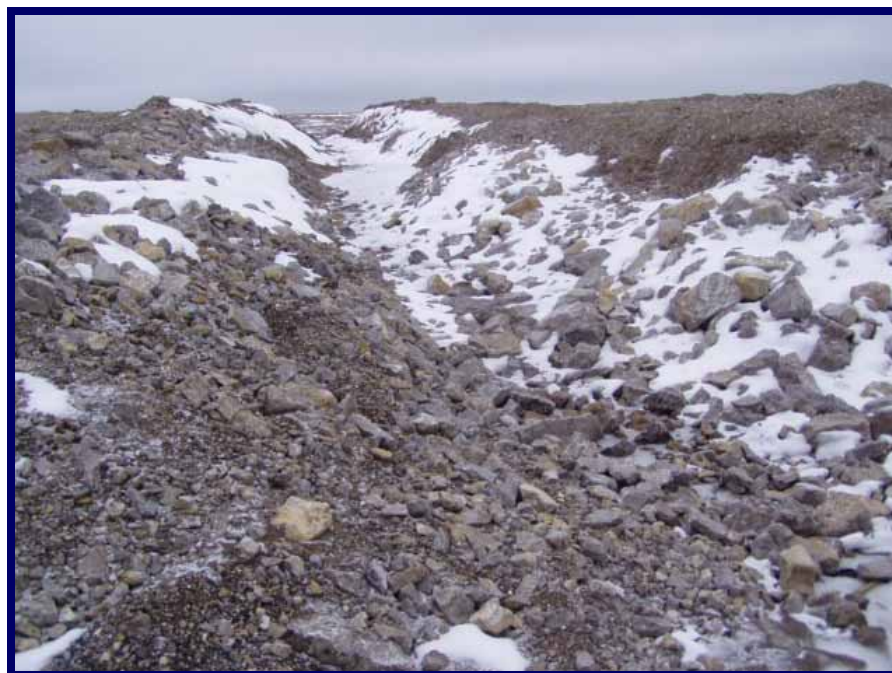
Photo 59: Same stream channel as in previous photos. This portion of channel is parallel with the crest of the slope and intercepts runoff from further upslope sources.

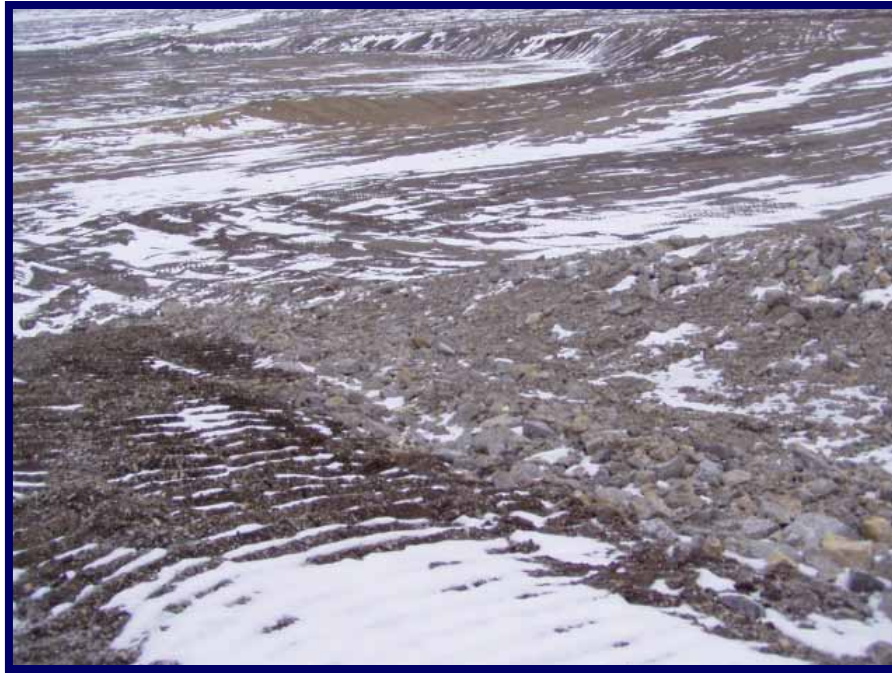
Photo 60: View of second riprap lined channel on west side of New Quarry, adjacent to one shown in above photos.

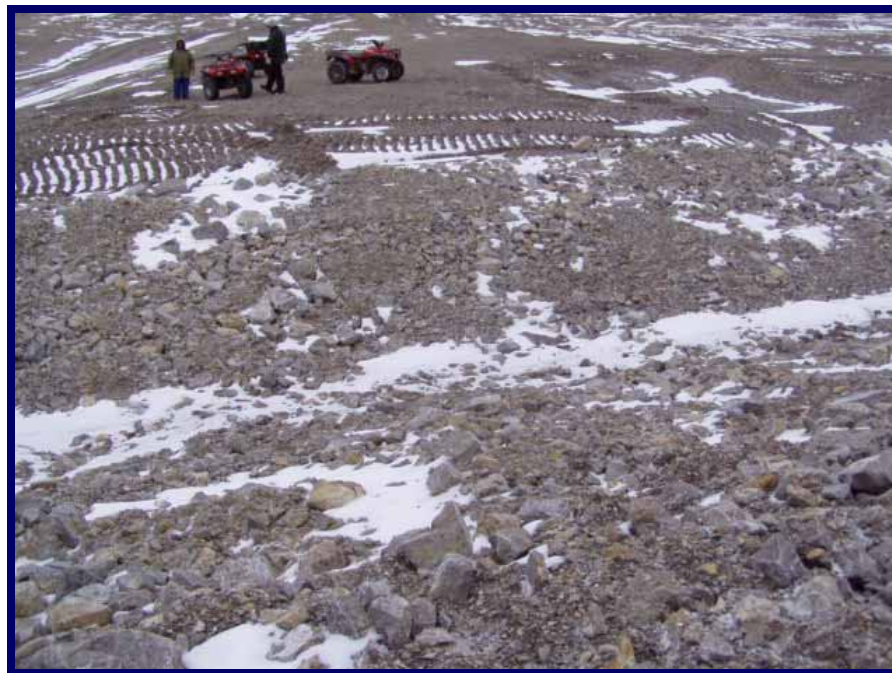
Photo 61: View of same channel as in previous photo showing riprap lining where channel cuts across decommissioned haul road. Looking south along west side of New Quarry.

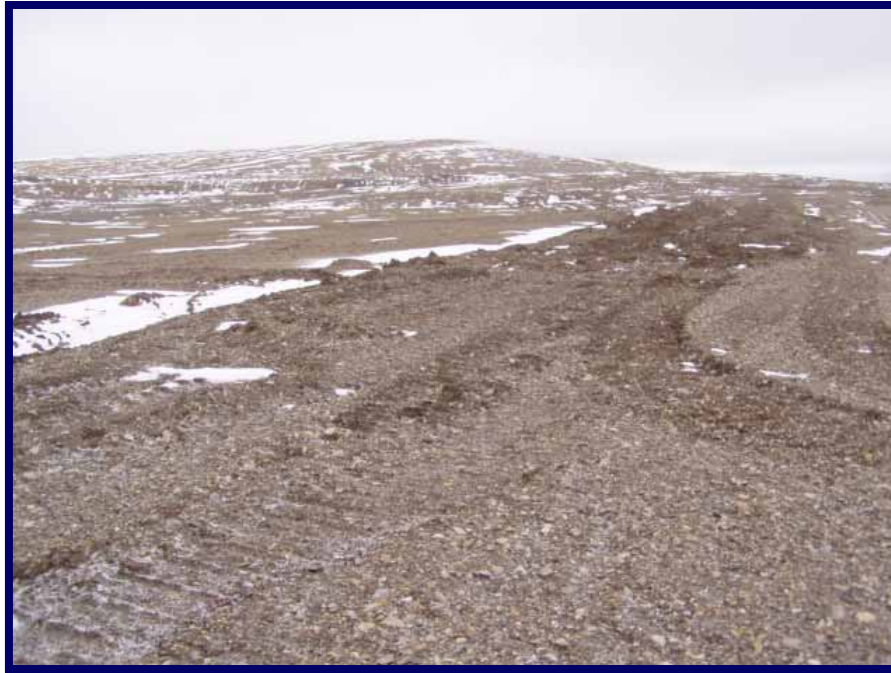
Photos 62: General view of reclaimed landscape looking north to northwest along decommissioned haul road along west side of New Quarry. Interceptor ditch leading to riprap lined channels shown in previous photos is visible along left side of road, infilled with drifting snow.

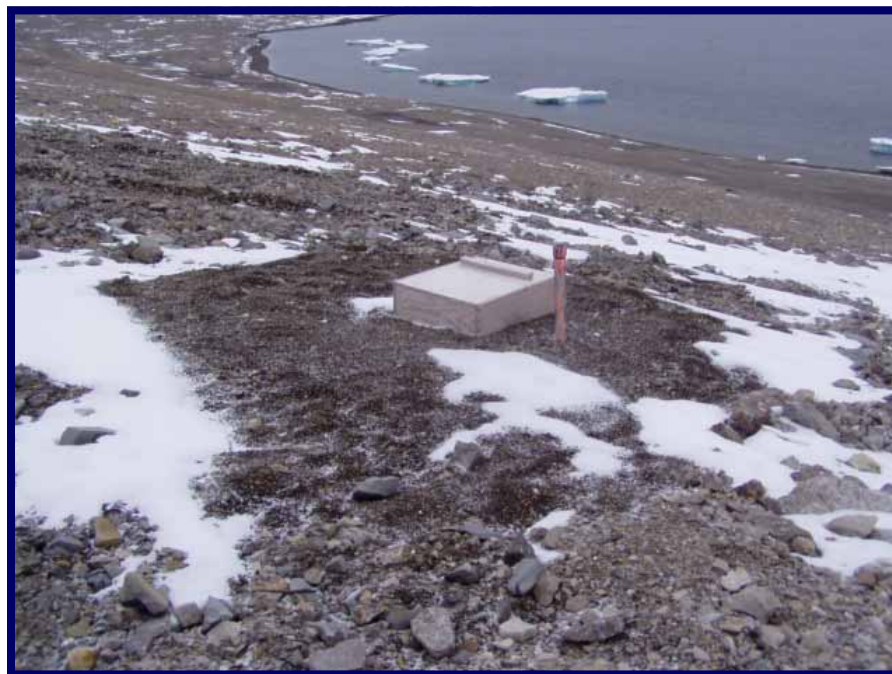
Teck Cominco has installed four thermistors cables with dataloggers to monitor ground temperatures in the cover and underlying waste to confirm that the seasonal active zone remains within the cover. The thermistors were replaced in 2006 and the data is reported by Teck Cominco in their annual reports. The results of the 2008 measurements will be reported in the third quarter report being prepared at the time of this inspection. In general both areas of cover appeared stable with no signs of settlement, heaving or waste materials working their way through the cover. The thickness of the horizontal portion of the cover was locally increased near the eastern end during construction. Finer grained granular material was placed to fill in voids between rockfill that was too coarse.

Photo 70: Plywood protective cover for thermistor installation to monitor ground temperatures in landfill cover.

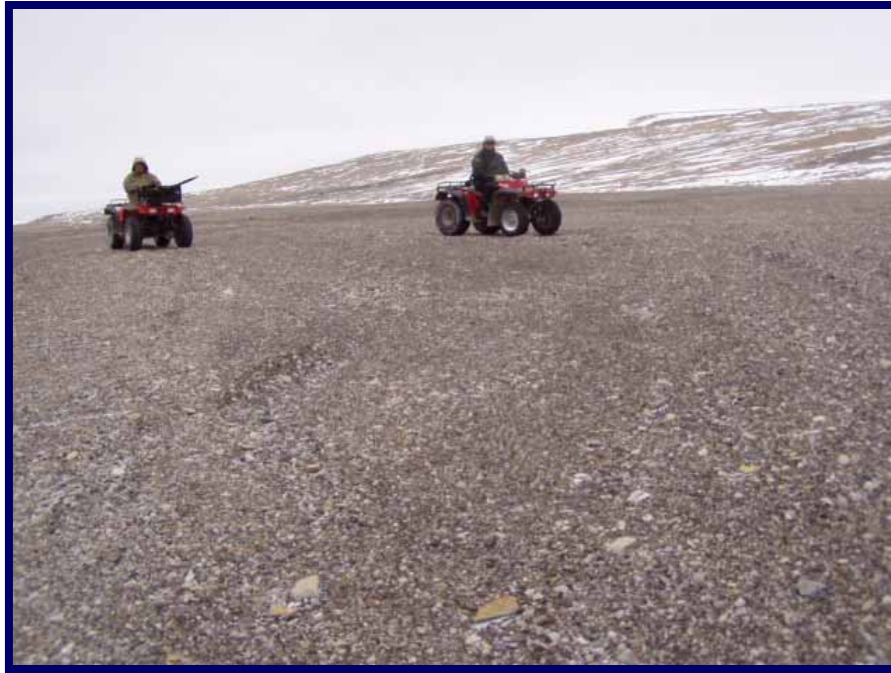
Photo 74: General view of horizontal portion of cover, near east end of landfill. This portion of the cover was supplemented by a layer of finer grained rockfill (gravel size) to fill in voids in coarse rockfill originally placed in this area during construction.

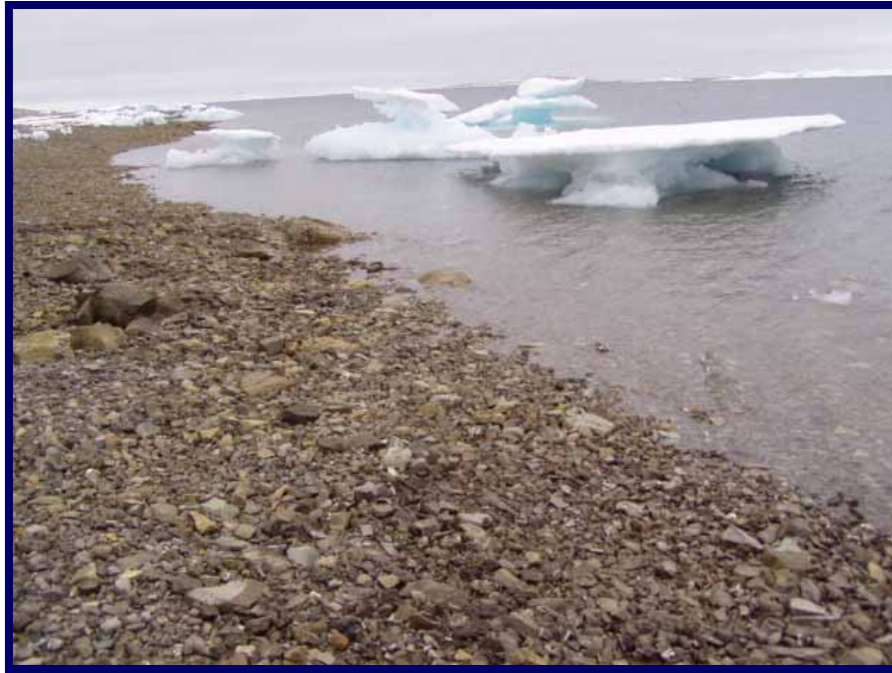
Photo 79: Looking south along marine shoreline from same point as previous photo. Note grounded icebergs and natural-looking reclaimed shoreline.

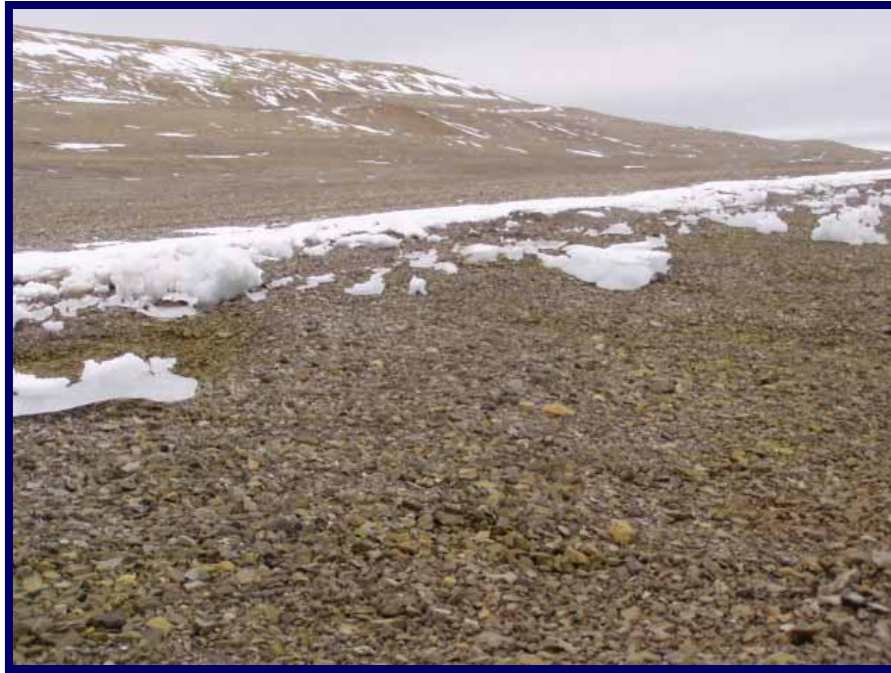
Reclamation work was undertaken by Teck Cominco on portions of the slope above beach level. This included some excavation and grading, such as the area above and below the former tank farm. Other portions of the slope above beach level are natural slopes. There were no obvious areas of instability noted during the inspection. The re-graded slopes all remain stable, with no sign of erosion or slumping.

Photo 83: Looking south to southeast from beach towards former tank farm area (bench on slope in background). Note reclaimed slopes are stable, with no signs of erosion or slumping.

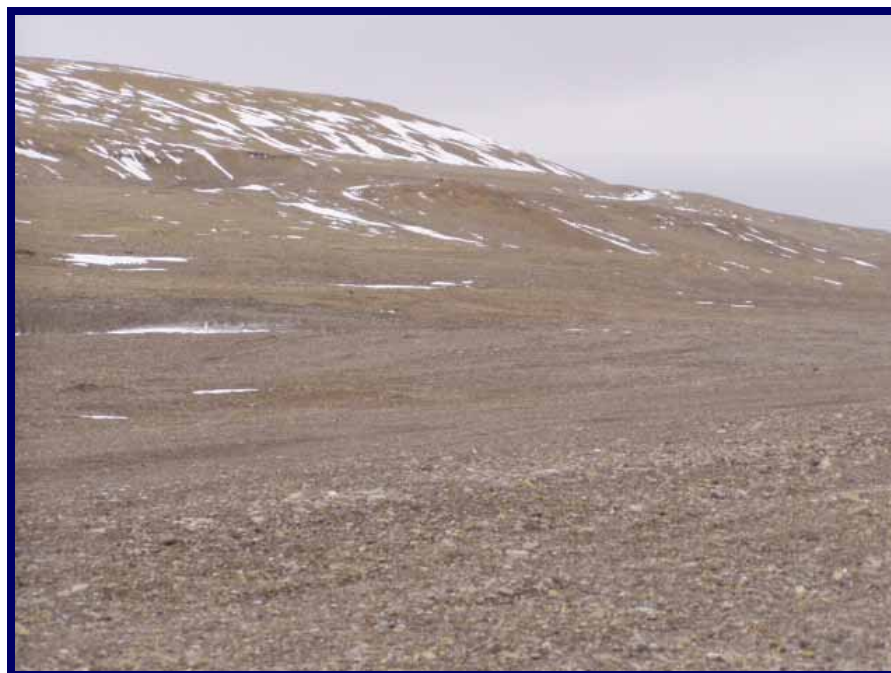
Photo 84: Closer view of reclaimed slopes around former tank farm area.

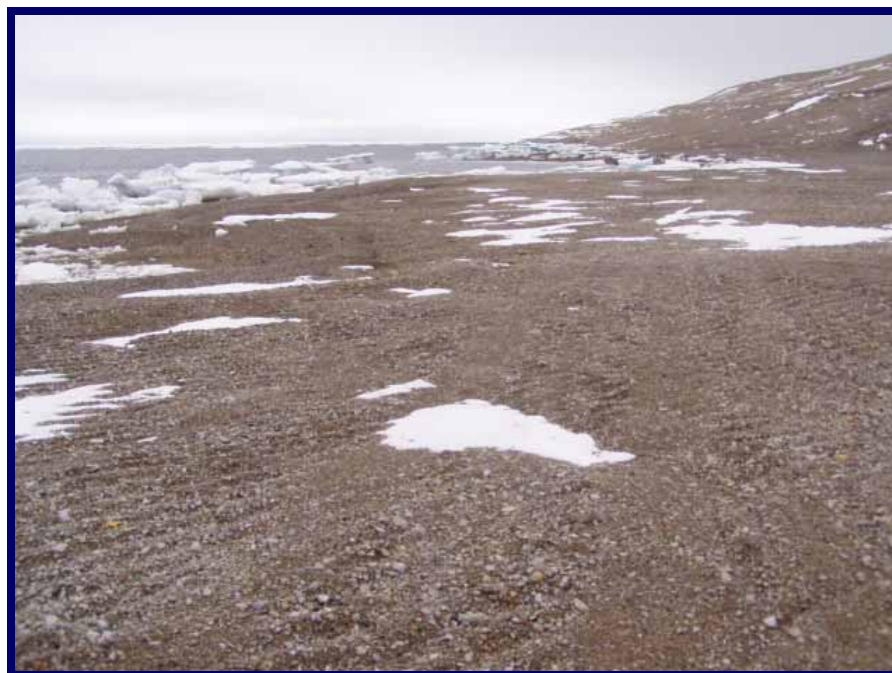
Photo 86: Reclaimed foreshore area in front of Main Portal, looking north.

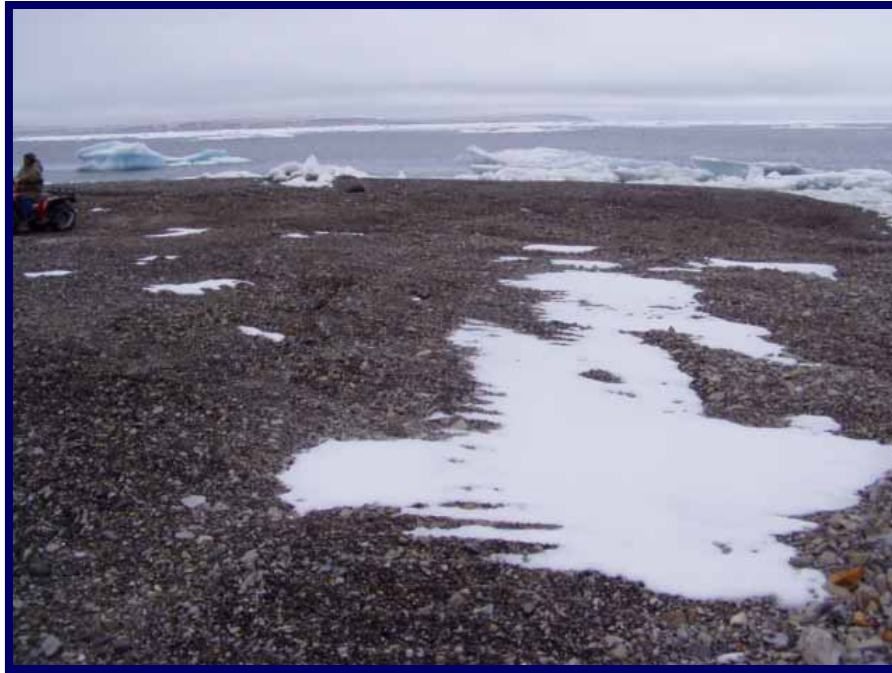
Photo 87: Looking west towards former dock area.

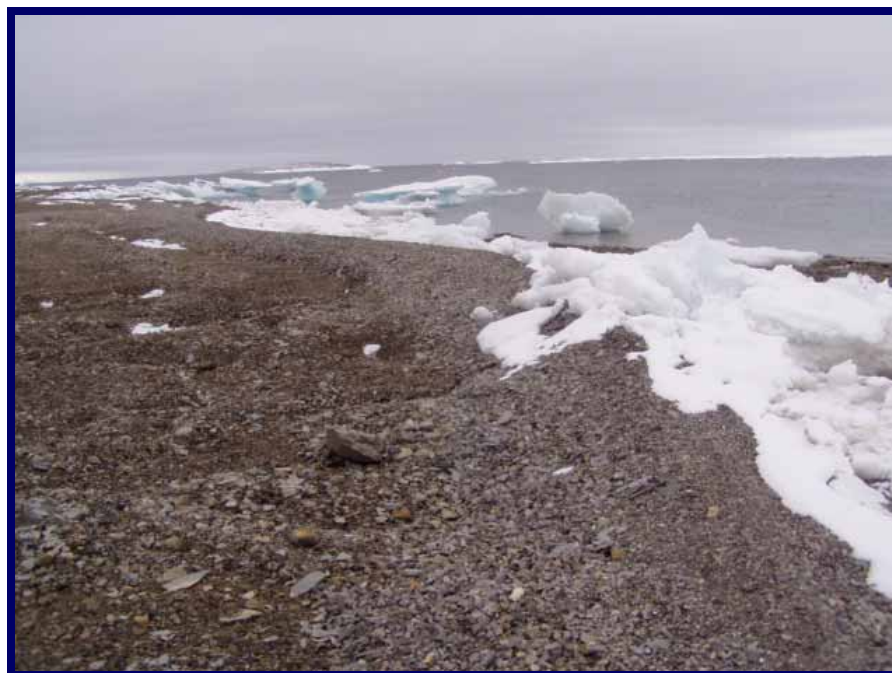
Photo 88: Looking south along beach from former dock site area.

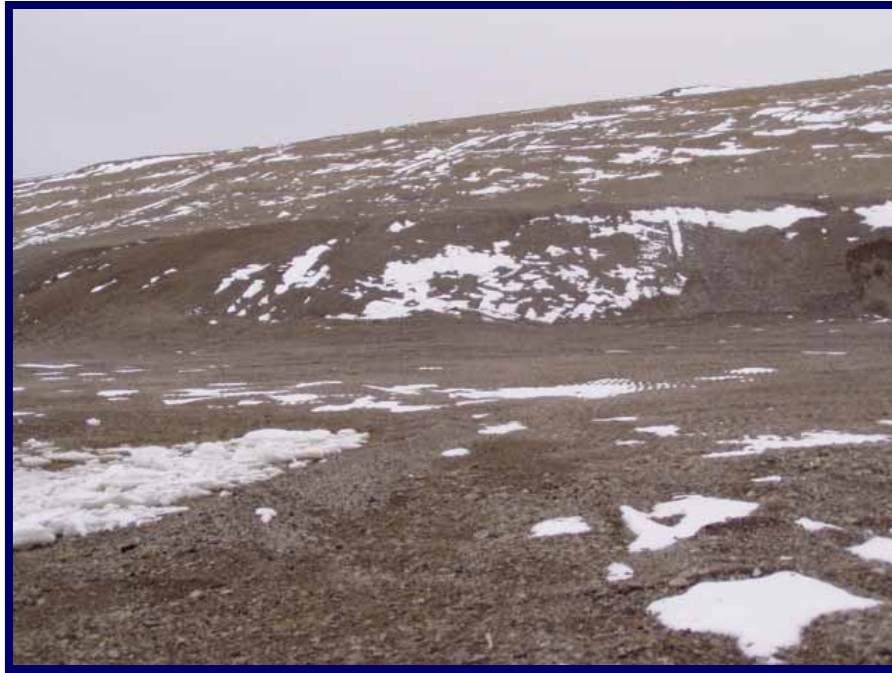
Photo 91: View of reclaimed slope just to the north of Main Portal (visible on right side of photo).

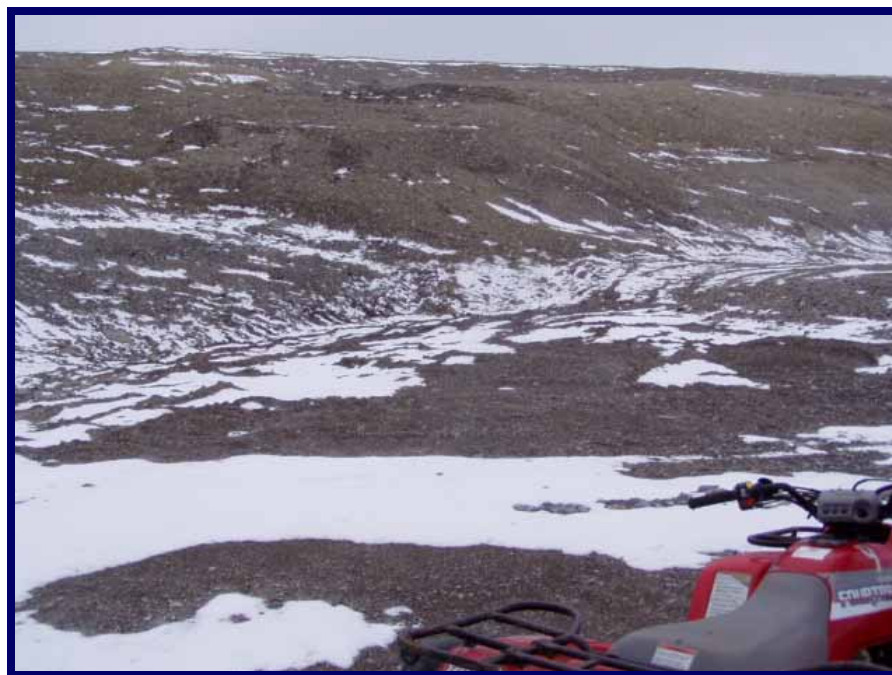
Photo 100: North Portal area. Very difficult to tell where portal was.

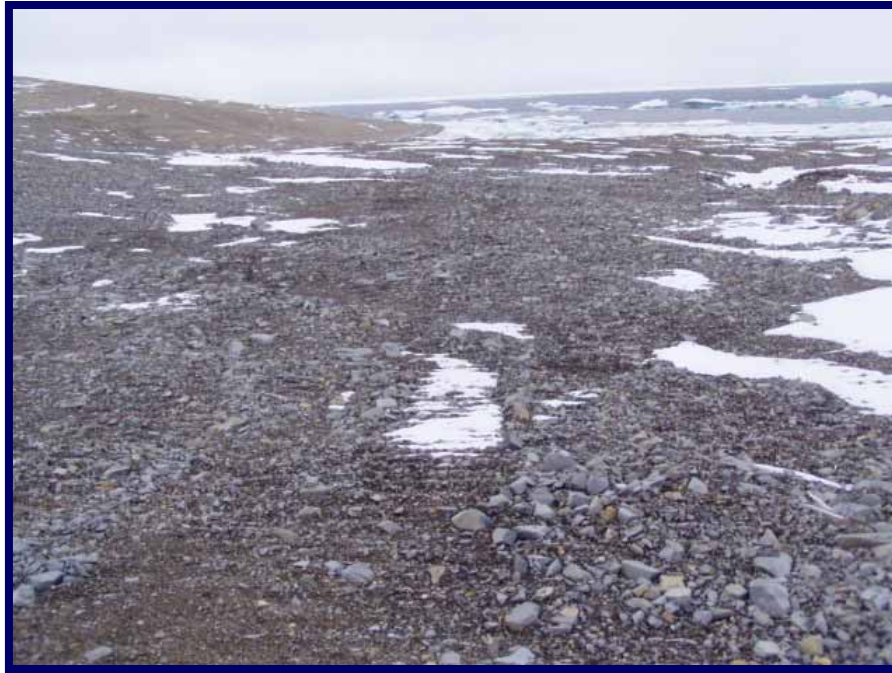
Photo 101: Reclaimed shoreline area in front of North Portal, looking west.

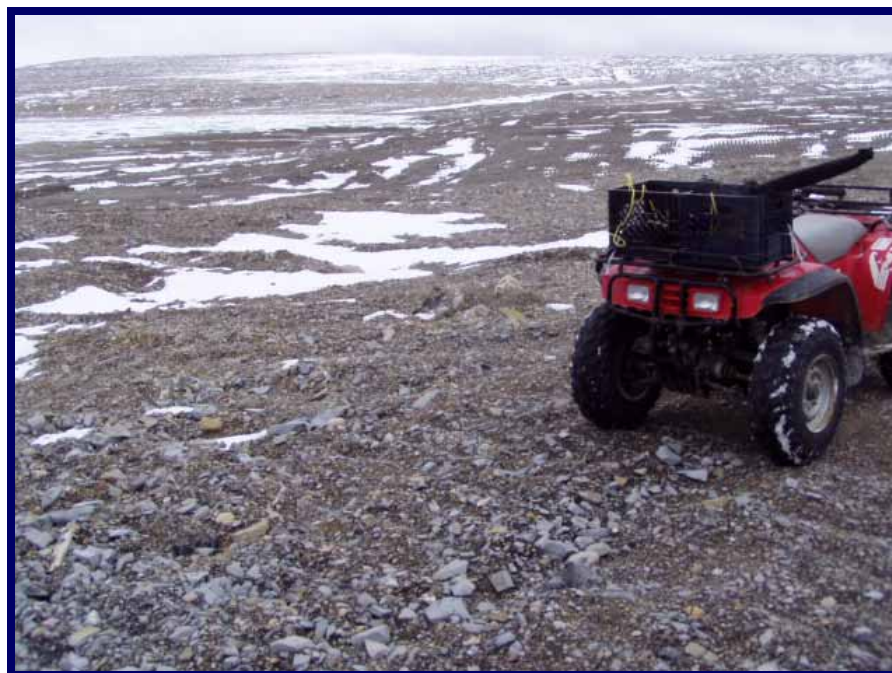
Photo 102: Reclaimed area in front of North Portal, looking east.

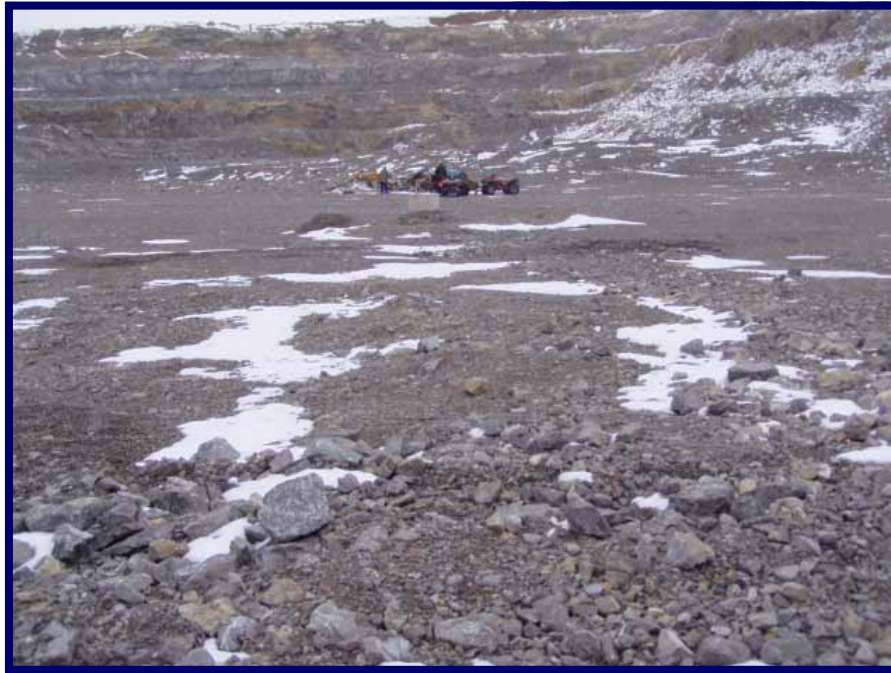
Miscellaneous pieces of scrap metal and demolition debris collected by Teck Cominco from around the site during their annual visits has been placed on top of the landfill cover within the quarry. Teck Cominco intends to bury this material within the LRD Quarry Landfill next year as part of the final site clean up before removing their equipment from site. BGC recommended that the location for disposal of this debris should be chosen carefully to avoid disturbing the cover. BGC suggested excavating close to the south-facing side of the quarry, along the toe of the rock slope, where the active zone within the fill may be deeper due to warming from the adjacent rock. The excavation may have to proceed in stages to allow frozen backfill to melt. The debris should be covered with the same minimum thickness of cover as used elsewhere in the LRD Quarry Landfill.

Photo 97: Looking east across landfill cover. Box in distance is thermistor installation. Quads are parked next to a small pile of debris collected by Teck Cominco from around the site. This material will be buried next year in a designated area within Little Red Dog Quarry.

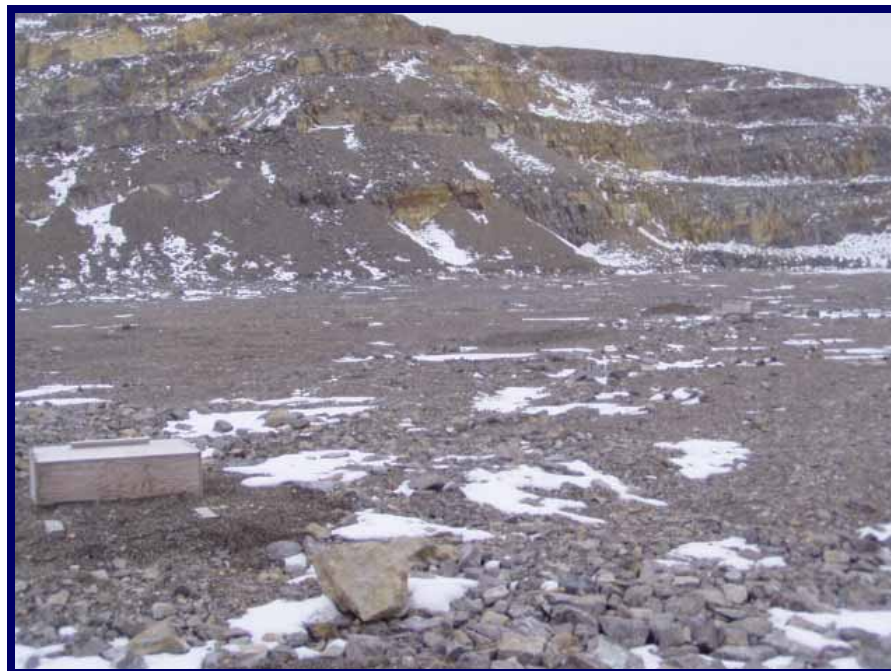
Photo 98: Looking south across landfill cover towards excavated rock slopes. Plywood box housing dataloggers for thermistors is in foreground.

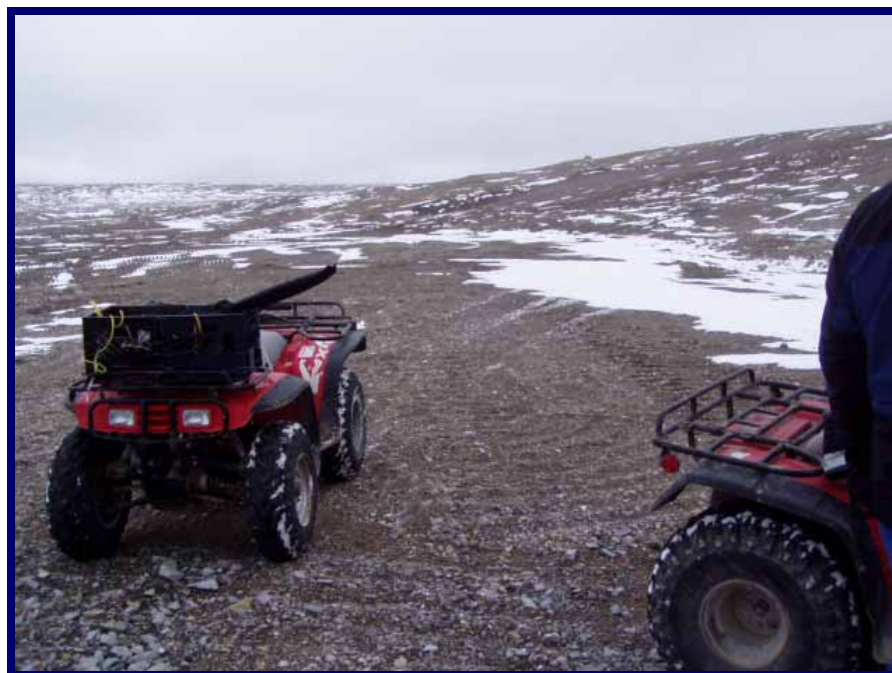
Photo 103: Looking southeast towards reclaimed area around subsidence zone from area around North Portal.

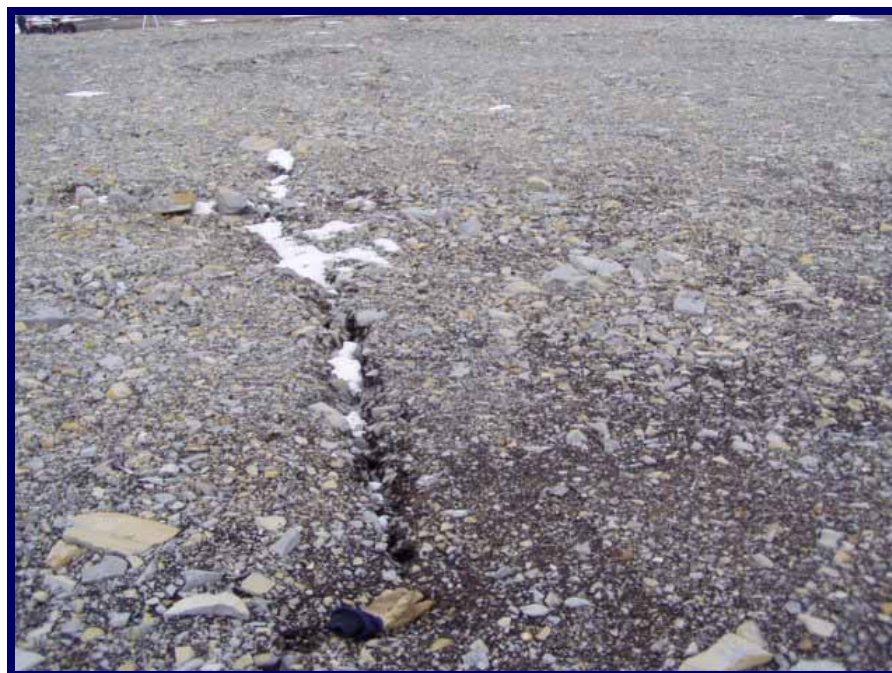
The surface expression of the subsidence zone has not changed visually from previous inspections. The subsidence trough runs roughly north-south and is flanked by several large cracks that were noted in all previous inspections. Teck Cominco conducts an annual survey of the topography across the subsidence zone that showed no significant change from year to year. This year, Teck Cominco initiated mapping of the visible cracks by survey. This information will help to support the interpretation from past surveys that the subsidence zone has stabilized since closure.

Photo 107: Same crack as in previous photo, looking north.
