INDIAN AND NORTHERN AFFAIRS CANADA

POLARIS MINE ABANDONMENT AND RECLAMATION

AUGUST 24, 2008 SITE VISIT AND INSPECTION

PROJECT NO.: 0131-013-06
DATE: NOVEMBER 6, 2008

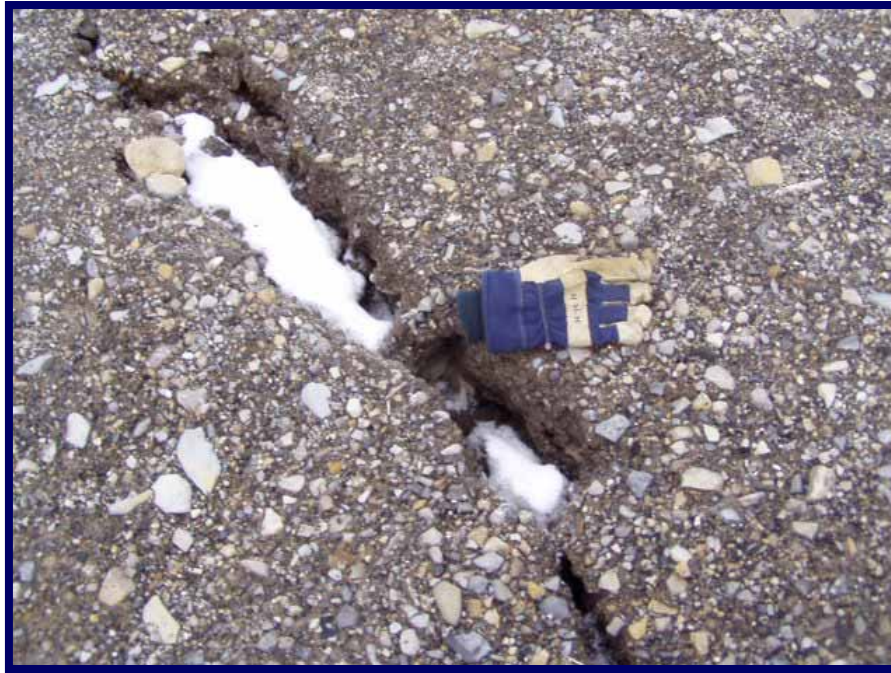
The surface expression of the subsidence zone has not changed visually from previous inspections. The subsidence trough runs roughly north-south and is flanked by several large cracks that were noted in all previous inspections. Teck Cominco conducts an annual survey of the topography across the subsidence zone that showed no significant change from year to year. This year, Teck Cominco initiated mapping of the visible cracks by survey. This information will help to support the interpretation from past surveys that the subsidence zone has stabilized since closure.

Photo 108: Close up of another snow-filled crack in subsidence zone.

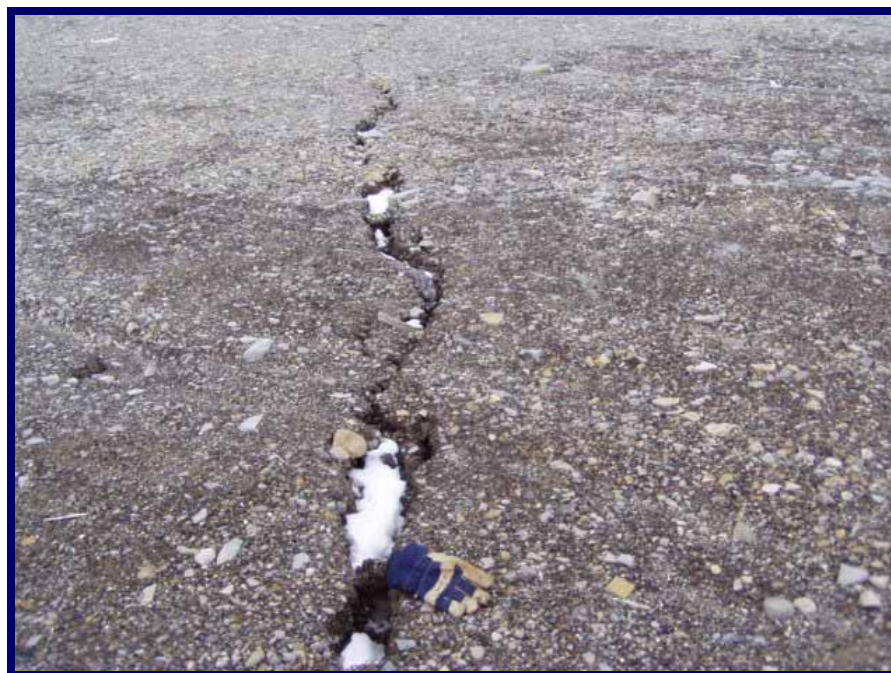
Photo 109: View along crack showing irregular trace and lateral extent.
