Defence Construction Canada

DYE-M Cape Dyer Year 1 Landfill Monitoring

AECOM

November 19, 2015

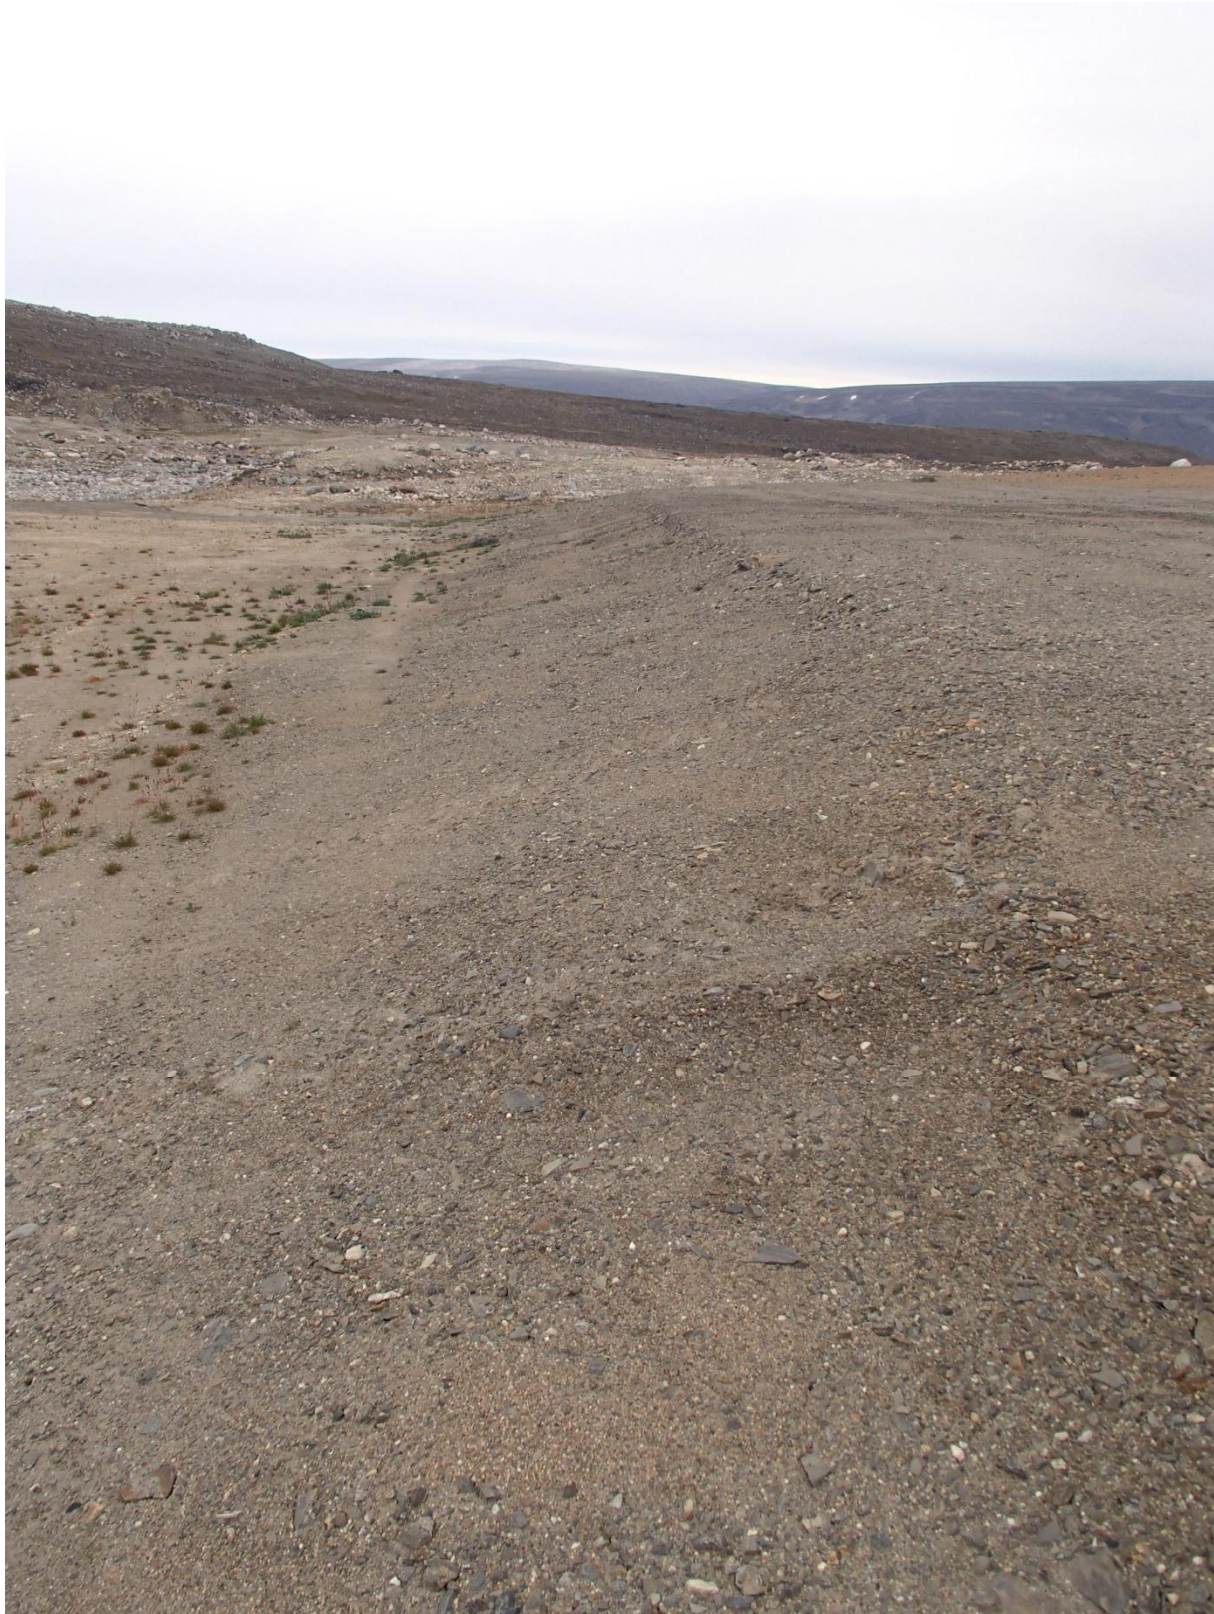
Photograph 84. Northeast corner looking south ↑

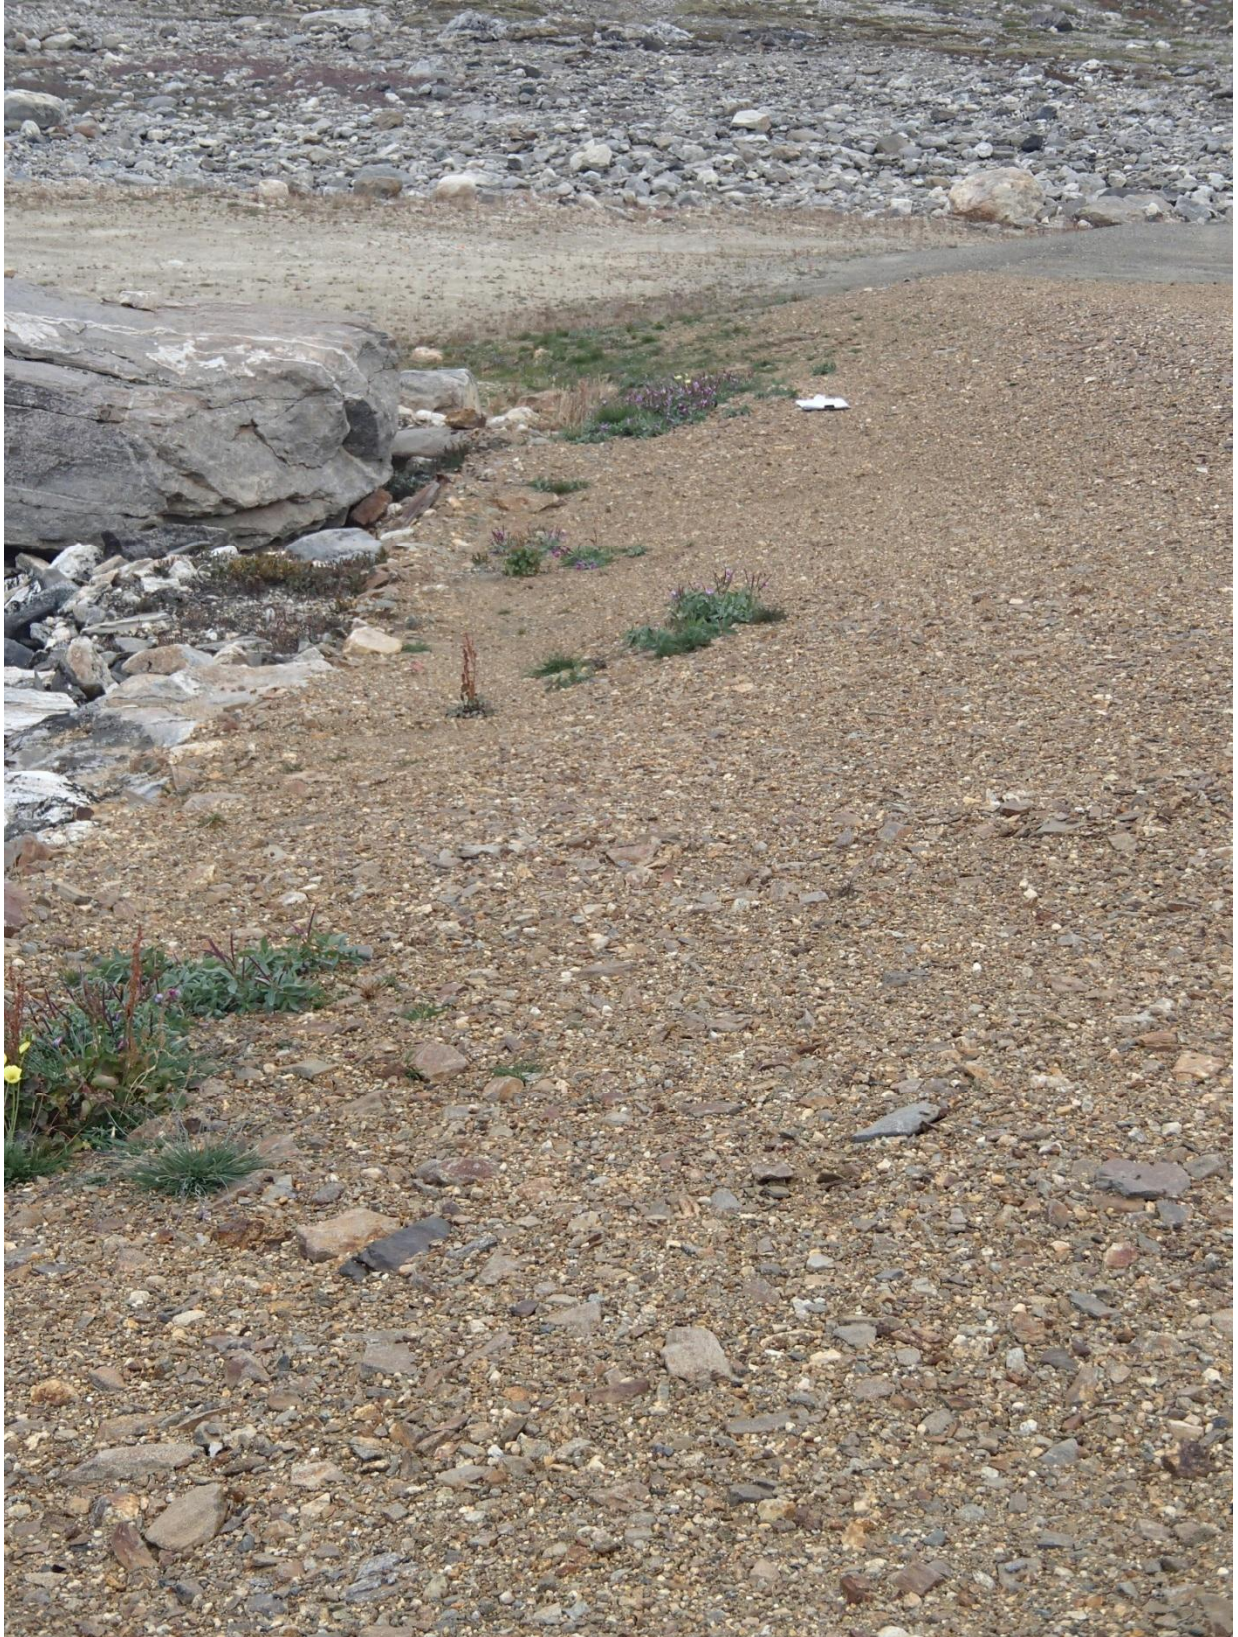
Photograph 86. **Northeast side slope looking east ↑**

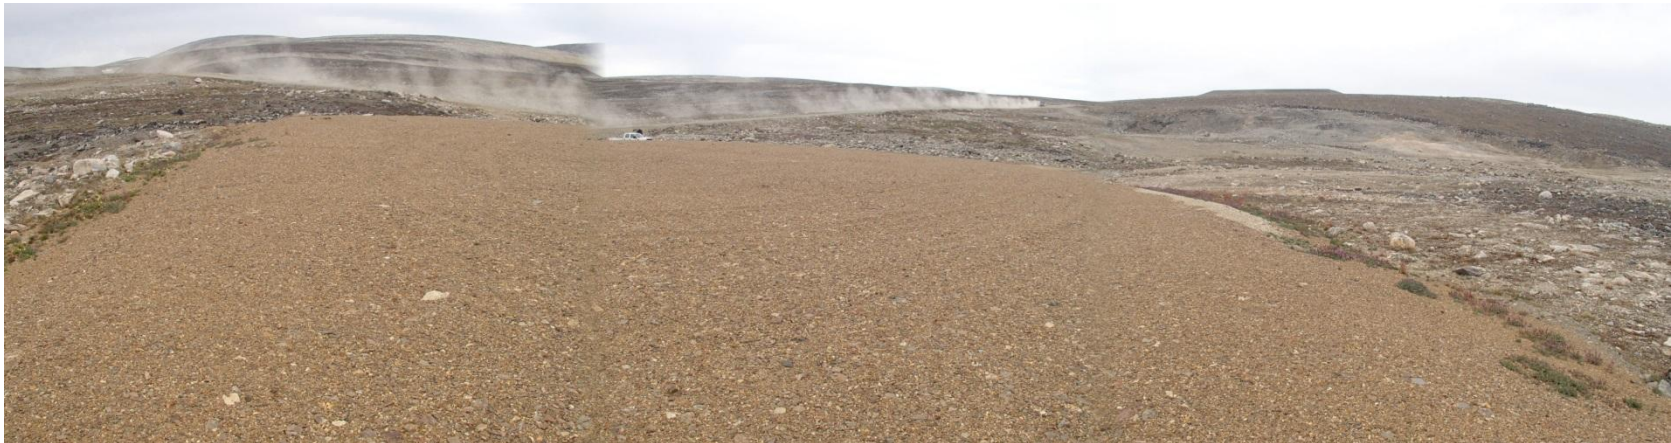
Photograph 87. Looking northeast from the southeast corner ↑

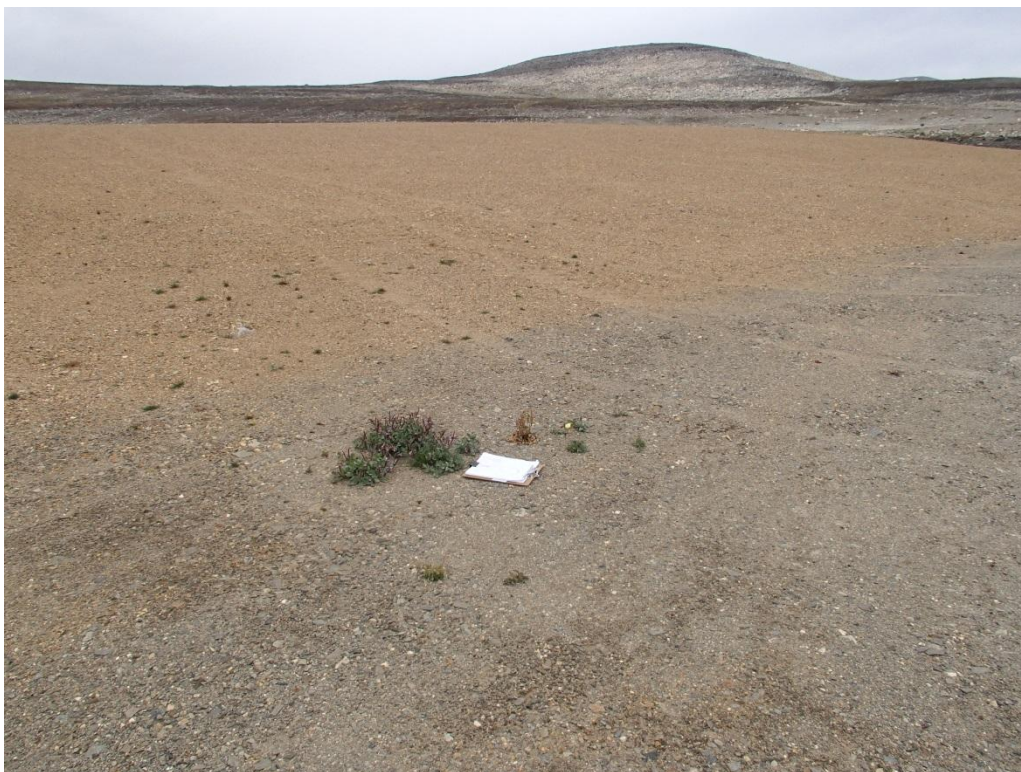
There was no substantial evidence of settlement or slope stability issues and therefore, the landfill performance is rated as acceptable. Occasional tire tracks were noted on the surface of the landfill.

Photograph 88. **Tire tracks on surface of landfill ↑**

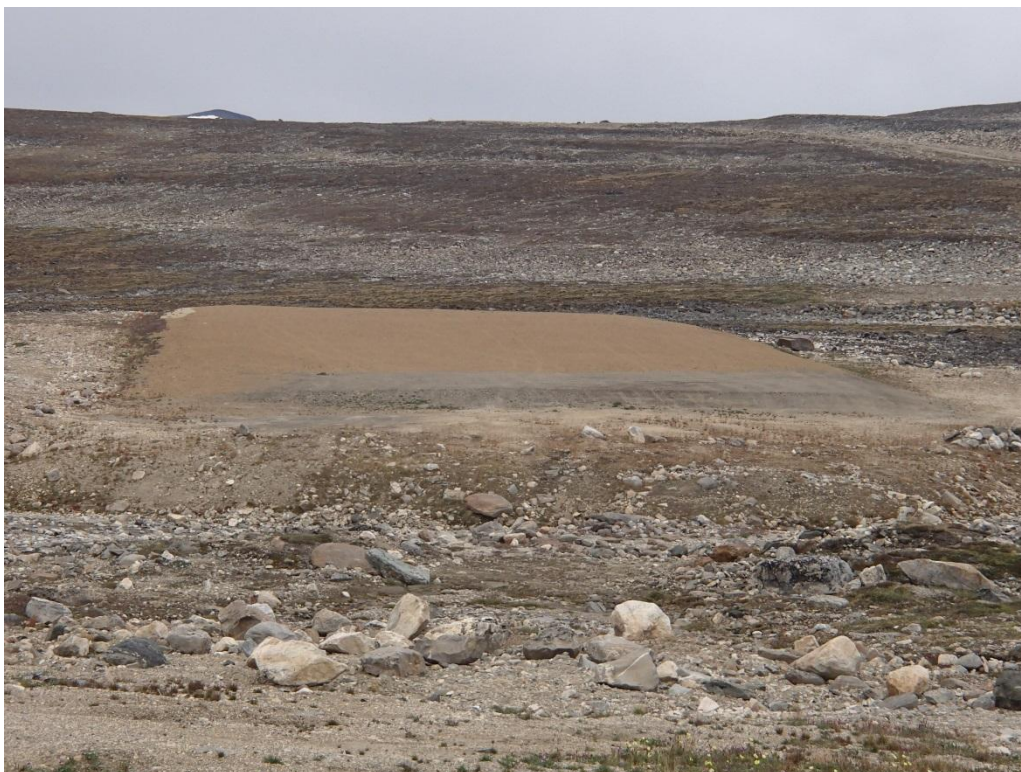
Photograph 89. **Landfill overview, looking west ↑**

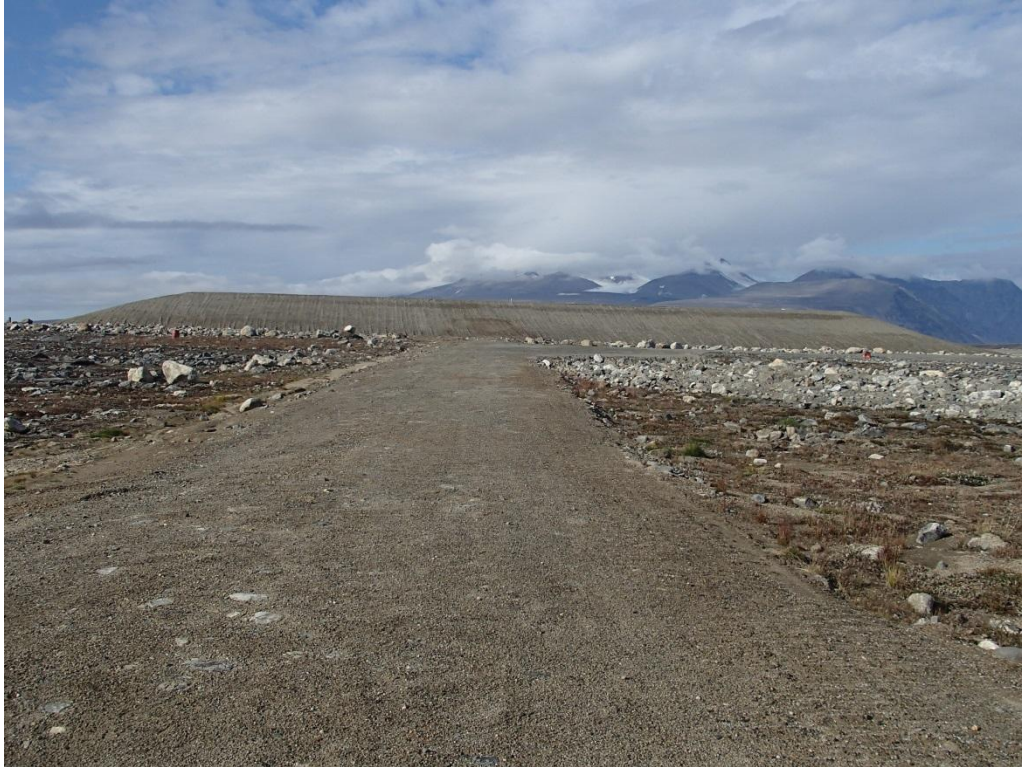
Photograph 122. Overview of landfill, looking west ↑

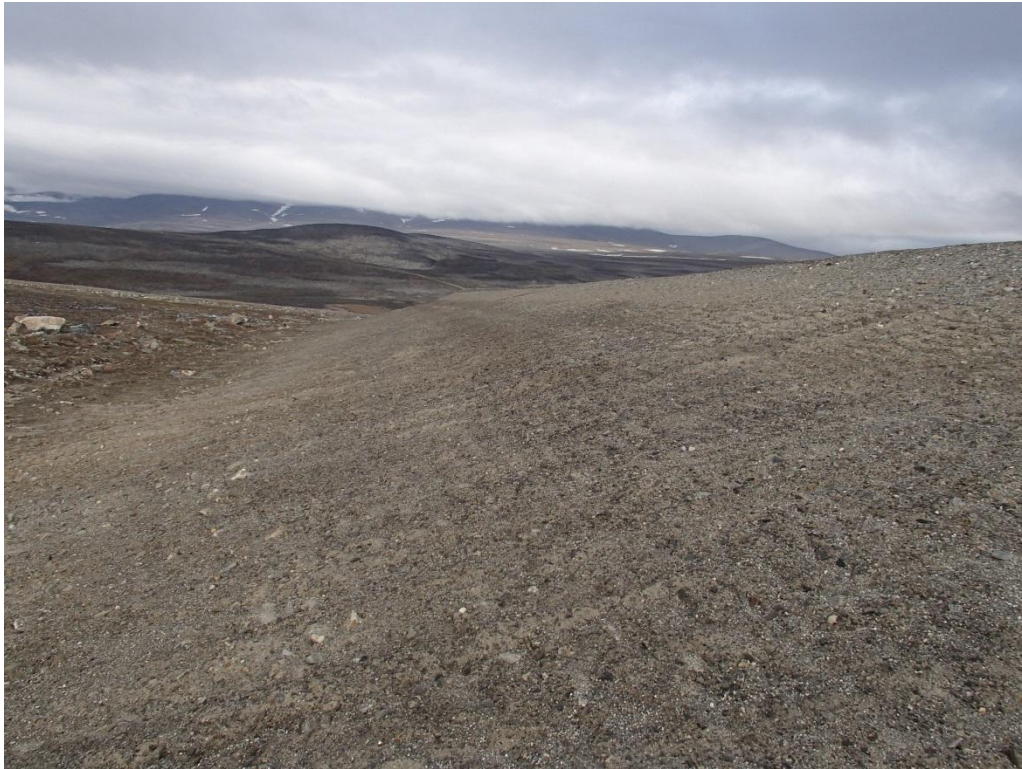
Photograph 124. South corner looking northwest ↑

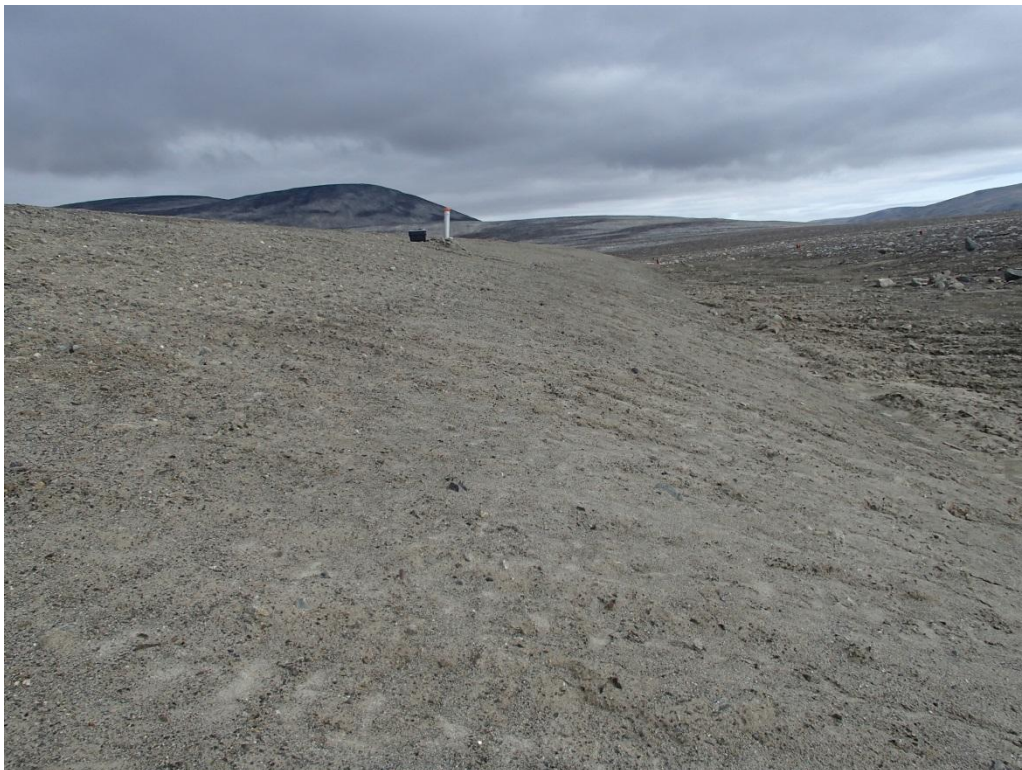
Photograph 125. South corner looking northeast ↑

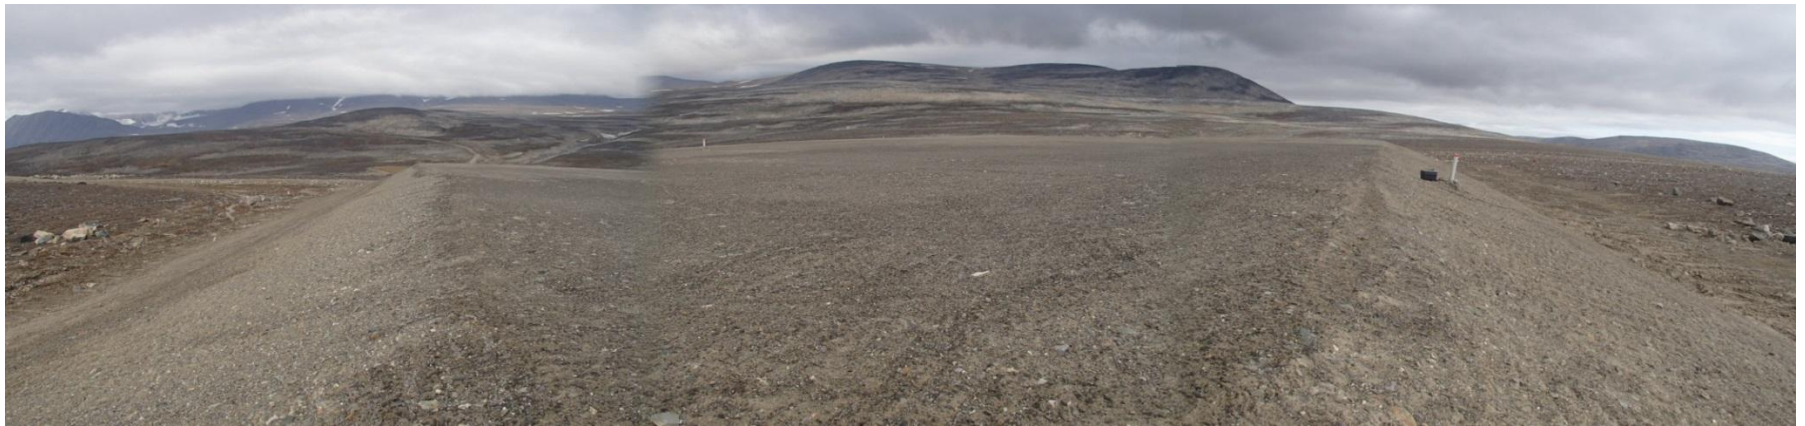
Photograph 126. South corner looking at surface of the landfill ↑

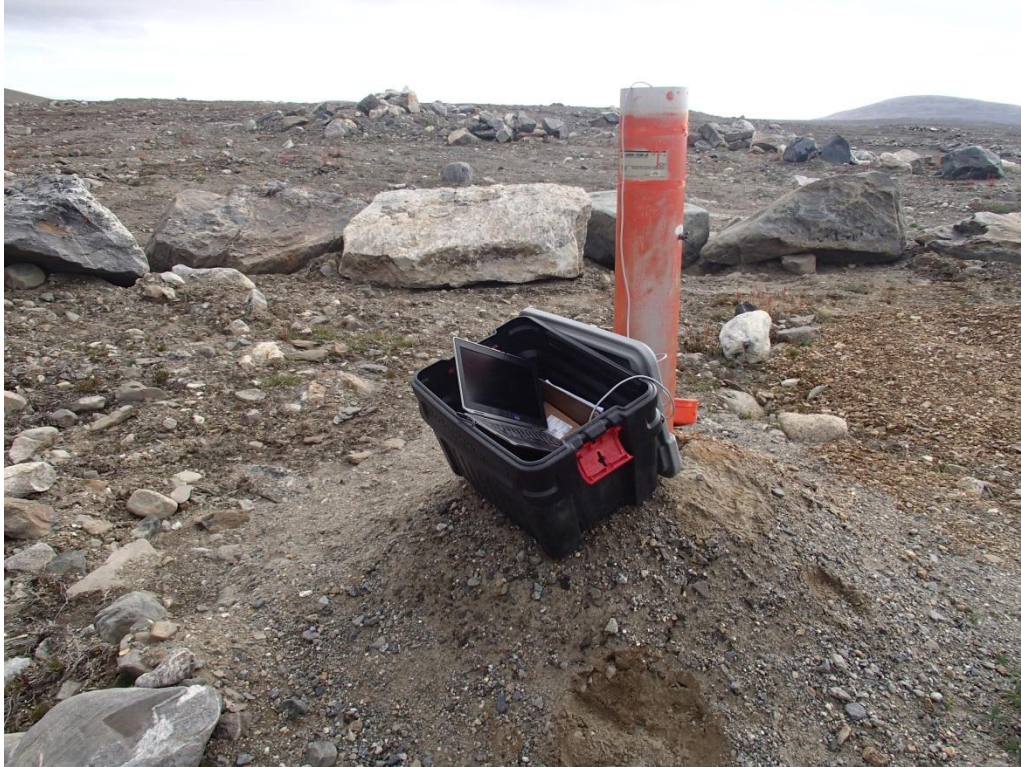
Photograph 127. Lower site background thermistor ↑

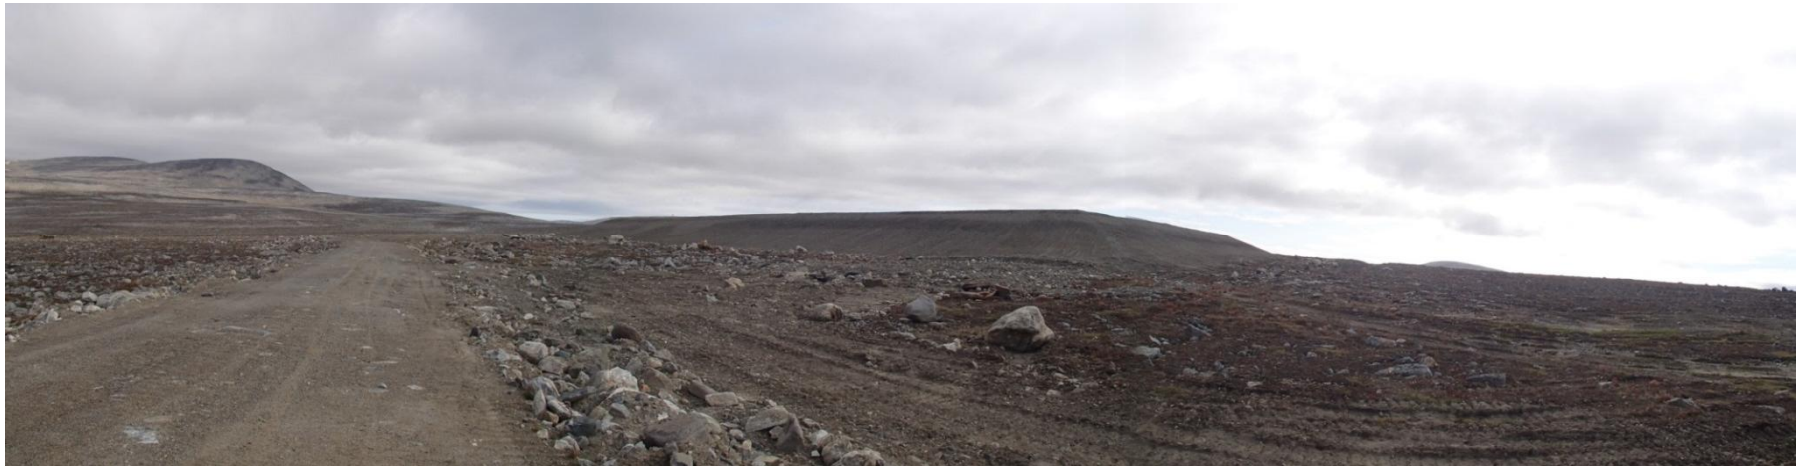
Photograph 128. Overview of the landfill from the northeast side ↑

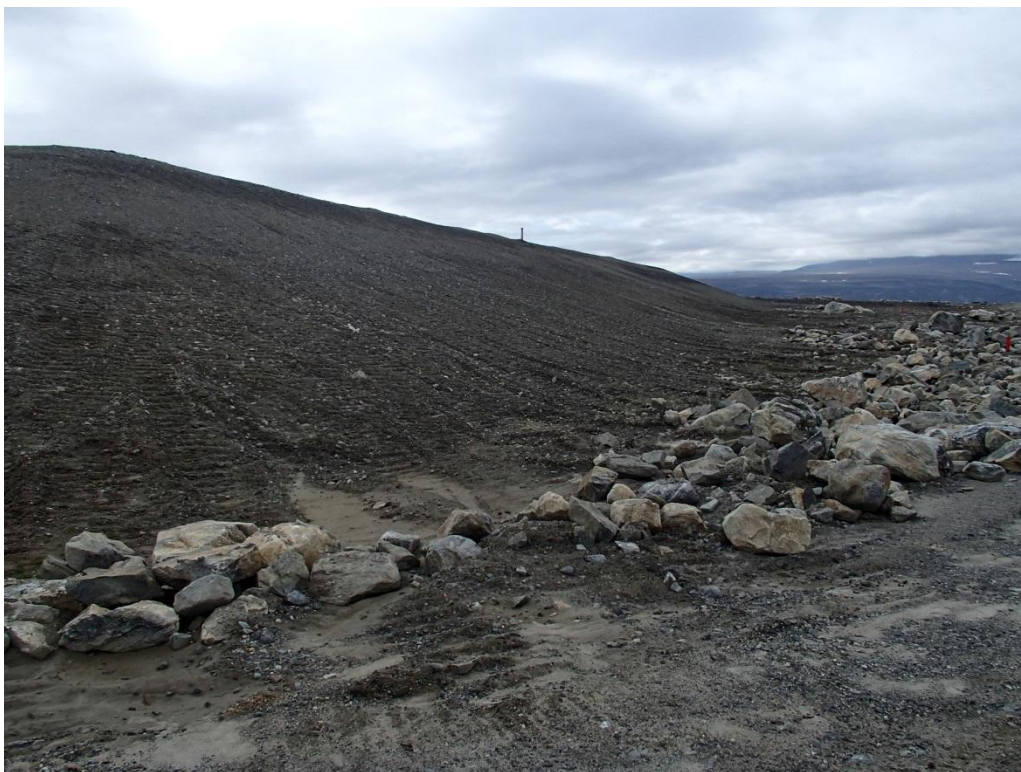
Photograph 129. Looking west from the northeast corner ↑

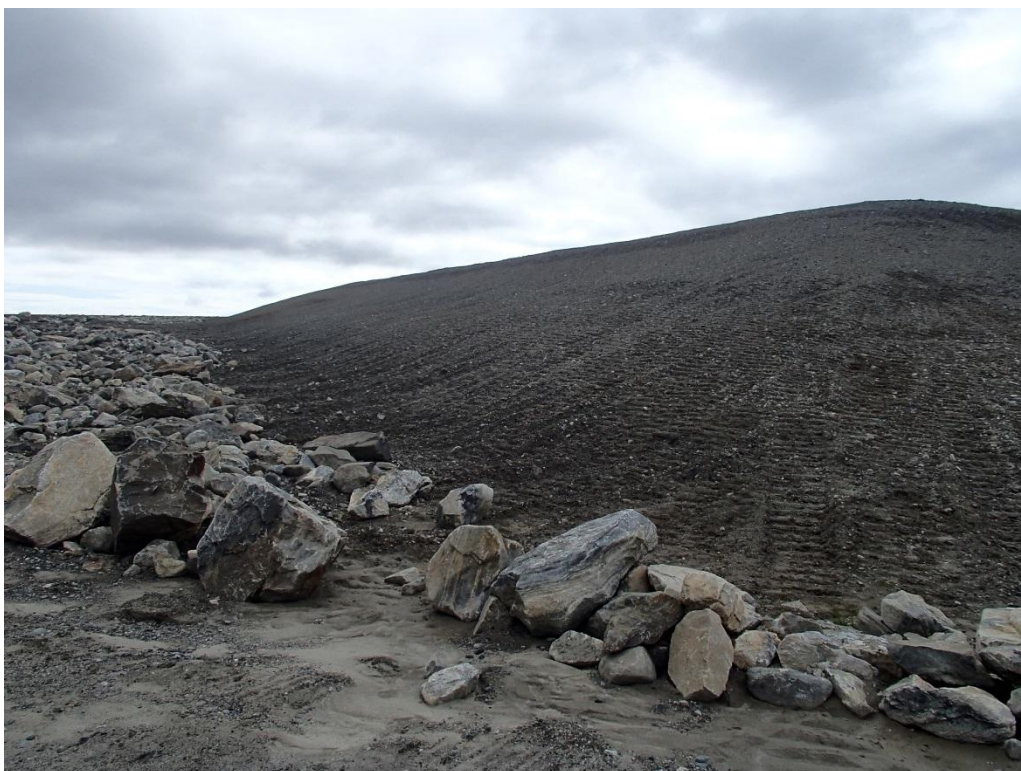
Photograph 130. Looking south from the northeast corner ↑

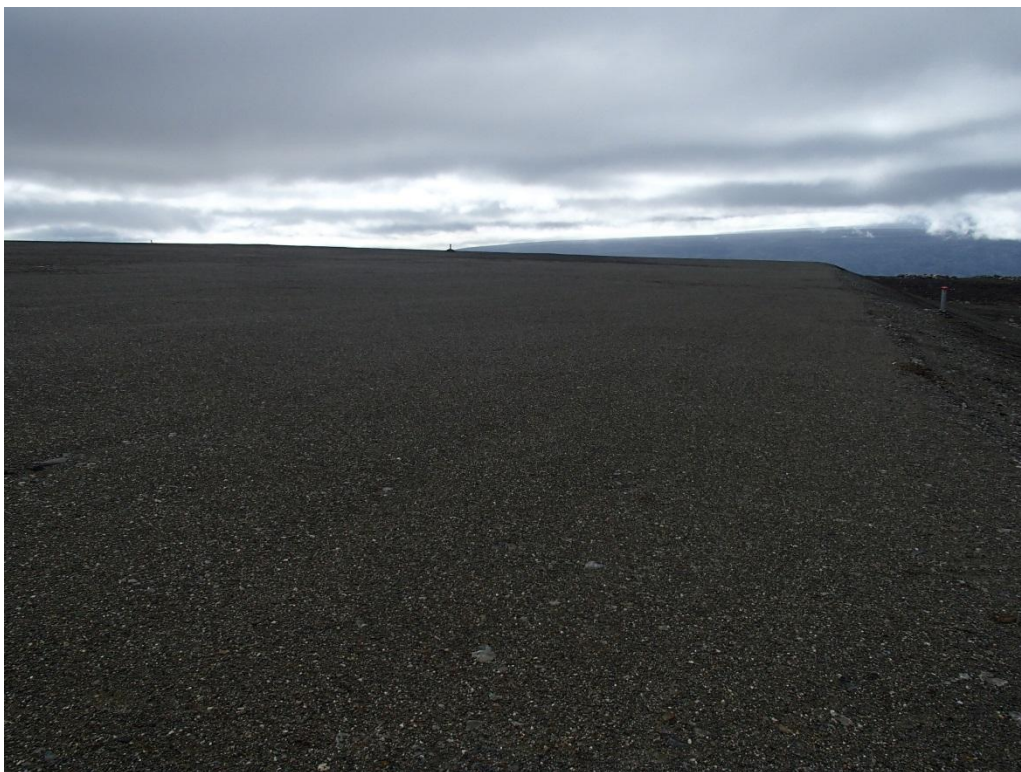
Photograph 131. **On top of the north corner of the landfill looking west ↑**

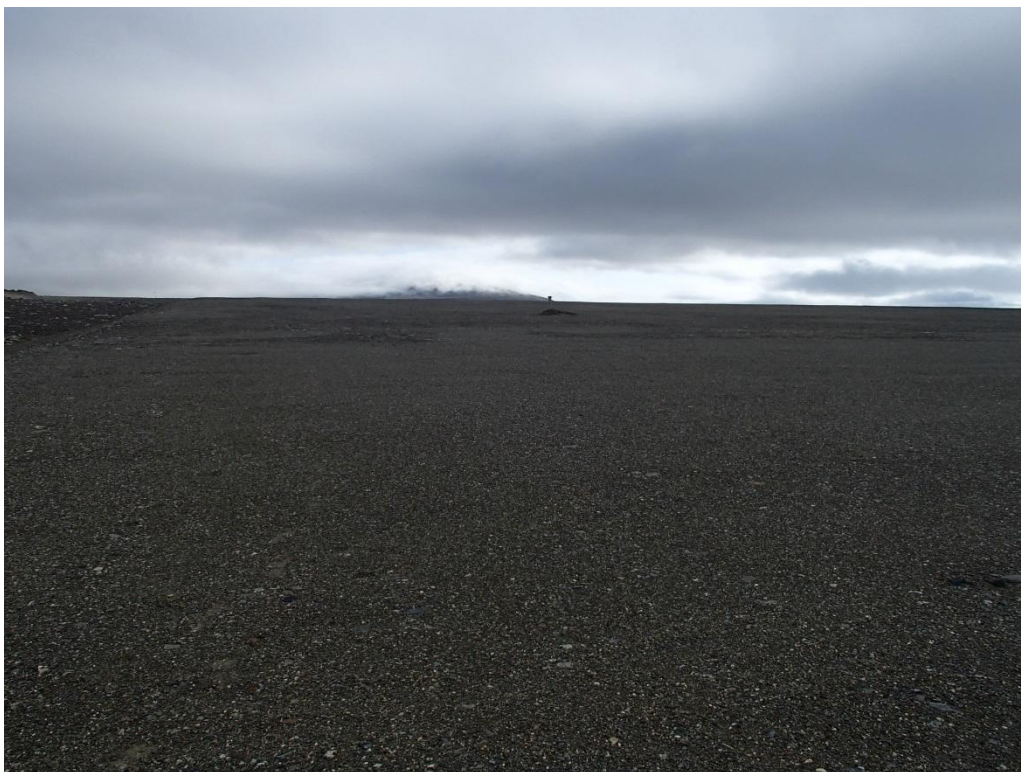
Photograph 132. **On top of the north corner of the landfill looking south ↑**

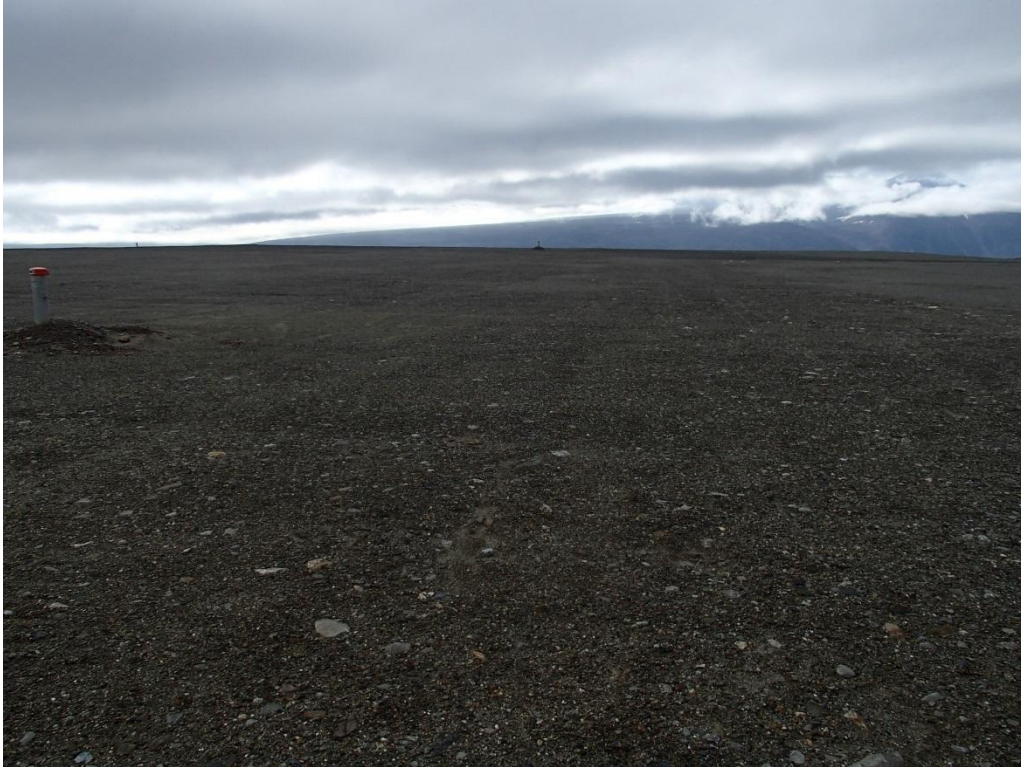
The occasional tire track, covering less than 1% of the surface, was observed on the surface of the landfill in soft areas. As there was no evidence of settlement or slope stability issues, the landfill performance is acceptable.

Photograph 133. **Looking west across soft area on landfill surface, as evidenced by tire tracks ↗**

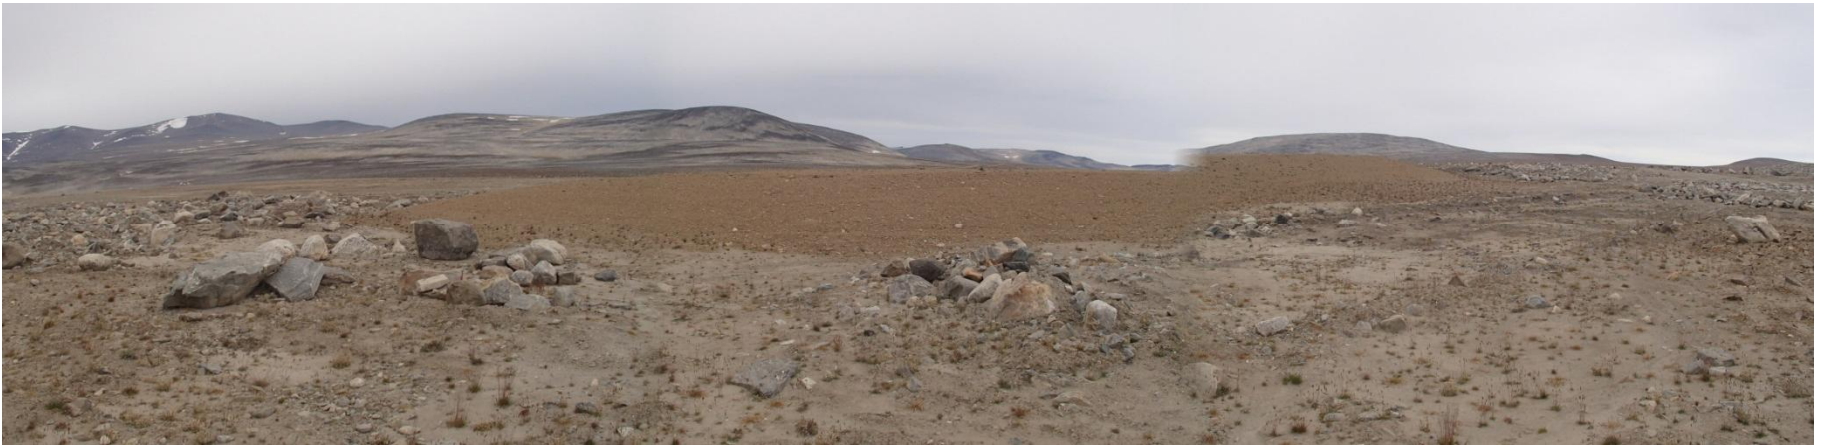
Photograph 90. Overview of the landfill looking northeast ↑

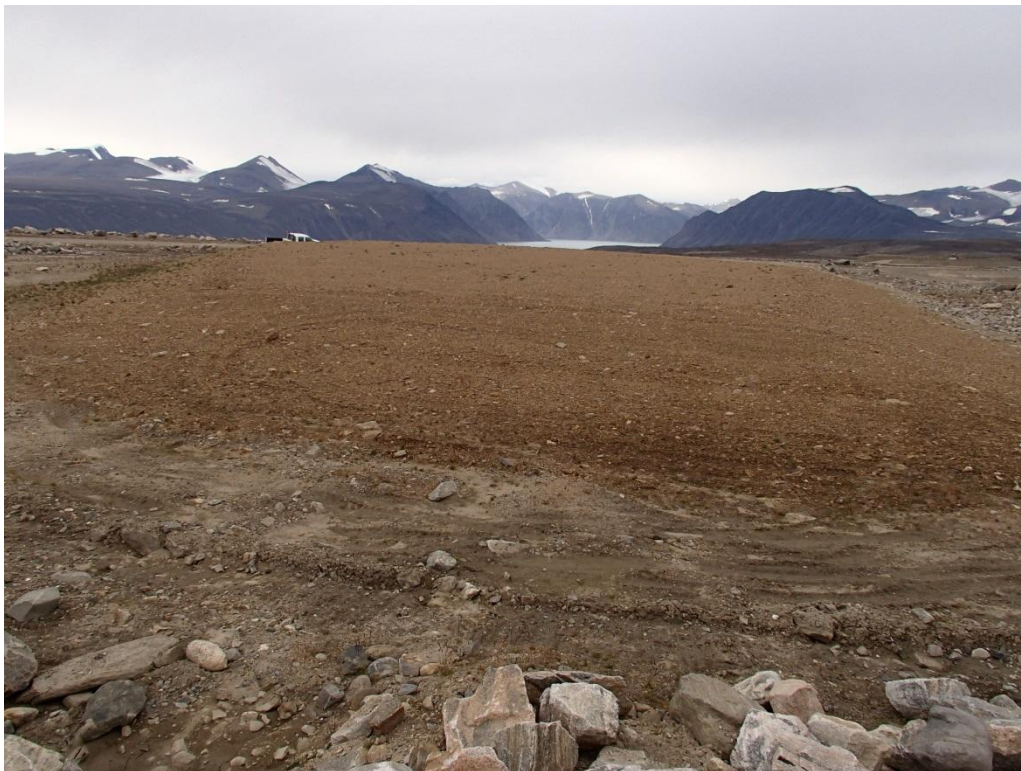
Photograph 92. Looking west across the landfill ↑

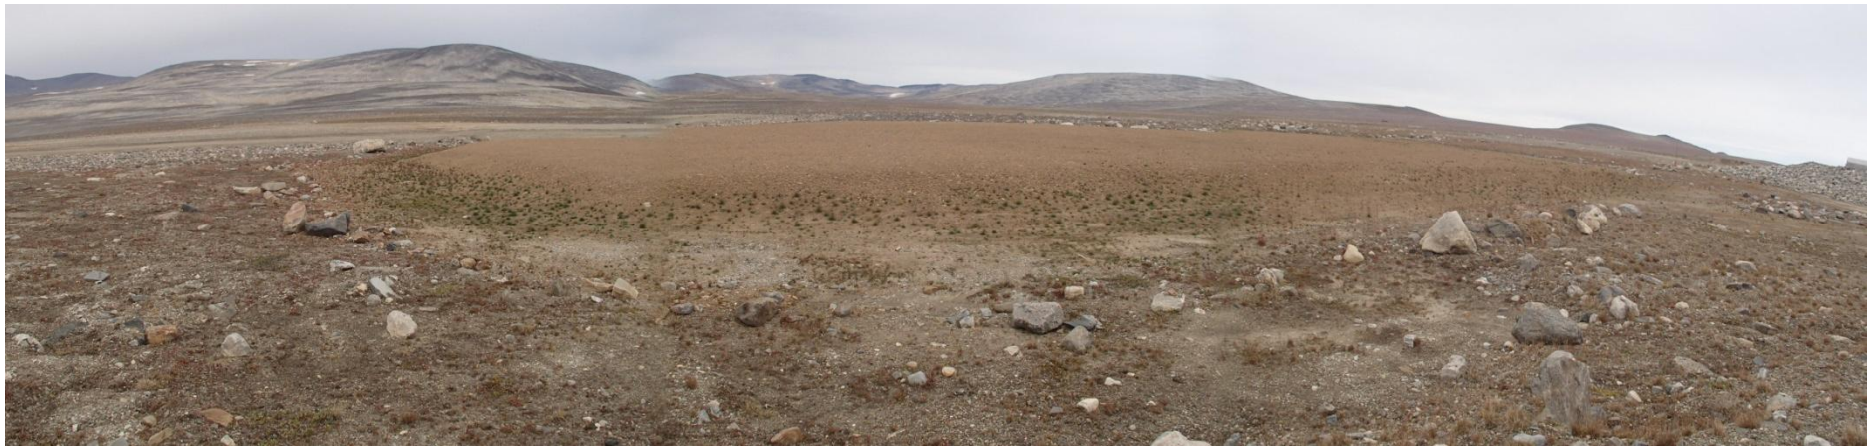
Photograph 93. **Overview of the landfill looking east ↑**

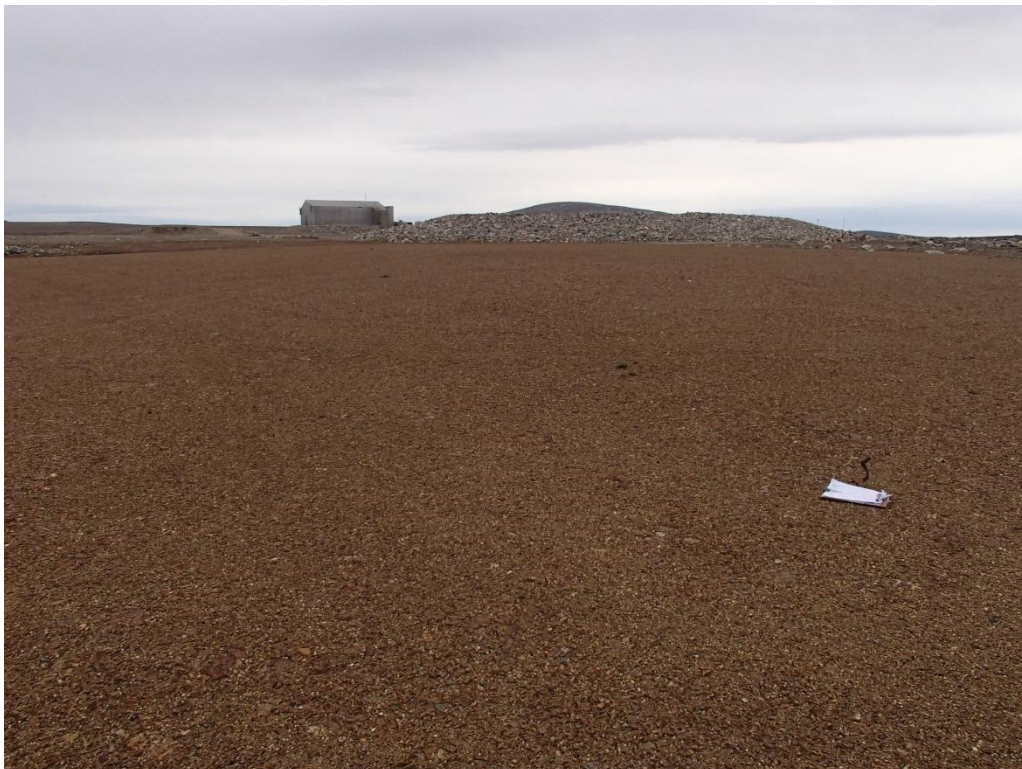
Photograph 96. Overview of the landfill looking south ↑

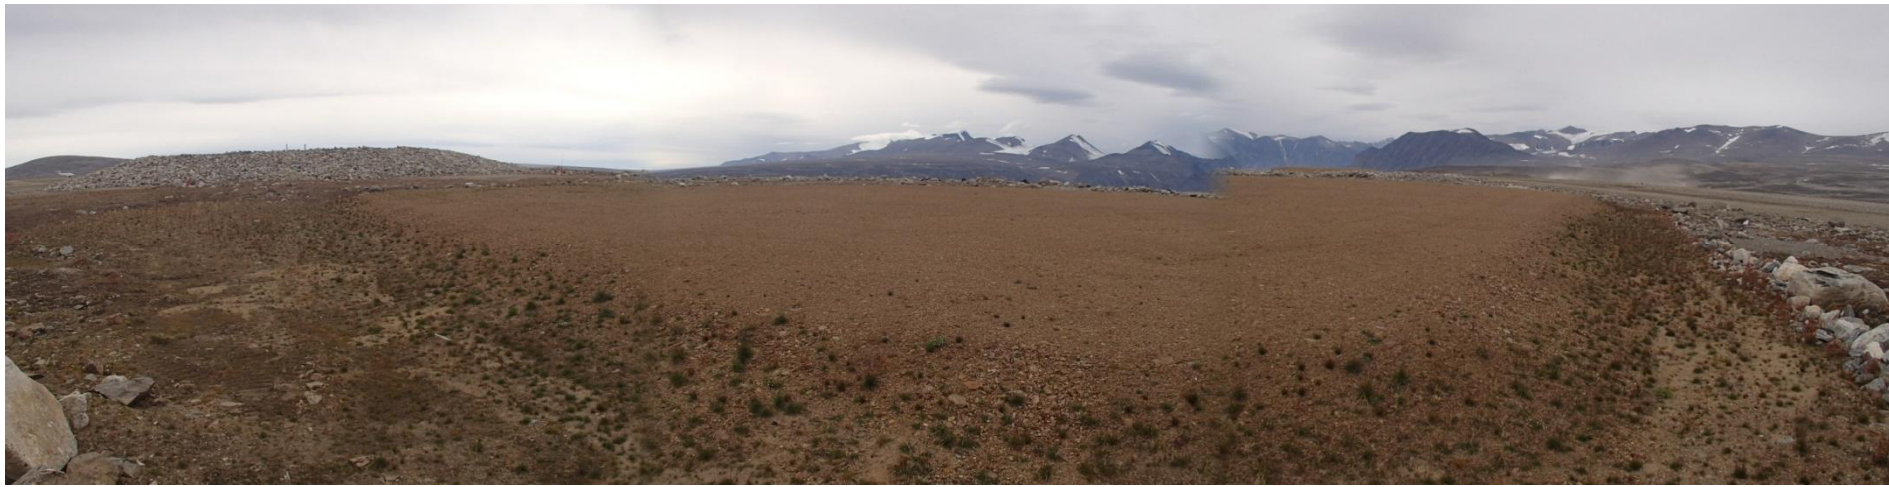
Photograph 97. Overview of the landfill looking west ↑

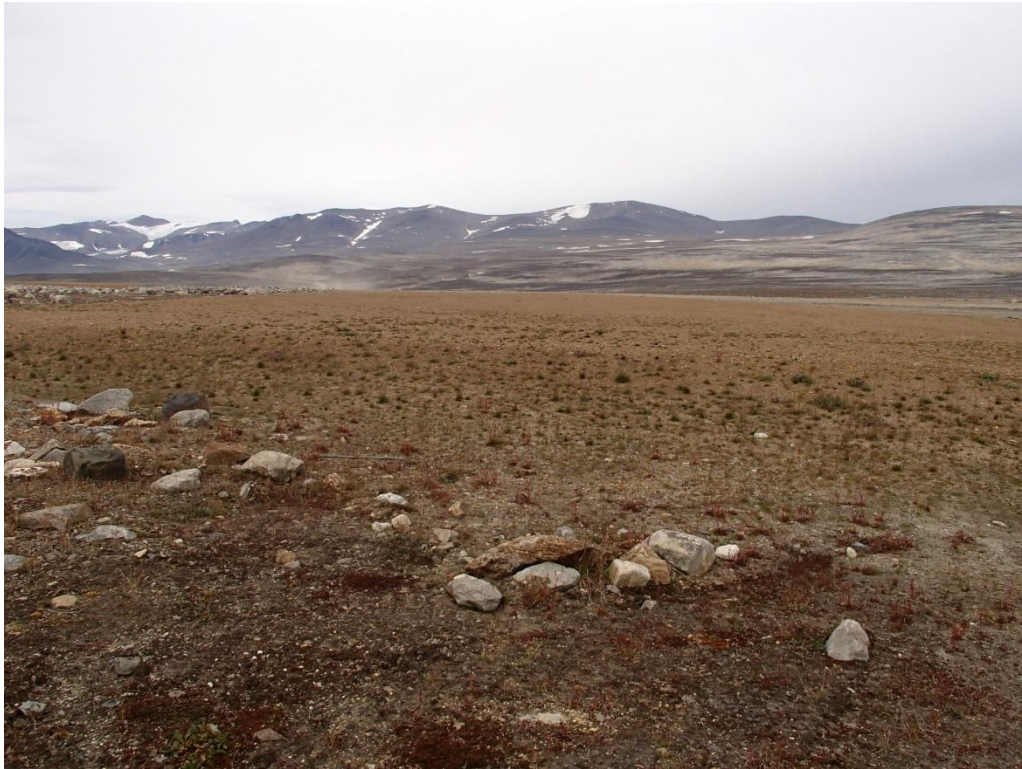
Photograph 98. Overview of the landfill looking north ↑

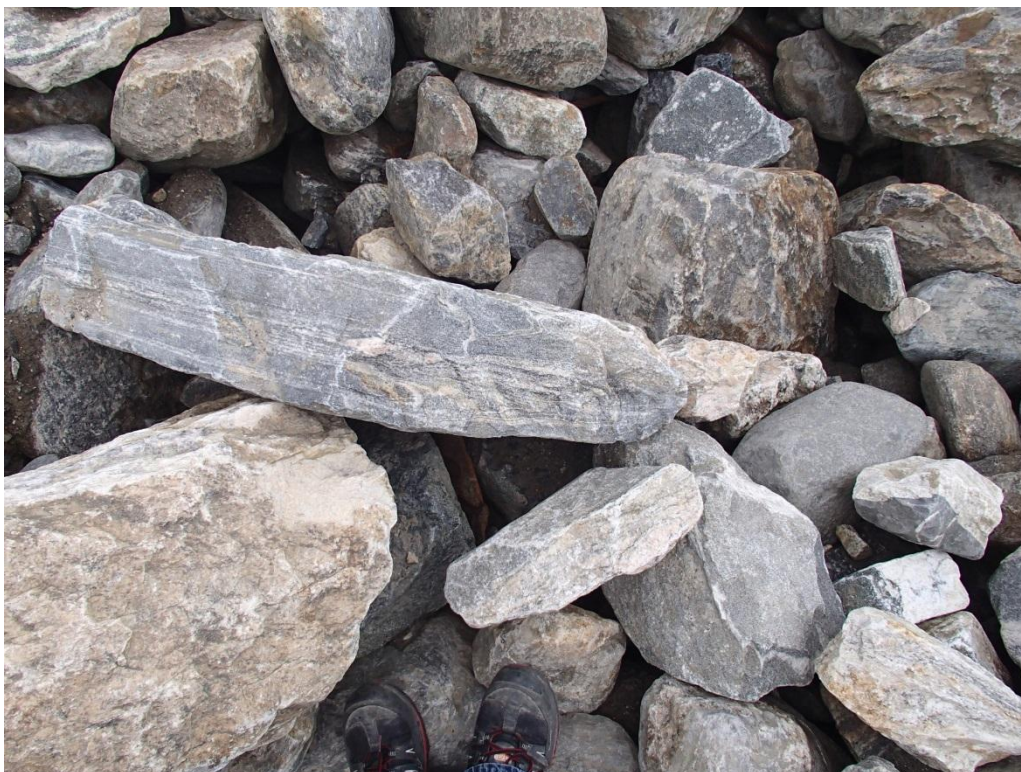
Photograph 100. Debris in Type 1 granular fill ↑

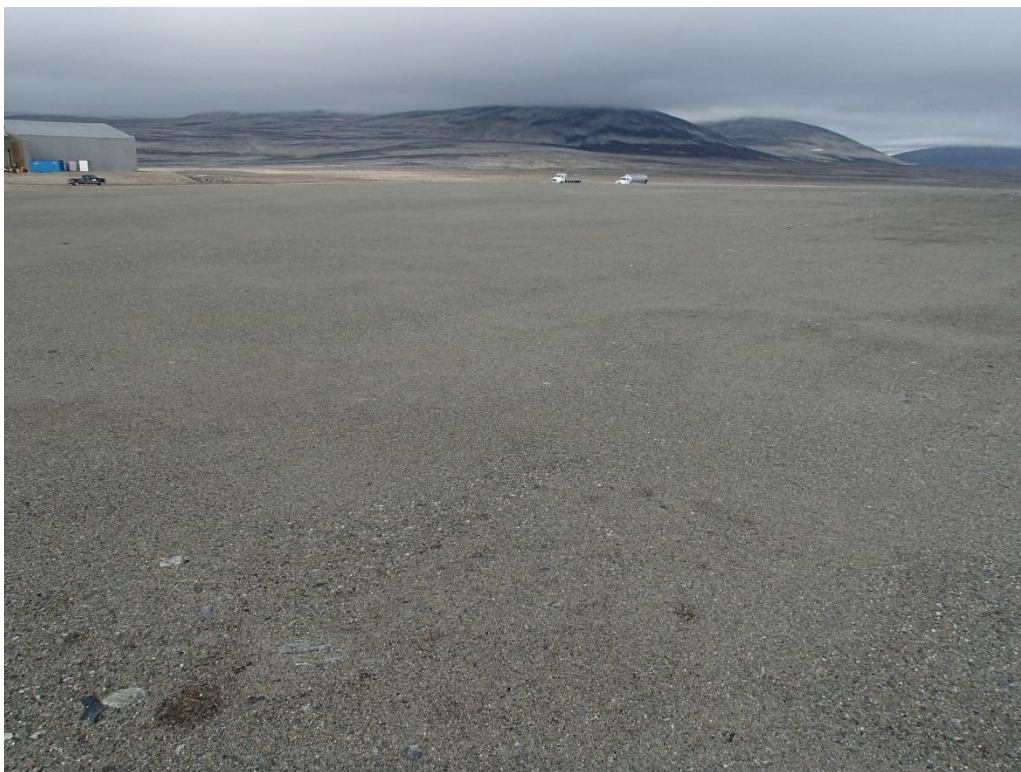
Photograph 135. Rough area in the centre of the landfill ↑

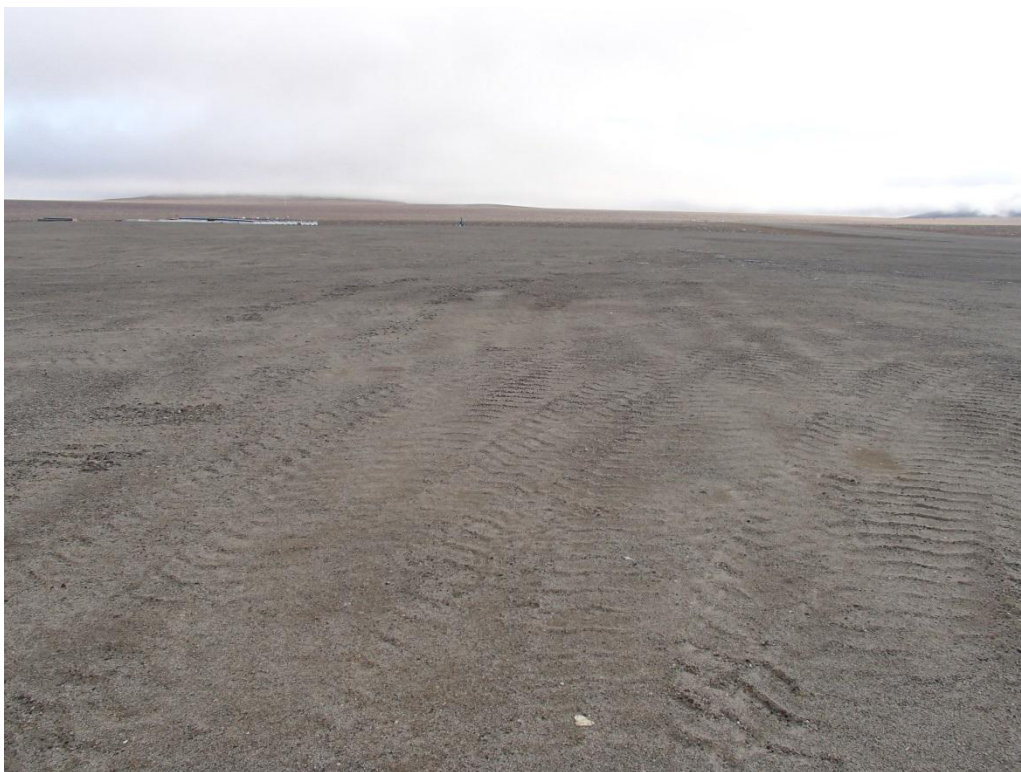
Tire tracks and a rough area were observed on the surface of the landfill. There was no evidence of settlement or slope stability issues and therefore, the landfill performance is rated as acceptable.

Photograph 139. **Rough area in the centre of the landfill** ↑
