Defence Construction Canada

DYE-M Cape Dyer Year 1 Landfill Monitoring

AECOM

November 19, 2015

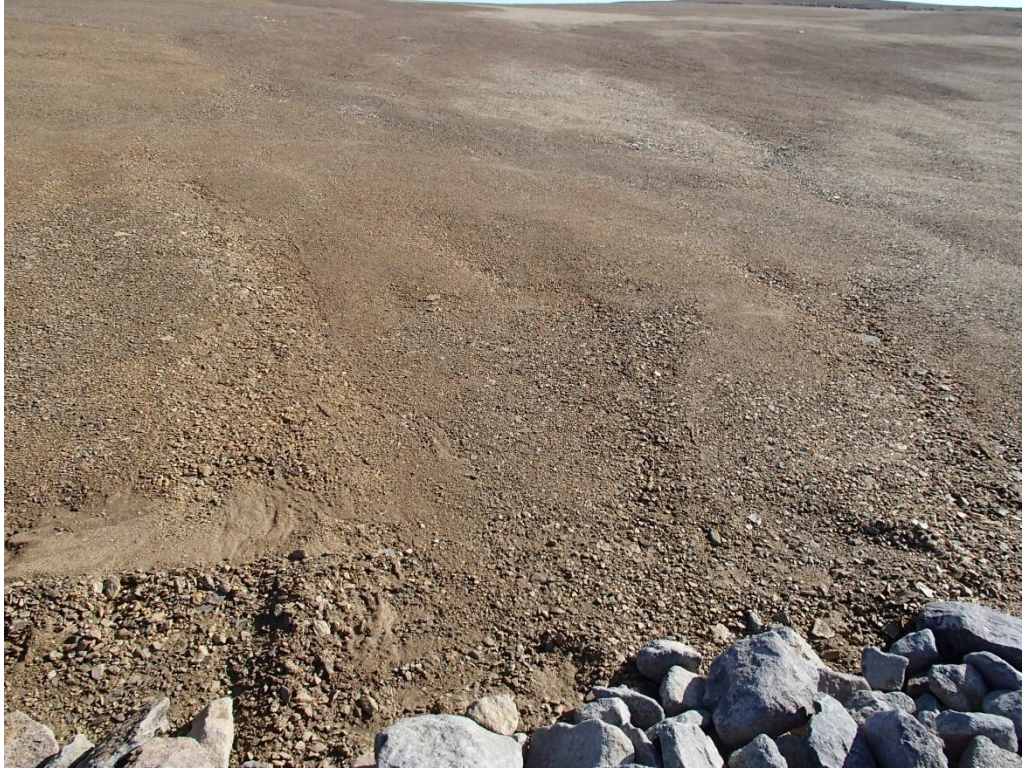
Two small areas of erosion were noted along the west edge and the centre west edge of the landfill. The erosion was minor and estimated to cover less than 5% of the surface of the landfill.

Photograph 21. **Area of minor erosion ↑**

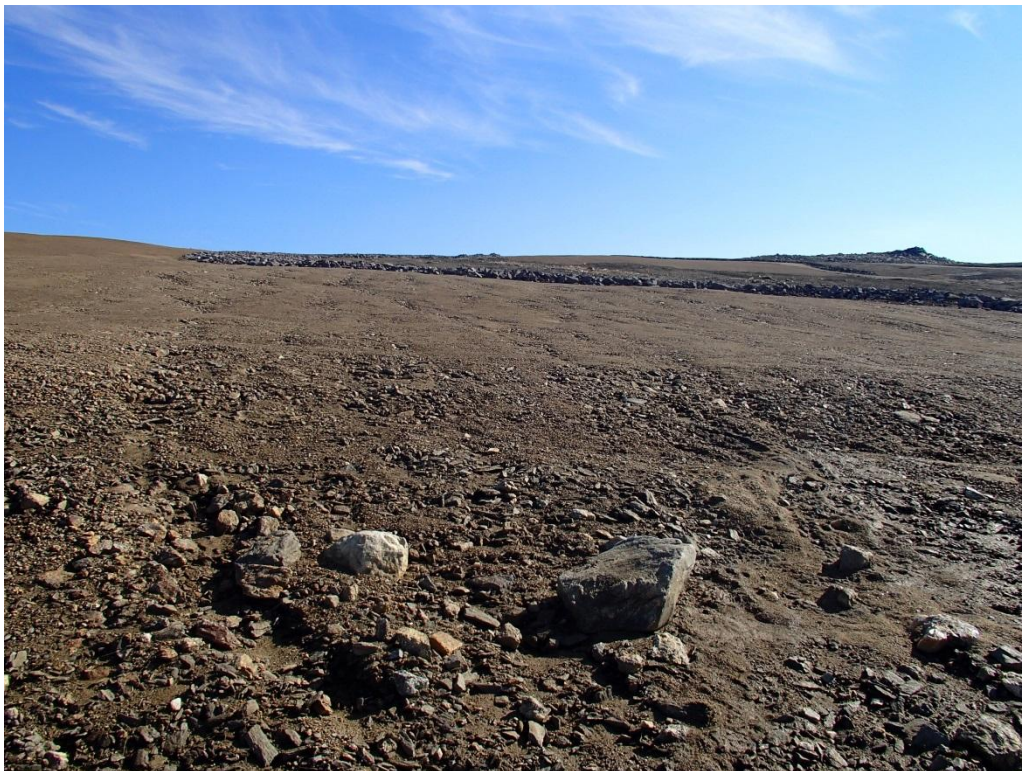
Photograph 22. **Area of minor erosion ↑**

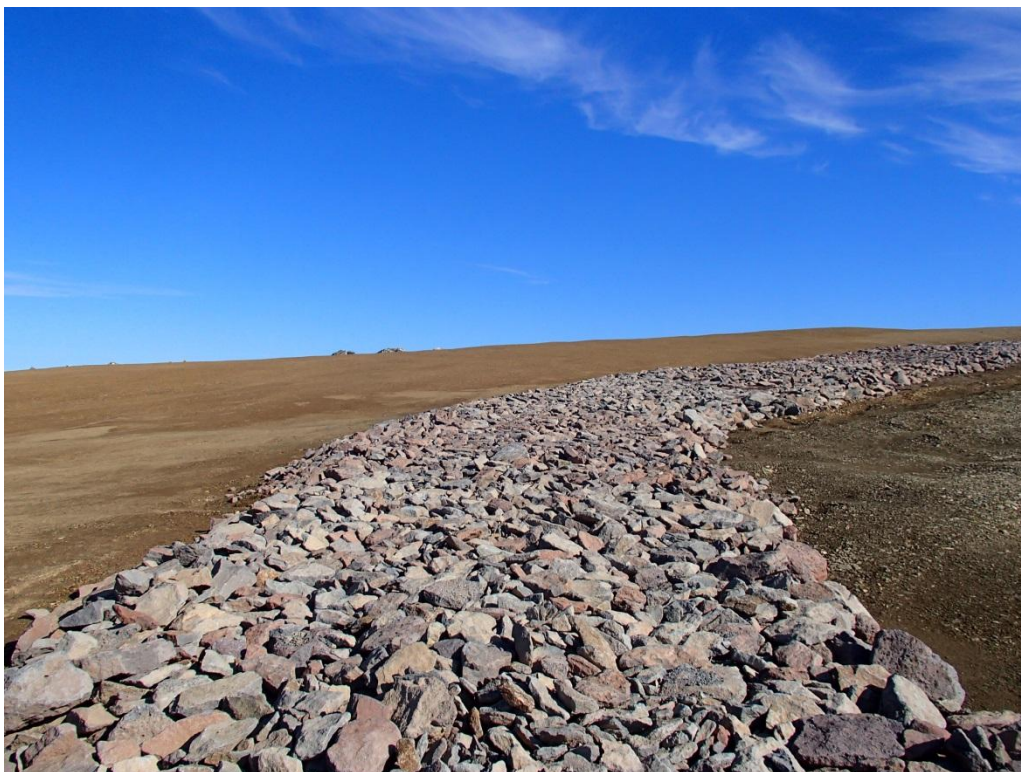
Photograph 23. Type 1 granular fill along the south toe ↑

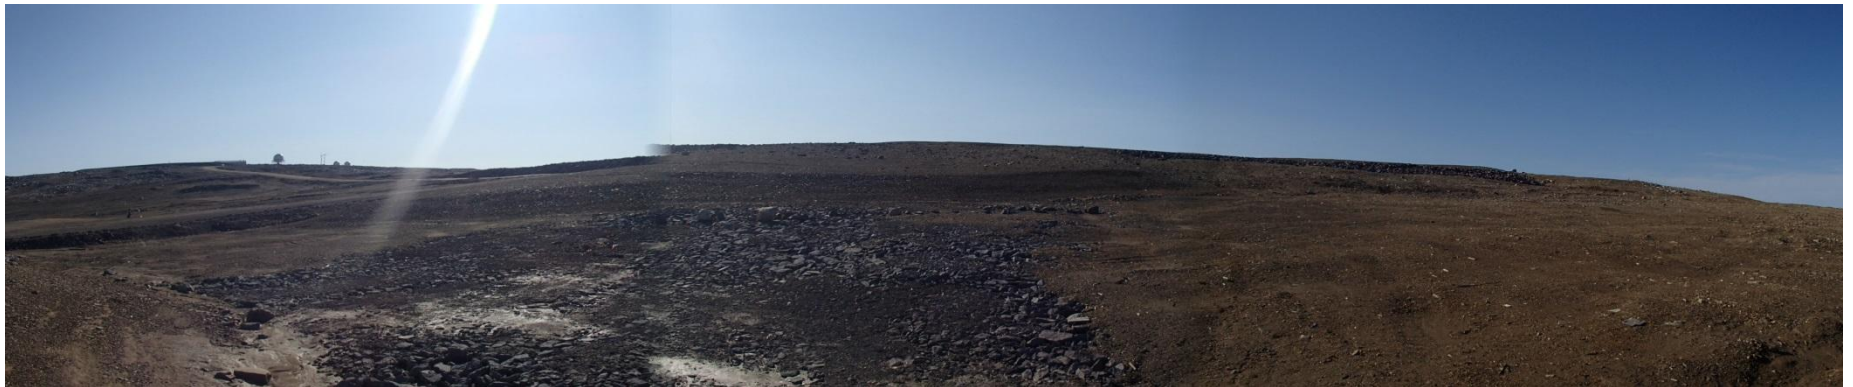
There was some damage noted on the south edge of the Centre Lobe A. The damage to Centre Lobe A is likely as a result of road clearing activities. There was minor evidence of settlement and therefore, the landfill performance is rated as acceptable.

Photograph 3. Overview of the Centre Lobe A looking south from north side ↑

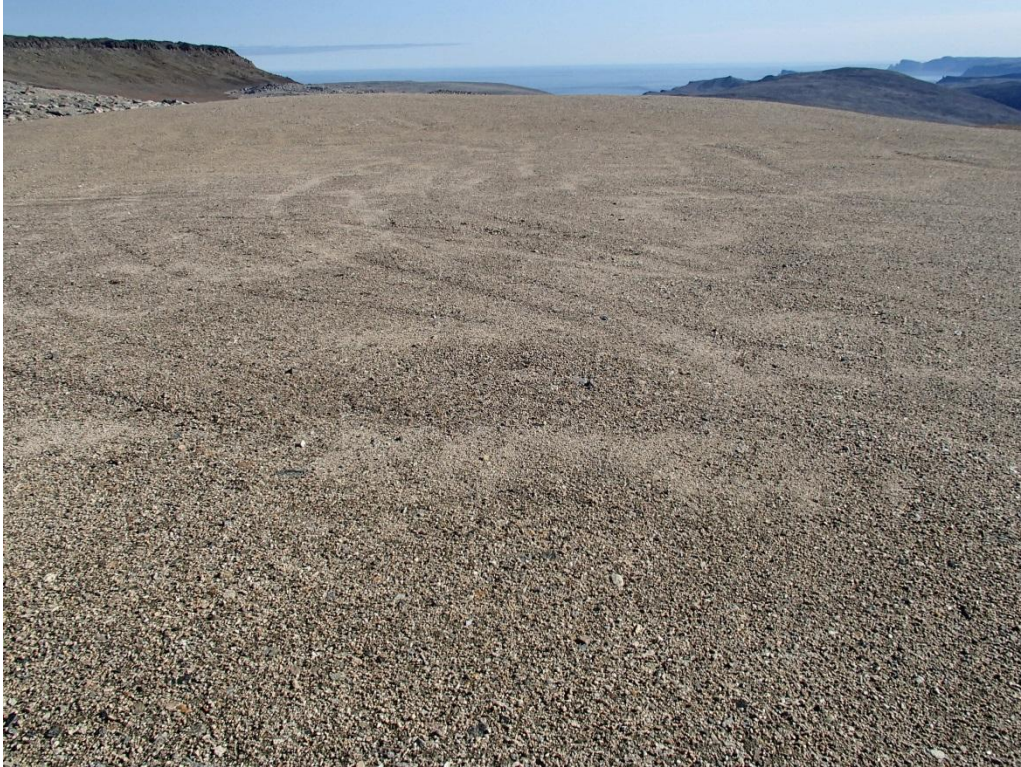
Photograph 69. Tire tracks on the surface of Lobes 2, 3 and 4 ↑

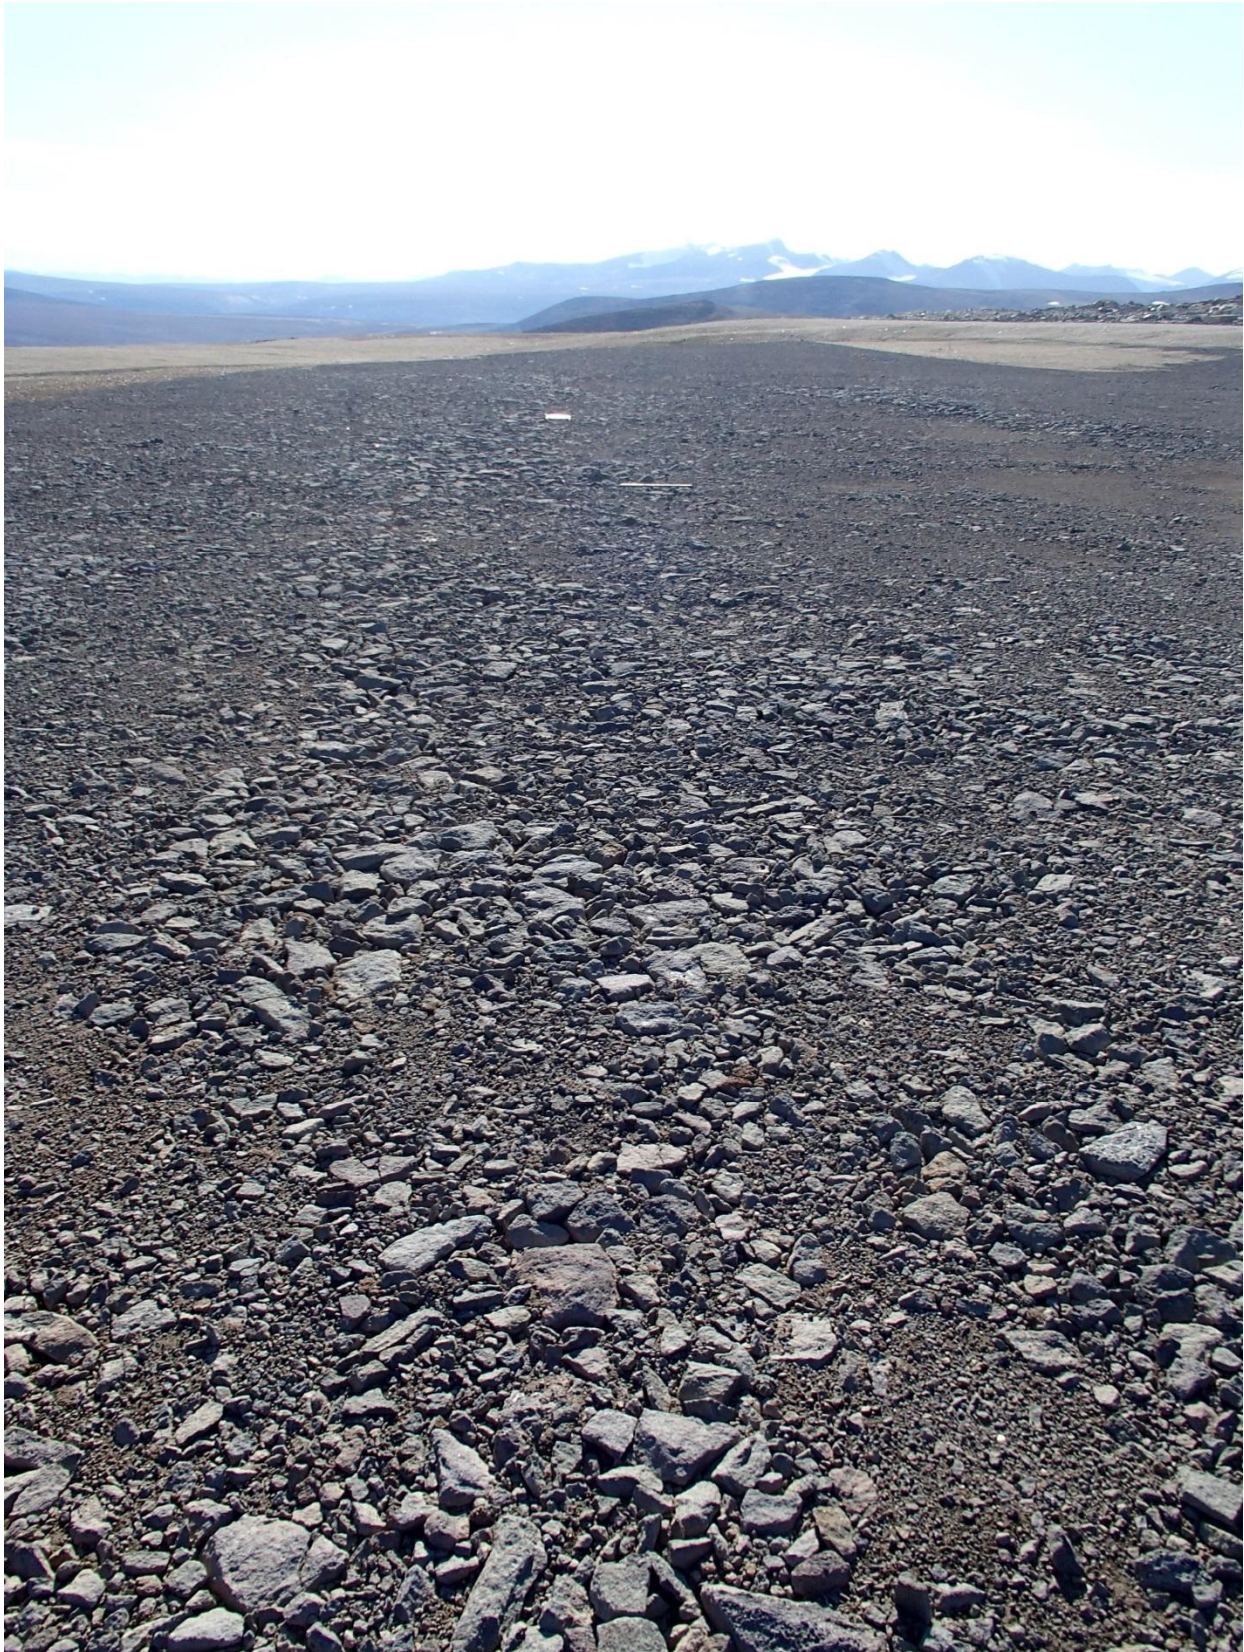
Photograph 73.

An area of erosion was noted at the south end of Lobe 2 and an area of segregation was noted in the centre of the lobe. Lobes 1 and 3 had minor tension cracks.

Area of segregation at the centre of Lobes 2, 3, and 4 ↑

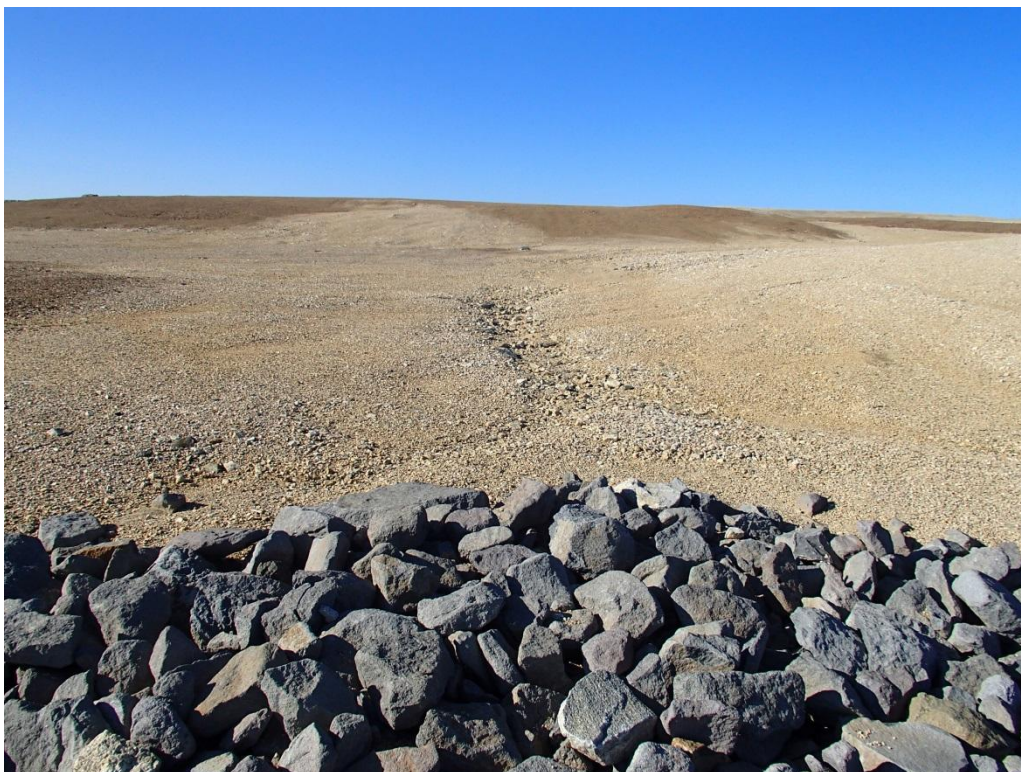
Photograph 75. Area of erosion at Lobes 2, 3 and 4 ↑

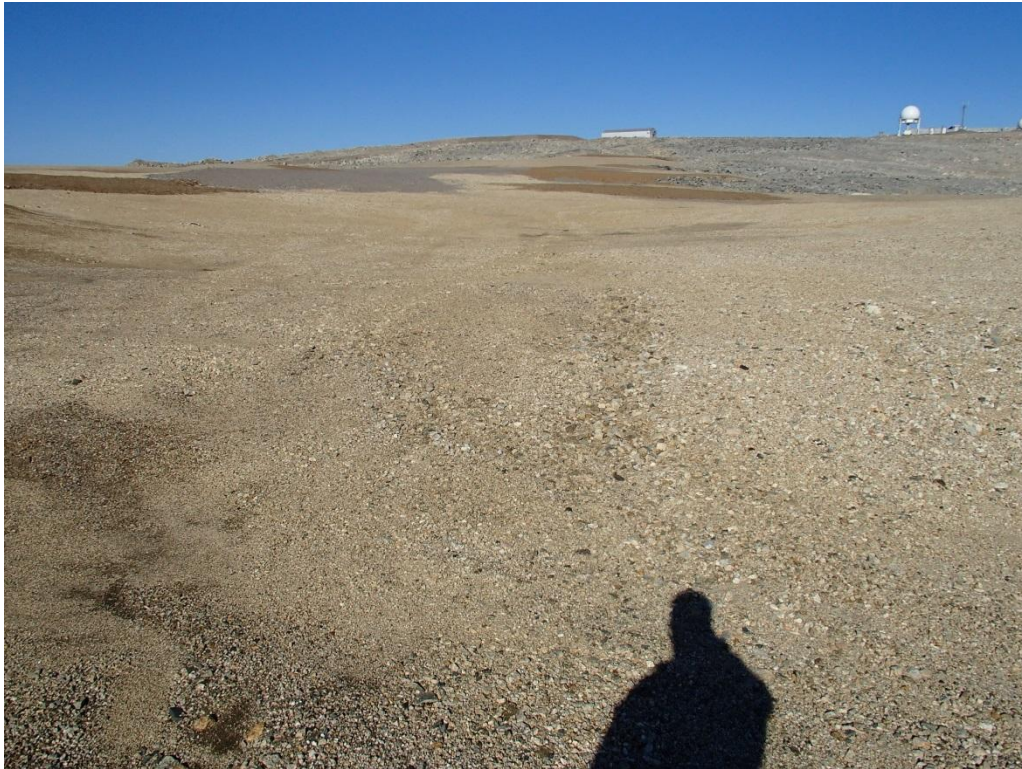
Photograph 76. Low area and area of minor erosion on Lobes 2, 3 and 4 ↑

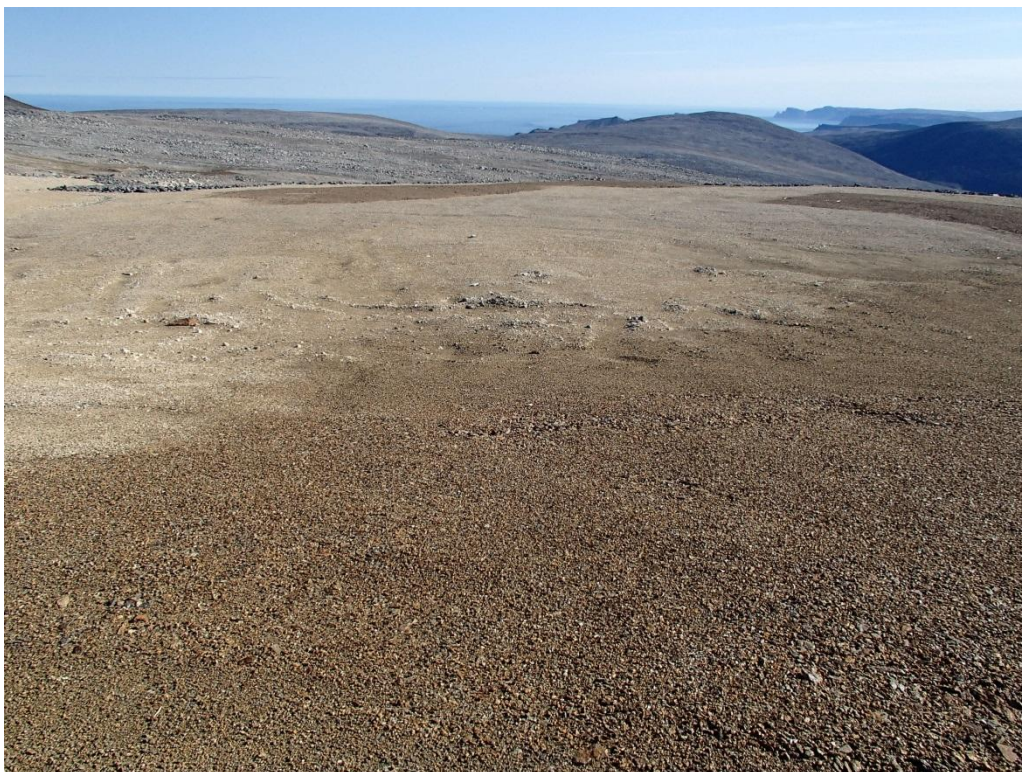
Photograph 77. Rough area on the surface of Lobes 2, 3 and 4 ↑

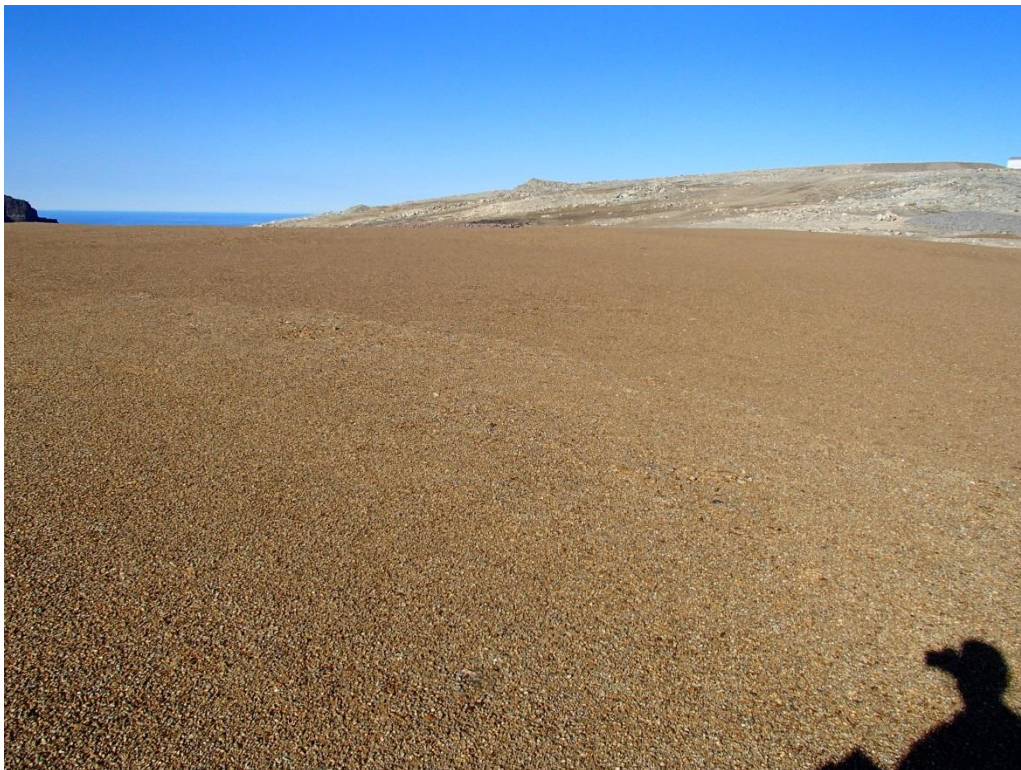
Photograph 80. Minor tension cracks on Lobe 1 ↑

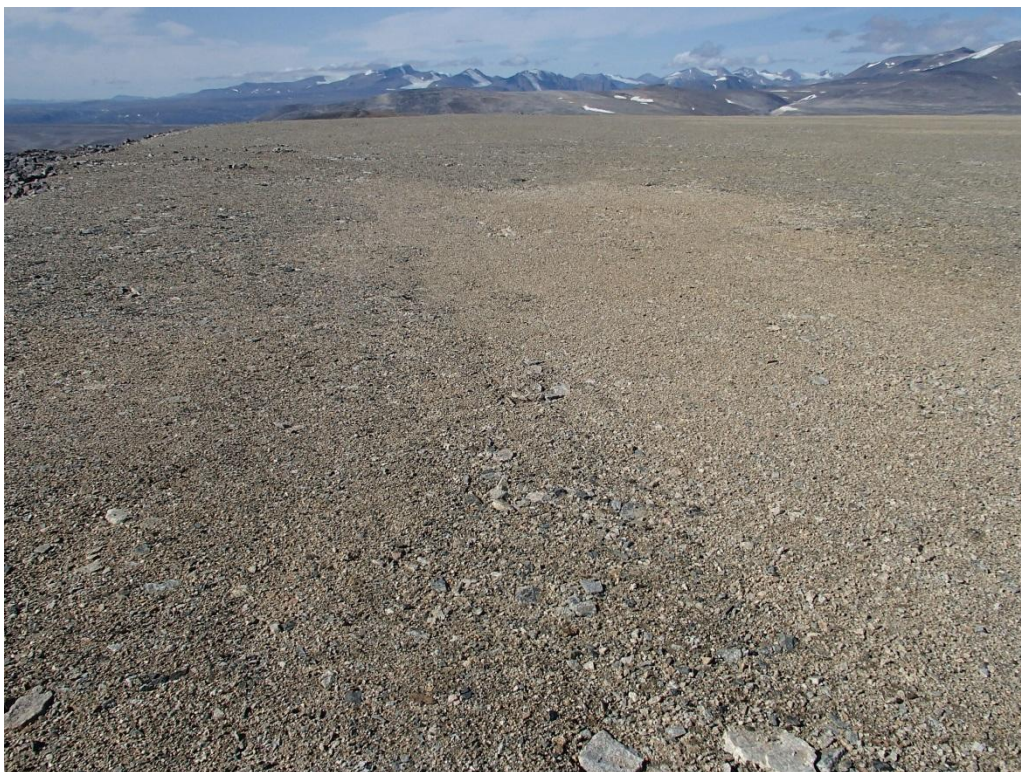
Tire tracks were observed on the surface of the landfill. Several areas of segregation were seen across the top of the landfill. There was no evidence of settlement or slope stability issues and therefore, the landfill performance is rated as acceptable.

Photograph 30. Area of segregation on the south portion of the landfill ↑

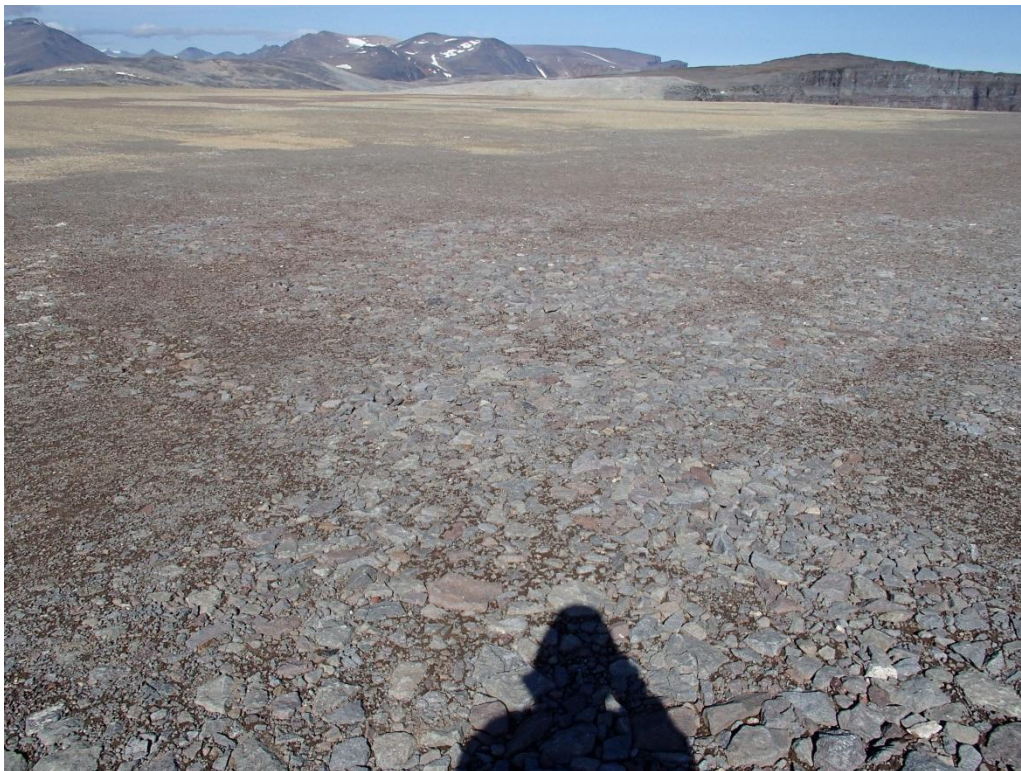
Photograph 31. Area of segregation on the southeast corner of the landfill ↑

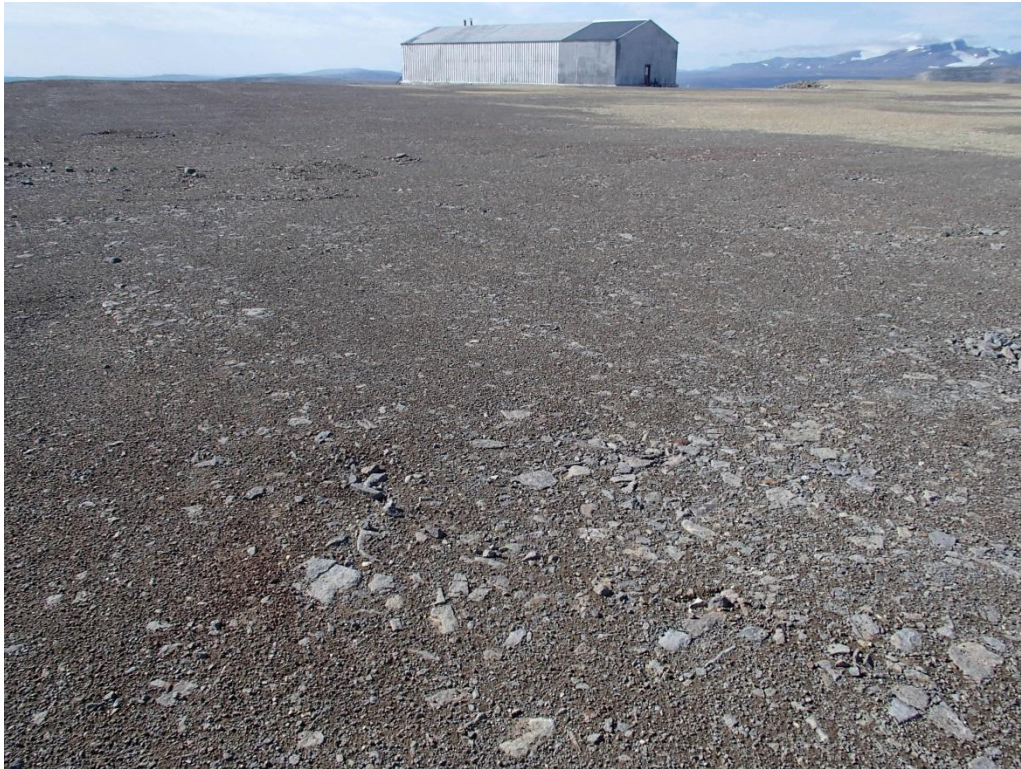
Photograph 32. Tire tracks on the east side of the landfill ↑

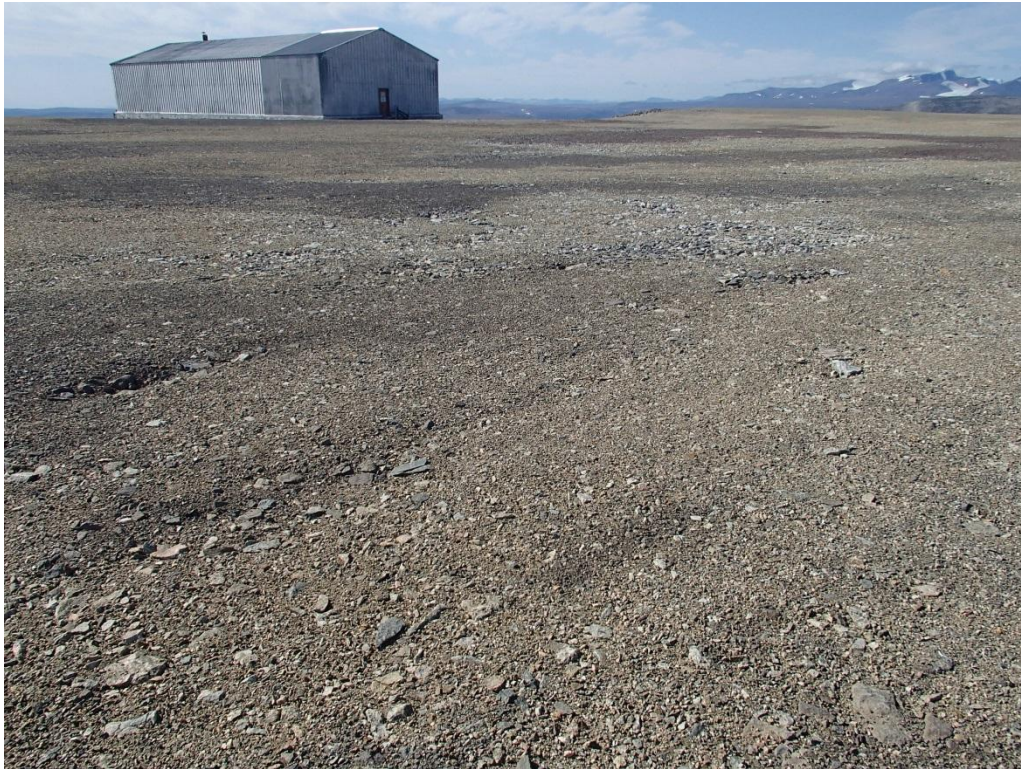
Photograph 34. **Area of segregation ↑**

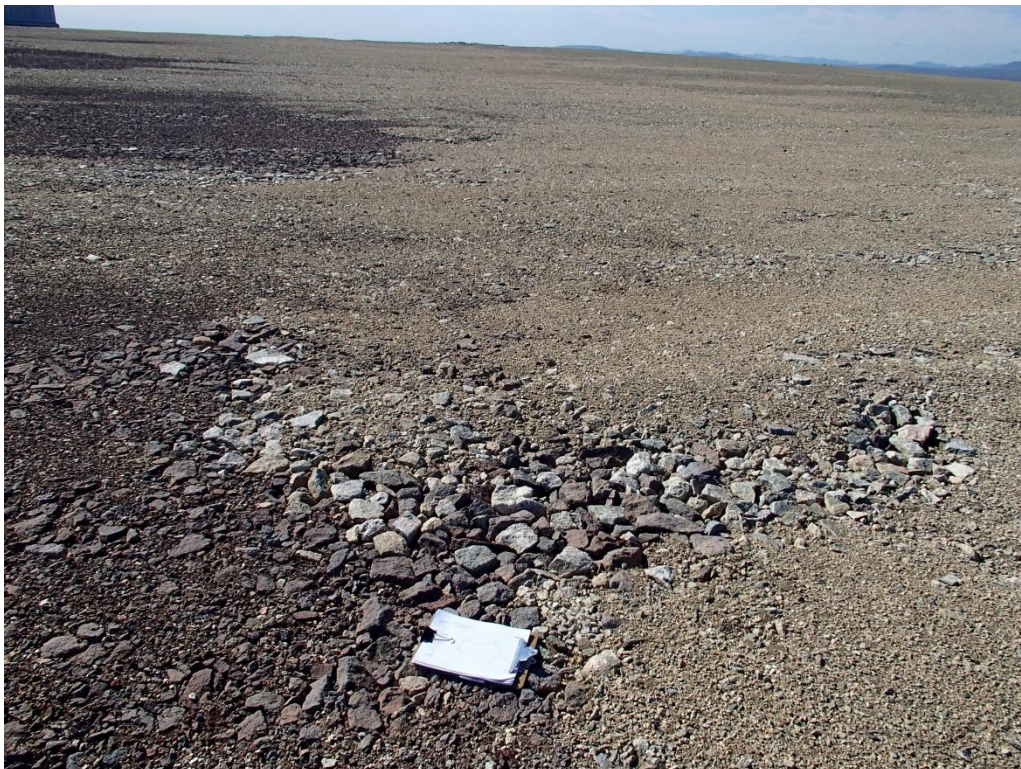
Photograph 35. **Area of segregation ↑**

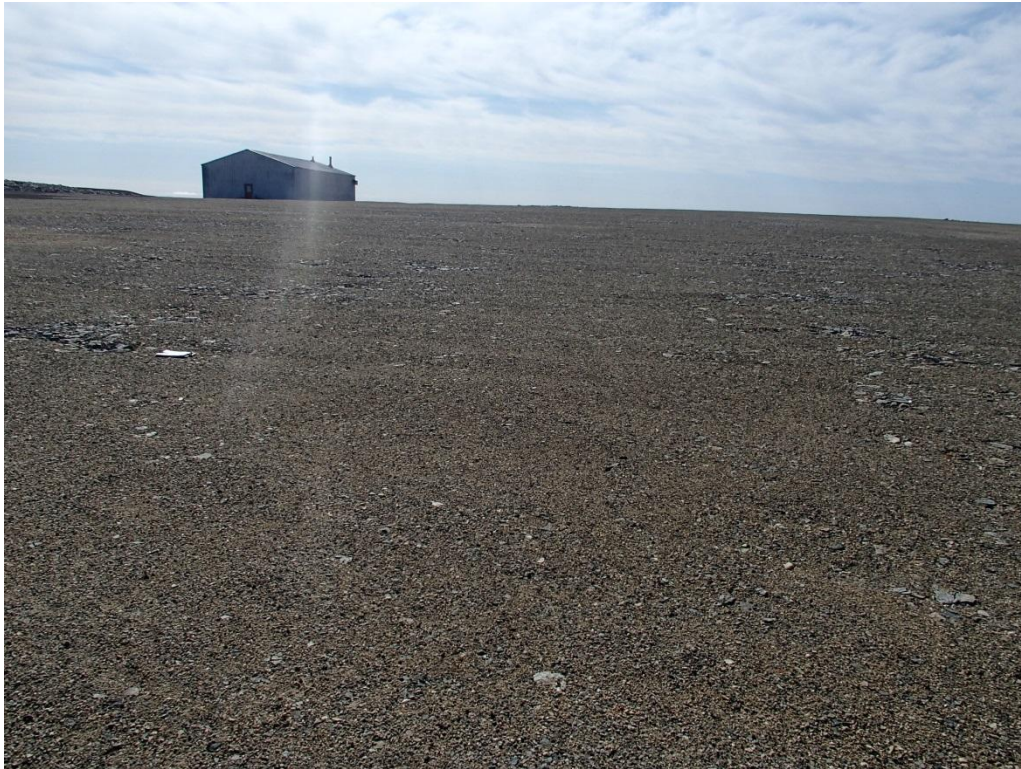
Photograph 36. **Area of segregation ↑**

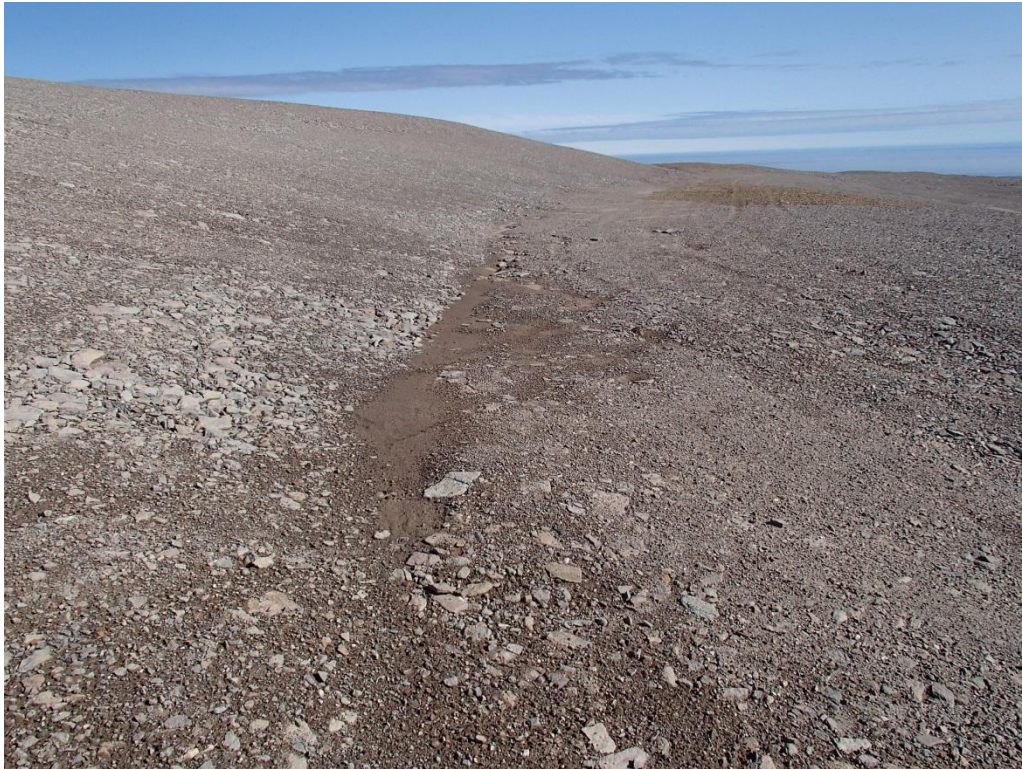
An area of sedimentation was observed in a low area in the centre of the regrade.

Photograph 51. Sedimentation along the ridge in the landfill ↑

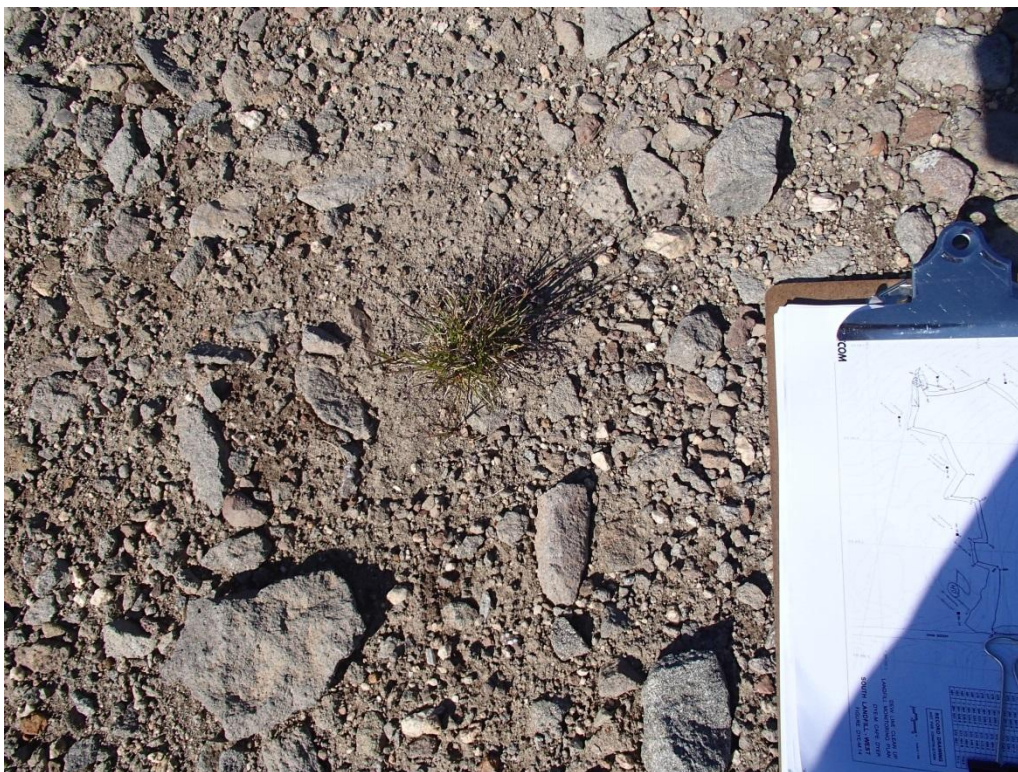
Areas of sparse vegetation were observed on the top surface of the landfill.

Photograph 43. Vegetation on the surface of the landfill ↑

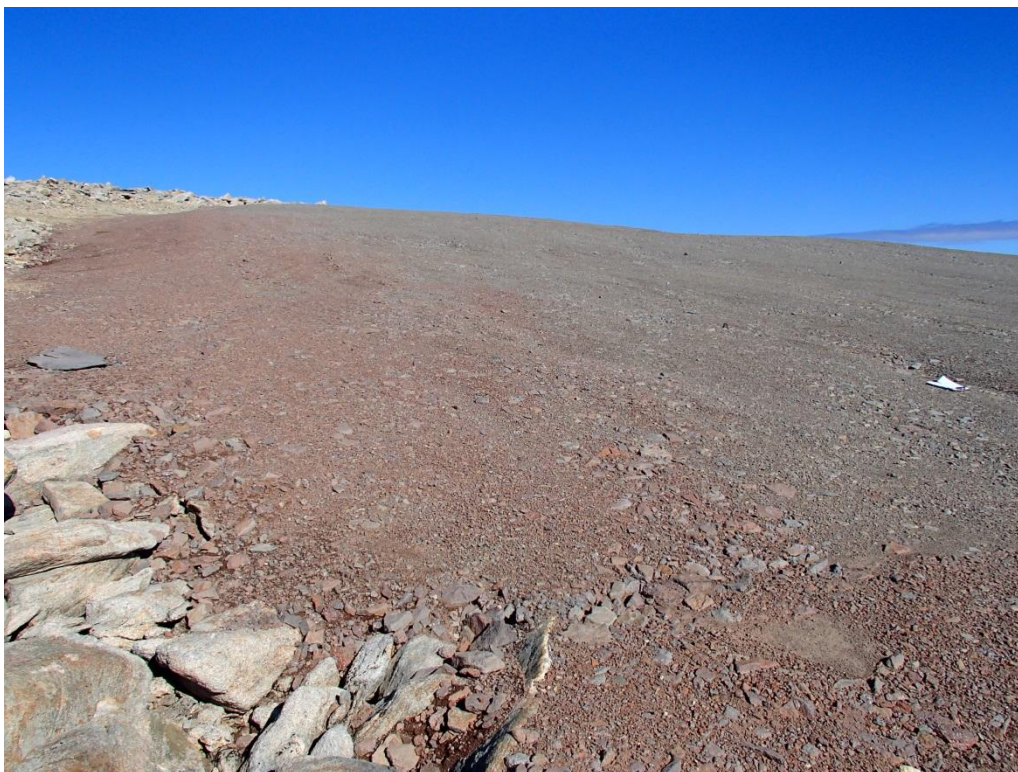
Photograph 44. Low spot and surface debris on the west side of the landfill ↑

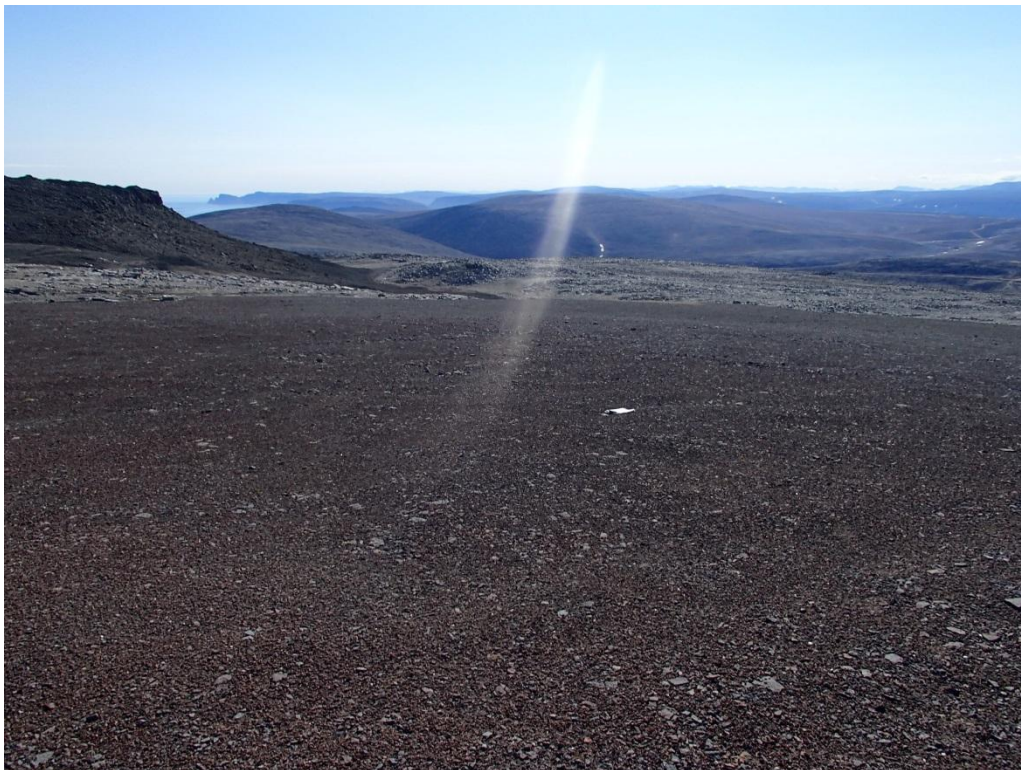
Photograph 45. Looking south from the north-centre portion of the landfill ↑

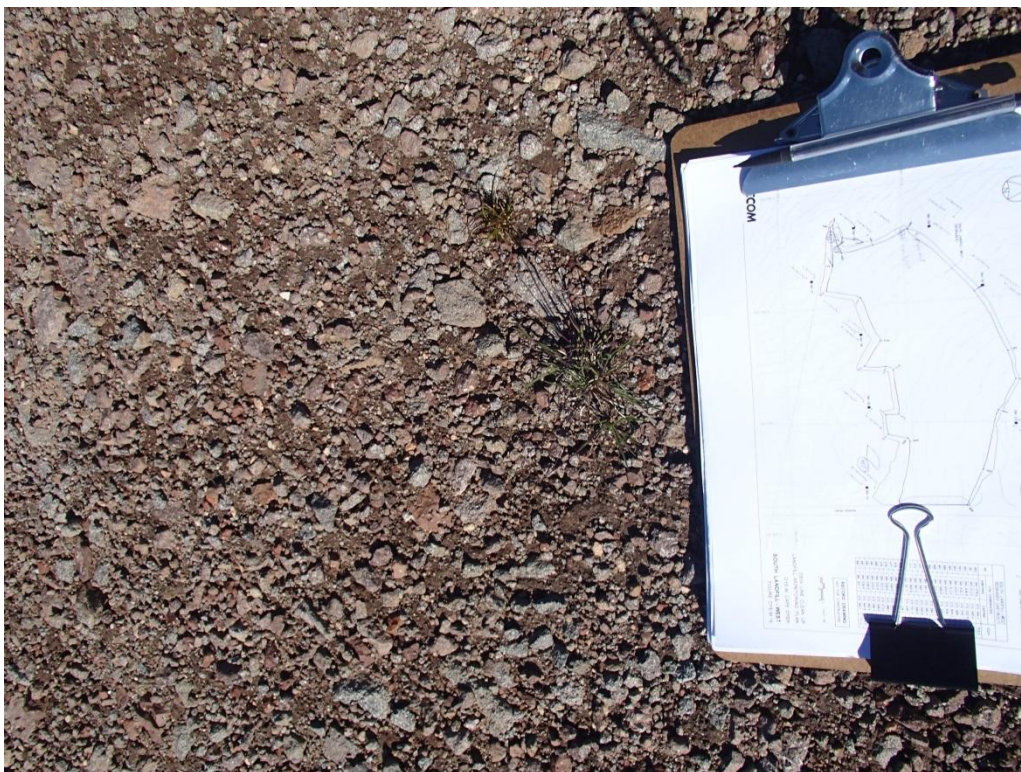
Photograph 46. Vegetation on the surface of the landfill ↑

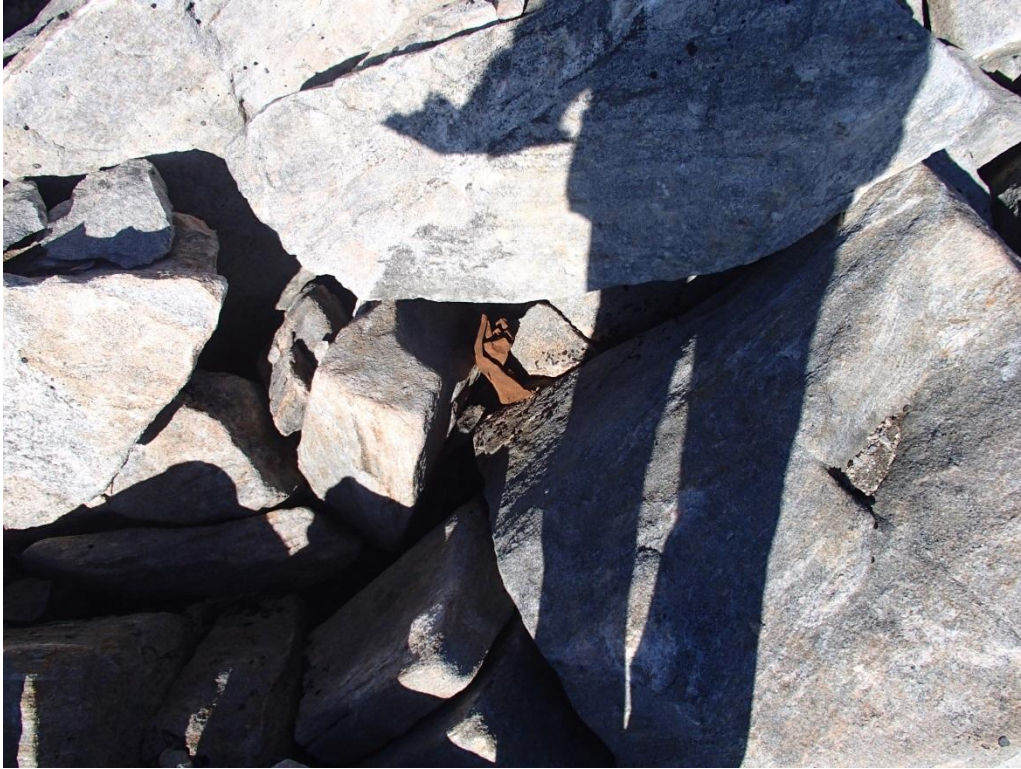
Photograph 47. Debris located between South Landfill – West and the Upper Site NWS Landfill ↑
