**DEW LINE CLEAN UP PROJECT  
FOX-C (EKALUGAD FJORD)  
DEW LINE SITE  
2004 GEOTECHNICAL INVESTIGATION**

**Project No. 1100065.001**

**MARCH 2005**

# **EBA Engineering Consultants Ltd.**

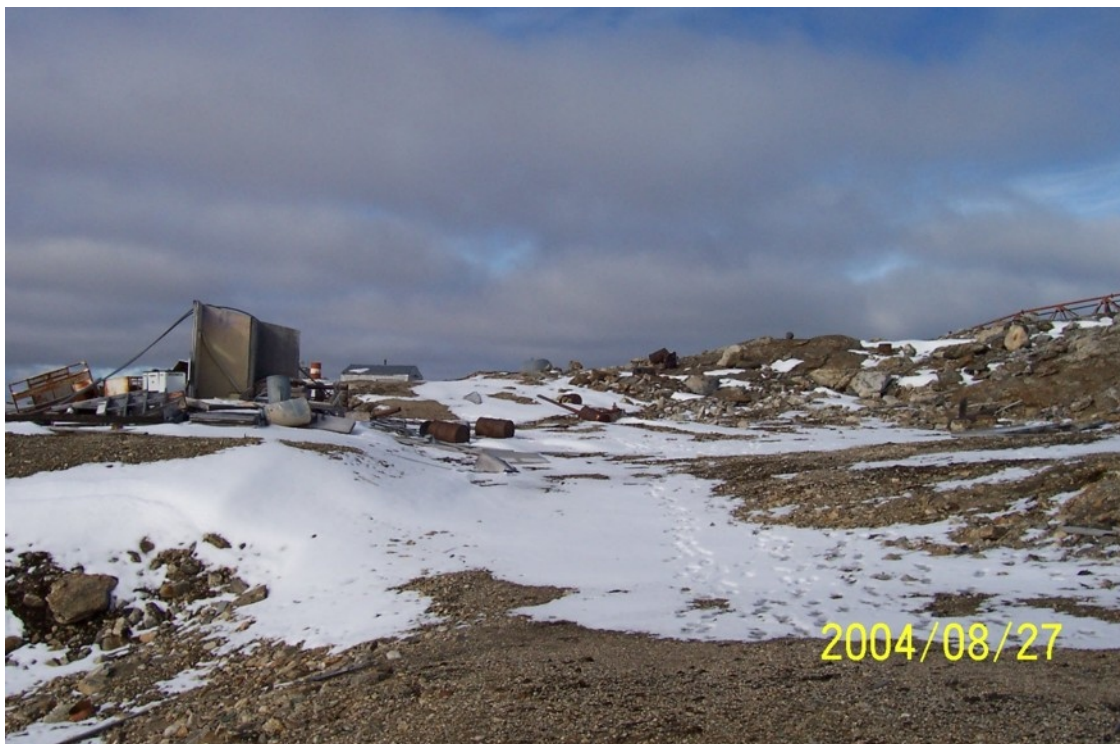
**Photo 5**

House Dump looking west, remnants of Inuit house on left, House Dump on right.

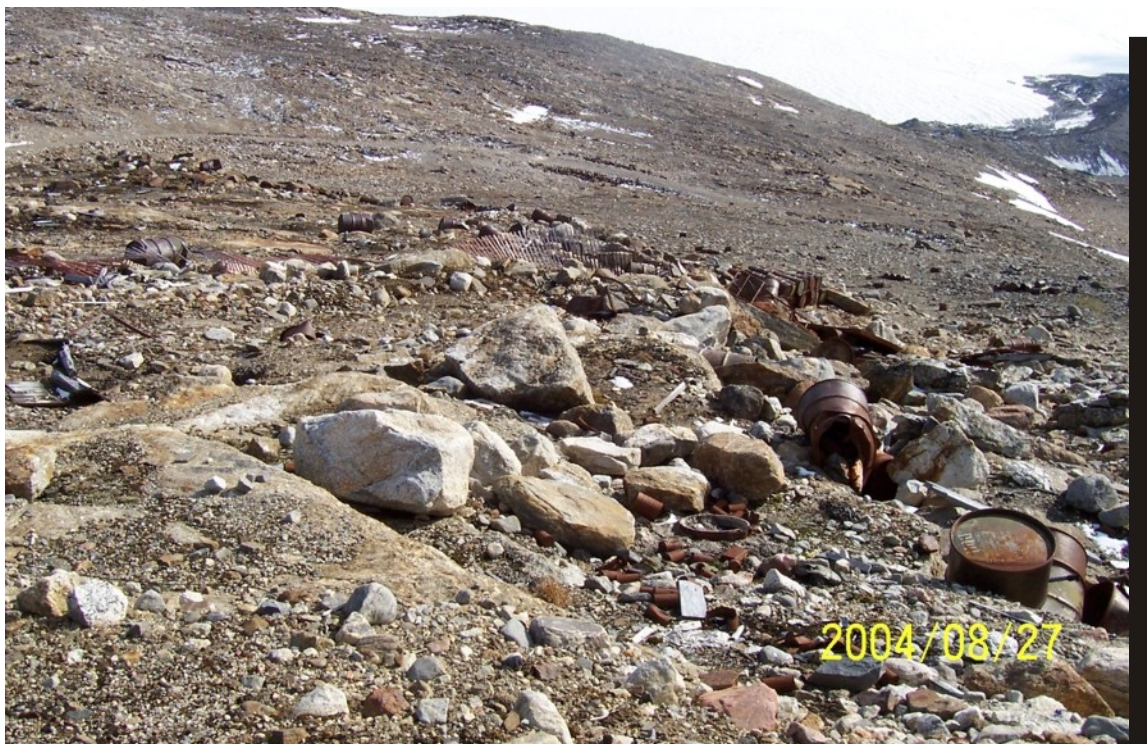
**Photo 7**

Original Dump looking southwest, west side of Station Road.

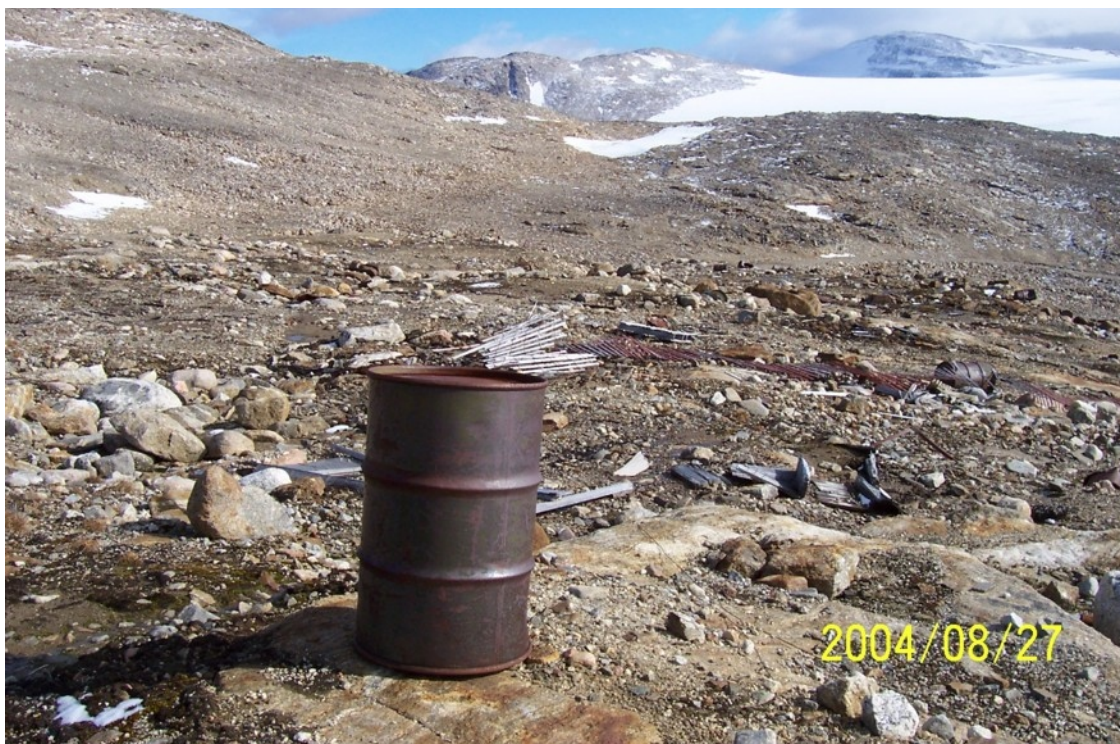
**Photo 8**

Original Dump looking southwest, east side of Station Road.

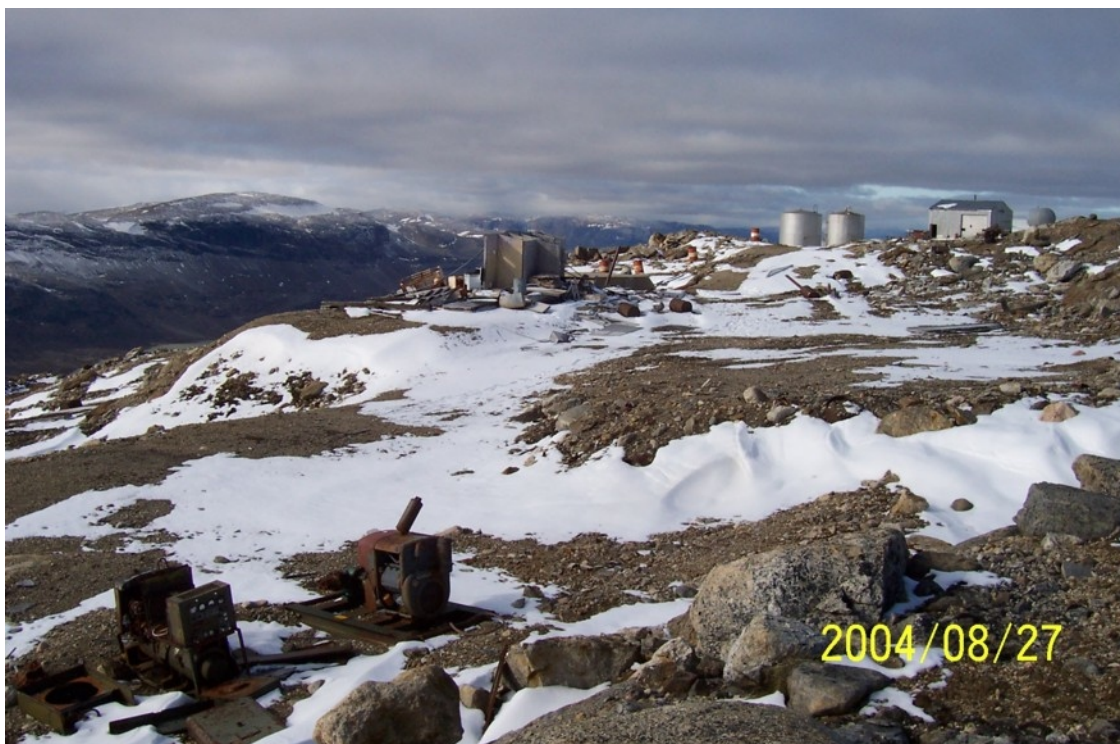
**Photo 14**

East Laydown Debris Area looking west, Lobe B in foreground.

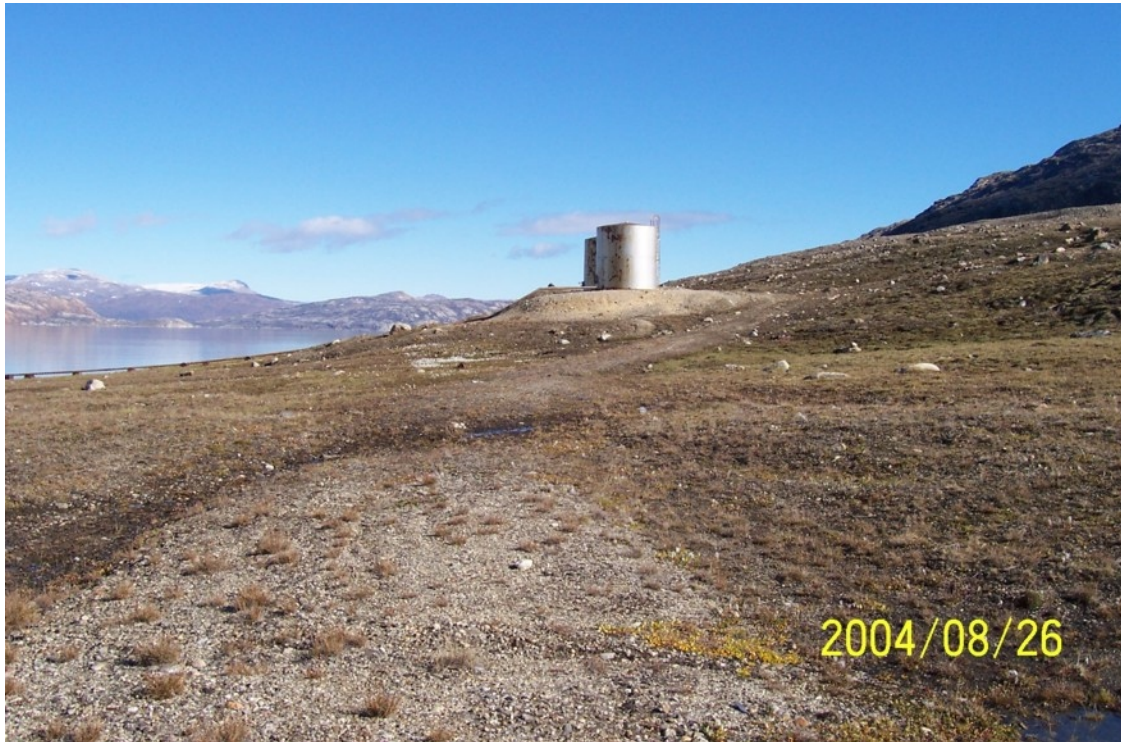
**Photo 15**

Beach POL Debris Area looking northeast, Lobe A in background.

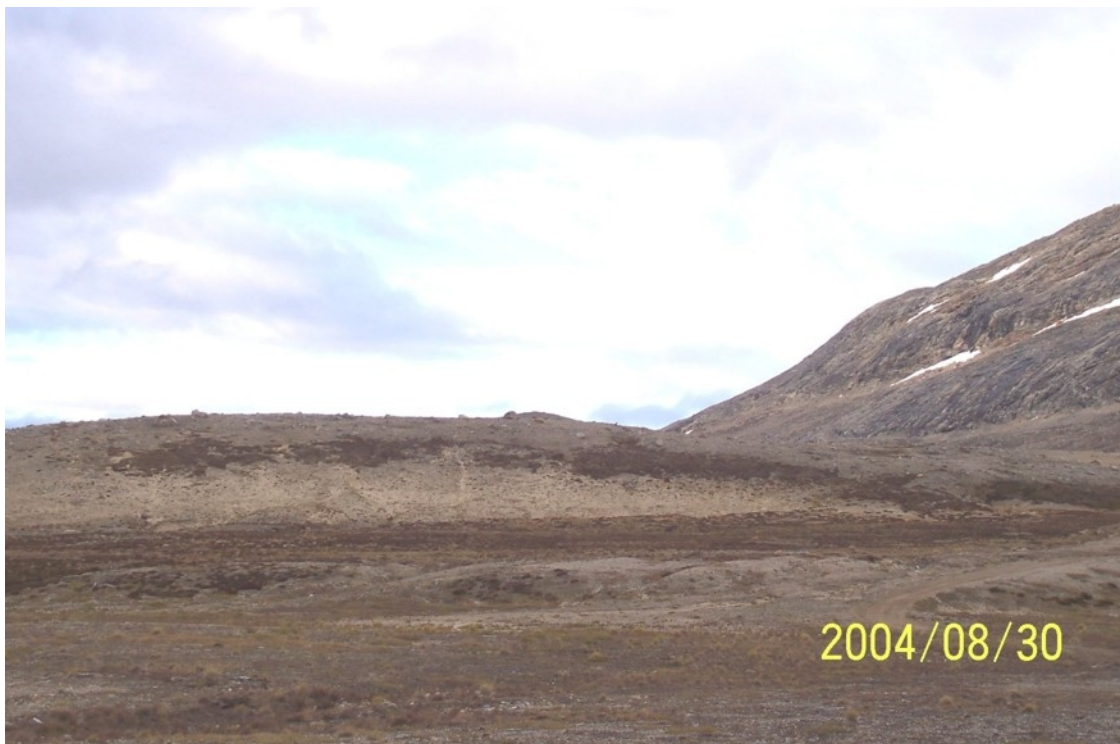
**Photo 17**  
Potential Debris Landfill Location 3 looking west.

Borrow Area 5 (Figure 9A and Photo 17) is a large relatively flat undisturbed area off Lake Road approximately 200 m east of the freshwater lake, as shown on Figure 9A and Photos 17. Potential Debris Landfill Location 3 is located within the area.

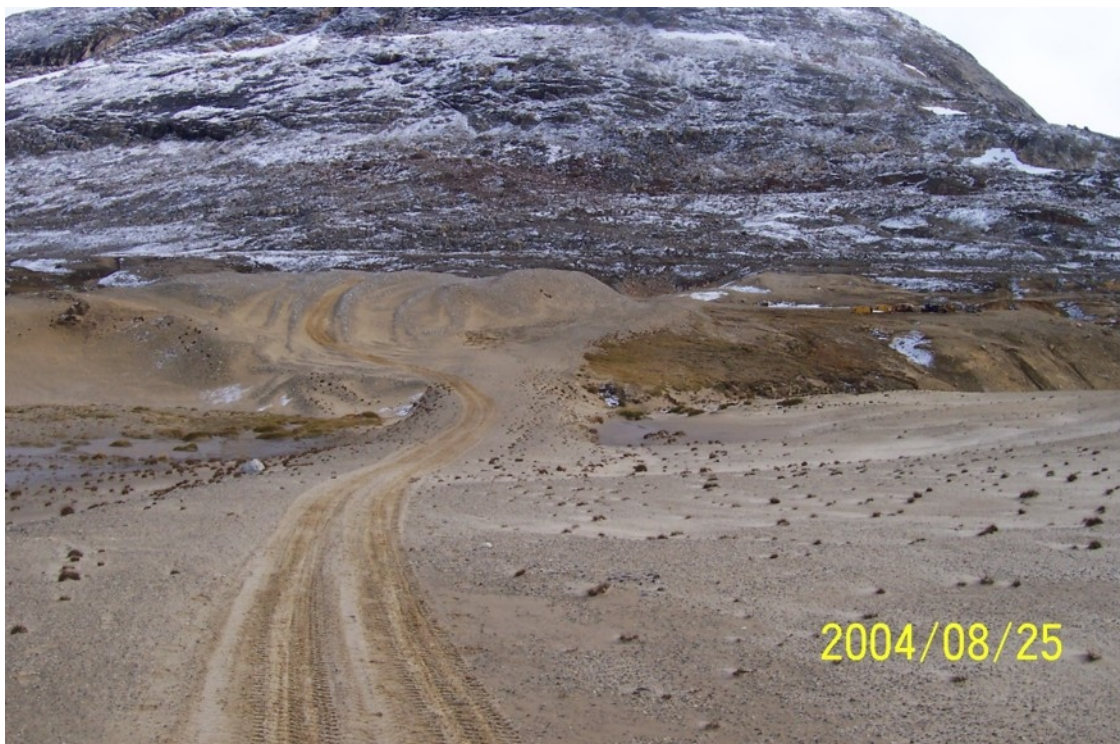
**Photo 23**  
Proposed Borrow Area 2 looking east.

Borrow Area 2 (Figures 1 and 10 and Photo 23) is located at the (Lake Road, Beach Road Station Road) Junction and contains a range of materials suitable for Type 1, Type 2, Type 3, Type 5, and Type 6 applications. Blending with fines from other sources would be required to meet the Type 2 gradation. A stockpile of sand and gravel and a partially developed area has exposed fine to medium grained sand. It appears that the stockpile was area derived from the respective borrow site.

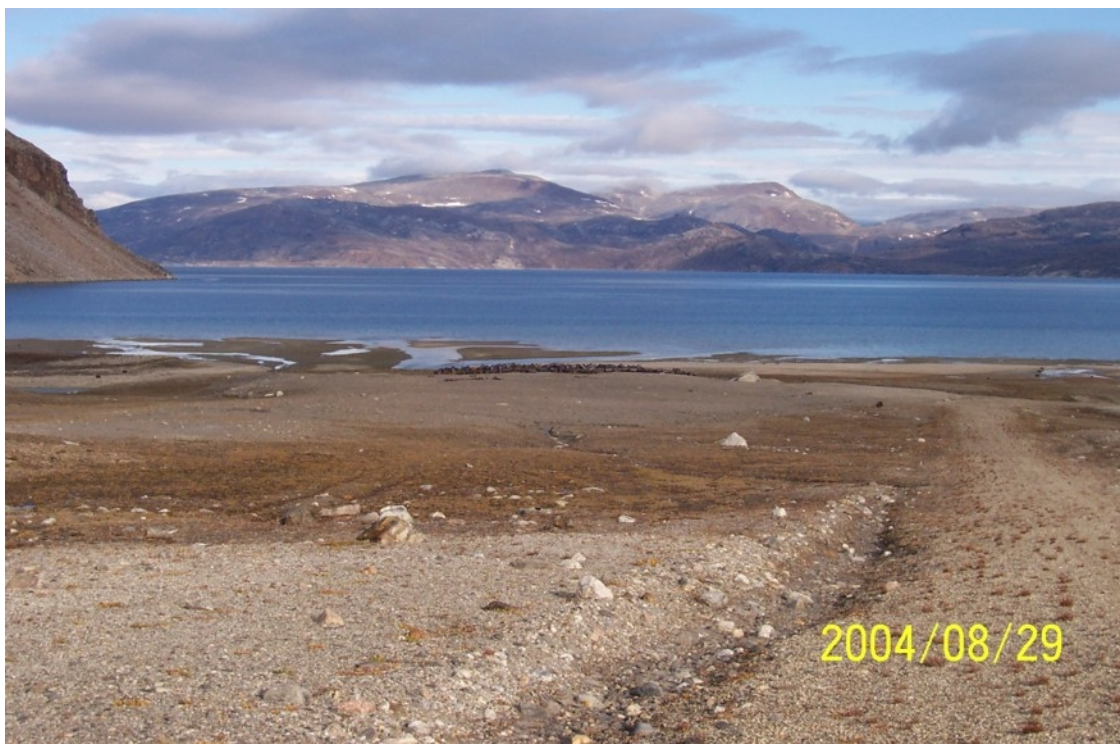
**Photo 24**  
Proposed Borrow Area 4 looking northwest.

Borrow Area 4 (Figure 12 and Photo 24) is located on the west side of Beach Road and approximately 600 m southwest of the Beach Area (Figure 1). Most of the proposed area is undisturbed; however, a barrel cache is present along the north perimeter.

The material in Borrow 4 is finer grained than the Type 4 specification in Section 6.1. The material would be acceptable for Type 4 Granular Fill if the moisture content at the time of construction is adequate to produce a workable material. Drying and blending with a granular material may be required. Selective excavation with some sorting to remove boulders and cobbles greater than 100 mm diameter would also be required to make the material suitable for Type 4 Granular Fill. The identified area shown on Figure 12 is approximately 25,000 m<sup>2</sup>. Assuming an average excavation thickness of 0.5 m, and a selective sourcing, an estimated volume of 8,000 m<sup>3</sup> of Type 4 Granular Fill would be available. Additional material may be available at greater depth or the area could be expanded to the south.

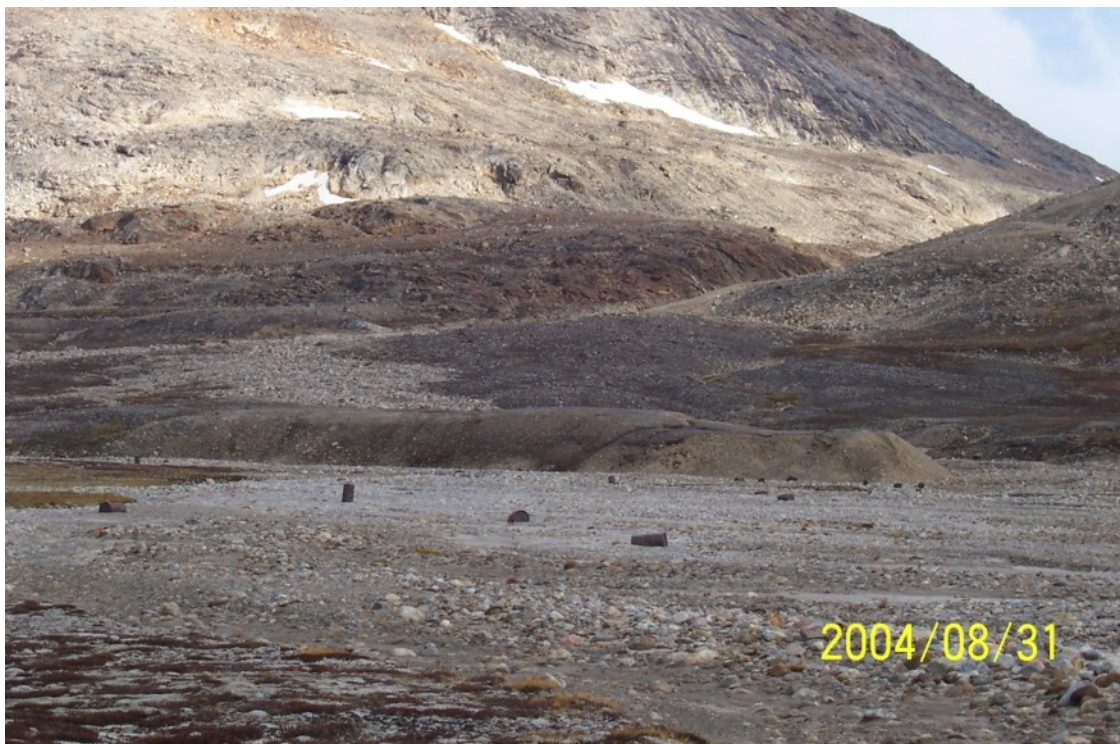
**Photo 25**  
Proposed Borrow Area 7 looking northeast.

Borrow Area 7 (Figure 6 and Photos 25 through 28) is a large relatively flat, terraced area off Station Road approximately 350 m east of the junction of the access roads. The area is on the south side of the glacier fed river and is predominantly undisturbed.

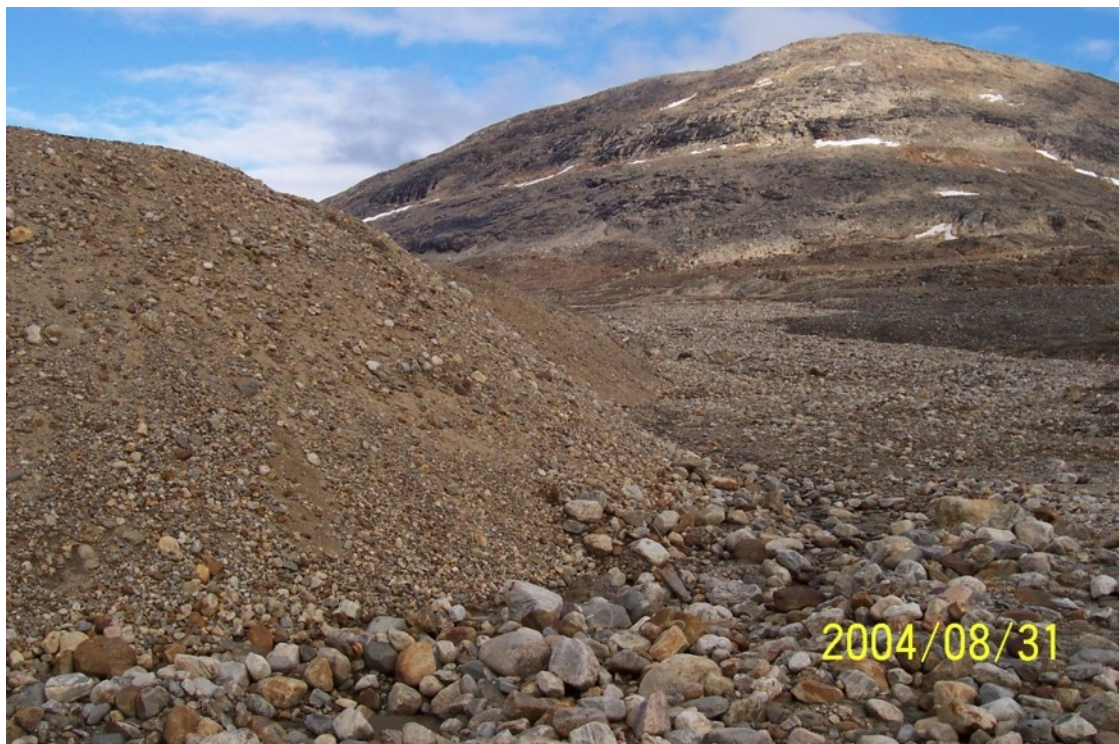
**Photo 28**

Proposed Borrow Area 7 looking northeast, slope face.

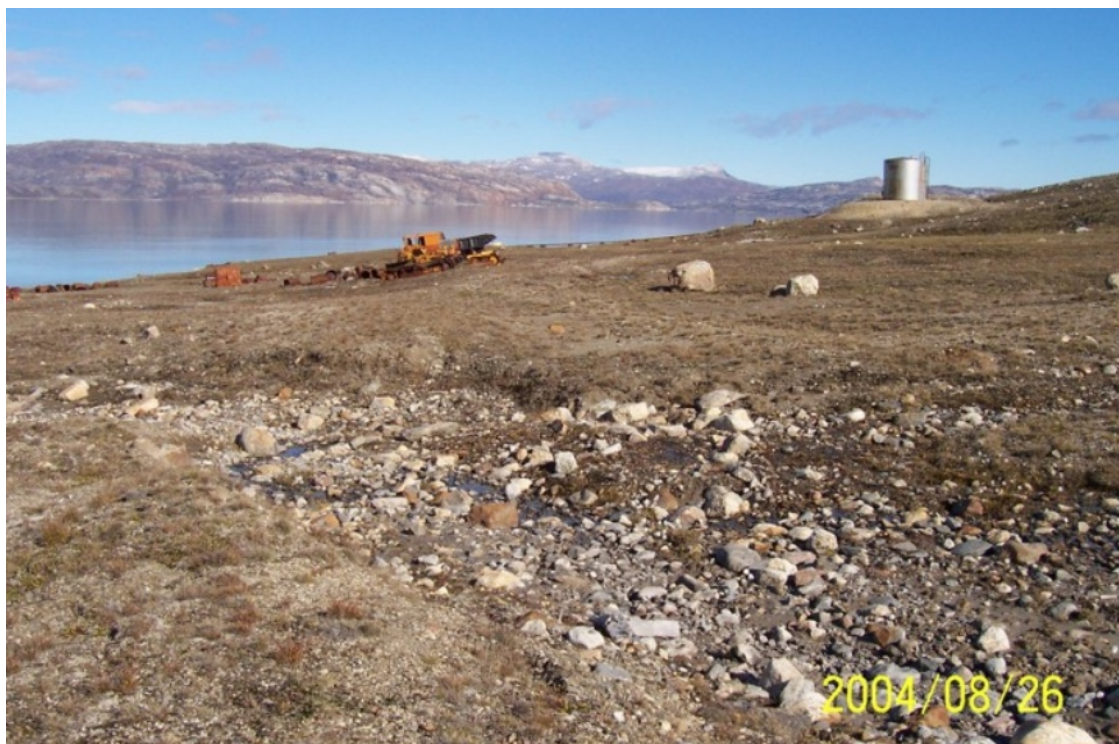
**Photo 29**

Beach Road (Figures 1, 10, 11, 12 and 13A and Photos 29 to 39) is approximately 2.2 km long. The existing road width (shoulder to shoulder) ranges from approximately 2.3 to 4.5 m and is typically 3 m.

Beach Road looking northeast.

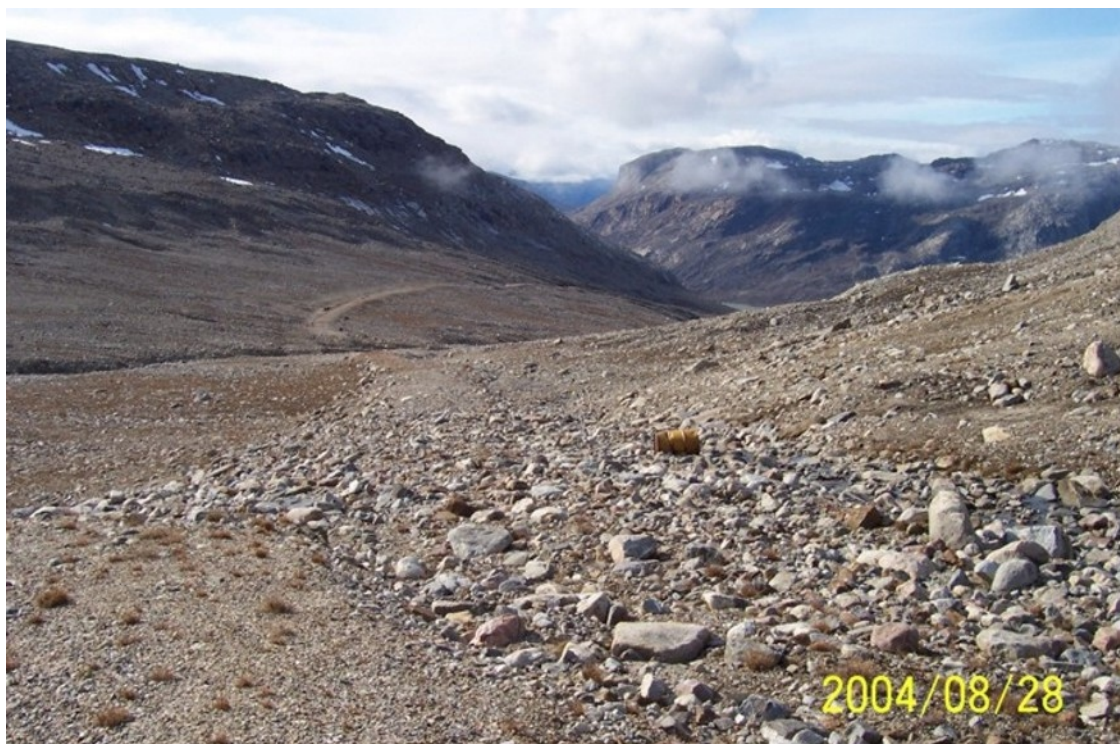
**Photo 56**  
Station Road looking north.

From Kilometre 3.0 to the end of Station Road the road was constructed by placing fill over boulders and rock outcrops. The existing road surface width (shoulder to shoulder) throughout this section ranges from approximately 2.5 to 6.0 m, but is typically 4 to 6 m. The road conditions are shown in Photos 56 and 63. Approximately 1,000 m of the road located on cross sloped terrain requires resurfacing due to erosion and washouts. Construction of pull out sections may be required to facilitate two-way haul traffic.

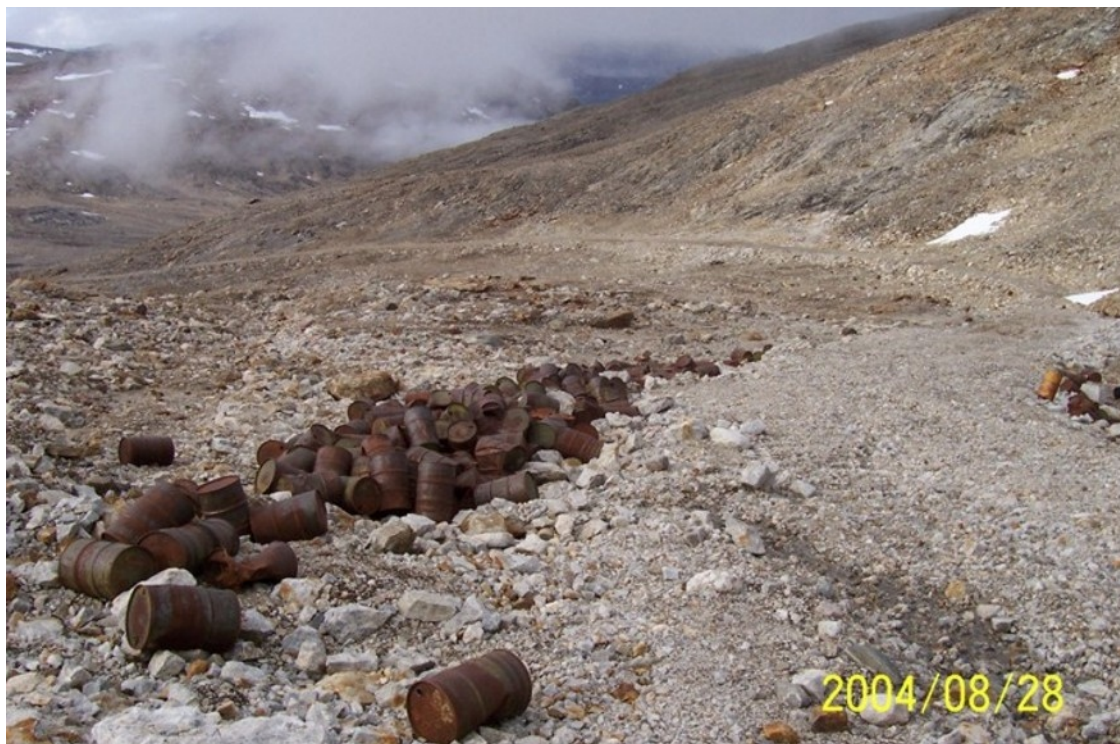
**Photo 59**  
Station Road looking southwest.

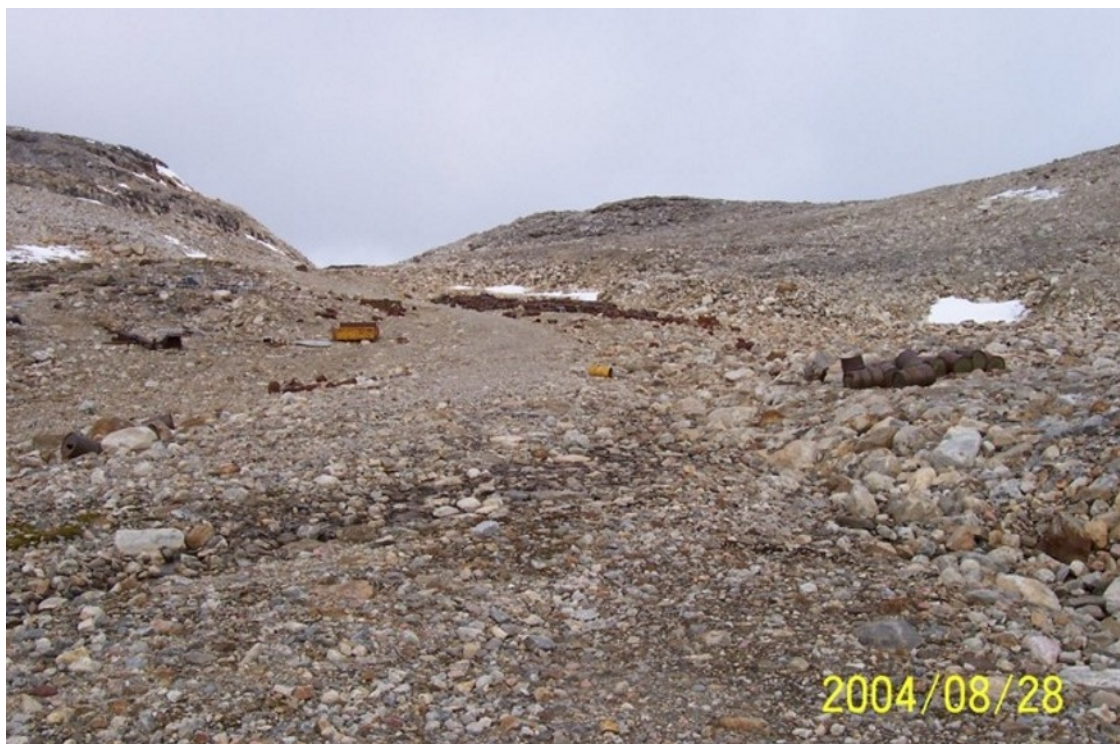
**Photo 60**  
Station Road looking northwest.

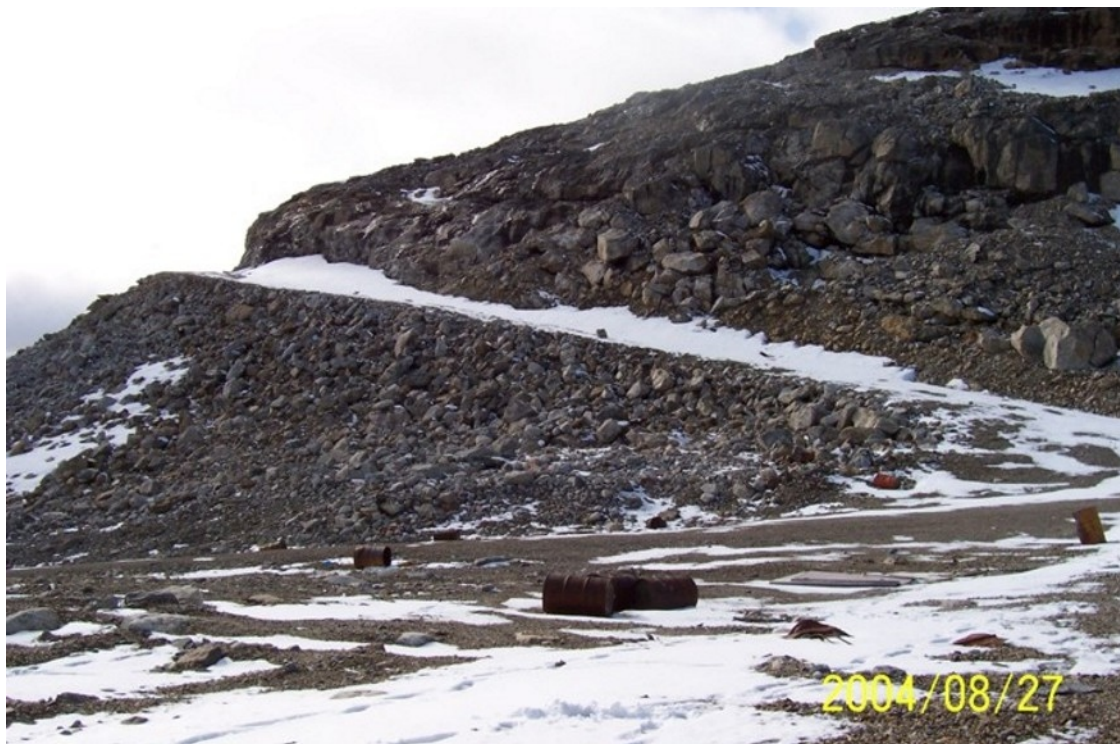
**Photo 61**  
Station Road looking west.

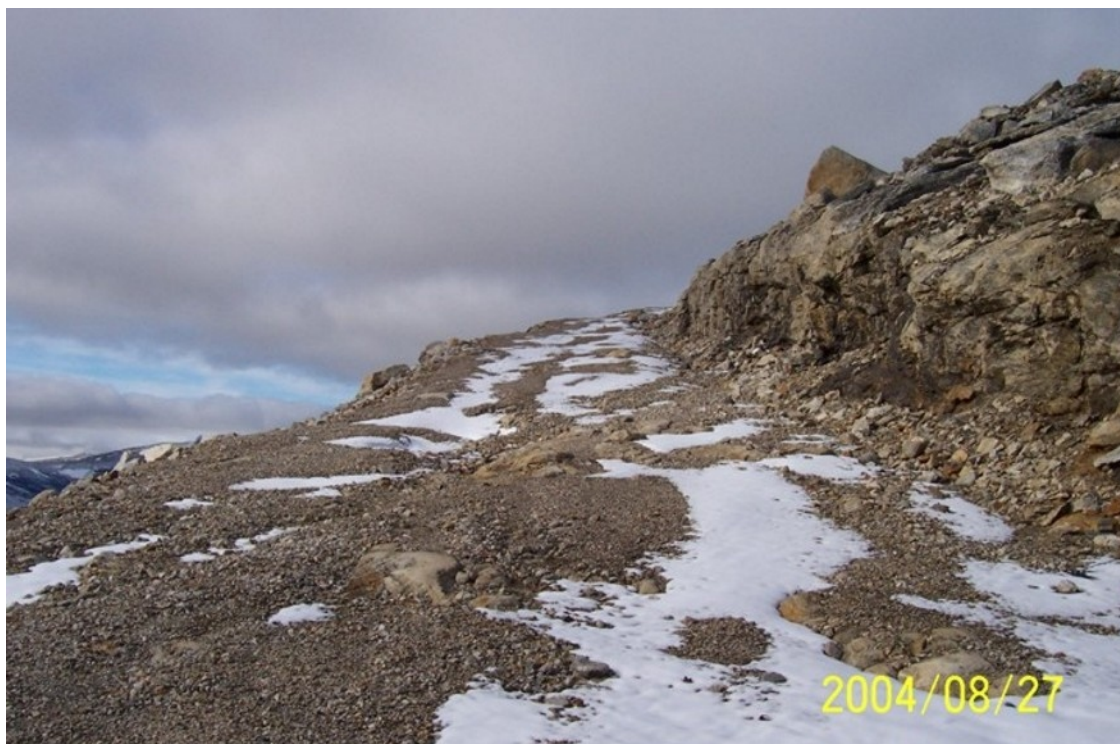
**Photo 62**  
Station Road looking west.

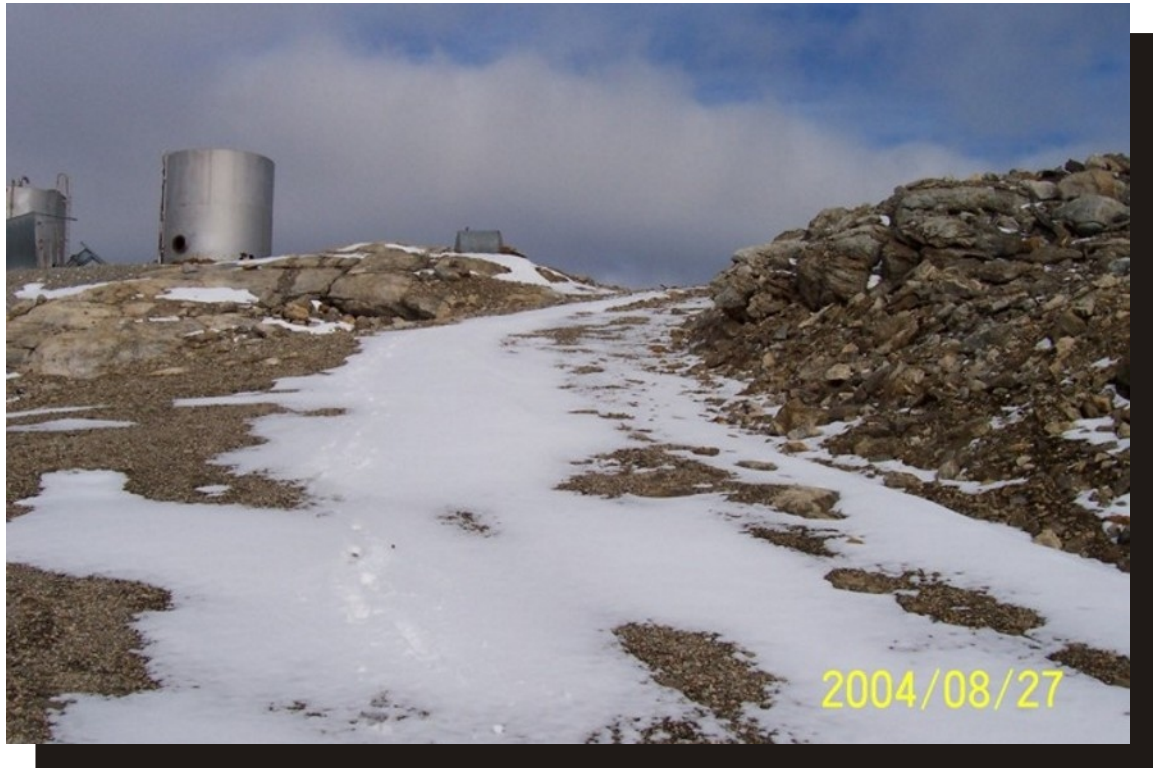
**Photo 63**  
Station Road looking north.
