QIKIQ15 BAFFIN REGION DEW LINE SITE MONITORING

2016 FOX-3 Monitoring Report

Report Number: 1530908-2000-R3-V2

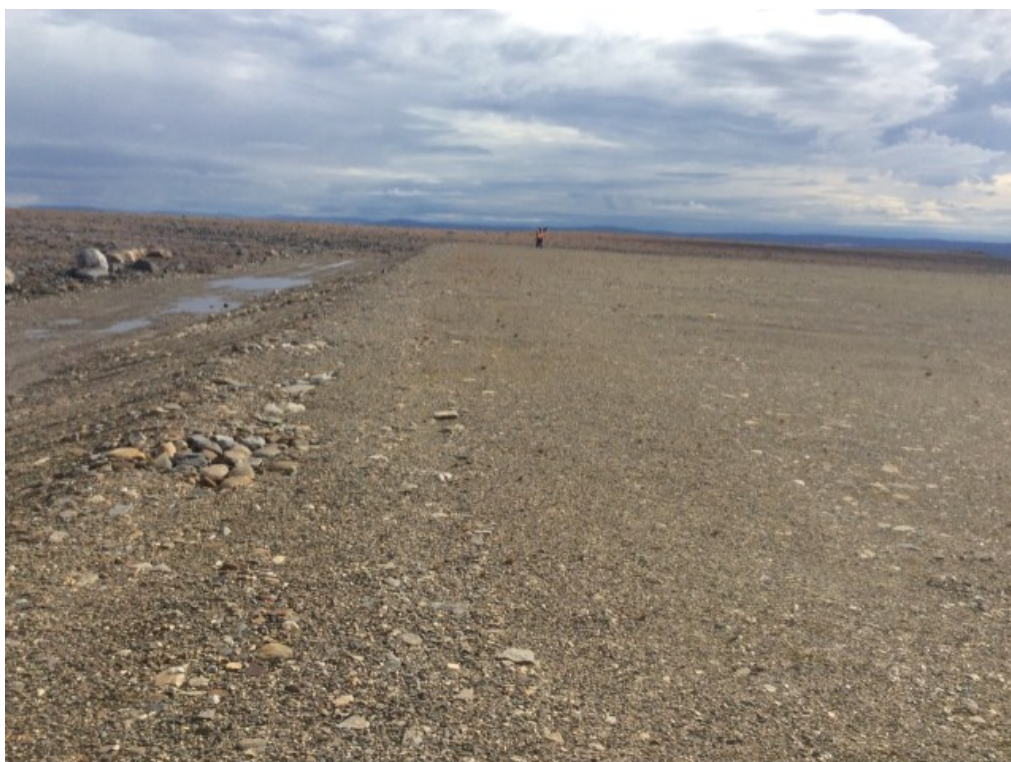
Photo 1: FOX-3 – Non Hazardous Waste Landfill – North crest, facing east (ATT72_Photo72.jpg)

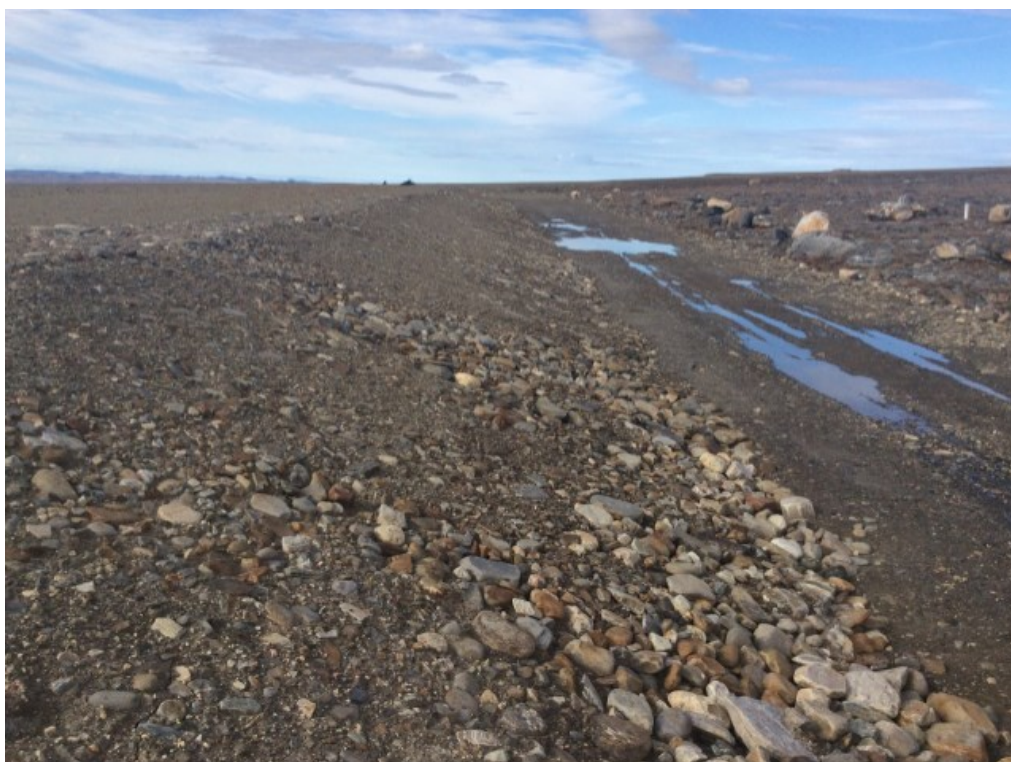
Photo 2: FOX-3 – Non Hazardous Waste Landfill – North slope and toe, facing west (ATT73_Photo73.jpg)

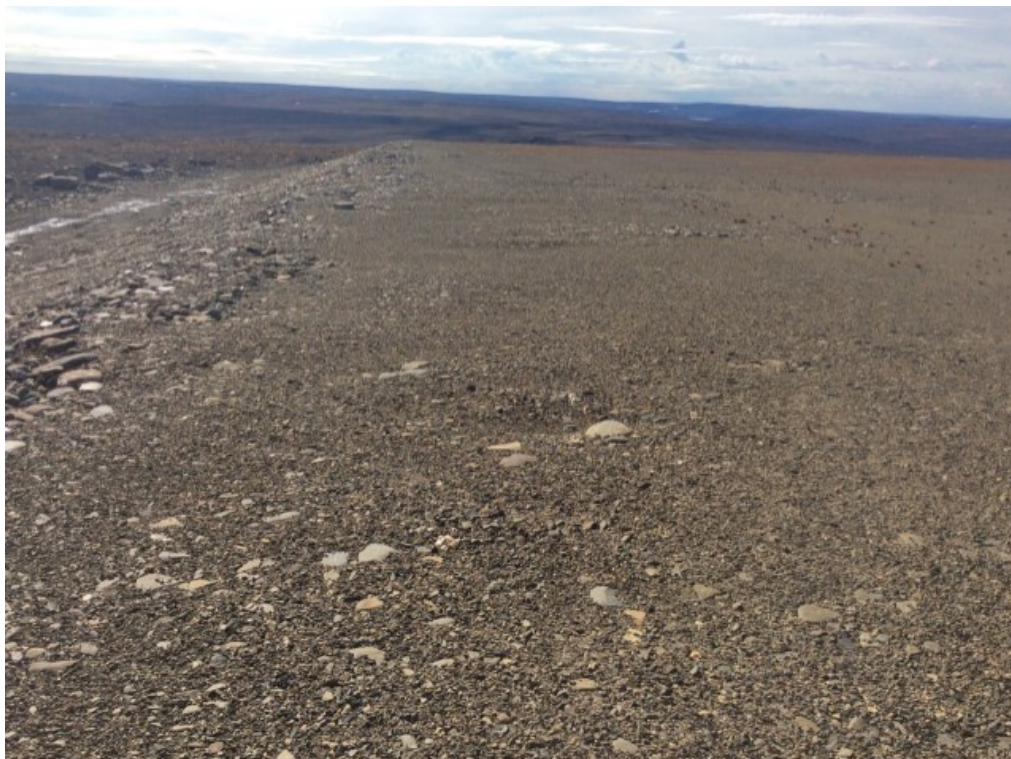
Photo 3: FOX-3 – Non Hazardous Waste Landfill – East crest, facing south (ATT74_Photo74.jpg)

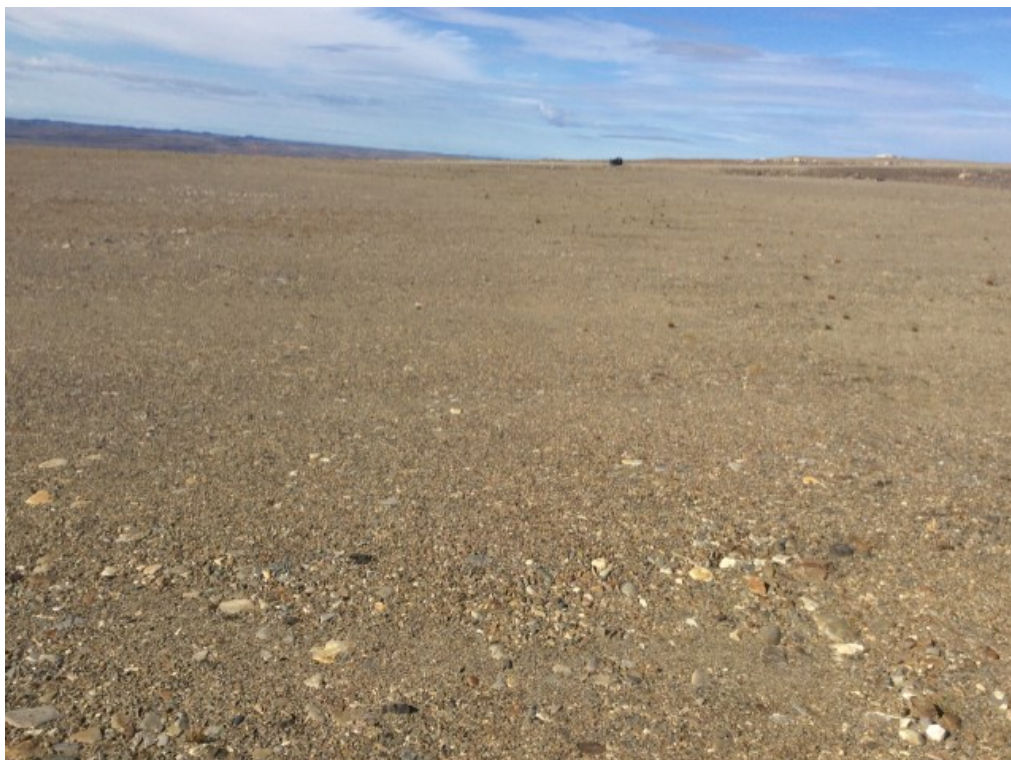
Photo 4: FOX-3 – Non Hazardous Waste Landfill – Cover surface, facing west (ATT75_Photo75.jpg)

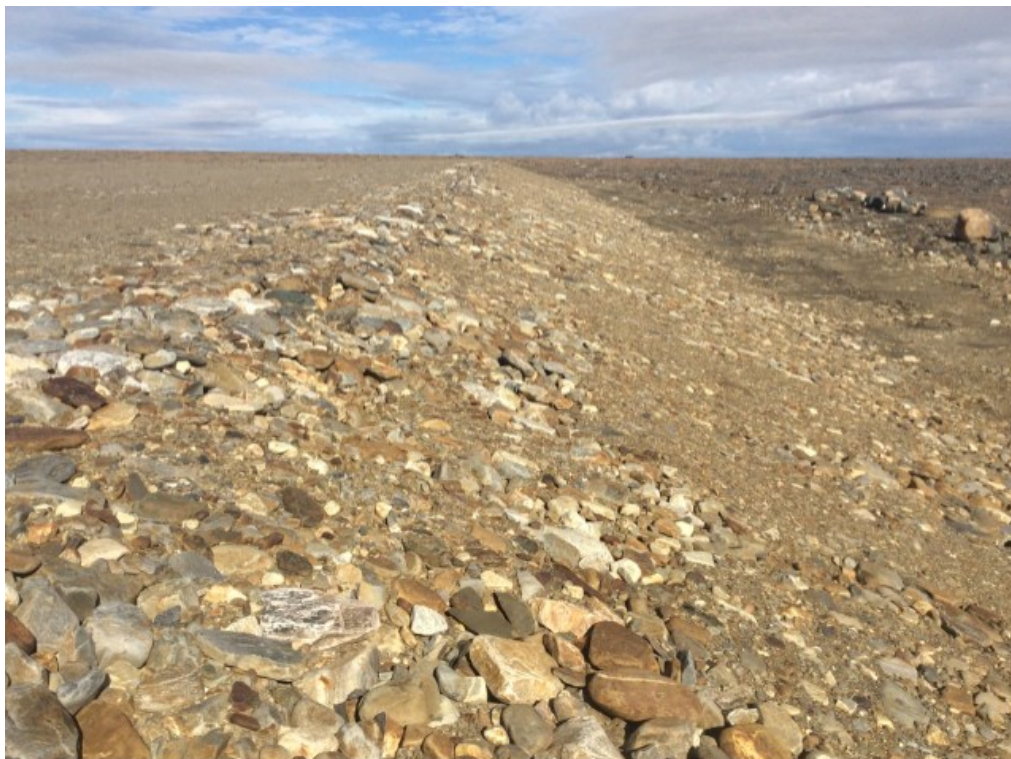
Photo 5: FOX-3 – Non Hazardous Waste Landfill – East slope, facing north (ATT76_Photo76.jpg)

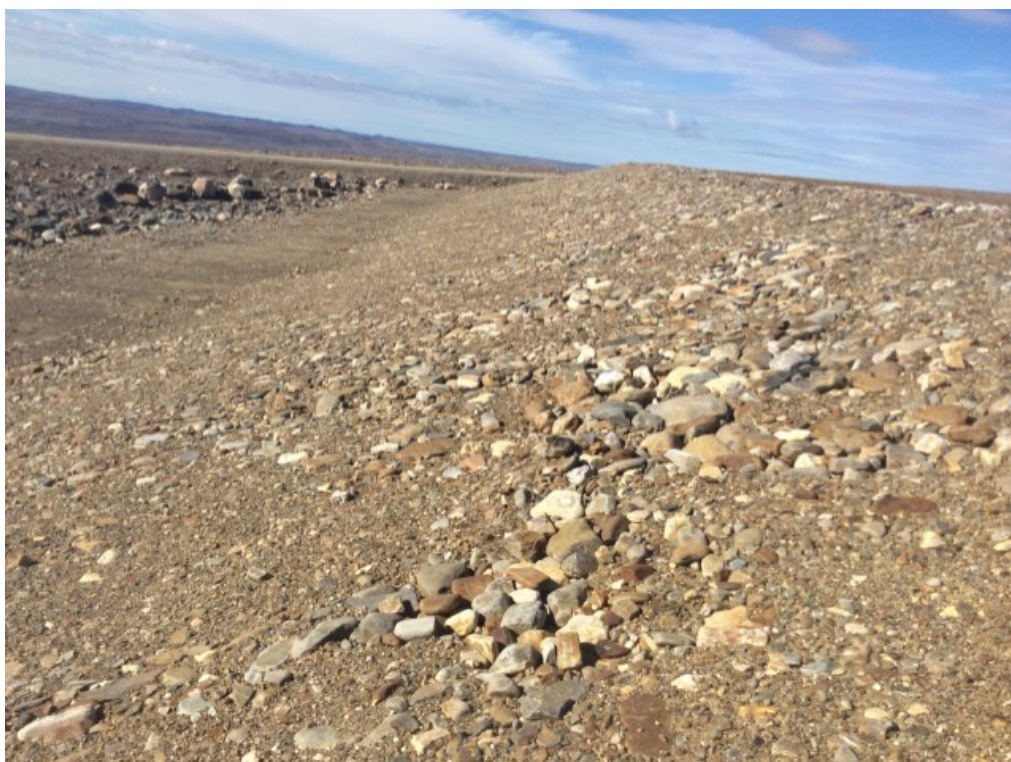
Photo 6: FOX-3 – Non Hazardous Waste Landfill – South slope and toe, facing west (ATT77_Photo77.jpg)

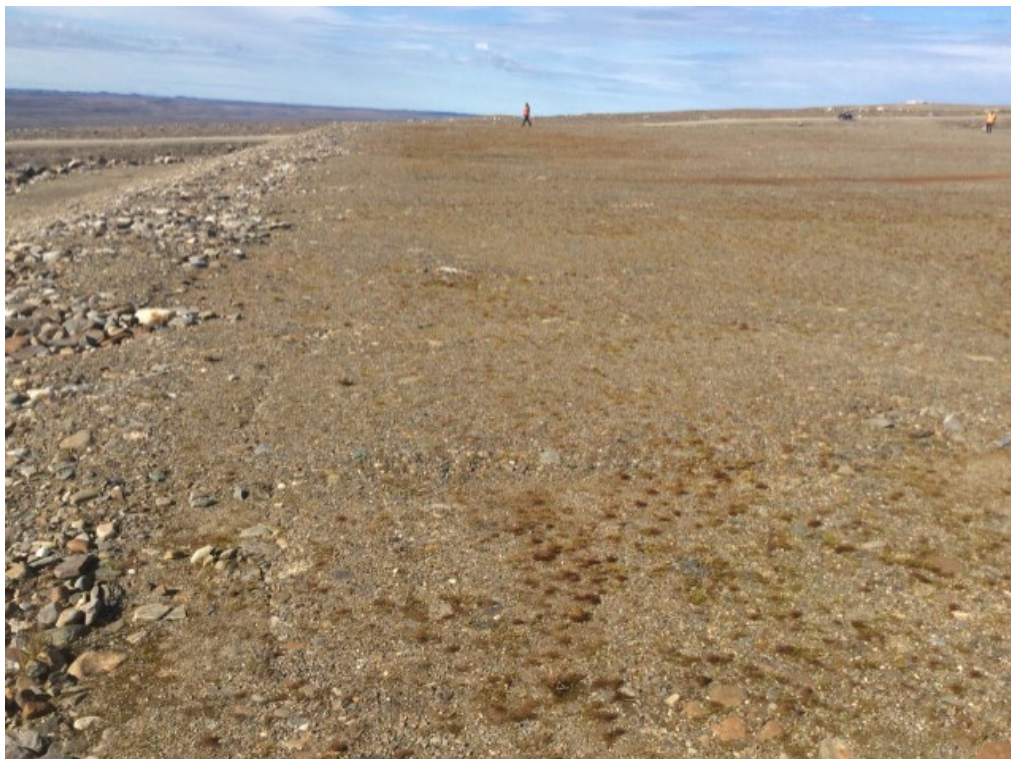
Photo 7: FOX-3 – Non Hazardous Waste Landfill – South crest, facing west (ATT78_Photo78.jpg)

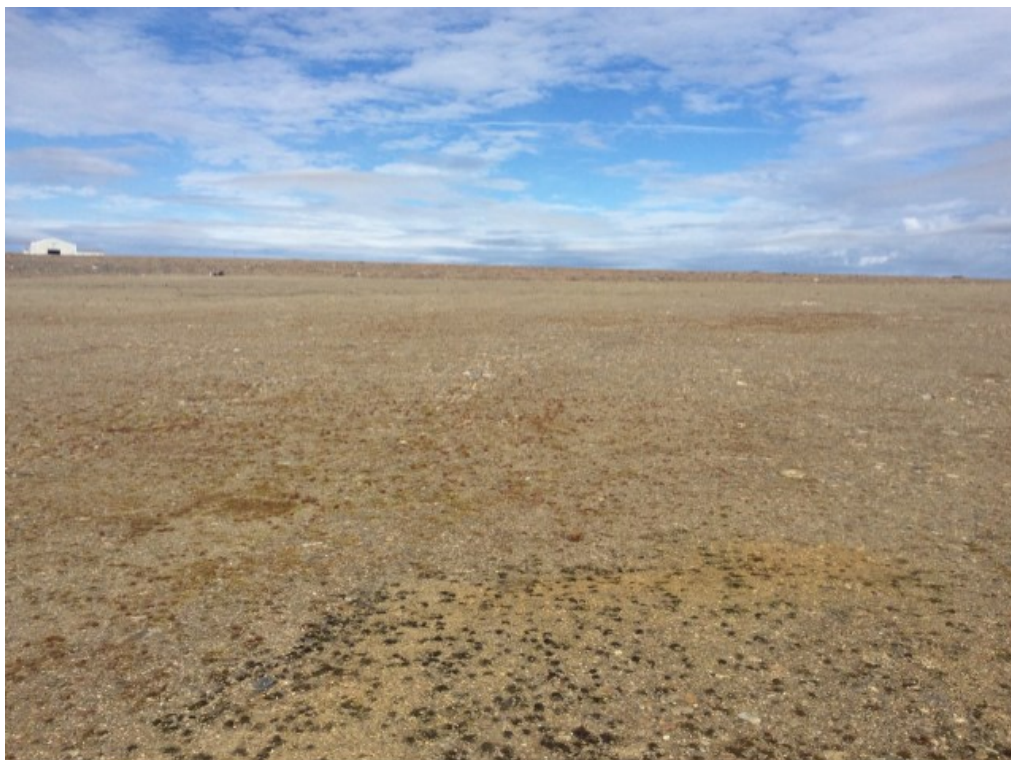
Photo 8: FOX-3 – Non Hazardous Waste Landfill – Cover surface, facing north (ATT79_Photo79.jpg)

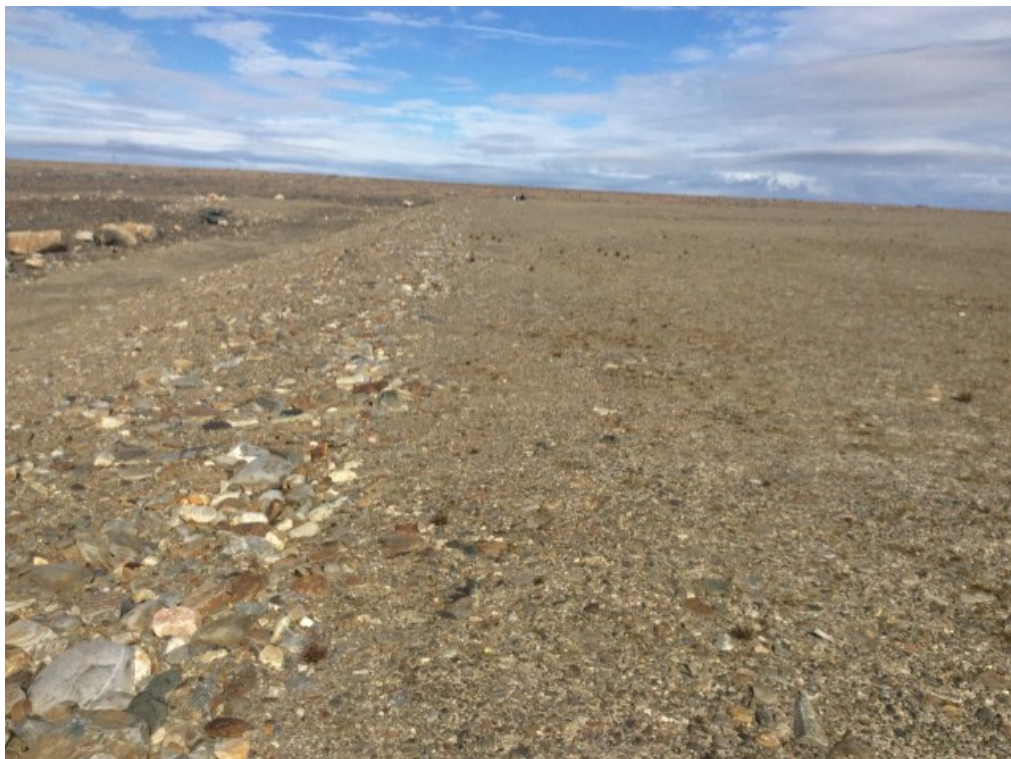
Photo 9: FOX-3 – Non Hazardous Waste Landfill – West crest, facing north (ATT80_Photo80.jpg)

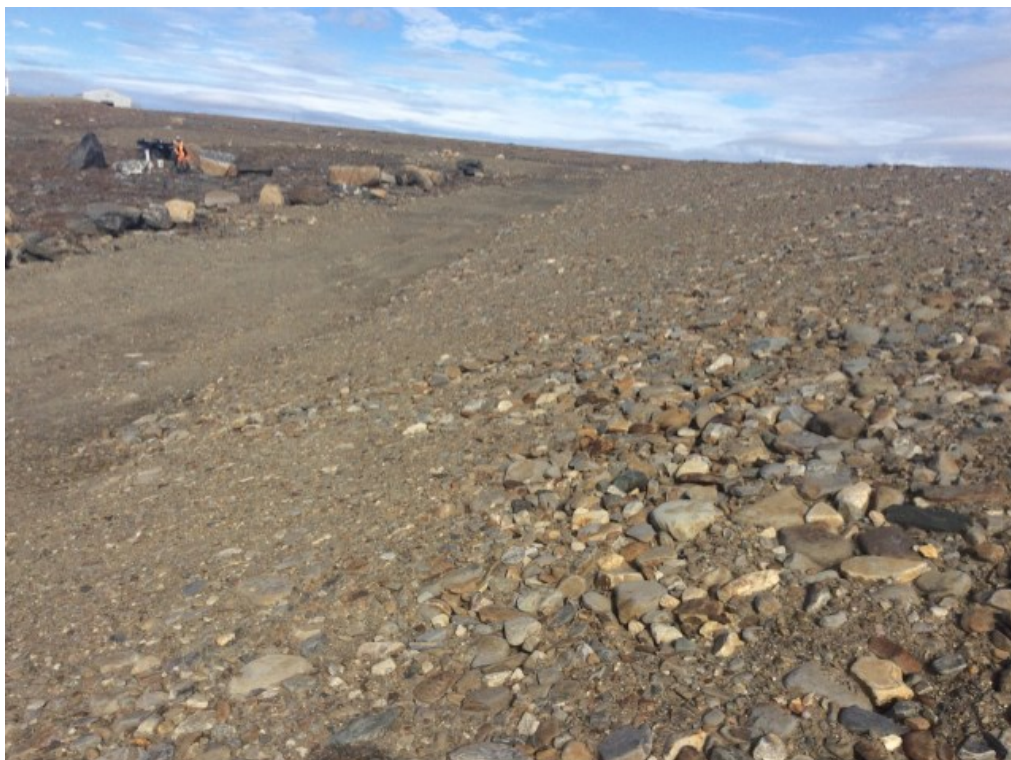
Photo 10: FOX-3 – Non Hazardous Waste Landfill – West slope and toe, facing north (ATT81_Photo81.jpg)

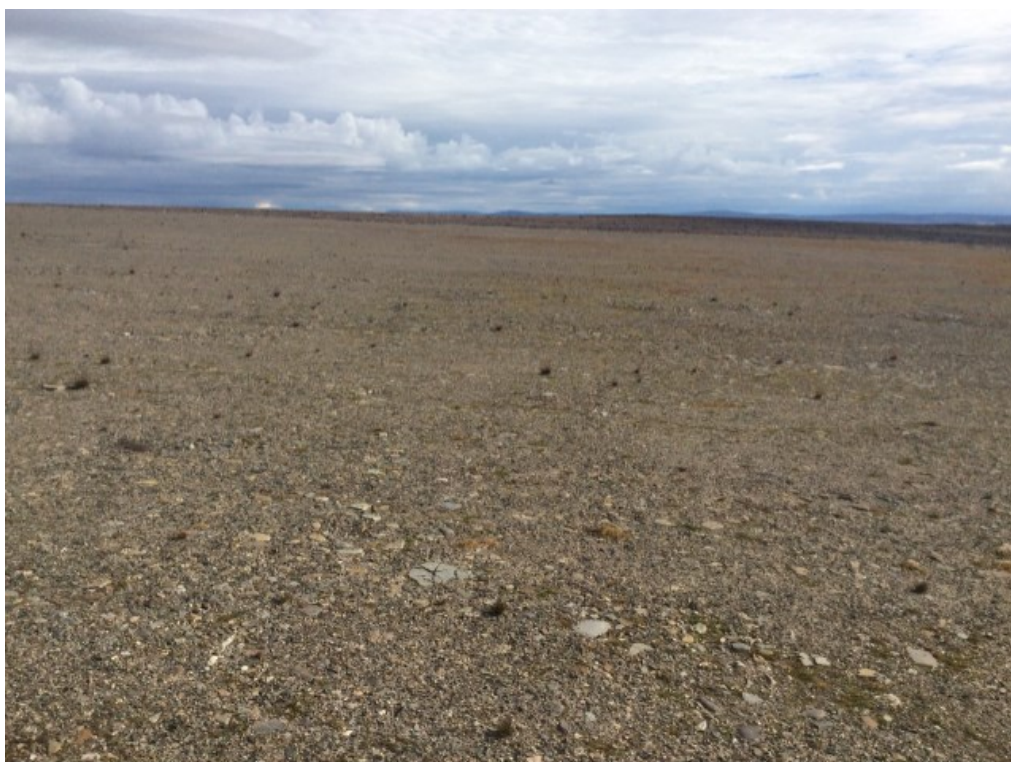
Photo 11: FOX-3 – Non Hazardous Waste Landfill – Cover surface, facing east (ATT82_Photo82.jpg)

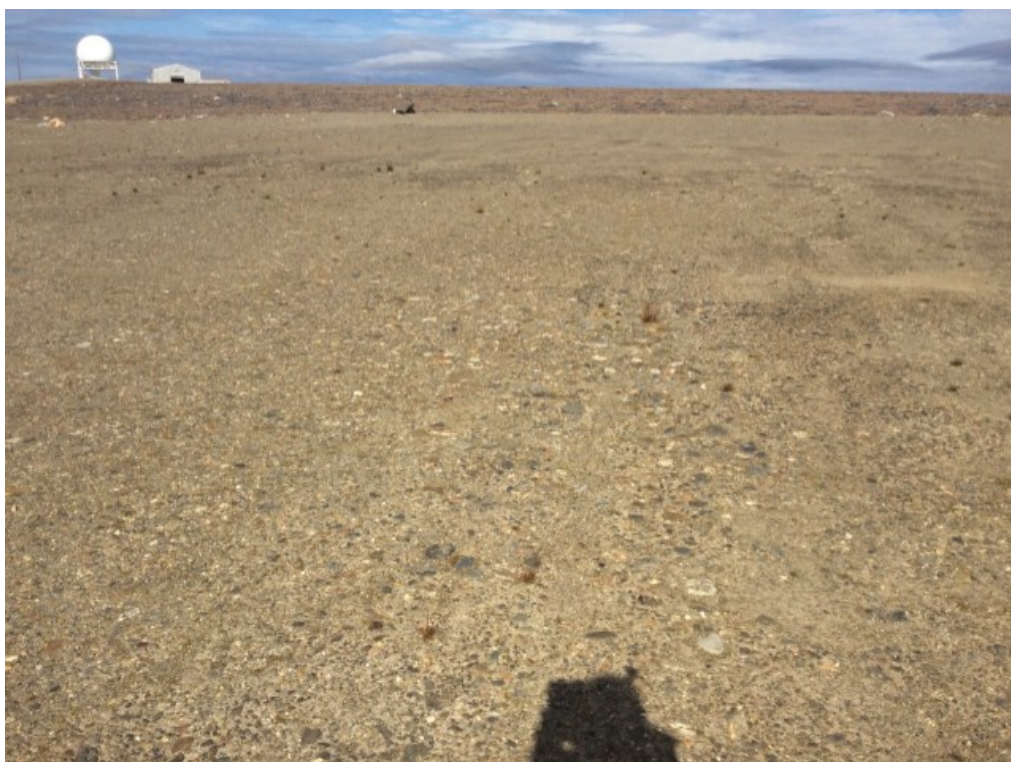
Photo 12: FOX-3 – Non Hazardous Waste Landfill – Cover surface, facing north (ATT83_Photo83.jpg)

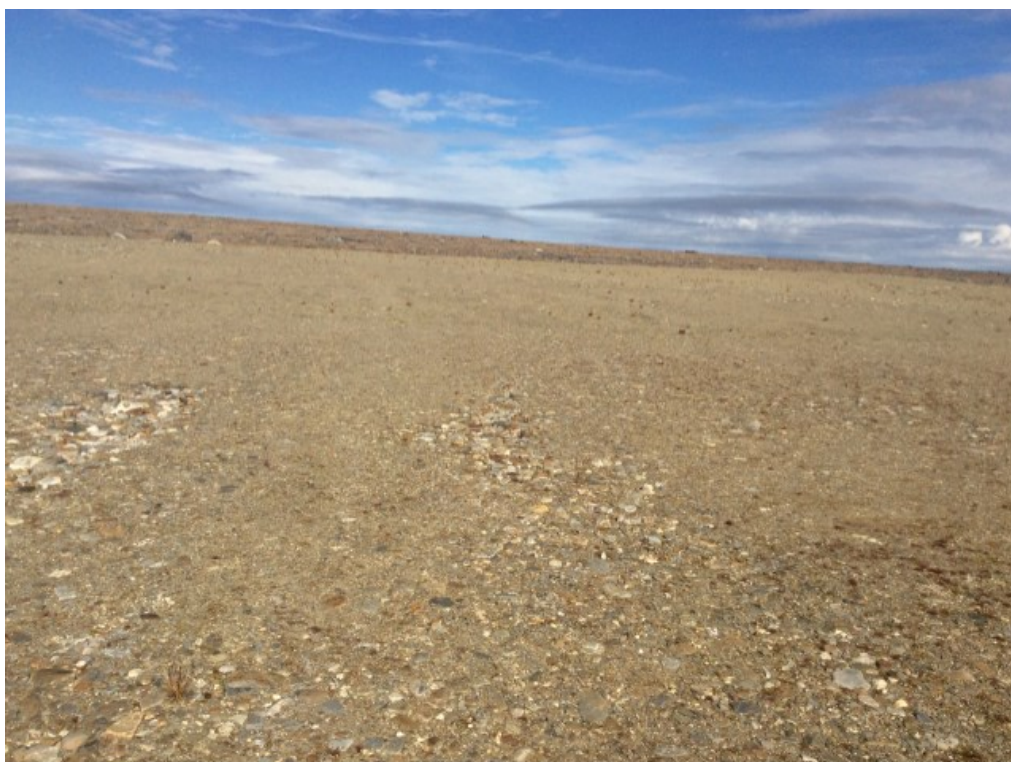
Photo 13: FOX-3 – Non Hazardous Waste Landfill – Cover surface, facing north (ATT84_Photo84.jpg)

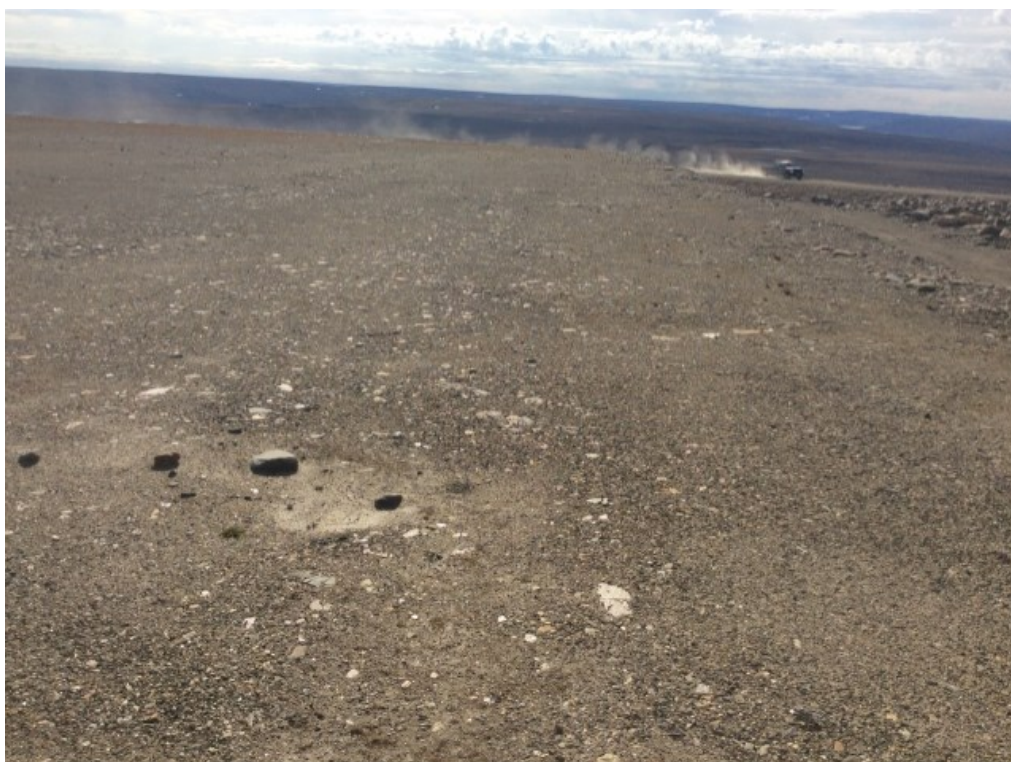
Photo 14: FOX-3 – Non Hazardous Waste Landfill – West crest, facing south (ATT85_Photo85.jpg)

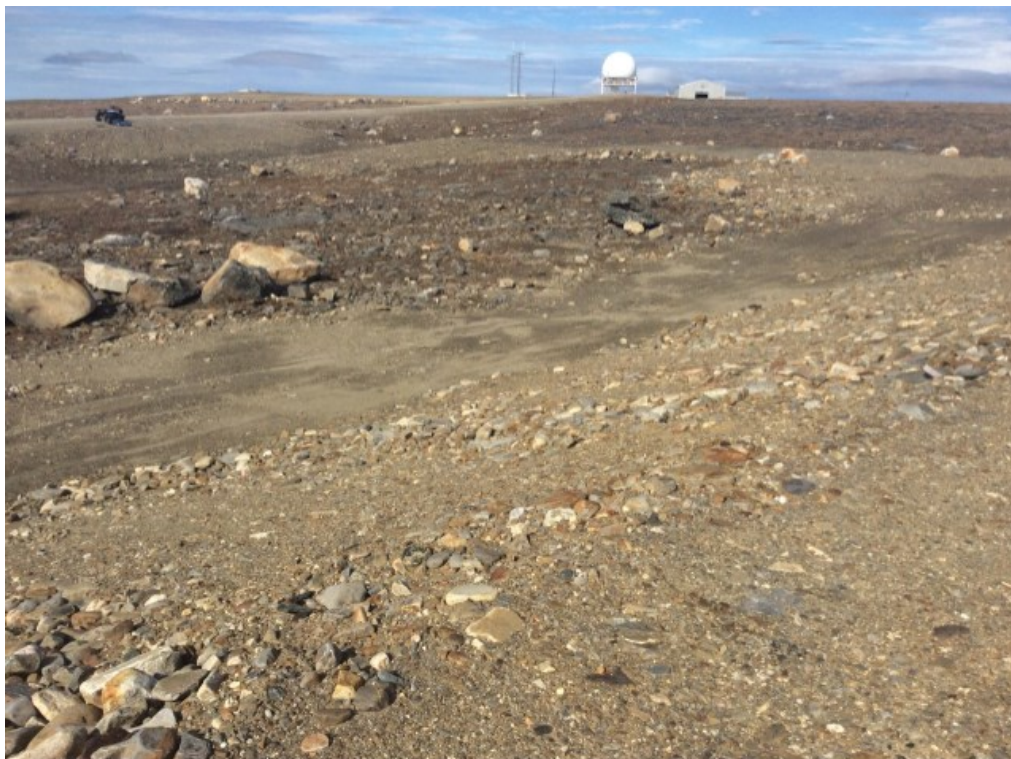
Photo 15: FOX-3 – Non Hazardous Waste Landfill – West toe – no ponded water along toe (previous Feature H), facing north (ATT43_Photo43.jpg)

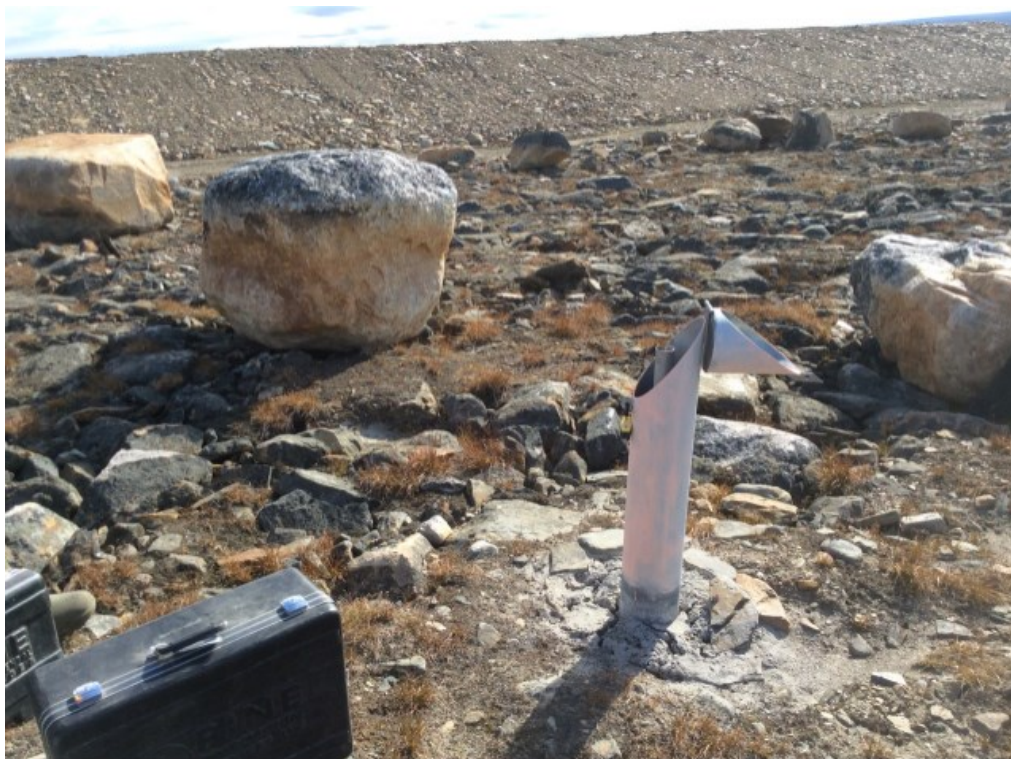
Photo 29: FOX-3 – Non Hazardous Waste Landfill – Monitoring Well MW-06 (ATT99_Photo99.jpg)

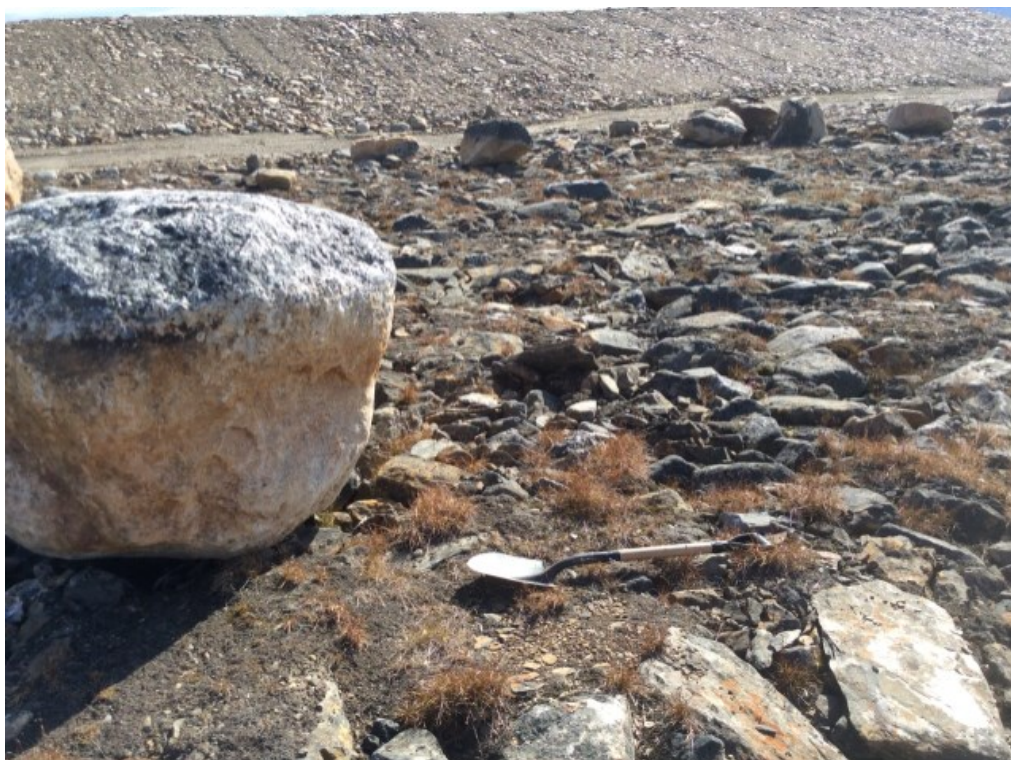
Photo 30: FOX-3 – Non Hazardous Waste Landfill – Soil sampling before excavation at MW-06 (ATT100_Photo100.jpg)

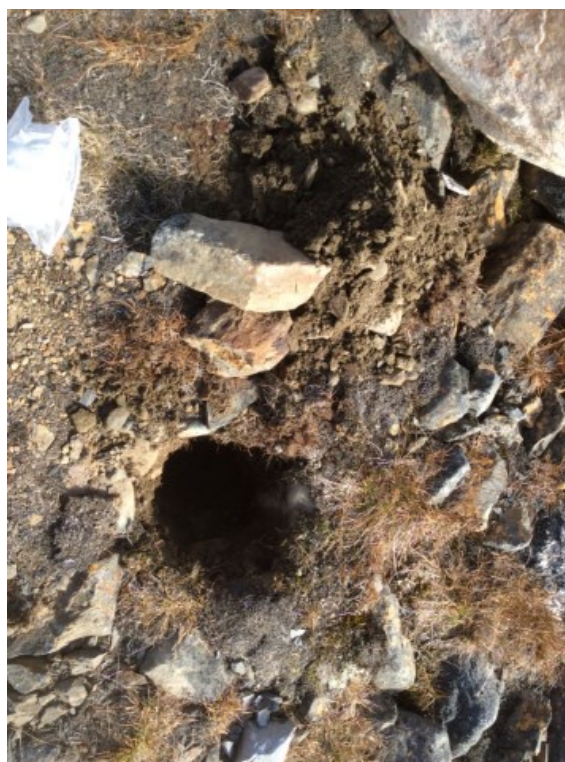
Photo 31: FOX-3 – Non Hazardous Waste Landfill – Soil sampling after excavation at MW-06 (ATT101_Photo101.jpg)

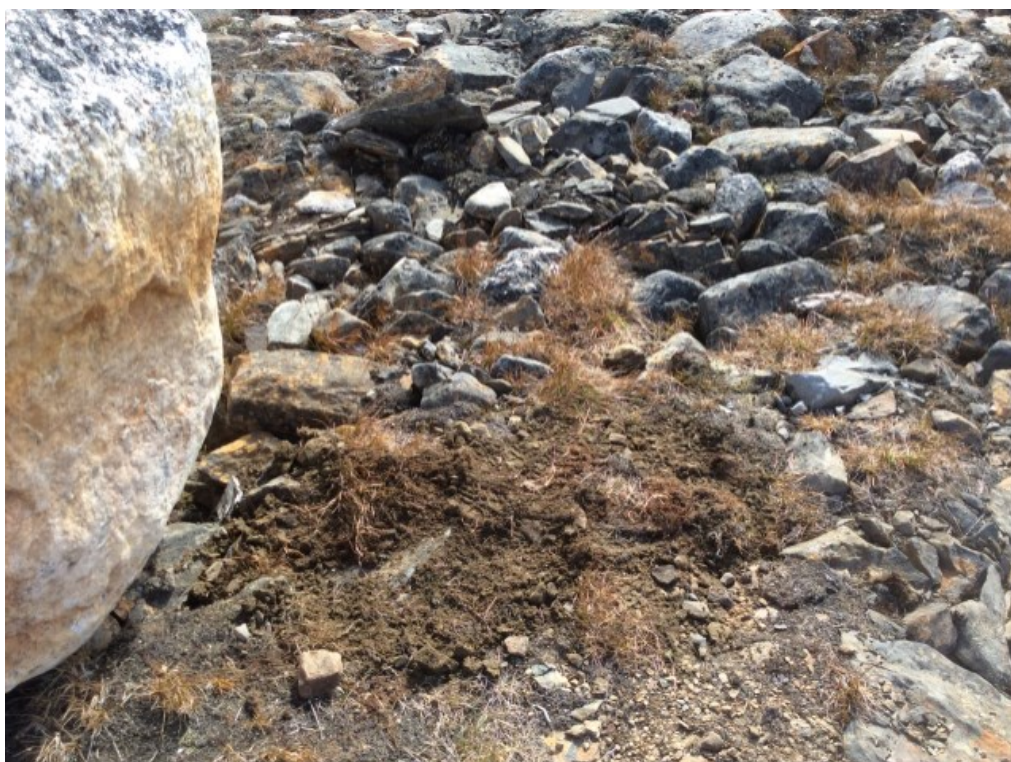
Photo 32: FOX-3 – Non Hazardous Waste Landfill – Soil sampling after backfilling at MW-06 (ATT102_Photo102.jpg)

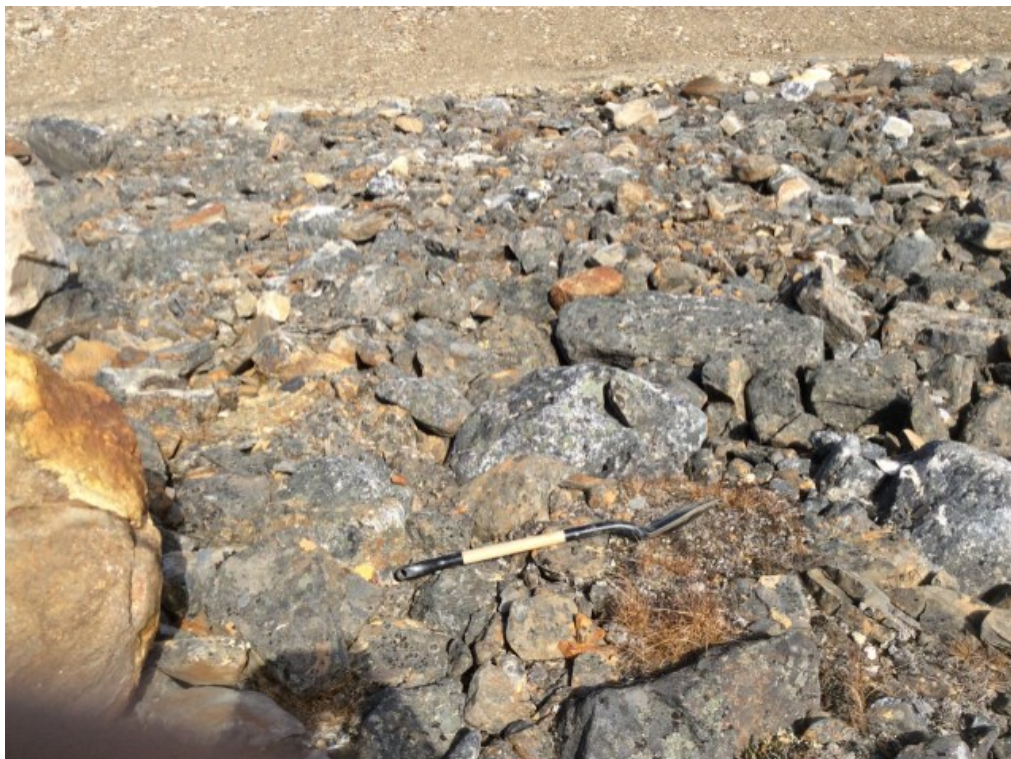
Photo 33: FOX-3 – Non Hazardous Waste Landfill – Soil sampling before excavation at MW-08 (ATT103_Photo103.jpg)

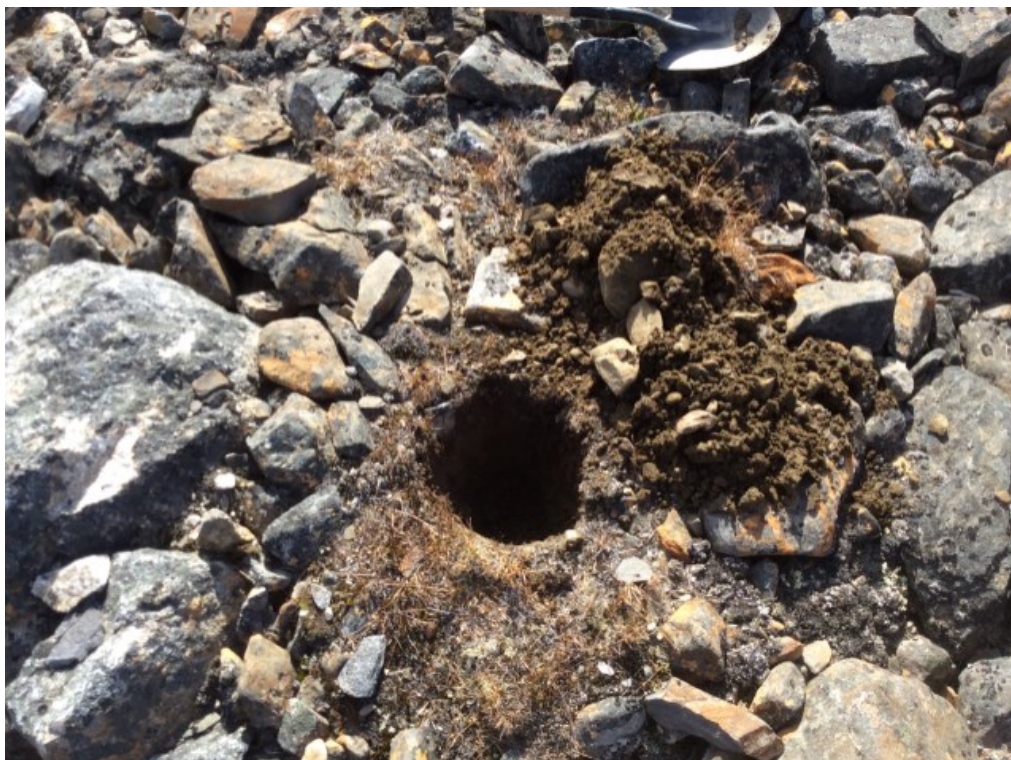
Photo 34: FOX-3 – Non Hazardous Waste Landfill – Soil sampling after excavation at MW-08 (ATT104_Photo104.jpg)

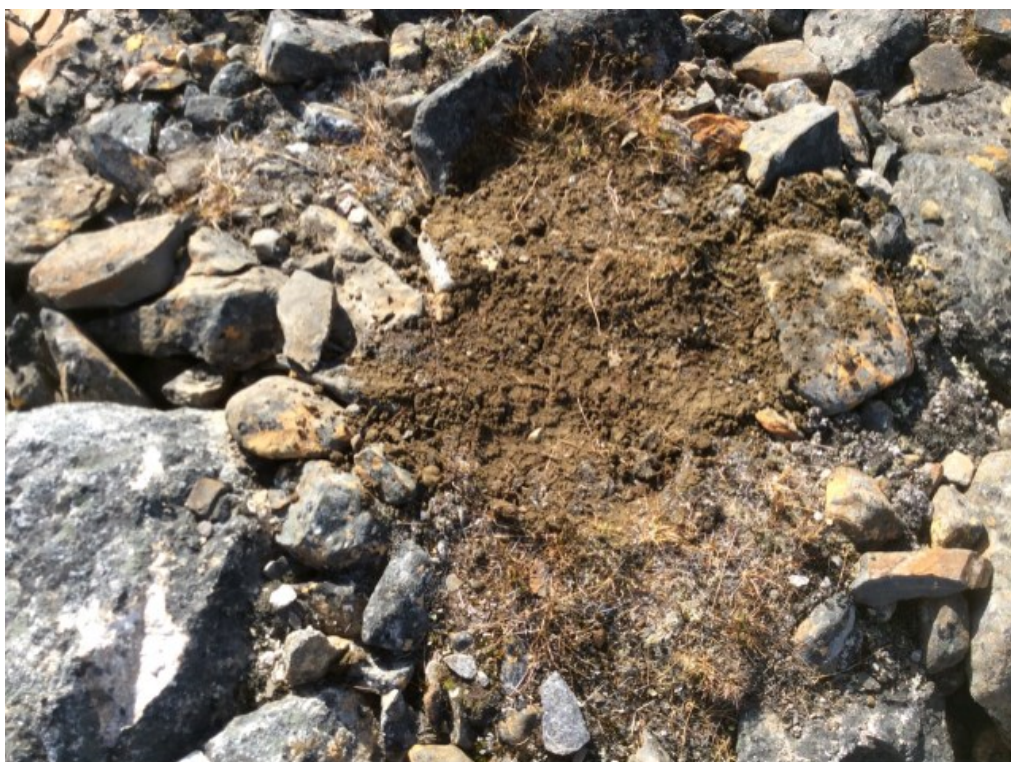
Photo 35: FOX-3 – Non Hazardous Waste Landfill – Soil sampling after backfilling at MW-08 (ATT105_Photo105.jpg)

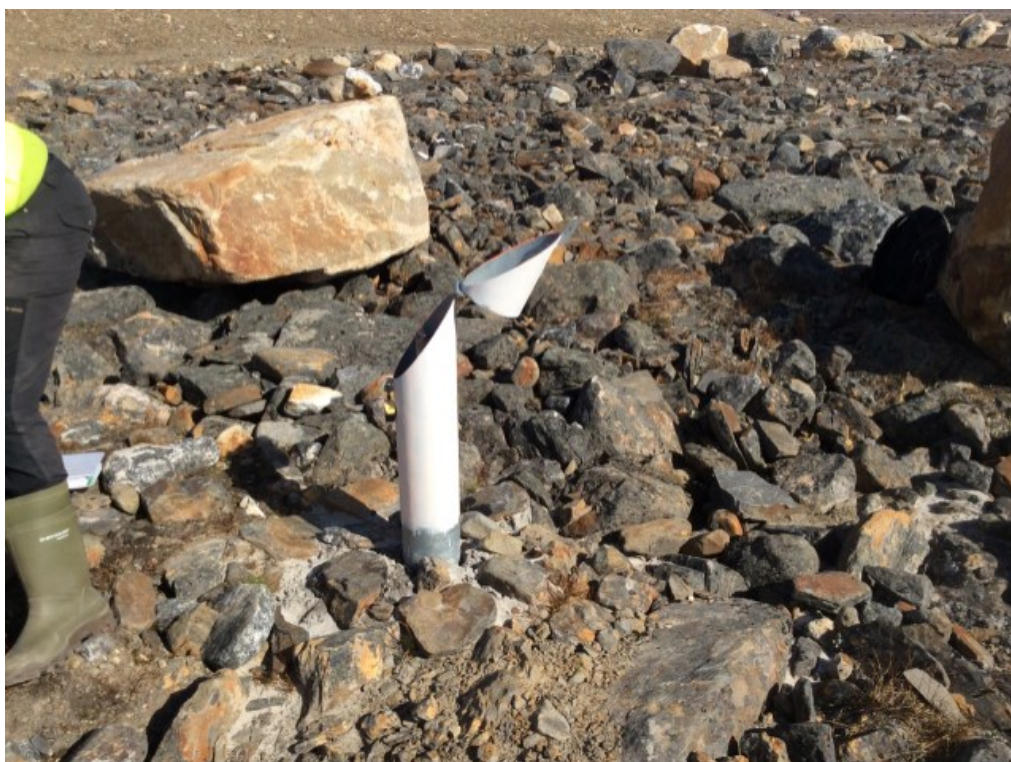
Photo 36: FOX-3 – Non Hazardous Waste Landfill – Monitoring Well MW-08 (ATT106_Photo106.jpg)

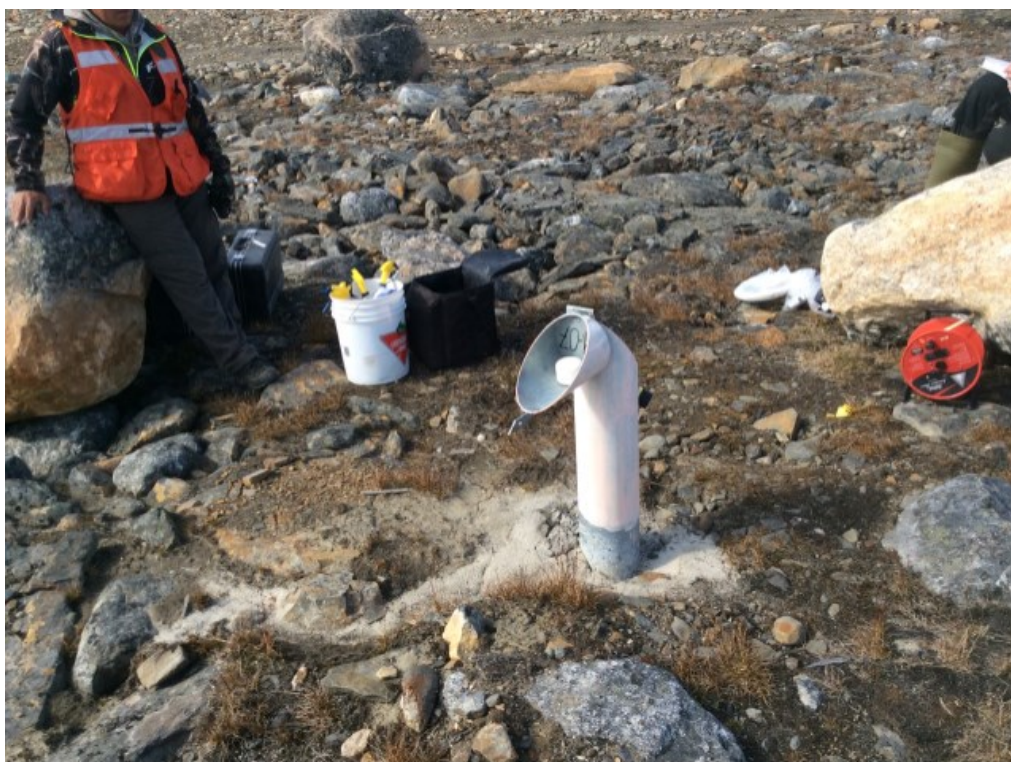
Photo 37: FOX-3 – Non Hazardous Waste Landfill – Monitoring Well MW-07 (ATT107_Photo107.jpg)

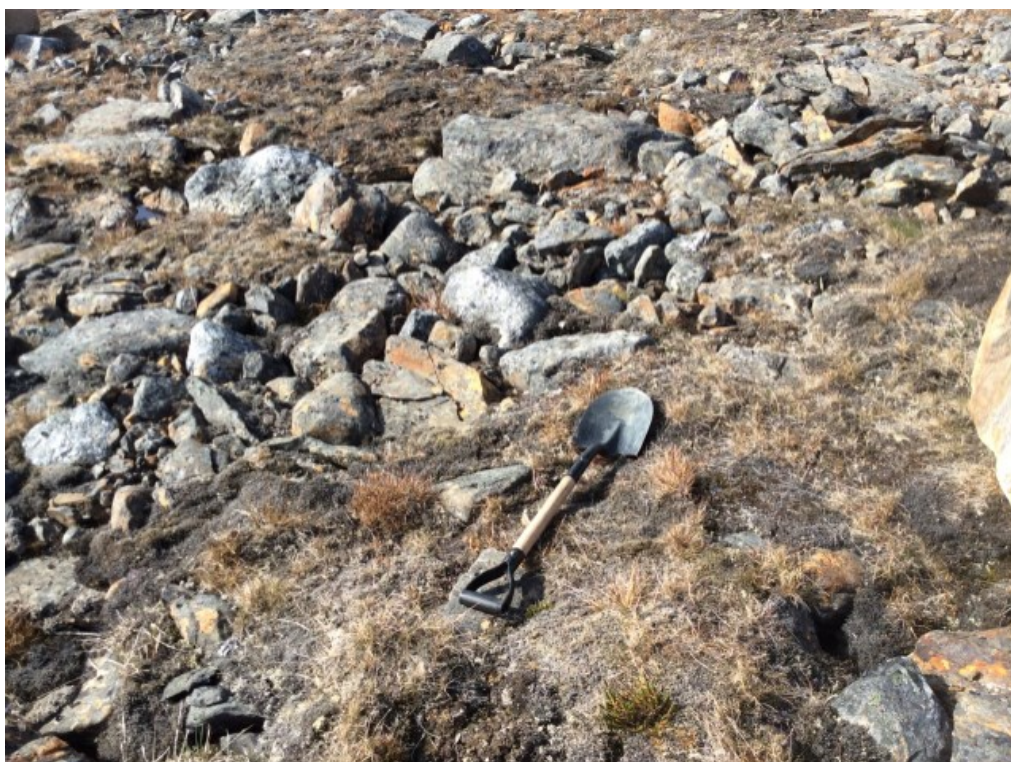
Photo 38: FOX-3 – Non Hazardous Waste Landfill – Soil sampling before excavation at MW-07 (ATT108_Photo108.jpg)

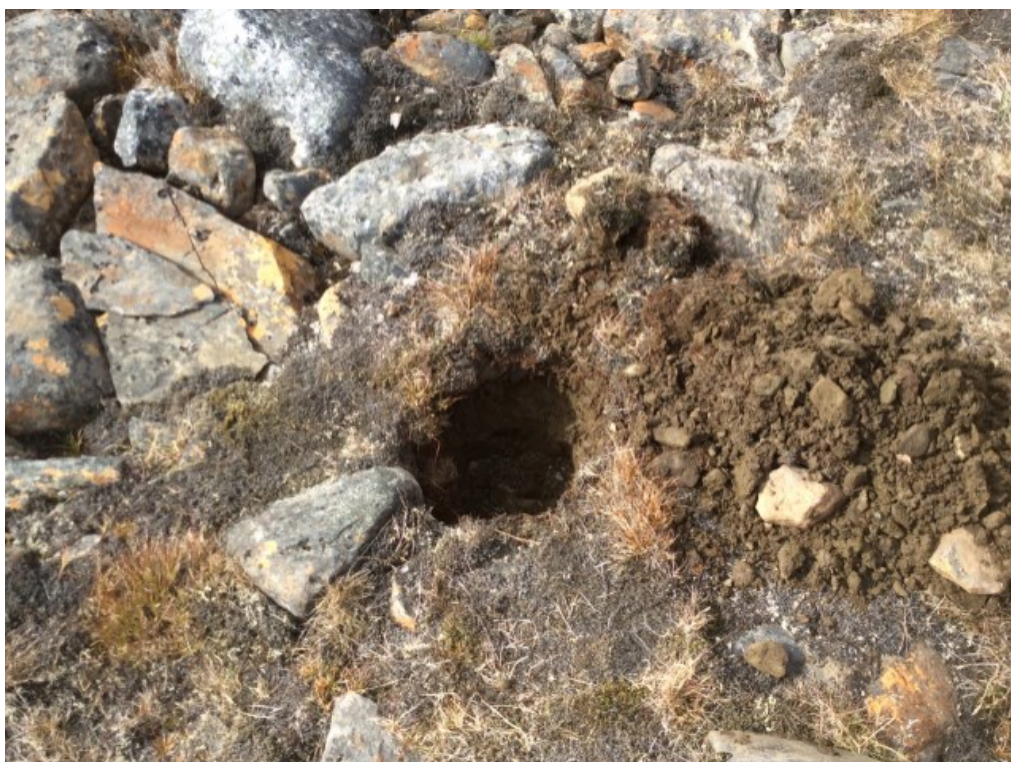
Photo 39: FOX-3 – Non Hazardous Waste Landfill – Soil sampling after excavation at MW-07 (ATT109_Photo109.jpg)

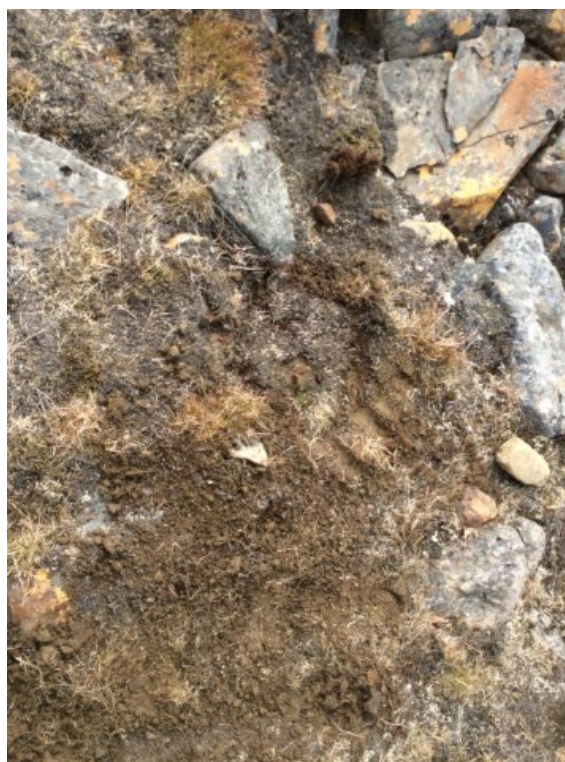
Photo 40: FOX-3 – Non Hazardous Waste Landfill – Soil sampling after backfilling at MW-07 (ATT110_Photo110.jpg)

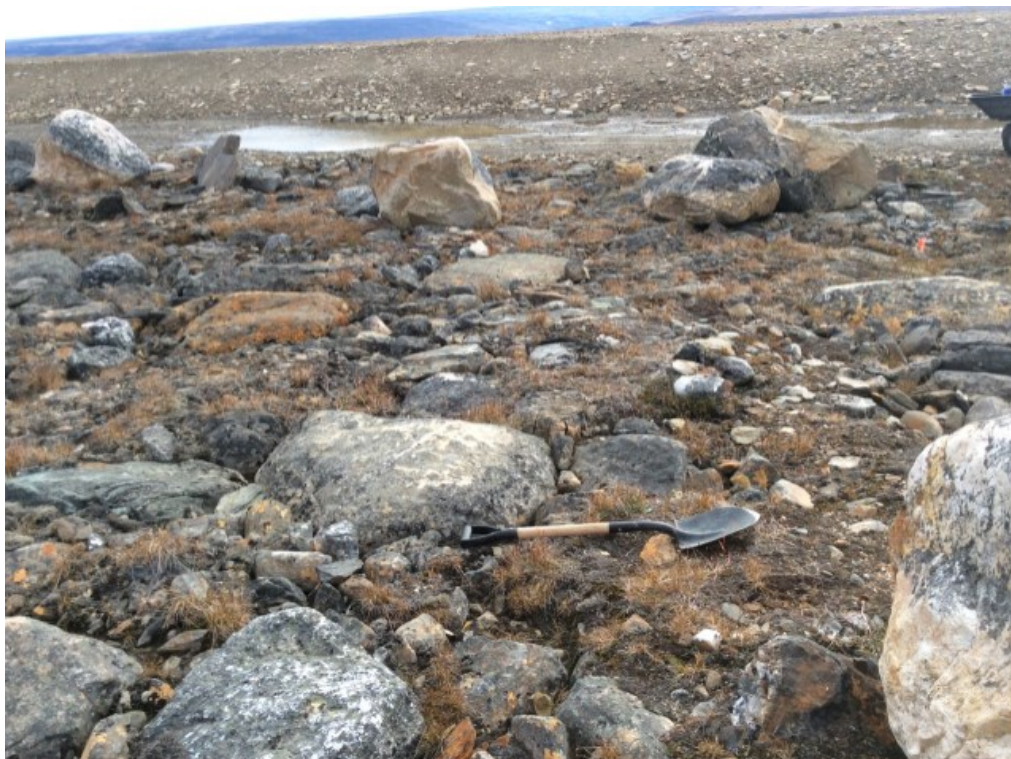
Photo 41: FOX-3 – Non Hazardous Waste Landfill – Soil sampling before excavation at MW-05 (ATT111_Photo111.jpg)

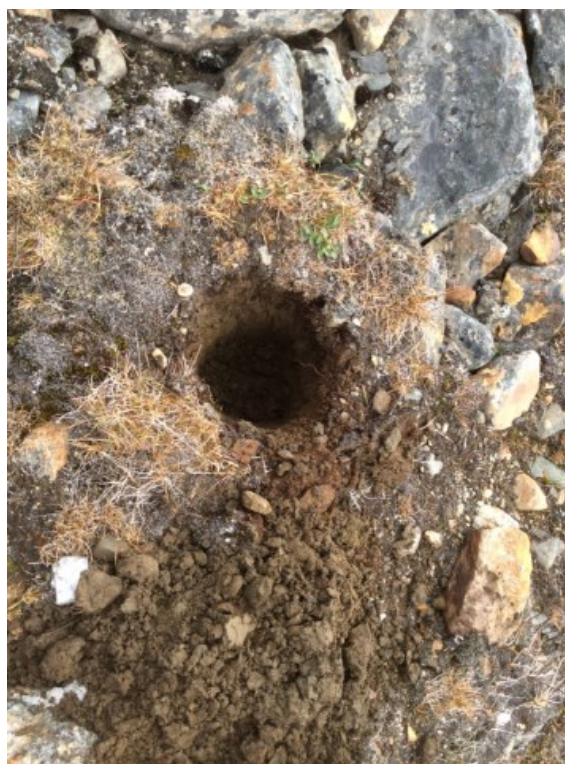
Photo 42: FOX-3 – Non Hazardous Waste Landfill – Soil sampling after excavation at MW-05 (ATT112_Photo112.jpg)

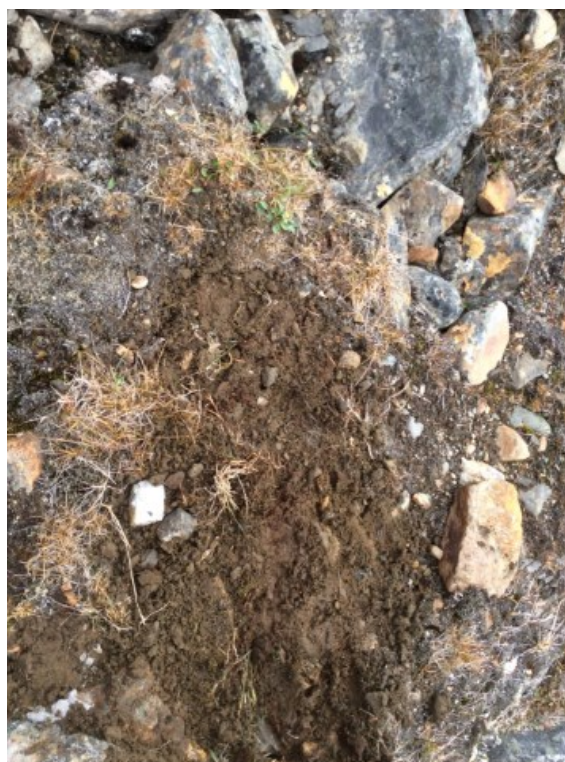
Photo 43: FOX-3 – Non Hazardous Waste Landfill – Soil sampling after backfilling at MW-05 (ATT113_Photo113.jpg)
