QIKIQ15 BAFFIN REGION DEW LINE SITE MONITORING

2016 FOX-3 Monitoring Report

Report Number: 1530908-2000-R3-V2

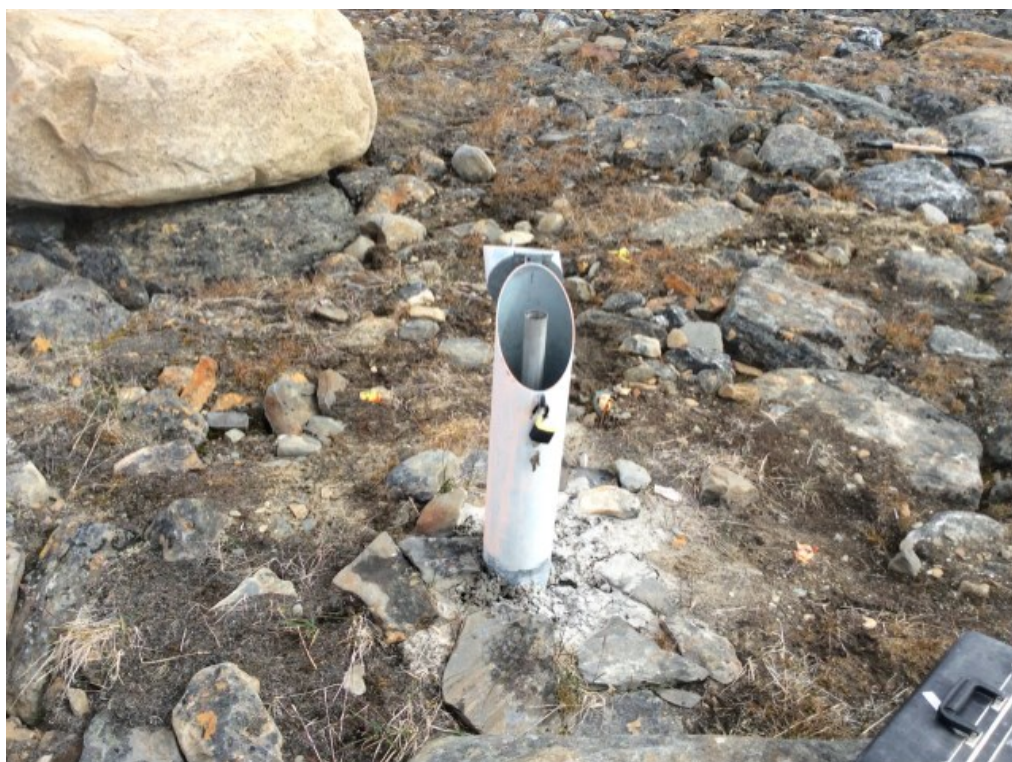
Photo 44: FOX-3 – Non Hazardous Waste Landfill – Monitoring Well MW-05 (ATT114_Photo114.jpg)

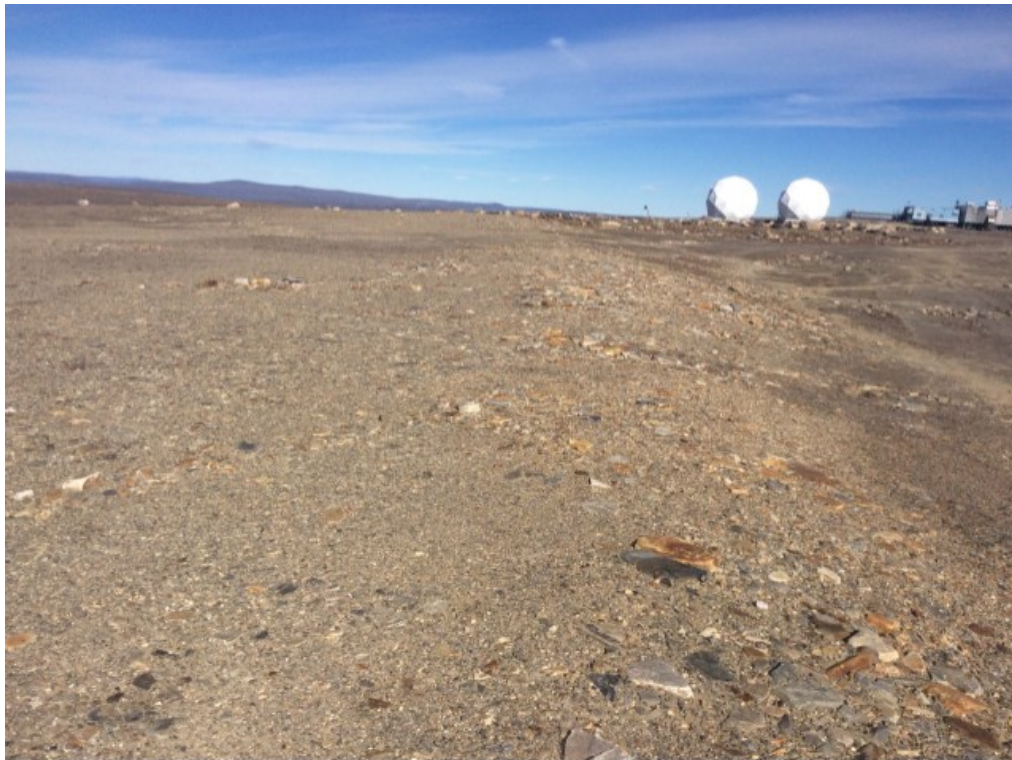
Photo 45: FOX-3 – Station West Landfill – East crest, facing northeast (ATT19_Photo19.jpg)

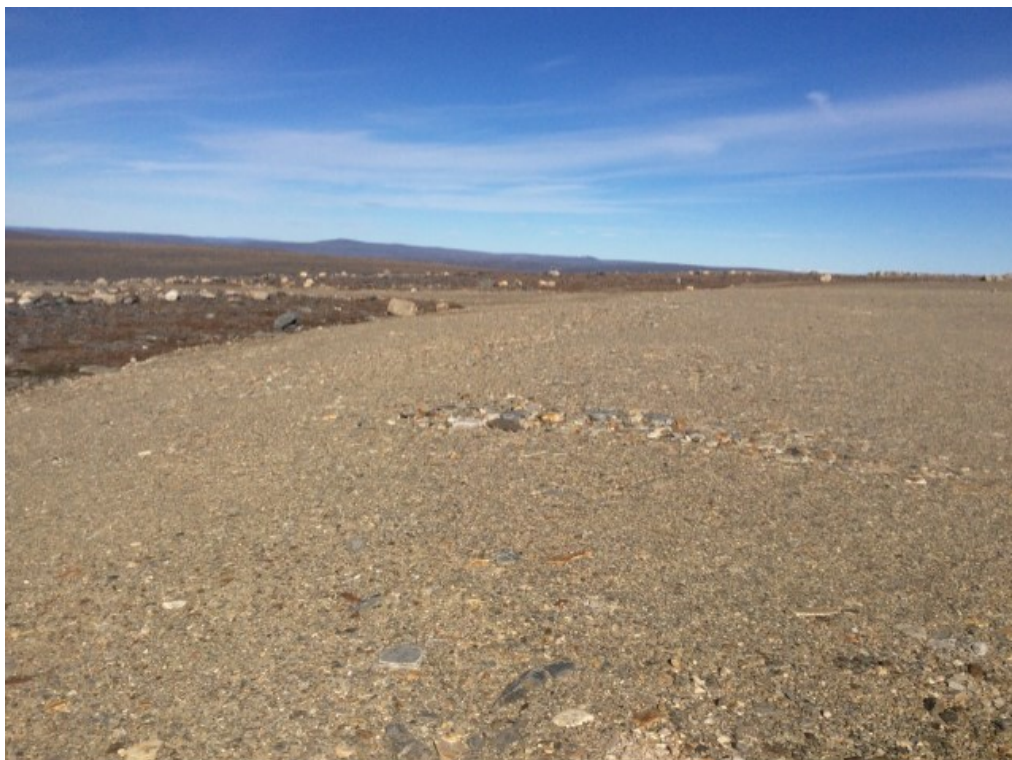
Photo 46: FOX-3 – Station West Landfill – West crest, facing north (ATT20_Photo20.jpg)

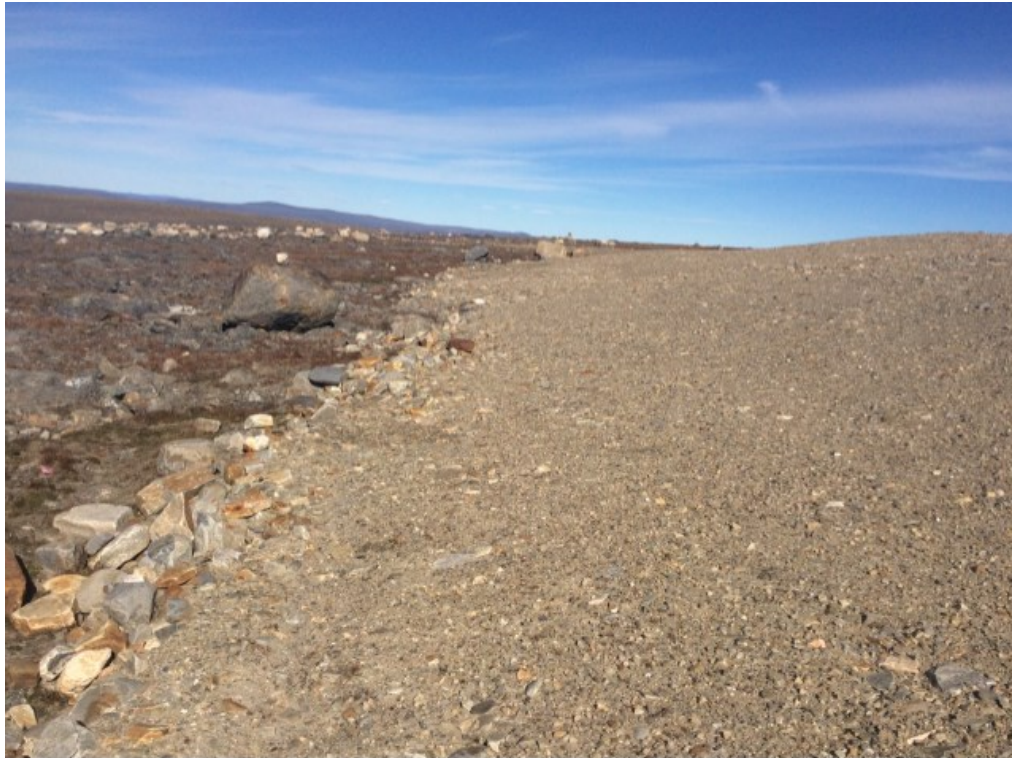
Photo 47: FOX-3 – Station West Landfill – West toe, facing northeast (ATT21_Photo21.jpg)

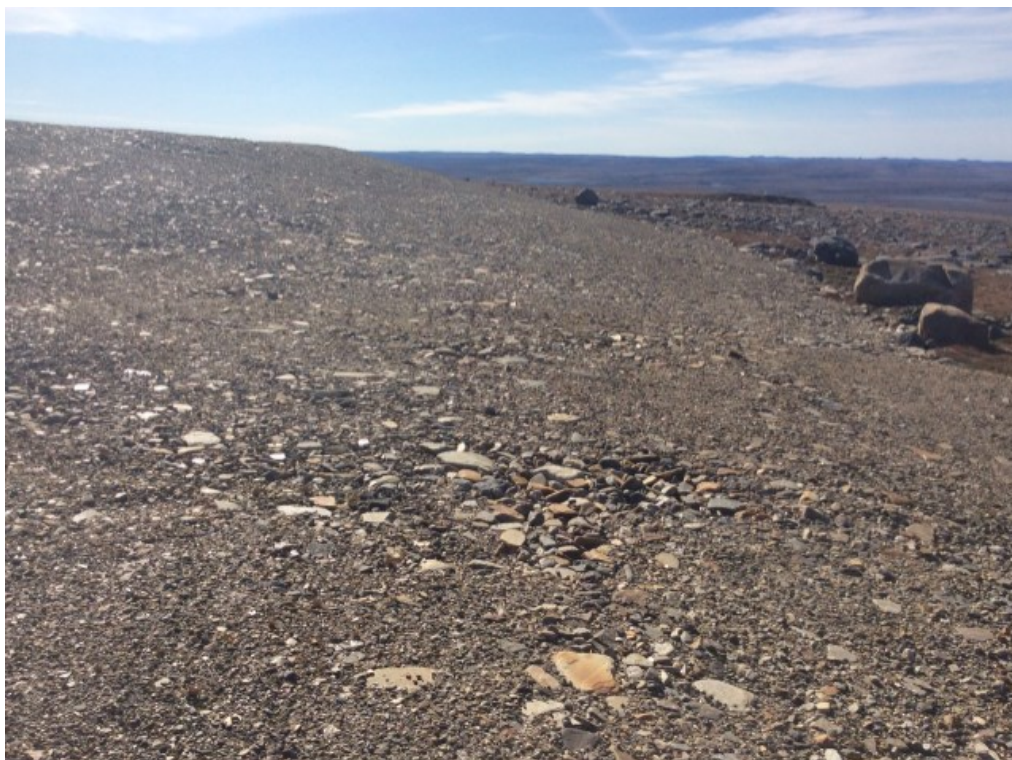
Photo 48: FOX-3 – Station West Landfill – West slope and toe, facing southwest (ATT22_Photo22.jpg)

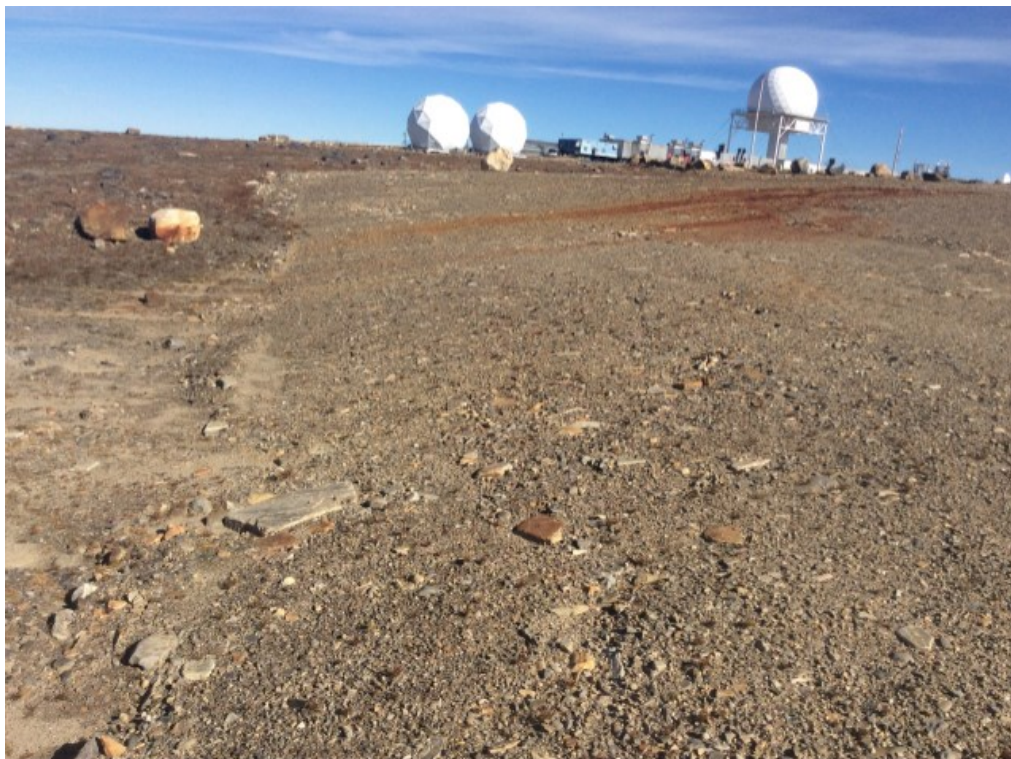
Photo 49: FOX-3 – Station West Landfill – North west slope and toe, facing northeast (ATT23_Photo23.jpg)

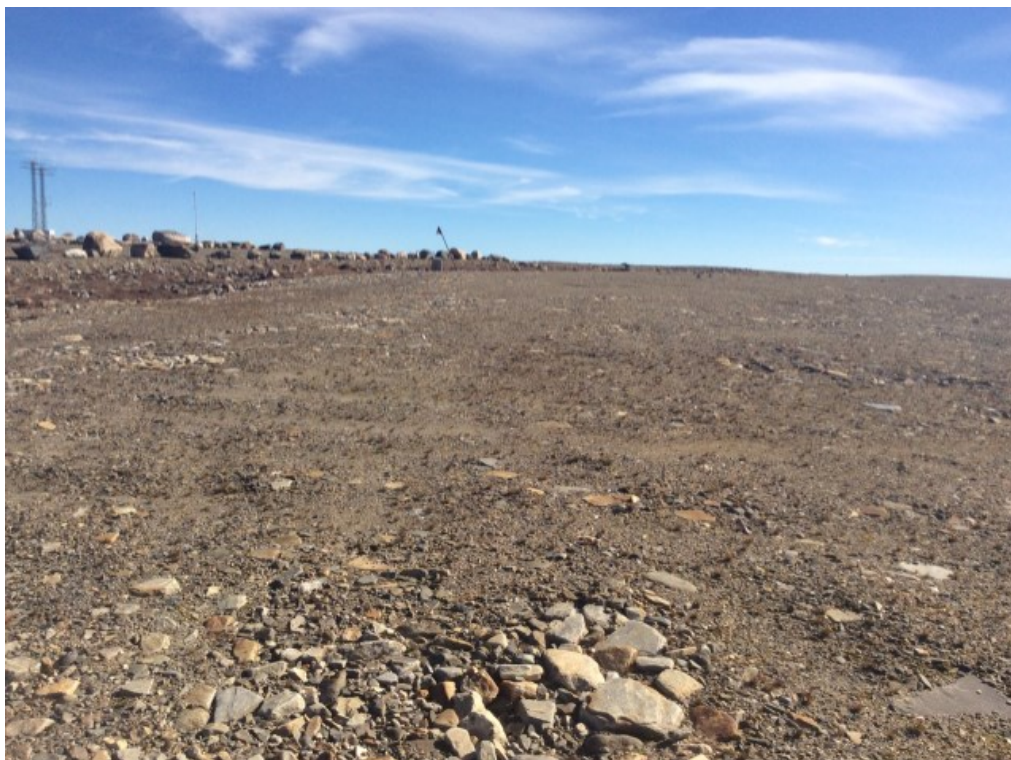
Photo 50: FOX-3 – Station West Landfill – Northeast crest, facing southeast (ATT24_Photo24.jpg)

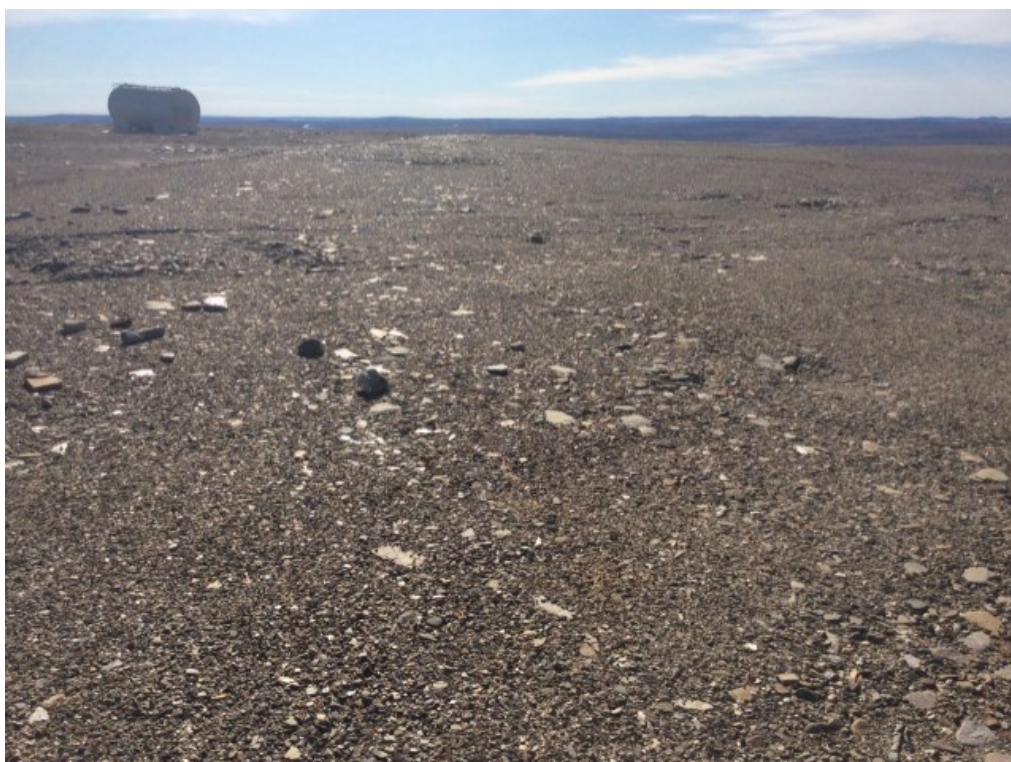
Photo 51: FOX-3 – Station West Landfill – Cover surface, facing south (ATT25_Photo25.jpg)

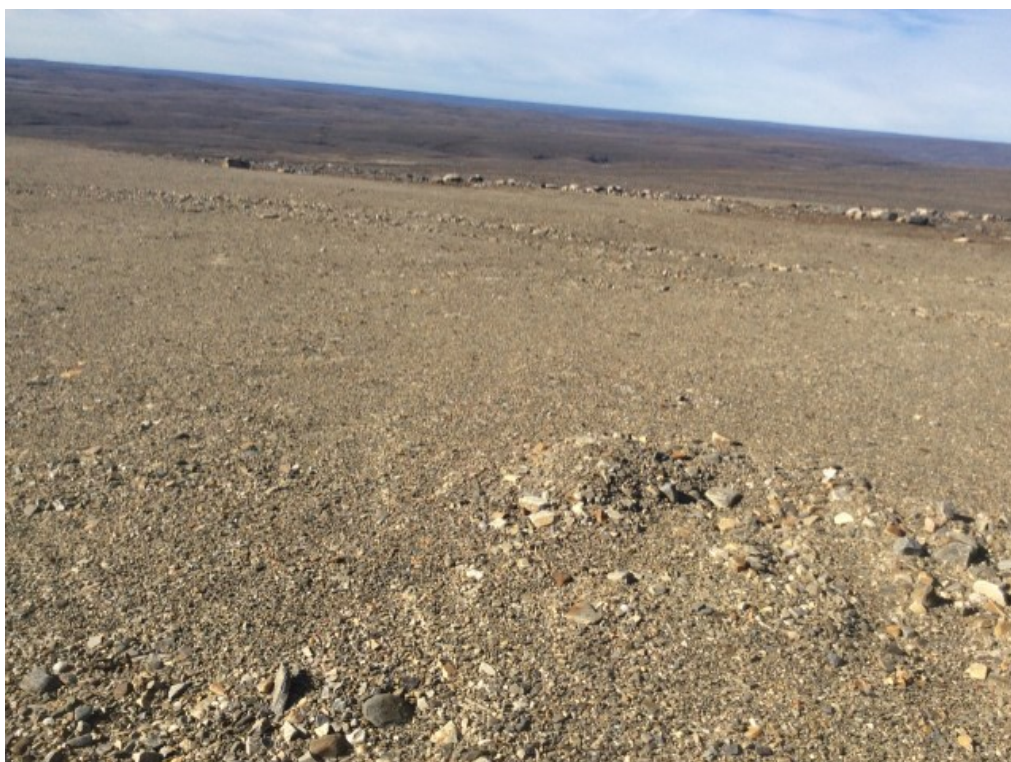
Photo 52: FOX-3 – Station West Landfill – Cover surface, facing southwest (ATT26_Photo26.jpg)

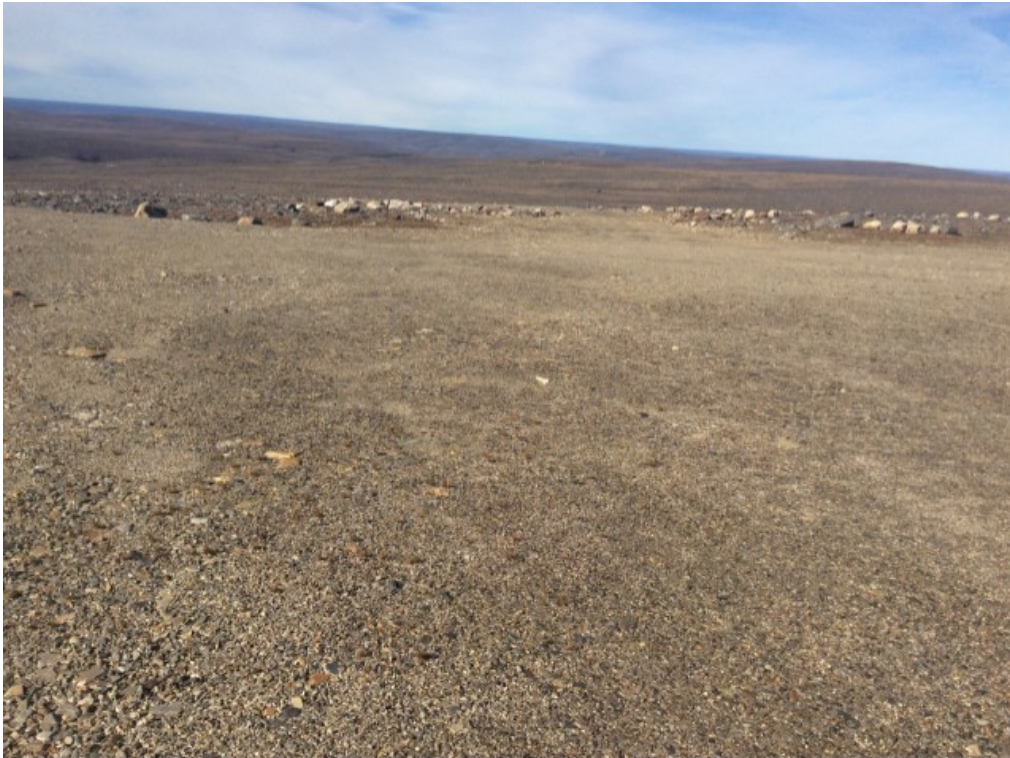
Photo 53: FOX-3 – Station West Landfill – Cover surface, facing southwest (ATT27_Photo27.jpg)

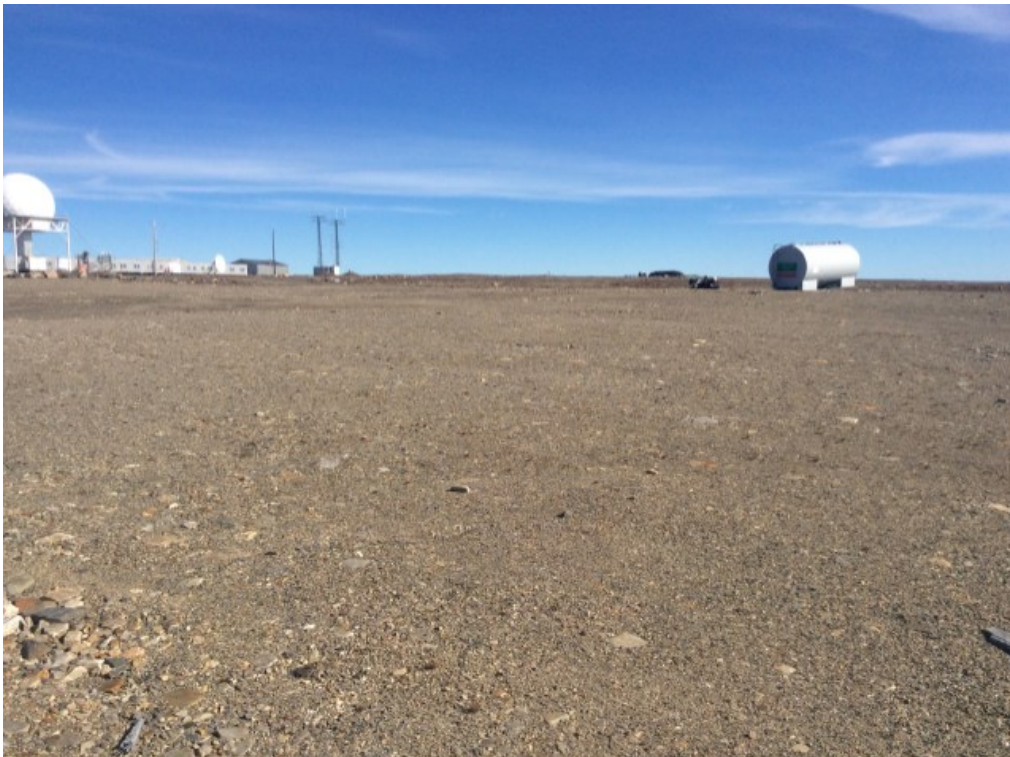
Photo 54: FOX-3 – Station West Landfill – Cover surface, facing northeast (ATT28_Photo28.jpg)

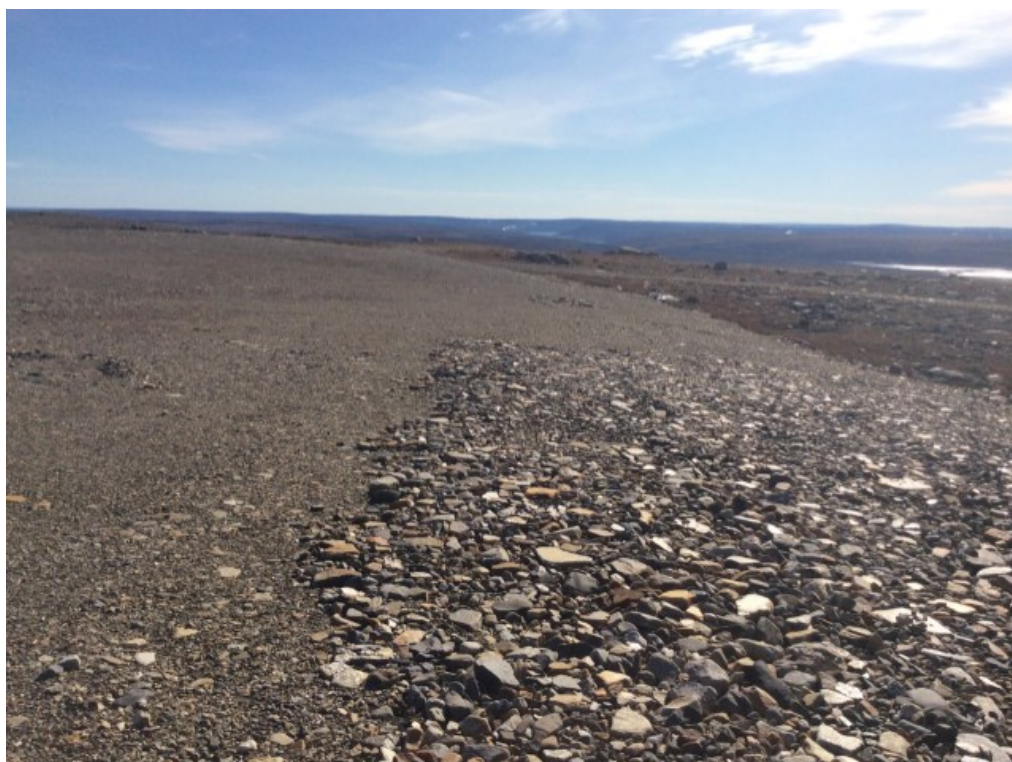
Photo 55: FOX-3 – Station West Landfill – Southwest slope, facing southwest (ATT29_Photo29.jpg)

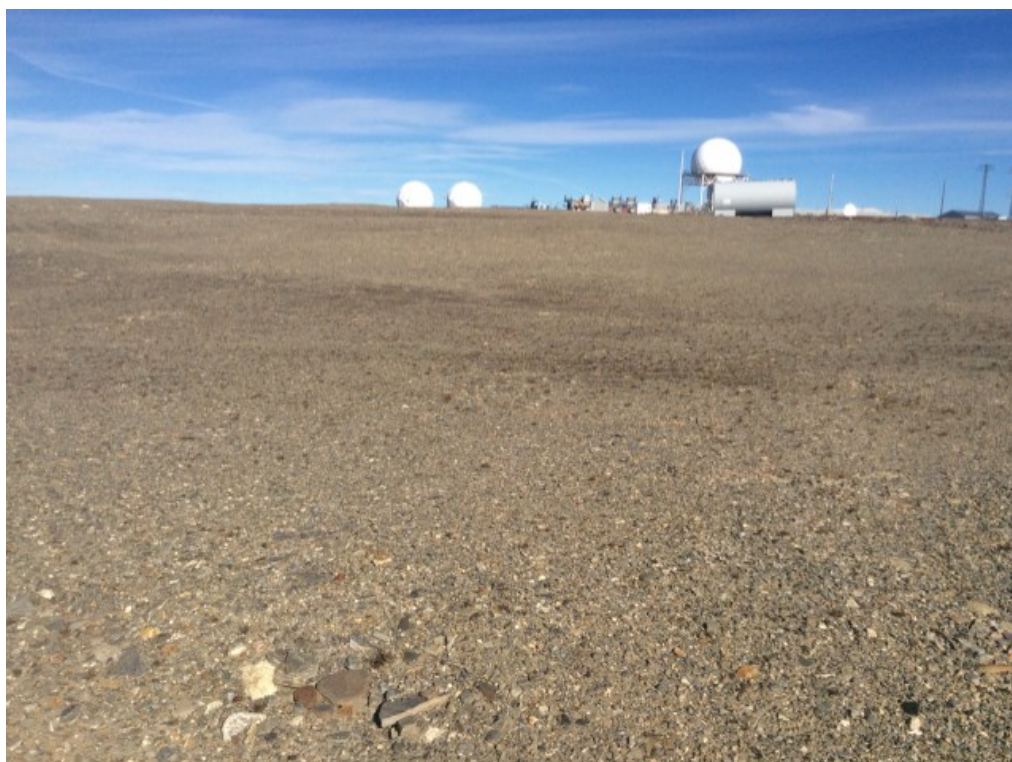
Photo 56: FOX-3 – Station West Landfill – Cover surface, facing northeast (ATT30_Photo30.jpg)

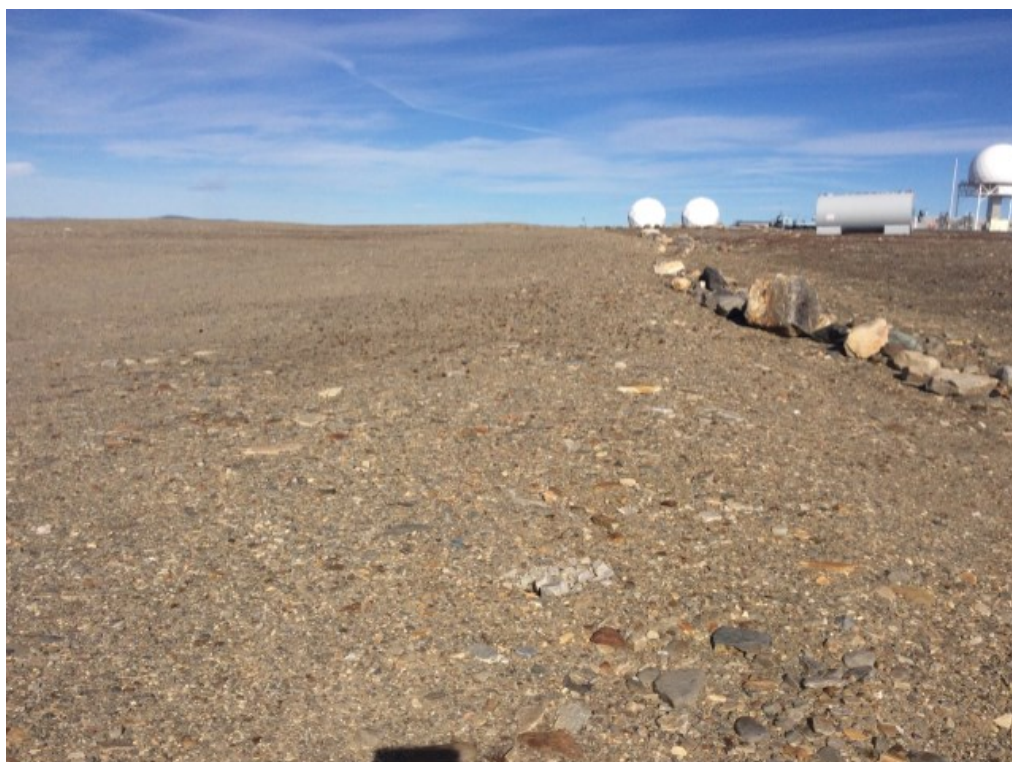
Photo 57: FOX-3 – Station West Landfill – Southeast crest, facing northeast (ATT31_Photo31.jpg)

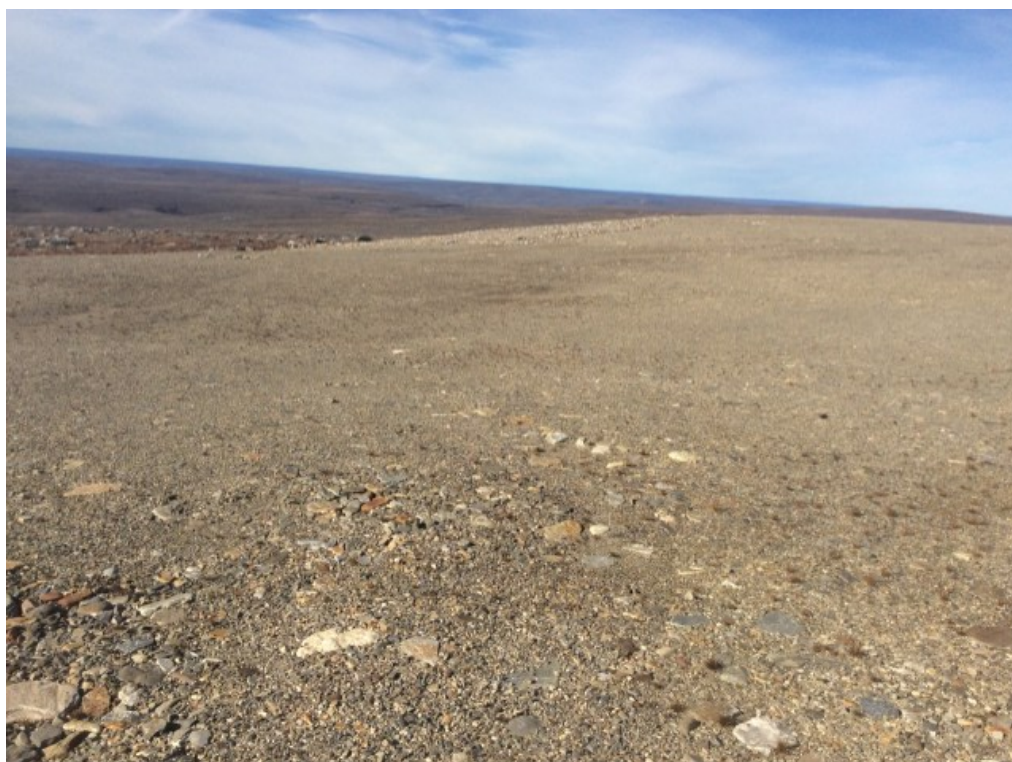
Photo 58: FOX-3 – Station West Landfill – Cover surface, facing northwest (ATT32_Photo32.jpg)

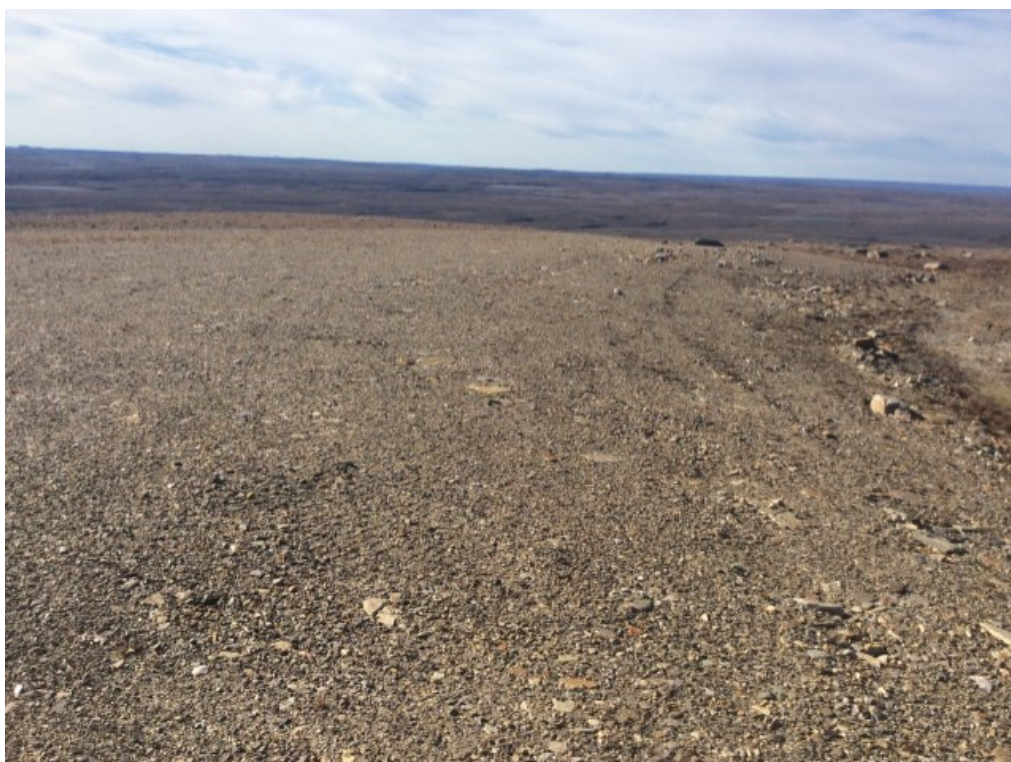
Photo 59: FOX-3 – Station West Landfill – Cover surface, facing west (ATT33_Photo33.jpg)

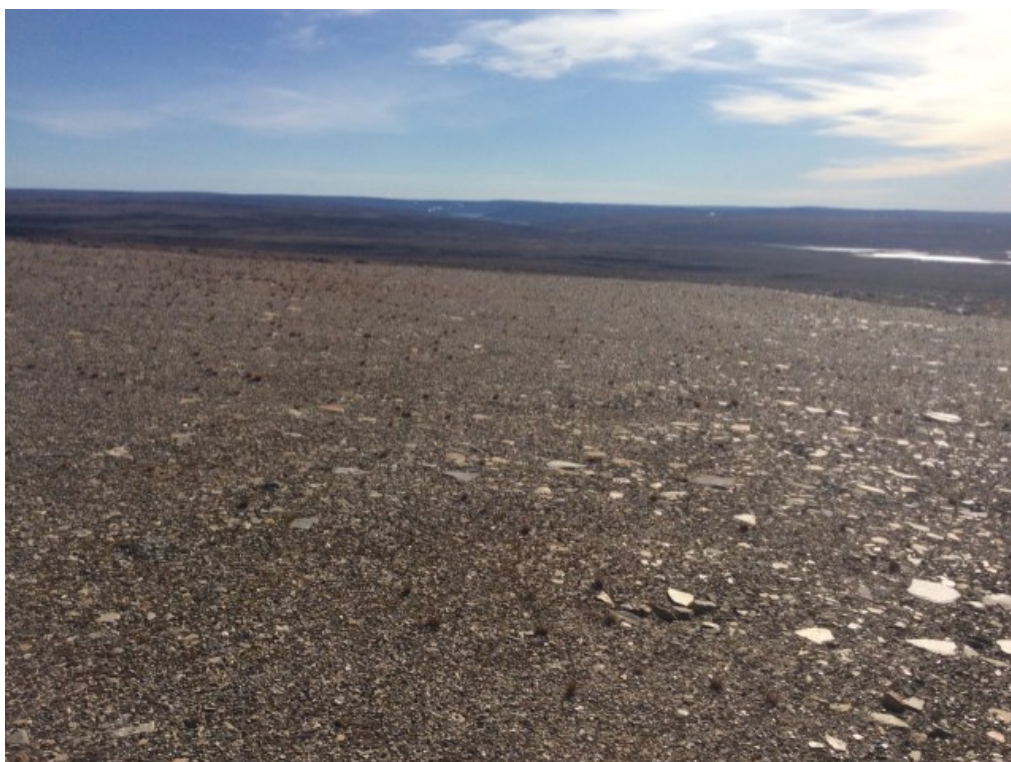
Photo 60: FOX-3 – Station West Landfill – Cover surface, facing southeast (ATT34_Photo34.jpg)

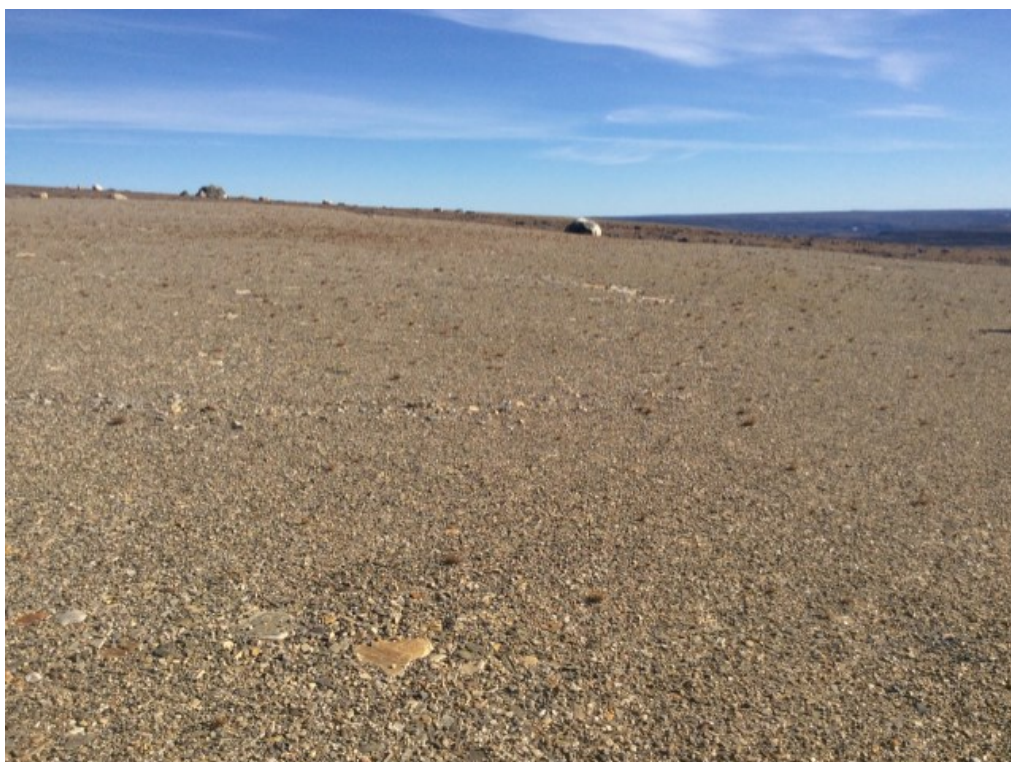
Photo 61: FOX-3 – Station West Landfill – Cover surface, facing east (ATT35_Photo35.jpg)

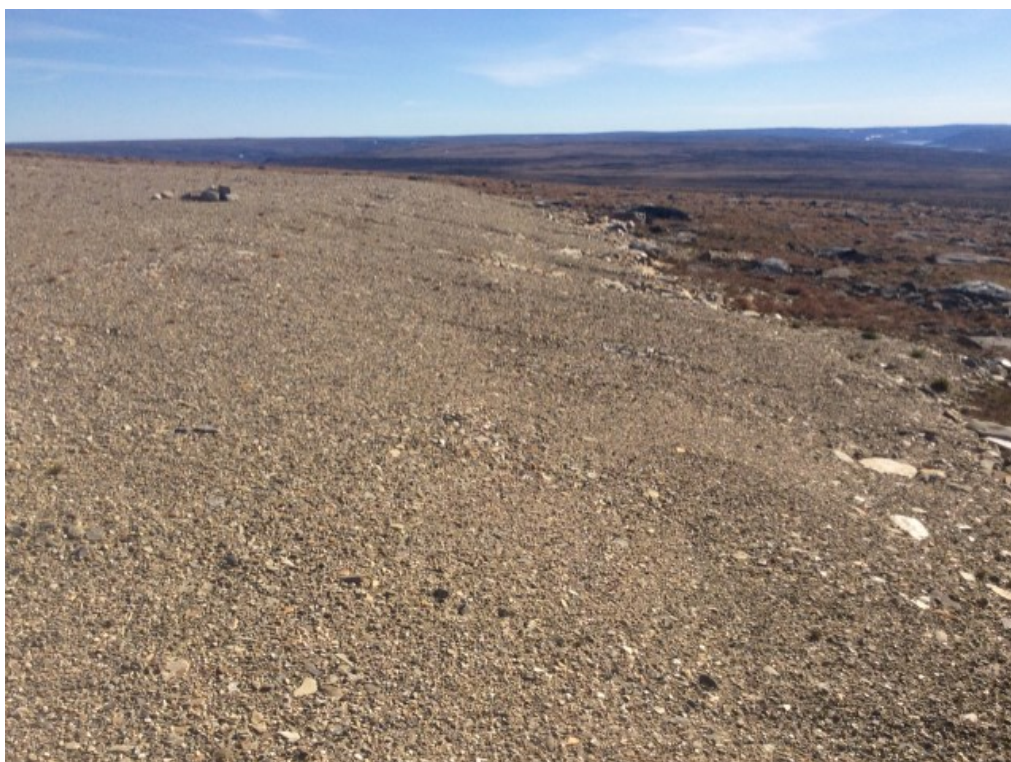
Photo 62: FOX-3 – Station West Landfill – Wet slope and toe, facing south (ATT36_Photo36.jpg)

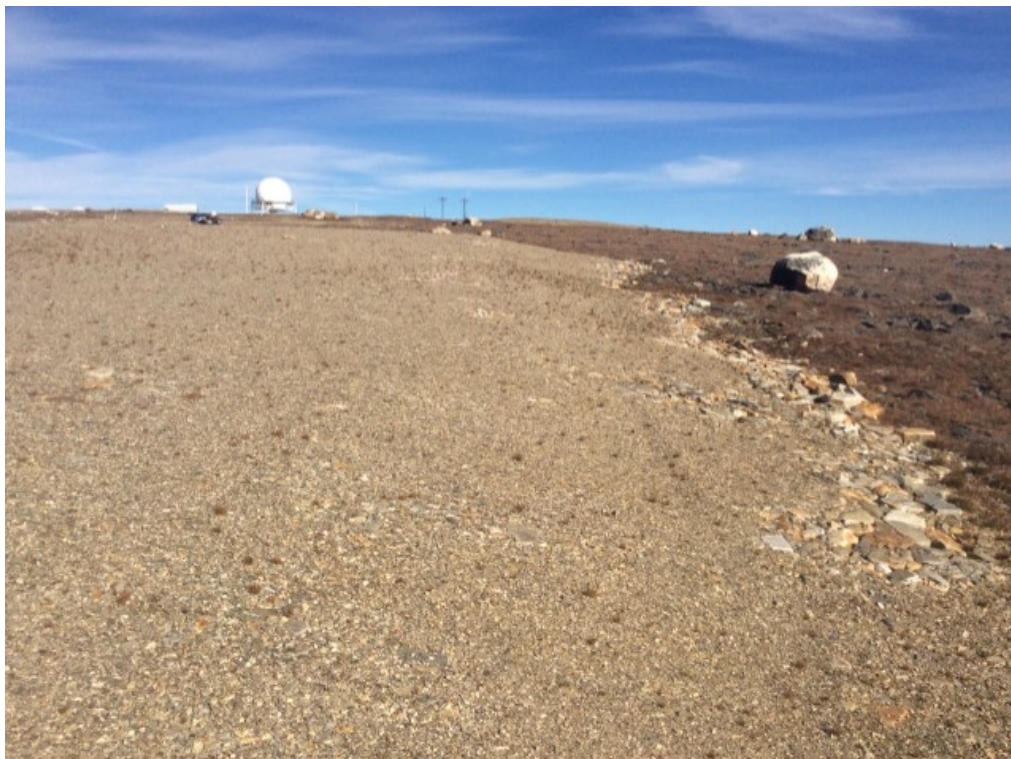
Photo 63: FOX-3 – Station West Landfill – South slope and toe, facing east (ATT37_Photo37.jpg)

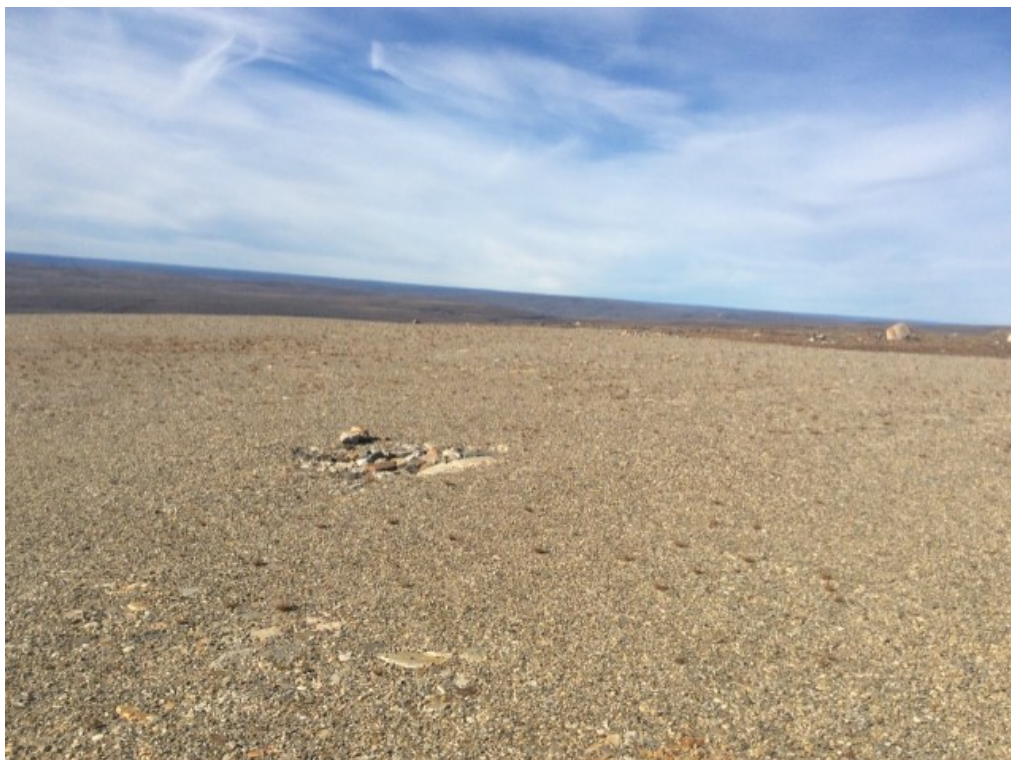
Photo 64: FOX-3 – Station West Landfill – Cover surface, facing northwest (ATT38_Photo38.jpg)

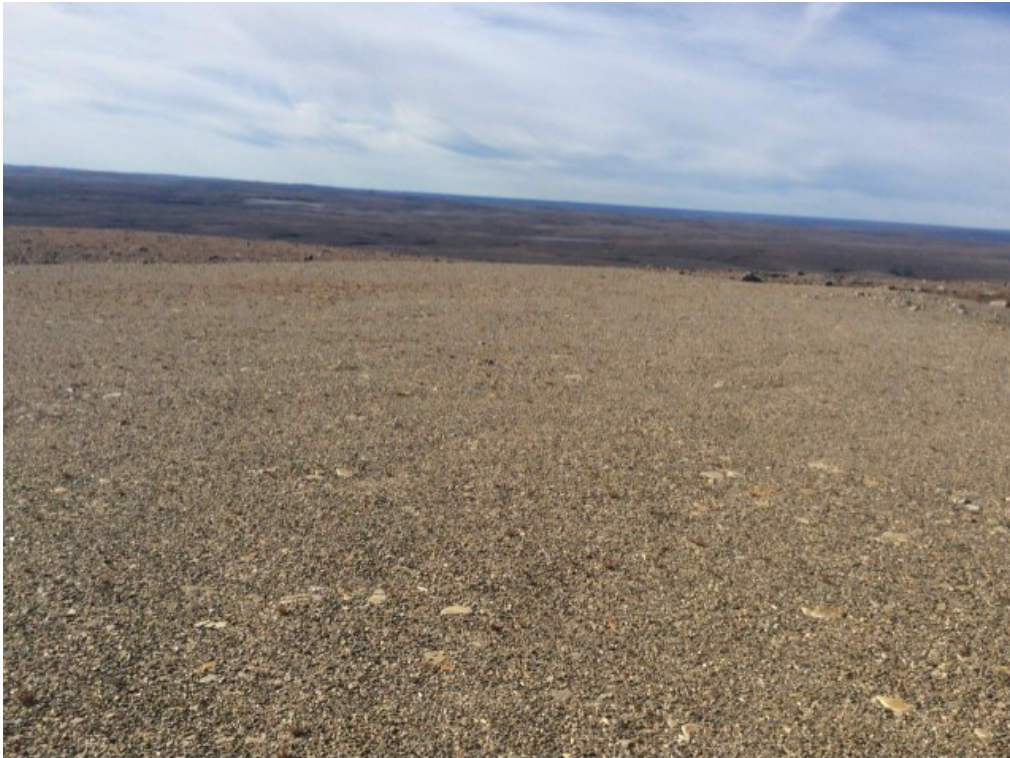
Photo 65: FOX-3 – Station West Landfill – Cover surface, facing west (ATT39_Photo39.jpg)

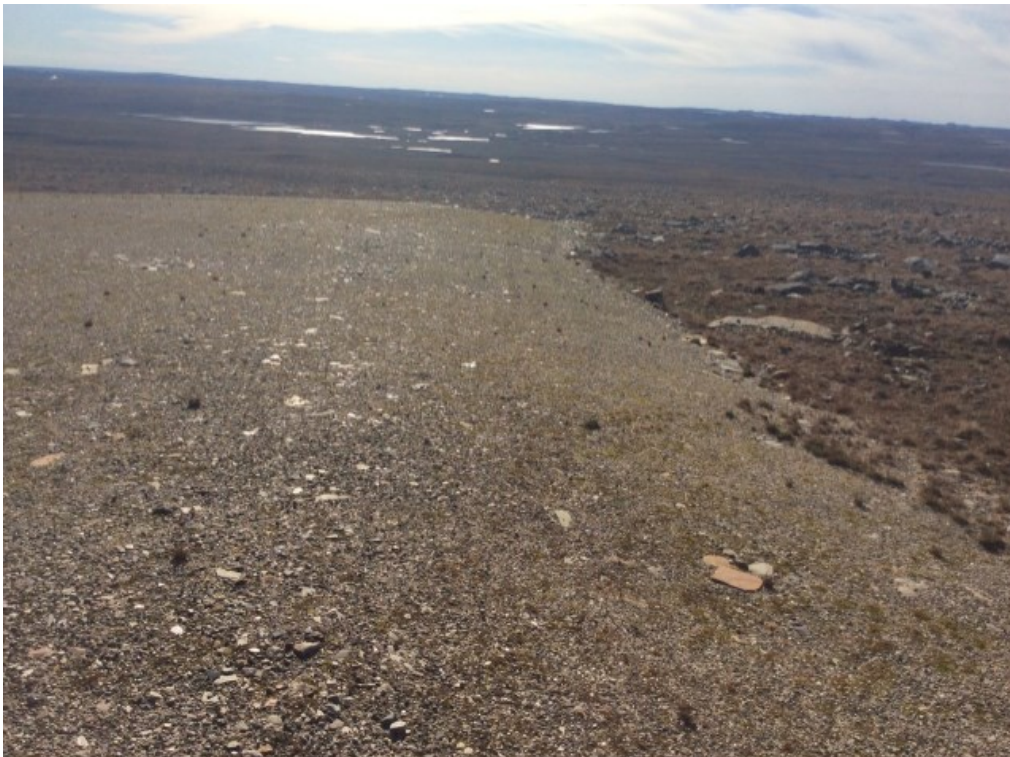
Photo 66: FOX-3 – Station West Landfill – Northwest slope, facing southwest (ATT40_Photo40.jpg)

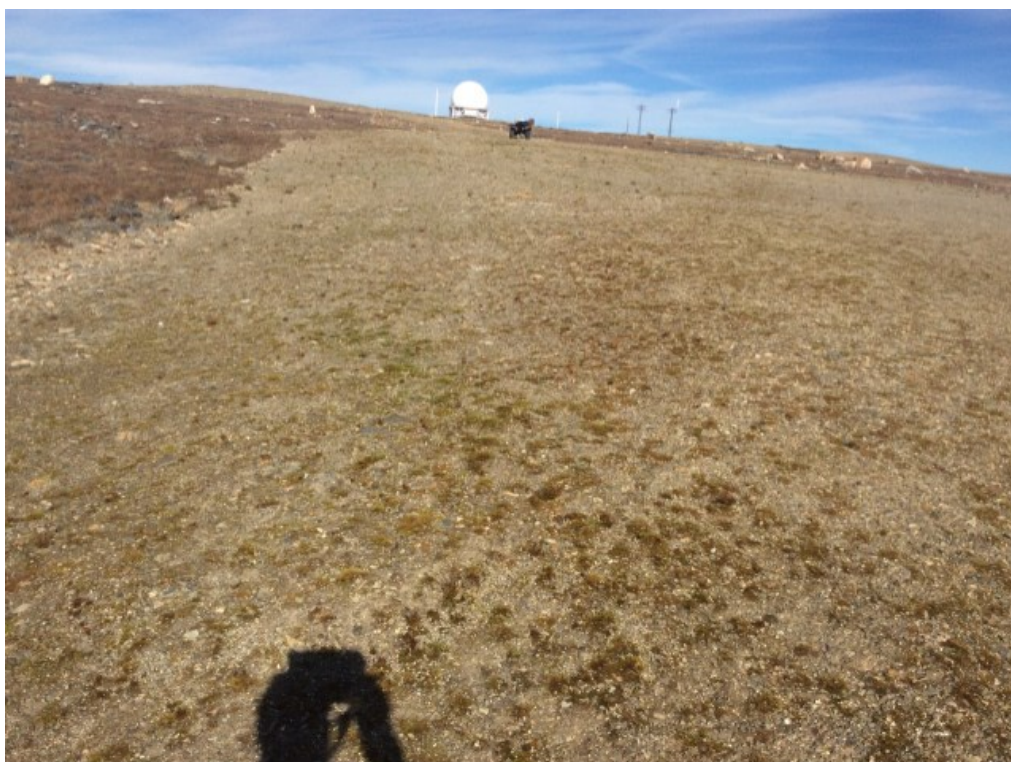
Photo 67: FOX-3 – Station West Landfill – Northwest slope, facing northeast (ATT41_Photo41.jpg)

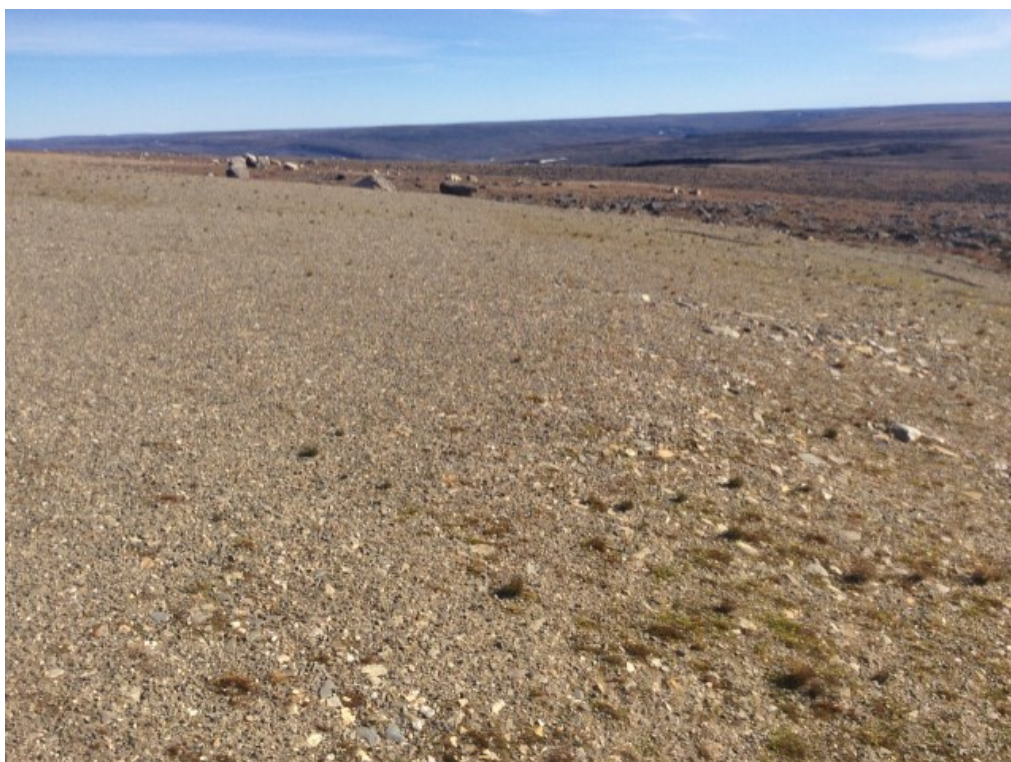
Photo 68: FOX-3 – Station West Landfill – Southwest slope, facing southeast (ATT42_Photo42.jpg)

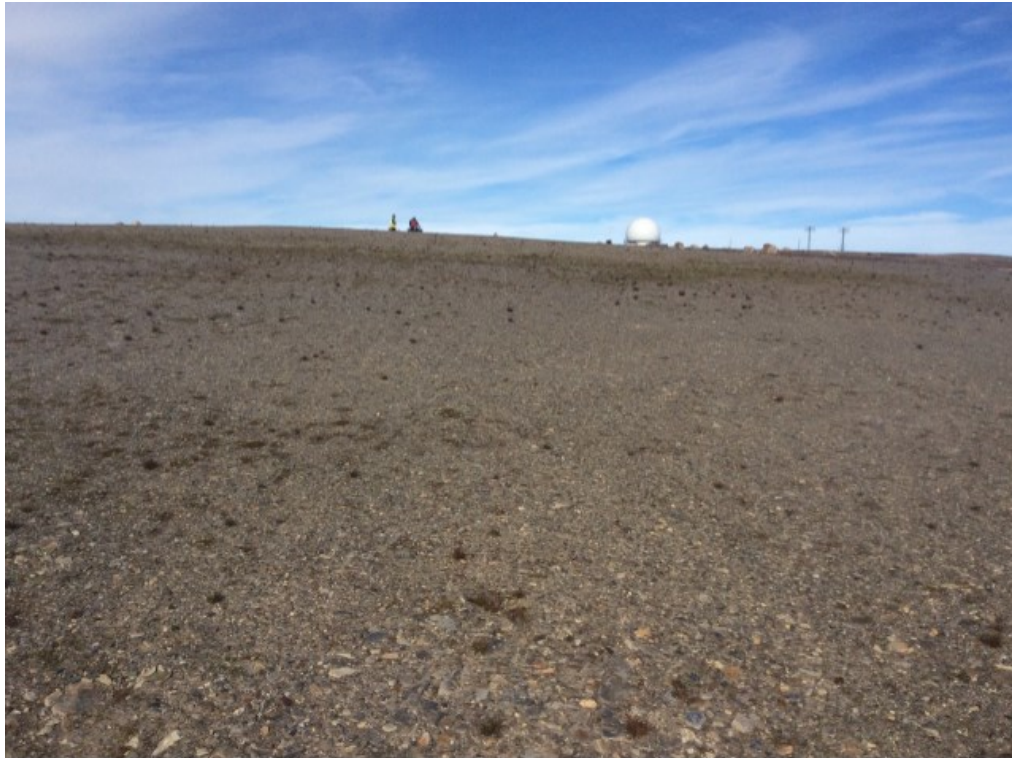
Photo 69: FOX-3 – Station West Landfill – Cover surface, facing northeast (ATT43_Photo43.jpg)

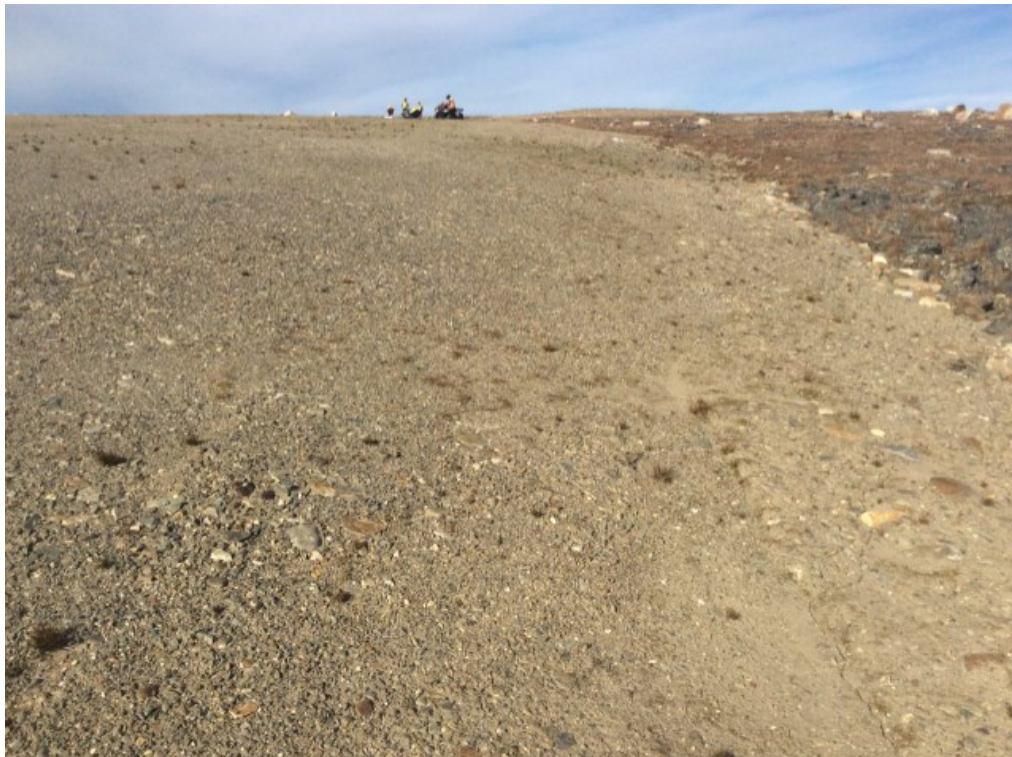
Photo 70: FOX-3 – Station West Landfill – Southeast slope, facing northeast (ATT44_Photo44.jpg)

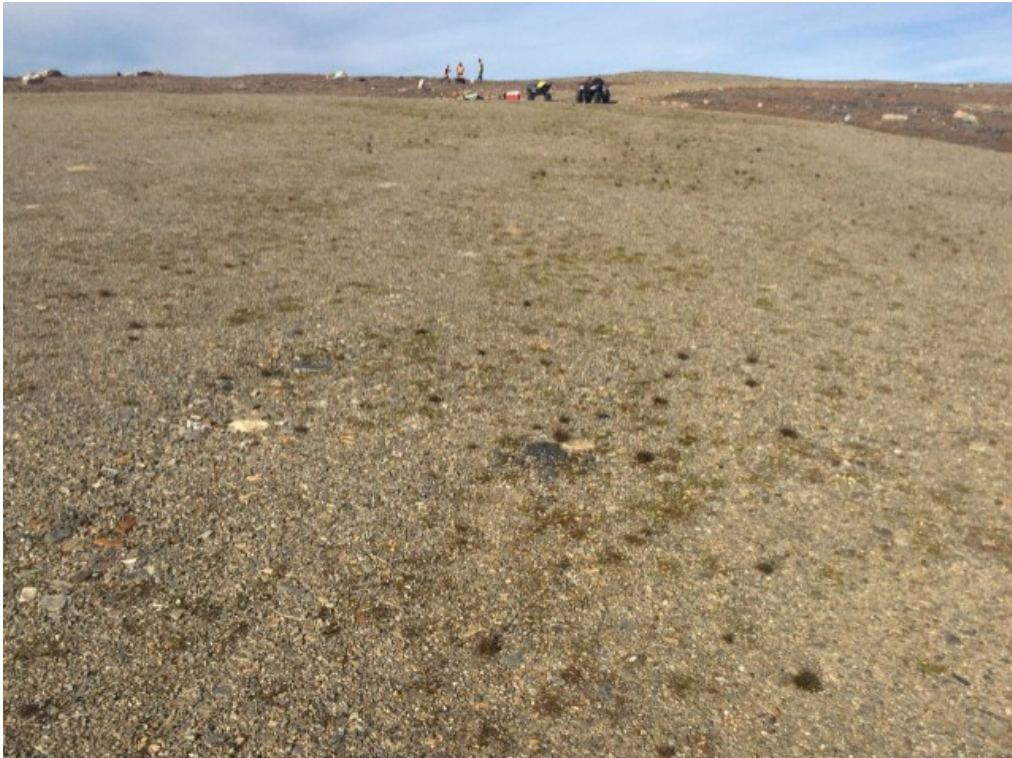
Photo 71: FOX-3 – Station West Landfill – Cover surface, facing north (ATT45_Photo45.jpg)

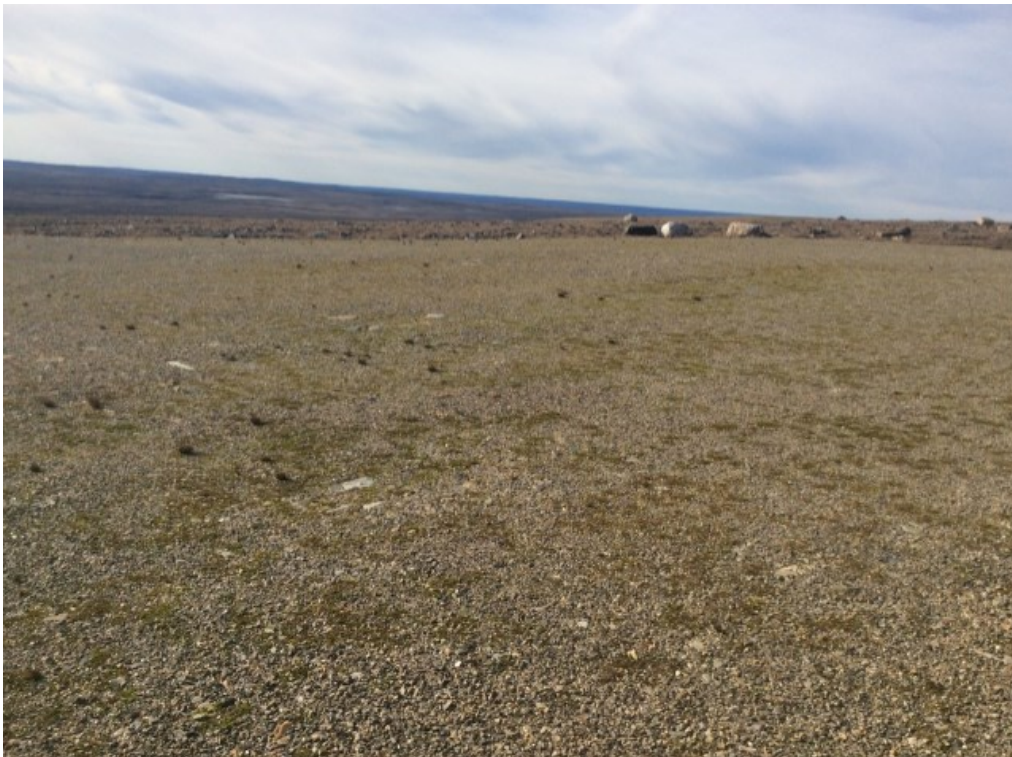
Photo 72: FOX-3 – Station West Landfill – Cover surface, facing west (ATT46_Photo46.jpg)
