QIKIQ15 BAFFIN REGION DEW LINE SITE MONITORING

2016 FOX-3 Monitoring Report

Report Number: 1530908-2000-R3-V2

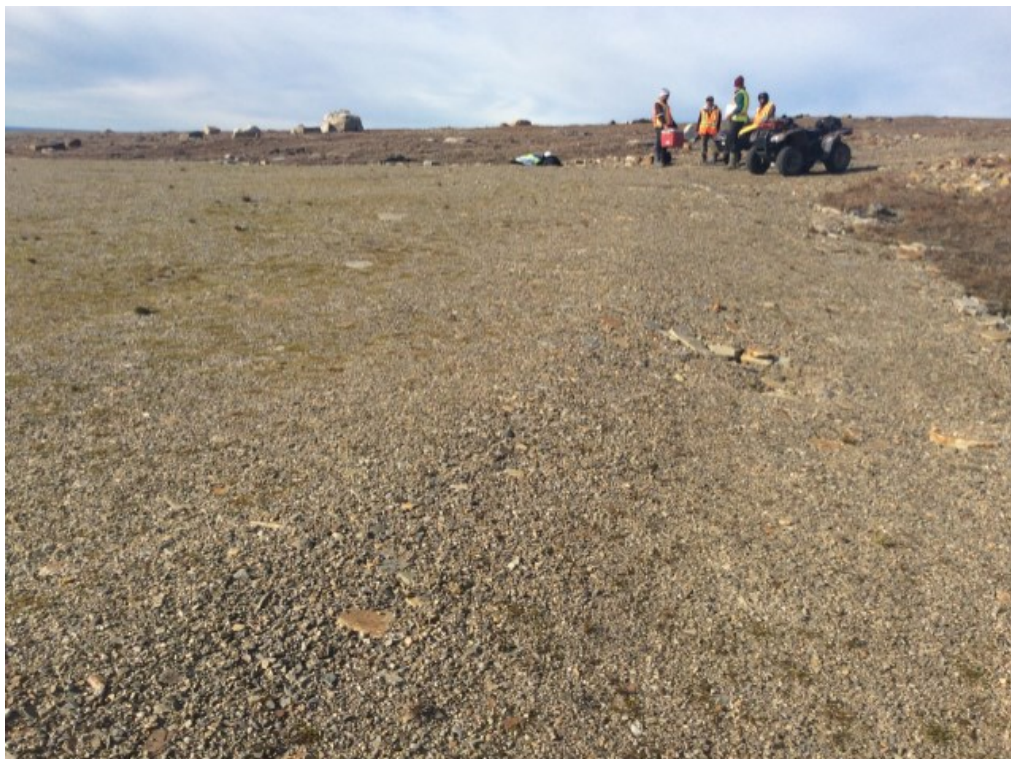
Photo 73: FOX-3 – Station West Landfill – Northeast slope, facing northwest (ATT47_Photo47.jpg)

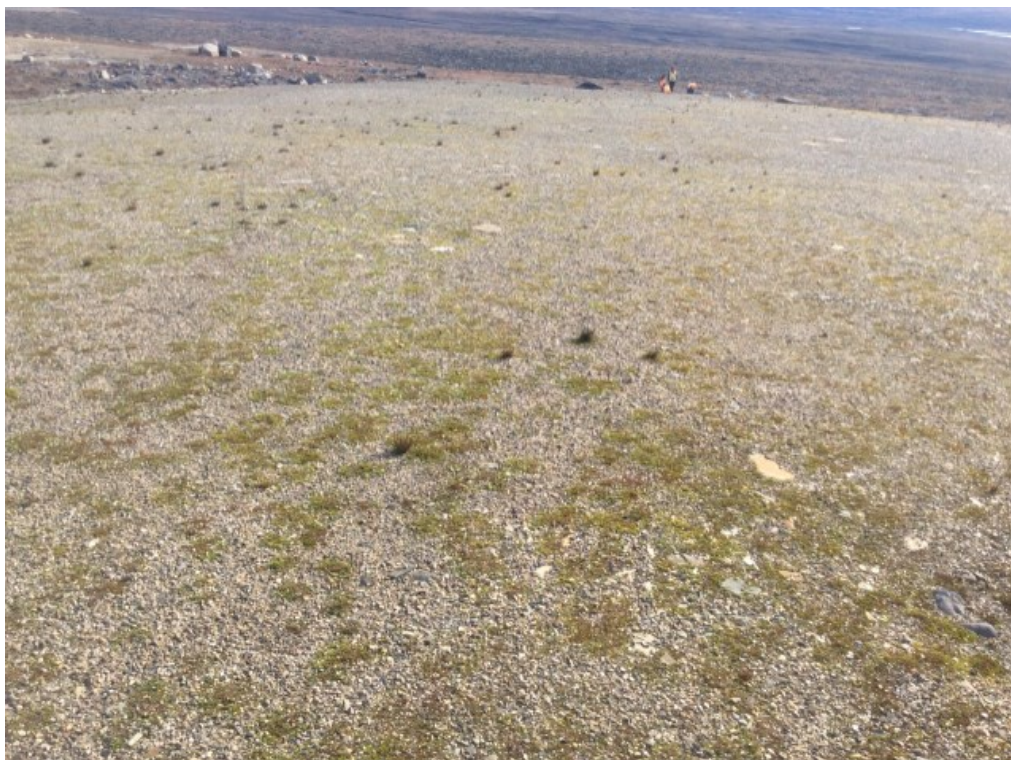
Photo 74: FOX-3 – Station West Landfill – Cover surface, facing south (ATT48_Photo48.jpg)

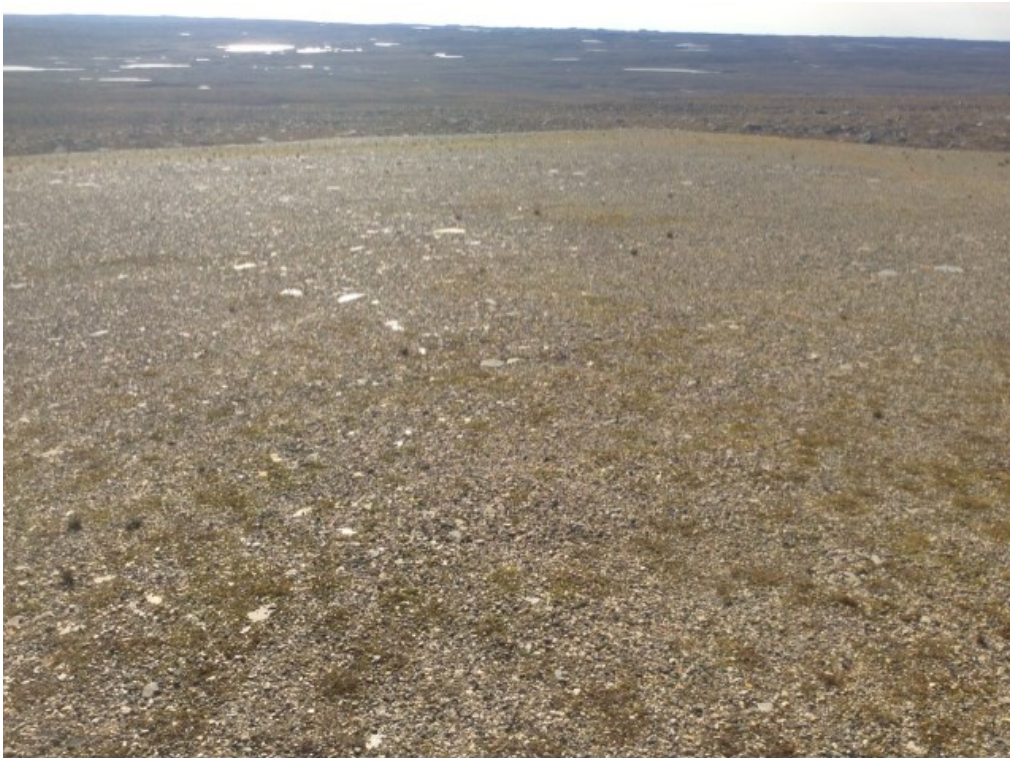
Photo 75: FOX-3 – Station West Landfill – Cover surface, facing southwest (ATT49_Photo49.jpg)

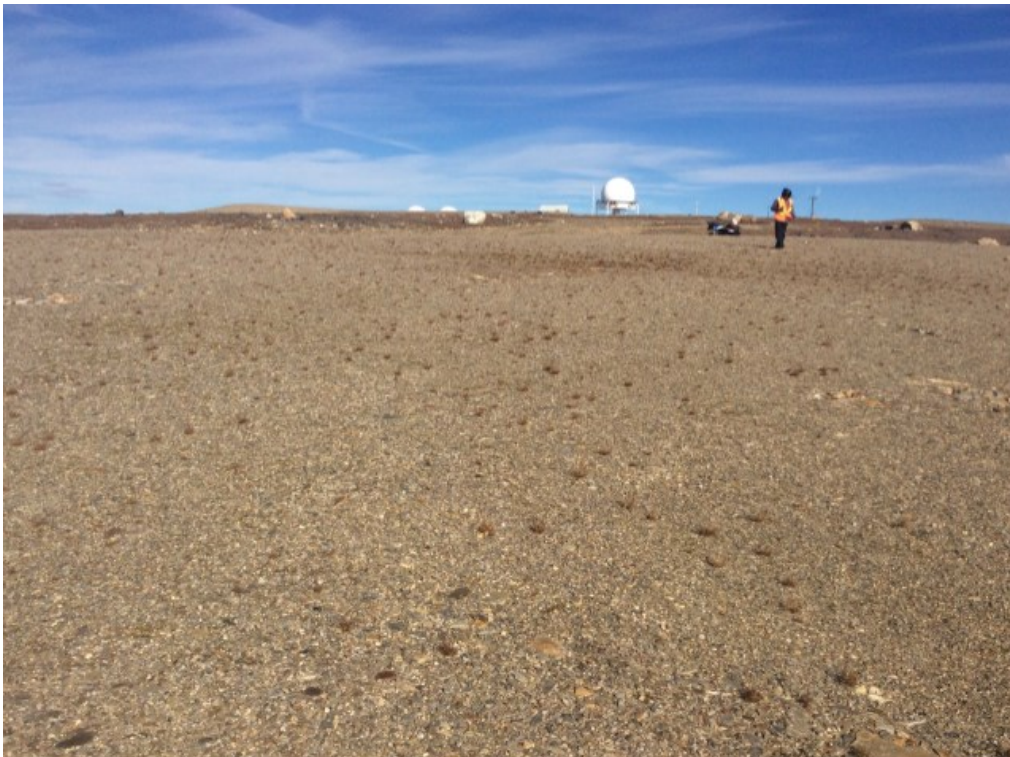
Photo 76: FOX-3 – Station West Landfill – Lobe E2, west crest – previous minor settlement (previous Feature J), facing northeast (ATT22_Photo22.jpg)

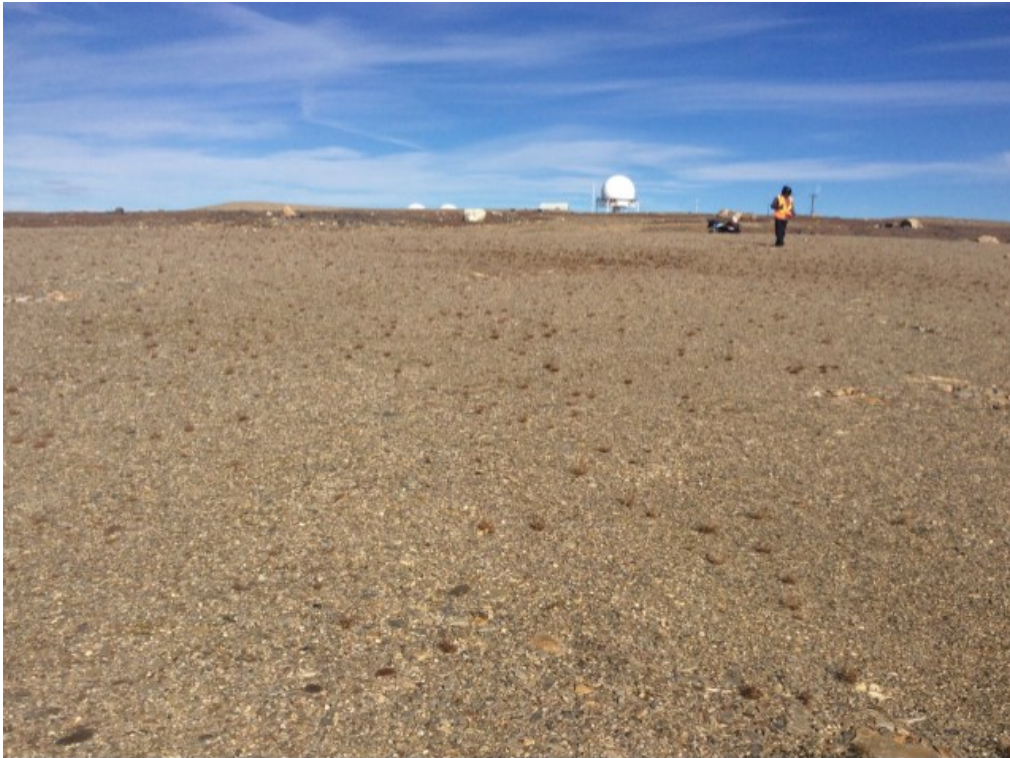
Photo 77: FOX-3 – Station West Landfill – Lobe E2, cover surface – Feature Z – Sparse vegetation [Acceptable], facing northeast (ATT22_Photo22.jpg)

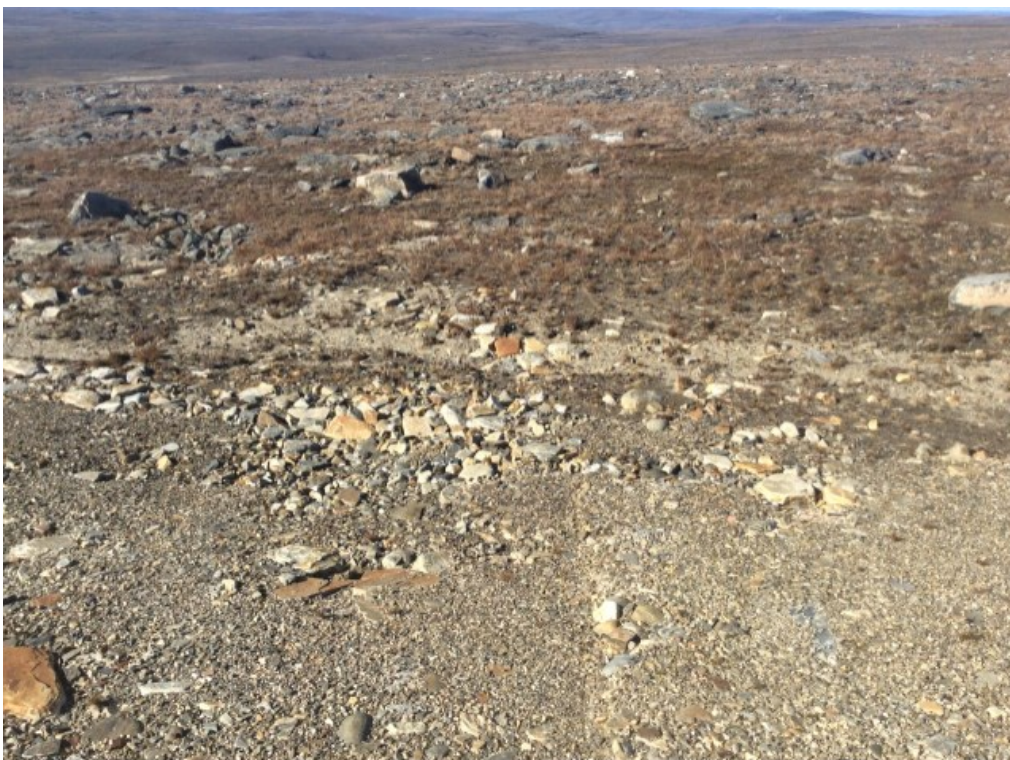
Photo 78: FOX-3 – Station West Landfill – Lobe E2, north toe – No ponded water along toe (previous Feature AA) [Acceptable], facing east (ATT21_Photo21.jpg)

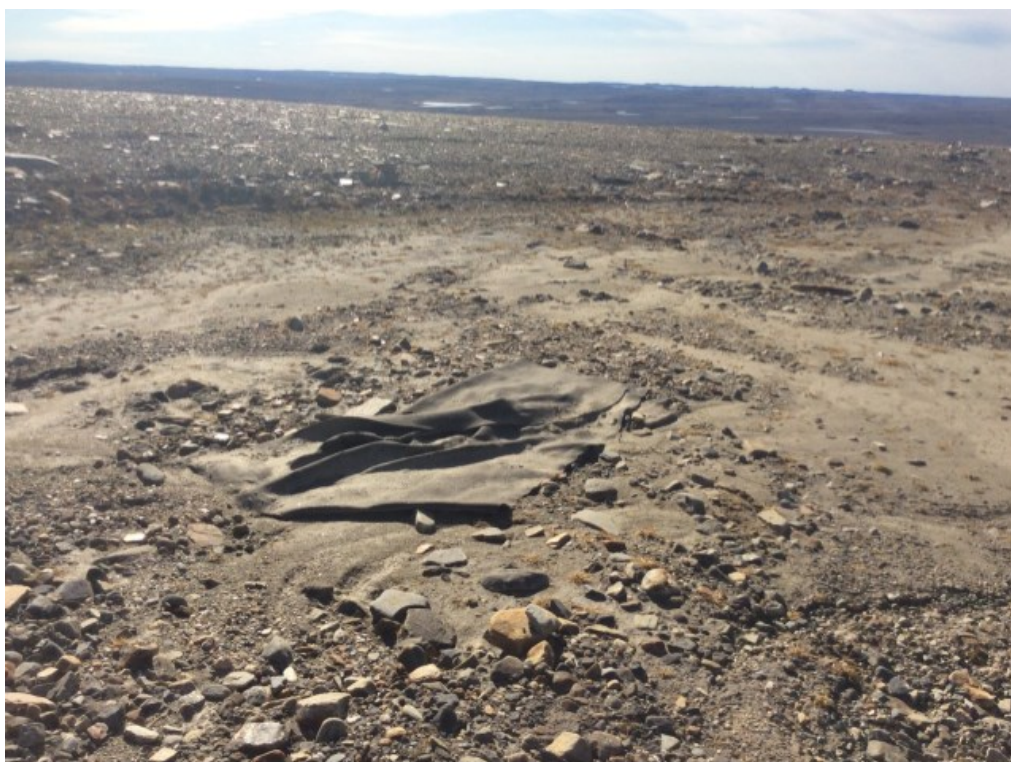
Photo 79: FOX-3 – Station West Landfill – Lobe E2, northeast toe – Feature I – Geotextile [Acceptable], facing west (ATT20_Photo20.jpg)

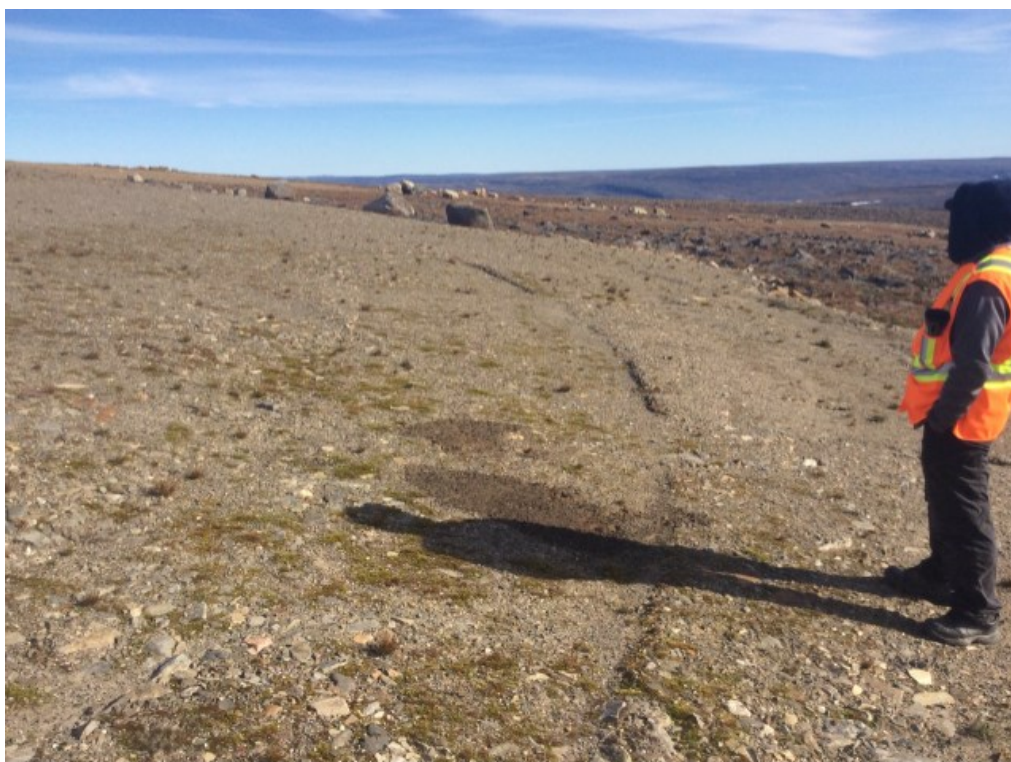
Photo 80: FOX-3 – Station West Landfill – Lobe F, southwest slope – Feature M – Minor self-armouring erosion [Acceptable], facing southeast (ATT25_Photo25.jpg)

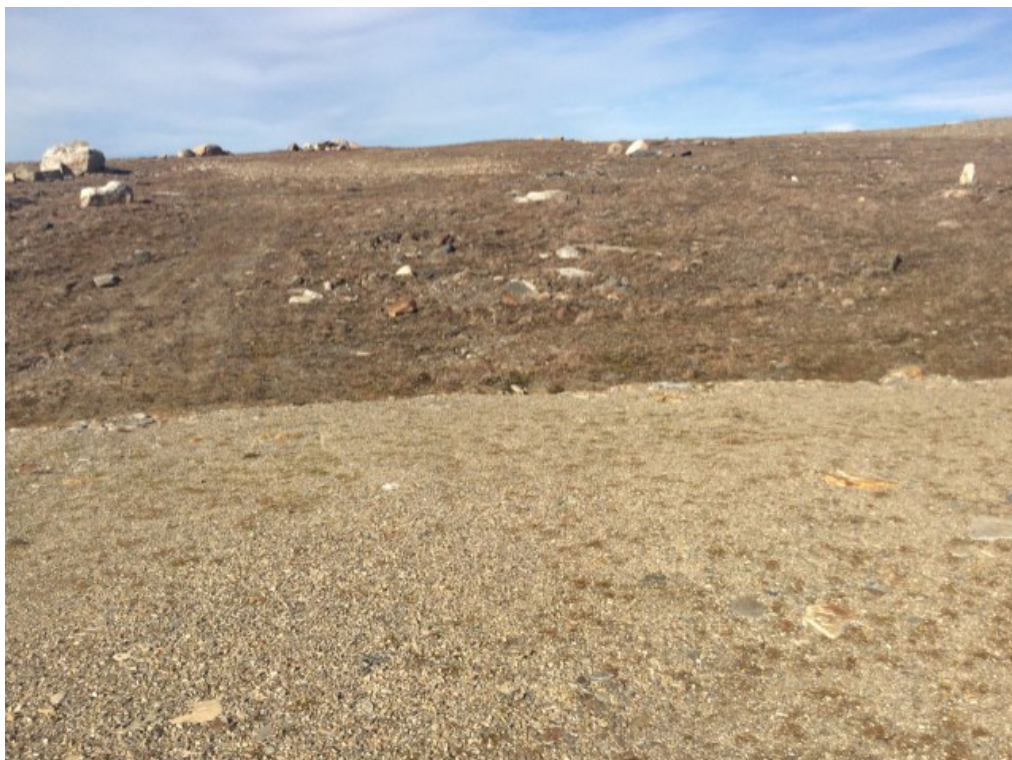
Photo 82: FOX-3 – Station West Landfill – Lobe F, north toe – No ponded water along toe (previous Feature AB) [Acceptable], facing southeast (ATT23_Photo23.jpg)

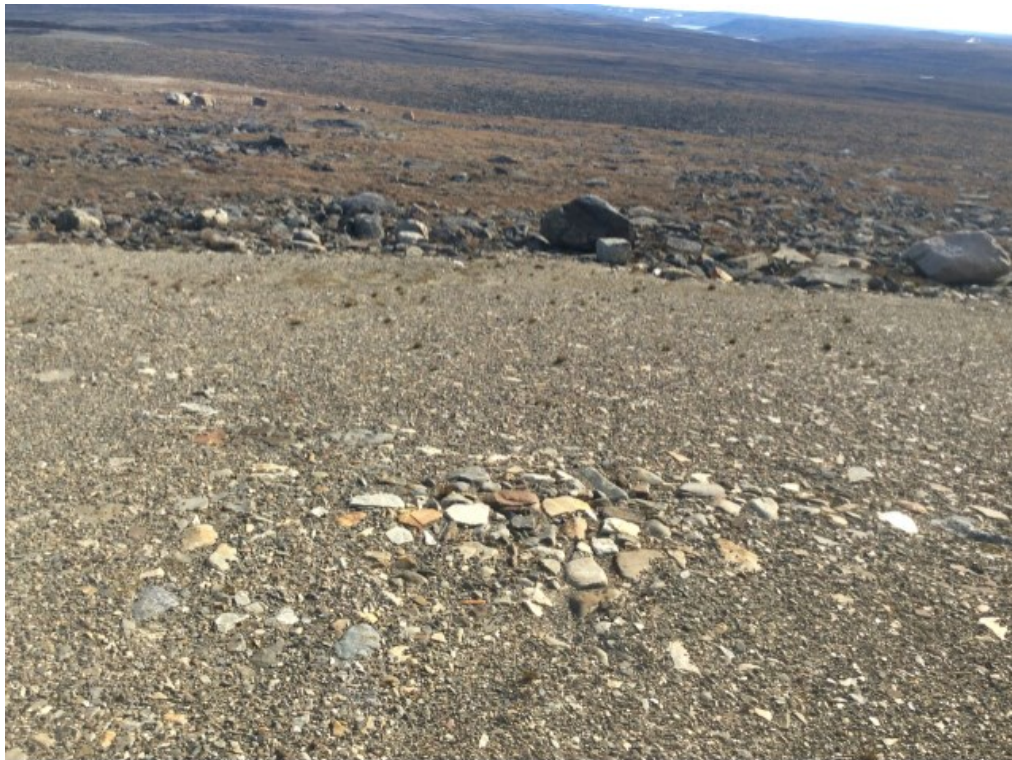
Photo 83: FOX-3 – Station West Landfill – Lobe F, southeast slope – Feature P – Minor self-armouring erosion [Acceptable], facing southeast (ATT26_Photo26.jpg)

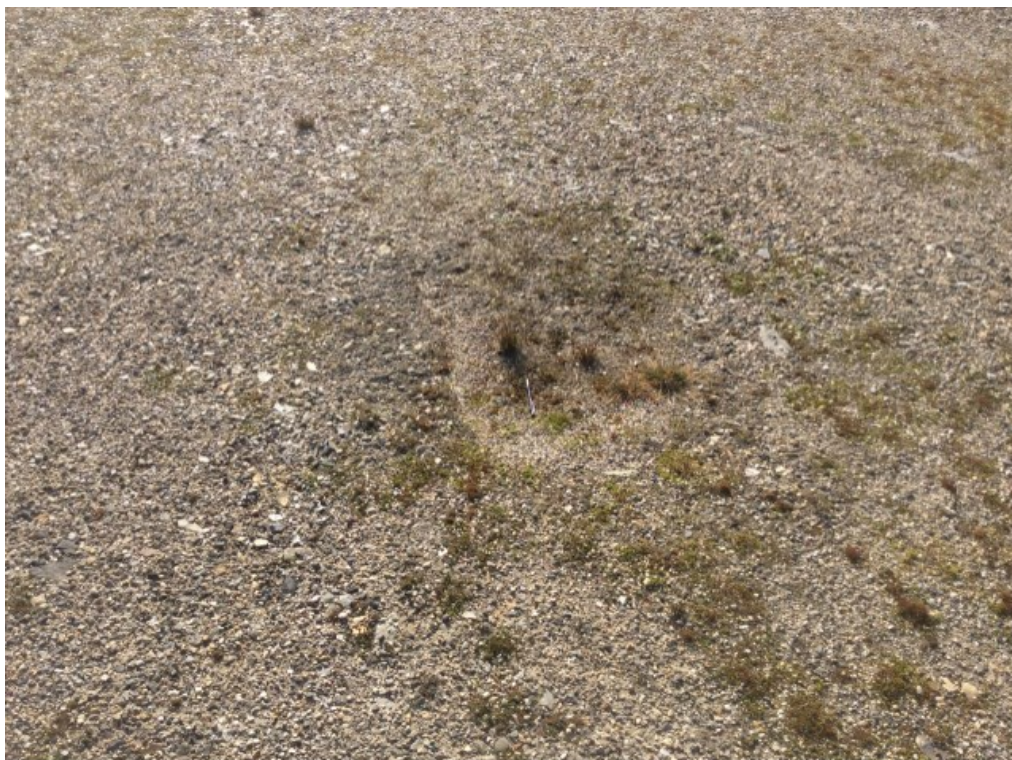
Photo 84: FOX-3 – Station West Landfill – Lobe F, north crest surface – Feature K – shallow depression [Acceptable], facing southwest (ATT30_Photo30.jpg)

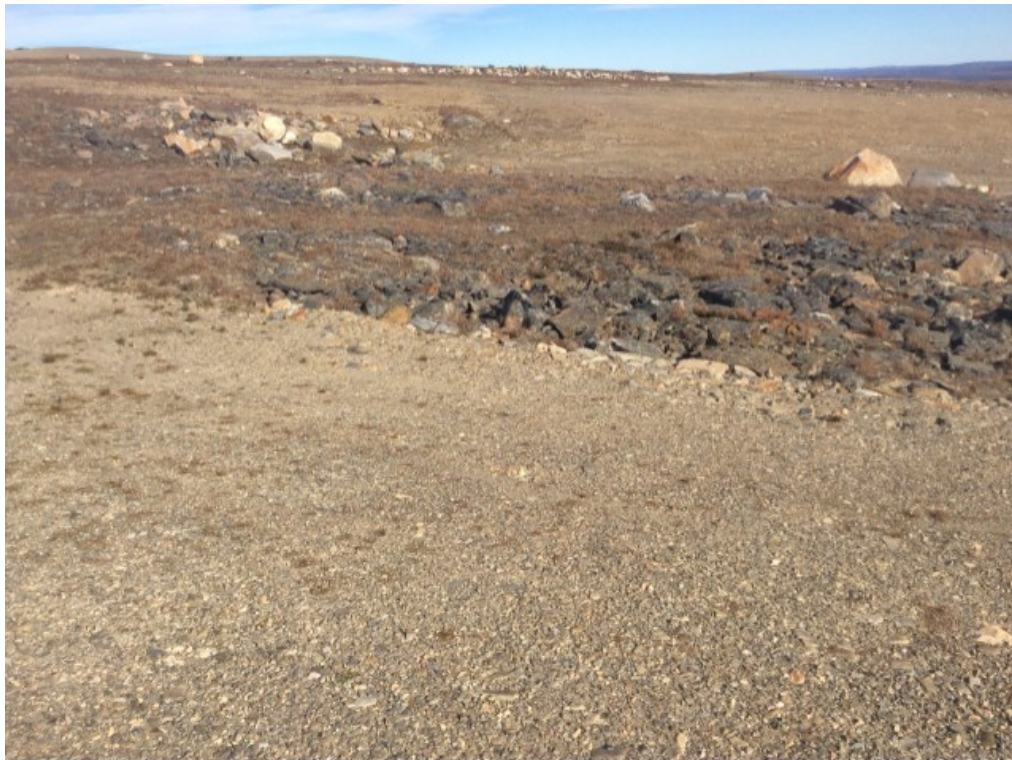
Photo 85: FOX-3 – Station West Landfill – Lobe F, east toe – No ponded water along toe (previous Feature AB) [Acceptable], facing northeast (ATT29_Photo29.jpg)

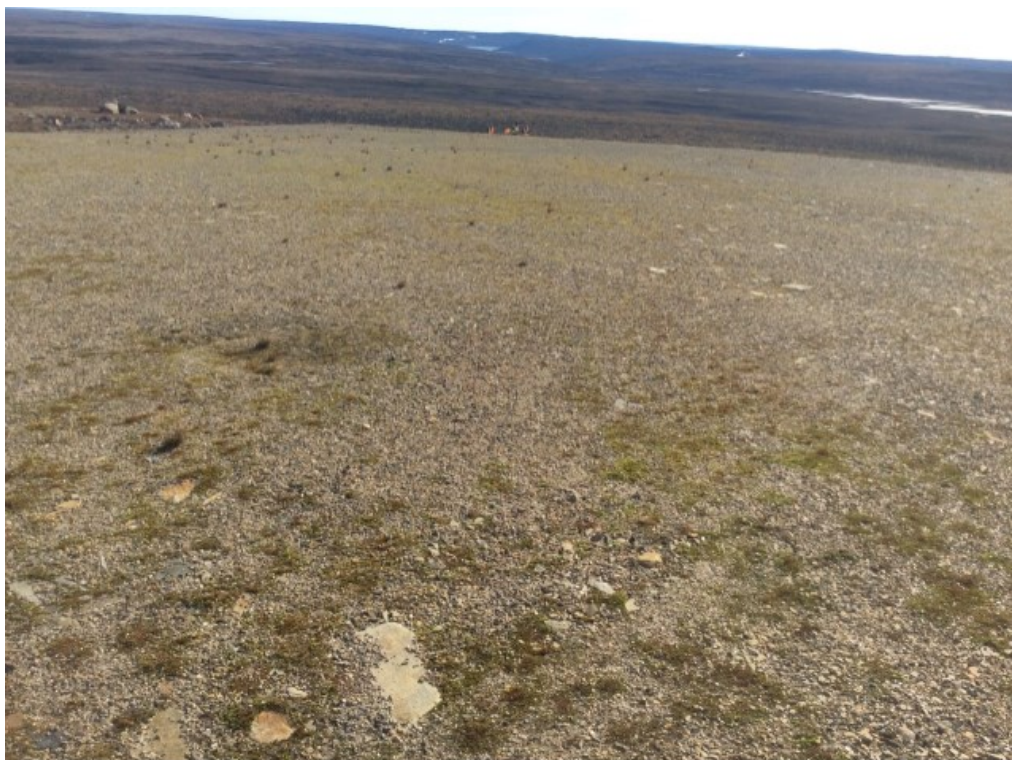
Photo 86: FOX-3 – Station West Landfill – Lobe F, cover surface – Feature Z – Moss and sparse grass [Acceptable], facing southwest (ATT31_Photo31.jpg)

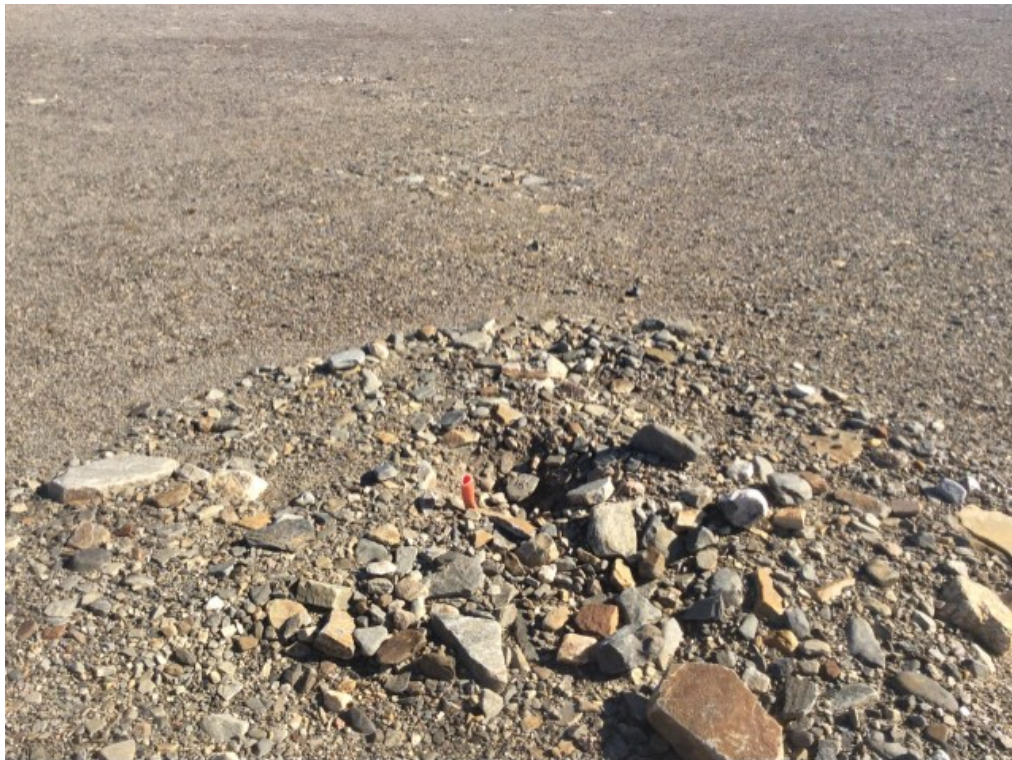
Photo 87: FOX-3 – Station West Landfill – Lobe A, southwest crest – Feature C/S – Orange plastic conduit. [Acceptable], facing southwest (ATT19_Photo19.jpg)

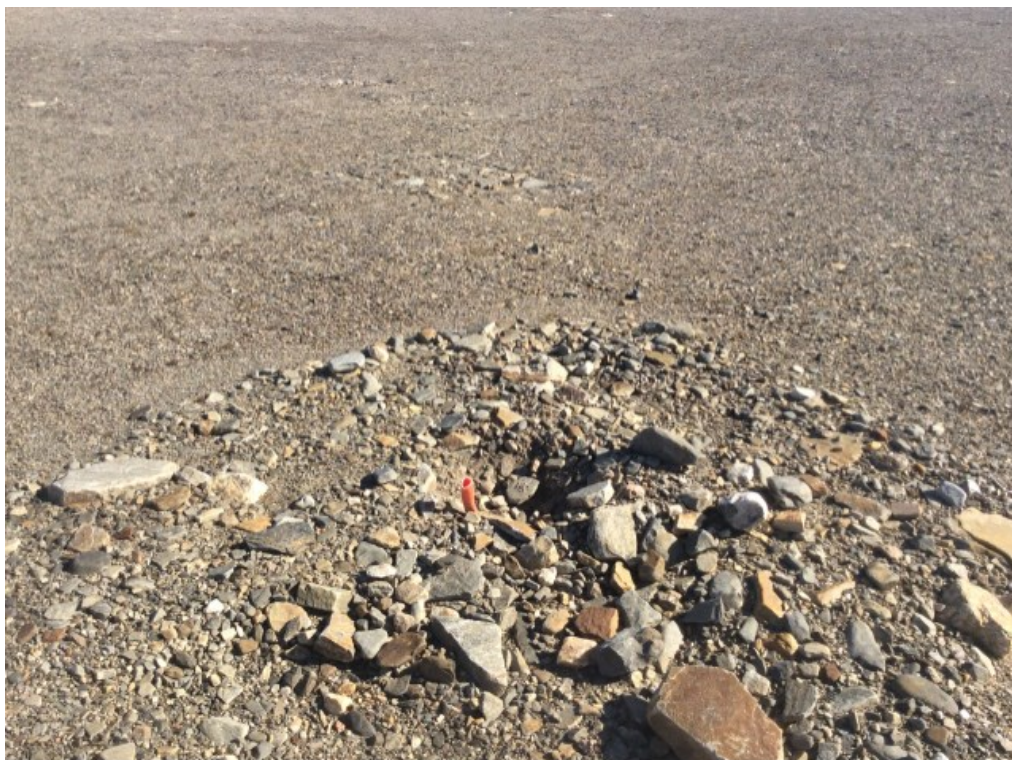
Photo 88: FOX-3 – Station West Landfill – Lobe A, southwest crest – rough area around Feature C/S, facing southwest (ATT19_Photo19.jpg)

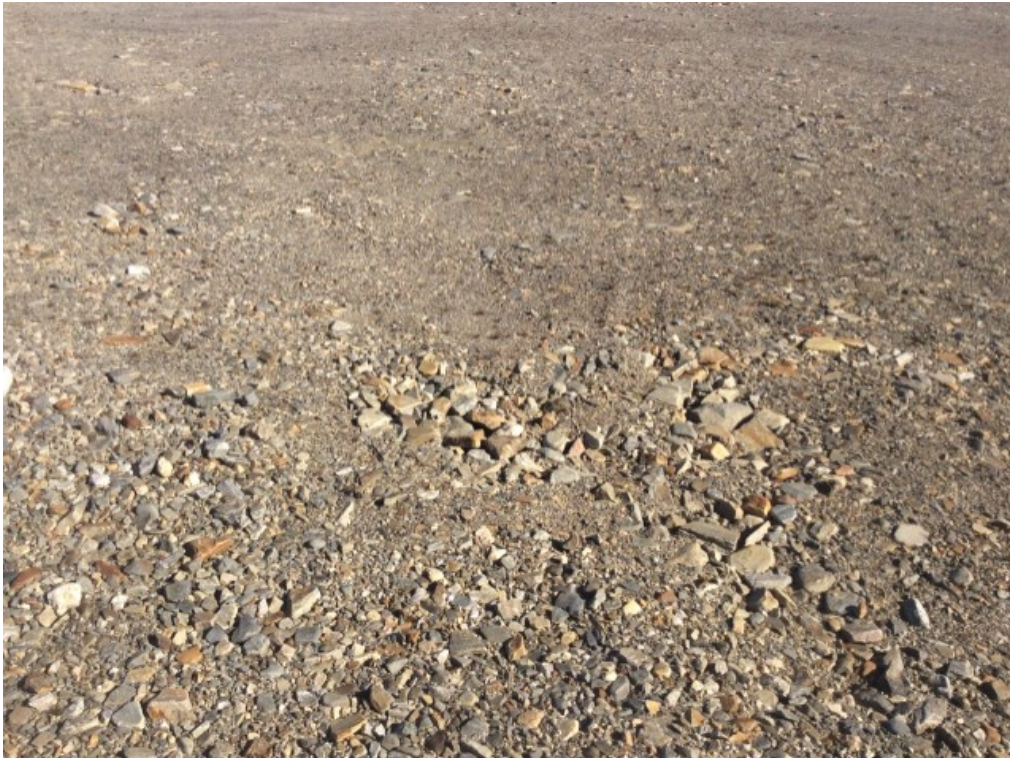
Photo 89: FOX-3 – Station West Landfill – Lobe A, central crest surface – Feature W – Shallow depressions [Acceptable], facing southeast (ATT11_Photo11.jpg)

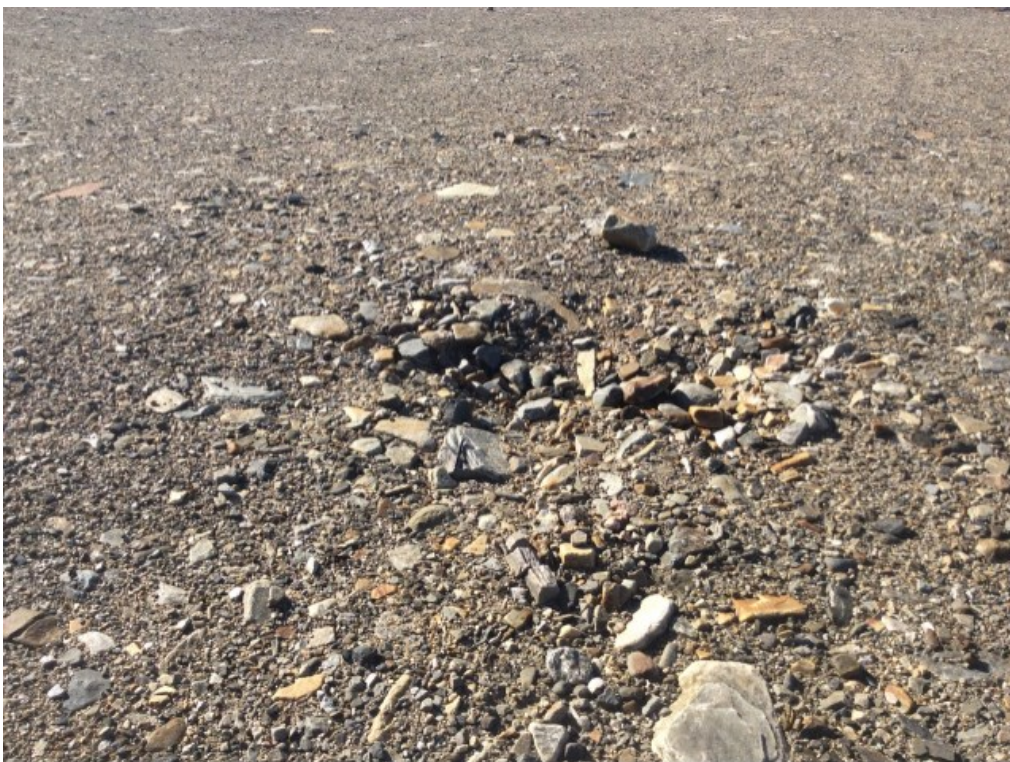
Photo 90: FOX-3 – Station West Landfill – Lobe A, north crest surface – Feature E – Shallow depressions [Acceptable], facing south (ATT18_Photo18.jpg)

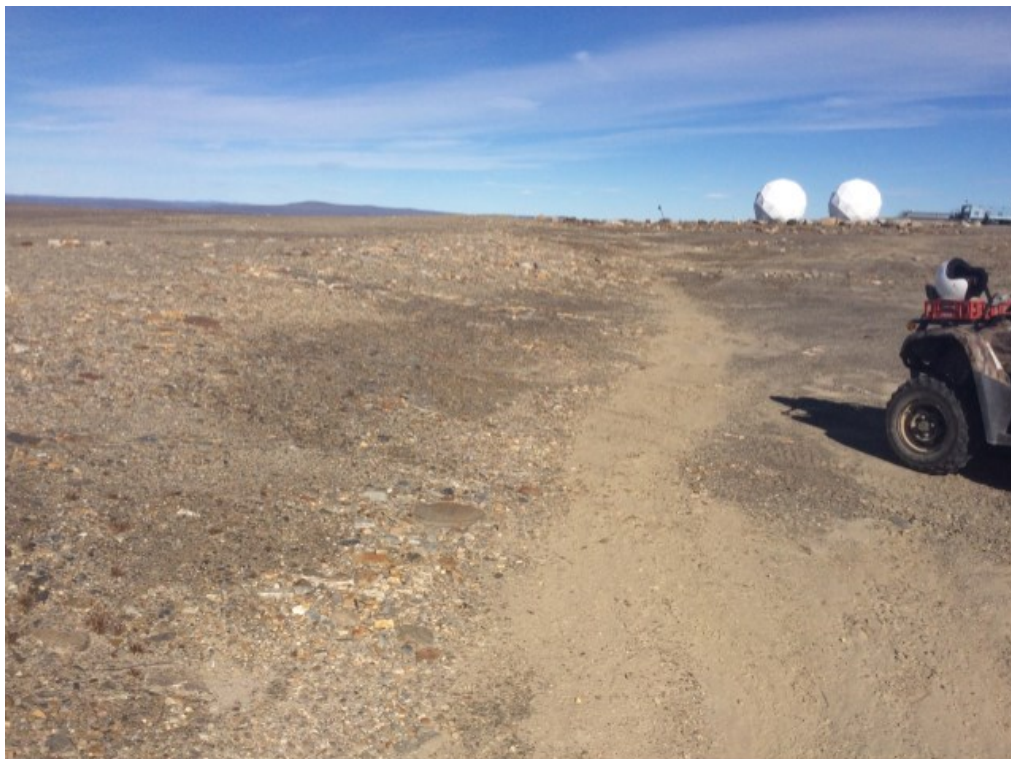
Photo 91: FOX-3 – Station West Landfill – Lobe A, east toe – No running water along toe (previous Feature X), facing northeast (ATT9_Photo9.jpg)

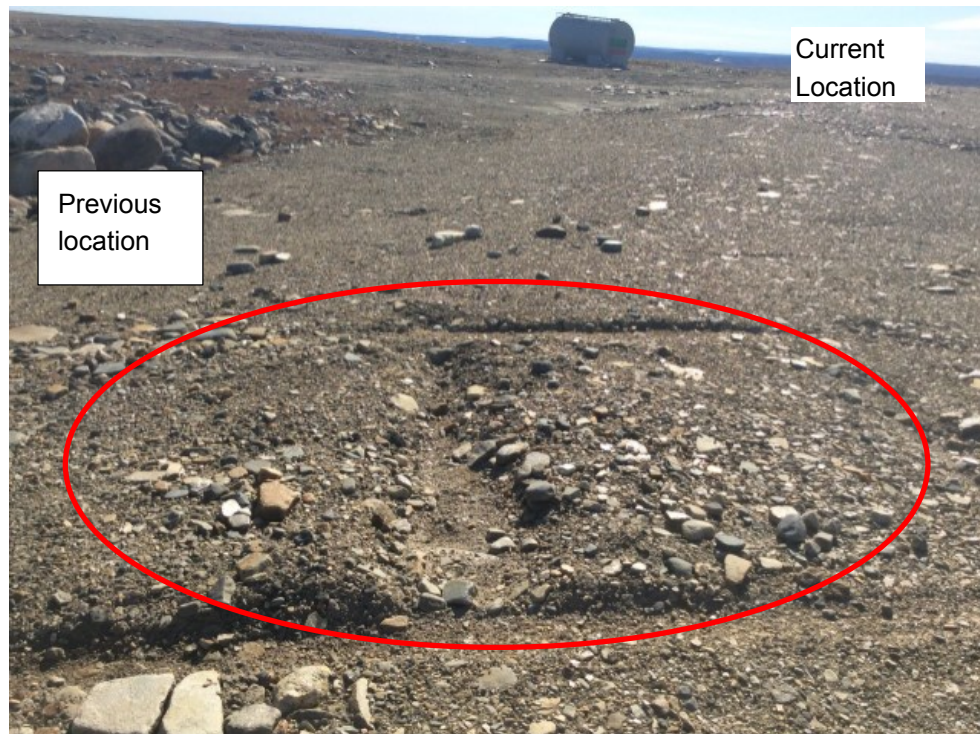
Photo 93: FOX-3 – Station West Landfill – Lobe A, the previous and current location of the fuel tank (Feature Y) [Acceptable], facing southwest (ATT15_Photo15.jpg)

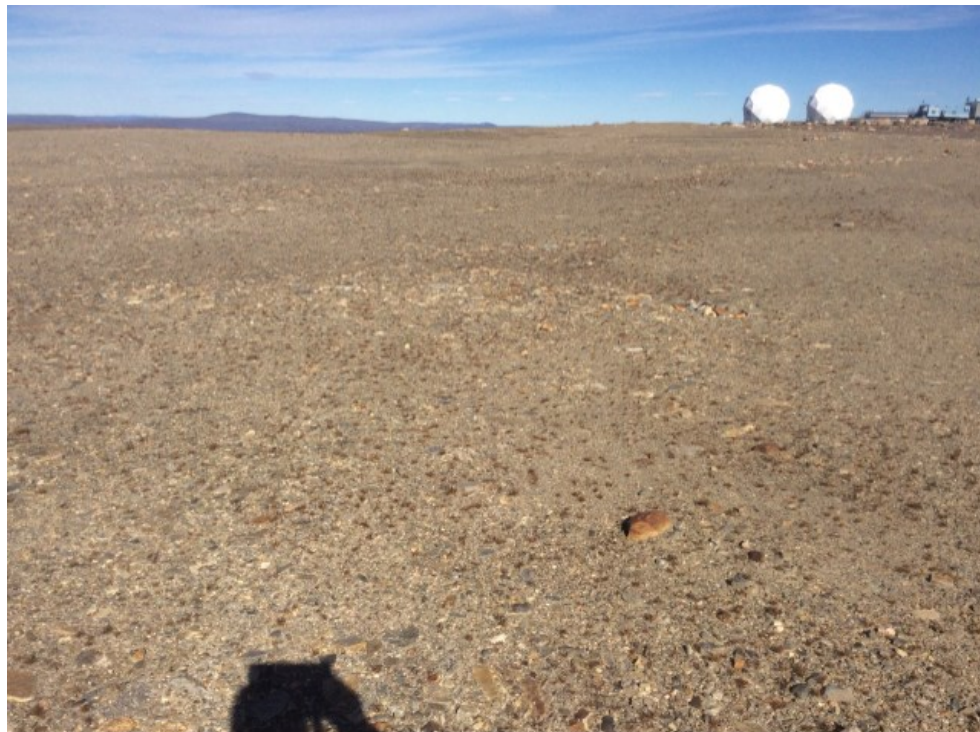
Photo 94: FOX-3 – Station West Landfill – Lobe A, Feature AC - Sparse vegetation, facing northeast (ATT10_Photo10.jpg)

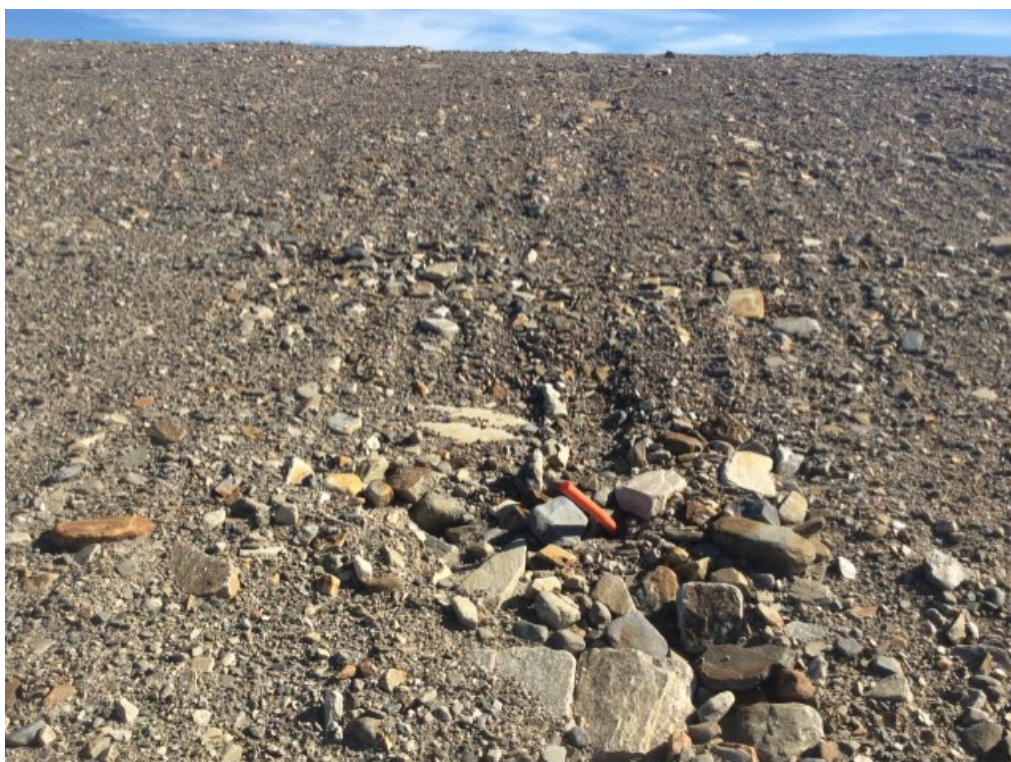
Photo 95: FOX-3 – Station West Landfill – Lobe A, Feature C - Plastic tube, facing southeast (ATT12_Photo12.jpg)

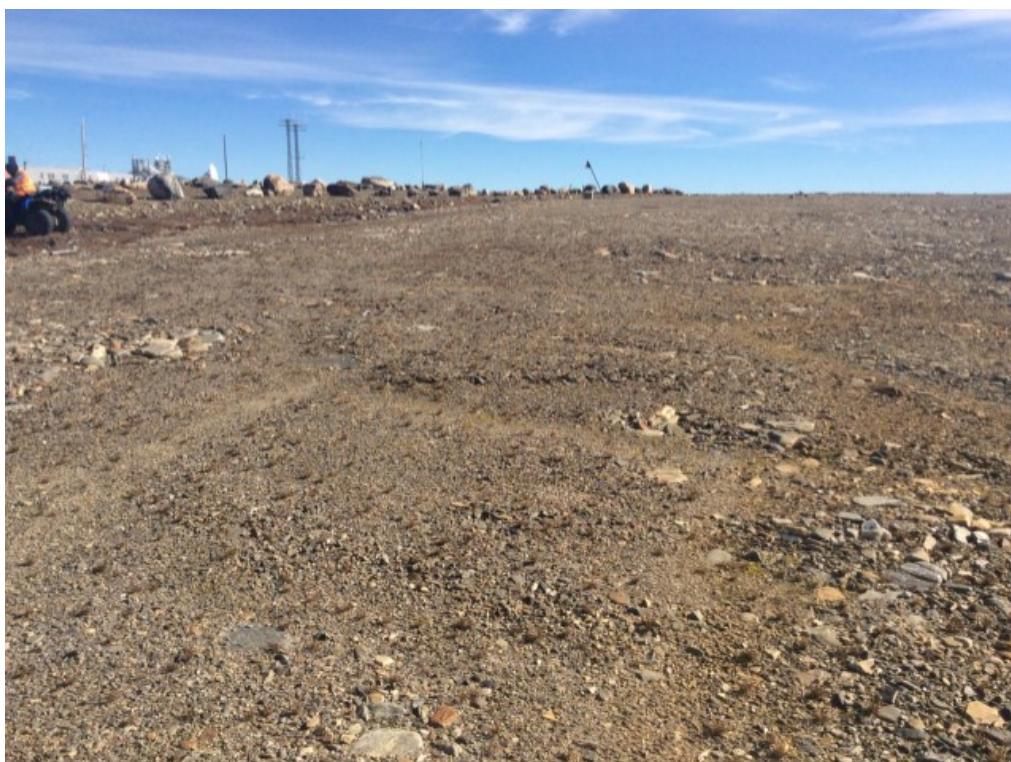
Photo 96: FOX-3 – Station West Landfill – Lobe A, Feature AC – Sparse vegetation, facing southeast (ATT14_Photo14.jpg)

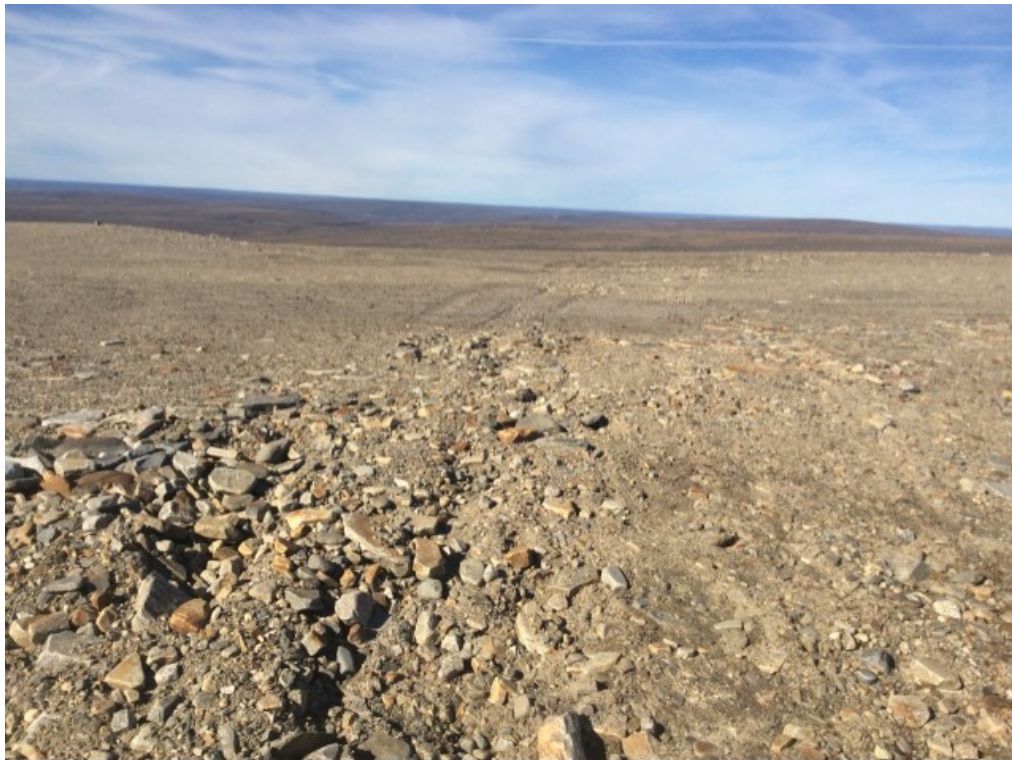
Photo 97: FOX-3 – Station West Landfill – Lobe A, east crest and slope – Feature AD – Tire track on the cover surface and east slope, facing northwest (ATT16_Photo16.jpg)

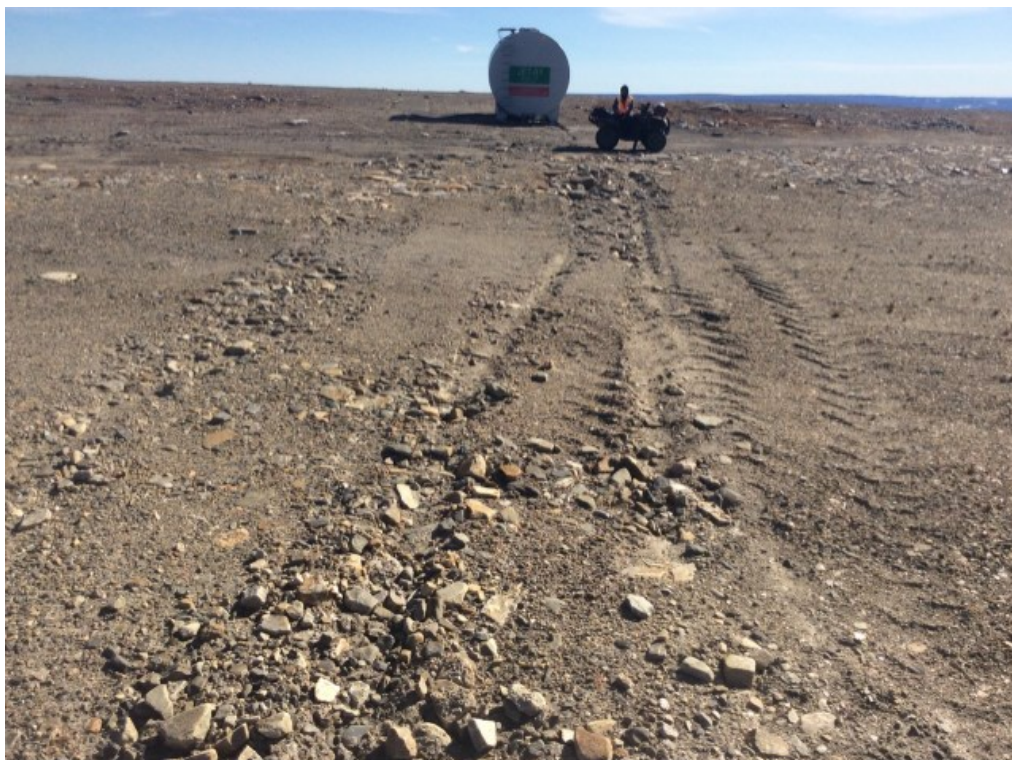
Photo 98: FOX-3 – Station West Landfill – Lobe A, cover surface – Feature AD – Tire track on the cover surface and east slope – Feature Y is also shown, facing southeast (ATT17_Photo17.jpg)

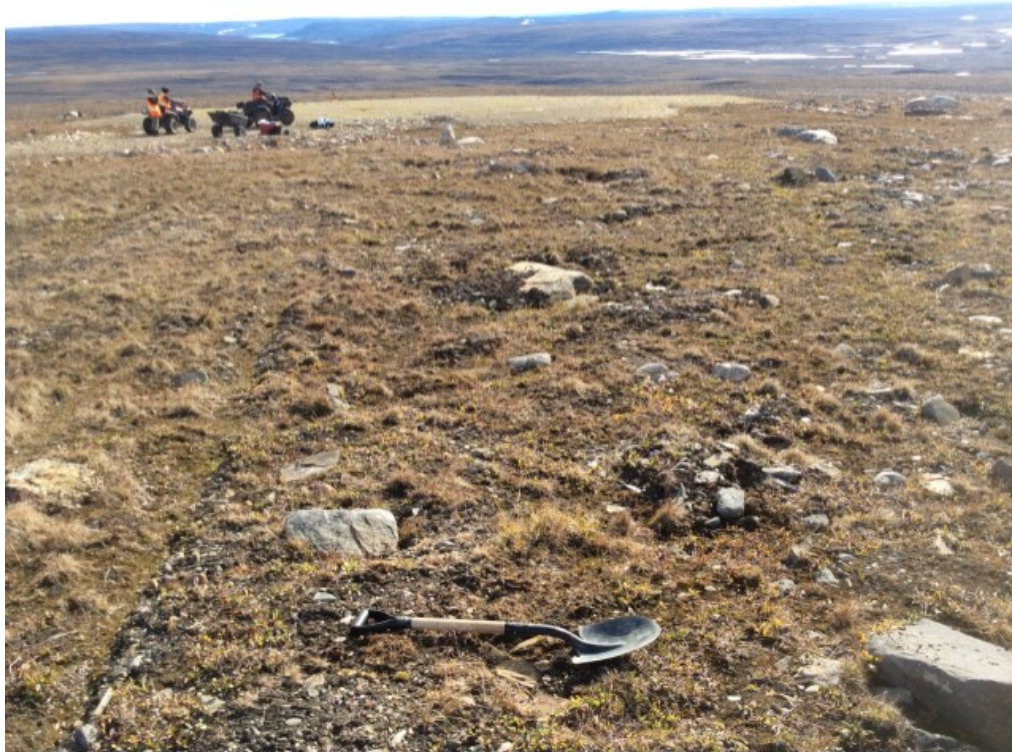
Photo 101: FOX-3 – Station West Landfill – Soil sampling before excavation at F3-10 (ATT84_Photo84.jpg)

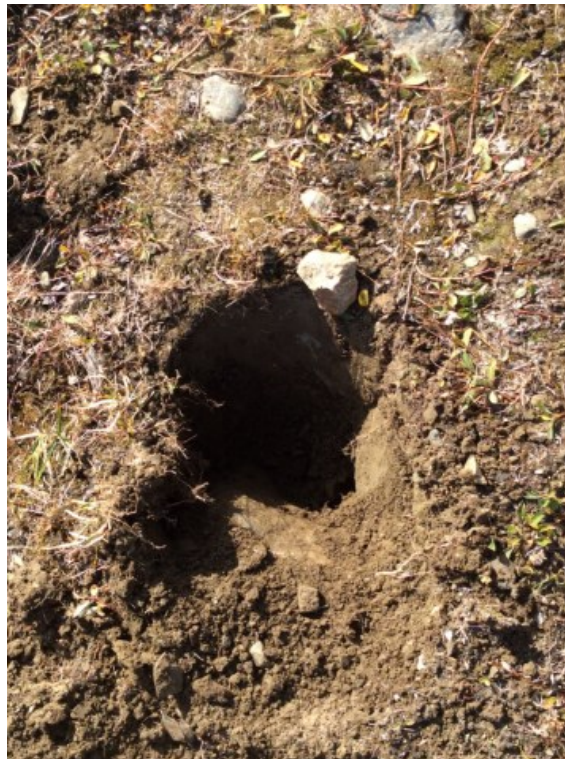
Photo 102: FOX-3 – Station West Landfill – Soil sampling after excavation at F3-10 (ATT85_Photo85.jpg)

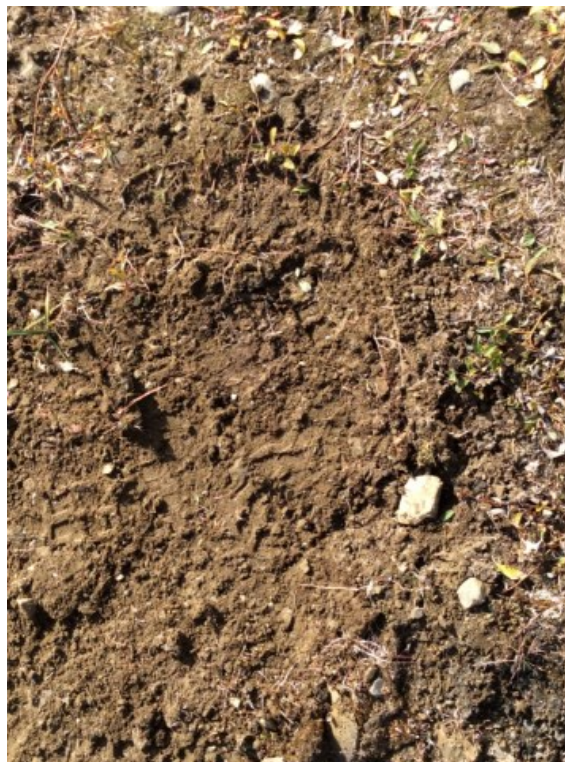
Photo 103: FOX-3 – Station West Landfill – Soil sampling after backfilling at F3-10 (ATT86_Photo86.jpg)

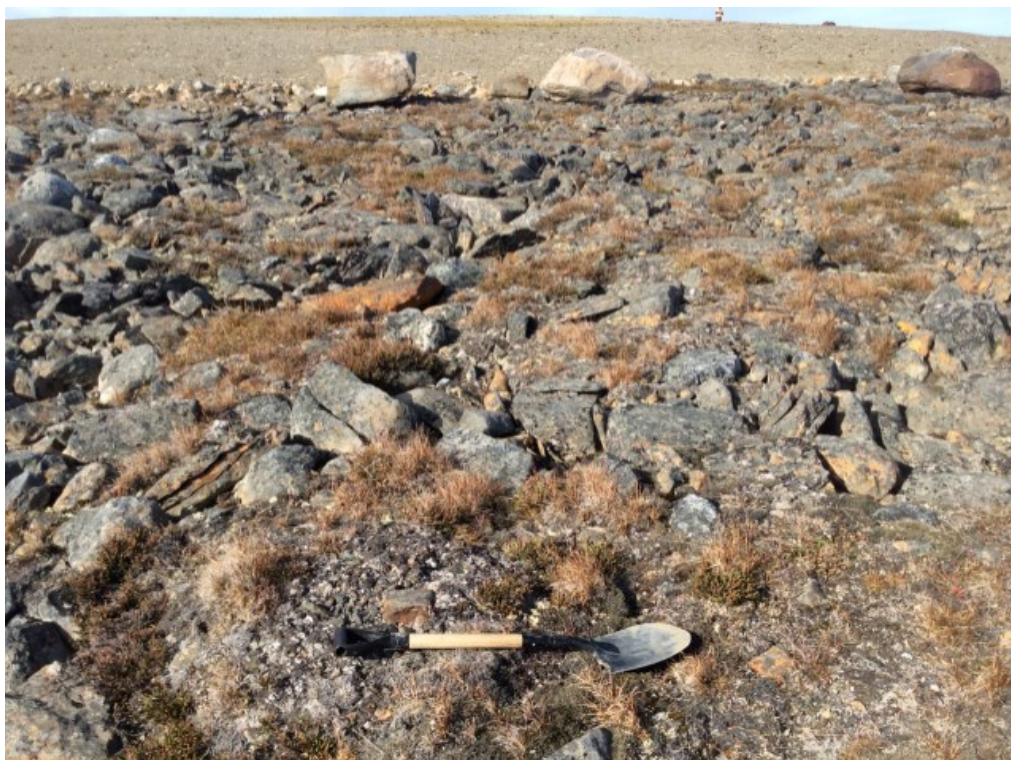
Photo 104: FOX-3 – Station West Landfill – Soil sampling before excavation at F3-11 (ATT87_Photo87.jpg)

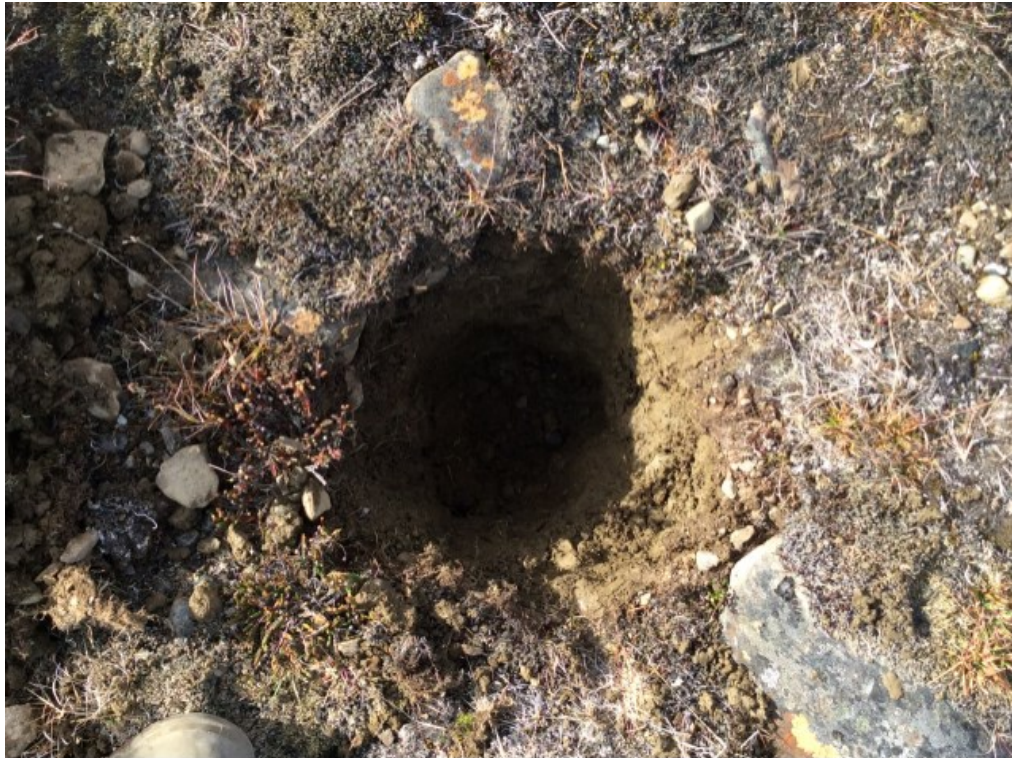
Photo 105: FOX-3 – Station West Landfill – Soil sampling after excavation at F3-11 (ATT88_Photo88.jpg)

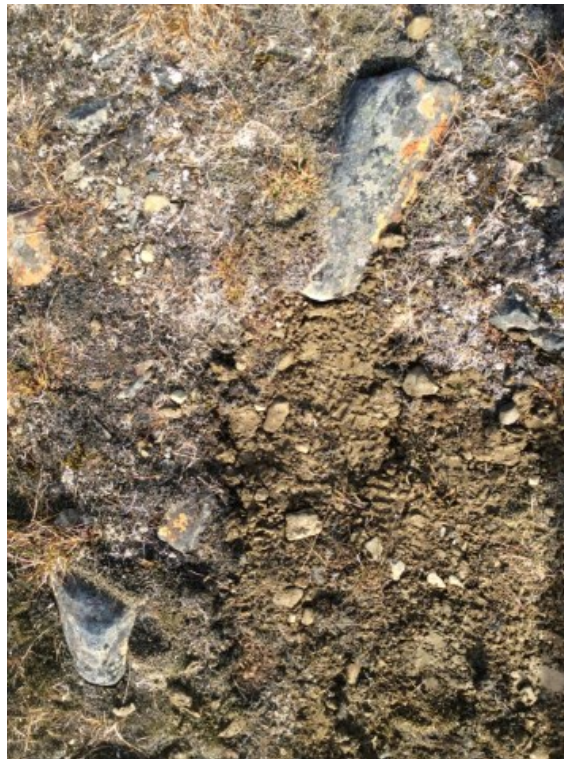
Photo 106: FOX-3 – Station West Landfill – Soil sampling after backfilling at F3-11 (ATT89_Photo89.jpg)
