QIKIQ15 BAFFIN REGION DEW LINE SITE MONITORING

2016 FOX-3 Monitoring Report

Report Number: 1530908-2000-R3-V2

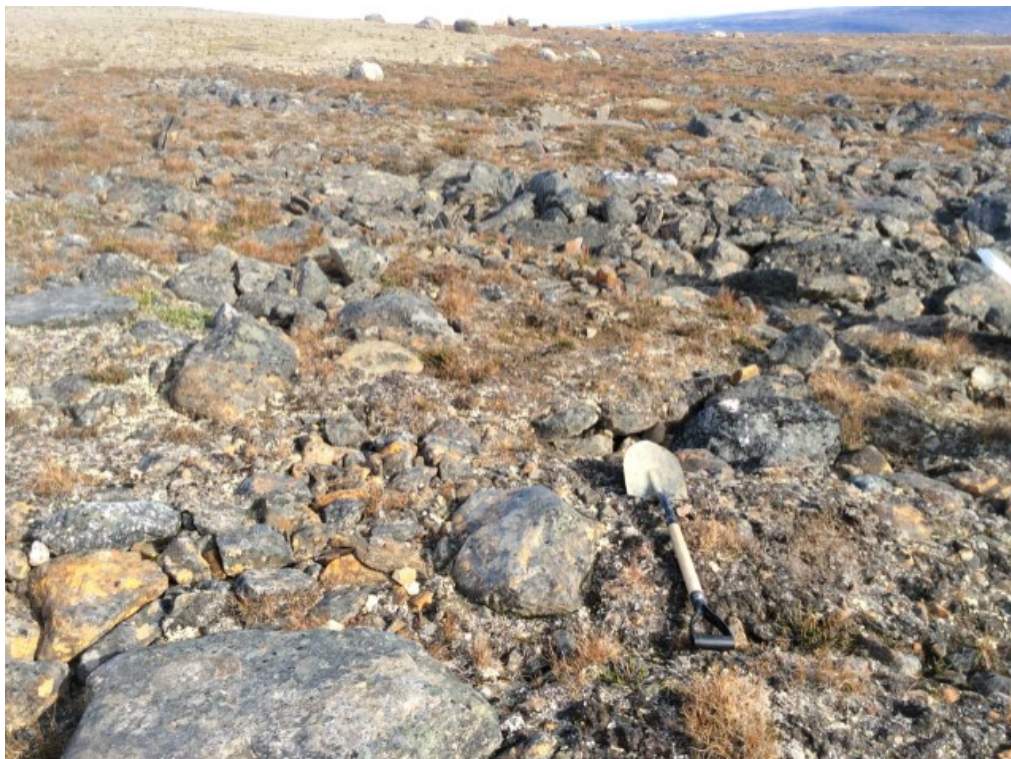
Photo 107: FOX-3 – Station West Landfill – Soil sampling before excavation at F3-12 (ATT90_Photo90.jpg)

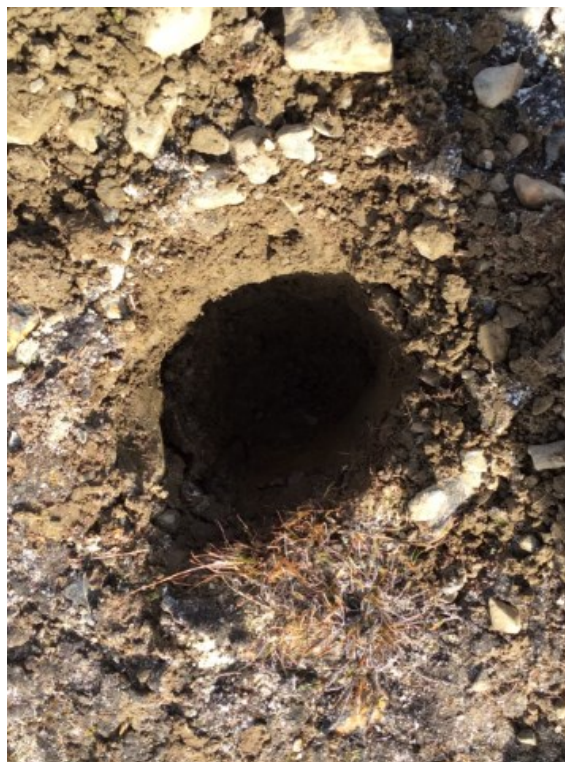
Photo 108: FOX-3 – Station West Landfill – Soil sampling after excavation at F3-12 (ATT91_Photo91.jpg)

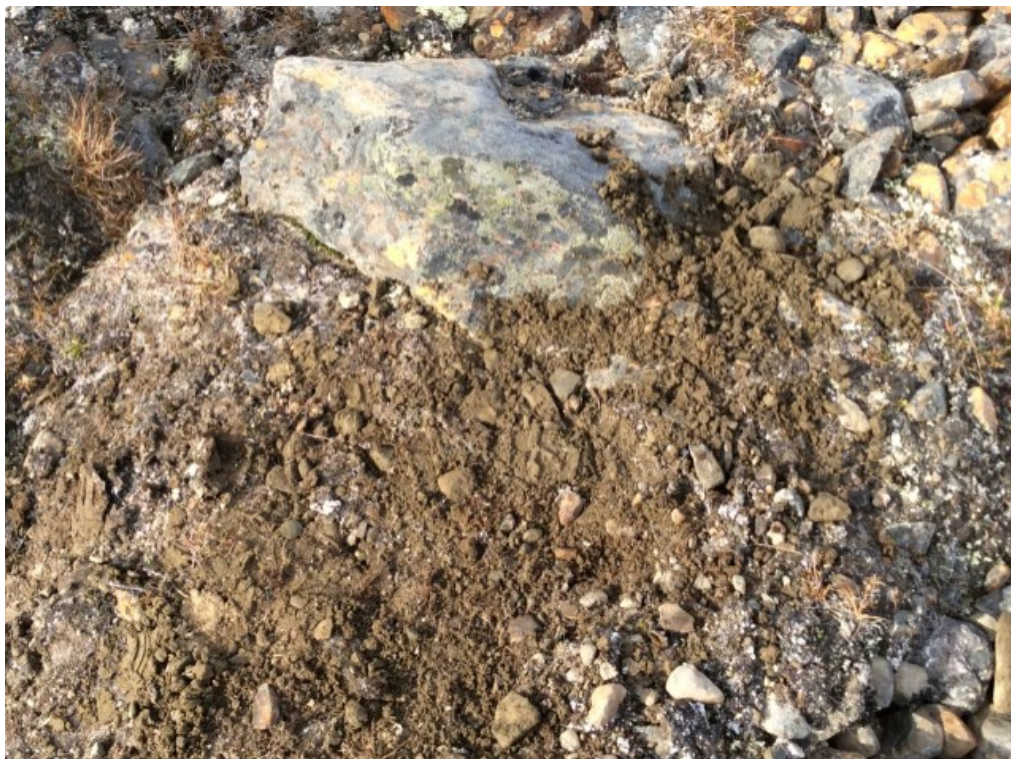
Photo 109: FOX-3 – Station West Landfill – Soil sampling after backfilling at F3-12 (ATT92_Photo92.jpg)

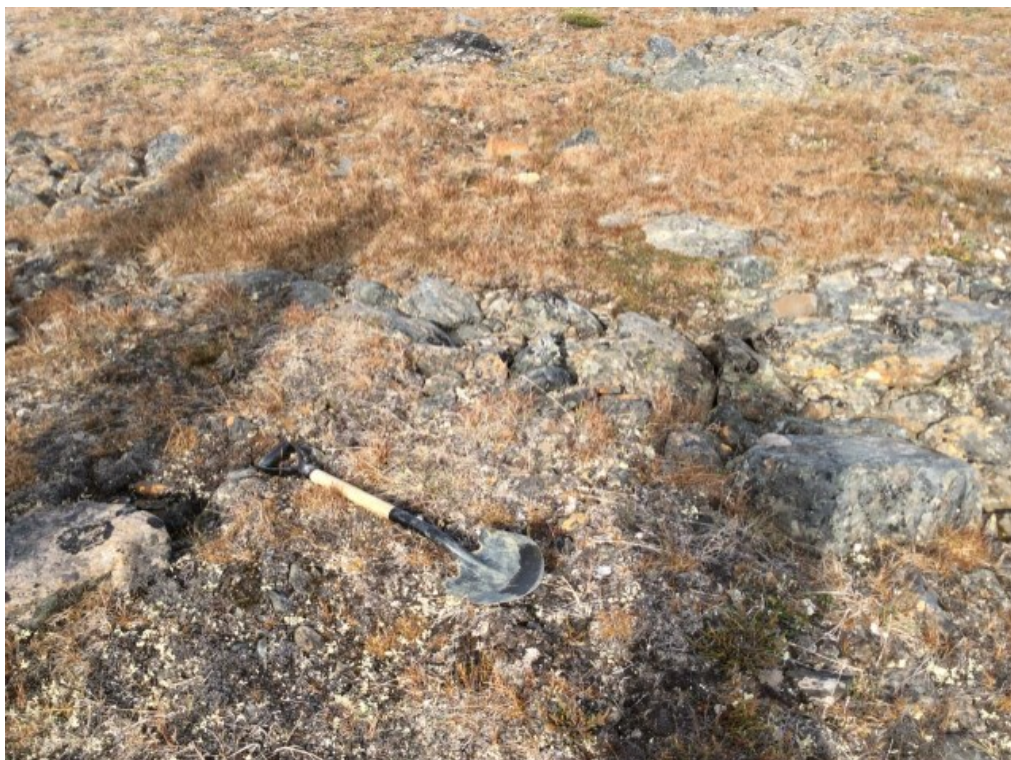
Photo 110: FOX-3 – Station West Landfill – Soil sampling before excavation at F3-9 (ATT93_Photo93.jpg)

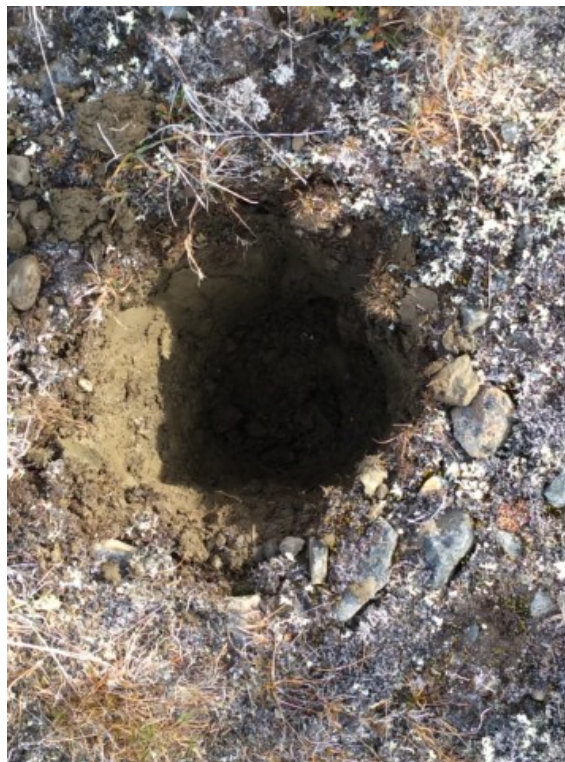
Photo 111: FOX-3 – Station West Landfill – Soil sampling after excavation at F3-9 (ATT94_Photo94.jpg)

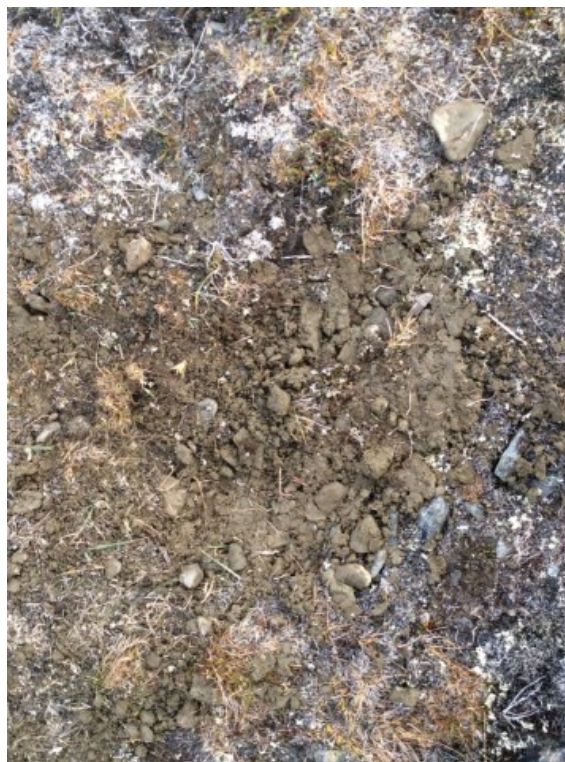
Photo 112: FOX-3 – Station West Landfill – Soil sampling after backfilling at F3-9 (ATT95_Photo95.jpg)

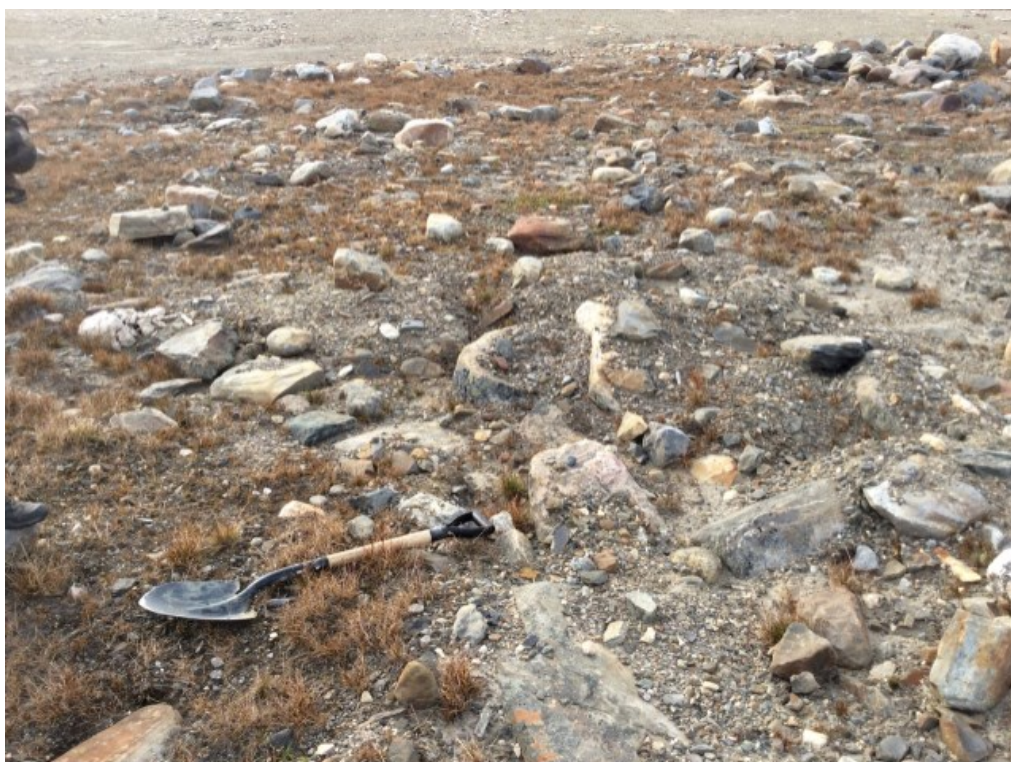
Photo 113: FOX-3 – Station West Landfill – Soil sampling before excavation at F3-8 (ATT96_Photo96.jpg)

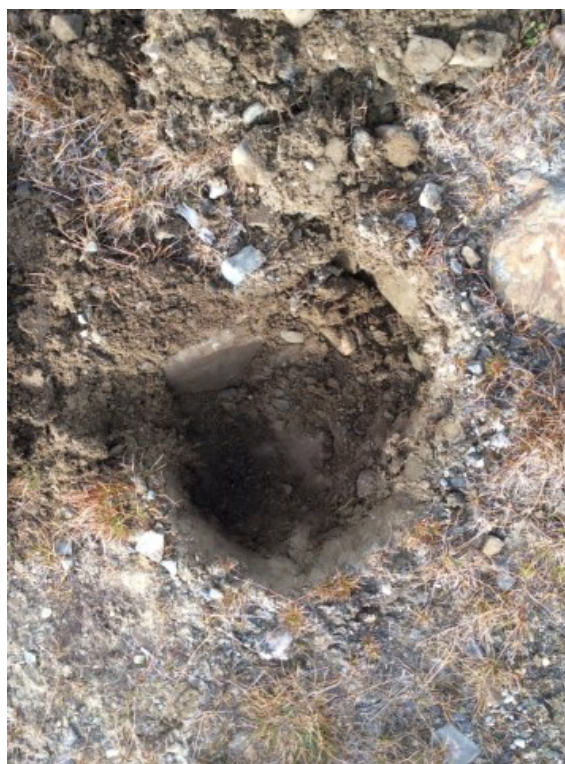
Photo 114: FOX-3 – Station West Landfill – Soil sampling after excavation at F3-8 (ATT97_Photo97.jpg)

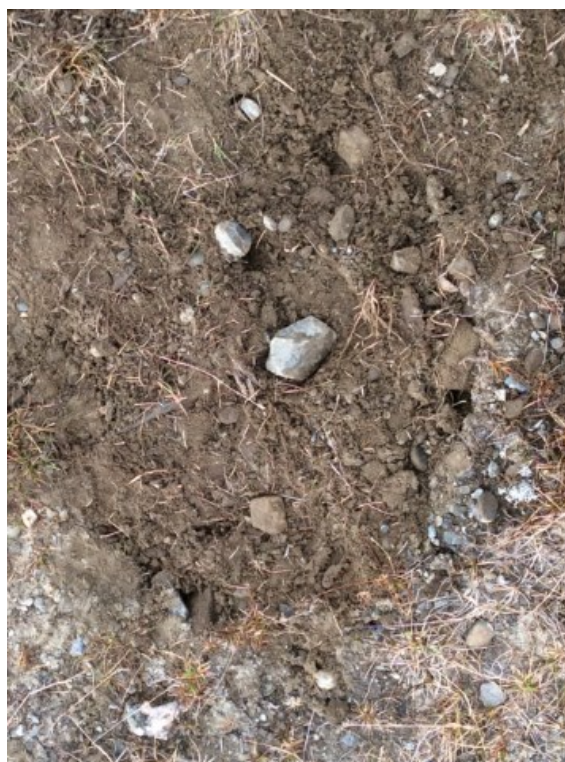
Photo 115: FOX-3 – Station West Landfill – Soil sampling after backfilling at F3-8 (ATT98_Photo98.jpg)

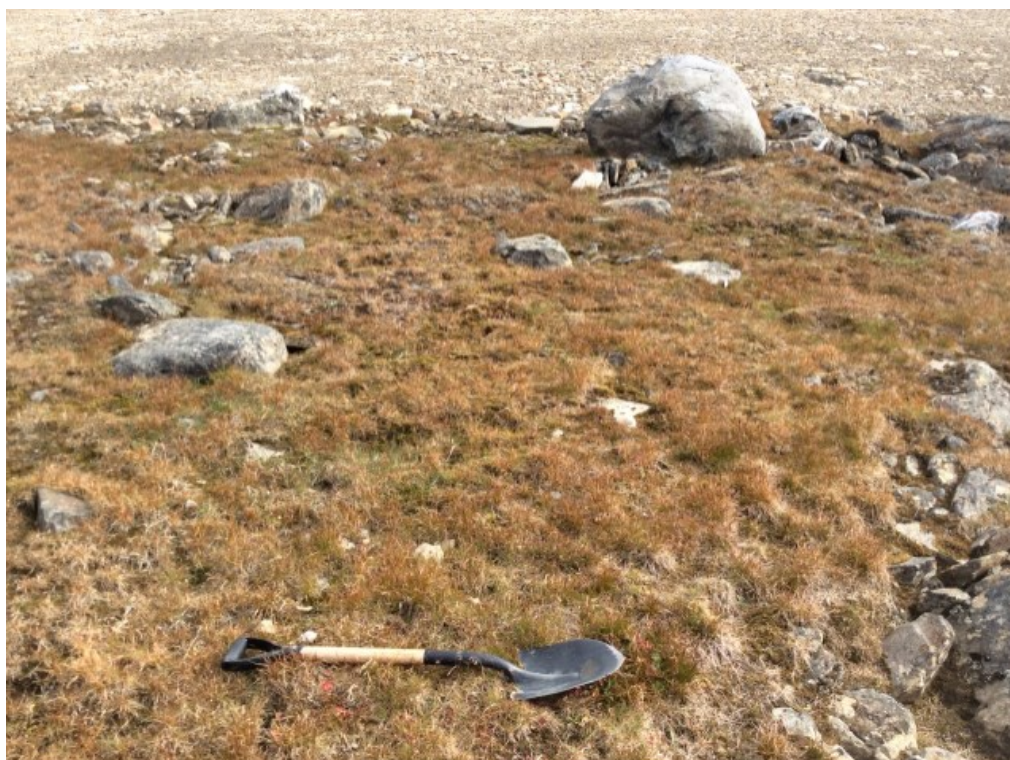
Photo 116: FOX-3 – Station West Landfill – Soil sampling before excavation at F3-5 (ATT124_Photo124.jpg)

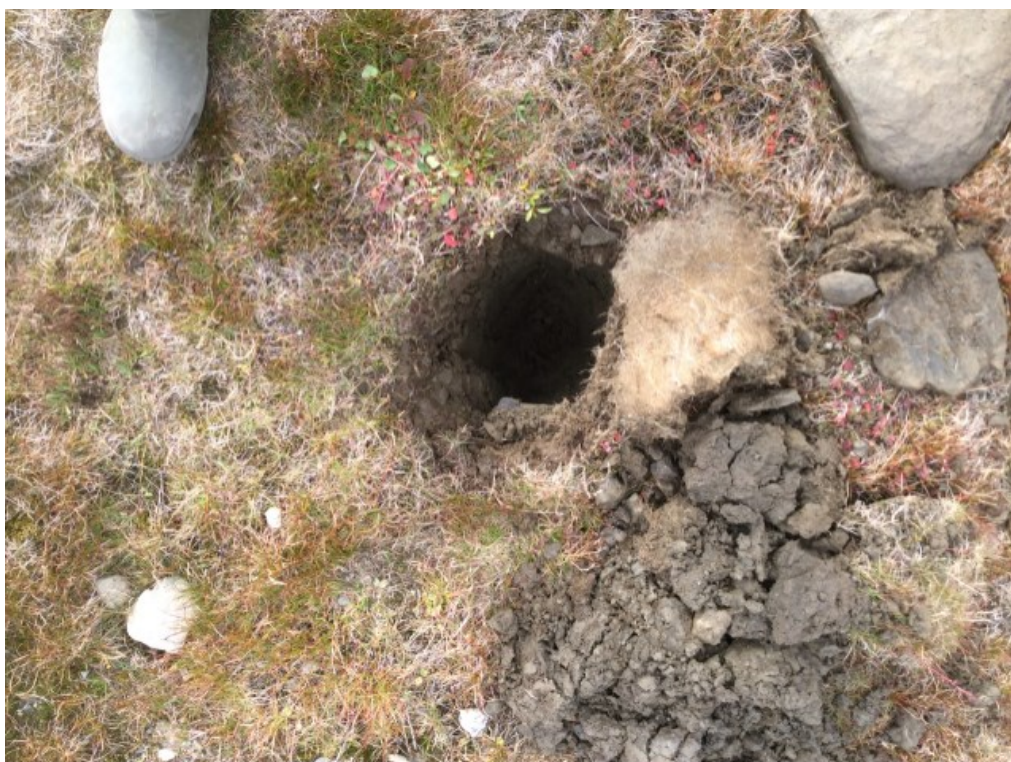
Photo 117: FOX-3 – Station West Landfill – Soil sampling after excavation at F3-5 (ATT125_Photo125.jpg)

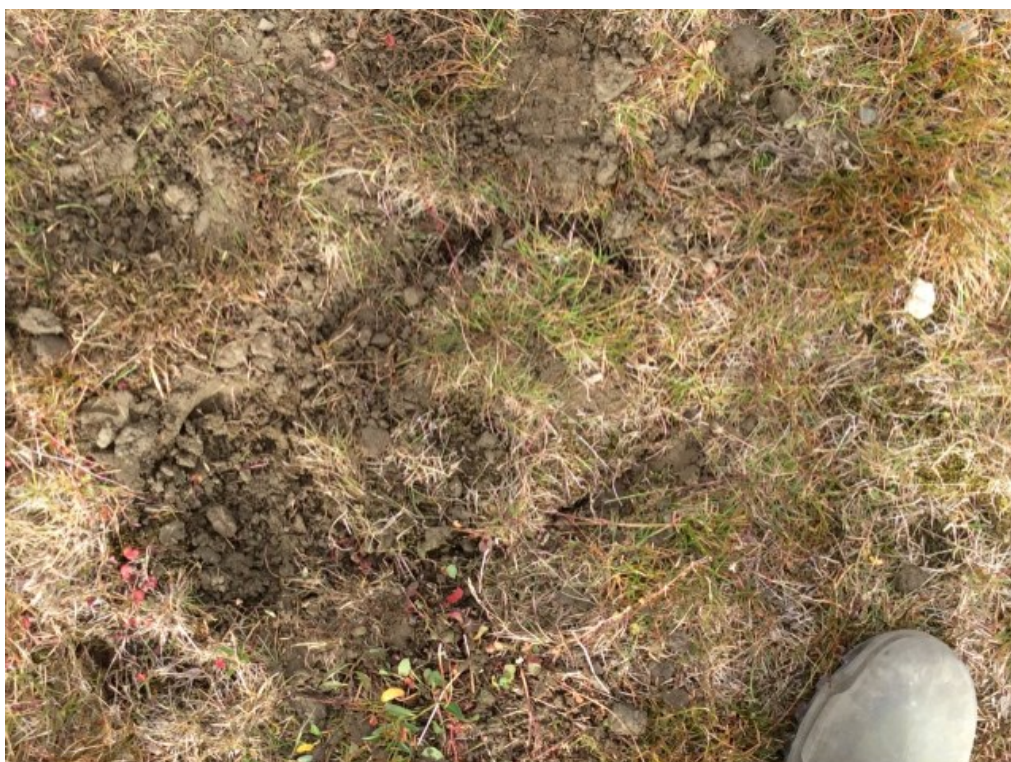
Photo 118: FOX-3 – Station West Landfill – Soil sampling after backfilling at F3-5 (ATT126_Photo126.jpg)

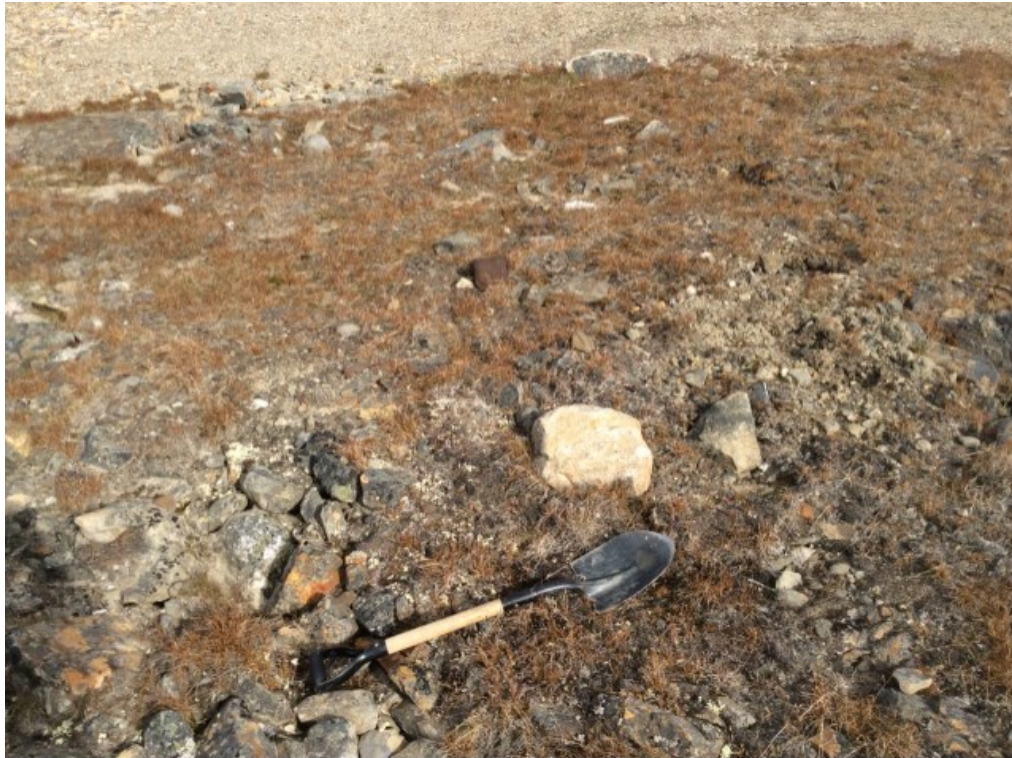
Photo 119: FOX-3 – Station West Landfill – Soil sampling before excavation at F3-7 (ATT127_Photo127.jpg)

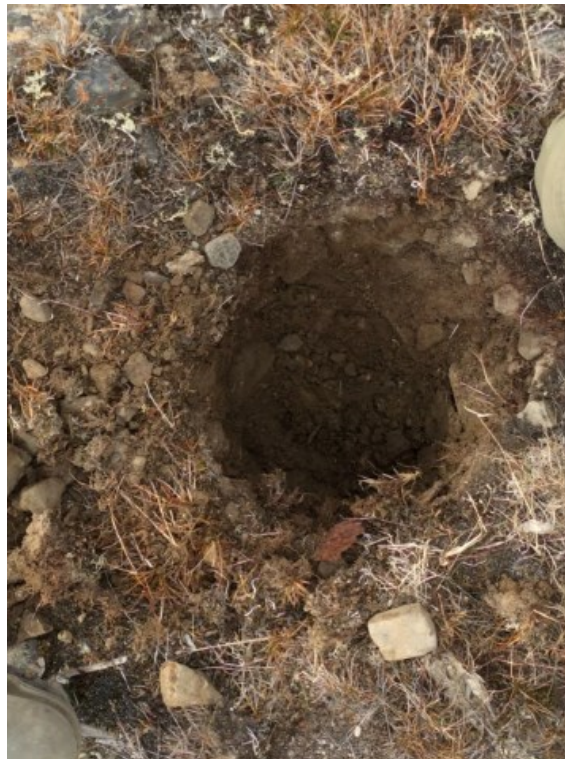
Photo 120: FOX-3 – Station West Landfill – Soil sampling after excavation at F3-7 (ATT128_Photo128.jpg)

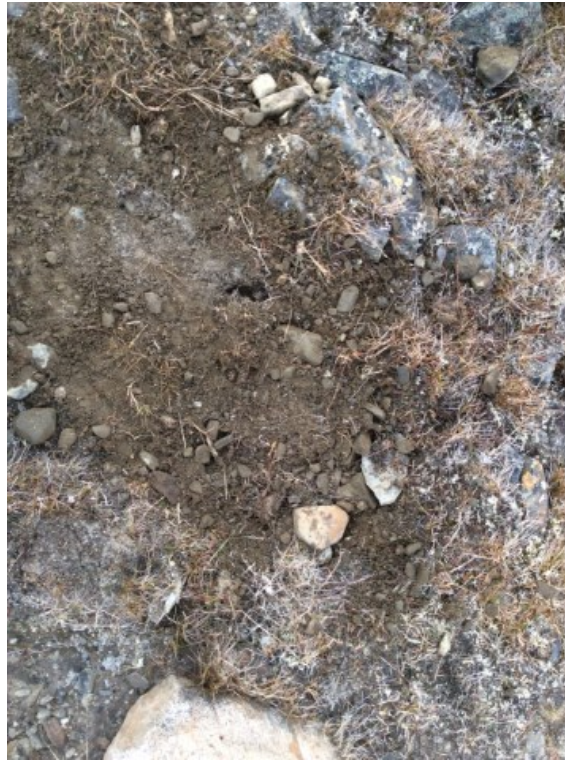
Photo 121: FOX-3 – Station West Landfill – Soil sampling after backfilling at F3-7 (ATT129_Photo129.jpg)

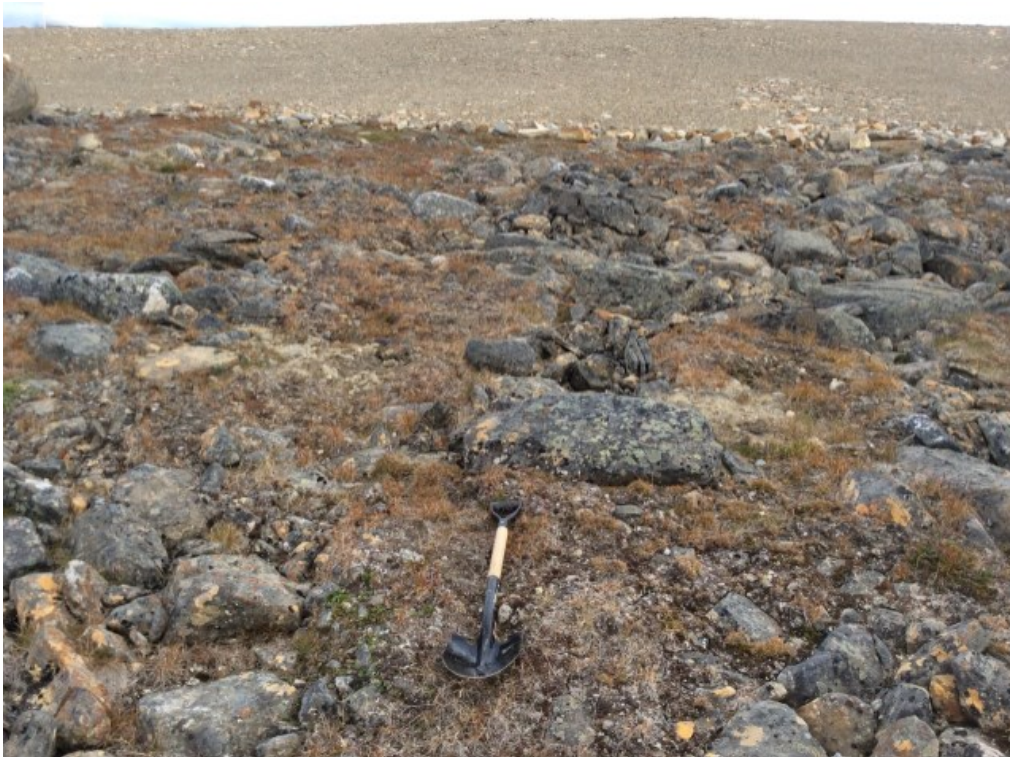
Photo 122: FOX-3 – Station West Landfill – Soil sampling before excavation at F3-6 (ATT130_Photo130.jpg)

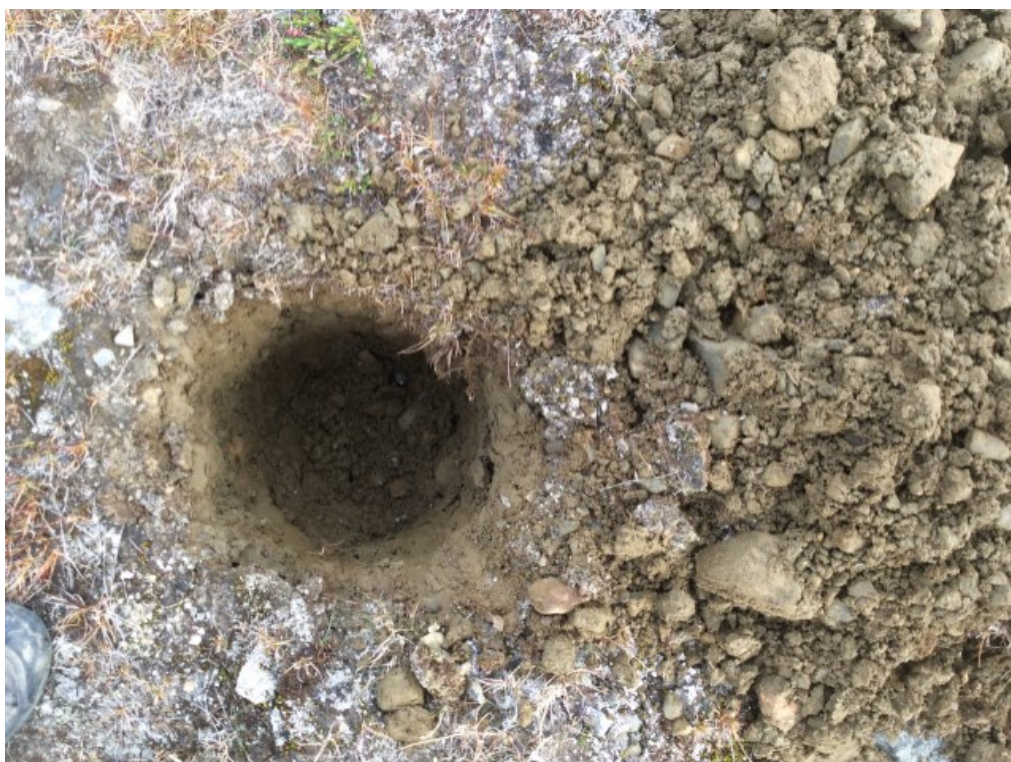
Photo 123: FOX-3 – Station West Landfill – Soil sampling after excavation at F3-6 (ATT131_Photo131.jpg)

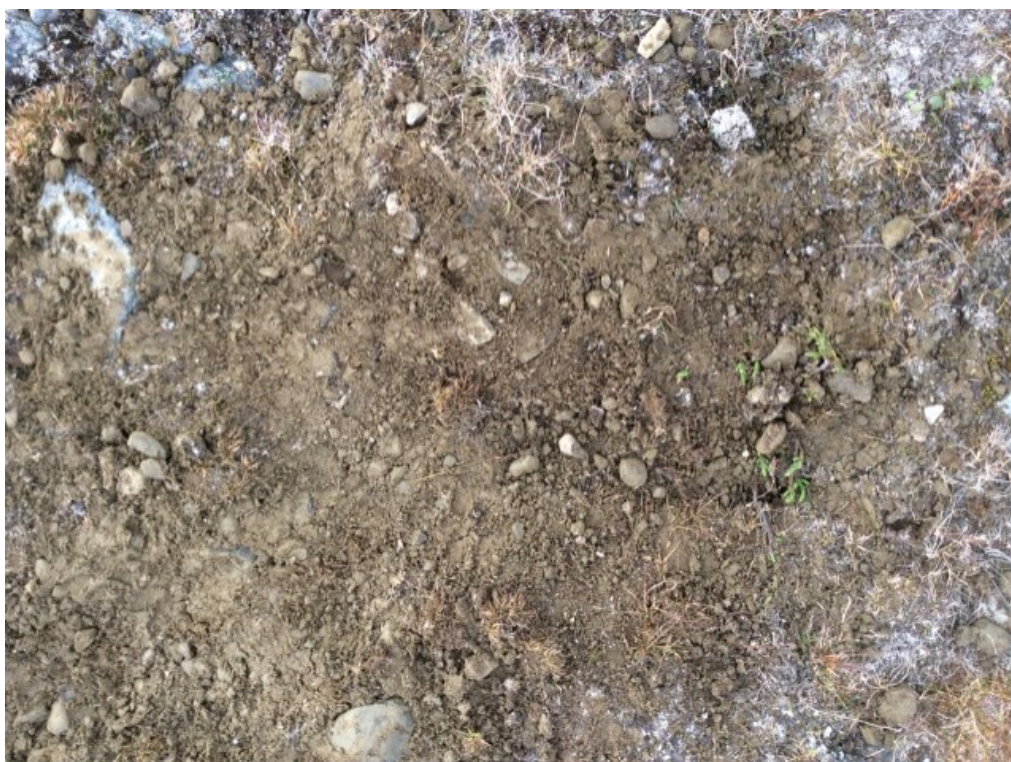
Photo 124: FOX-3 – Station West Landfill – Soil sampling after backfilling at F3-6 (ATT132_Photo132.jpg)

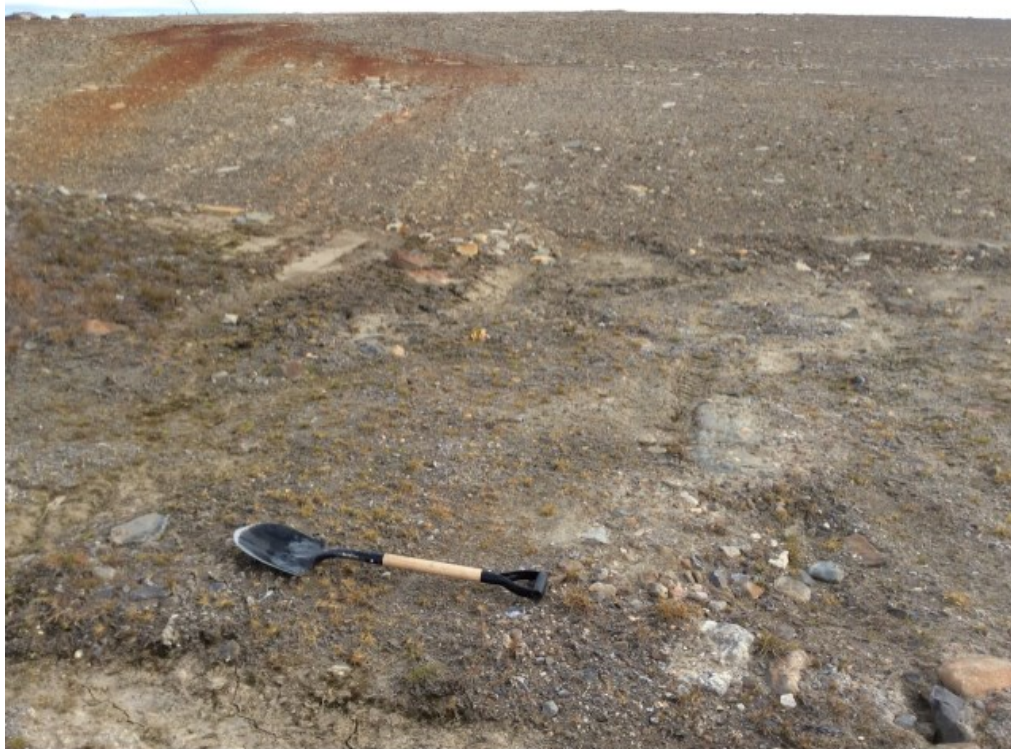
Photo 125: FOX-3 – Station West Landfill – Soil sampling before excavation at F3-4 (ATT133_Photo133.jpg)

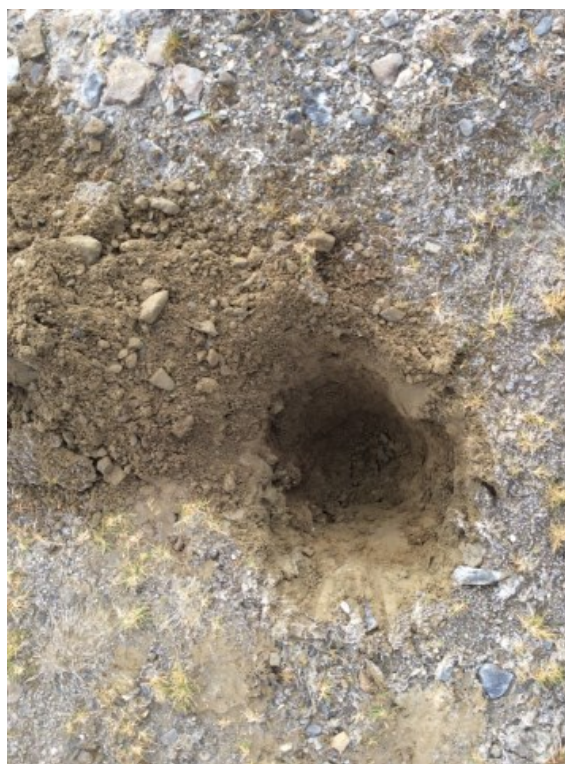
Photo 126: FOX-3 – Station West Landfill – Soil sampling after excavation at F3-4 (ATT134_Photo134.jpg)

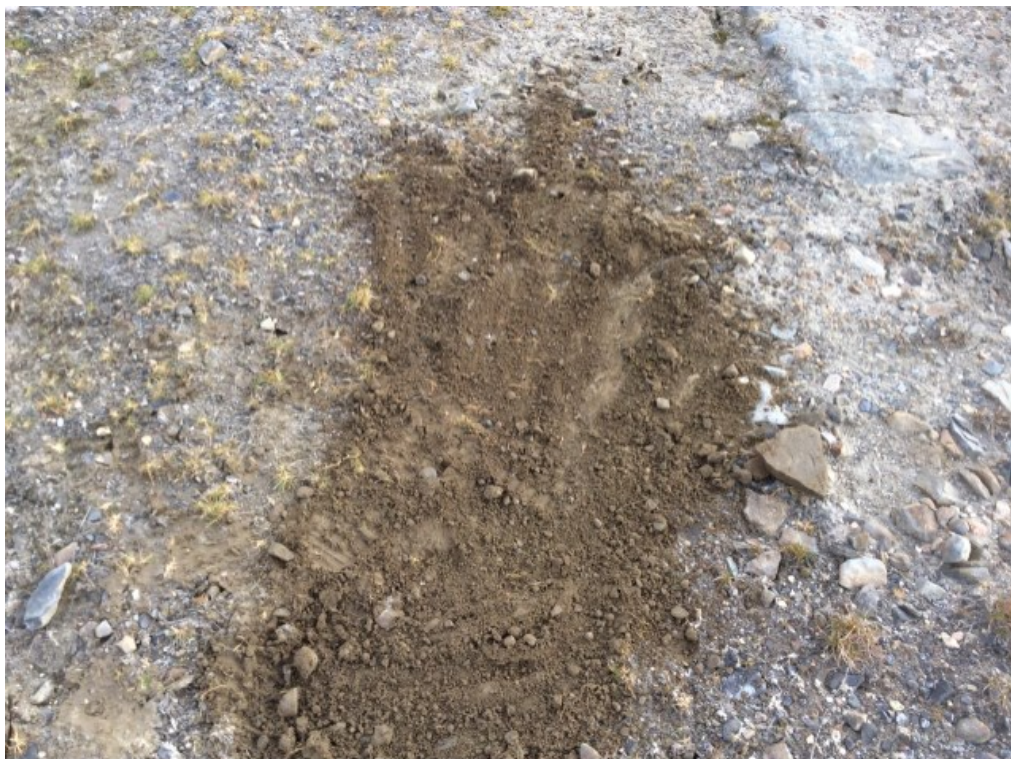
Photo 127: FOX-3 – Station West Landfill – Soil sampling after backfilling at F3-4 (ATT135_Photo135.jpg)

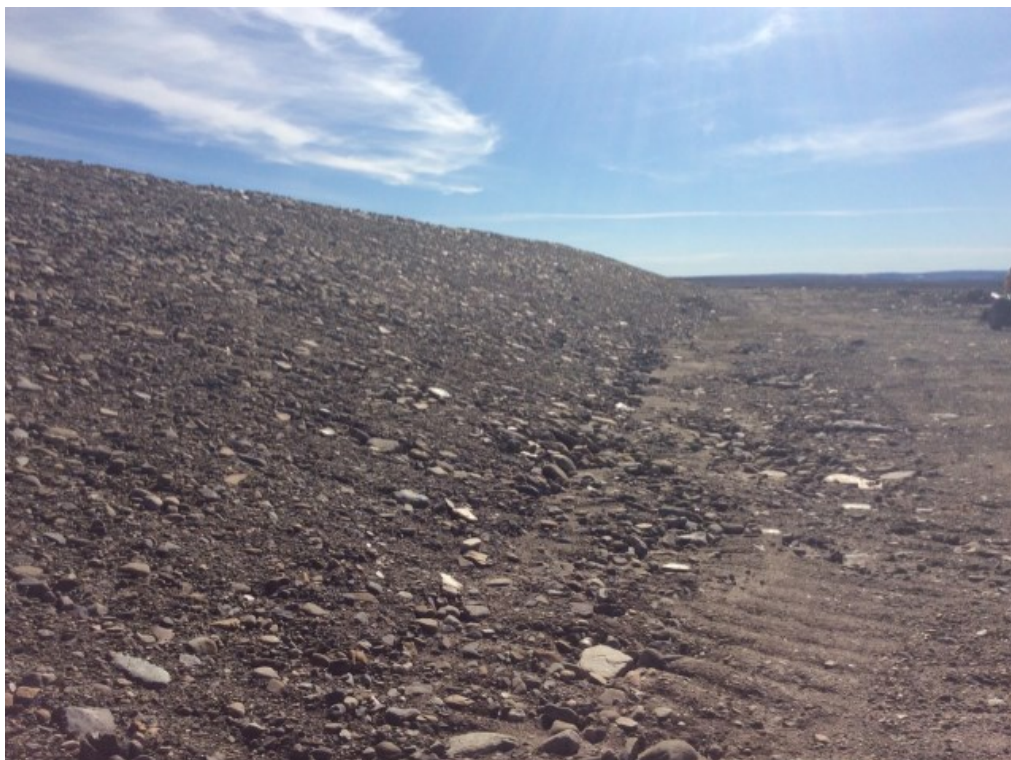
Photo 128: FOX-3 – Tier II Disposal Facility – West toe and slope, facing south (ATT5_Photo5.jpg)

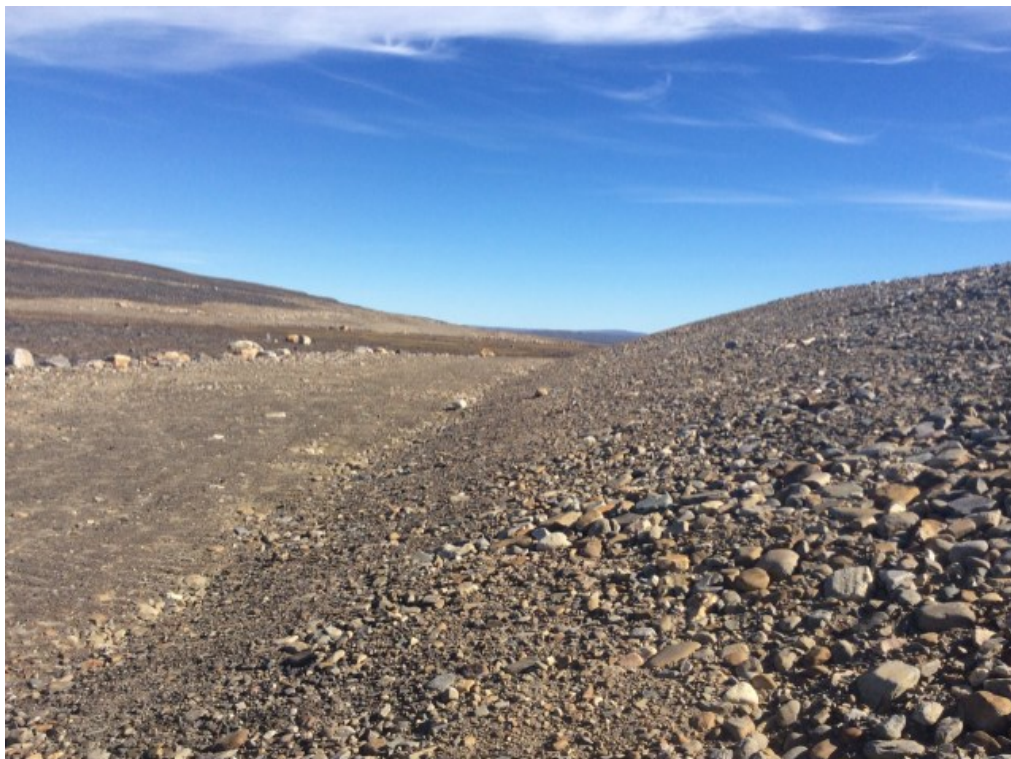
Photo 129: FOX-3 – Tier II Disposal Facility – North slope and toe, facing east (ATT6_Photo6.jpg)

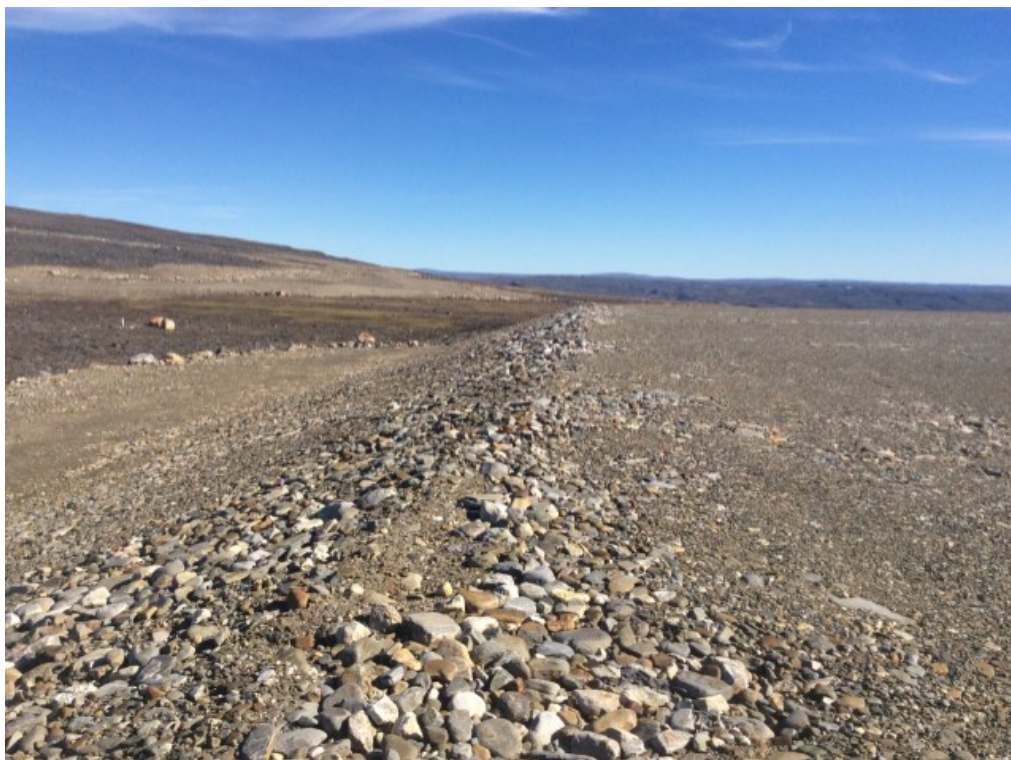
Photo 130: FOX-3 – Tier II Disposal Facility – North crest, facing east (ATT7_Photo7.jpg)

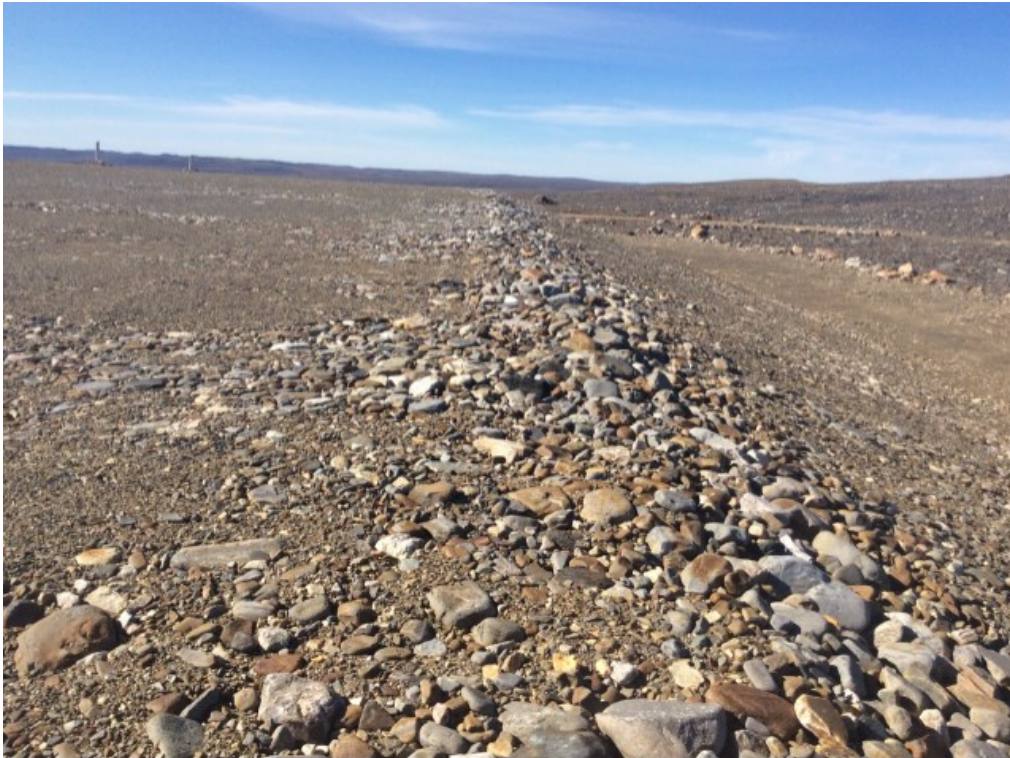
Photo 131: FOX-3 – Tier II Disposal Facility – North crest, facing west (ATT8_Photo8.jpg)

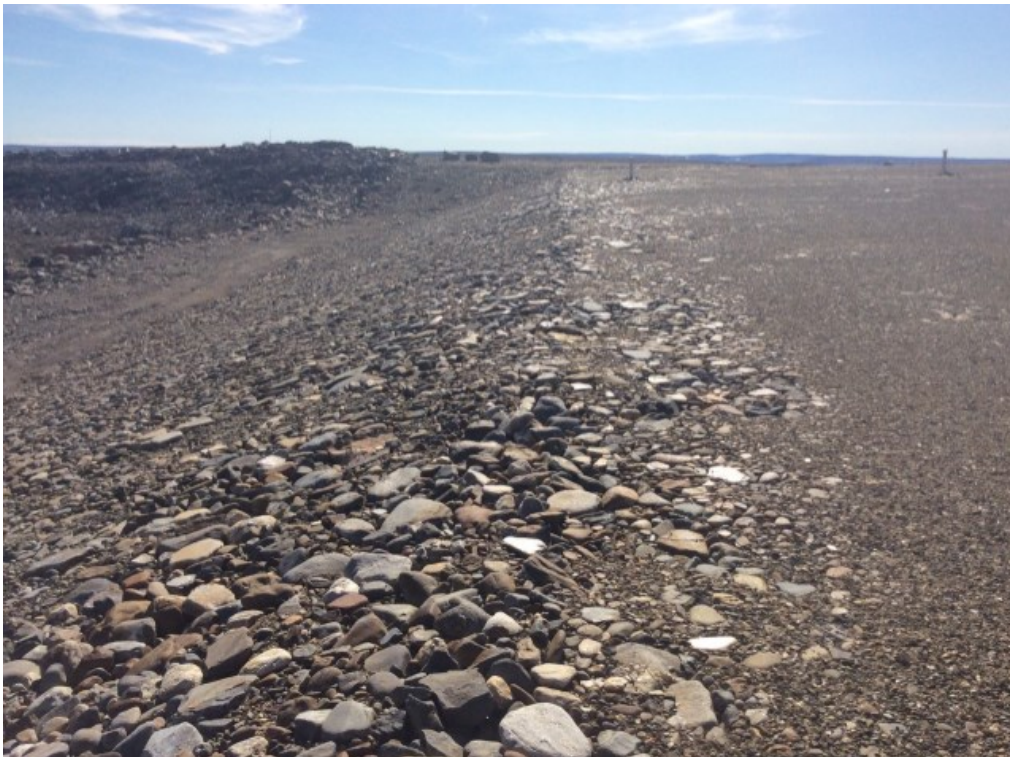
Photo 132: FOX-3 – Tier II Disposal Facility – East crest, facing south (ATT9_Photo9.jpg)

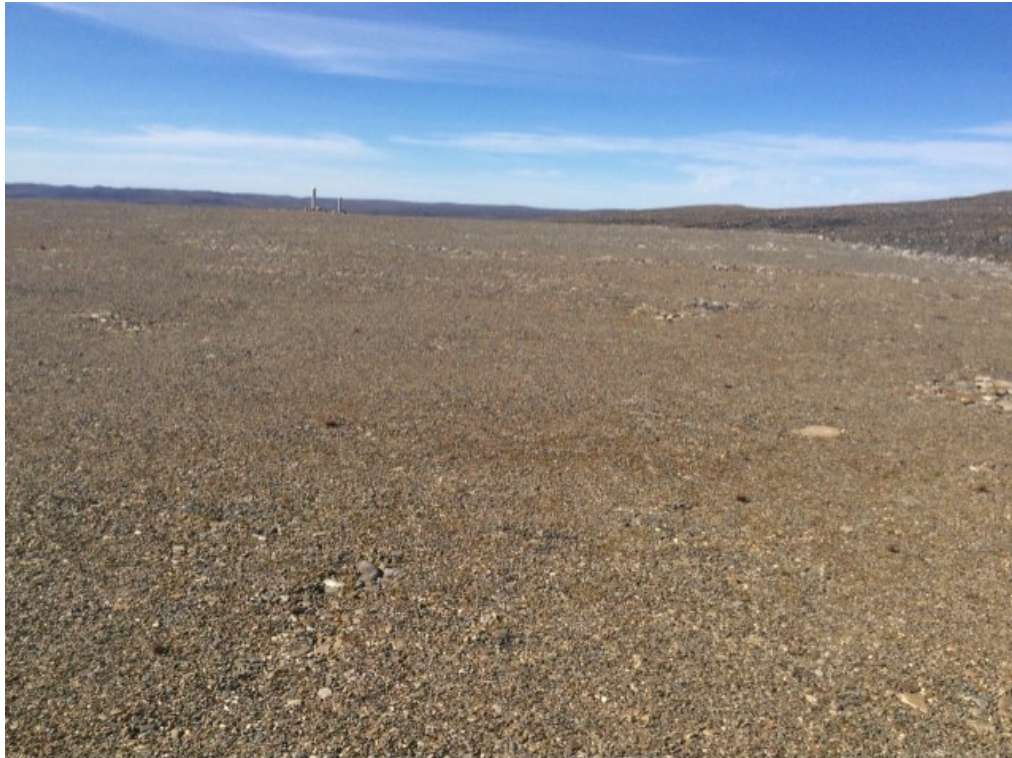
Photo 133: FOX-3 – Tier II Disposal Facility – Cover surface, facing west (ATT10_Photo10.jpg)

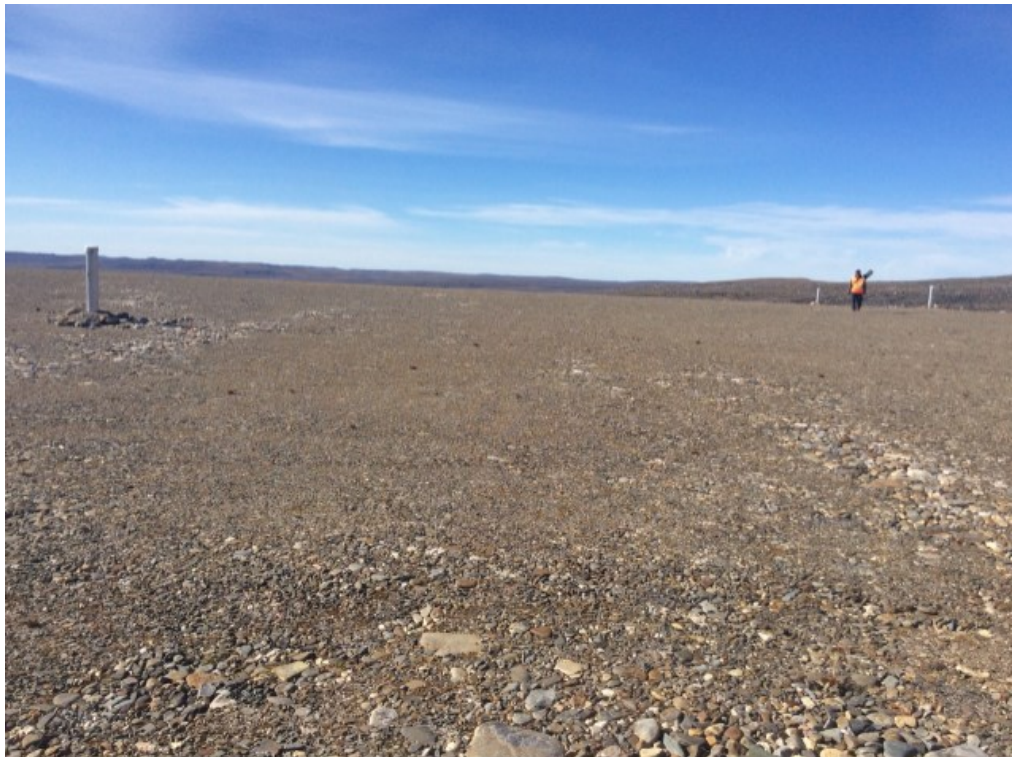
Photo 134: FOX-3 – Tier II Disposal Facility – Cover surface, facing west (ATT11_Photo11.jpg)

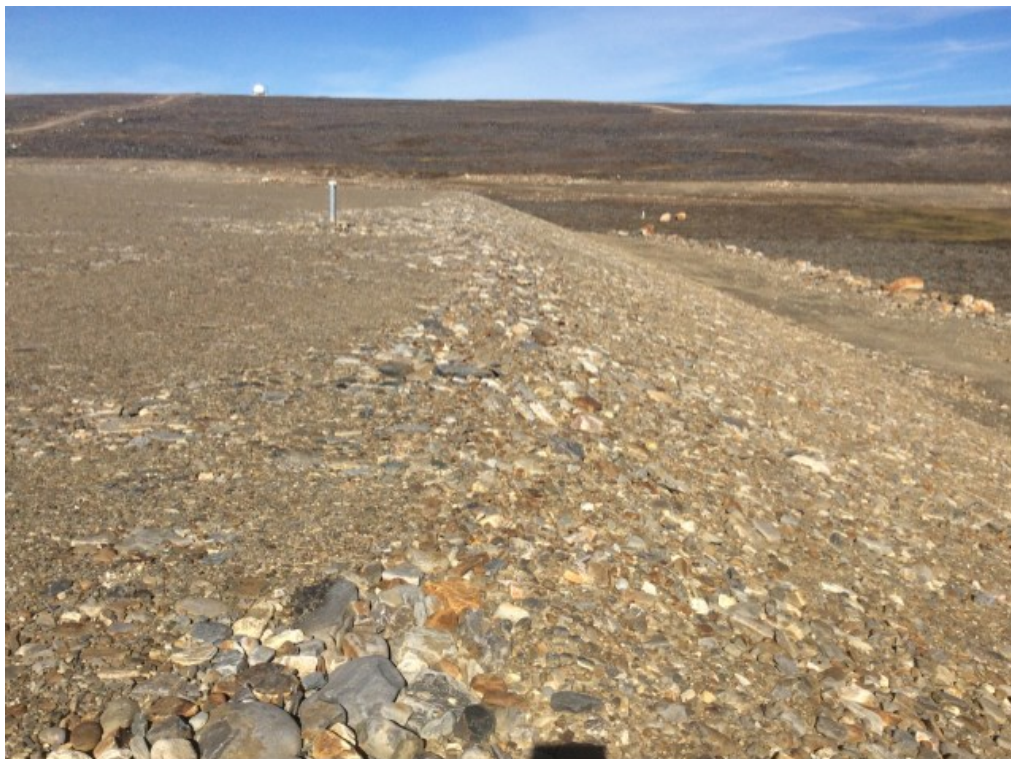
Photo 135: FOX-3 – Tier II Disposal Facility – East crest and slope, facing north (ATT12_Photo12.jpg)

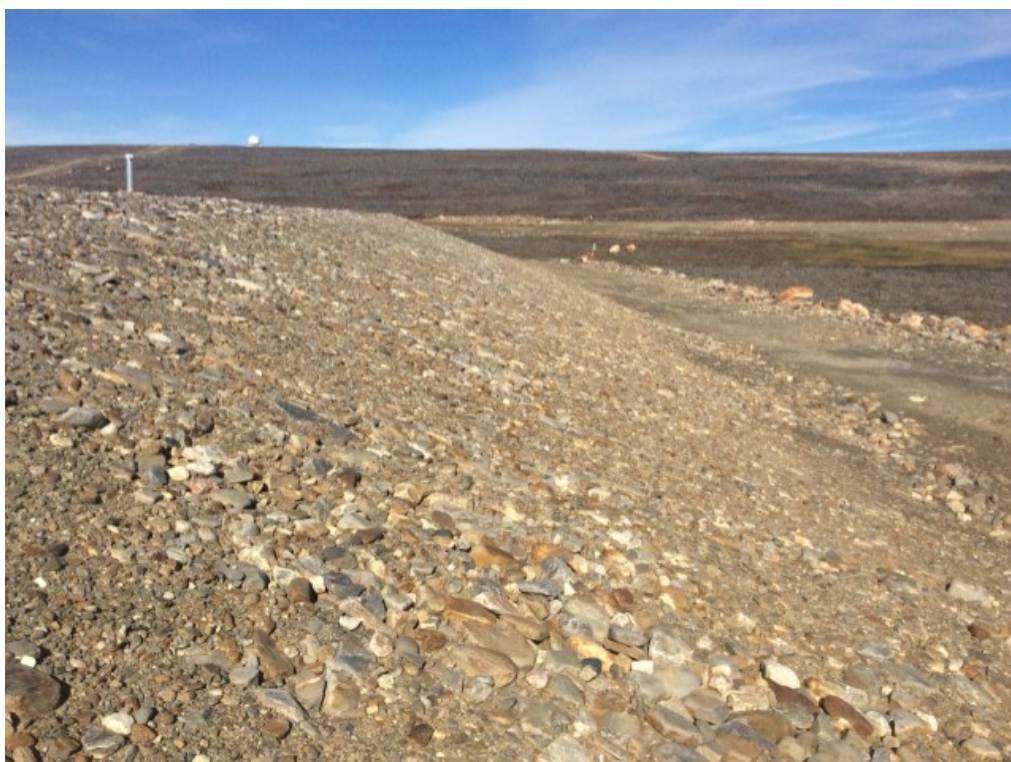
Photo 136: FOX-3 – Tier II Disposal Facility – East slope and toe, facing north (ATT13_Photo13.jpg)

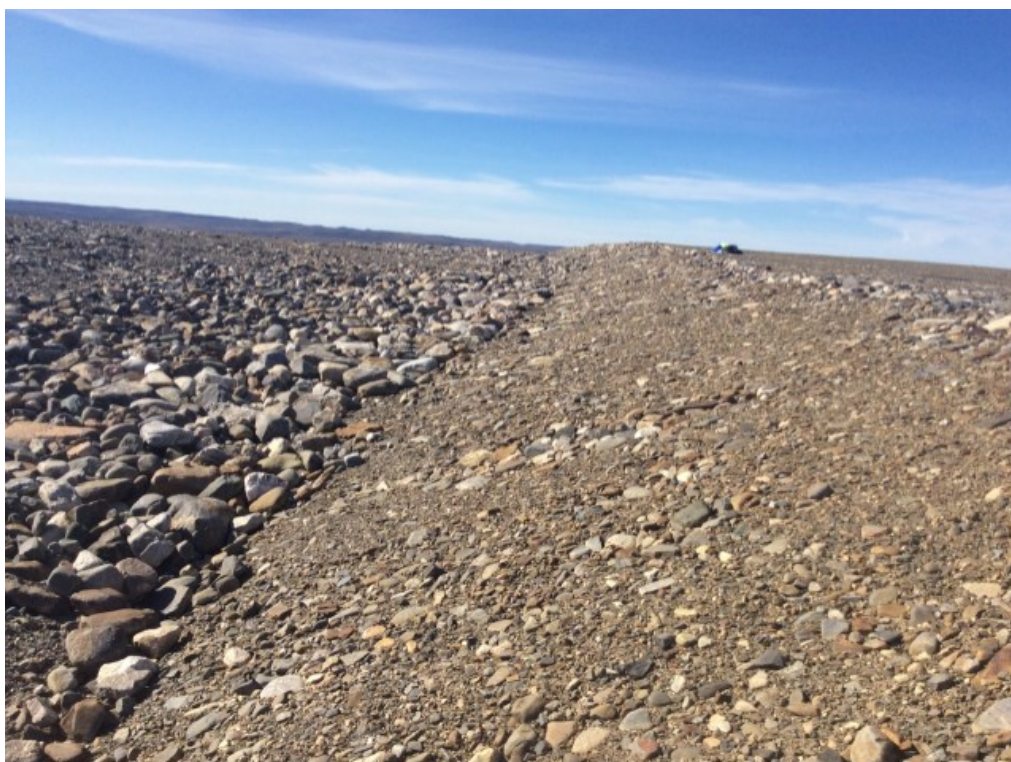
Photo 137: FOX-3 – Tier II Disposal Facility – South slope and toe, facing west (ATT14_Photo14.jpg)

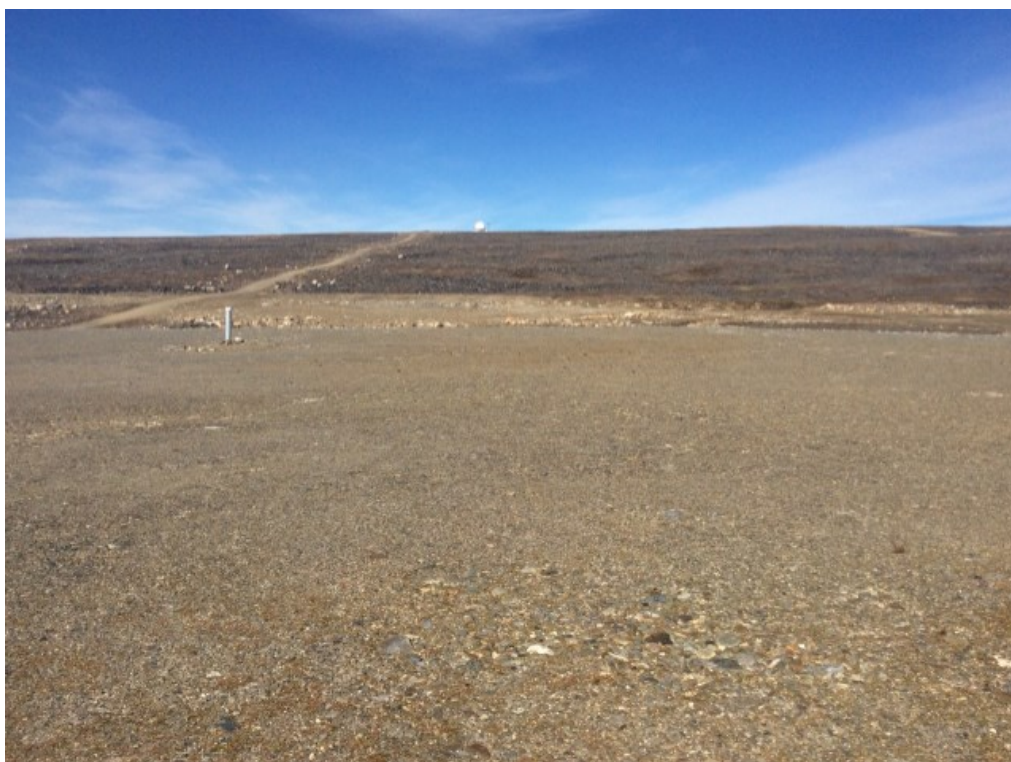
Photo 138: FOX-3 – Tier II Disposal Facility – Cover surface, facing north (ATT15_Photo15.jpg)
