QIKIQ15 BAFFIN REGION DEW LINE SITE MONITORING

2016 FOX-3 Monitoring Report

Report Number: 1530908-2000-R3-V2

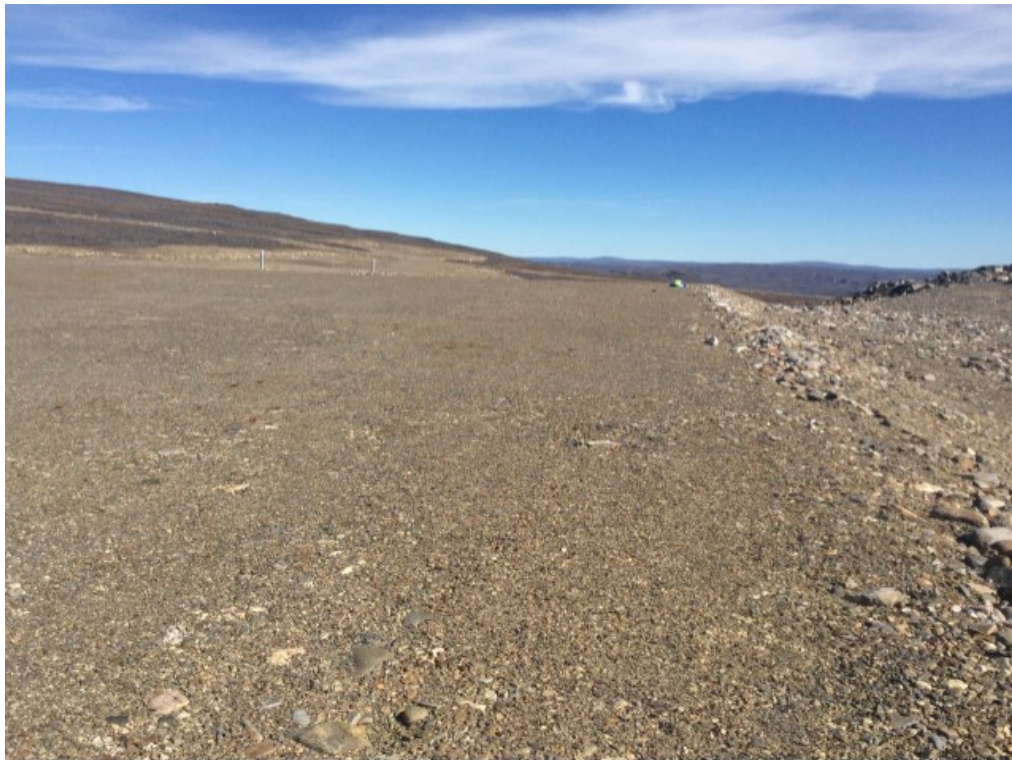
Photo 139: FOX-3 – Tier II Disposal Facility – South crest, facing east (ATT16_Photo16.jpg)

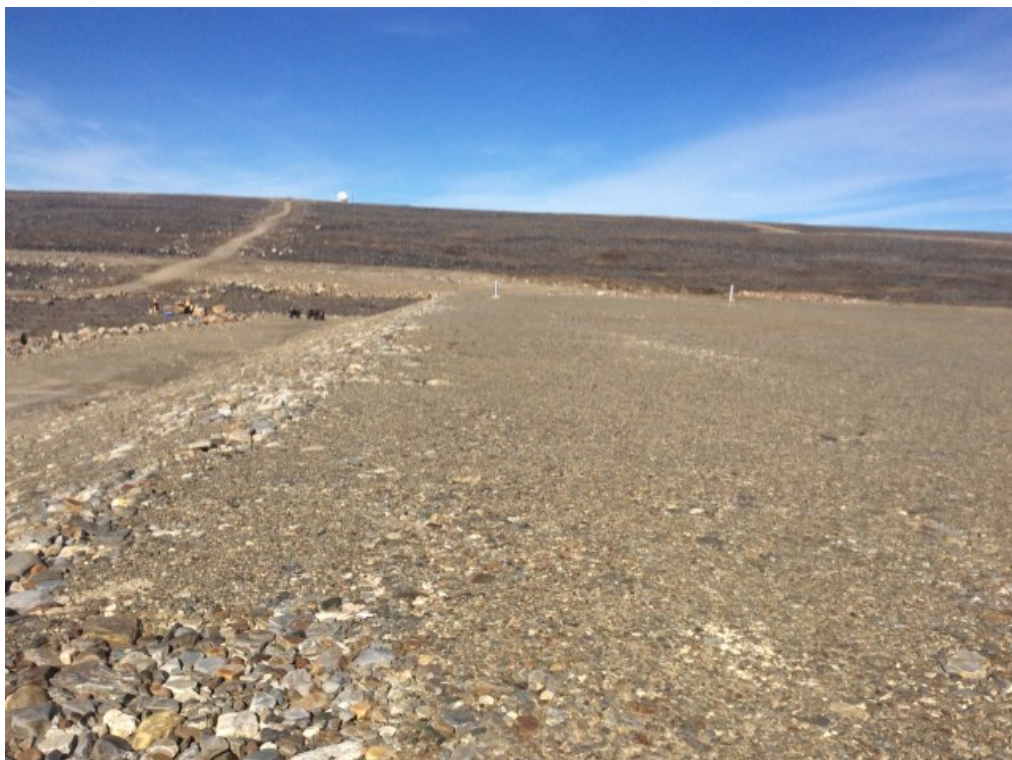
Photo 140: FOX-3 – Tier II Disposal Facility – West crest, facing north (ATT17_Photo17.jpg)

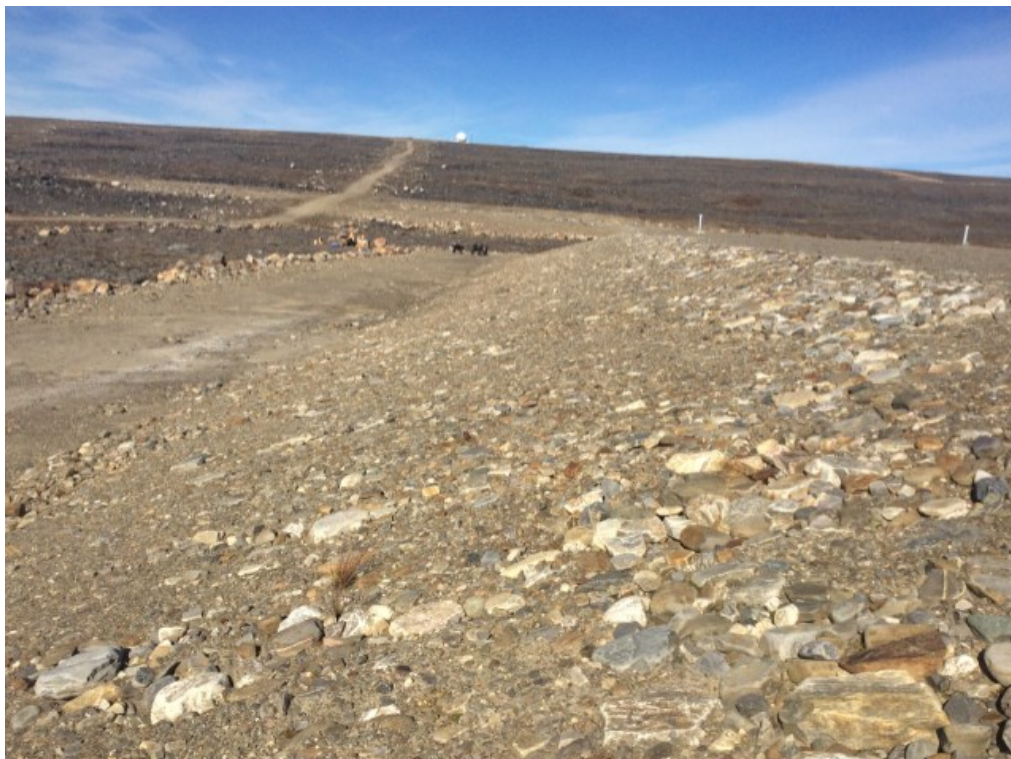
Photo 141: FOX-3 – Tier II Disposal Facility – West slope, facing north (ATT18_Photo18.jpg)

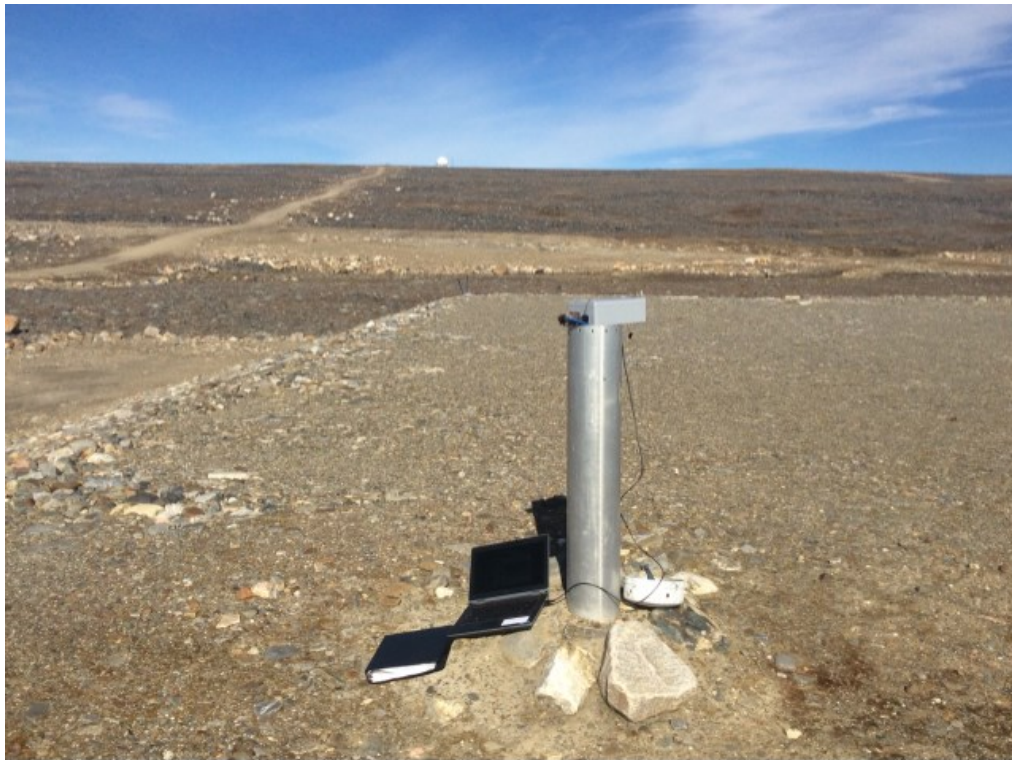
Photo 144: FOX-3 – Tier II Disposal Facility – VT-2, facing north (ATT3_Photo3.jpg)

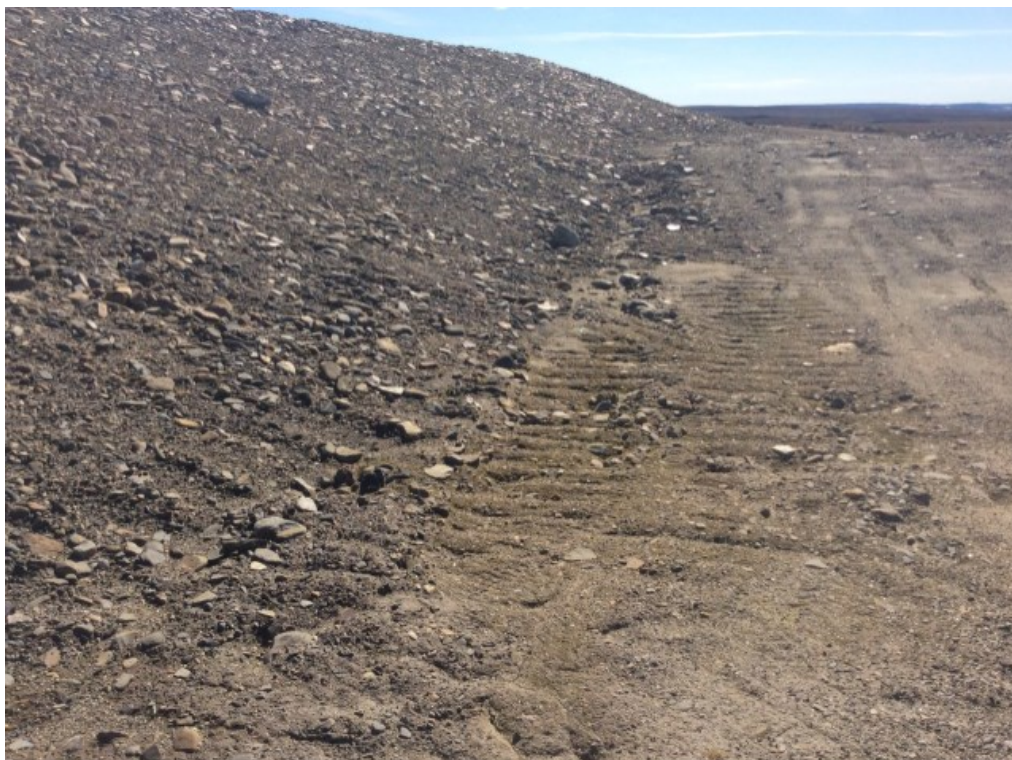
Photo 145: FOX-3 – Tier II Disposal Facility – VT-1, facing north (ATT4_Photo4.jpg)

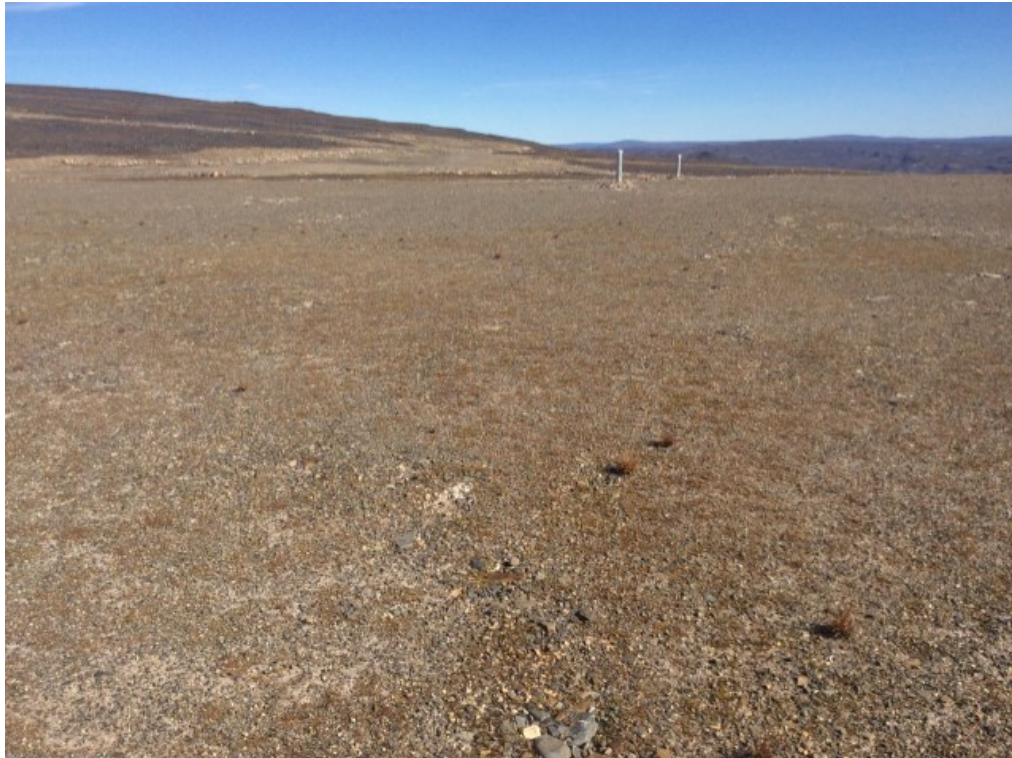
Photo 147: FOX-3 – Tier II Disposal Facility – Central cover surface – Feature L – Some very sparse vegetation [Acceptable], facing east (ATT8_Photo8.jpg)

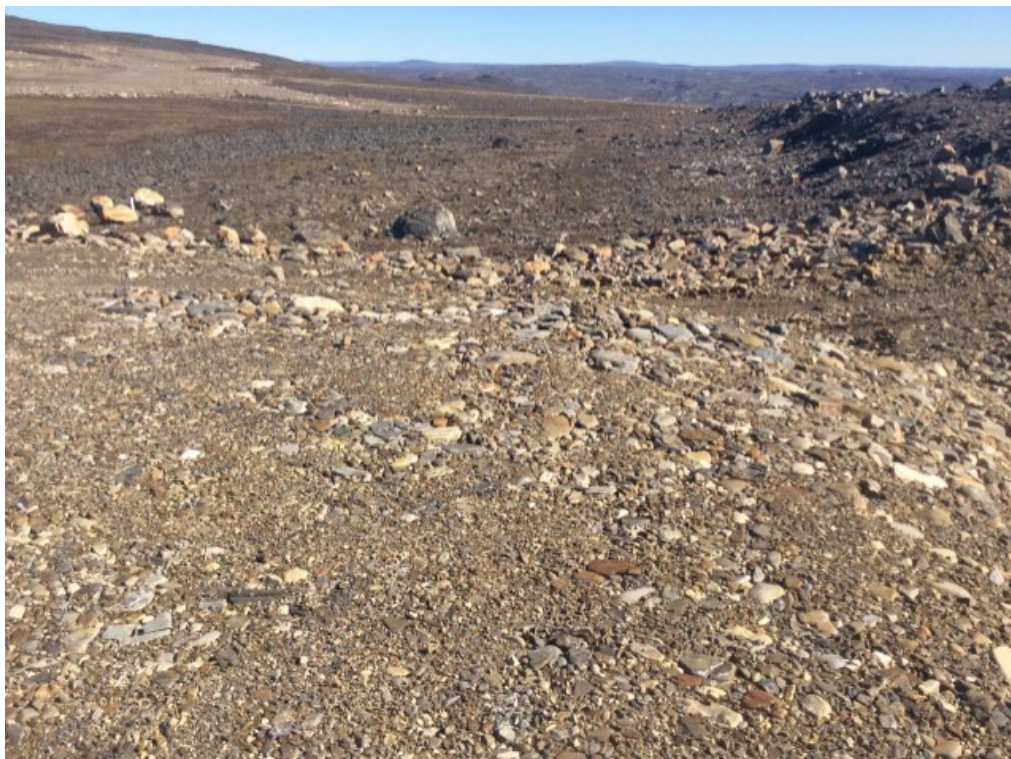
Photo 149: FOX-3 – Tier II Disposal Facility – Crest surface in southeast corner – (Previous Feature I- no ponded water-minor Depression), facing southeast (ATT4_Photo4.jpg)

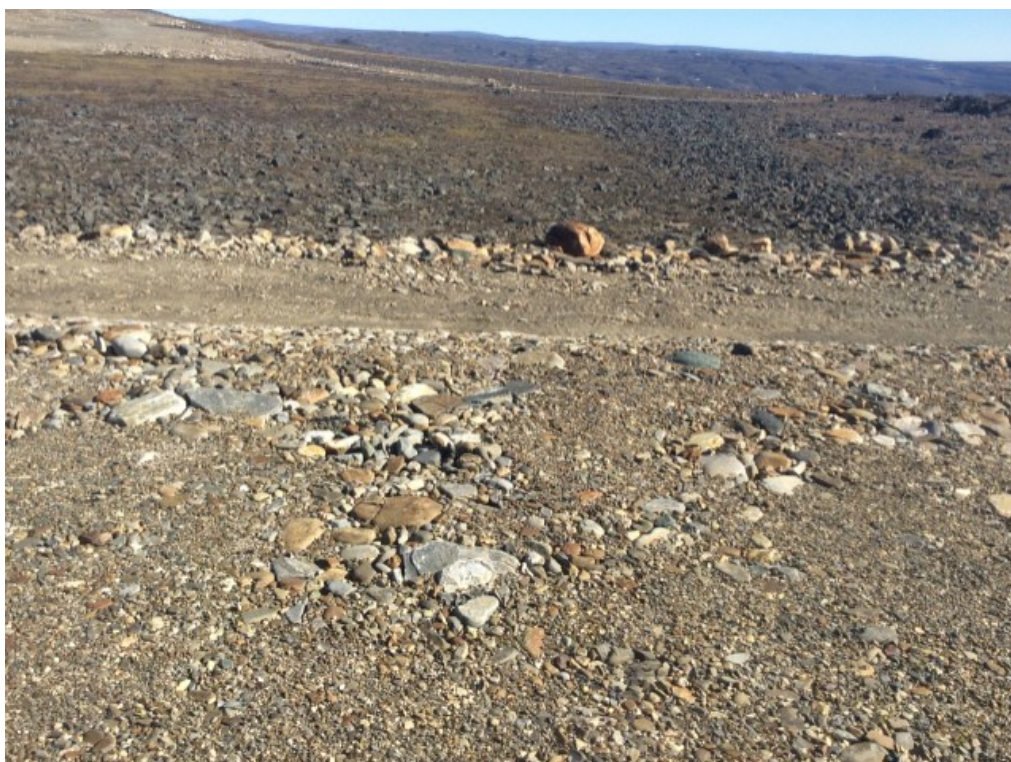
Photo 150: FOX-3 – Tier II Disposal Facility – East crest – Feature N – minor settlement [Acceptable], facing northeast (ATT3_Photo3.jpg)

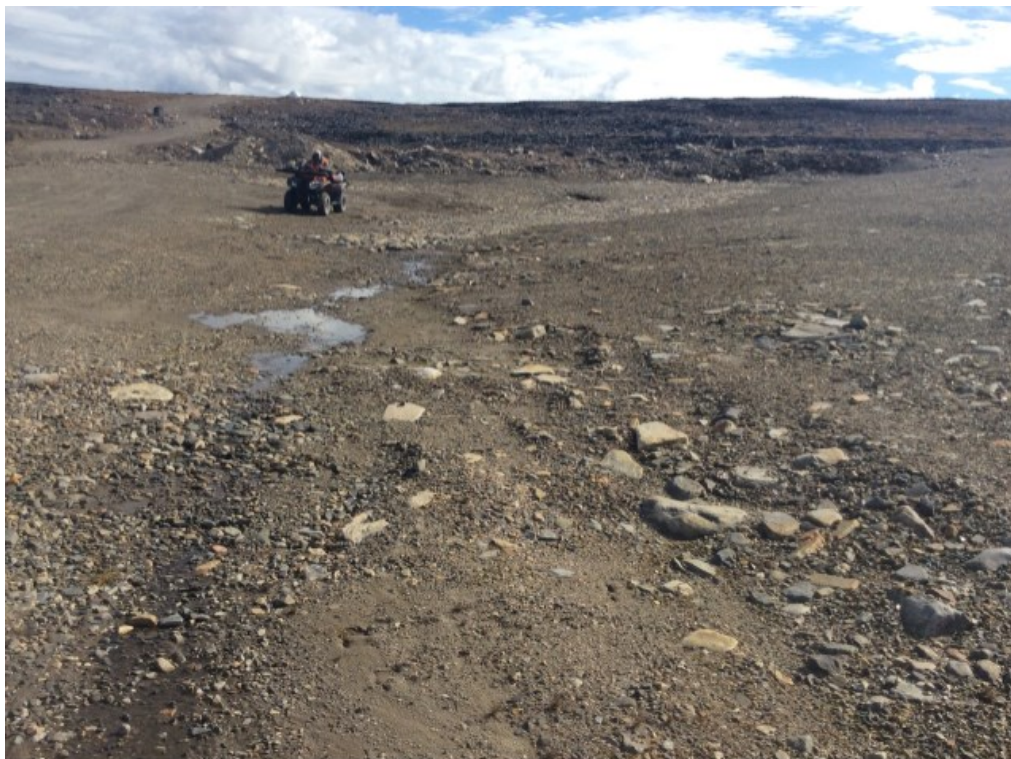
Photo 169: FOX-3 – West Landfill – Feature D – ponded water at the north toe, facing east (ATT86_Photo86.jpg)

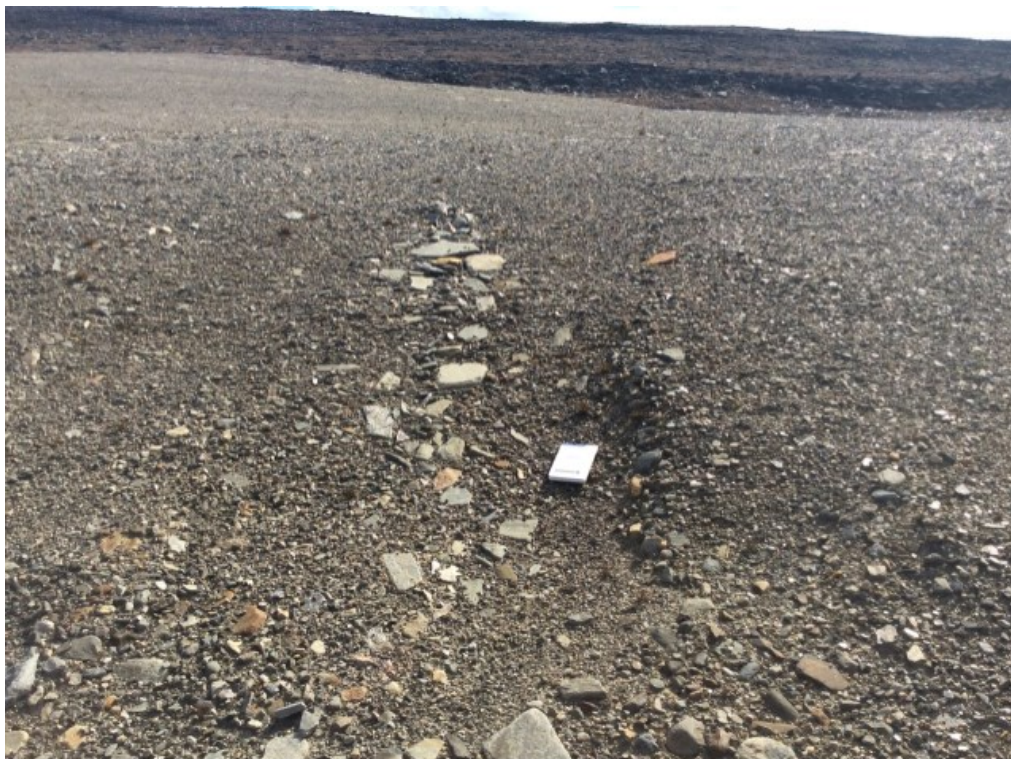
Photo 181: FOX-3 – West Landfill – West slope – Feature E – Minor settlement [Acceptable], facing northeast (ATT56_Photo56.jpg)

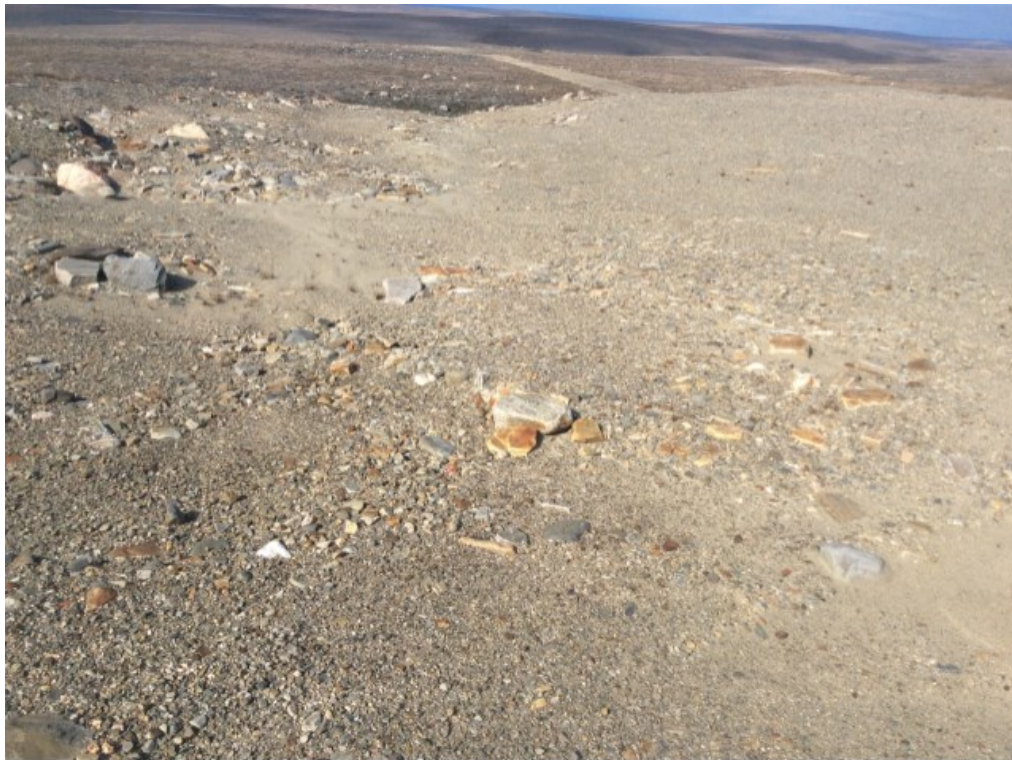
Photo 183: FOX-3 – West Landfill – South toe – No ponded water (previous Feature G), facing northwest (ATT55_Photo55.jpg)

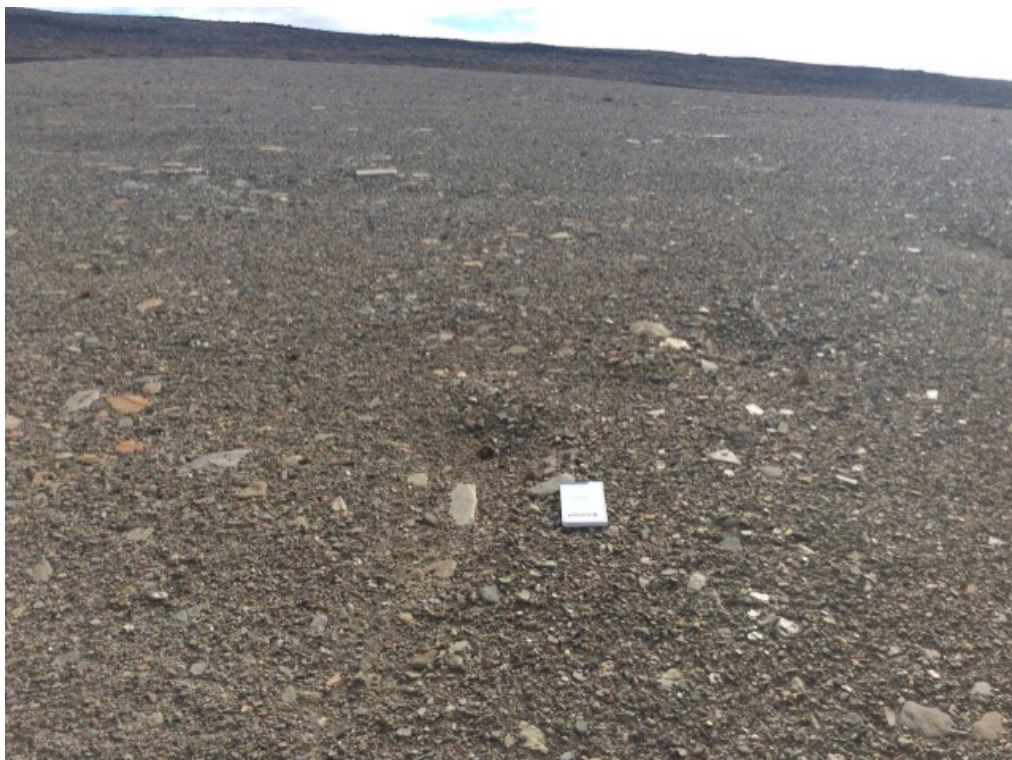
Photo 184: FOX-3 – West Landfill – Northwest slope – Feature K – Minor settlement [Acceptable], facing north (ATT57_Photo57.jpg)

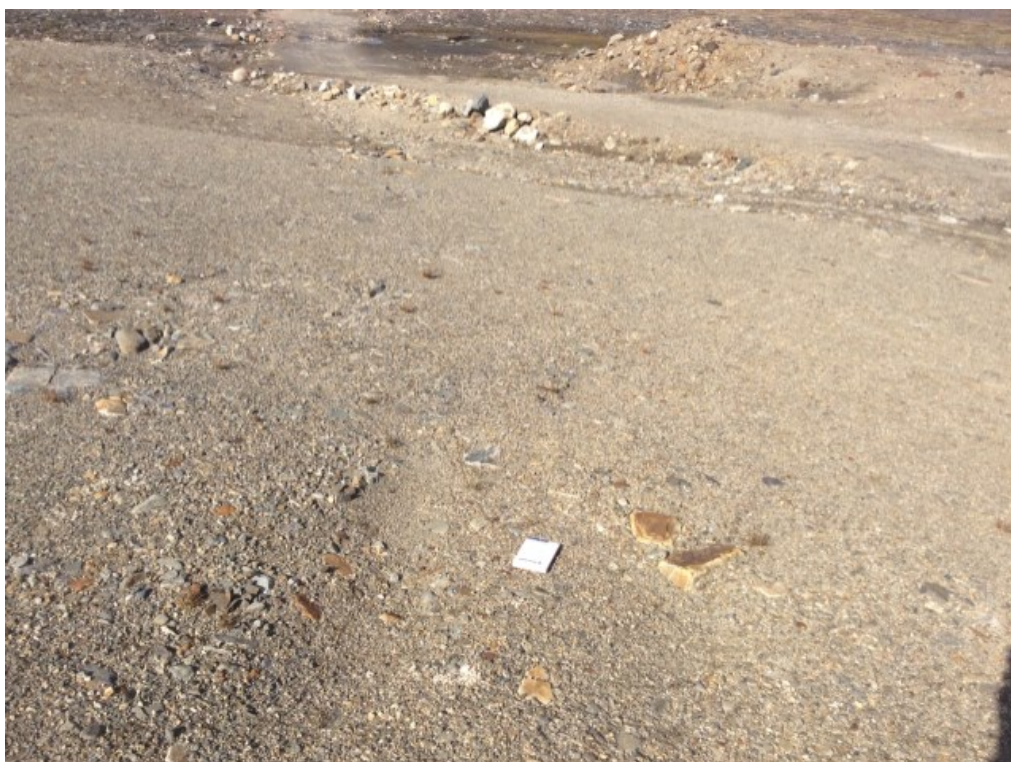
Photo 186: FOX-3 – West Landfill – North slope – Feature J – Minor settlement [Acceptable], facing north (ATT49_Photo49.jpg)

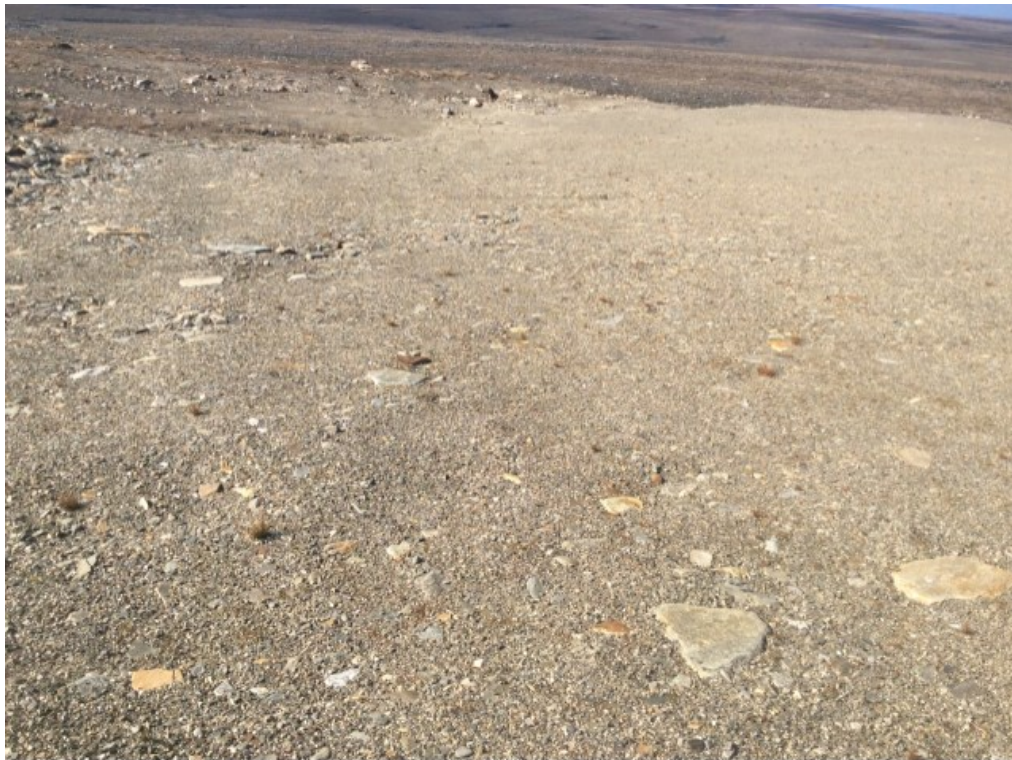
Photo 187: FOX-3 – West Landfill – Crest surface – Feature I – Moss and sparse vegetation, facing northwest (ATT54_Photo54.jpg)

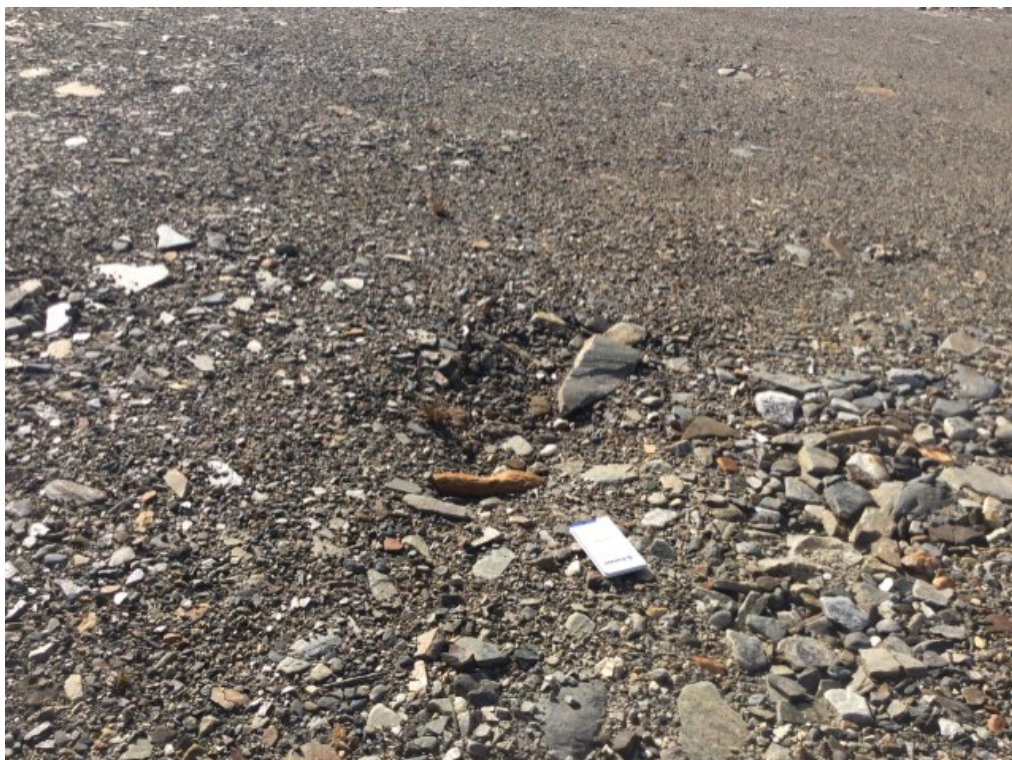
Photo 188: FOX-3 – West Landfill – Cover surface – Feature A – Minor settlement and rough area [Acceptable], facing northeast (ATT52_Photo52.jpg)

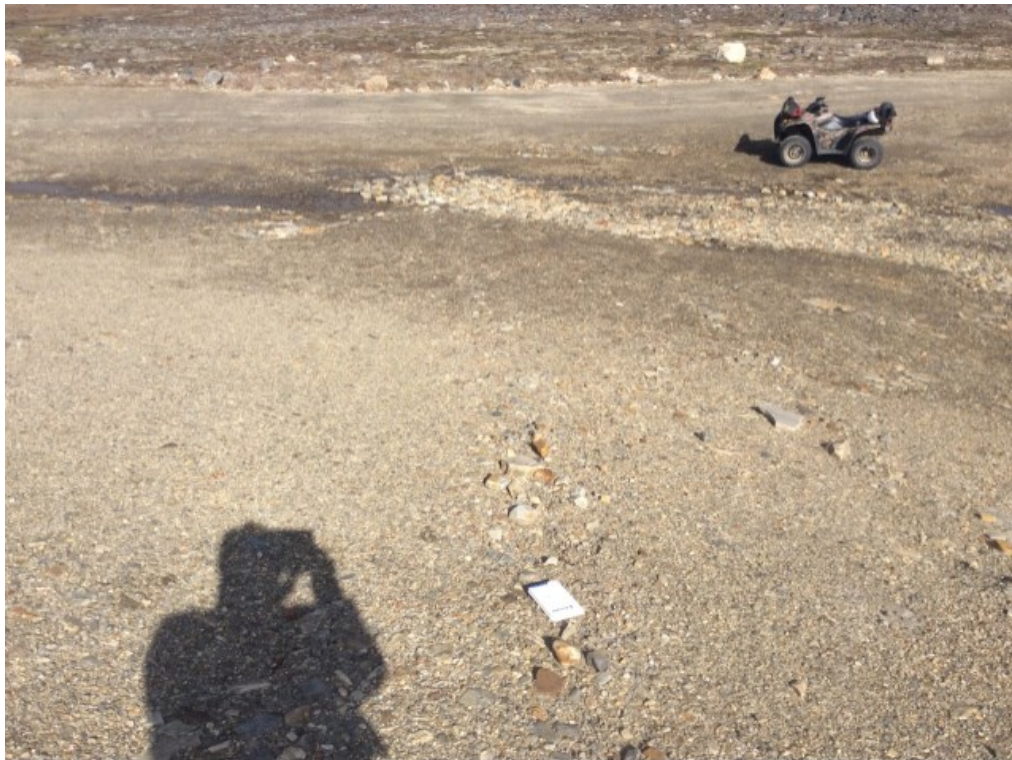
Photo 189: FOX-3 – West Landfill – North slope – Feature H – minor self-armouring erosion [Acceptable], facing northeast (ATT51_Photo51.jpg)

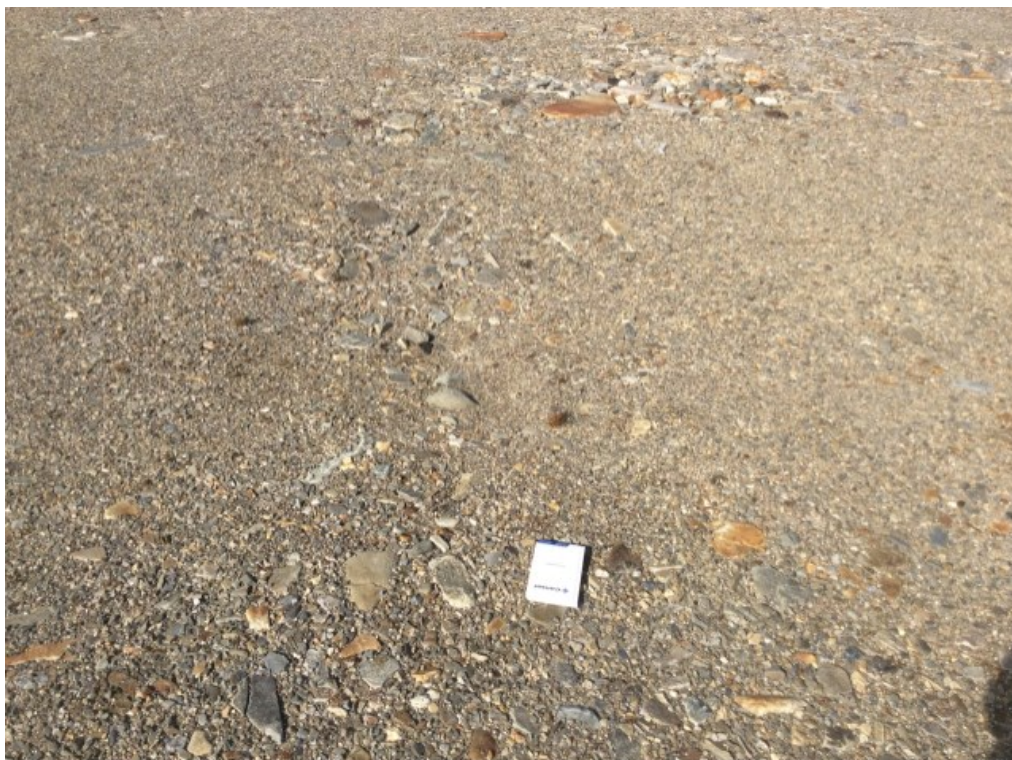
Photo 190: FOX-3 – West Landfill – Cover surface – Feature B – Minor settlement with no ponded water. [Acceptable], facing northeast (ATT53_Photo53.jpg)

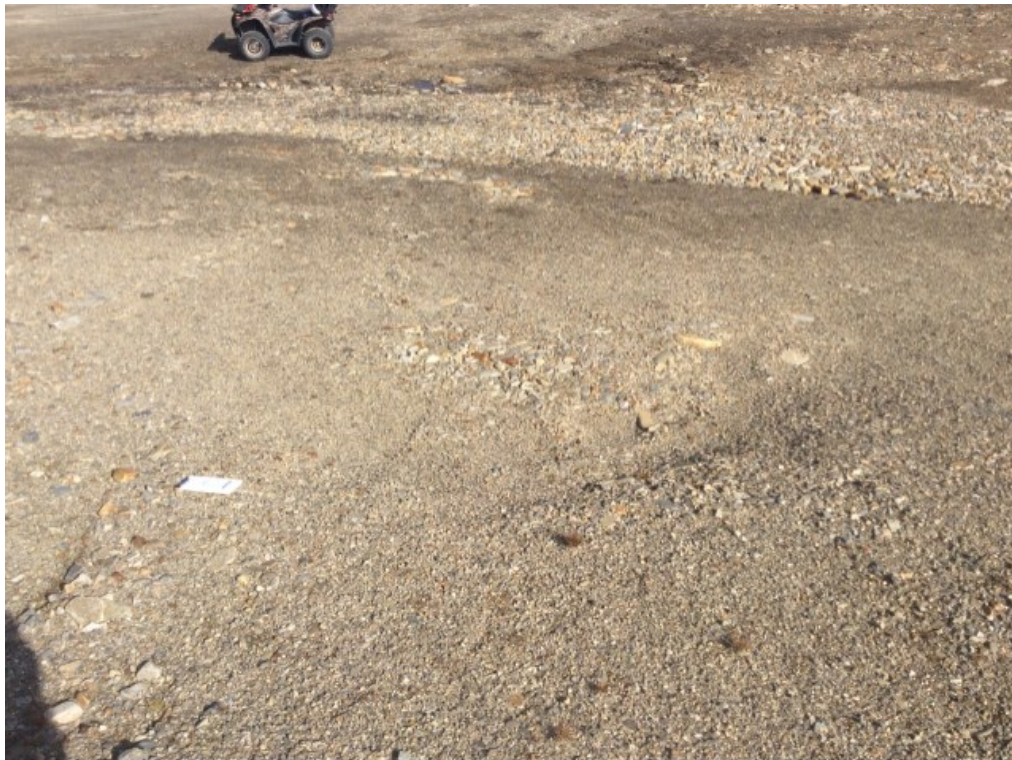
Photo 191: FOX-3 – West Landfill – North slope – Feature F – Minor settlement [Acceptable], facing north (ATT50_Photo50.jpg)

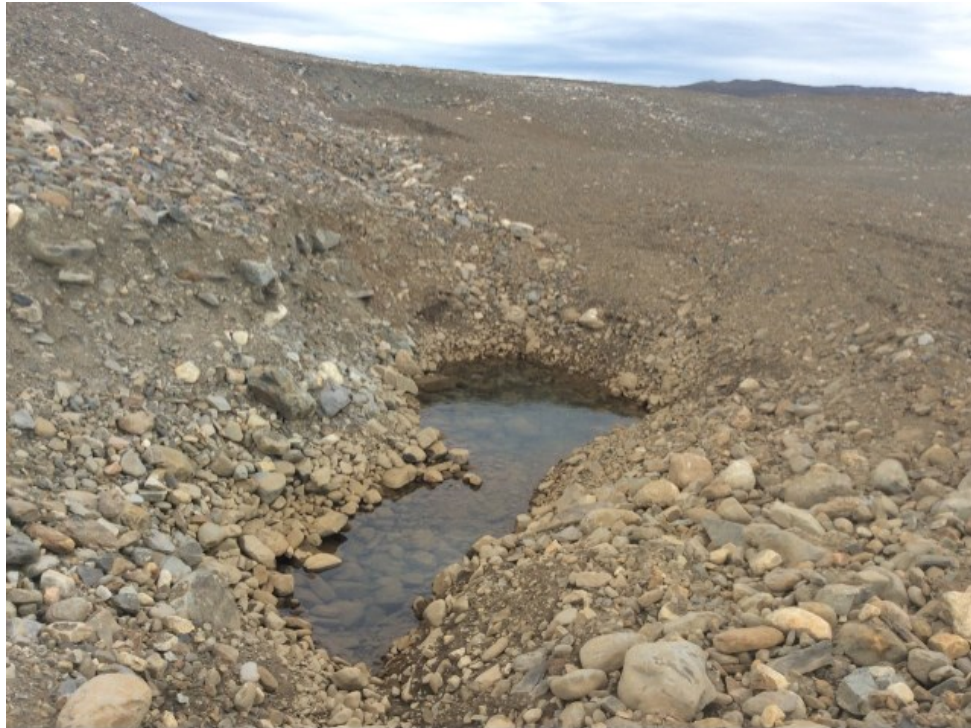
Photo E1: FOX-3 – Thermokarst Area – Feature C – Ponded water in low point of thermokarst settlement area, facing northeast (ATT59_Photo59.jpg)

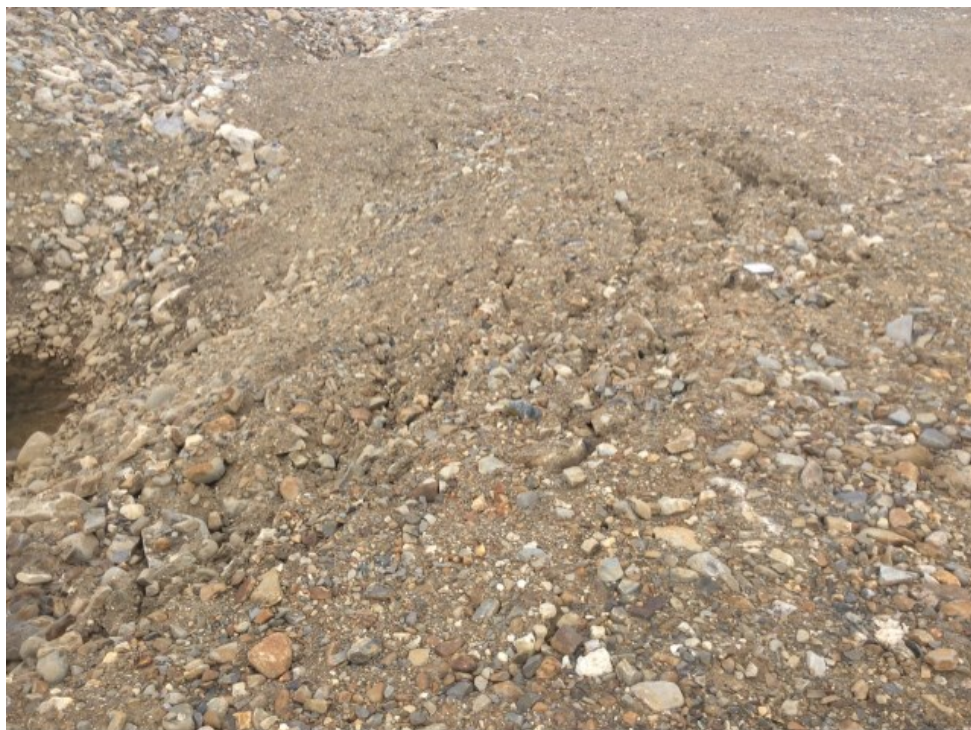
Photo E2: FOX-3 – Thermokarst Area – Feature D – Crack along the ponding area, facing northwest (ATT60_Photo60.jpg)

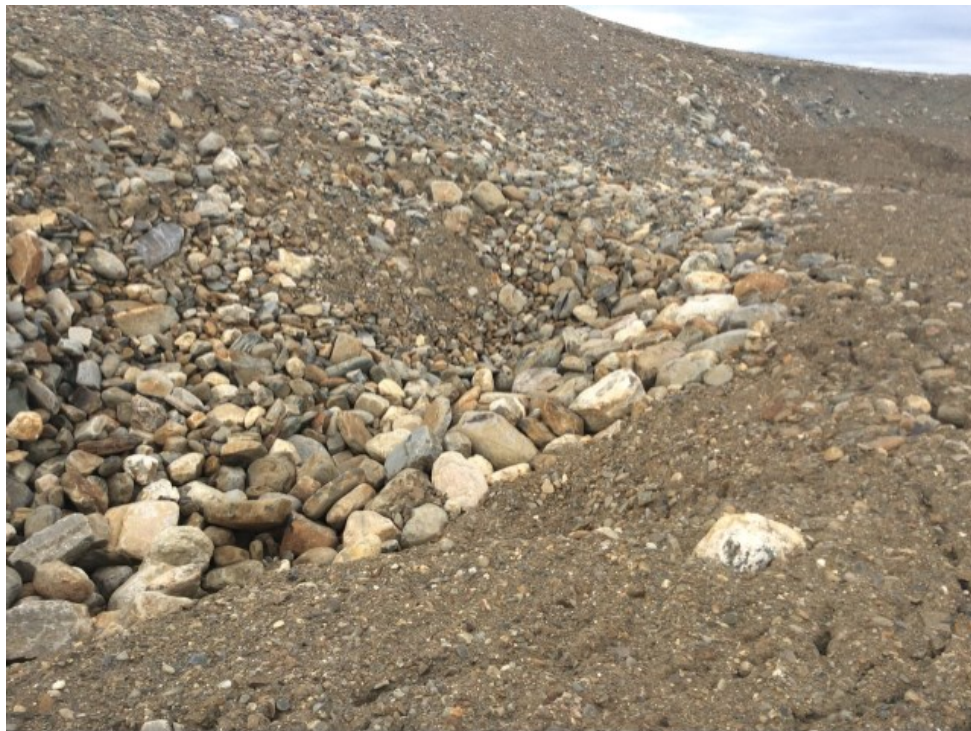
Photo E3: FOX-3 – Thermokarst Area – Area of ponded water observed in 2015 (Feature C-not shown on Figure E-1). No water in 2016, facing northwest (ATT61_Photo61.jpg)

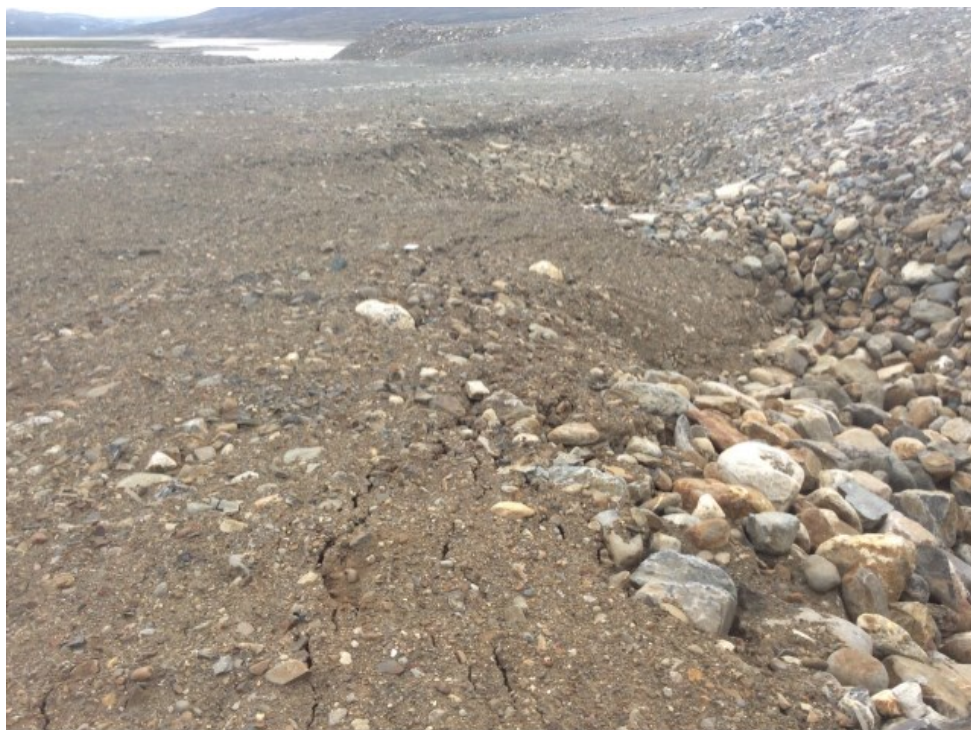
Photo E4: FOX-3 – Thermokarst Area – Feature D – Cracking, facing southwest (ATT62_Photo62.jpg)

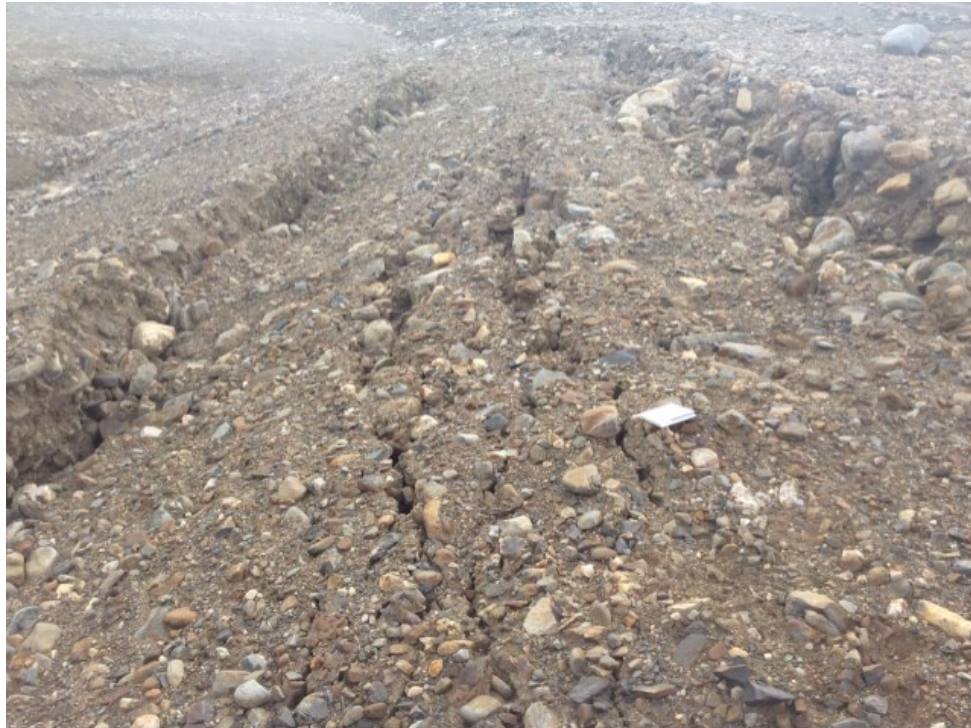
Photo E5: FOX-3 – Thermokarst Area – Feature B – Cracking along the edge of settlement – Looking south (ATT63_Photo63.jpg)

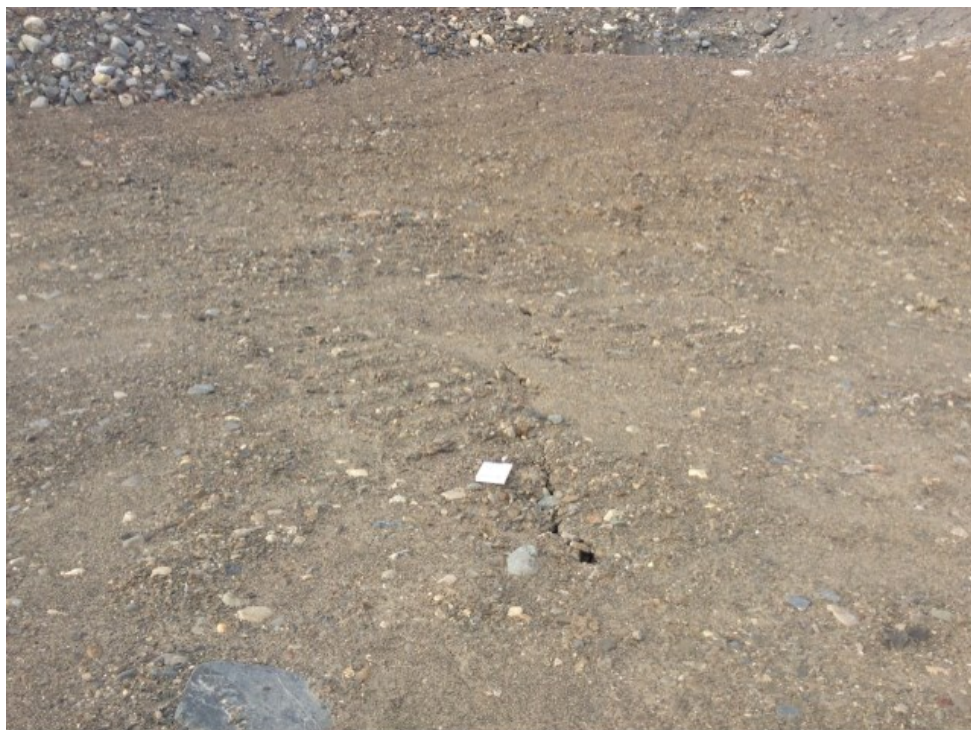
Photo E6: FOX-3 – Thermokarst Area – Feature E – Cracking extended towards the settlement area, facing northwest (ATT64_Photo64.jpg)

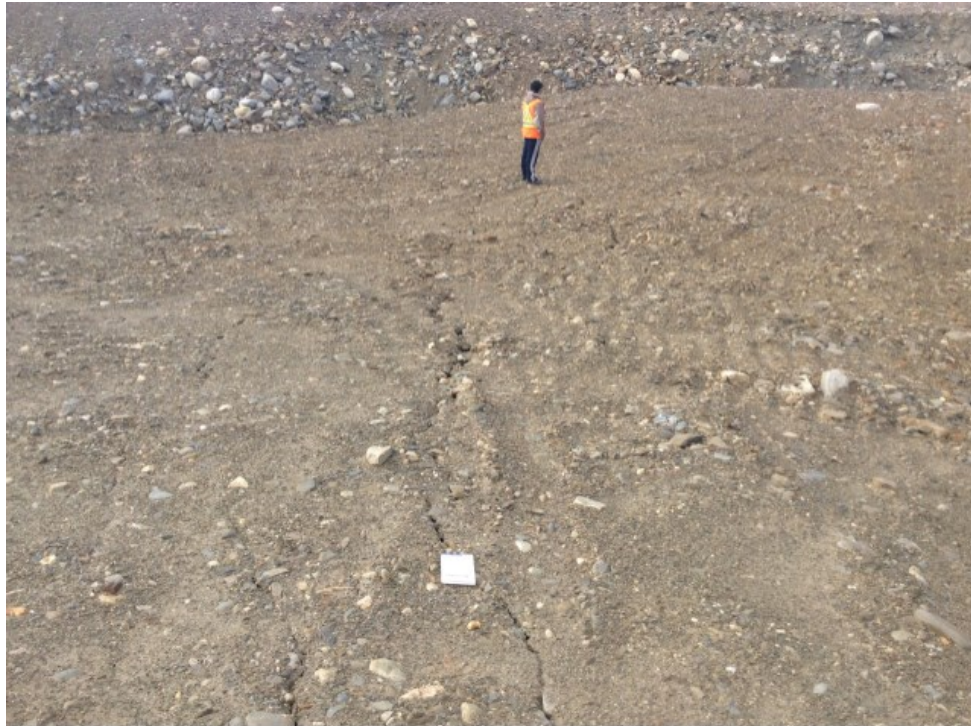
Photo E7: FOX-3 – Thermokarst Area – Feature E – Cracking extended towards the settlement area, facing northwest (ATT65_Photo65.jpg)

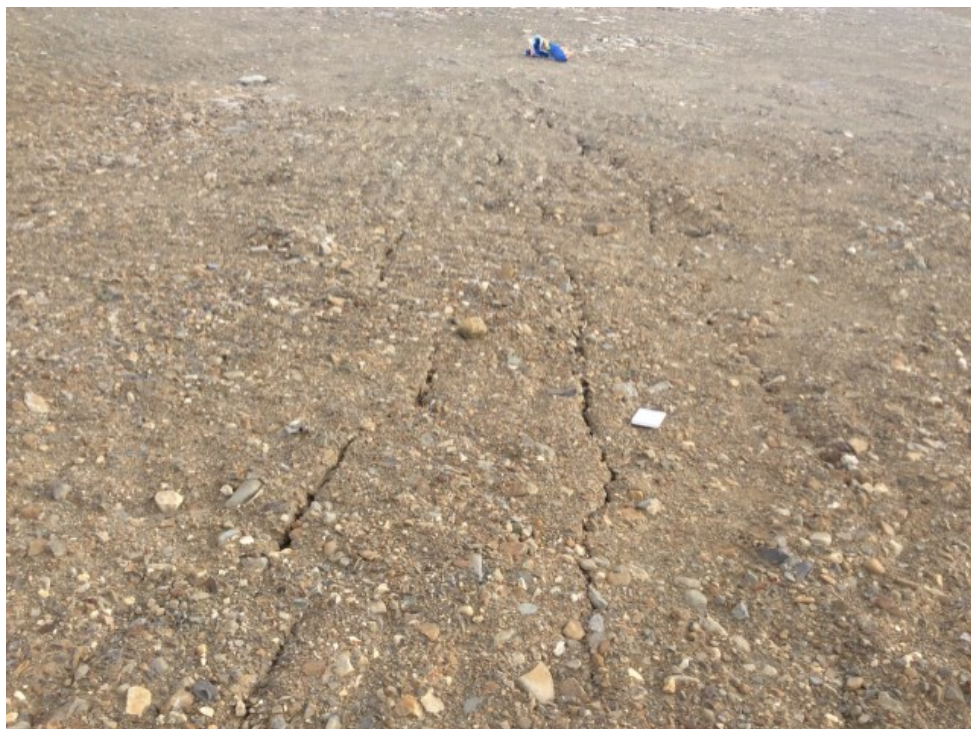
Photo E8: FOX-3 – Thermokarst Area – Feature E – Cracking extended towards the settlement area, facing southeast (ATT66_Photo66.jpg)

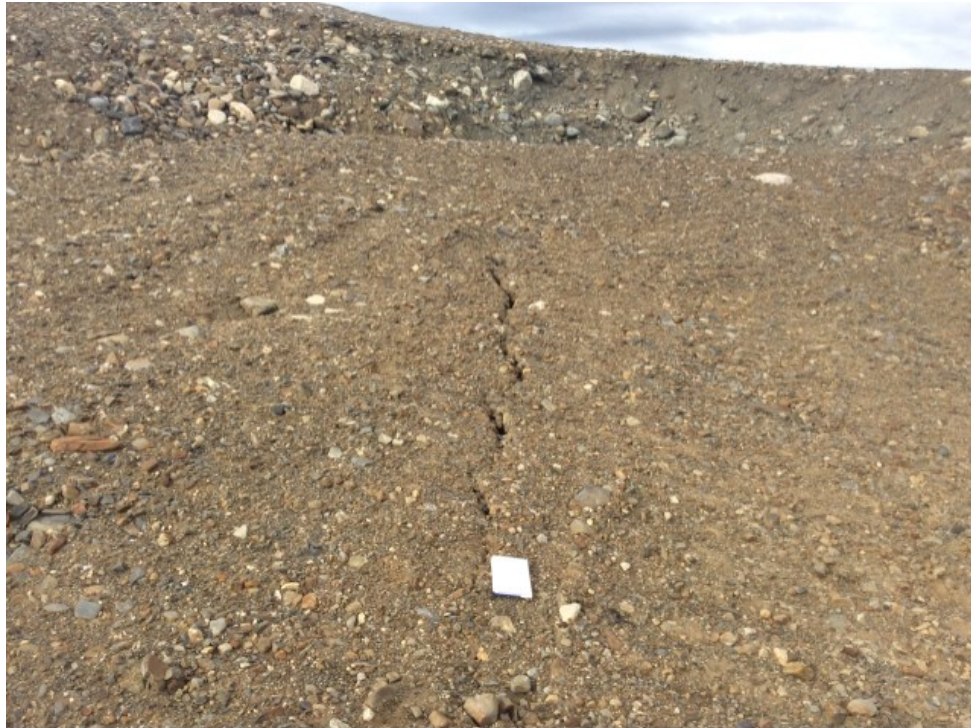
Photo E9: FOX-3 – Thermokarst Area – Feature E – Cracking extended along the edge of settlement, facing north (ATT67_Photo67.jpg)

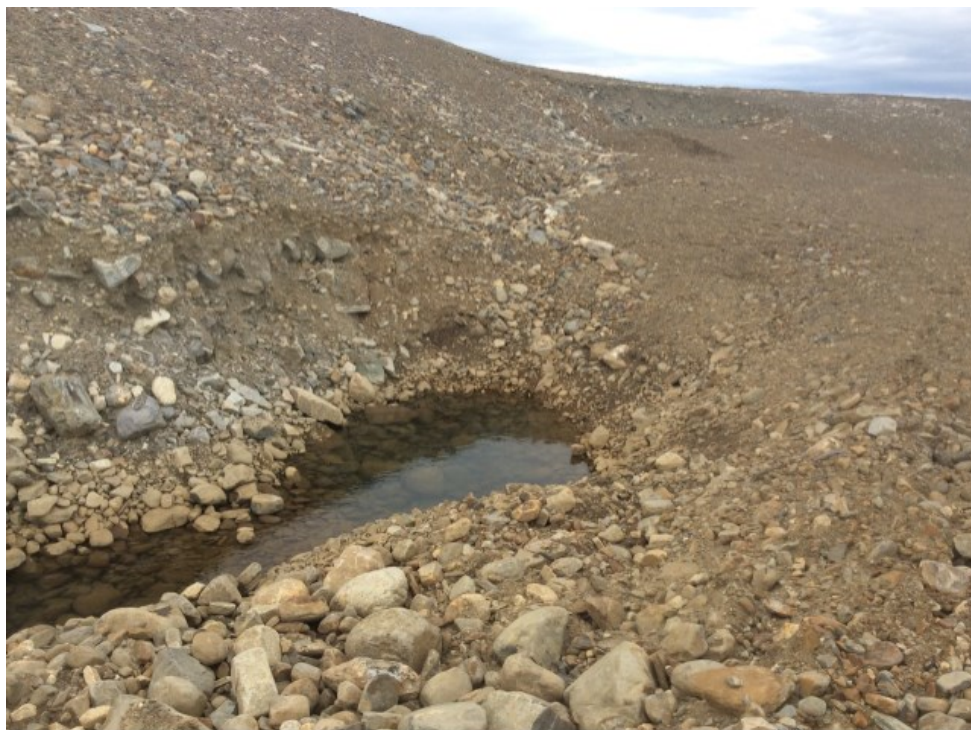
Photo E10: FOX-3 – Thermokarst Area – Feature C – Ponded water in low point of thermokarst settlement area, facing northeast (ATT98_Photo98.jpg)

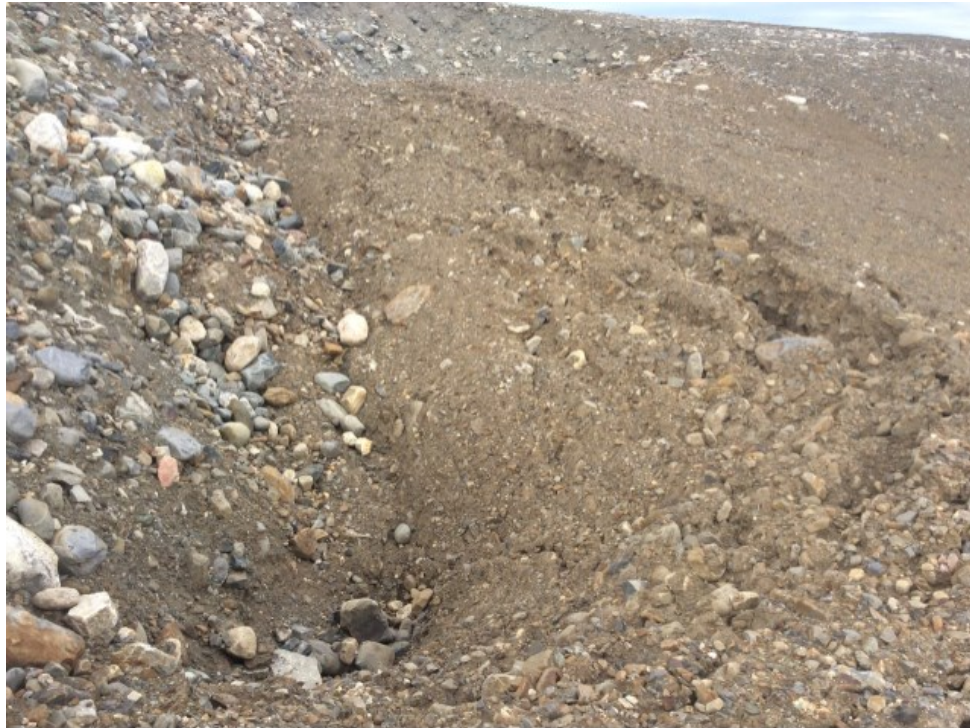
Photo E11: FOX-3 – Thermokarst Area – Edge of thaw settlement (Feature A), facing northeast (ATT99_Photo99.jpg)
