QIKIQ15 BAFFIN REGION DEW LINE SITE MONITORING

2016 FOX-3 Monitoring Report

Report Number: 1530908-2000-R3-V2

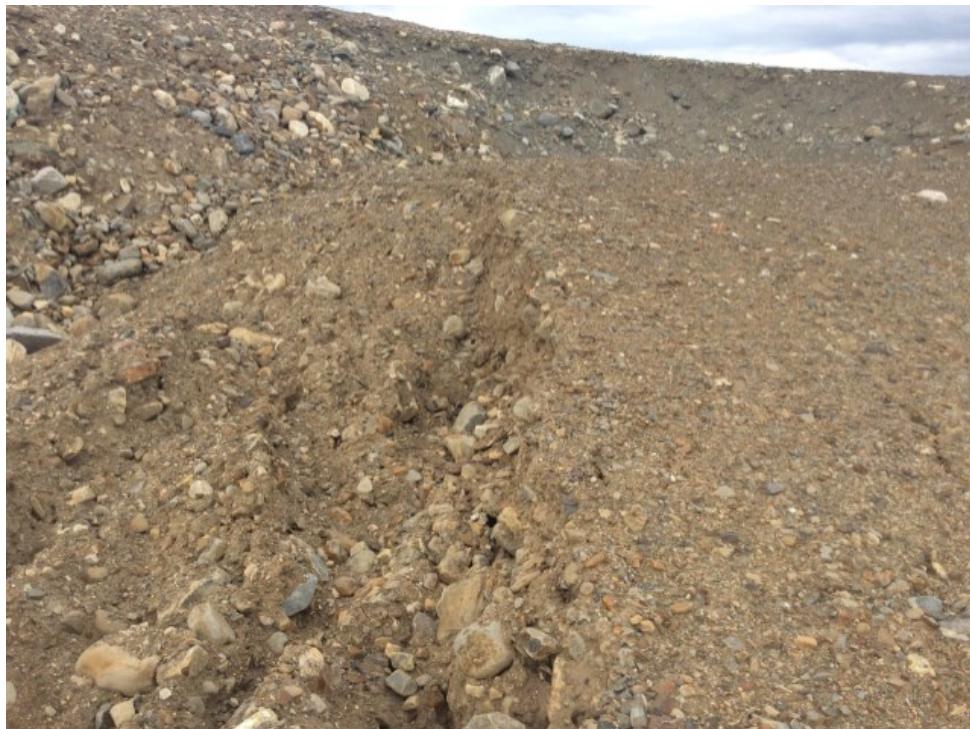
Photo E12: FOX-3 – Thermokarst Area – Edge of thaw settlement (Feature A), facing north (ATT100_Photo100.jpg)

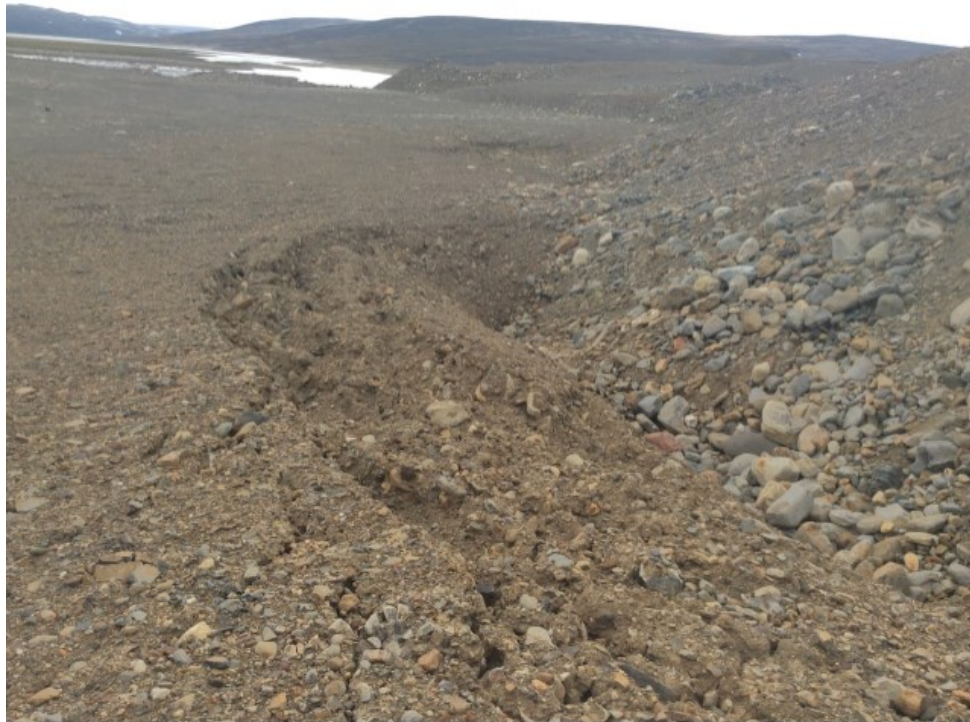
Photo E13: FOX-3 – Thermokarst Area – Edge of thaw settlement (Feature A) facing southwest(ATT101_Photo101.jpg)

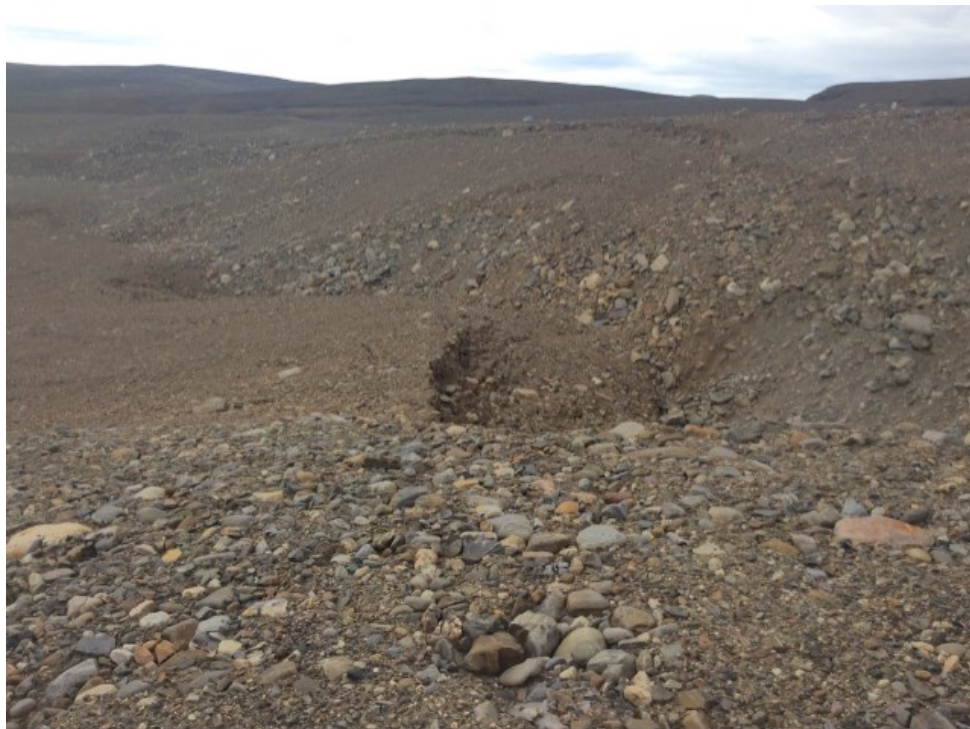
Photo E14: FOX-3 – Thermokarst Area – Settlement area overview, facing southwest (ATT102_Photo102.jpg)

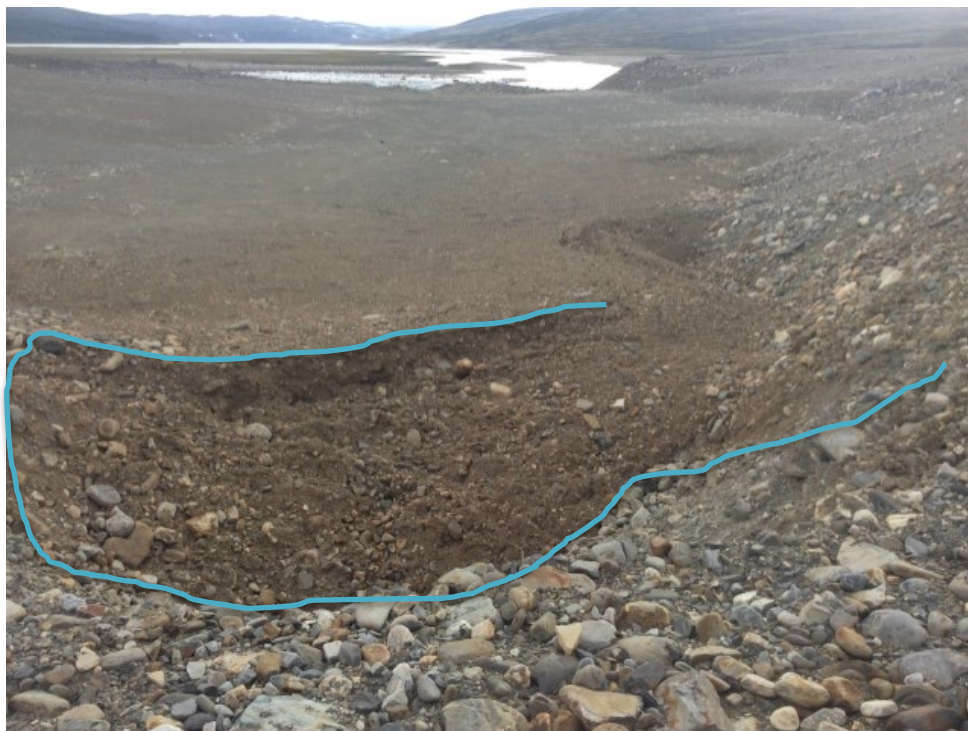
Photo E15: FOX-3 – Thermokarst Area – Settlement area (Feature A), facing southwest (ATT103_Photo103.jpg)

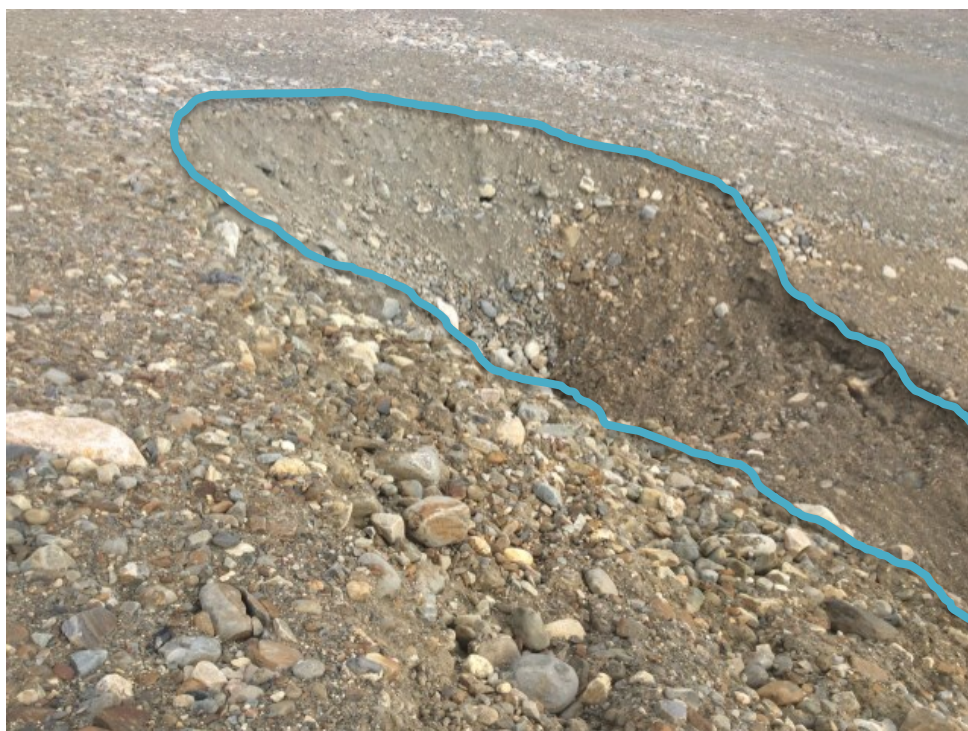
Photo E16: FOX-3 – Thermokarst Area – Settlement area (Feature A), facing northeast (ATT104_Photo104.jpg)

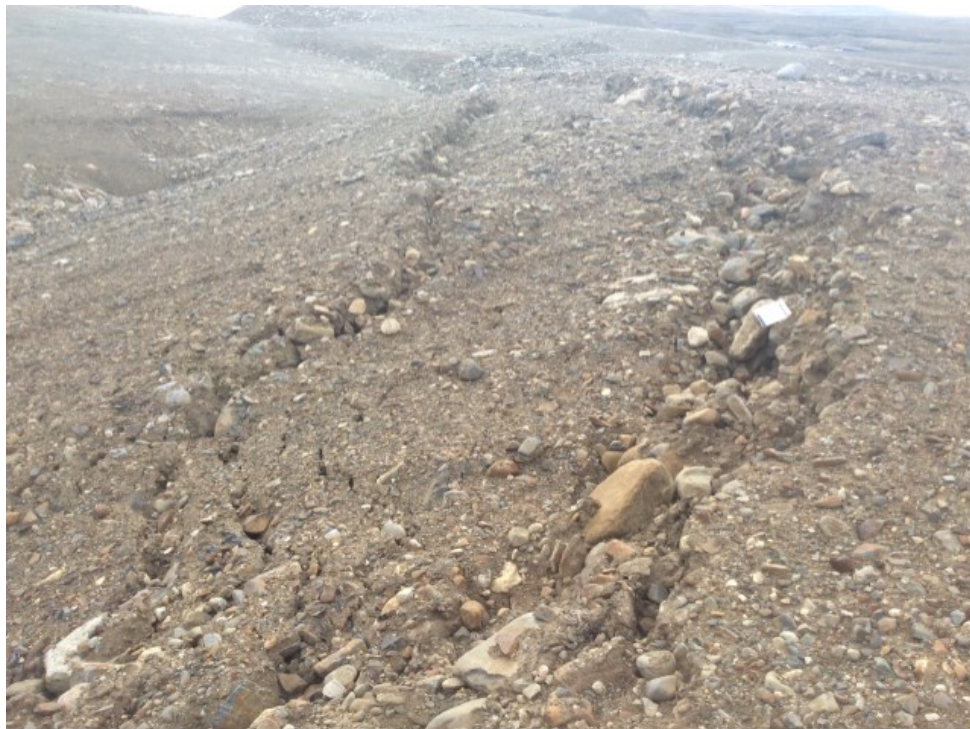
Photo E17: FOX-3 – Thermokarst Area – Top of upper tension crack (Feature B), facing southwest (ATT105_Photo105.jpg)

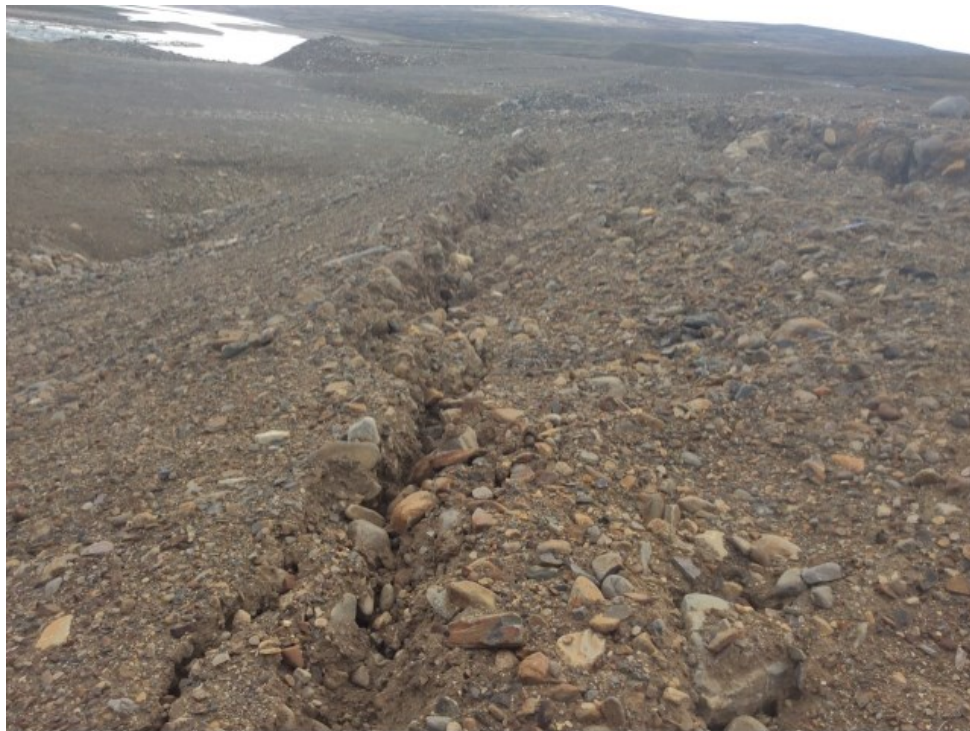
Photo E19: FOX-3 – Thermokarst Area – Perimeter of thaw settlement (Feature A), facing southwest (ATT107_Photo107.jpg)

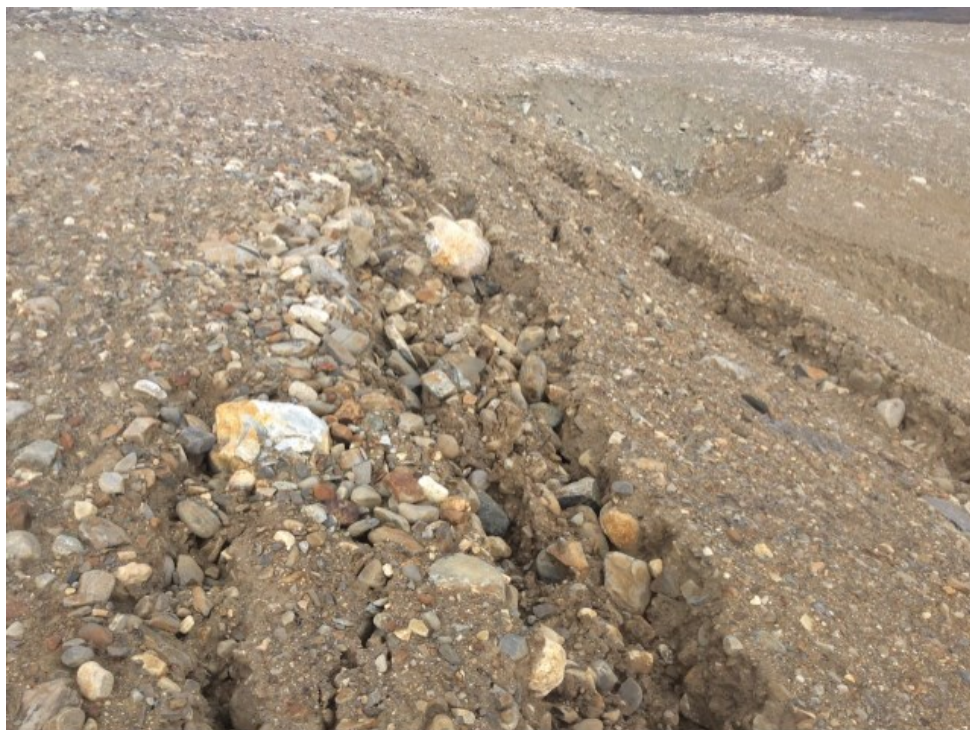
Photo E20: FOX-3 – Thermokarst Area – Top of tension crack (Feature B), facing northeast (ATT108_Photo108.jpg)

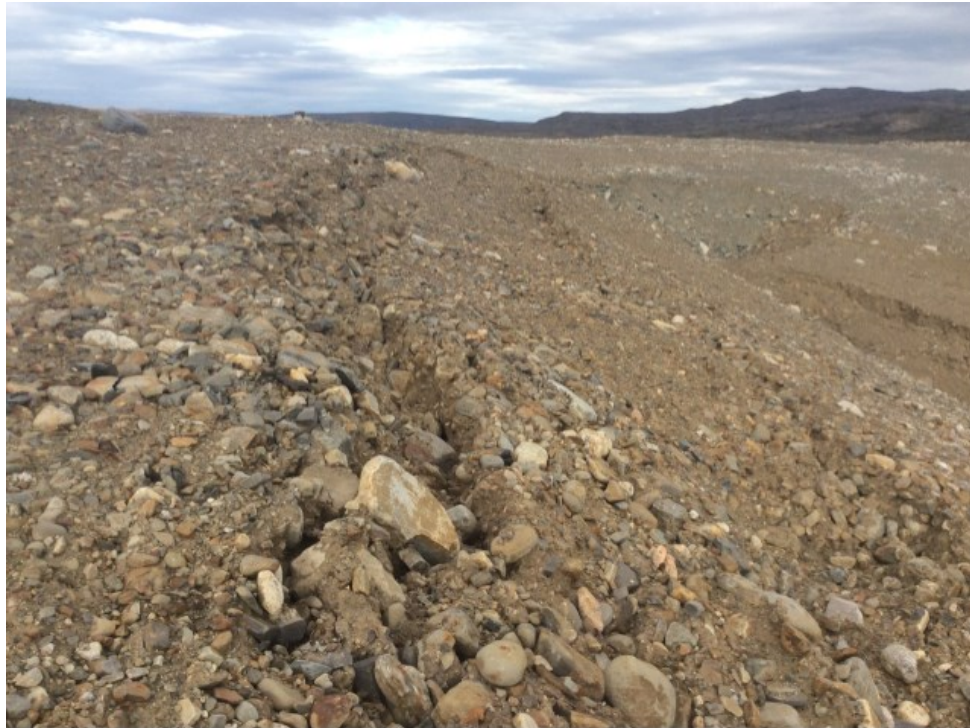
Photo E21: FOX-3 – Thermokarst Area – Top of tension crack (Feature B), facing northeast (ATT109_Photo109.jpg)

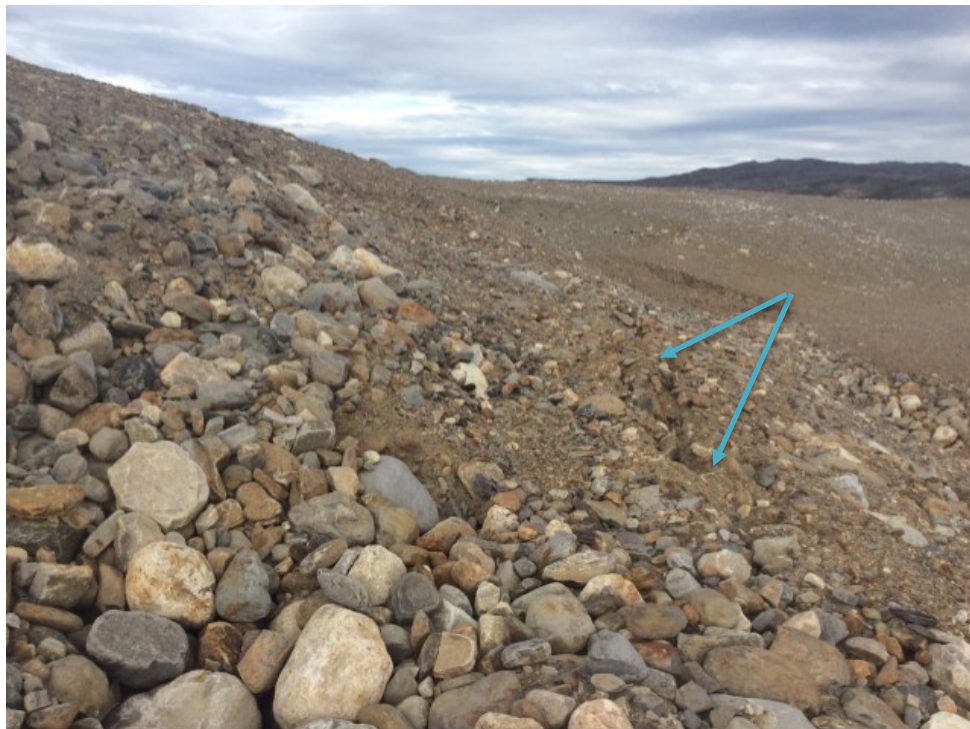
Photo E23: FOX-3 – Thermokarst Area – Extended tension crack (Feature B), facing northeast (ATT111_Photo111.jpg)

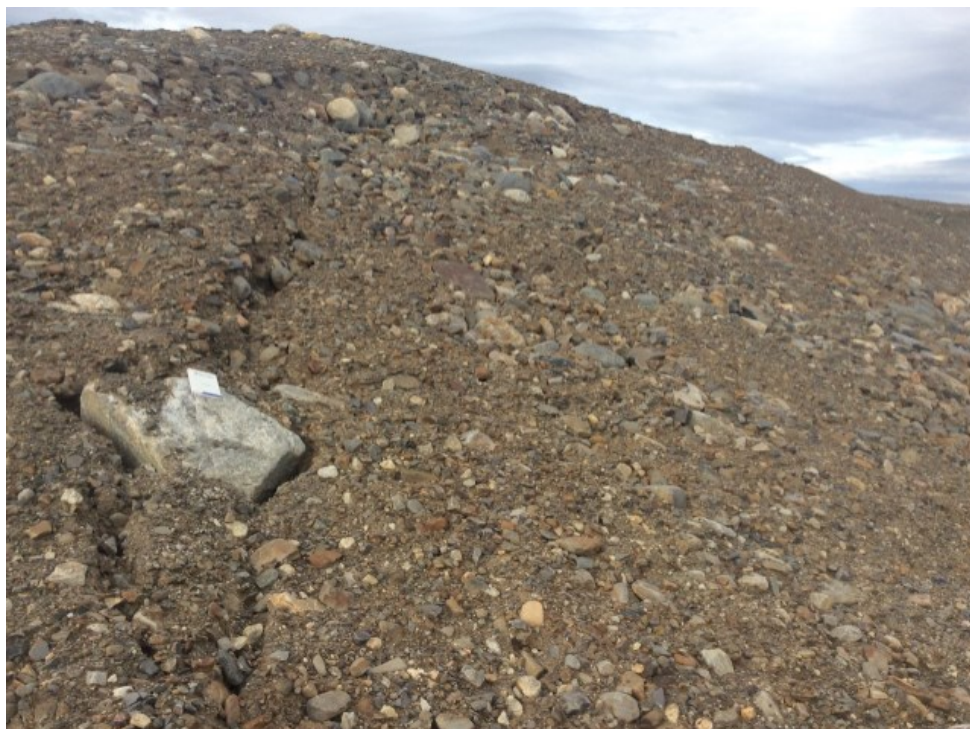
Photo E24: FOX-3 – Thermokarst Area – Extension of tension crack (Feature B), facing northwest (ATT112_Photo112.jpg)

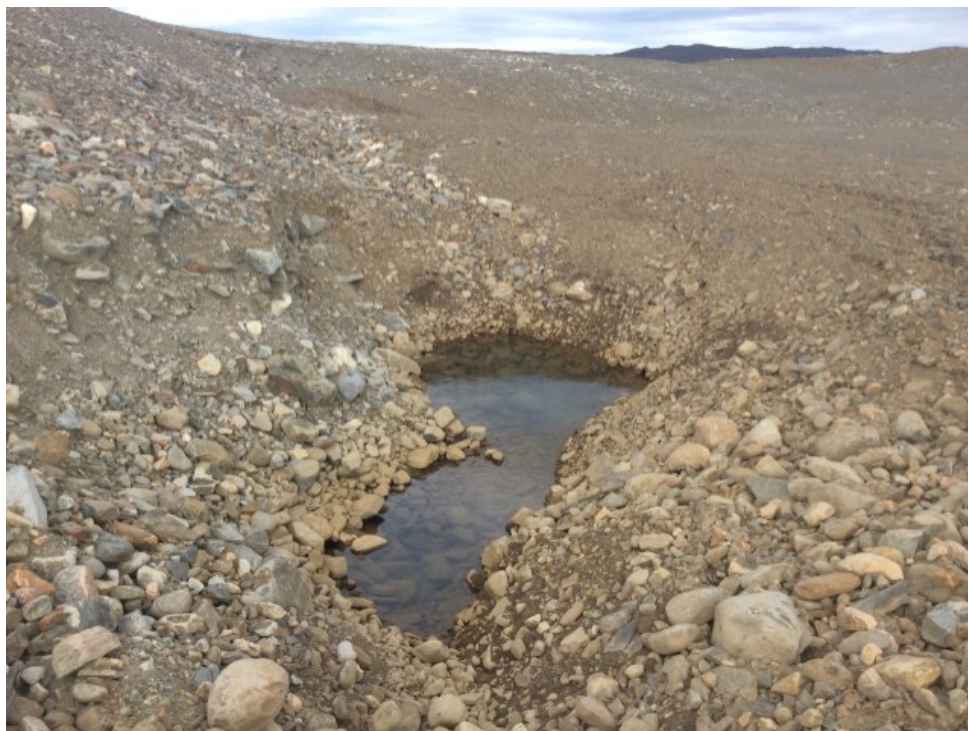
Photo E25: FOX-3 – Thermokarst Area – Perimeter of thaw settlement, facing northeast (ATT113_Photo113.jpg)

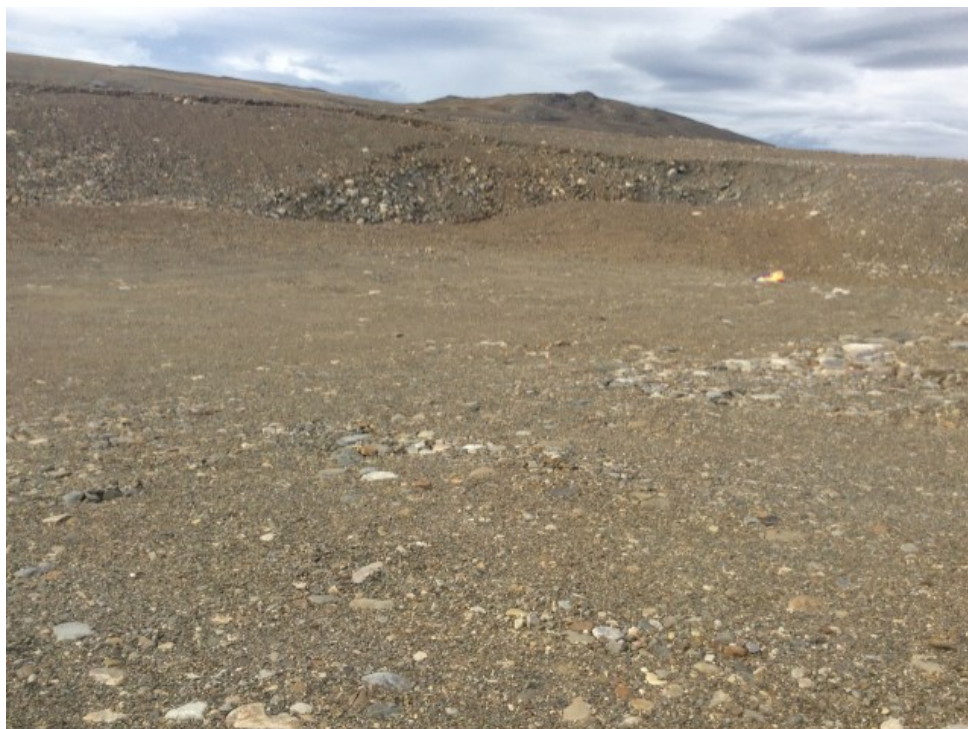
Photo E27: FOX-3 – Thermokarst Area – Overview, facing northwest (ATT115_Photo115.jpg)

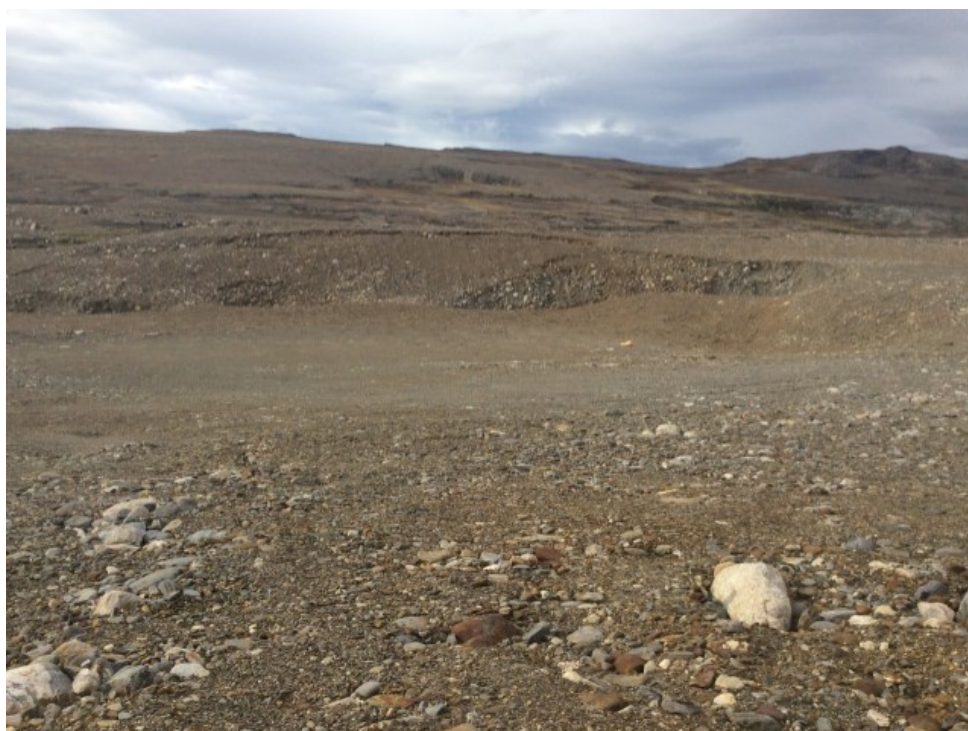
Photo E28: FOX-3 – Thermokarst Area – Overview, facing northwest (ATT116_Photo116.jpg)

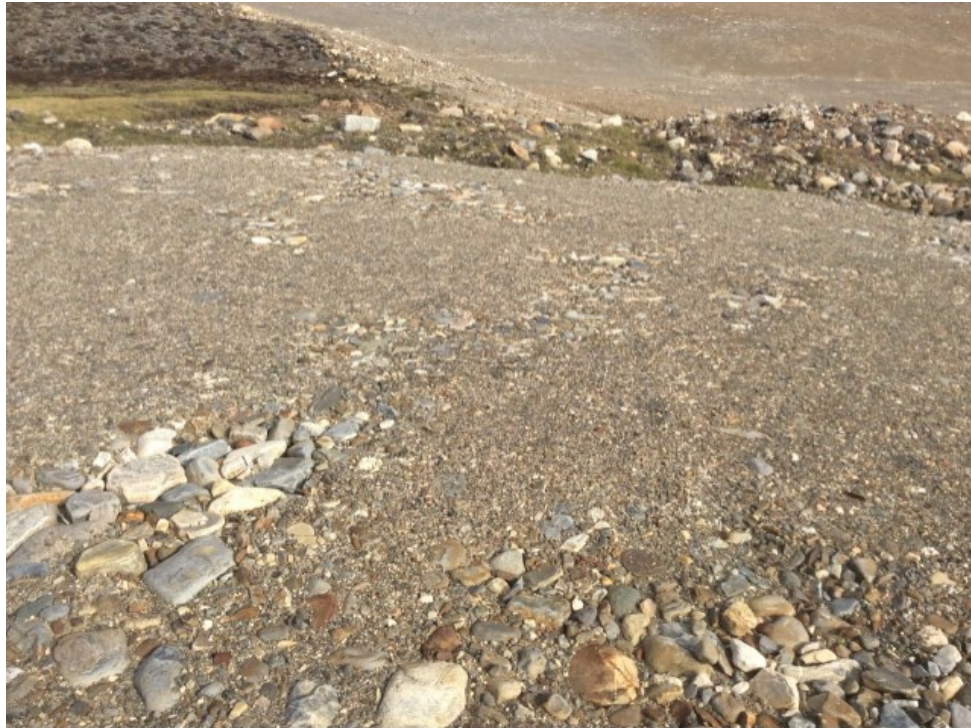
Photo E29: FOX-3 – Airstrip Landfill (Lobe M) – cover surface, facing east (ATT123_Photo123.jpg)

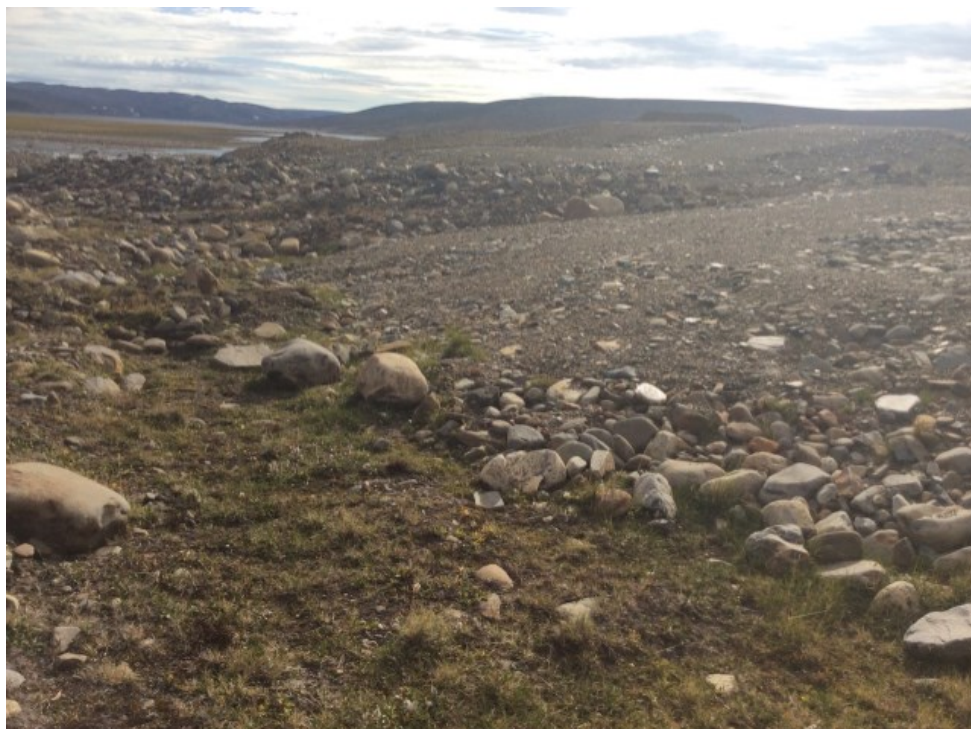
Photo E30: FOX-3 – Airstrip Landfill (Lobe M) – east slope, facing south (ATT124_Photo124.jpg)

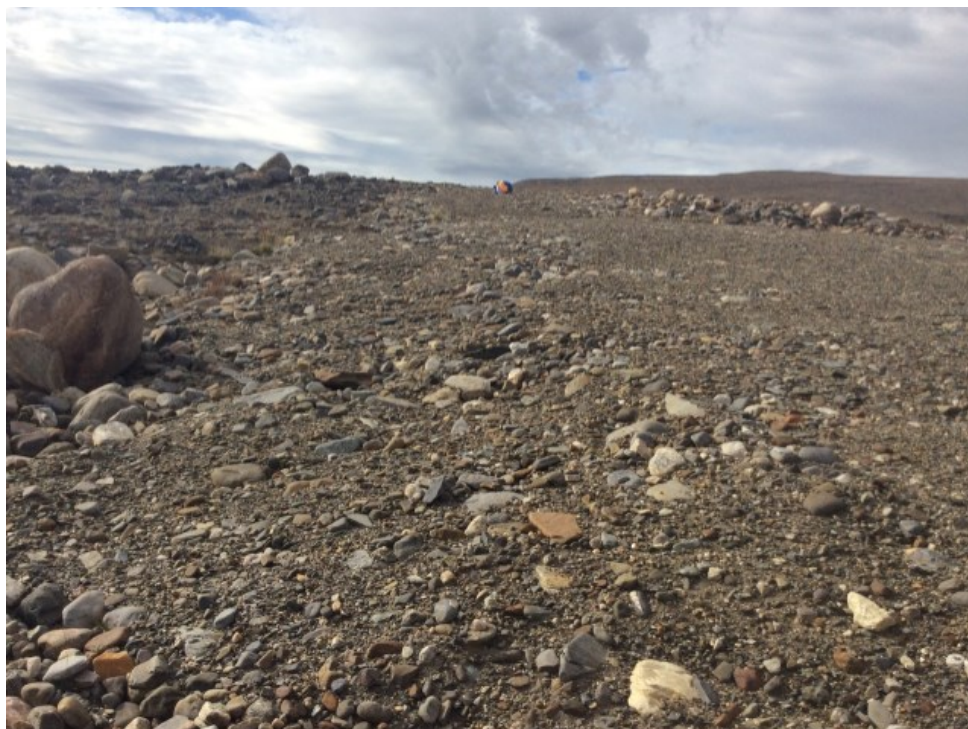
Photo E31: FOX-3 – Airstrip Landfill (Lobe M) – south slope, facing west (ATT125_Photo125.jpg)

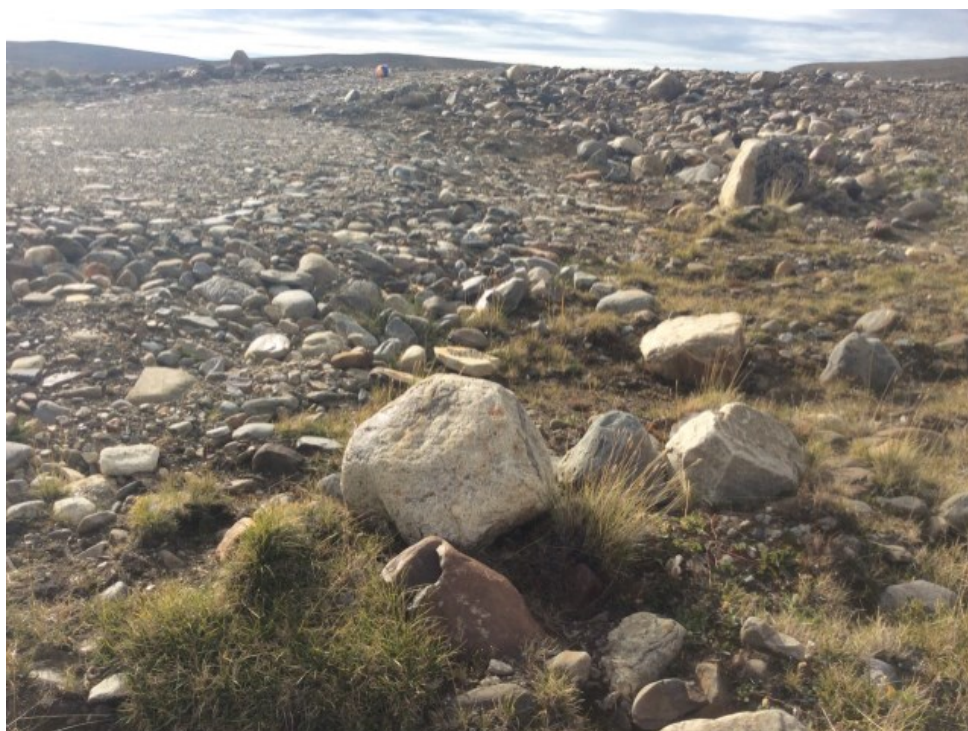
Photo E32: FOX-3 – Airstrip Landfill (Lobe M) – north slope, facing west (ATT126_Photo126.jpg)

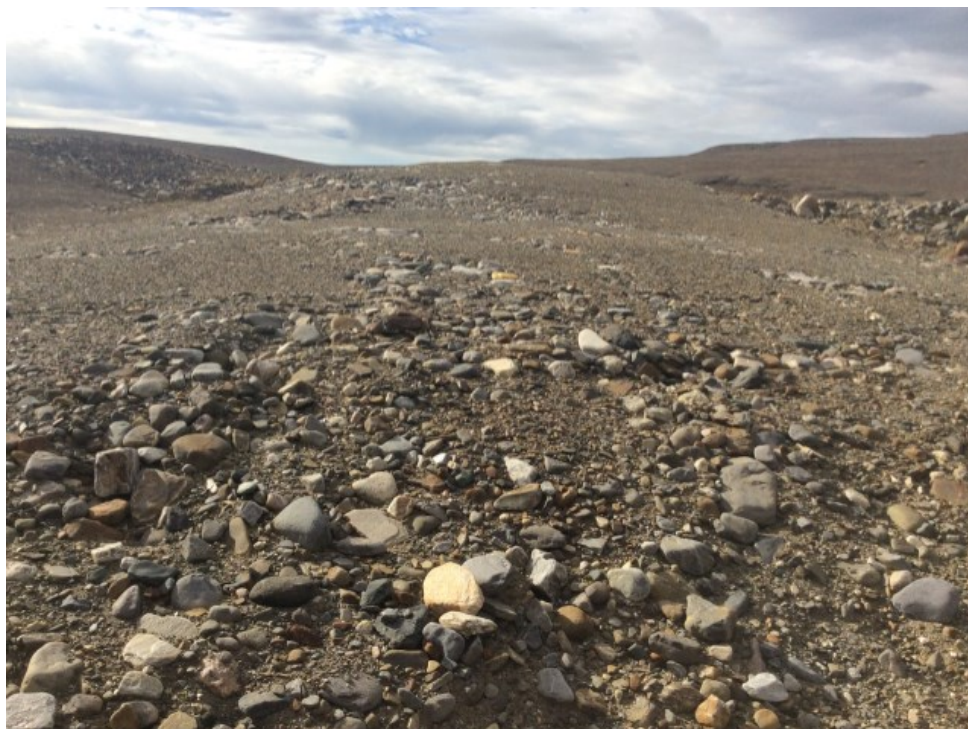
Photo E33: FOX-3 – Airstrip Landfill (Lobe L) – east slope, facing west (ATT117_Photo117.jpg)

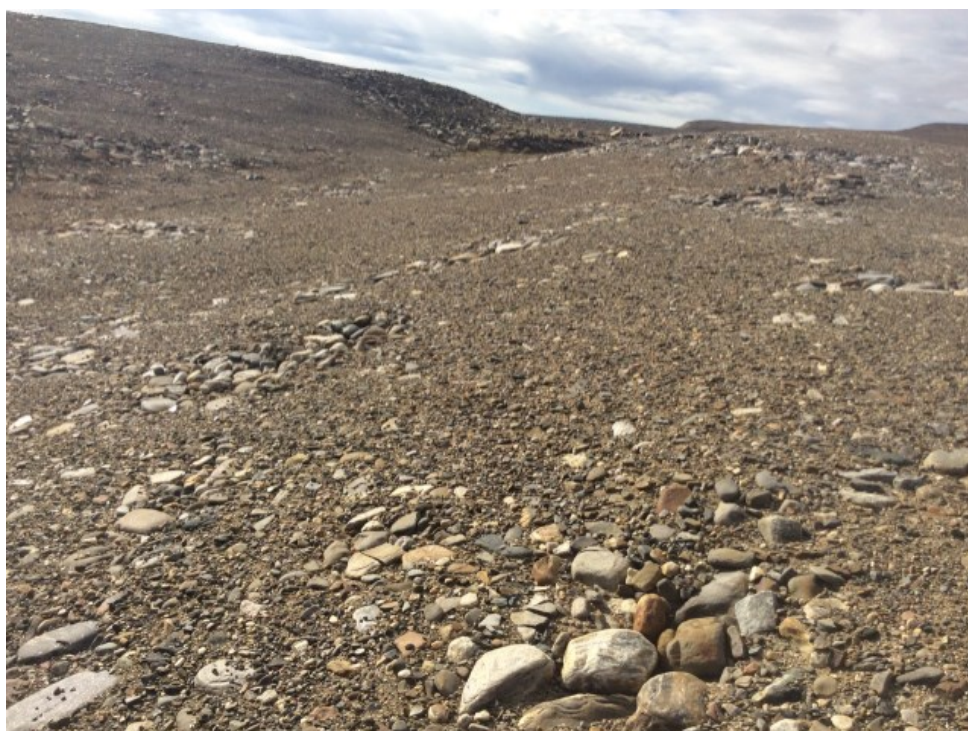
Photo E34: FOX-3 – Airstrip Landfill (Lobe L) – south slope, facing west (ATT118_Photo118.jpg)

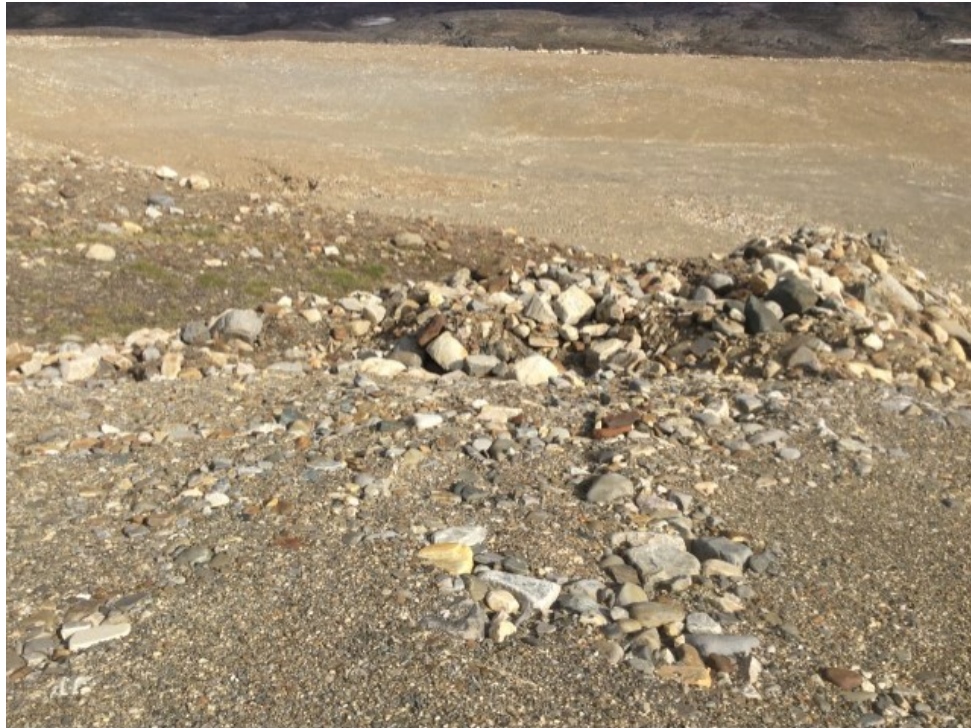
Photo E35: FOX-3 – Airstrip Landfill (Lobe L) – east slope, facing east (ATT119_Photo119.jpg)

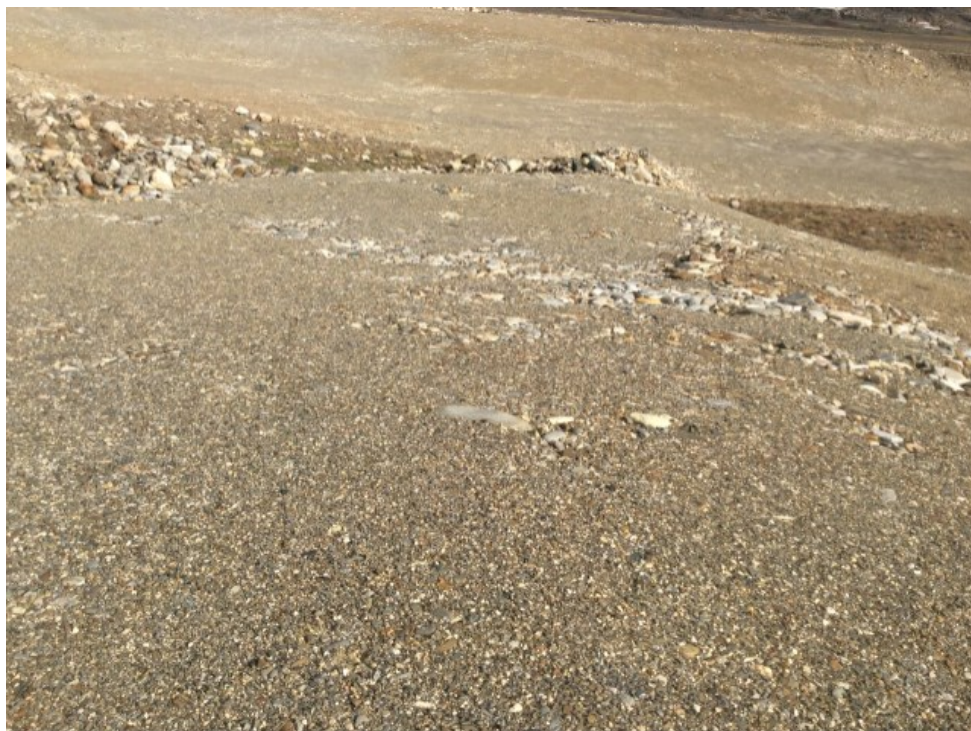
Photo E36: FOX-3 – Airstrip Landfill (Lobe L) – cover surface, facing east (ATT120_Photo120.jpg)

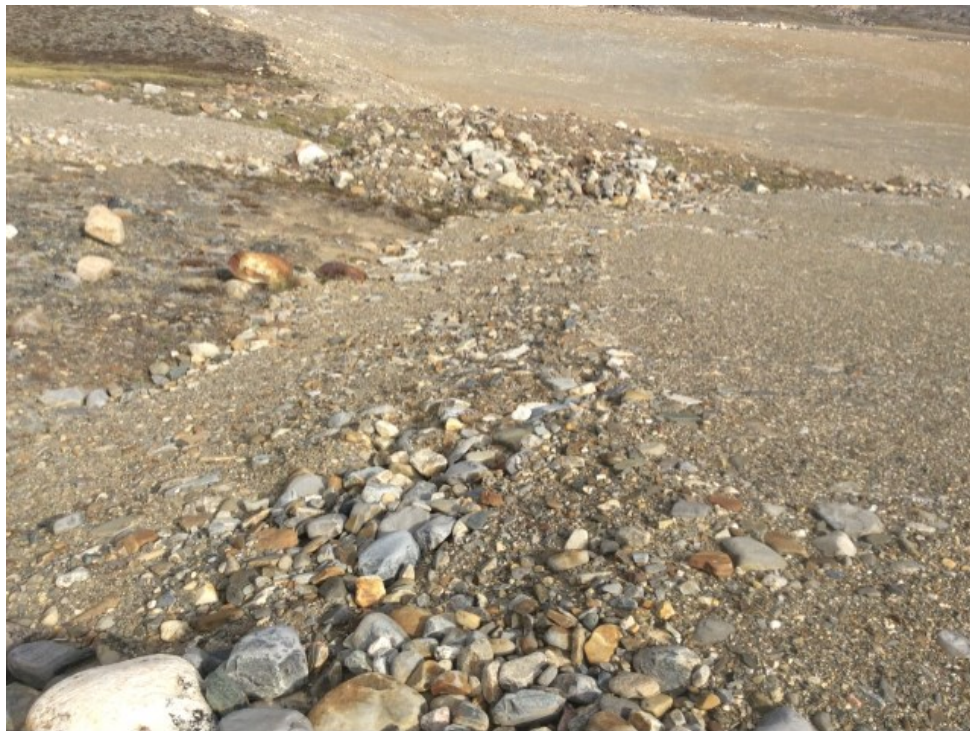
Photo E37: FOX-3 – Airstrip Landfill (Lobe L) – north slope, facing east (ATT121_Photo121.jpg)

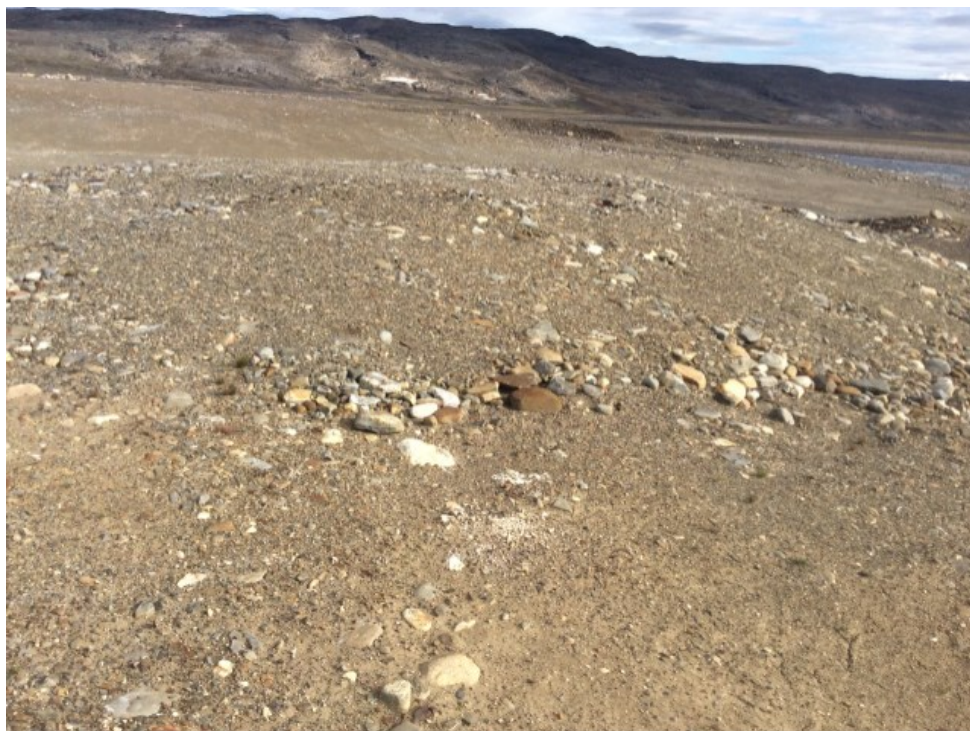
Photo E38: FOX-3 – Airstrip Landfill (Lobe L) – west slope, facing southeast (ATT122_Photo122.jpg)

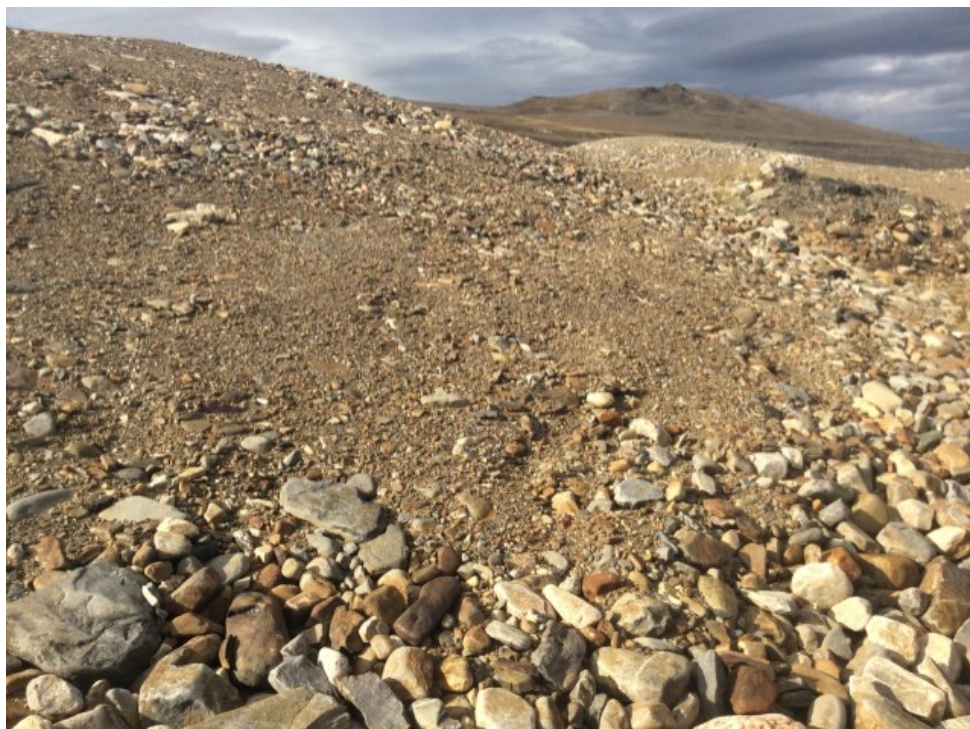
Photo E39: FOX-3 – Airstrip Landfill (Lobe I) – east slope and toe, facing north (ATT127_Photo127.jpg)

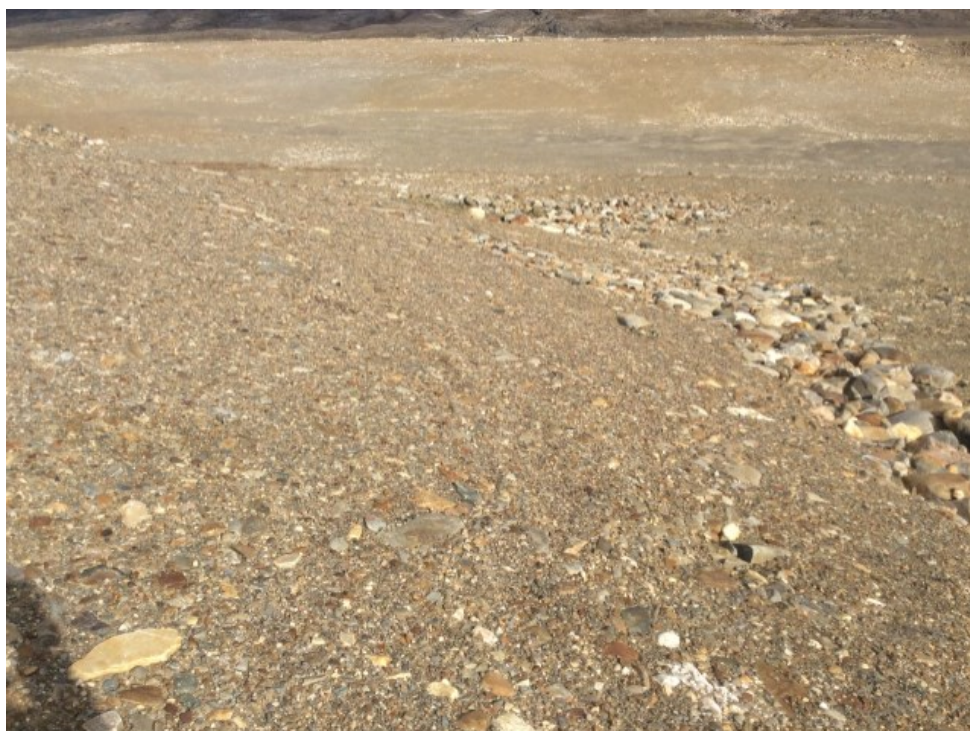
Photo E40: FOX-3 – Airstrip Landfill (Lobe I) – south slope, facing northeast (ATT128_Photo128.jpg)

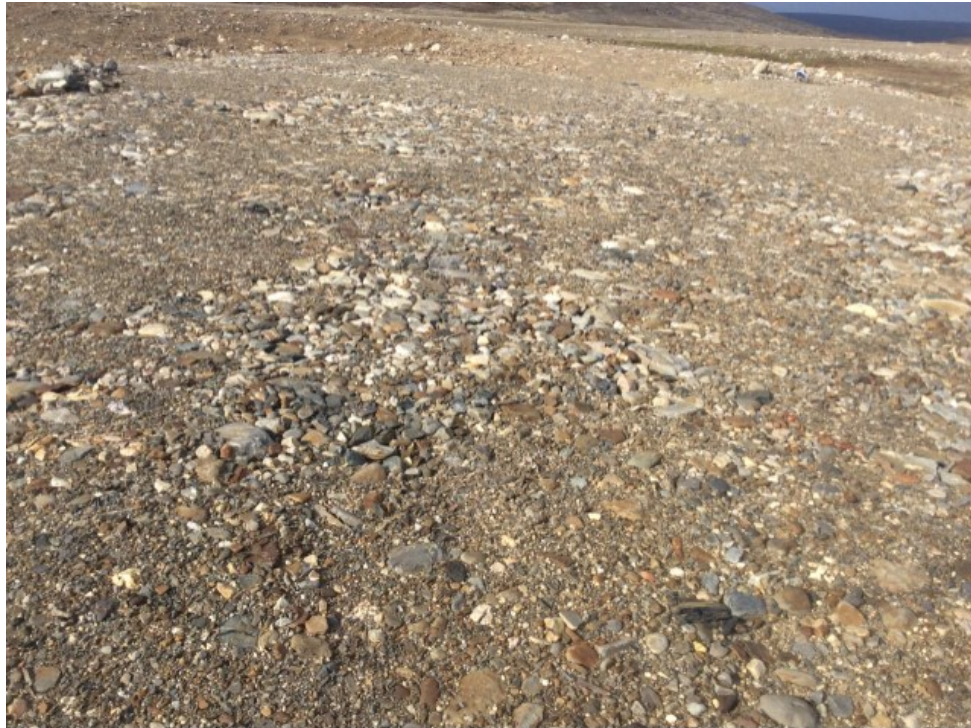
Photo E41: FOX-3 – Airstrip Landfill (Lobe I) – cover surface, facing north (ATT129_Photo129.jpg)

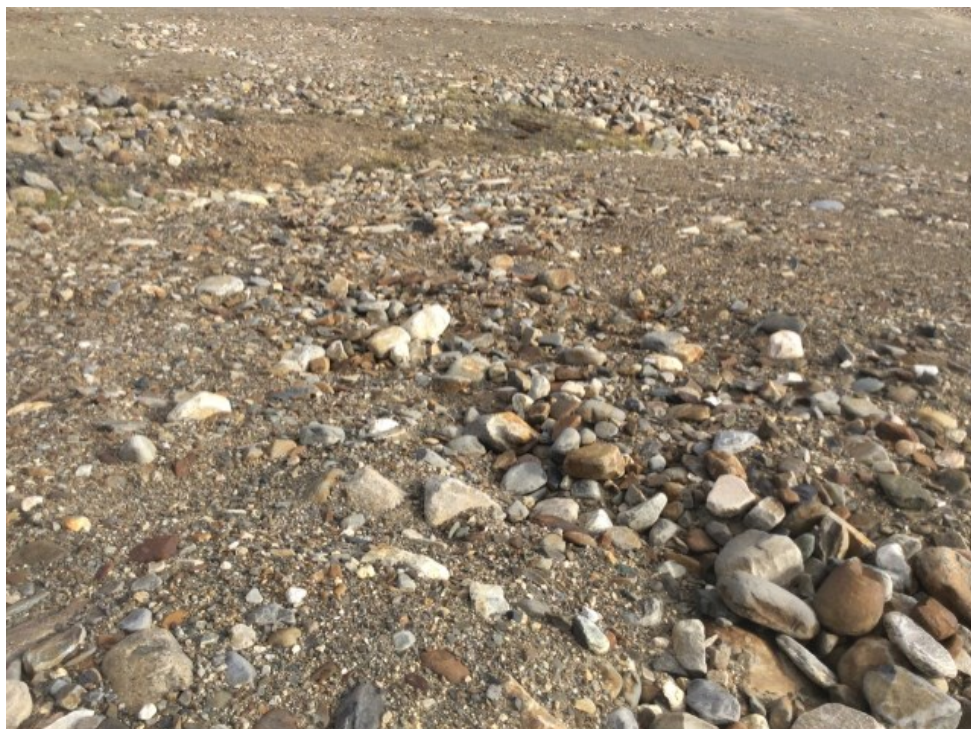
Photo E42: FOX-3 – Airstrip Landfill (Lobe I) – east slope, facing east (ATT130_Photo130.jpg)

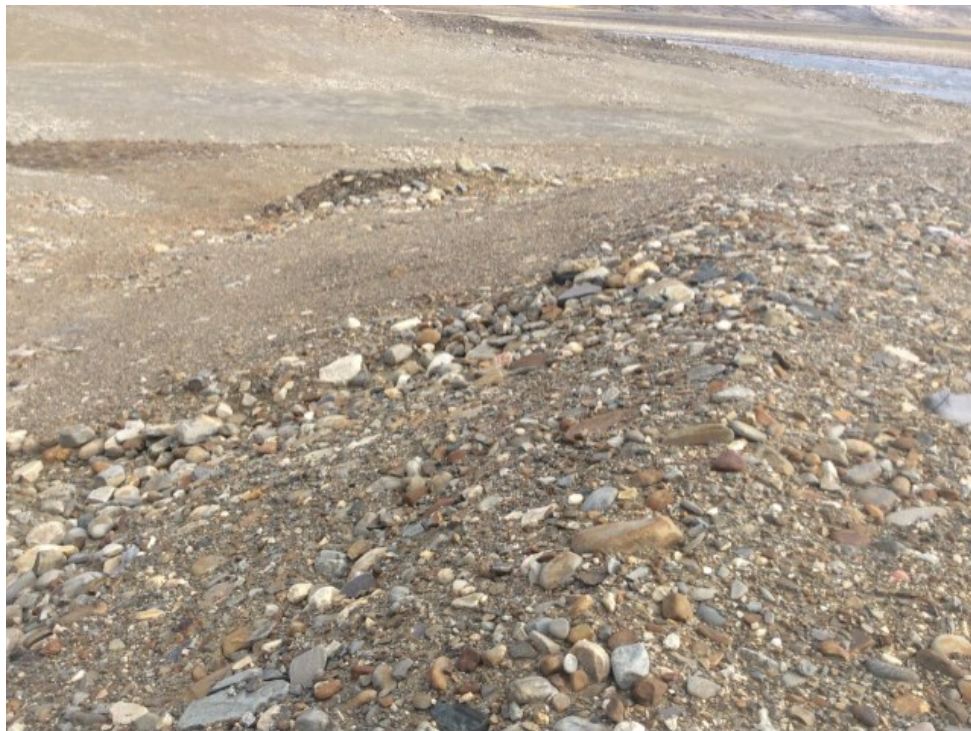
Photo E43: FOX-3 – Airstrip Landfill (Lobe I) – northeast slope and crest, facing southeast (ATT131_Photo131.jpg)

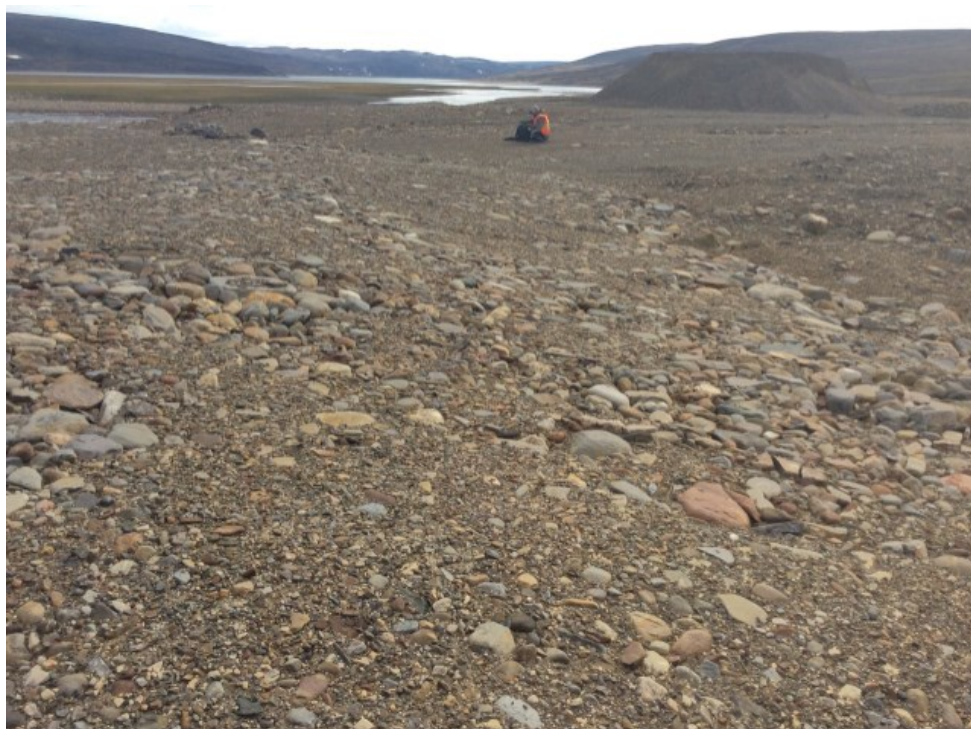
Photo E44: FOX-3 – Airstrip Landfill (Lobe I) – west slope, facing south (ATT132_Photo132.jpg)

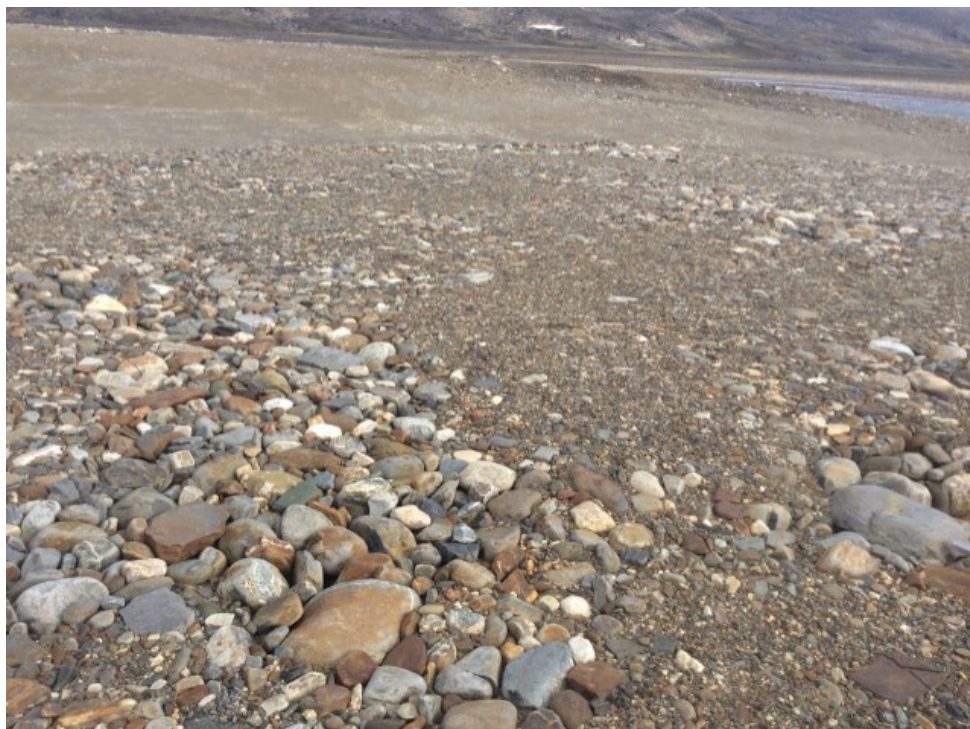
Photo E45: FOX-3 – Airstrip Landfill (Lobe I) – cover surface, facing east (ATT133_Photo133.jpg)
