QIKIQ15 BAFFIN REGION DEW LINE SITE MONITORING

2016 FOX-3 Monitoring Report

Report Number: 1530908-2000-R3-V2

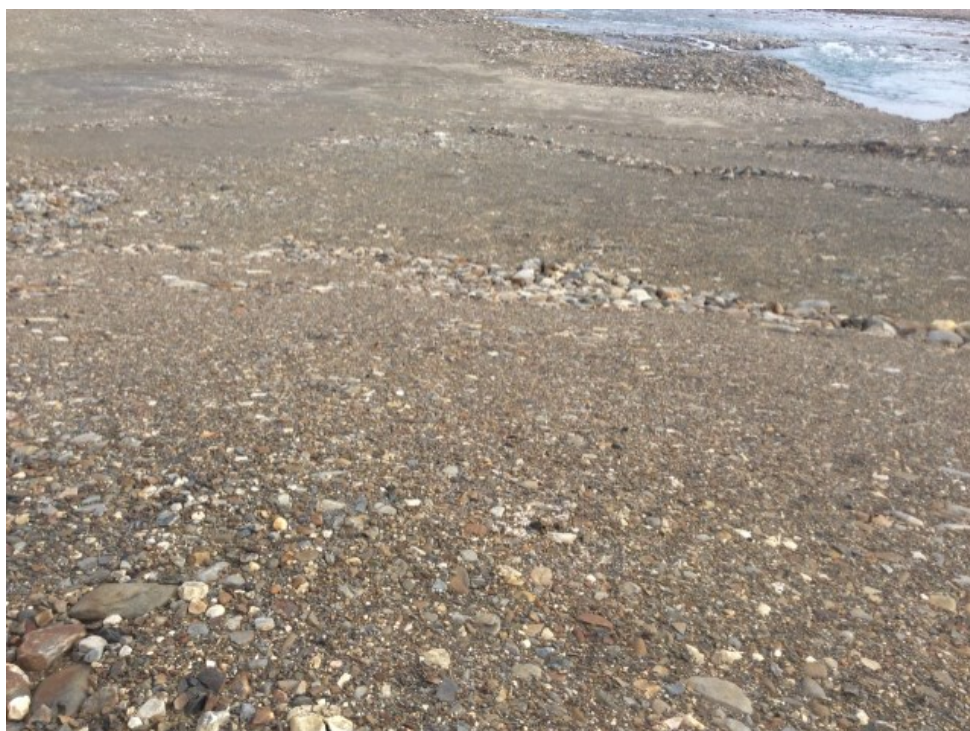
Photo E46: FOX-3 – Airstrip Landfill (Lobe I) – east slope, facing southeast (ATT134_Photo134.jpg)
