Defence Construction Canada

The Collection of Landfill Monitoring Data at the PIN-3 Lady Franklin Point Site – 2008

October, 2008

Project Number: 80-297-3

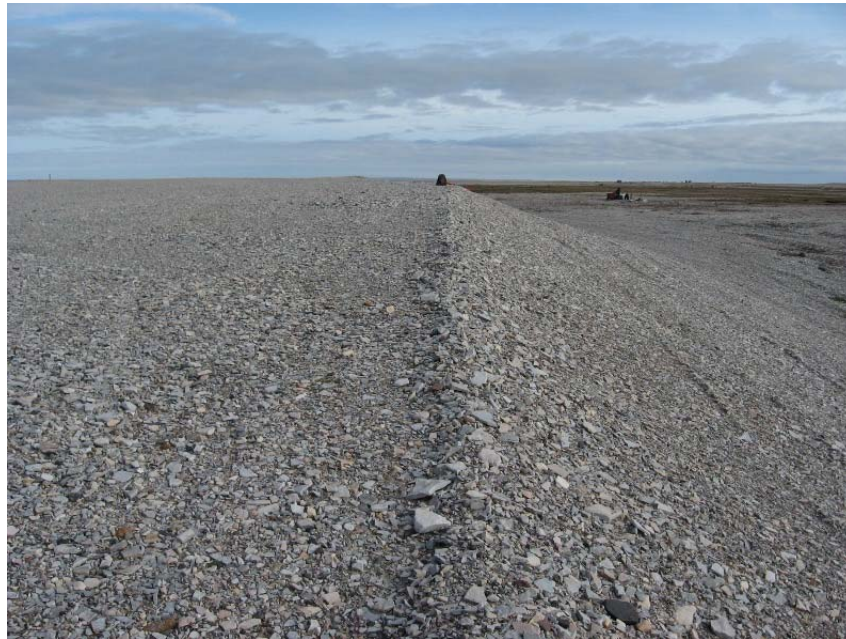
Photograph MLF-1. Looking N from SE corner. Backpack for scale along crest. ↑

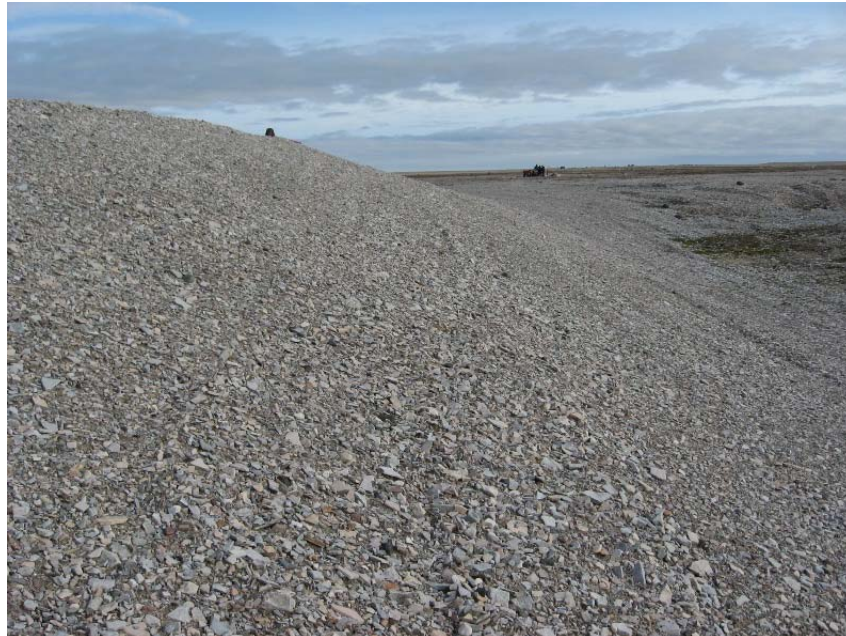
Photograph MLF-2. Looking N from centre slope at the SE corner. MW-5 visible in distance. ↑

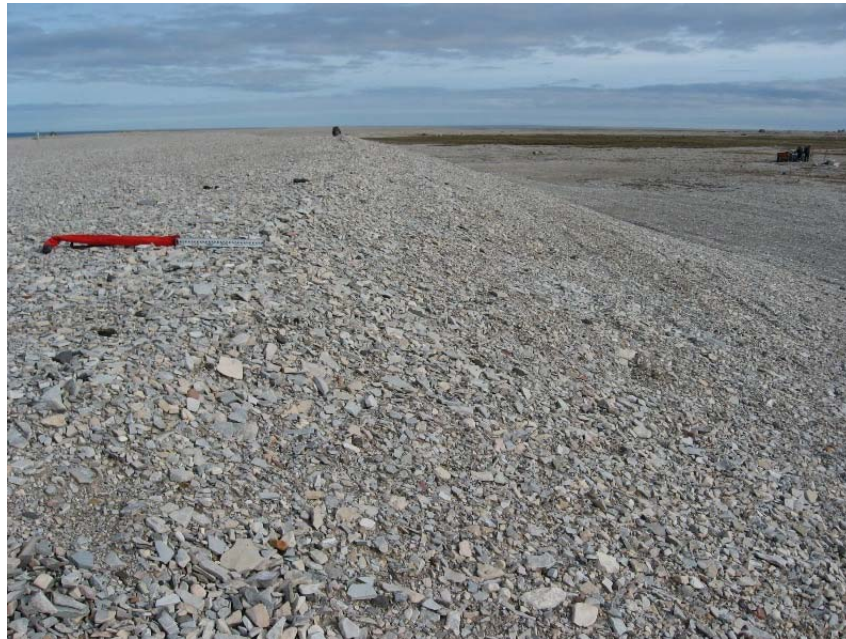
Photograph MLF-3. Looking N along east crest.

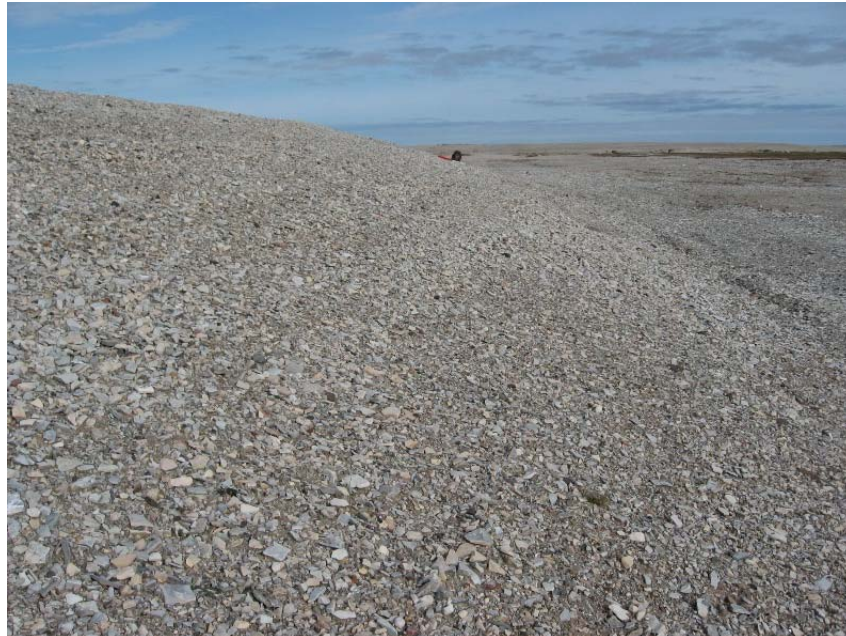
Photograph MLF-4. Looking N along E slope toe. Backpack and scale adjacent to MW-5. ↑

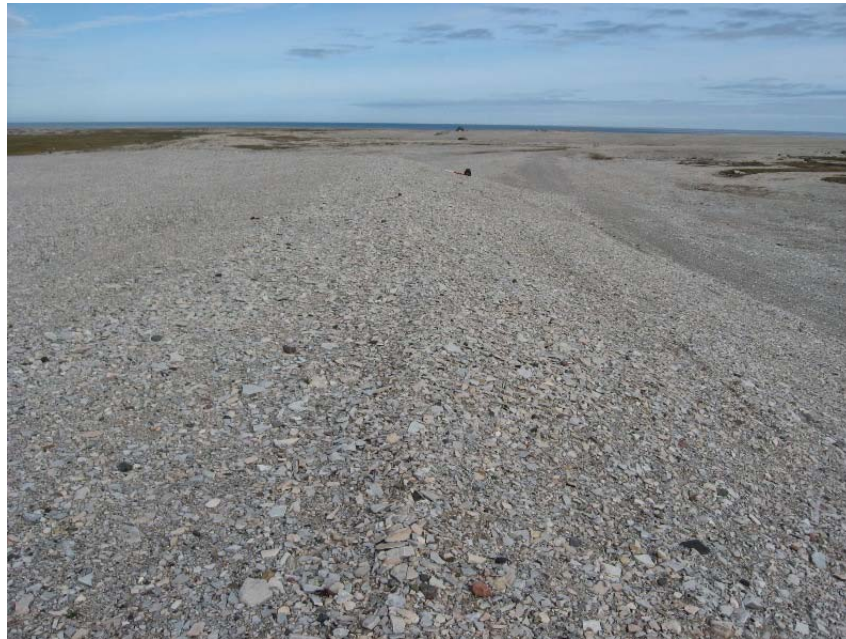
Photograph MLF-5. Looking N along E crest, looking to NE corner. ↑

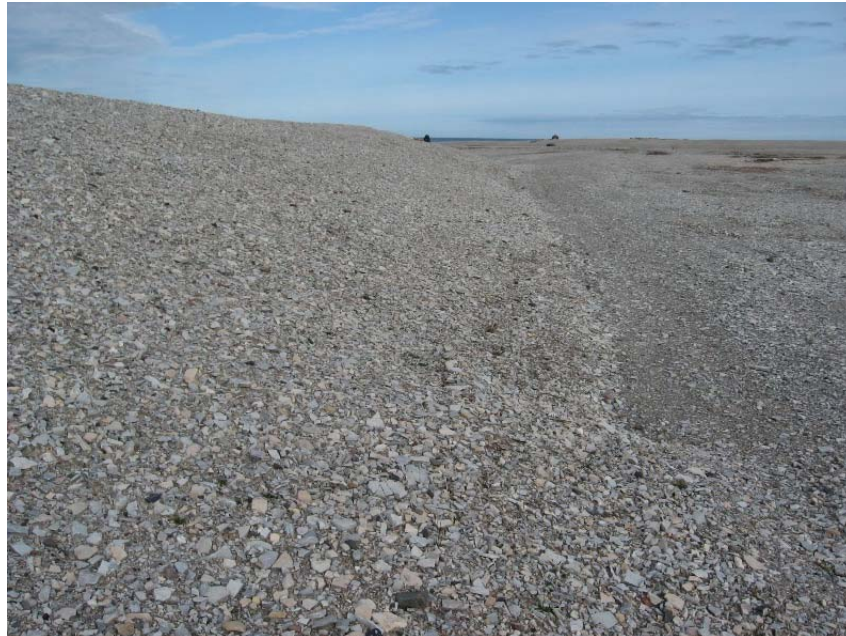
Photograph MLF-6. Looking N from d/s toe to NE corner. ↑

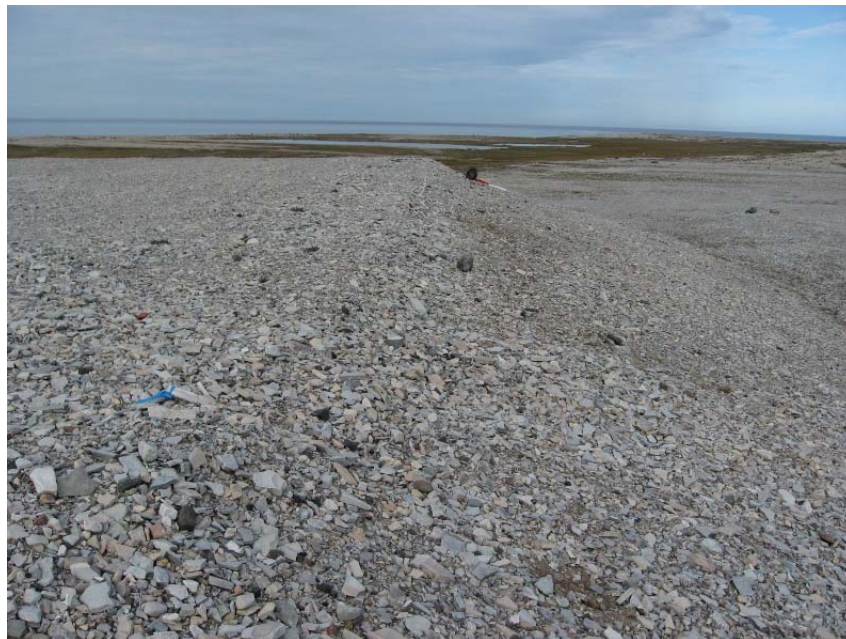
Photograph MLF-7. Looking NW along crest from NE corner. ↑

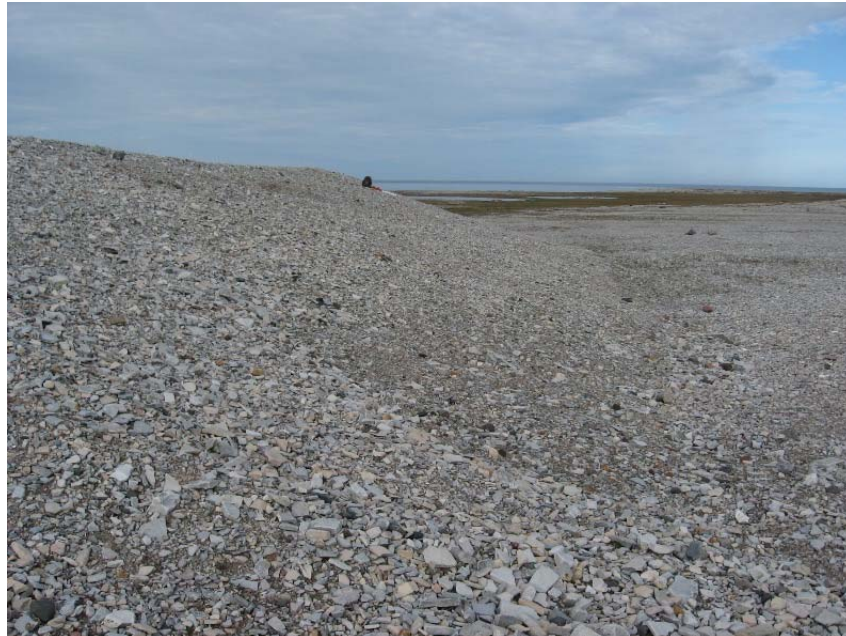
Photograph MLF-8. Looking NW along toe from NE corner. ↑

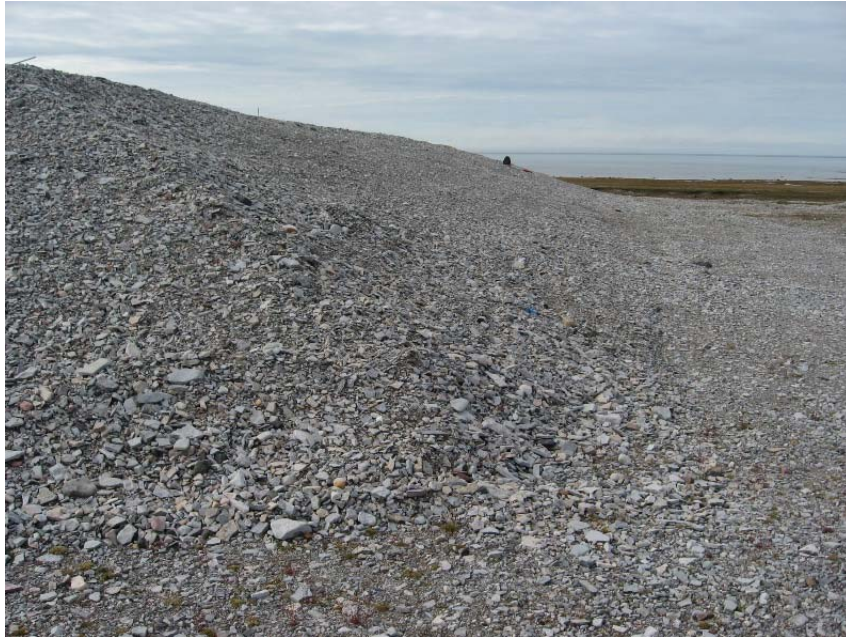
Photograph MLF-9. Looking SW from NW corner (5m N of toe). Everything looks stable.
Backpack in same location as MLF-10 ↑

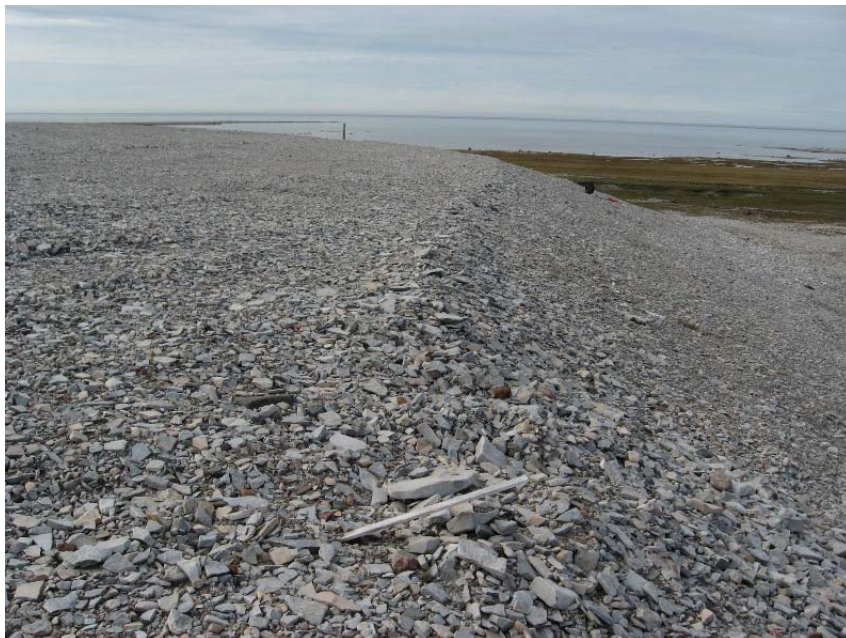
Photograph MLF-10. Looking SW along crest from NW crest. VT-2 visible in the distance. ↑

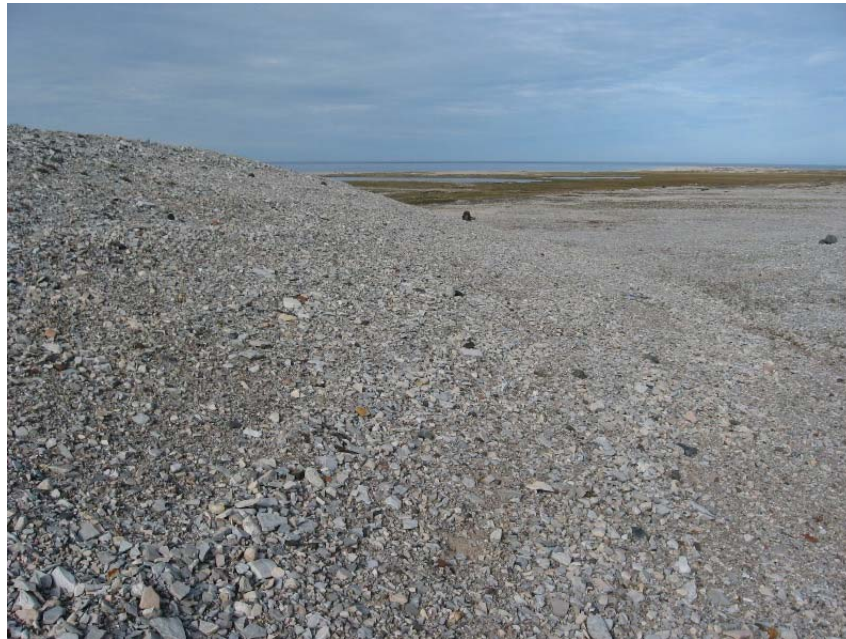
Photograph MLF-11. Looking NW from mid-slope N side MLF. Backpack at sharply defined corner. ↑

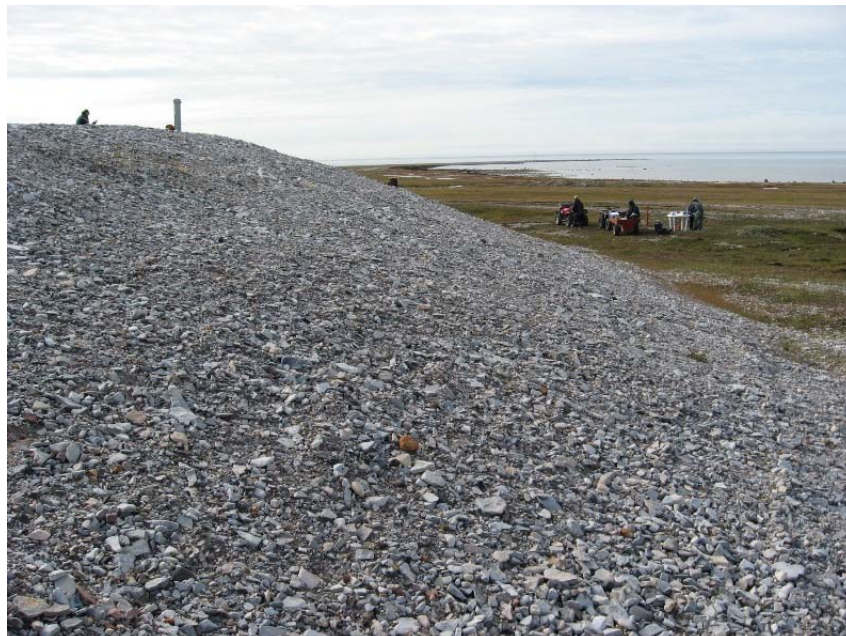
Photograph MLF-12. Looking SSW from NW landfill. Both MW-6 and VT-2 visible. (MW-6 being sampled). ↑

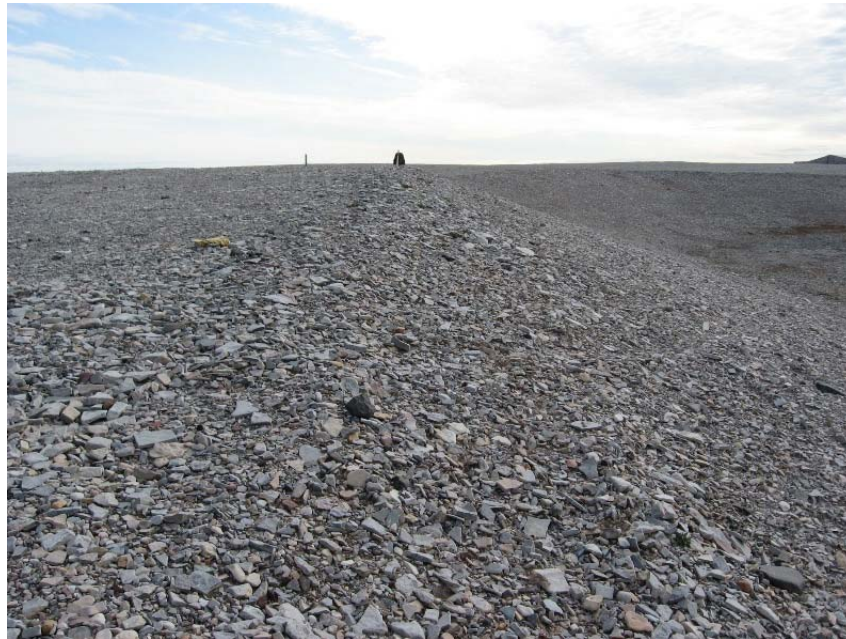
Photograph MLF-13. Looking ESE along crest from next to VT-2.

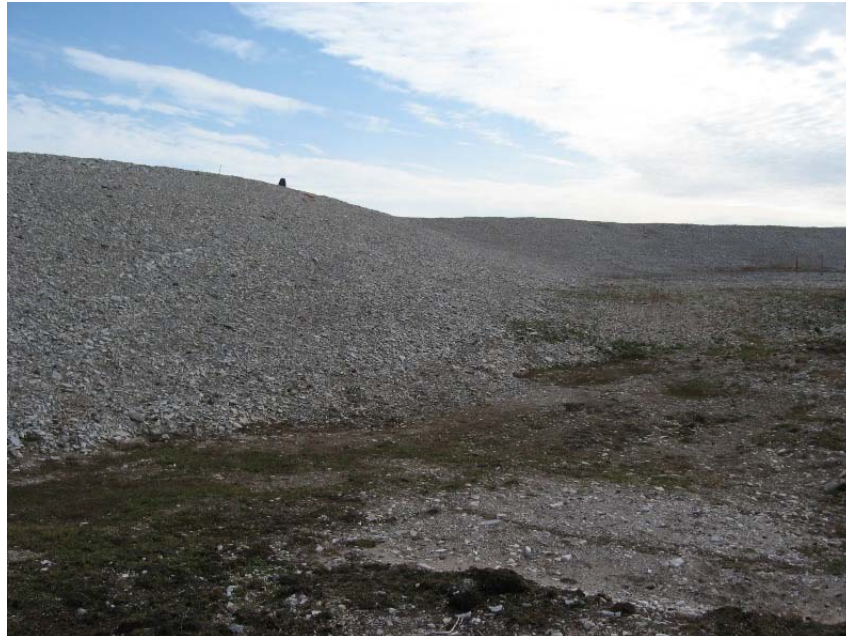
Photograph MLF-14. Looking E from about 8m S of MW-6.

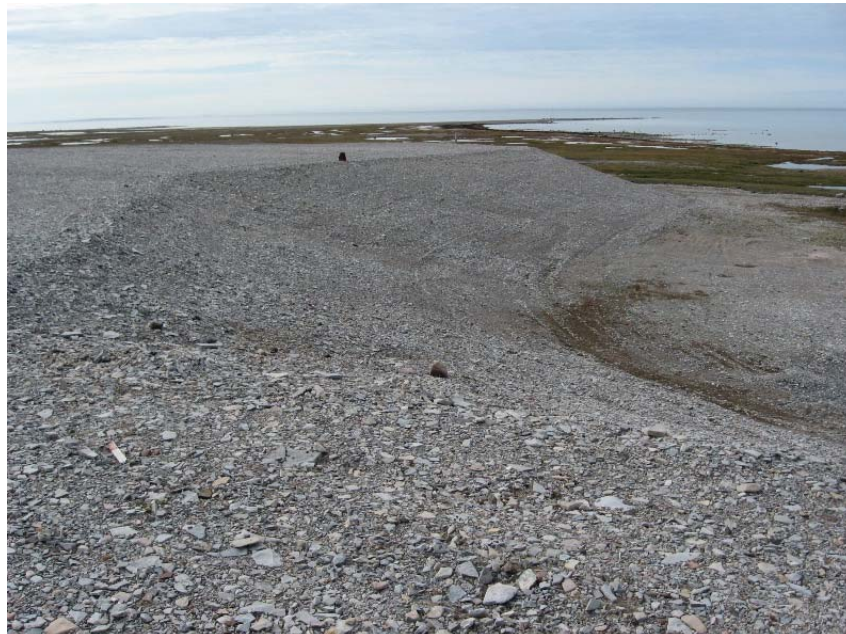
Photograph MLF-16. Looking S. VT-4 visible in the distance. ↑

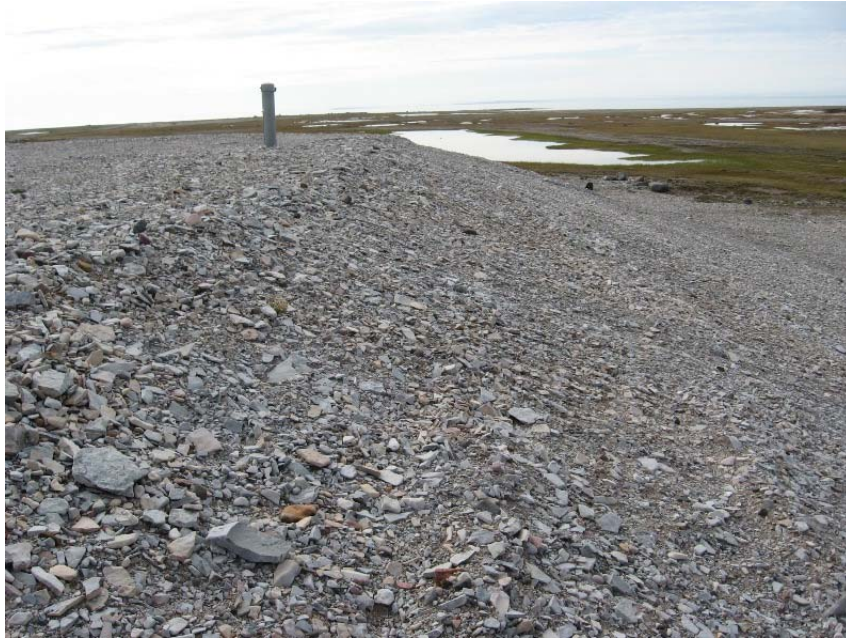
Photograph MLF-17. Looking S along crest to SW corner. VT-4 visible. ↑

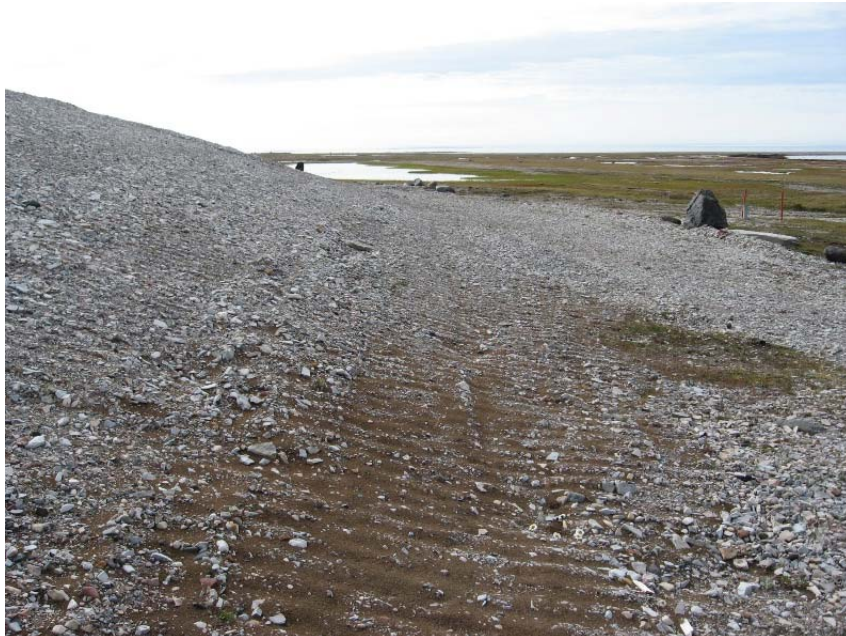
Photograph MLF-18. Looking S along toe to SW corner. MW-8 visible in right of frame. ↑

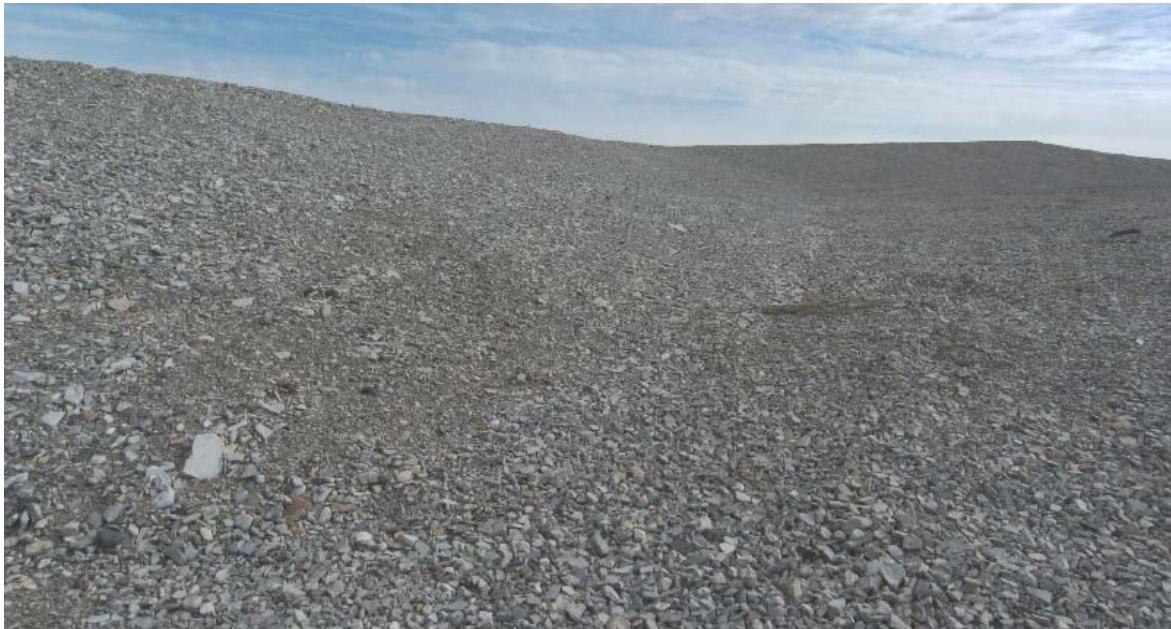
Photograph MLF-19. Panoramic looking E from toe of SW corner. ↑

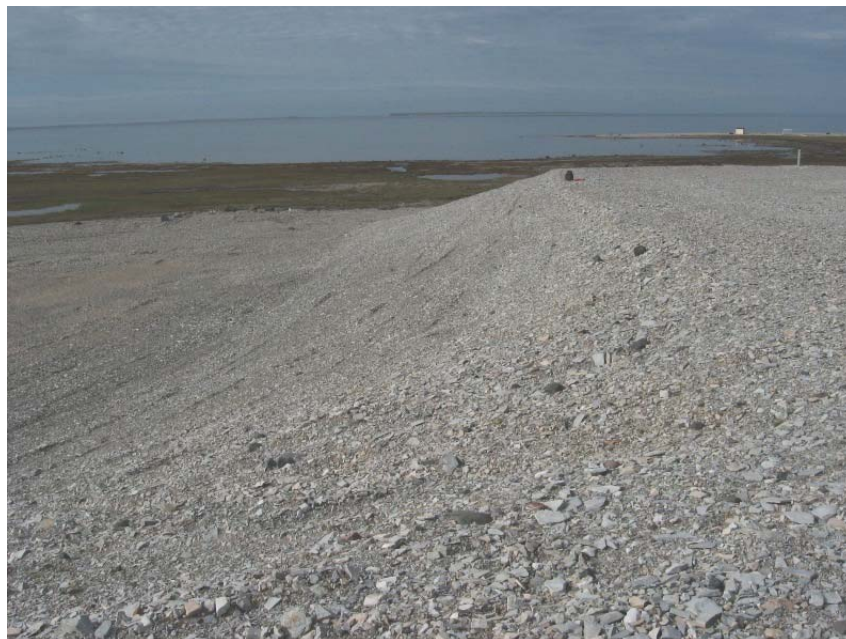
Photograph MLF-20. Looking W to SW corner (VT-4 to right). ↑

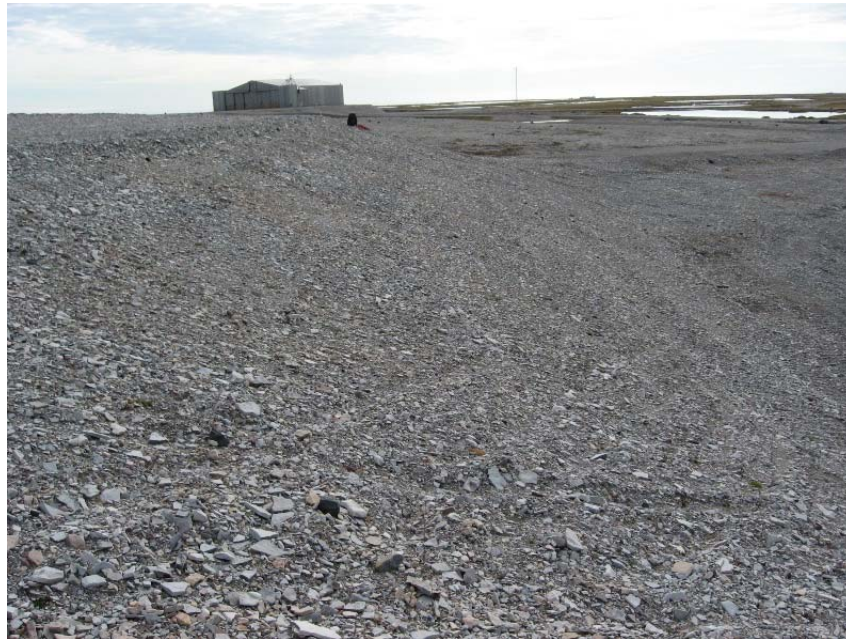
Photograph MLF-21. Looking SE to SE corner and access ramp. Hangar visible in the background. ↑

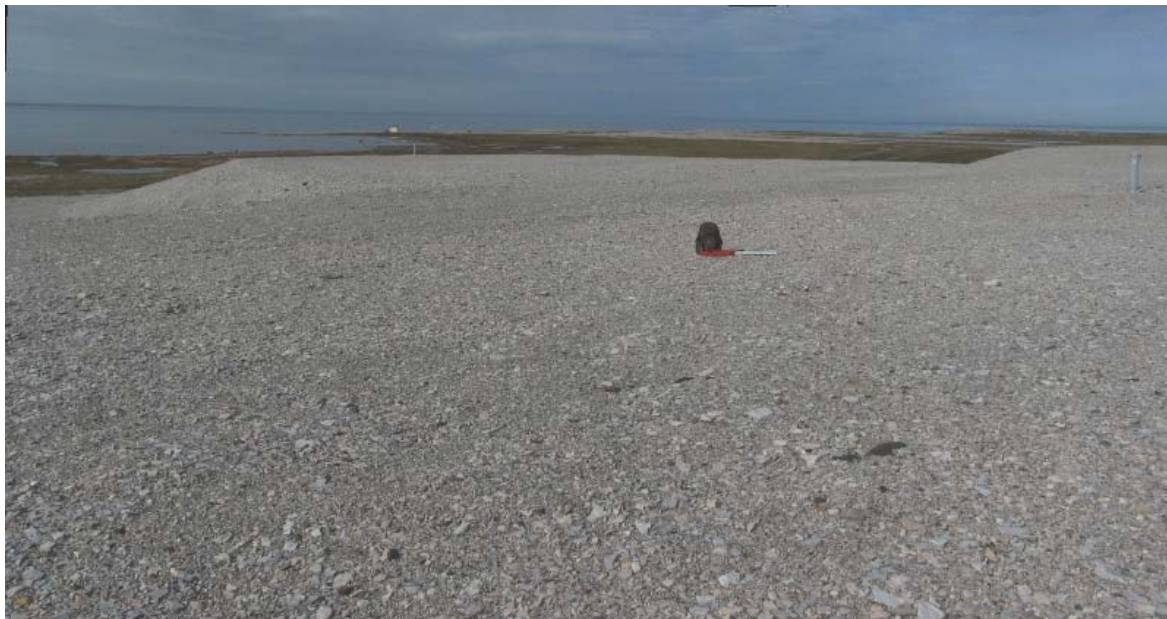
Photograph MLF-22. Looking W to VT-4 from near SE corner. ↑

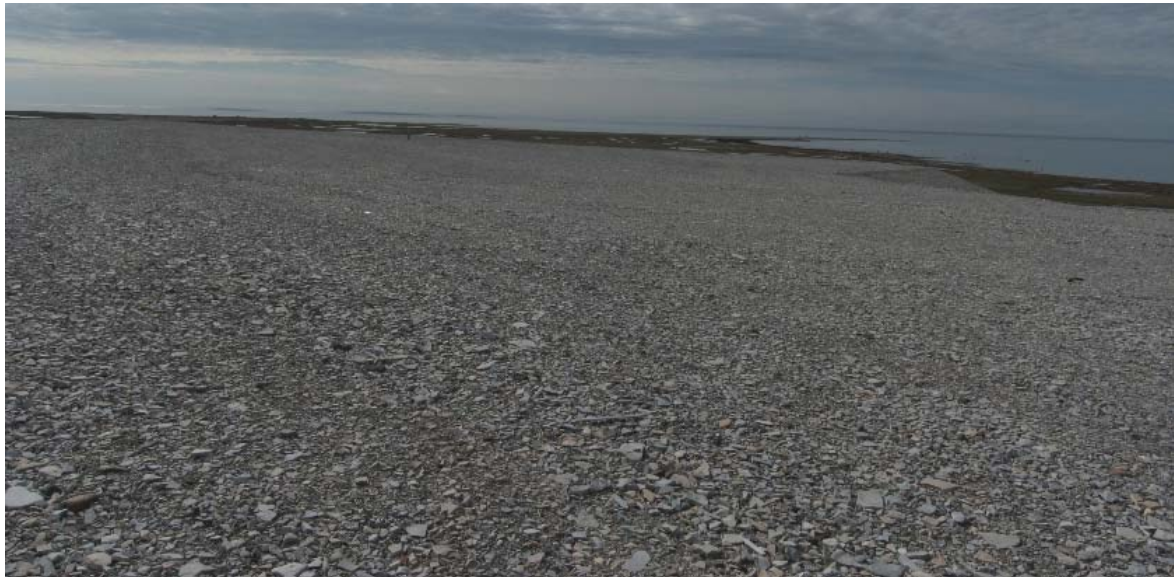
Photograph MLF-24. Panoramic looking SSW to VT-3 and VT-4 from about 9m E of VT-1 ↑

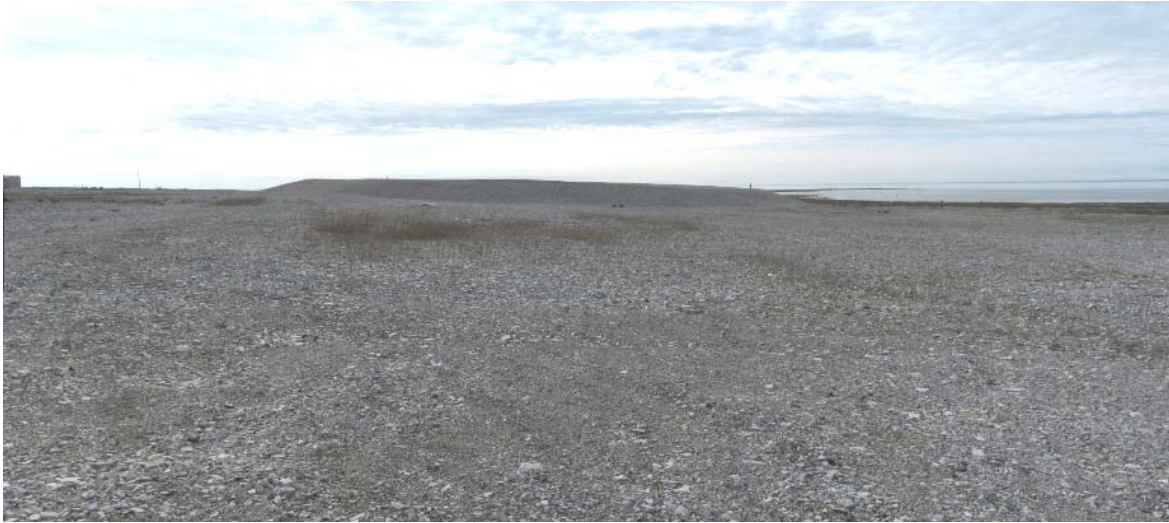
Photograph MLF-27. Looking SSE from about 150m NNW of NW corner.

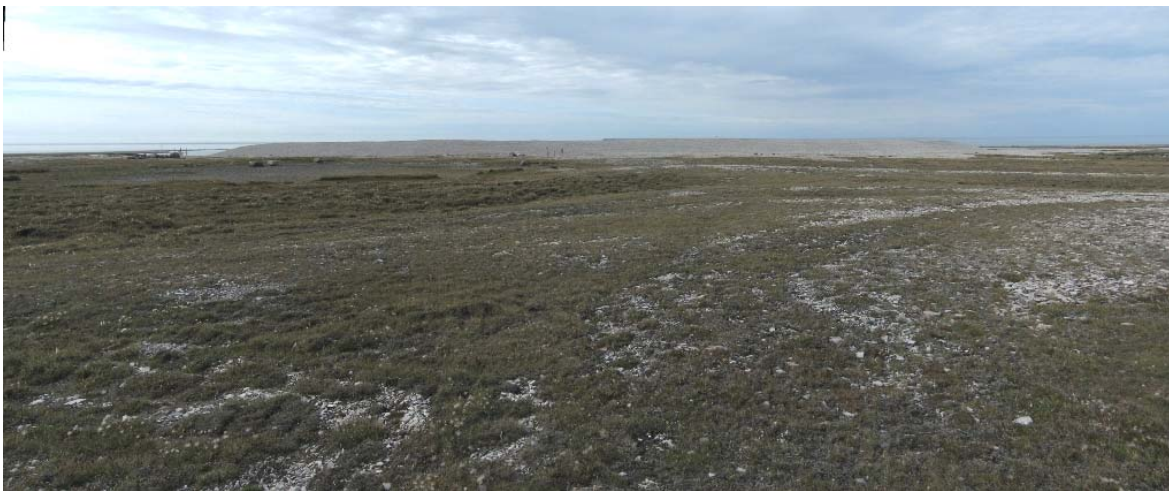
Photograph MLF-28. Looking WSW to E side of landfill. MW-5 visible central frame.

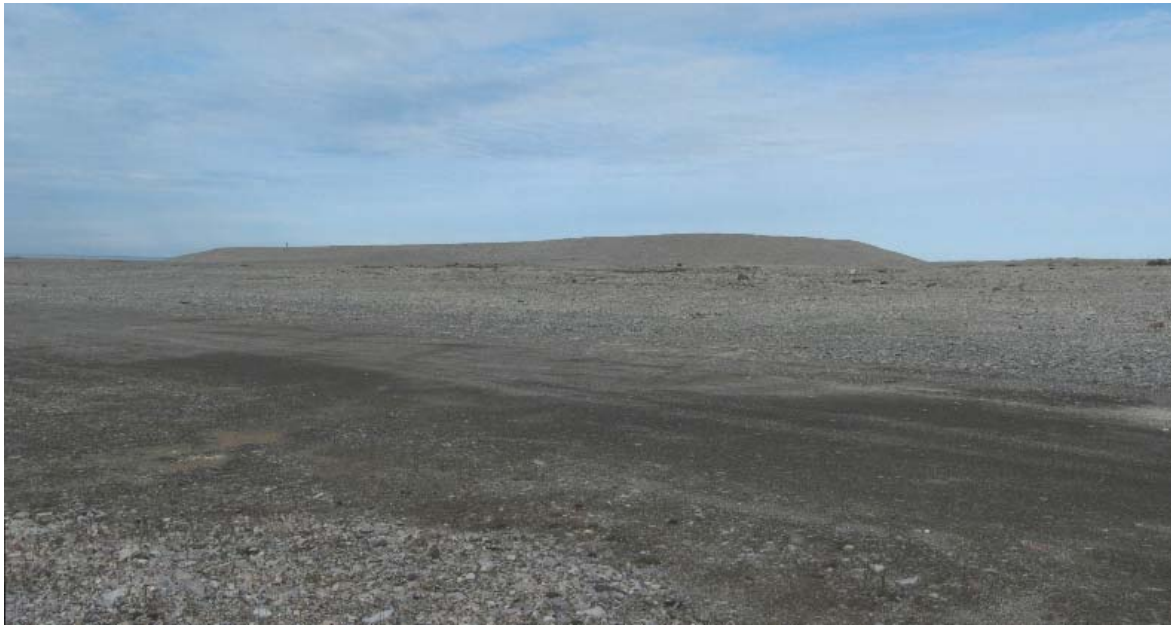
Photograph MLF-29. Looking NW to SE corner of landfill and access ramp. ↑

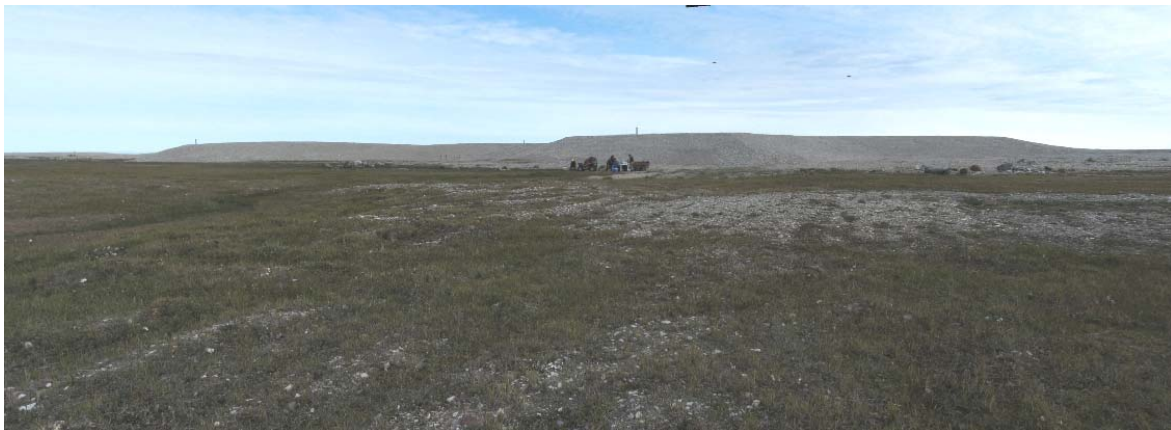
Photograph MLF-30. Looking NE to NW corner. MW-8 being sampled. ↑

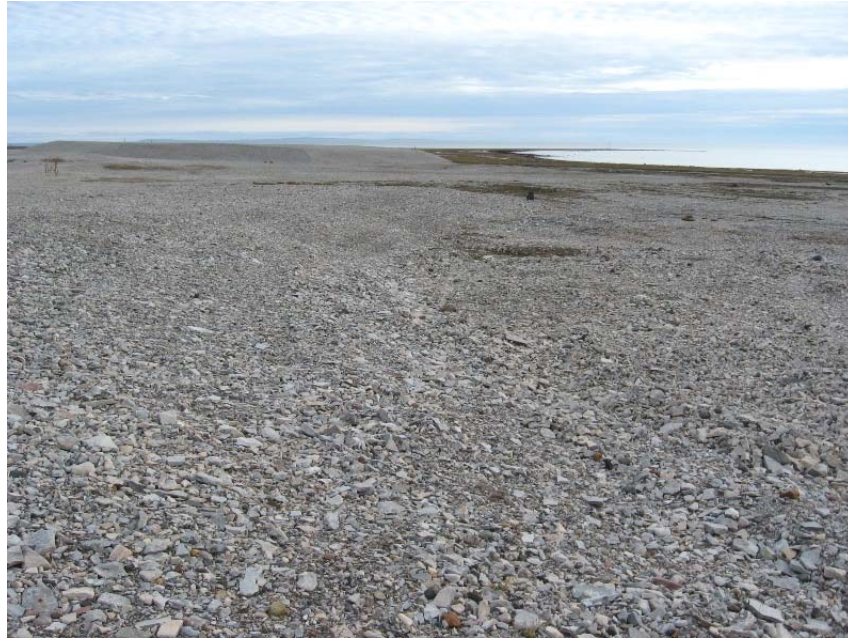
Photograph NWS-5. Looking S to SE corner of East cell. NW corner of Main LF visible in the background. Note ponded water and algae. ↑

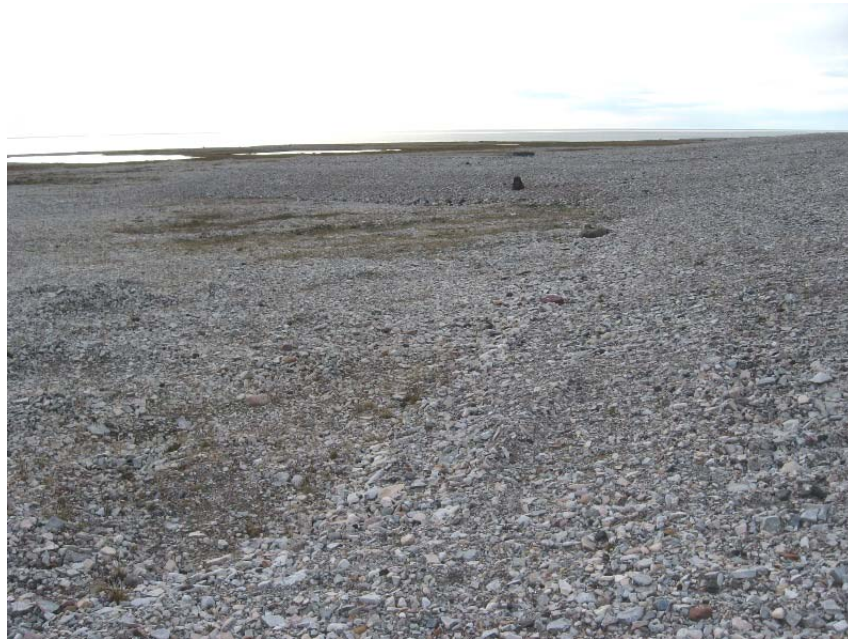
Photograph NWS-7. Looking W to the indentation along the S side of the East cell.

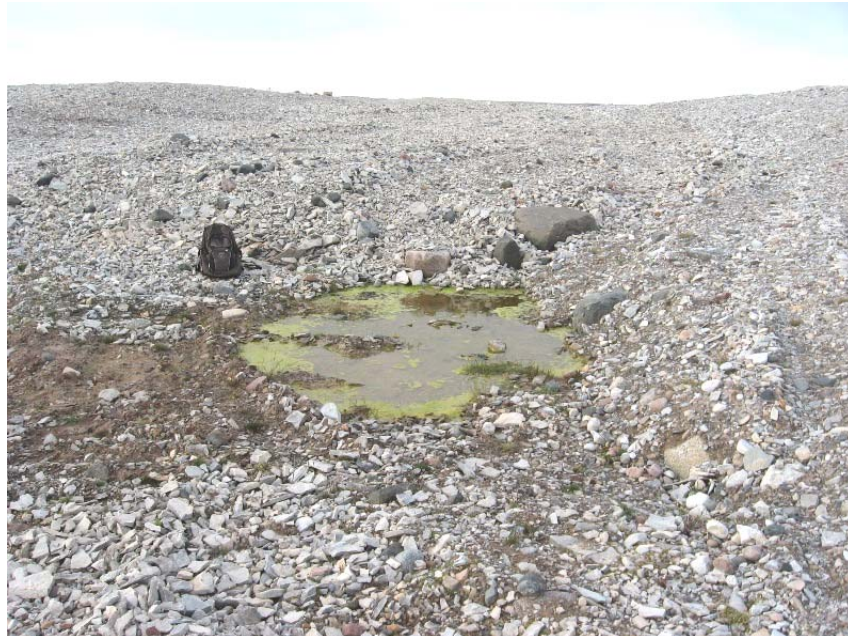
Minor rutting that was observed last year, which was presumed to be a remnant of construction equipment traffic is completely self-armoured and stable. The area of ponded water adjacent to the southeast corner of the central lobe appears substantially unchanged from last year. A slight increase in the apparent volume of ponded water is consistent with the relative increase in precipitation experienced by the site in the weeks prior to the visual inspection. The ponded water is clear and there is no clear evidence that the ponded water is seepage related. The presence of ponded water at this location is not considered problematic.

Photograph NWS-8. Looking N to ponded water along W side of East cell, SE of the SE corner of the Central cell. Note algal growth.

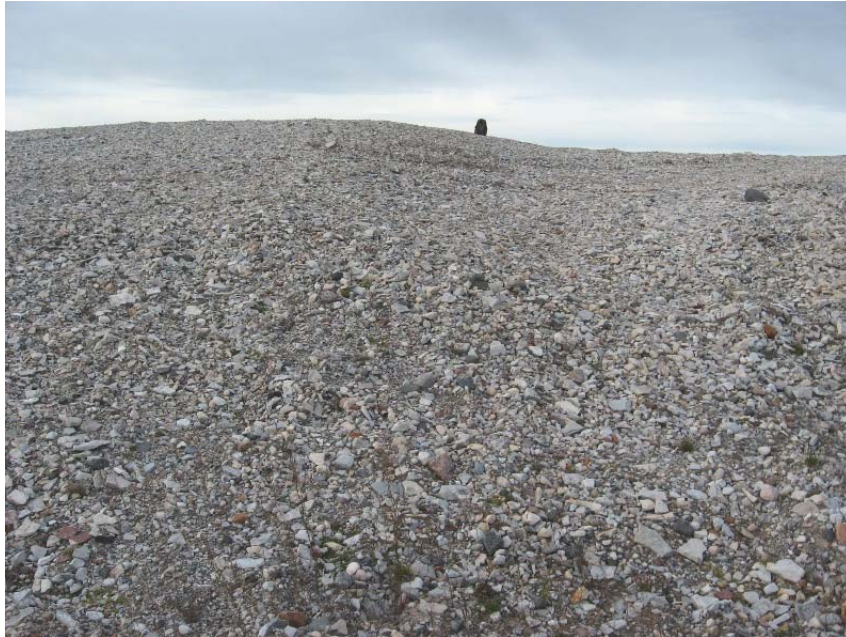
Photograph NWS-9. Looking N along E side of Central cell from the SE corner. Perimeter of landfill is hard to delineate as the entire area is gravel covered. ↑

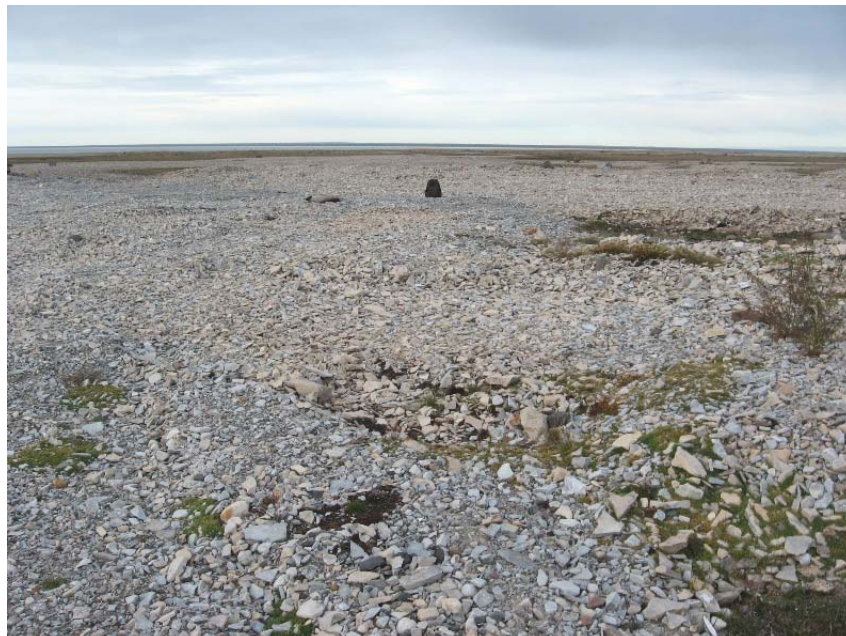
Photograph NWS-14. Looking NE from central east side of the West cell. Gravelly toe getting away from poorly defined crest. Very minimal relief. ↑

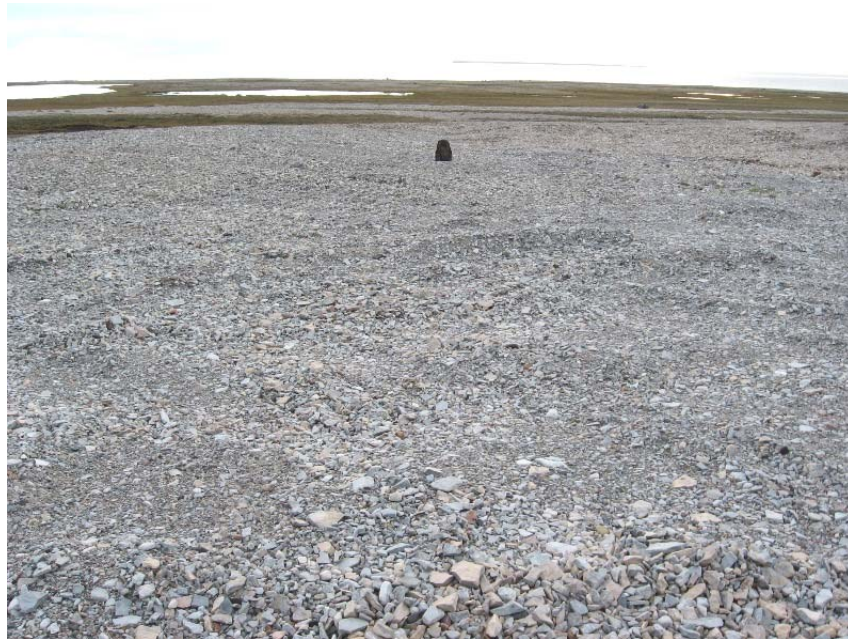
Photograph NWS-15. Looking W from NE limit of cover to what appears to be NE crest. Landfill limits are poorly defined due to the continuous gravel cover in the area around the landfill cells. ↑

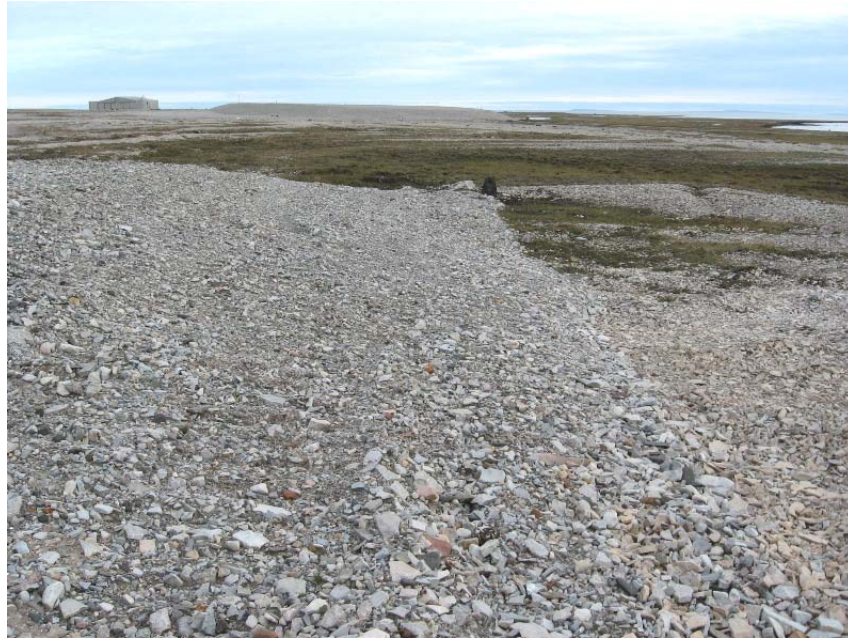
Photograph NWS-17. Looking S to SW corner of West cell from NW corner. Stable interface with organics. Main LF and hangar visible in the background. ↑

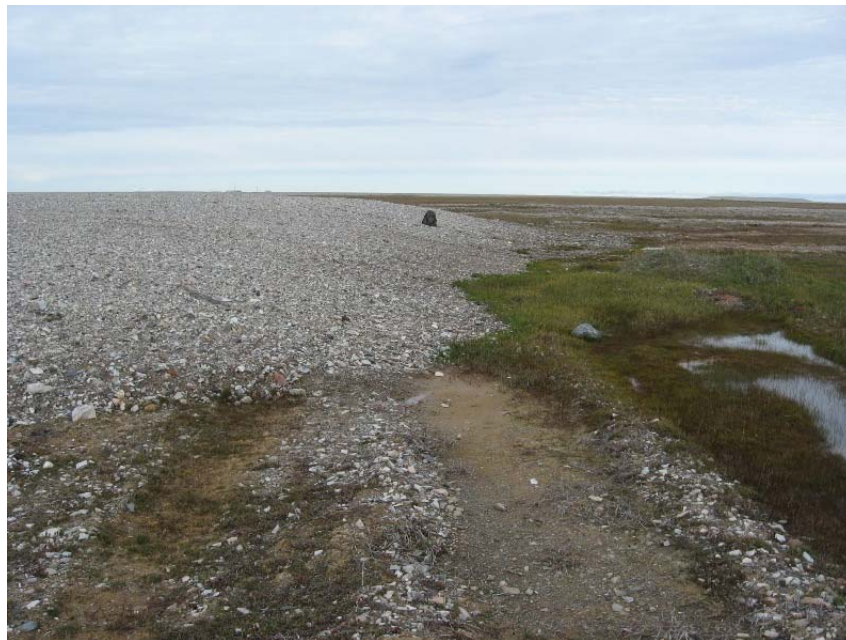
Photograph SLF-2. Looking N from SE corner of the East Cell. Note the high water table and large puddles. ↑

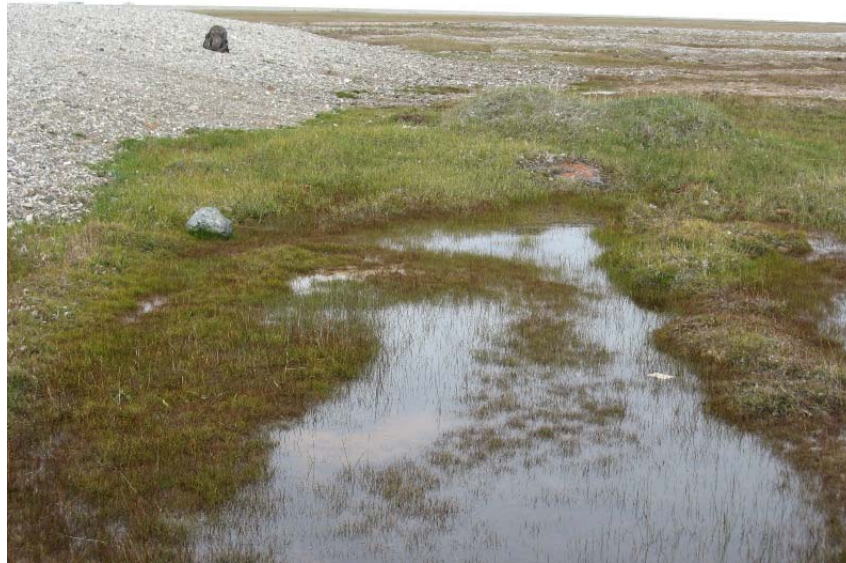
Photograph SLF-3. Looking N from SE corner of the East Cell to area of significant ponding. Similar photo to last year for comparison. Note high water level. ↑

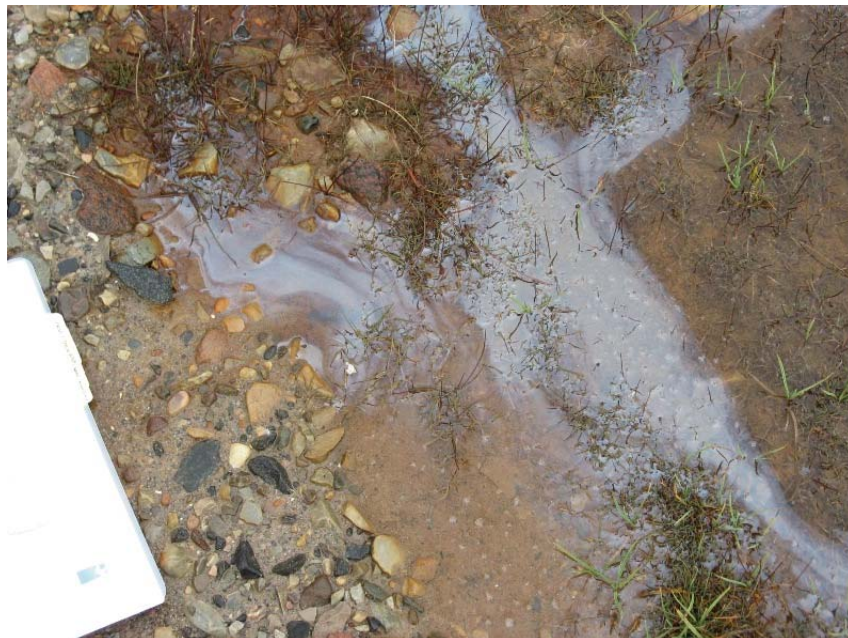
previously noted staining and/or suspected seepage (refer to photos 4, 10, 11, 19, 20, 23). Additionally, much of the ponded water, both within the surrounding muskeg and adjacent to the landfill cover was observed to have a “rainbow sheen”.

Photograph SLF-6. Close-up of typical "rainbow sheen". ↑

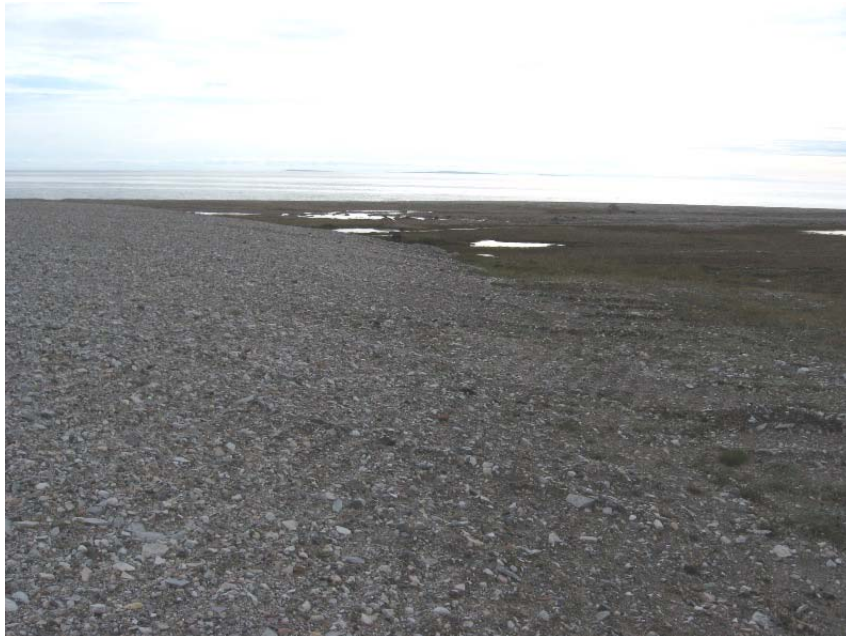
Photograph SLF-10. Looking S along W side of East cell. Abundant algae growth in ponded water adjacent to backpack.

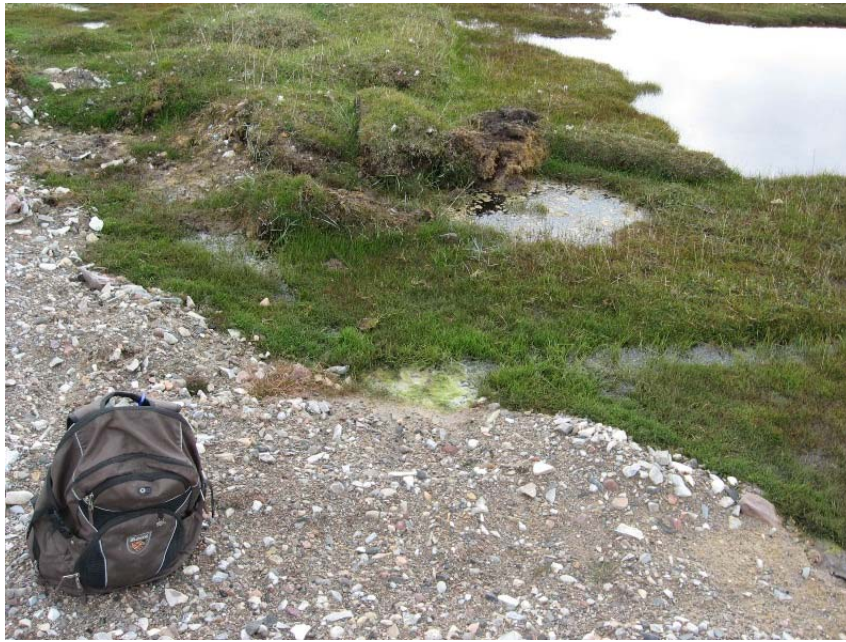
Photograph SLF-11. Algal growth close-up along W side of East cell. ↑

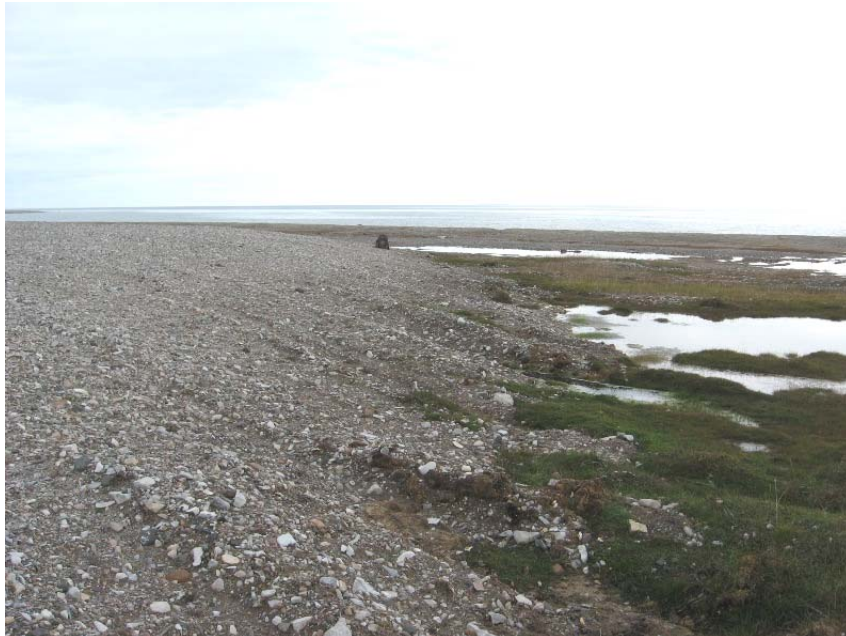
Photograph SLF-12. Looking SSE to SW corner fo landfill. Abundant ponded water. ↑
