Defence Construction Canada

The Collection of Landfill Monitoring Data at the PIN-3 Lady Franklin Point Site – 2008

October, 2008

Project Number: 80-297-3

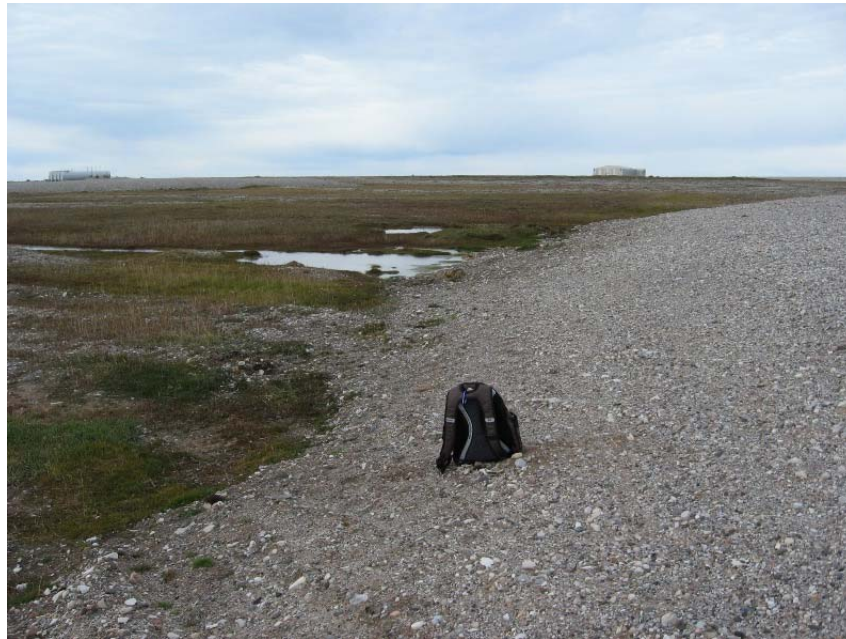
Photograph SLF-13. Looking NNW to ponded water along SW corner. Note hangar in background. ↑

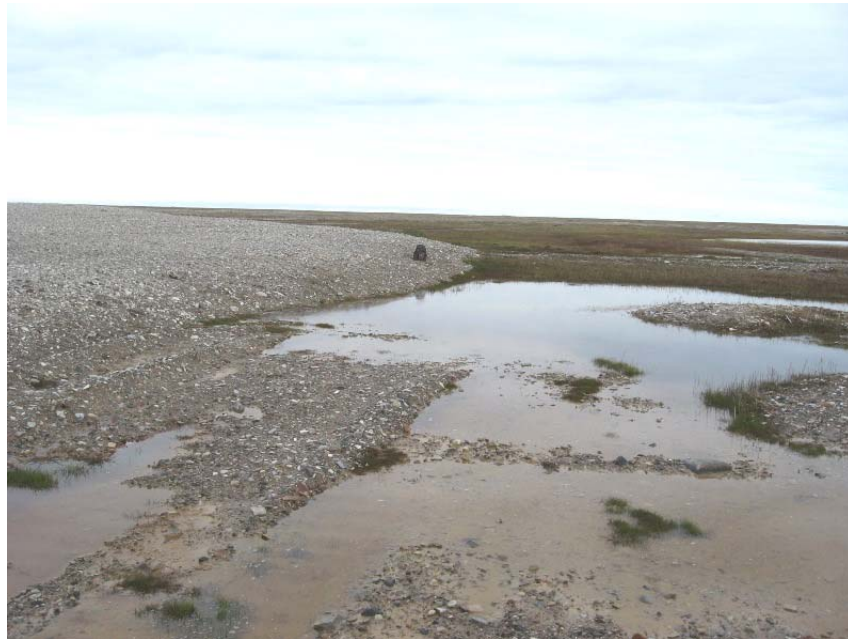
Photograph SLF-15. Looking ENE along south toe of East cell to the SE corner. Note large pond of water compared to previous two years. ↑

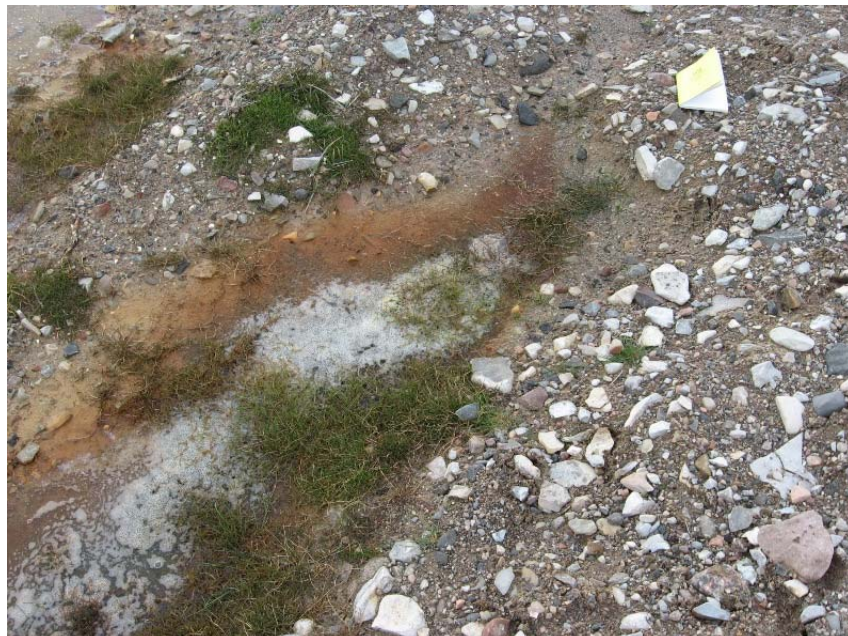
Vegetation Stress	No								
Seepage Points	Yes	Southeast corner of East Cell	1	1	surficial	point	Trickle of seepage flowing to rust stained ponded water	Photograph 16	Only one flowing point observed (slow trickle). High water level around perimeter of East Cell (relative to previous inspections).
Debris Exposed	No								
Presence/ Condition of Monitoring Instruments	No								
Other Features of Note.	No								
Additional Photos	Yes						Additional Photos	Photographs 1, 3, 5, 9, 10, 17, 18, 19, 21, 24, 27	General photos for documentation, no features of note

Photograph SLF-16. Close-up of seepage point along the southern perimeter of the East Cell. Same point photographed last 2 years. ↑

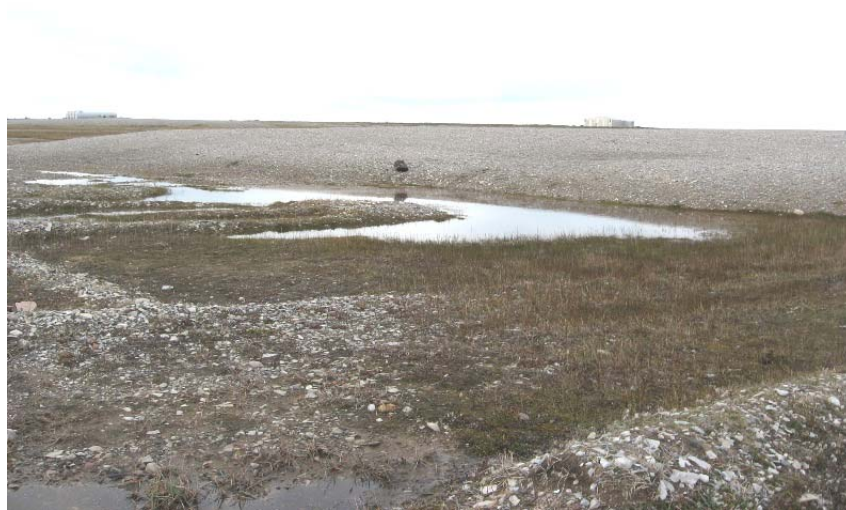
Photograph SLF-17. Looking NNW to area of known seepage adjacent to the SE corner of East Cell of the South Landfill. ↑

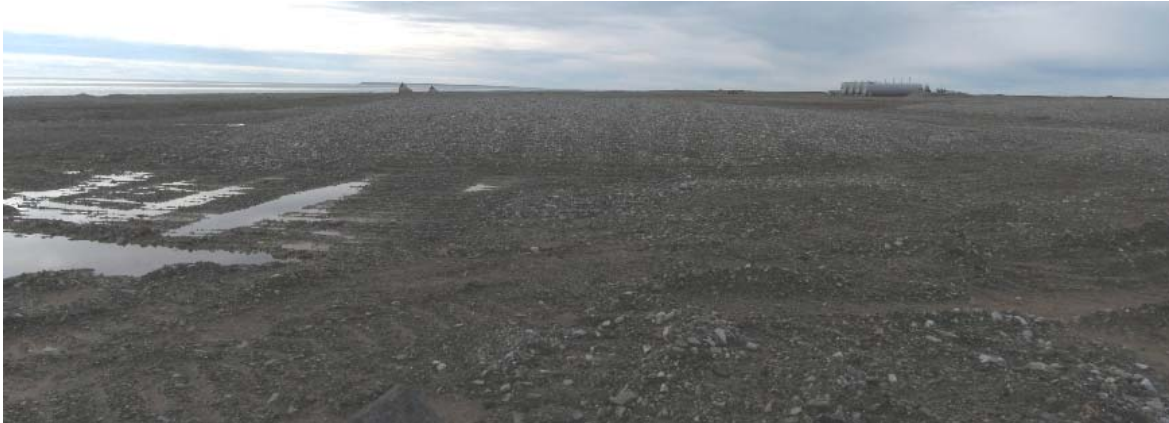
previously noted staining and/or suspected seepage (refer to photos 4, 10, 11, 19, 20, 23). Additionally, much of the ponded water, both within the surrounding muskeg and adjacent to the landfill cover was observed to have a “rainbow sheen”.

Photograph SLF-19. Looking W to E side of the south lobe of the West Cell. Note algal growth (bright green) at toe. ↑

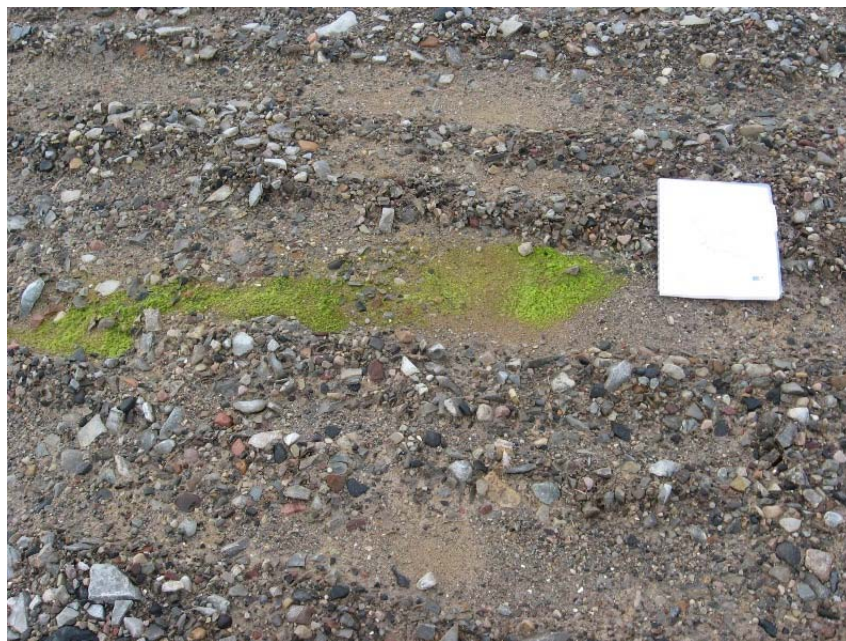
Photograph SLF-20. Close-up of algal growth along toe of eastern perimeter of the southern lobe of the West Cell. ↑

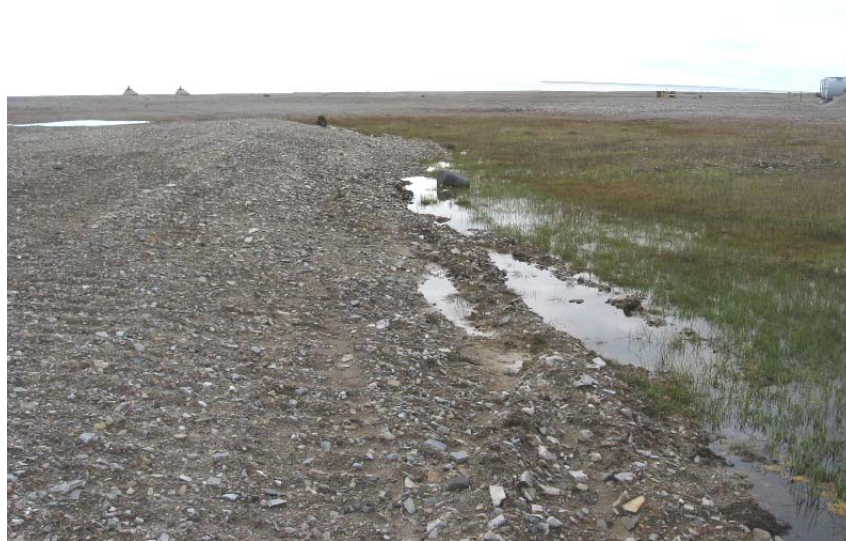
Photograph SLF-25. Looking W to the NW corner of North cell. Ponded water along most of toe.

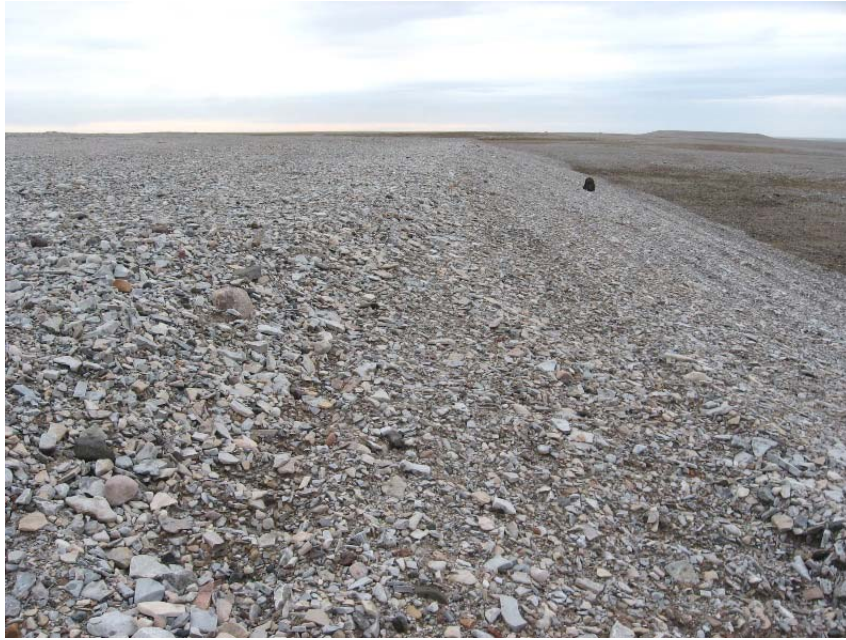
Photograph NonHaz-9. Looking E along crest from SW corner. Note final granular capping layer does not extend all the way to original granular side slope (i.e. ends abruptly, does not grade uniformly). ↑

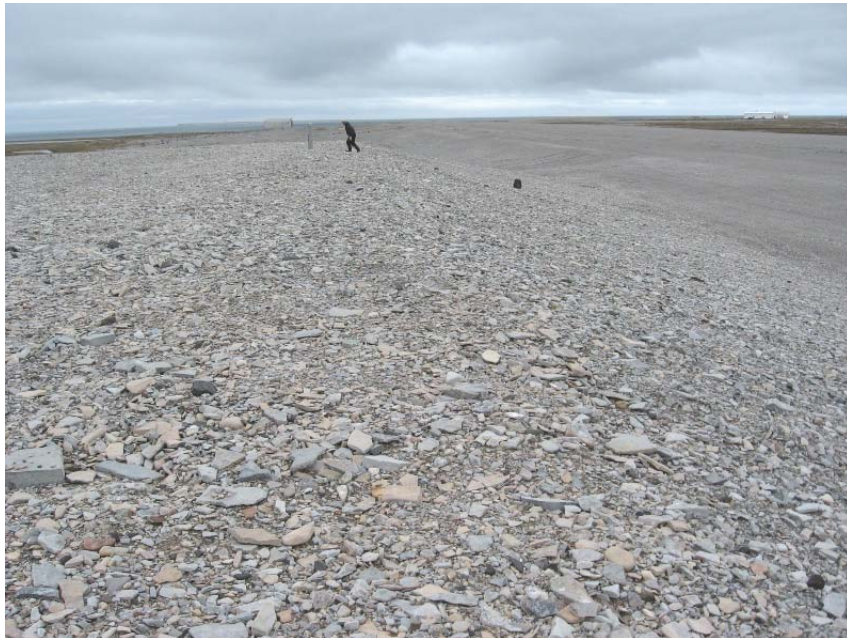
Photograph T2-4. Looking W along crest of N face from adjacent to VT-6. Looking to VT-5. A large zone of depression (approx. 10m x 10m and up to 0.5m deep) centred about 12m north of VT-5 appears unchanged from previous inspection. No indications of slope movement. ↑

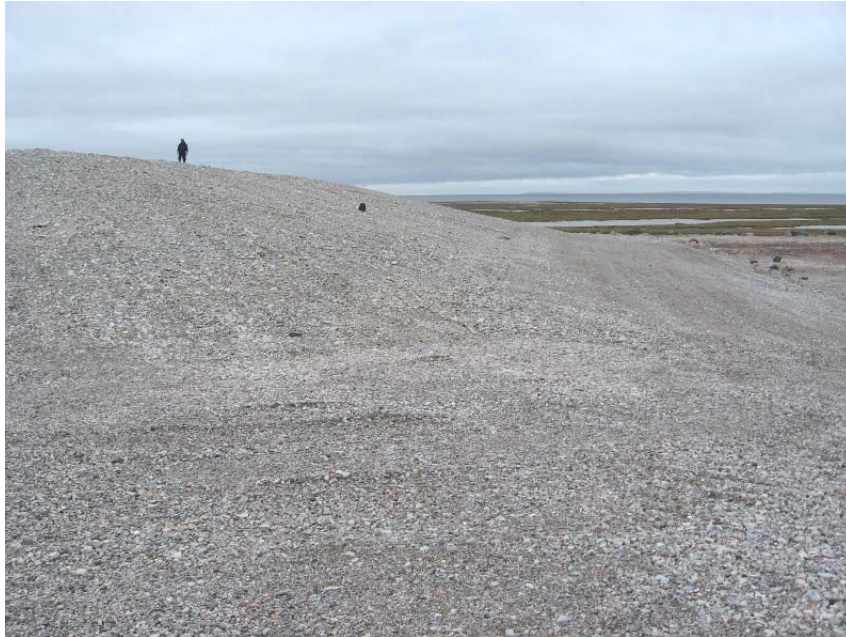
Photograph T2-7 Looking S along downstream toe of W slope from about 20m N of NW toe. Broad zones of depression are visible which is consistent with poor construction finish. There is no evidence of slope instability. ↑

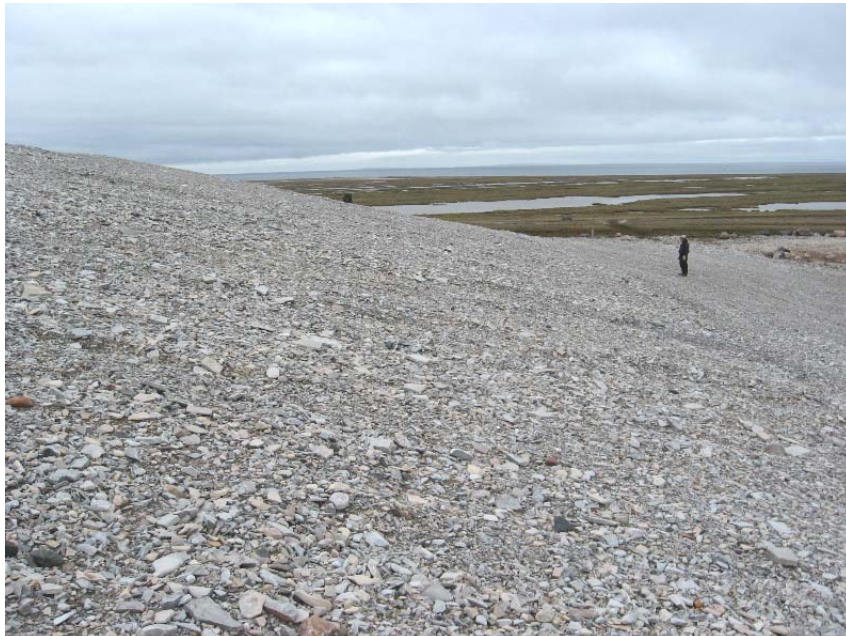
Photograph T2-10. Looking S along W slope from about midslope. No features of note. Slope appears stable. ↑

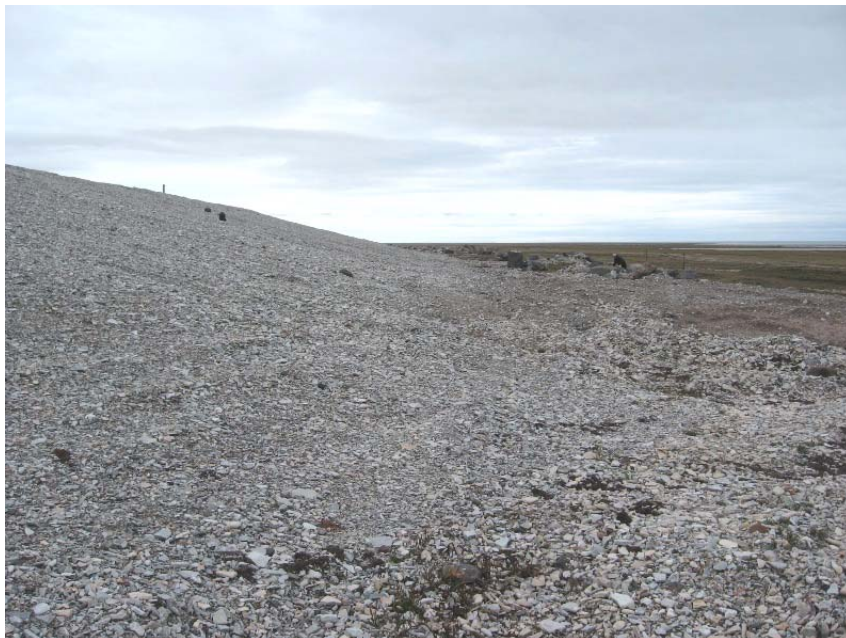
Photograph T2-12. Looking E along S slope from partway up slope near SW corner. MW-11 visible in distance to the south of the toe of slope. Slope has relatively gentle grade and abuts into organic layer. No indications of slope instability. ↑

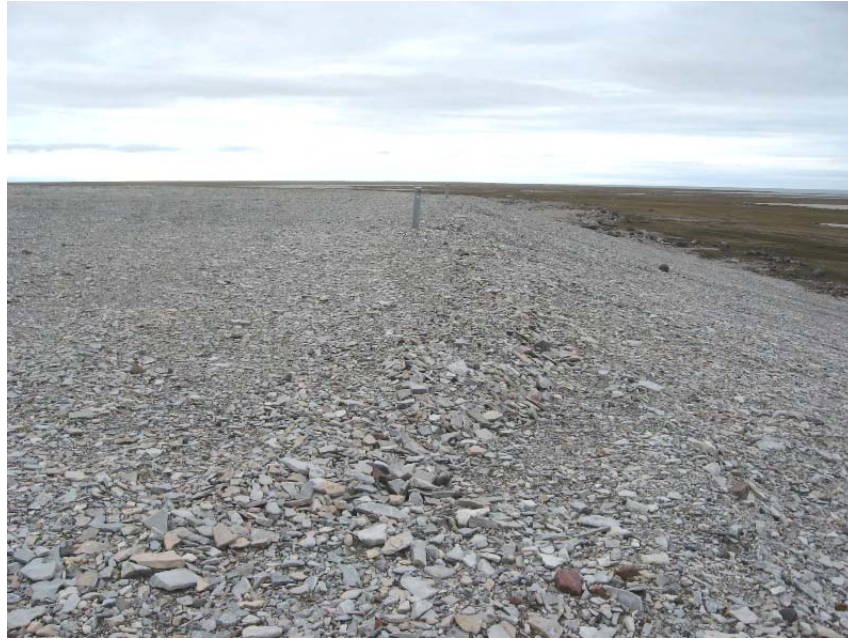
Photograph T2-13. Looking E from SW crest of the LF. VT-7 in foreground, VT-8 further away. Deep rutting (up to 0.5m deep x 1m wide x 5 m long) appears to be a construction remnant. The rut is self armoured and not susceptible to further erosion. ↑

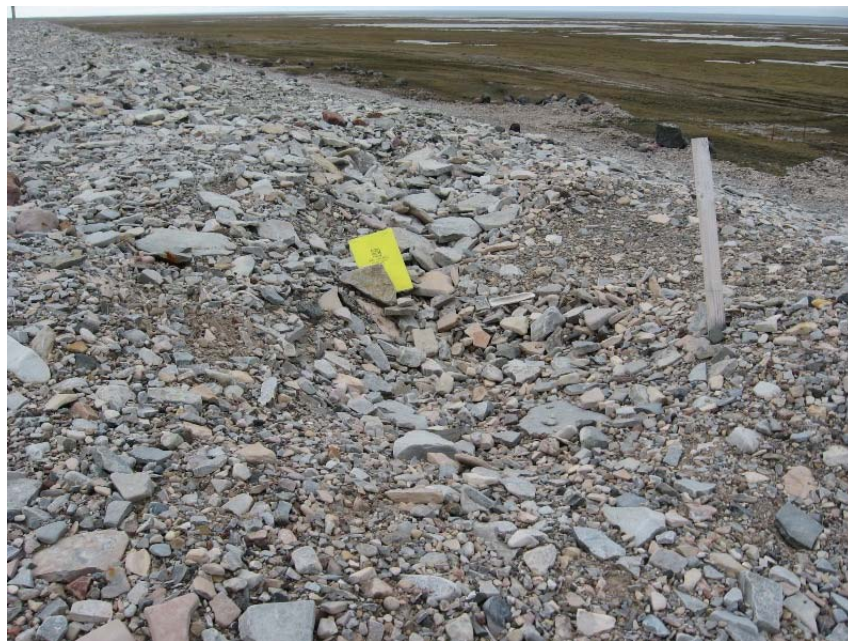
Photograph T2-14. Close-up of deep rut along crest of SW corner. Unchanged from previous two inspections. ↑

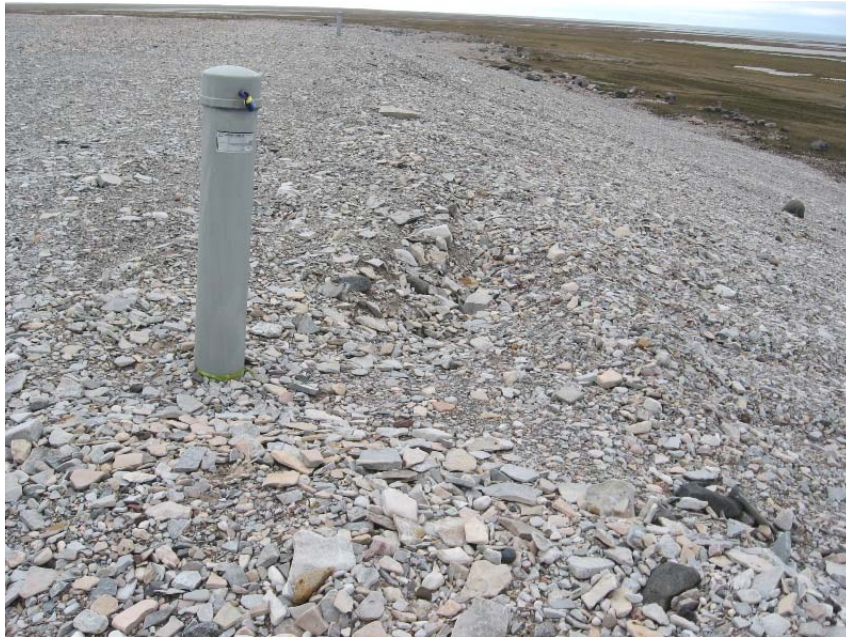
Photograph T2-15. Close-up of deep rut adjacent to VT-7. Unchanged from previous two inspections. The rut is self armoured and not susceptible to further erosion. No indications of slope instability. ↑

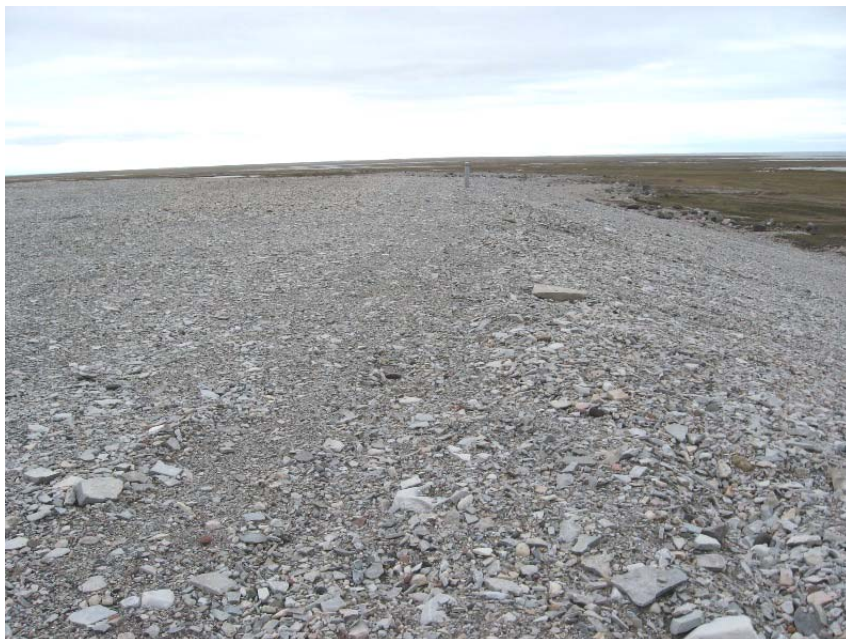
Photograph T2-16. Looking E along crest to VT-8 from adjacent to VT-7. No features of note. ↑

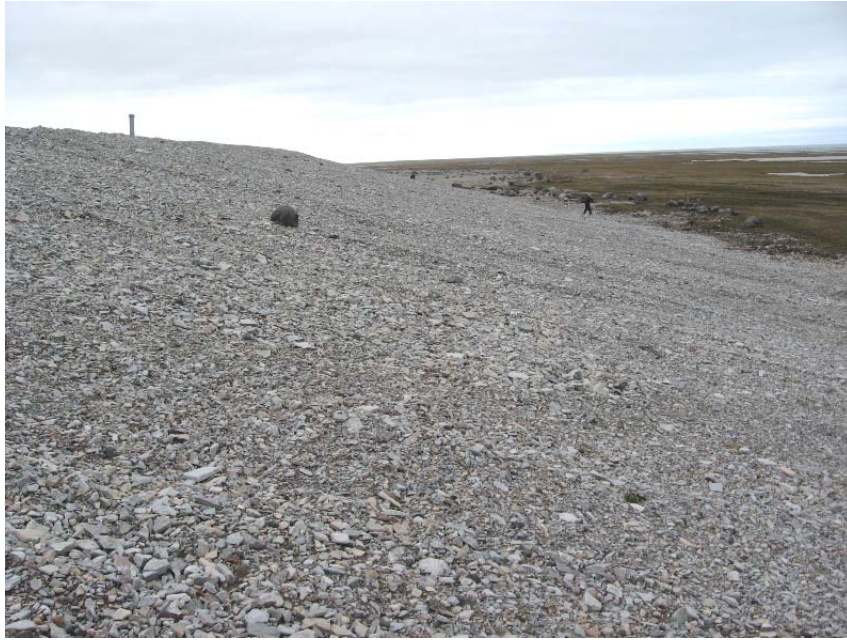
Photograph T2-17. Looking E from mid-slope of the S slope. VT-8 visible along crest. No features of note. ↑

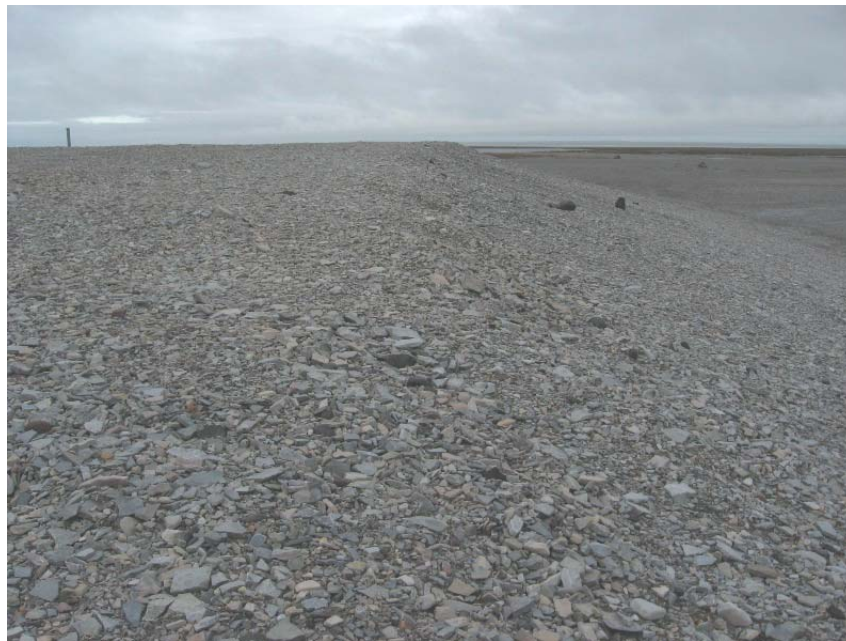
Photograph T2-20. Looking N along E crest from about SE corner. Significant vehicle ruts and inconsistent construction finish in the area. Slope appears stable and the surface irregularities are self armouring and not susceptible to further erosion. ↑

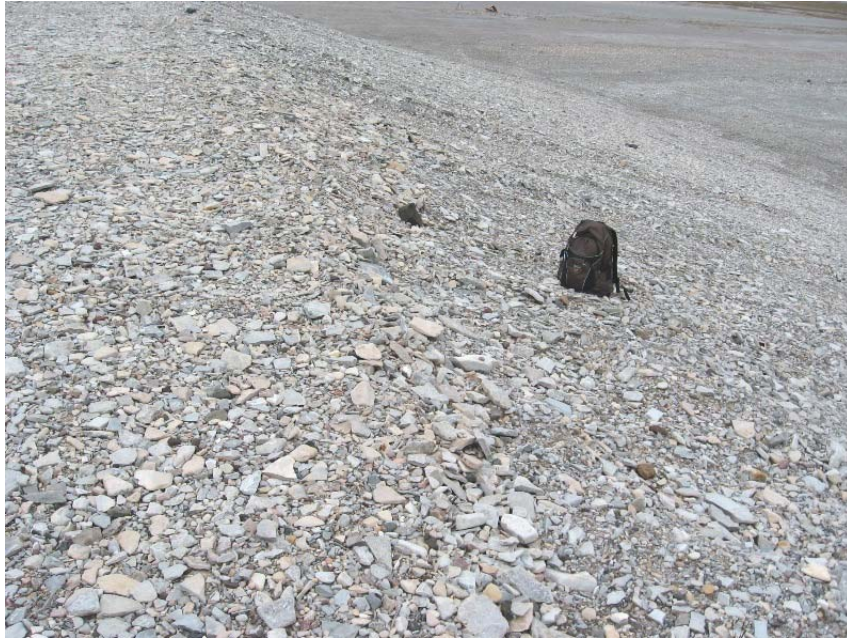
Photograph T2-21. Close-up of ruts, looking NE from crest of E slope, about 25 m N of SE corner of landfill. ↑

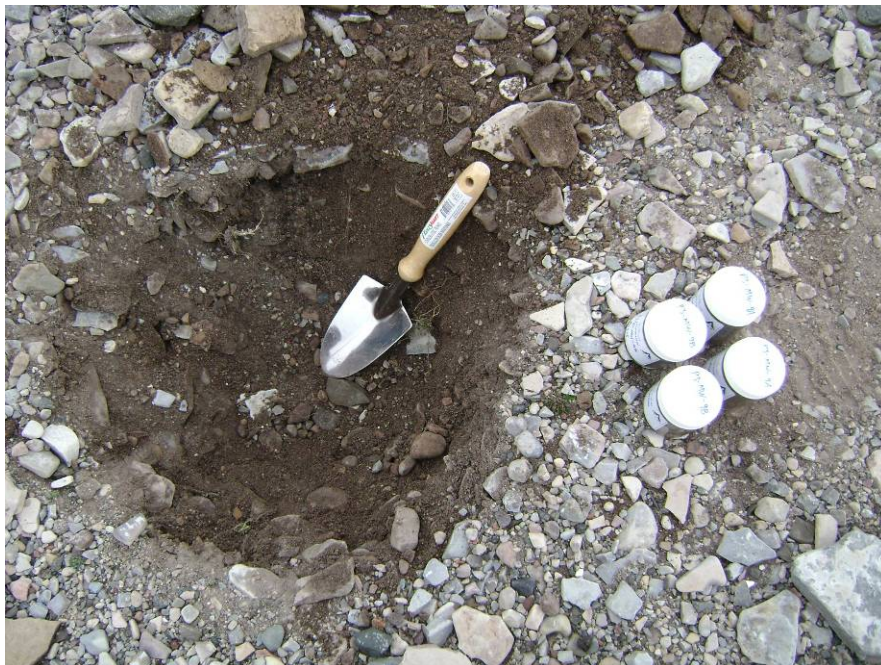
Photograph 2. Test pit at MW-9. Samples P3-MW-9A and P3-MW-9B collected.____ ↑

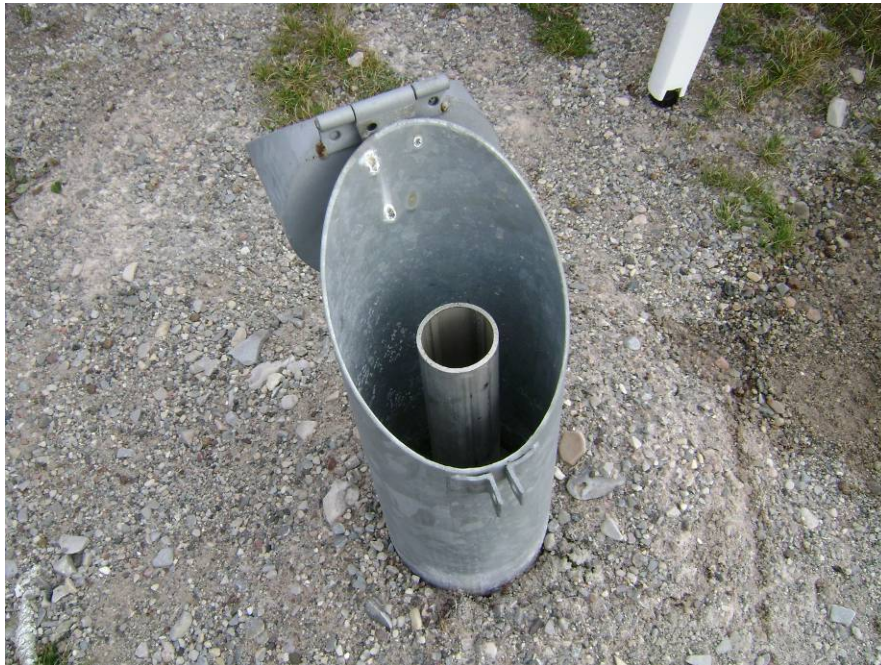
Photograph 4. Monitoring well MW-11. Sample P3-MW-11 collected.____ ↑

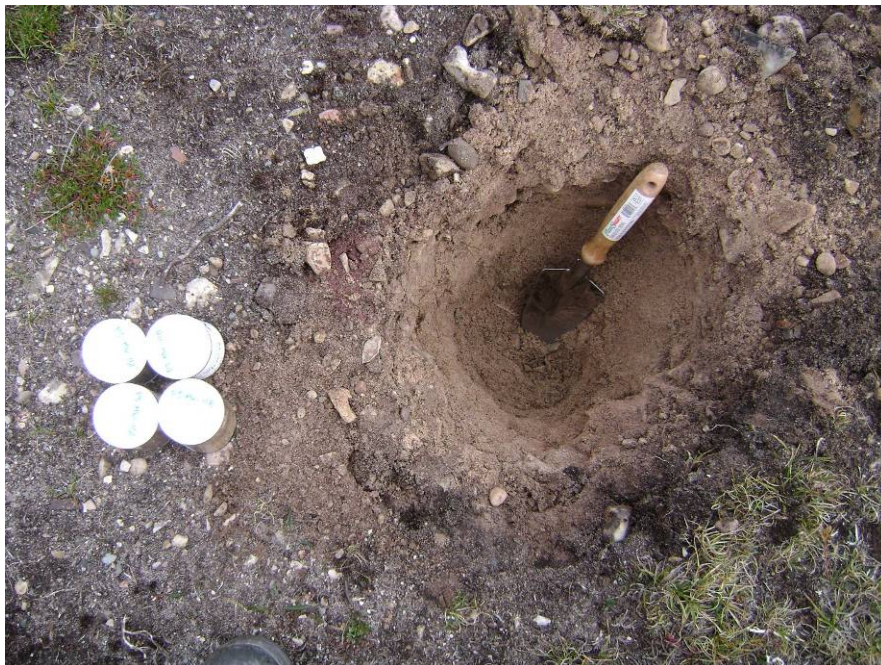
Photograph 5. Test pit at MW-11. Samples P3-MW-11A and P3-MW-11B collected.____ ↑

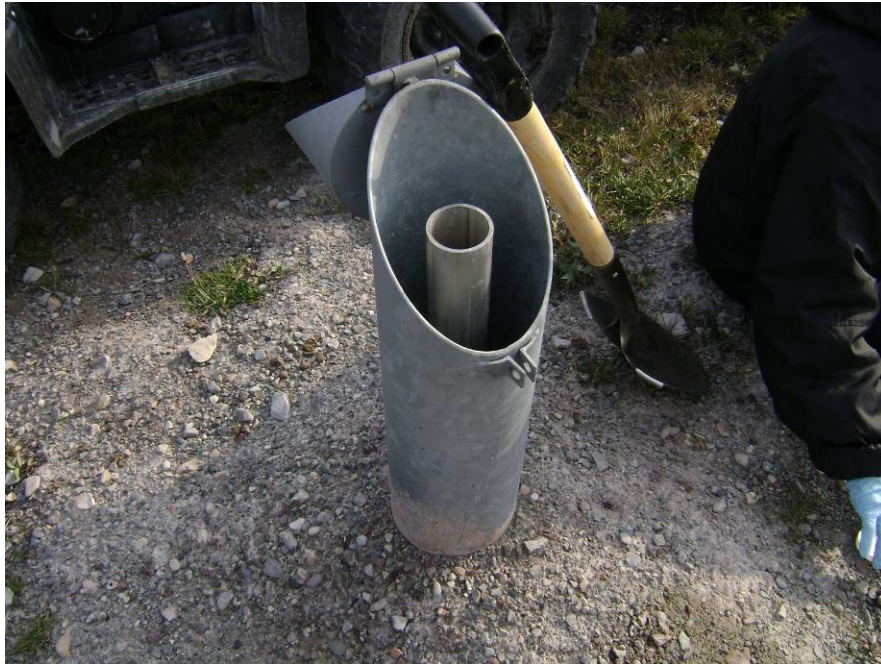
Photograph 6. Monitoring well MW-12. Sample P3-MW-12 collected.____ ↑

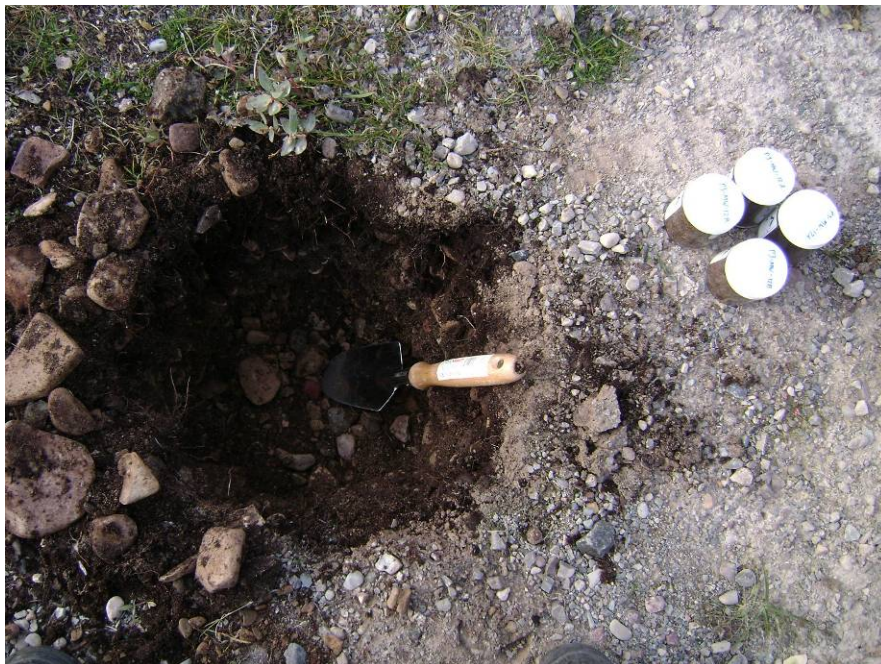
Photograph 7. Test pit at MW-12. Samples P3-MW-12A and P3-MW-12B collected.____ ↑
