## **The Collection of Landfill Monitoring Data at the PIN-3 Lady Franklin Point Site – 2008**

**AECOM Canada Ltd.**

January, 2009

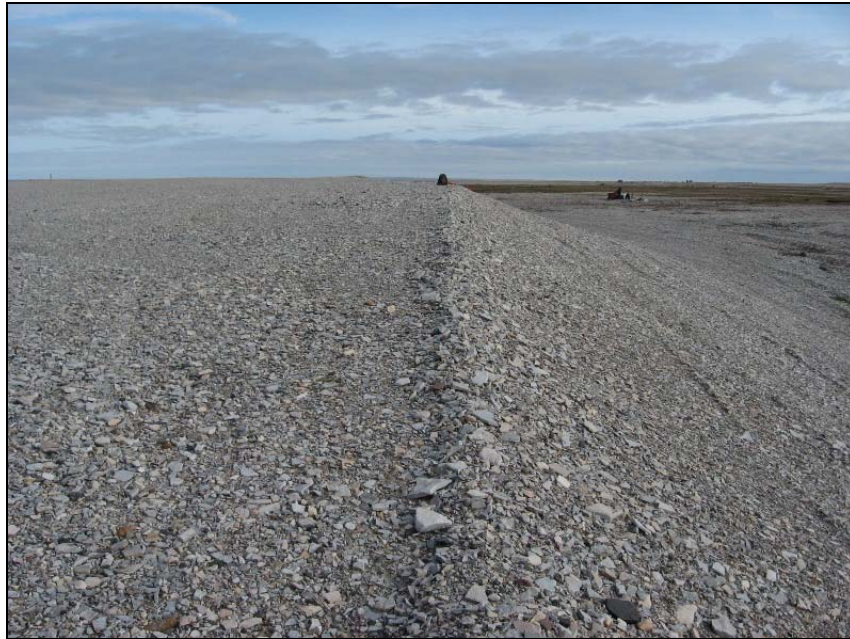
**Photograph MLF-1.** Looking N from SE corner. Backpack for scale along crest. ↑

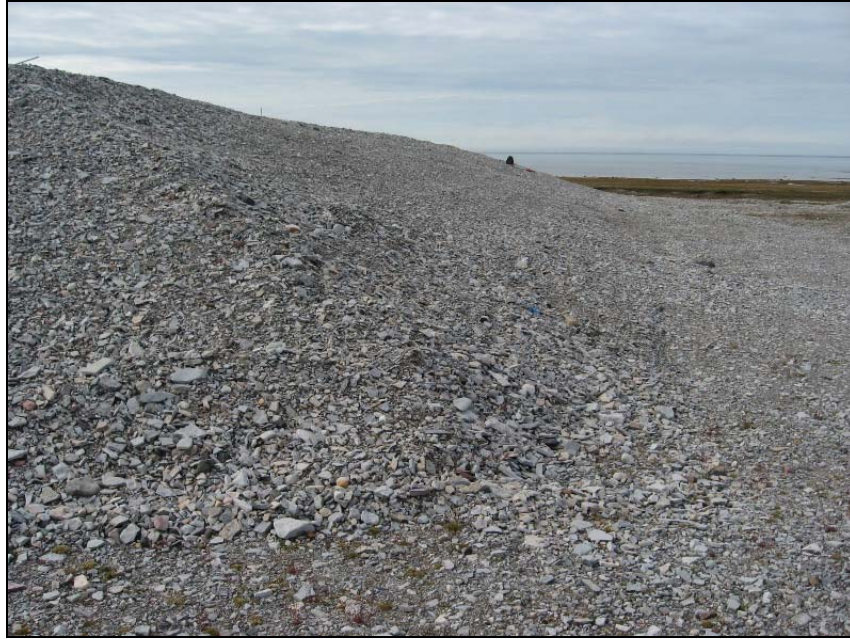
**Photograph MLF-9.** Looking SW from NW corner (5m N of toe). Everything looks stable.  
Backpack in same location as MLF-10    ↑

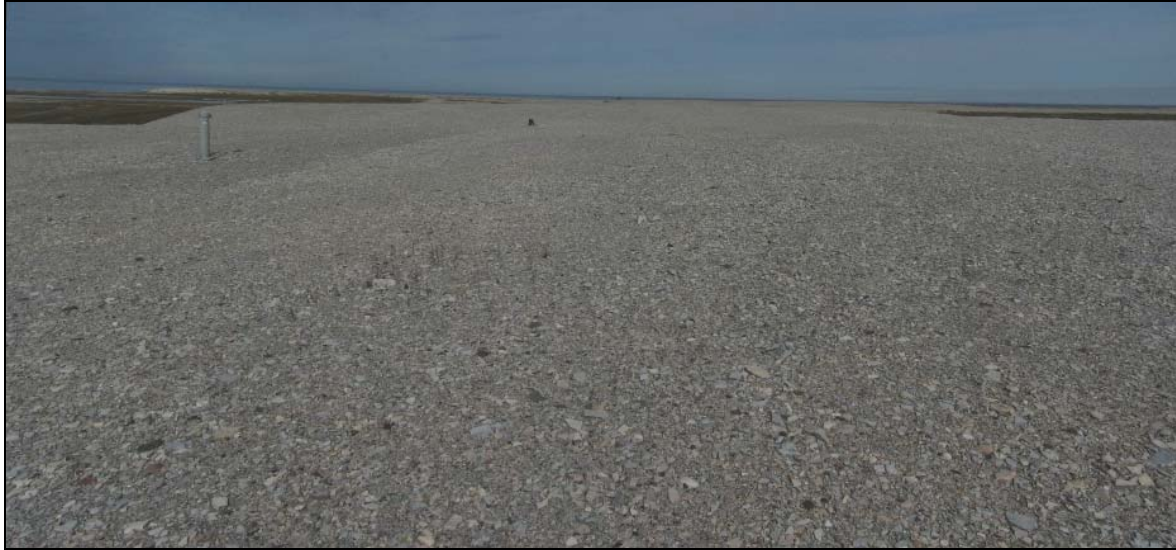
**Photograph MLF-23.** Panoramic looking NNW to N. VT-3 visible near, and VT-1 to right in distance. Backpack is near centre of depression. ↑

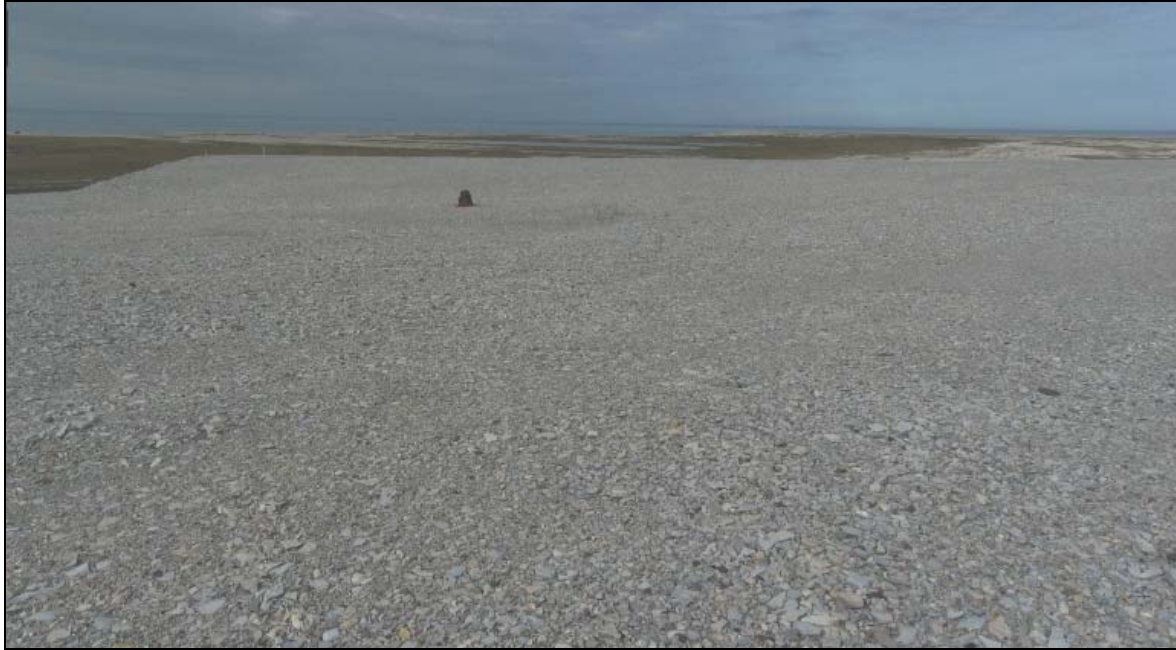
The overall performance of the landfill is considered acceptable. The noted areas of broad depression should continue to be monitored.

**Photograph MLF-25.** Panoramic looking NW from 2m S of VT-1. Backpack in centre of area of generalized depression. Appears unchanged from previous two inspections.   ↑

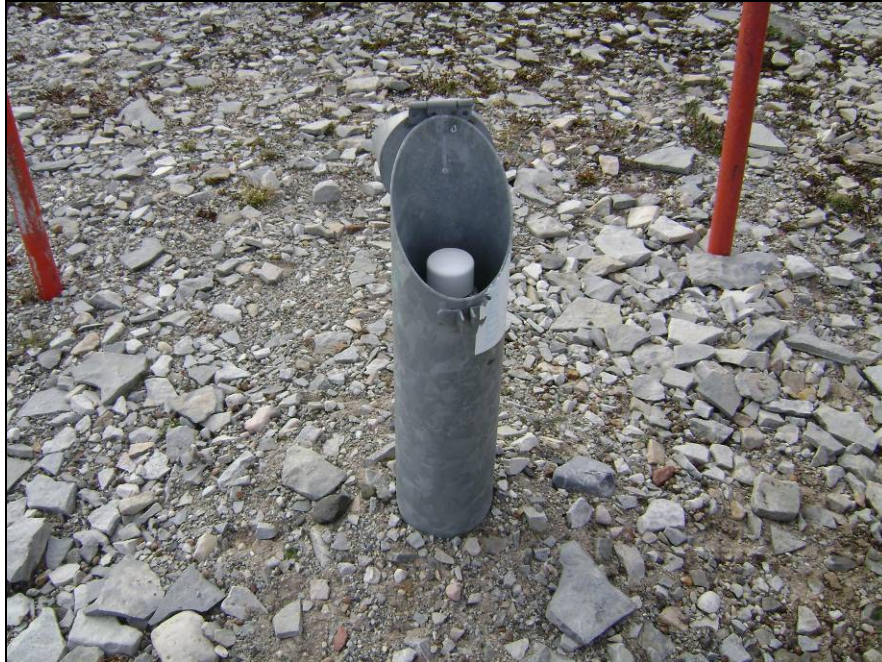
**Photograph 1.** Monitoring well MW-5. Sample P3-MW-5 collected. ↑

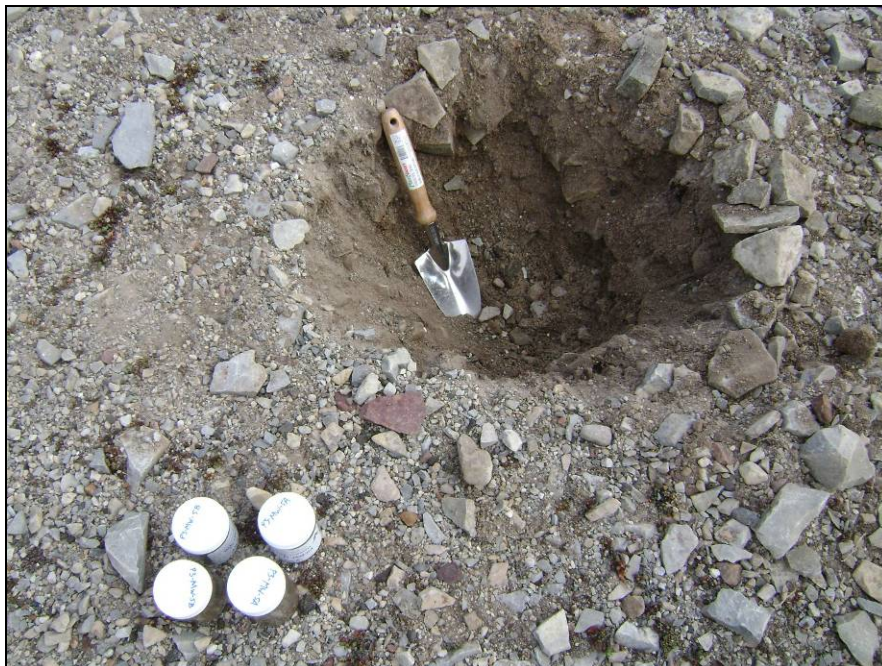
**Photograph 2.** Test pit at MW-5. Samples P3-MW-5A and P3-MW-5B collected. ↑

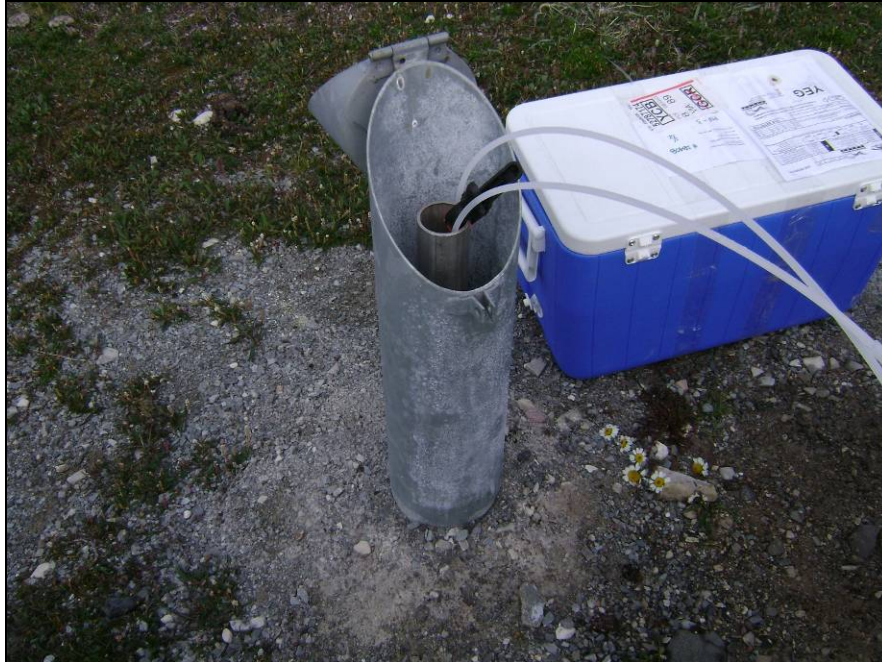
**Photograph 3.** Monitoring well MW-6. Sample P3-MW-6 collected. ↑

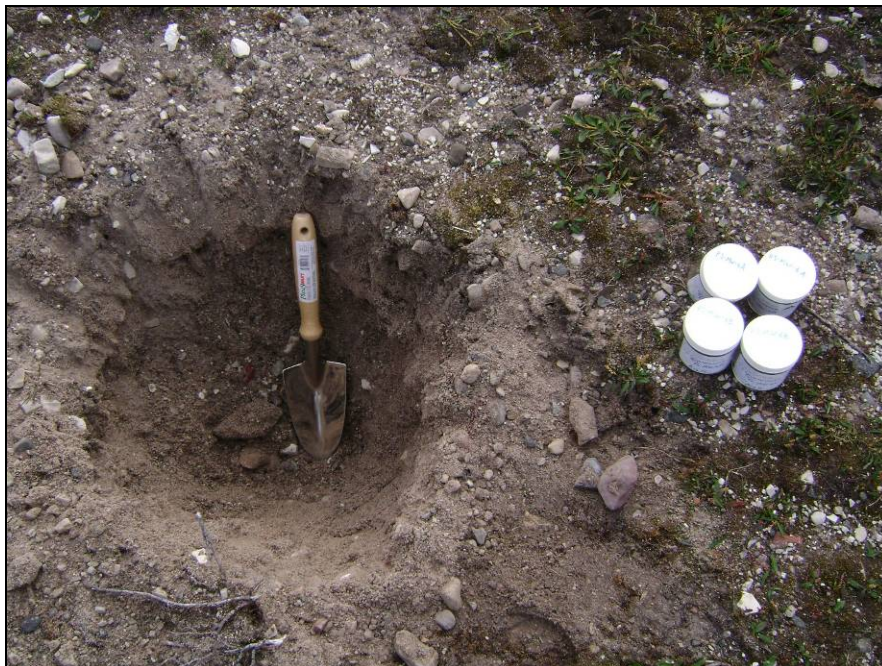
**Photograph 4.** Test pit at MW-6. Samples P3-MW-6A and P3-MW-6B collected. ↑

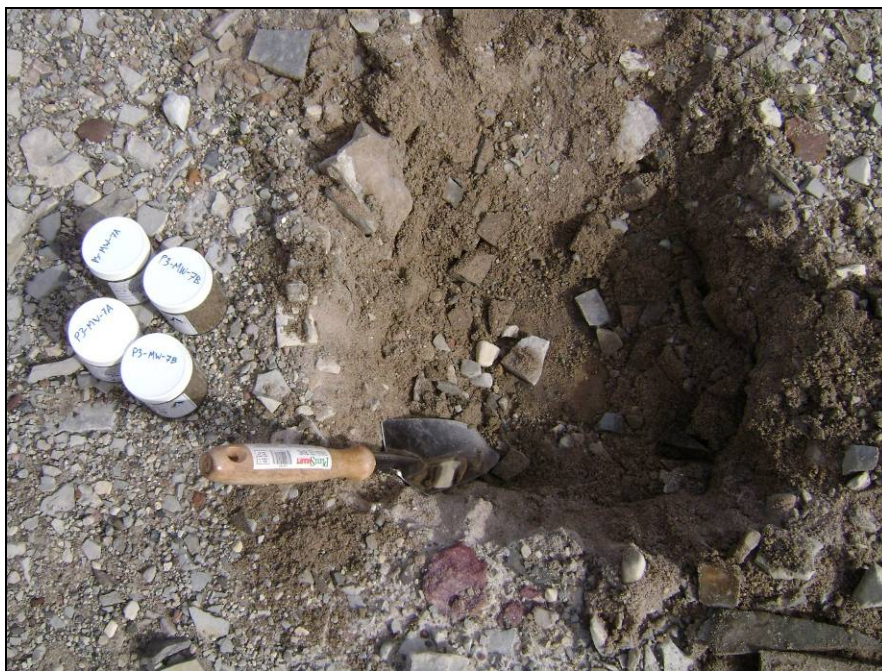
**Photograph 6.** Test pit at MW-7. Samples P3-MW-7A and P3-MW-7B collected. Bedrock at 0.15m ↑

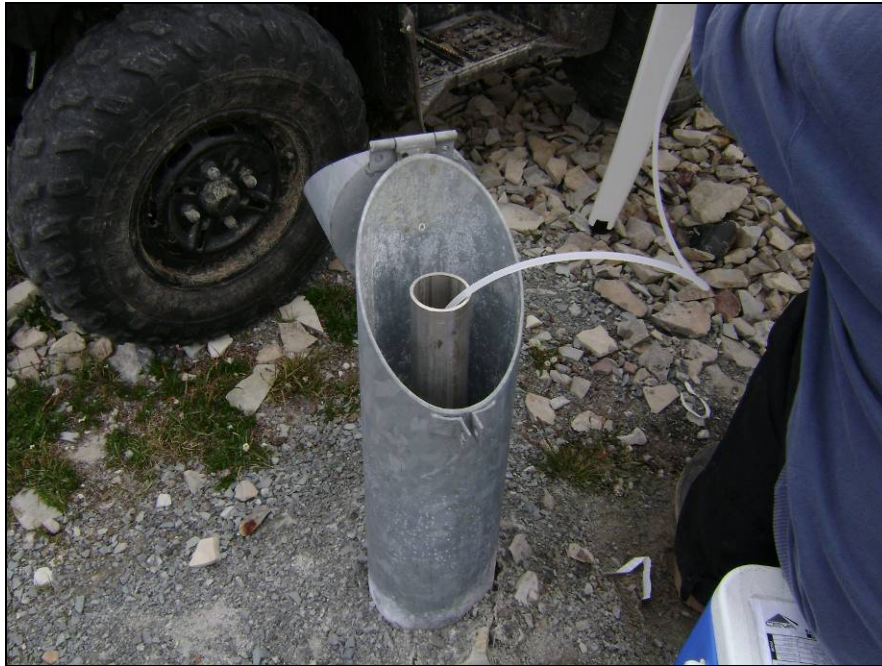
**Photograph 7.** Monitoring well MW-8. Samples P3-MW-8 and P3-MW-13 (Duplicate) collected. ↑

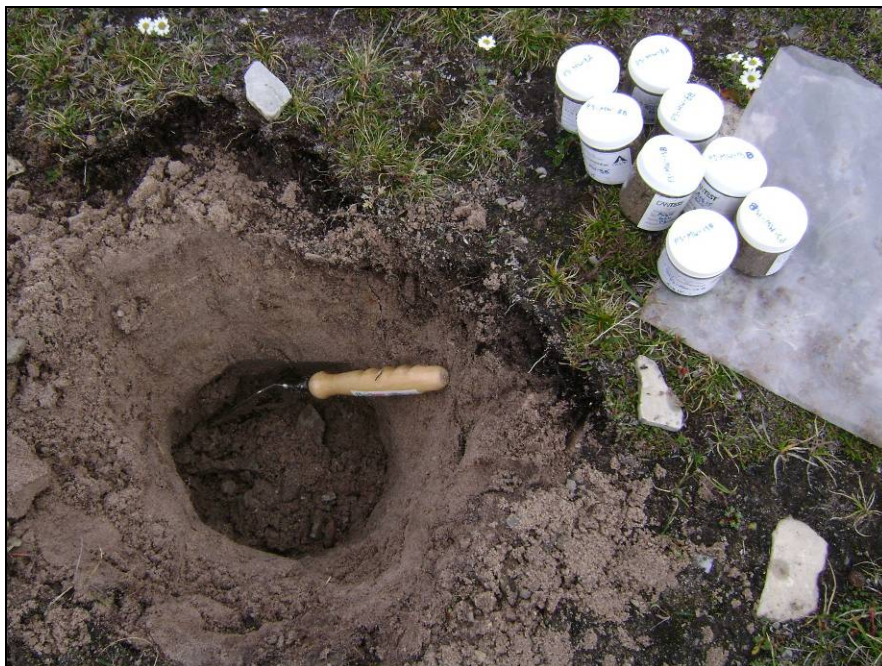
**Photograph 8.** Test pit at MW-8. Samples P3-MW-8A, P3-MW-8B, and P3-MW-13B (Duplicate) collected. ↑

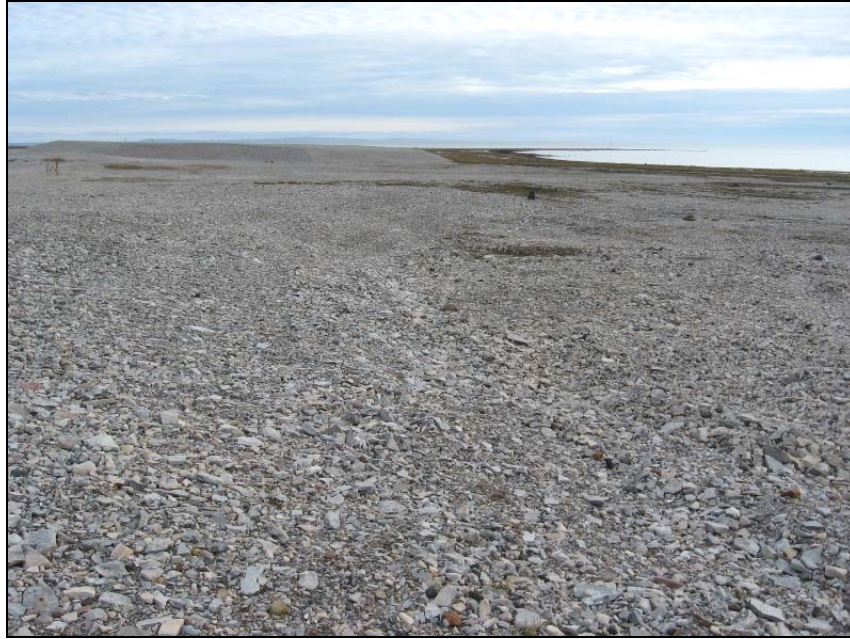
**Photograph NWS-5.** Looking S to SE corner of East cell. NW corner of Main LF visible in the background. Note ponded water and algae. ↑

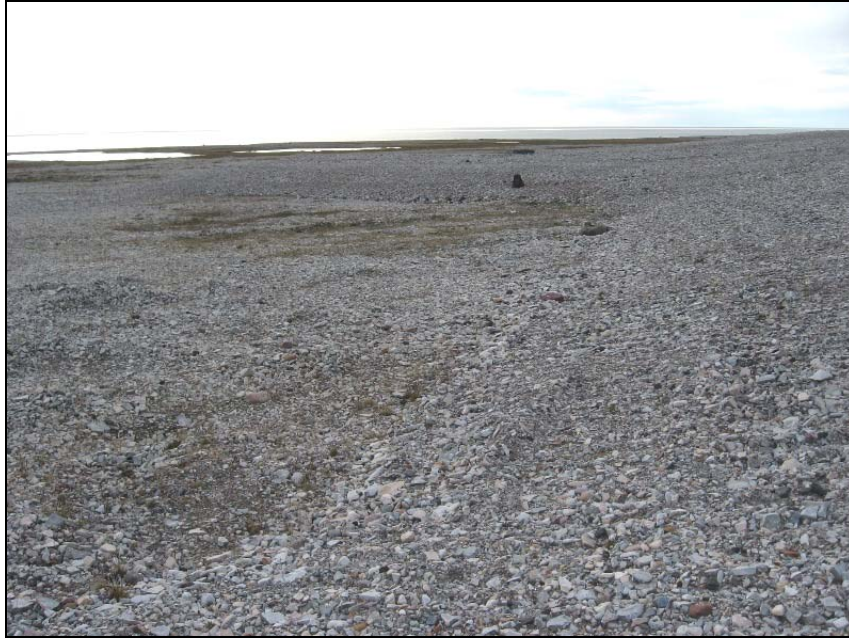
**Photograph NWS-7.** Looking W to the indentation along the S side of the East cell. ↑

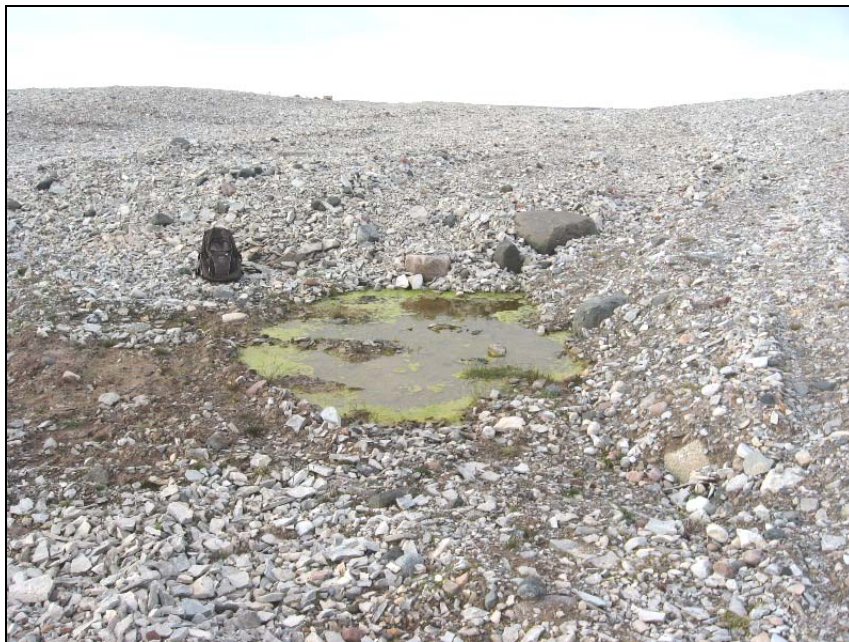
Minor rutting that was observed last year, which was presumed to be a remnant of construction equipment traffic is completely self-armoured and stable. The area of ponded water adjacent to the southeast corner of the central lobe appears substantially unchanged from last year. A slight increase in the apparent volume of ponded water is consistent with the relative increase in precipitation experienced by the site in the weeks prior to the visual inspection. The ponded water is clear and there is no clear evidence that the ponded water is seepage related. The presence of ponded water at this location is not considered problematic.

**Photograph NWS-8.** Looking N to ponded water along W side of East cell, SE of the SE corner of the Central cell. Note algal growth. ↑

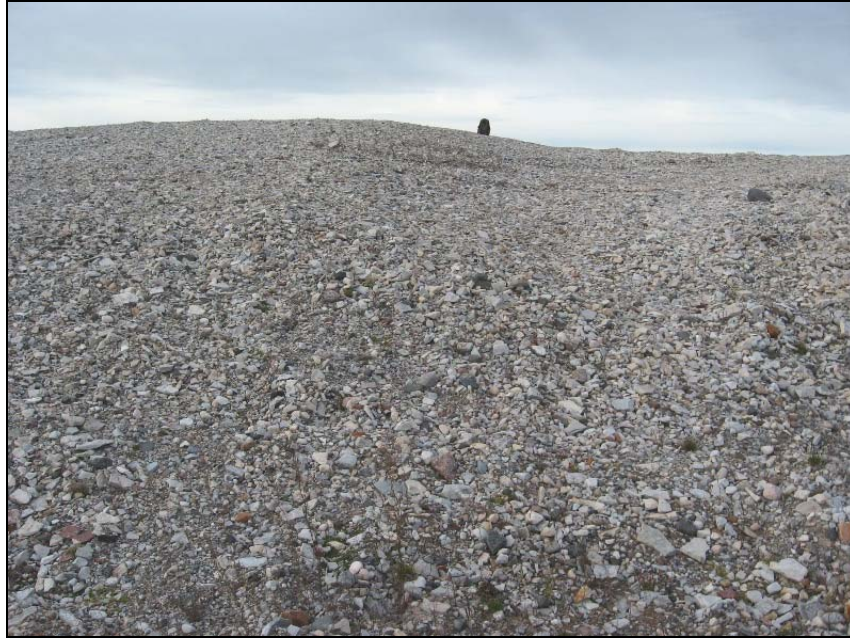
**Photograph NWS-9.** Looking N along E side of Central cell from the SE corner. Perimeter of landfill is hard to delineate as the entire area is gravel covered. ↑

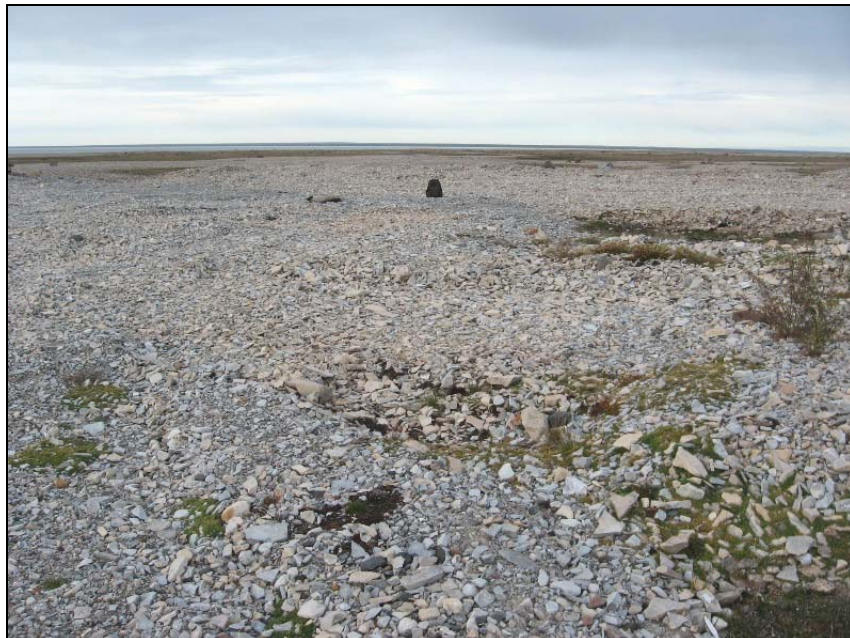
**Photograph NWS-14.** Looking NE from central east side of the West cell. Gravelly toe getting away from poorly defined crest. Very minimal relief. ↑

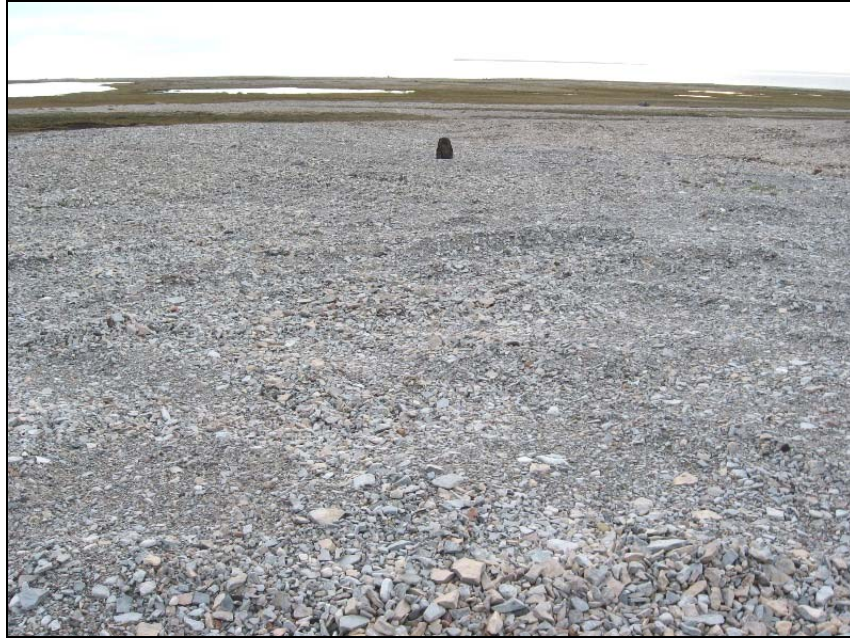
**Photograph NWS-15.** Looking W from NE limit of cover to what appears to be NE crest. Landfill limits are poorly defined due to the continuous gravel cover in the area around the landfill cells. ↑

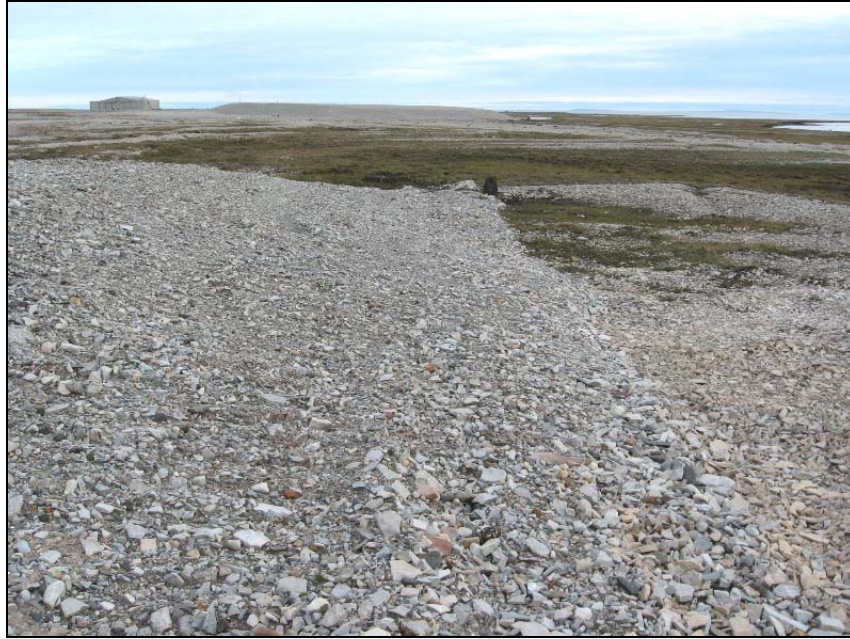
**Photograph NWS-17.** Looking S to SW corner of West cell from NW corner. Stable interface with organics. Main LF and hangar visible in the background. ↑

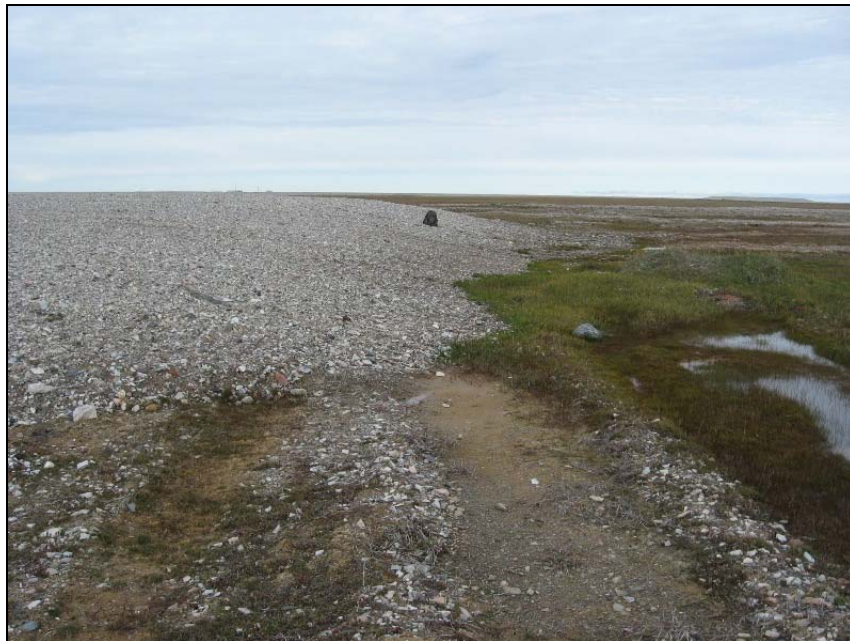
The water level in the surrounding muskeg is higher than observed in 2006 and 2007, reflecting the increased precipitation in the months prior to the 2008 visual inspection. The Eastern Cell and the north lobe of the Western Cell have water ponded along the perimeter toe (refer to Photographs 2, 3, 7, 8, 10, 12, 13, 14, 15, 17, 23, 25, 26). Similar to the previous two inspections (2006 and 2007), several areas of known or suspected seeps were also observed along the perimeter toe of the East landfill cell. Areas of possible seepage were specifically noted adjacent to the northeast, southwest and southeast portions of the East landfill cell (refer to Photographs 3, 4, 7, 11, 16) and along the eastern perimeter of both lobes of the West Cell (refer to Photographs 19, 20, 22, 24 and 25). The areas of ponded water around the perimeter of the landfill cover appears to be a result of a high water level in the surrounded muskeg terrain which accumulates in construction-related disturbances (e.g. areas of displaced muskeg). Algal blooms were observed in many areas of previously noted staining and/or suspected seepage (refer to photos 4, 10, 11, 19, 20, 23). Additionally, much of the ponded water, both within the surrounding muskeg and adjacent to the landfill cover was observed to have a “rainbow sheen”.

**Photograph SLF-2.** Looking N from SE corner of the East Cell. Note the high water table and large puddles. ↑

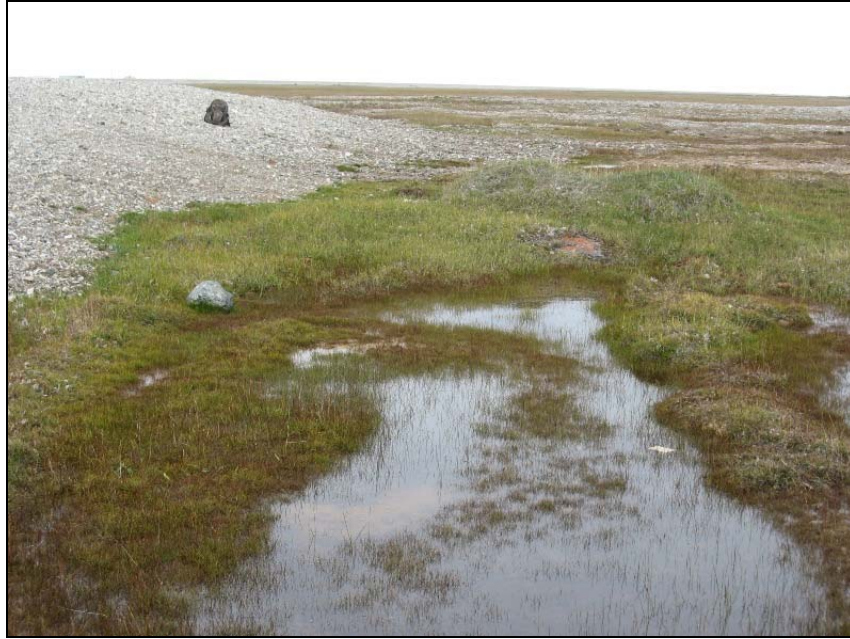
**Photograph SLF-3.** Looking N from SE corner of the East Cell to area of significant ponding. Similar photo to last year for comparison. Note high water level. ↑

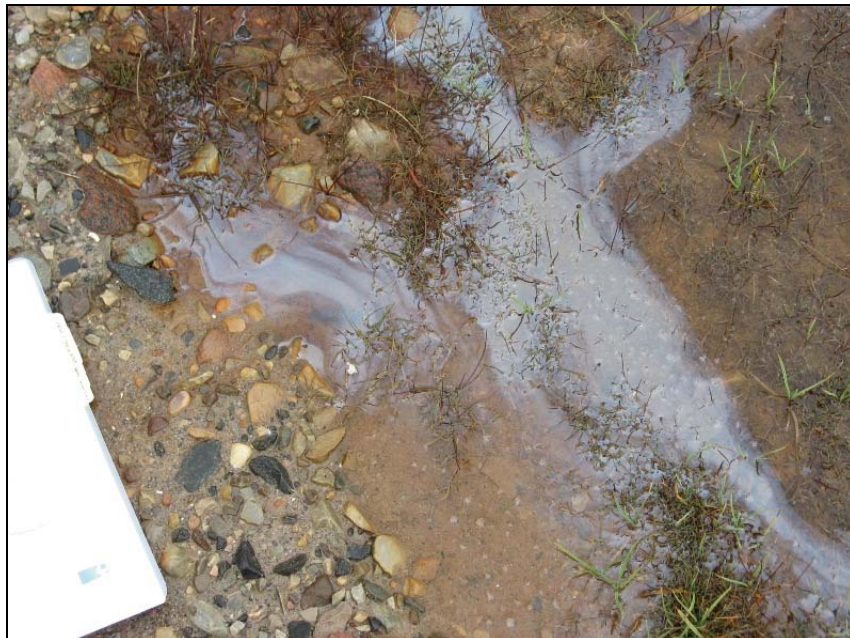
**Photograph SLF-6.** Close-up of typical "rainbow sheen". ↑

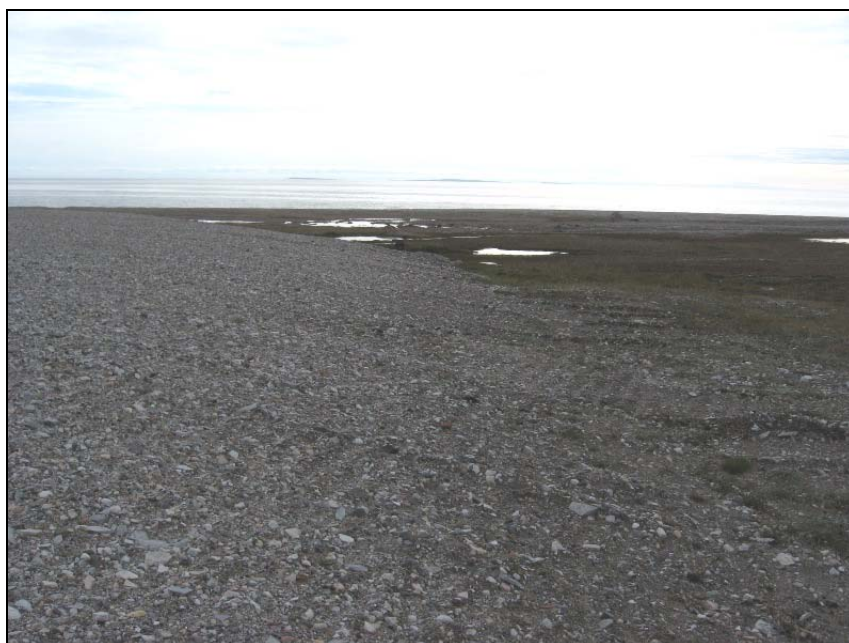
**Photograph SLF-10.** Looking S along W side of East cell. Abundant algae growth in ponded water adjacent to backpack. ↑

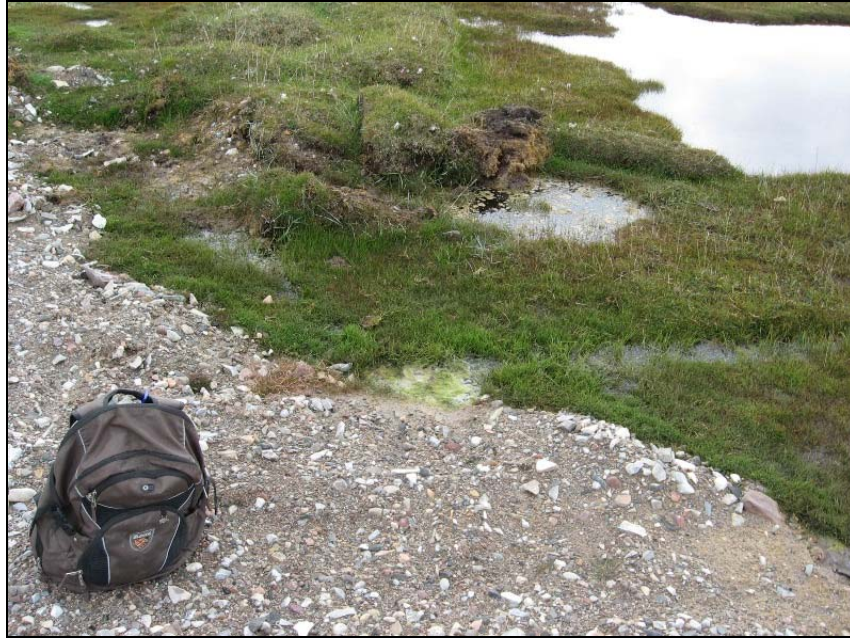
**Photograph SLF-11.** Algal growth close-up along W side of East cell. ↑

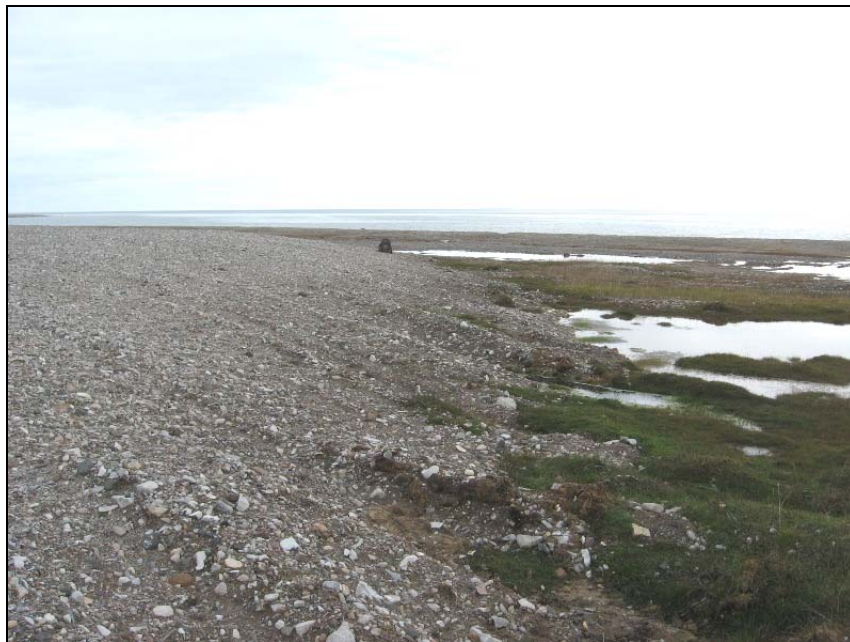
**Photograph SLF-12.** Looking SSE to SW corner of landfill. Abundant ponded water. ↑

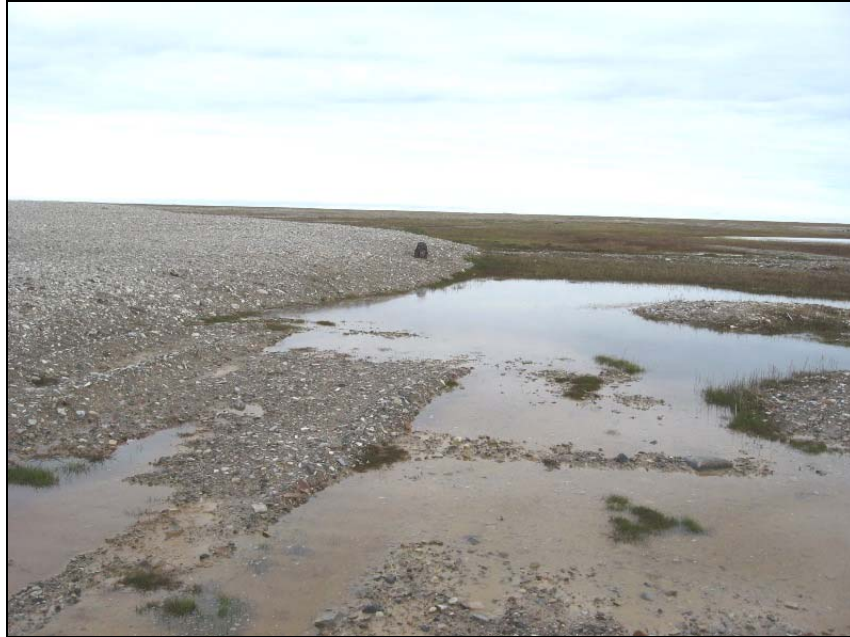
**Photograph SLF-15.** Looking ENE along south toe of East cell to the SE corner. Note large pond of water compared to previous two years. ↑

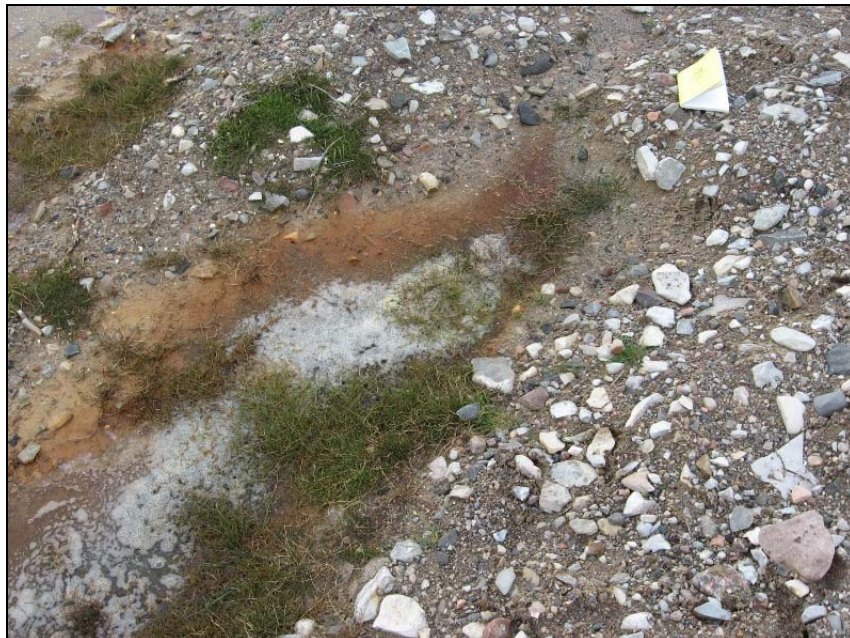
Vegetation Stress	No								
Seepage Points	Yes	Southeast corner of East Cell	1	1	surficial	point	Trickle of seepage flowing to rust stained ponded water	Photograph 16	Only one flowing point observed (slow trickle). High water level around perimeter of East Cell (relative to previous inspections).
Debris Exposed	No								
Presence/ Condition of Monitoring Instruments	No								
Other Features of Note.	No								
Additional Photos	Yes						Additional Photos	Photographs 1, 3, 5, 9, 10, 17, 18, 19, 21, 24, 27	General photos for documentation, no features of note

**Photograph SLF-16.** Close-up of seepage point along the southern perimeter of the East Cell. Same point photographed last 2 years. ↑

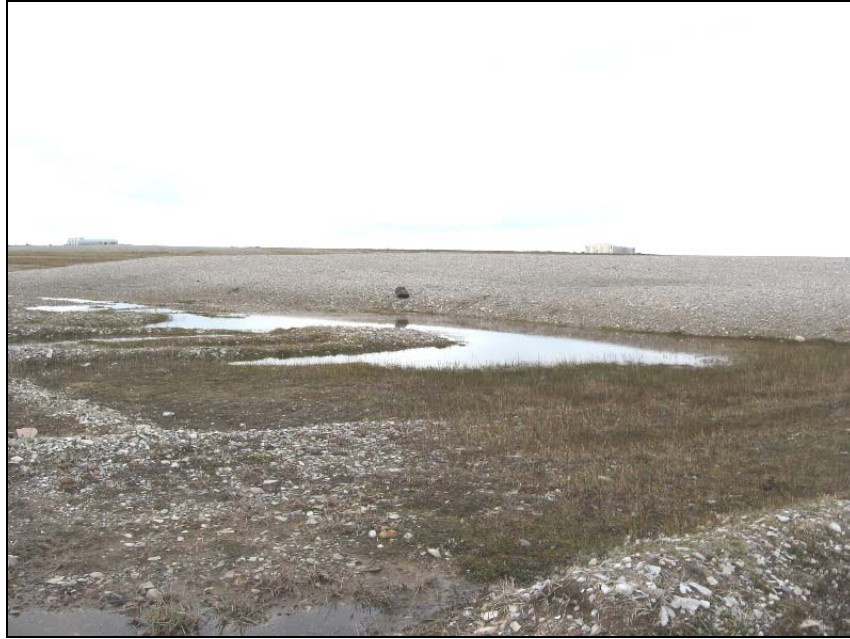
**Photograph SLF-17.** Looking NNW to area of known seepage adjacent to the SE corner of East Cell of the South Landfill. ↑

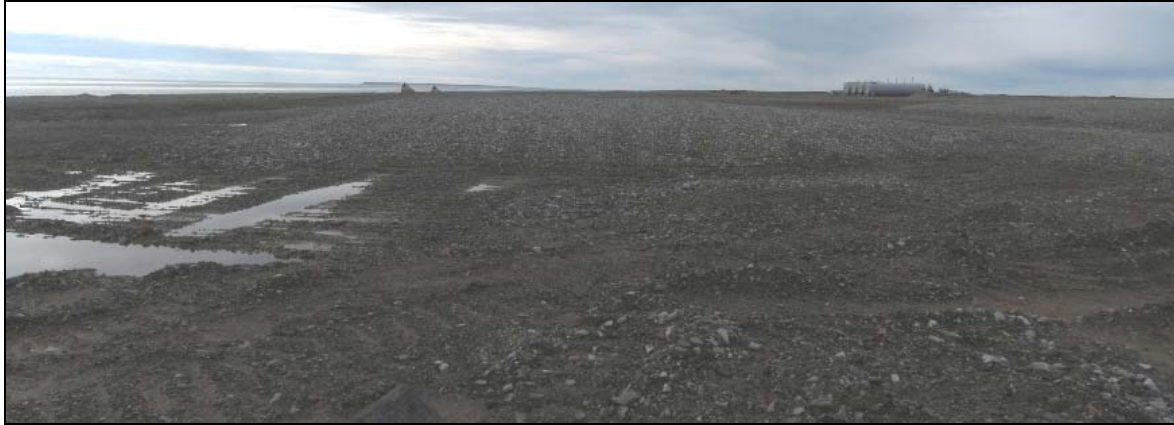
**Photograph SLF-19.** Looking W to E side of the south lobe of the West Cell. Note algal growth (bright green) at toe. ↑

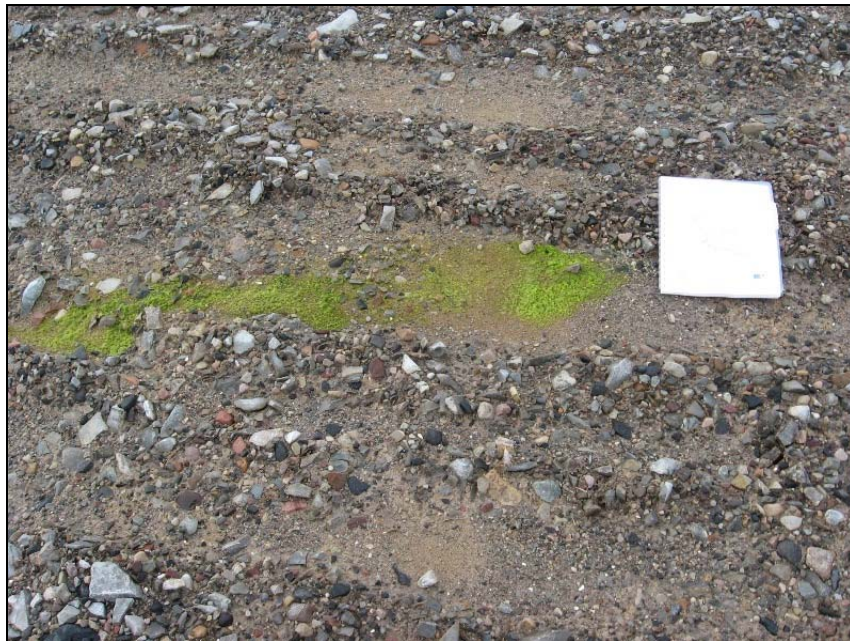
**Photograph SLF-20.** Close-up of algal growth along toe of eastern perimeter of the southern lobe of the West Cell. ↑

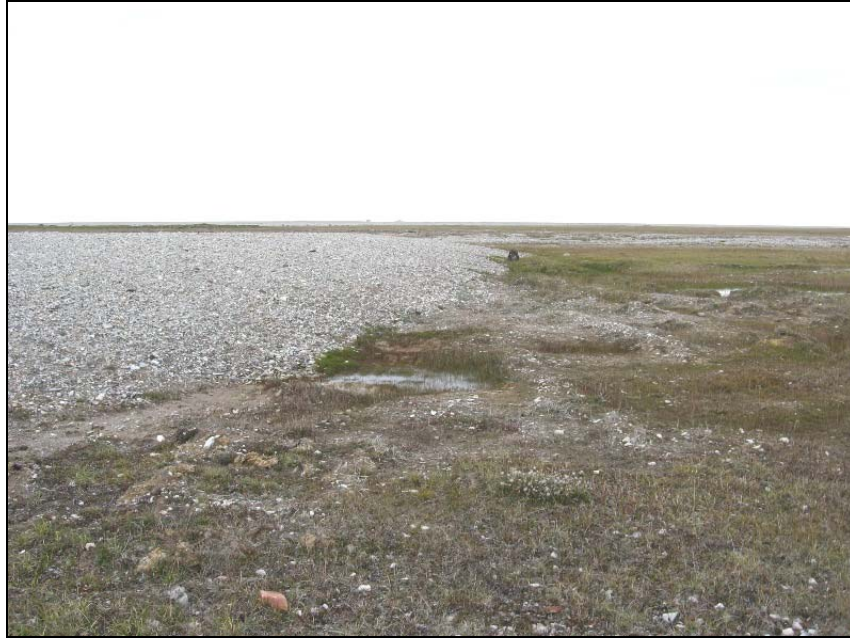
**Photograph SLF-21.** Looking N along E side of main (northern) lobe of the West Cell. ↑

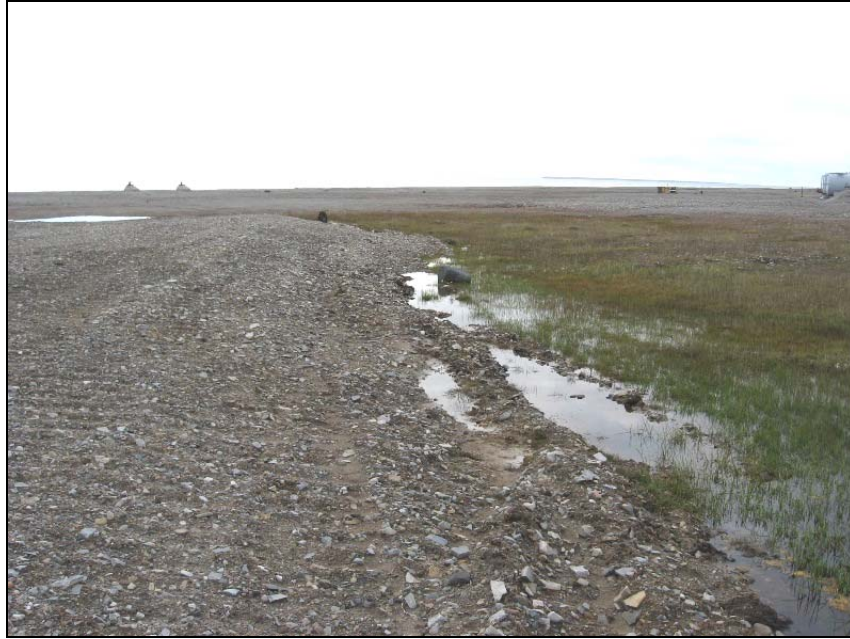
**Photograph SLF-25.** Looking W to the NW corner of North cell. Ponded water along most of toe. ↑

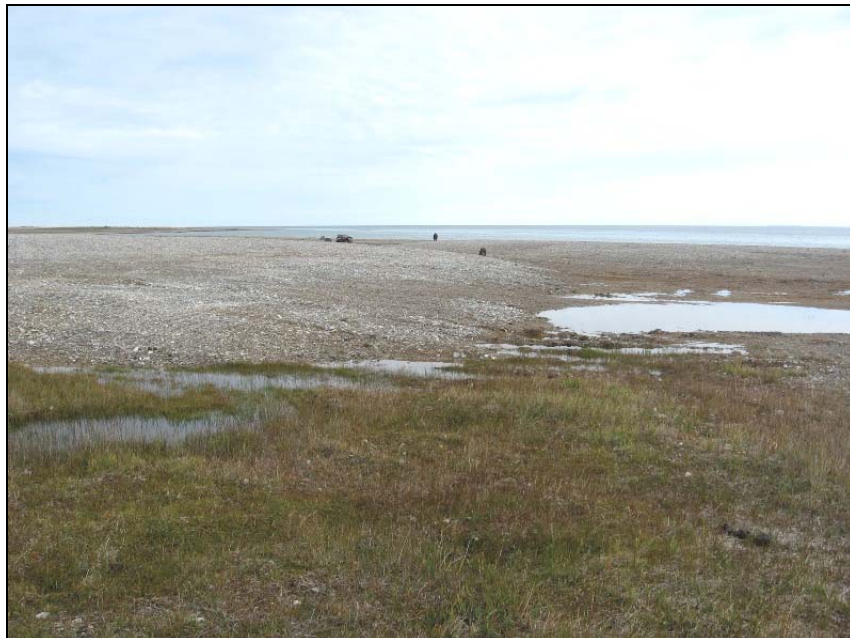
**Photograph SLF-26.** Looking SE from 15m NW of NW corner along W side of North cell. South lobe visible in background. ↑

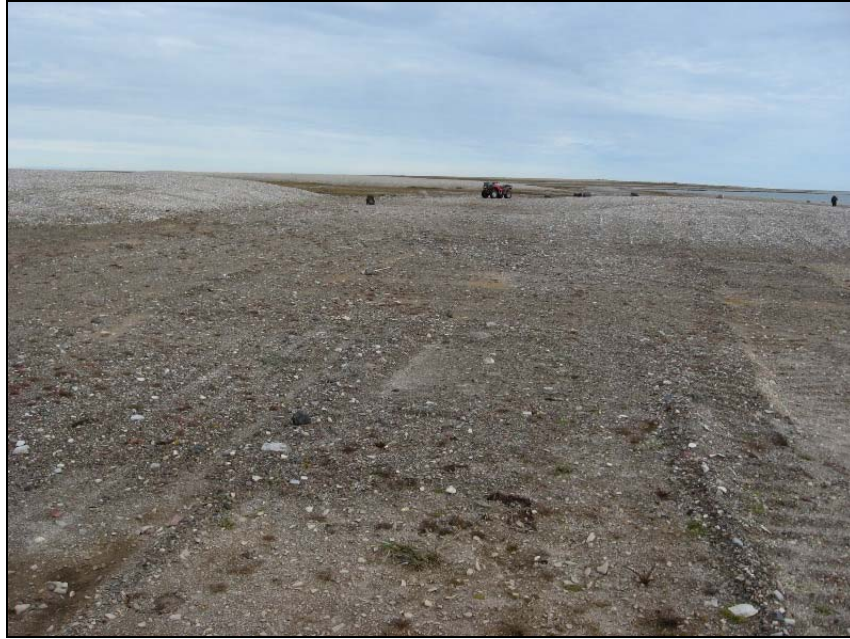
**Photograph SLF-27.** Looking E to East cell. Taken from ~25m W of NW corner of the South Landfill West southern lobe. Northern and southern portions of the West Cell are visible in the foreground. ↑

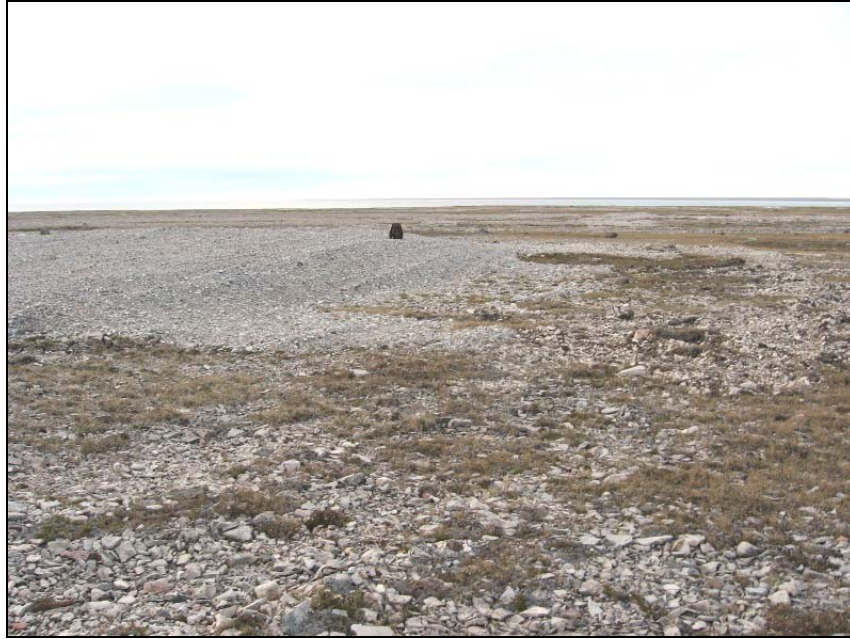
**Photograph NLF-1.** Looking N along E side of East cell from 20m S of SE corner. ↑

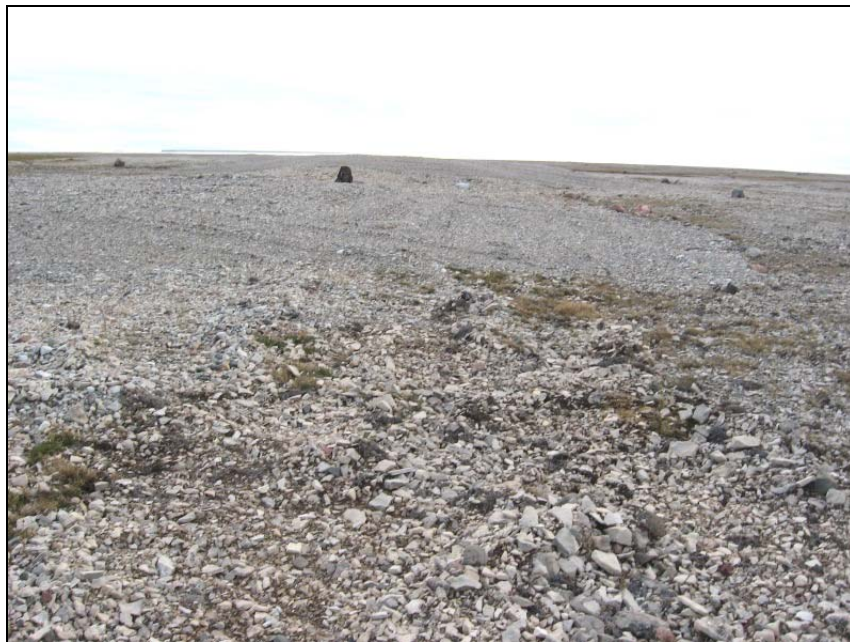
**Photograph NLF-2.** Looking W to NE corner of East cell. Central cell visible in background. ↑

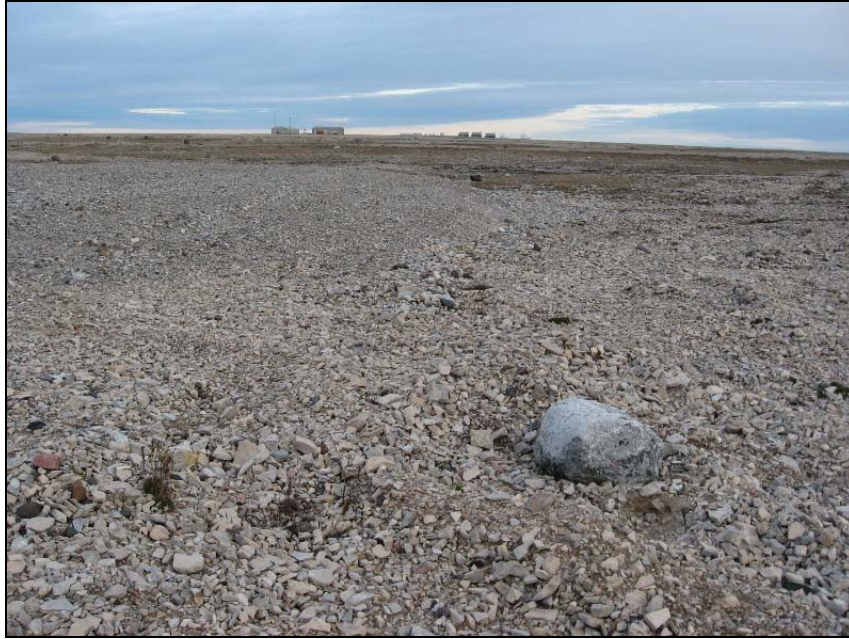
**Photograph NLF-3.** Looking S to NW corner of East cell. Backpack fallen over at SW corner. Radar balls visible in background. ↑

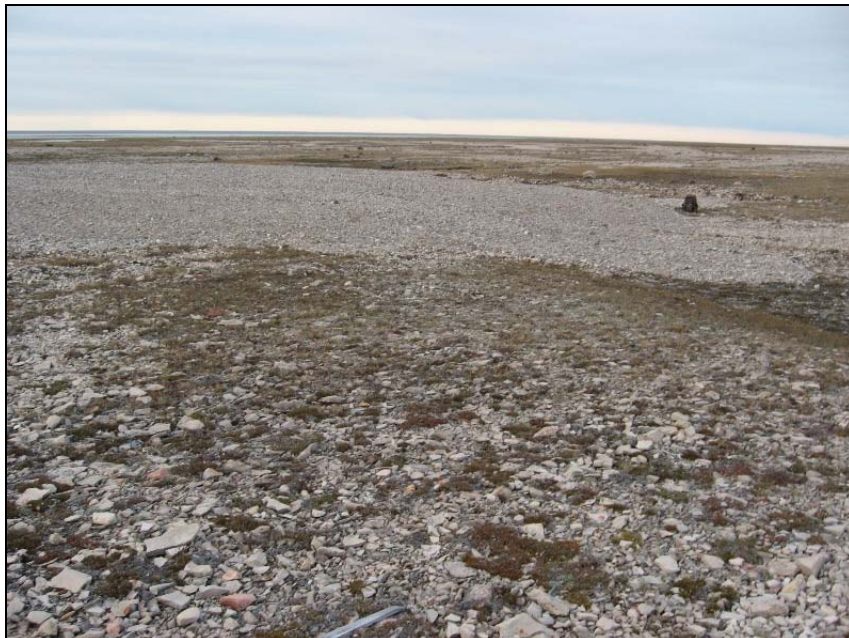
**Photograph NLF-4.** Looking NE to SE corner and S side of East cell. ↑

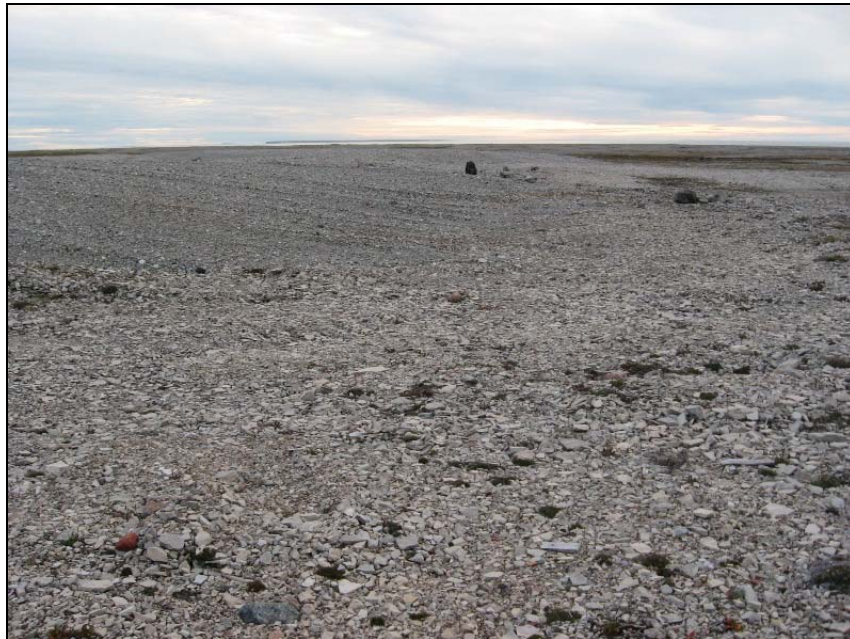
**Photograph NLF-6.** Looking W along N toe of Central cell from about 20m E of NE corner. ↑
