## **The Collection of Landfill Monitoring Data at the PIN-3 Lady Franklin Point Site – 2008**

**AECOM Canada Ltd.**

January, 2009

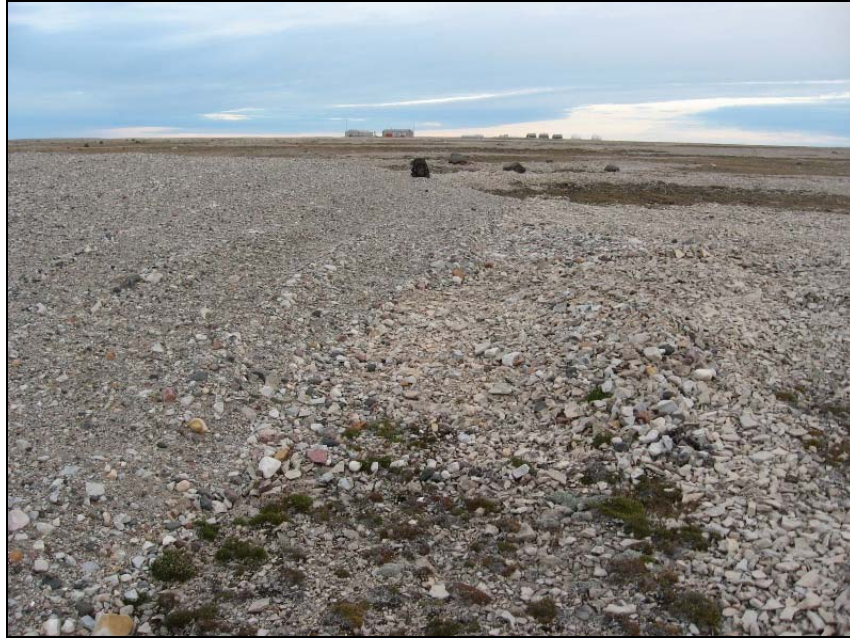
**Photograph NLF-7.** Looking S from NW corner to SE corner of central cell. ↑

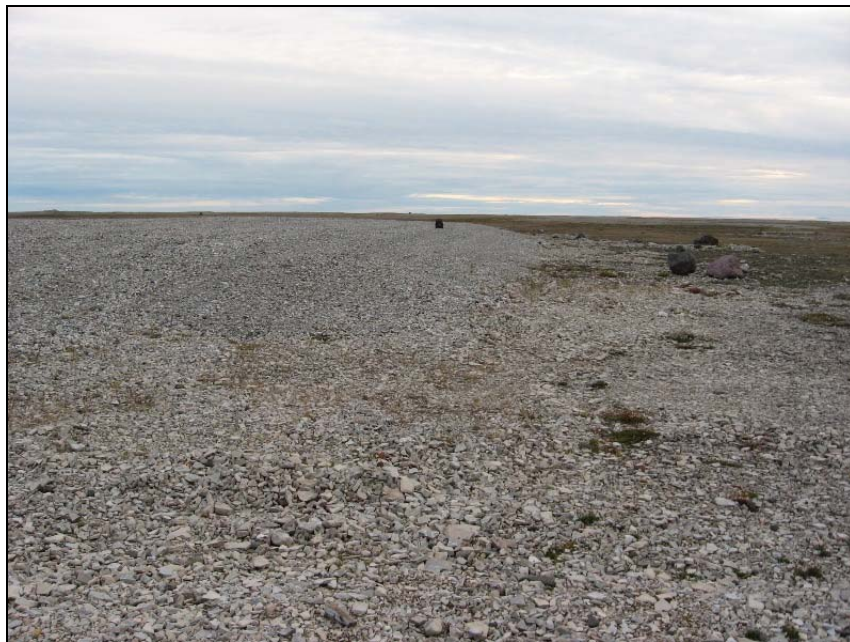
**Photograph NLF-8.** Looking WSW along N toe of West cell from 20m E of NE corner. ↑

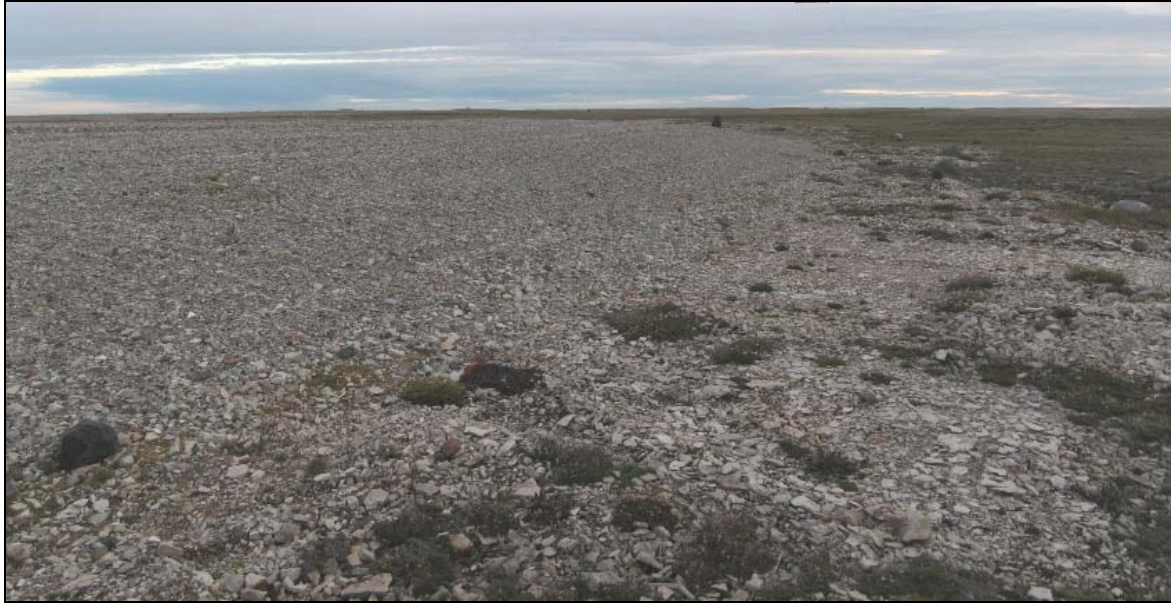
**Photograph NLF-9.** Panoramic looking WSW to NW corner along Central N side of West cell. ↑

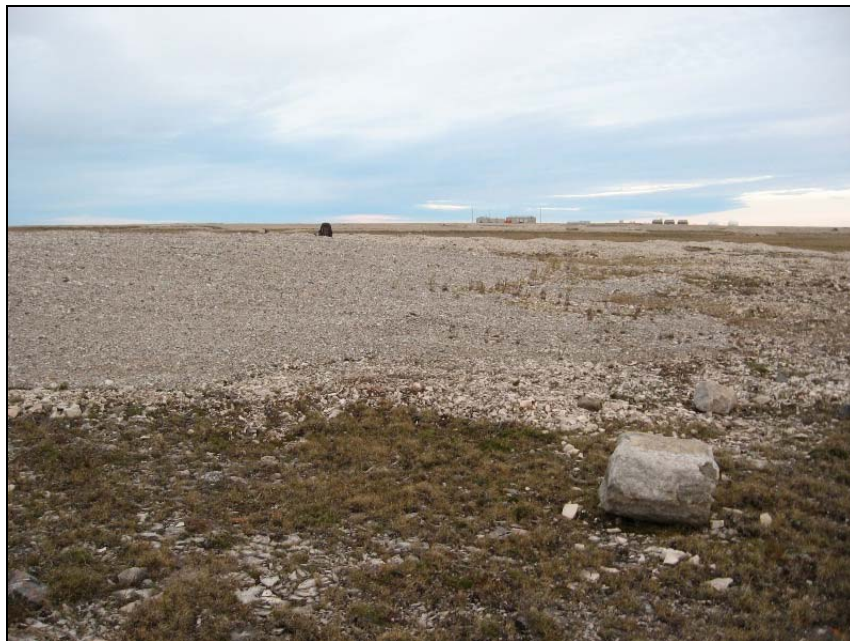
**Photograph NLF-10.** Looking SSE along W side of West cell from 15 m N of NW corner. Warehouse visible in distance. ↑

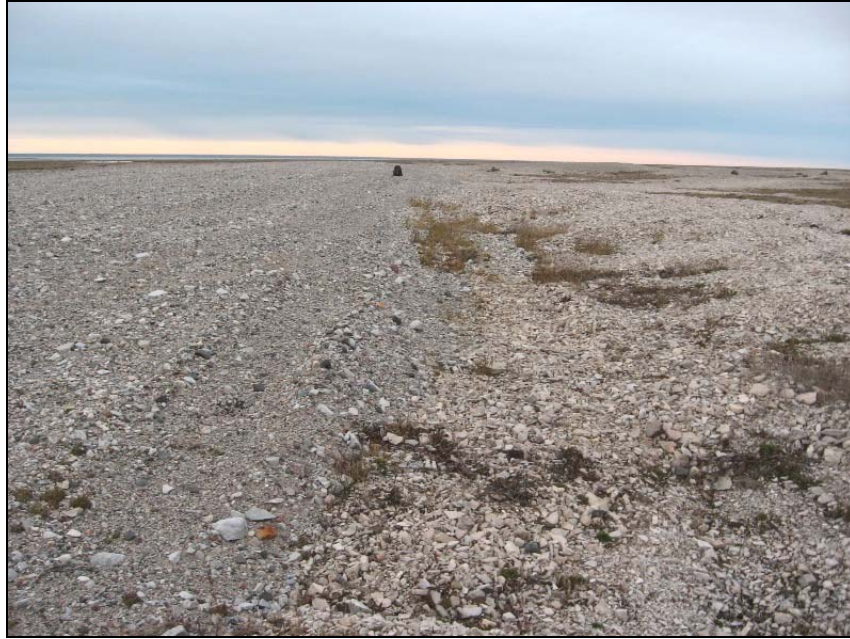
**Photograph NLF-11.** Looking ENE along S side of West cell from SW corner. ↑

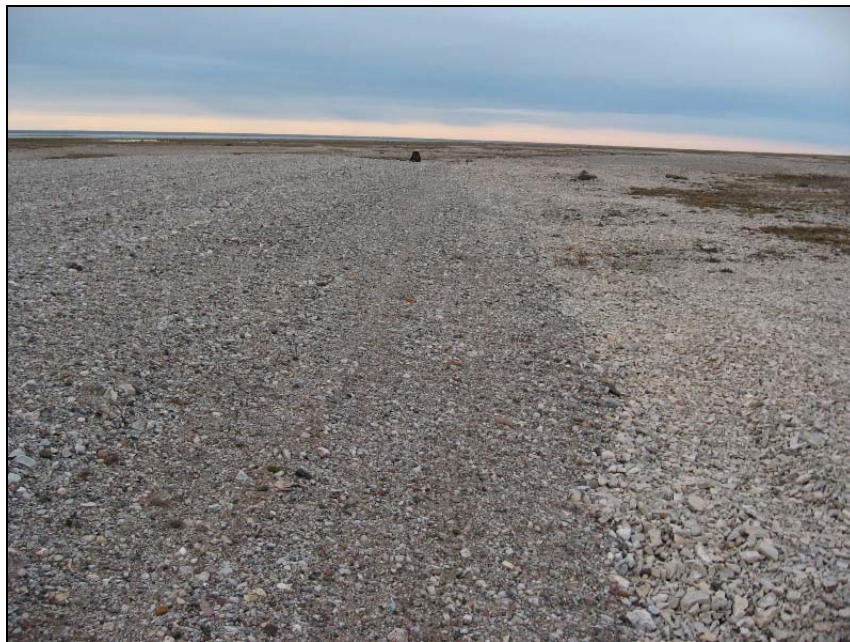
**Photograph NLF-12.** Looking ENE to the SE corner of West cell from central portion of S "crest". ↑

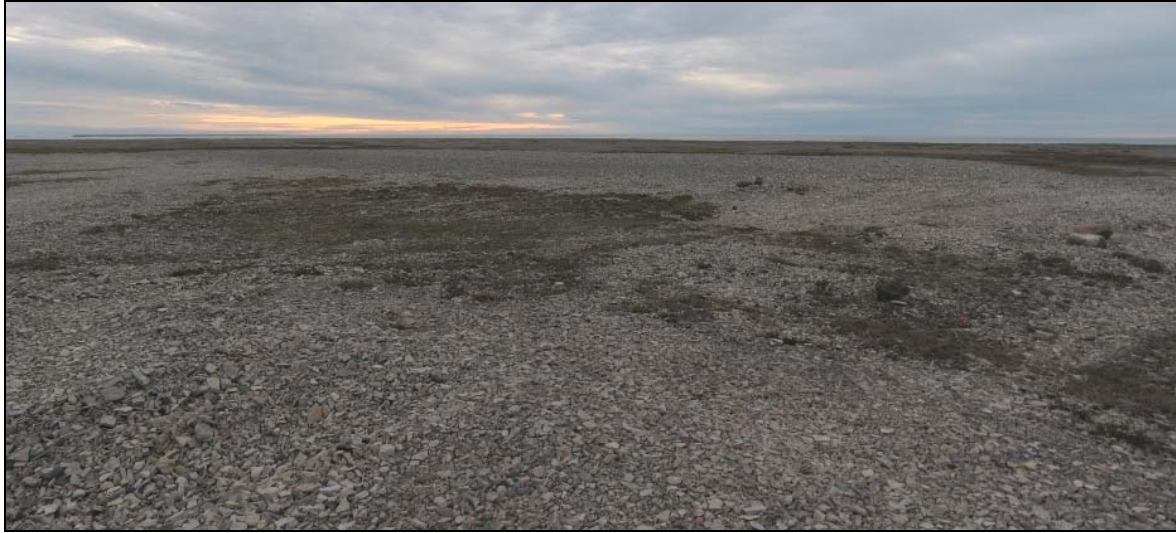
**Photograph NLF-13.** Looking NW to the SE corner of West cell. Panoramic showing eastern profile. ↑

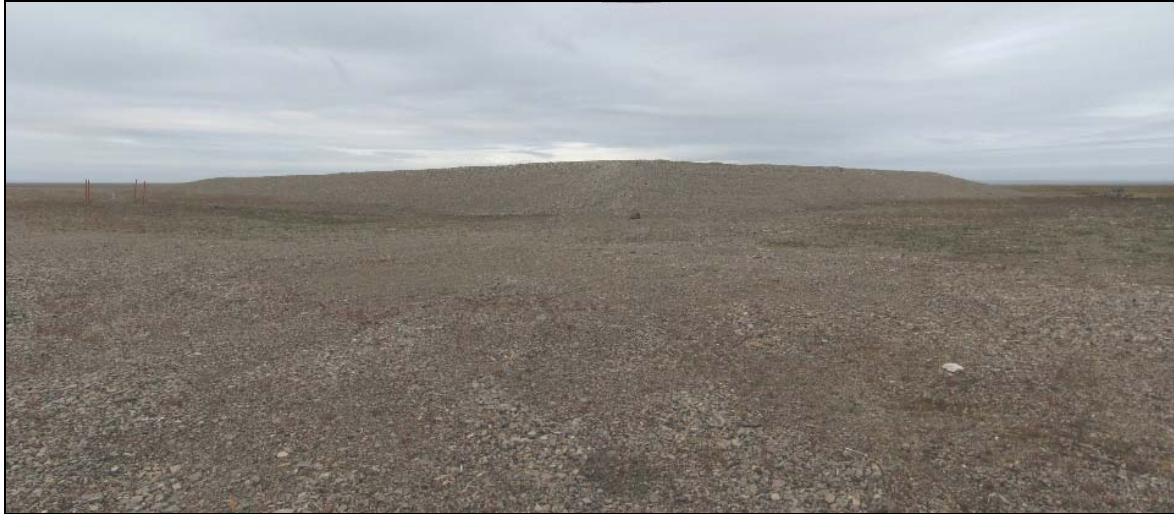
**Photograph NonHaz-1.**

Panoramic looking SW to NE corner. ↑

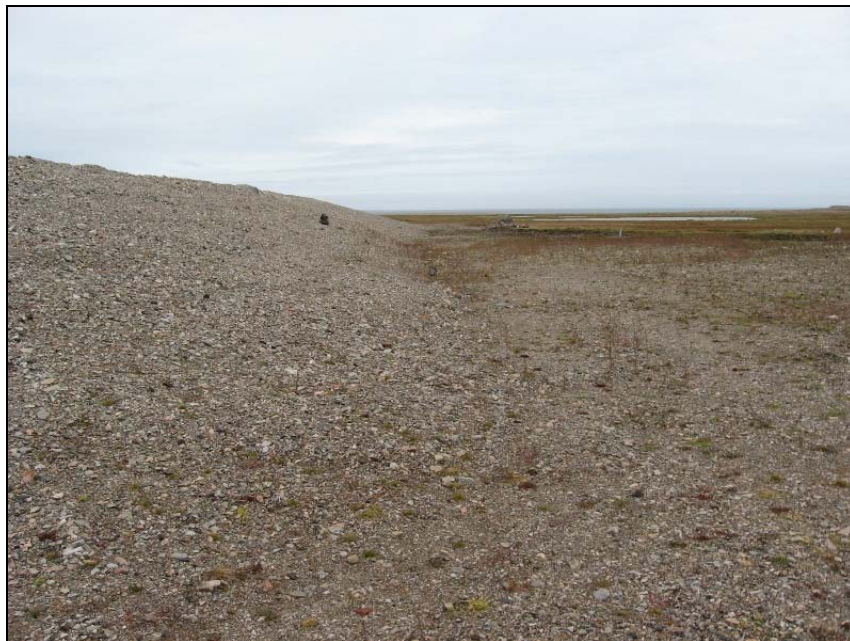
**Photograph NonHaz-2.**

Looking W along N toe from NE corner. MW-14 visible along right side of picture. ↑

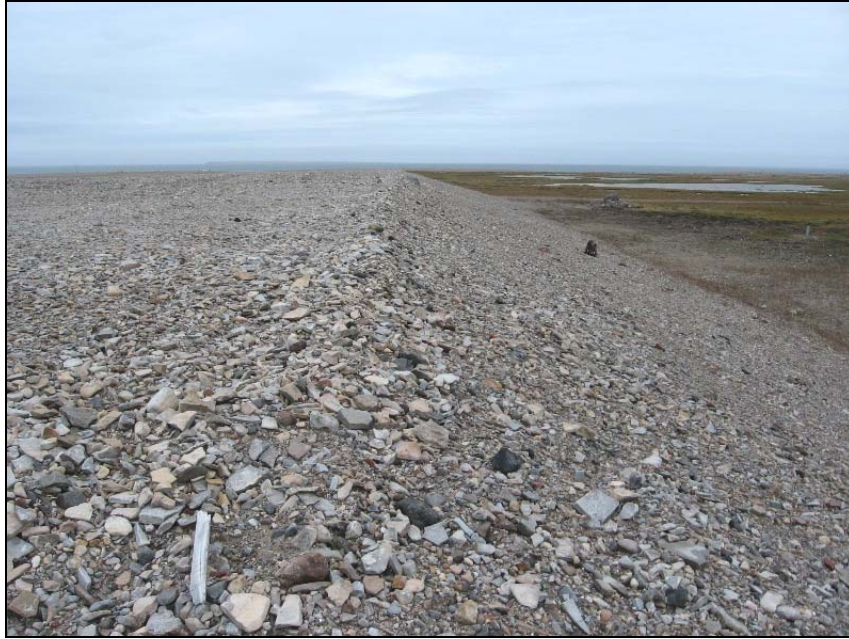
Damp, organic rich soil was observed adjacent to the toe of the landfill at several locations along the toe of the west and north slopes (refer to Photographs NonHaz-3 and NonHaz-7) where the landfill encroaches onto muskeg. There was no indication of seepage, slope instability or slope movement at any of these locations. The moist soil conditions are most likely associated with recent precipitation and a high water table.

**Photograph NonHaz-3.** Looking W along N crest from NE corner. 2m NE of NE crest. ↑

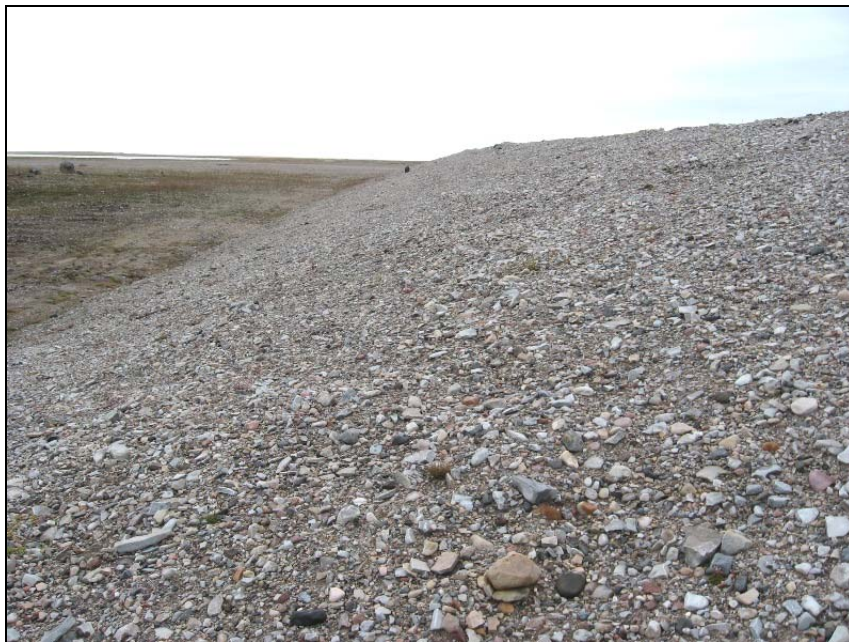
**Photograph NonHaz-4.** Looking E from midslope along NW corner. ↑

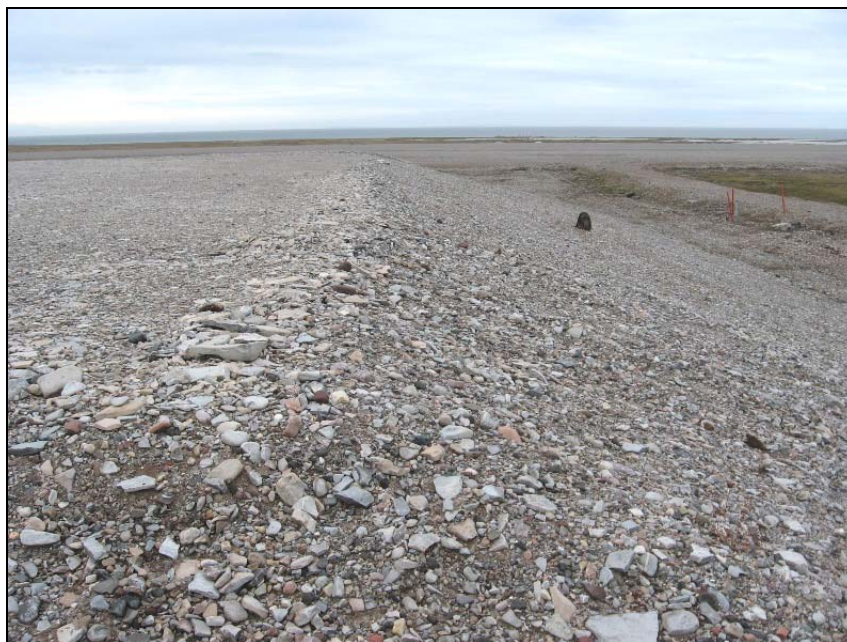
**Photograph NonHaz-5.**

Looking S along crest from NW corner. ↑

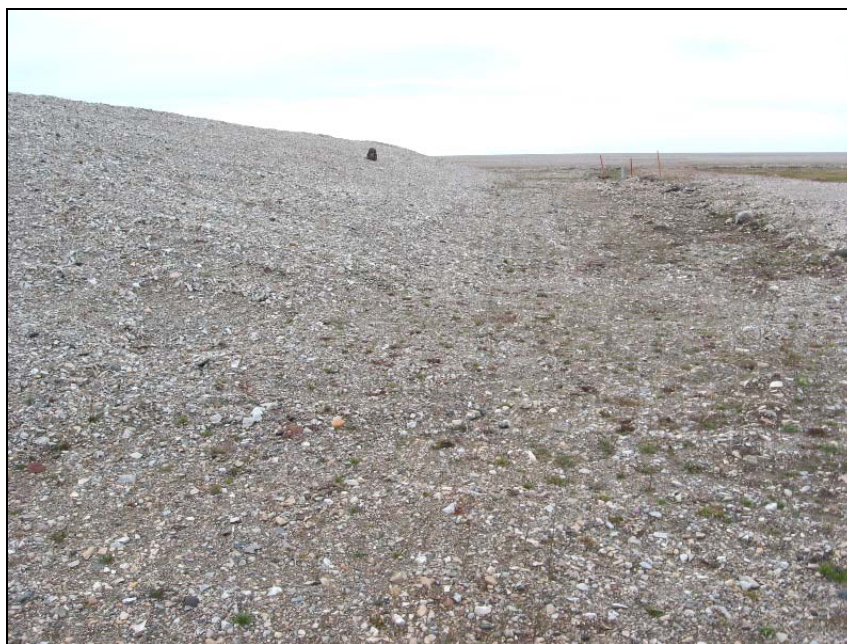
**Photograph NonHaz-6.**

Looking S along toe from NW corner. ↑

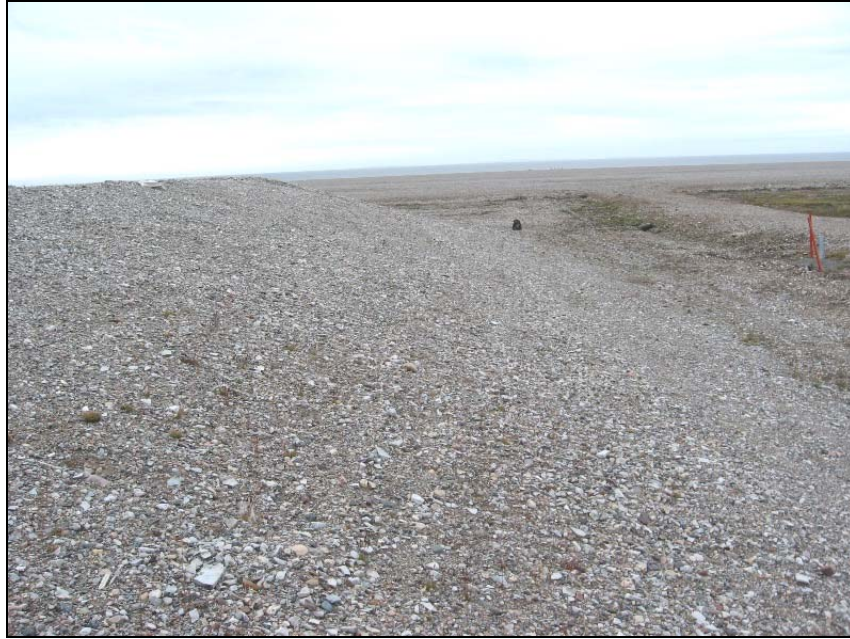
**Photograph NonHaz-7.**

Looking S along W toe from about 1/3 south of the NW corner.  
MW-15 visible to the right. ↑

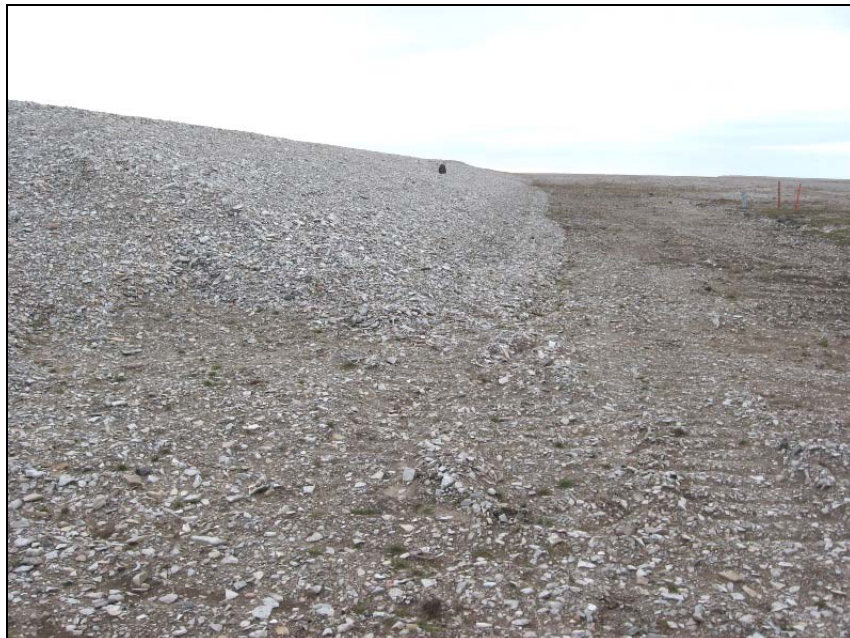
**Photograph NonHaz-8.**

Looking E along S toe from near SW corner. MW-16 visible in  
frame. ↑

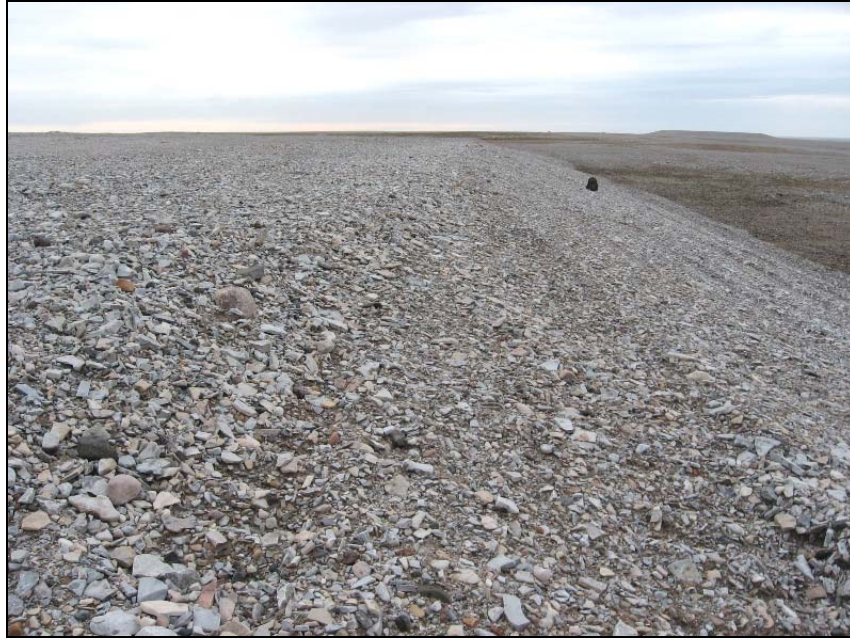
**Photograph NonHaz-9.** Looking E along crest from SW corner. Note final granular capping layer does not extend all the way to original granular side slope (i.e. ends abruptly, does not grade uniformly). ↑

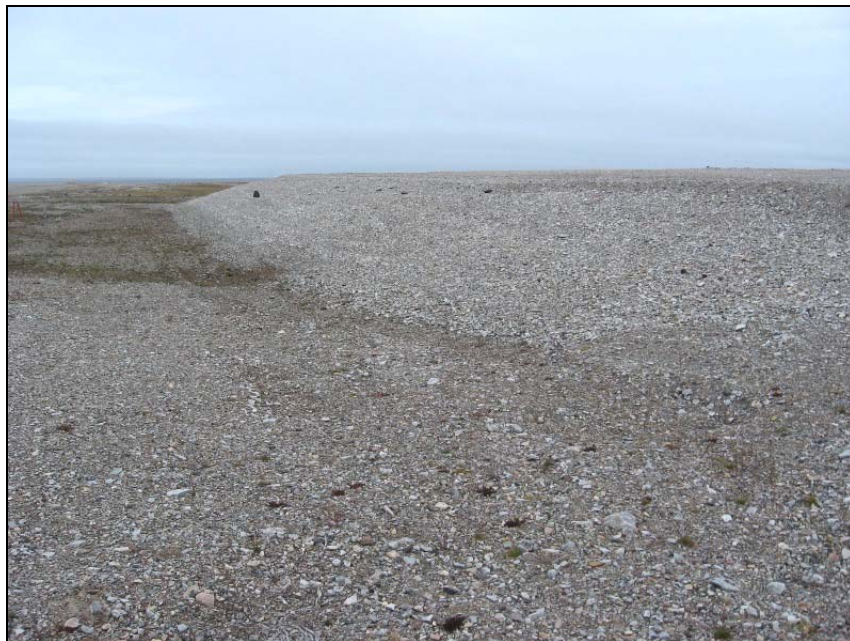
**Photograph NonHaz-10.** Looking WNW along S toe from about 10m SE of SE corner (near beginning of access ramp). ↑

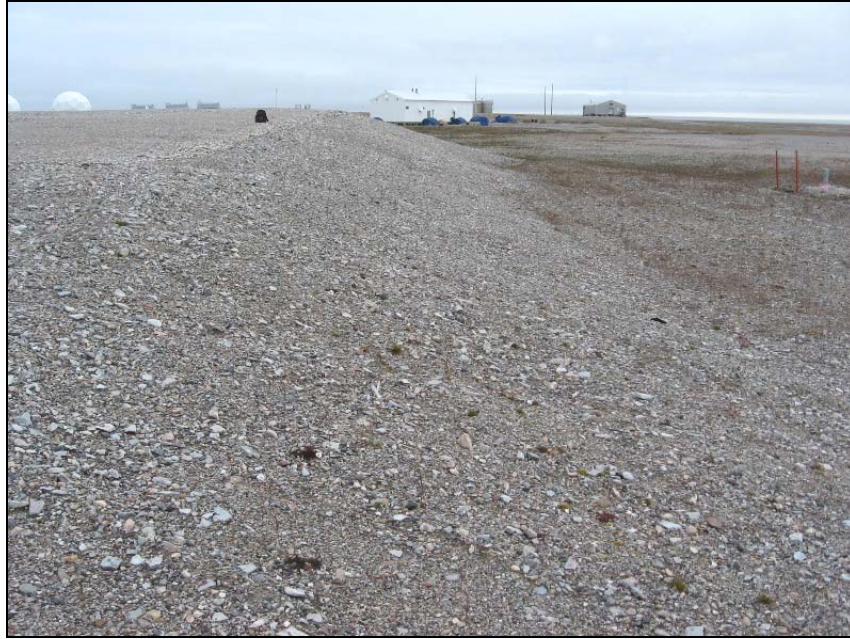
**Photograph NonHaz-11.** Looking N towards camp from midslope on the SE corner. ↑

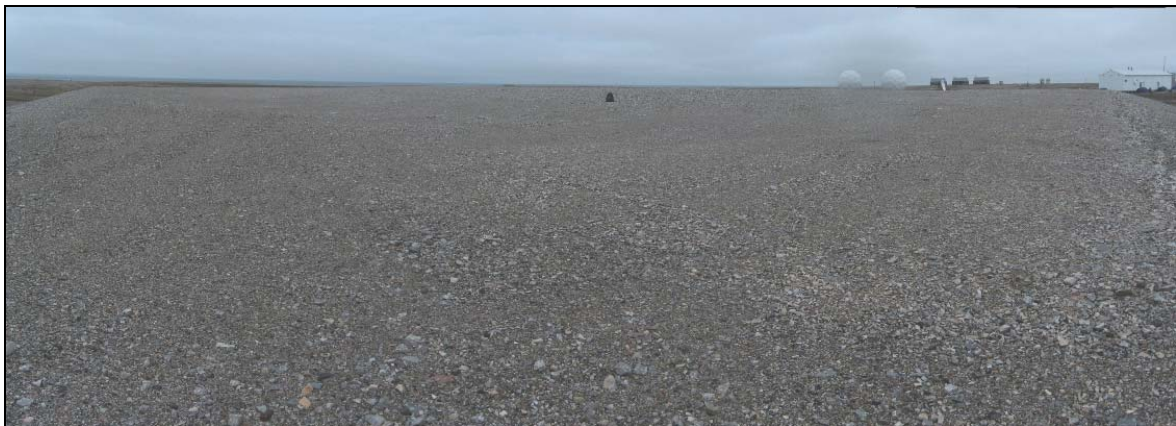
**Photograph NonHaz-12.** Panoramic from SE corner scanning L to R starting near SW corner. ↑

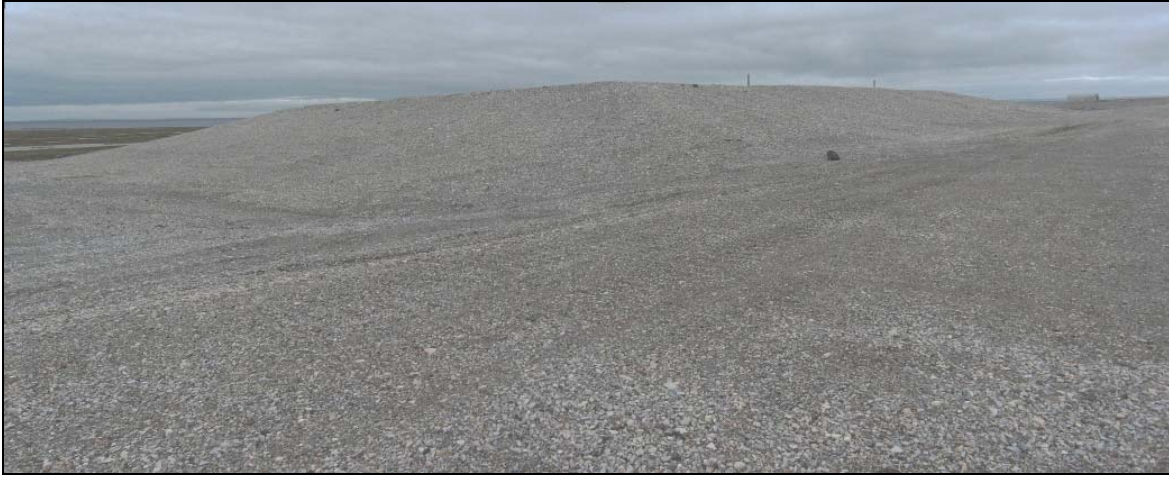
**Photograph T2-1.** Looking SE to NE corner from about 25m NE of NE corner. ↑

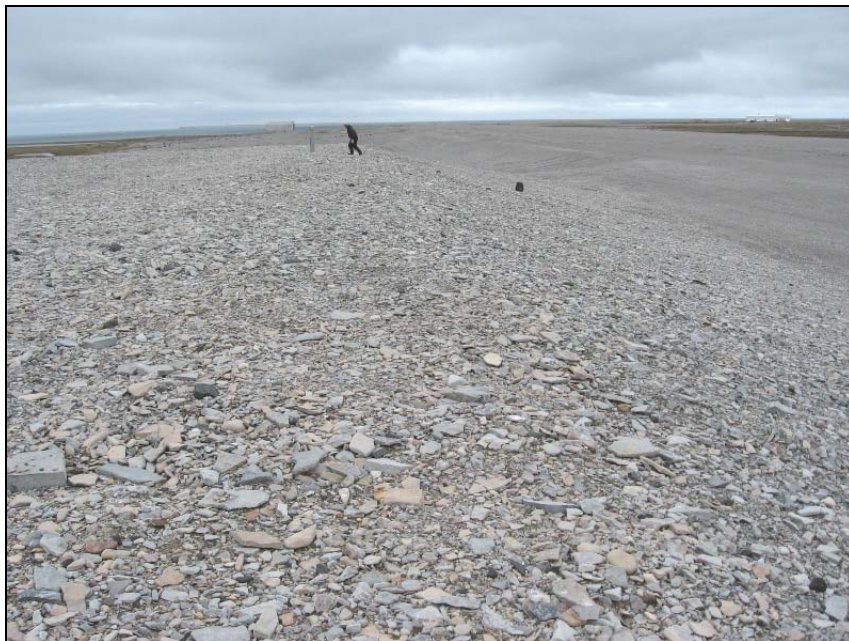
**Photograph T2-4.** Looking W along crest of N face from adjacent to VT-6. Looking to VT-5. A large zone of depression (approx. 10m x 10m and up to 0.5m deep) centred about 12m north of VT-5 appears unchanged from previous inspection. No indications of slope movement. ↑

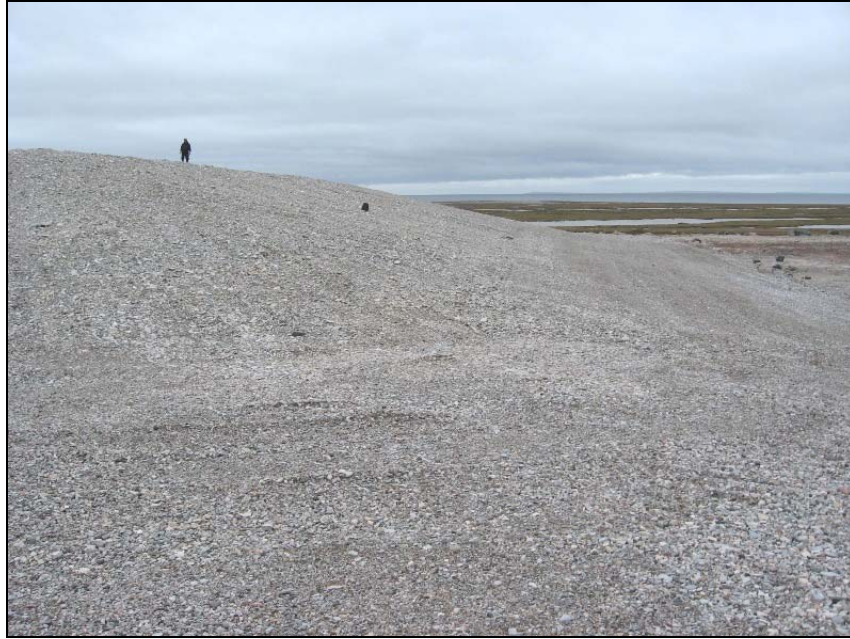
**Photograph T2-7** Looking S along downstream toe of W slope from about 20m N of NW toe. Broad zones of depression are visible which is consistent with poor construction finish. There is no evidence of slope instability. ↑

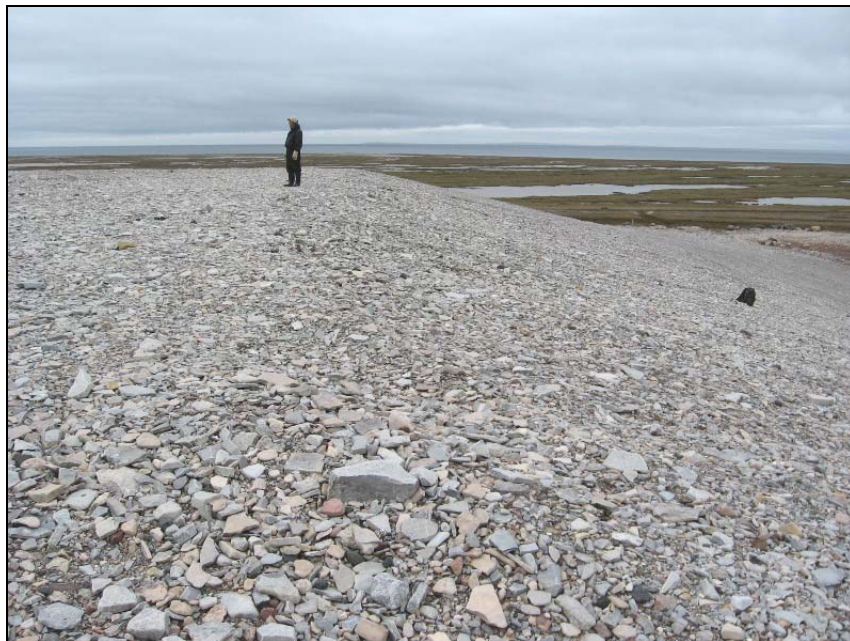
**Photograph T2-8.** Looking S along crest from NW corner. ↑

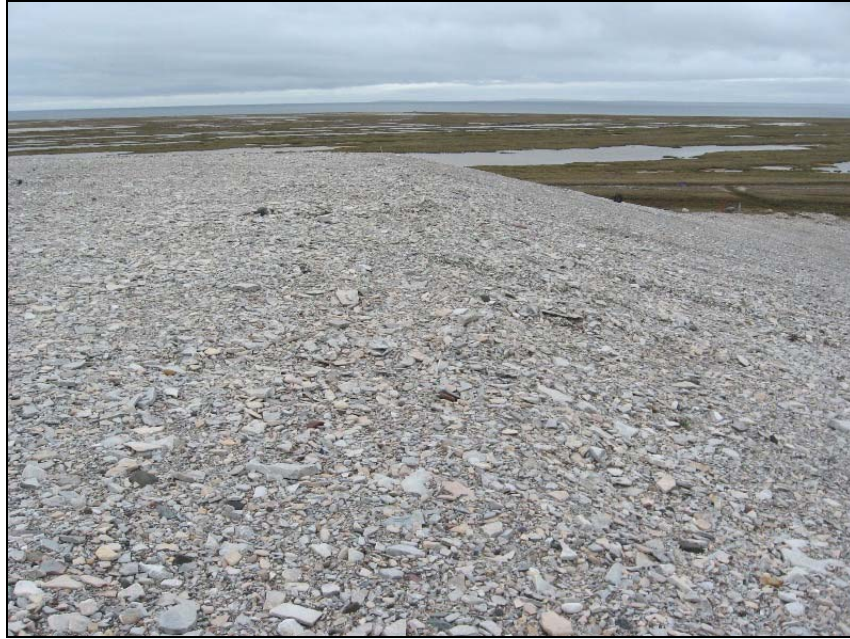
**Photograph T2-9.** Looking S along W crest from about midway towards S slope. No features of note. ↑

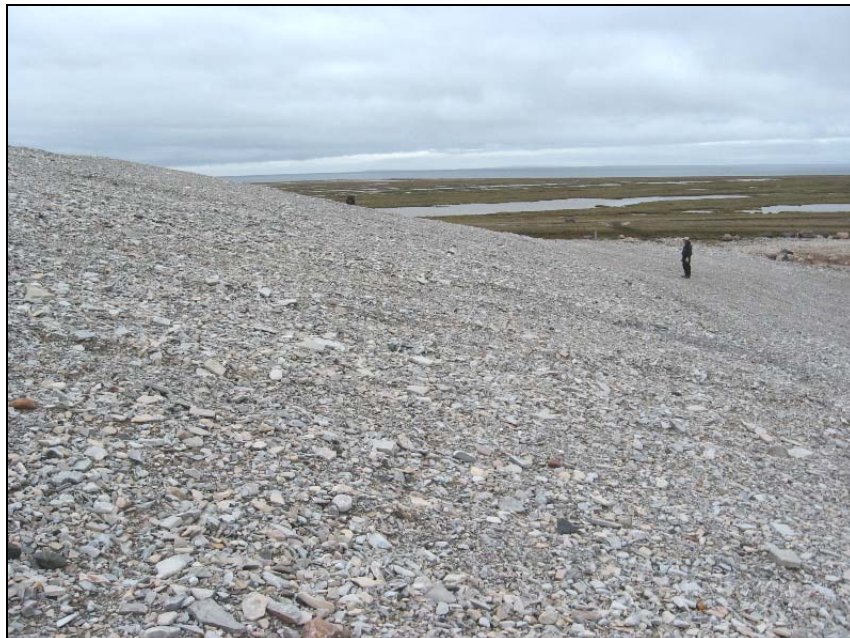
**Photograph T2-10.** Looking S along W slope from about midslope. No features of note. Slope appears stable. ↑

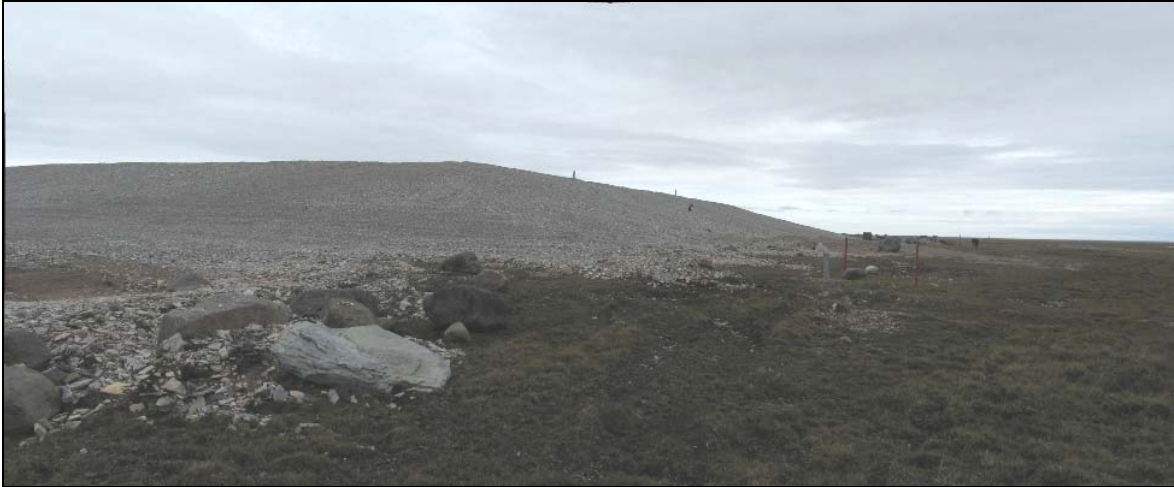
**Photograph T2-11.**

Looking NE to SW corner of the landfill. MW-10 visible in the foreground. ↑

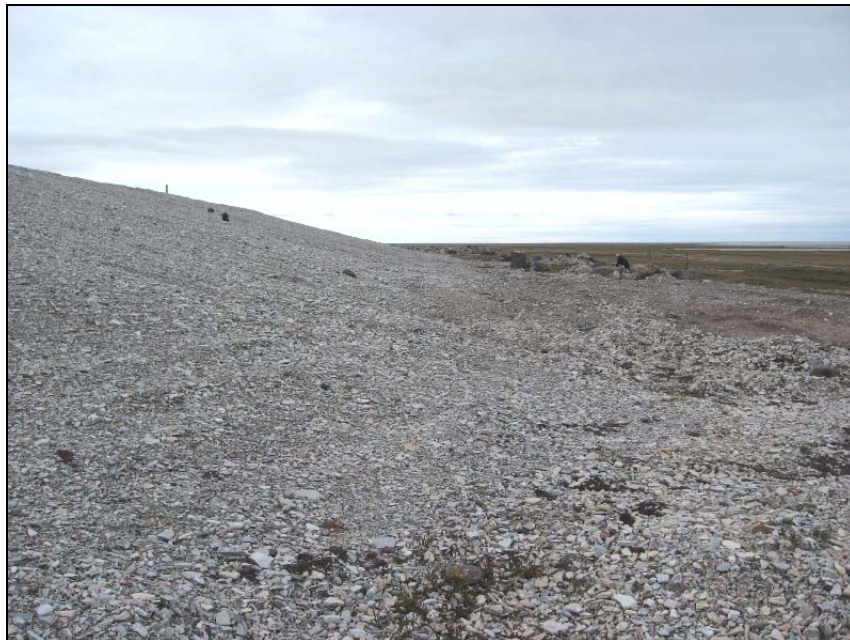
**Photograph T2-12.** Looking E along S slope from partway up slope near SW corner. MW-11 visible in distance to the south of the toe of slope. Slope has relatively gentle grade and abuts into organic layer. No indications of slope instability. ↑

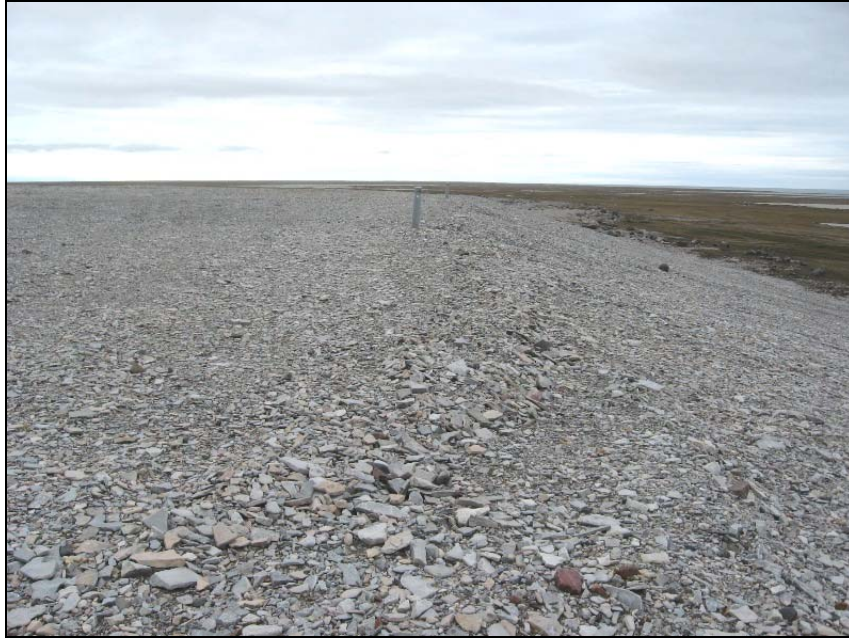
**Photograph T2-13.** Looking E from SW crest of the LF. VT-7 in foreground, VT-8 further away. Deep rutting (up to 0.5m deep x 1m wide x 5 m long) appears to be a construction remnant. The rut is self armoured and not susceptible to further erosion. ↑

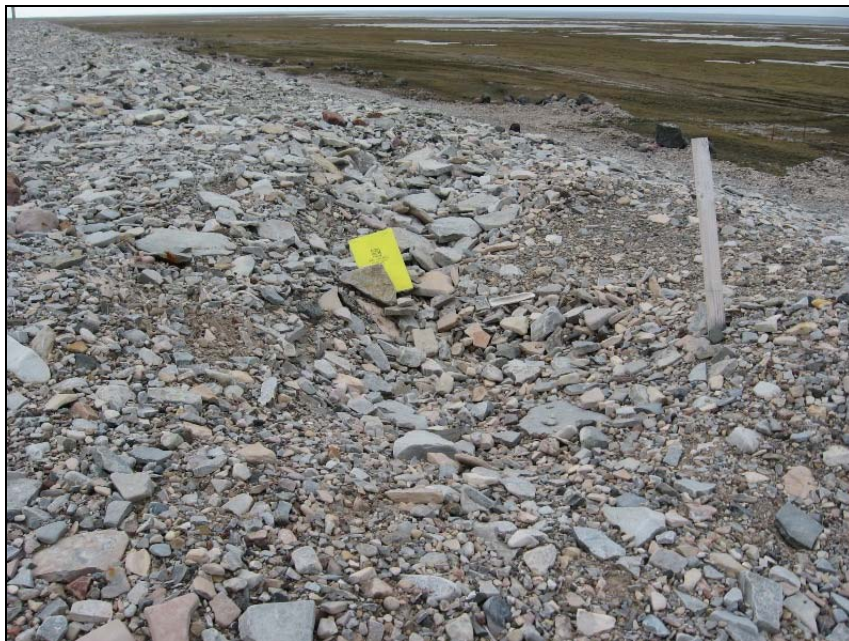
**Photograph T2-14.** Close-up of deep rut along crest of SW corner. Unchanged from previous two inspections. ↑

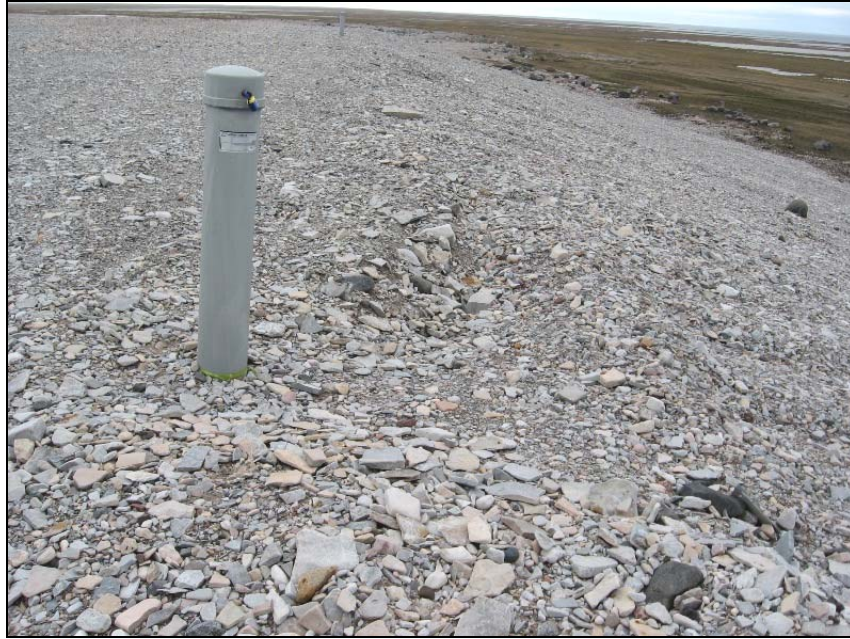
**Photograph T2-15.** Close-up of deep rut adjacent to VT-7. Unchanged from previous two inspections. The rut is self armoured and not susceptible to further erosion. No indications of slope instability. ↑

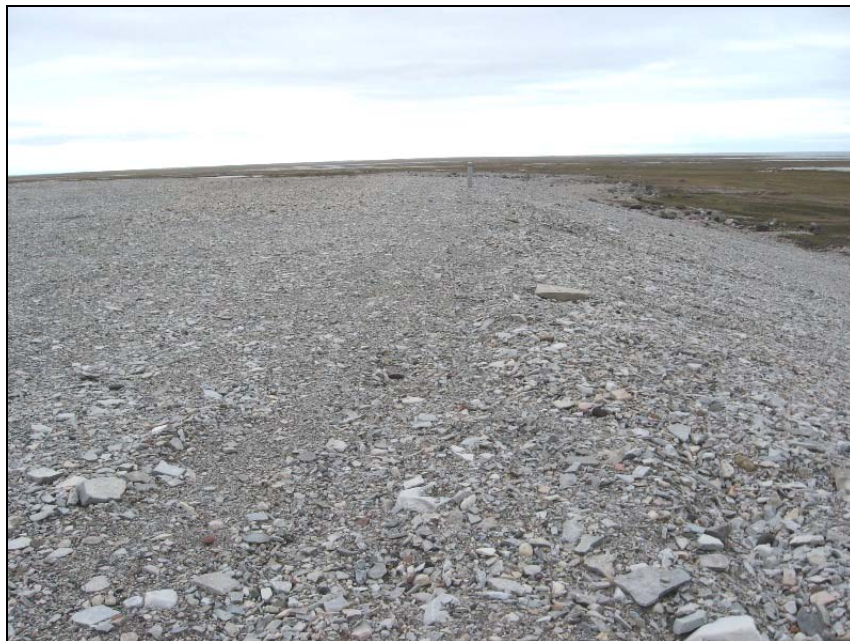
**Photograph T2-16.** Looking E along crest to VT-8 from adjacent to VT-7. No features of note. ↑

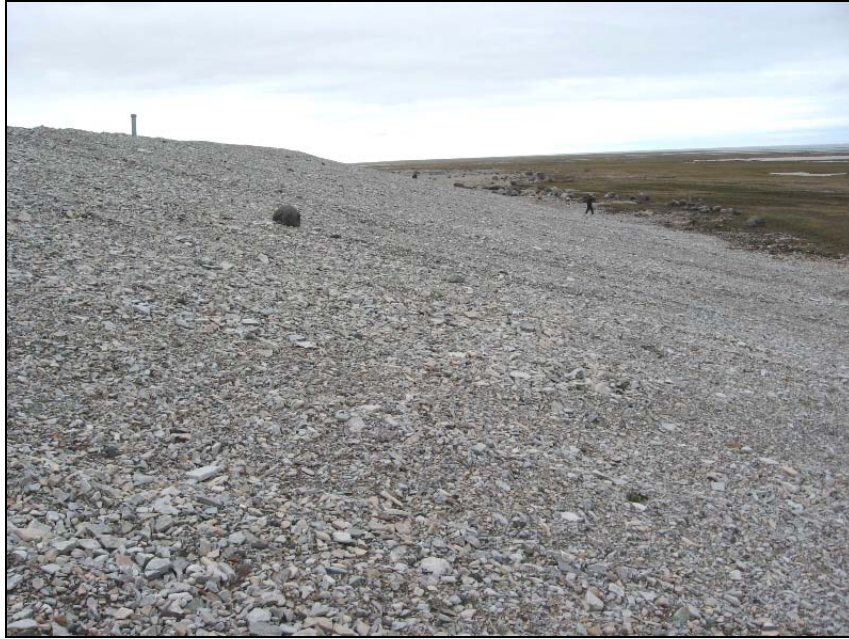
**Photograph T2-17.** Looking E from mid-slope of the S slope. VT-8 visible along crest. No features of note. ↑

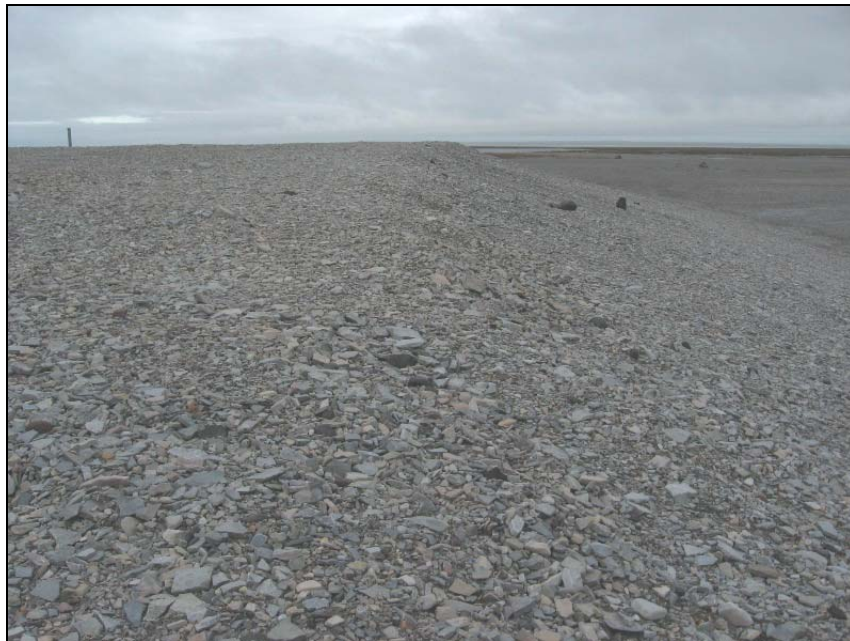
**Photograph T2-20.** Looking N along E crest from about SE corner. Significant vehicle ruts and inconsistent construction finish in the area. Slope appears stable and the surface irregularities are self armoured and not susceptible to further erosion. ↑

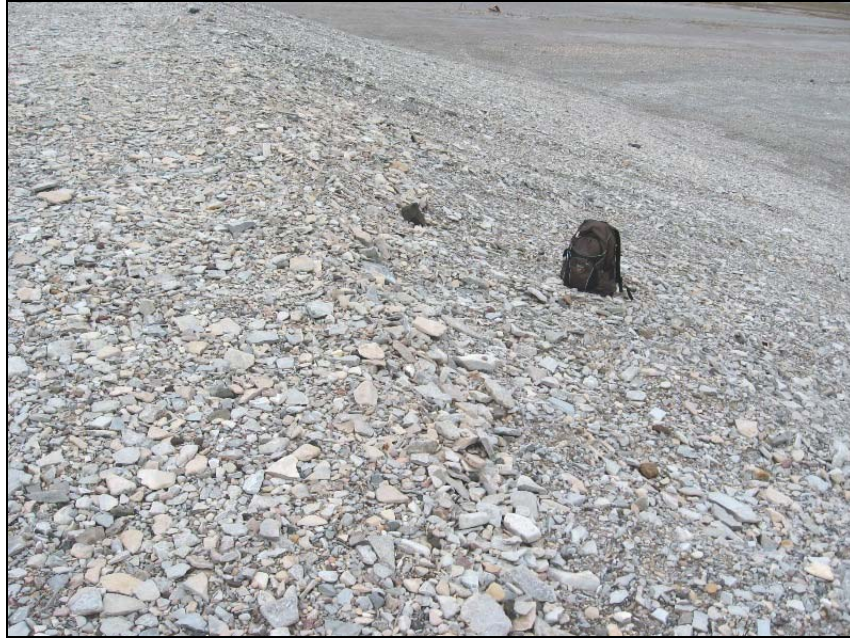
**Photograph T2-21.** Close-up of ruts, looking NE from crest of E slope, about 25 m N of SE corner of landfill. ↑

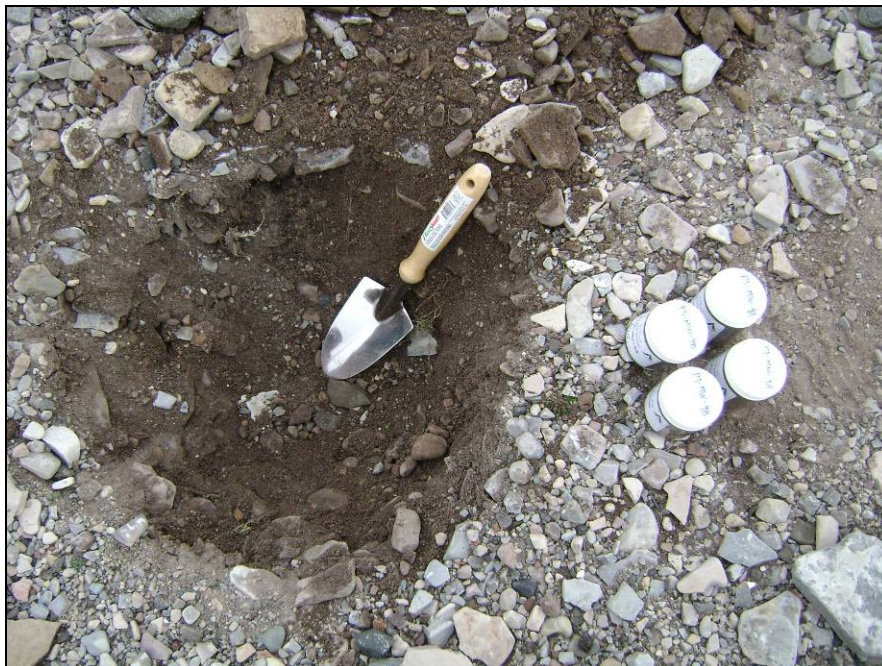
**Photograph 2.** Test pit at MW-9. Samples P3-MW-9A and P3-MW-9B collected. ↑

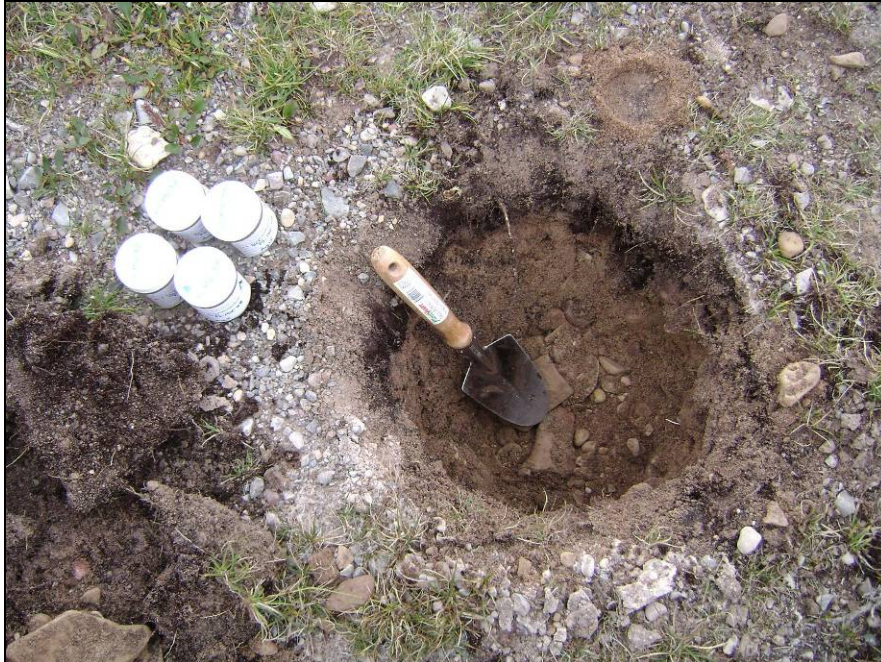
**Photograph 3.** Test pit at MW-10 – Samples P3-MW-10A and P3-MW-10B collected.  
NOTE: photo of MW-10 was inadvertently deleted and is unrecoverable, however the well appeared unchanged from 2007 upon inspection. ↑

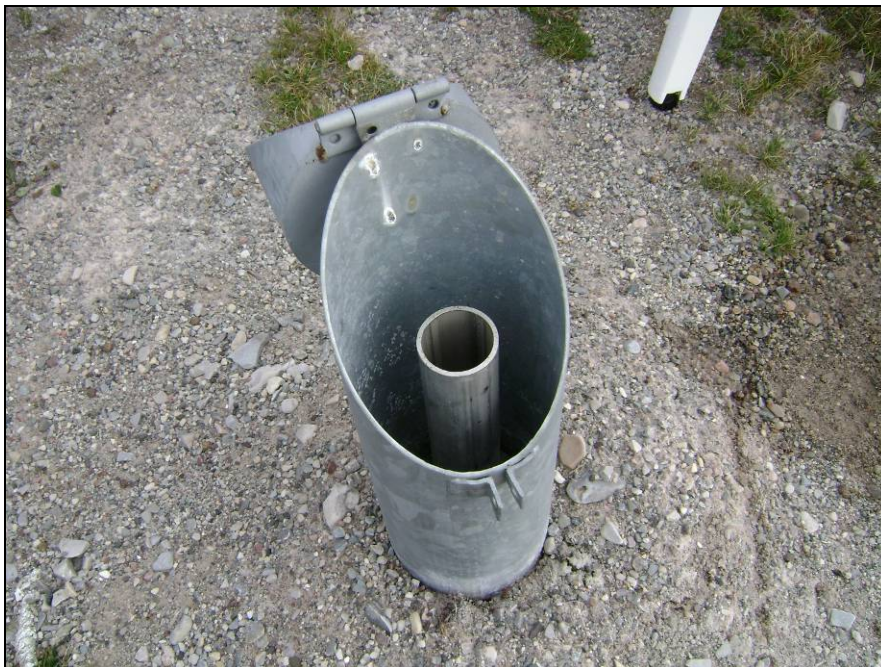
**Photograph 4.** Monitoring well MW-11. Sample P3-MW-11 collected. ↑

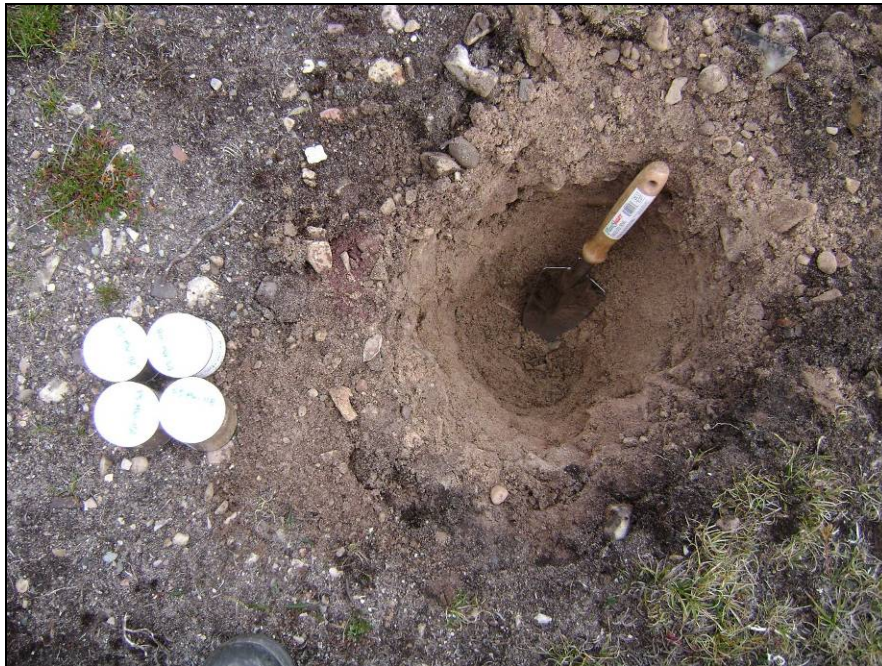
**Photograph 5.** Test pit at MW-11. Samples P3-MW-11A and P3-MW-11B collected. ↑

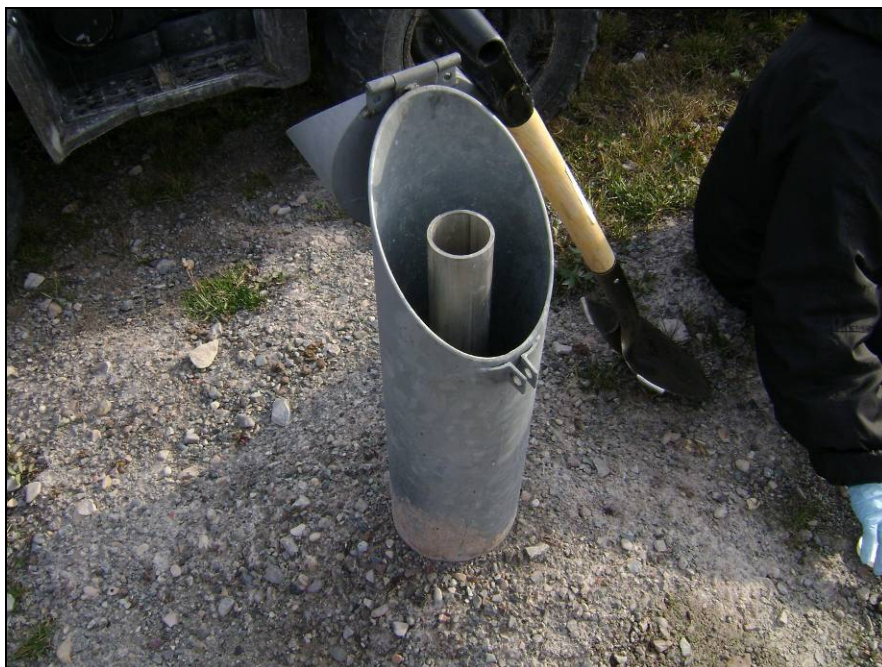
**Photograph 6.** Monitoring well MW-12. Sample P3-MW-12 collected. ↑
