## **The Collection of Landfill Monitoring Data at the PIN-3 Lady Franklin Point Site – 2008**

**AECOM Canada Ltd.**

January, 2009

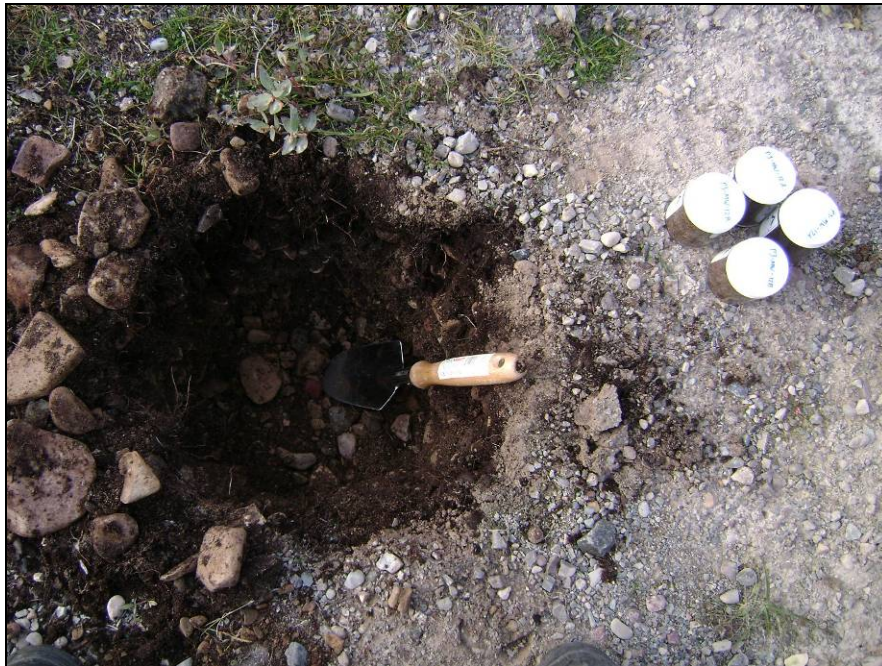
**Photograph 7.** Test pit at MW-12. Samples P3-MW-12A and P3-MW-12B collected. ↑

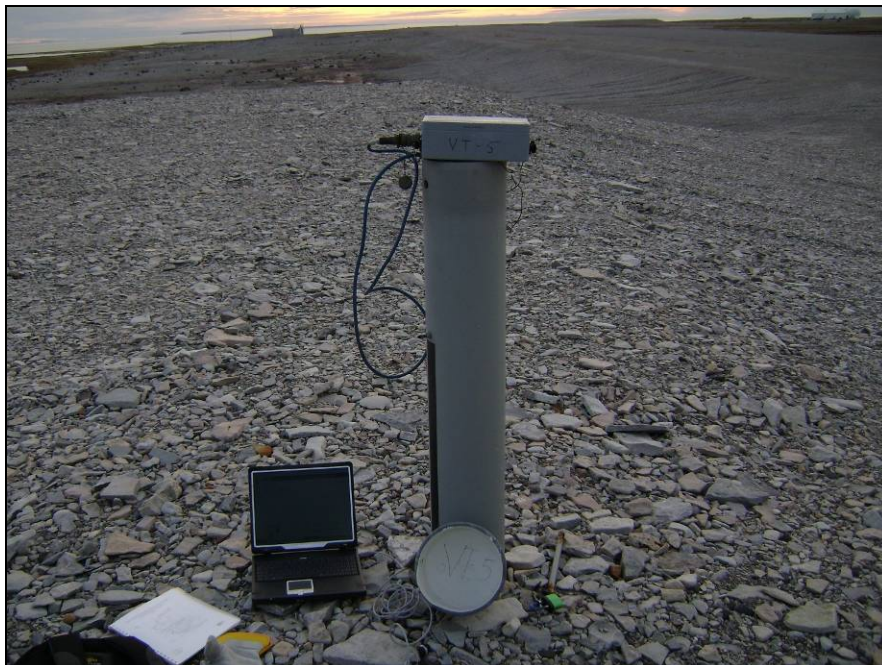
**Photograph 8.** Vertical thermistor VT-5. ↑

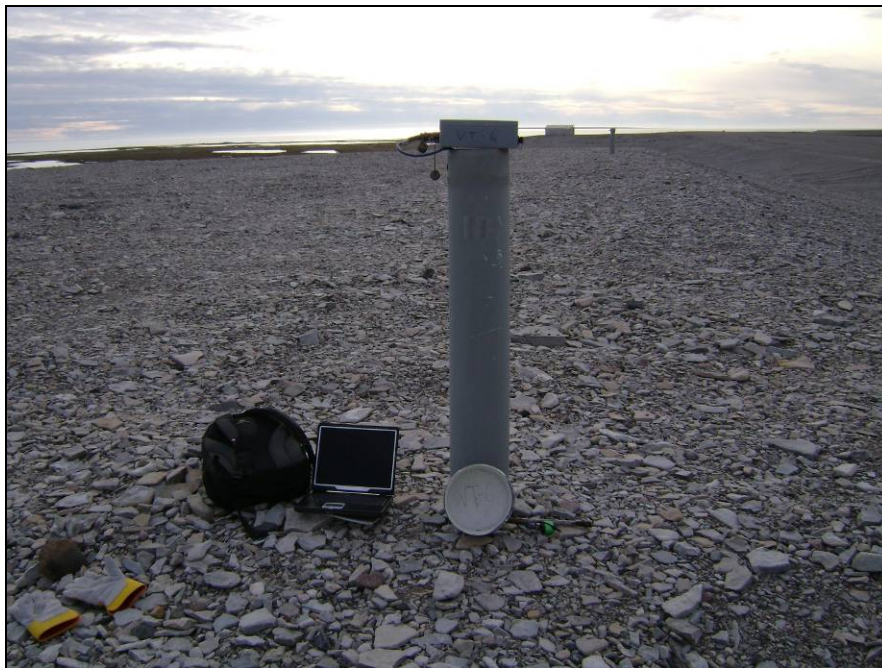
**Photograph9.** Vertical thermistor VT-6. ↑

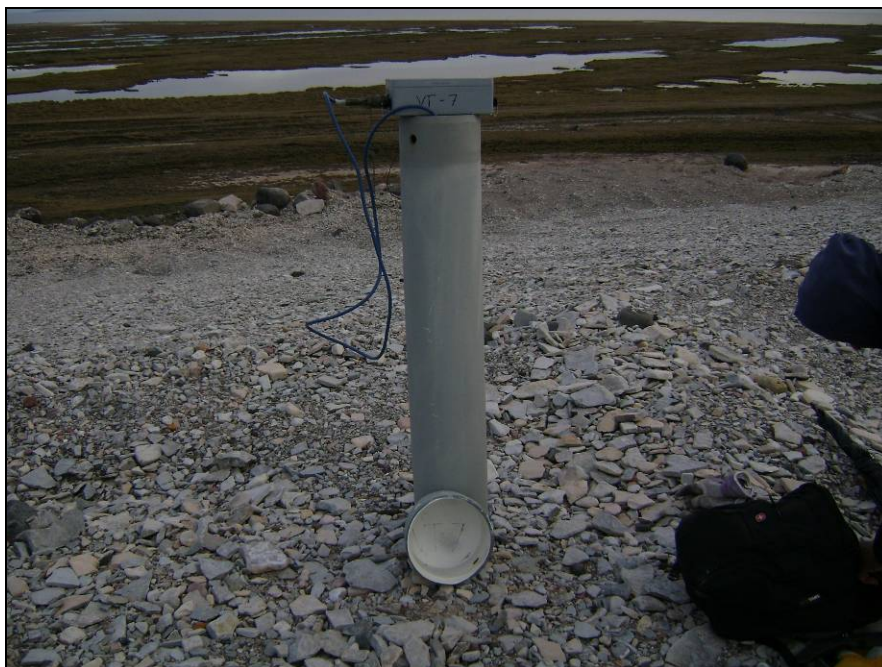
**Photograph 10.** Vertical thermistor VT-7. ↑

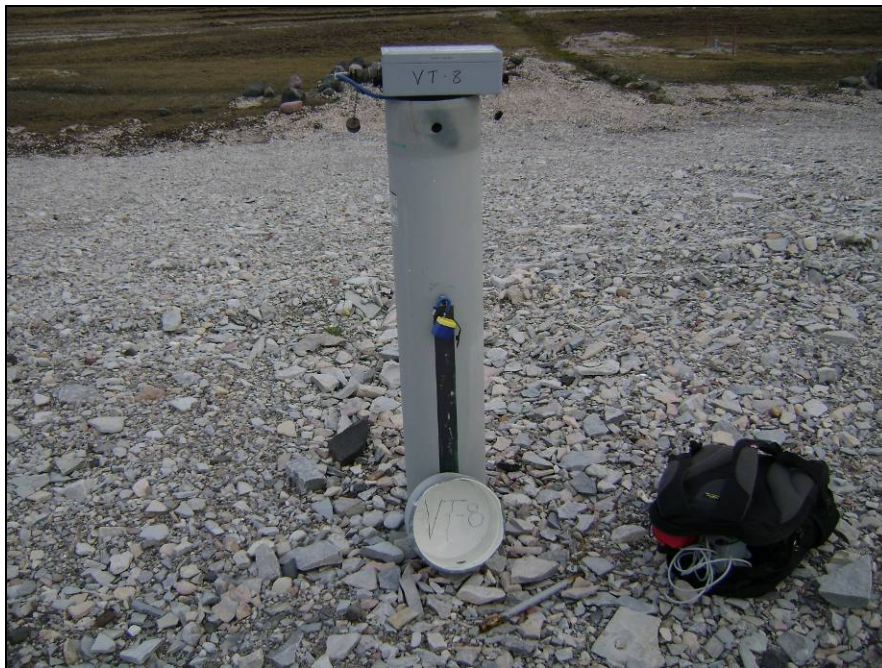
**Photograph 11.** Vertical thermistor VT-8. ↑
