**Defence Construction Canada**

## **The Collection of Landfill Monitoring Data at the CAM-2 Gladman Point Site**

November, 2008

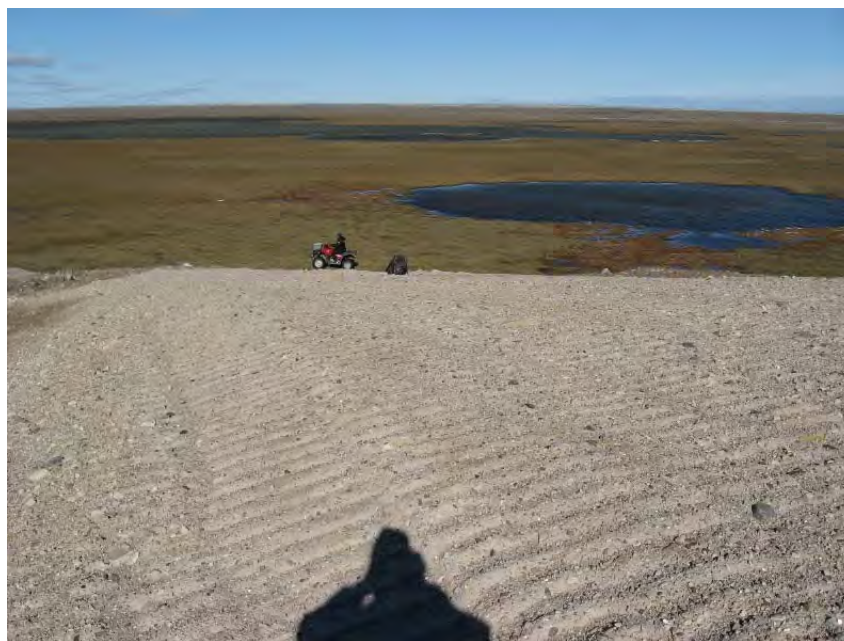
**Photograph STA-7.** Looking NE to NE toe of main landfill cell. Granular cover appears stable. No features of note. ↑

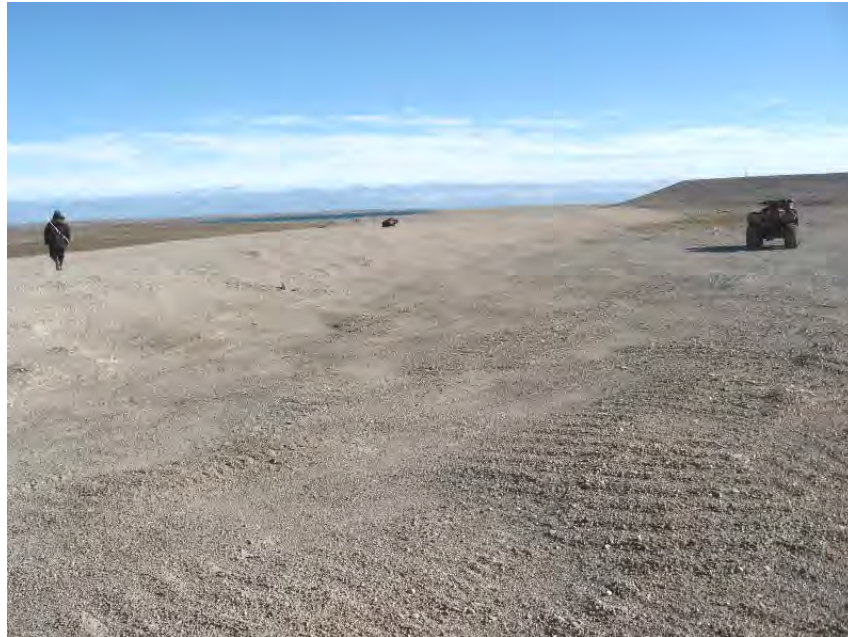
**Photograph STA-9.** Looking SSE along W side of the main cell of the Station landfill to the SW corner. Minor relief. Granular cover appears stable. ↑

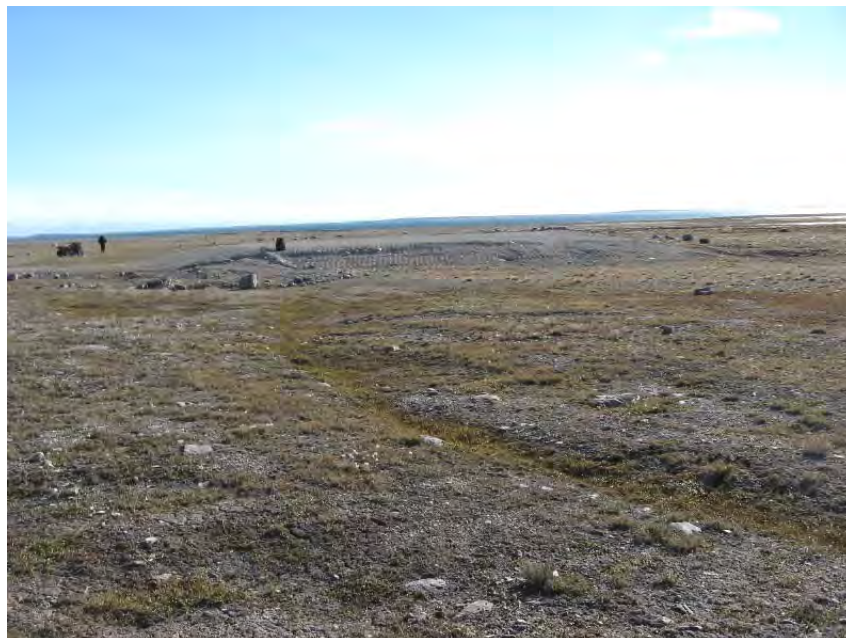
**Photograph STA-14.** Looking S to the NE corner of the NW most of the 2 small cells. Granular cover appears stable. No features of note. ↑

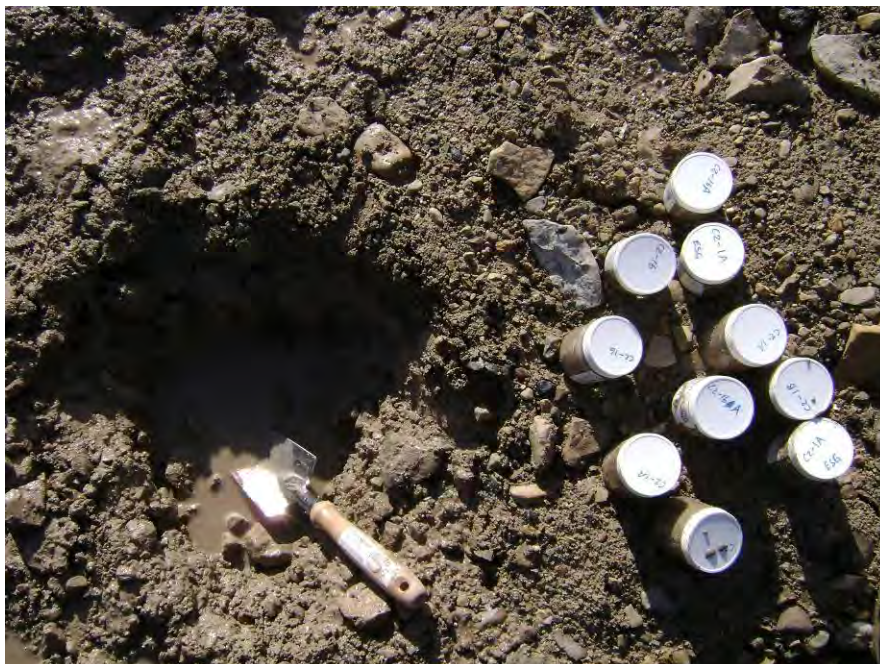
**Photograph 1.** Test pit at C2-1. Samples C2-1A, C2-1B, and C2-16A (Duplicate) collected. Water table 0.20m.↑

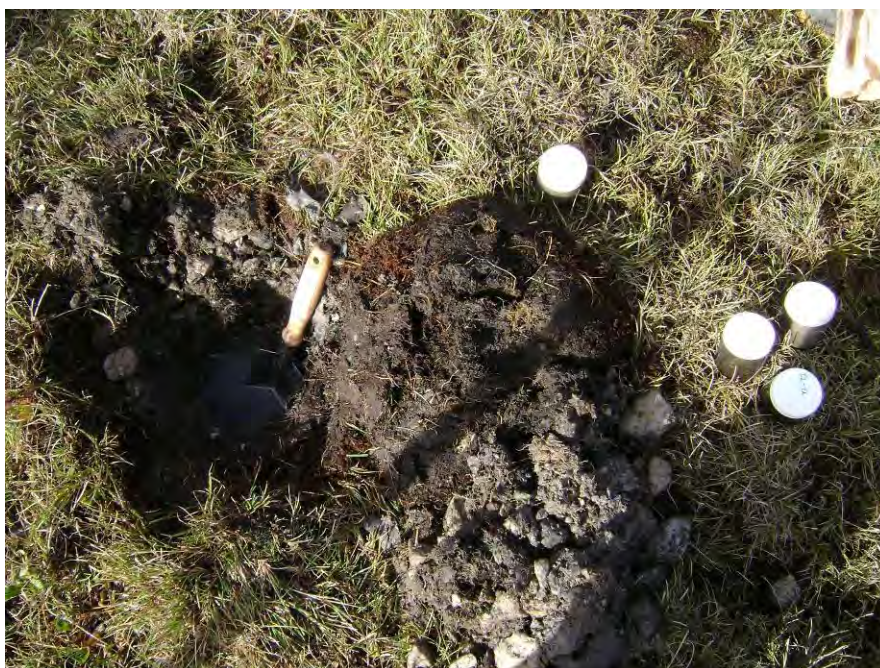
**Photograph 2.** Test pit at C2-2. Samples C2-2A and C2-2B collected. Water table at 0.20m.↑

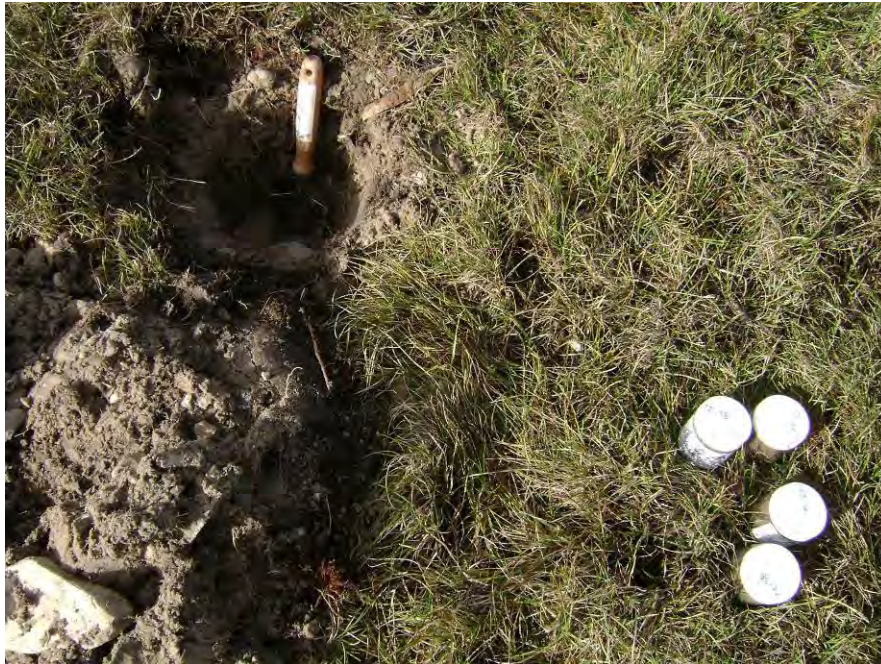
**Photograph 3.** Test pit at C2-3. Samples C2-3A and C2-3B collected. Water table at 0.40m.↑

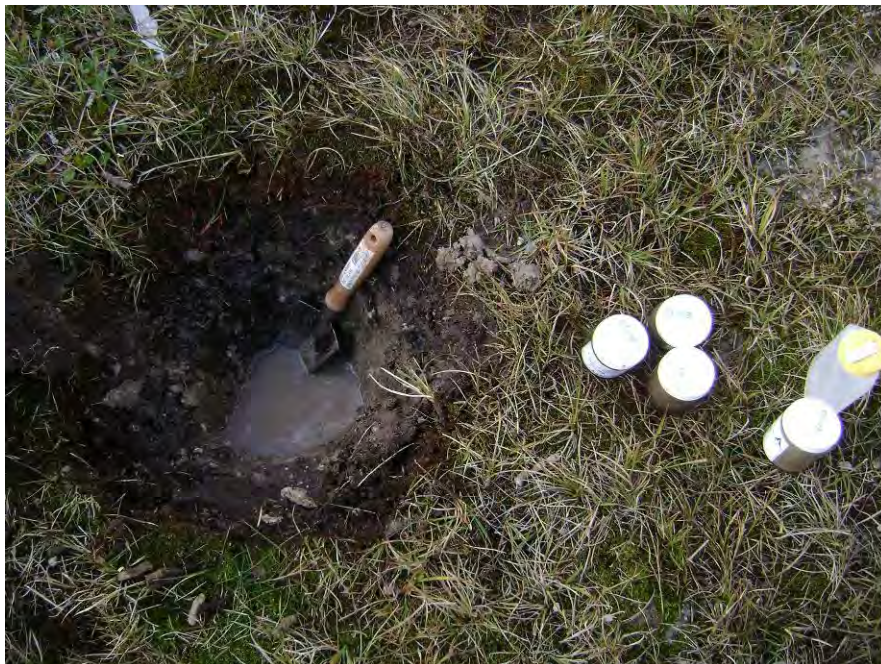
**Photograph 4.** Test pit at C2-4. Samples C2-4A and C2-4B collected. Water table at 0.10m.↑

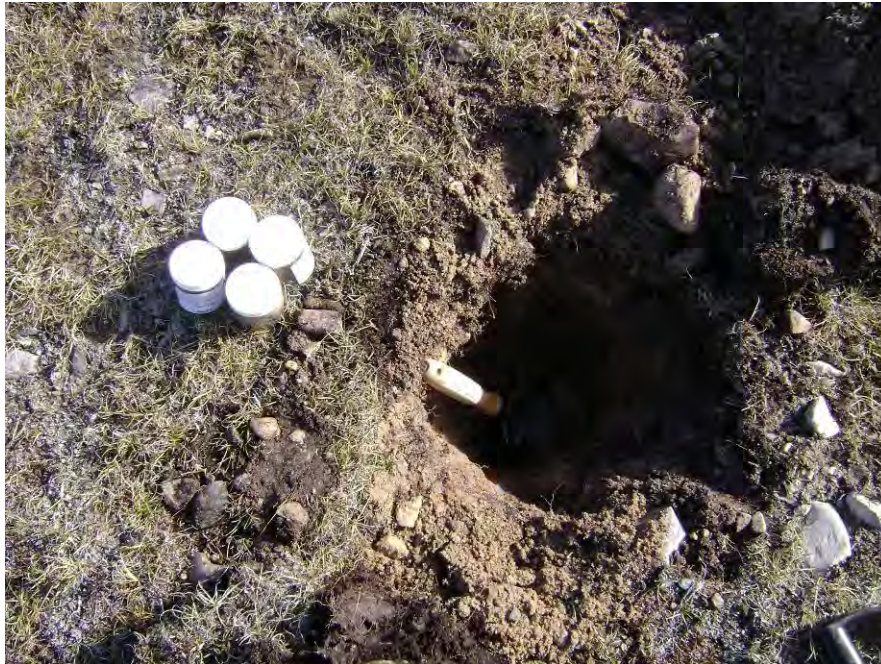
**Photograph 5.** Test pit at C2-5. Samples C2-5A and C2-5B collected.↑

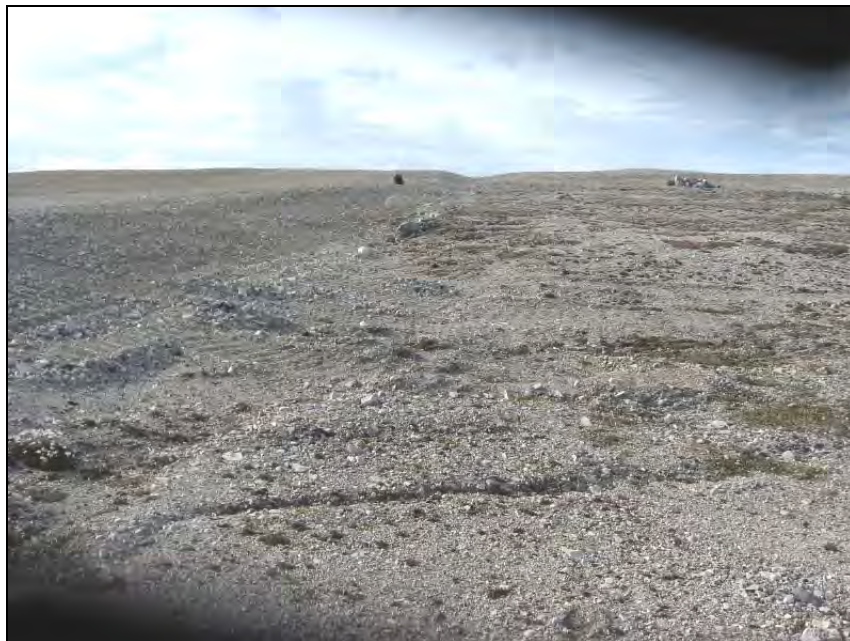
**Photograph WLFN-6.** Looking SSW along the W side of the large central landfill cell. Granular cover appears stable. 3rd cell is visible at the right side of the frame. ↑

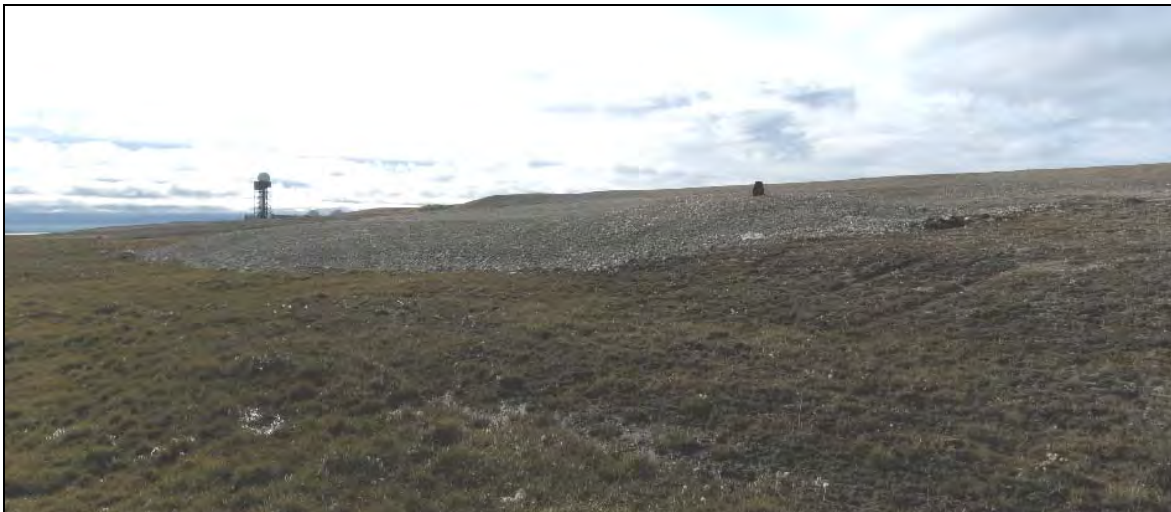
**Photograph WLFN-12.** Looking S to small eastern cell. Granular cover appears stable. Smallest SE cell visible in background. ↑

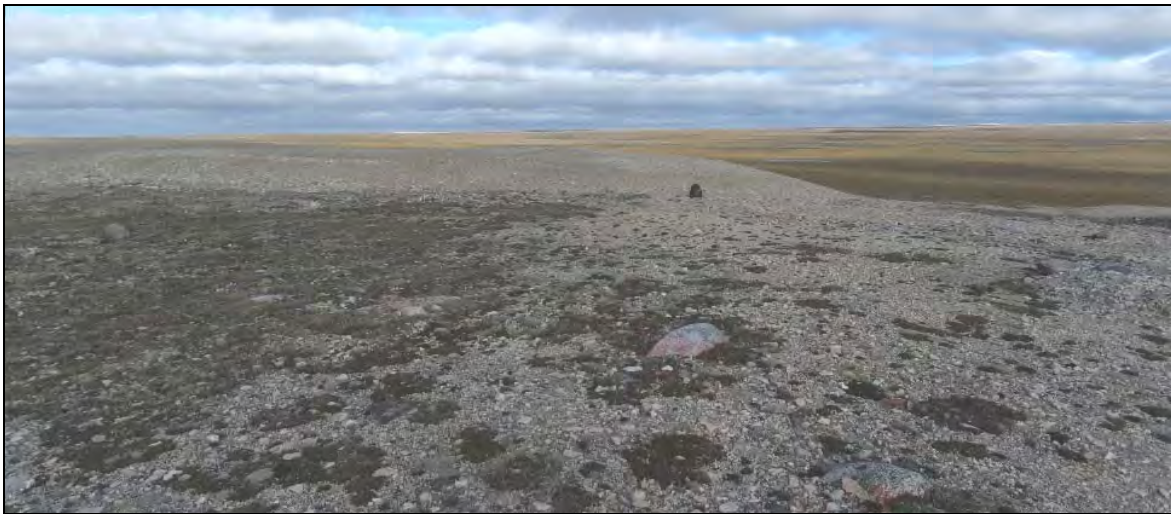
**Photograph WLFN-16.** Looking N to the S end of the long SW cell. Note elevations difference to SE cell. ↑

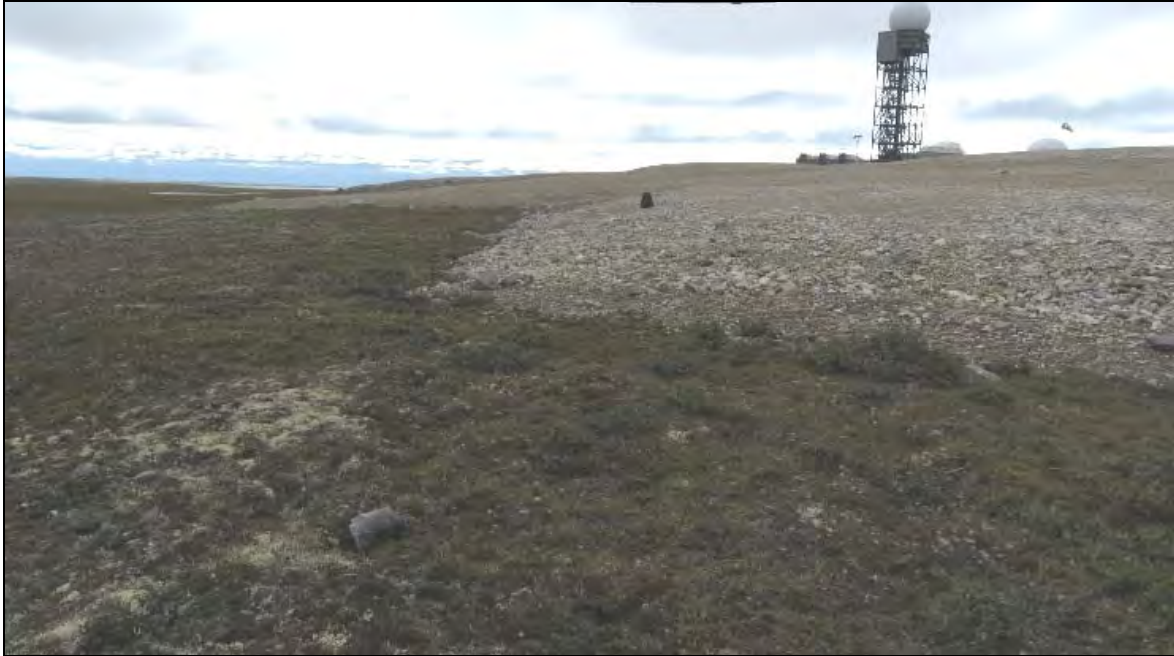
**Photograph WLFS-11.** Looking S along E side of largest, most southerly landfill cell. Viewed from NE corner. ↑

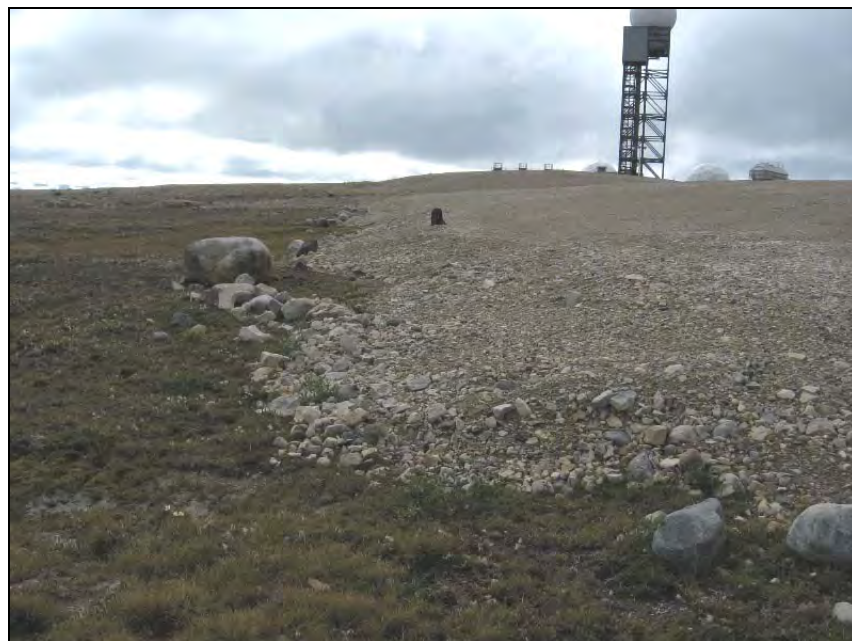
**Photograph WLFS-12.** Looking S along E side of large southern cell to the SE corner. Radar tower in background. ↑

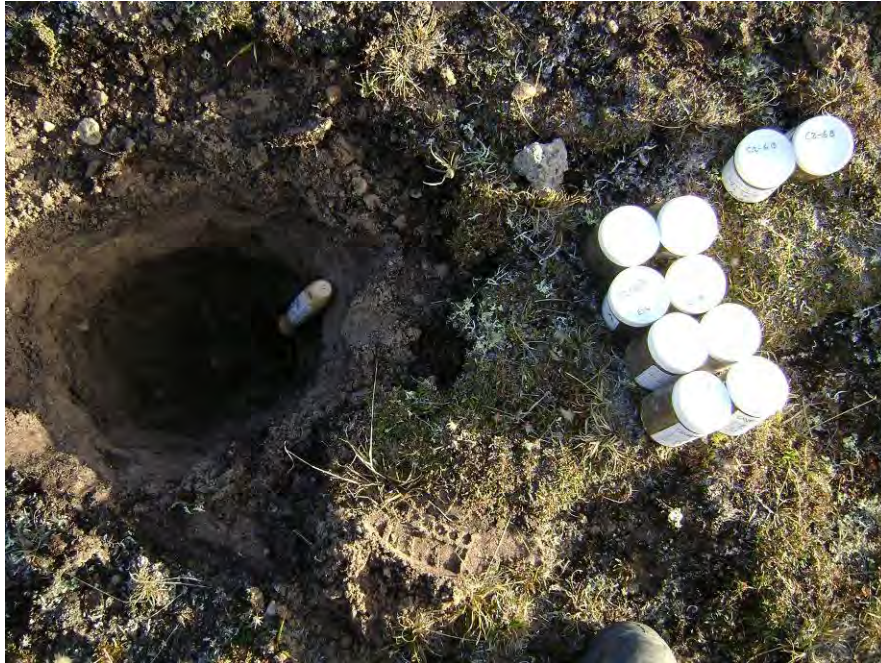
**Photograph 1.** Test pit at C2-6. Samples C2-6A, C2-6B, and C2-15A (Duplicate) collected. ↑

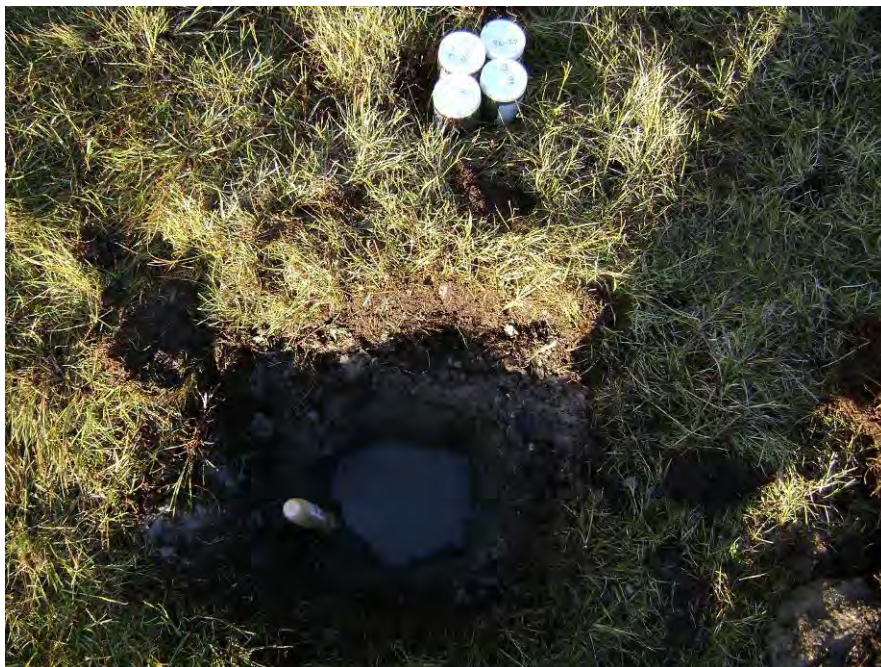
**Photograph 2.** Test pit at C2-7. Samples C2-7A and C2-7B collected. Water table at 0.30m. ↑

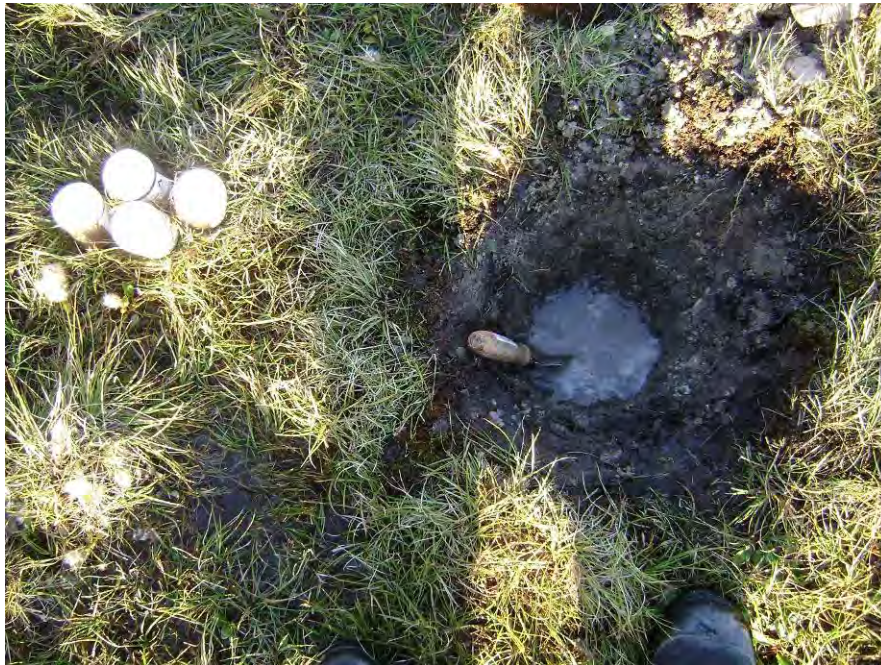
**Photograph 3.** Test pit at C2-8. Samples C2-8A and C2-8B collected. Water table at 0.25m. ↑

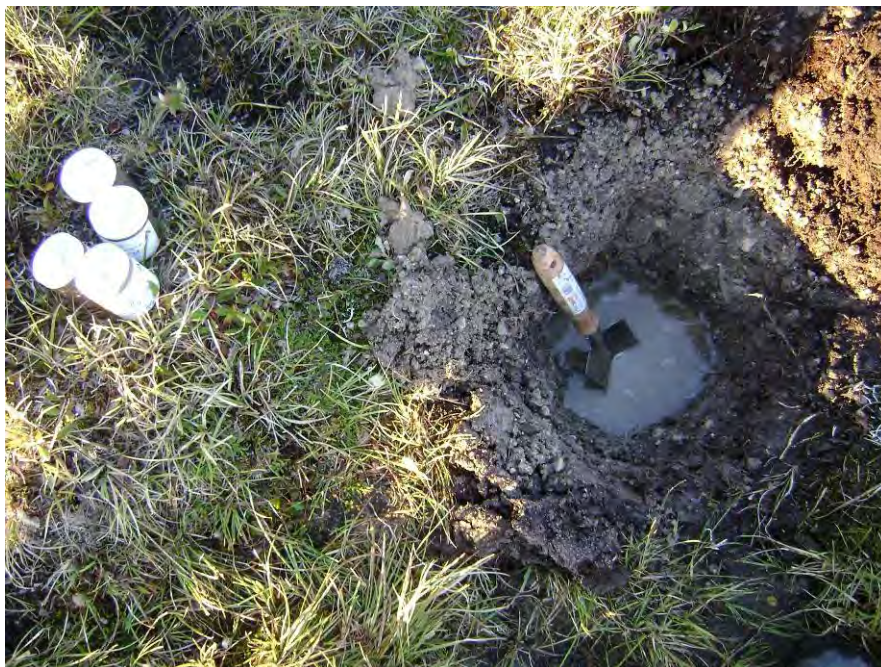
**Photograph 4.** Test pit at C2-9. Samples C2-9A and C2-9B collected. Water table at 0.25m. ↑

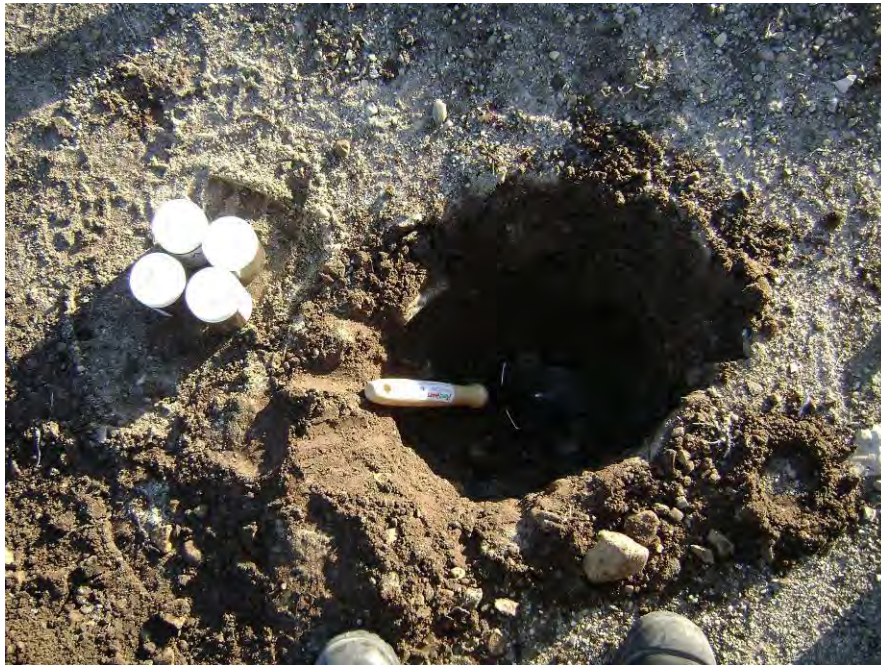
**Photograph 5.** Test pit at C2-10. Samples C2-10A and C2-10B collected. ↑

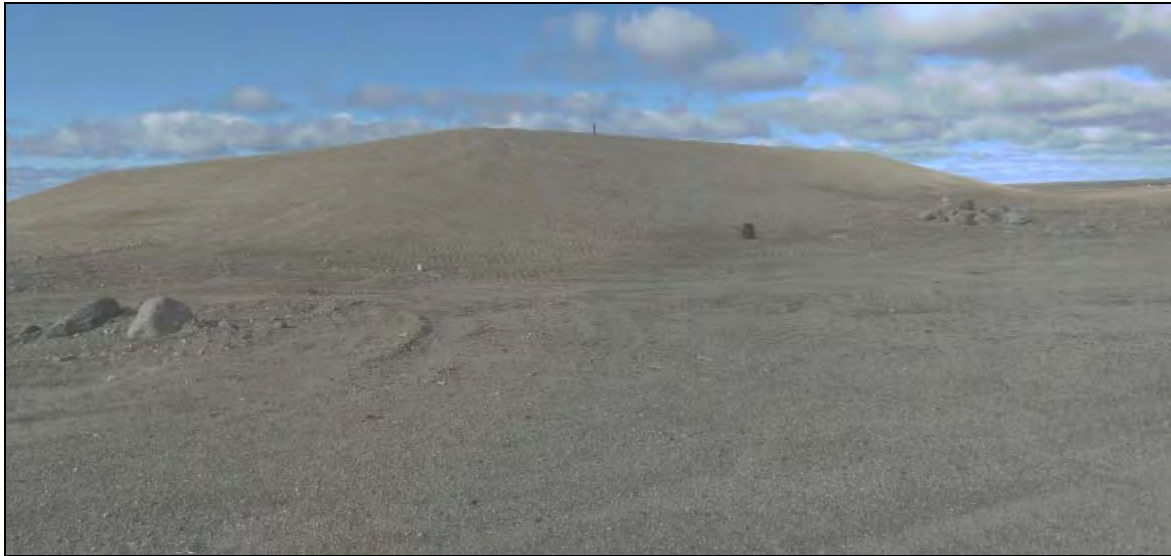
**Photograph T2-1.** Panoramic of N side of landfill looking SW from about 30m NE of NE corner. ↑

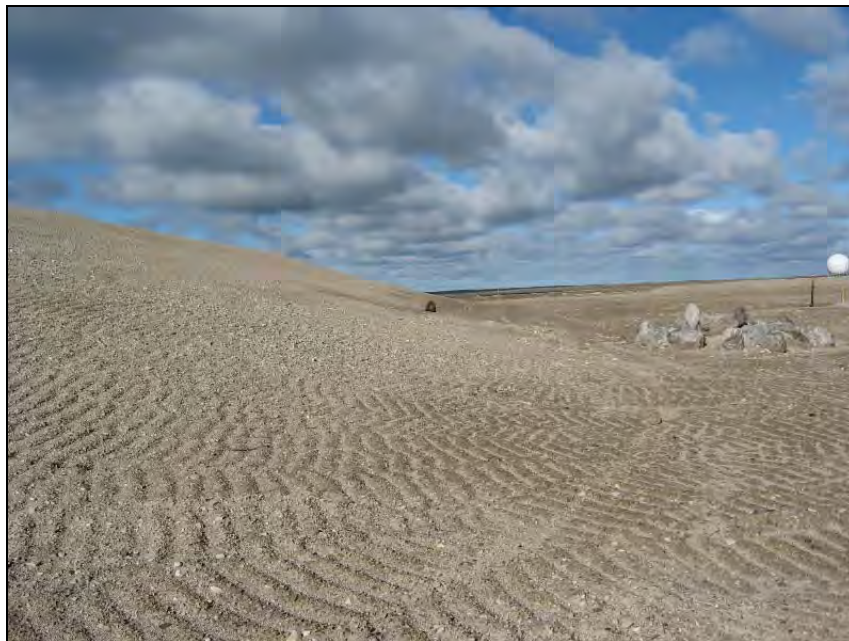
**Photograph T2-2.** Looking WNW along toe of slope from NE toe. ↑

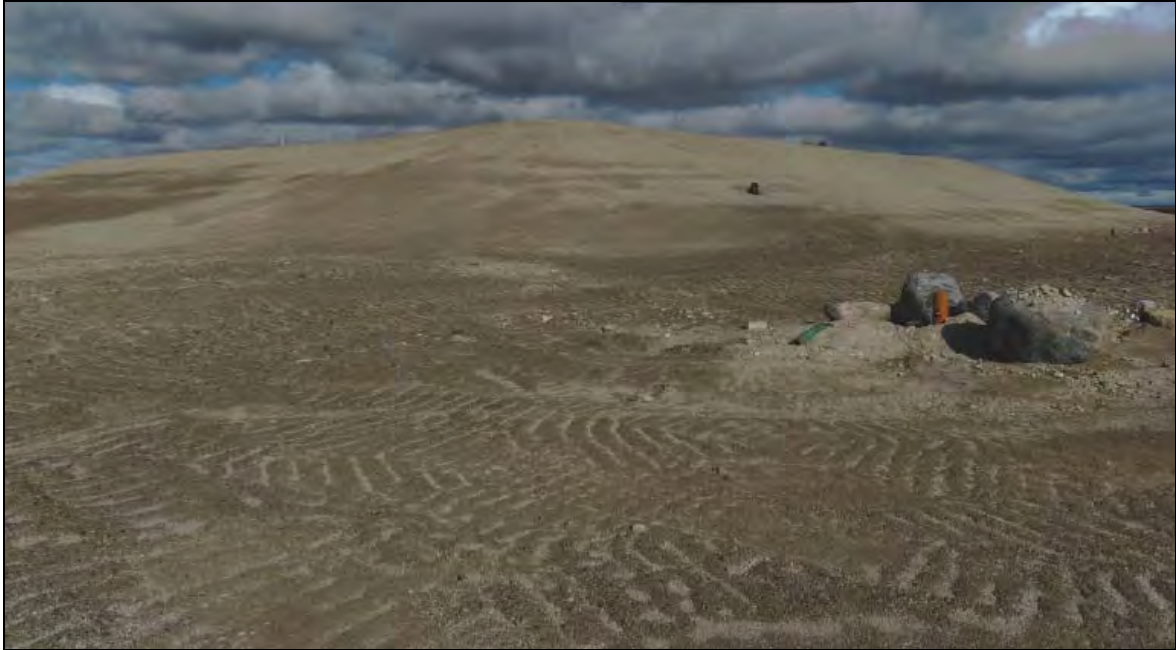
**Photograph T2-11.** Looking NW to SE corner of landfill. MW2 visible in foreground. ↑

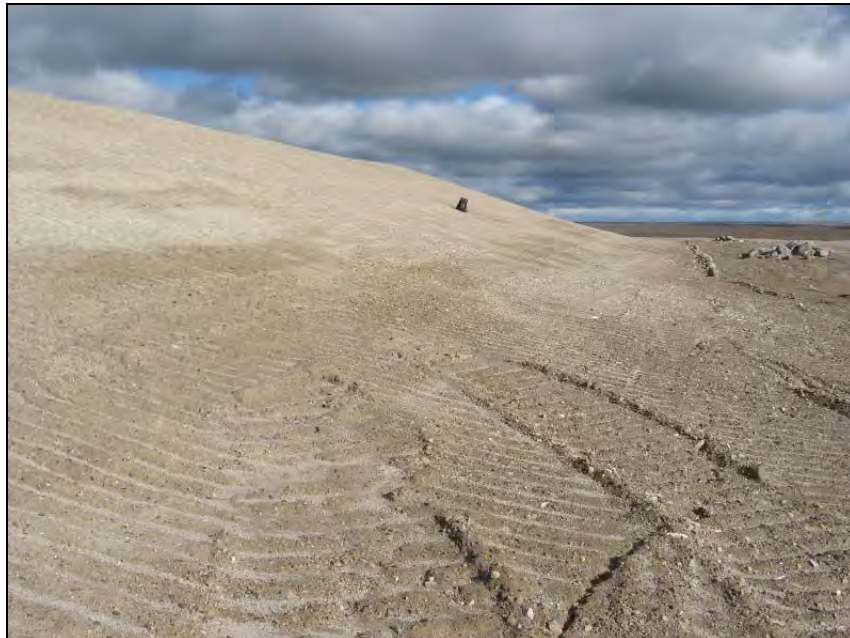
**Photograph T2-12.** Looking NNE along toe of E slope from SE corner. ↑

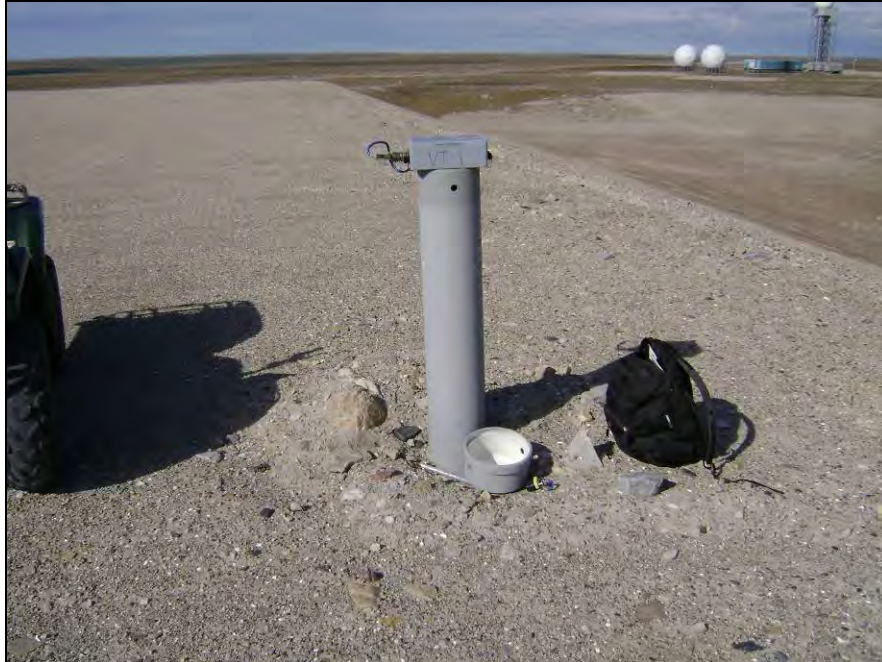
**Photograph 9.** Vertical thermistor VT-1. ↑

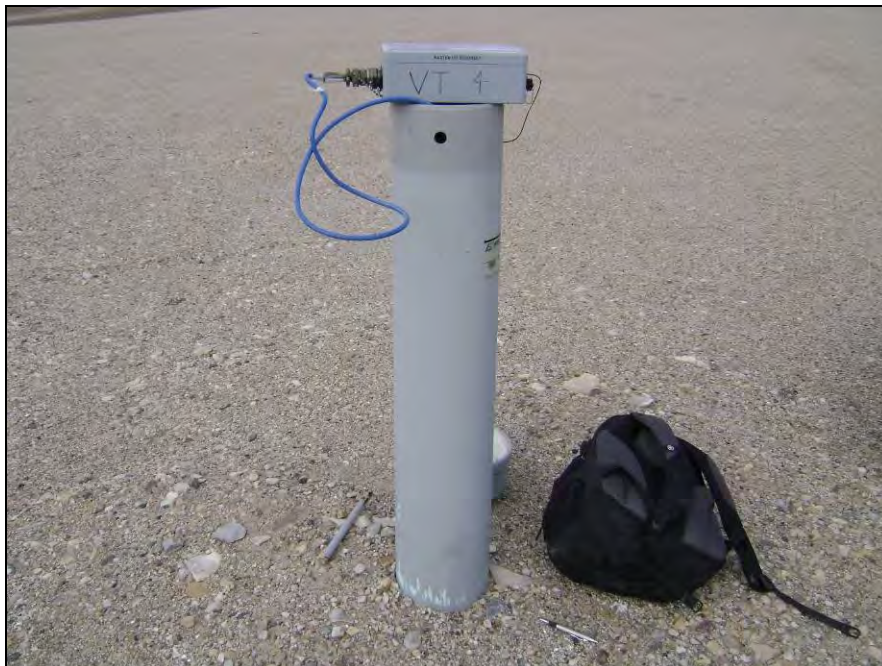
**Photograph 12.** Vertical thermistor VT-4. ↑

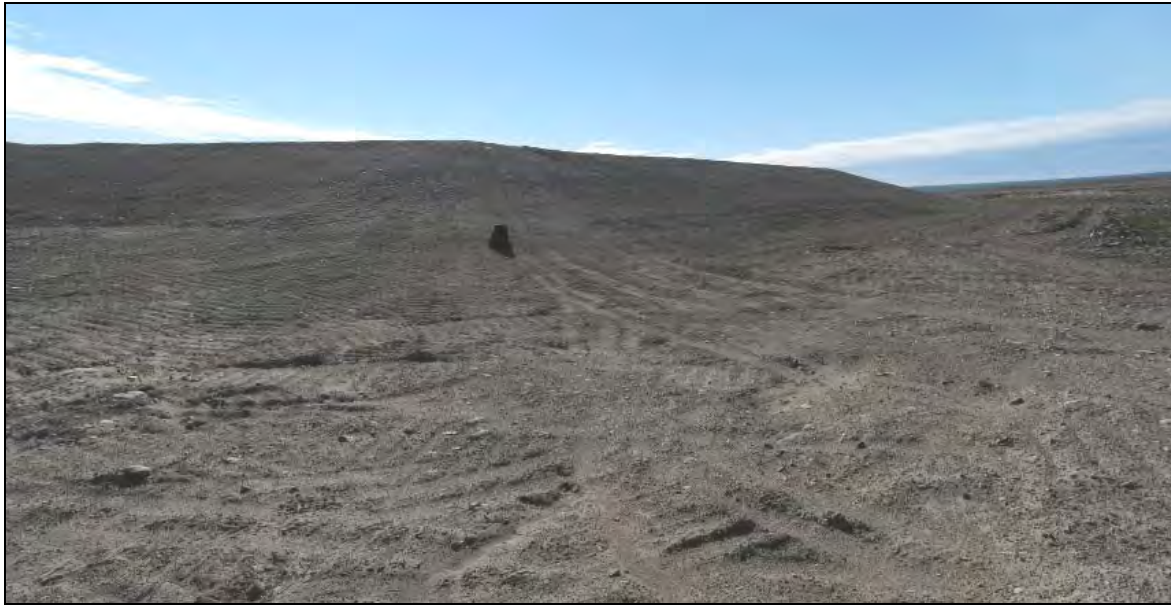
**Photograph NH-1.** Looking SW towards NE corner of Landfill. ↑

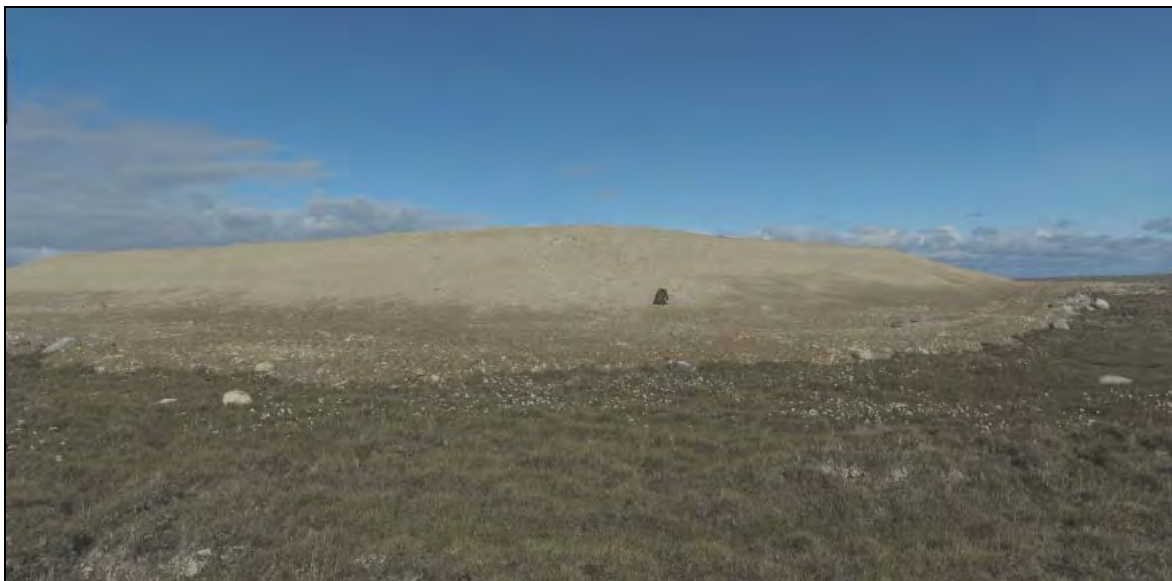
**Photograph NH-6.** Panoramic looking NE from adjacent to MW-8 looking to SW corner of LF. ↑

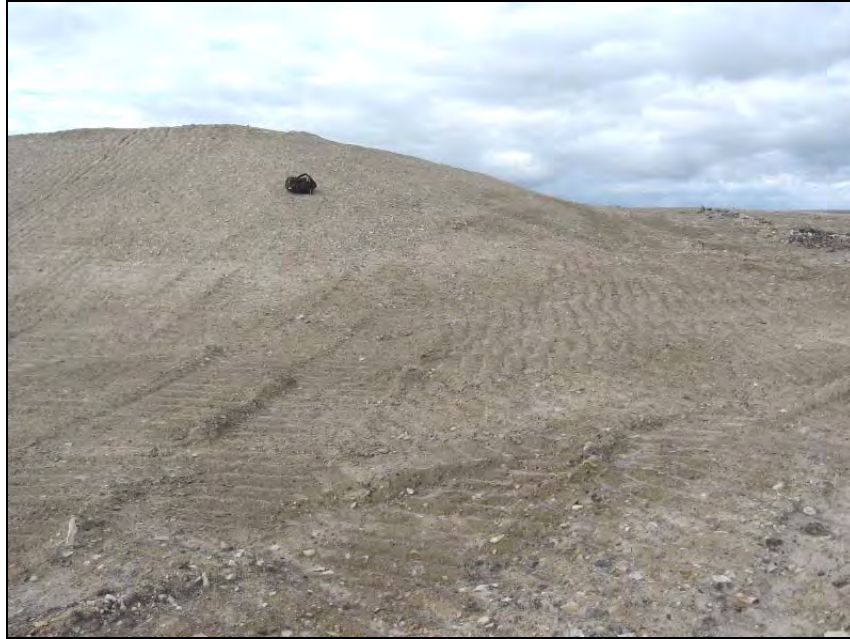
**Photograph NH-15.** Looking N along E toe from SE corner. ↑

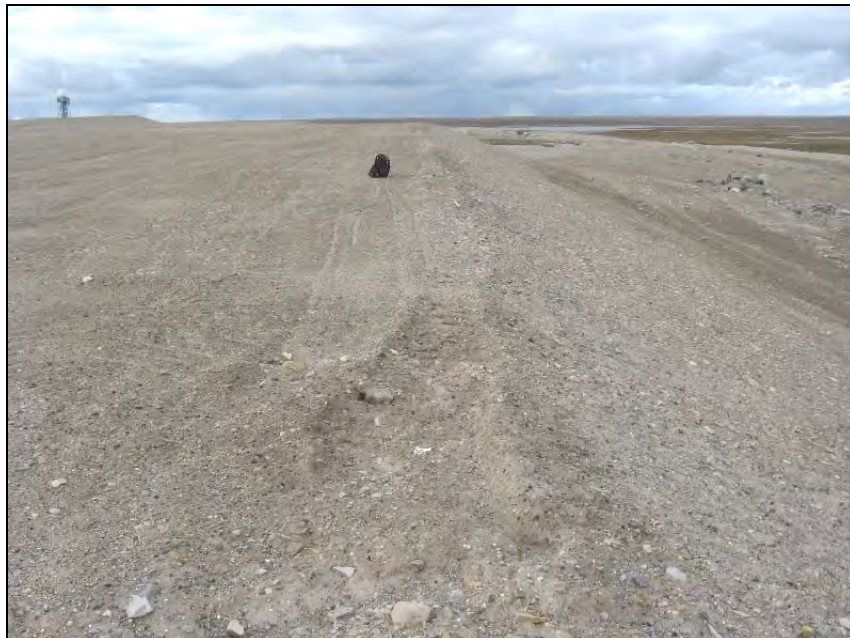
**Photograph NH-16.** Looking N along crest from SE corner. ↑

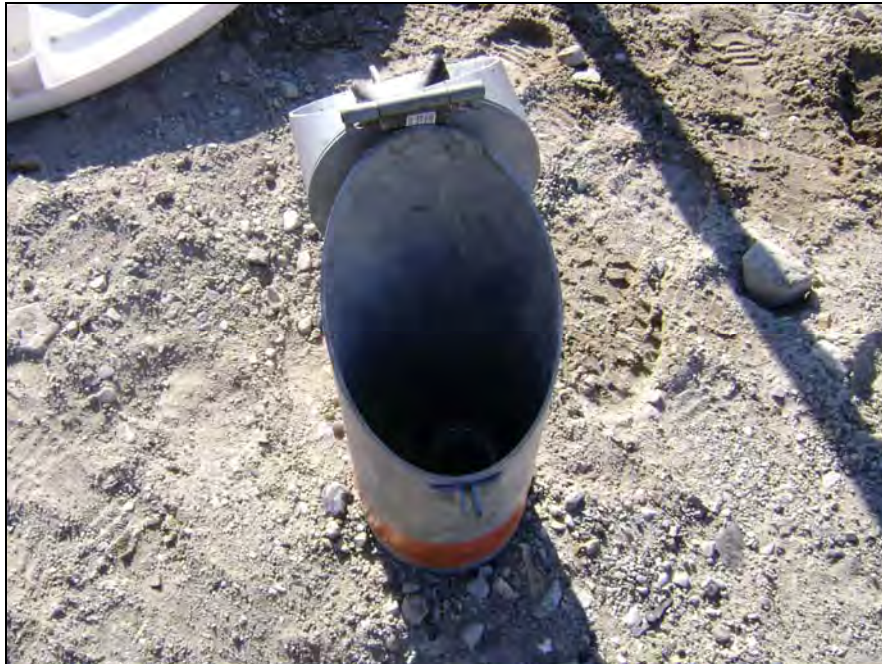
**Photograph 1.** Monitoring Well MW-5. Sample C2-MW-5 collected. ↑

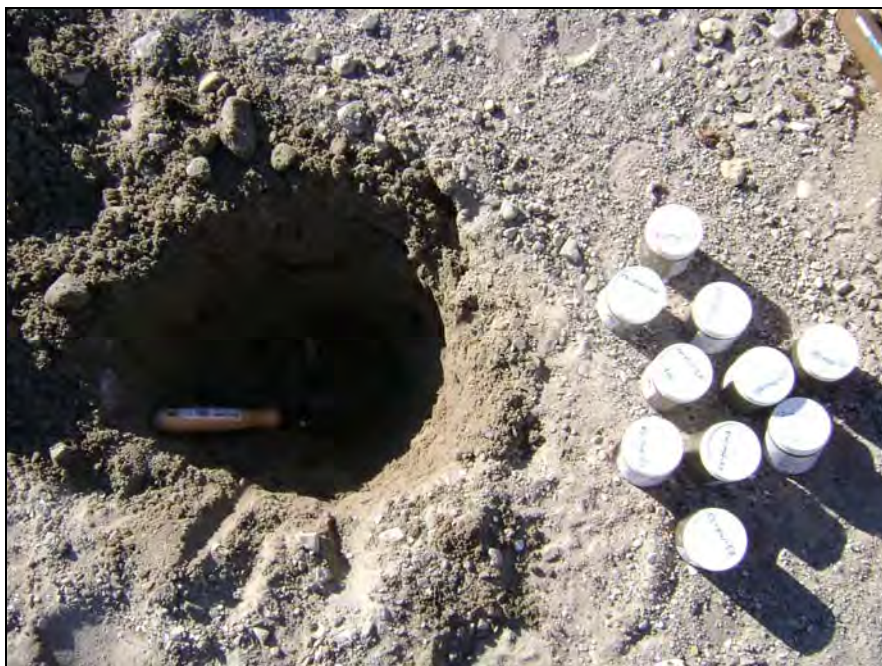
**Photograph 2.** Test pit at MW-5. Samples C2-MW-5A, C2-MW-5B, and C2-MW-10A (Duplicate) collected. ↑

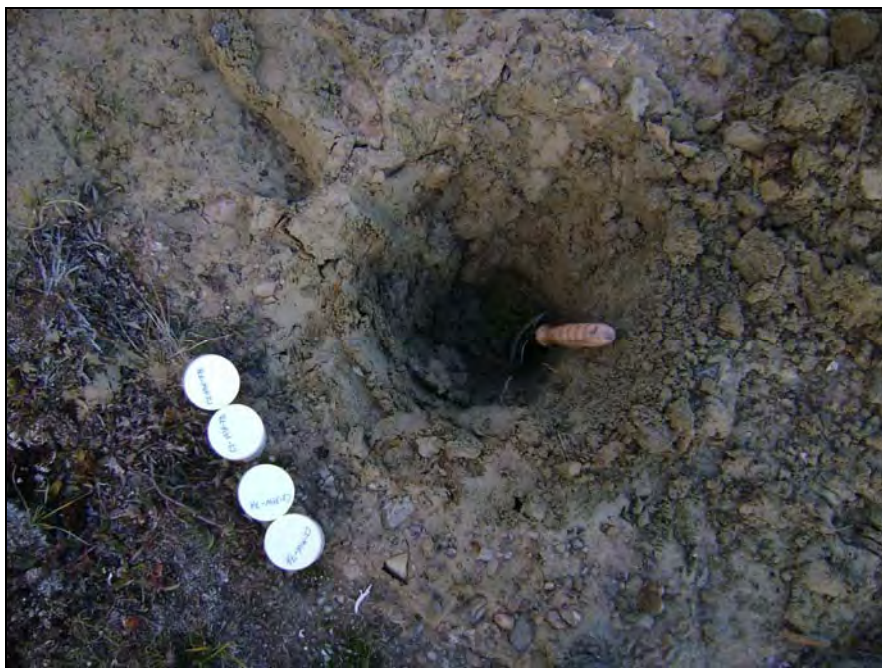
**Photograph 6.** Test pit at MW-7. Samples C2-MW-7A and C2-MW-7B collected. ↑
