## **The Collection of Landfill Monitoring Data at the CAM-2 Gladman Point Site – 2008 Final Report**

**The Collection of Landfill Monitoring Data at the  
CAM-2 Gladman Point Site**

**AECOM Canada Ltd.**

January, 2009

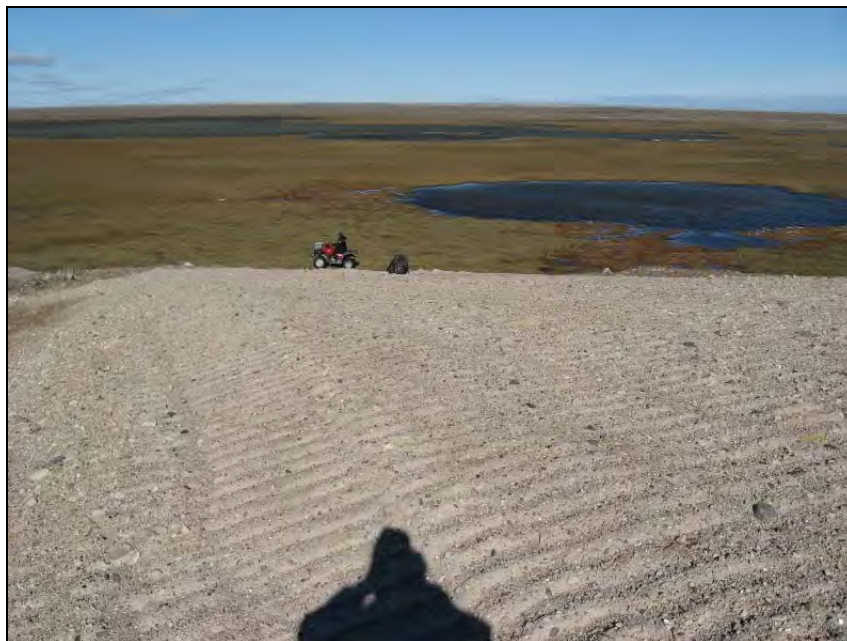
**Photograph STA-7.** Looking NE to NE toe of main landfill cell. Granular cover appears stable. No features of note. ↑

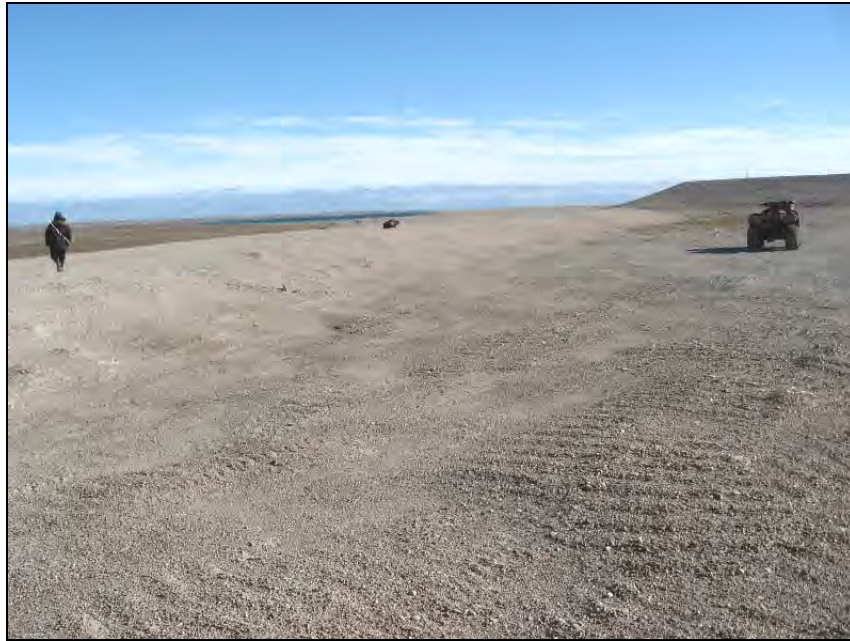
**Photograph STA-9.** Looking SSE along W side of the main cell of the Station landfill to the SW corner. Minor relief. Granular cover appears stable. ↑

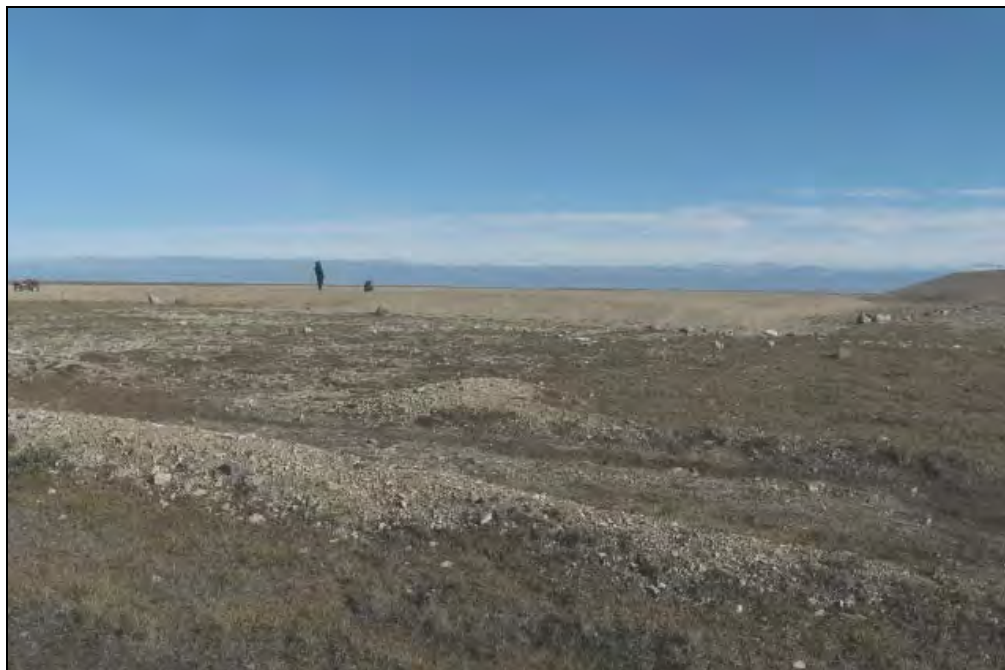
**Photograph STA-10.** Looking E to NW corner of the small SW cell of the Station Landfill. Granular cover appears stable. Honda parked adjacent to main cell on the extreme left of the photo. Tier II landfill (NE corner) visible in the background. ↑

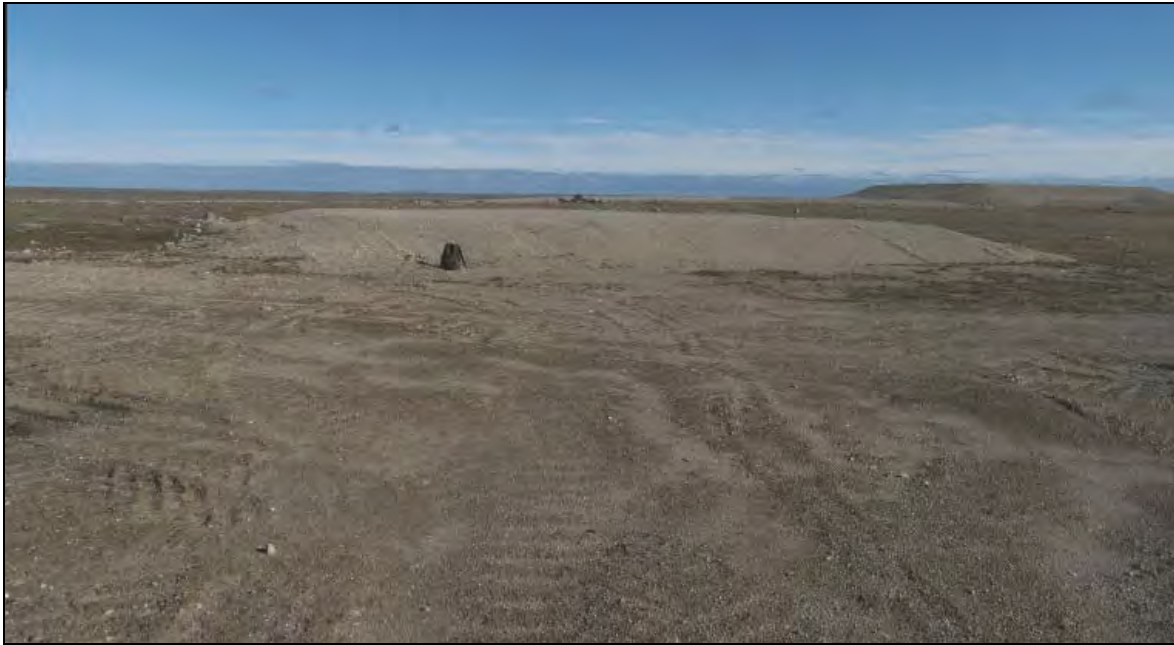
**Photograph STA-13.** Looking SE to the NW corner of the SE most of the two small landfill cells. Granular cover appears stable. No features of note. ↑

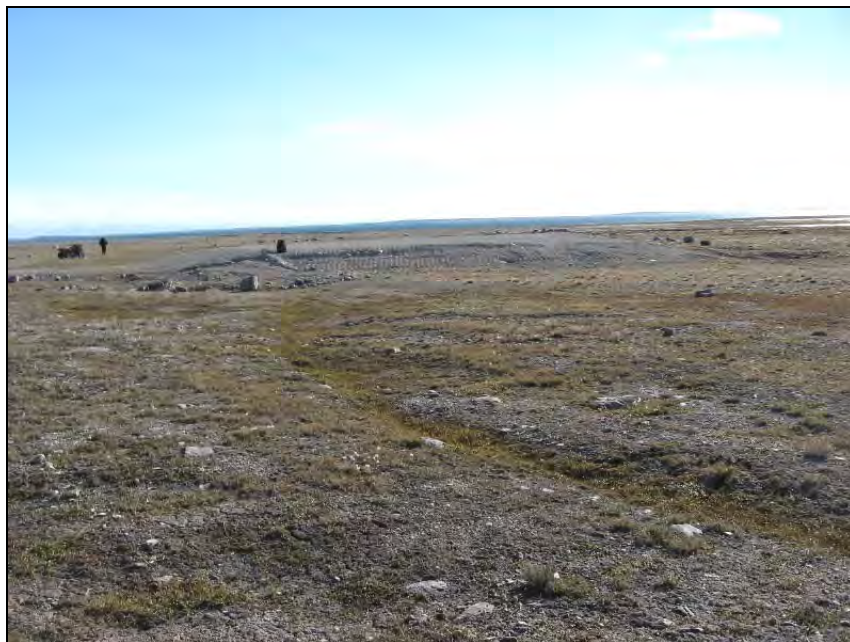
**Photograph STA-14.** Looking S to the NE corner of the NW most of the 2 small cells. Granular cover appears stable. No features of note. ↑

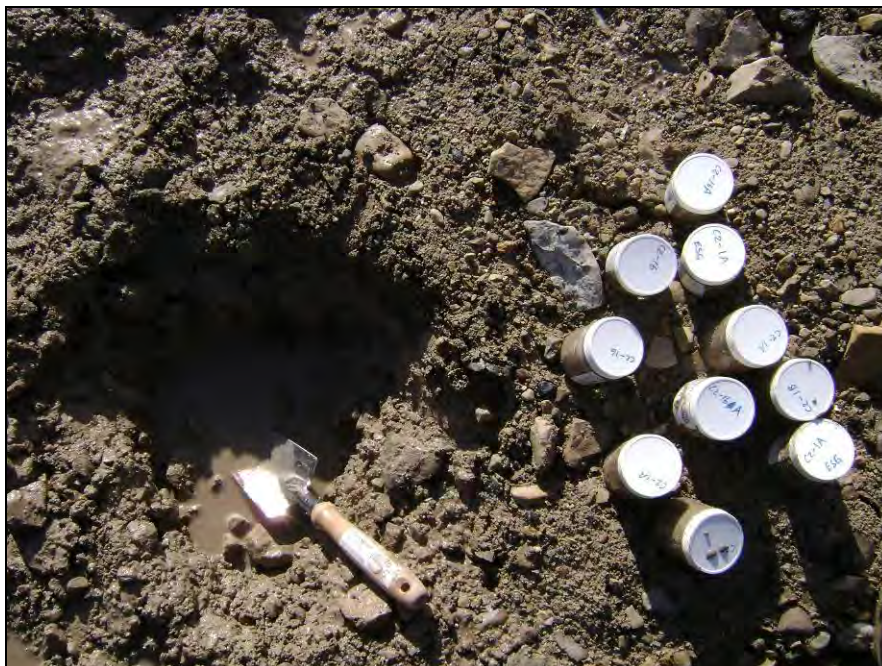
**Photograph 1.** Test pit at C2-1. Samples C2-1A, C2-1B, and C2-16A (Duplicate) collected. Water table 0.20m.↑

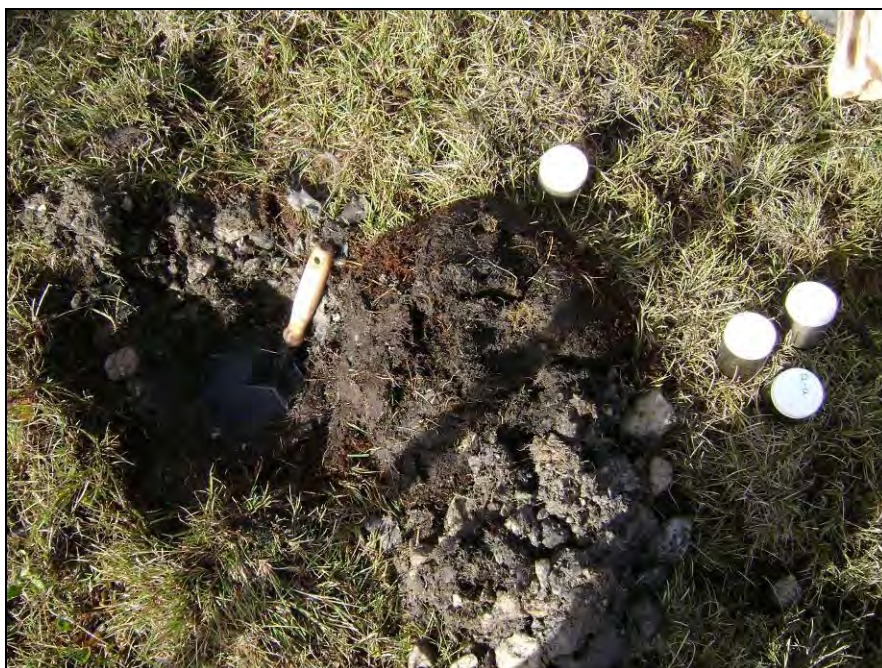
**Photograph 2.** Test pit at C2-2. Samples C2-2A and C2-2B collected. Water table at 0.20m.↑

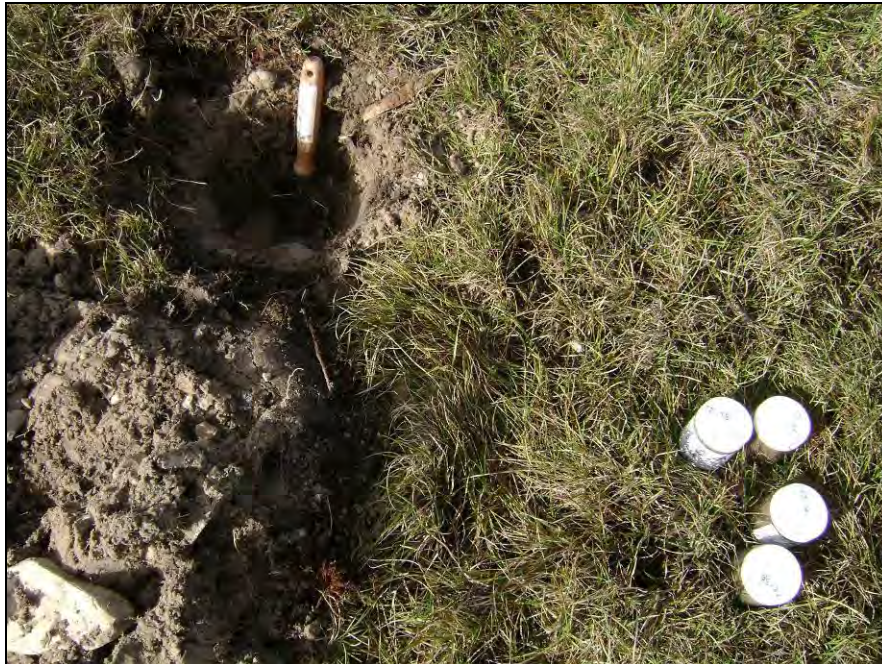
**Photograph 3.** Test pit at C2-3. Samples C2-3A and C2-3B collected. Water table at 0.40m.↑

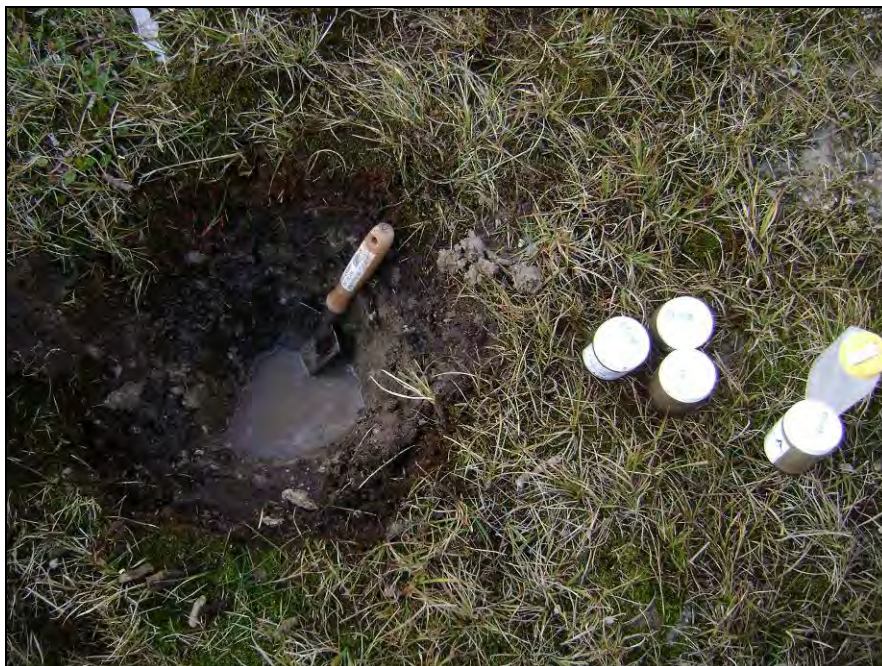
**Photograph 4.** Test pit at C2-4. Samples C2-4A and C2-4B collected. Water table at 0.10m.↑

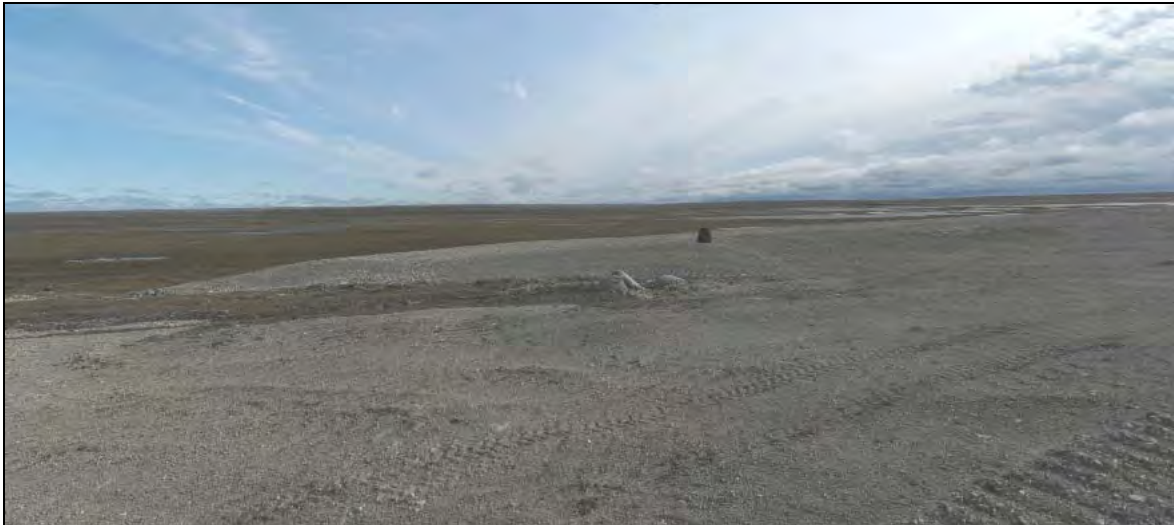
**Photograph WLFN-2.** Looking E to NW corner of 2nd lobe from N. Backpack is near the SW corner for scale. No features of note. ↑

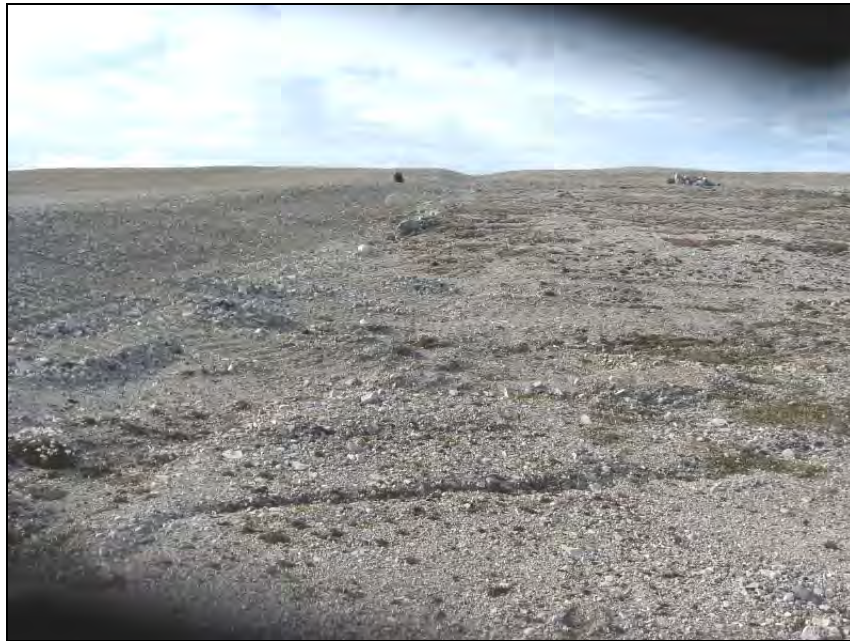
**Photograph WLFN-6.** Looking SSW along the W side of the large central landfill cell. Granular cover appears stable. 3rd cell is visible at the right side of the frame. ↑

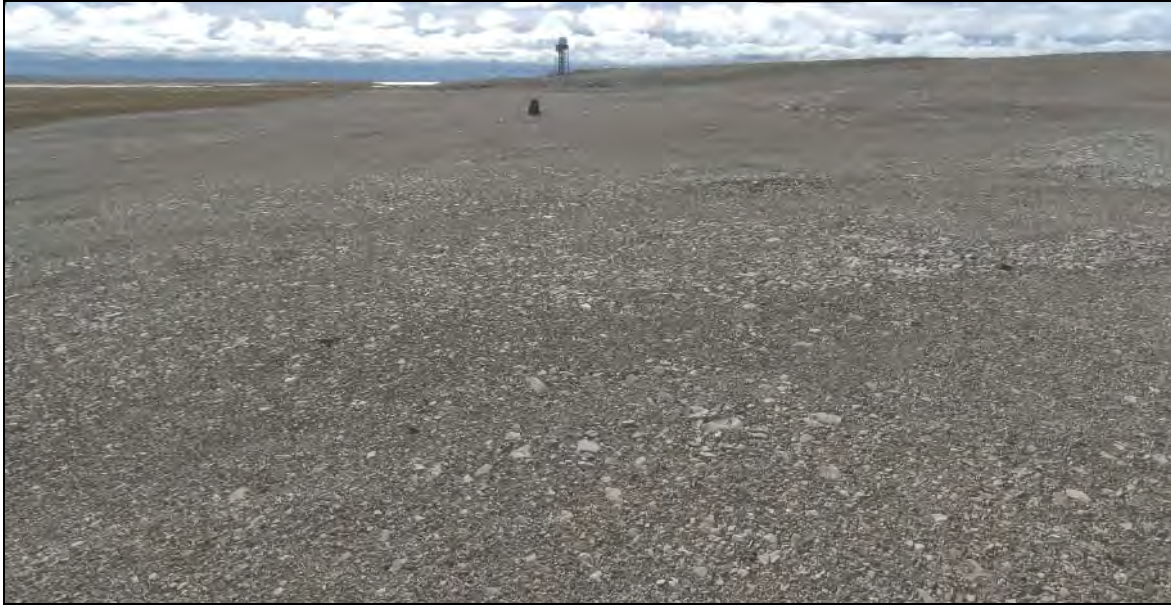
**Photograph WLFN-9.** Panoramic along top of the large central cell. Looking SE from N corner. No features of note. ↑

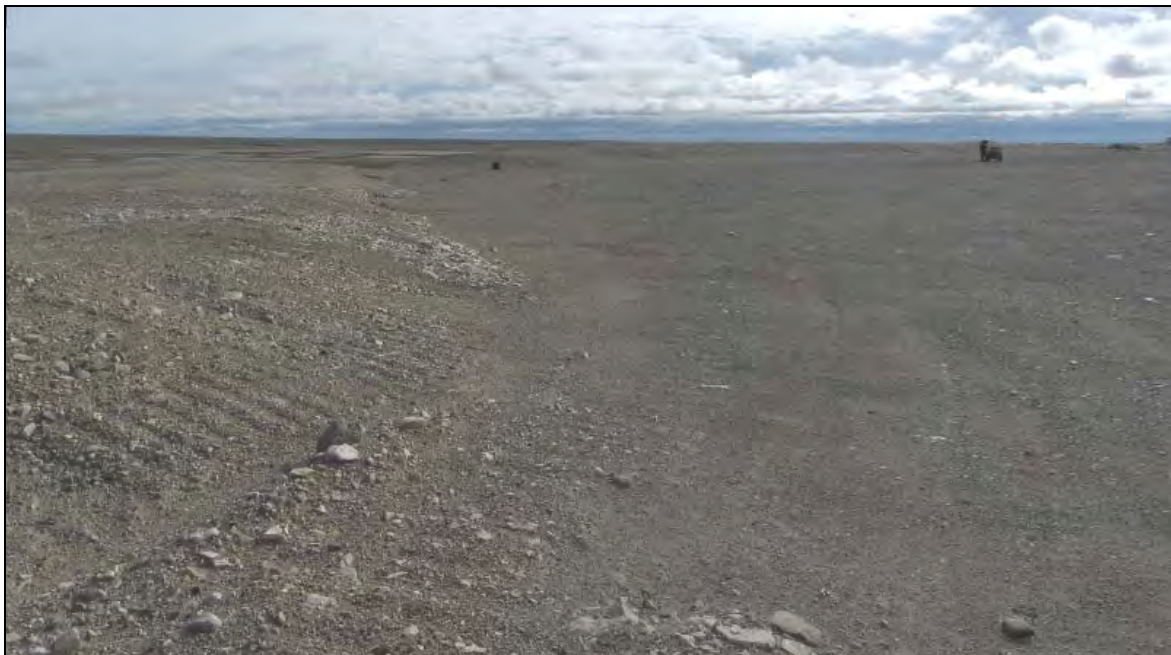
**Photograph WLFN-10.** Looking SE from SW corner of large central cell. Looking to NW corner of long SW cell. ATV in background. No features of note. ↑

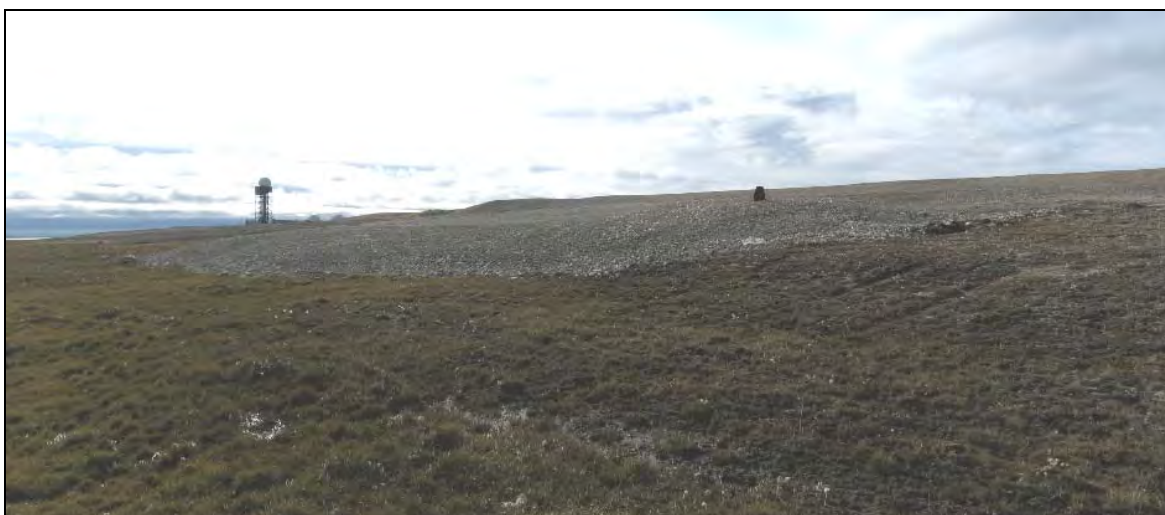
**Photograph WLFN-12.** Looking S to small eastern cell. Granular cover appears stable. Smallest SE cell visible in background.     ↑

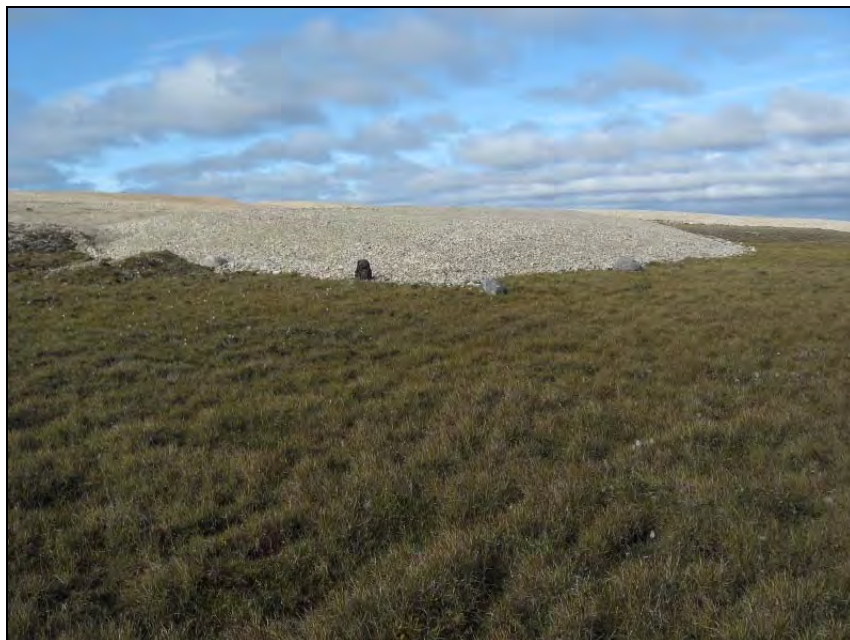
**Photograph WLFN-14.** Looking WNW to SE corner of small E cell. Granular cover appears stable. No features of note. ↑

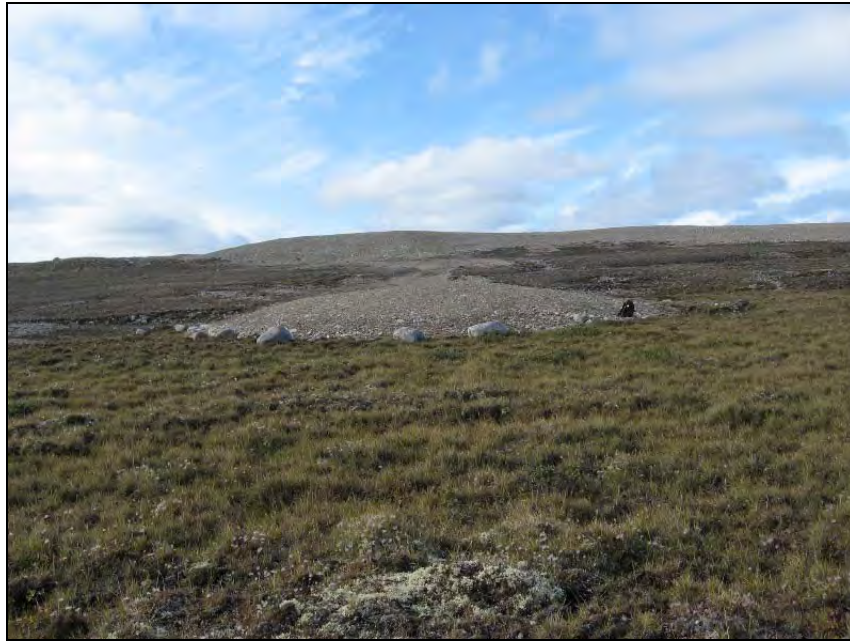
**Photograph WLFN-15.** Looking W to smallest SE cell. Granular cover appears stable. Long SW landfill cell visible in background. ↑

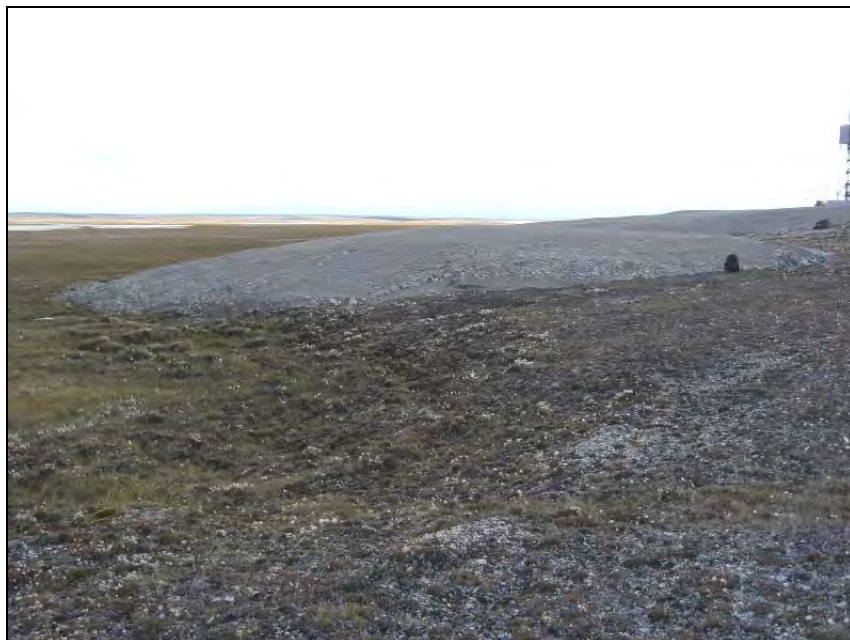
**Photograph WLFS-4.** Looking S to N side of 2nd cell on the E side. Granular cover appears stable.  
No features of note. ↑

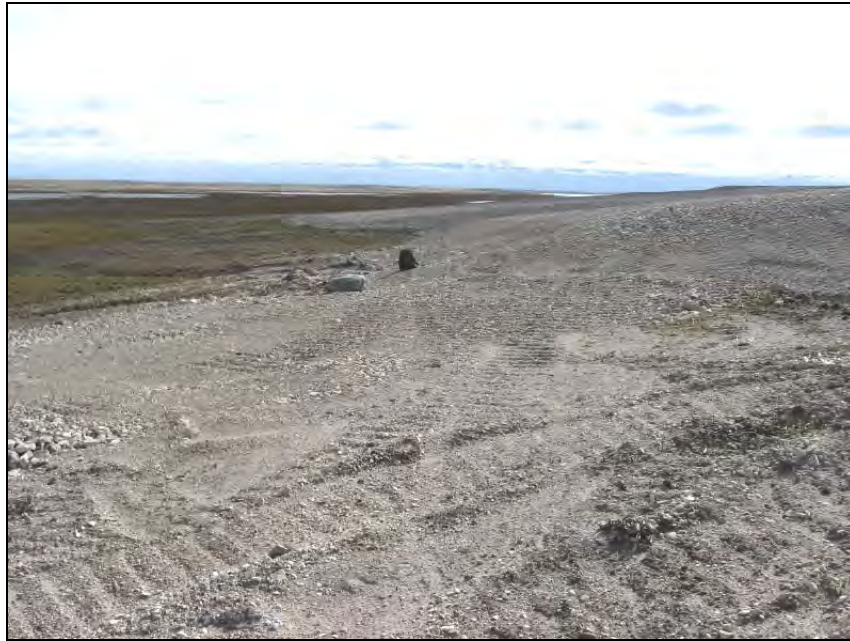
**Photograph WLFS-5.** Looking ESE along NE side of 3rd cell. No features of note. Granular cover appears stable. ↑

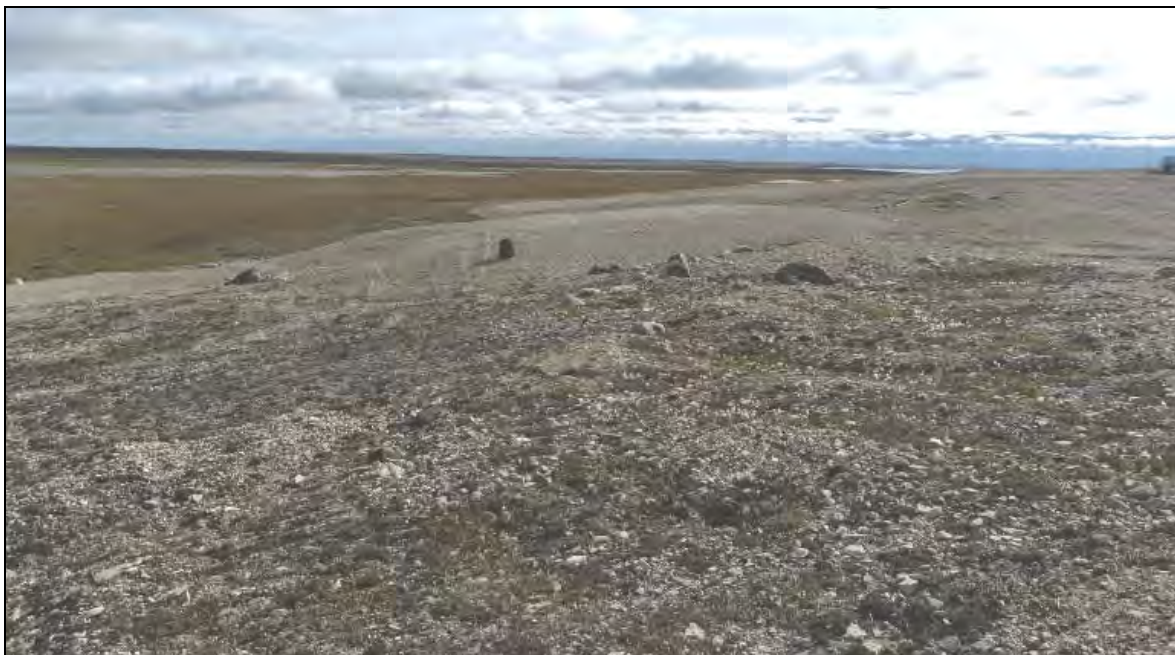
**Photograph WLFS-6.** Looking E to NW corner of 3rd cell. Largest (southern most) landfill cell visible in the background. ↑

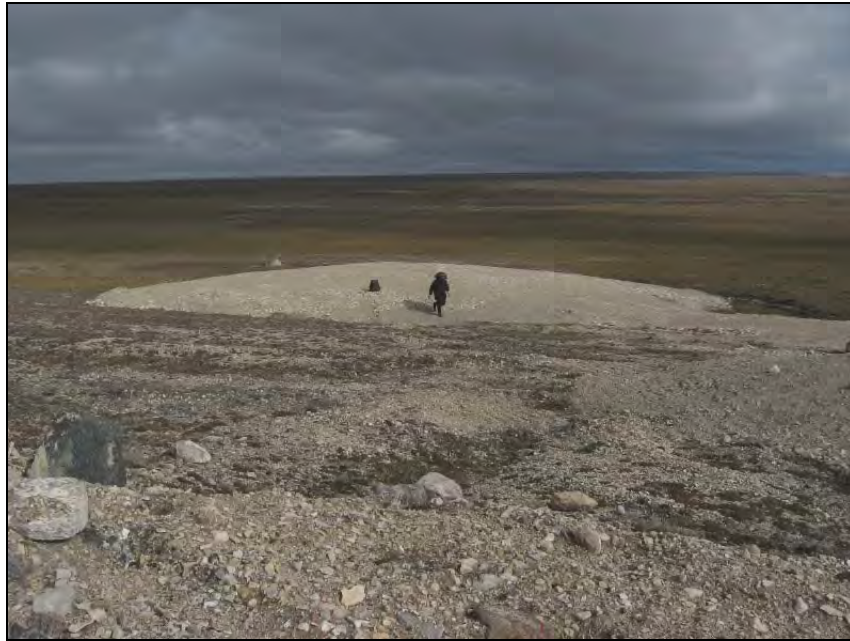
**Photograph WLFS-7.** Looking NE to 2nd cell from near NW corner of 3rd cell. ↑

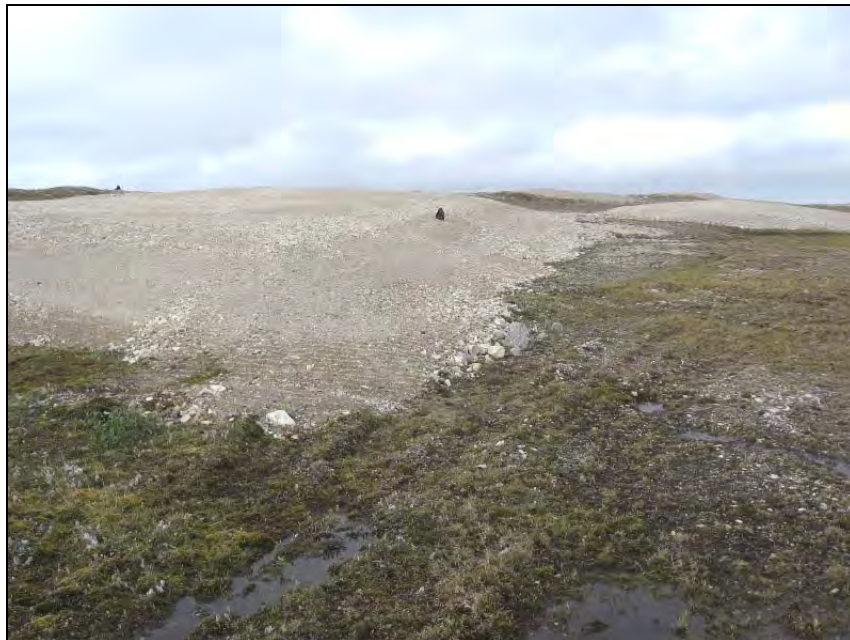
**Photograph WLFS-8.** Looking NW along east side of 3rd cell from NE corner of large S cell. Granular cover appears stable. ↑

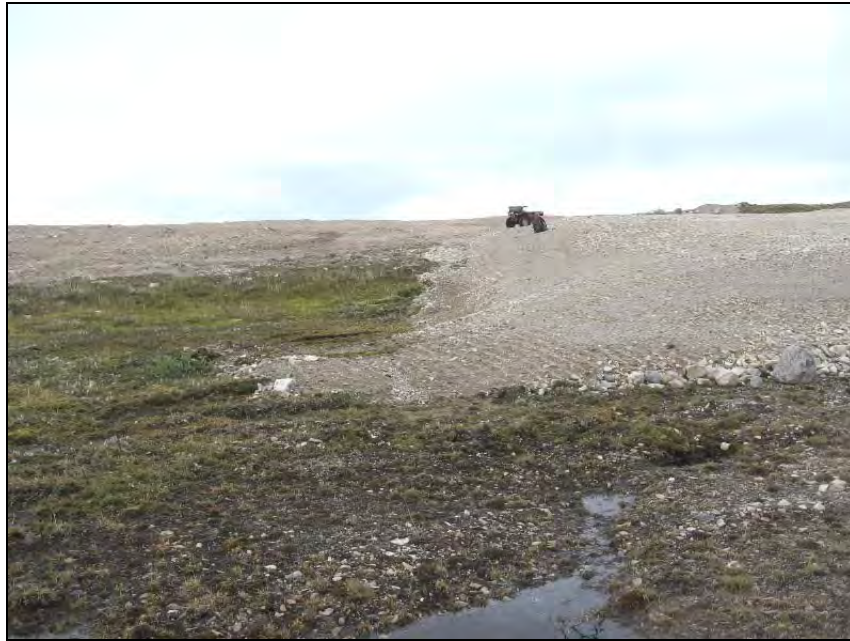
**Photograph WLFS-9.** Looking WSW along S side of 3rd cell. No features of note. ↑

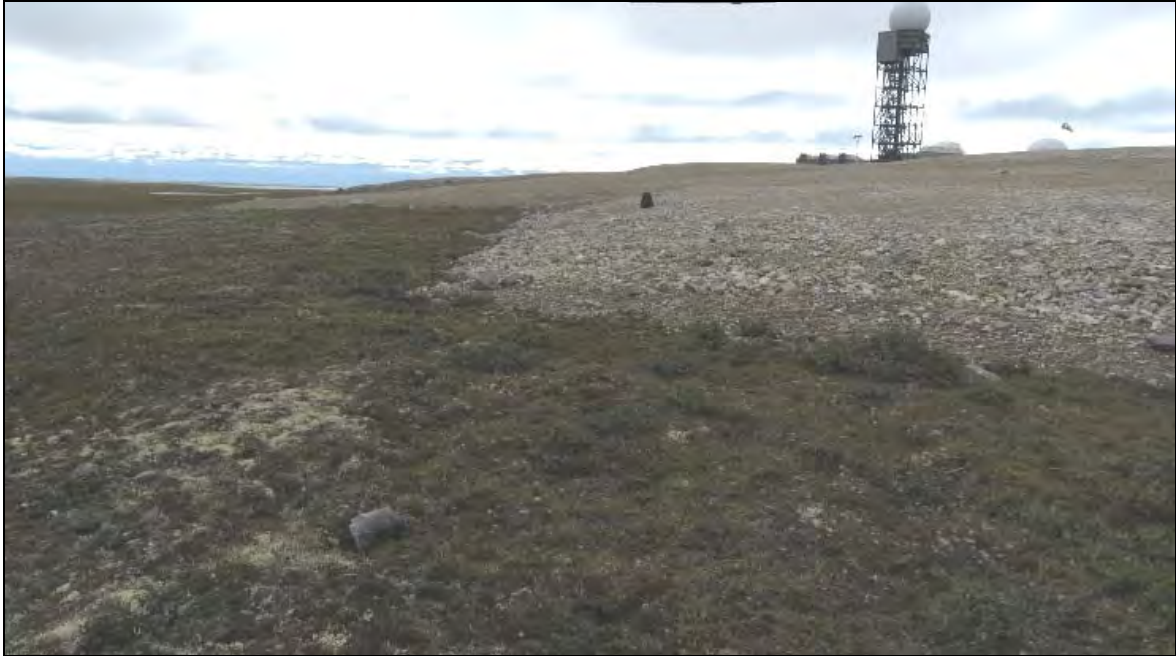
**Photograph WLFS-11.** Looking S along E side of largest, most southerly landfill cell. Viewed from NE corner. ↑

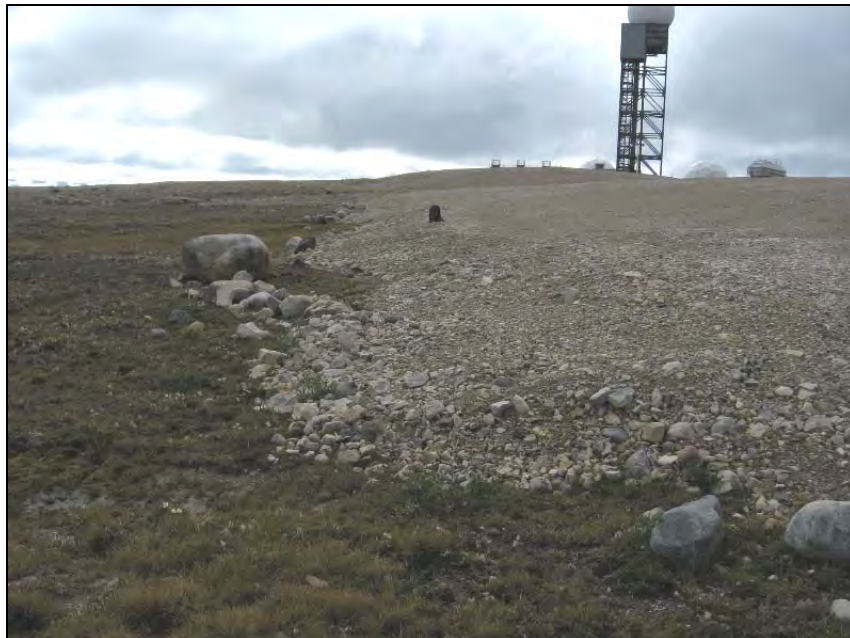
**Photograph WLFS-12.** Looking S along E side of large southern cell to the SE corner. Radar tower in background. ↑

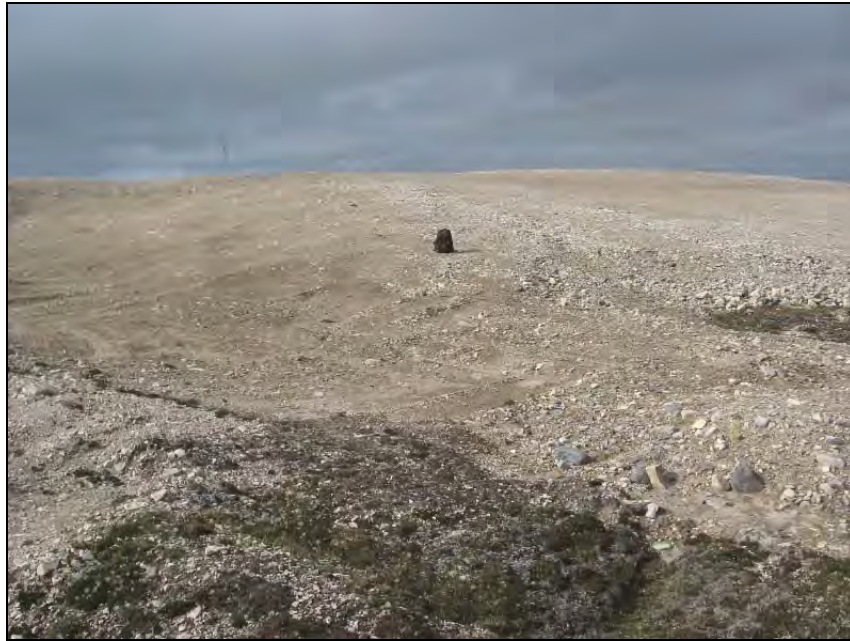
**Photograph WLFS-13.** Looking W to SE corner of large southern landfill cell. Drainage swale is visible, however it does not appear to be protected by erosion protection. ↑

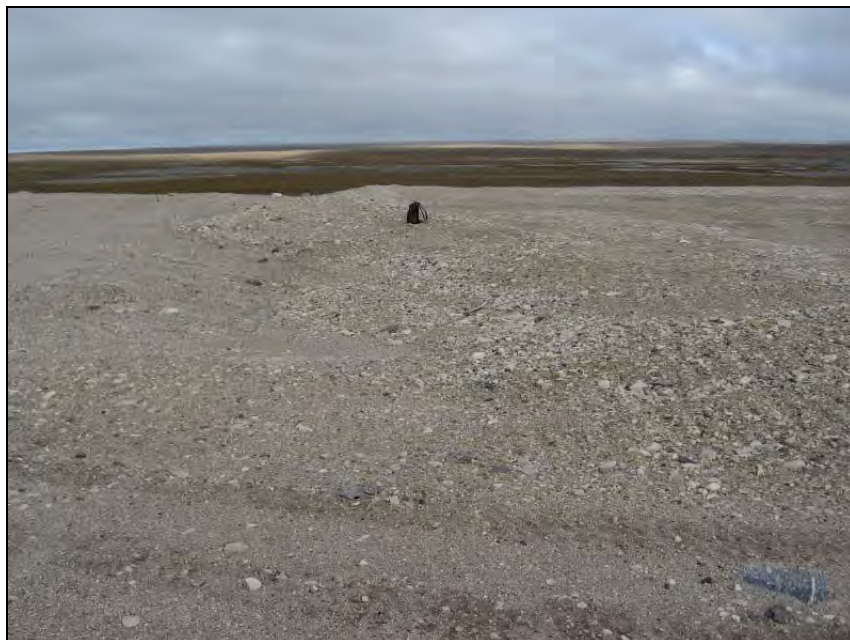
**Photograph WLFS-14.** Looking NNE from SW corner of the south cell. ↑

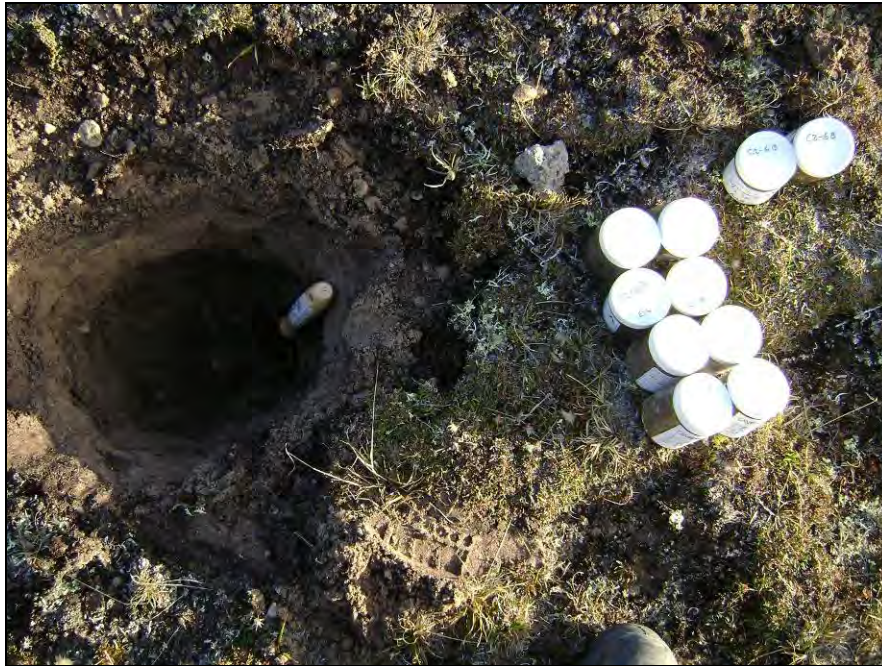
**Photograph 1.** Test pit at C2-6. Samples C2-6A, C2-6B, and C2-15A (Duplicate) collected. ↑

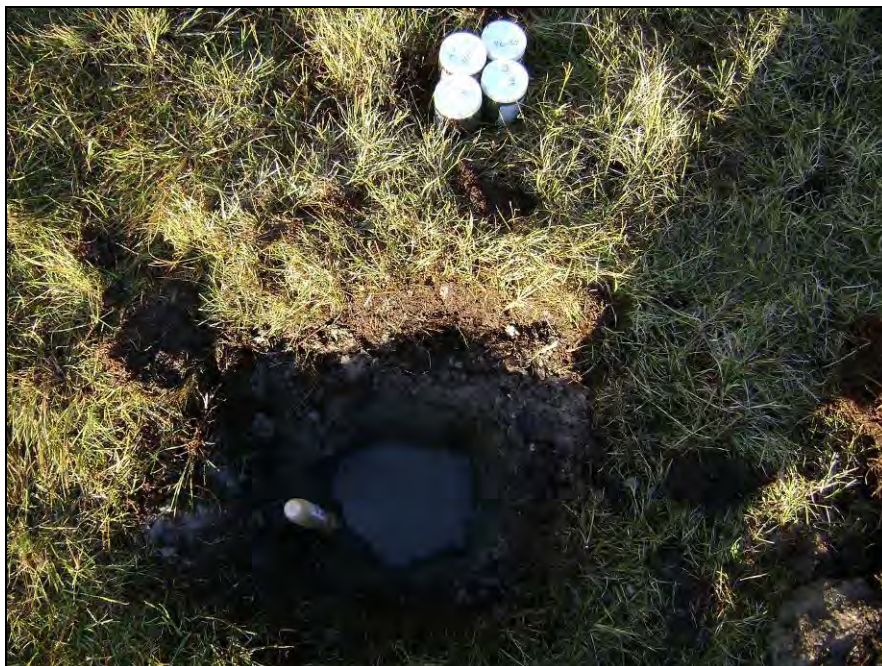
**Photograph 2.** Test pit at C2-7. Samples C2-7A and C2-7B collected. Water table at 0.30m. ↑

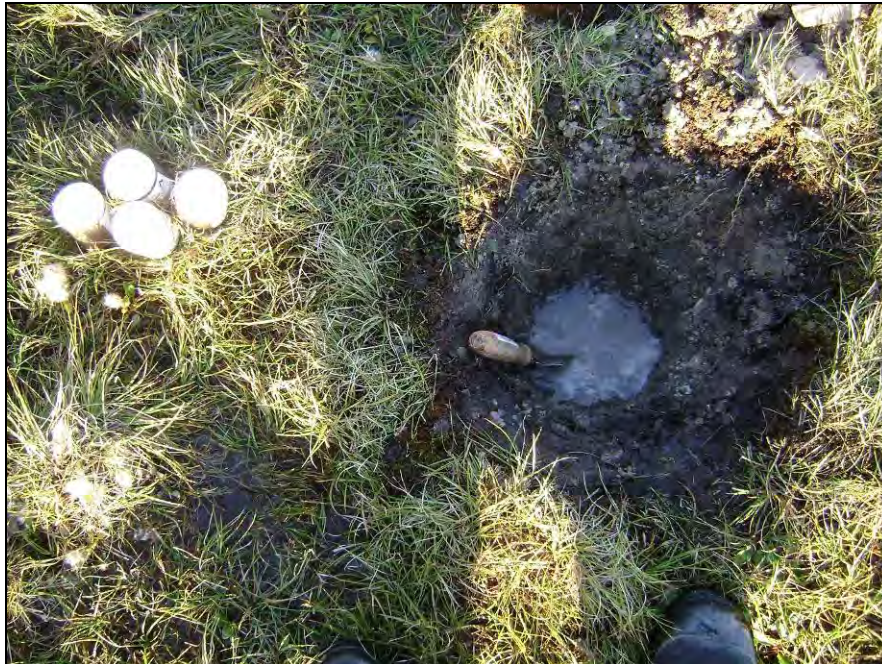
**Photograph 3.** Test pit at C2-8. Samples C2-8A and C2-8B collected. Water table at 0.25m. ↑

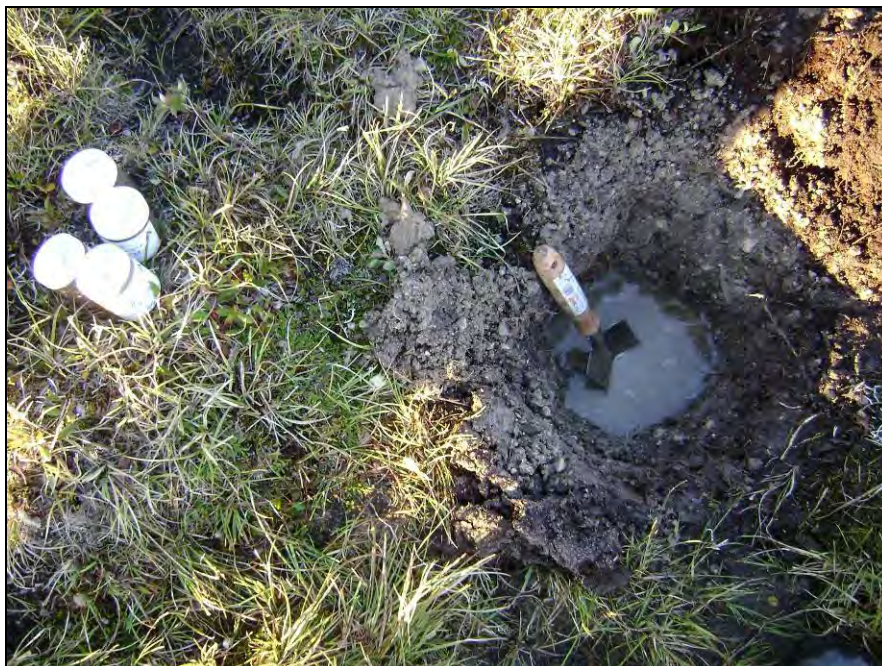
**Photograph 4.** Test pit at C2-9. Samples C2-9A and C2-9B collected. Water table at 0.25m. ↑

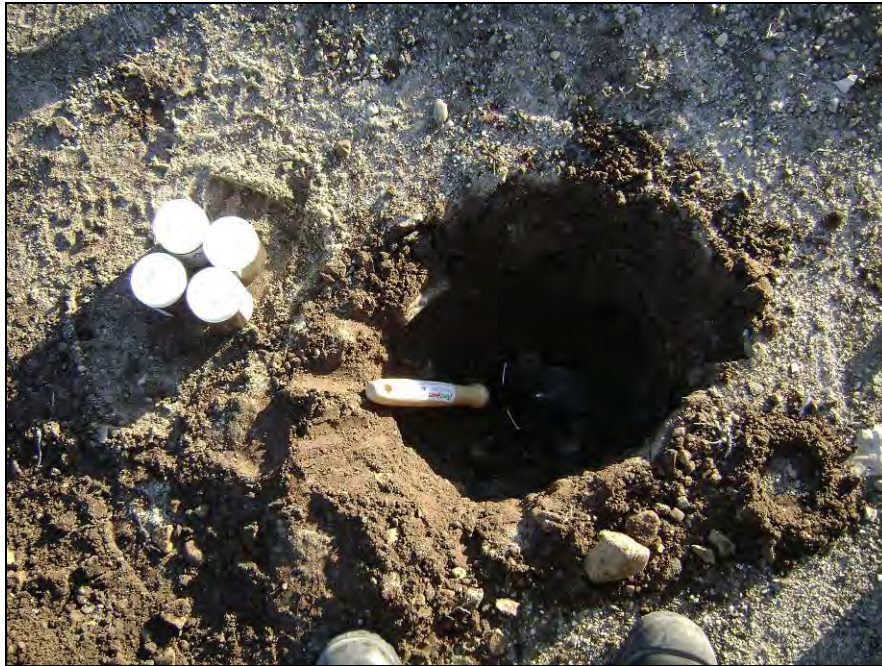
**Photograph 5.** Test pit at C2-10. Samples C2-10A and C2-10B collected. ↑

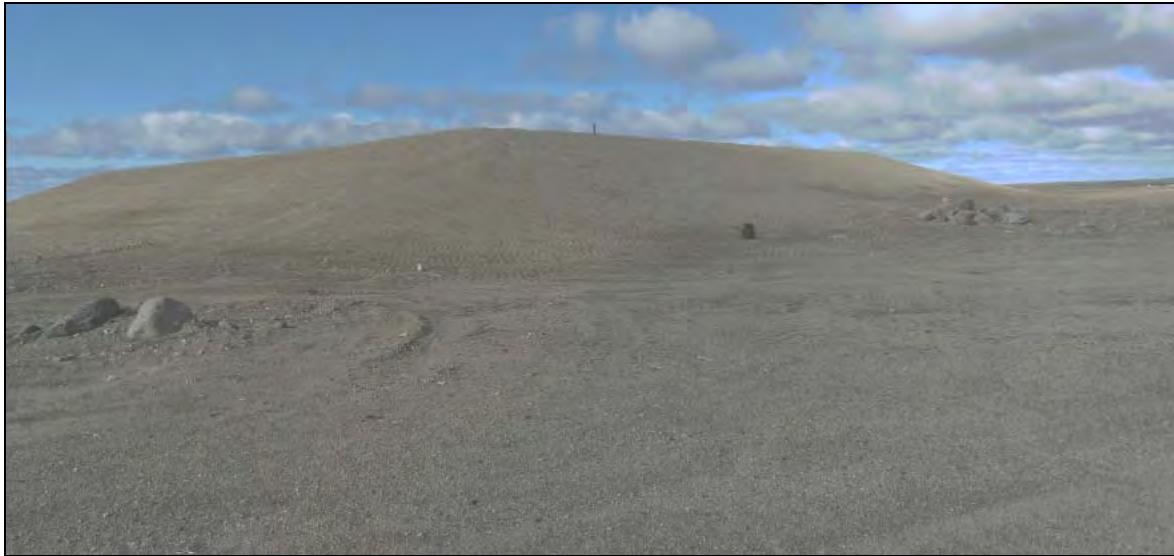
**Photograph T2-1.** Panoramic of N side of landfill looking SW from about 30m NE of NE corner. ↑

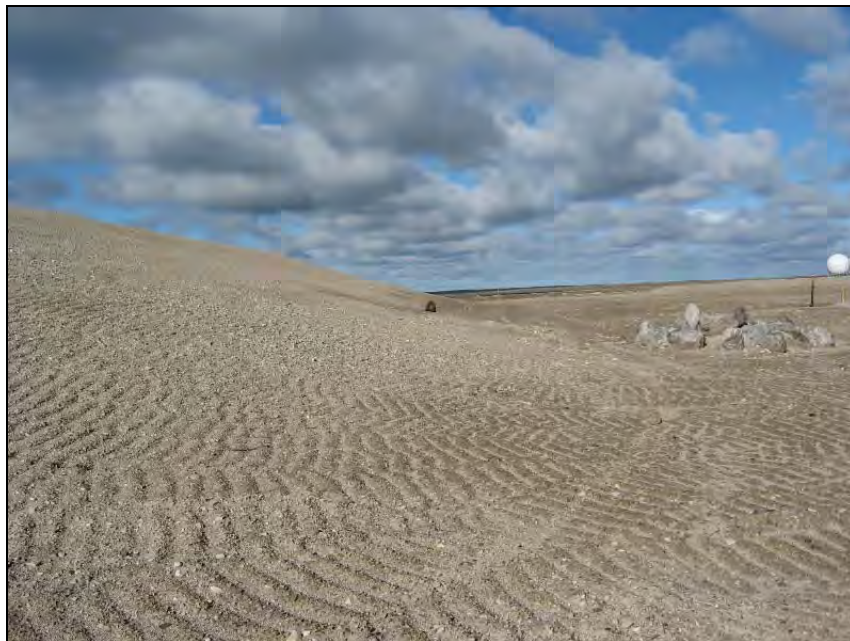
**Photograph T2-2.** Looking WNW along toe of slope from NE toe. ↑

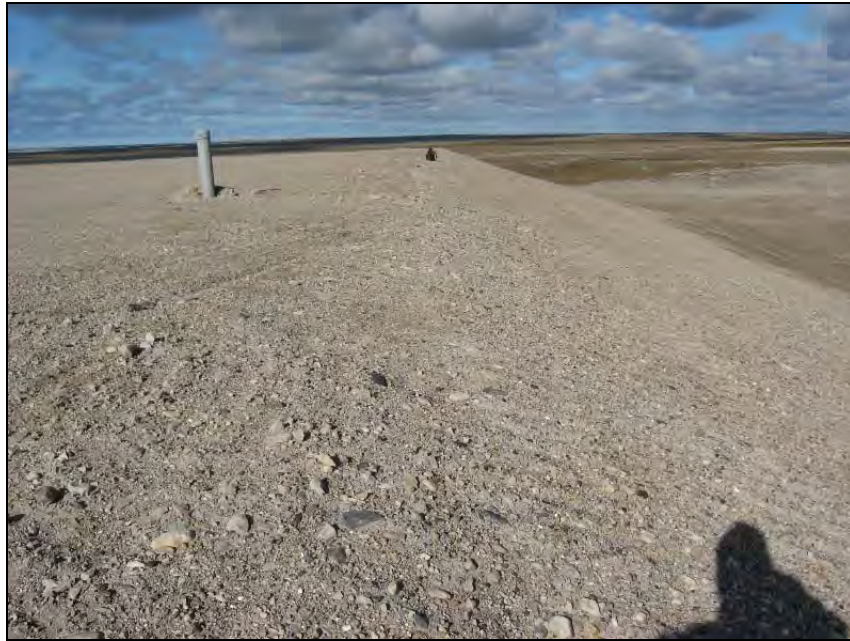
**Photograph T2-3.** Looking WNW along crest. Thermistor VT-1 is visible. ↑

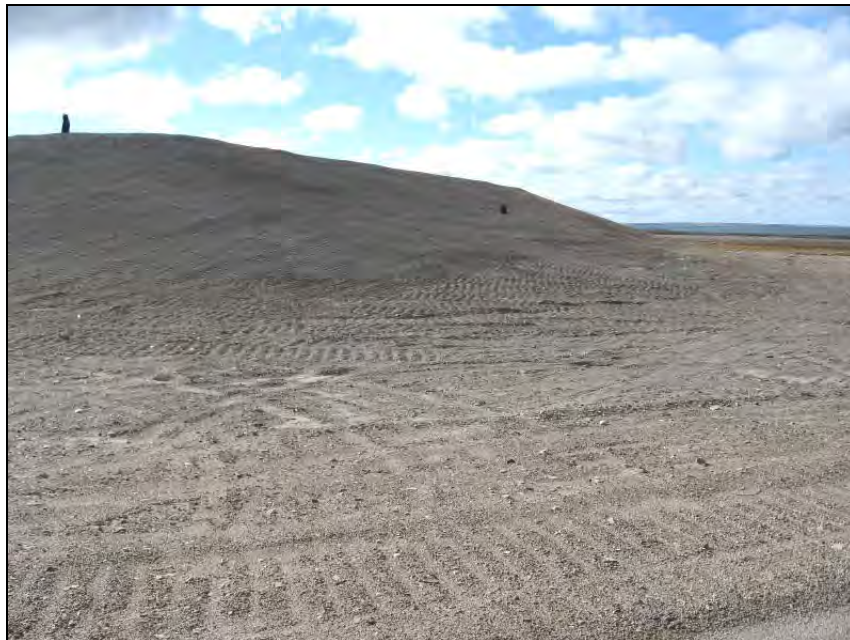
**Photograph T2-4.** Looking S along west slope of LF from about 30m NW of NW corner. ↑

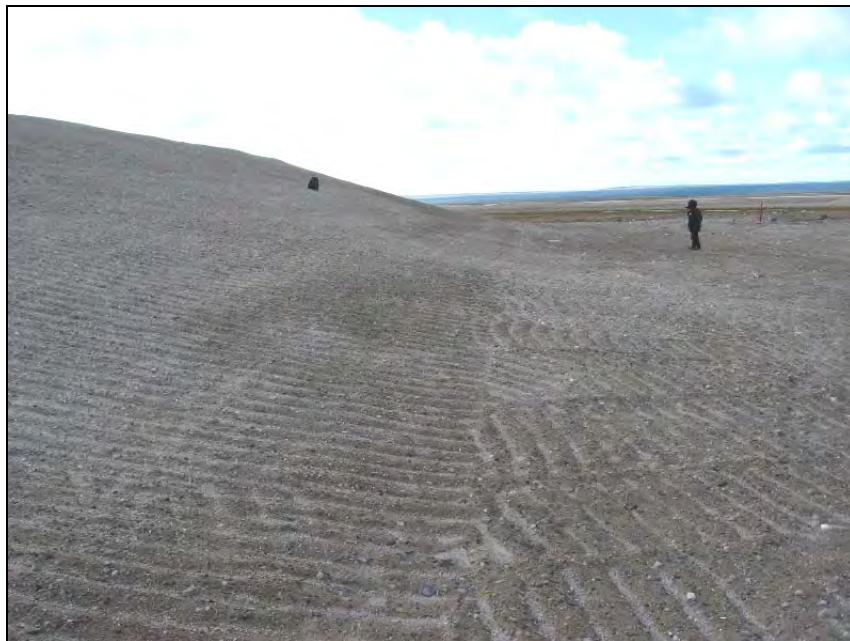
**Photograph T2-6.** Looking S along toe of W slope from NW corner. ↑

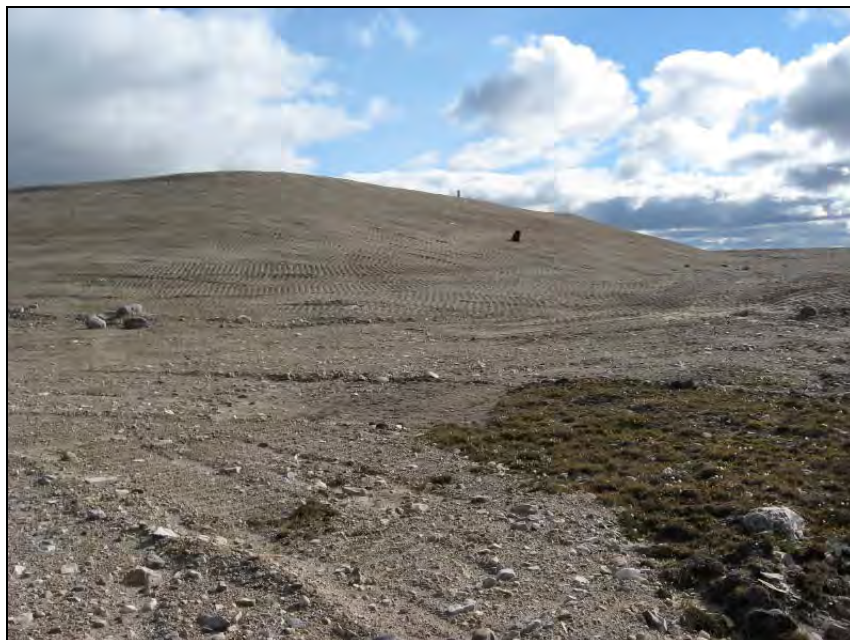
**Photograph T2-8.** Looking E to SW corner from about 30m SW of SW corner. ↑
