## **The Collection of Landfill Monitoring Data at the CAM-2 Gladman Point Site – 2008 Final Report**

**The Collection of Landfill Monitoring Data at the  
CAM-2 Gladman Point Site**

**AECOM Canada Ltd.**

January, 2009

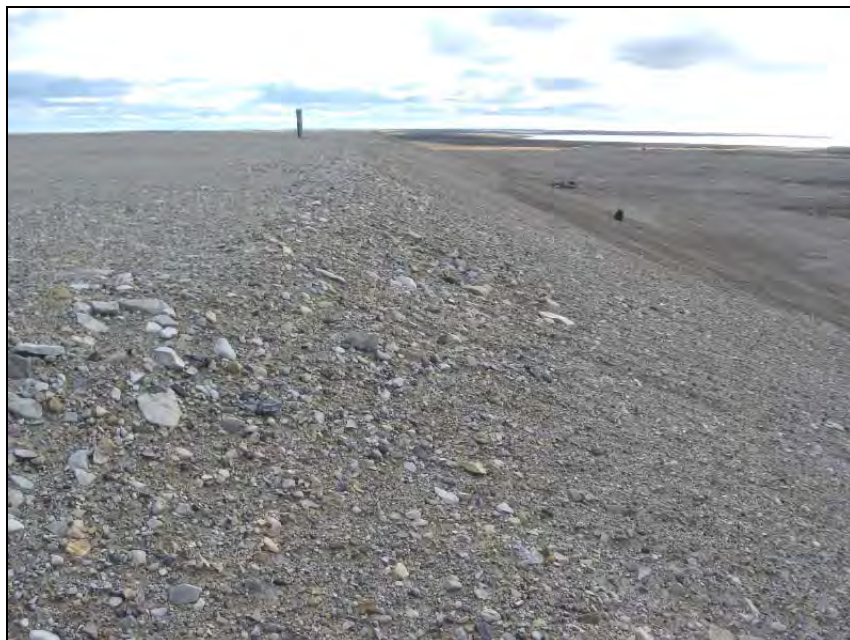
**Photograph T2-10.** Looking E along crest from SW corner. ↑

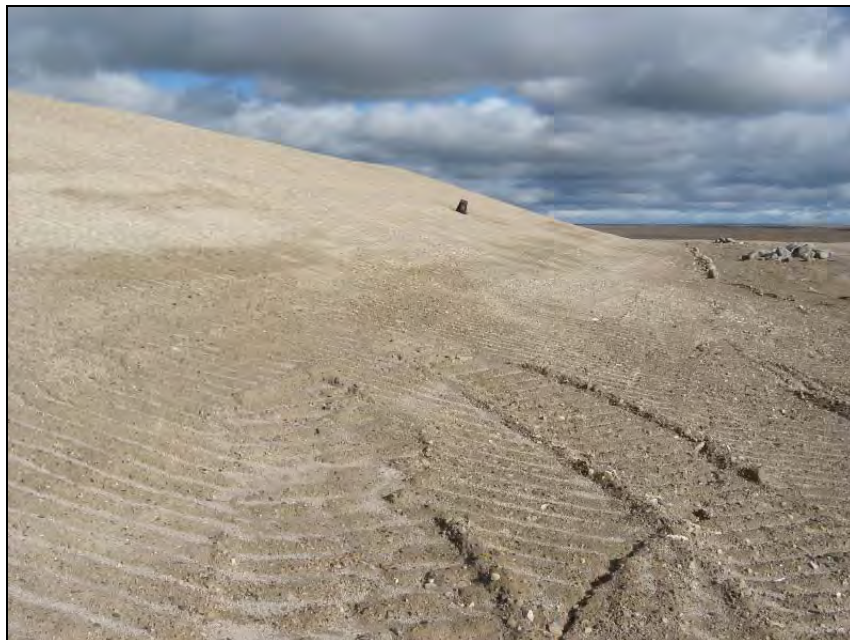
**Photograph T2-12.** Looking NNE along toe of E slope from SE corner. ↑

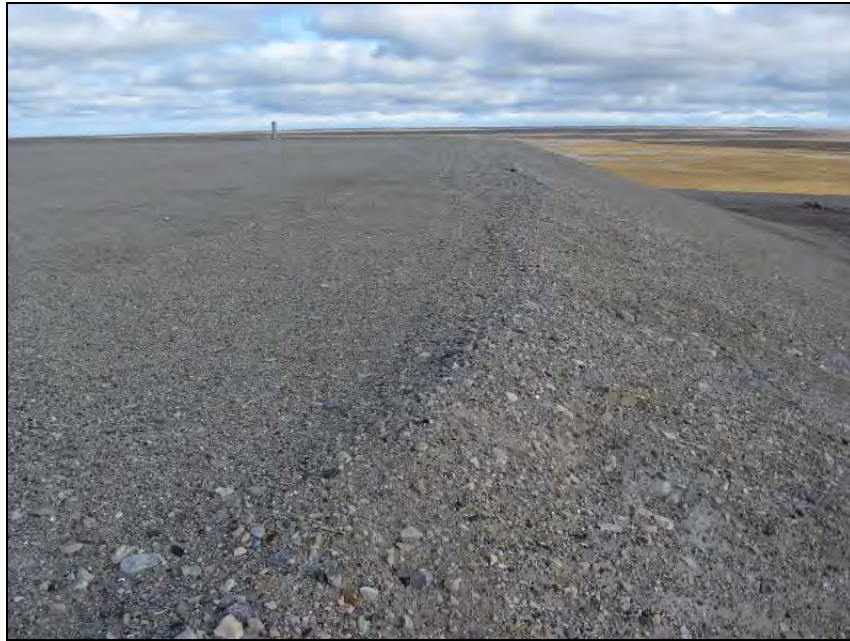
**Photograph T2-13.** Looking N along E crest from SE crest corner. ↑

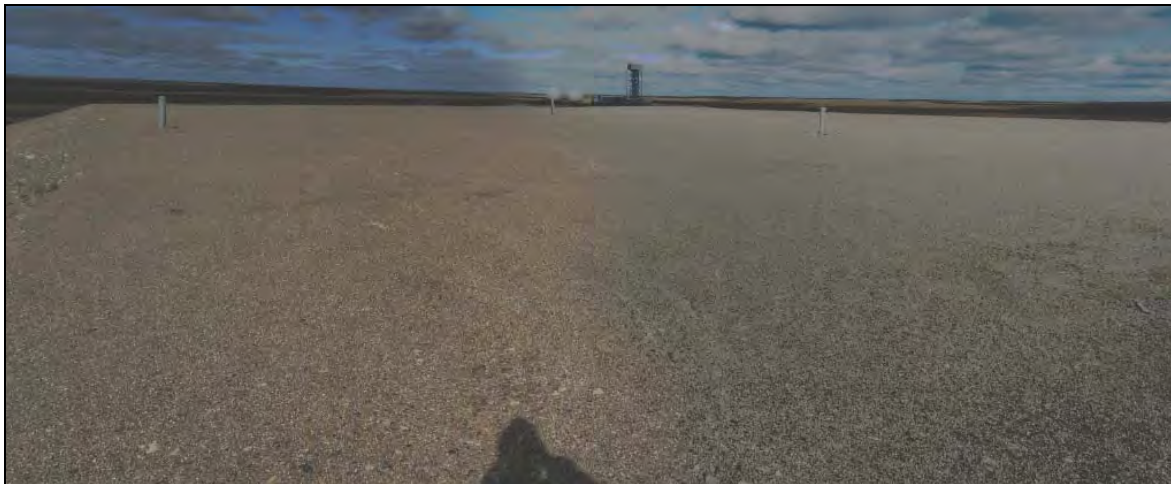
**Photograph T2-14.** Looking NW from near SE corner. Panoramic showing about 2/3 of top surface of the landfill. Granular cover appears stable. ↑

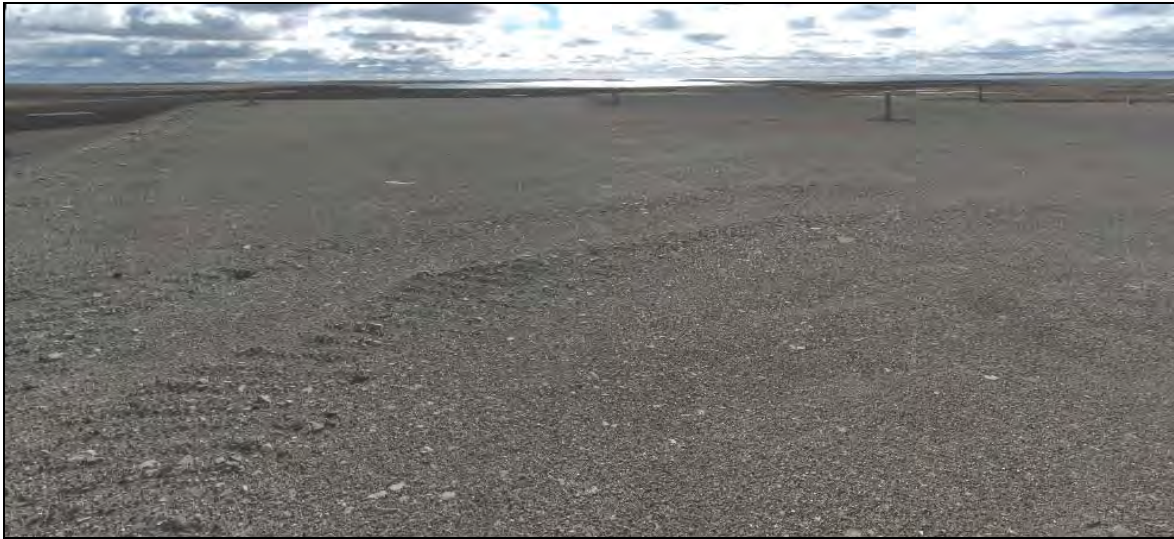
**Photograph T2-15.** Looking ESE from NW corner. Panoramic showing upper surface of landfill. Granular cover appears stable with no indications of problematic conditions. ↑

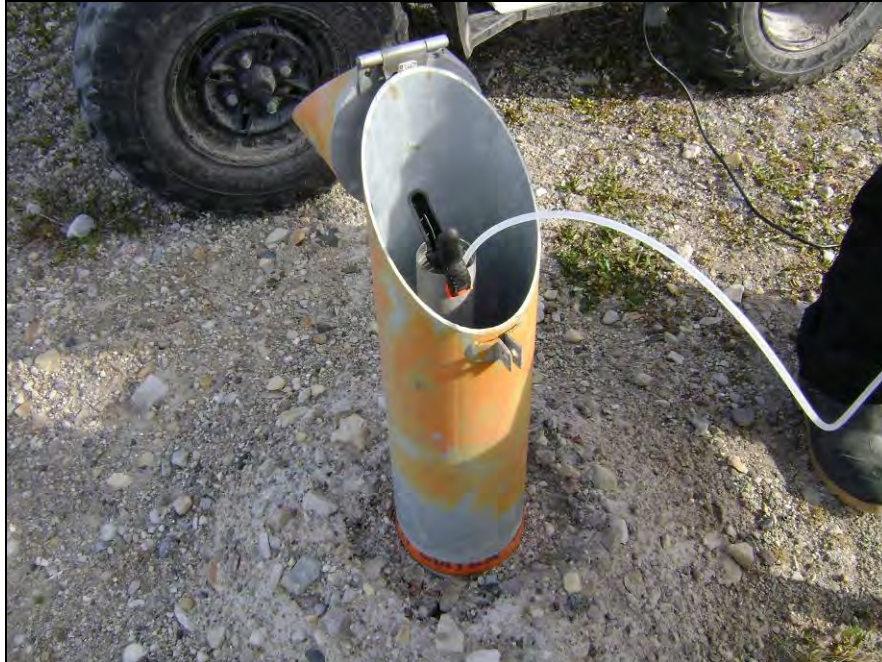
**Photograph 1.** Monitoring well MW-1. Sample C2-MW-1 collected. ↑

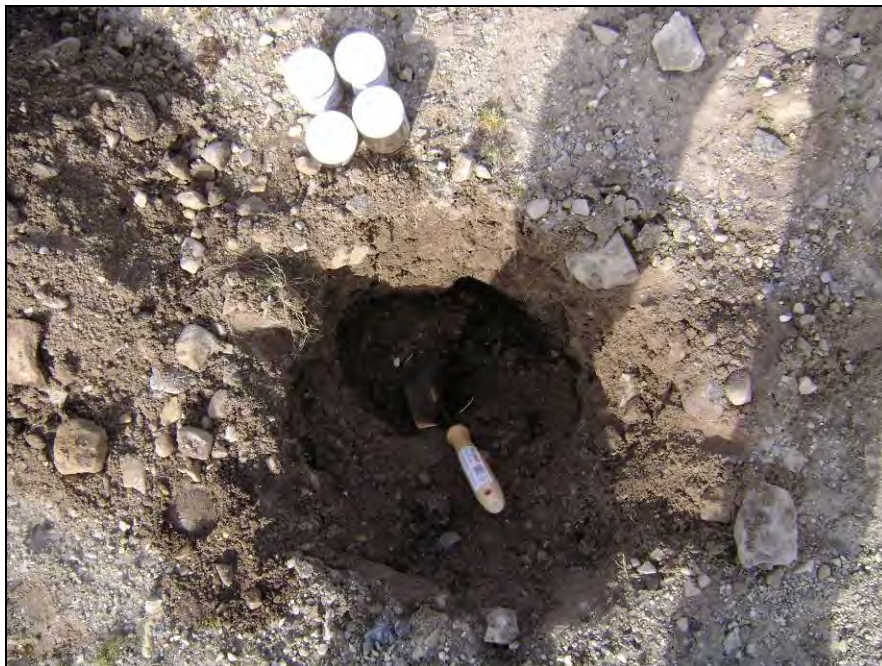
**Photograph 2.** Test pit at MW-1. Samples C2-MW-1A and C2-MW-1B collected. ↑

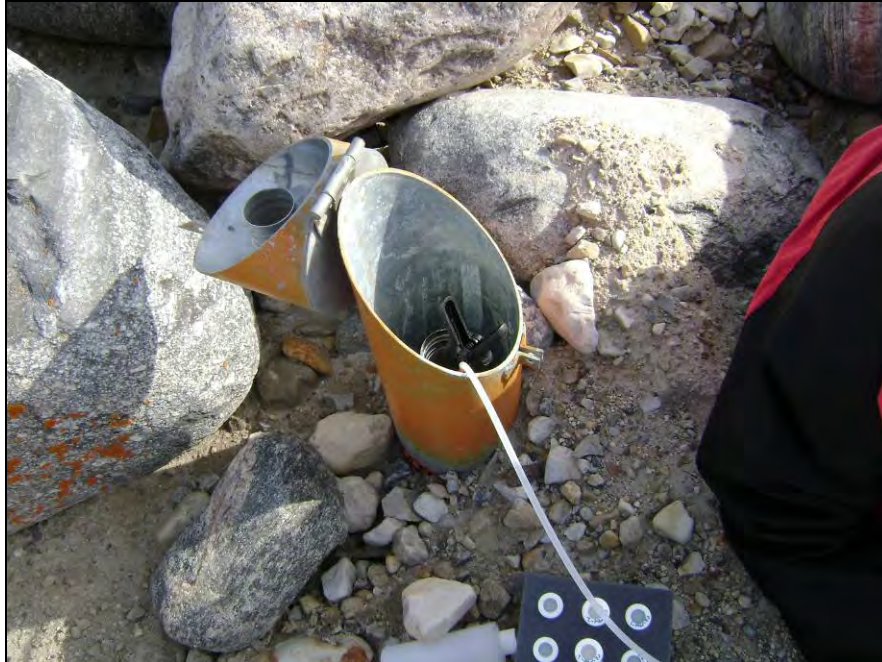
**Photograph 3.** Monitoring well MW-2. Sample C2-MW-2 collected. ↑

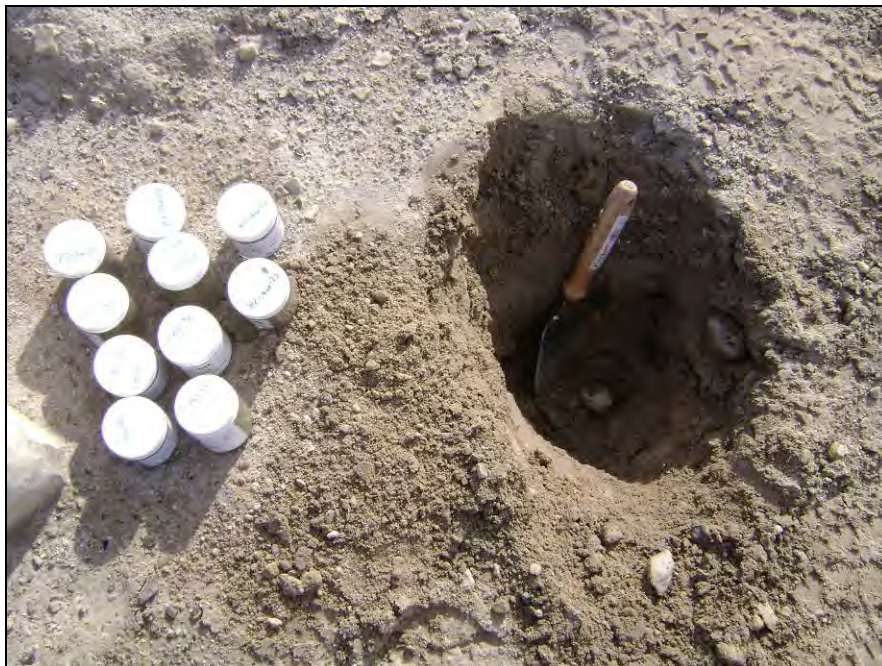
**Photograph 4.** Test pit at MW-2. Samples C2-MW-2A, C2-MW-2B, and C2-MW-9A (Duplicate) collected. ↑

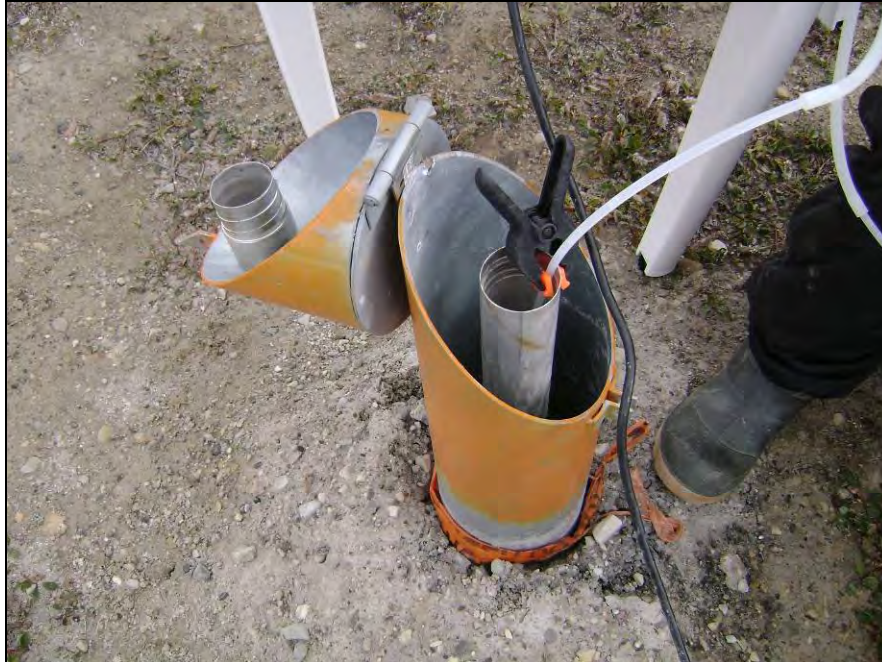
**Photograph 5.** Monitoring well MW-3. Sample C2-MW-3 collected. ↑

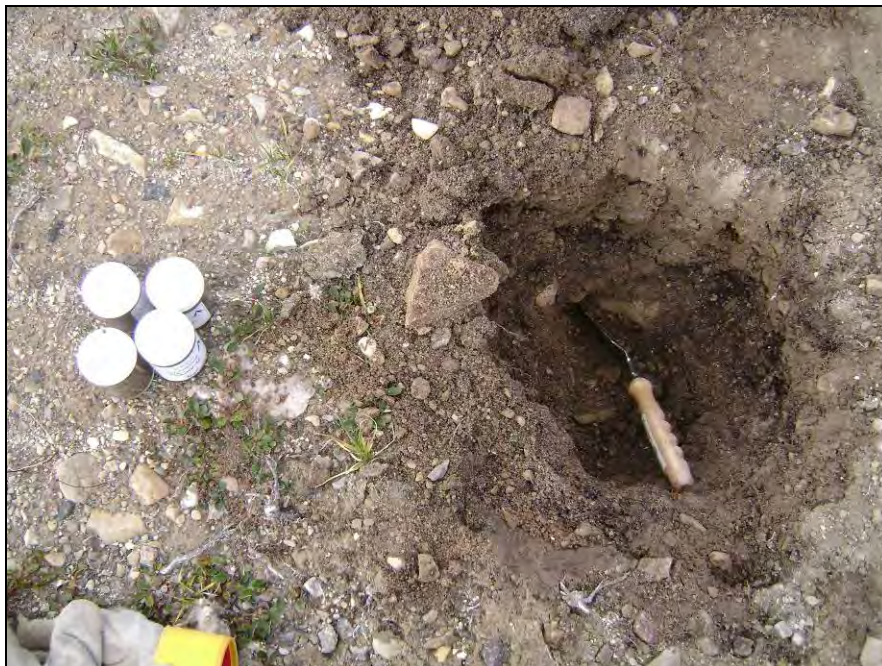
**Photograph 6.** Test pit at MW-3. Samples C2-MW-3A and C2-MW-3B collected. ↑

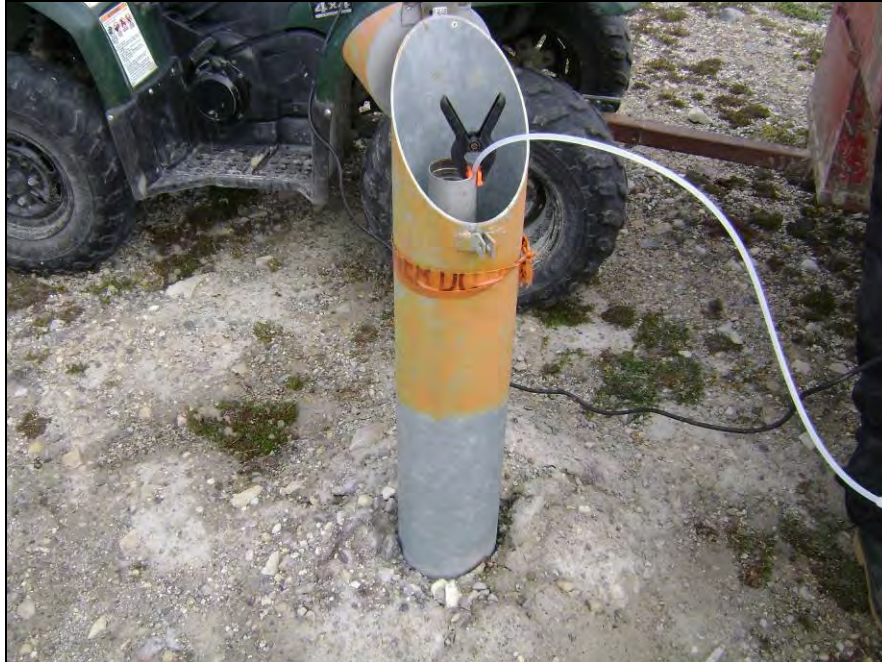
**Photograph 7.** Monitoring well MW-4. Sample C2-MW-4 collected. ↑

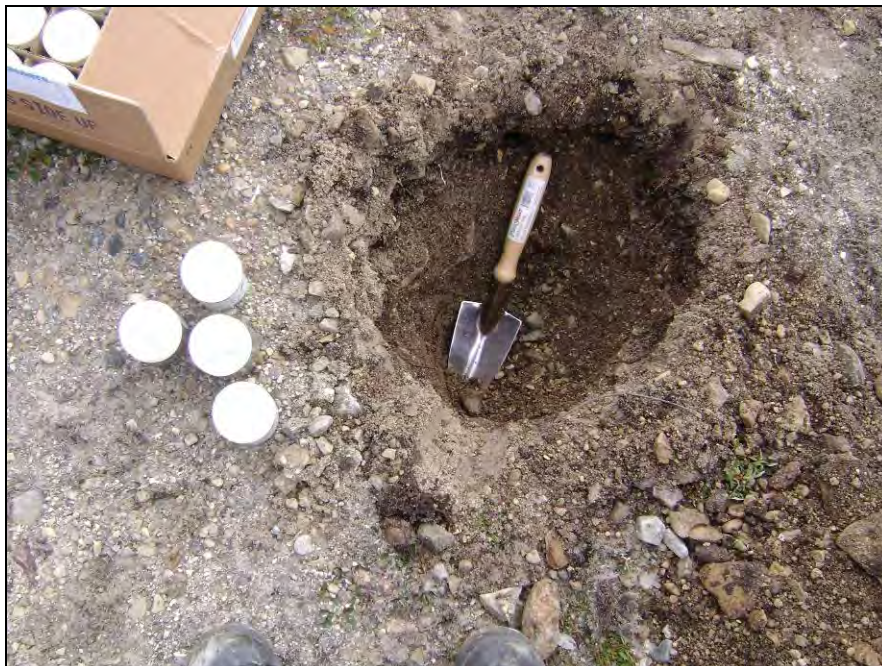
**Photograph 8.** Test pit at MW-4. Samples C2-MW-4A and C2-MW-4B collected. ↑

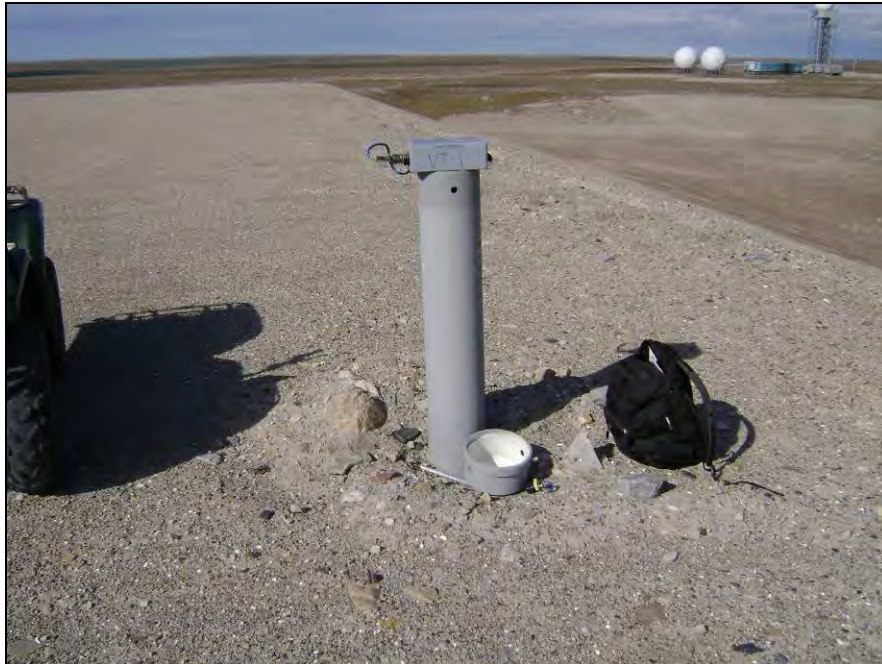
**Photograph 9.** Vertical thermistor VT-1. ↑

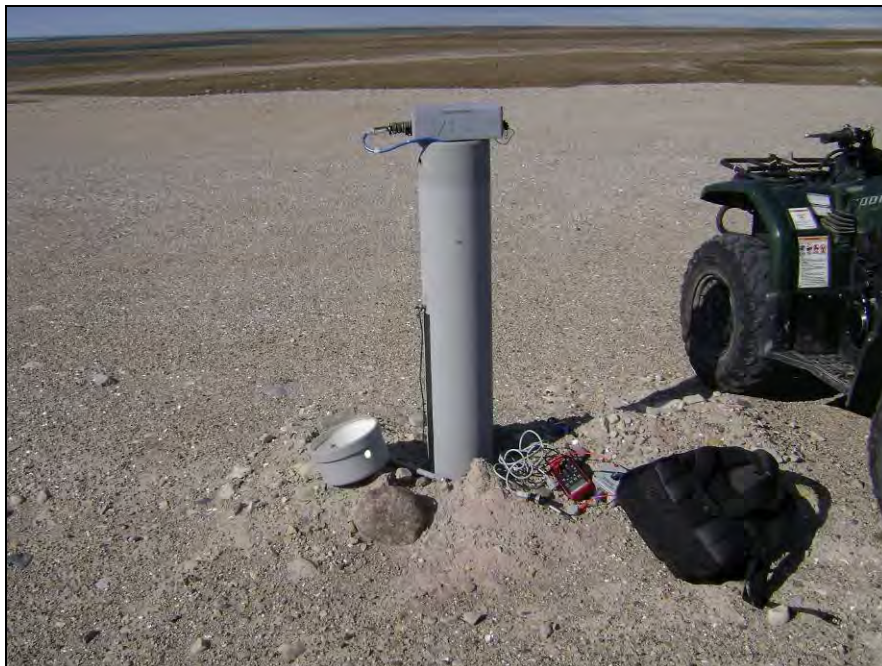
**Photograph 10.** Vertical thermistor VT-2. ↑

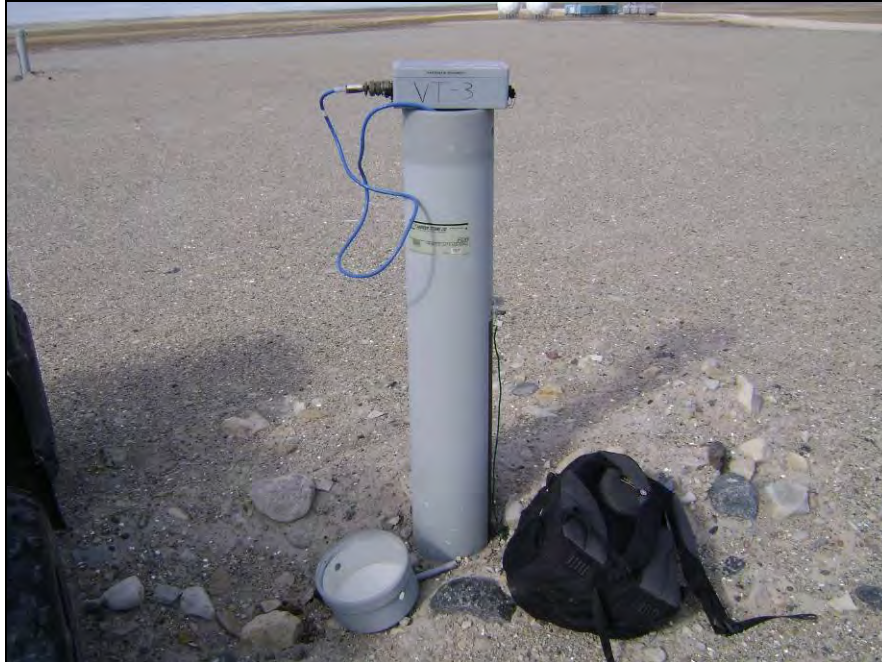
**Photograph 11.** Vertical thermistor VT-3. ↑

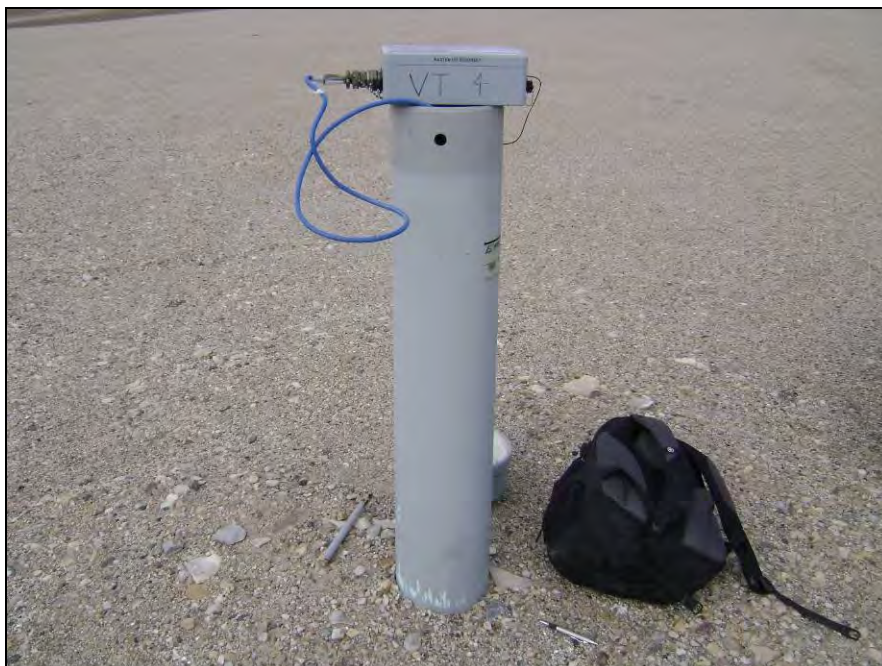
**Photograph 12.** Vertical thermistor VT-4. ↑

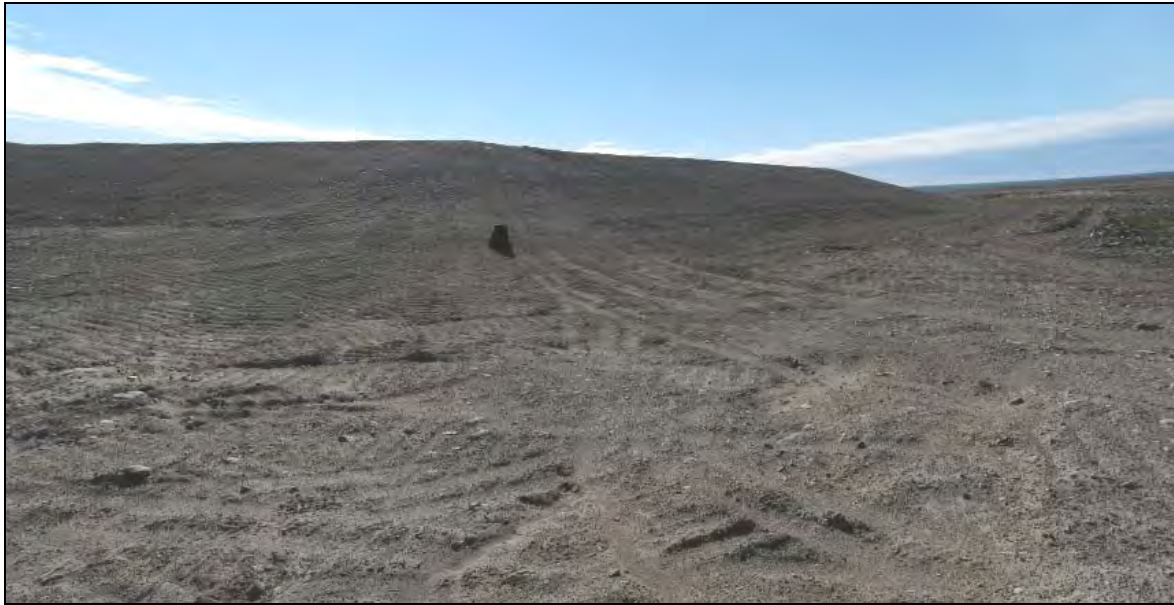
**Photograph NH-1.** Looking SW towards NE corner of Landfill. ↑

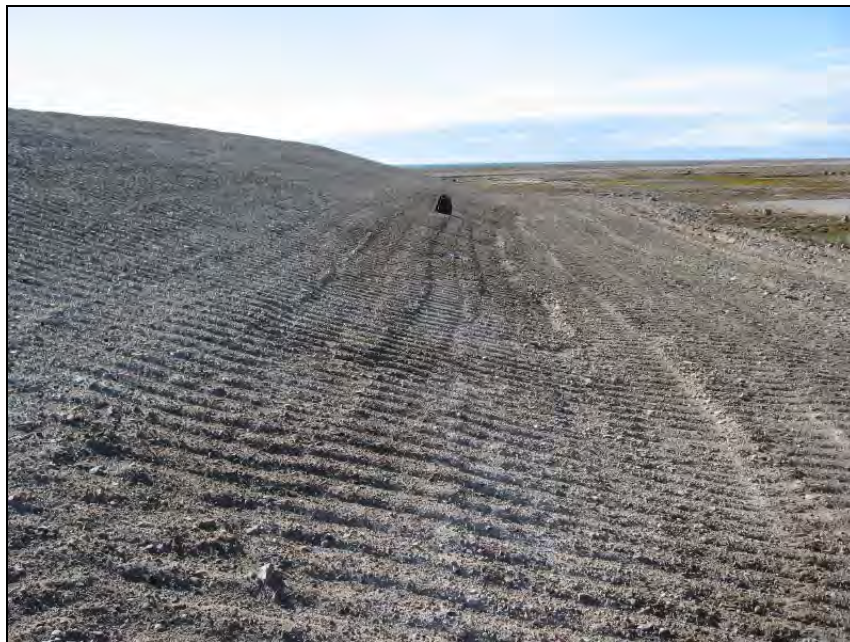
**Photograph NH-2.** Looking W along the toe of the N side of NE corner. ↑

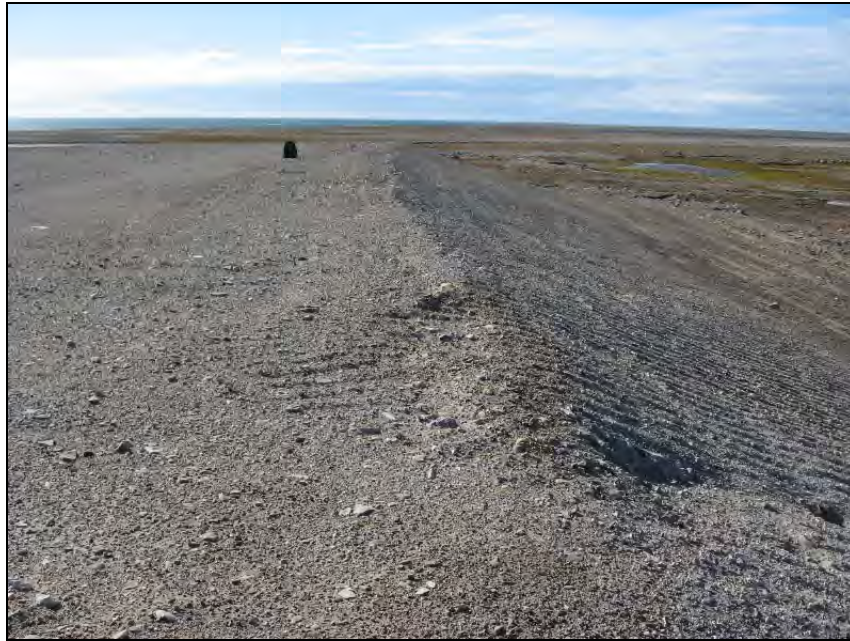
**Photograph NH-3.** Looking W along crest from NE corner. ↑

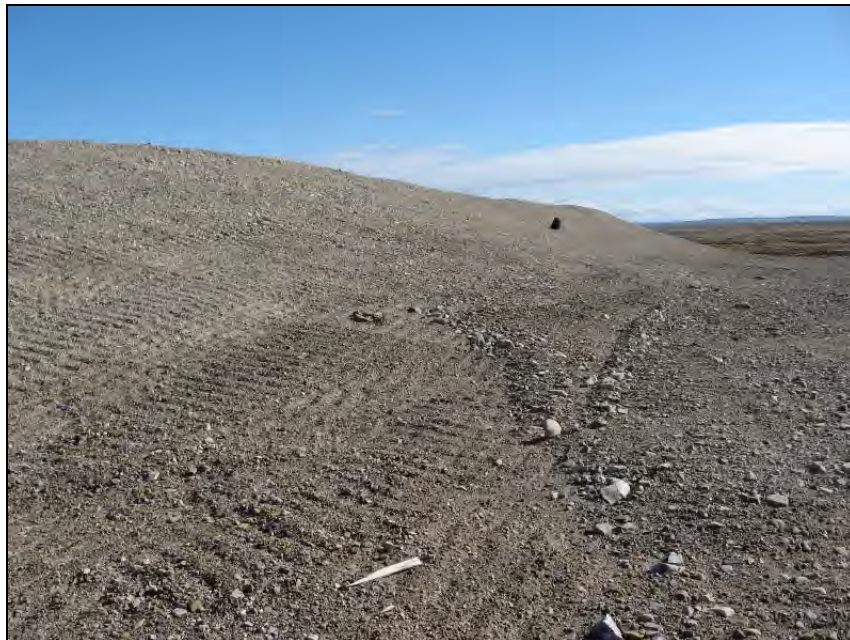
**Photograph NH-4.** Looking S along W side of LF from 10m NW of NW corner. ↑

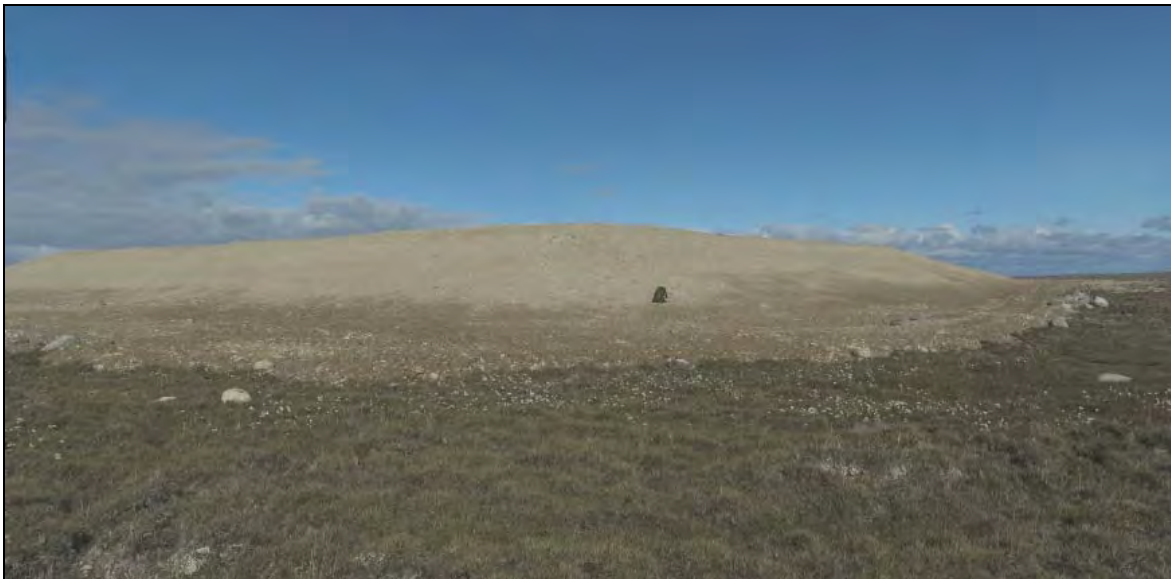
**Photograph NH-6.** Panoramic looking NE from adjacent to MW-8 looking to SW corner of LF. ↑

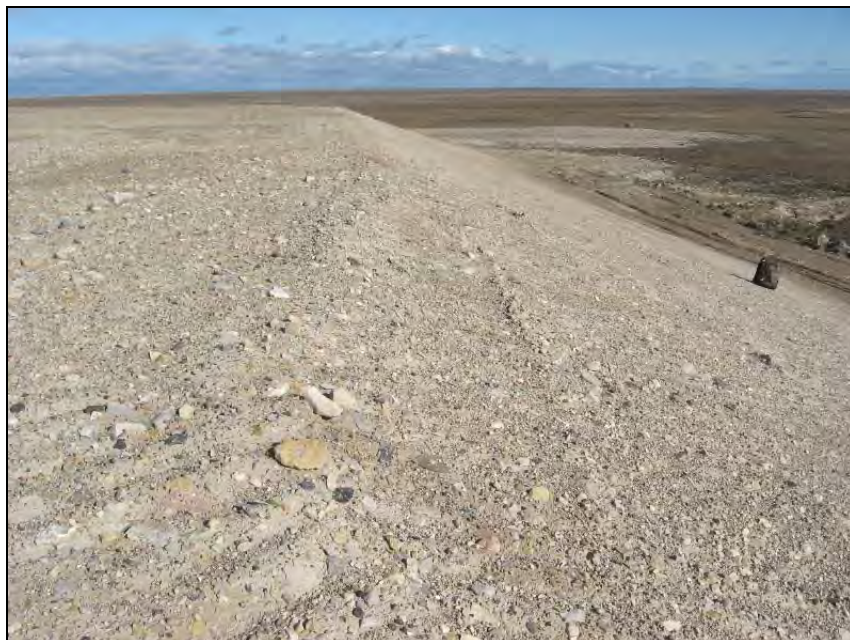
**Photograph NH-8.** Looking ENE along crest from SW top of LF. ↑

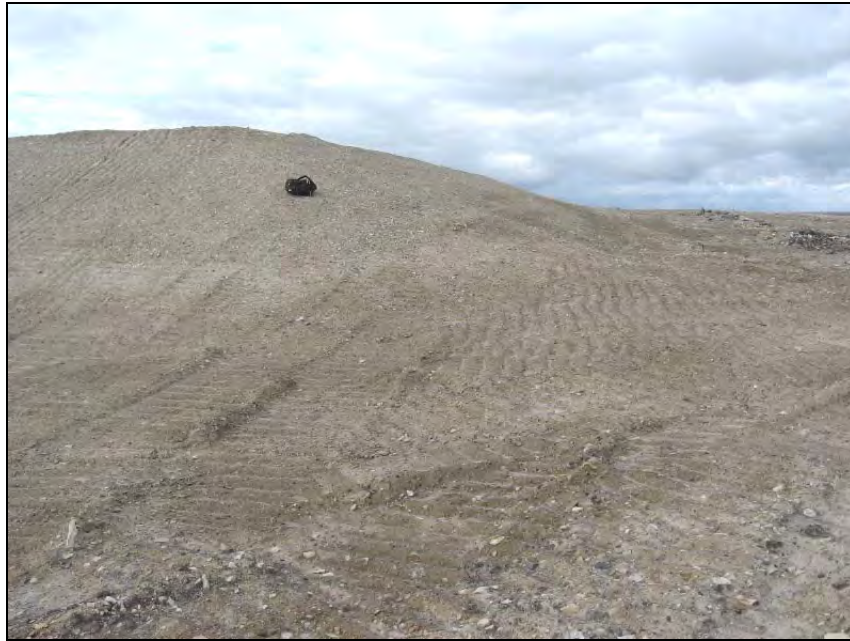
**Photograph NH-15.** Looking N along E toe from SE corner. ↑

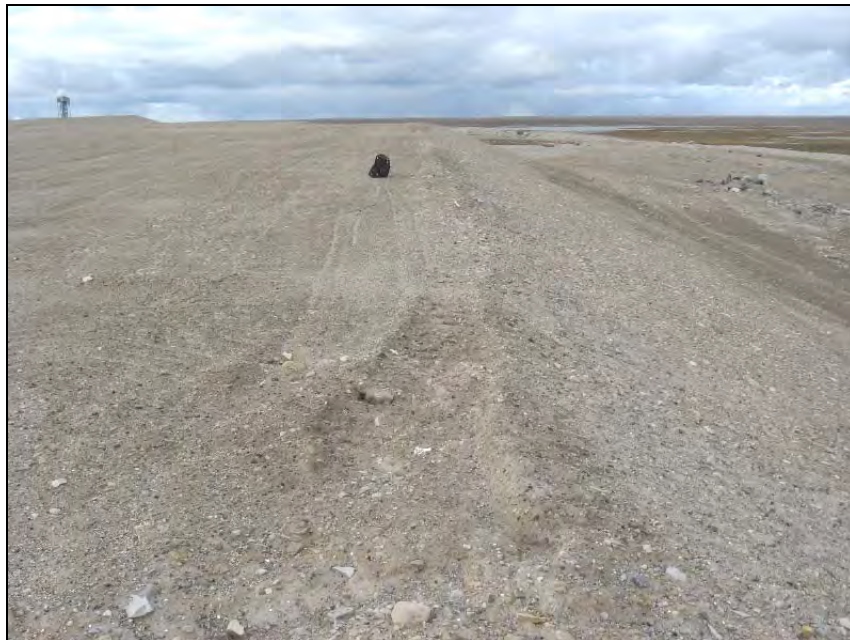
**Photograph NH-16.** Looking N along crest from SE corner. ↑

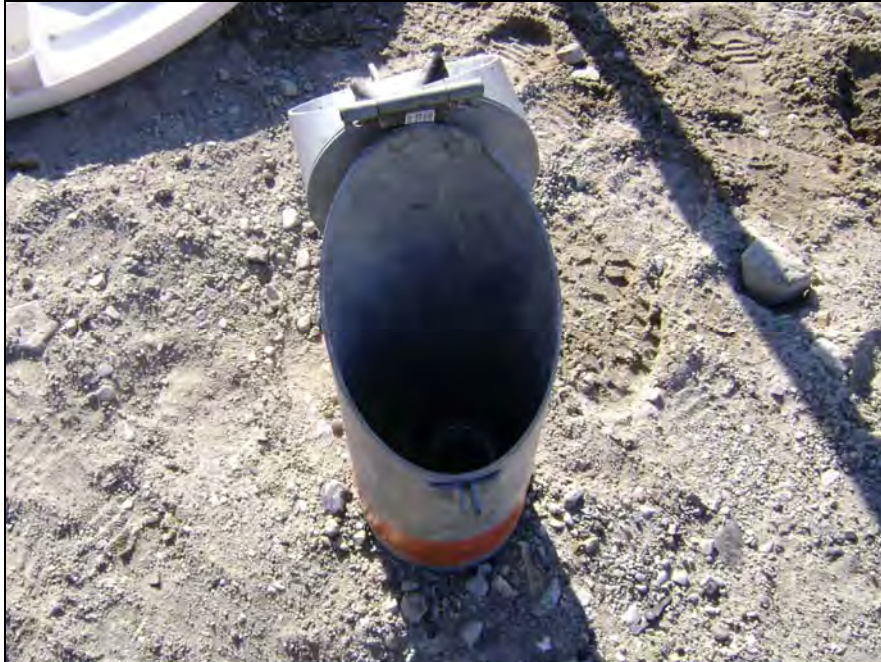
**Photograph 1.** Monitoring Well MW-5. Sample C2-MW-5 collected. ↑

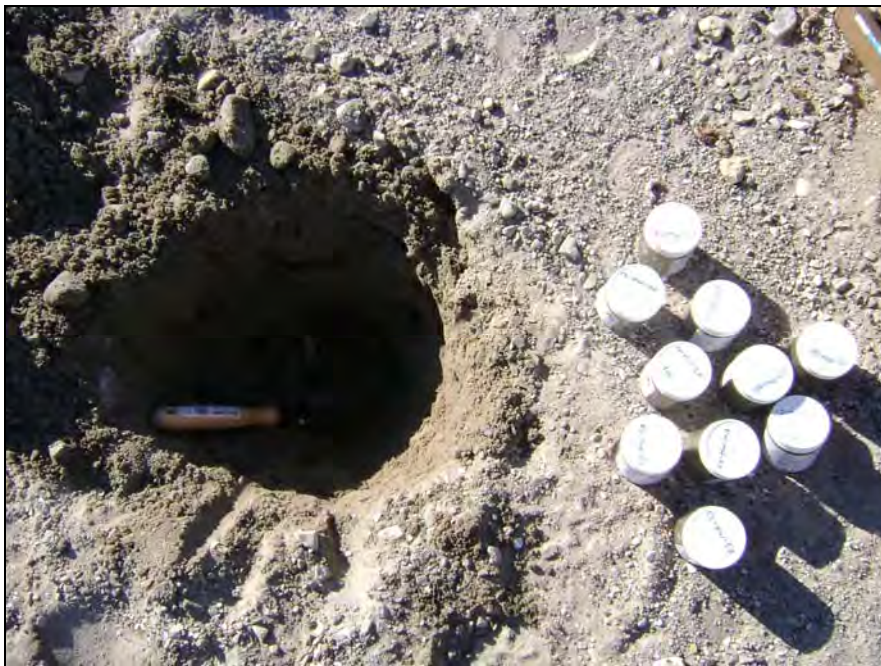
**Photograph 2.** Test pit at MW-5. Samples C2-MW-5A, C2-MW-5B, and C2-MW-10A (Duplicate) collected. ↑

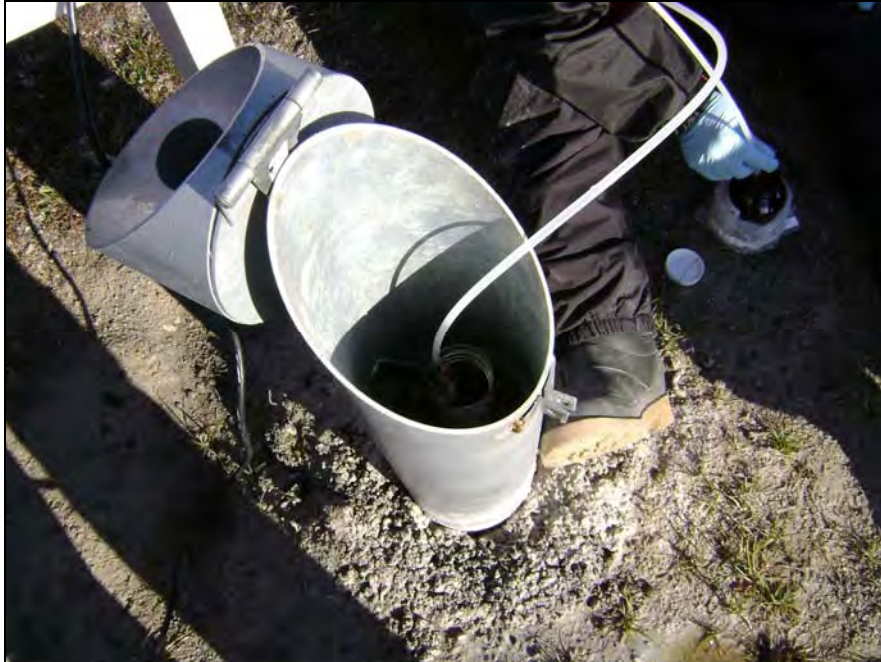
**Photograph 3.** Monitoring Well MW-6. Sample C2-MW-6 collected. ↑

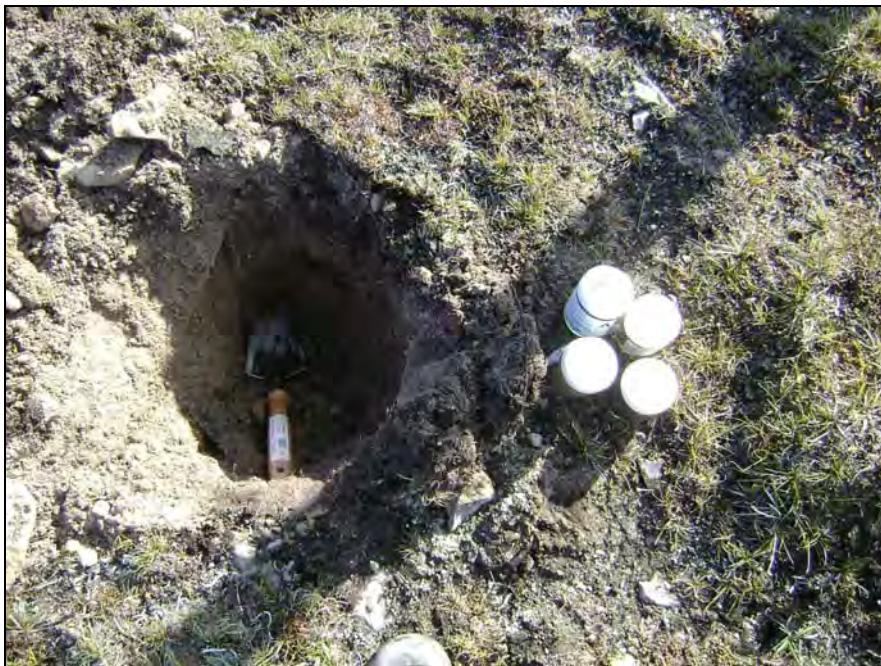
**Photograph 4.** Test pit at MW-6. Samples C2-MW-6A and C2-MW-6B collected. ↑

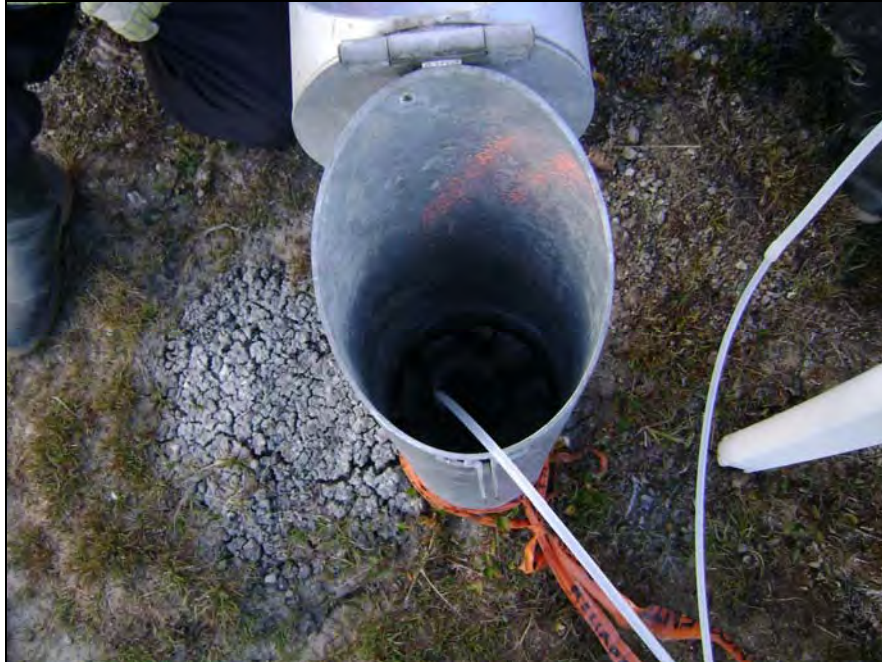
**Photograph 5.** Monitoring Well MW-7. Sample C2-MW-7 collected. ↑

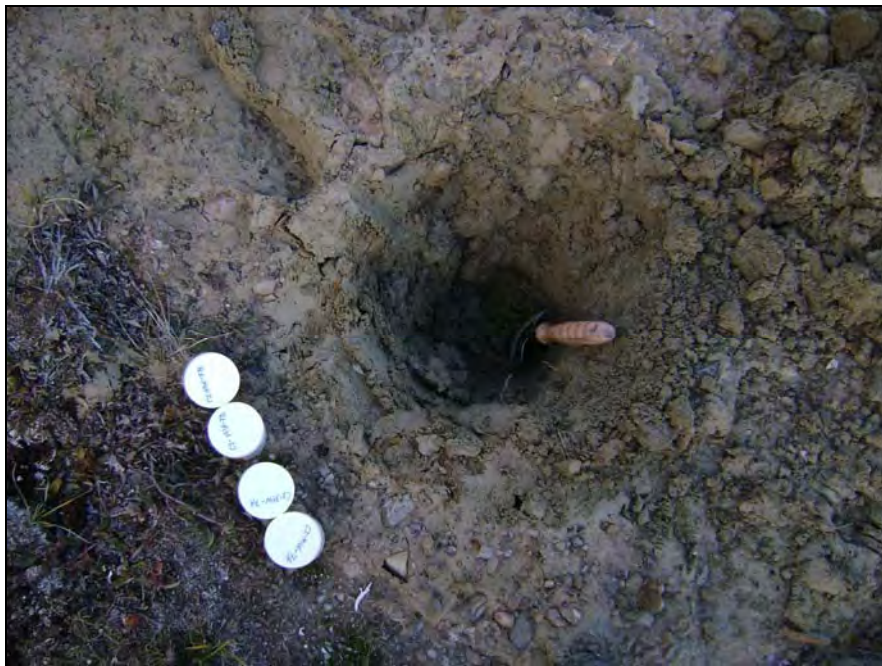
**Photograph 6.** Test pit at MW-7. Samples C2-MW-7A and C2-MW-7B collected. ↑

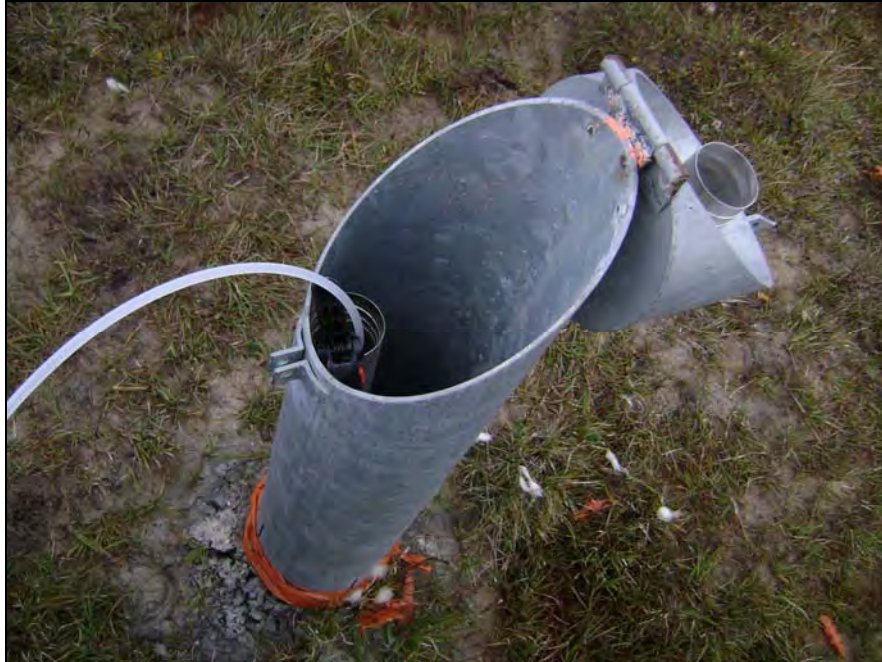
**Photograph 7.** Monitoring Well MW-8. Sample C2-MW-8 collected. ↑

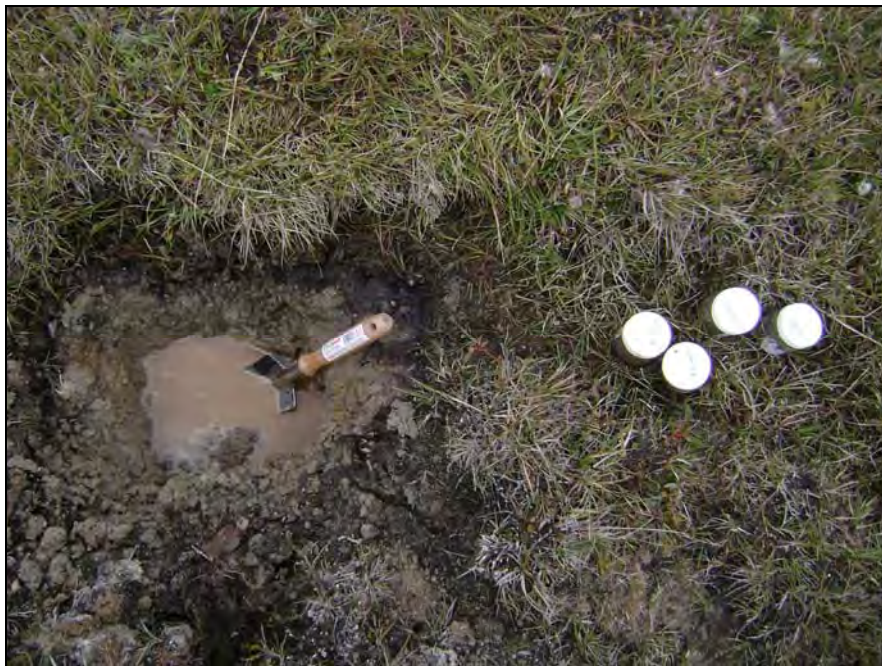
**Photograph 8.** Test pit at MW-8. Samples C2-MW-8A and C2-MW-8B collected. Water table at 0.20m. ↑
