HOPE LAKE
REMEDICATION PROJECT

REMEDIAL ACTION PLAN

**REMEDIAL ACTION PLAN
HOPE LAKE, NUNAVUT**

Y22101167.005

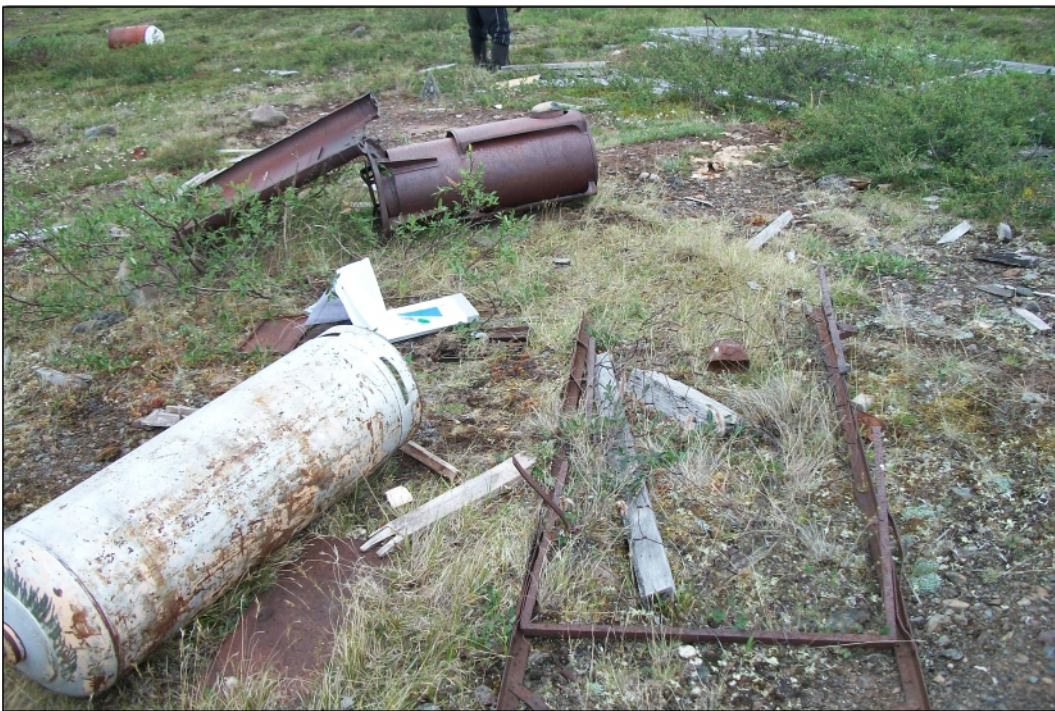
Photo 6

Husky Creek WK197 South Site: APEC 1, propane tank, heater and miscellaneous debris

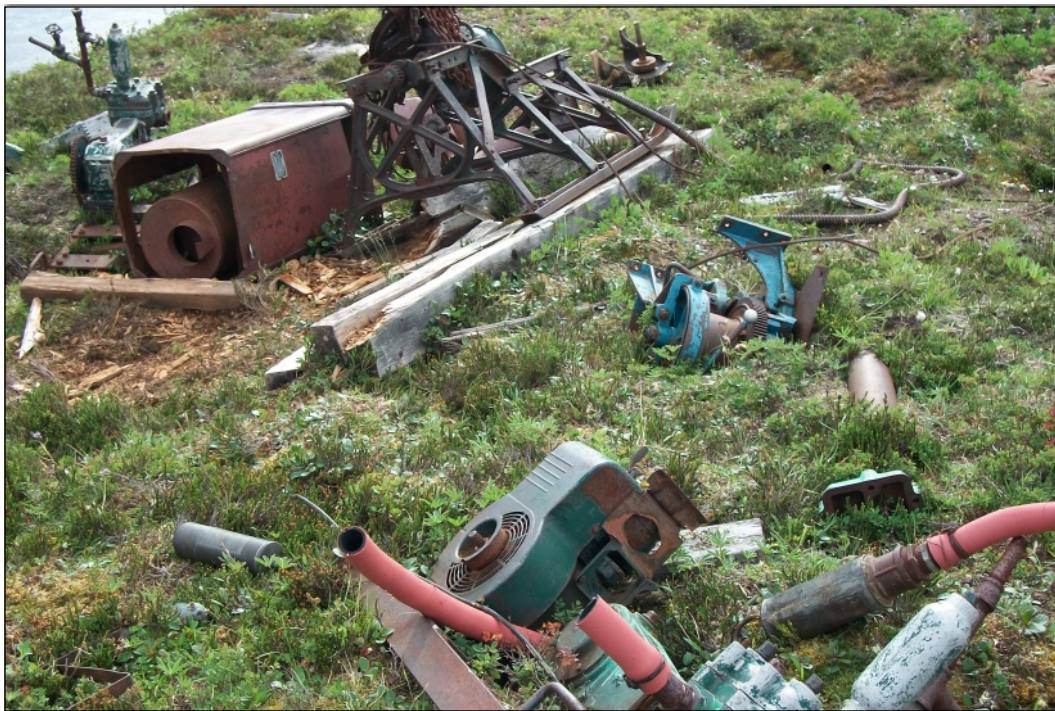
Photo 7

Husky Creek WK197 South Site: APEC 2, pump parts, pulley system, heater, and miscellaneous metal and wood debris

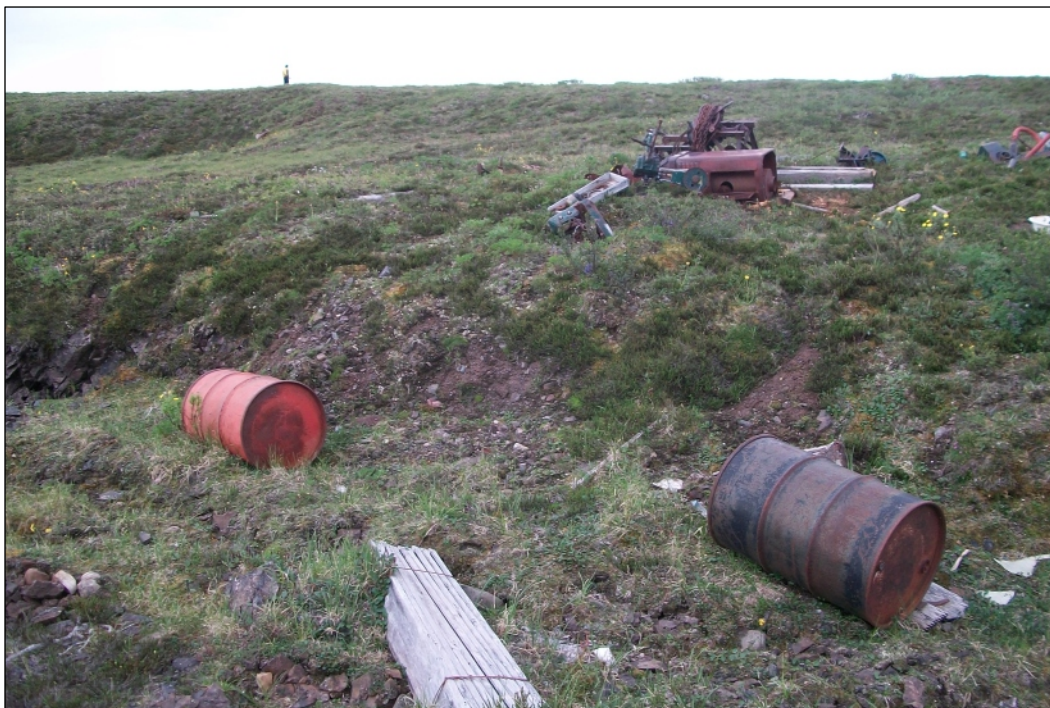
Photo 8

Husky Creek WK197 South Site: APEC 3, drums and wood debris, looking south up into APEC 2

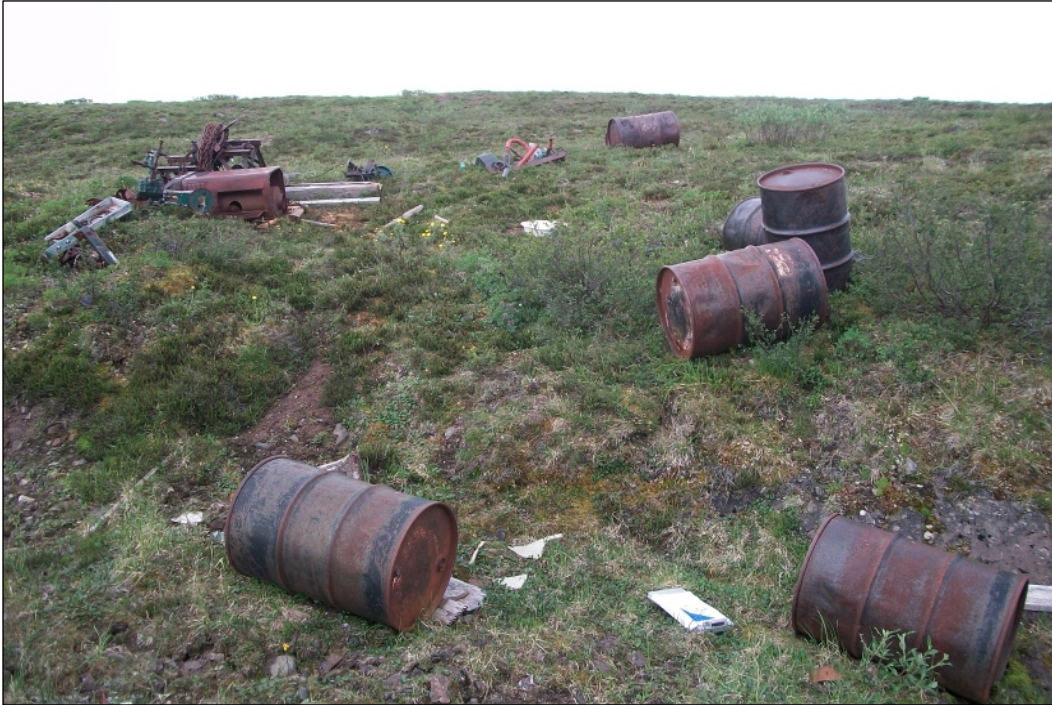
Photo 9
Husky Creek WK197 South Site: APEC 3, additional drums

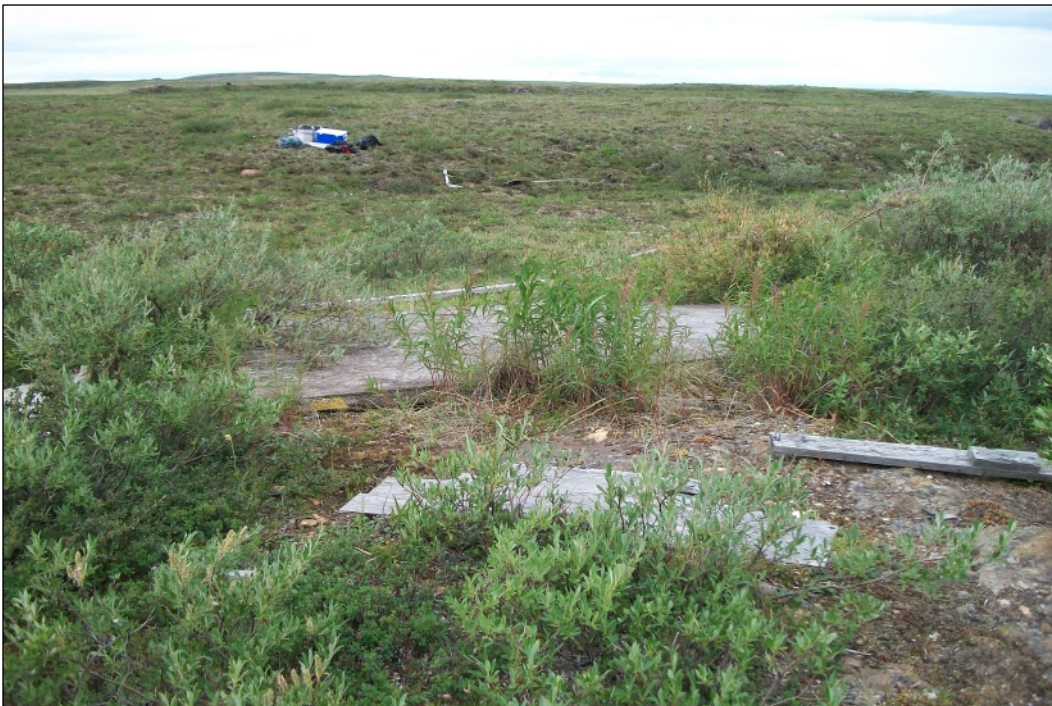
Photo 10
Husky Creek WK197 South Site: APEC 5, collapsed structure

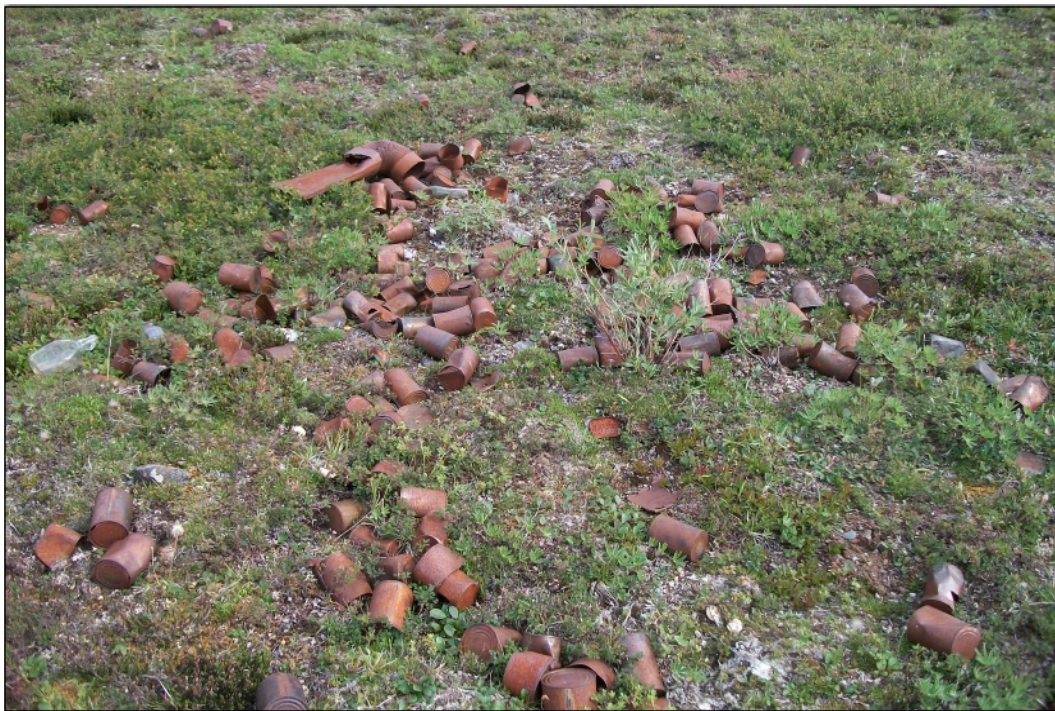
Photo 11
Husky Creek WK197 South Site: APEC 10, can cache

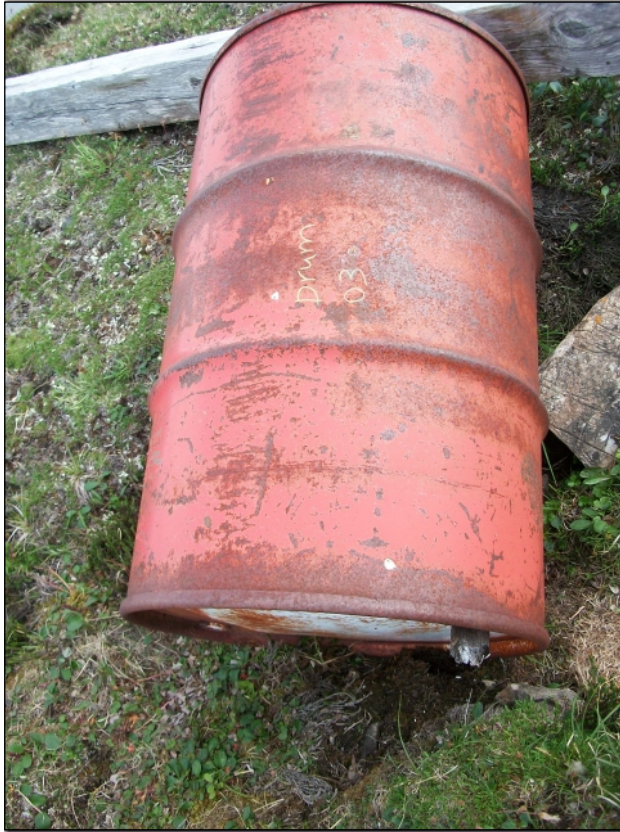
Photo 13
Husky Creek WK197 South Site: drum with red leachable lead paint

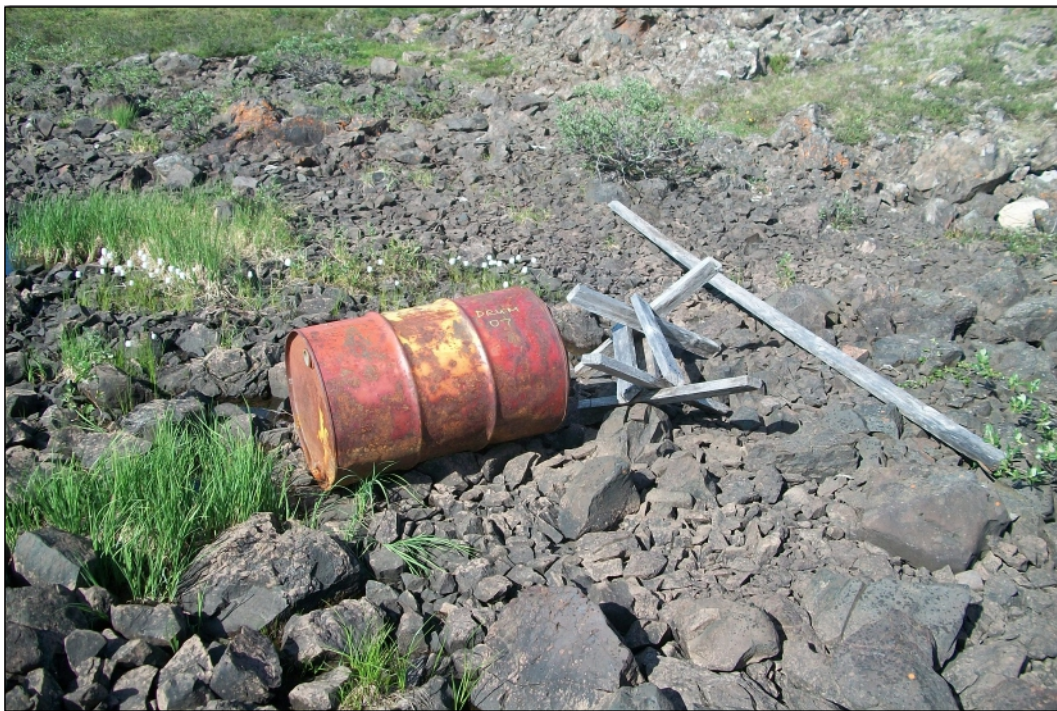
Photo 18
Husky Creek WK197 North Site: APEC 9A, drum and wood debris

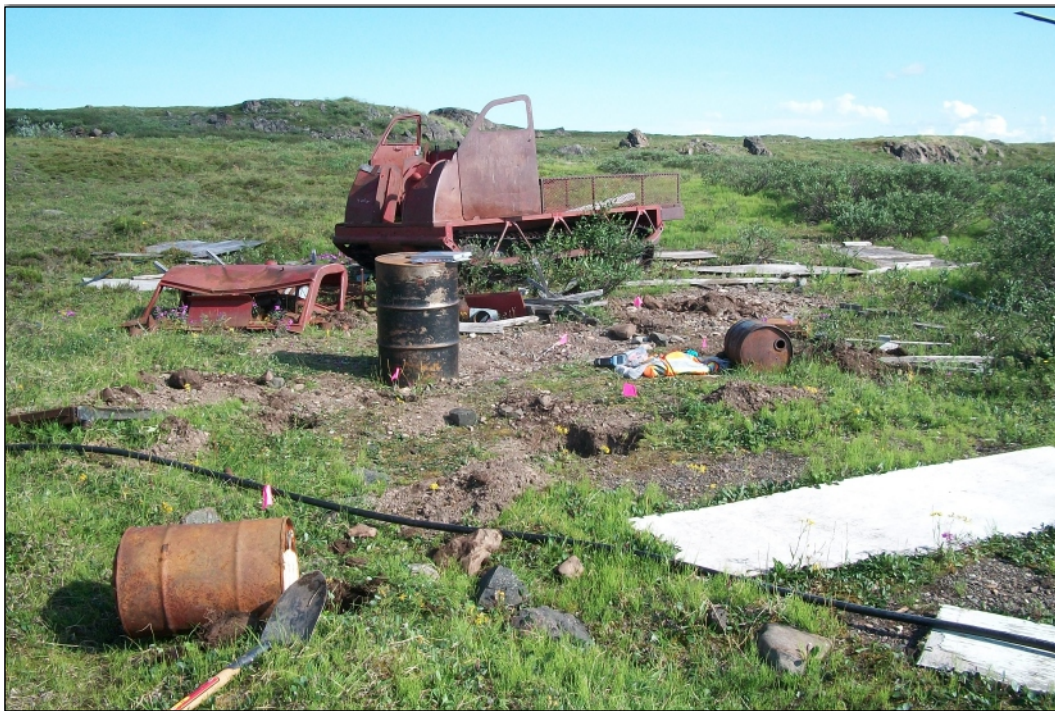
Photo 19

Husky Creek WK197 North Site: APEC 7, Bombadier snow machine, drums and miscellaneous wood and metal debris

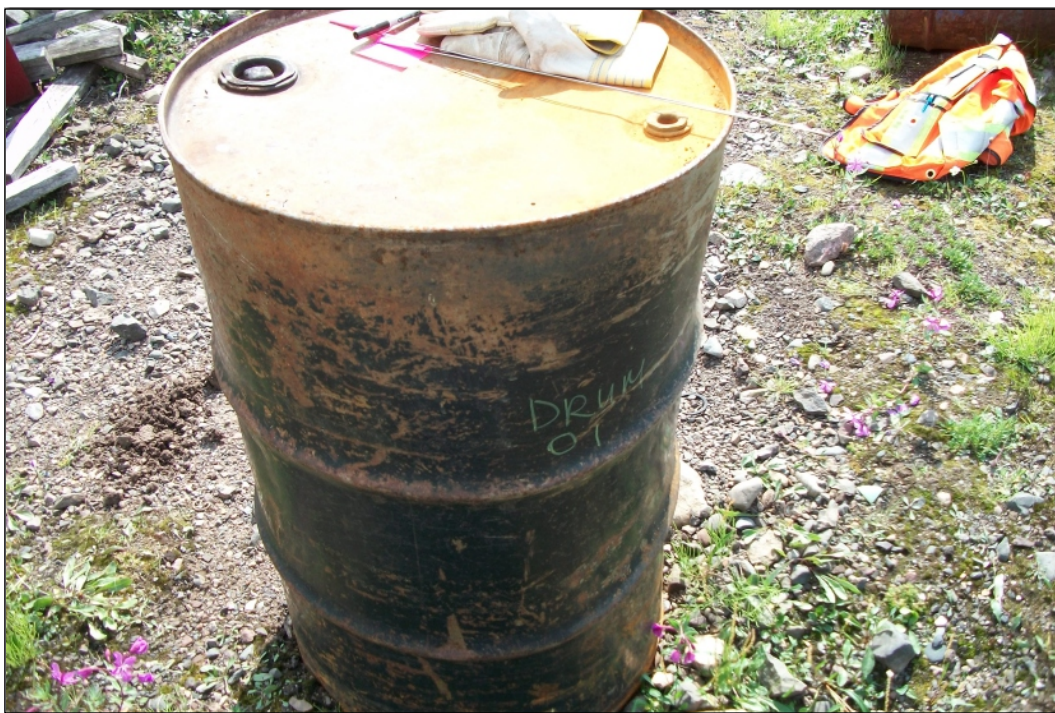
Photo 20

Husky Creek WK197 North Site: drum with black leachable lead paint

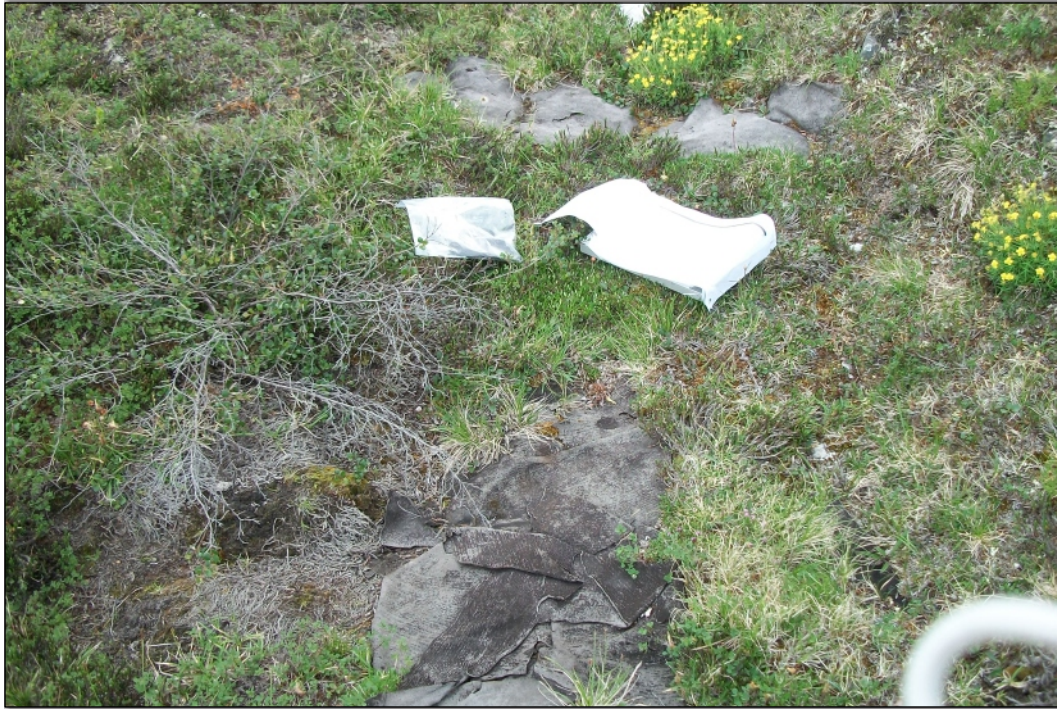
Photo 29

Willow Creek WK172 Main Site: APEC 1, black shingles that do not contain asbestos

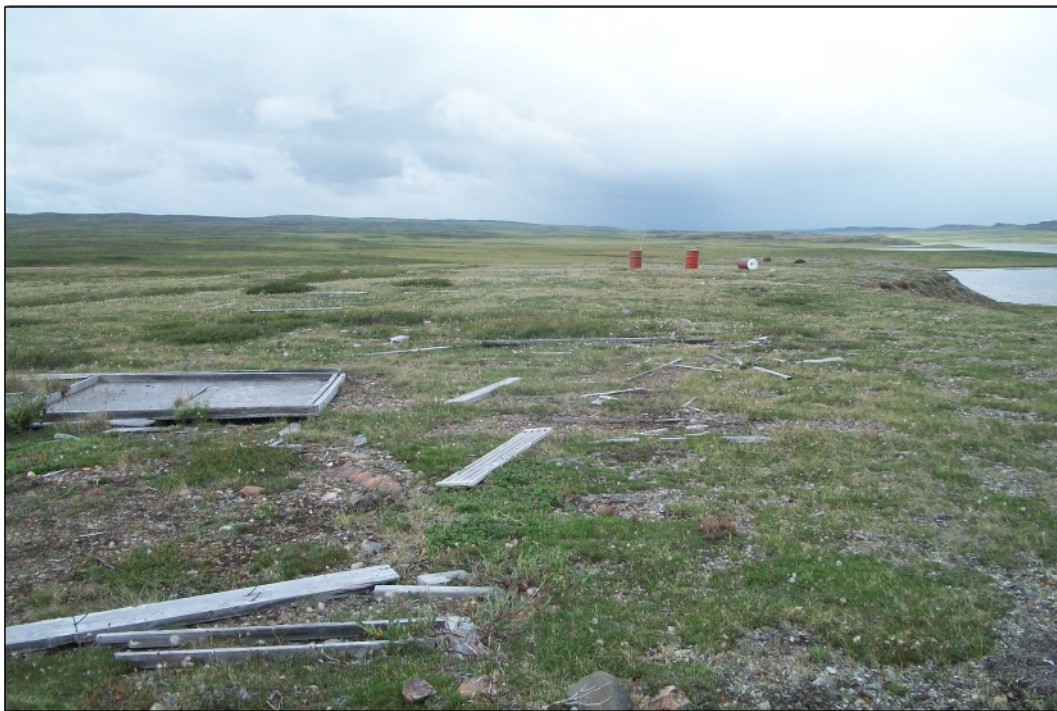
Photo 30

Willow Creek WK172 Main Site: APEC 2, drums and a collapsed structure

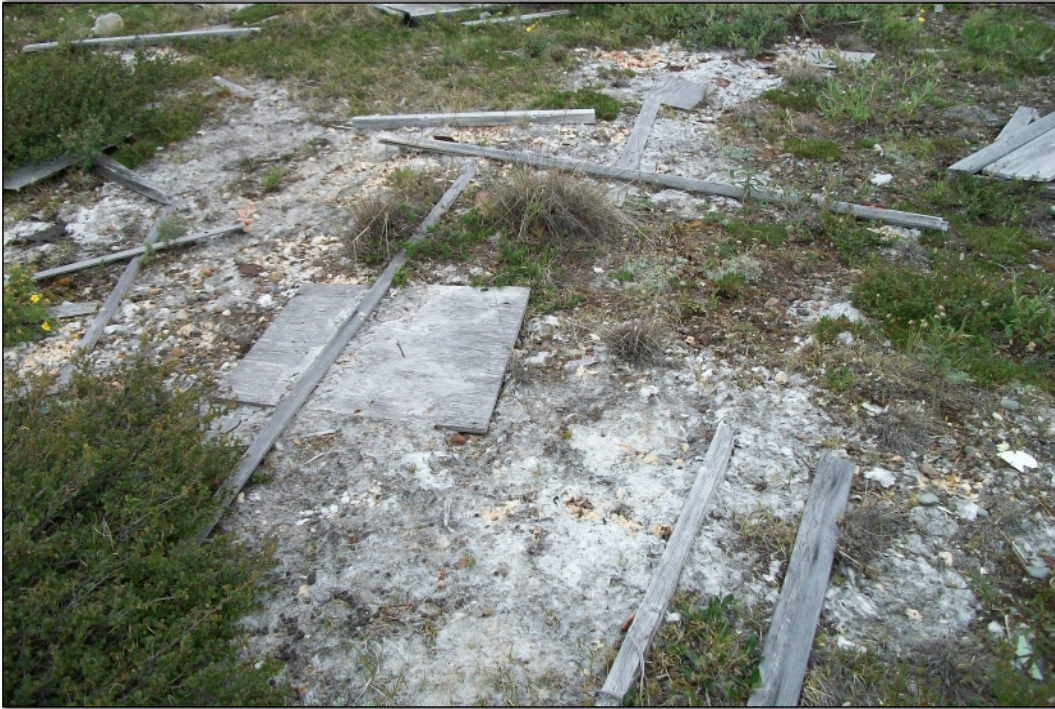
Photo 31

Willow Creek WK172 Main Site: APEC 2, fibreglass insulation that does not contain asbestos

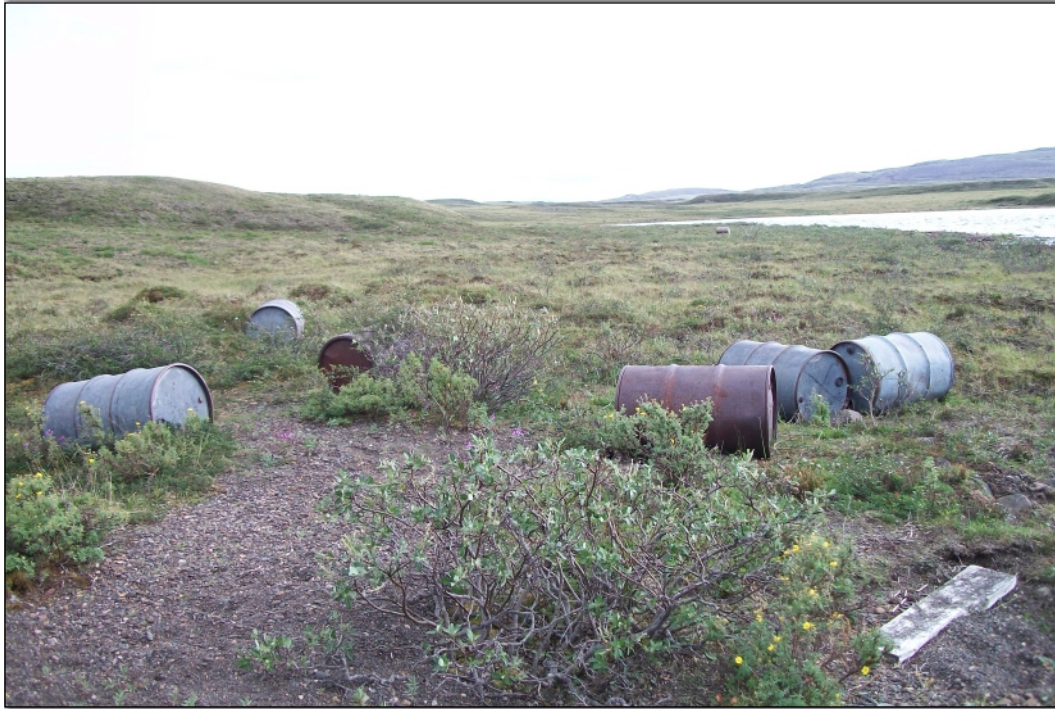
Photo 34
Willow Creek WK172 Main Site: APEC 3, drums and lumber and APEC 4 drums and wood debris were scattered along the high water mark

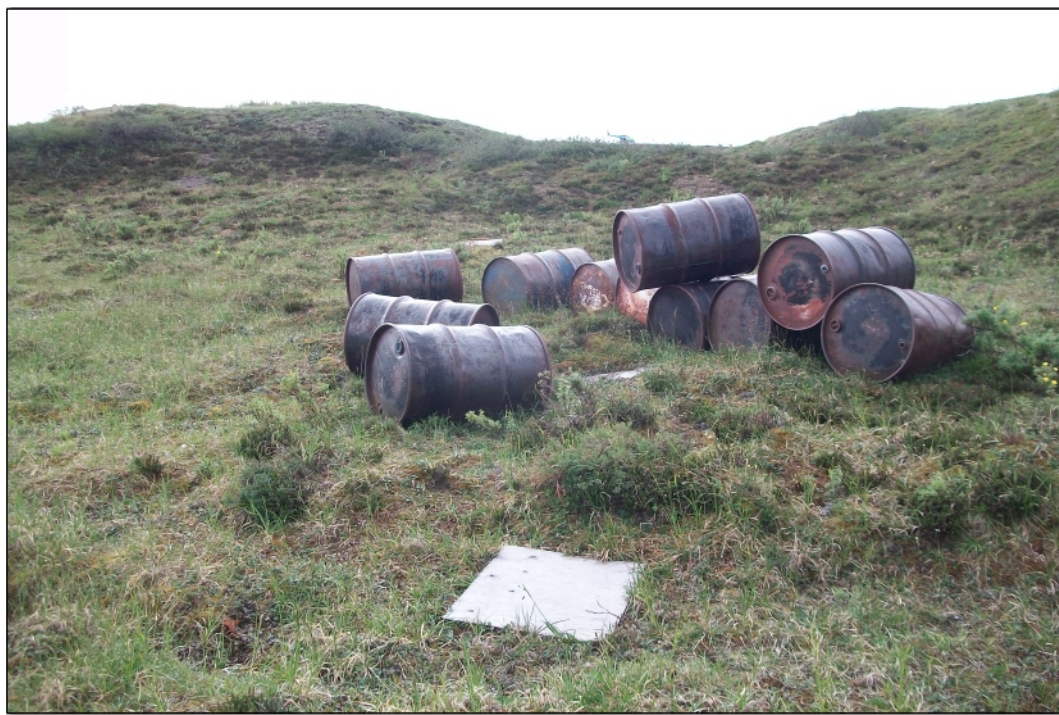
Photo 37

Willow Creek WK172 Main Site: APEC 7, metal food cans, camp implements, and one empty drum

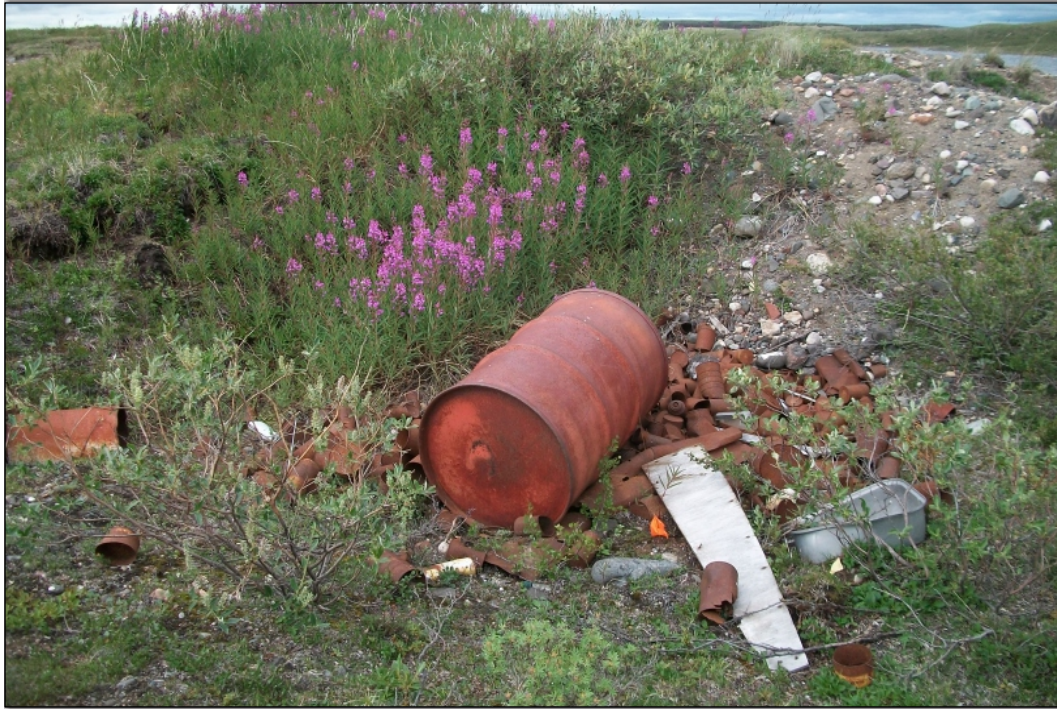
Photo 38

Willow Creek WK172 Main Site: APEC 9, collapsed core shack with core boxes

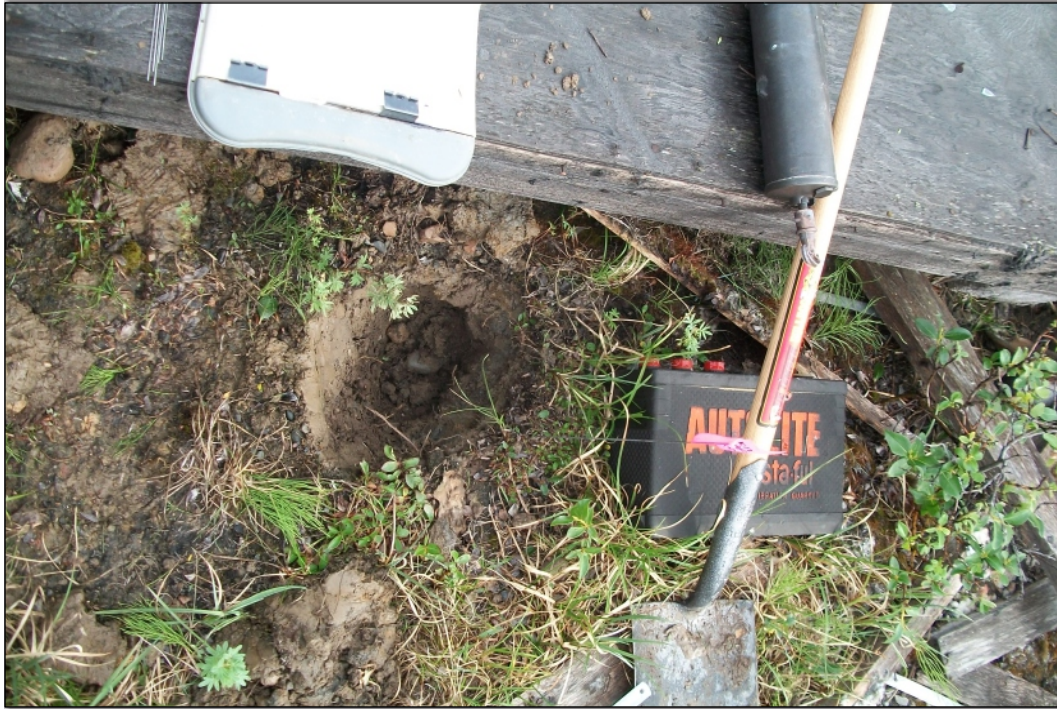
Photo 42
Willow Creek WK172 Main Site: APEC 9, battery

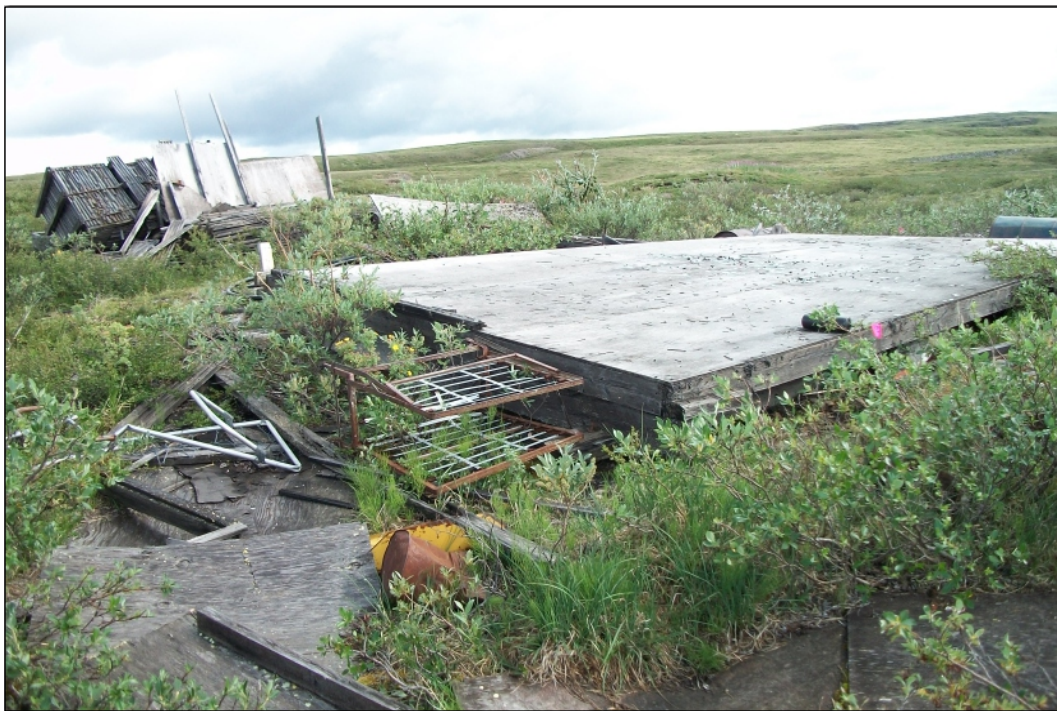
Photo 45

Willow Creek WK172 Main Site: APEC 11, empty drums, wood debris and drill rods

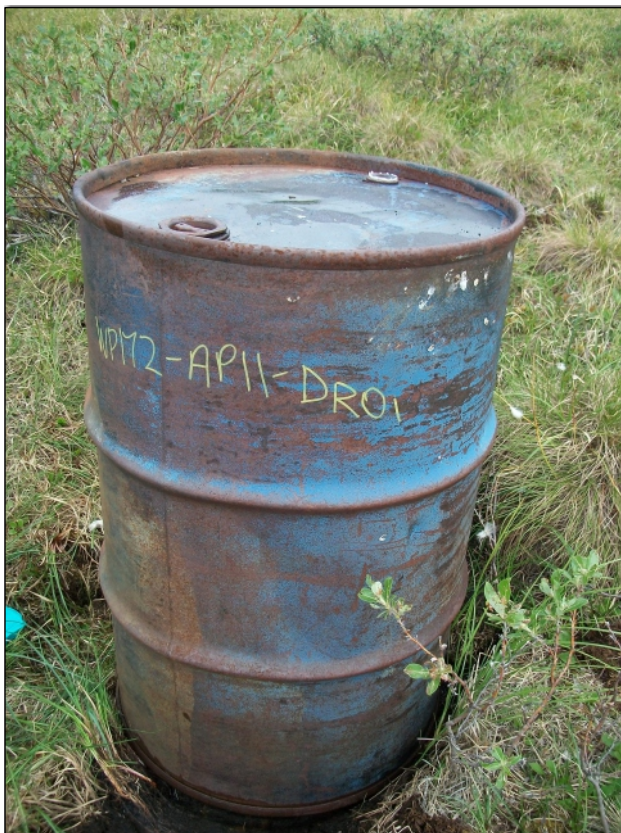
Photo 47

Willow Creek WK172 Main Site: APEC 11, red drum with leachable lead paint

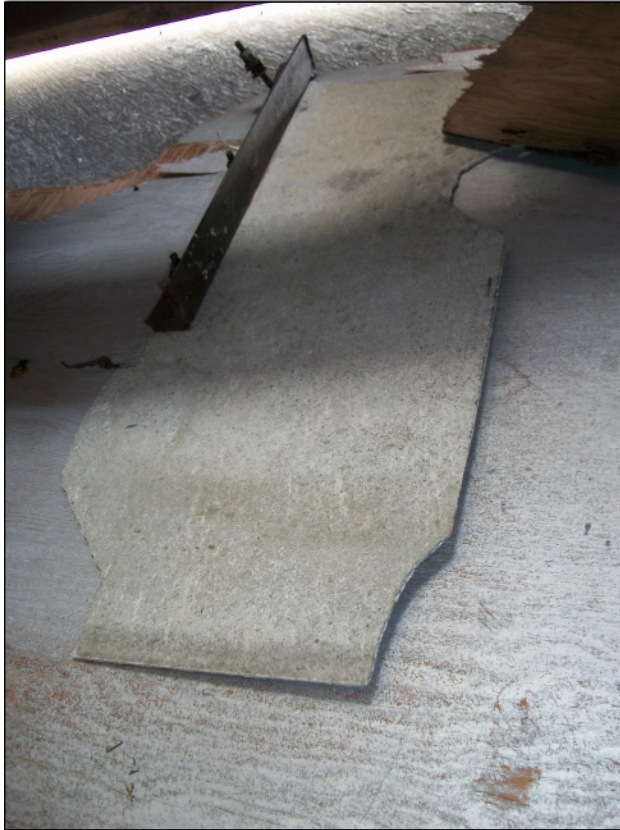
Photo 55

Willow Creek WK172 Main Site: APEC 14, Structure 05
from WESA report, asbestos containing fibreboard behind
the heater

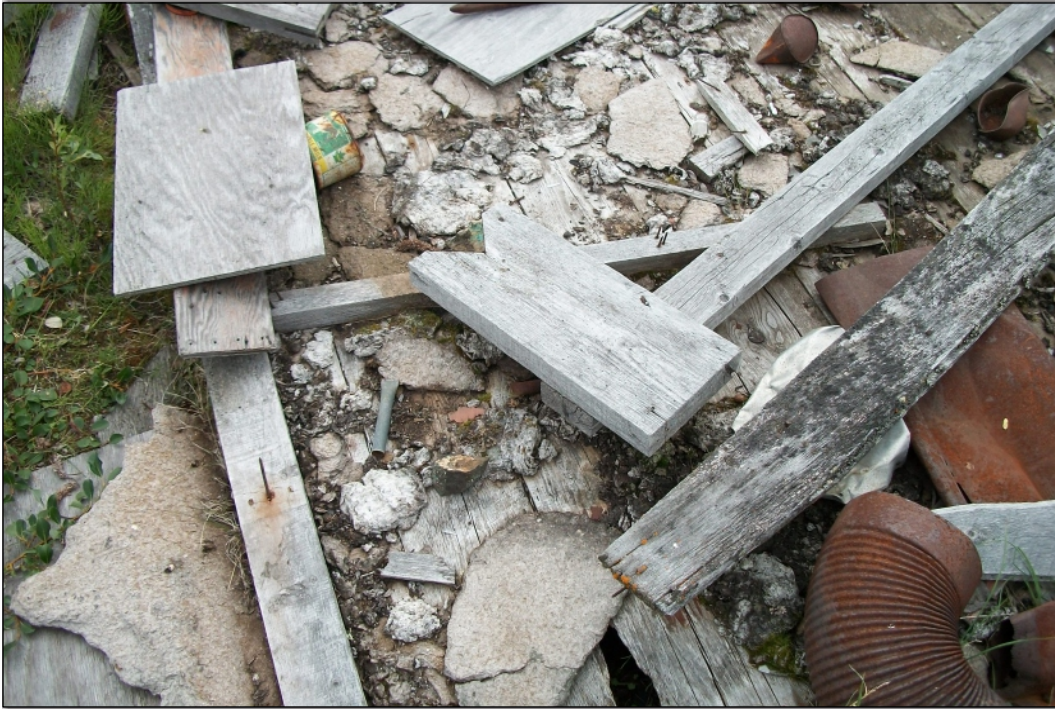
Photo 67

67	Willow Creek	WKB01 South Cabin: APEC 19, asbestos containing insulating material on platform
68	Willow Creek	WKB01 South Cabin: APEC 20, leaning structure with cable, empty jerry can, car battery, five drums, metal debris and cans
69	Willow Creek	WKB01 South Cabin: APEC 21, drum cache
70	Willow Creek	WKB01 South Cabin: APEC 21, dock and one red drum with leachable lead paint
71	Willow Creek	WKB01 South Cabin: APEC 21, drum and broken battery
72	Willow Creek	WKB01 South Cabin: APEC 21, sediment sample WKB01-AP21-SD01
73	Willow Creek	WKB01 South Cabin: APEC 22, drum cache
74	Willow Creek	WKB01 South Cabin: APEC 22, drum cache and soil samples WKB01-AP22-SS03 and WKB01-AP22-SS04
75	Willow Creek	WKB01 South Cabin: APEC 22, asbestos containing insulating material around drum
76	Willow Creek	WKB02 Southwest Cabin: aerial view of WKB02 looking south
77	Willow Creek	WKB02 Southwest Cabin: Willow Creek Cabin Southwest - east view of debris area from outcrop

Willow Creek WKB01 South Cabin: APEC 19, asbestos containing insulating material on platform

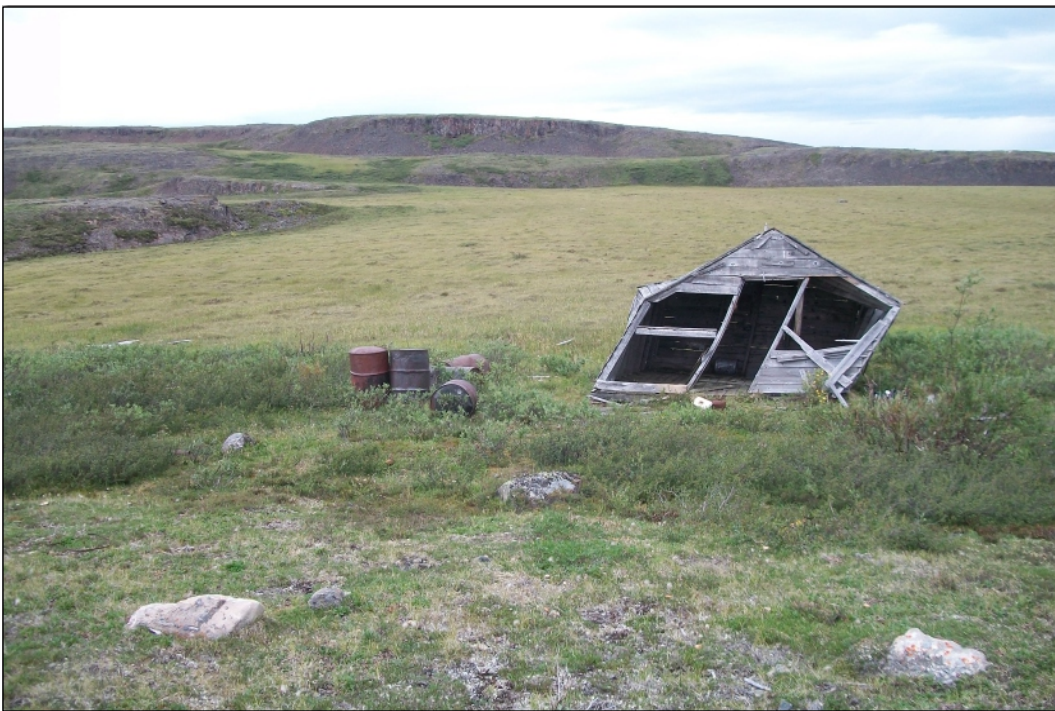
Photo 68

Willow Creek WKB01 South Cabin: APEC 20, leaning structure with cable, empty jerry can, car battery, five drums, metal debris and cans

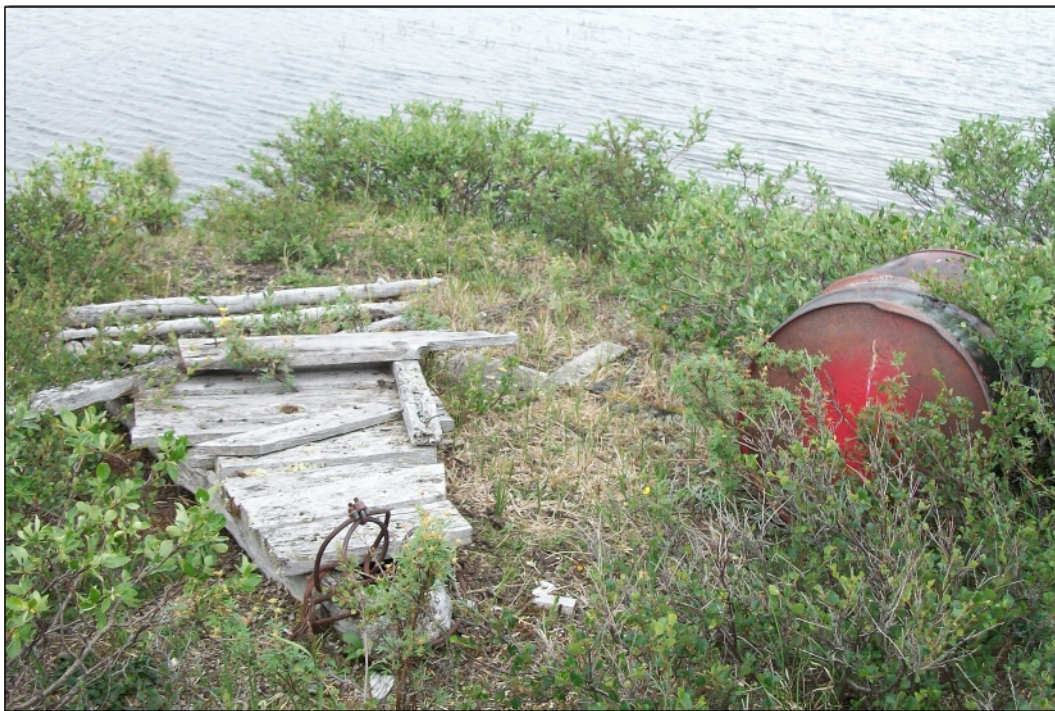
Photo 70

Willow Creek WKB01 South Cabin: APEC 21, dock and one red drum with leachable lead paint

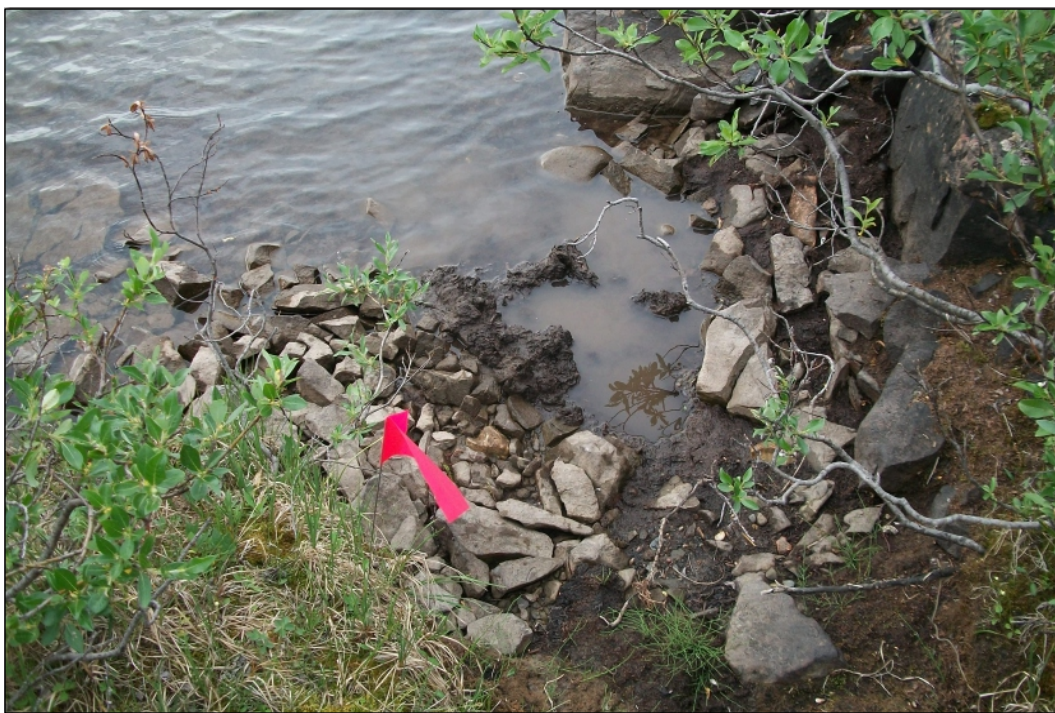
Photo 72

Willow Creek WKB01 South Cabin: APEC 21, sediment sample WKB01-AP21-SD01

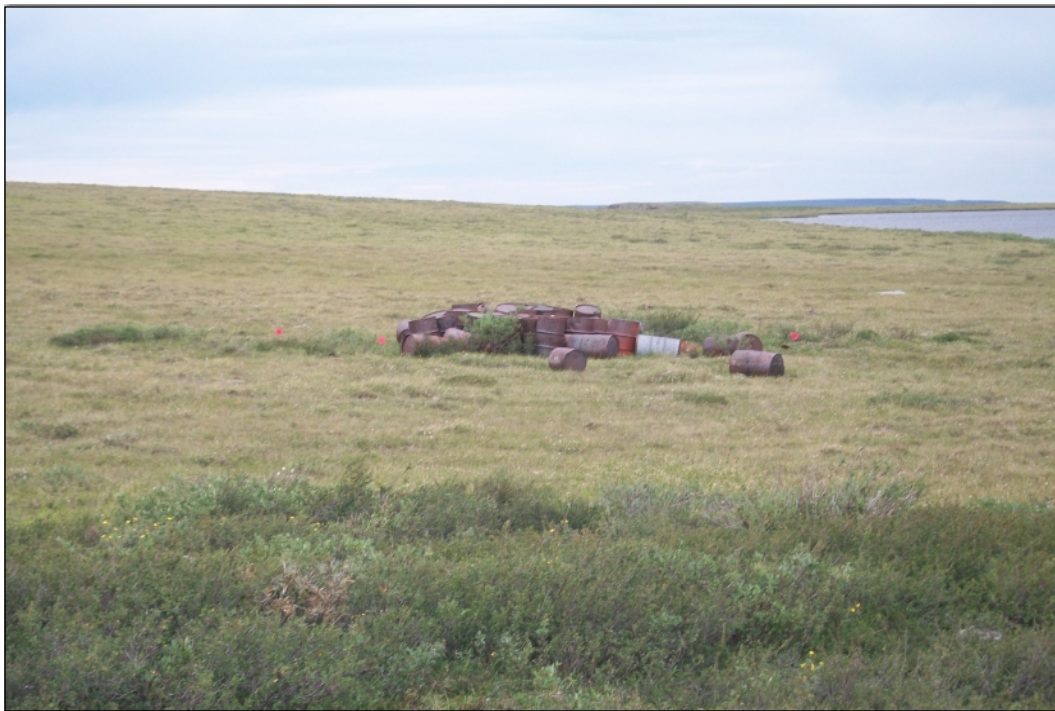
Photo 73
Willow Creek WKB01 South Cabin: APEC 22, drum cache

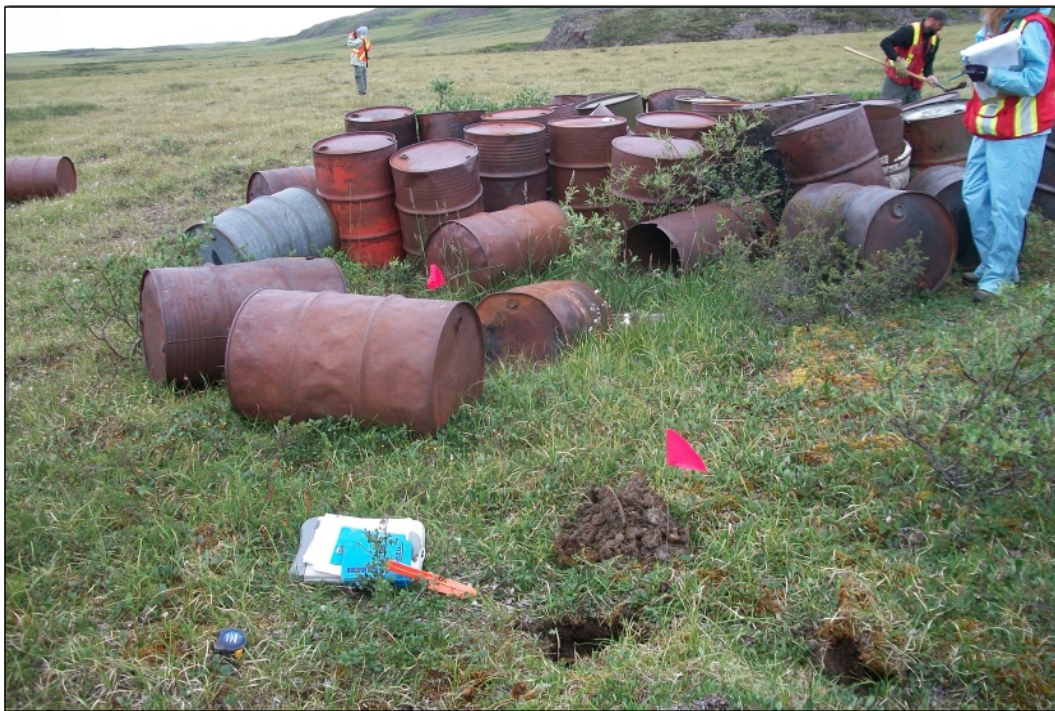
Photo 74
Willow Creek WKB01 South Cabin: APEC 22, drum cache and soil samples WKB01-AP22-SS03 and WKB01-AP22-SS04

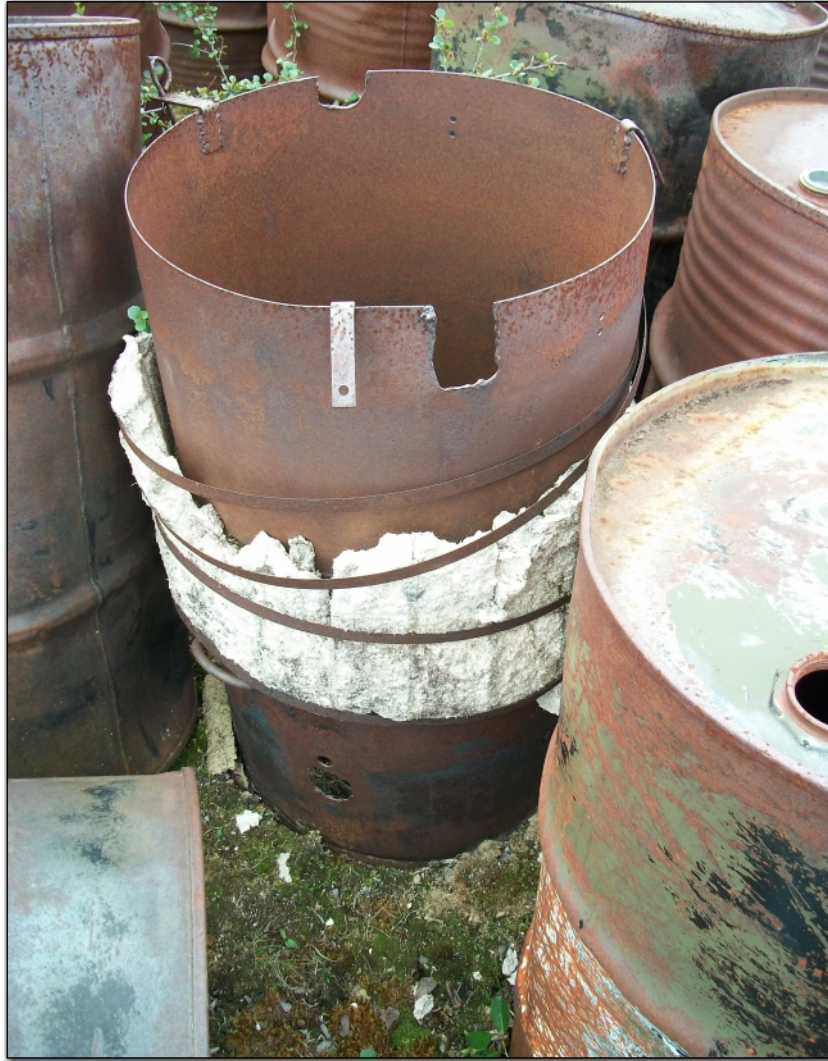
Photo 75

Willow Creek WKB01 South Cabin: APEC 22, asbestos containing insulating material around drum

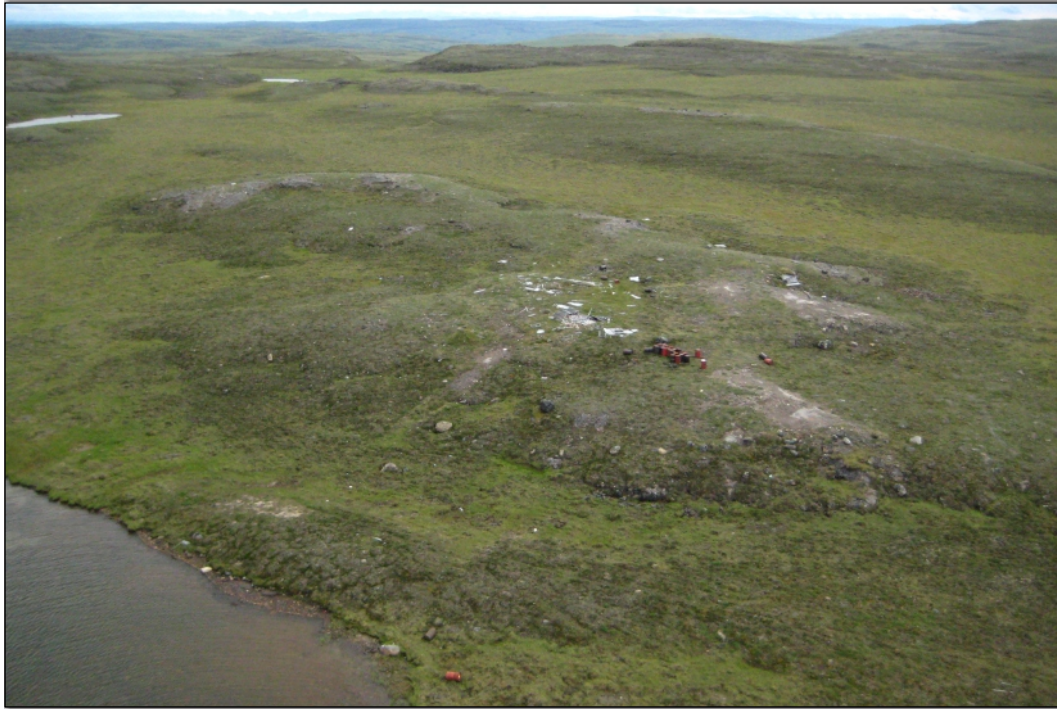
Photo 76

Willow Creek WKB02 Southwest Cabin: aerial view of WKB02 looking south

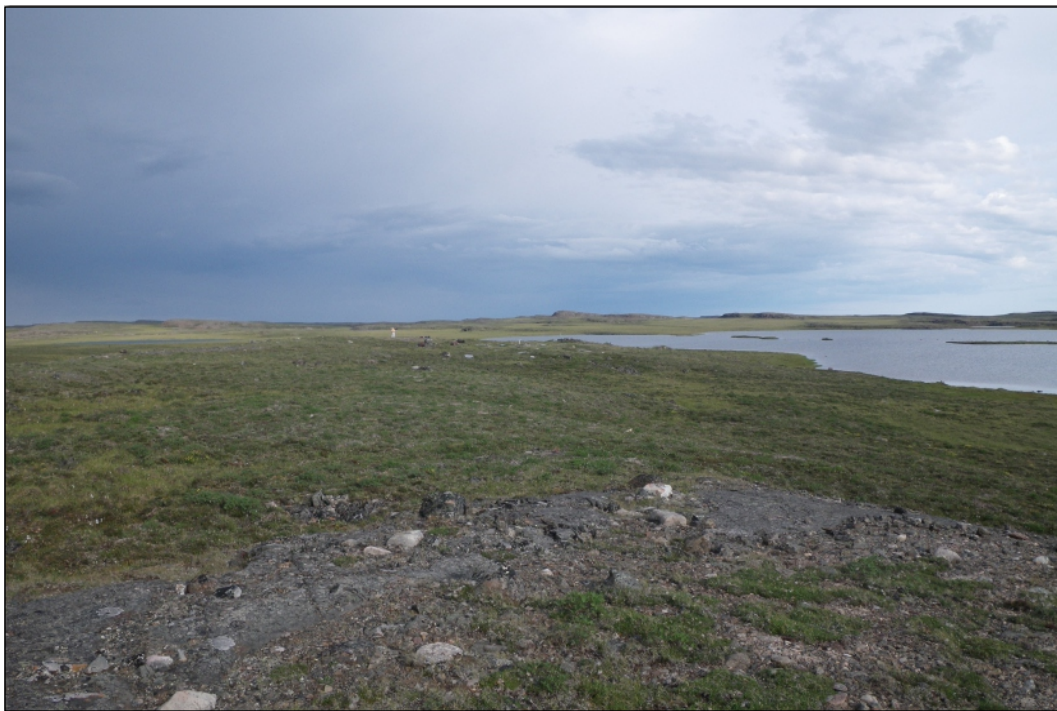
Photo 77

Willow Creek WKB02 Southwest Cabin: Willow Creek Cabin Southwest - east view of debris area from outcrop

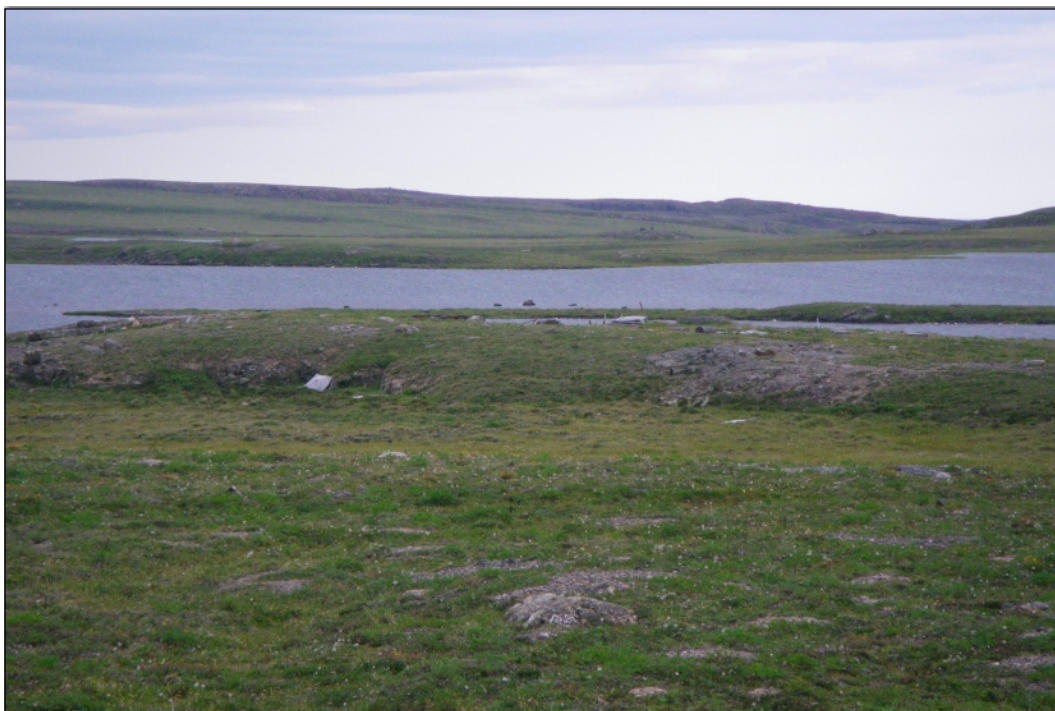
Photo 78

Willow Creek WKB02 Southwest Cabin: Willow Creek Cabin Southwest - northwest view of debris area
