HOPE LAKE
REMEDICATION PROJECT

REMEDIAL ACTION PLAN

**REMEDIAL ACTION PLAN
HOPE LAKE, NUNAVUT**

Y22101167.005

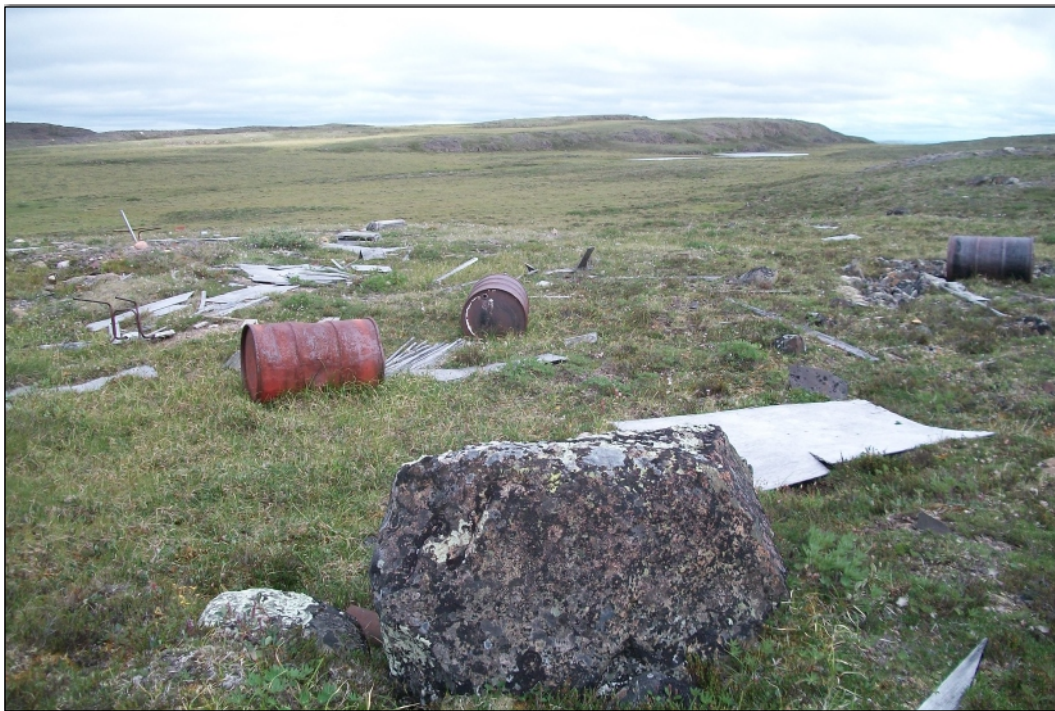
Photo 80

Willow Creek WKB02 Southwest Cabin: APEC 23, three empty drums, wood and metal debris

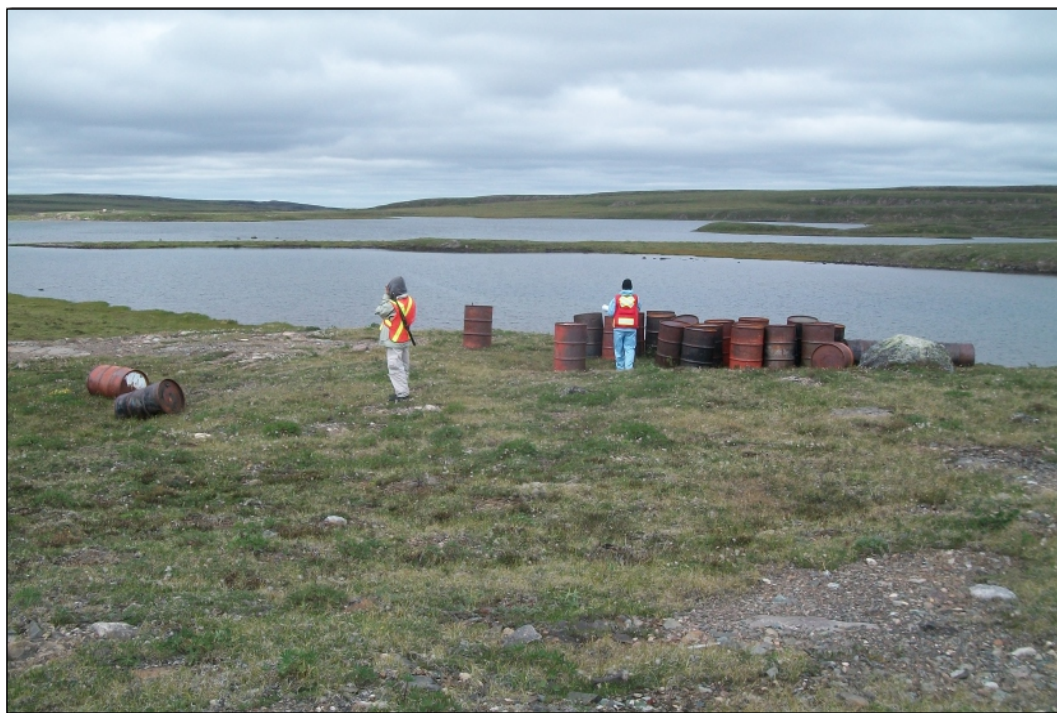
Photo 86
Willow Creek WKB02 Southwest Cabin: APEC 25, drum
sampled is below criteria

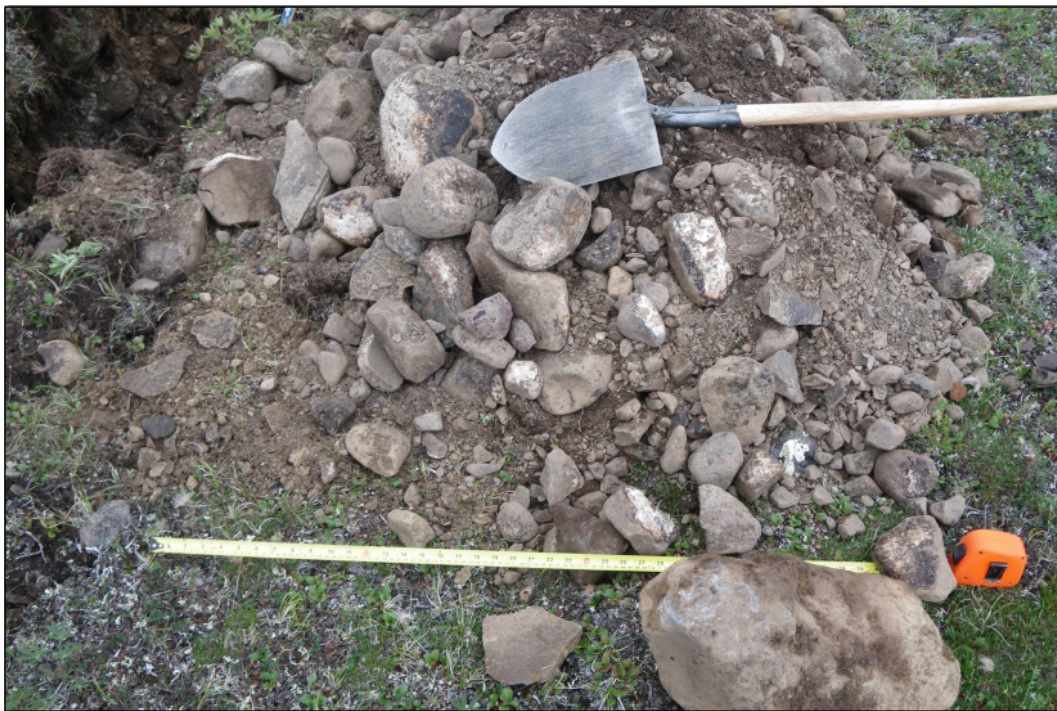
Photo 103

South of LF-2 and LF-3 on the other side of a small creek is a previously exploited borrow area. However, it appears to be a small area adjacent to a block field that would be difficult to develop as a borrow (Photo 103 of ESA).

Hope Lake WK027: east view of boulder field southeast of barrel cache

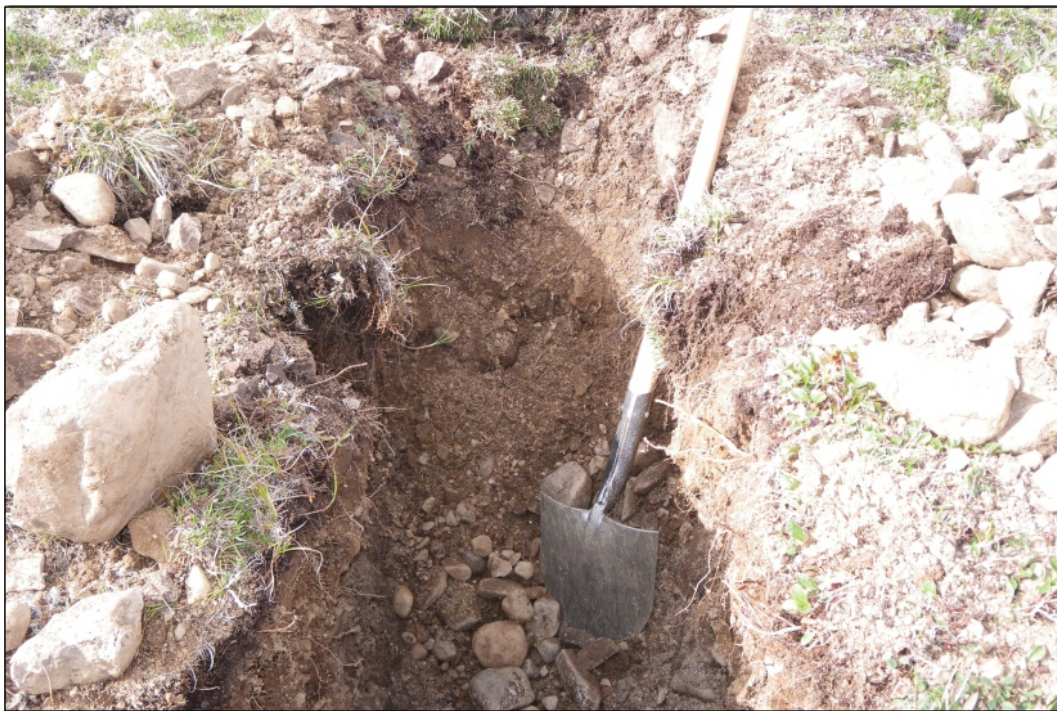
Test pit TP-10-22 was excavated in a disturbed area next to the airstrip. Test pit TP-10-23 was excavated in an undisturbed area about 50 m east of TP-10-22. Both areas have sand and gravel soils with some silt and cobbles and boulders as indicated in the logs and sieve results (Photos 109 and 110 of ESA). Although granular has been removed from this area,

Hope Lake WK027: southwest view of TP23 at Airstrip Borrow Prospect

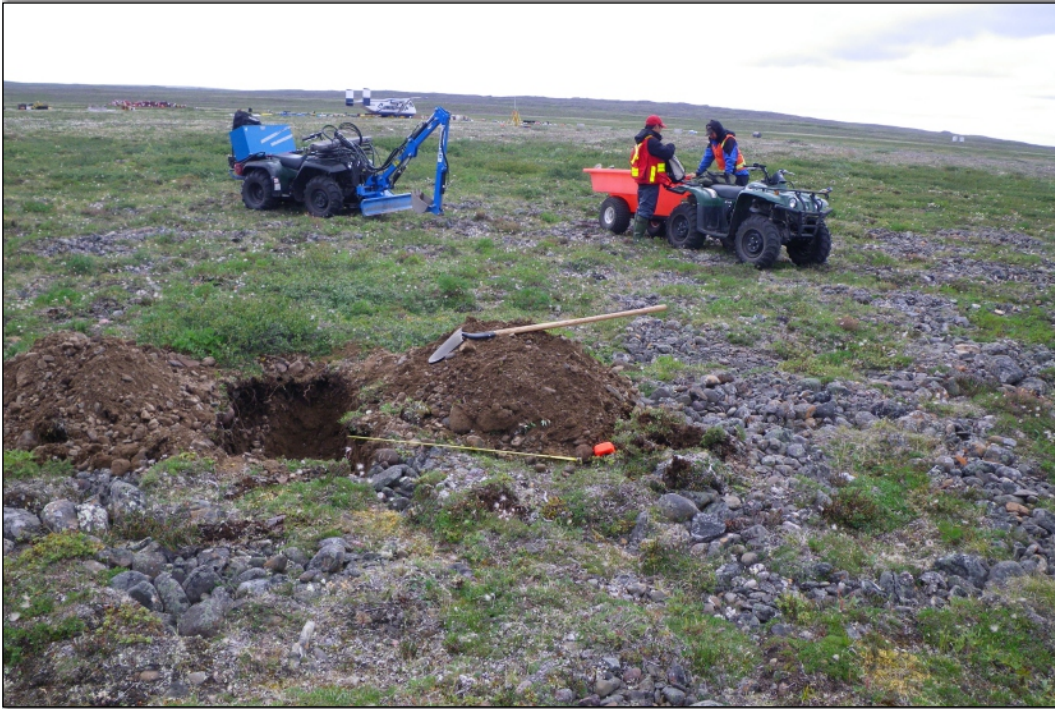
Photo 110

Hope Lake WK027: view of TP23 spoil pile

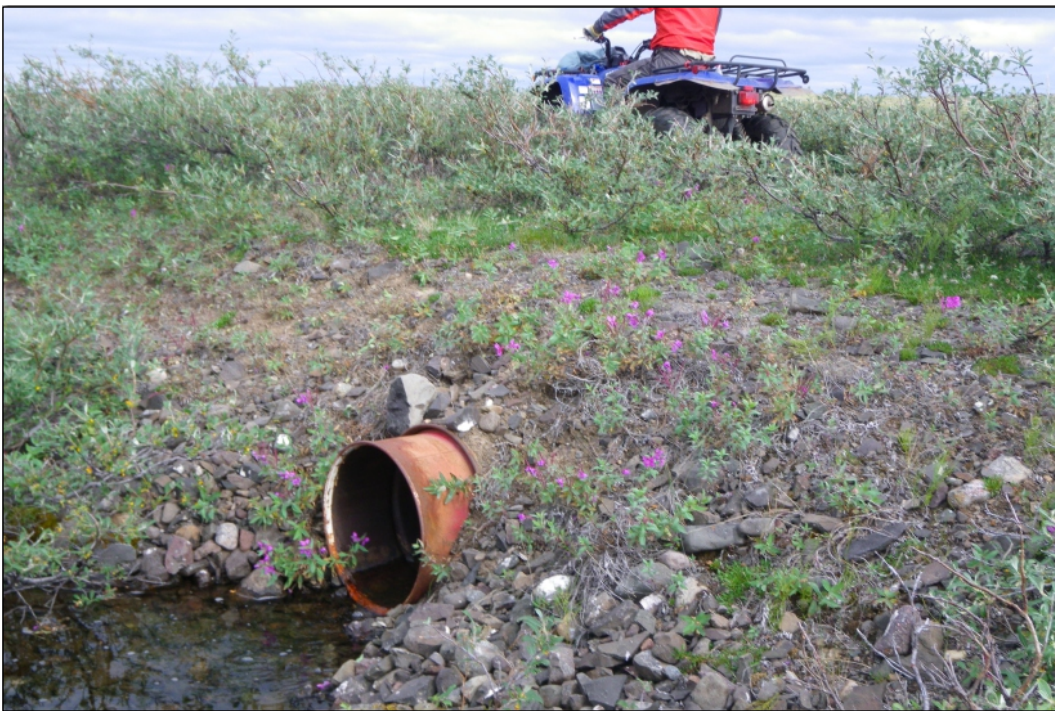
Photo 113

Hope Lake WK027: Hope Lake Road between site and airstrip, 4 drum culvert

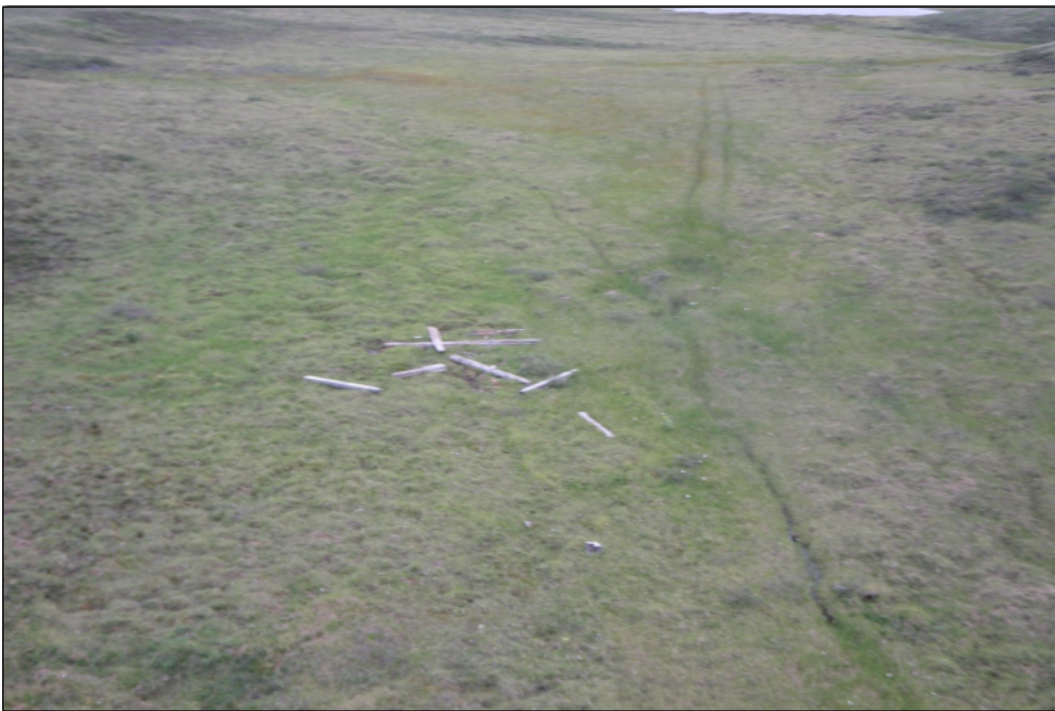
Photo 119

Hope Lake WK027: Hope Lake to Willow Creek Trail, trail crossing wetland

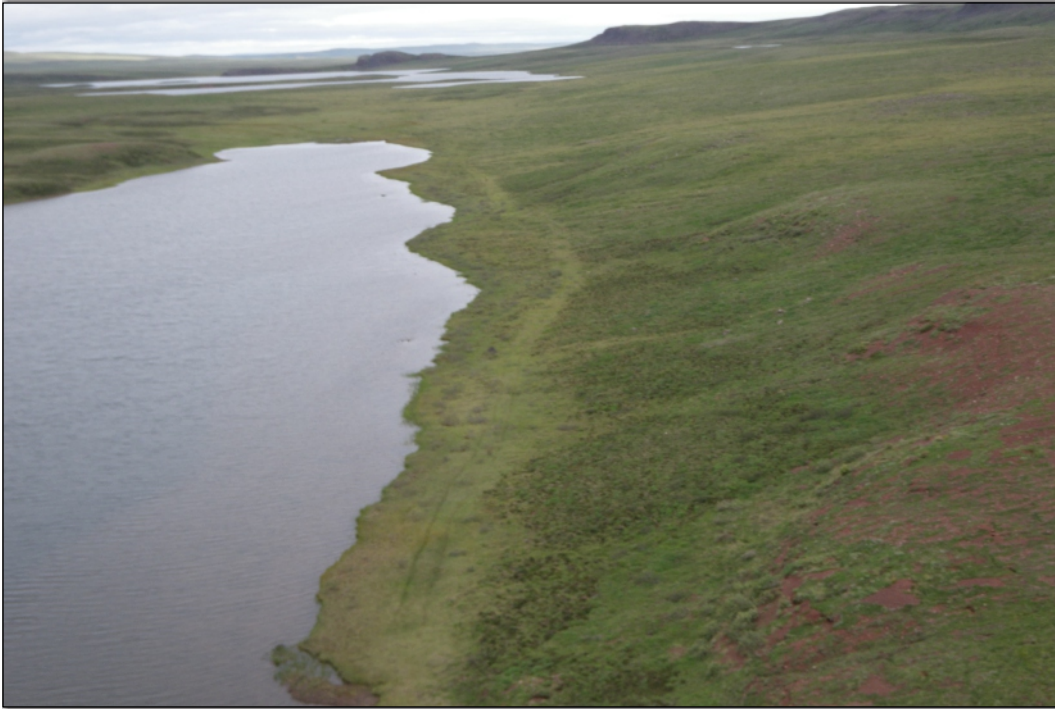
Photo 120

Hope Lake WK027: Hope Lake to Willow Creek Trail, overland with debris

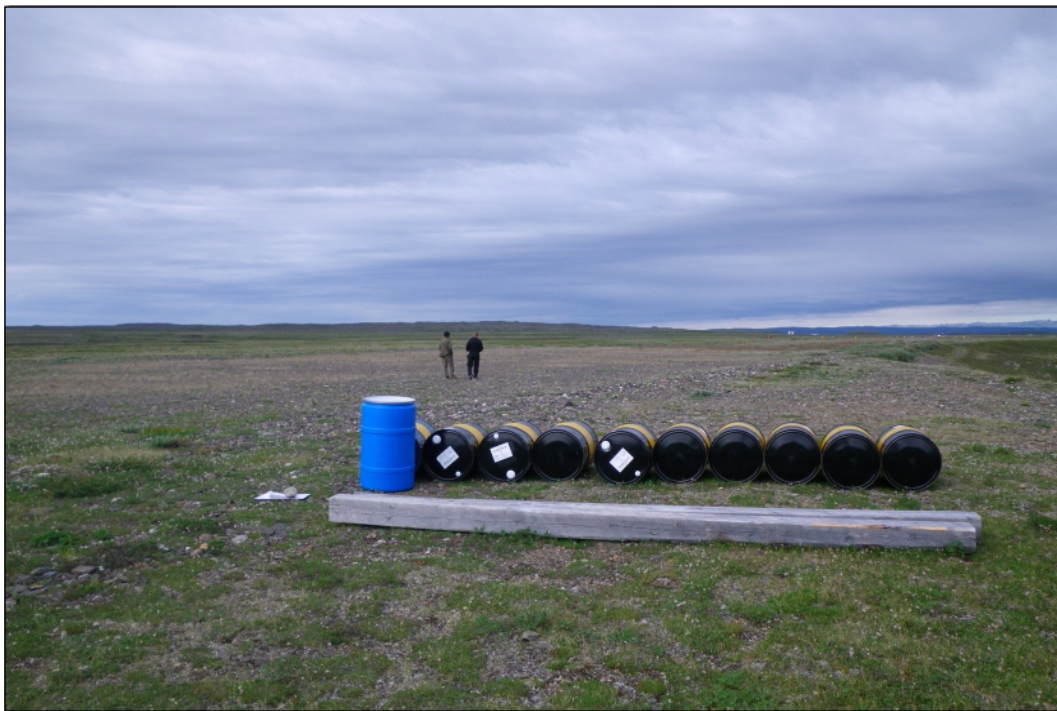
Photo 127

Hope Lake WK027: Hope Lake airstrip, northwest view of vegetation covering surface

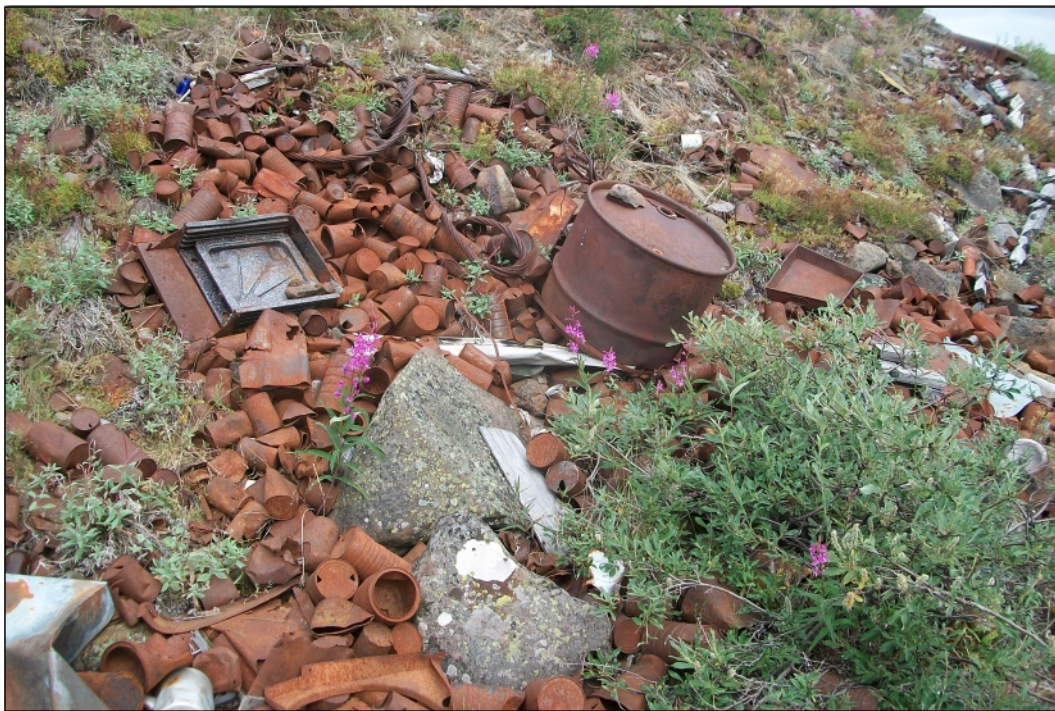
Photo 131

Hope Lake WK027: APEC 1A, heavily rusted drums scattered on south facing slope (looking west)

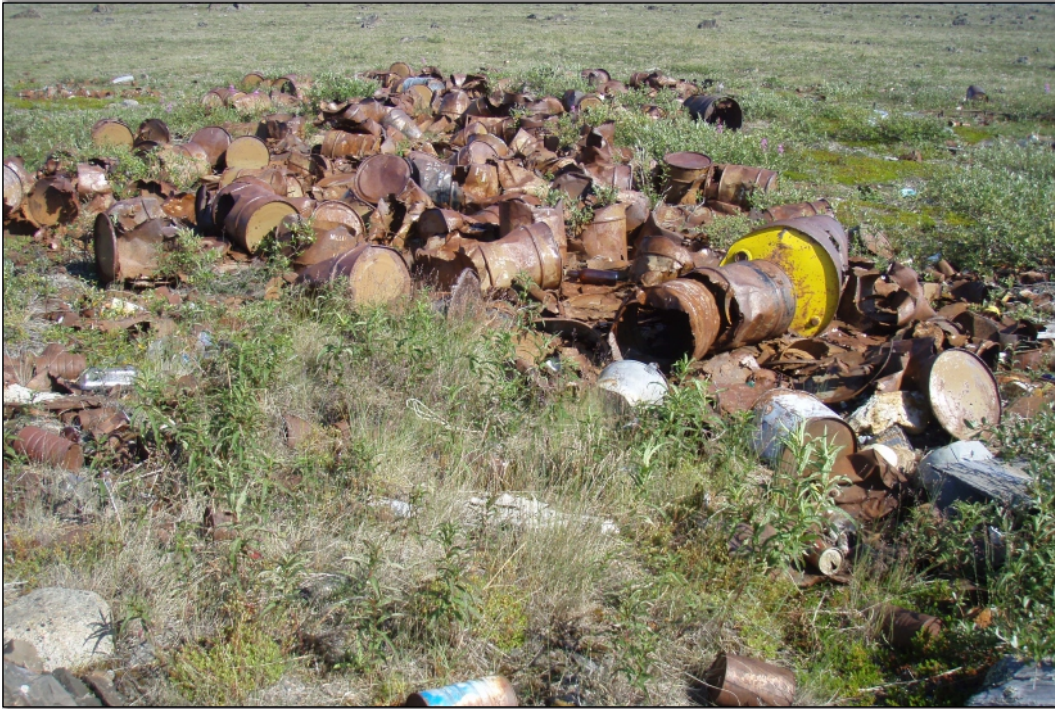
Photo 132

Hope Lake WK027: APEC 1A, close up of drums on slope

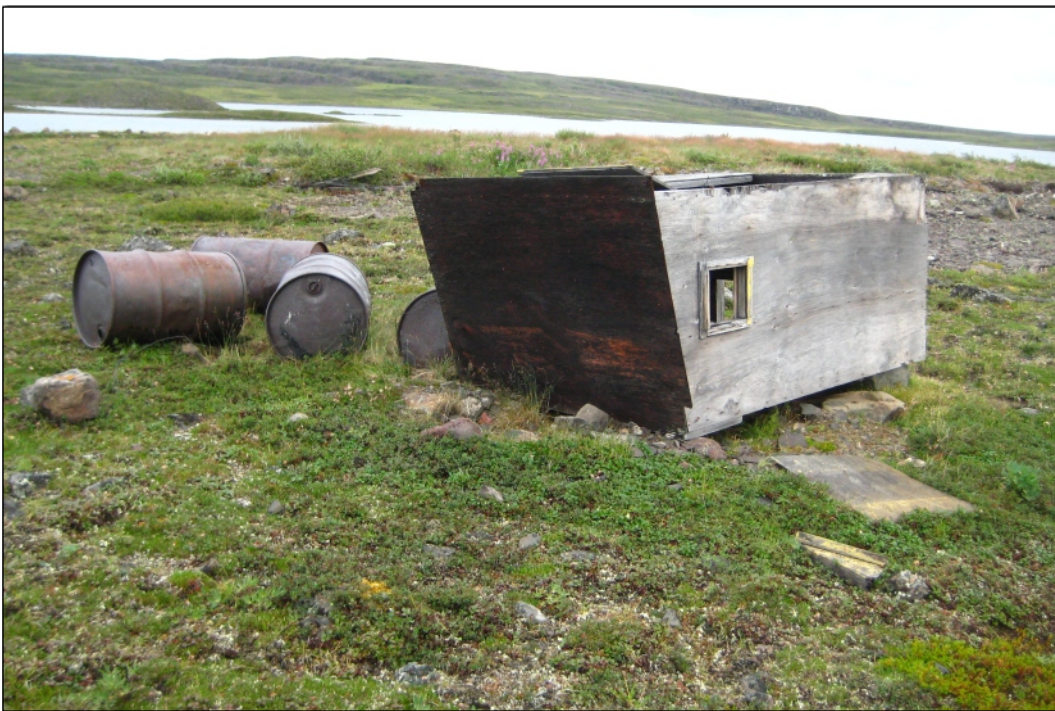
Photo 135

Hope Lake WK027: APEC 1B, area of former tent foundation (looking east)

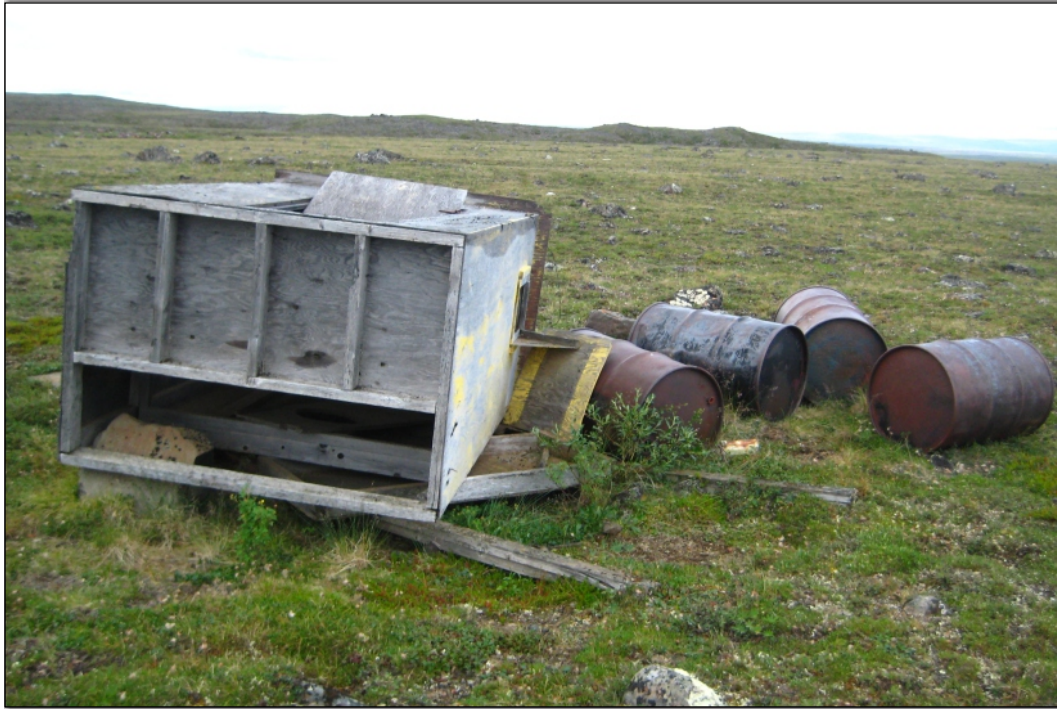
Photo 136

Hope Lake WK027: APEC 1B, former outhouse (looking east)

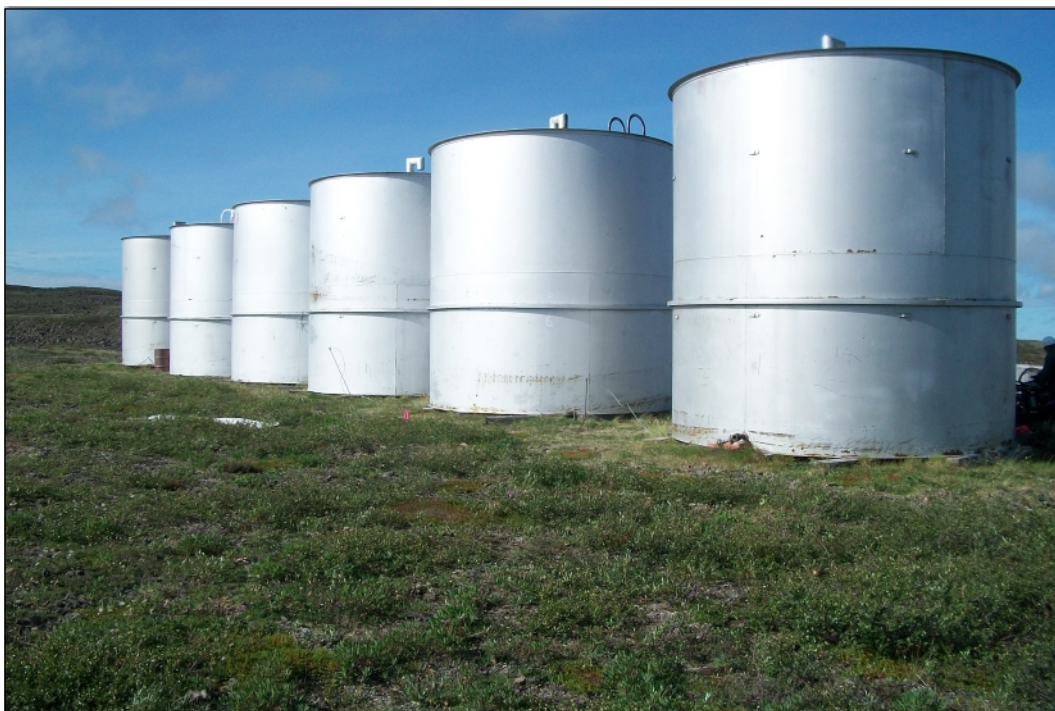
Photo 138

Hope Lake WK027: APEC 2A, six POL tanks, west side of tanks, tanks with leachable lead paint

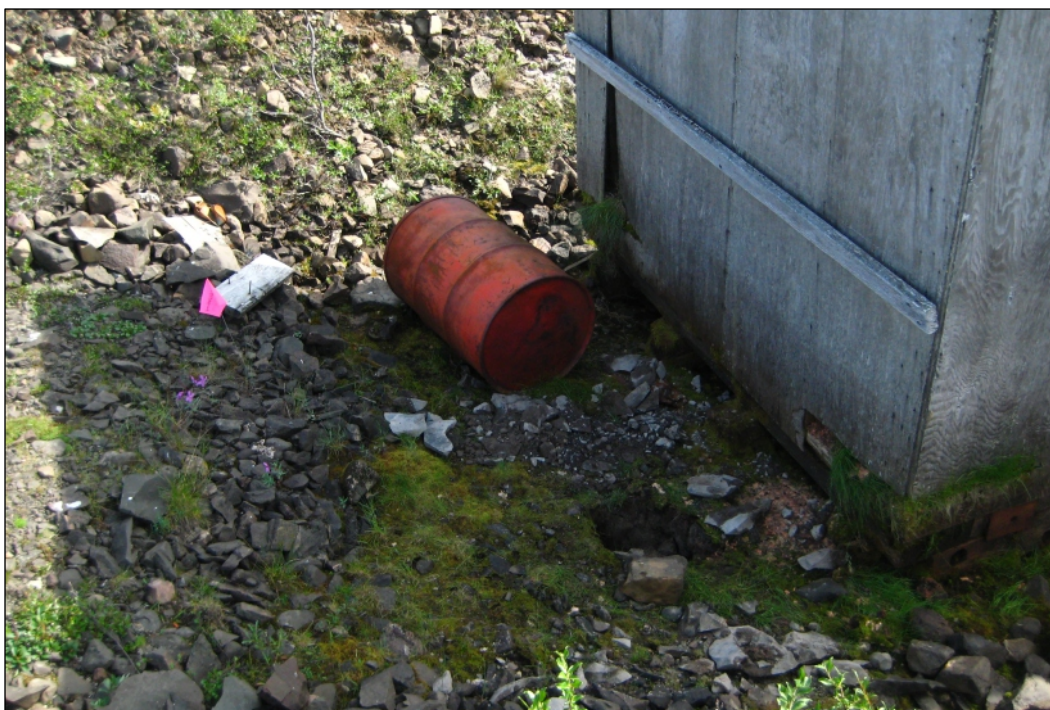
Photo 143

Hope Lake WK027: APEC 2A, wooden structure in excavated hole with groundwater monitoring well

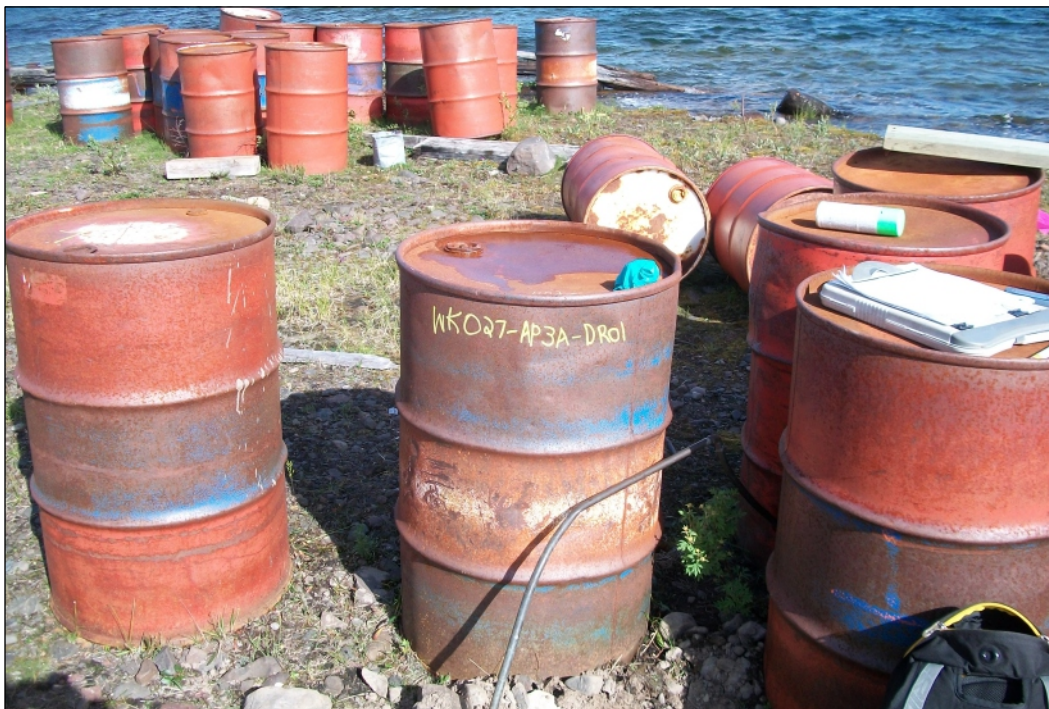
Photo 152
Hope Lake WK027: APEC 3A, dock and rusted drum

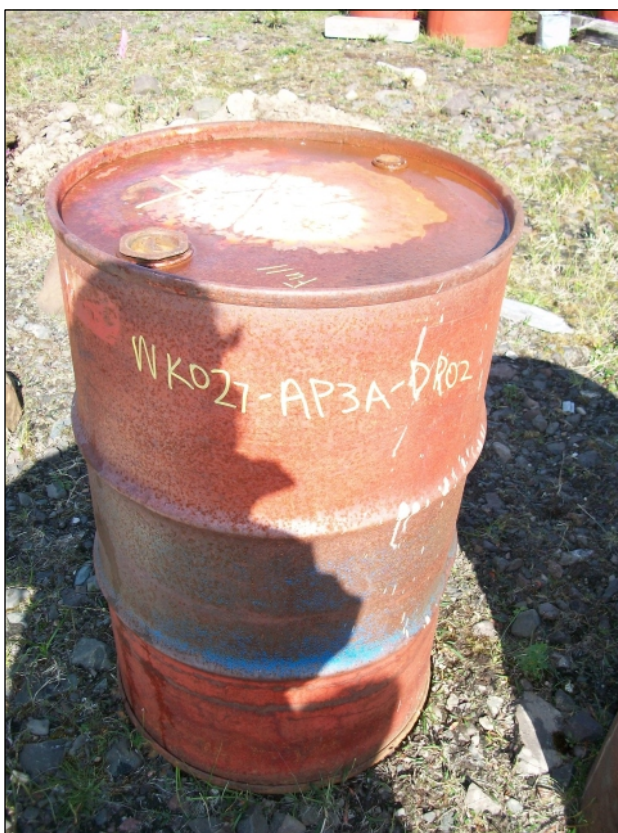
Photo 153

Hope Lake WK027: APEC 3A, drum content sample below guidelines for organic content

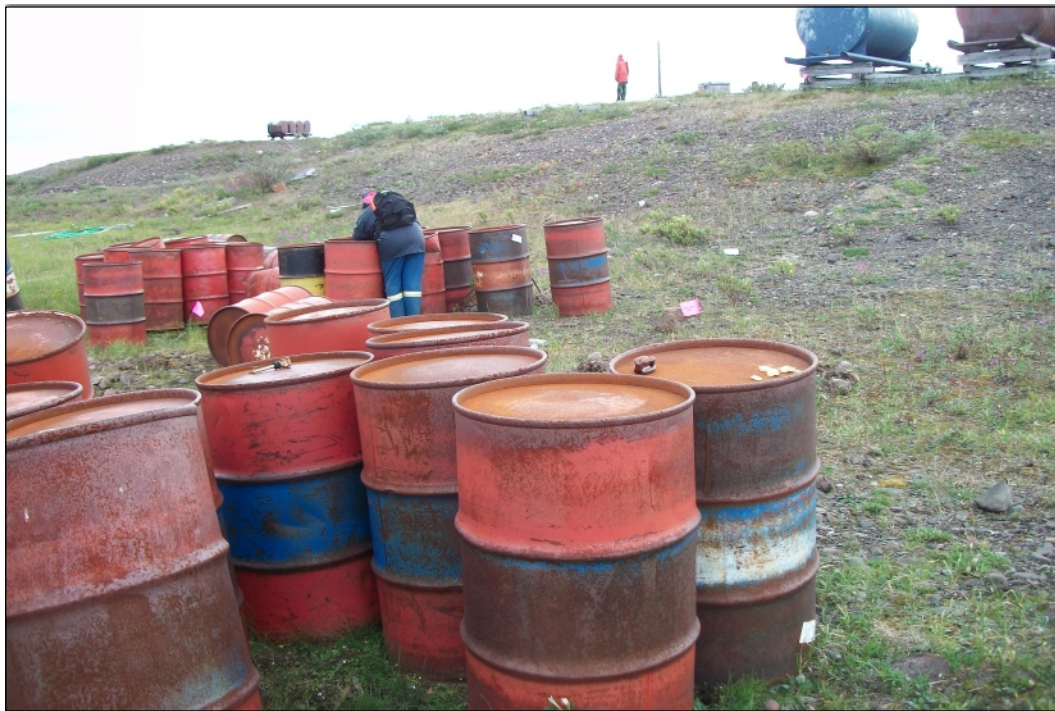
Photo 154

Hope Lake WK027: APEC 3A, leachable lead paint on red drum, drum aqueous content below guidelines

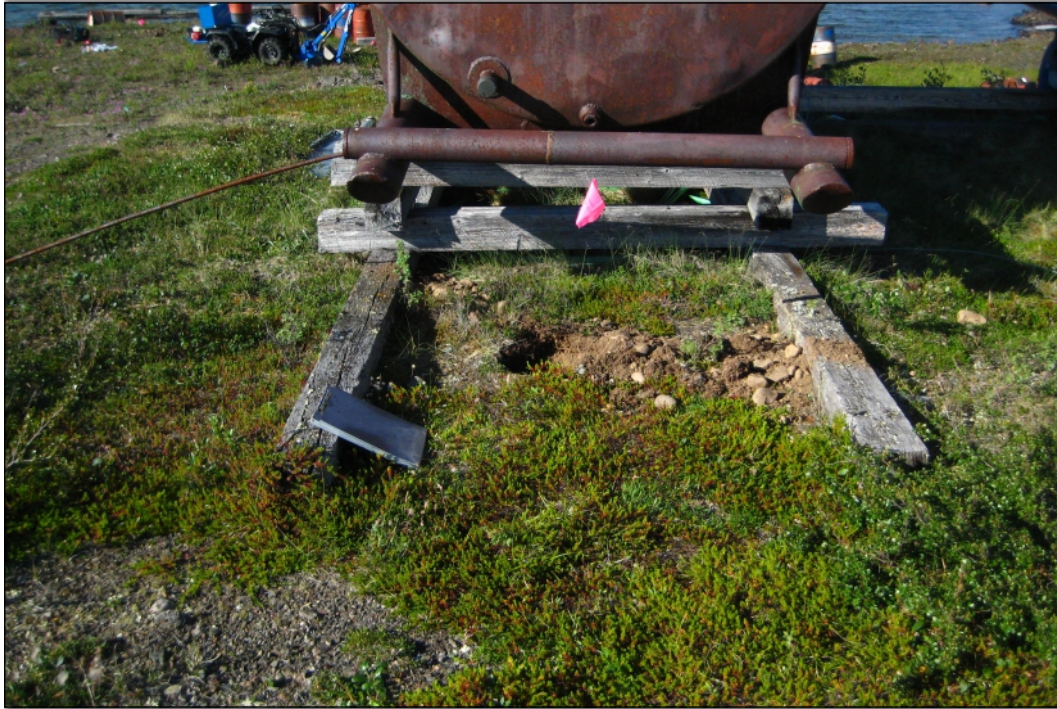
Photo 156

Hope Lake WK027: APEC 3B, two 9,600 litre tanks, leachable lead paint on blue tank

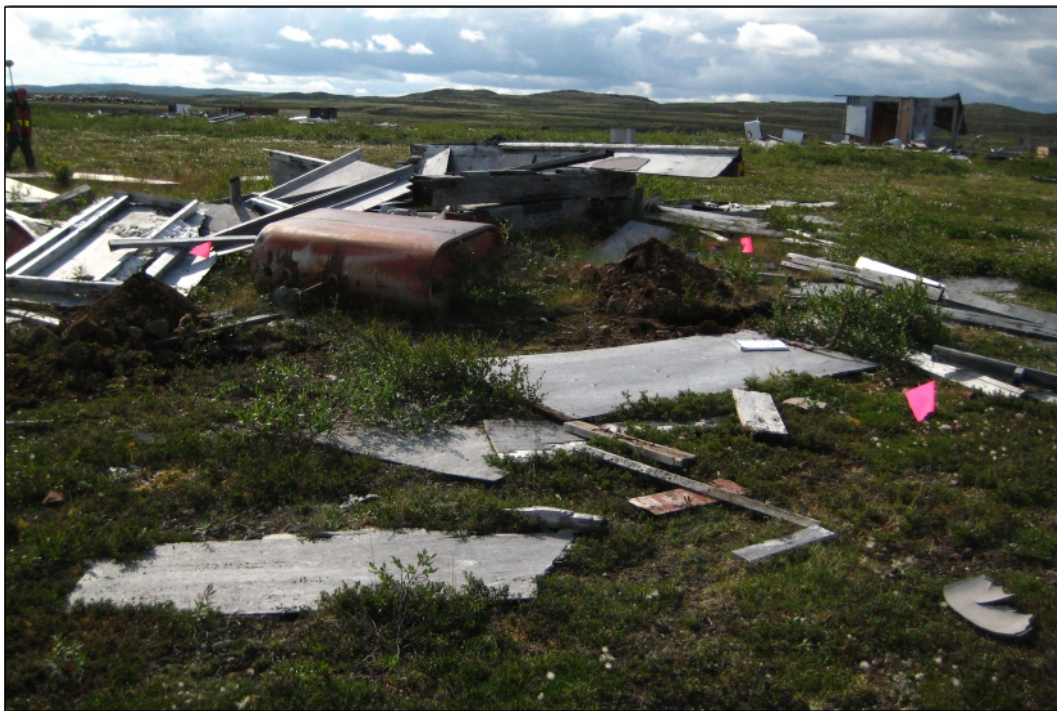
Photo 157

Hope Lake WK027: APEC 3B, sample location WK027-AP3B-SS03

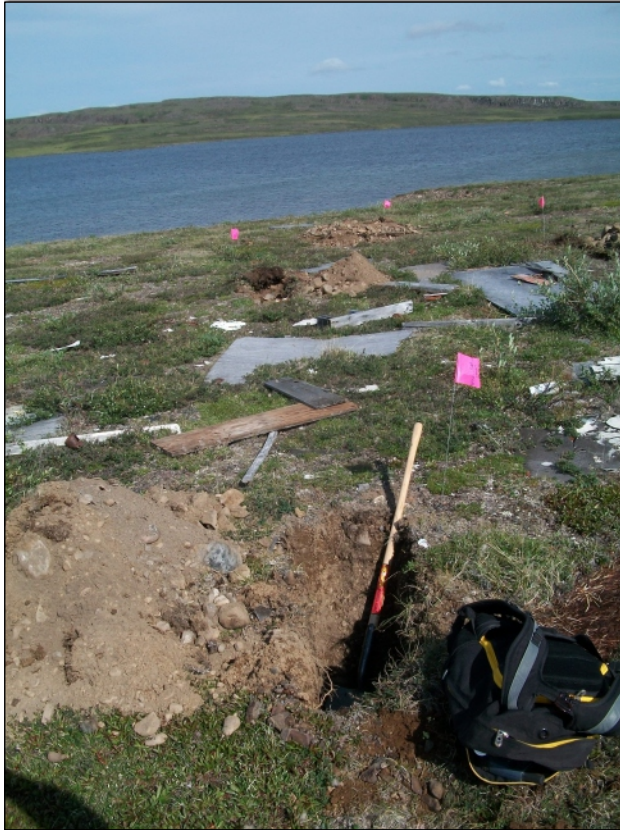
Photo 158

Hope Lake WK027: APEC 3C, heating oil tank and wood debris, soil sample locations WK027-AP3C-SS01, 02 and 03

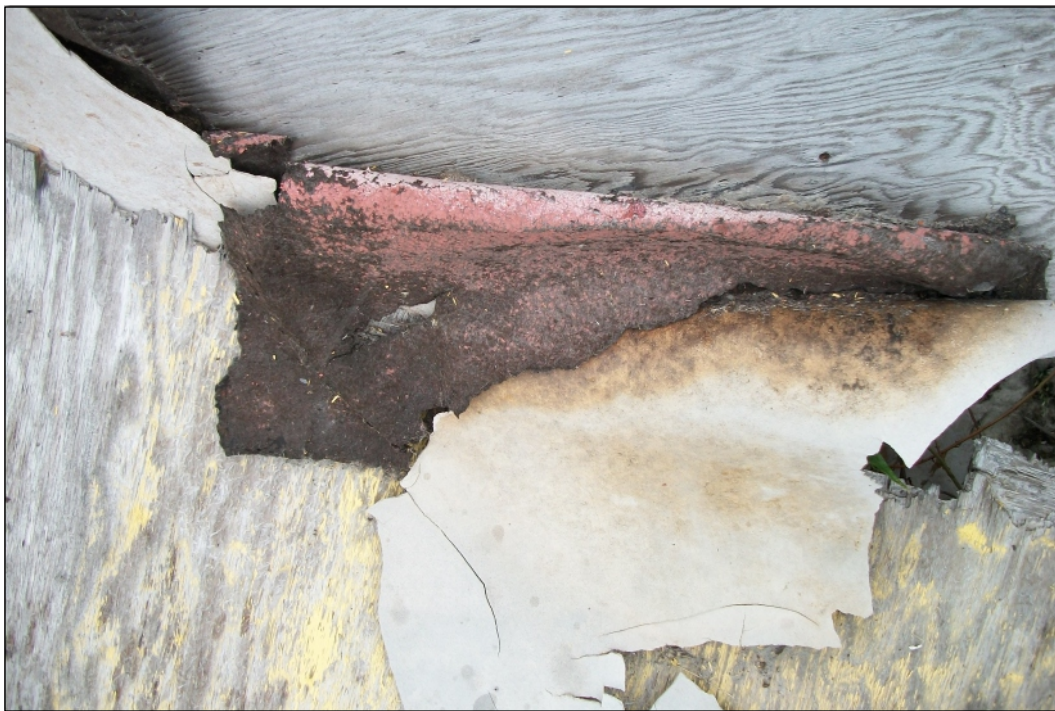
Photo 159
Hope Lake WK027: APEC 3C, soil test pits north toward
Hope Lake

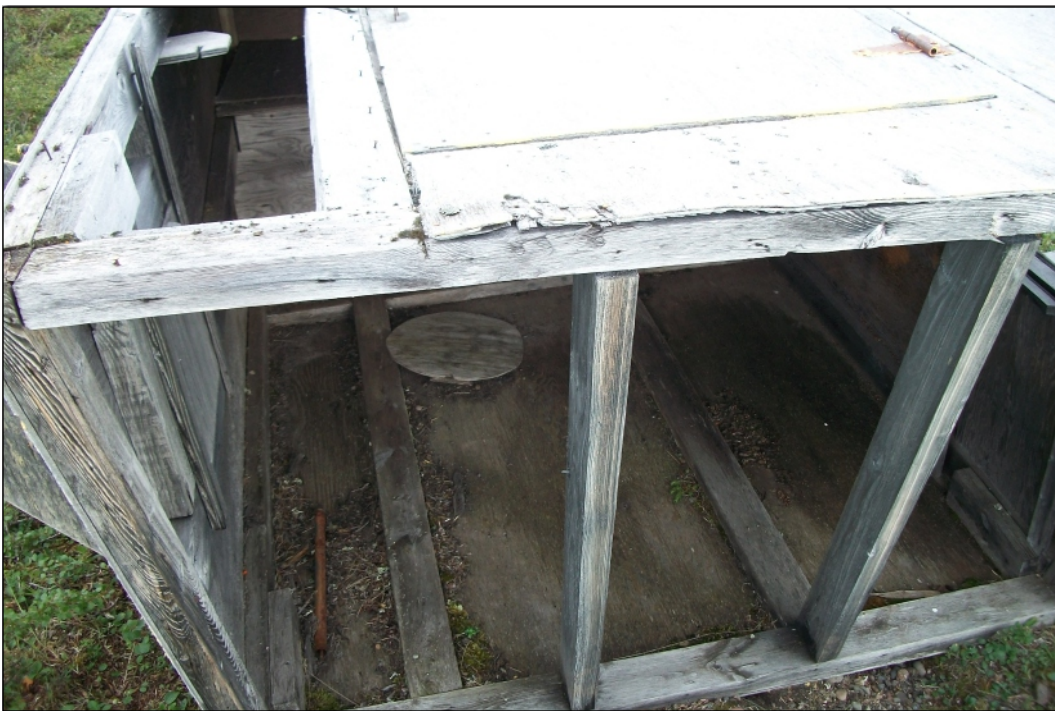
Photo 161

Hope Lake WK027: APEC 3C, mastic asbestos containing material observed in most APEC 3 structures

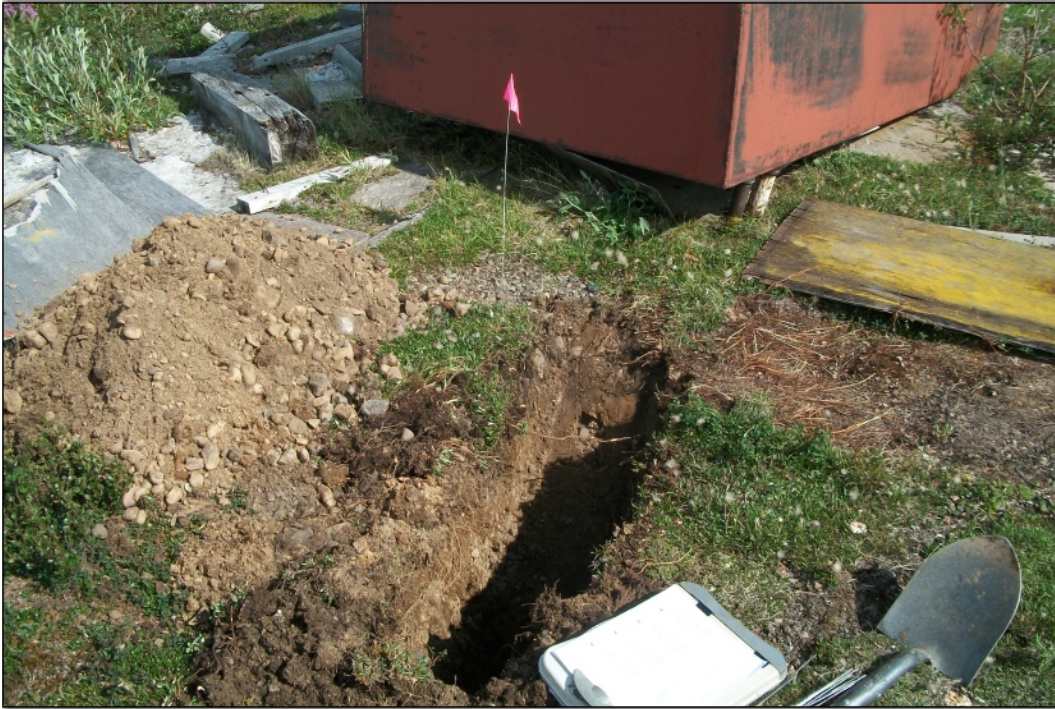
Photo 162

Hope Lake WK027: APEC 3D, collapsed outhouse

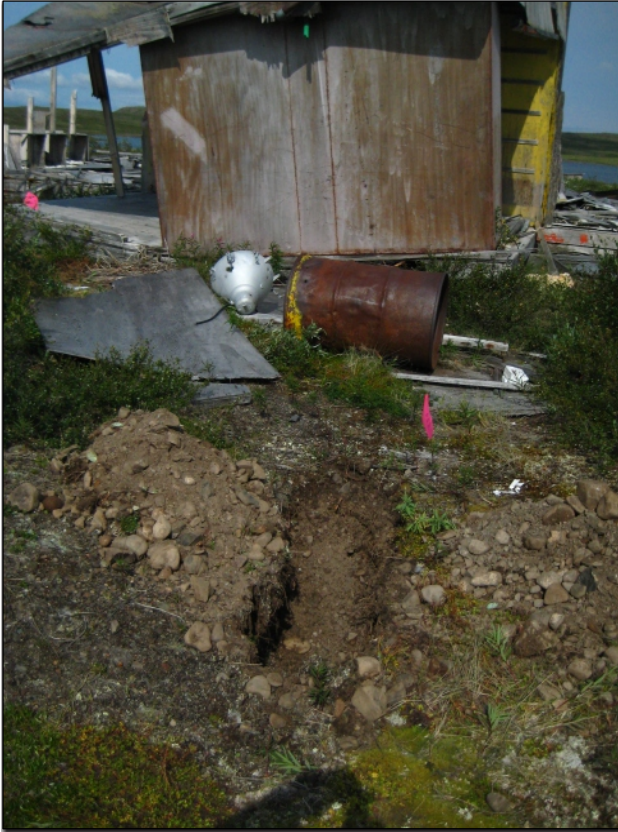
Photo 166

Hope Lake WK027: APEC 3F, collapsed shack and APEC 3Q, scattered wood debris and crushed drum in background

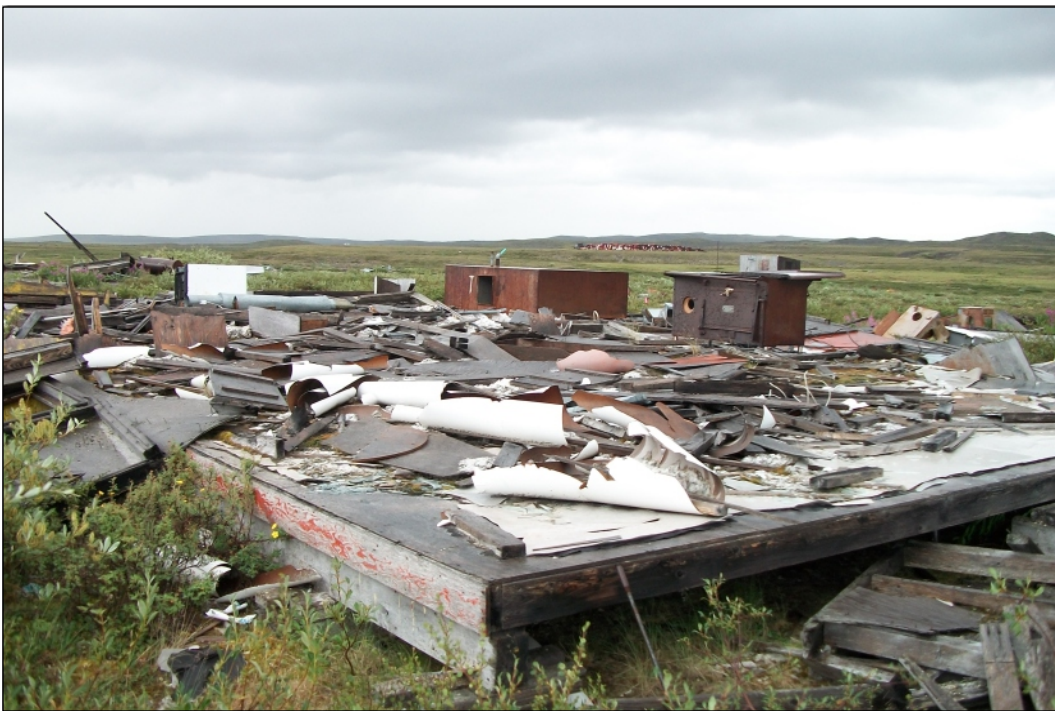
Photo 169

Hope Lake WK027: APEC 3G, Structure 05, mostly wood debris

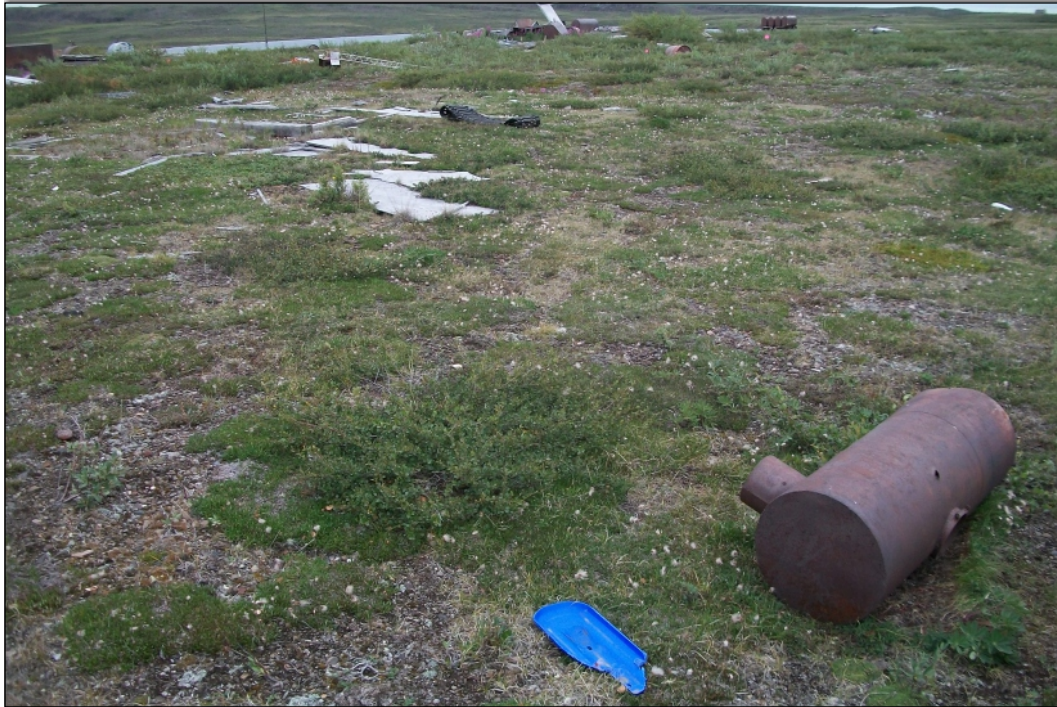
Photo 170

Hope Lake WK027: APEC 3H, collapsed structure with stove, tank, and debris

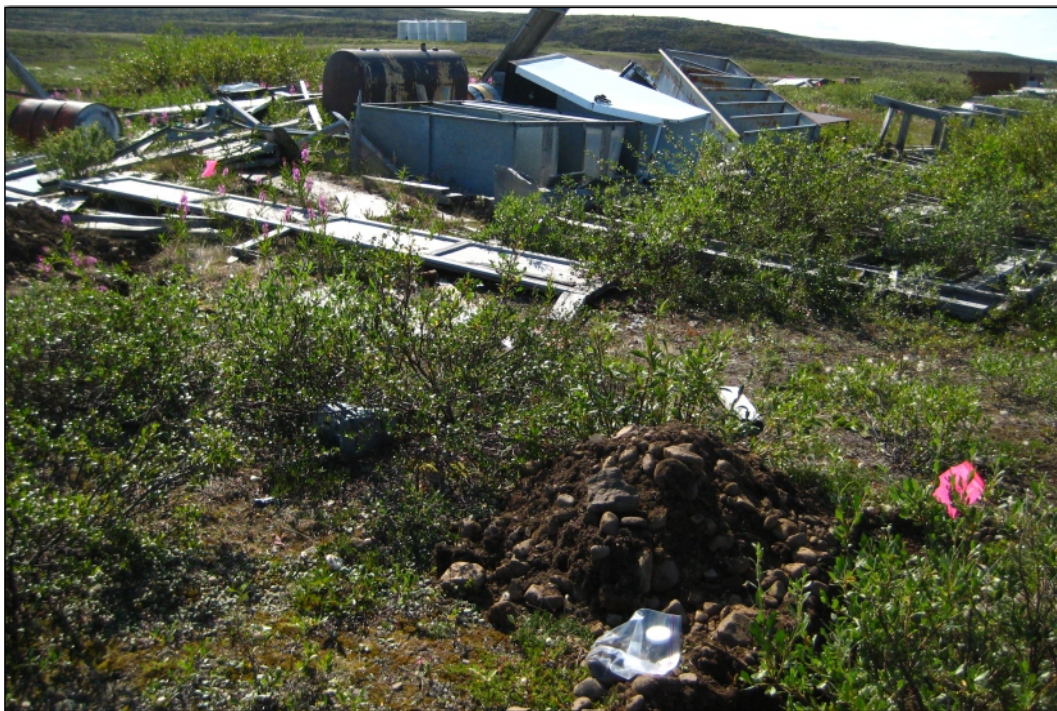
Photo 171

Hope Lake Wk027: APEC 3I, heater duct and wood debris

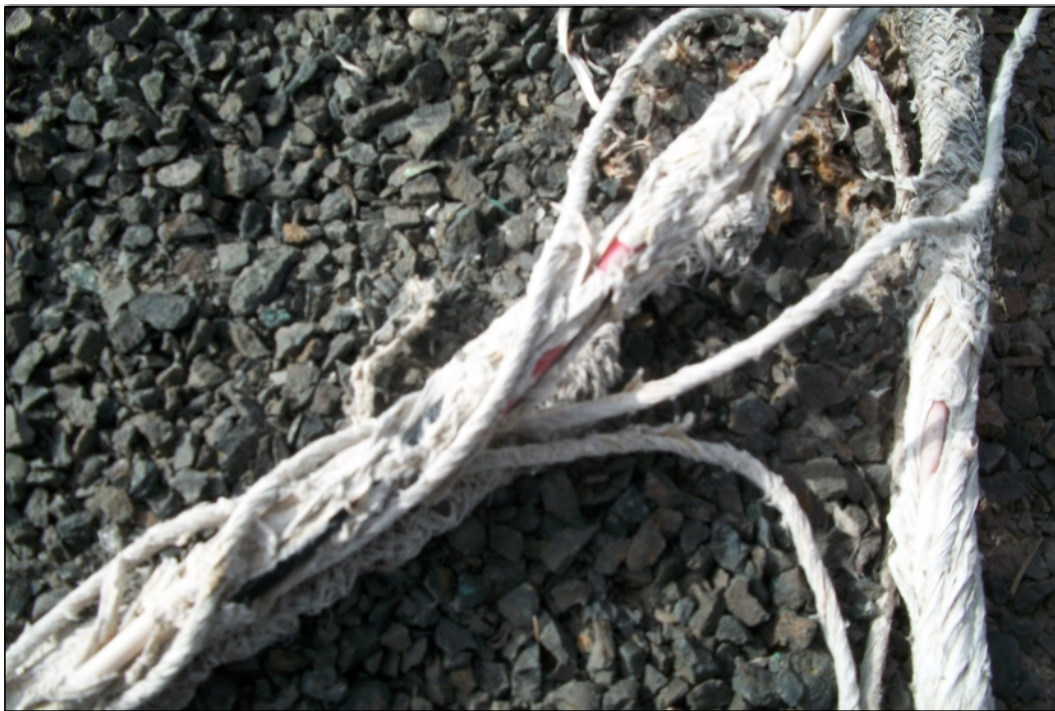
Photo 180
Hope Lake WK027: APEC 3O, soil sample location
WK027-AP3O-SS01 down gradient of former assay lab

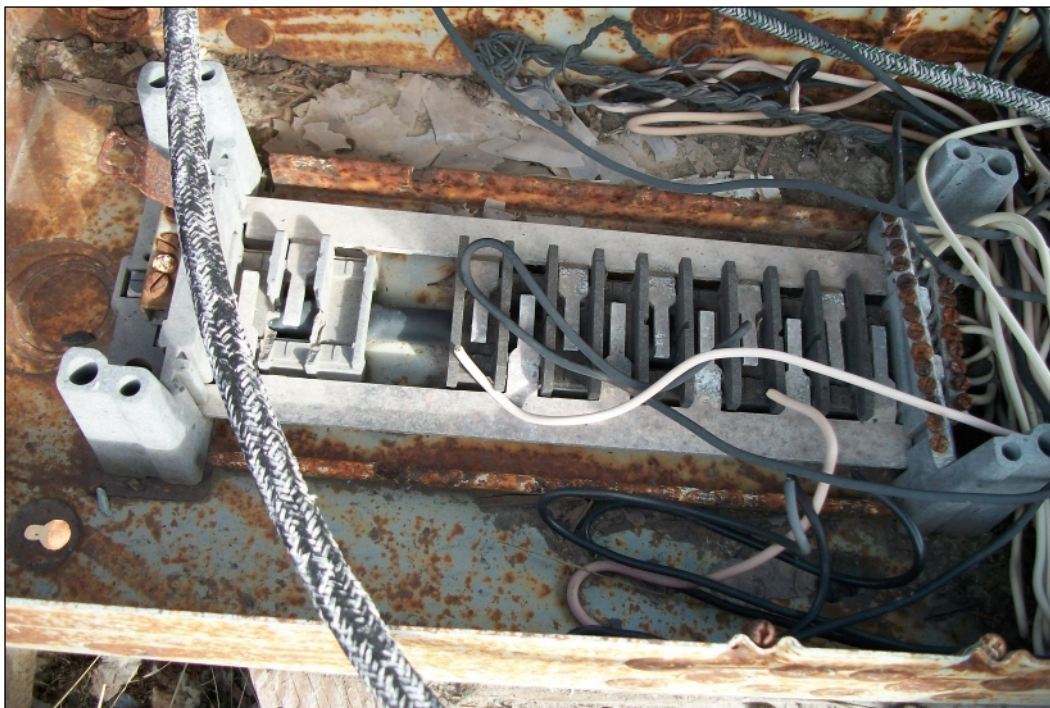
Photo 181

Hope Lake WK027: APEC 30, black and white textile wrap around electrical wiring sampled, does not contain asbestos
