HOPE LAKE
REMEDICATION PROJECT

REMEDIAL ACTION PLAN

**REMEDIAL ACTION PLAN
HOPE LAKE, NUNAVUT**

Y22101167.005

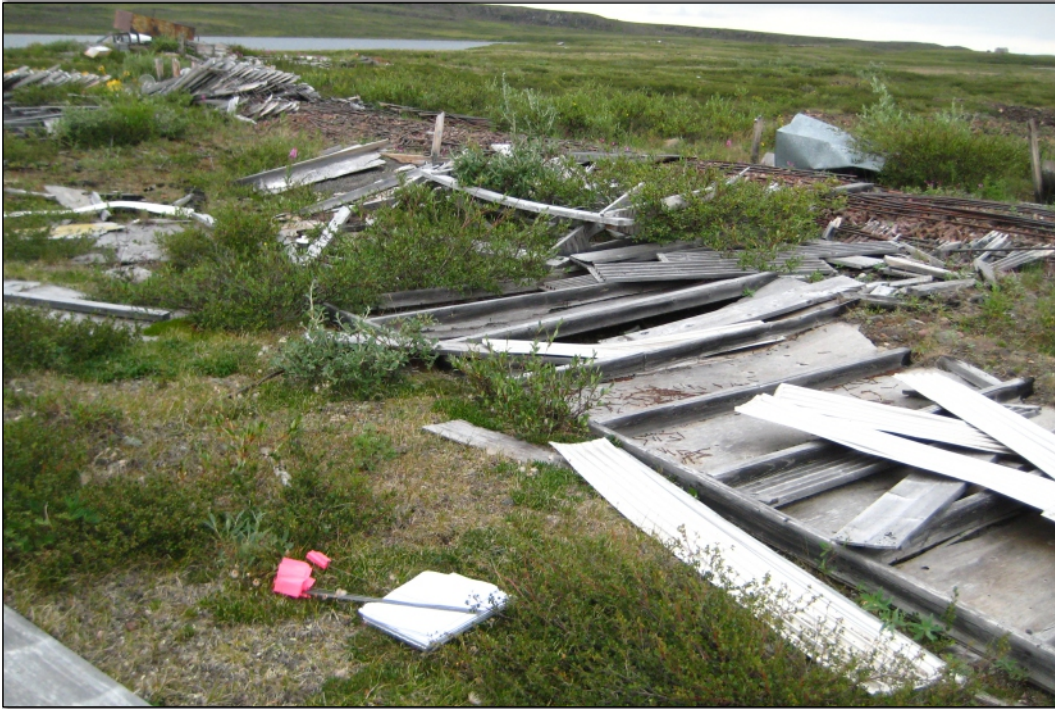
Photo 182

Hope Lake WK027: APEC 30, electrical insulators containing asbestos

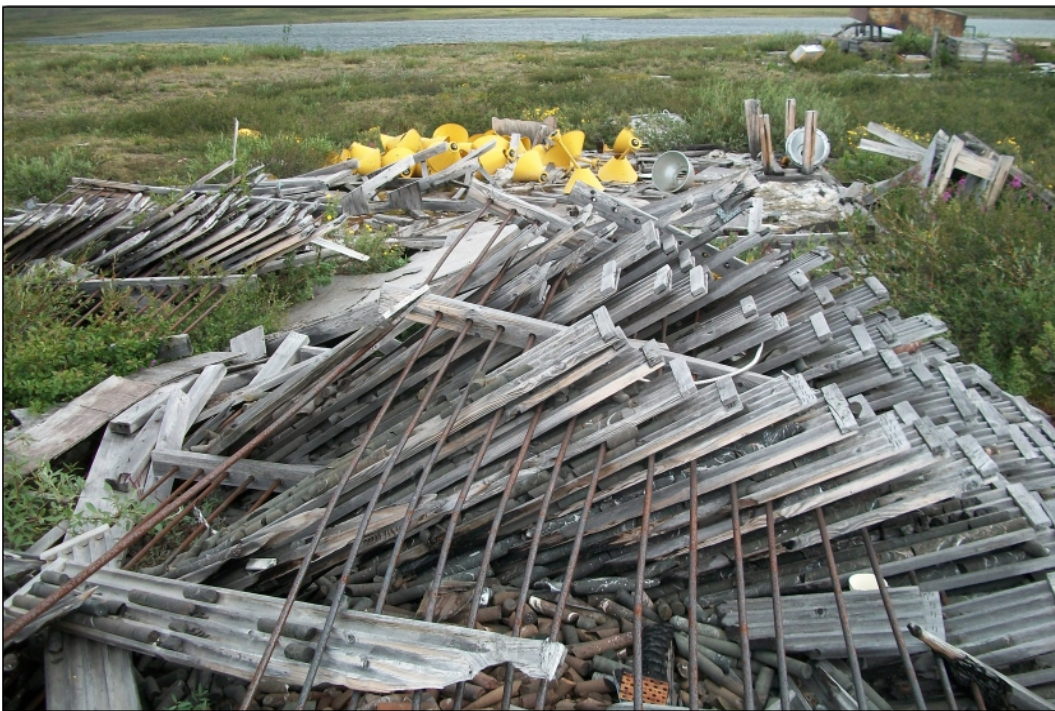
Photo 183
Hope Lake WK027: APEC 3P, collapsed core shack

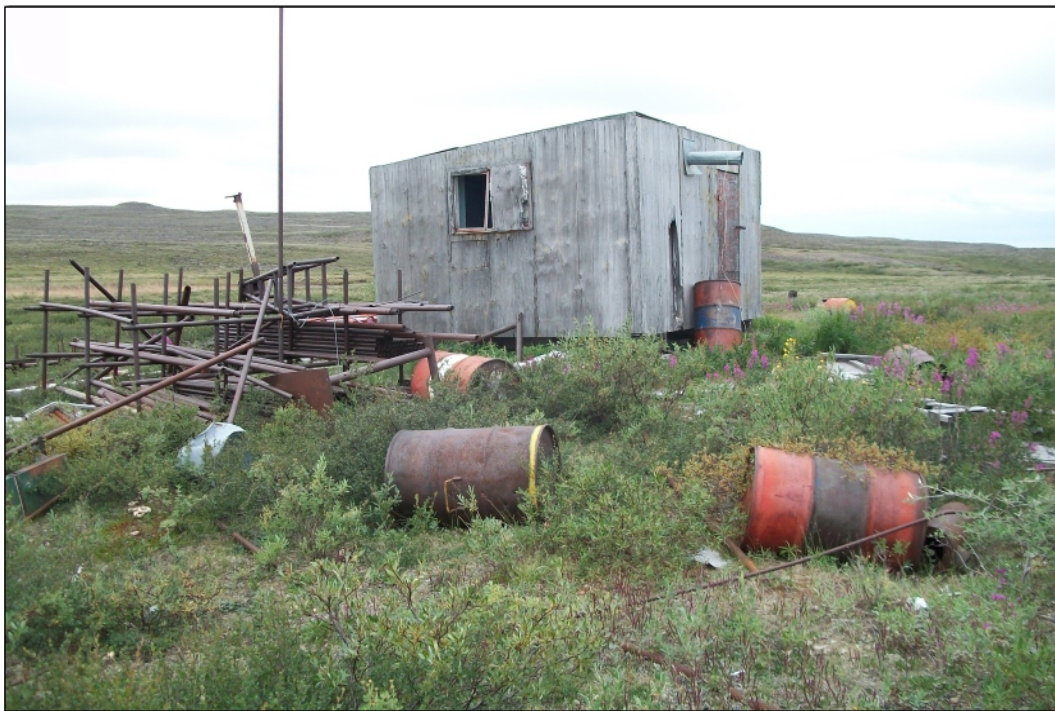
Photo 185

Hope Lake WK027: APEC 3P, non-hazardous materials, may have been a drilling compound

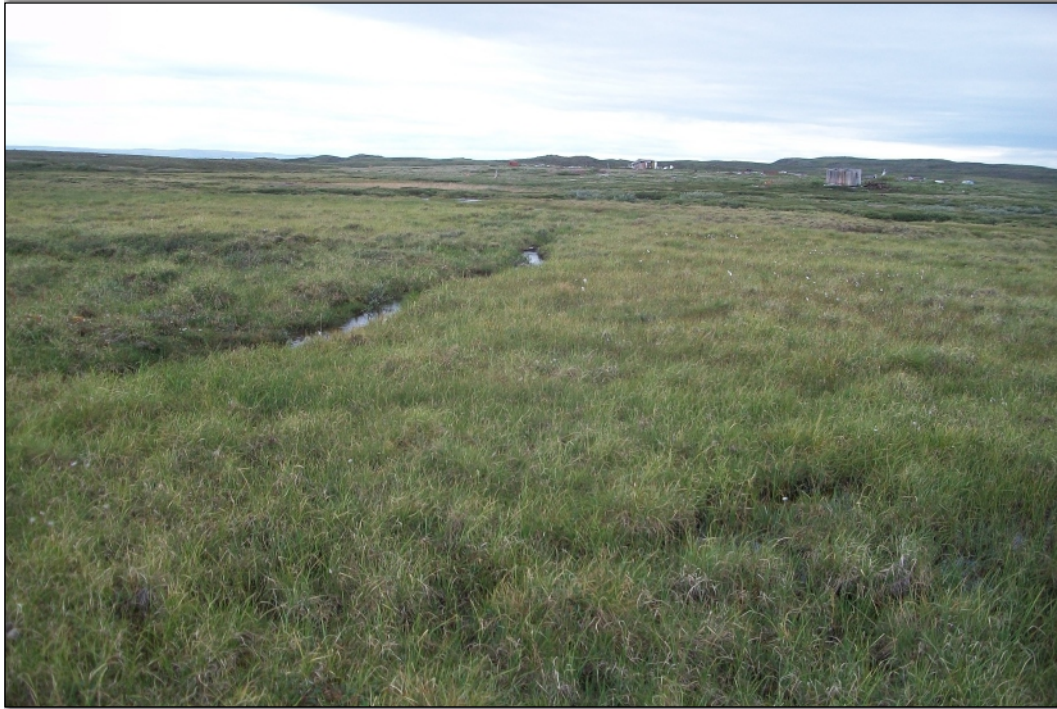
Photo 186

Hope Lake WK027: APEC 3R, Structure 09

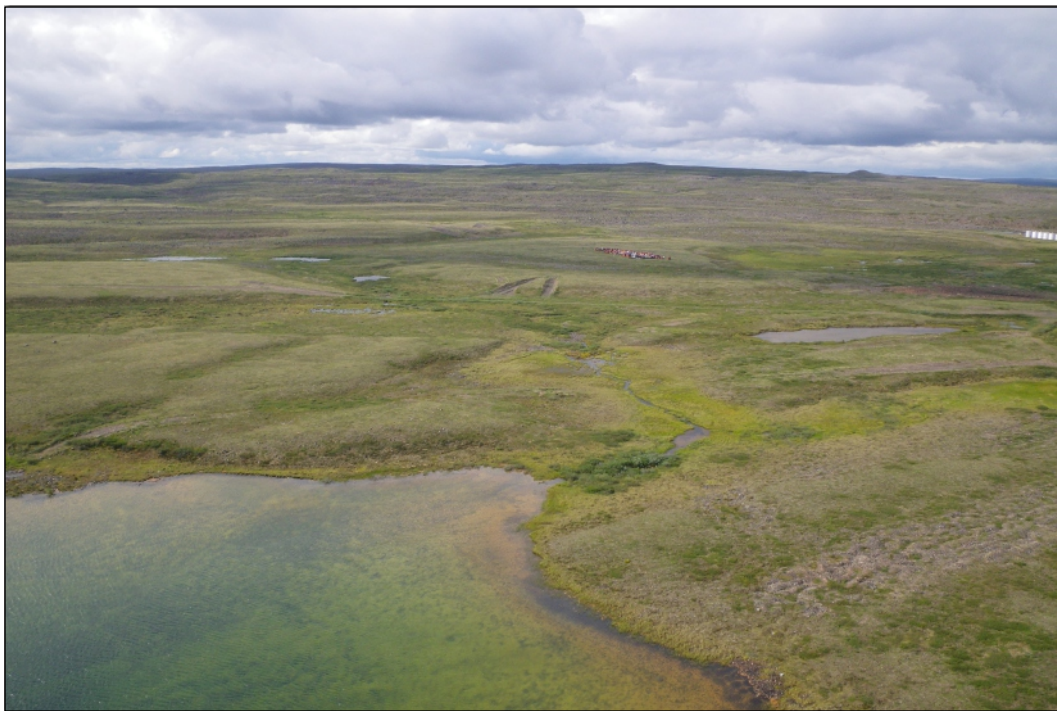
Photo 187

Hope Lake WK027: APEC 3U, suspected outfall area, looking north to APEC 3

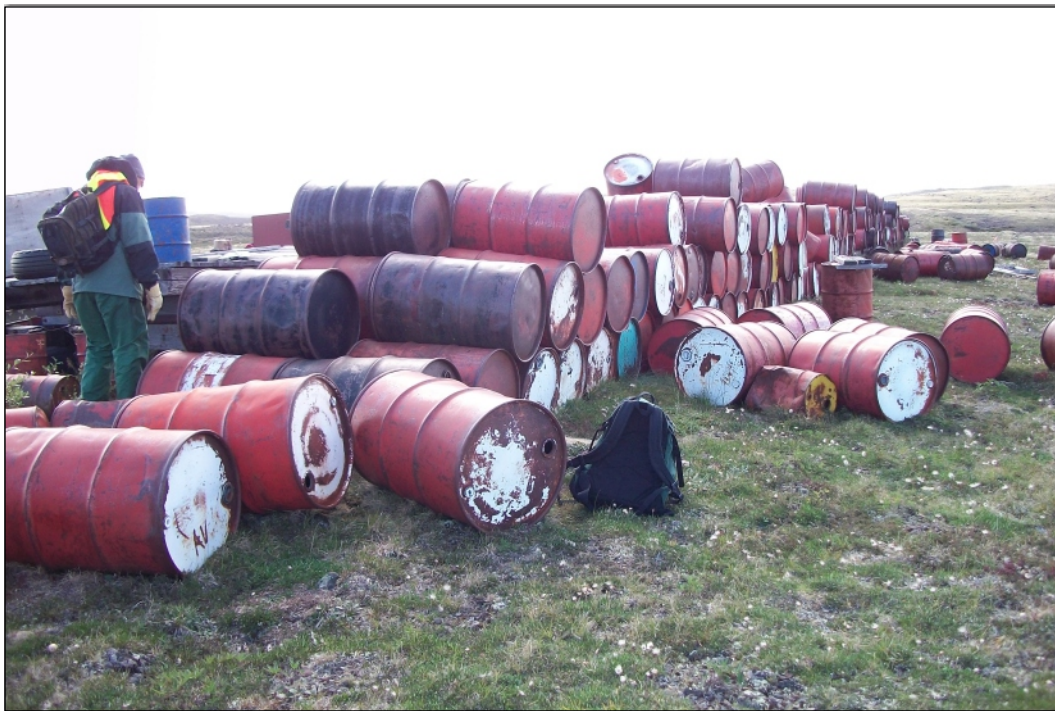
Photo 188

Hope Lake WK027: APEC 3V, aerial view of drum cache

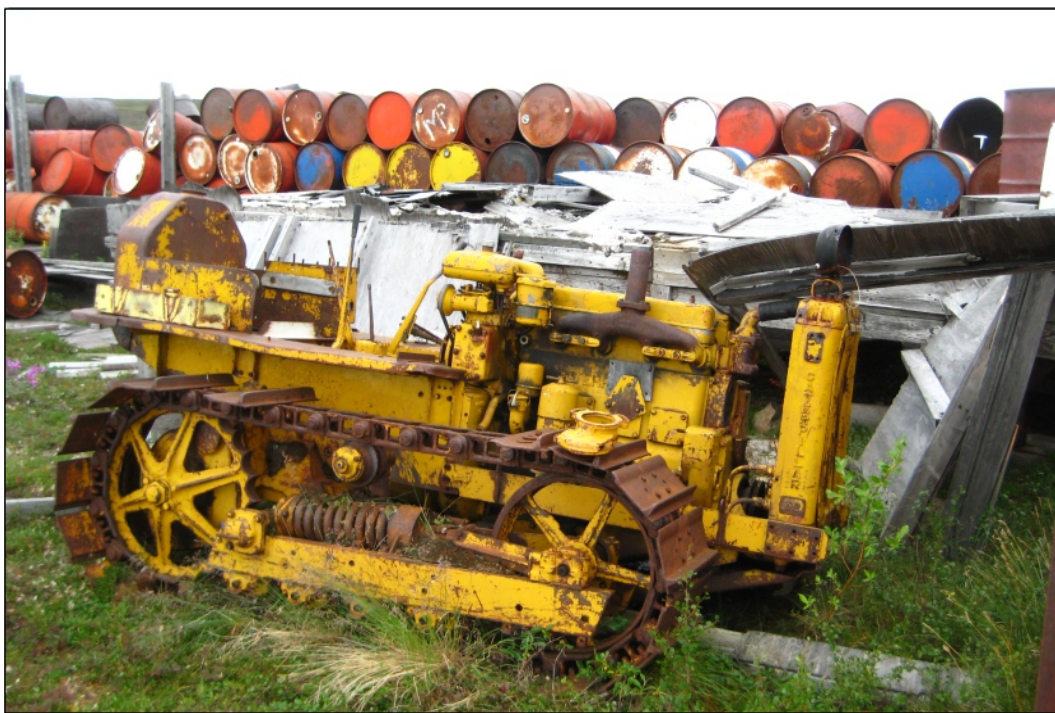
Photo 189
Hope Lake WK027: APEC 3V, large drum cache

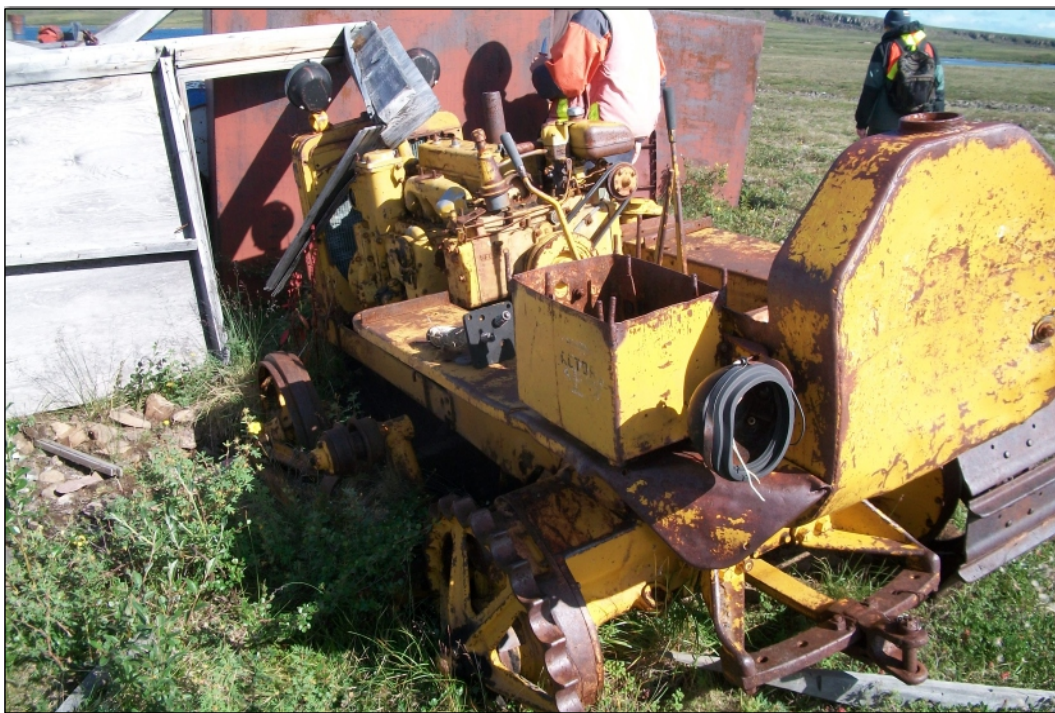
Photo 190
Hope Lake WK027: APEC 3V, yellow caterpillar

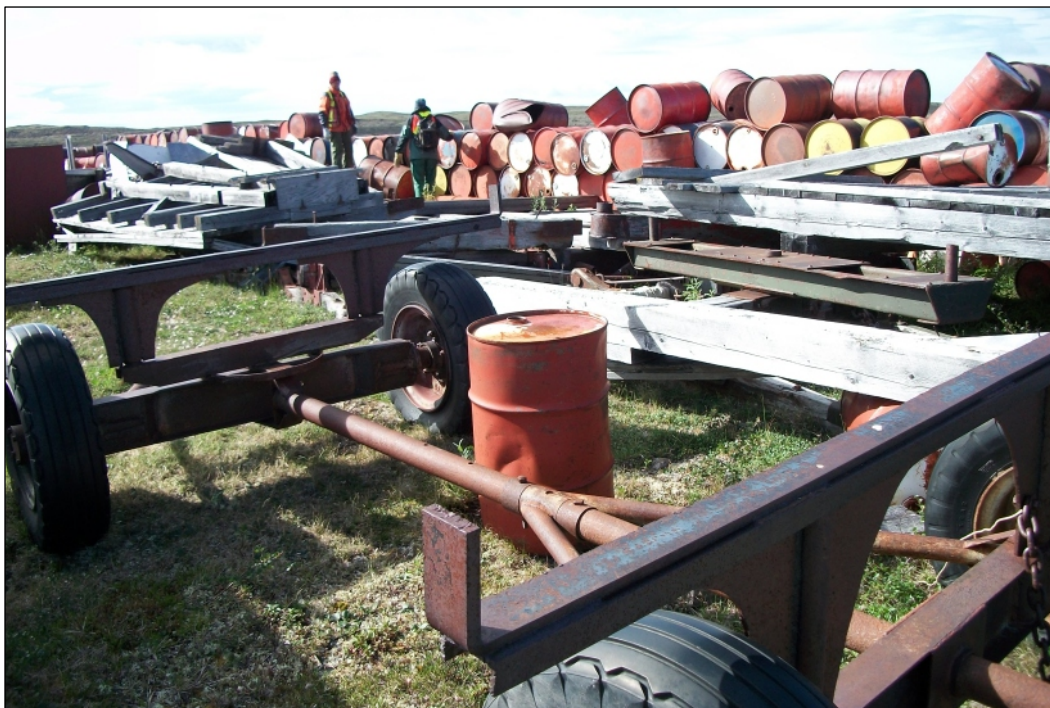
Photo 191

Hope Lake WK027: APEC 3V, yellow caterpillar contains leachable lead paint

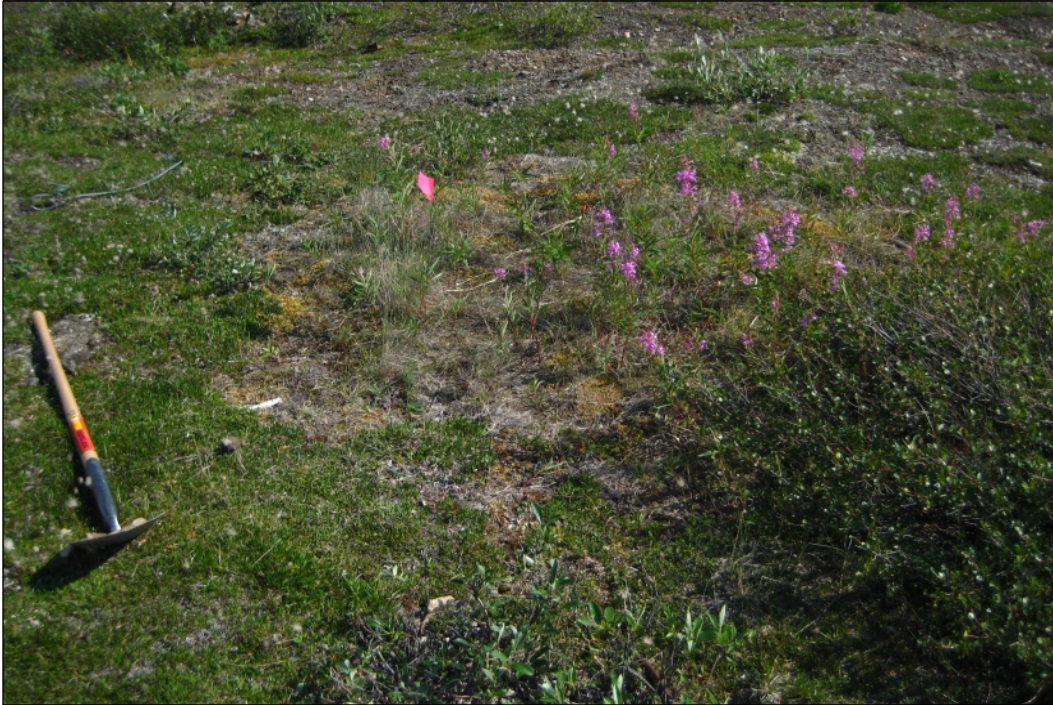
Photo 192

Hope Lake WK027: APEC 3V, trailers and drums

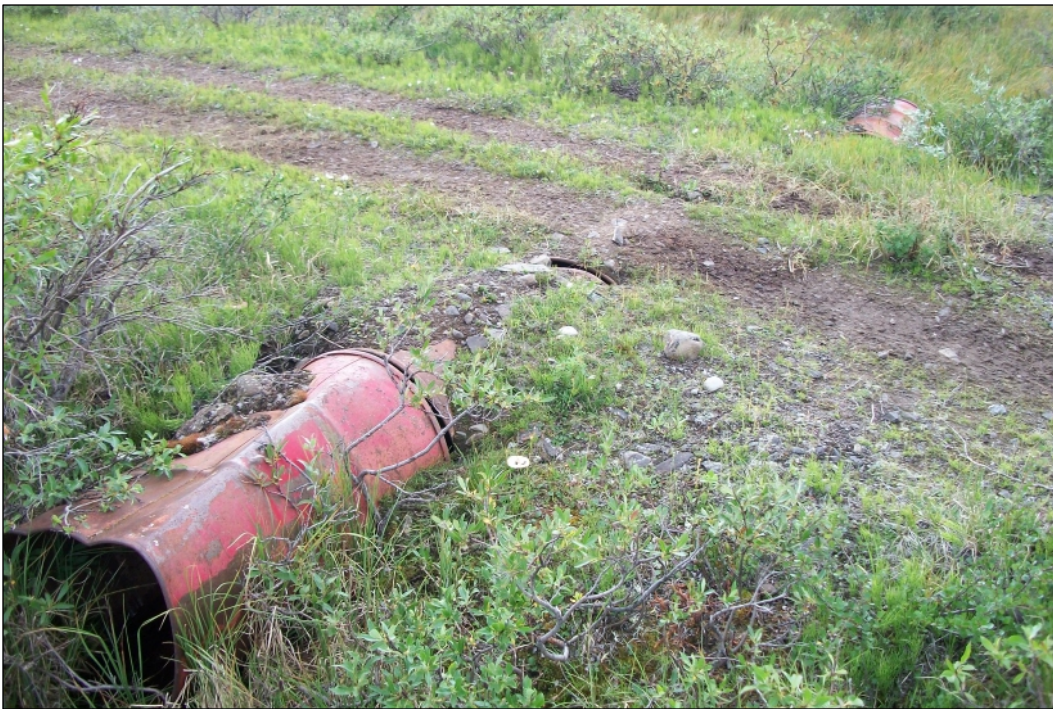
Photo 193

Hope Lake WK027: APEC 3W, small area of distressed vegetation

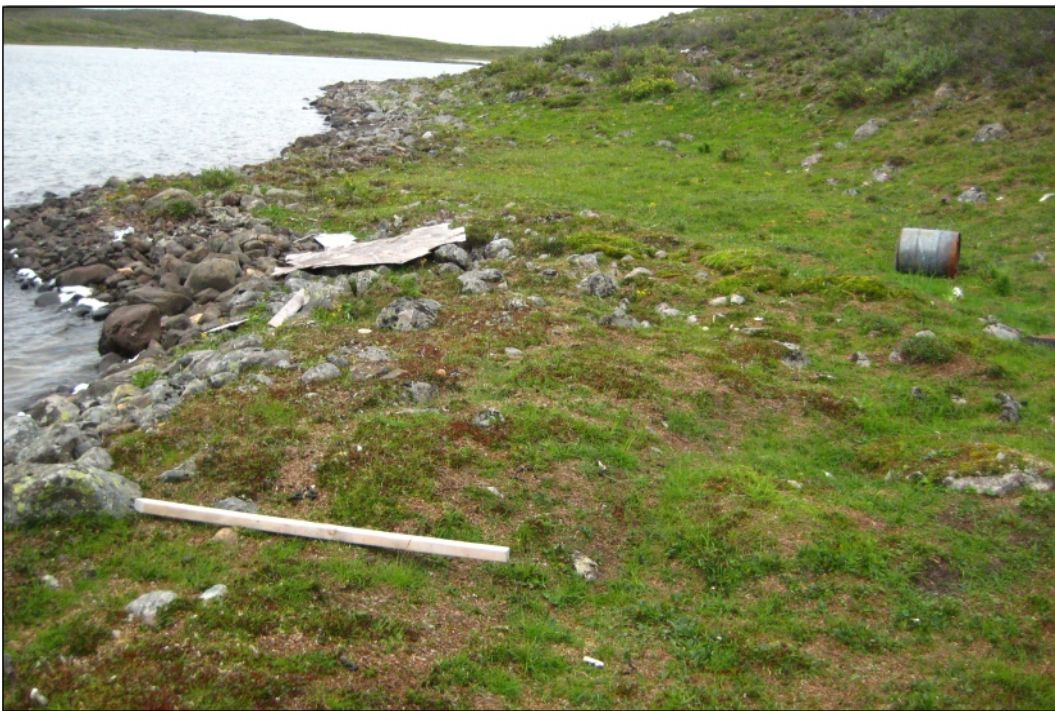
Photo 205

Hope Lake WK027: APEC 4E, debris in Hope Lake, northeast of tanks

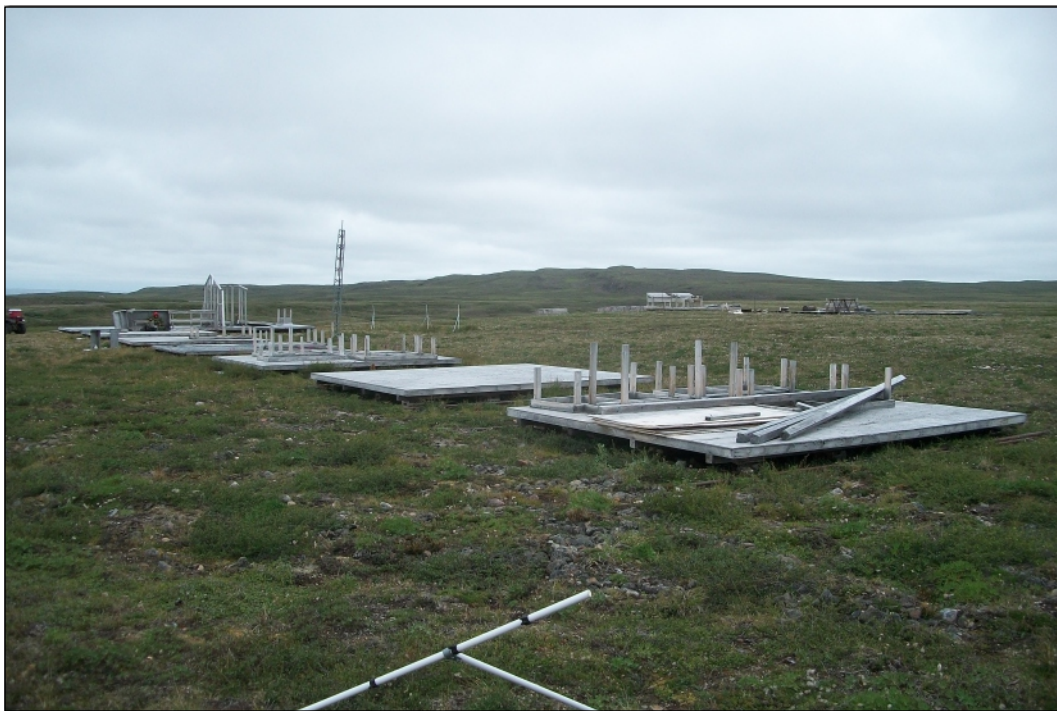
Photo 211

Hope Lake WK027: APEC 5, drum and disturbed vegetation

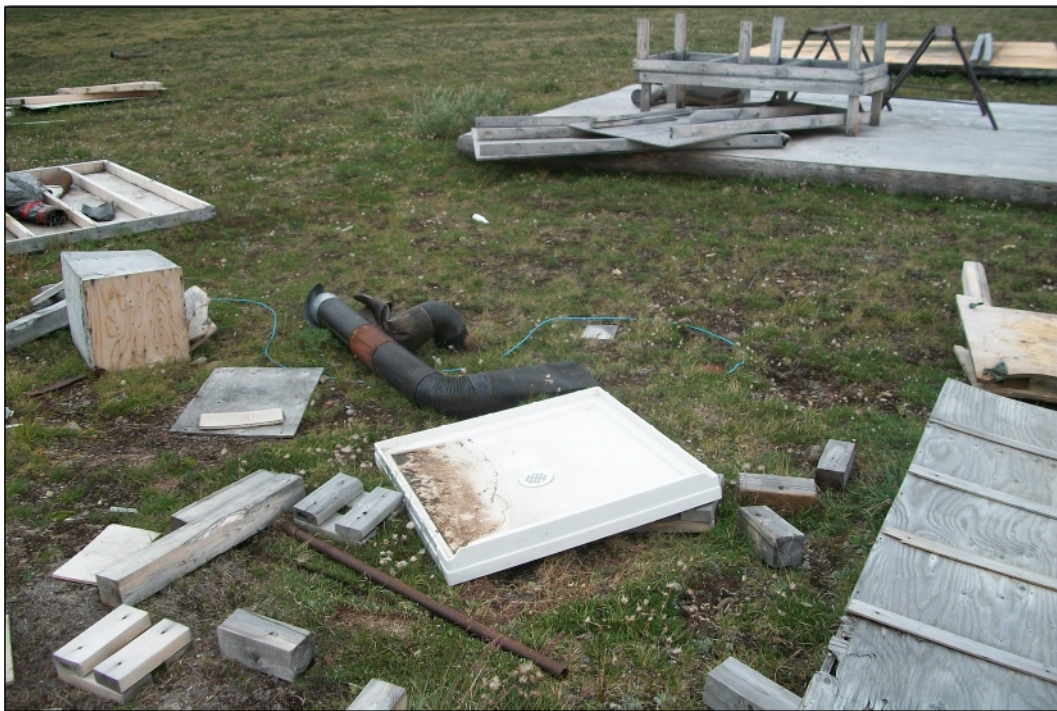
Photo 213

Hope Lake WK027: APEC 5, building platform in good condition; blue paint sampled doesn't contain lead over guidelines

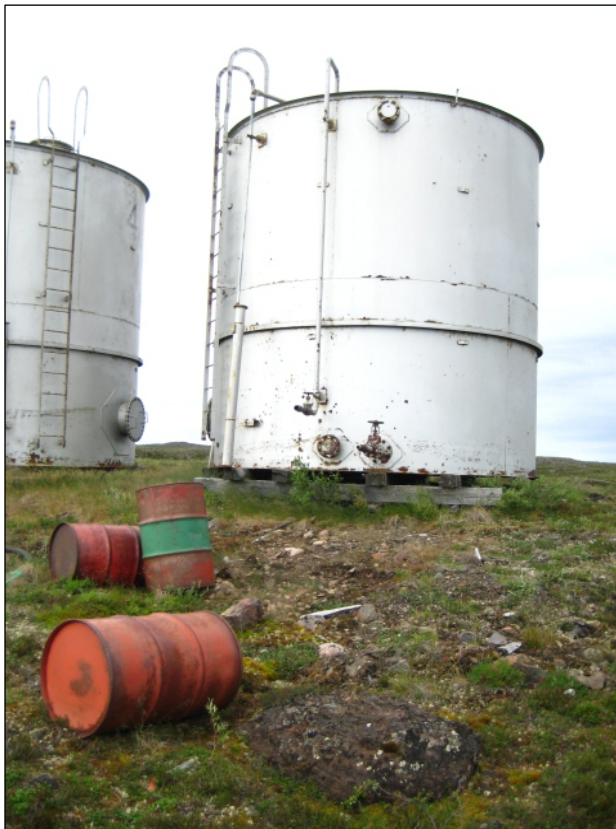
Photo 219

Hope Lake WK027: APEC 6A, green hose running from POL tanks

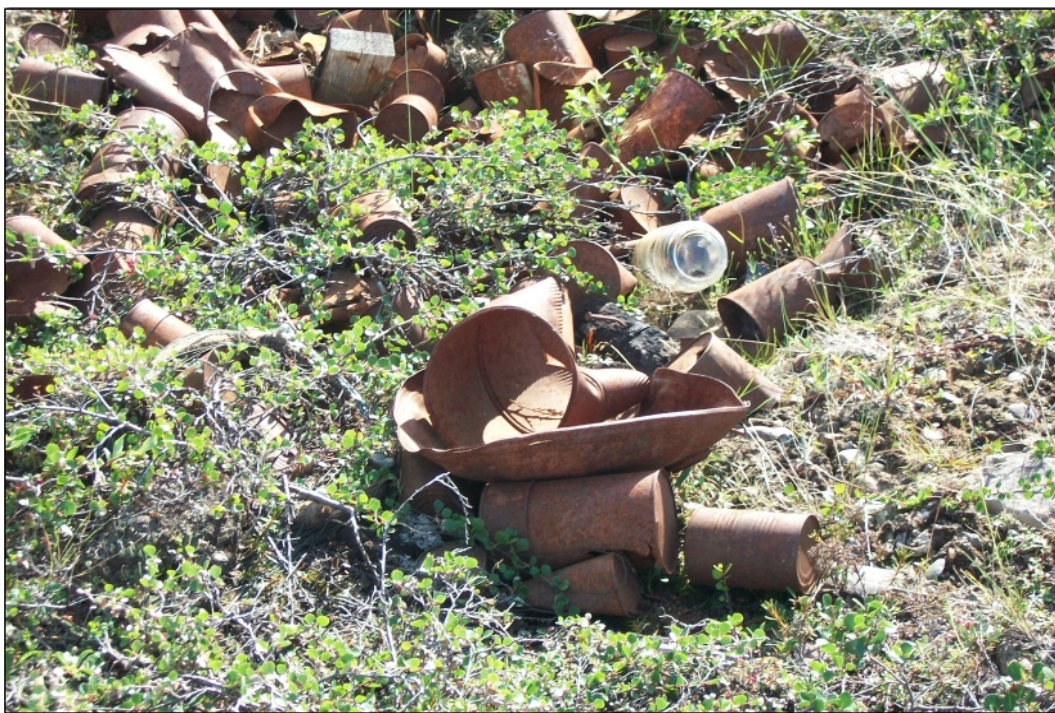
Photo 227
Hope Lake WK027: APEC 7A, drums in lowland area

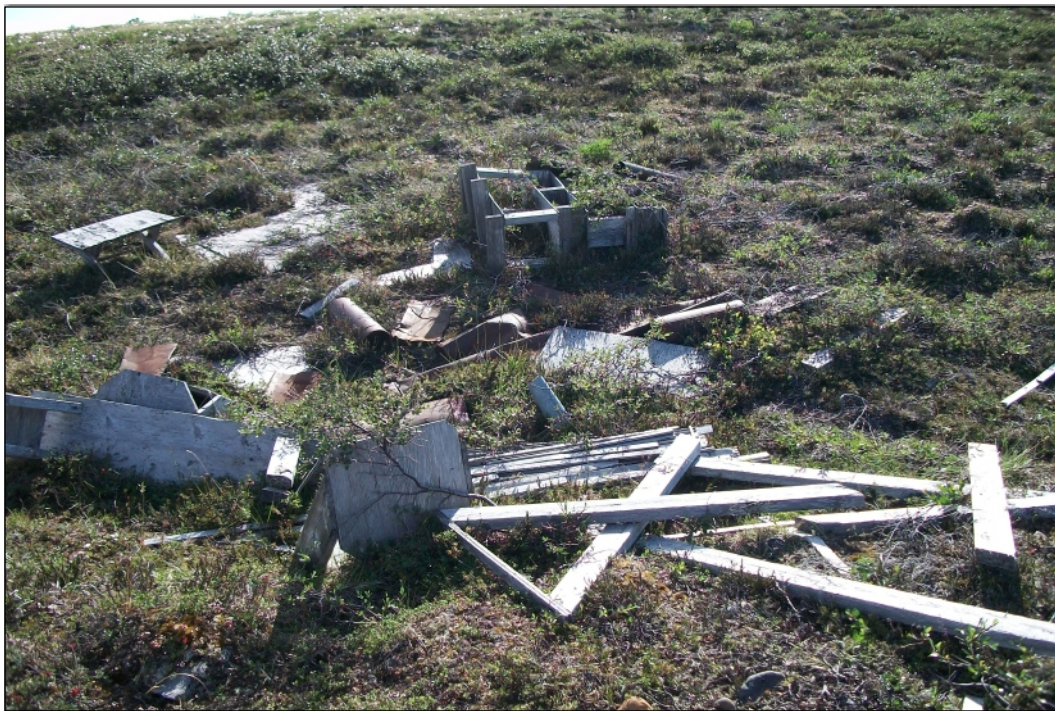
Photo 228
Hope Lake WK027: APEC 7C, 200m south of airstrip, metal debris

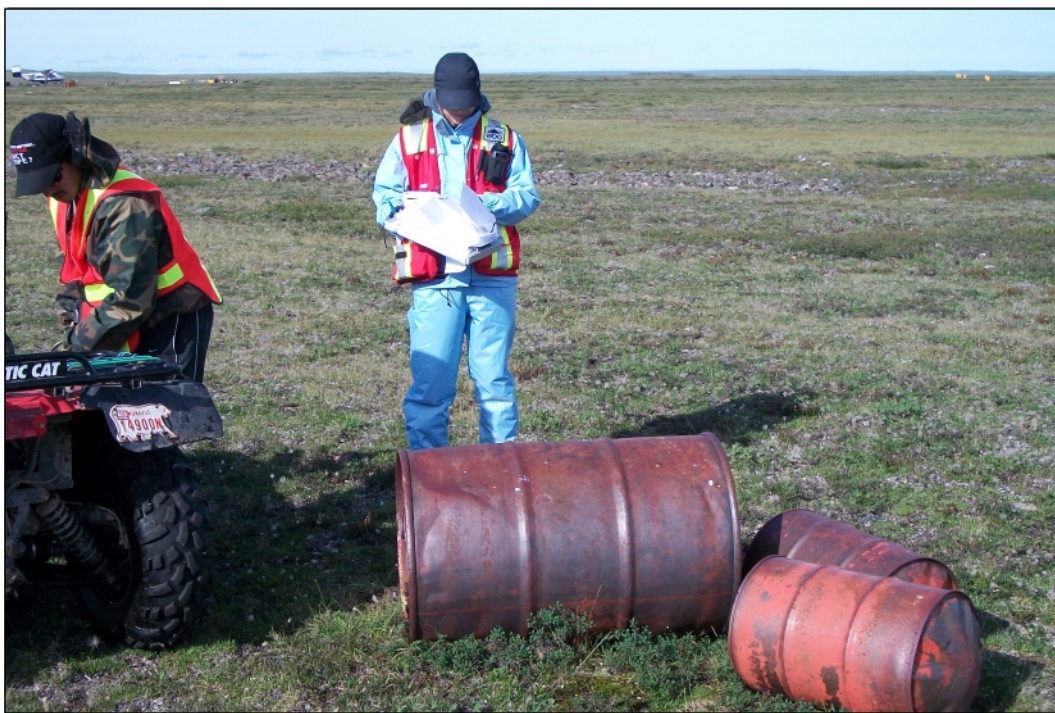
Photo 229

Hope Lake WK027: APEC 7C, 200m south of airstrip, metal debris

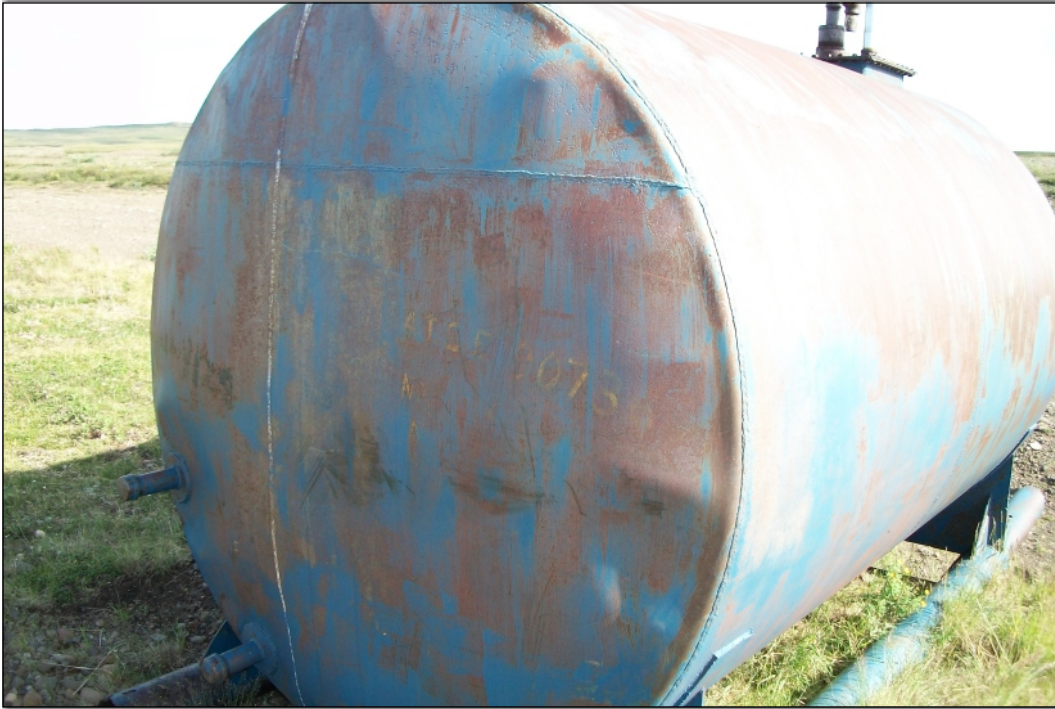
Photo 230

Hope Lake WK027: APEC 7C, 200m south of airstrip, red leachable lead paint on drum

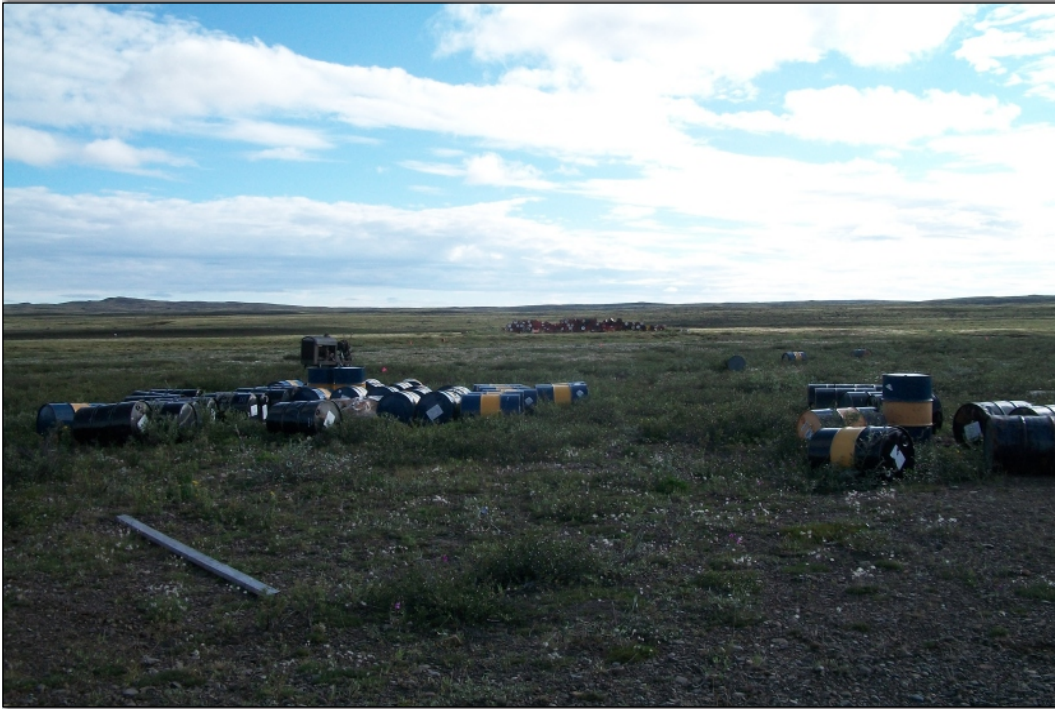
Photo 245

Hope Lake WK027: APEC 7H, APEC 7I in foreground and APEC 7O in background

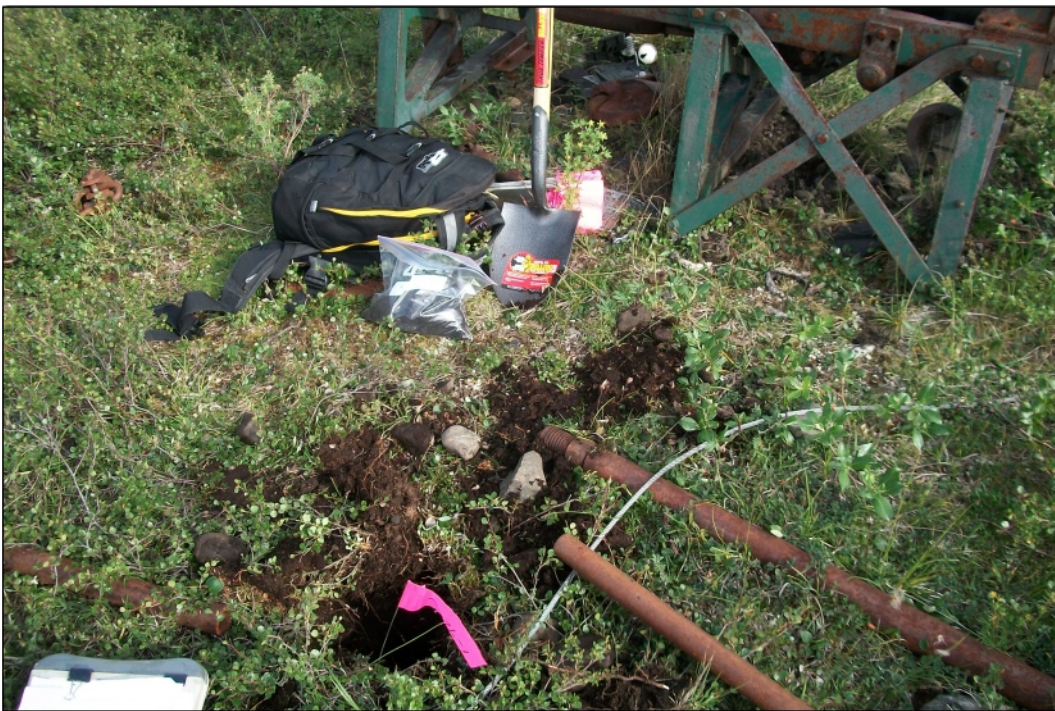
Photo 246

Hope Lake WK027: APEC 7I, old drill, WK027-AP7I-SS01

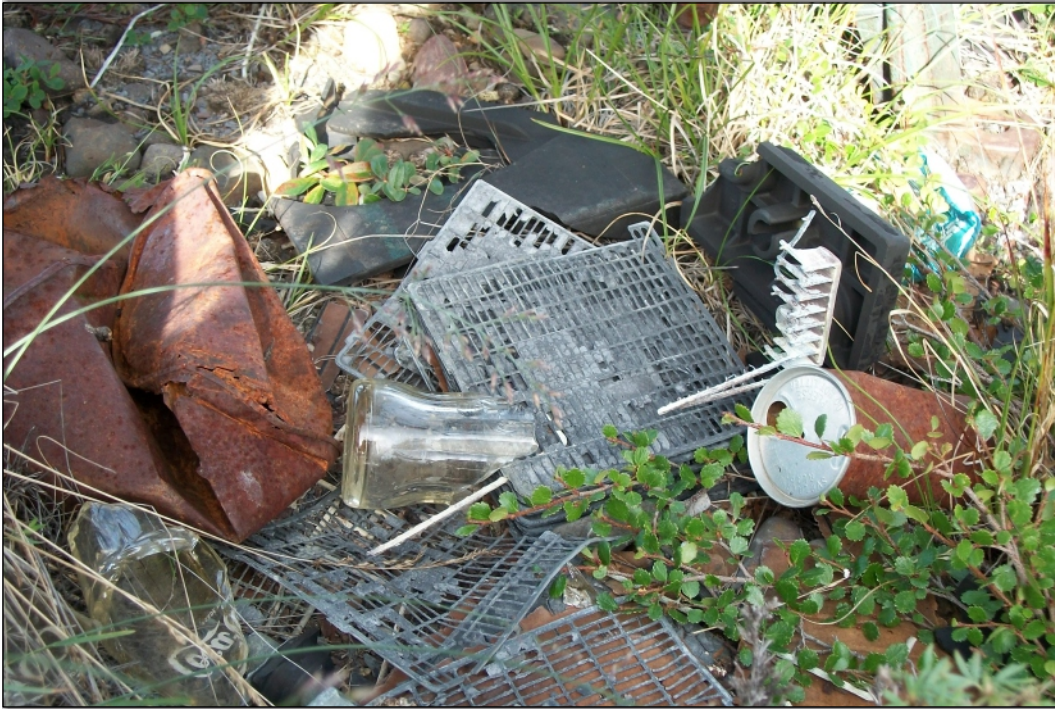
Photo 247
Hope Lake WK027: APEC 7I, battery parts

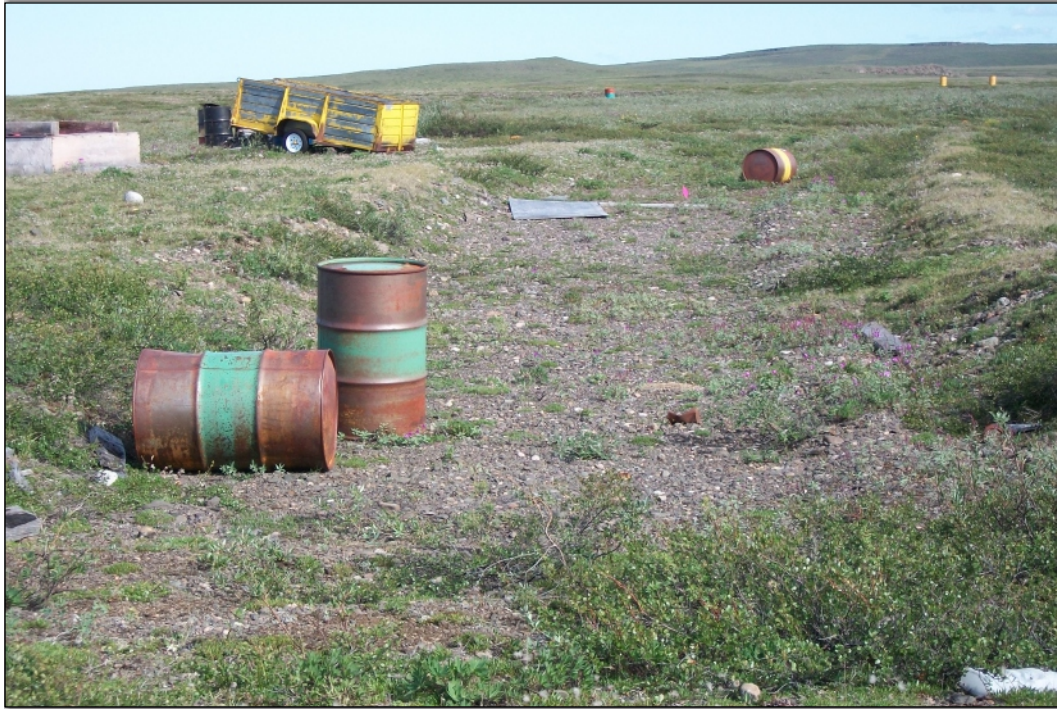
Photo 251
Hope Lake WK027: APEC 7L

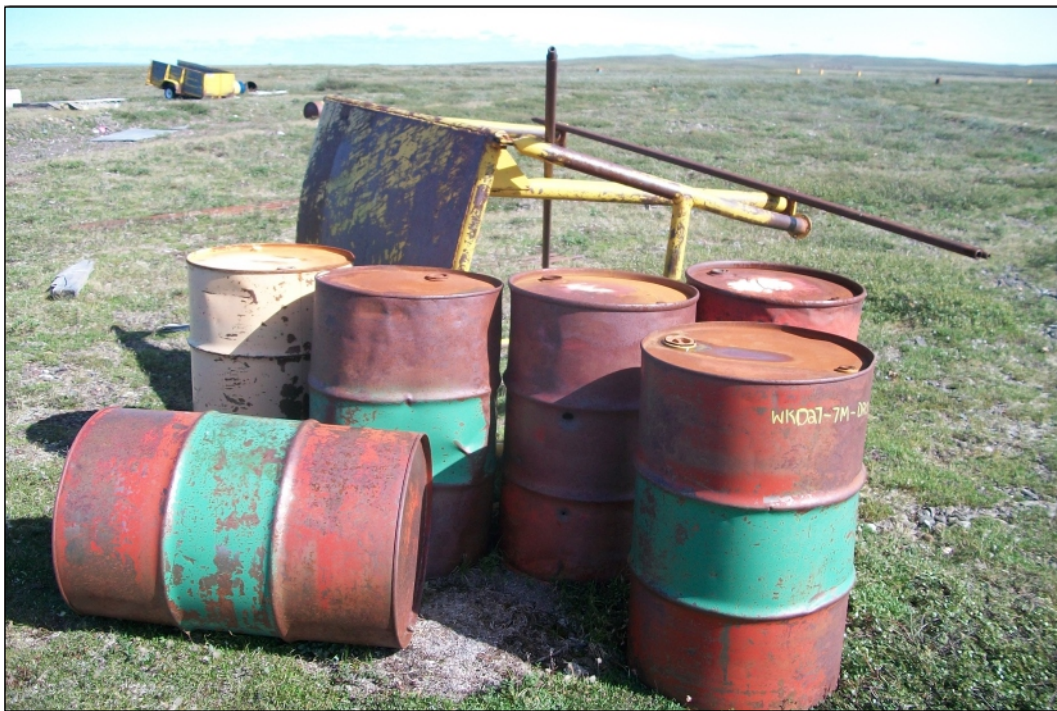
Photo 252
Hope Lake WK027: APEC 7M, six drums, frame and drill rods

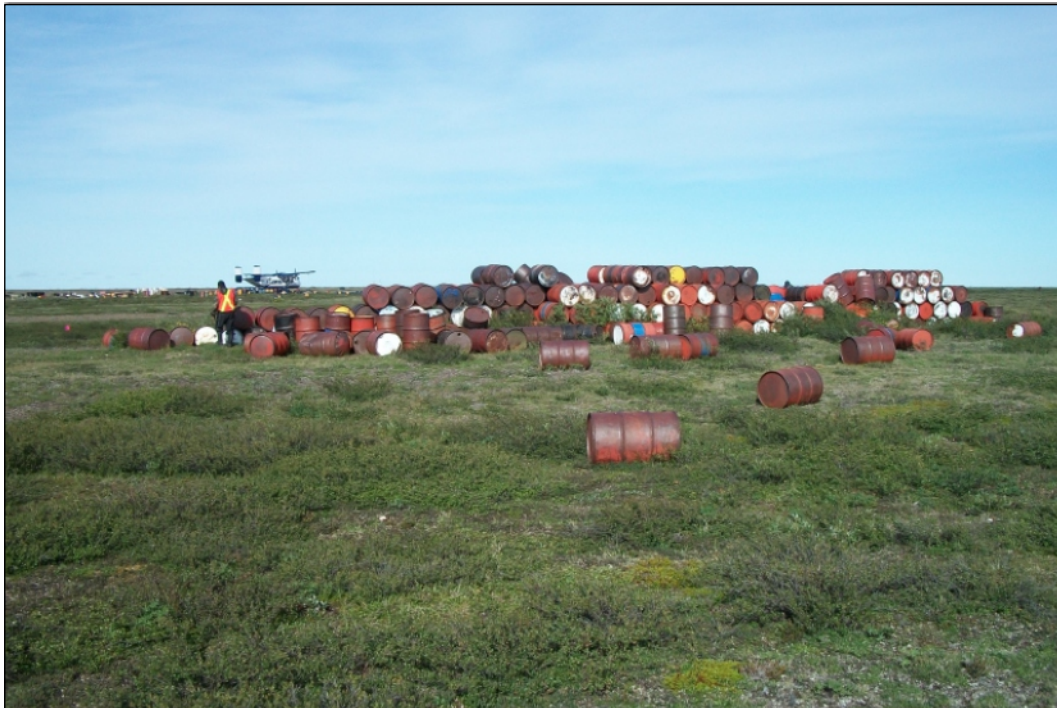
Photo 253
Hope Lake WK027: APEC 7O, drum cache

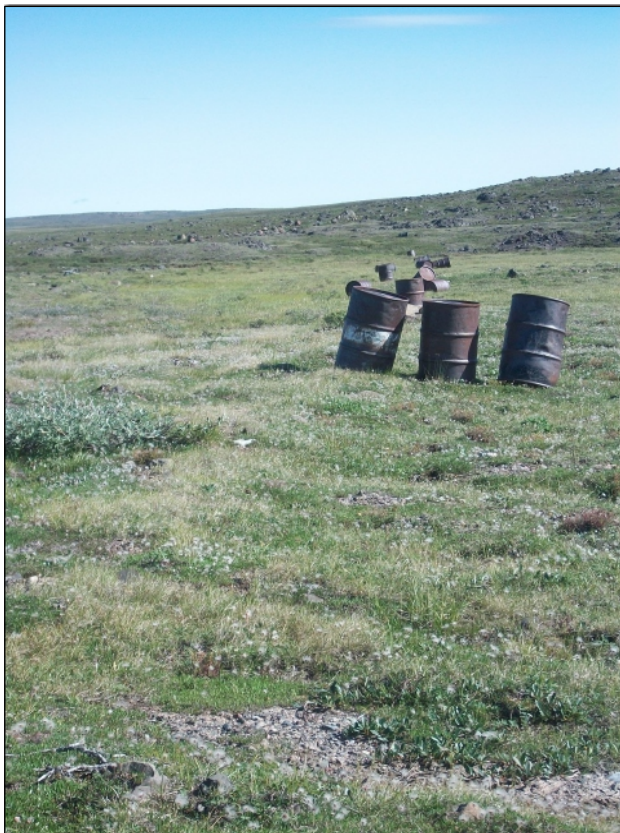
Photo 254
Hope Lake WK027: APEC 7P, drums

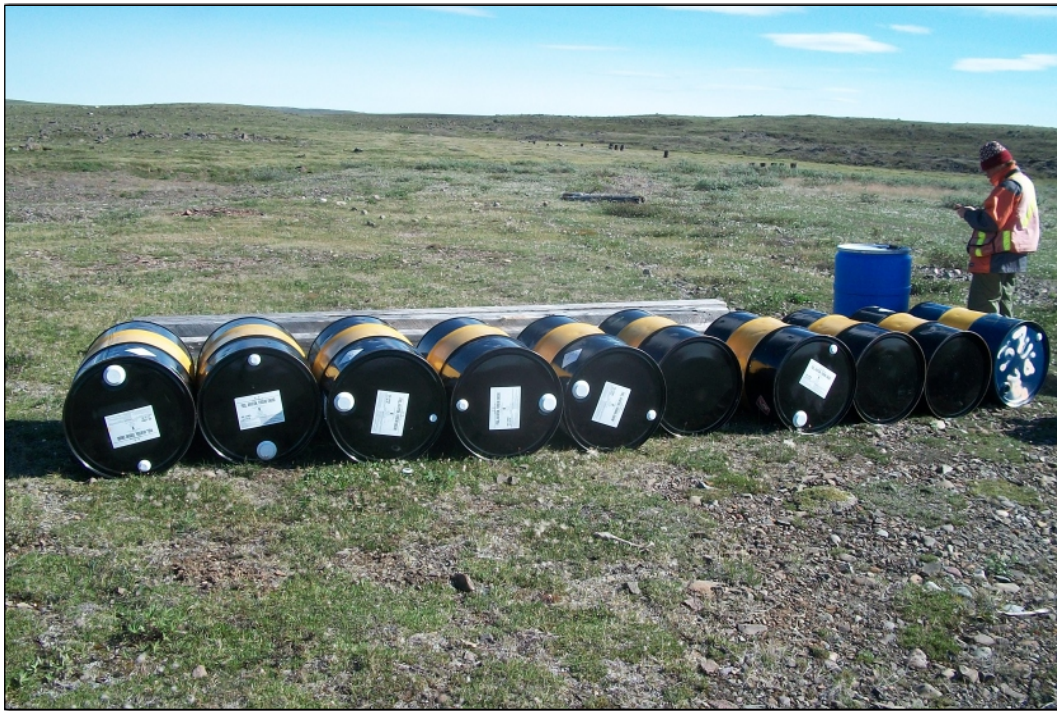
Photo 255
Hope Lake WK027: APEC 7P, new drums at end of airstrip

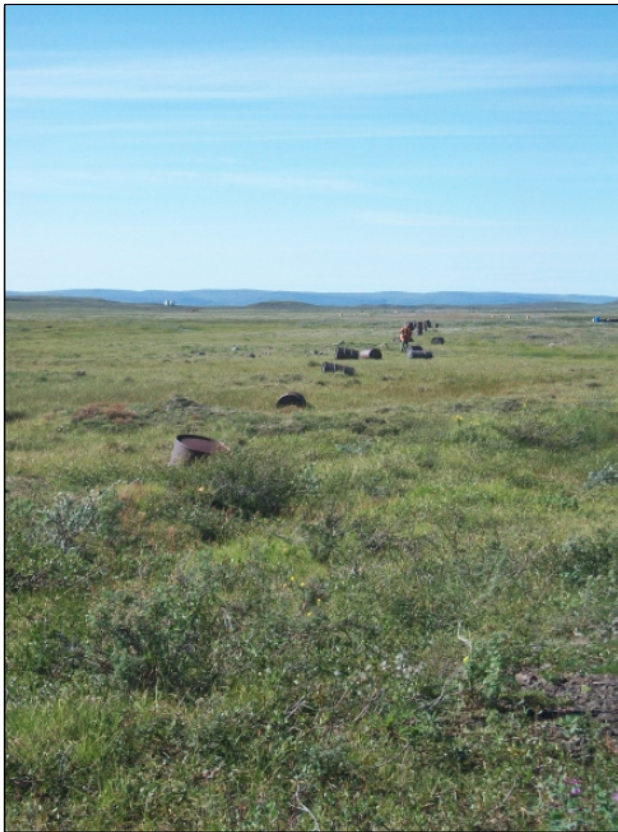
Photo 256
Hope Lake WK027: APEC 7P, drums at southeast end of airstrip
