HOPE LAKE
REMEDICATION PROJECT
REMEDIAL ACTION PLAN

**REMEDIAL ACTION PLAN
HOPE LAKE, NUNAVUT**

**SOLICITATION NUMBER: EW699-110498/001/NCS
PWGSC PROJECT NUMBER: R.040717.012
SUPPLY ARRANGEMENT NUMBER: EW699-100053/003/NCS**

March 2011

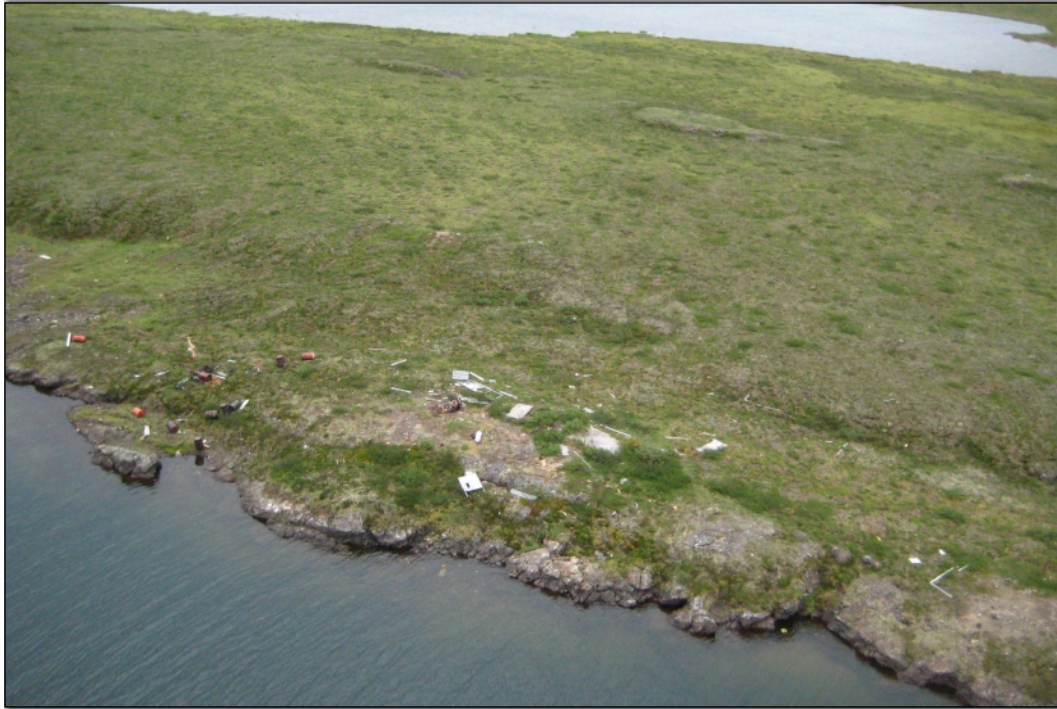
Photo 1
Husky Creek WK197 South Site: aerial view looking south

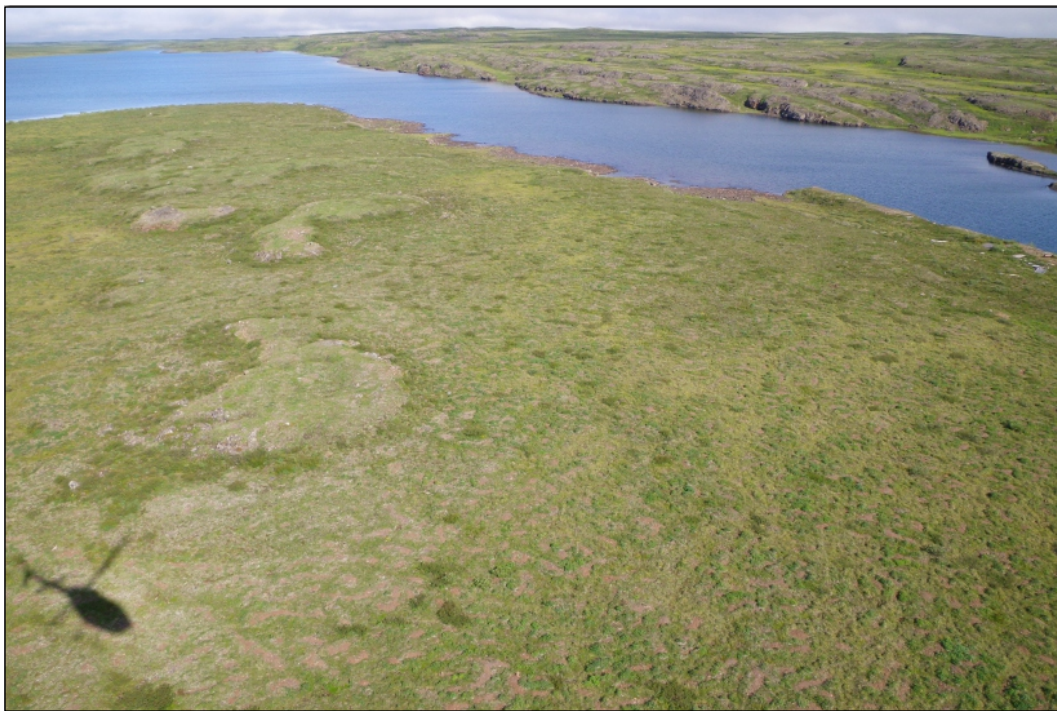
Photo 2
Husky Creek WK197 South Site: northwest aerial view of terrain west of debris area

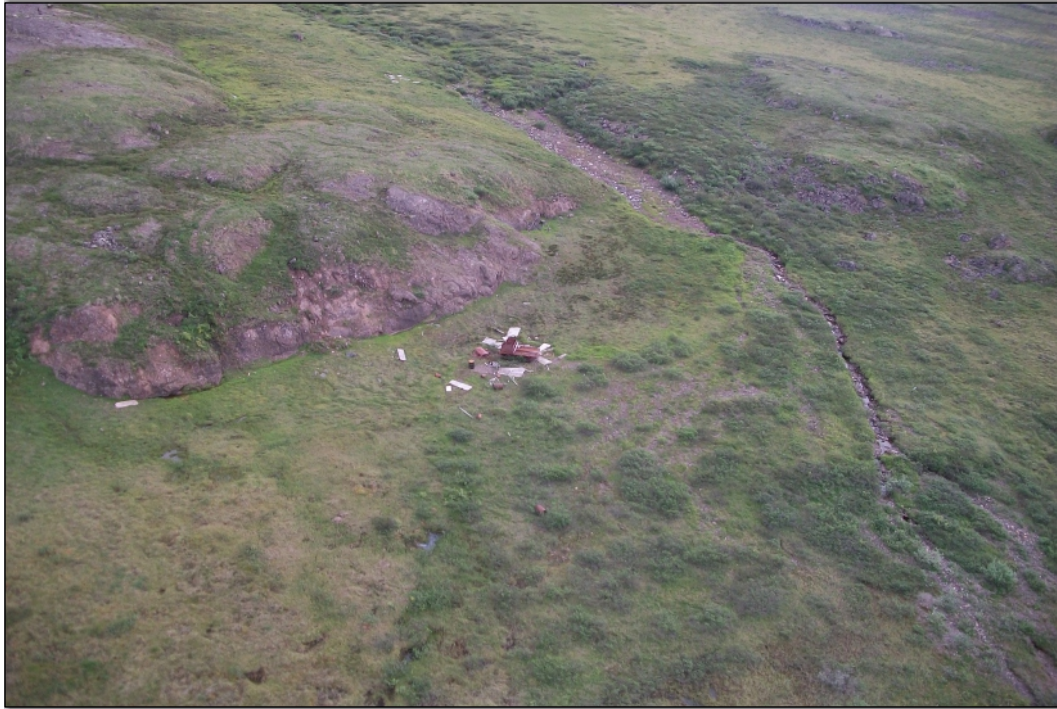
Photo 3
Husky Creek WK197 North Site: aerial view looking north

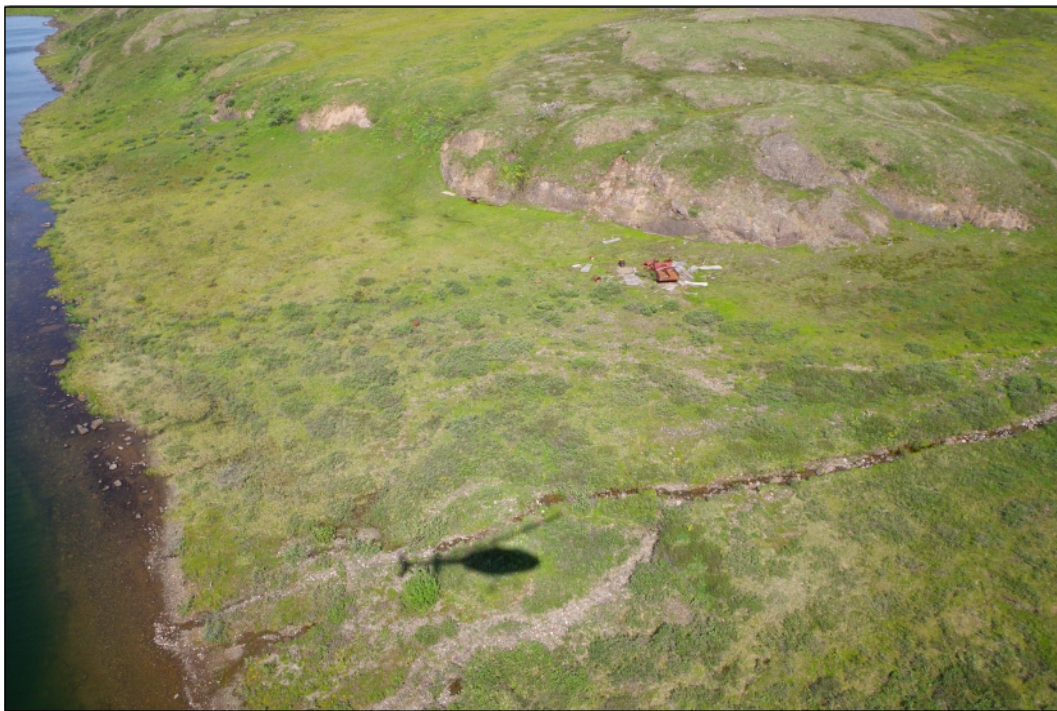
Photo 4
Husky Creek WK197 North Site: northwest aerial view of shoreline with debris area

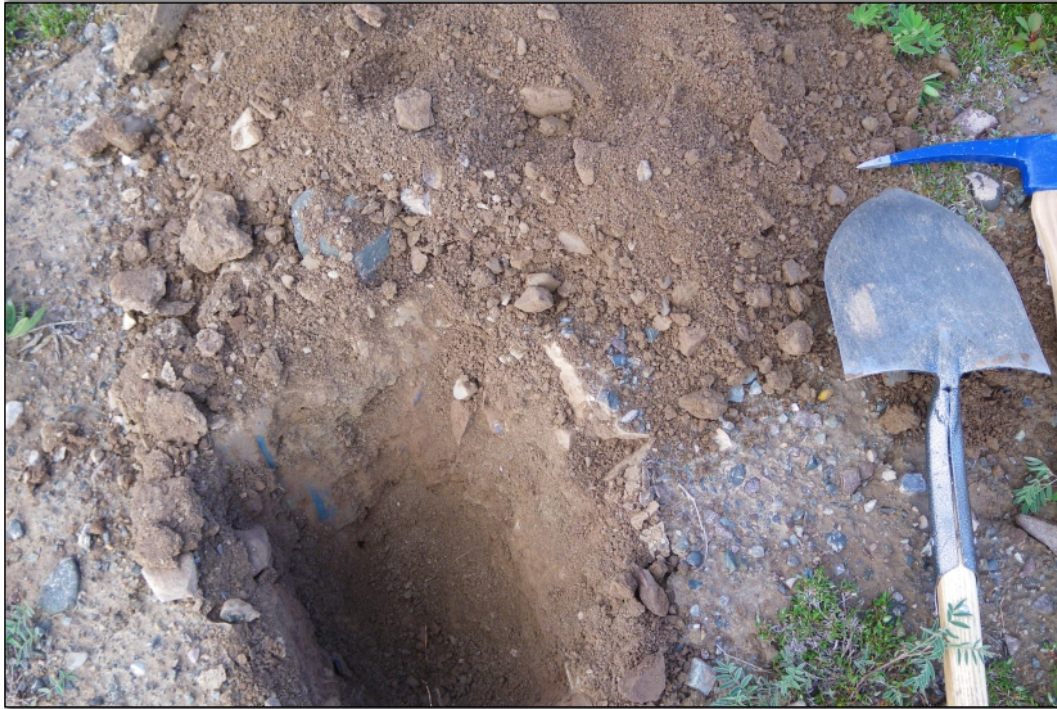
Photo 5

Husky Creek WK197 South Site: closeup of test pit soils east of debris area

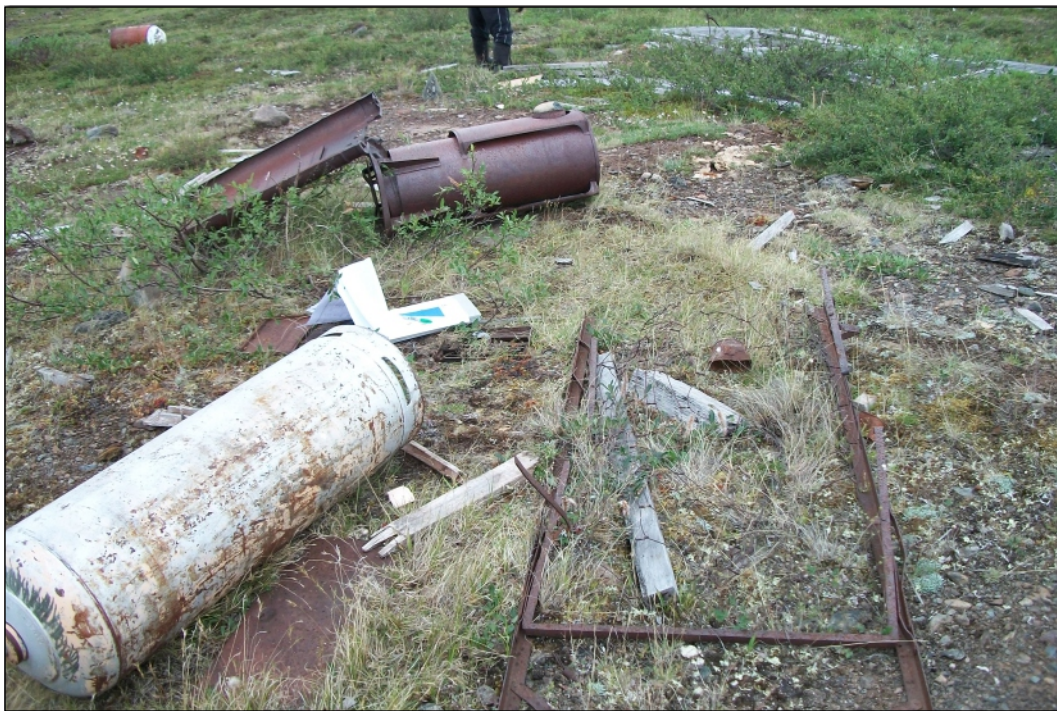
Photo 6

Husky Creek WK197 South Site: APEC 1, propane tank, heater and miscellaneous debris

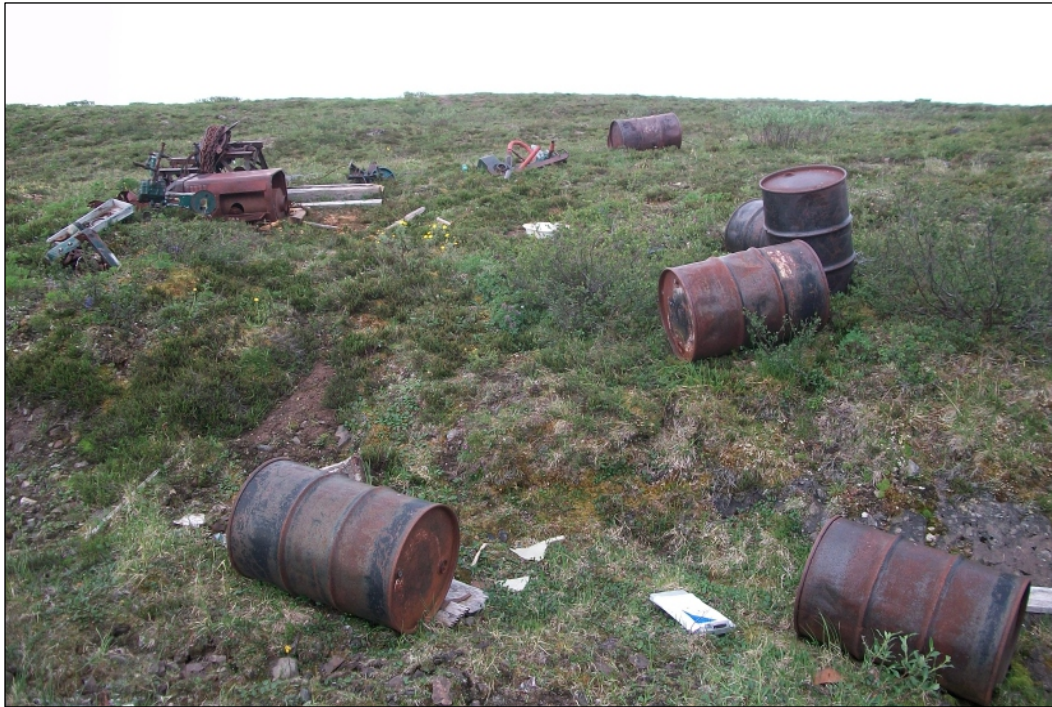
Photo 9
Husky Creek WK197 South Site: APEC 3, additional drums

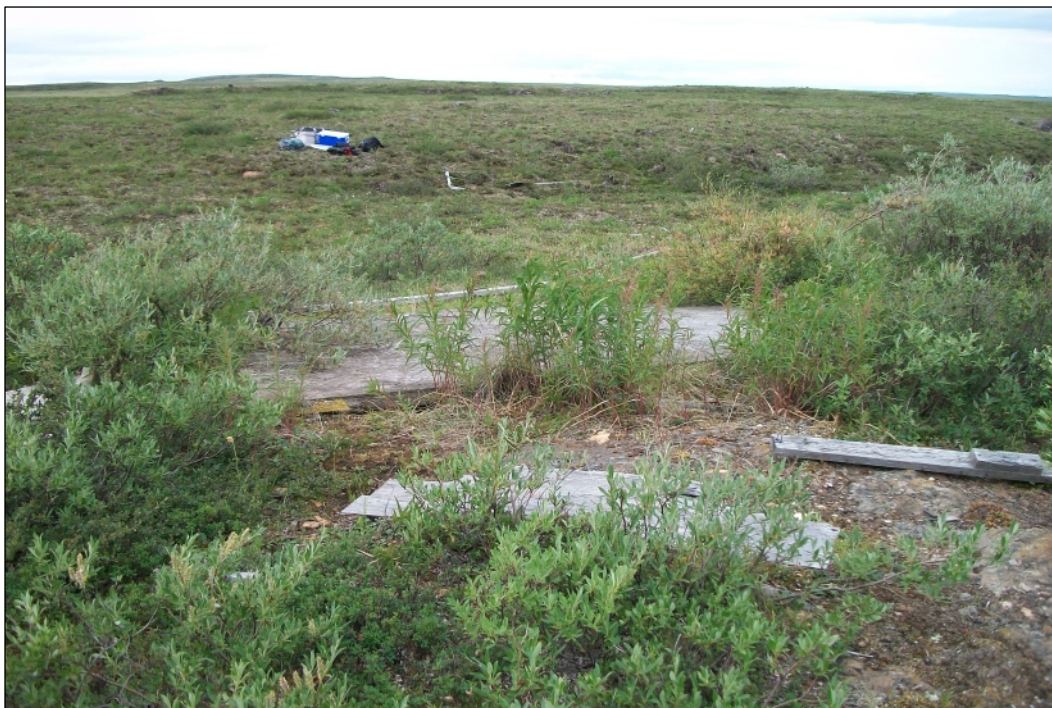
Photo 10
Husky Creek WK197 South Site: APEC 5, collapsed structure

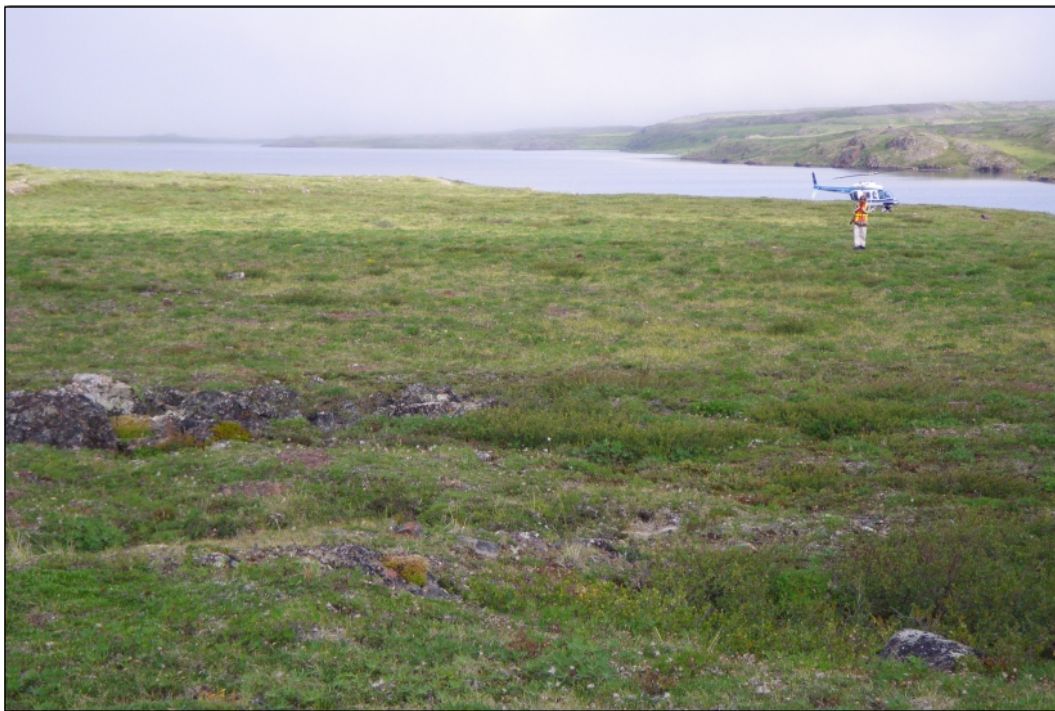
Photo 14
Husky Creek WK197 North Site: northwest aerial view of shoreline with debris area

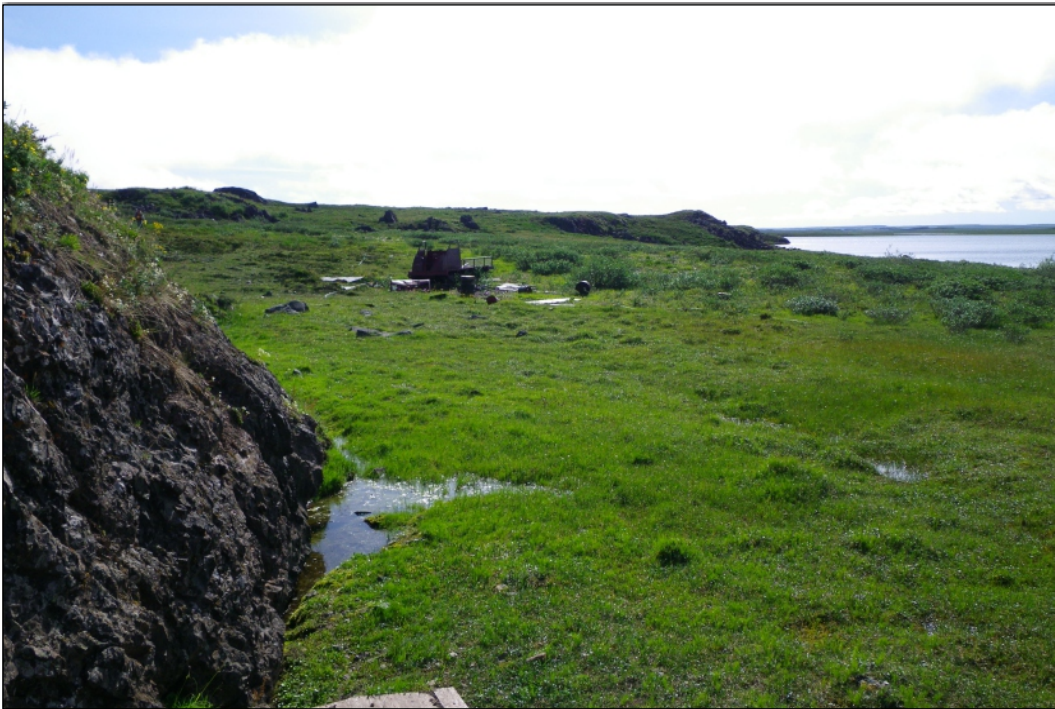
Photo 15

Husky Creek WK197 North Site: south view of shoreline area with debris in background

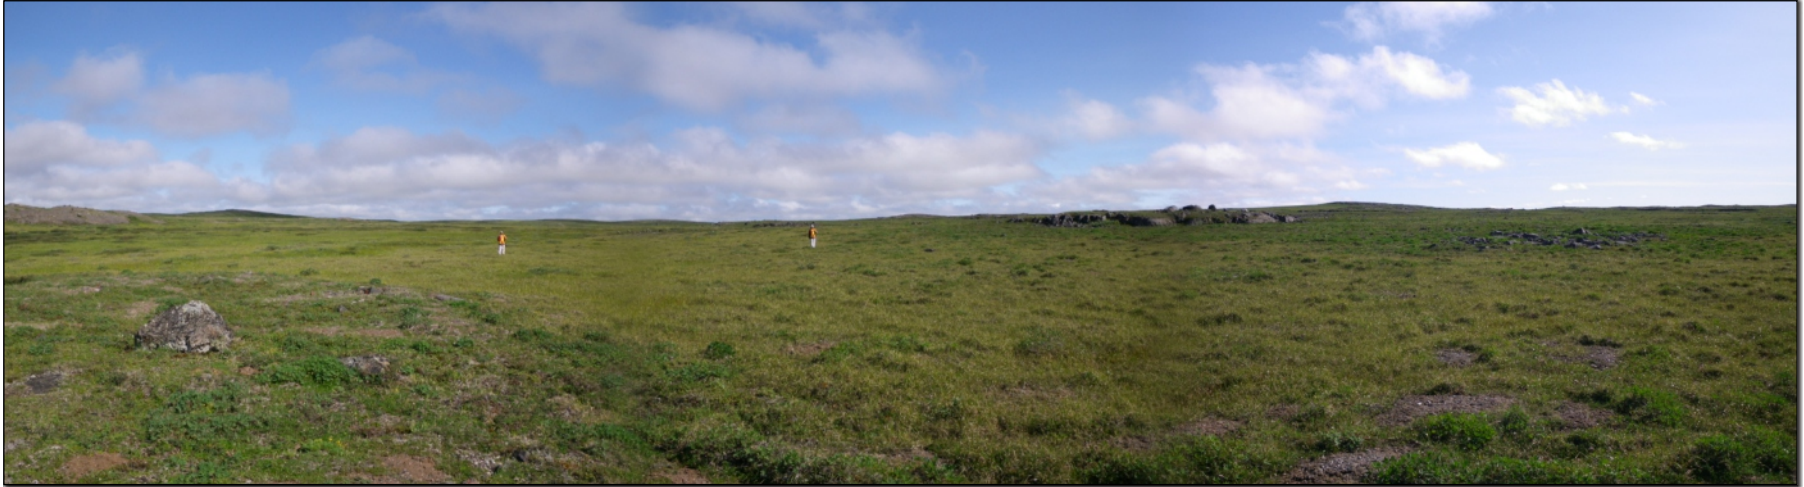
Photo 16

Husky Creek WK197 North Site: southeast view of upland terrain east of shoreline area

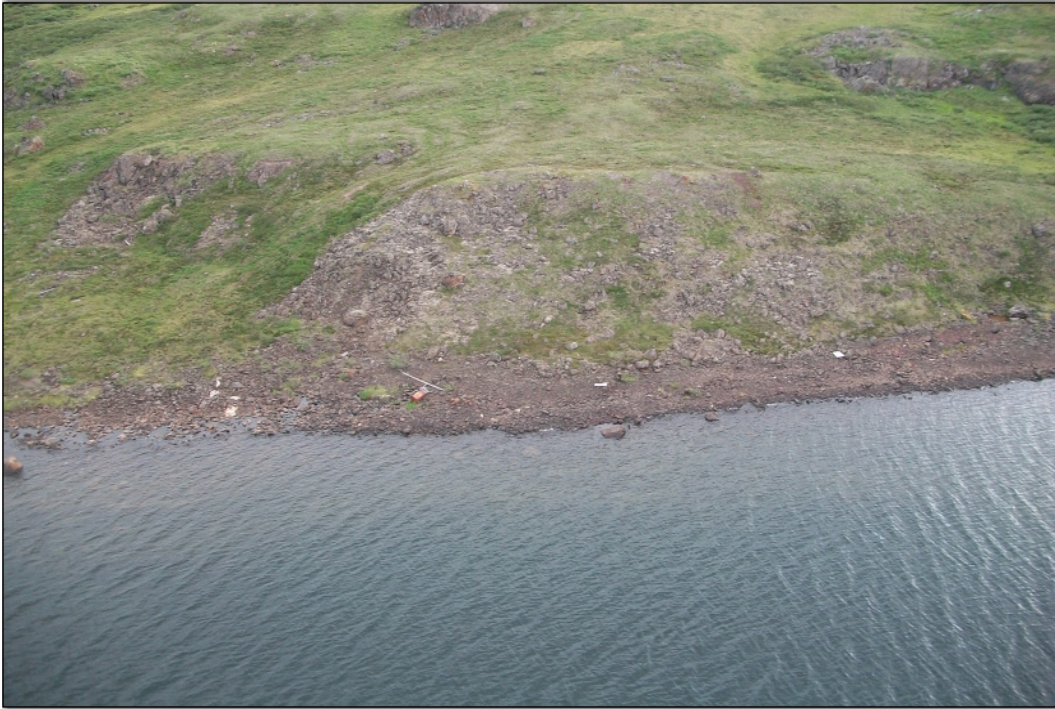
Photo 17
Husky Creek WK197 North Site: APEC 9A, aerial shot

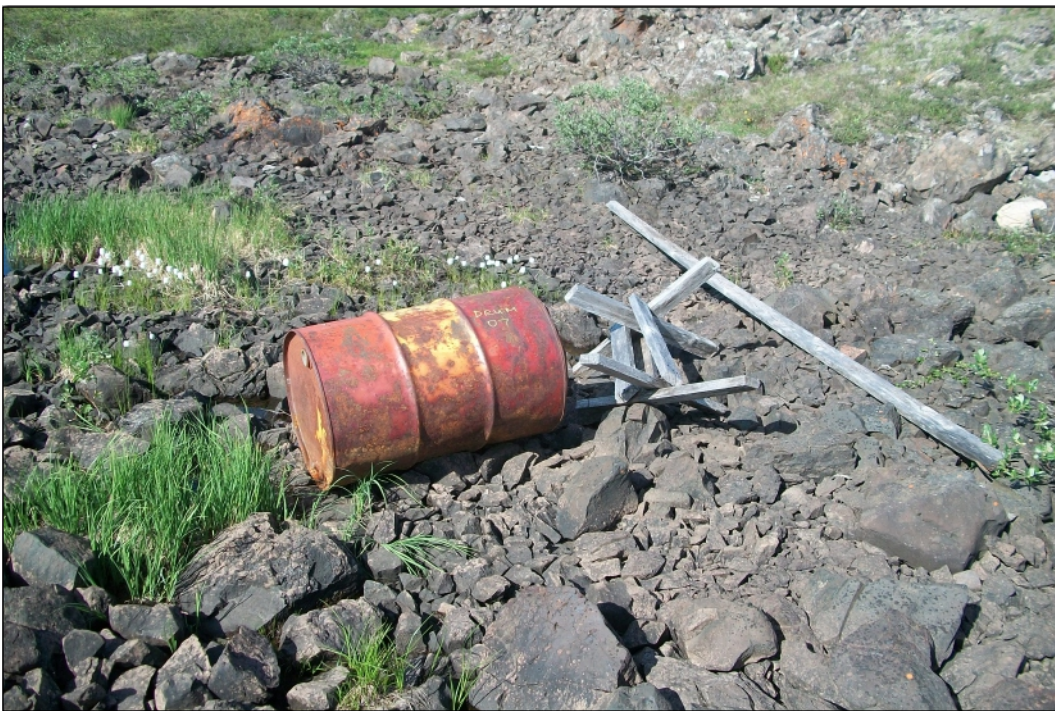
Photo 18
Husky Creek WK197 North Site: APEC 9A, drum and wood debris

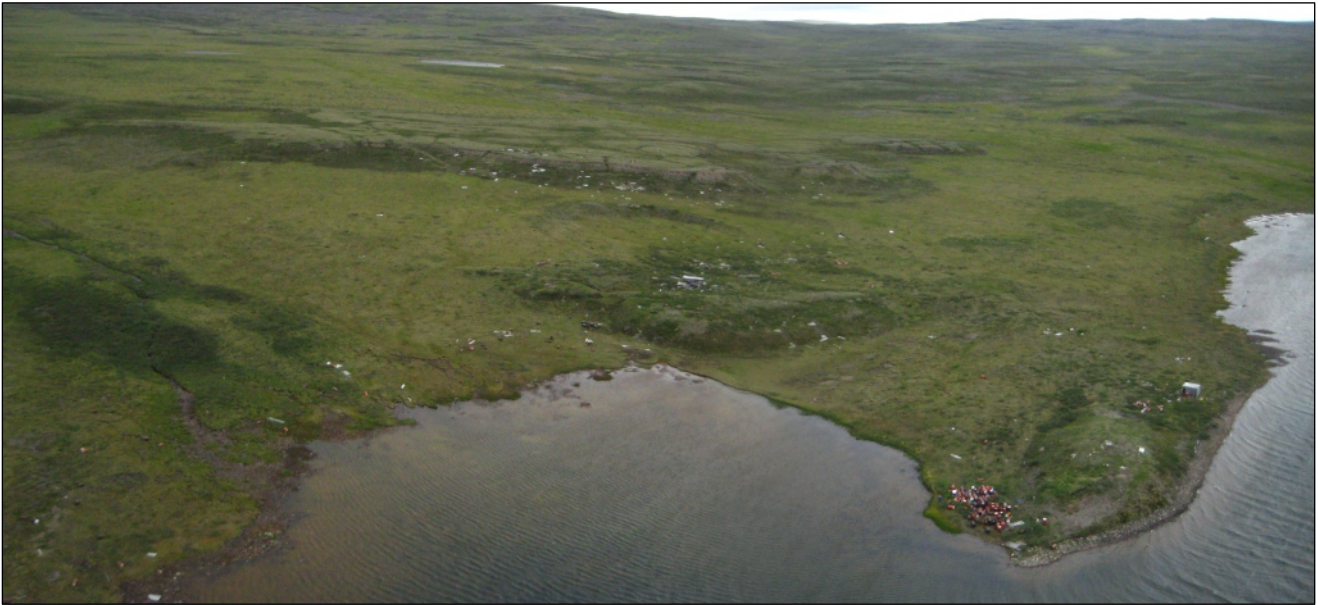
Photo 21

Willow Creek WK172 Main Site: aerial view of Willow Creek looking south

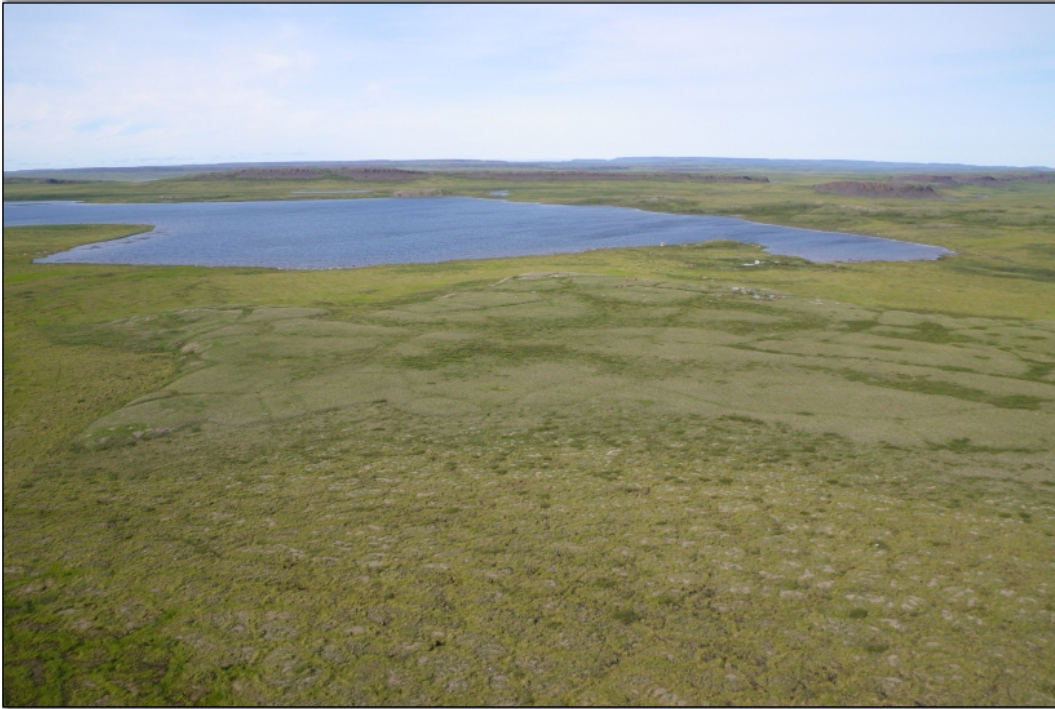
Photo 23

Willow Creek WK172 Main Site: north aerial view of southern debris area

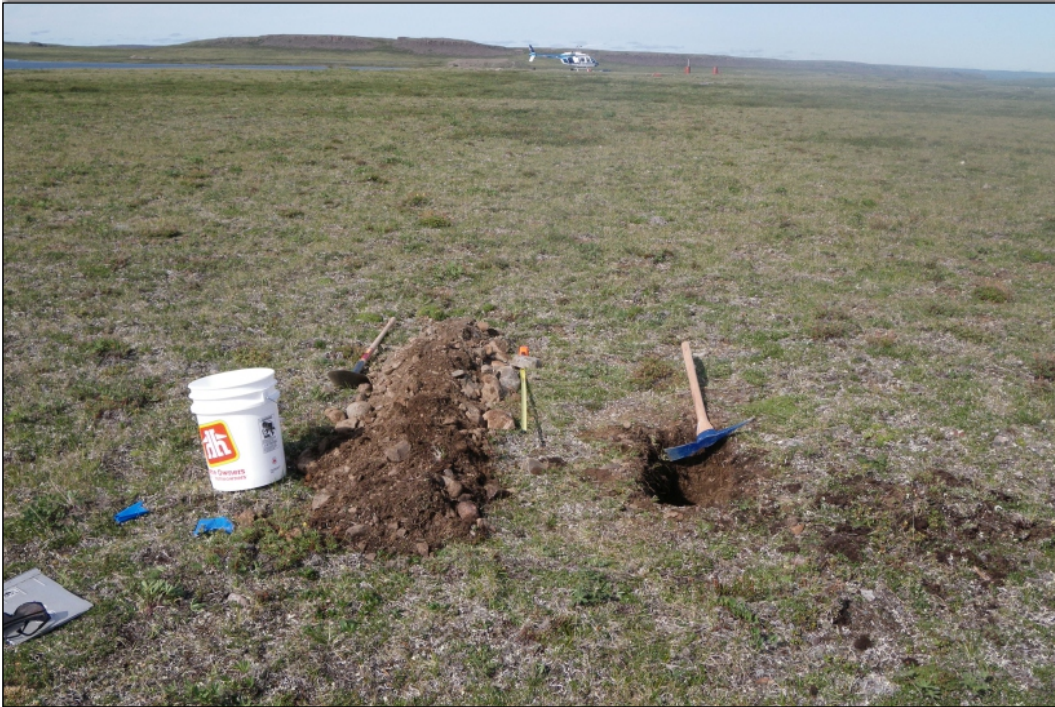
Photo 25

Willow Creek WK172 Main Site: northeast view of test pit 4

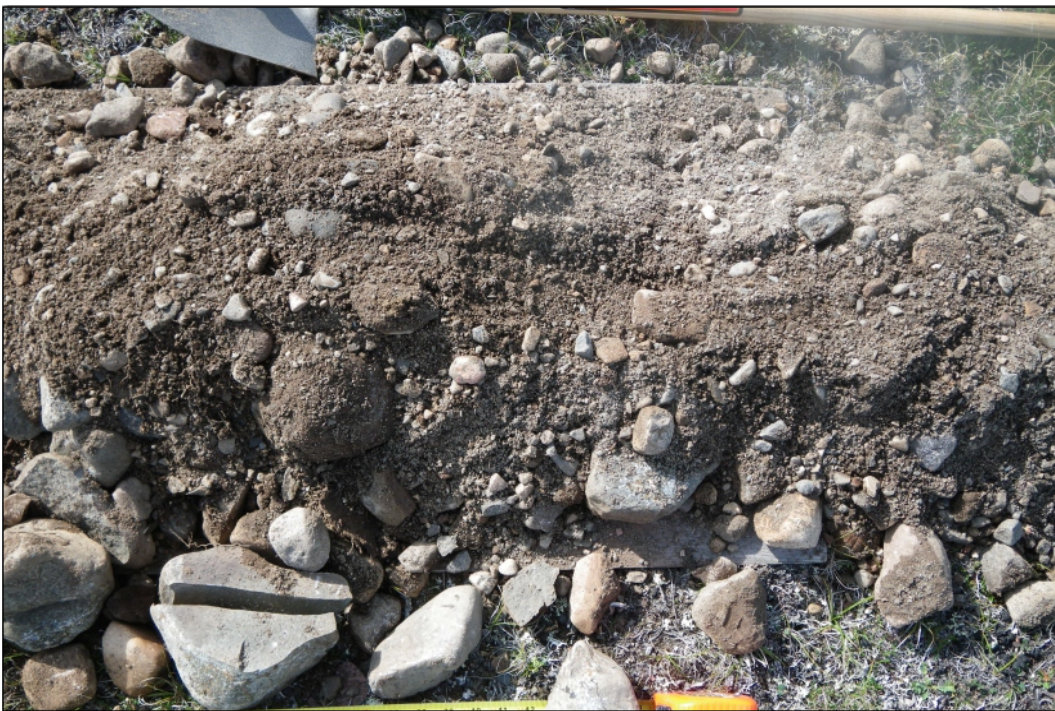
Photo 26

Willow Creek WK172 Main Site: spoil pile from test pit 4

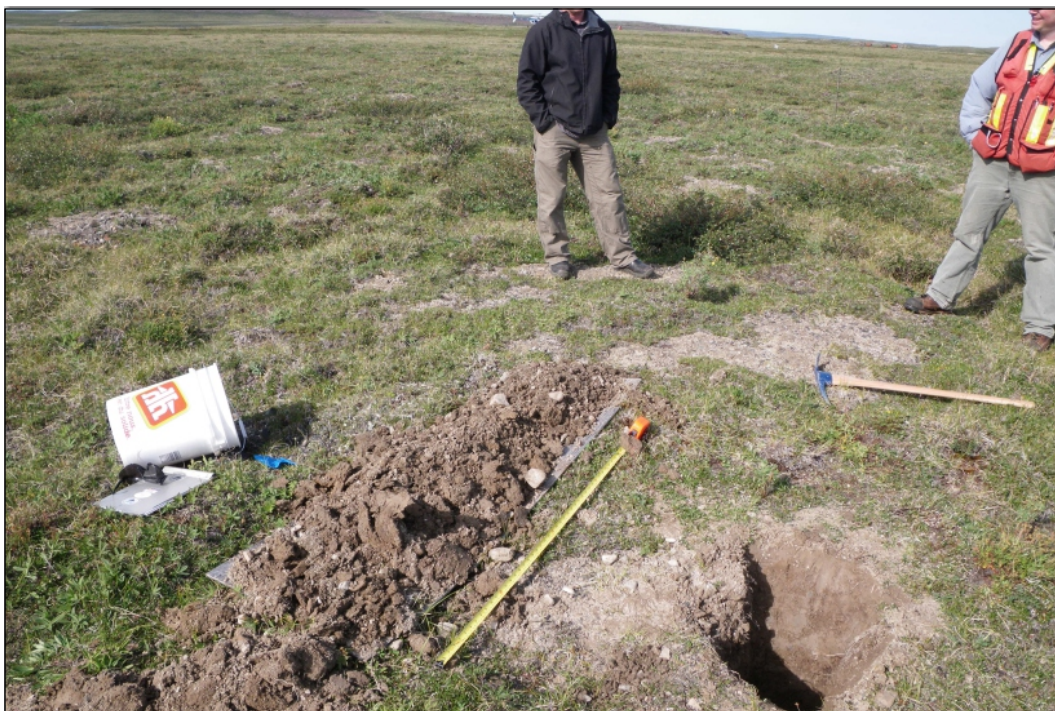
Photo 27
Willow Creek WK172 Main Site: northeast view of test pit 5

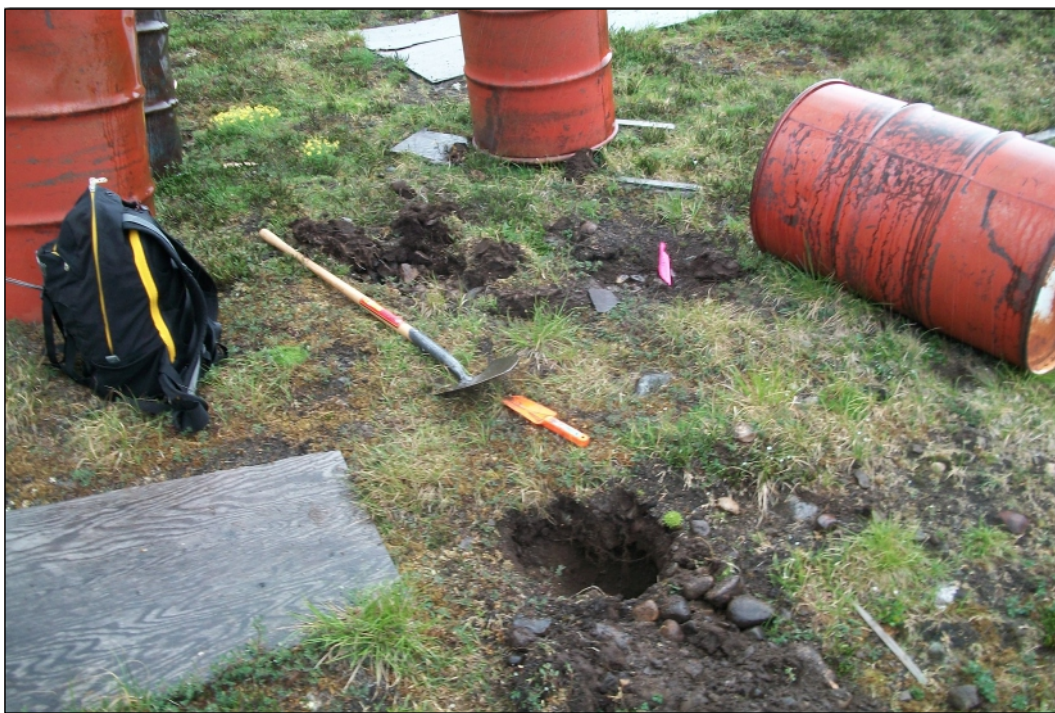
Photo 28
Willow Creek WK172 Main Site: APEC 1, drums and scattered wood debris

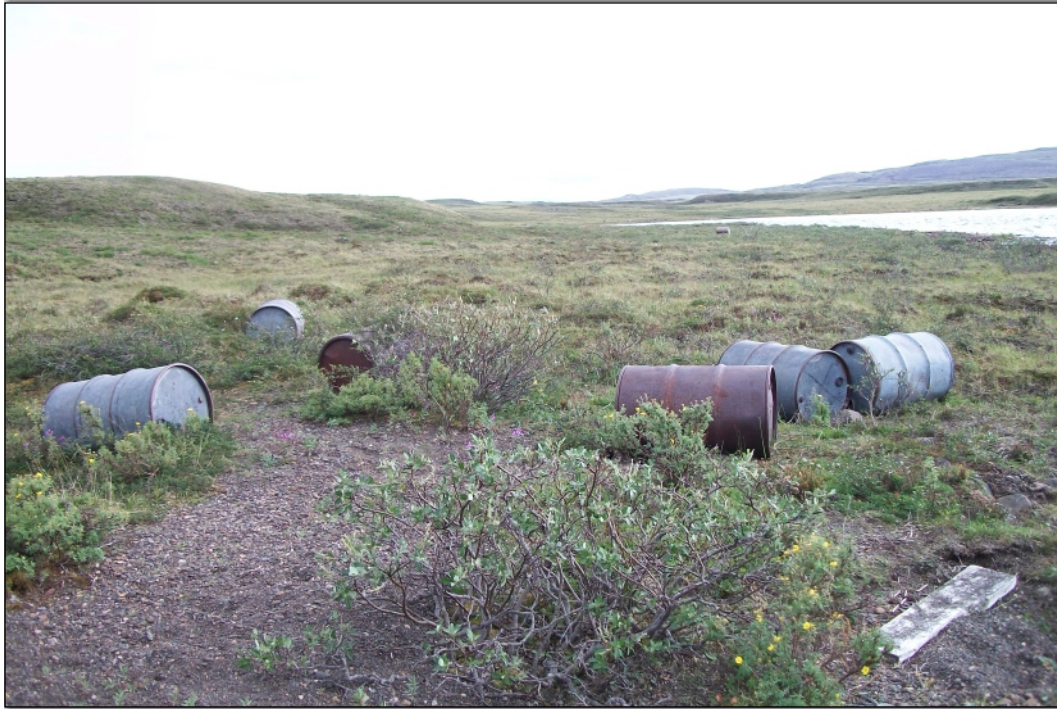
Photo 32

Willow Creek WK172 Main Site: looking north toward APEC 3, 5, and 16

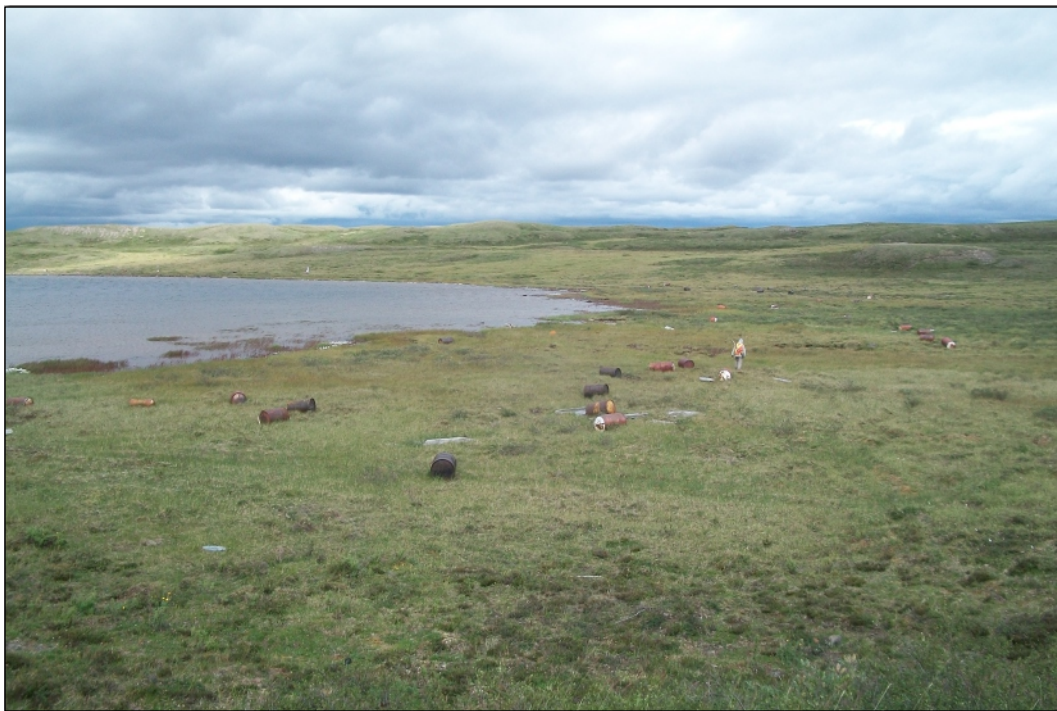
Photo 33
Willow Creek WK172 Main Site: APEC 3, unpainted drums

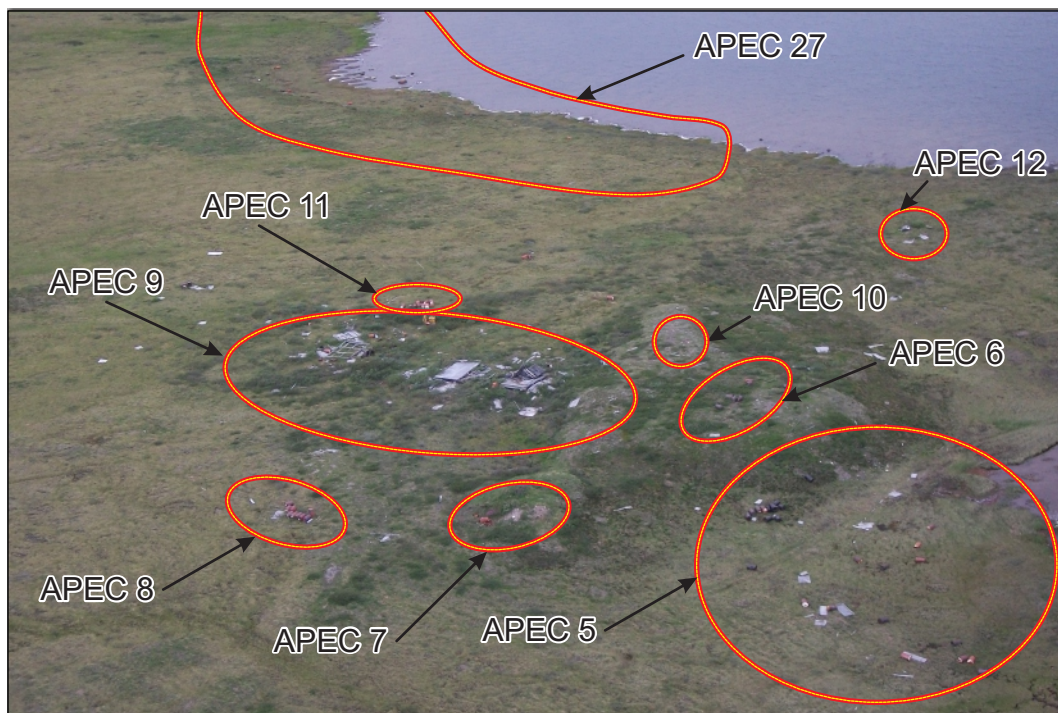
Photo 34
Willow Creek WK172 Main Site: APEC 3, drums and lumber and APEC 4 drums and wood debris were scattered along the high water mark

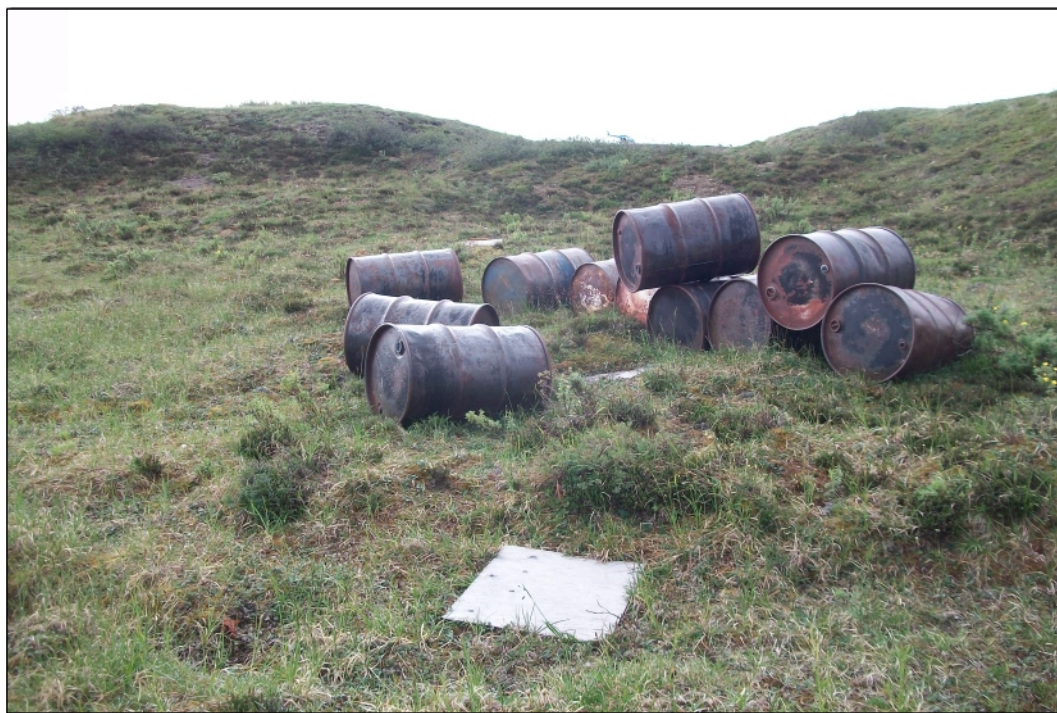
Photo 35

Willow Creek WK172 Main Site: aerial view of APECs 5, 6, 7, 8, 9, 10, 11, 12, and 27

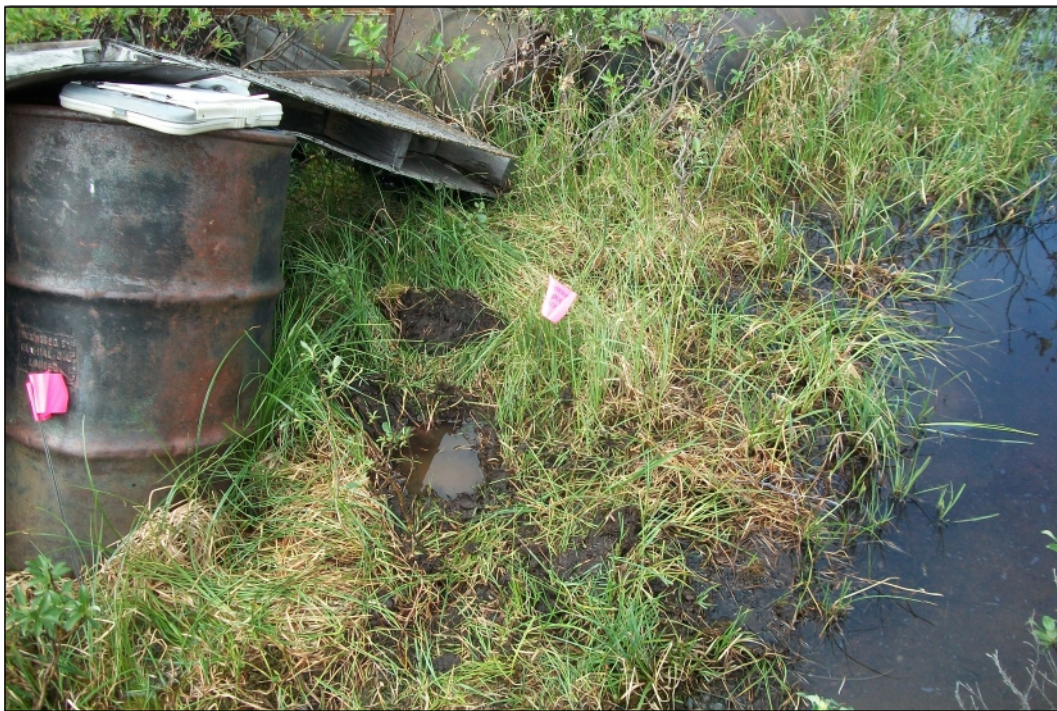
Photo 39

Willow Creek WK172 Main Site: APEC 9, area of standing water with partially submerged drums

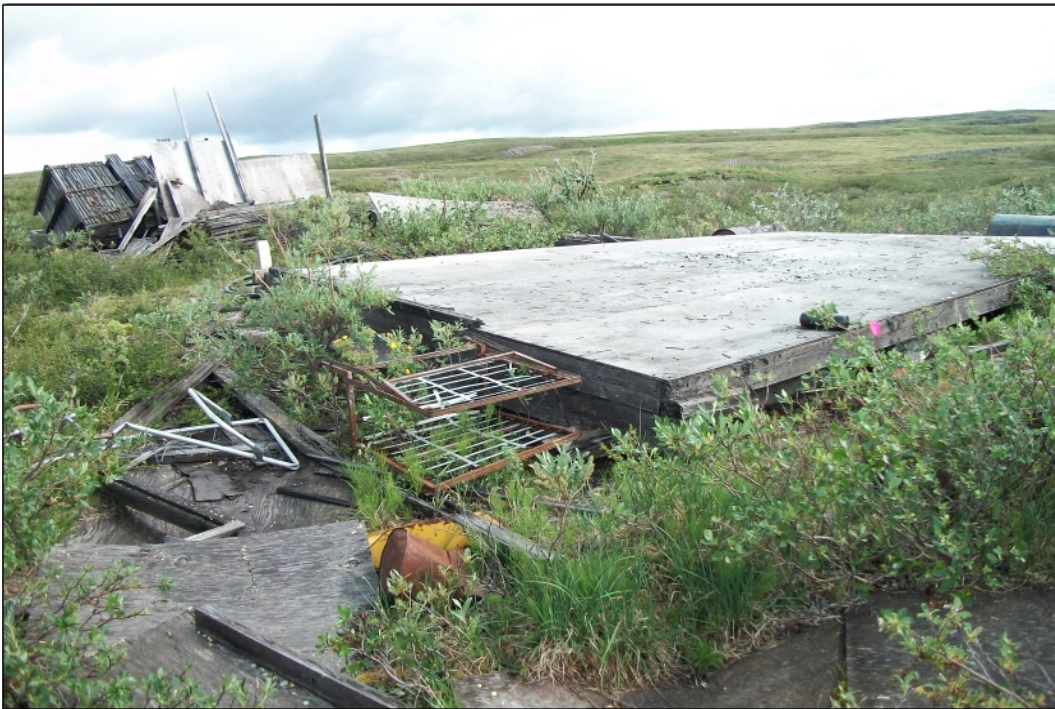
Photo 43

Willow Creek WK172 Main Site: APEC 9, red hose that does not contain asbestos

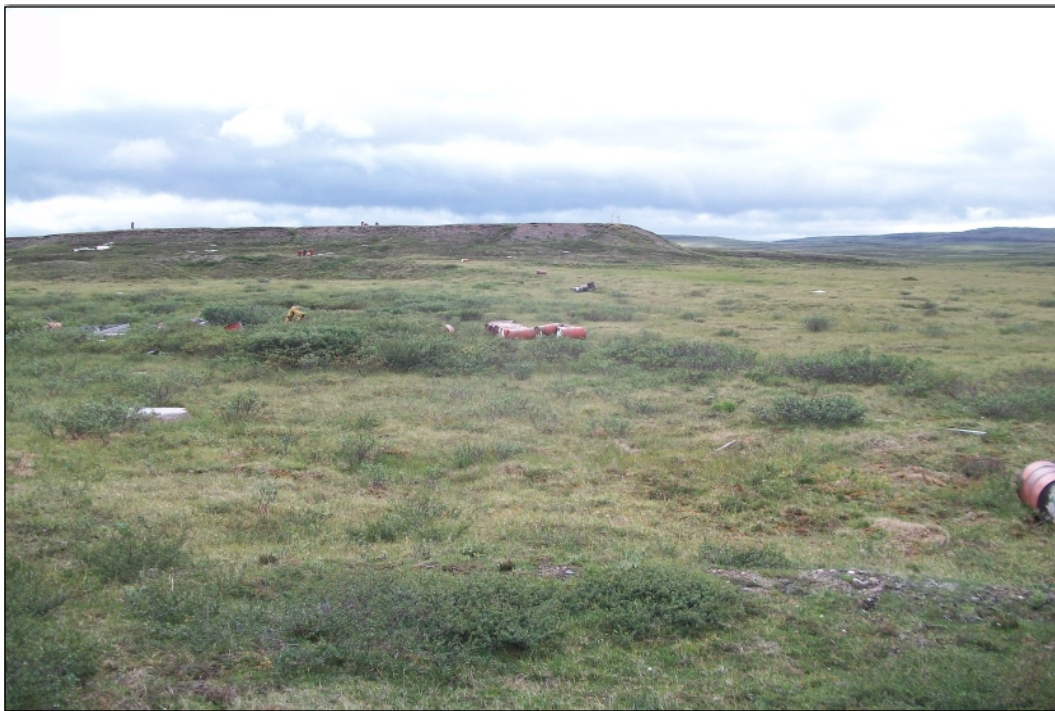
Photo 44

Willow Creek WK172 Main Site: APEC 9, Structures 01 and 02 from WESA report

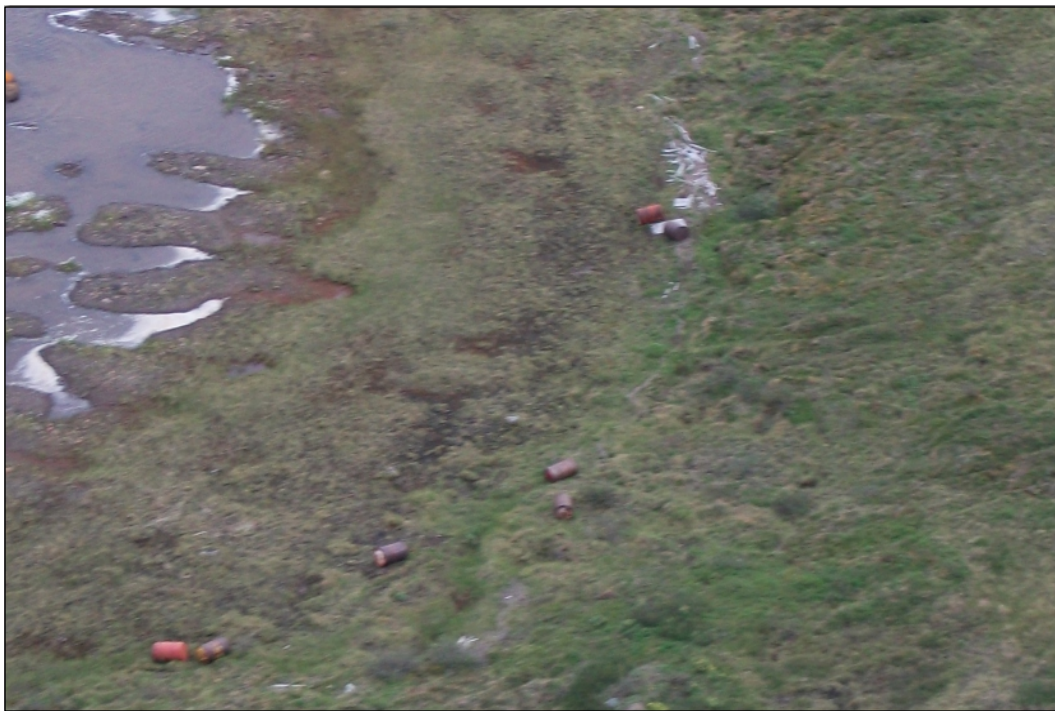
Photo 55

Willow Creek WK172 Main Site: APEC 14, Structure 05
from WESA report, asbestos containing fibreboard behind
the heater

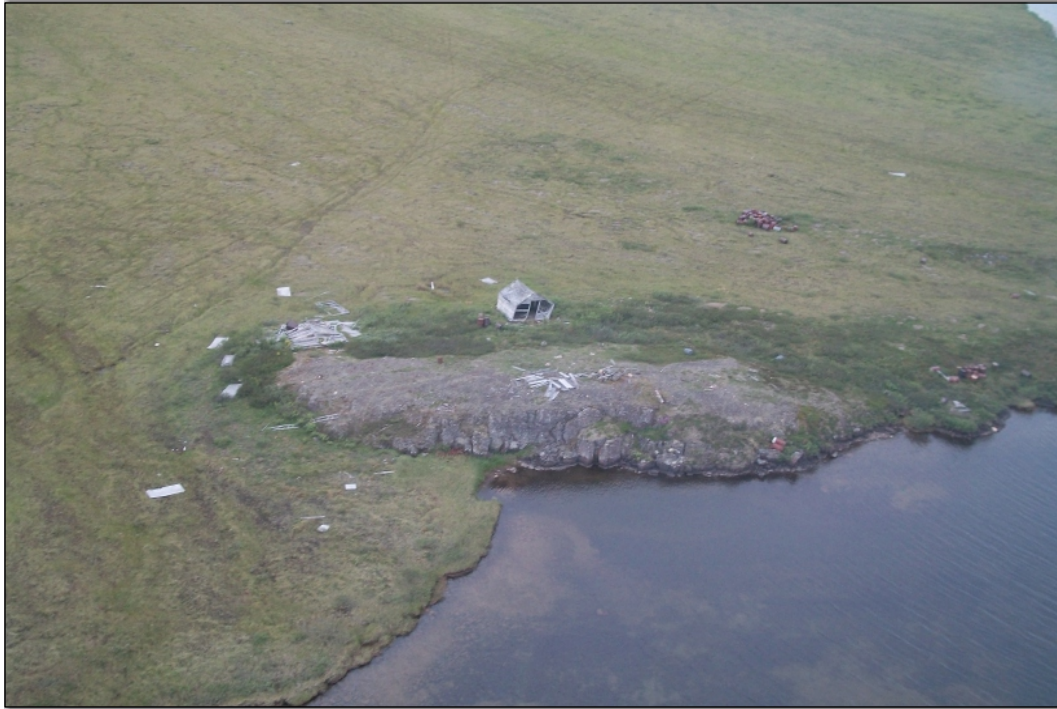
Photo 56

Willow Creek WK172 Main Site: APEC 27, wood debris and drums

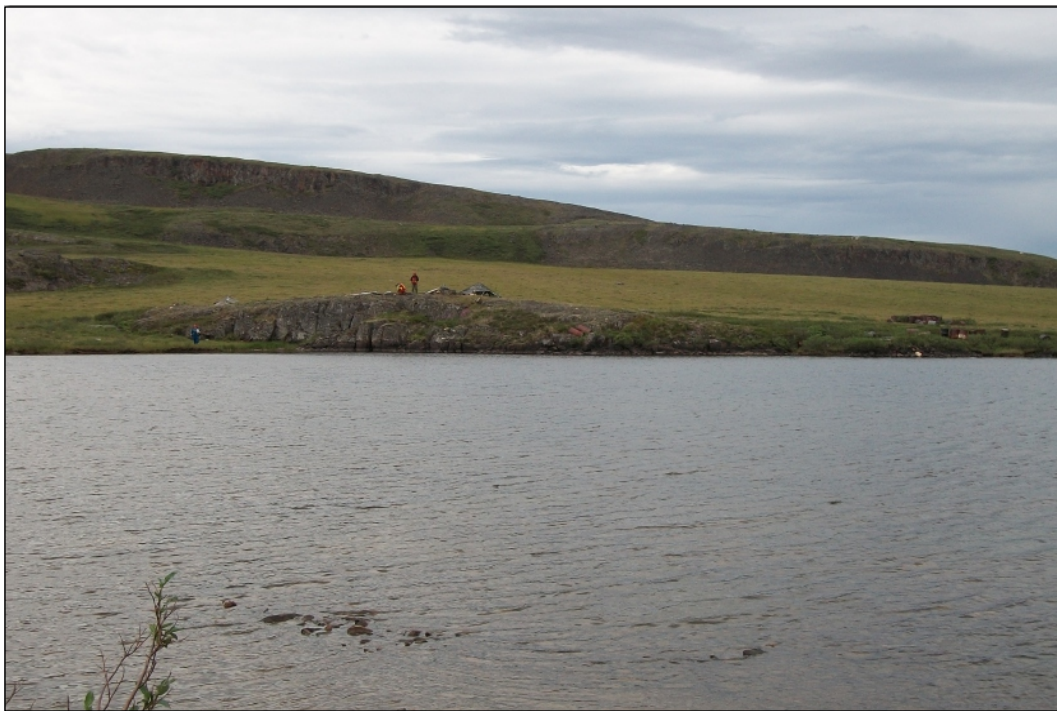
Photo 57
Willow Creek WKB01 South Cabin: aerial view of WKB01

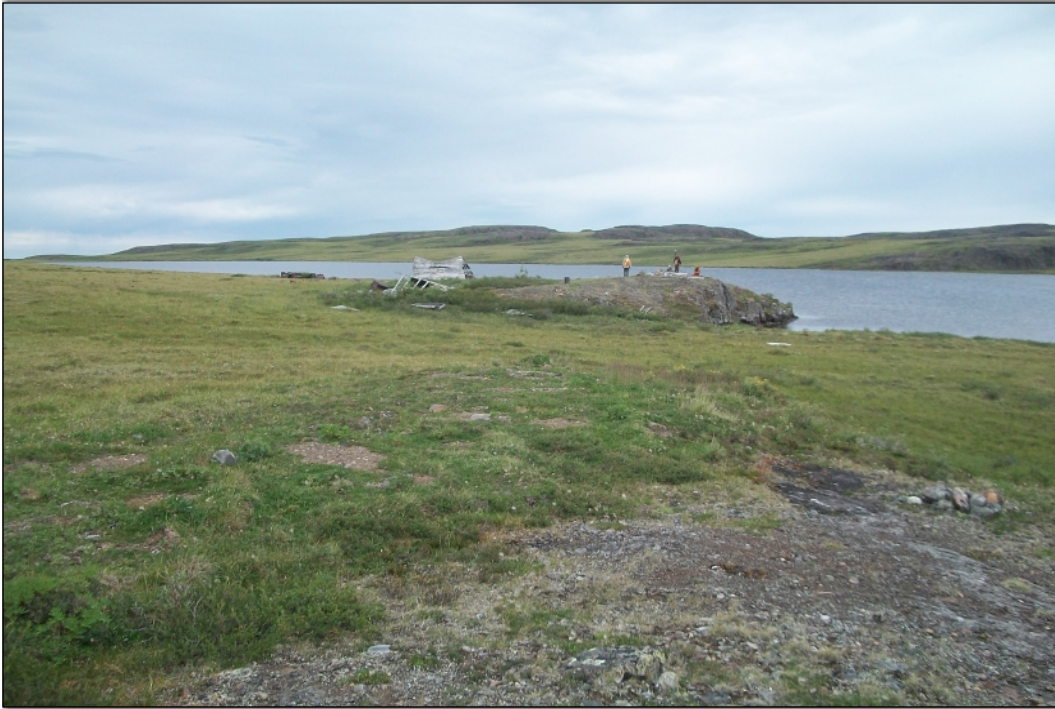
Photo 58
Willow Creek WKB01 South Cabin: looking west toward WKB01
