HOPE LAKE
REMEDICATION PROJECT
REMEDIAL ACTION PLAN

**REMEDIAL ACTION PLAN
HOPE LAKE, NUNAVUT**

**SOLICITATION NUMBER: EW699-110498/001/NCS
PWGSC PROJECT NUMBER: R.040717.012
SUPPLY ARRANGEMENT NUMBER: EW699-100053/003/NCS**

March 2011

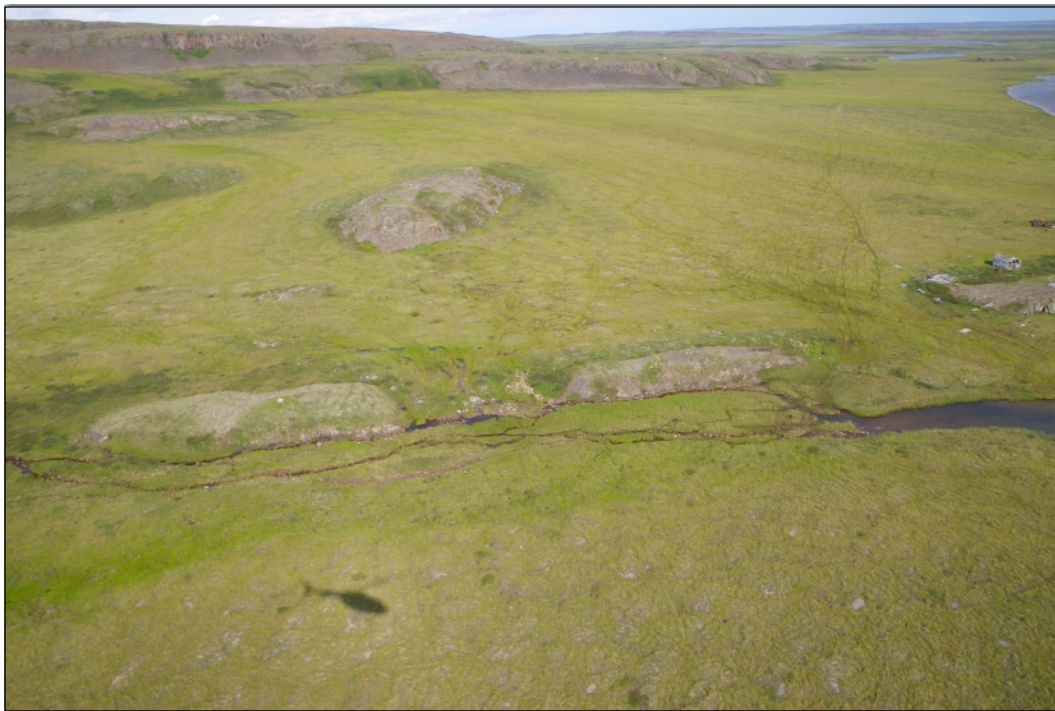
Photo 60

Willow Creek WKB01 South Cabin: southwest aerial view of area

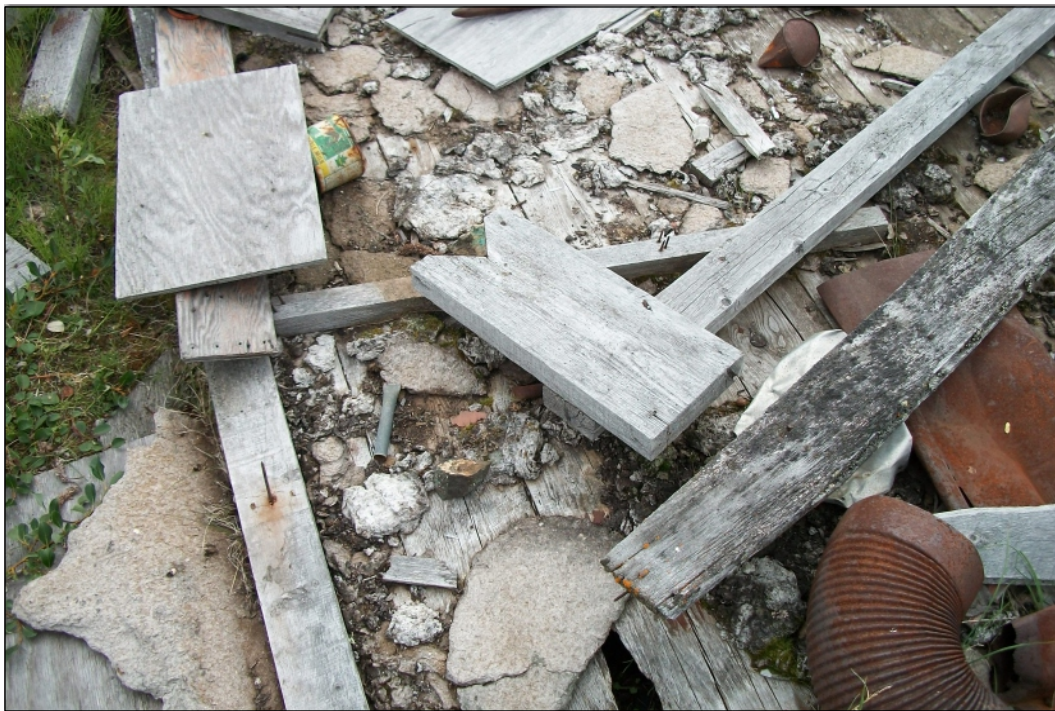
Photo 66

Willow Creek WKB01 South Cabin: APEC 19, wood platform with collapsed walls and roof, vents, cans, pots, a wood burning stove, and grey insulation

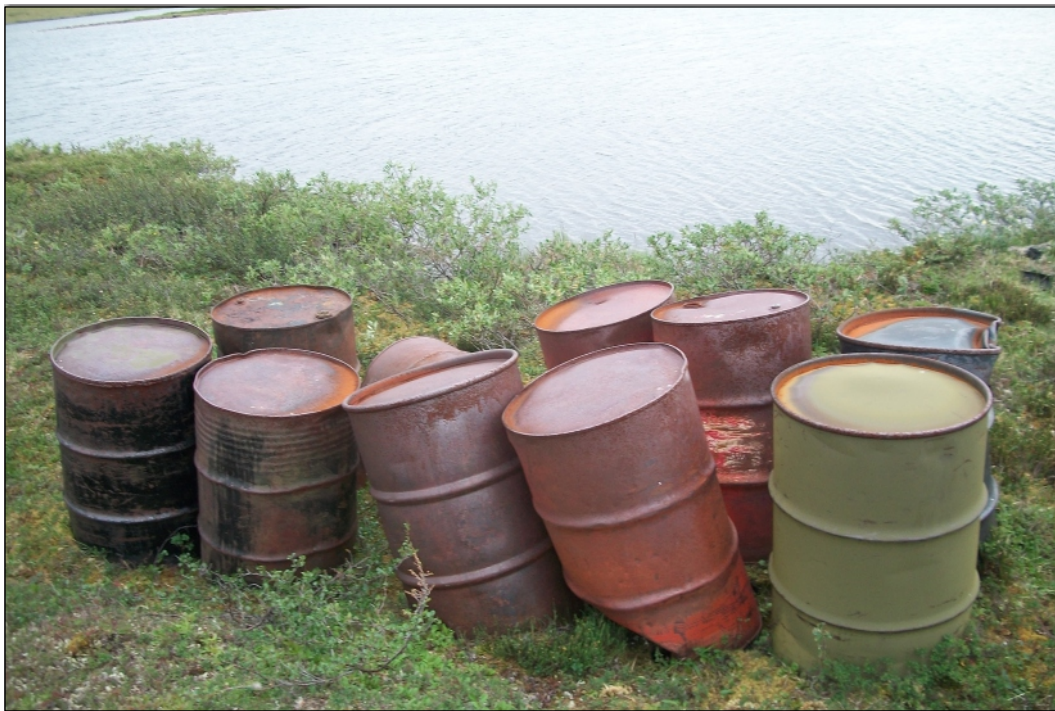
Photo 68

Willow Creek WKB01 South Cabin: APEC 20, leaning structure with cable, empty jerry can, car battery, five drums, metal debris and cans

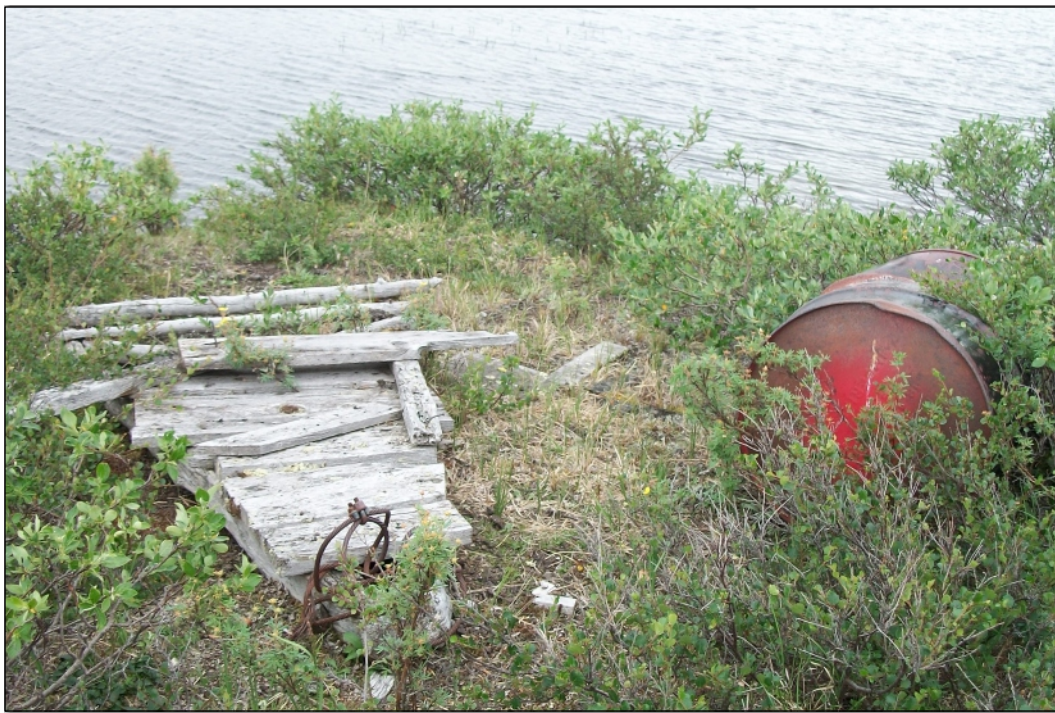
Photo 69
Willow Creek WKB01 South Cabin: APEC 21, drum cache

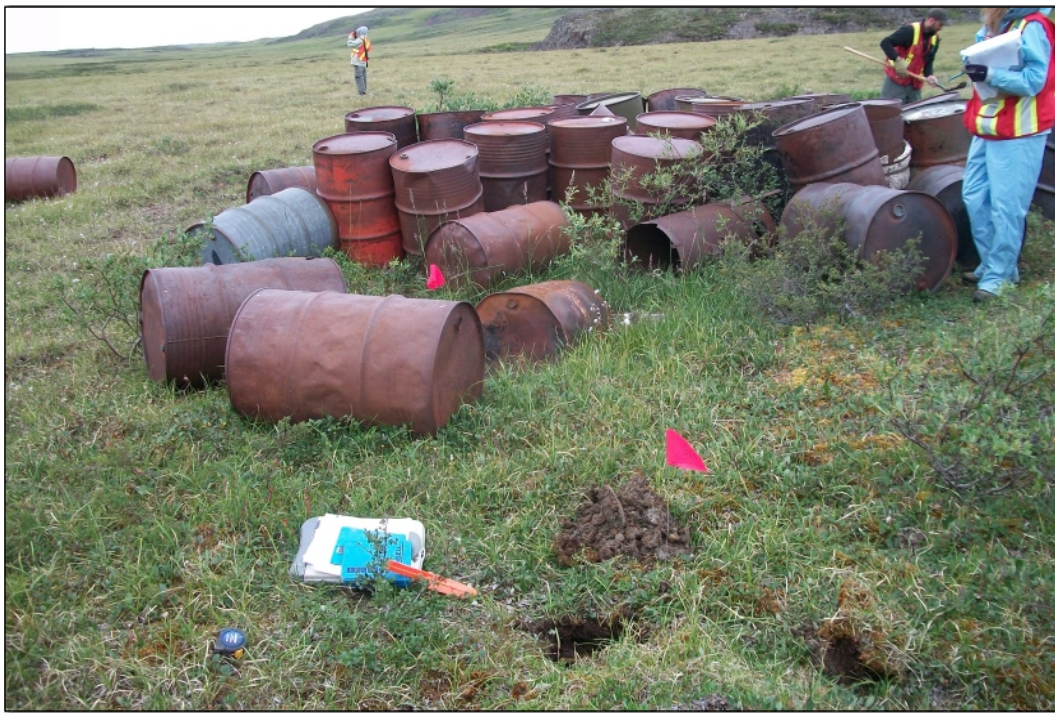
Photo 73
Willow Creek WKB01 South Cabin: APEC 22, drum cache

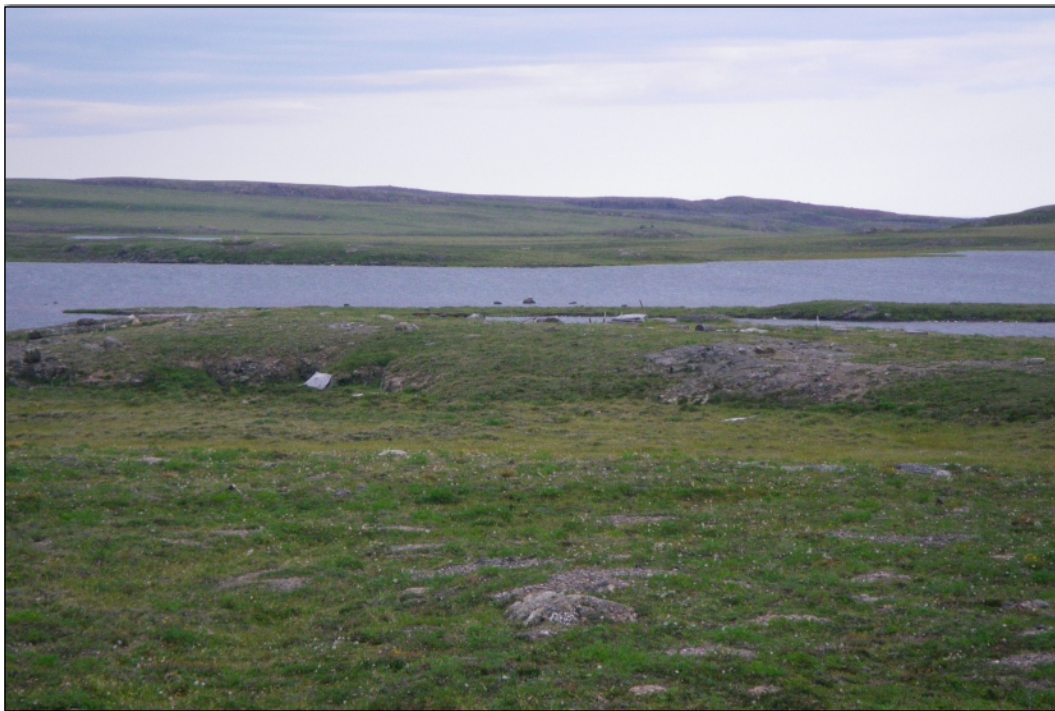
Photo 78

Willow Creek WKB02 Southwest Cabin: Willow Creek Cabin Southwest - northwest view of debris area

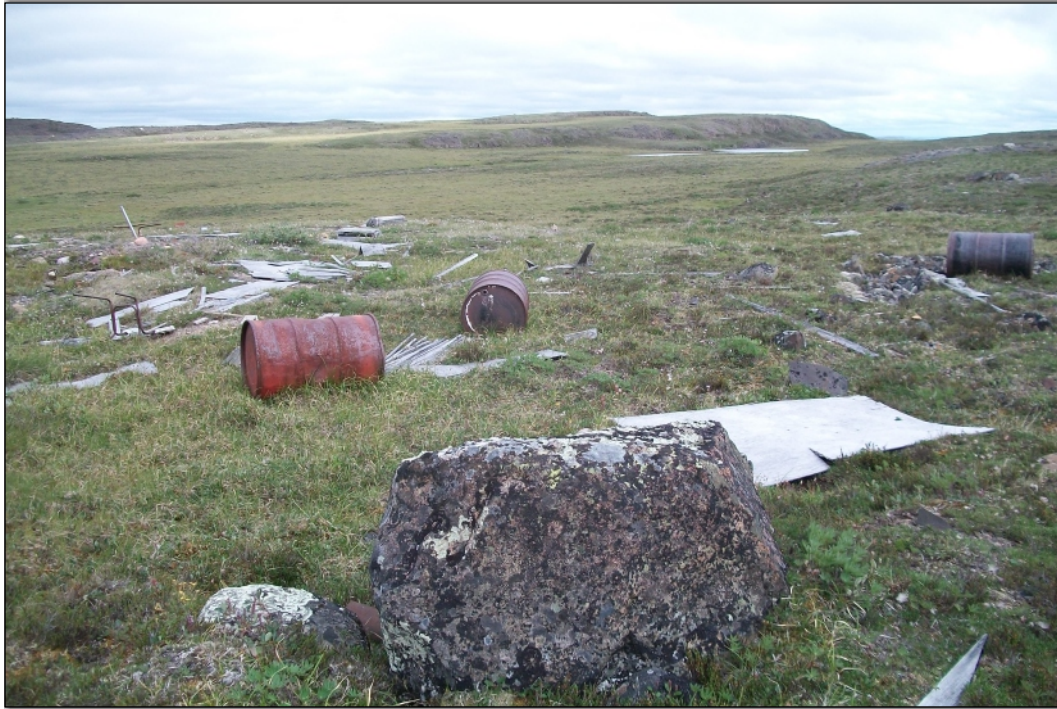
Photo 80

Willow Creek WKB02 Southwest Cabin: APEC 23, three empty drums, wood and metal debris

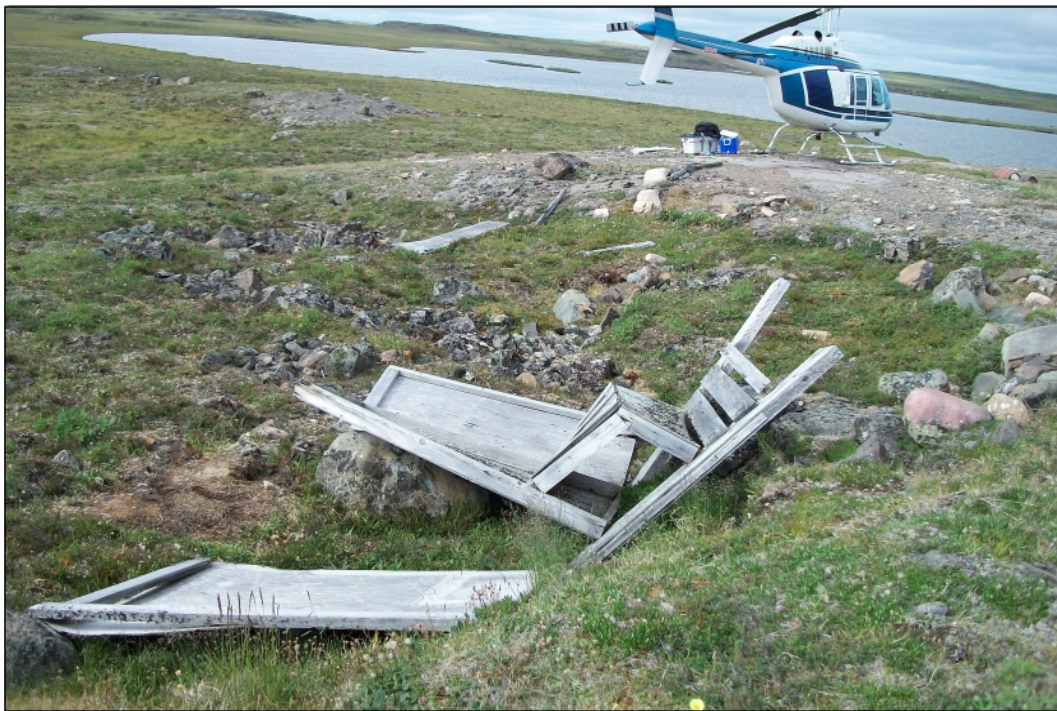
Photo 81

Willow Creek WKB02 Southwest Cabin: APEC 23, collapsed outhouse

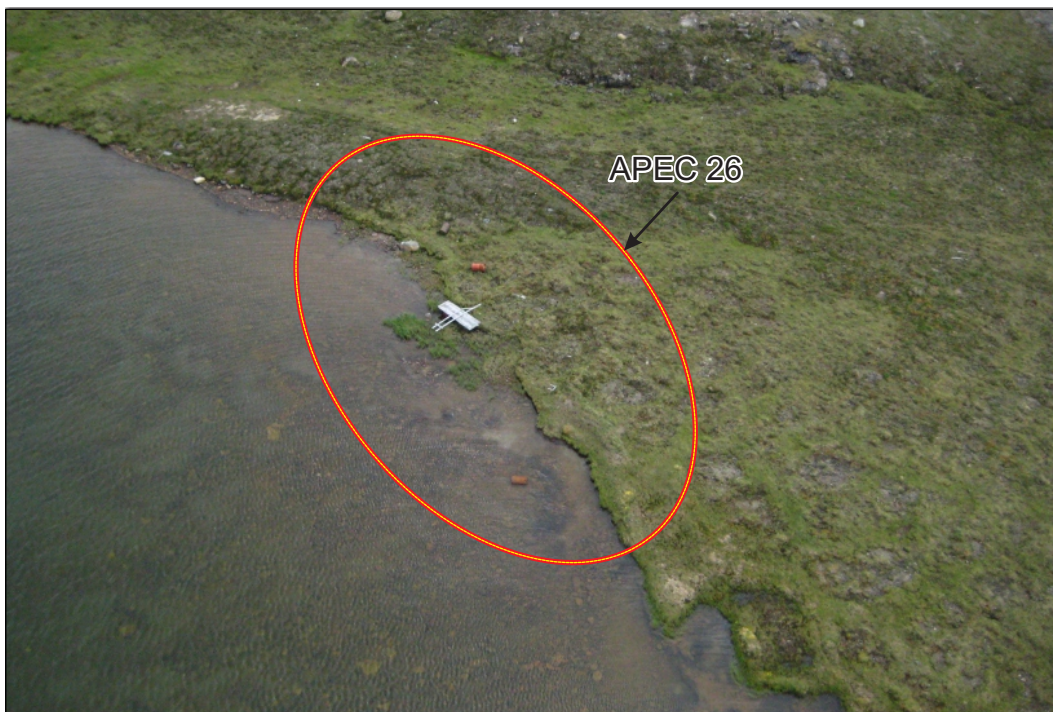
Photo 87
Willow Creek WKB02 Southwest Cabin: aerial view APEC 26, float plane dock

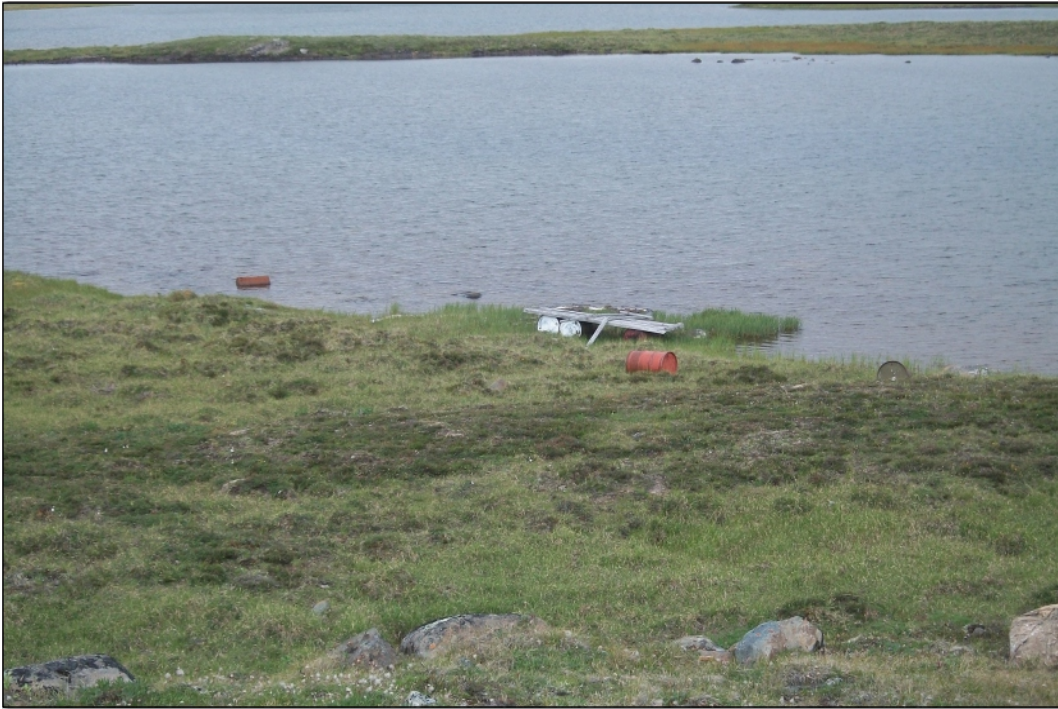
Photo 88

Willow Creek WKB02 Southwest Cabin: APEC 26, float plane dock

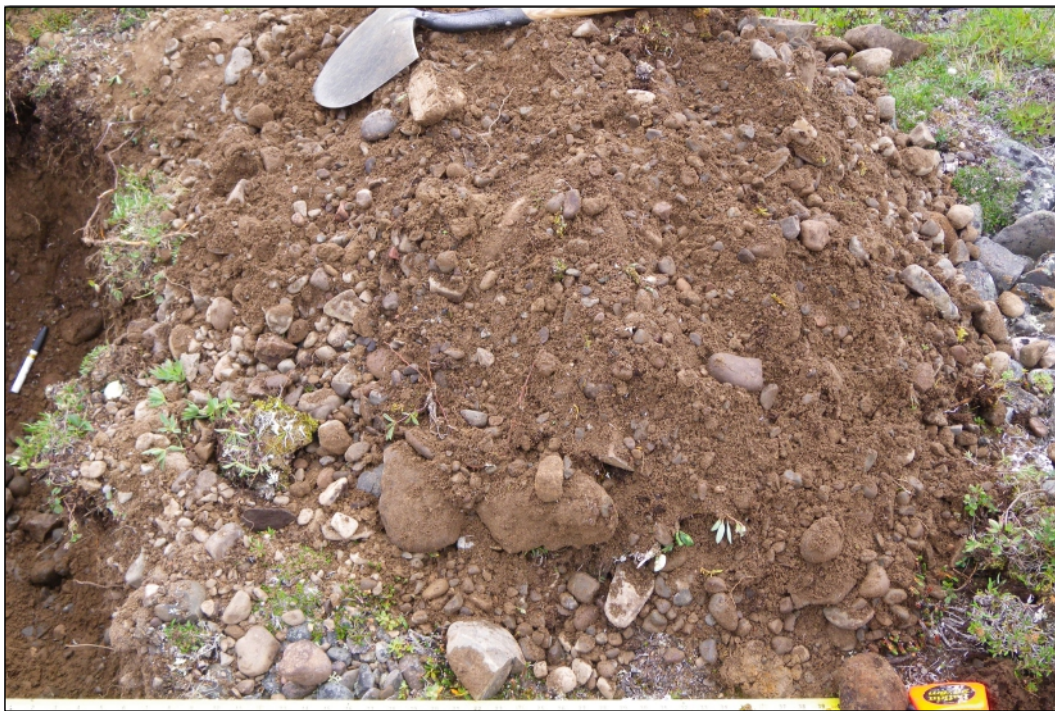
Photo 110

Test pit TP-10-22 was excavated in a disturbed area next to the airstrip. Test pit TP-10-23 was excavated in an undisturbed area about 50 m east of TP-10-22. Both areas have sand and gravel soils with some silt and cobbles and boulders as indicated in the logs and sieve results (Photos 109 and 110 of ESA). Although granular has been removed from this area,

Hope Lake WK027: view of TP23 spoil pile

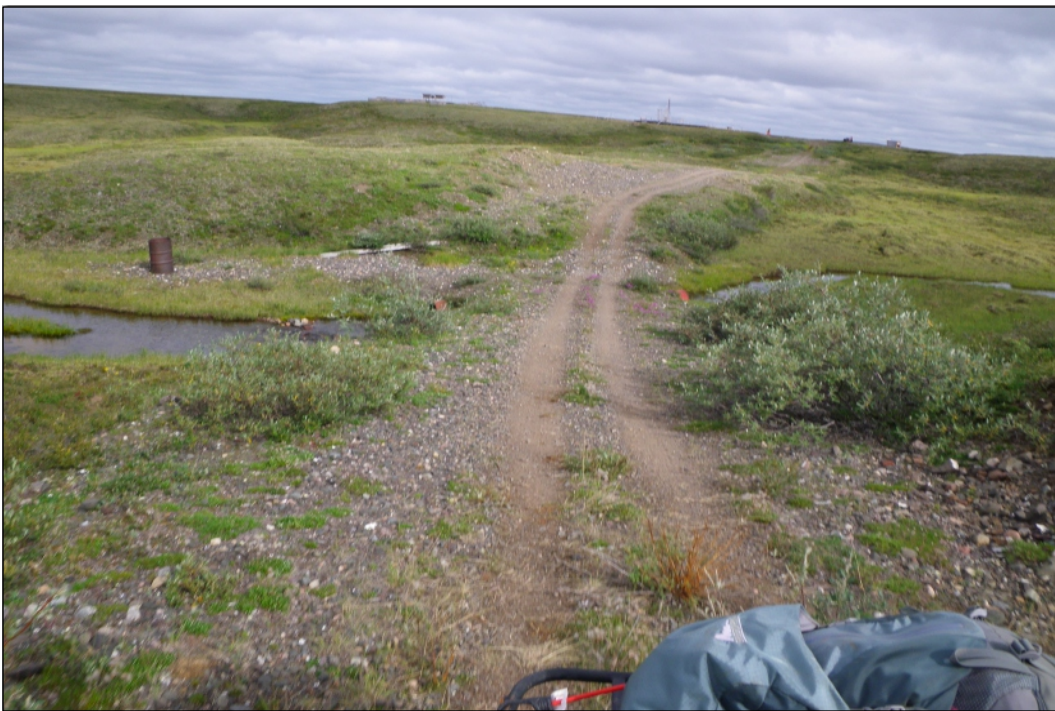
Photo 115

Hope Lake Wk027: Hope Lake Road between site and airstrip, vegetated area

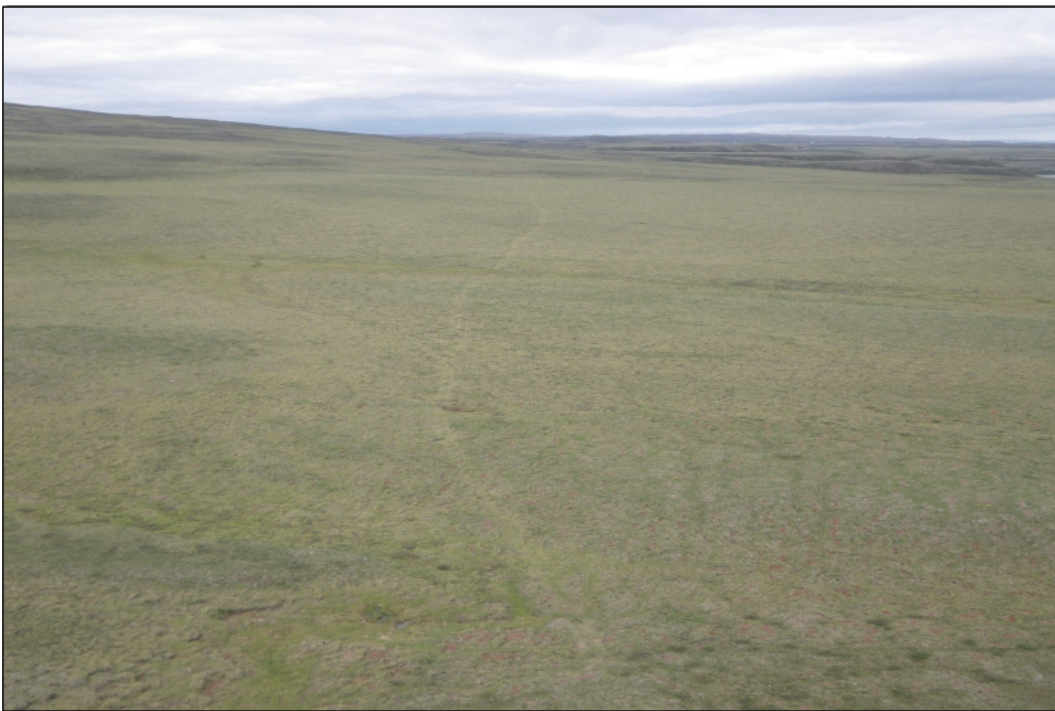
Photo 121

Hope Lake WK027: Hope Lake to Willow Creek Trail, along a lake shoreline

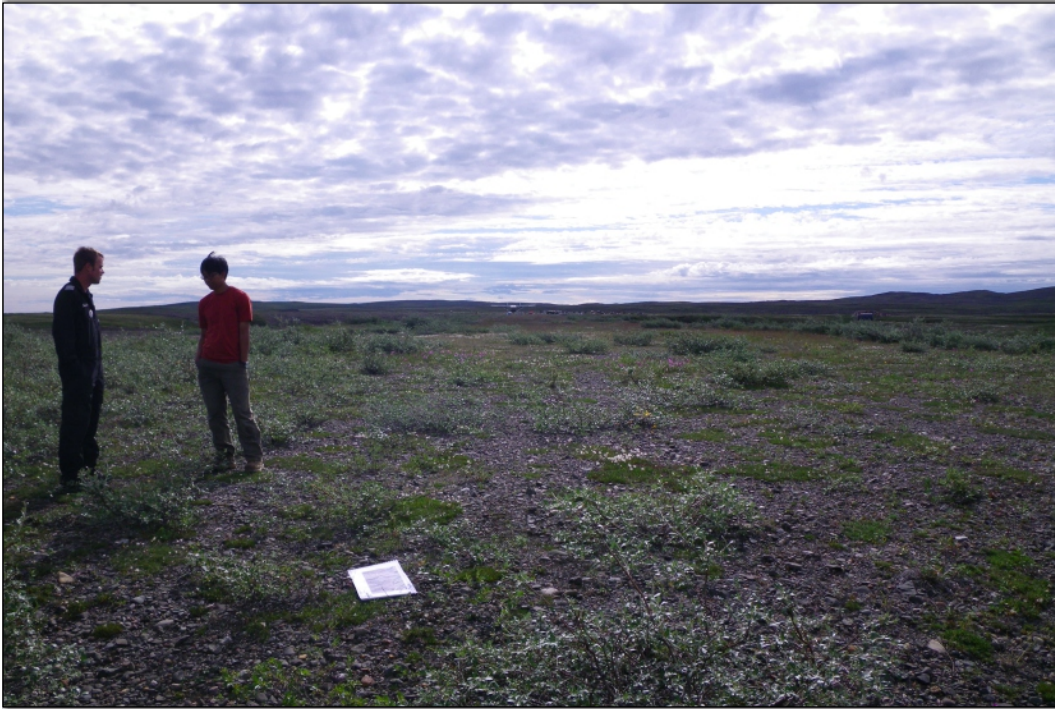
Photo 122

Hope Lake WK027: Hope Lake to Willow Creek Trail, across tundra

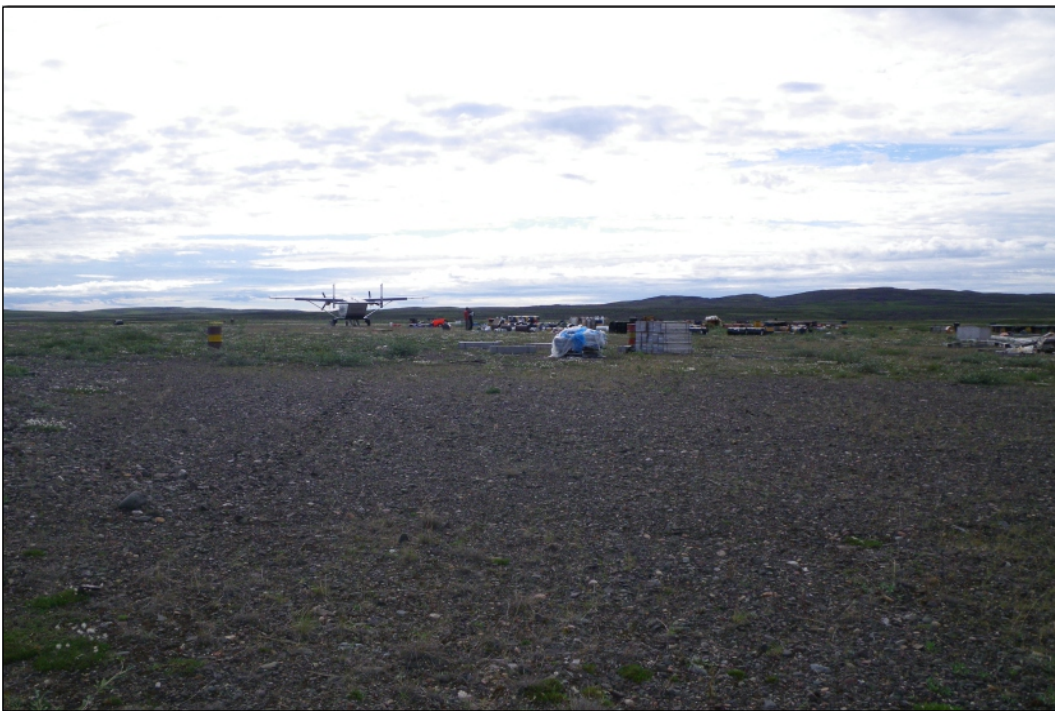
Photo 123

Hope Lake WK027: Hope Lake airstrip, southeast view of northwest boundary of airstrip

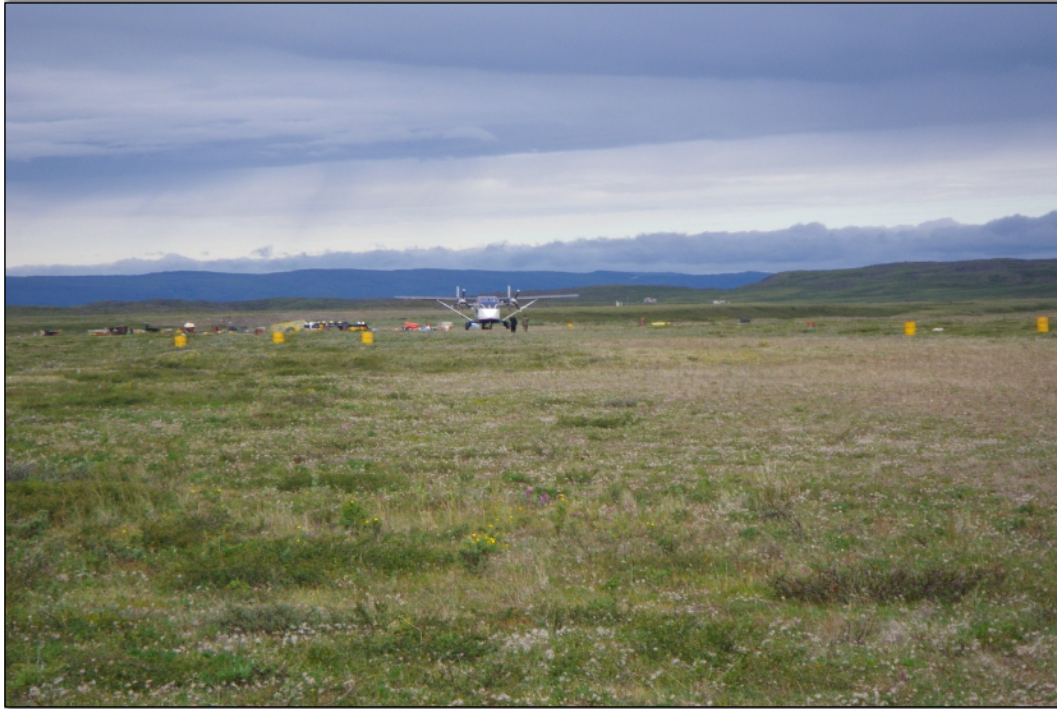
Photo 124

Hope Lake WK027: Hope Lake airstrip, southeast view of surface northwest of apron

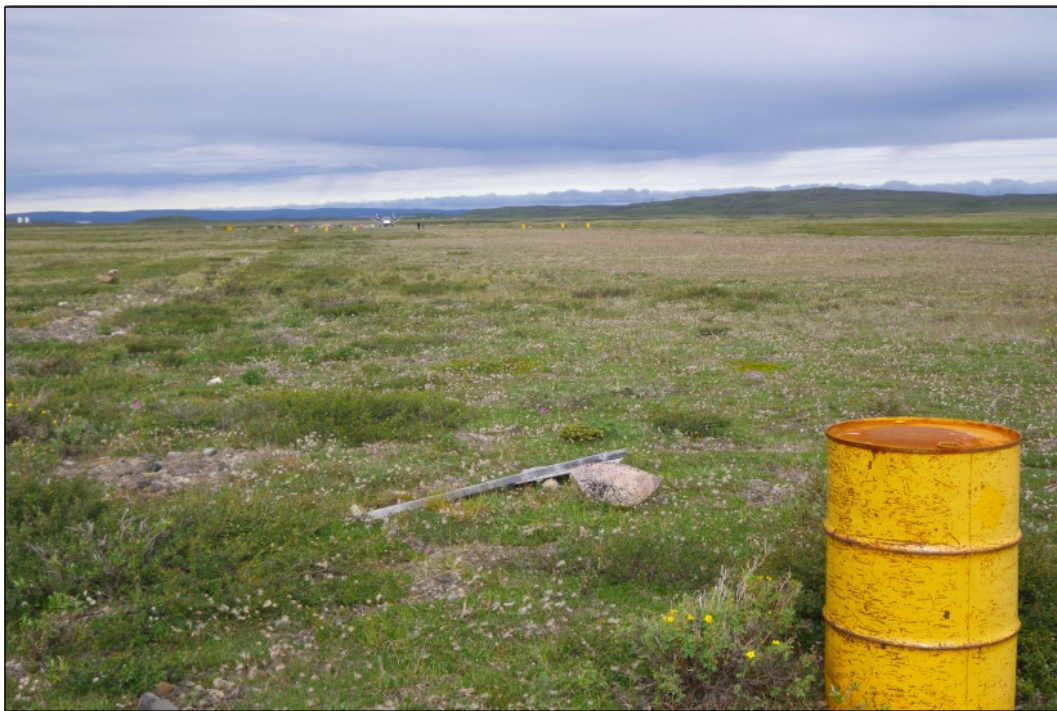
Photo 125

Hope Lake WK027: Hope Lake airstrip, northwest view of northwest row of yellow drums

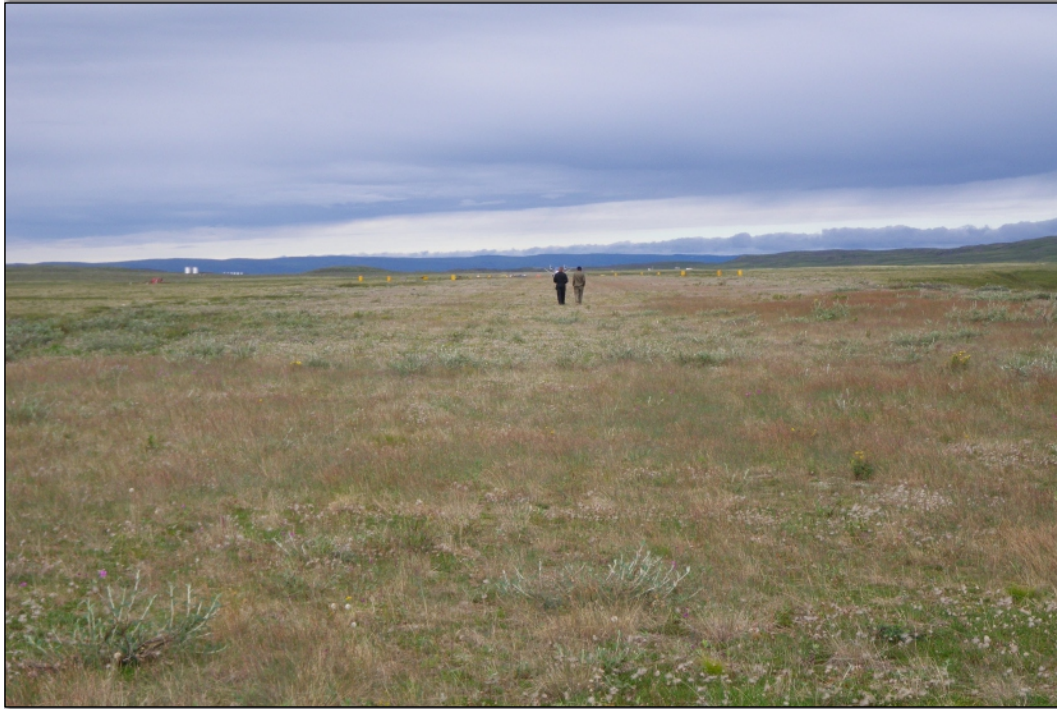
Photo 126

Hope Lake WK027: Hope Lake airstrip, north view of airstrip from southeast row of yellow drums

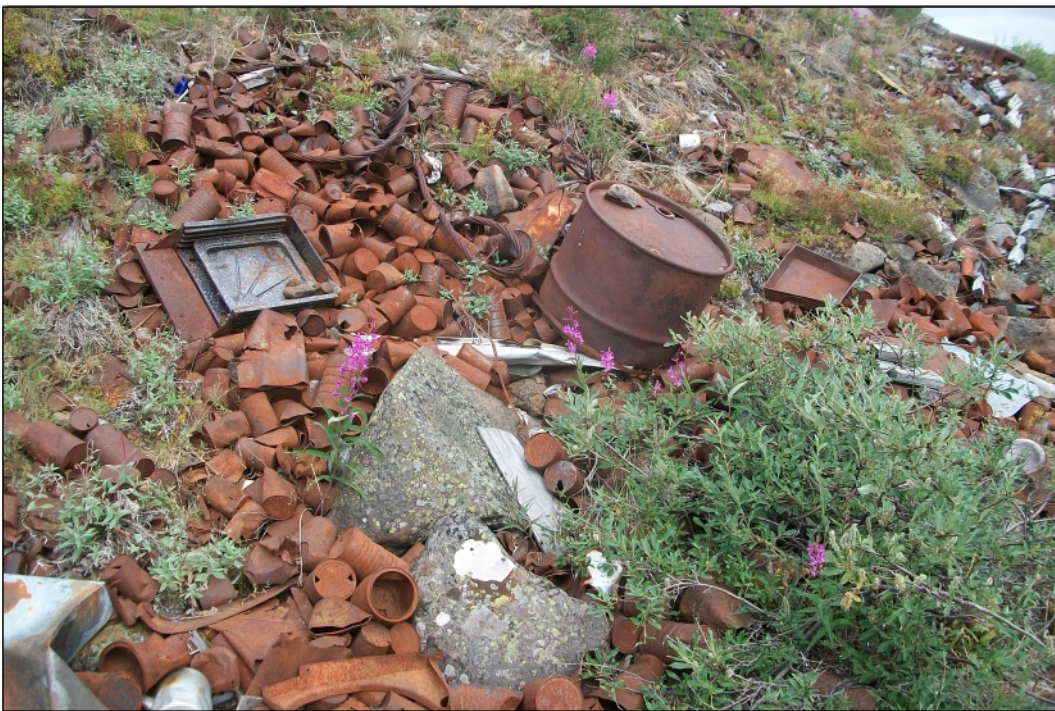
Photo 131

Hope Lake WK027: APEC 1A, heavily rusted drums scattered on south facing slope (looking west)

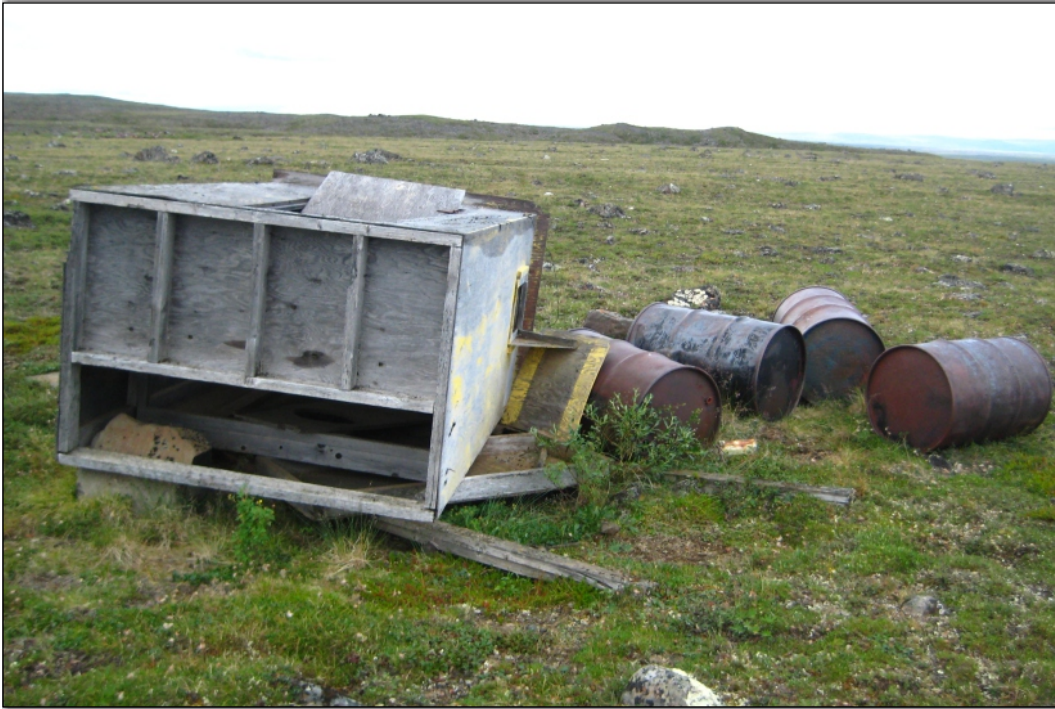
Photo 136

Hope Lake WK027: APEC 1B, former outhouse (looking east)

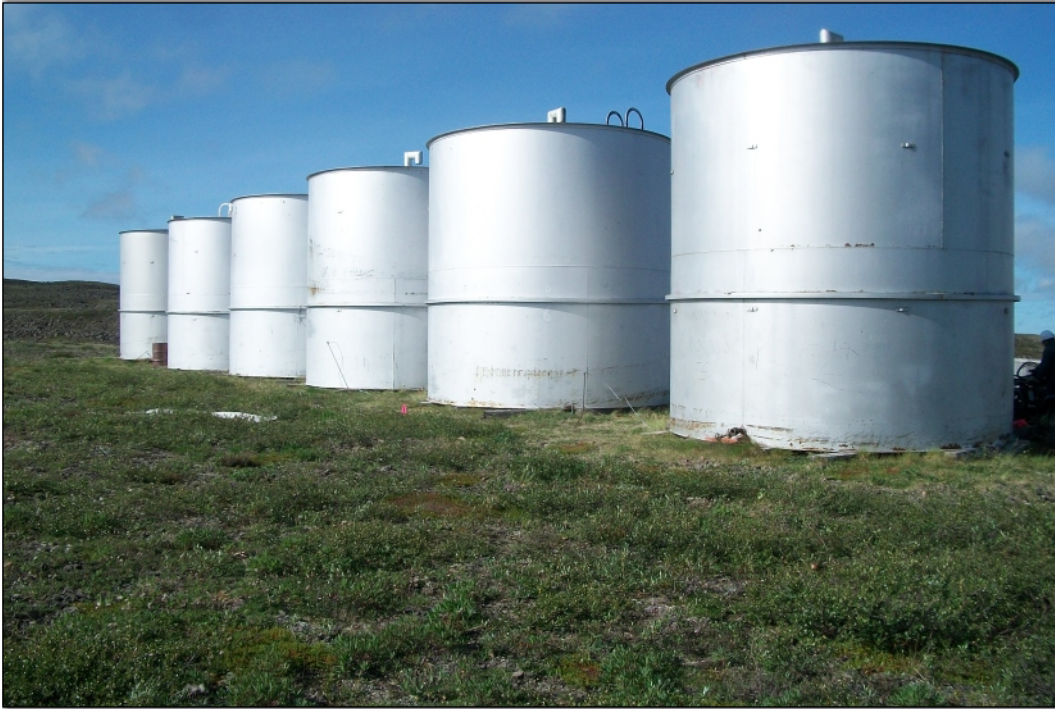
Photo 138

Hope Lake WK027: APEC 2A, six POL tanks, west side of tanks, tanks with leachable lead paint

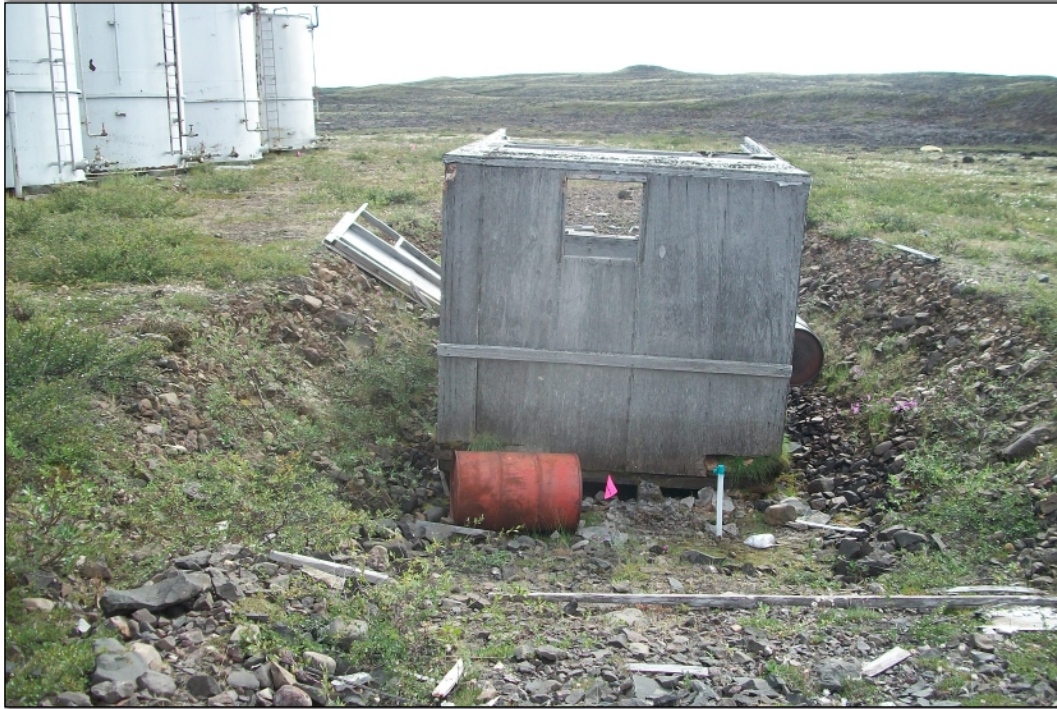
Photo 142

Hope Lake WK027: APEC 2A, Structure 17

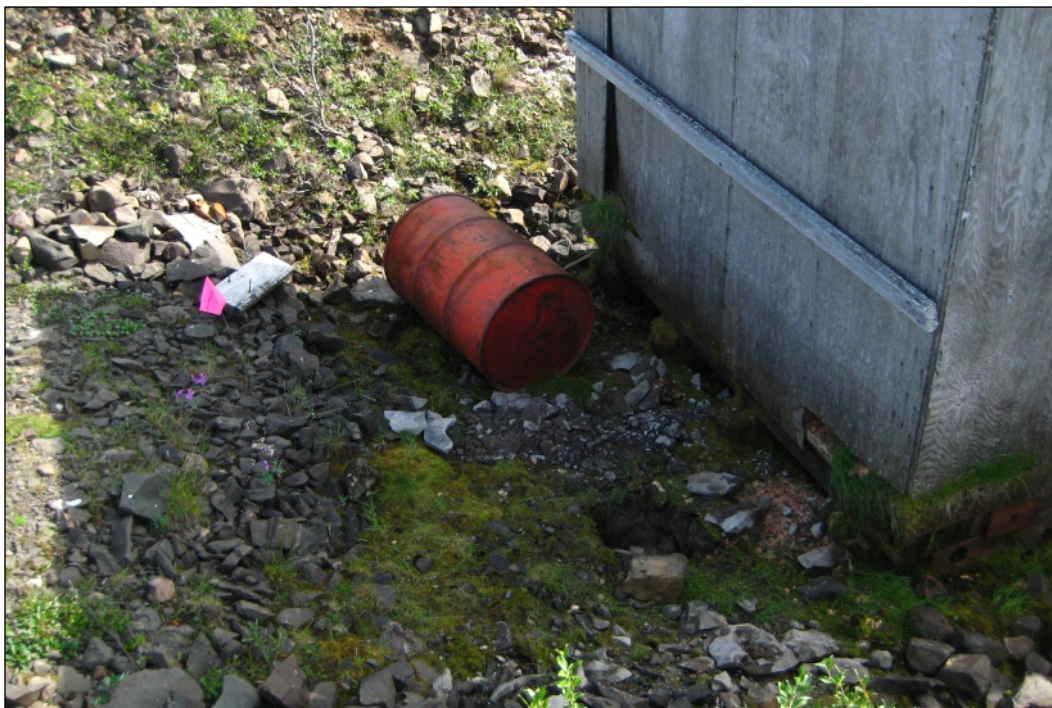
Photo 143

Hope Lake WK027: APEC 2A, wooden structure in excavated hole with groundwater monitoring well

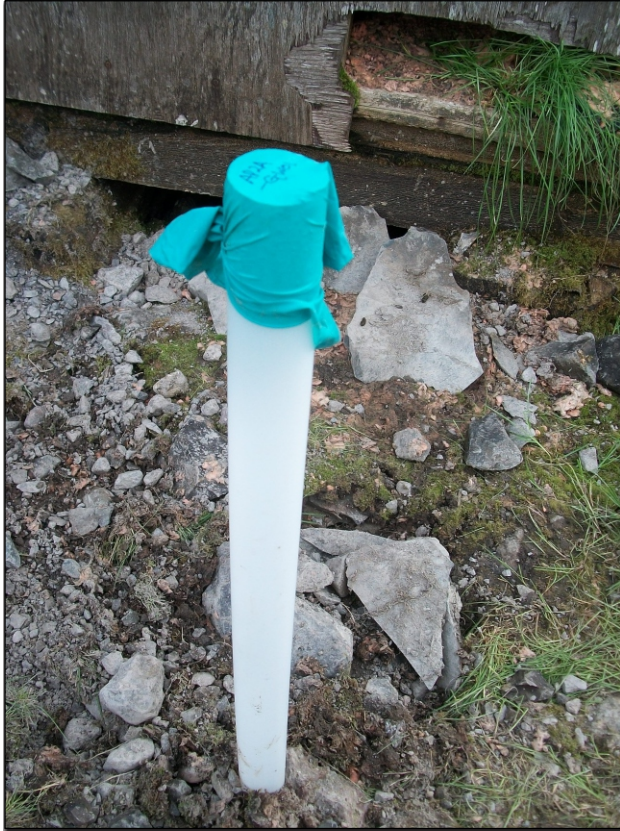
Photo 144

Hope Lake WK027: APEC 2A, soil sample location WK027-AP2A-SS05

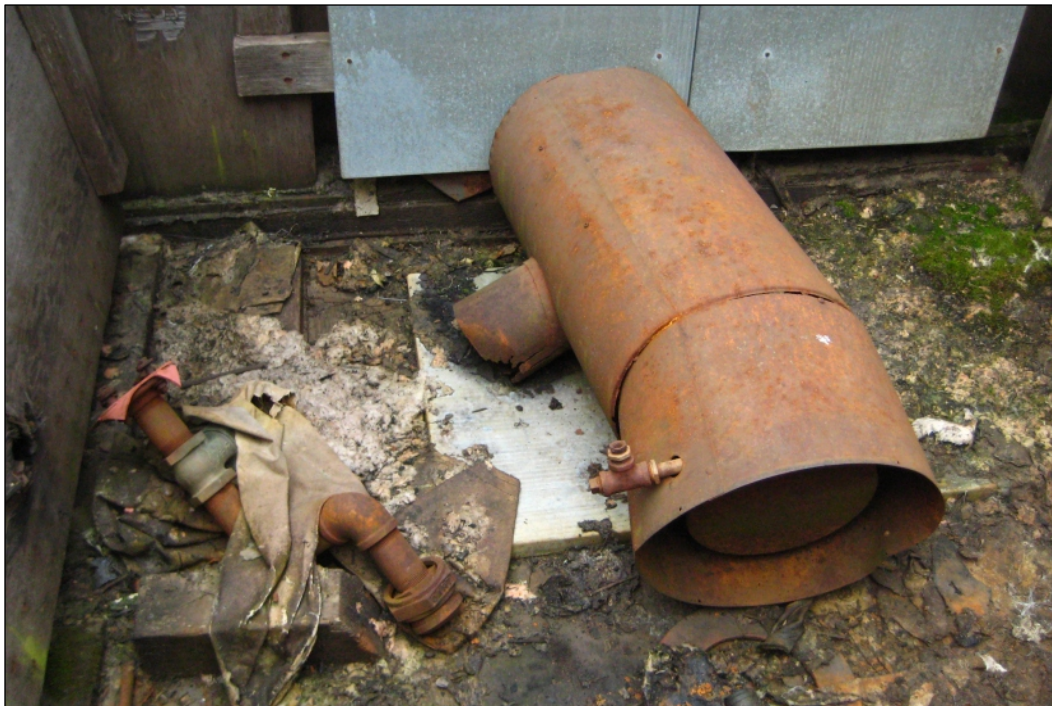
Photo 145
Hope Lake WK027: APEC 2A, groundwater monitoring well

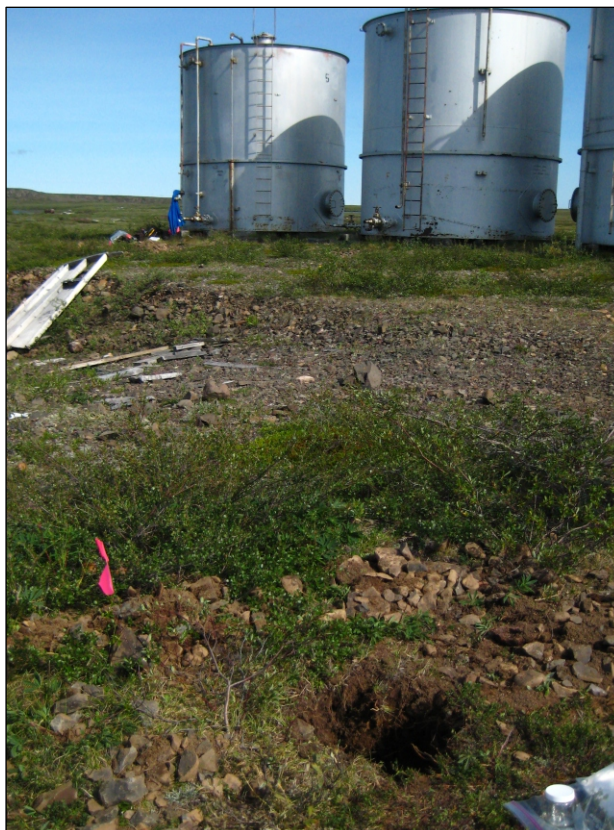
Photo 146
Hope Lake WK027: APEC 2A, within Structure 17

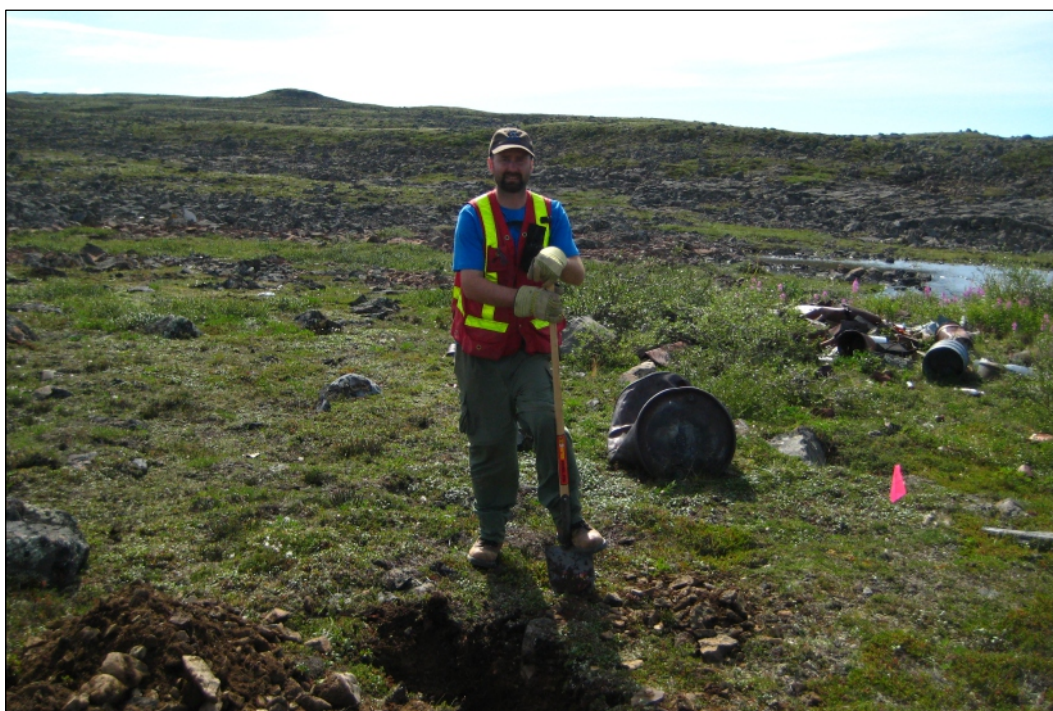
Photo 147

Hope Lake WK027: APEC 2A, soil sample location
WK027-AP2A-SS07

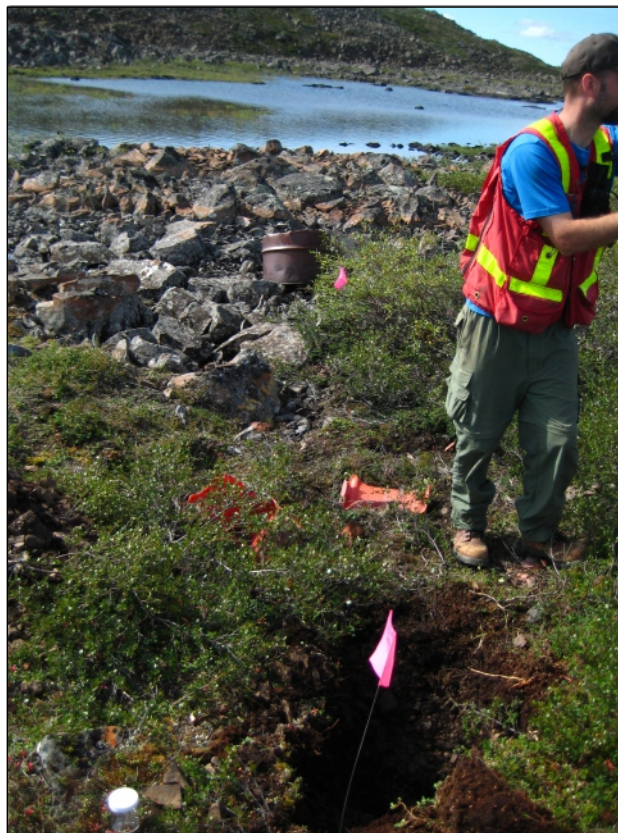
Photo 148

Hope Lake WK027: APEC 2B, soil sample location WK027-AP2B-SS01 upgradient of debris area

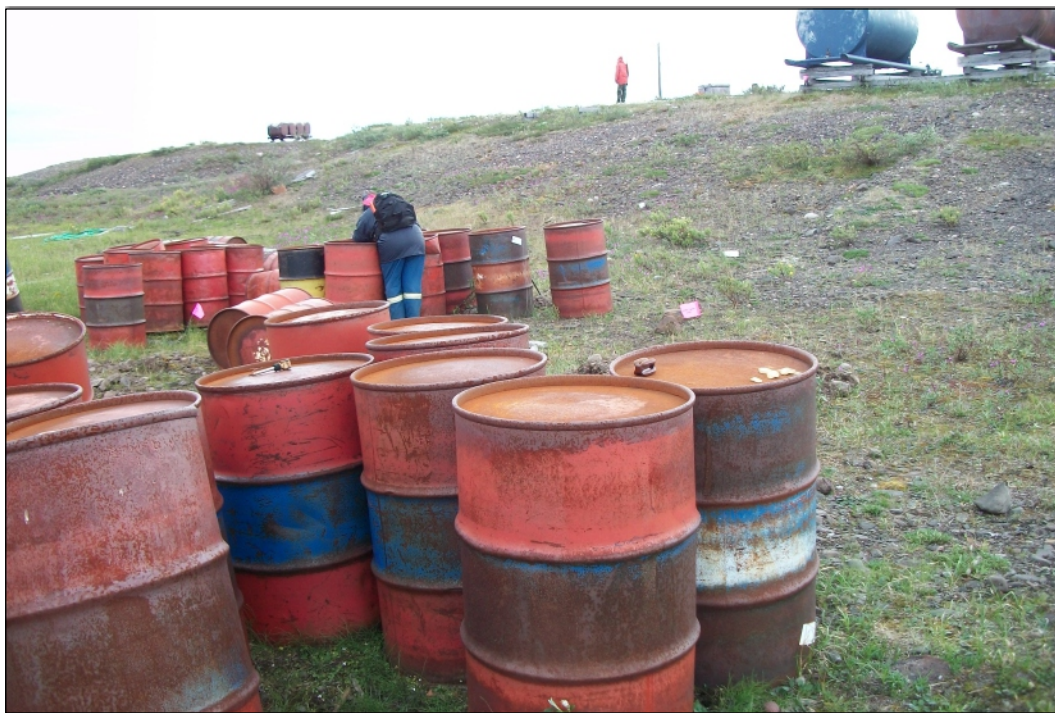
Photo 154

Hope Lake WK027: APEC 3A, leachable lead paint on red drum, drum aqueous content below guidelines

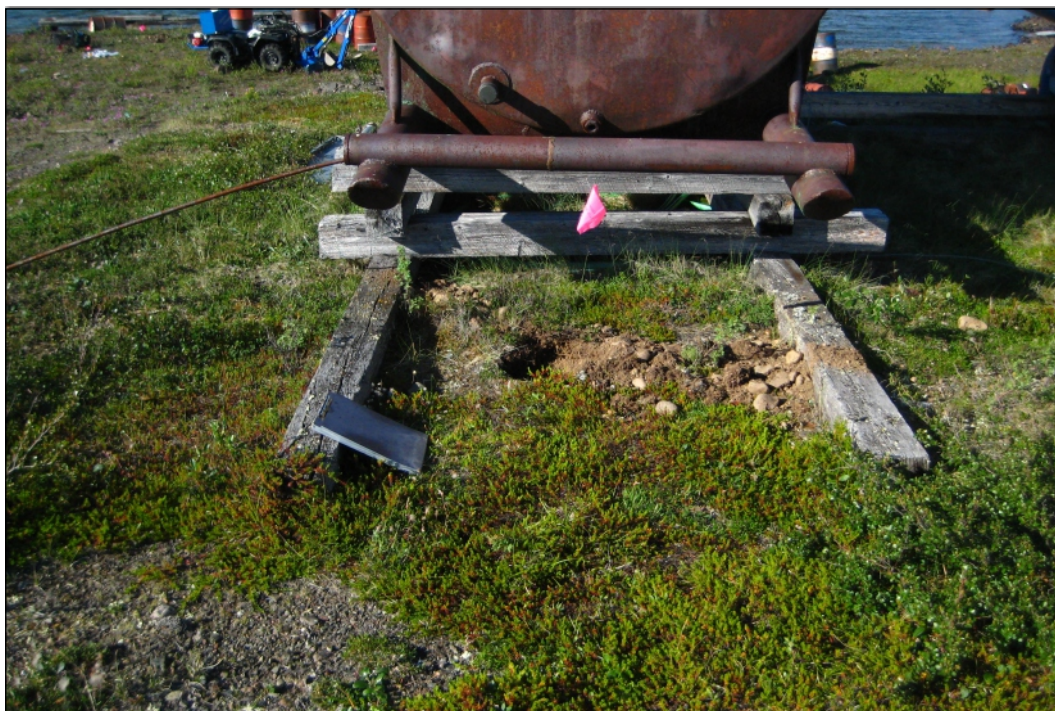
Photo 156

Hope Lake WK027: APEC 3B, two 9,600 litre tanks, leachable lead paint on blue tank
