HOPE LAKE
REMEDICATION PROJECT
REMEDIAL ACTION PLAN

**REMEDIAL ACTION PLAN
HOPE LAKE, NUNAVUT**

**SOLICITATION NUMBER: EW699-110498/001/NCS
PWGSC PROJECT NUMBER: R.040717.012
SUPPLY ARRANGEMENT NUMBER: EW699-100053/003/NCS**

March 2011

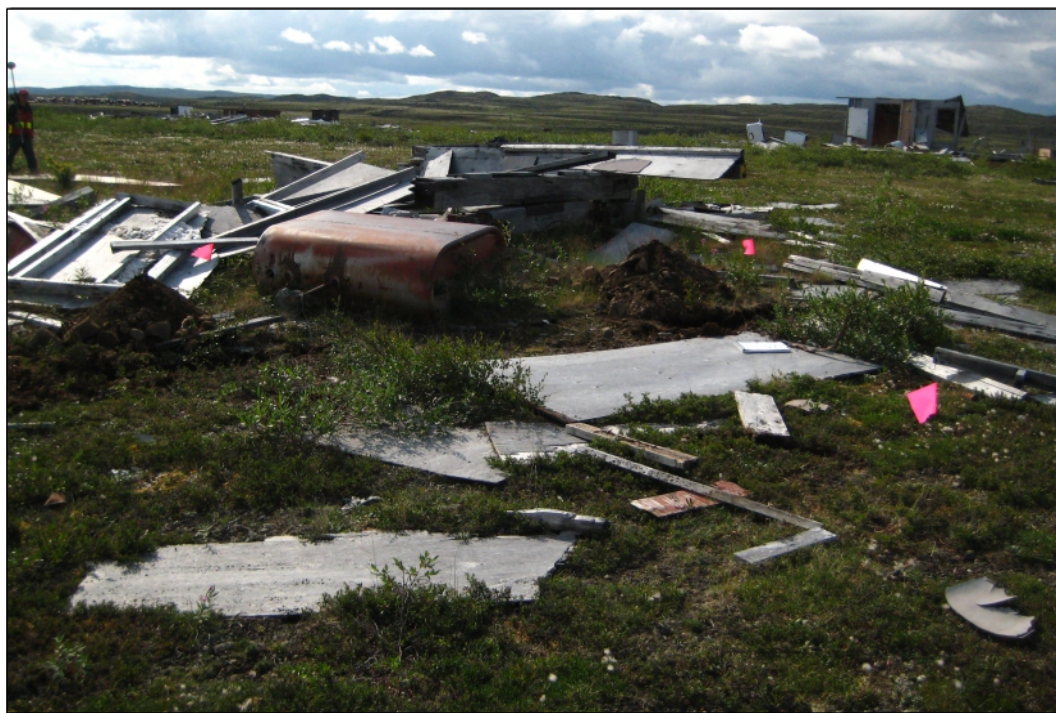
Photo 157

Hope Lake WK027: APEC 3B, sample location WK027-AP3B-SS03

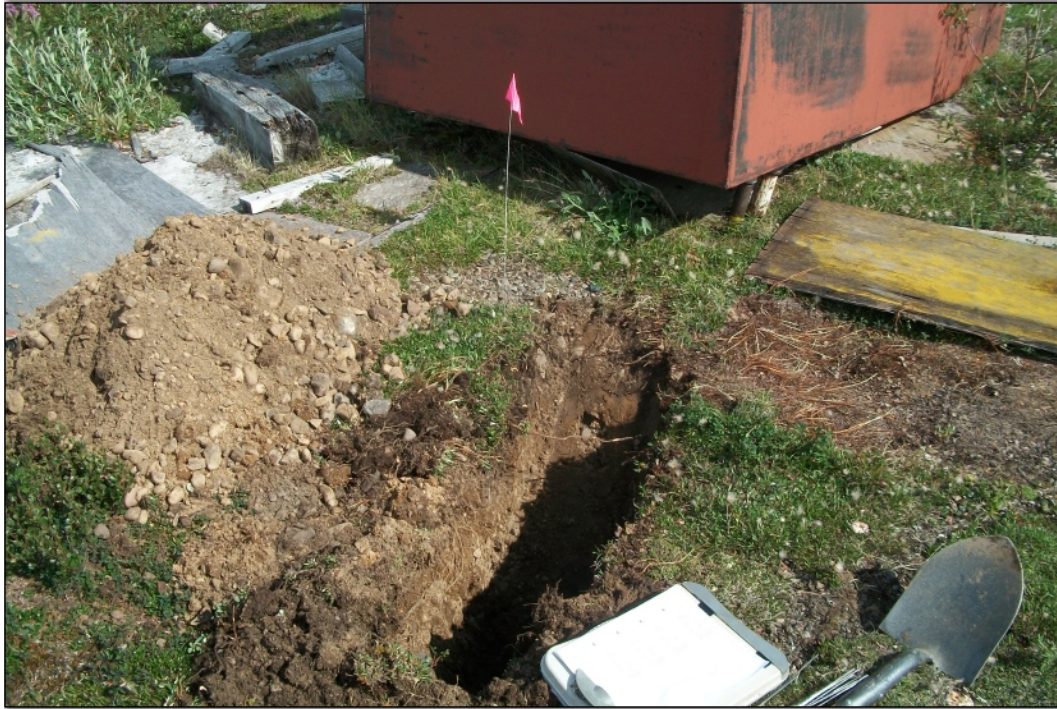
Photo 162

Hope Lake WK027: APEC 3D, collapsed outhouse

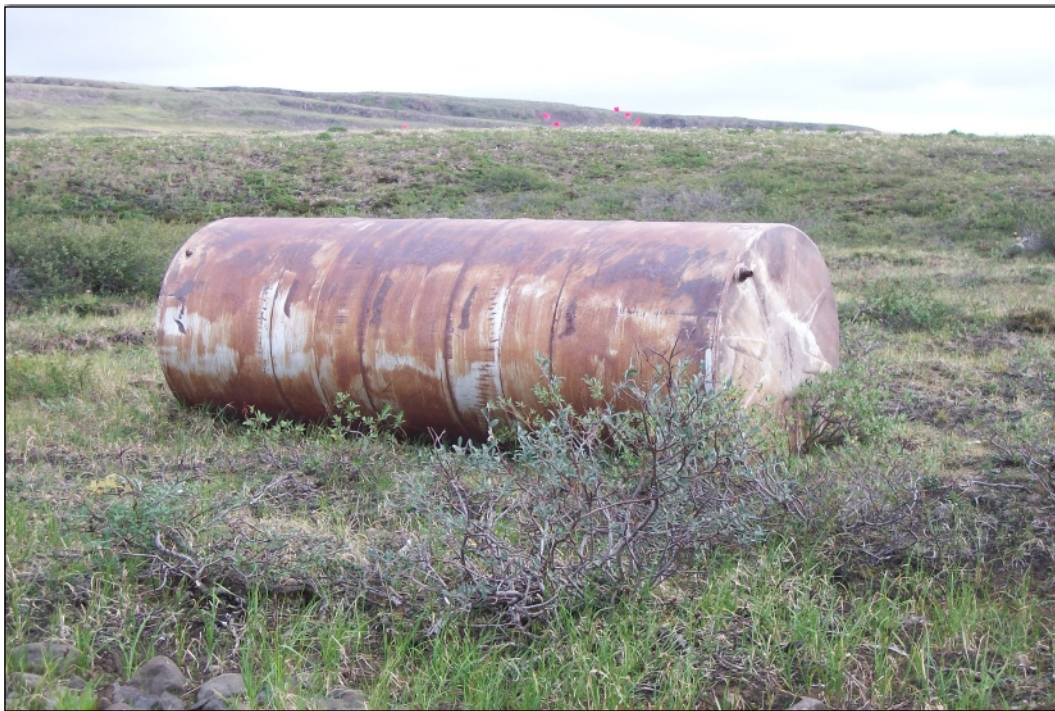
Photo 178

Hope Lake WK027: APEC 3M, collapsed managers quarters, leachable lead paint on black drum

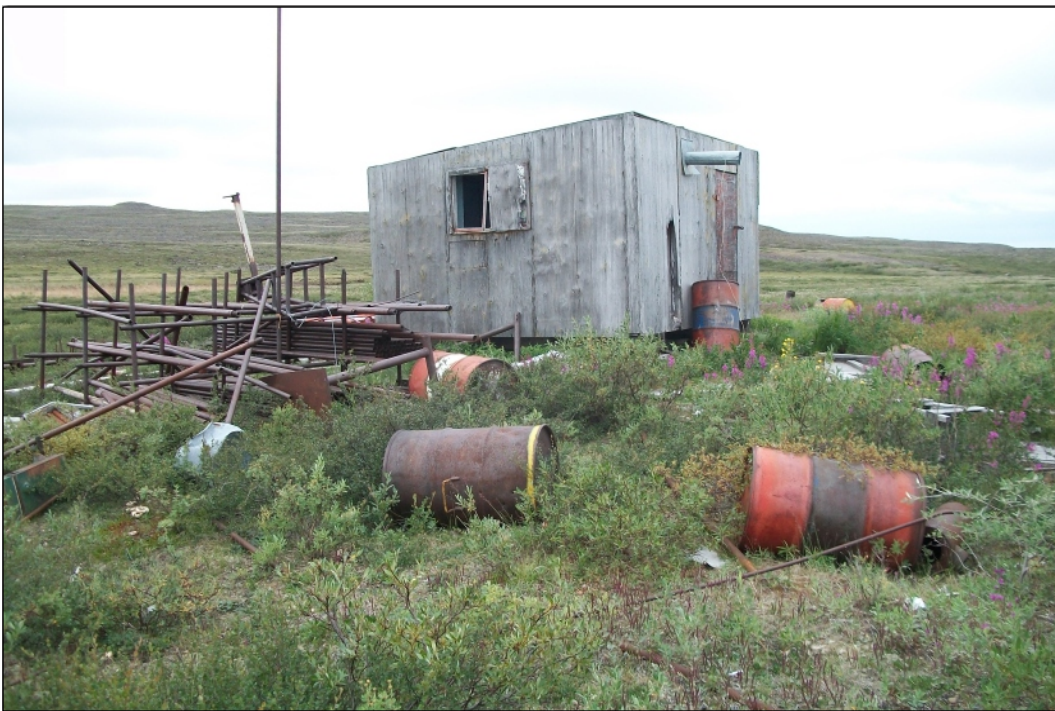
Photo 185

Hope Lake WK027: APEC 3P, non-hazardous materials, may have been a drilling compound

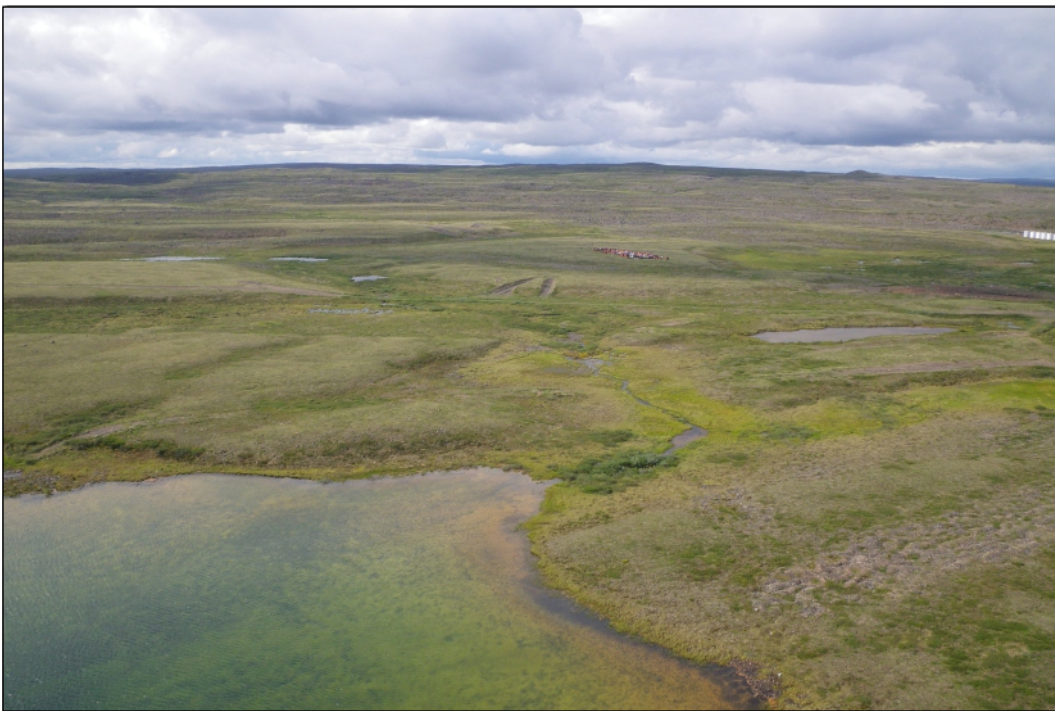
Photo 187

Hope Lake WK027: APEC 3U, suspected outfall area, looking north to APEC 3

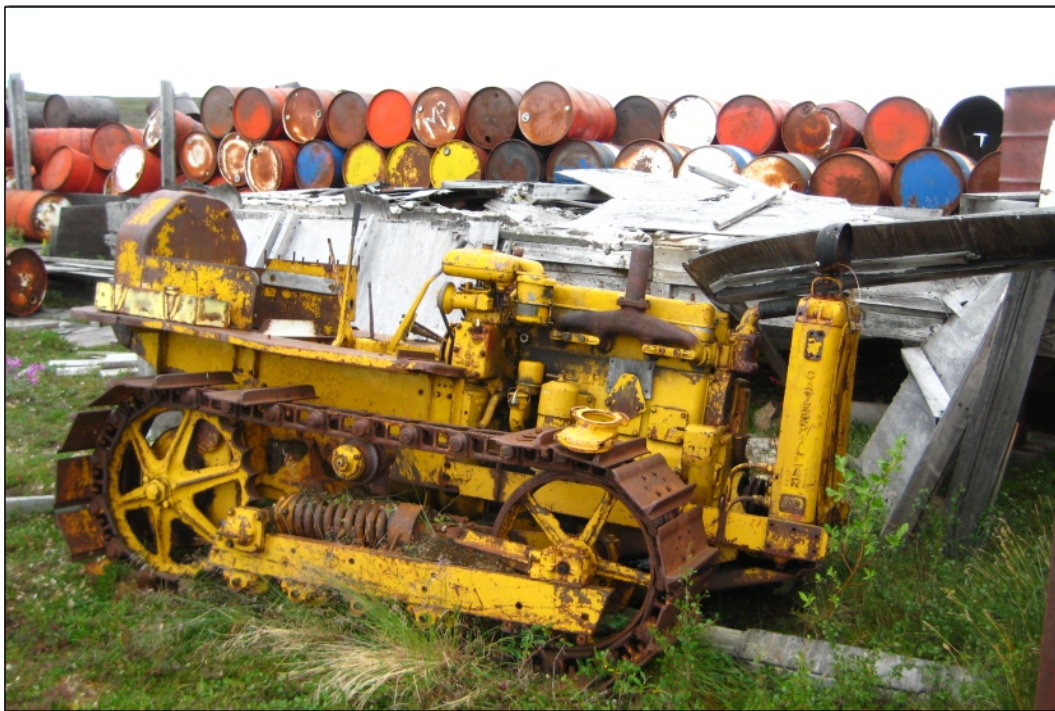
Photo 189
Hope Lake WK027: APEC 3V, large drum cache

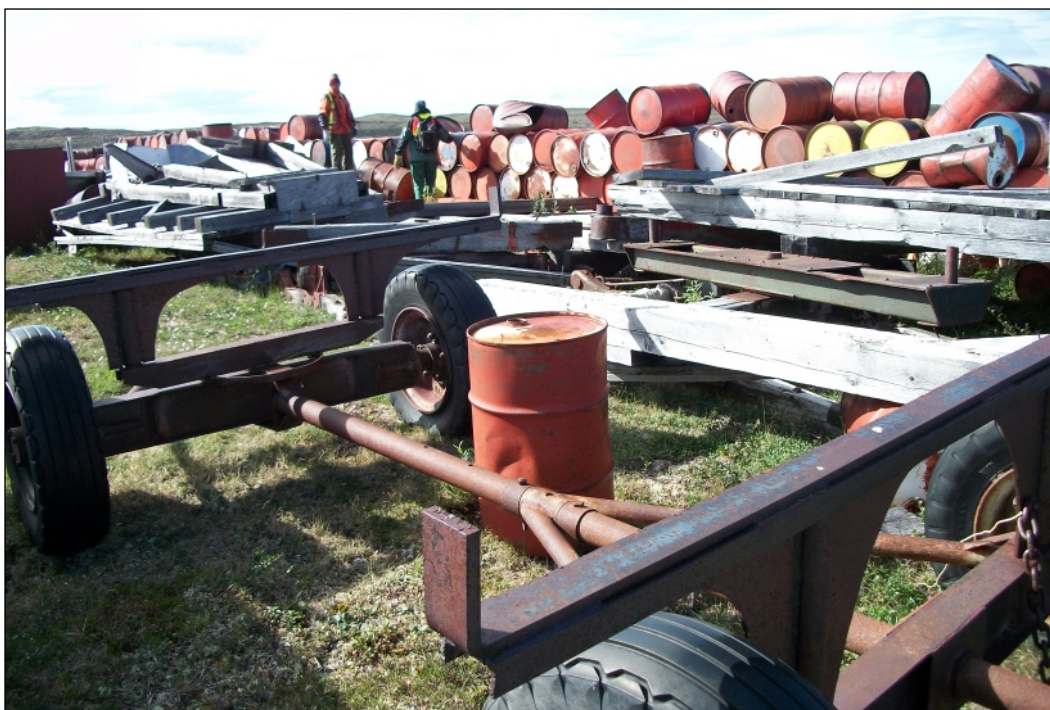
Photo 191

Hope Lake WK027: APEC 3V, yellow caterpillar contains leachable lead paint

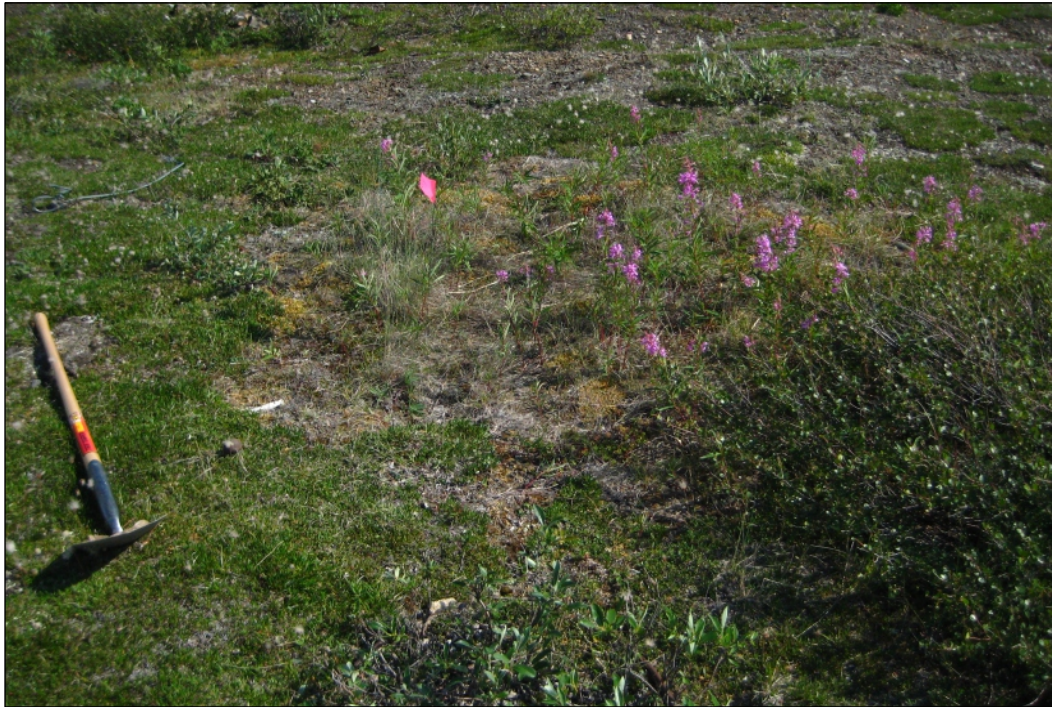
Photo 192

Hope Lake WK027: APEC 3V, trailers and drums

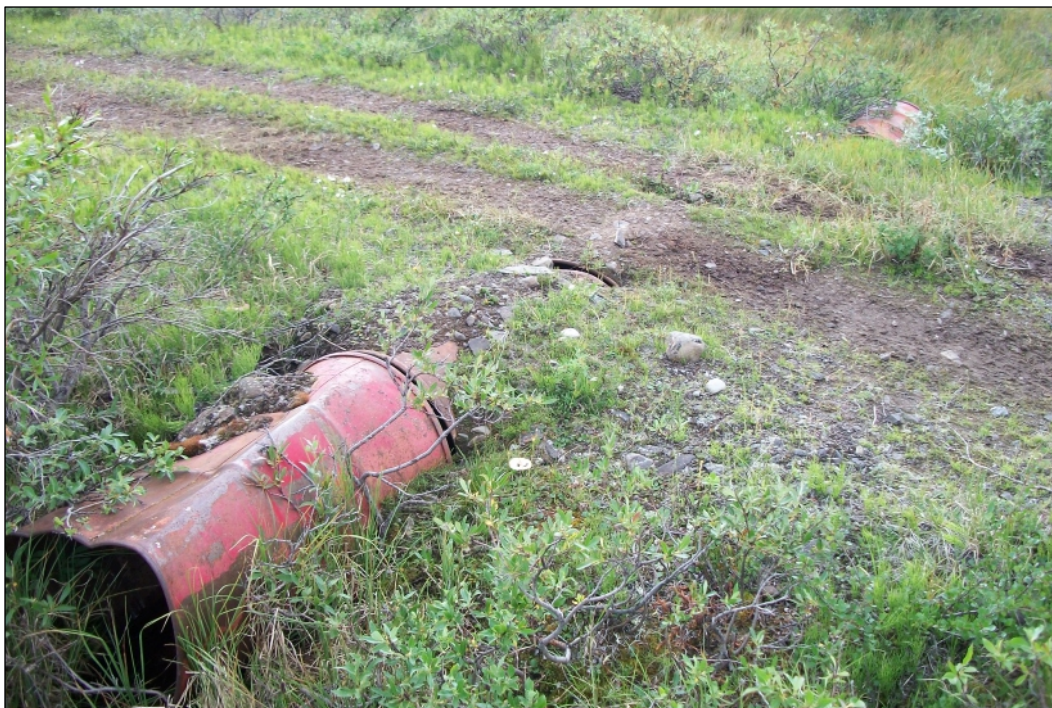
Photo 193

Hope Lake WK027: APEC 3W, small area of distressed vegetation

recommended that these point source areas be removed in areas showing vegetation distress.

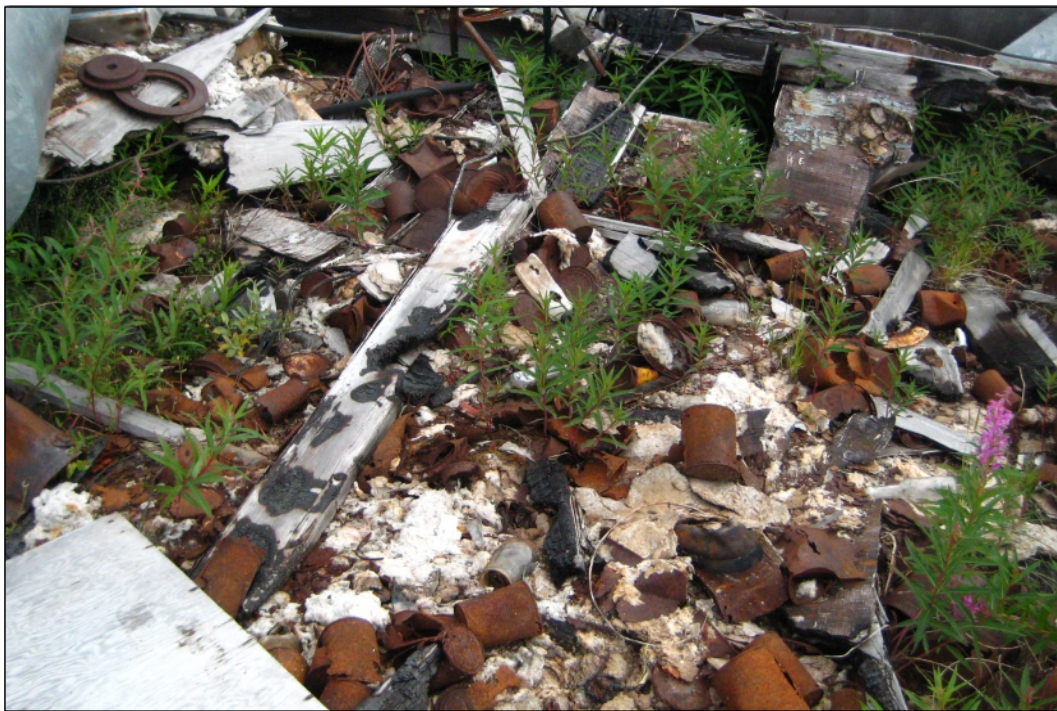
Photo 197

Hope Lake WK027: APEC 4A, tank, furnace, building foundation and miscellaneous debris

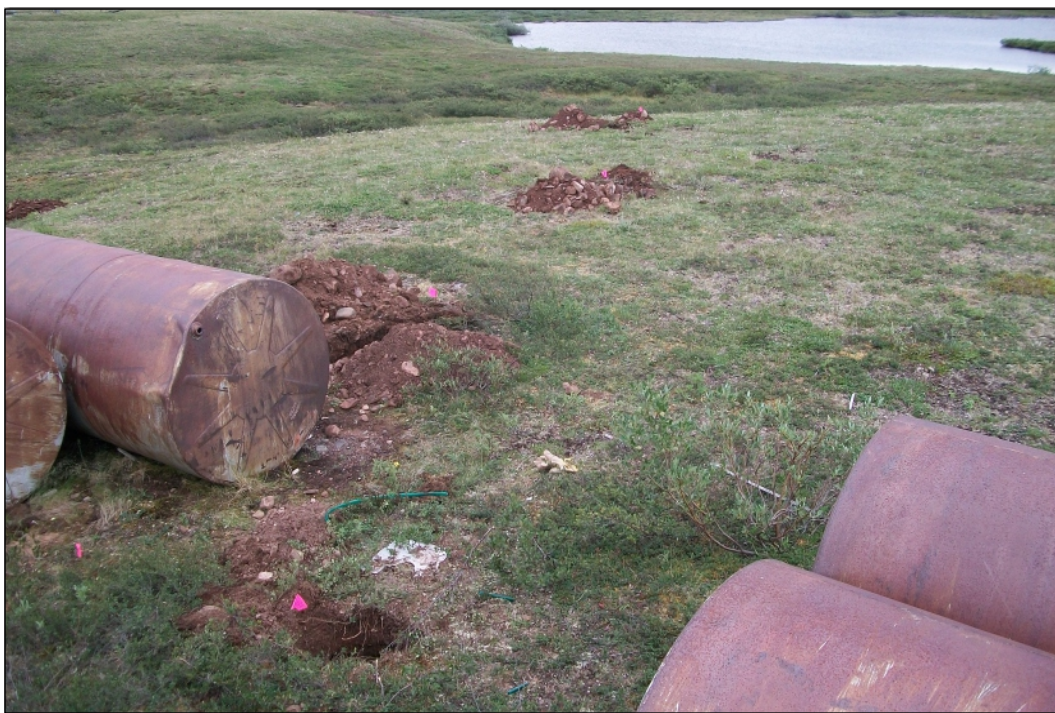
Photo 201

Hope Lake WK027: APEC 4D, looking northeast toward the sausage tanks with sample WK27-AP4D-SS08

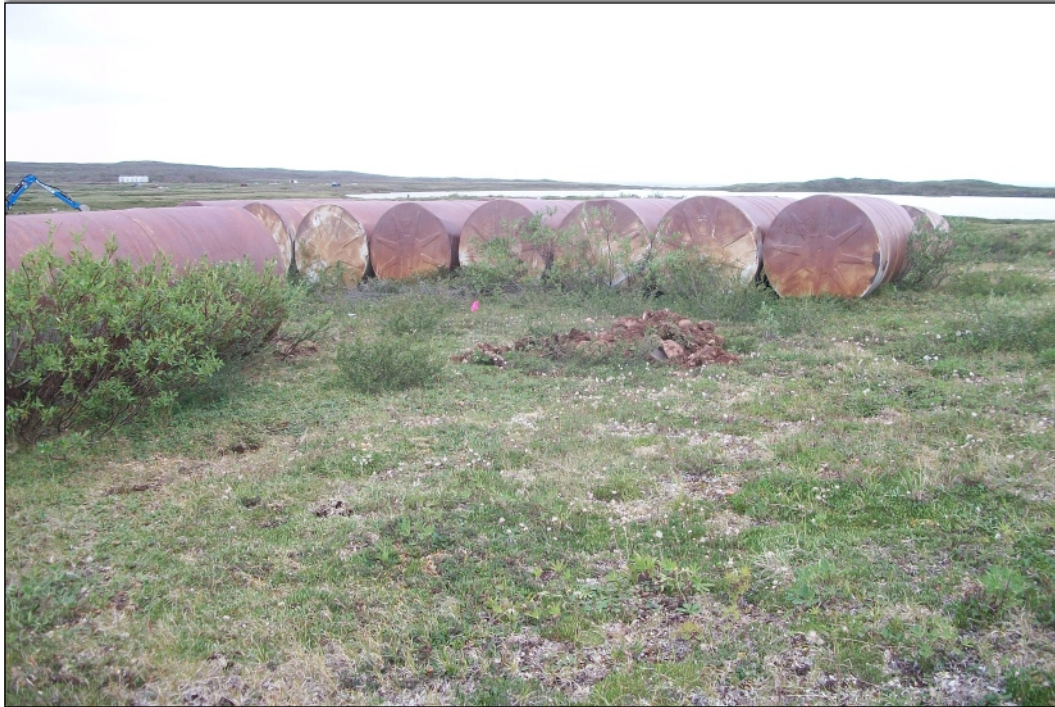
Photo 202

Hope Lake WK027: APEC 4D, looking southeast at sample points WK27-AP4D-SS04, 07, 10 and 11

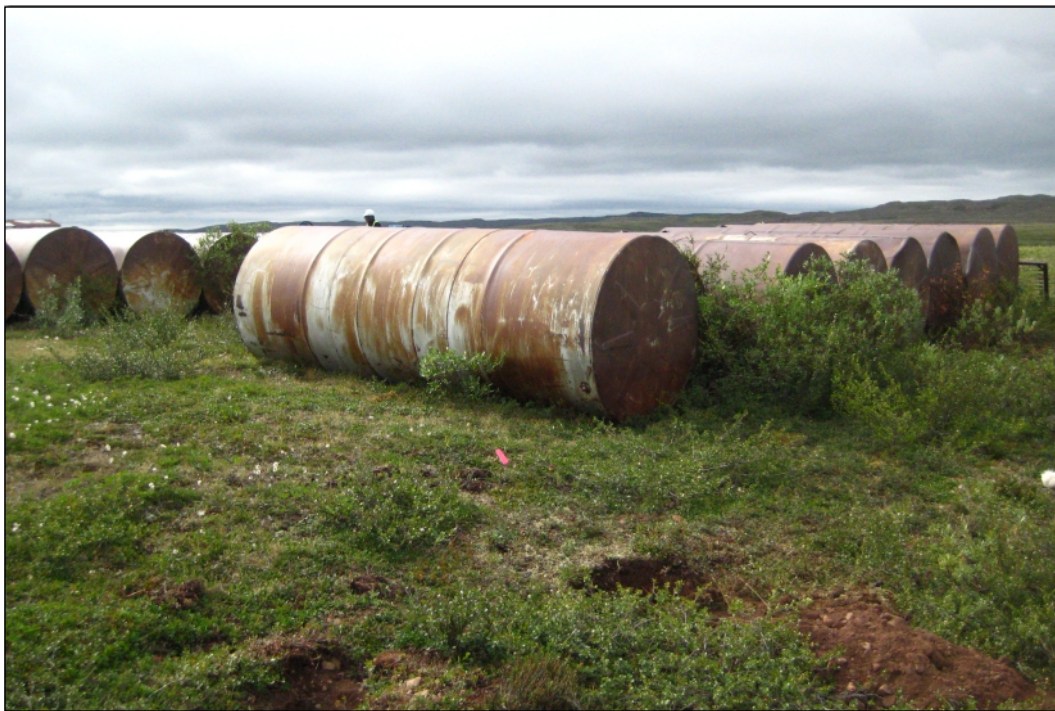
Photo 203

Hope Lake WK027: APEC 4D, looking southwest to the tanks and sample point WK27-AP4D-SS06

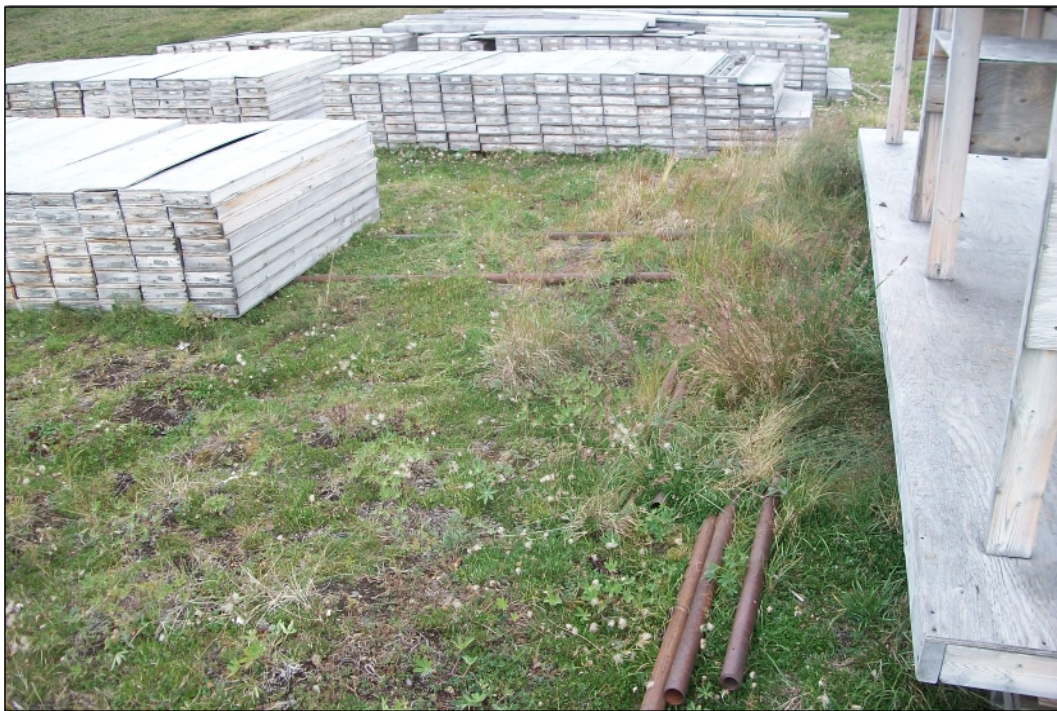
Photo 209

Hope Lake WK027: APEC 5, core boxes and building platform

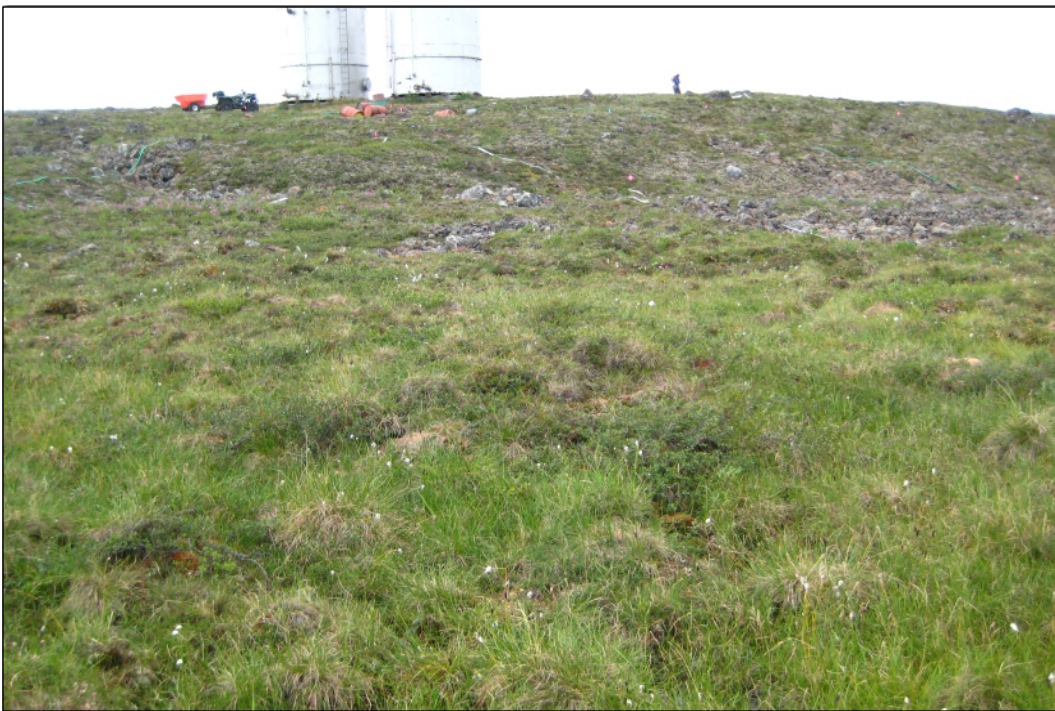
Photo 217

Hope Lake WK027: aerial view of APEC 6A, two POL Tanks and five drums

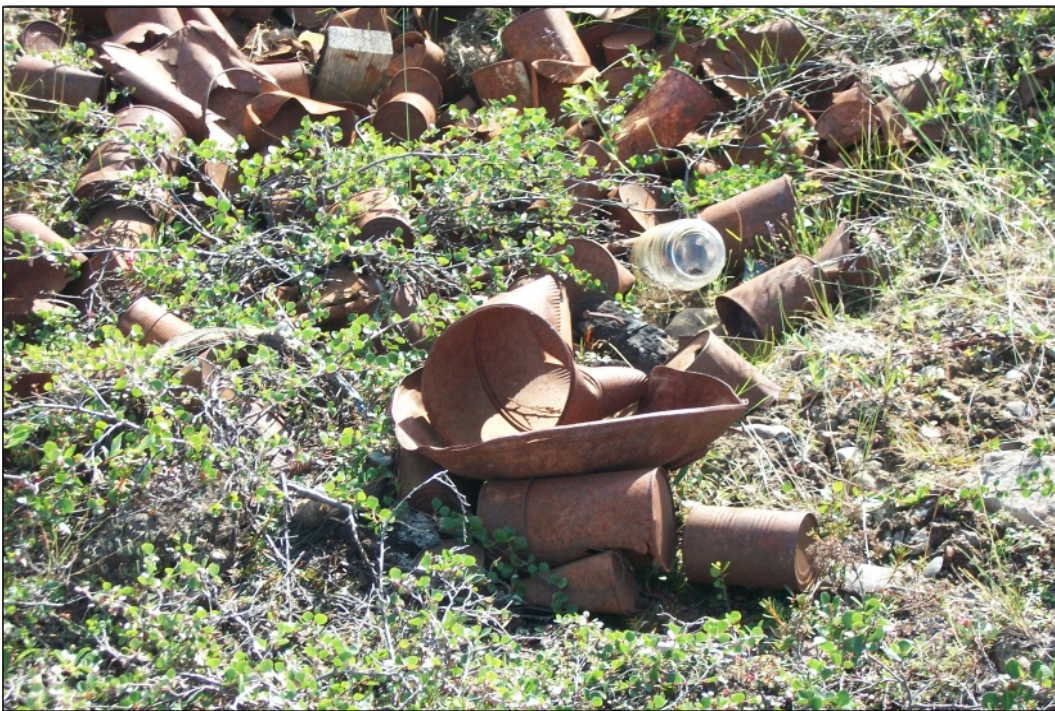
Photo 227
Hope Lake WK027: APEC 7A, drums in lowland area

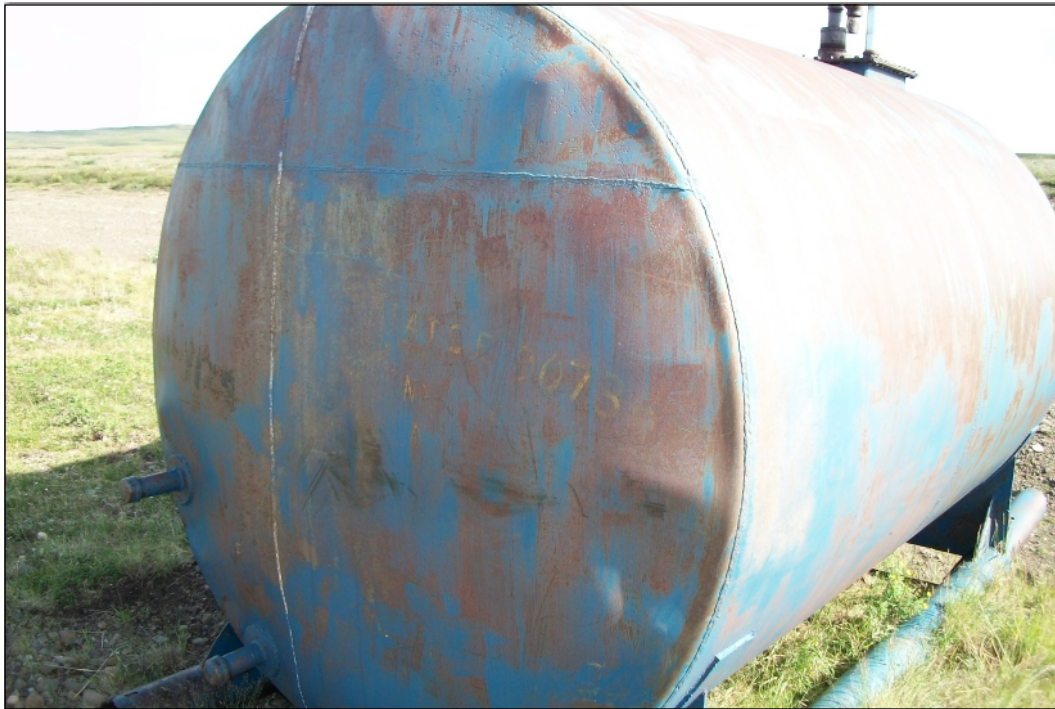
Photo 230

Hope Lake WK027: APEC 7C, 200m south of airstrip, red leachable lead paint on drum
