LONG-TERM LANDFILL MONITORING AT THE CAM-1 FORMER DEW LINE SITE

Jenny Lind Island, Nunavut

April 17, 2020

LONG-TERM LANDFILL MONITORING – CAM-1 FORMER DEW LINE SITE

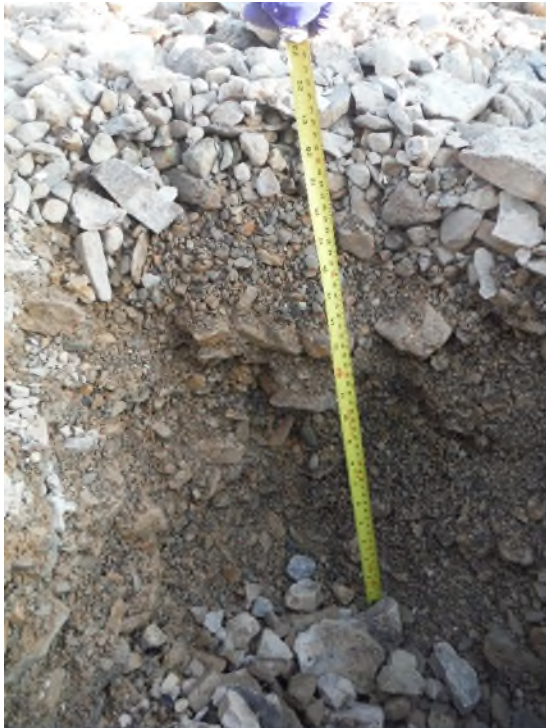
Photo 1 – Sample media at C1-33

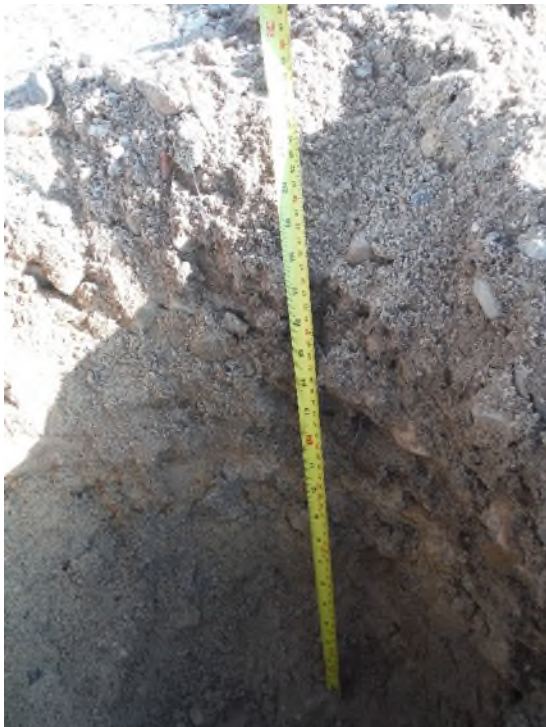
Photo 2 – Sample media at C1-15

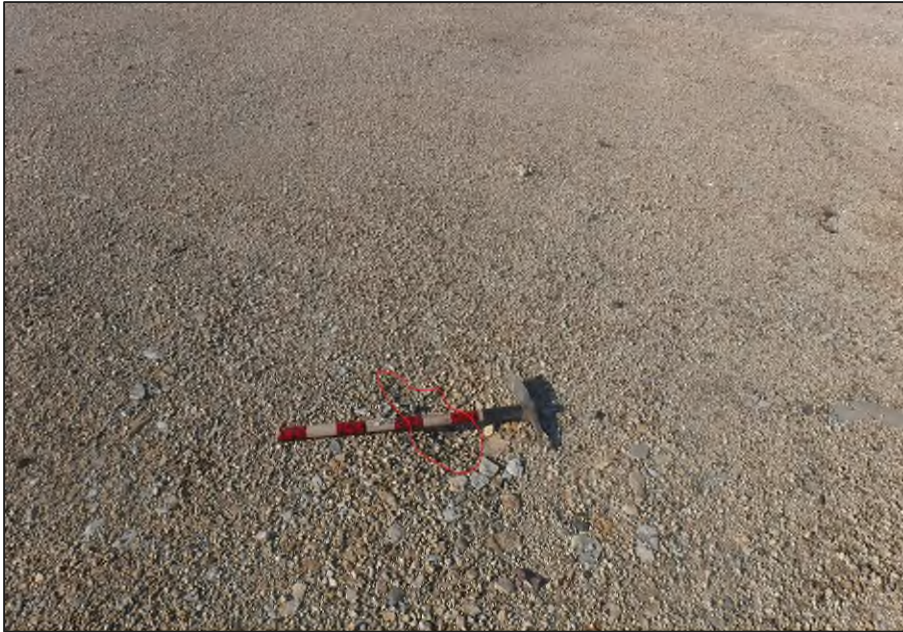
Photo: CAM-1 BAN-12
(Borrow Area North
Landfill)

Description:
View of Settlement
Feature "H" – looking
East.

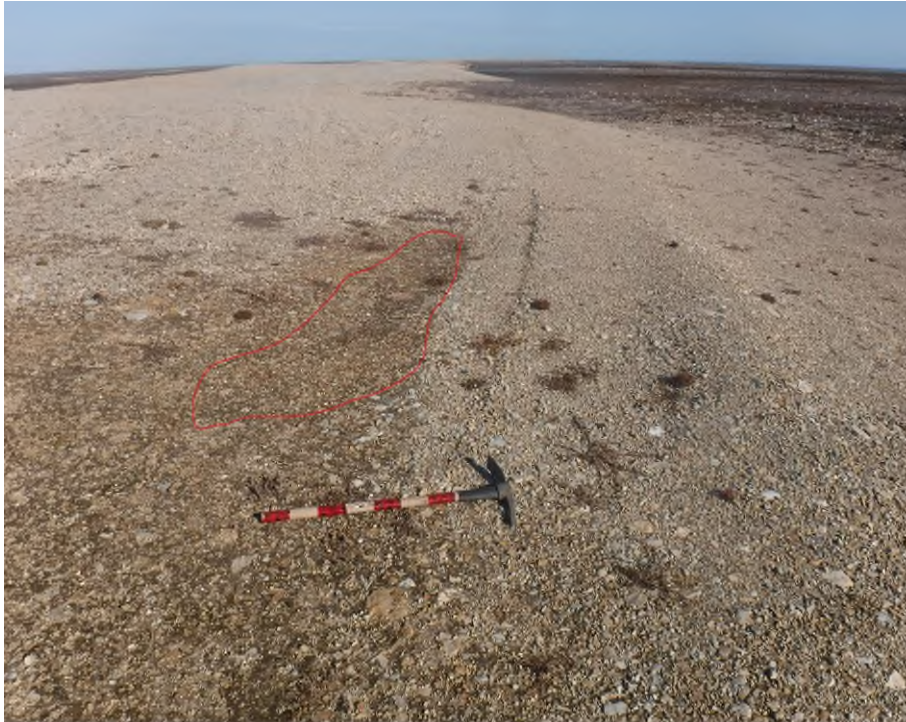
Photo: CAM-1 BAN-39
(Borrow Area North Landfill)

Description:
Minor settlement on east side of Lobes 4 and 5 at Landfill (Feature I)– view towards North. Also shows sparse vegetation (Feature Q)

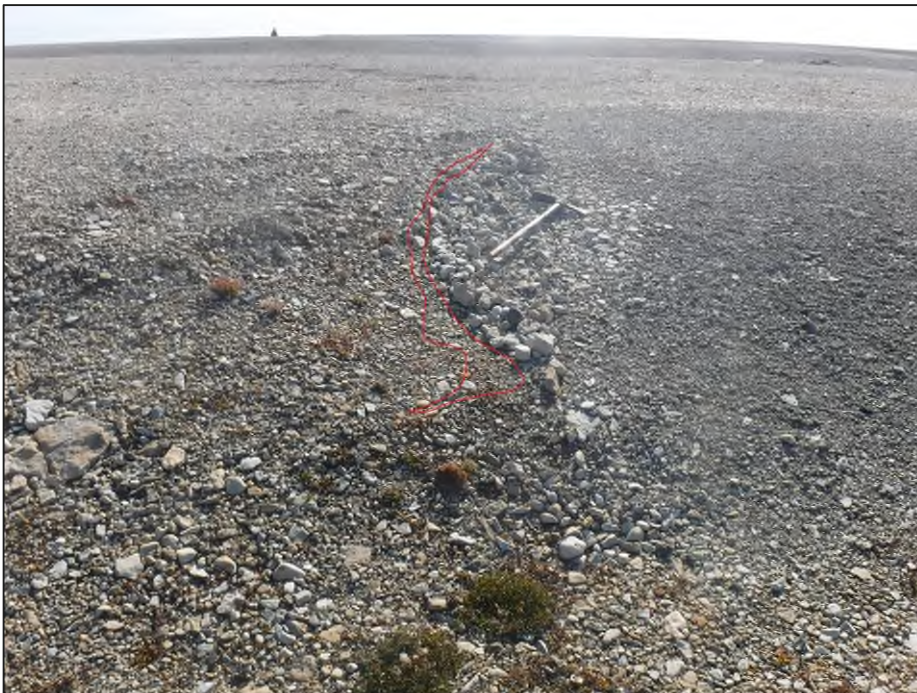
**Photo: CAM-1 NE-18
(Northeast Landfill)**

Uneven side slope on west side slope of Lobes 1 and 3 (Feature B) – looking South.

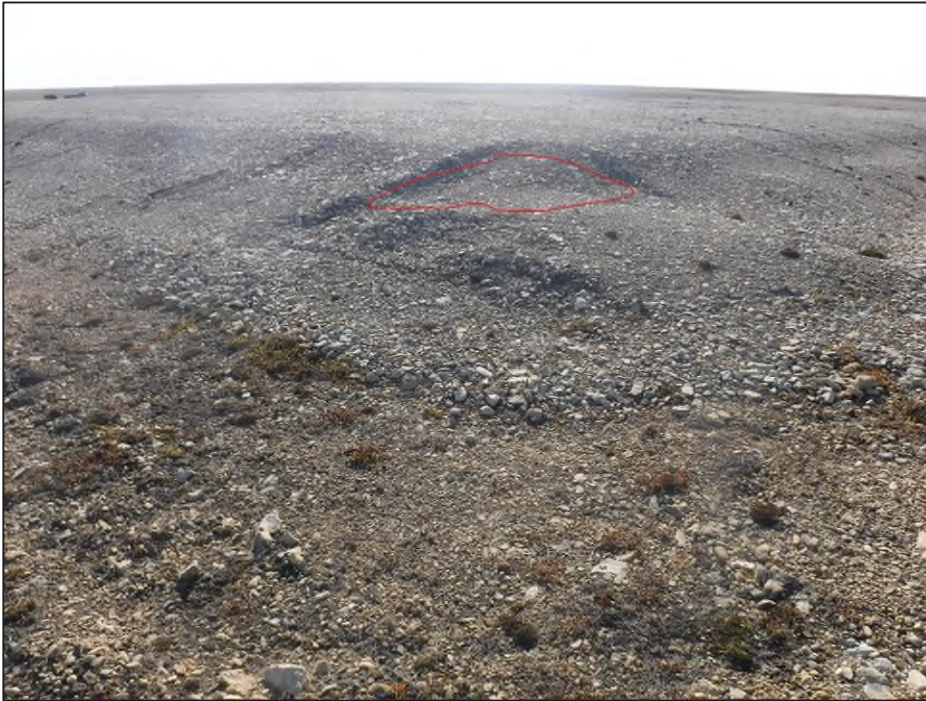
**Photo: CAM-1 NE-30
(Northeast Landfill)**

Minor erosion on north side slope of Lobes 1 and 3 (Feature C) – looking Southeast.

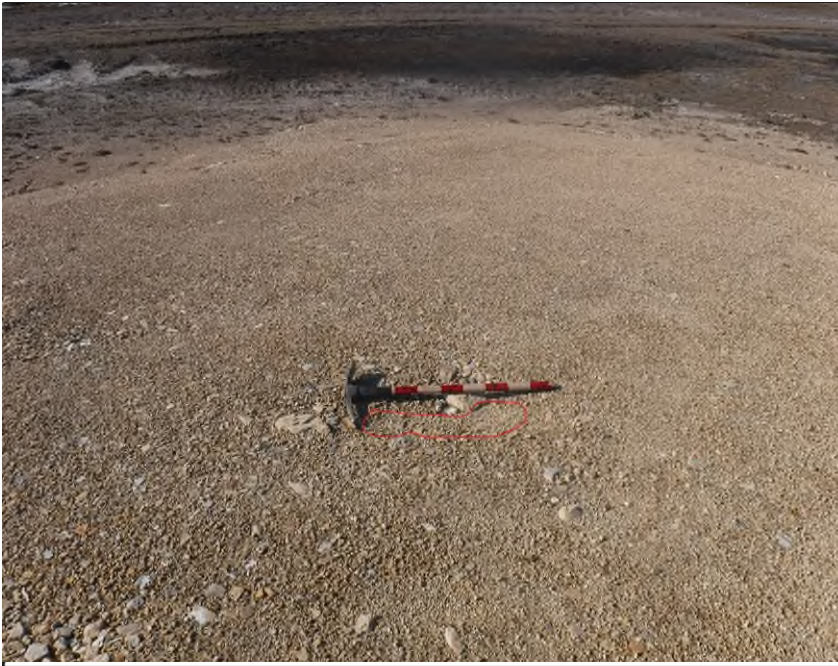
Photo: CAM-1 STNW-33 (Station West Landfill)

Minor settlement on northwest landfill cover (Feature N)-looking NE

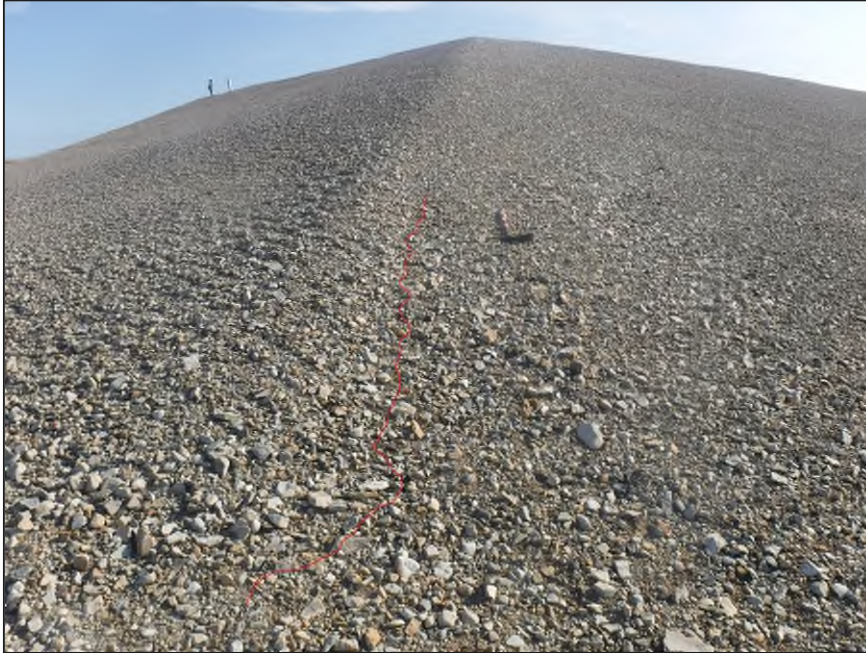
Photo: CAM-1 T2-26
(Tier II Disposal Facility)

Description:
Minor erosion channel
on north corner of DF –
looking S (Feature B1-
Erosion).

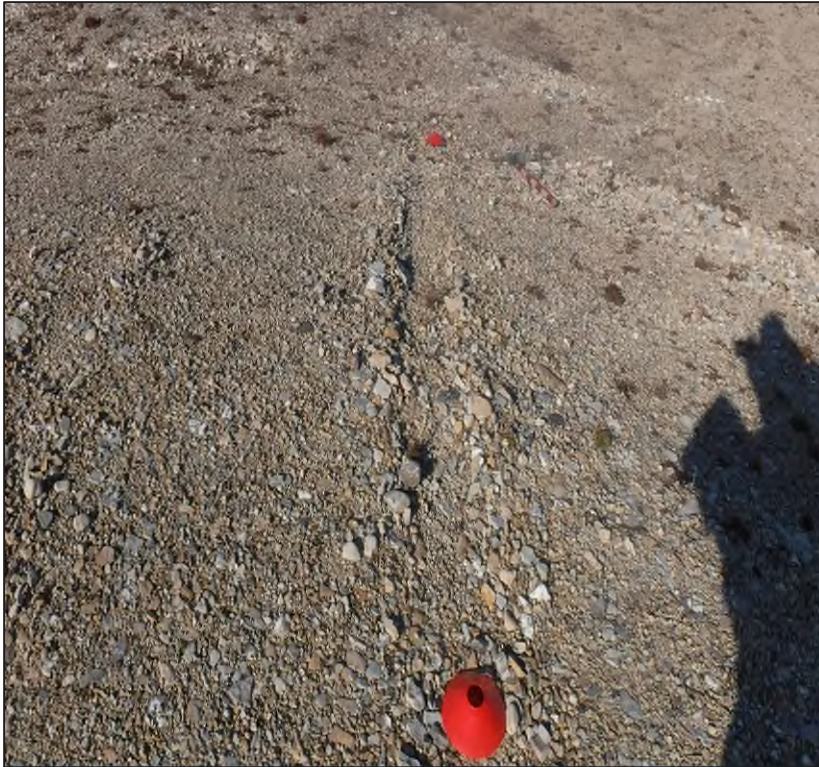
**Photo: CAM-1 SE-4
(Southeast Landfill)**

Description:
West side slope Lobe 1 –
Vehicle Ruts (Feature D)
– looking NW.

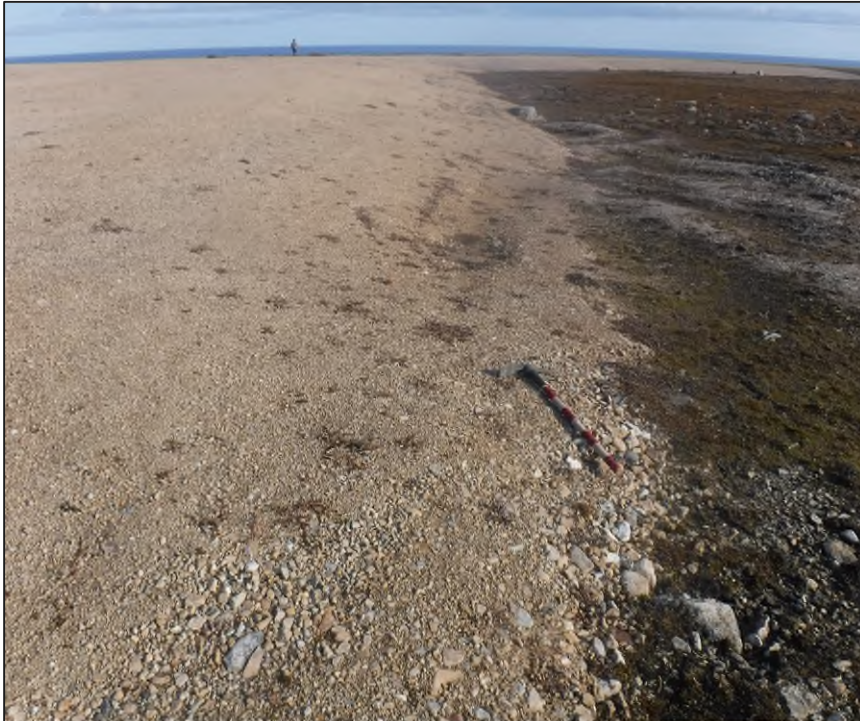
**Photo: CAM-1 STNE-2
(Station East Landfill)**

Southwest side slope
toe of landfill – looking
SE.

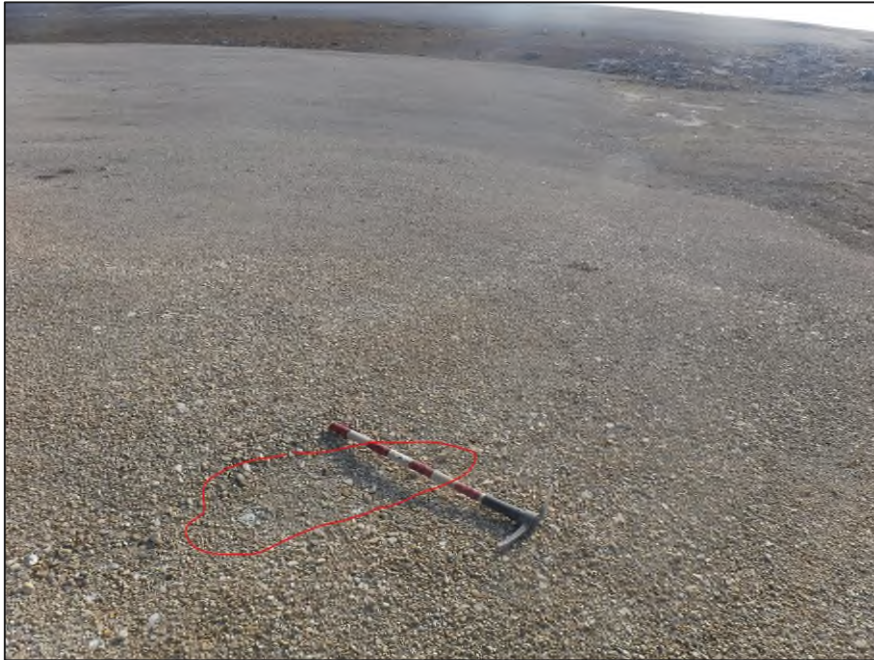
**Photo: CAM-1 STNE-11
(Station East Landfill)**

Minor settlement on
West landfill cover
(Feature C2)— looking
SW.

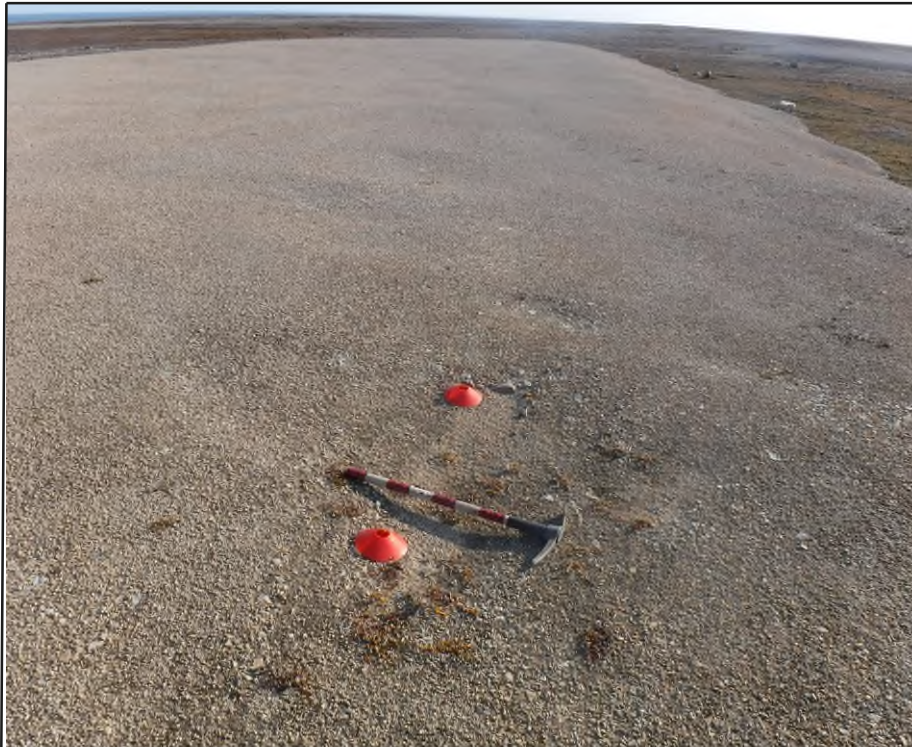
**Photo: CAM-1 STNE-36
(Station East Landfill)**

Minor settlement on southwest cover – looking S (Feature A3).

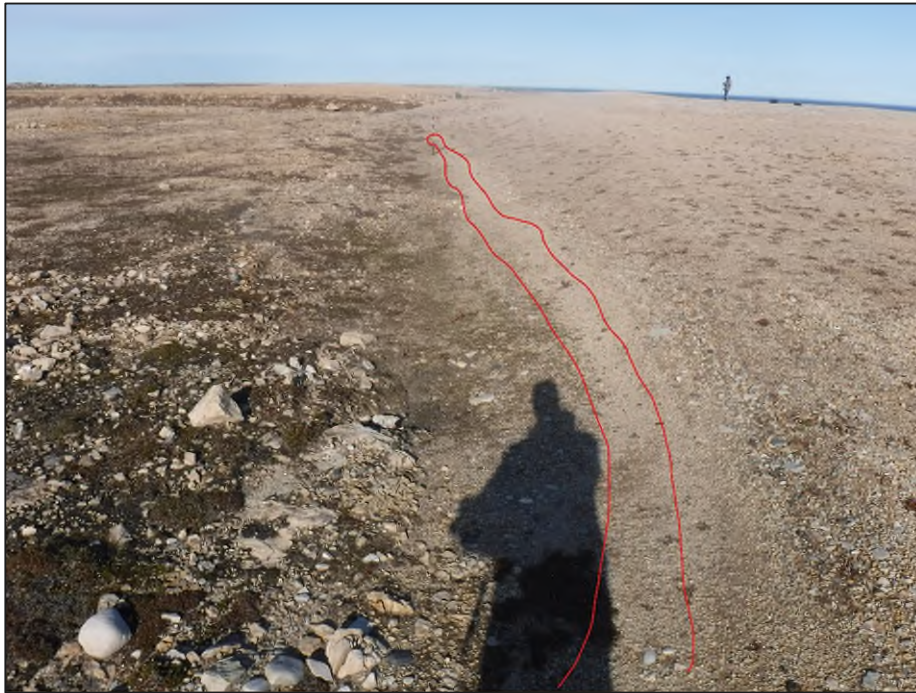
**Photo: CAM-1 Main-6
(Main Landfill)**

Minor erosion on toe of northwest side slope—looking NE (Feature D). Washing of fines/ beach sand formation during spring ponding.

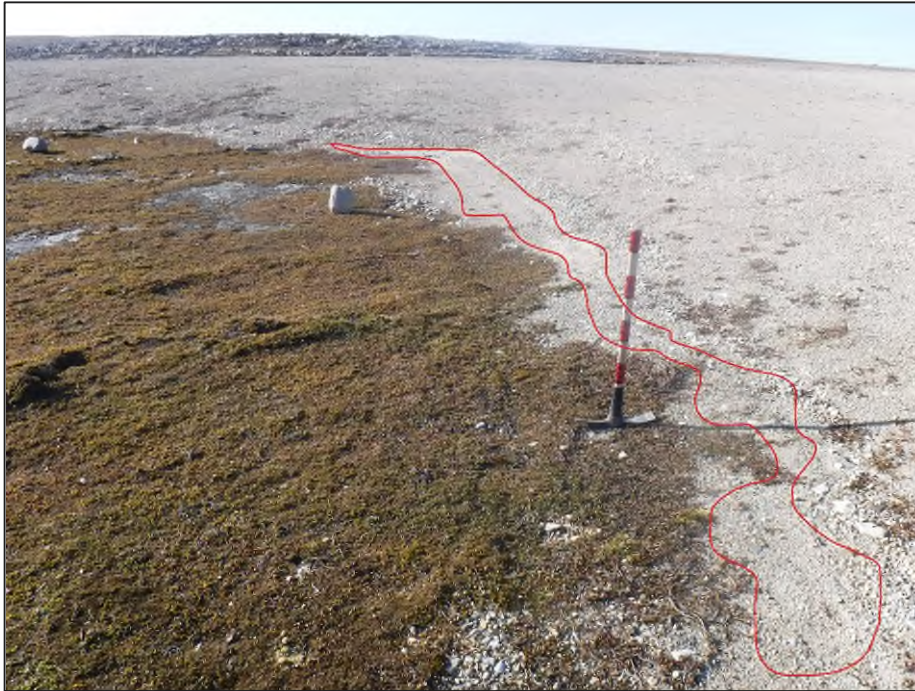
**Photo: CAM-1 Main-17
(Main Landfill)**

Minor erosion on southwest side toe of slope of landfill– looking NW (Feature E). Washing of fines/ beach sand formation during spring ponding.

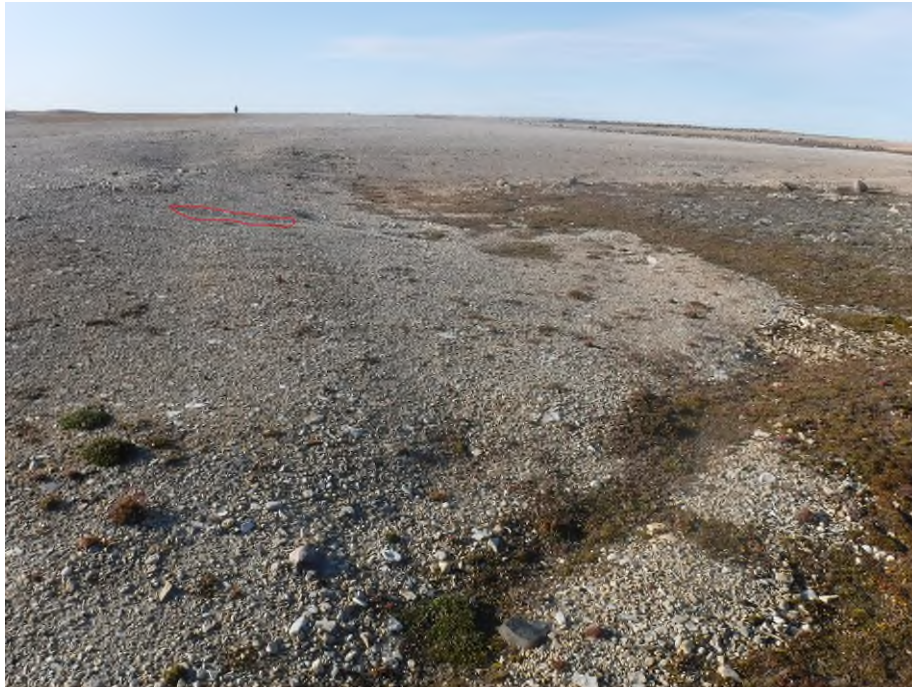
**Photo: CAM-1 Main-31
(Main Landfill)**

Minor depression on southeast side slope – looking NW (Feature C3 shown).

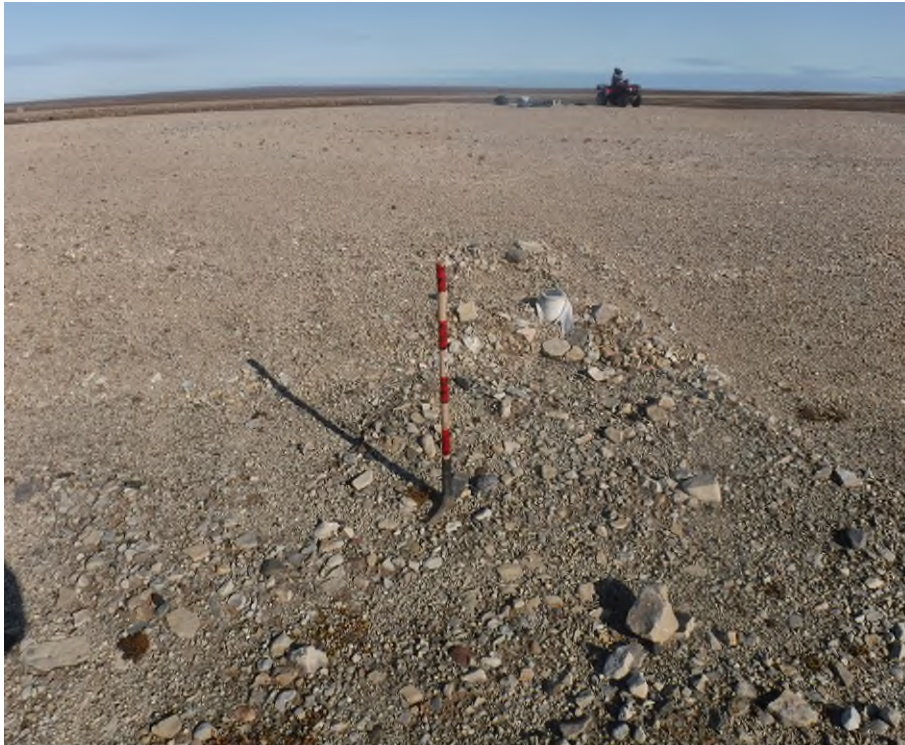
**Photo: CAM-1 USAF-9
(USAF Landfill)**

Corner marker post for
USAF landfill located
south of Lobe 1 –
looking N.

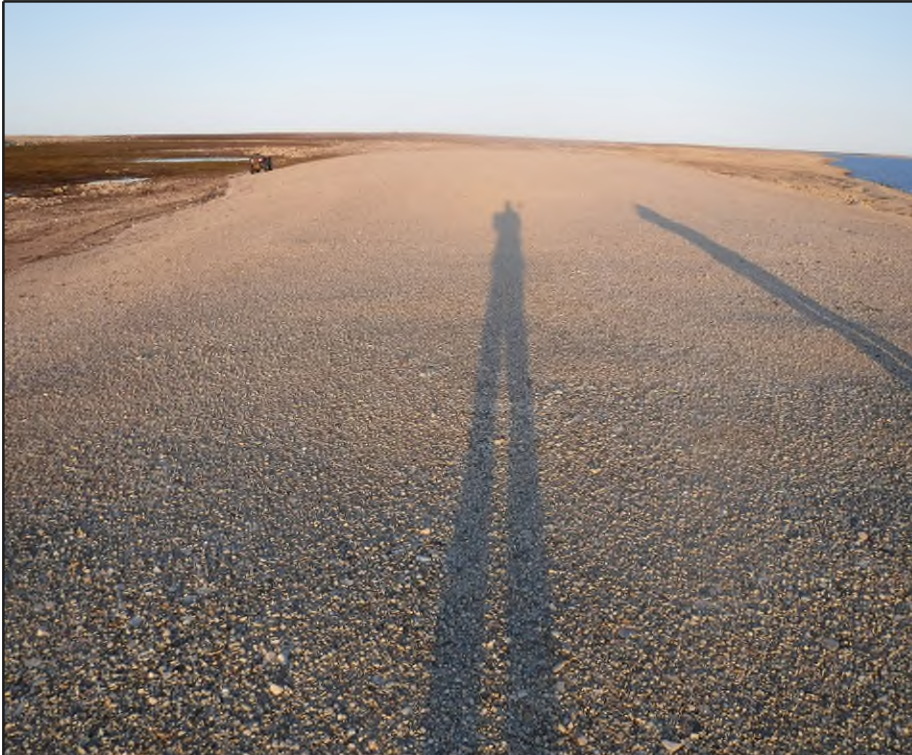
**Photo: CAM-1 EL-4
(East Landing Landfill)**

Description:
North side of East
Landing landfill –
looking E.

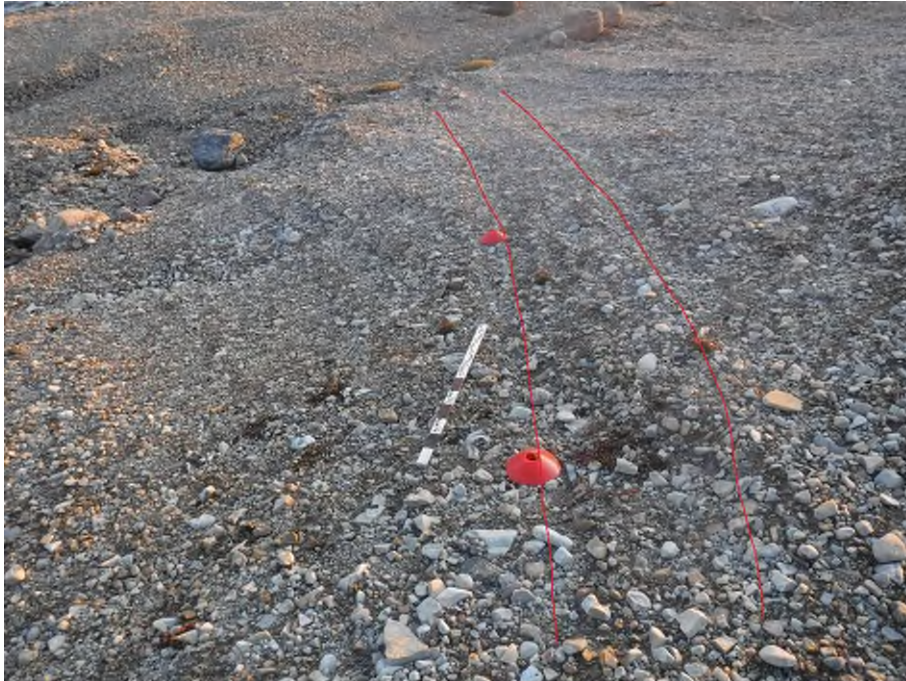
**Photo: CAM-1 EL-26
(East Landing Landfill)**

ATV tire ruts on
southeast side slope of
East Landing landfill –
looking SW (Feature D).

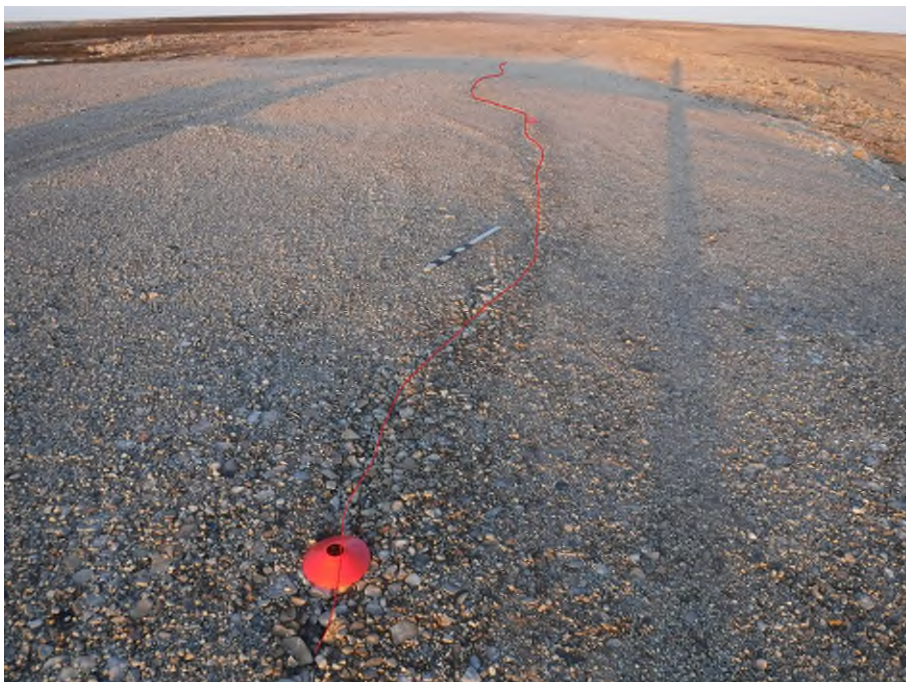
**Photo: CAM-1 EL-29
(East Landing Landfill)**

Tension crack on
southeast landfill cover–
looking ESE (Feature B).
