QIKIQ15 BAFFIN REGION DEW LINE SITE MONITORING

2017 CAM-5 Monitoring Report

Report Number: 1530908-3000-R3-V4

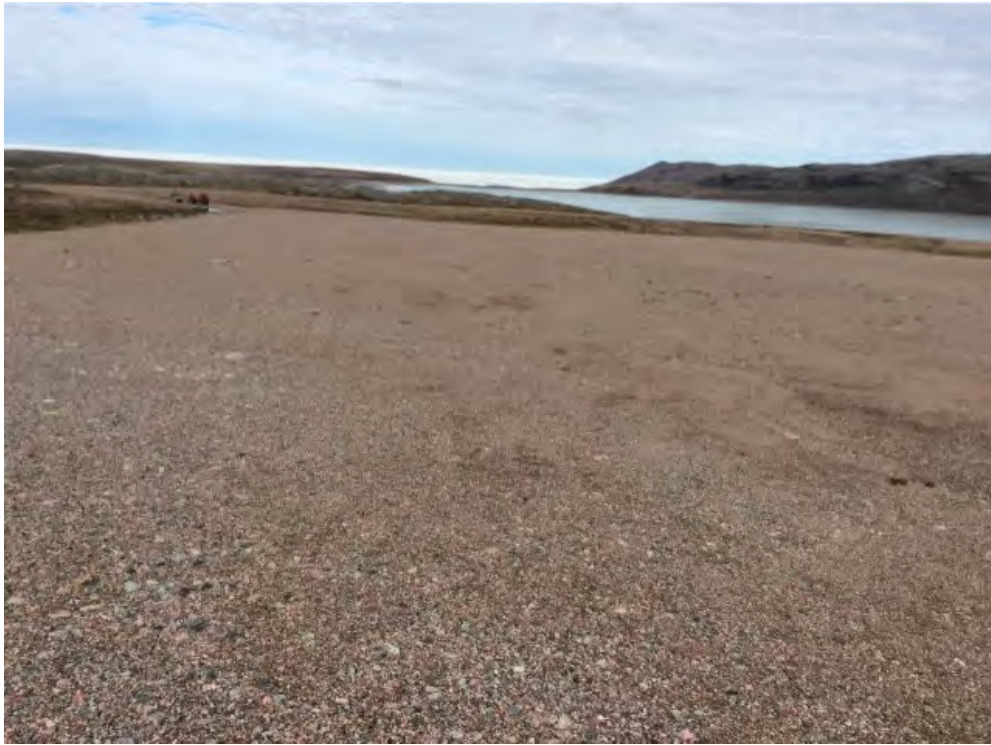
Photo 1: Lower Site Landfill South- Cover surface, facing northwest (CAM5_Photo192.jpg)

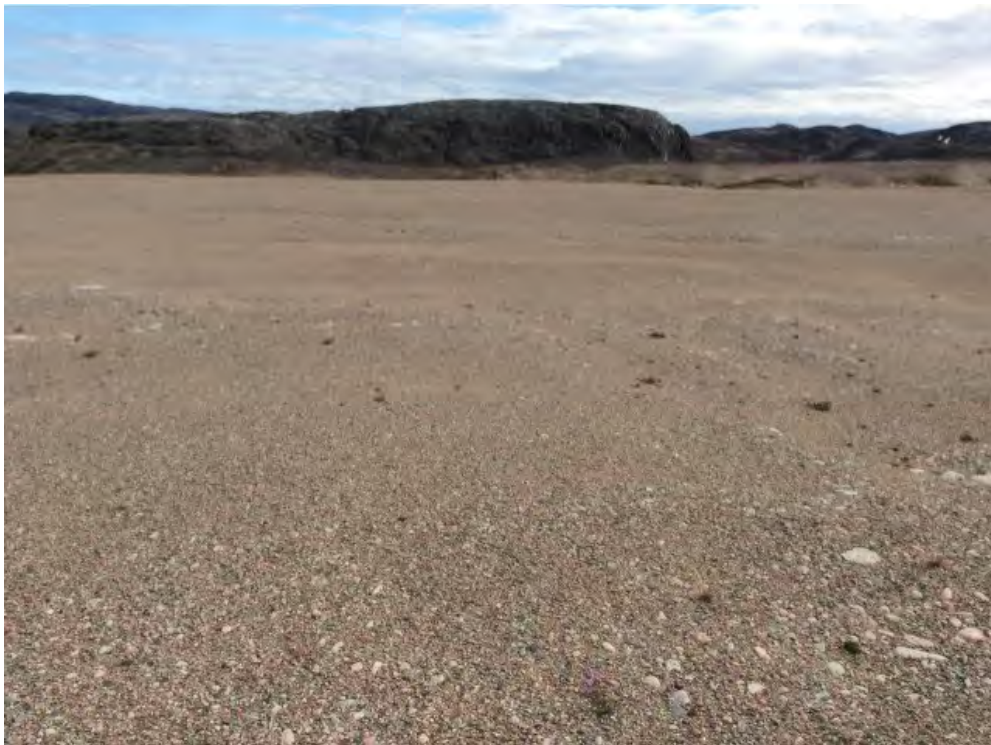
Photo 2: Lower Site Landfill South- Cover surface, facing northeast (CAM5_Photo194.jpg)

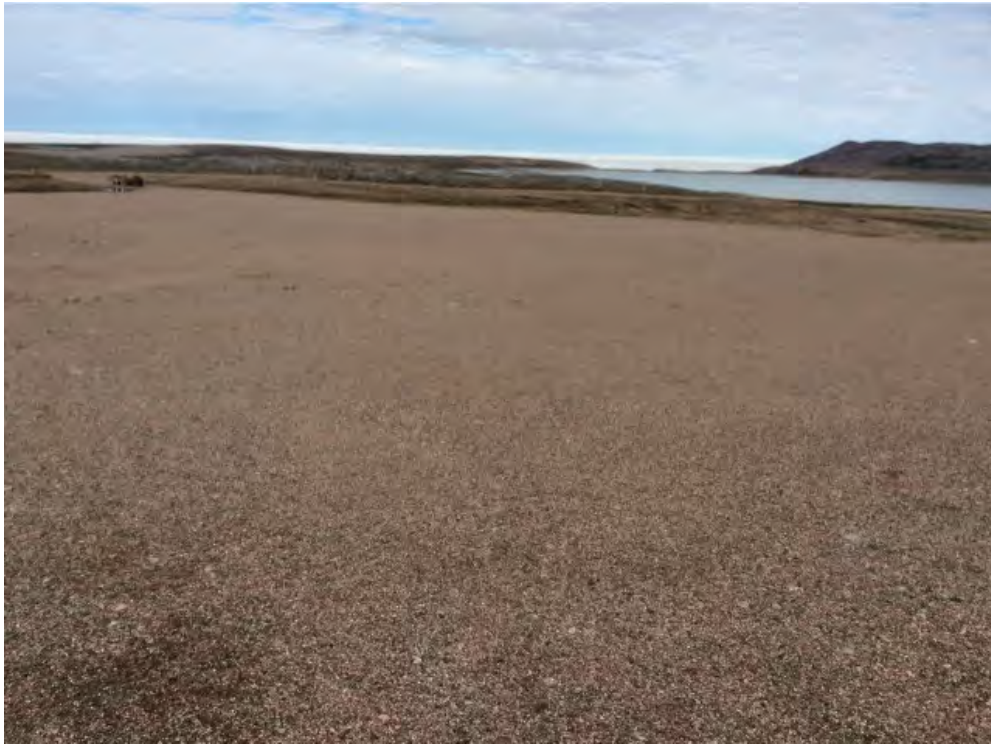
Photo 3: Lower Site Landfill South- Cover surface, facing northwest (CAM5_Photo195.jpg)

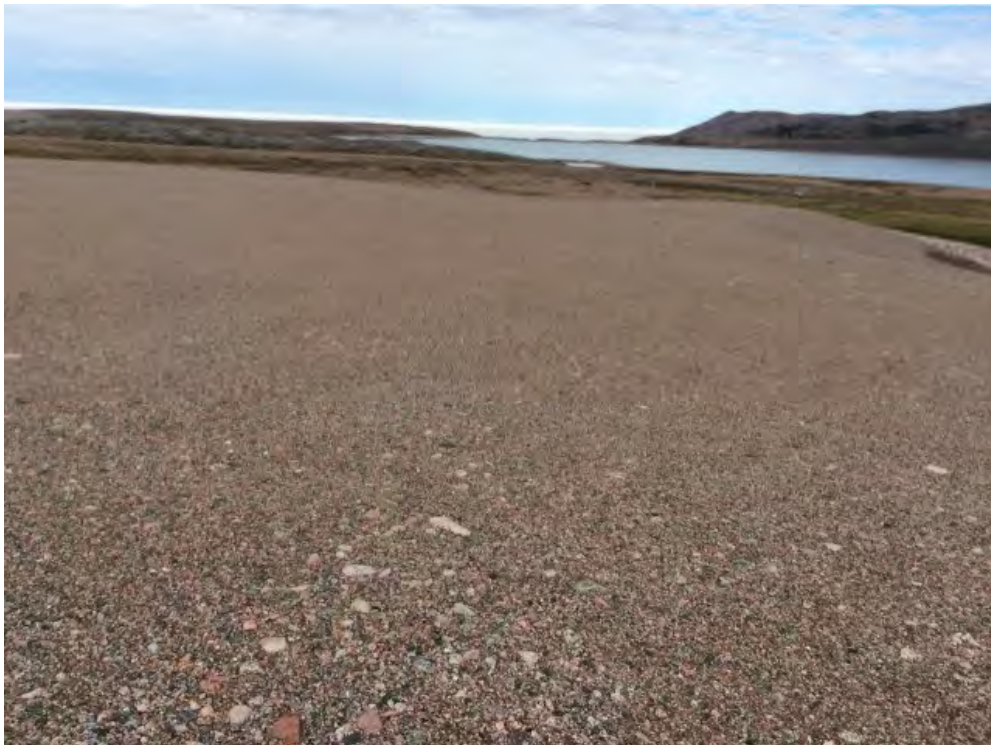
Photo 4: Lower Site Landfill South- Cover surface, facing northwest (CAM5_Photo197.jpg)

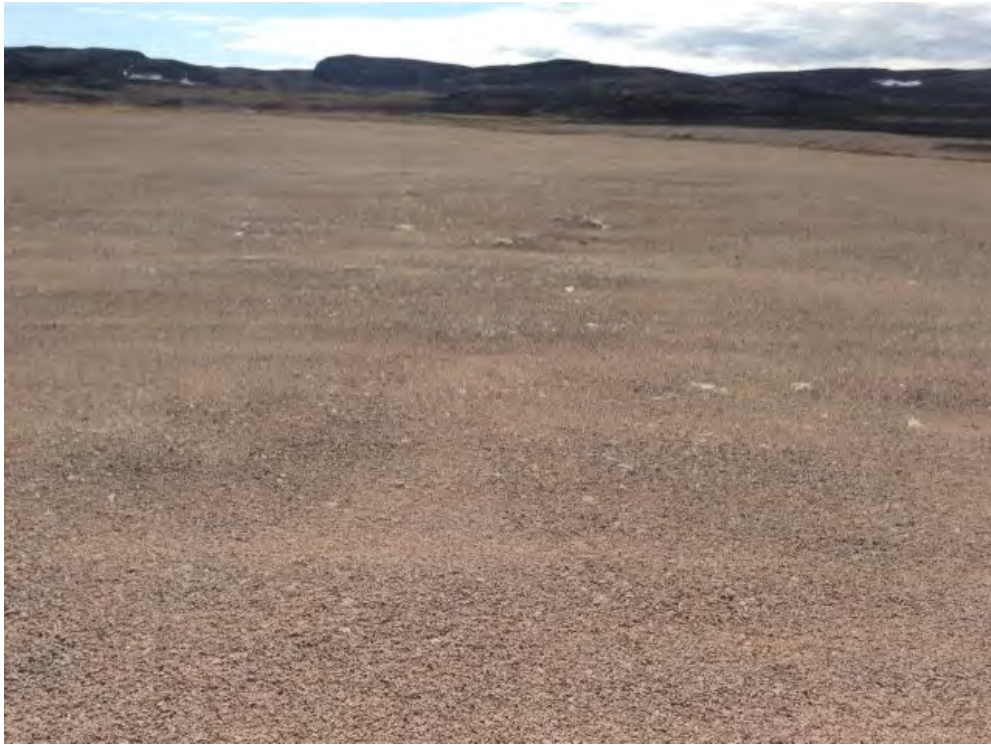
Photo 5: Lower Site Landfill South- Cover surface, facing southeast (CAM5_Photo202.jpg)

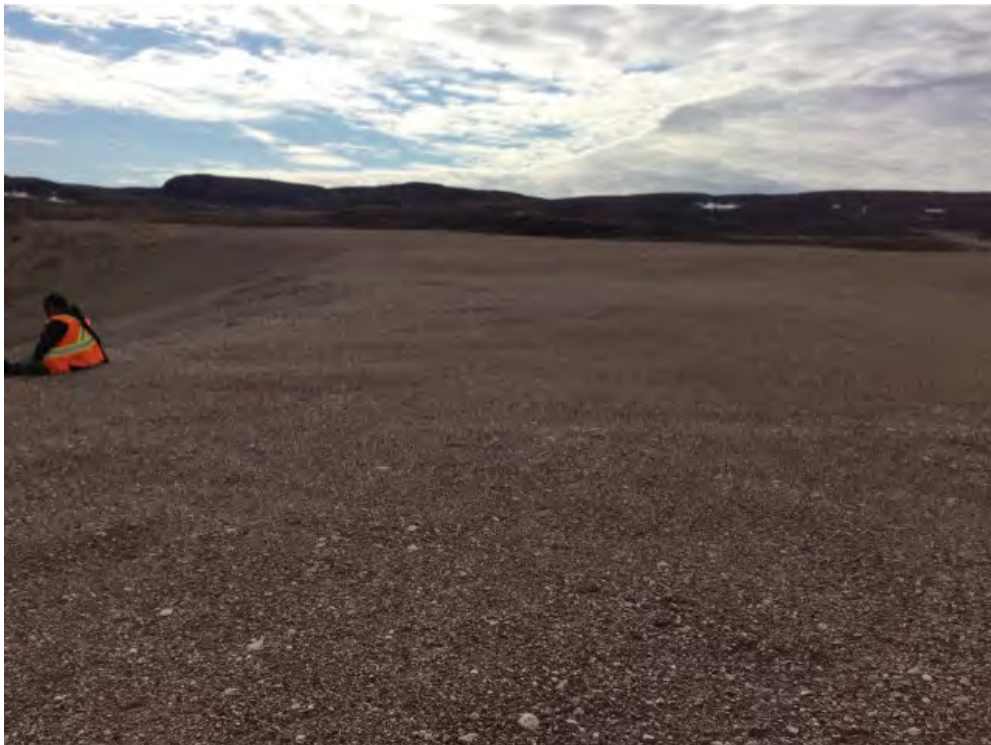
Photo 6: Lower Site Landfill South- Cover surface, facing south (CAM5_Photo204.jpg)

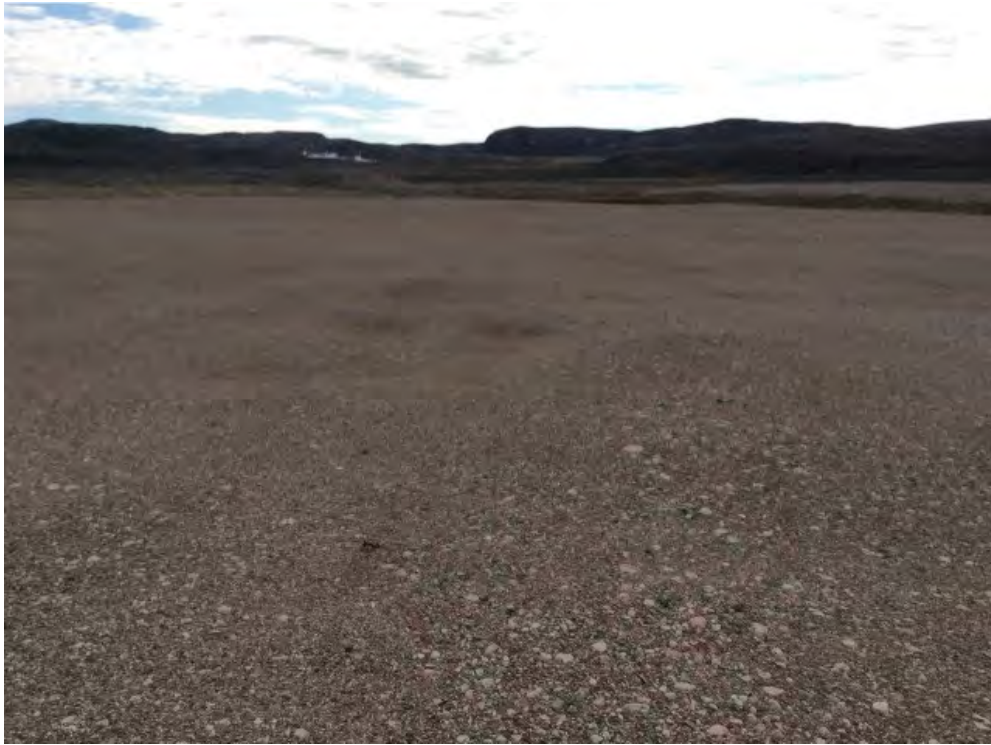
Photo 7: Lower Site Landfill South- Cover surface, facing southeast (CAM5_Photo208.jpg)

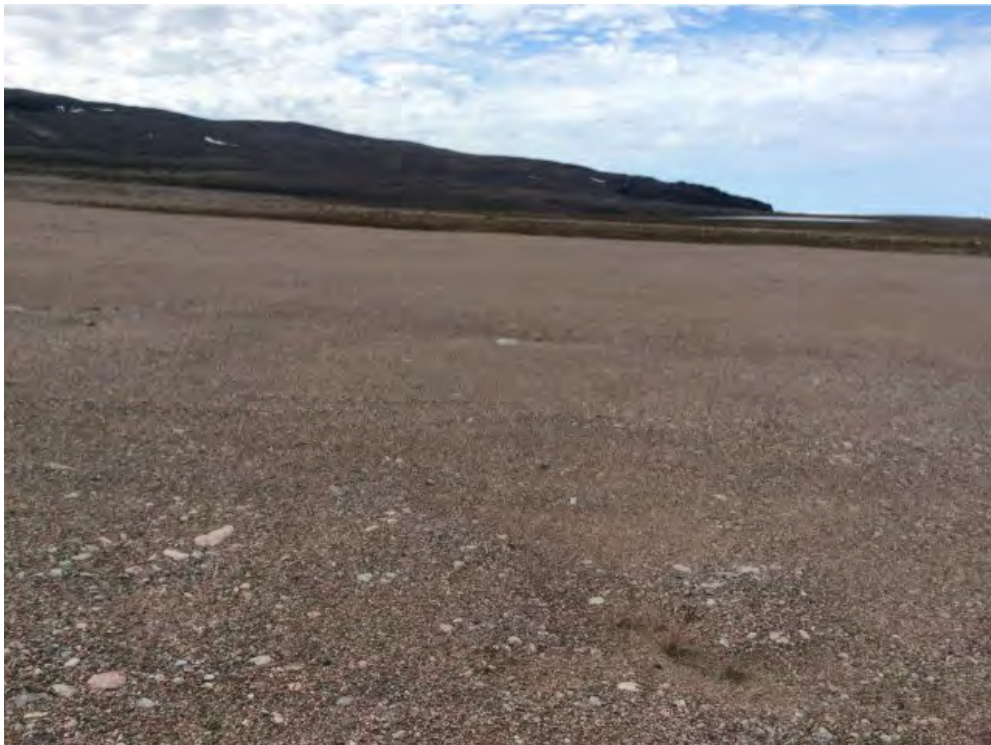
Photo 8: Lower Site Landfill South- Cover surface, facing west (CAM5_Photo209.jpg)

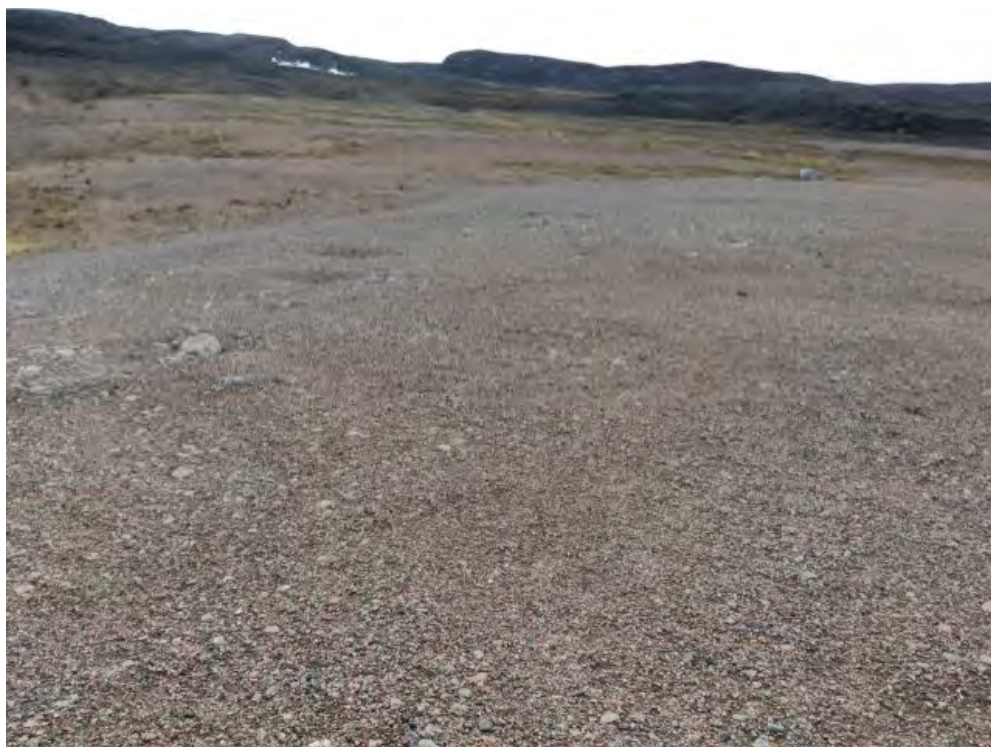
Photo 9: Lower Site Landfill South- East crest, facing south (CAM5_Photo199.jpg)

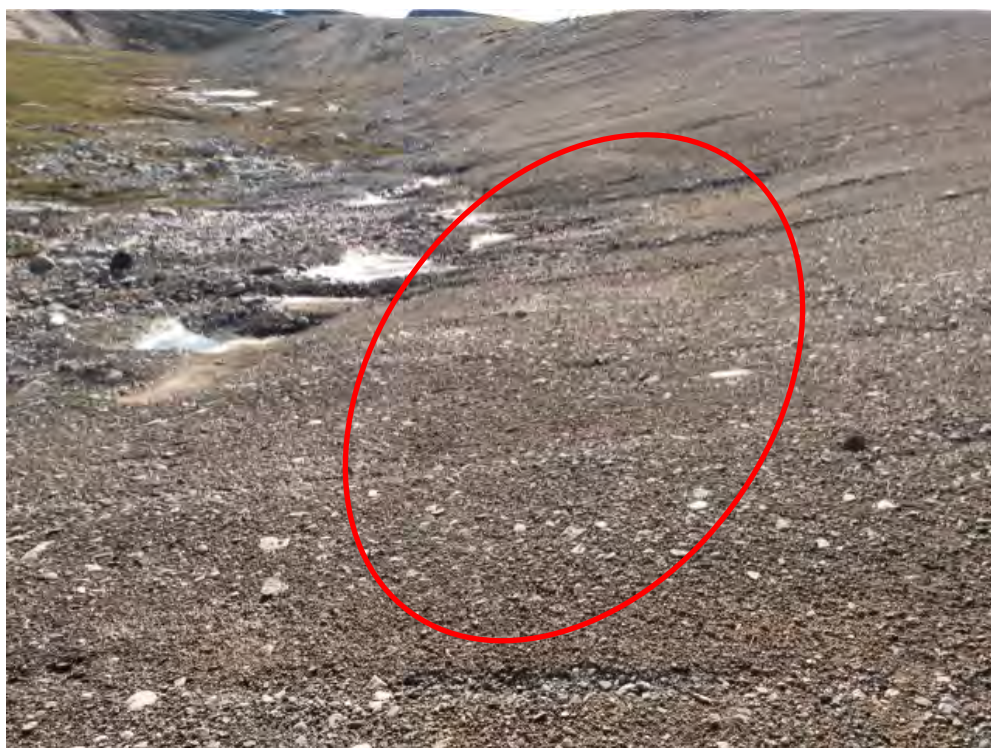
Photo 10: Lower Site Landfill South- East slope (north end of Feature W2-wet area), facing southeast (CAM5_Photo201.jpg)

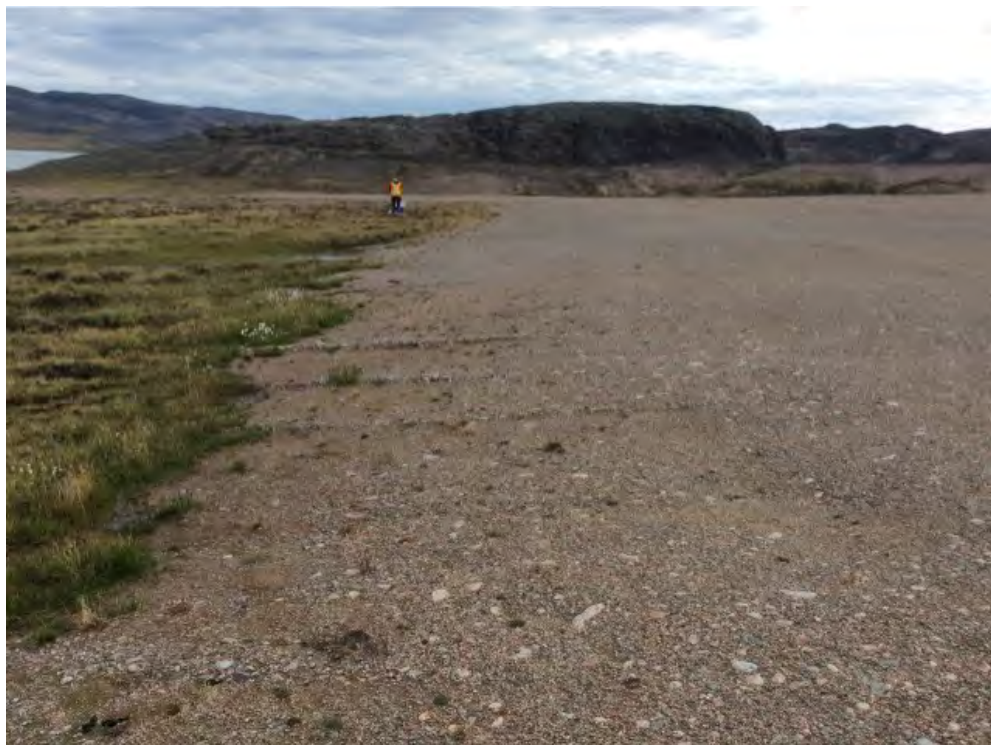
Photo 11: Lower Site Landfill South- northwest slope, facing northeast (CAM5_Photo190.jpg)

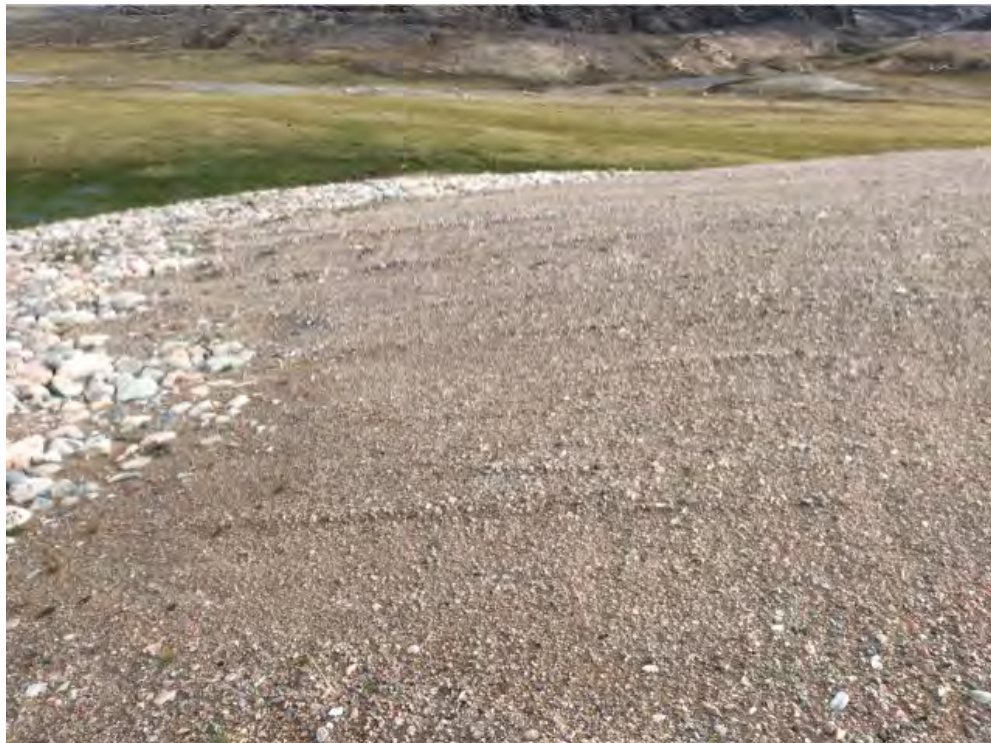
Photo 12: Lower Site Landfill South- North slope, facing east (CAM5_Photo205.jpg)

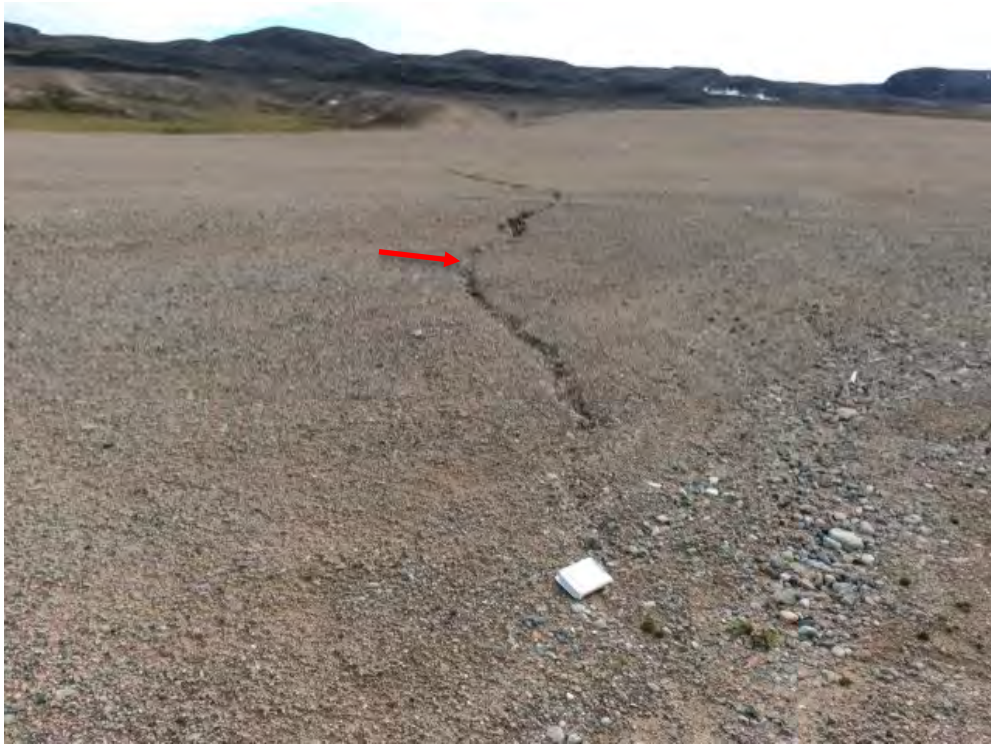
Photo 13: Lower Site Landfill South- Northwest slope (Feature S), facing southeast (CAM5_Photo206.jpg)

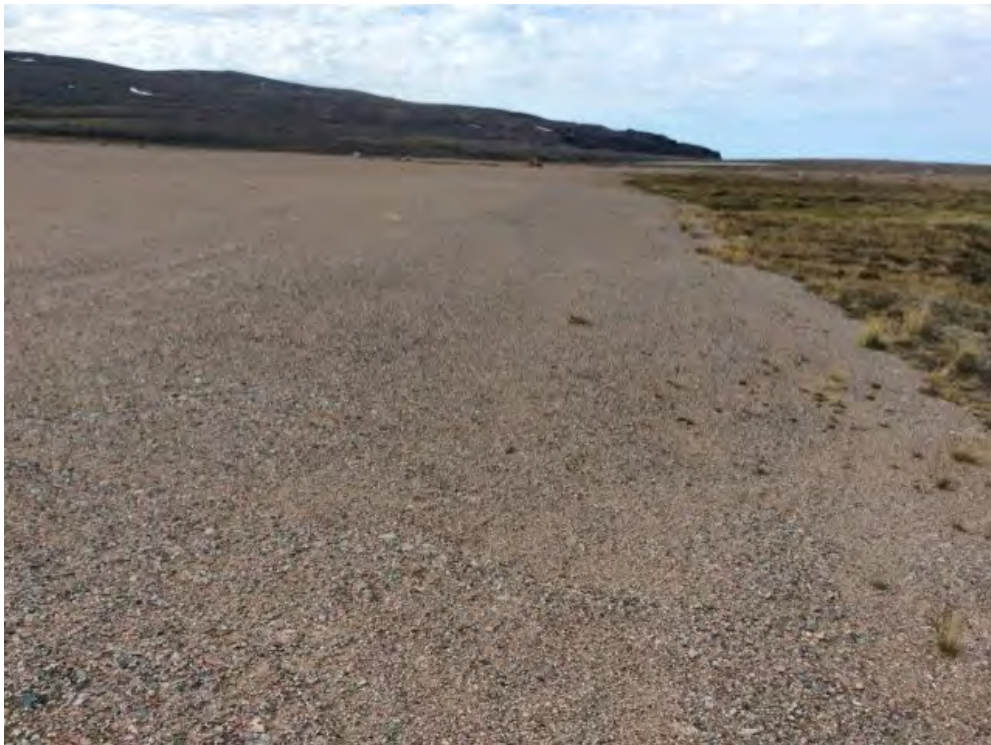
Photo 14: Lower Site Landfill South- Northwest slope, facing southwest (CAM5_Photo207.jpg)

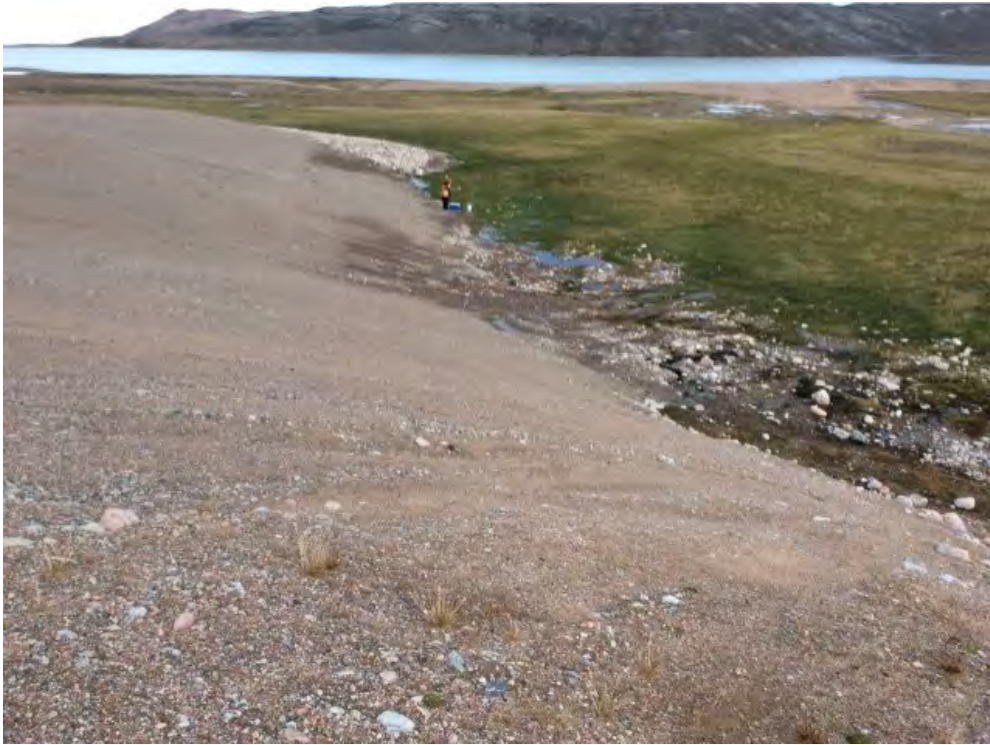
Photo 15: Lower Site Landfill South- East slope, facing northwest (CAM5_Photo200.jpg)

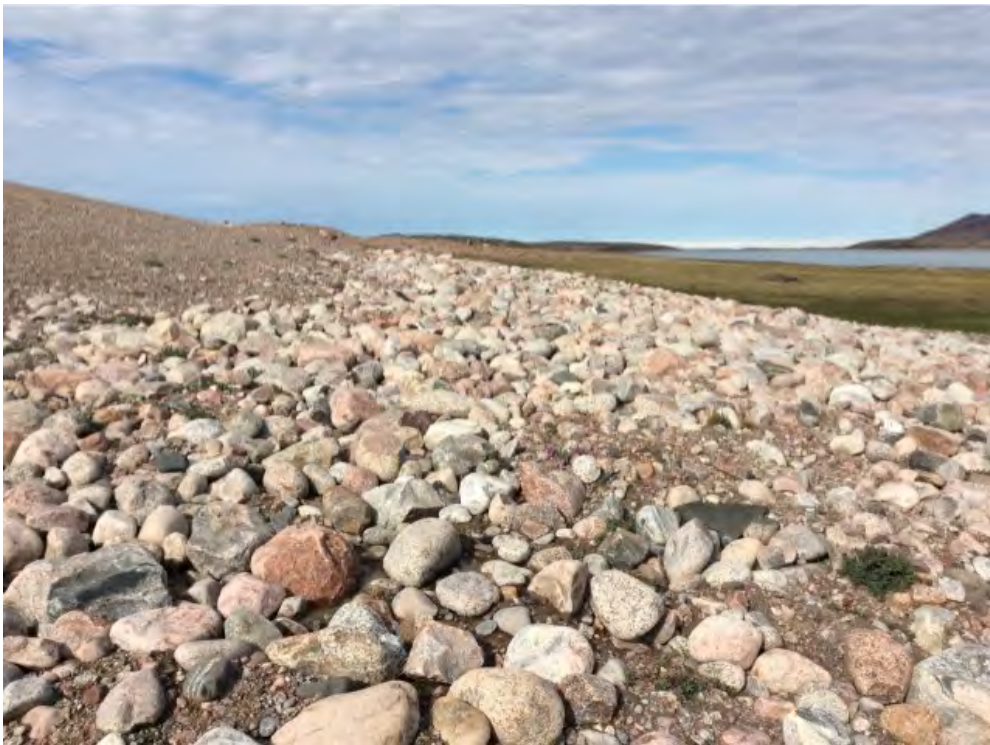
Photo 16: Lower Site Landfill South- Northeast slope, facing northwest (CAM5_Photo203.jpg)

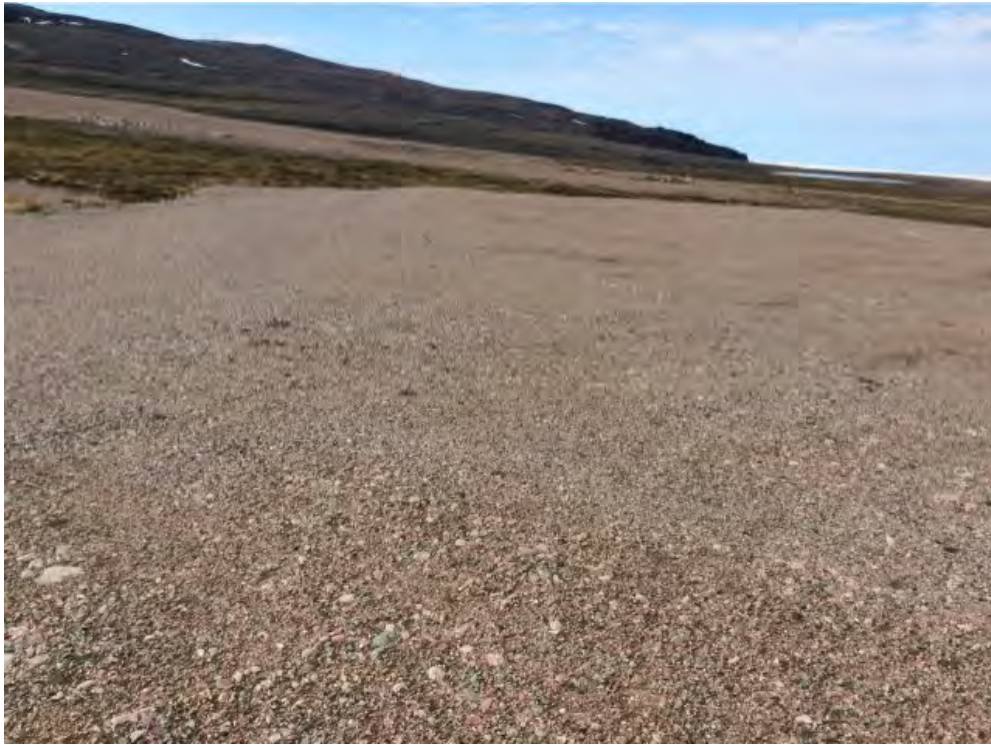
Photo 17: Lower Site Landfill South- South crest and slope, facing southwest (CAM5_Photo196.jpg)

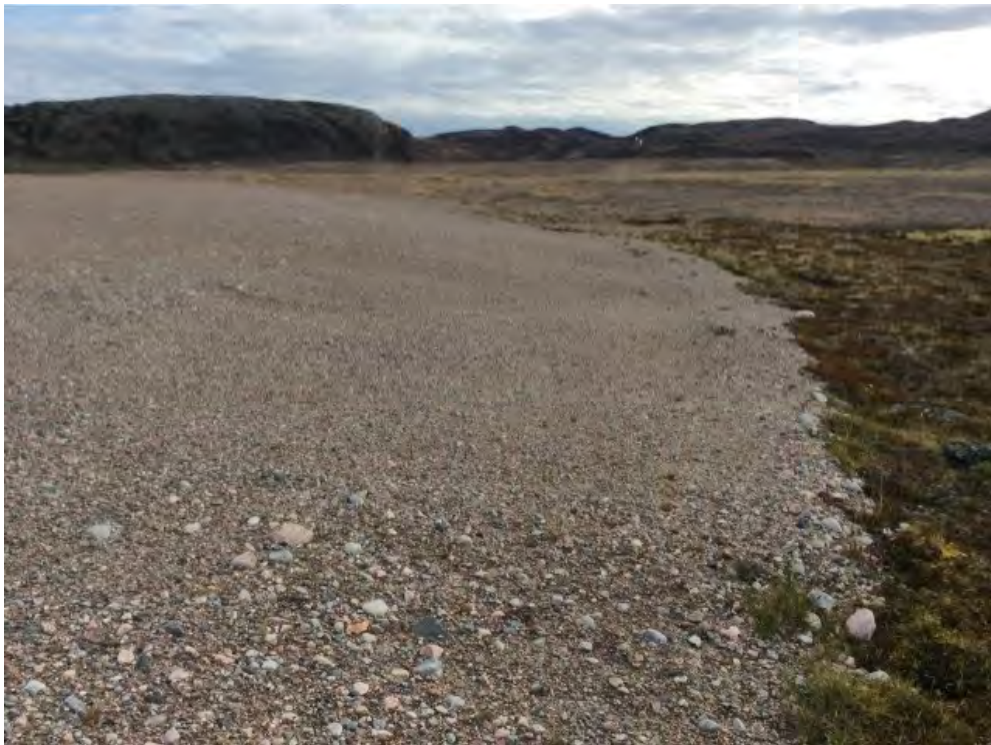
Photo 18: Lower Site Landfill South- South toe, facing northeast (CAM5_Photo193.jpg)

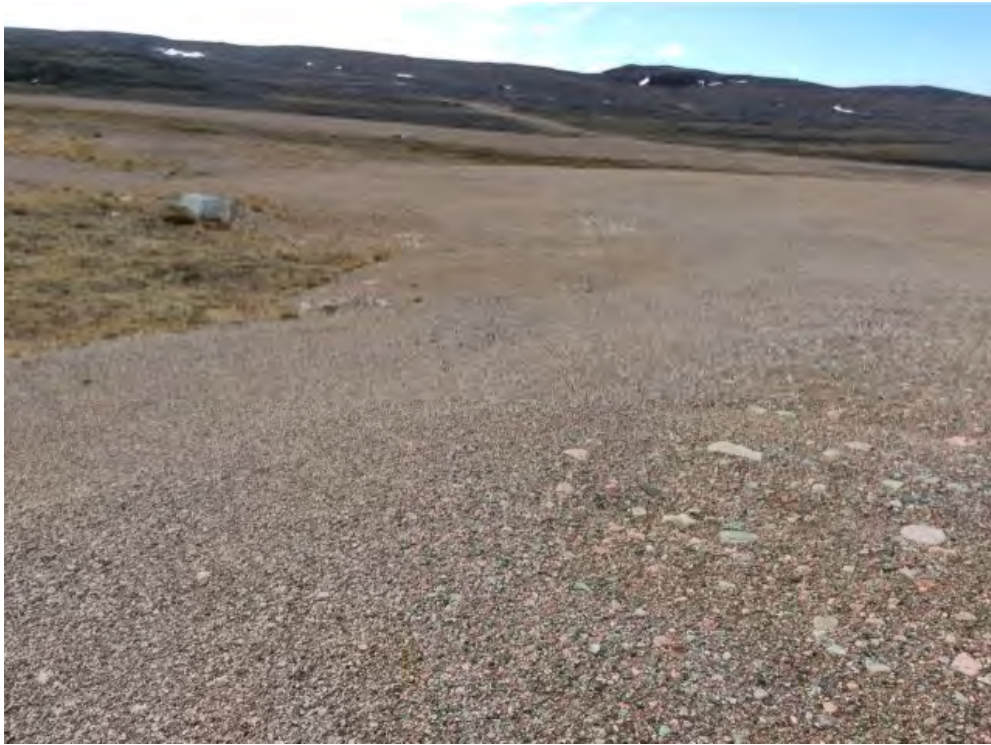
Photo 19: Lower Site Landfill South- Southeast slope, facing southwest (CAM5_Photo198.jpg)

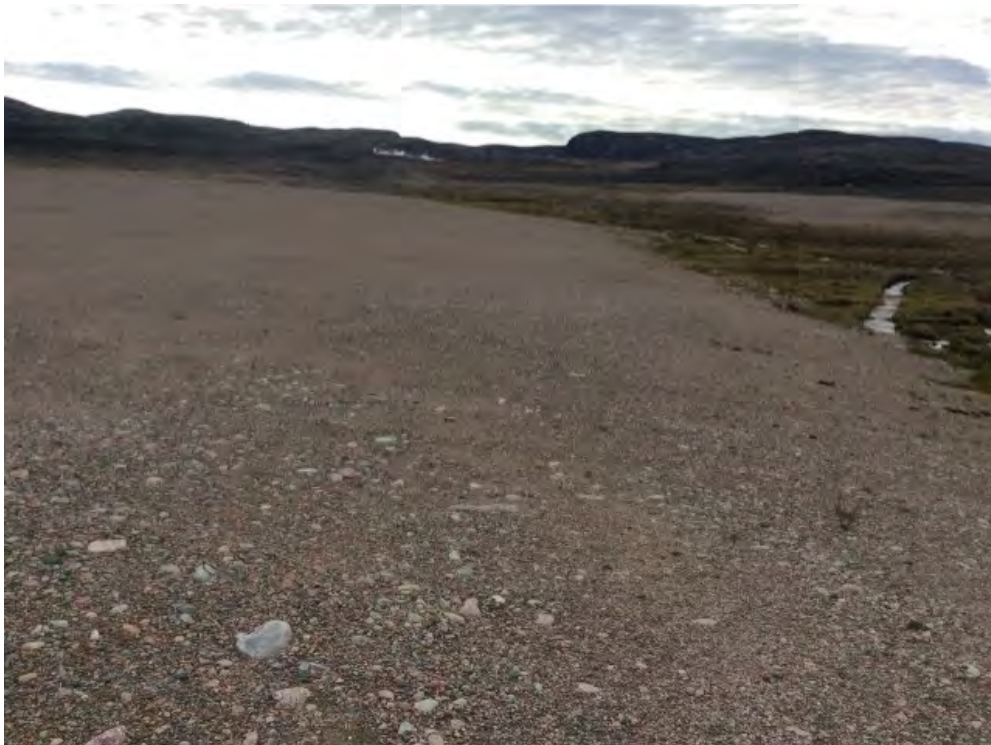
Photo 20: Lower Site Landfill South- West crest, facing southeast (CAM5_Photo191.jpg)

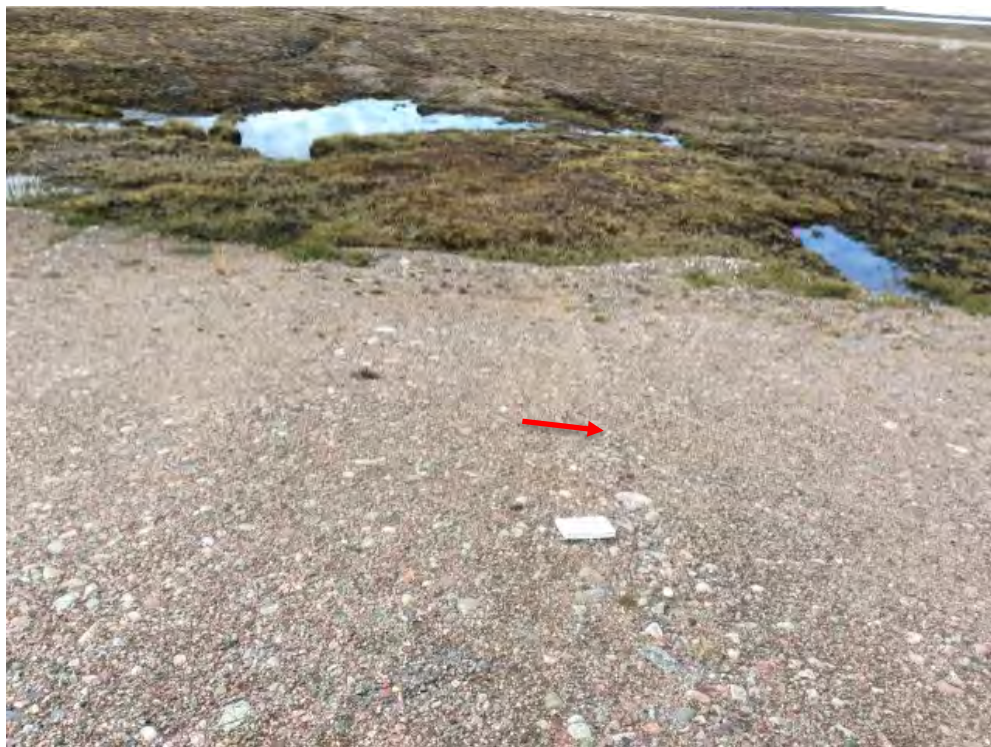
Photo 21: Lower Site Landfill South- West slope, Feature A4-Minor self-armouring erosion, facing southwest (Acceptable) (CAM5_Photo56.jpg)

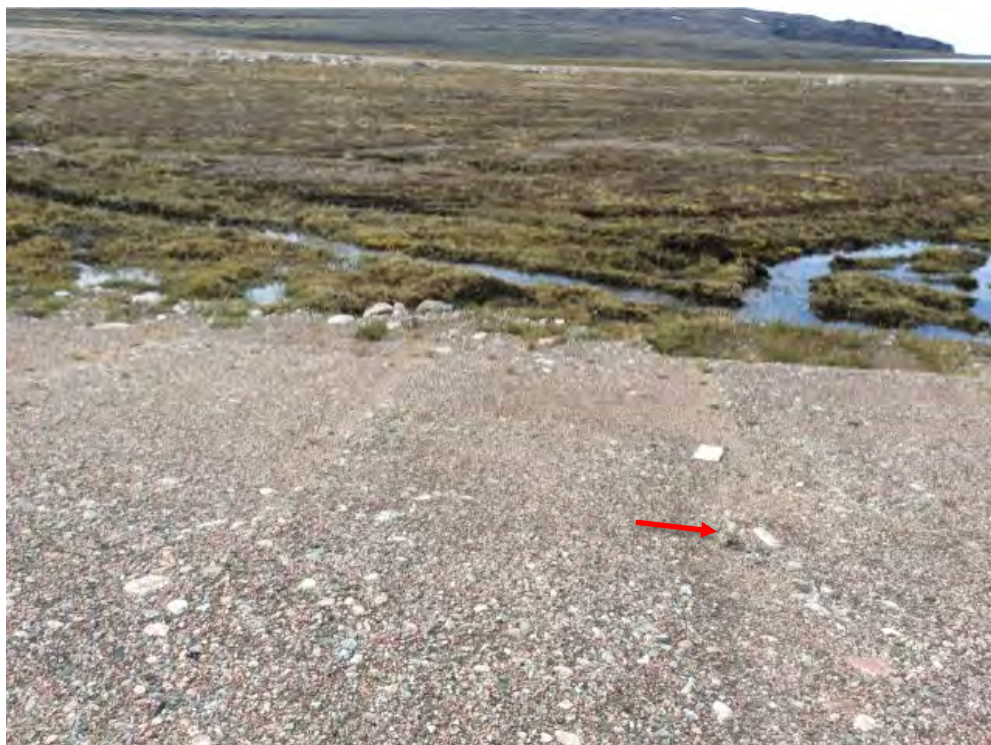
Photo 22: Lower Site Landfill South- West slope, Feature A3-Minor self-armouring erosion, facing southwest (Acceptable) (CAM5_Photo55.jpg)

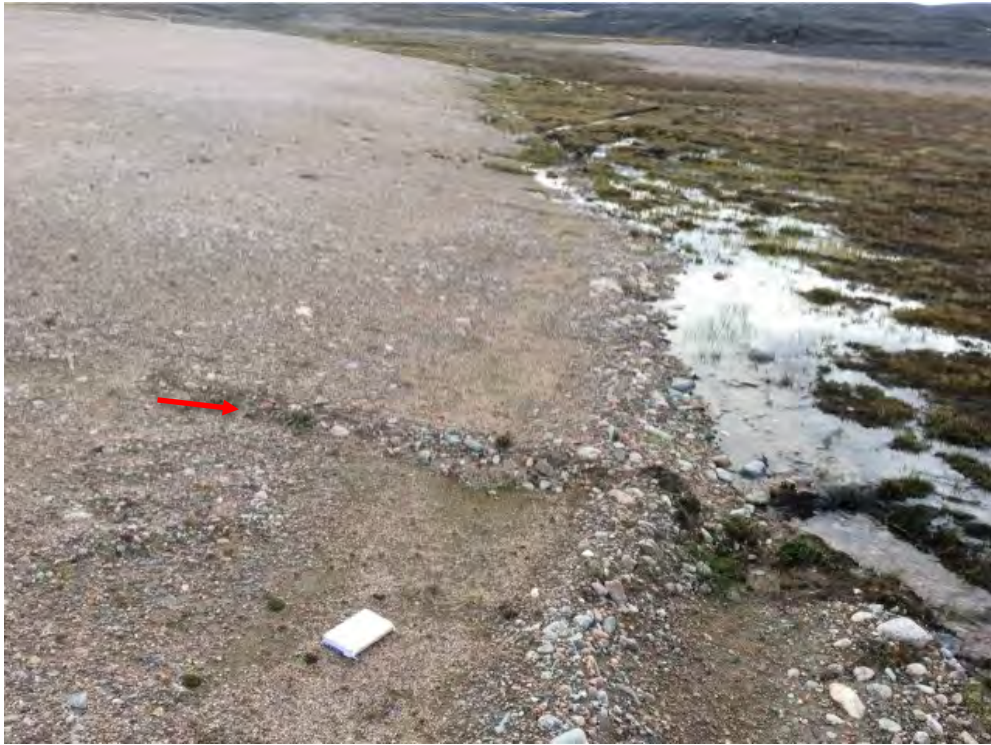
Photo 23: Lower Site Landfill South- West slope, Feature A2-Minor self-armouring erosion, facing southeast (Acceptable) (CAM5_Photo54.jpg)

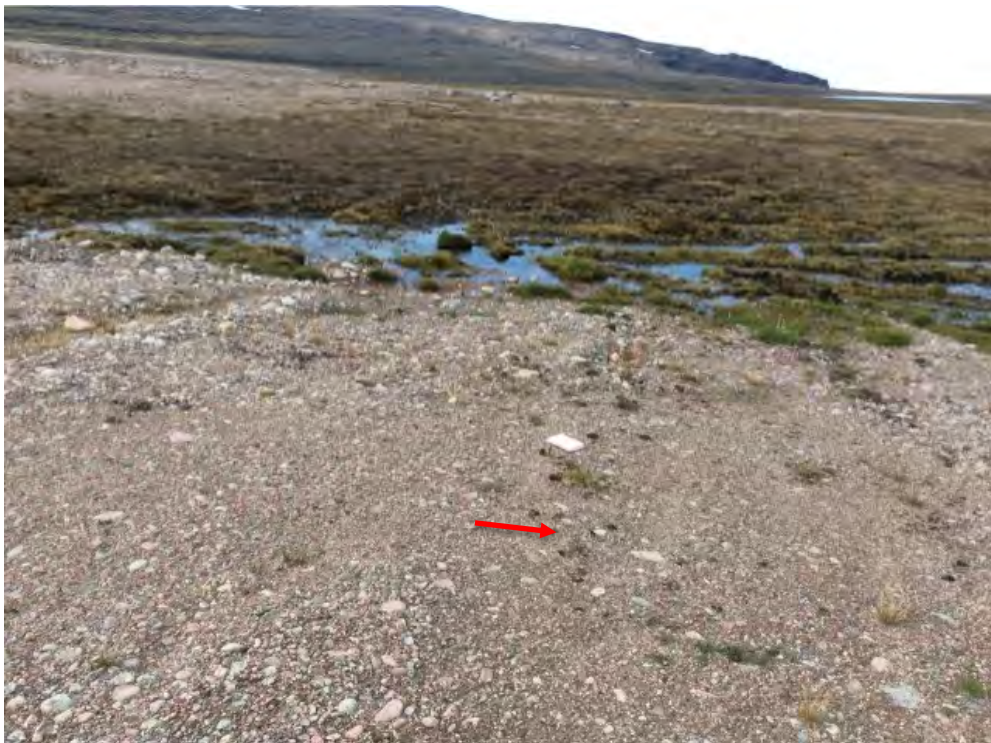
Photo 24: Lower Site Landfill South- West slope, Feature A5-Minor self-armouring erosion, facing southwest (Acceptable) (CAM5_Photo59.jpg)

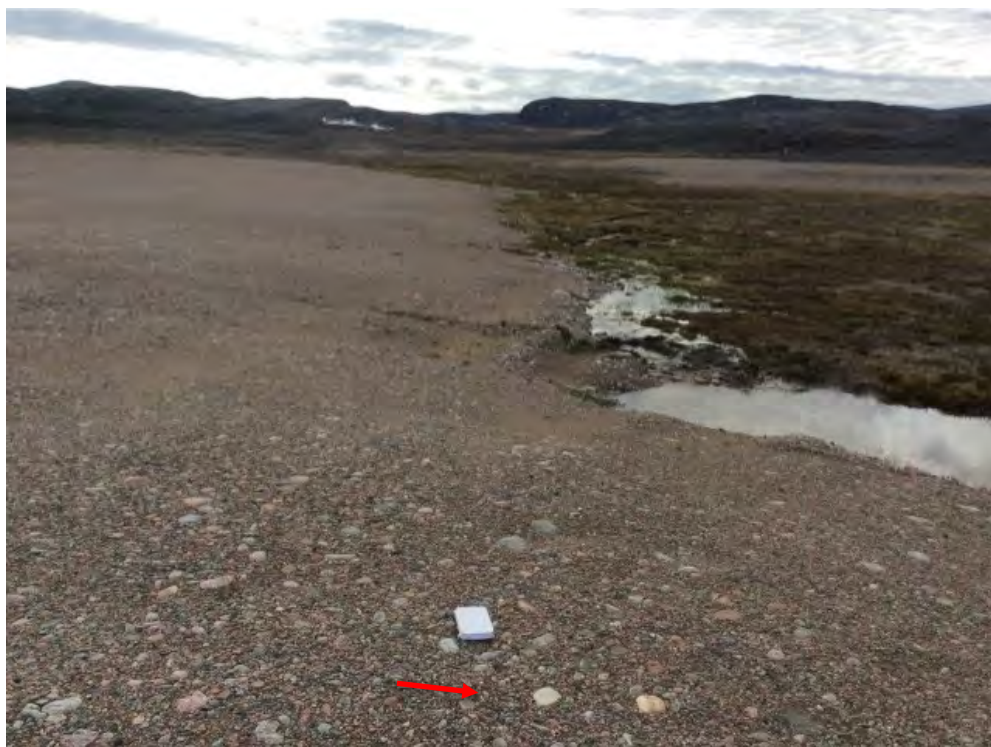
Photo 25: Lower Site Landfill South- West slope, Feature A1-Minor self-armouring erosion, facing southeast (Acceptable) (CAM5_Photo52.jpg)

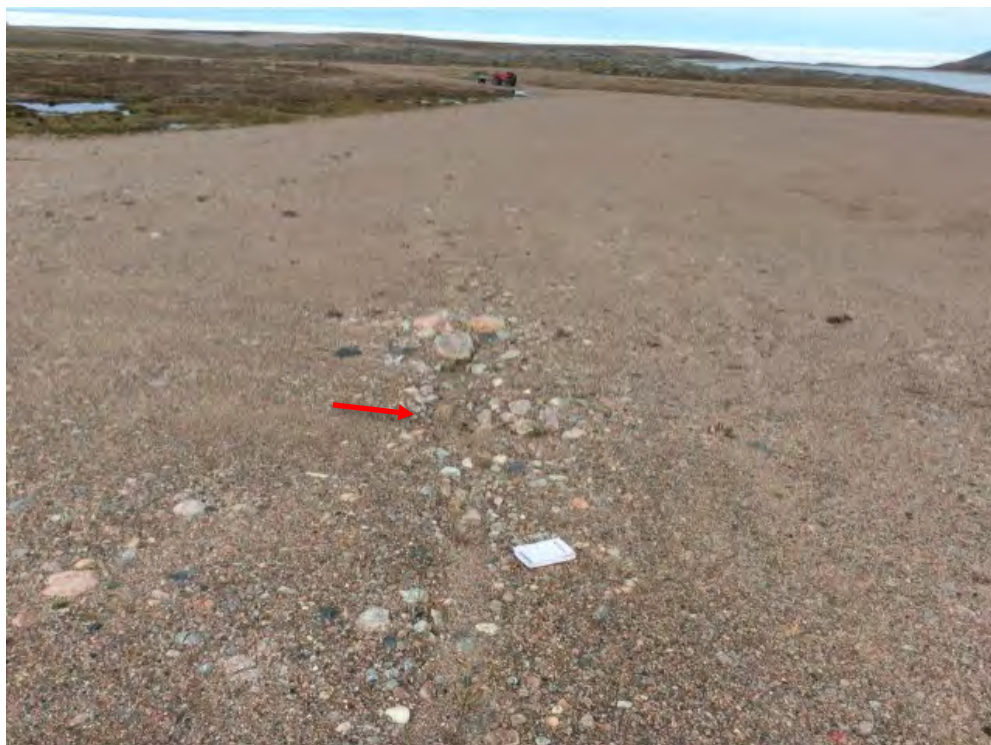
Photo 26: Lower Site Landfill South- Southwest crest, Feature D-Linear depression, facing northwest (Acceptable) (CAM5_Photo66.jpg)

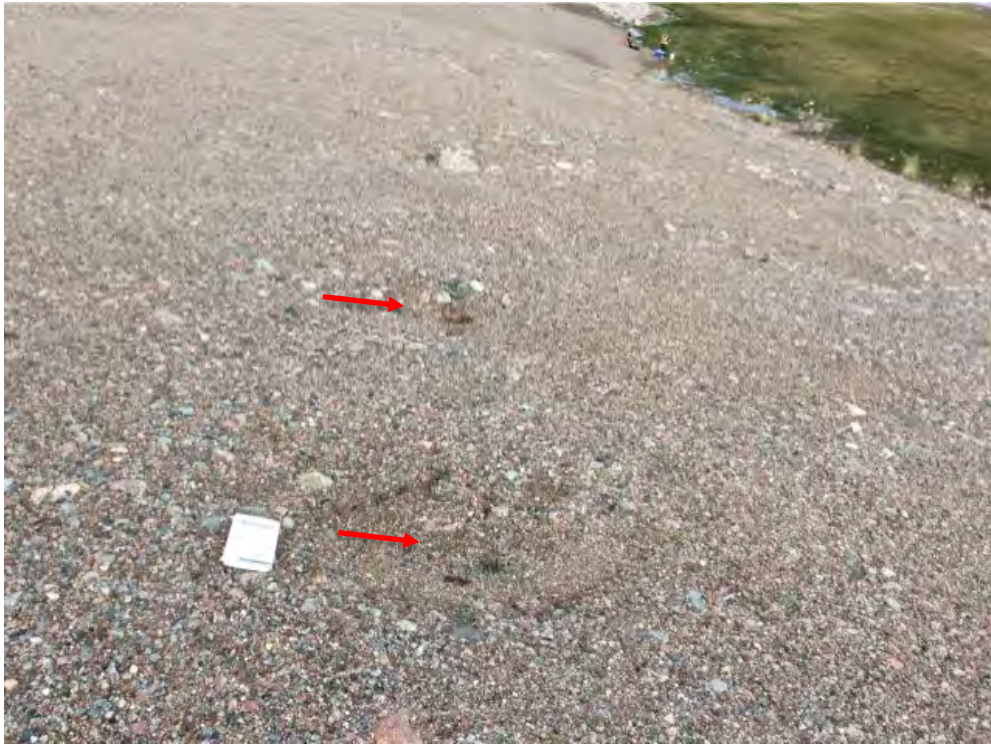
Photo 27: Lower Site Landfill South- Cover surface east corner, Feature E-Two small minor settlement areas, facing northwest (Acceptable) (CAM5_Photo70.jpg)

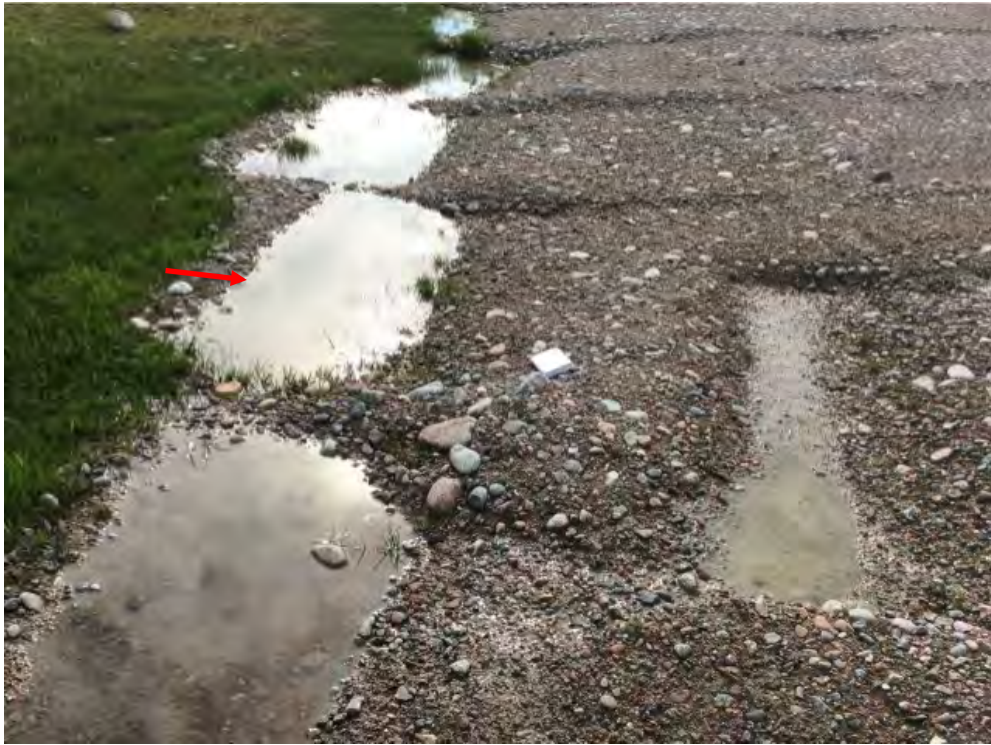
Photo 31: Lower Site Landfill South- East toe, Feature G-Ponded water, facing southeast (Acceptable) (CAM5_Photo87.jpg)

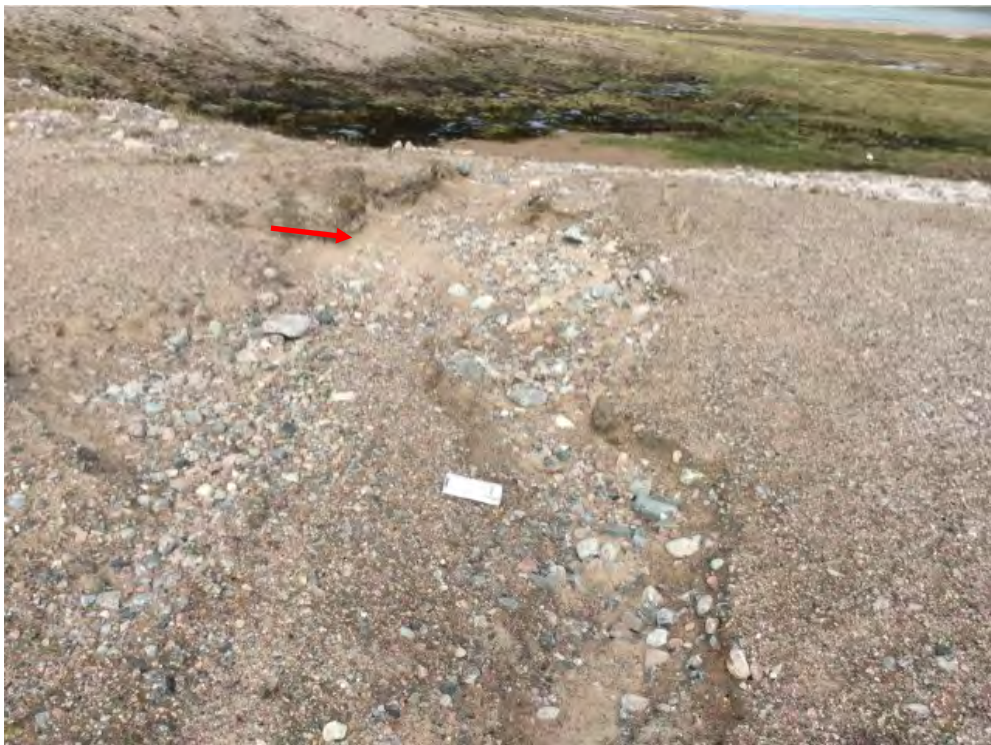
Photo 32: Lower Site Landfill South- Northwest slope, Feature H-Major erosion gully, facing northwest (Acceptable) (CAM5_Photo90.jpg)

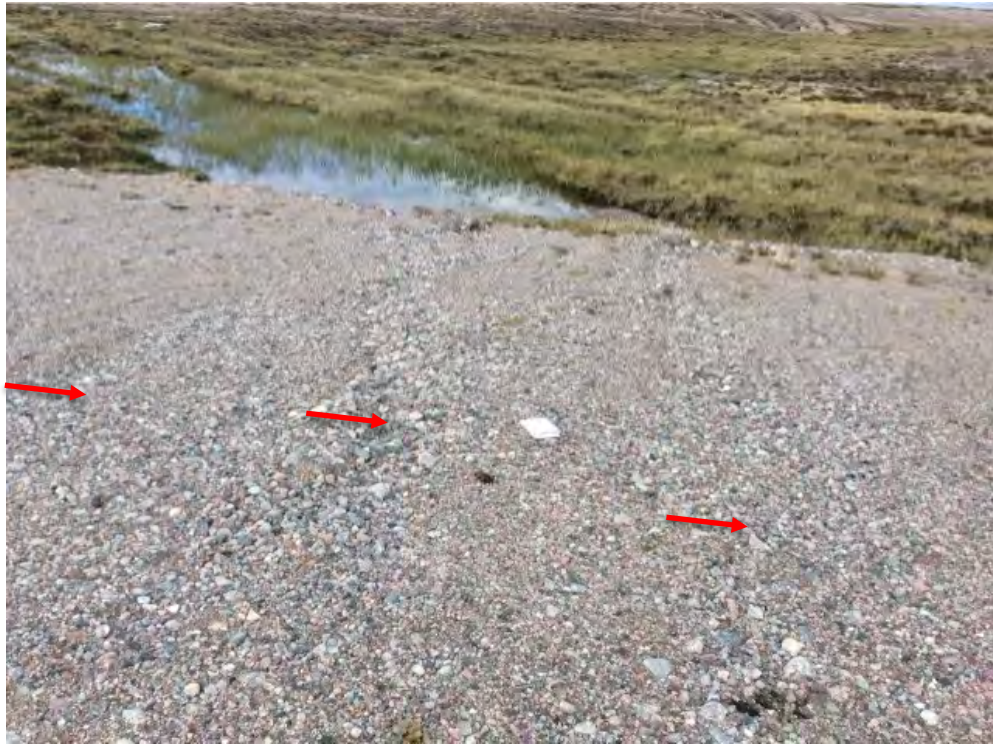
Photo 33: Lower Site Landfill South- Northwest slope, Feature I-Minor self-armouring erosion, facing northwest (Acceptable) (CAM5_Photo93.jpg)
