QIKIQ15 BAFFIN REGION DEW LINE SITE MONITORING

2017 CAM-5 Monitoring Report

Report Number: 1530908-3000-R3-V4

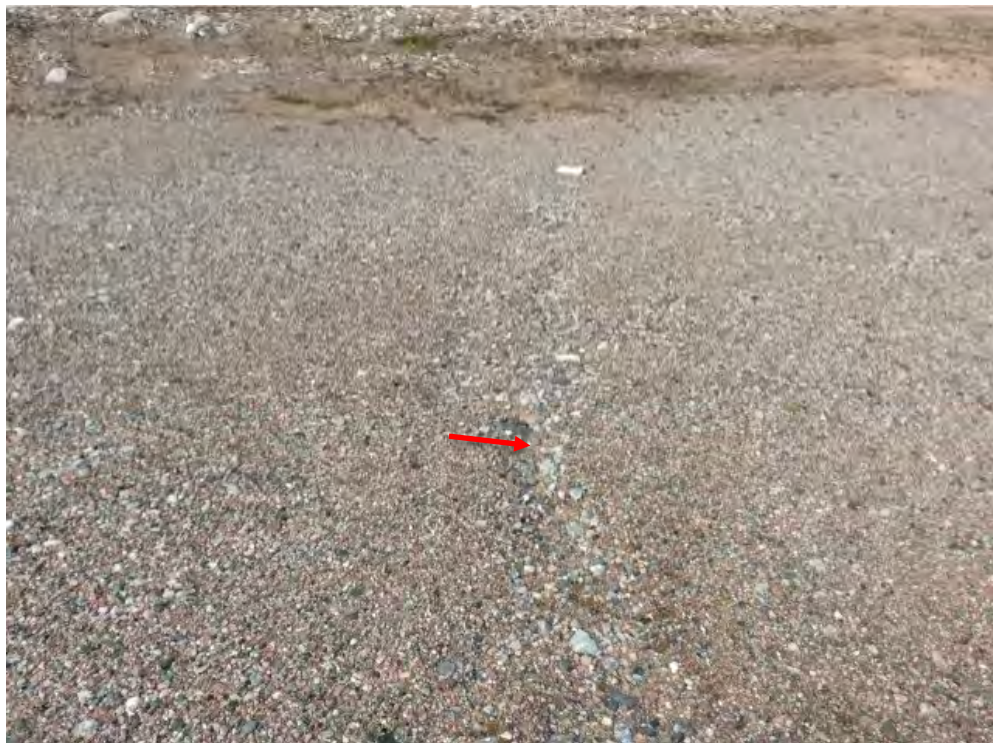
Photo 34: Lower Site Landfill South- Northwest slope, Feature J-Minor erosion channel, facing northwest (Acceptable) (CAM5_Photo91.jpg)

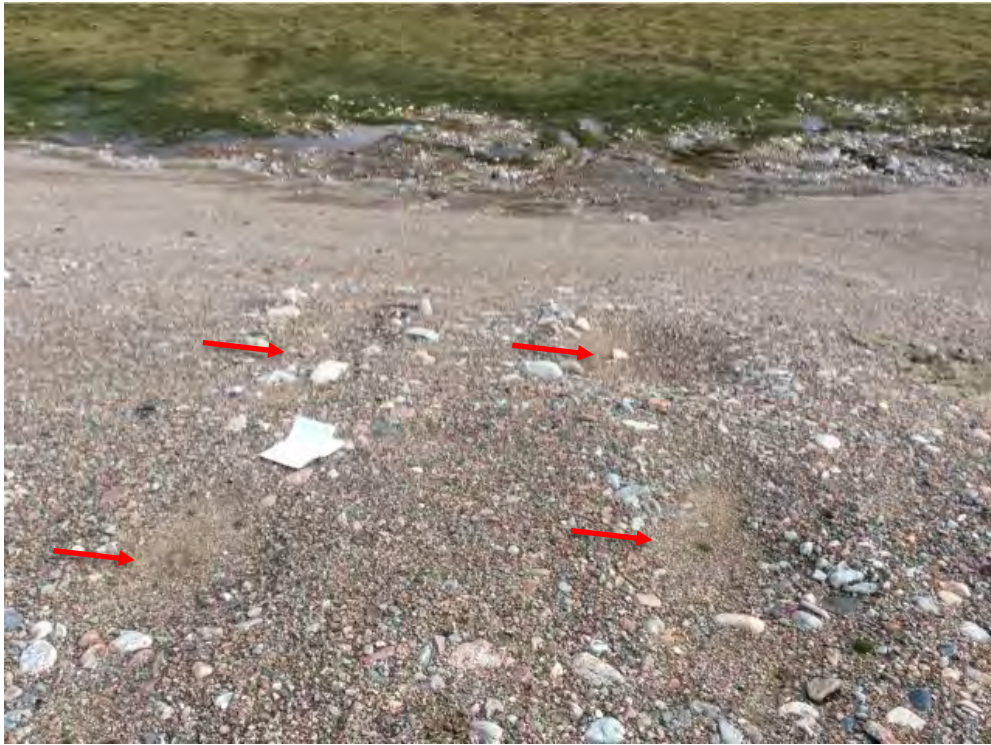
Photo 37: Lower Site Landfill South- East crest, Feature M-Minor settlement depressions, facing northeast (Acceptable) (CAM5_Photo77.jpg)

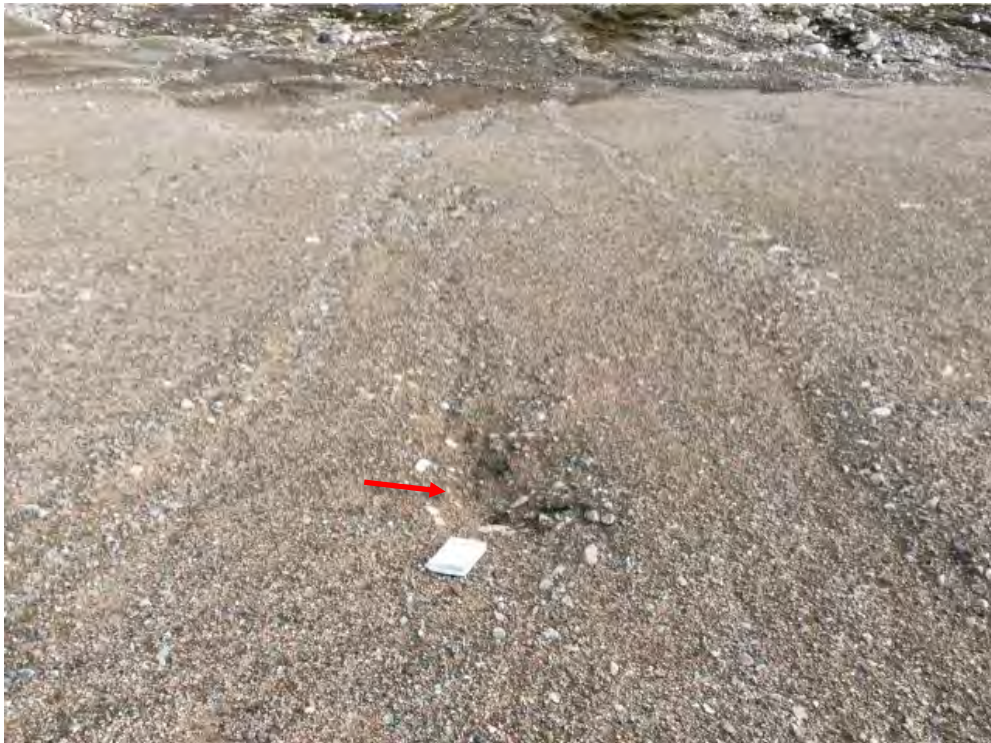
Photo 38: Lower Site Landfill South- East crest, Feature M-Minor settlement, facing northeast (Acceptable) (CAM5_Photo78.jpg)

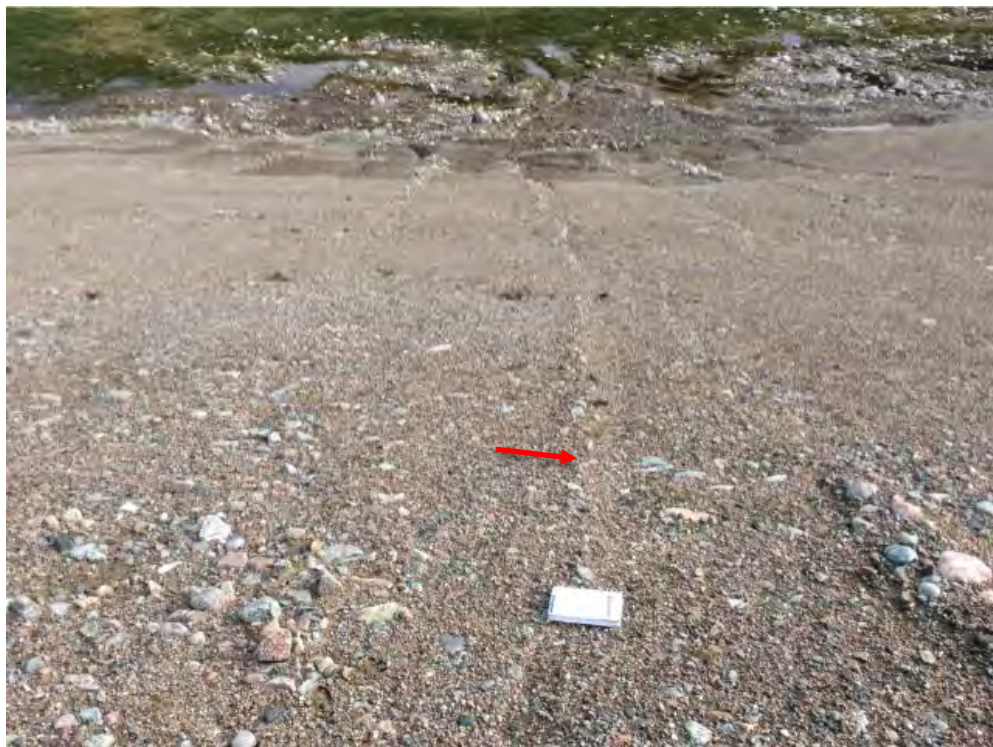
Photo 39: Lower Site Landfill South- East slope, Feature N-Minor erosion channel, facing northeast (Acceptable) (CAM5_Photo79.jpg)

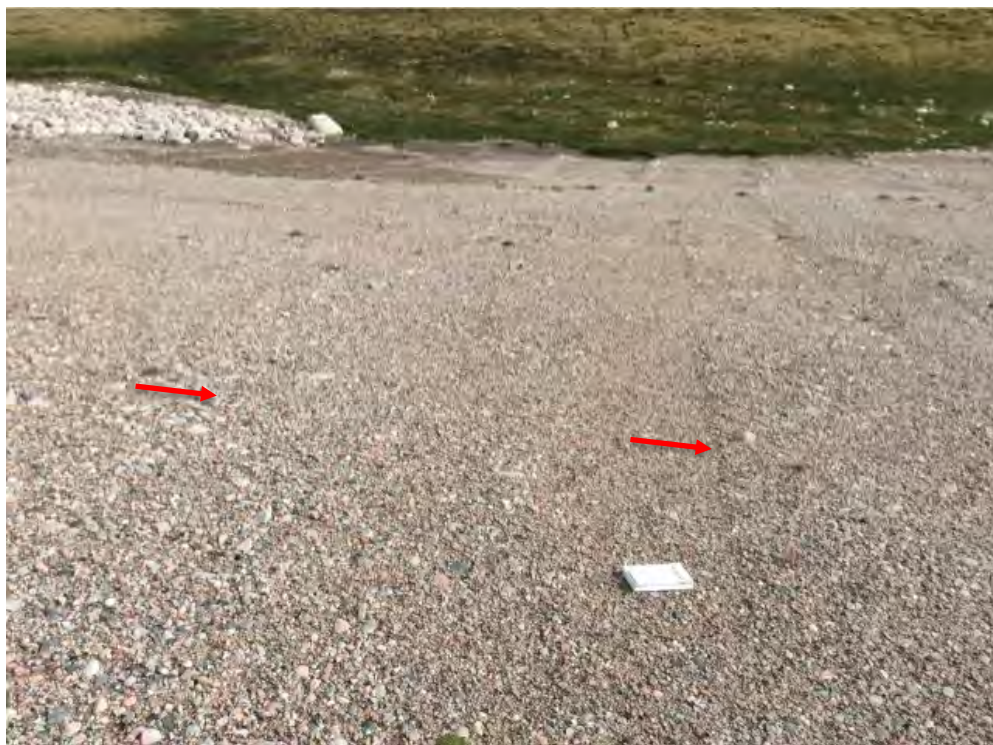
Photo 40: Lower Site Landfill South- East slope, Feature N-Minor self-armouring erosion, facing northeast (Acceptable) (CAM5_Photo89.jpg)

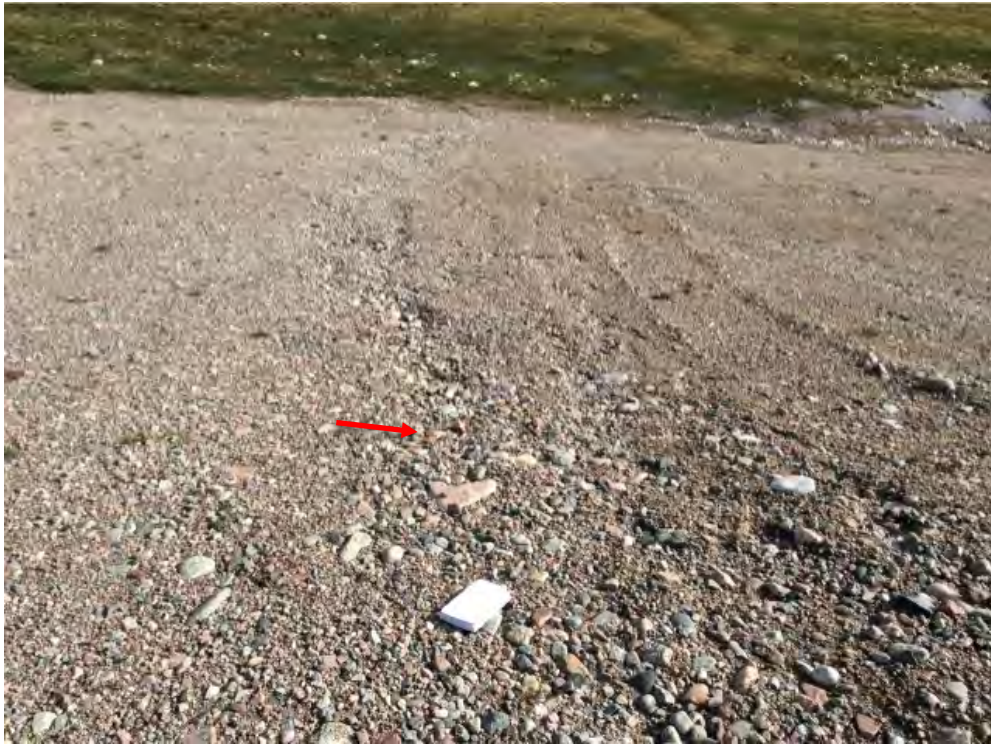
Photo 41: Lower Site Landfill South- East slope, Feature N-Minor self-armouring erosion, facing northeast (Acceptable) (CAM5_Photo85.jpg)

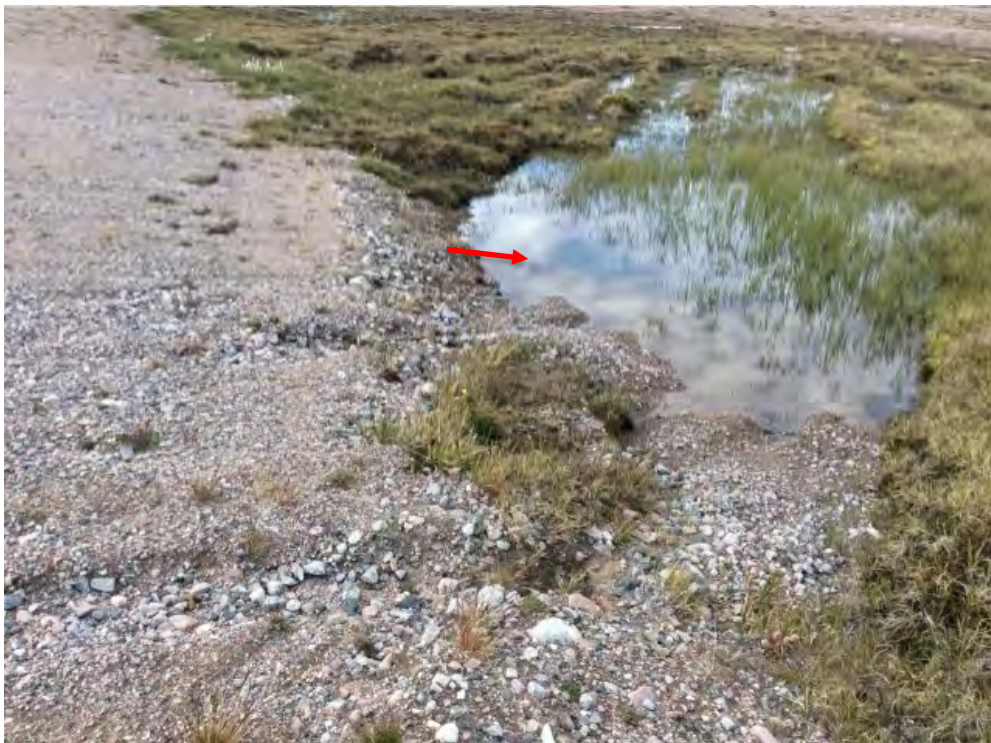
Photo 42: Lower Site Landfill South- Northwest toe, Feature O-Ponded water at toe, facing west (Acceptable) (CAM5_Photo94.jpg)

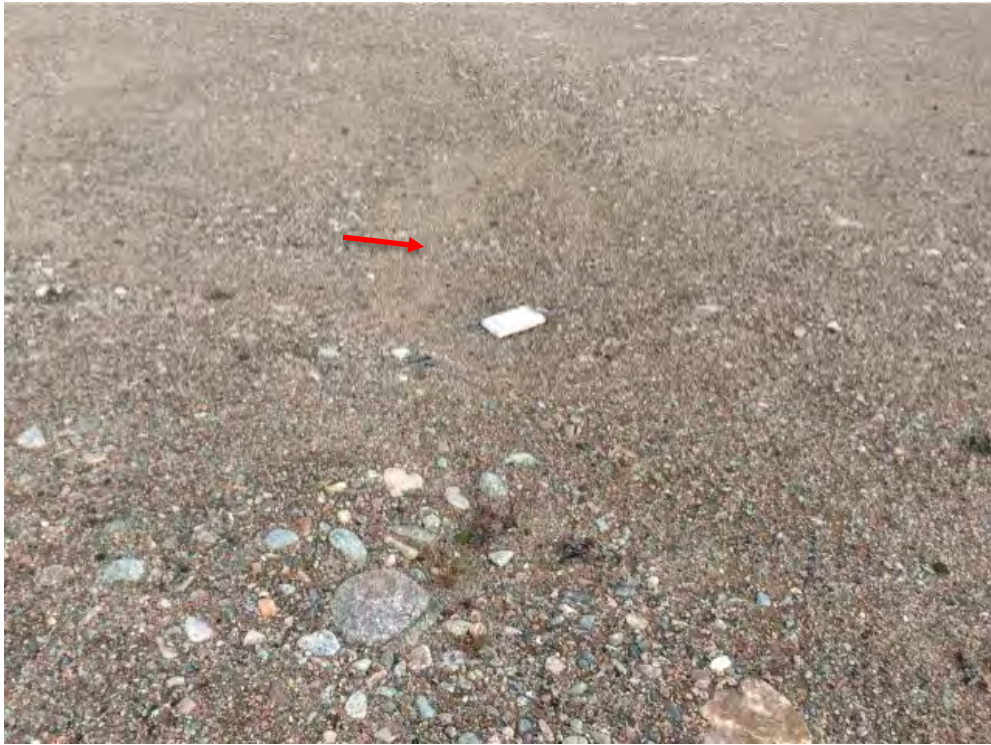
Photo 43: Lower Site Landfill South- Cover surface, Feature P-Minor settlement and erosion, facing northwest (Acceptable) (CAM5_Photo67.jpg)

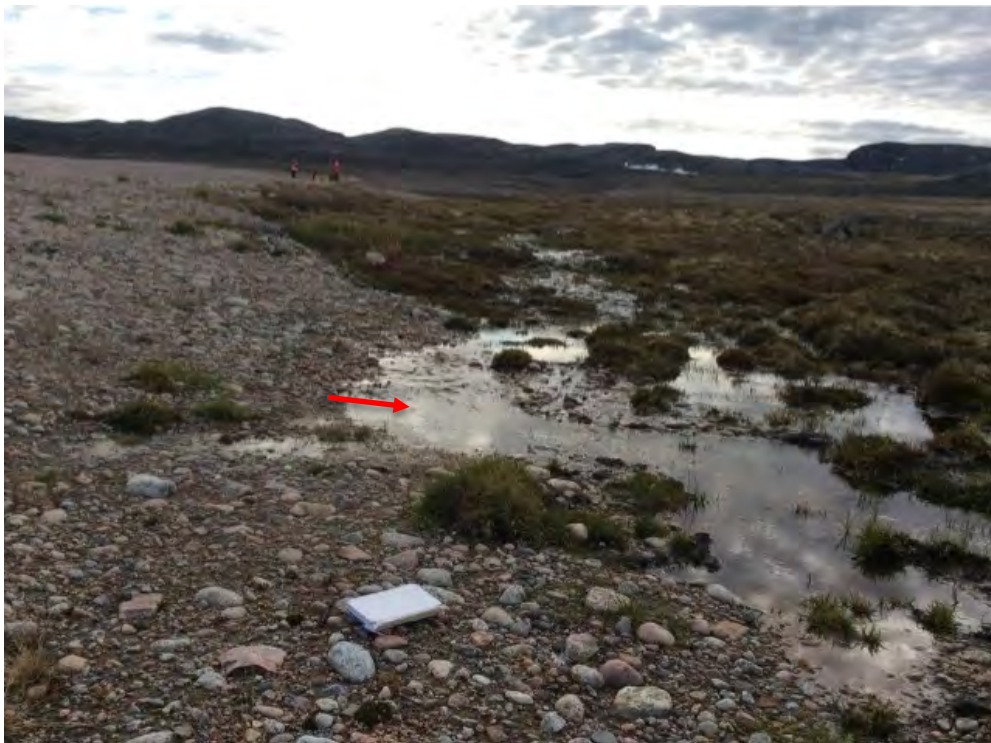
Photo 44: Lower Site Landfill South- Southwest toe, Feature Q1-Ponded water along toe, facing southeast (Acceptable) (CAM5_Photo58.jpg)

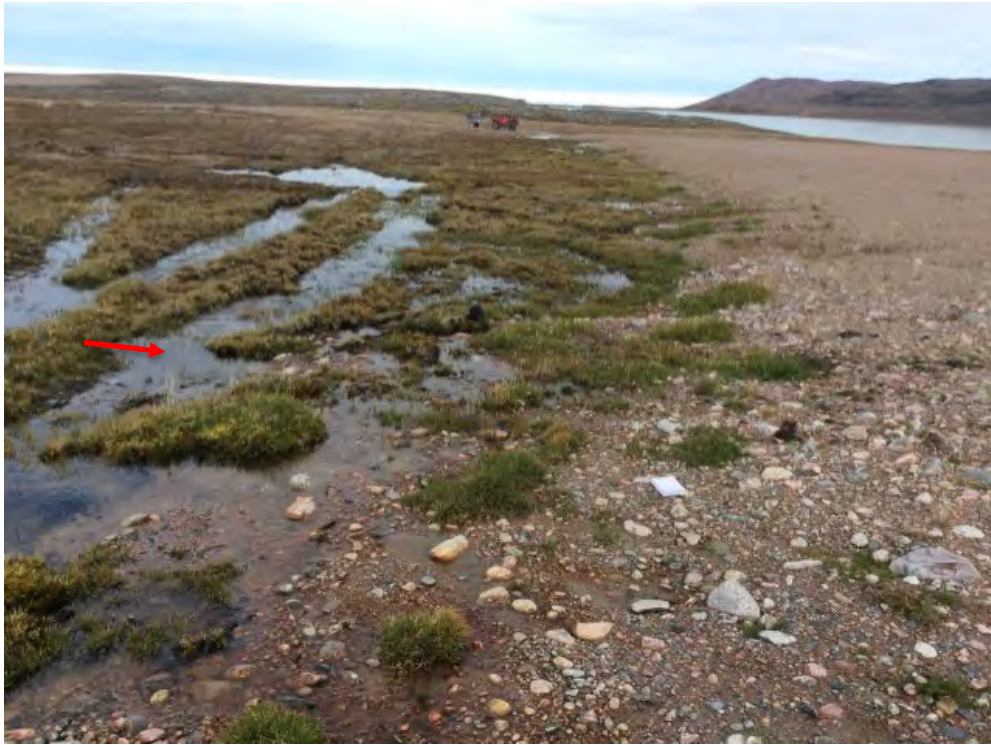
Photo 45: Lower Site Landfill South- Southwest toe, Feature Q1-Ponded water along toe, facing northwest (Acceptable) (CAM5_Photo57.jpg)

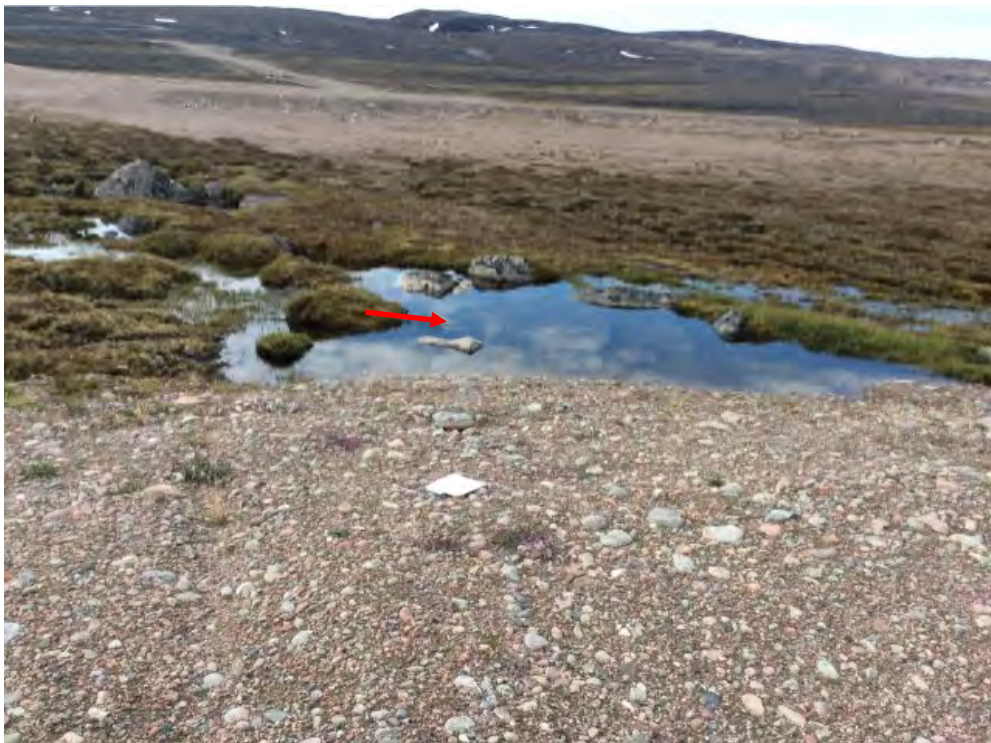
Photo 46: Lower Site Landfill South- Southwest toe, Feature Q1-Ponded water along toe, facing south (Acceptable) (CAM5_Photo60.jpg)

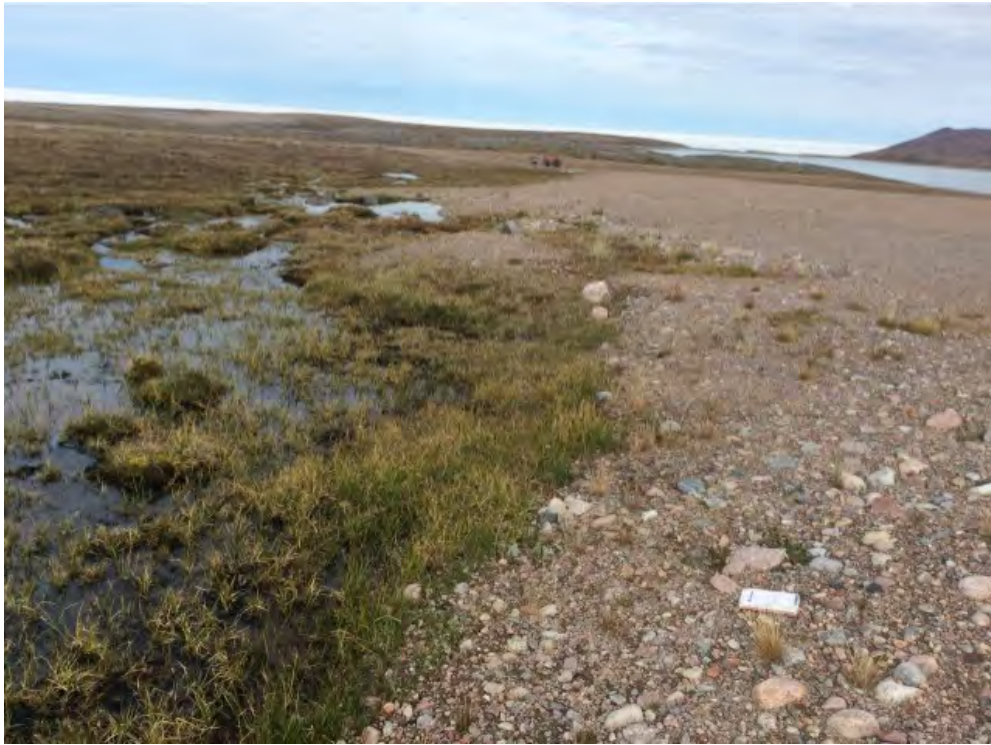
Photo 47: Lower Site Landfill South- Southwest toe, Feature Q1-Ponded water along toe, facing northwest (Acceptable) (CAM5_Photo61.jpg)

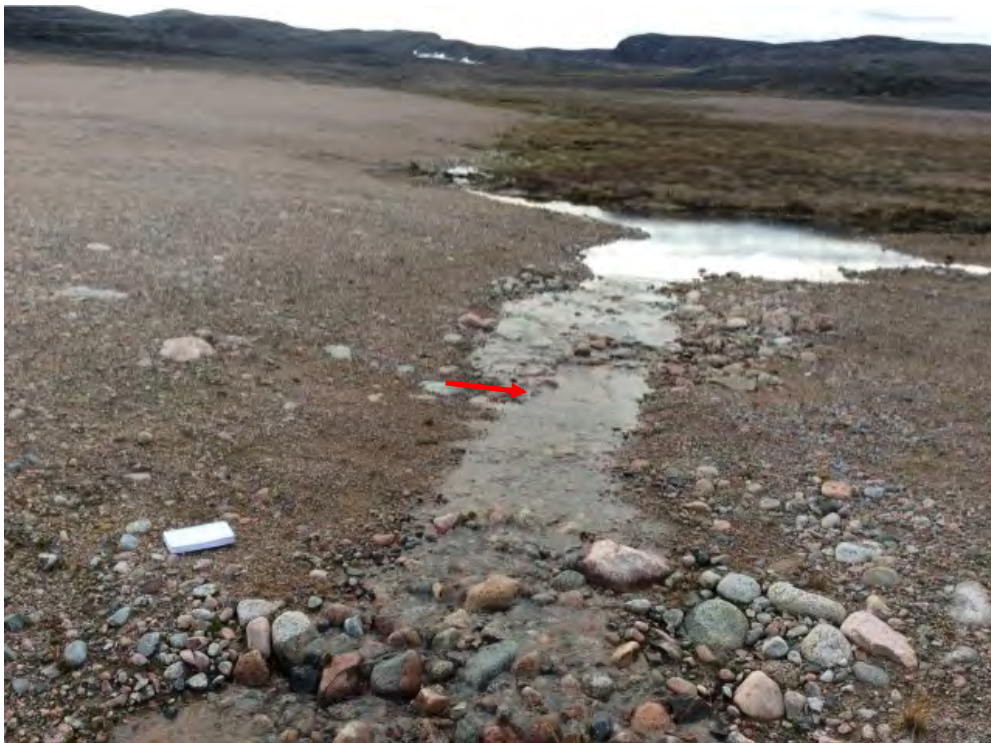
Photo 48: Lower Site Landfill South- Southwest toe, Feature Q2-Running water along the toe, facing southeast (Acceptable) (CAM5_Photo53.jpg)

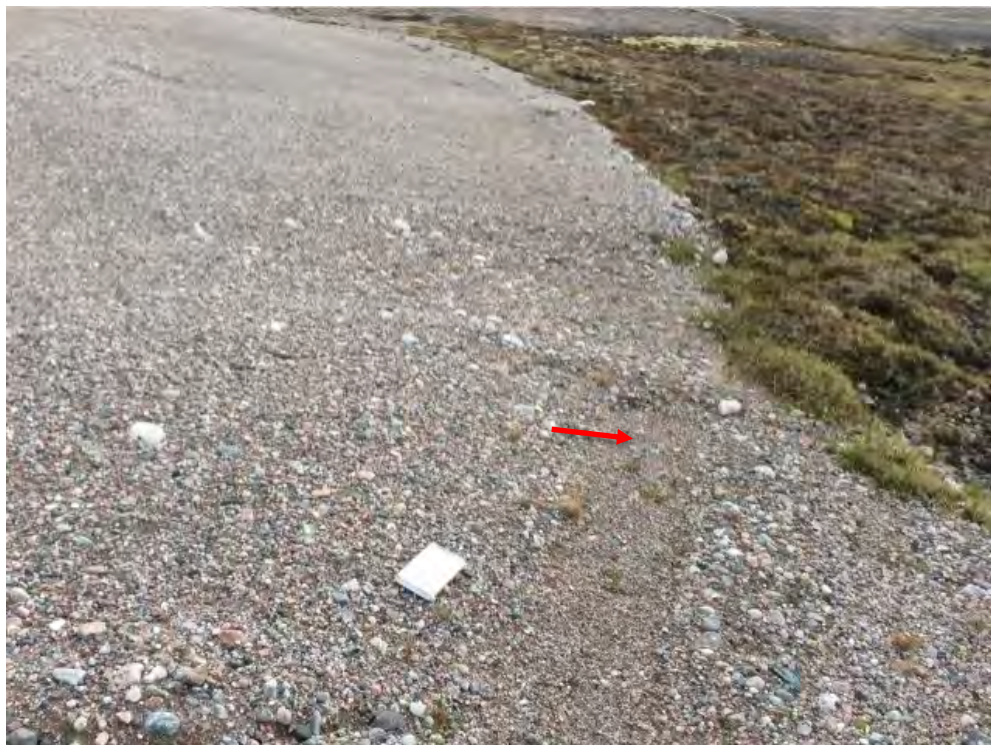
Photo 49: Lower Site Landfill South- South slope, Feature R-Minor settlement, facing east (Acceptable) (CAM5_Photo64.jpg)

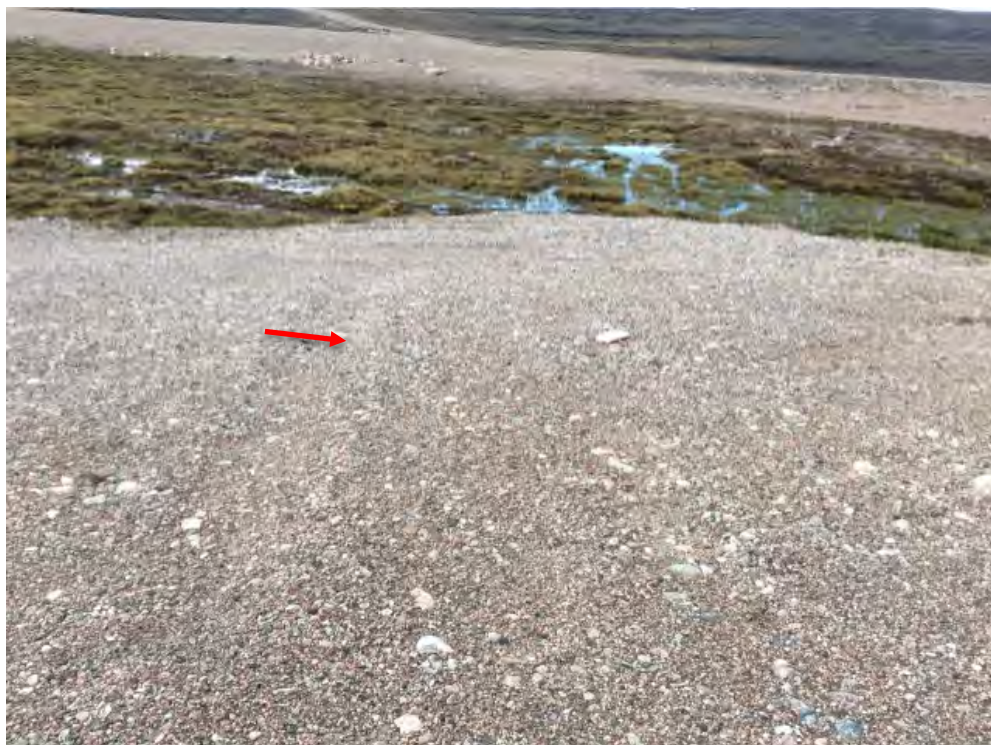
Photo 50: Lower Site Landfill South- cover surface near south slope, Feature V2-Minor erosion channels, facing southwest (Acceptable) (CAM5_Photo62.jpg)

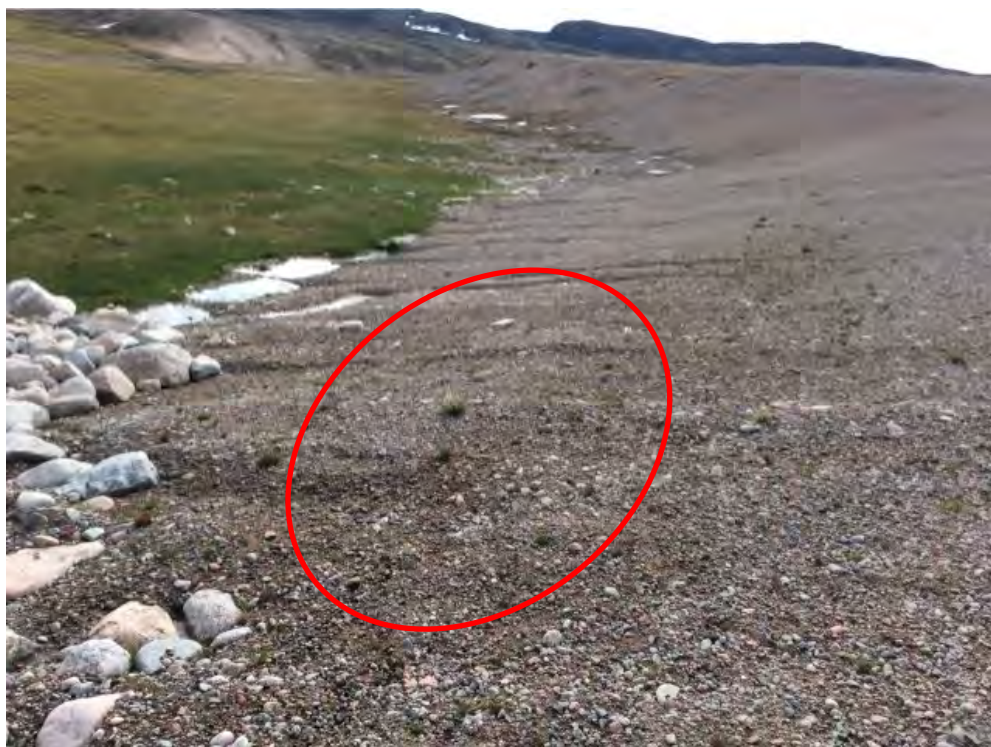
Photo 53: Lower Site Landfill South- East slope, Feature W1-Wet area on slope, facing southeast (Acceptable) (CAM5_Photo88.jpg)

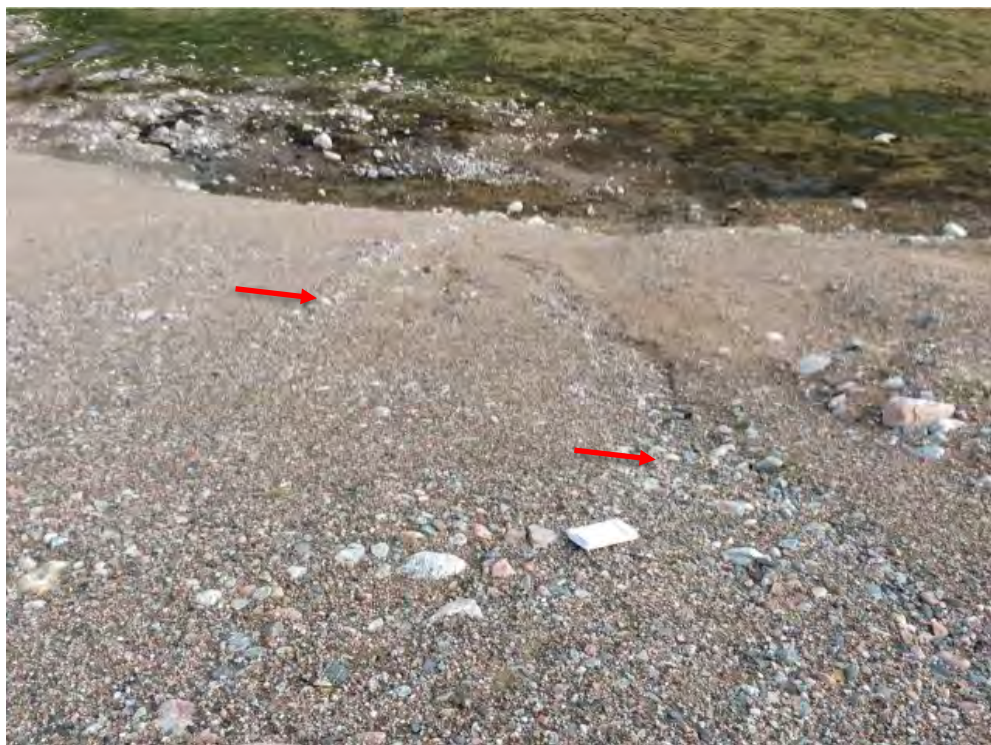
Photo 54: Lower Site Landfill South- East slope, Feature X-Minor self-armouring erosion, facing northeast (Acceptable) (CAM5_Photo73.jpg)

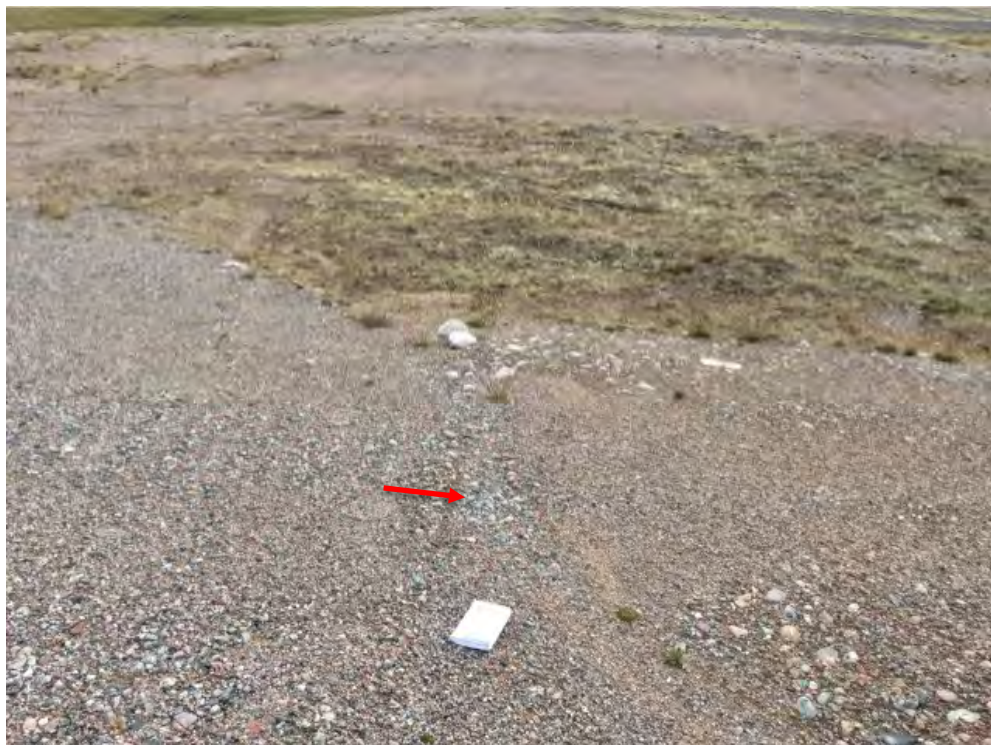
Photo 59: Lower Site Landfill South- Southeast slope, Feature AA -Self armouring erosion, facing southeast (Acceptable) (CAM5_Photo69.jpg)

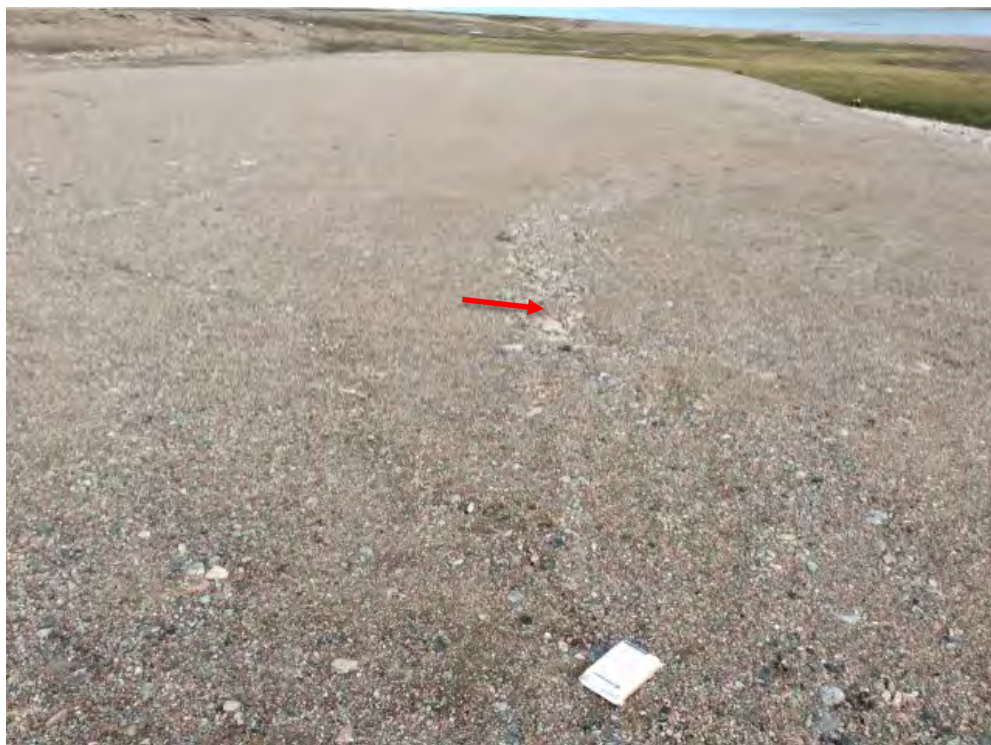
Photo 60: Lower Site Landfill South- Cover surface, Feature J -Self armouring erosion along northeast crest, facing northwest (CAM5_Photo76.jpg)

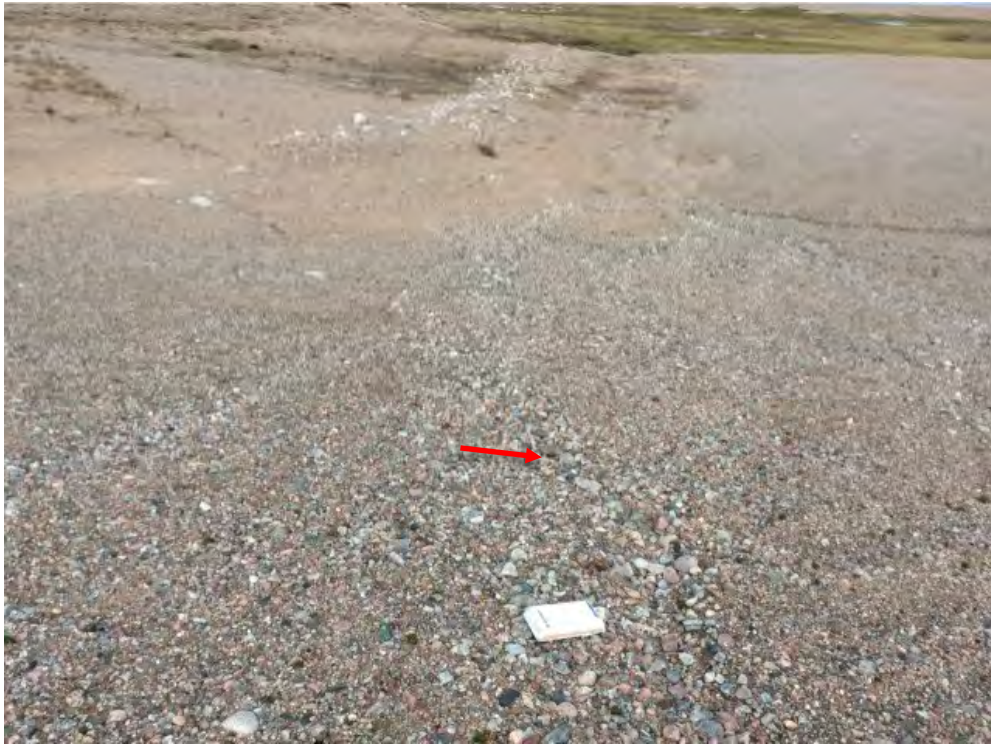
Photo 63: Lower Site Landfill South- Northwest slope, Feature AB—Minor self-armouring erosion, facing north (Acceptable) (CAM5_Photo92.jpg)

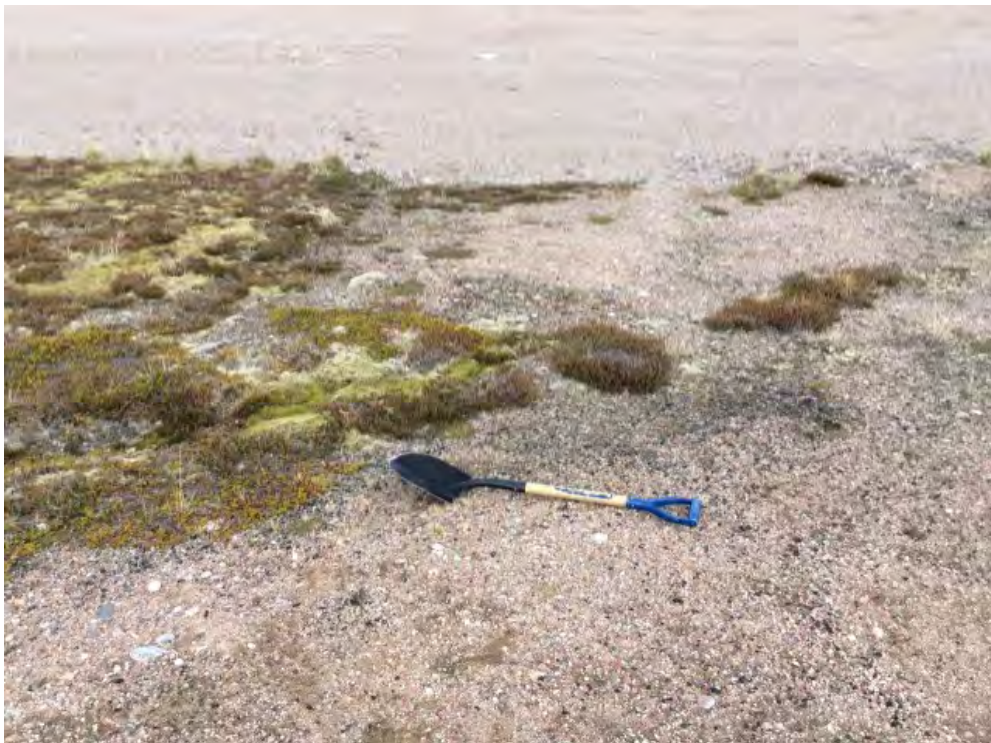
Photo 64: Lower Site Landfill South- Soil Sample C5-1-Before Excavation (CAM5_Photo126.jpg)

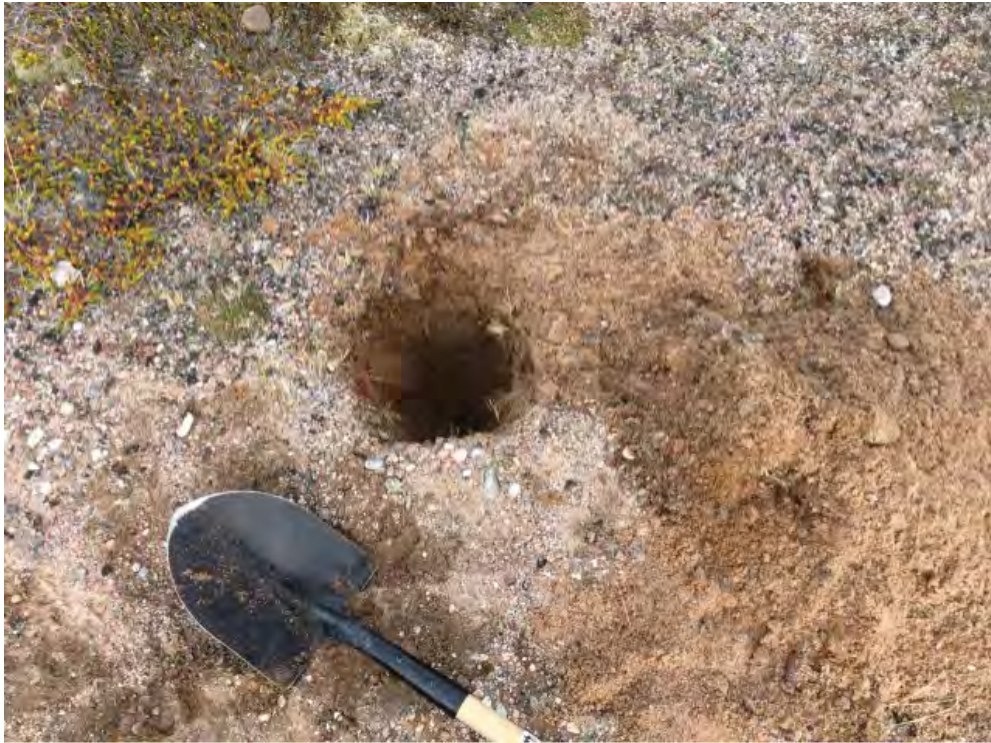
Photo 65: Lower Site Landfill South- Soil Sample C5-1-After Excavation (CAM5_Photo127.jpg)

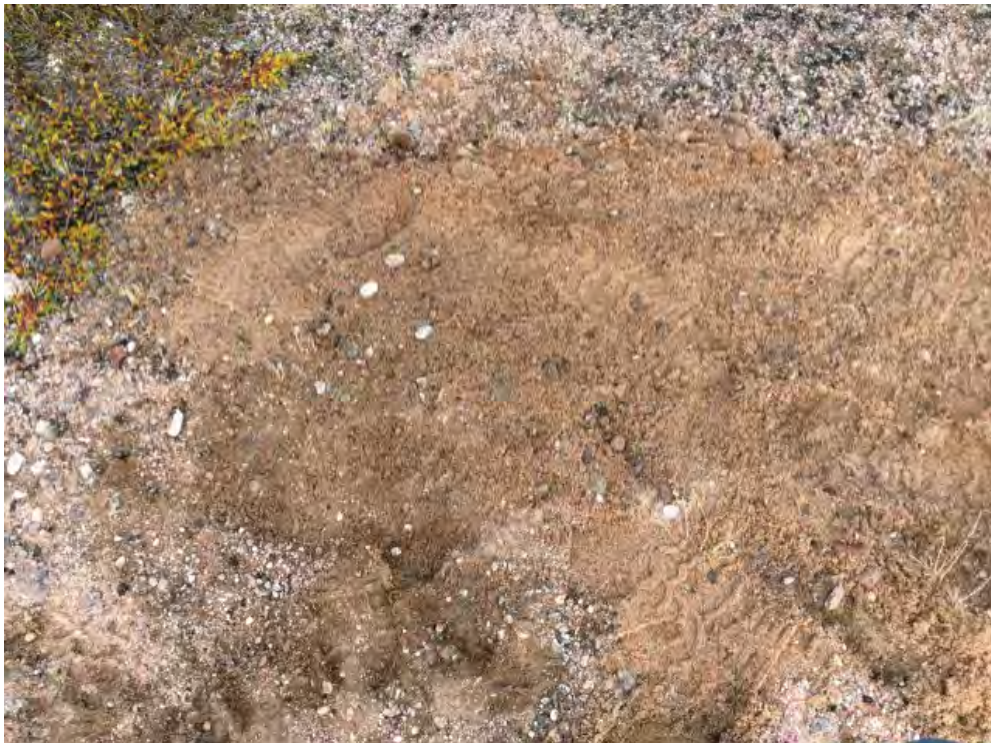
Photo 66: Lower Site Landfill South- Soil Sample C5-1-After Backfilling (CAM5_Photo128.jpg)

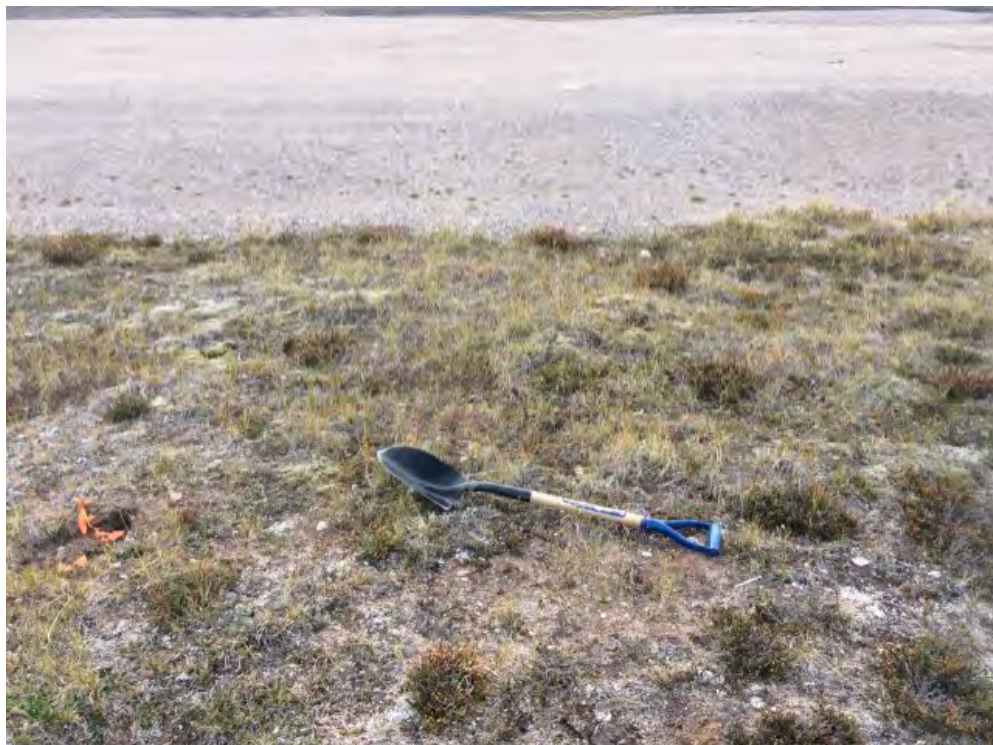
Photo 67: Lower Site Landfill South- Soil Sample C5-2-Before Excavation (CAM5_Photo123.jpg)

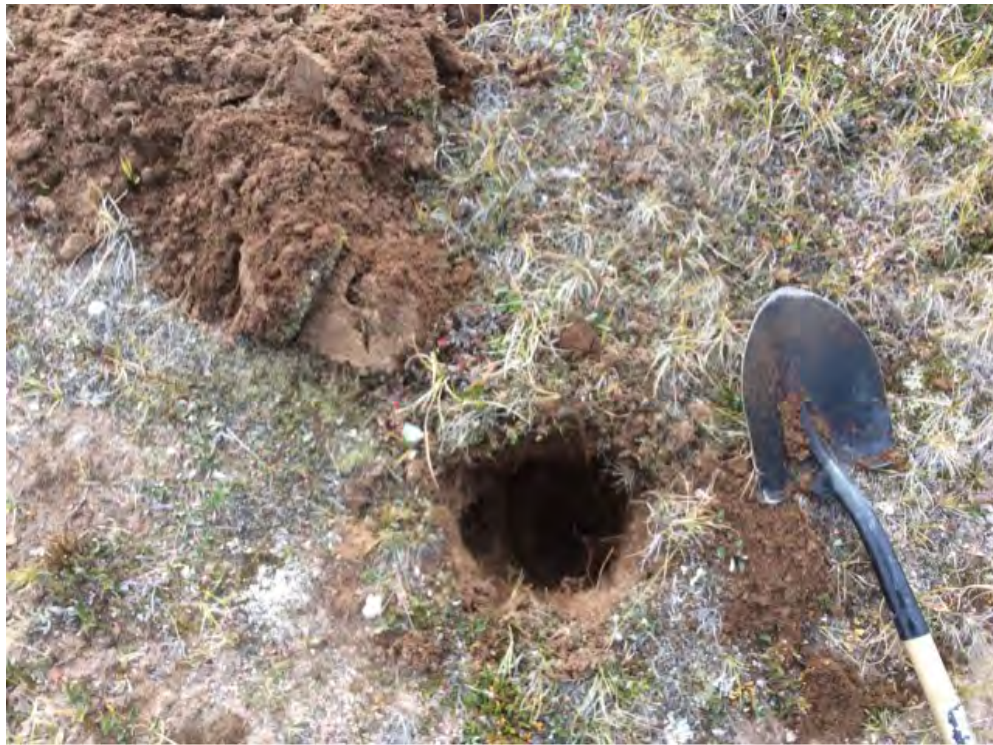
Photo 68: Lower Site Landfill South- Soil Sample C5-2-After Excavation (CAM5_Photo124.jpg)

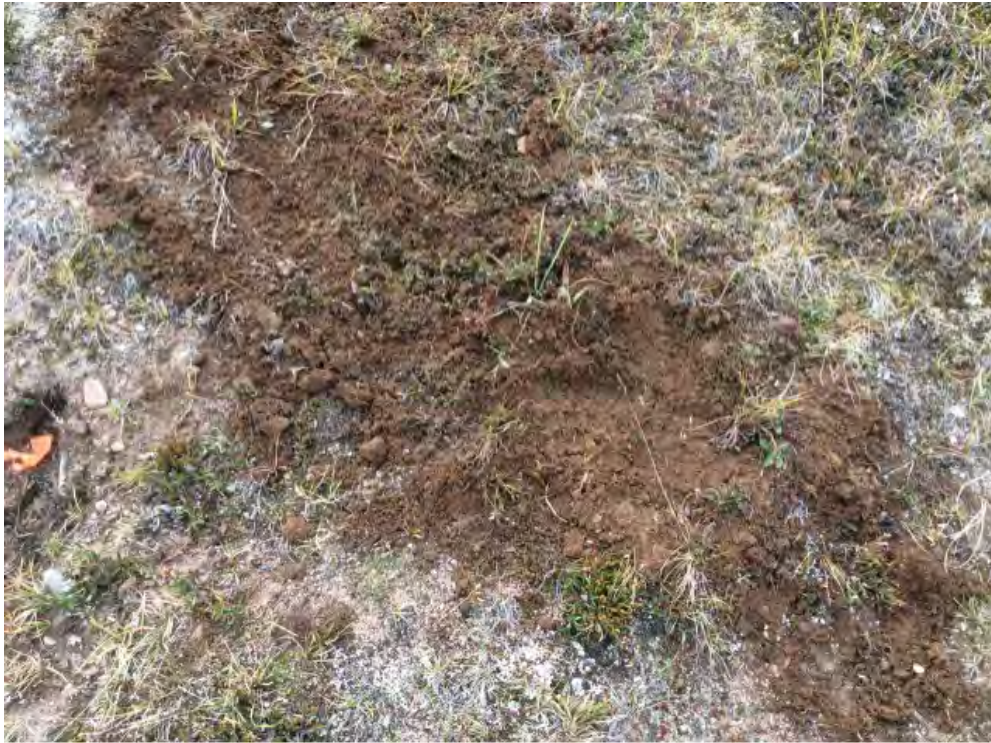
Photo 69: Lower Site Landfill South- Soil Sample C5-2-After Backfilling (CAM5_Photo125.jpg)

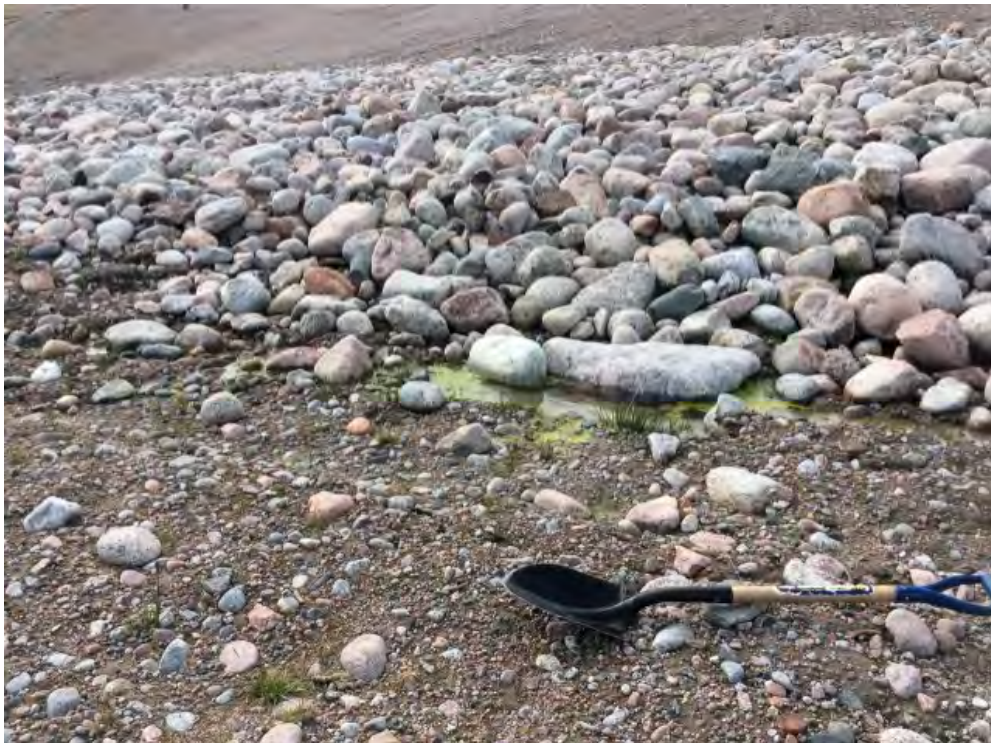
Photo 70: Lower Site Landfill South- Soil Sample C5-3-Before Excavation (CAM5_Photo135.jpg)

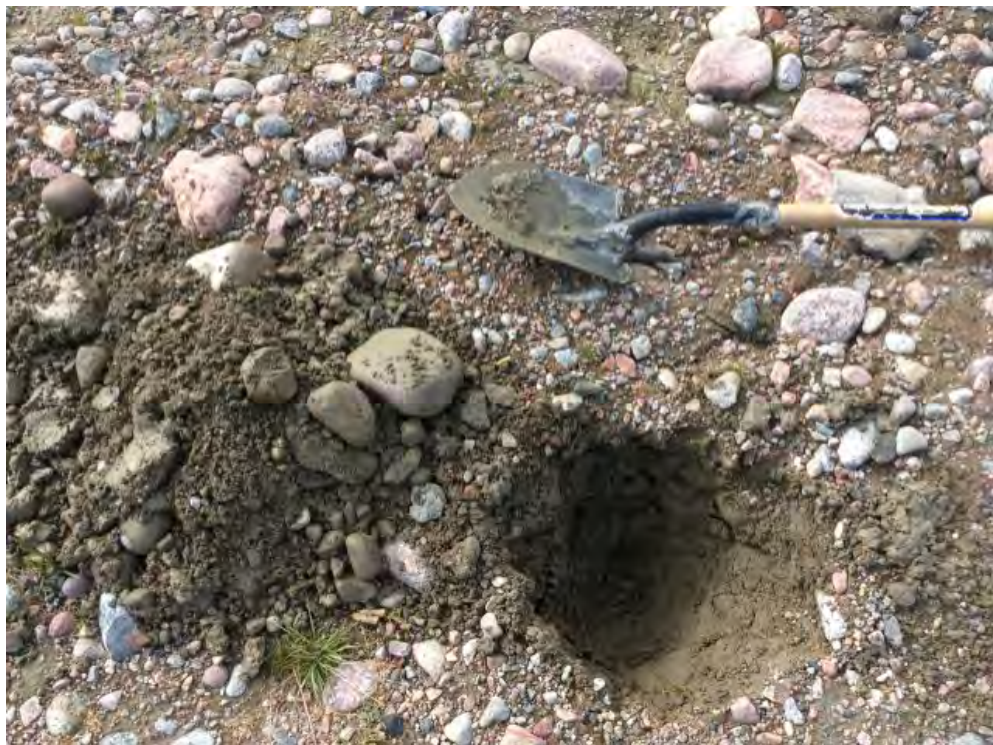
Photo 71: Lower Site Landfill South- Soil Sample C5-3-After Excavation (CAM5_Photo136.jpg)

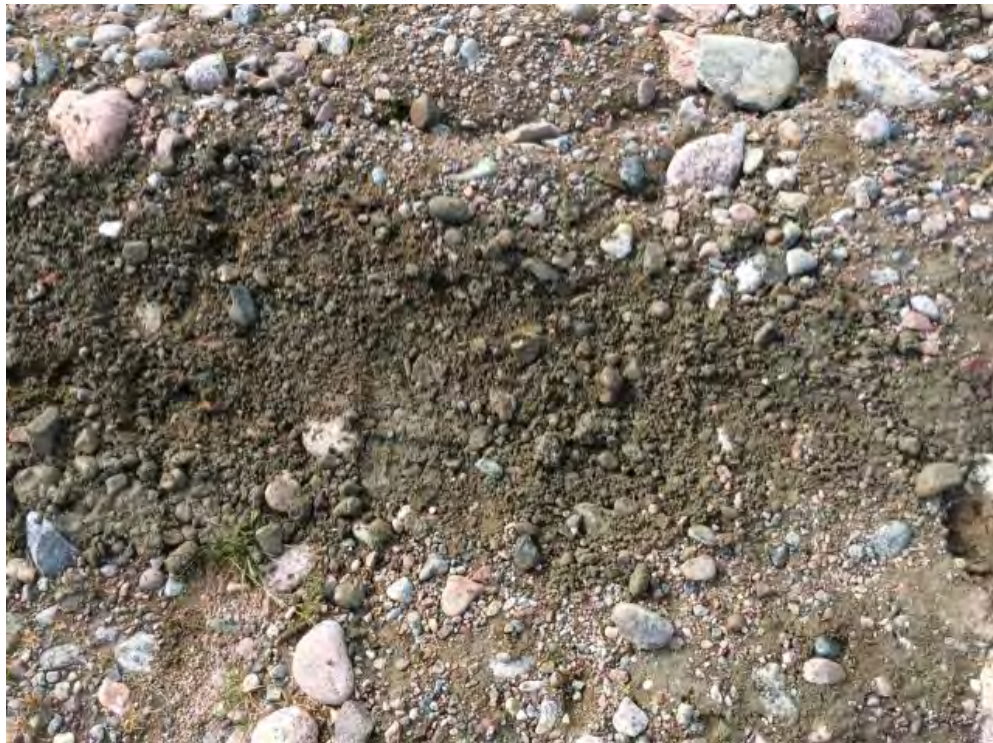
Photo 72: Lower Site Landfill South- Soil Sample C5-3-After Backfilling (CAM5_Photo137.jpg)

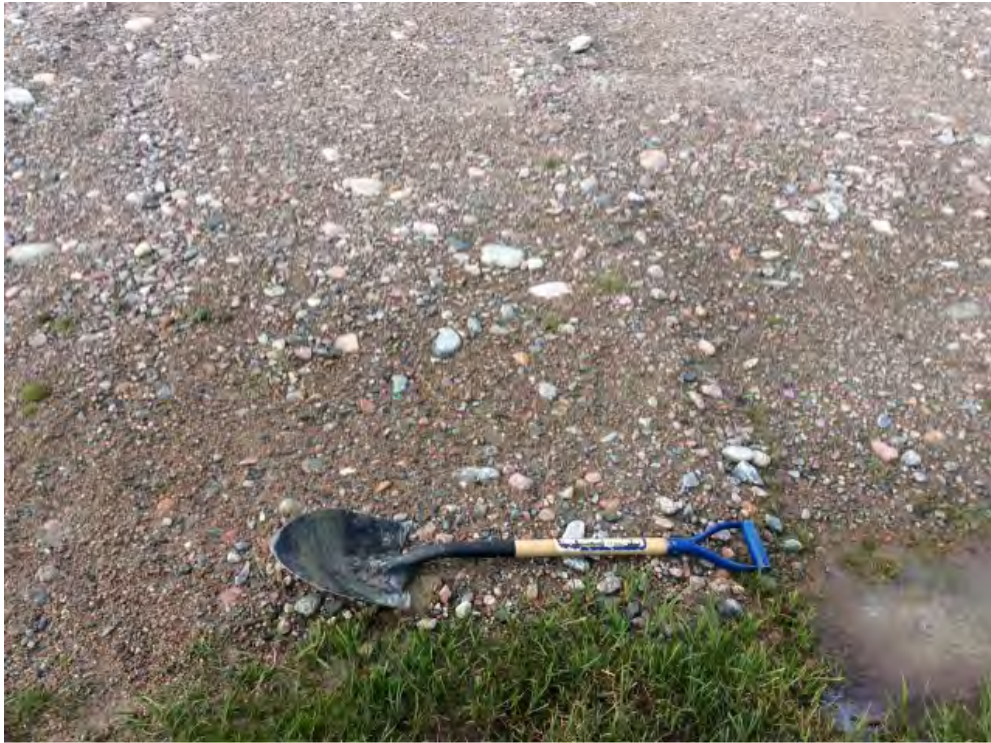
Photo 73: Lower Site Landfill South- Soil Sample C5-4-Before Excavation (CAM5_Photo132.jpg)
