QIKIQ15 BAFFIN REGION DEW LINE SITE MONITORING

2017 CAM-5 Monitoring Report

Report Number: 1530908-3000-R3-V4

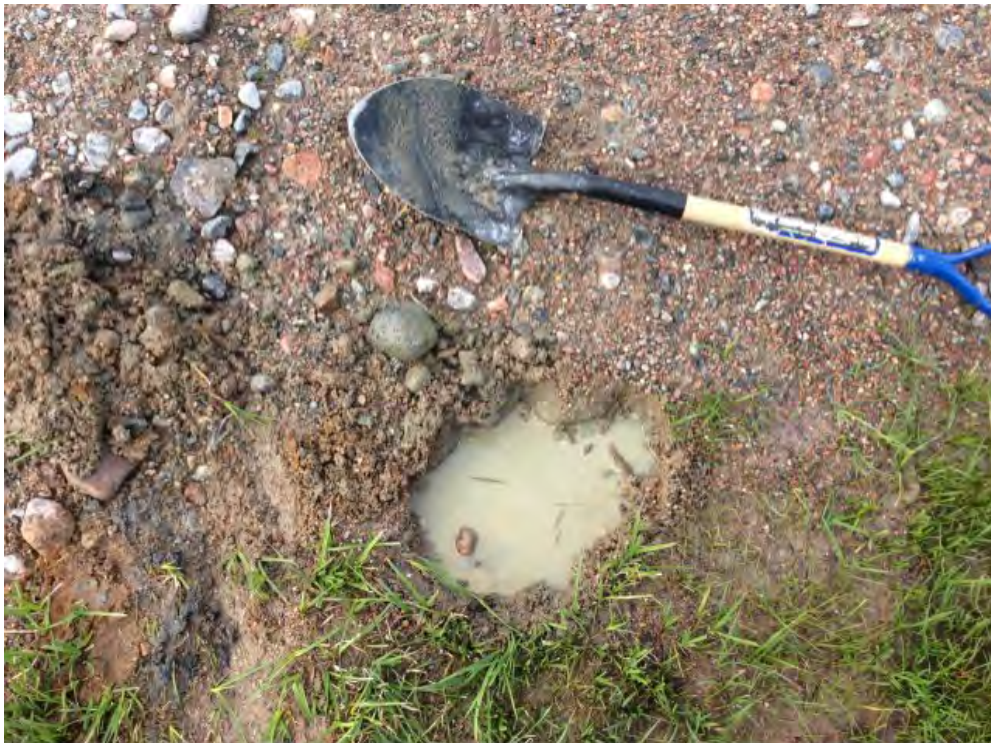
Photo 74: Lower Site Landfill South- Soil Sample C5-4-After Excavation (CAM5_Photo133.jpg)

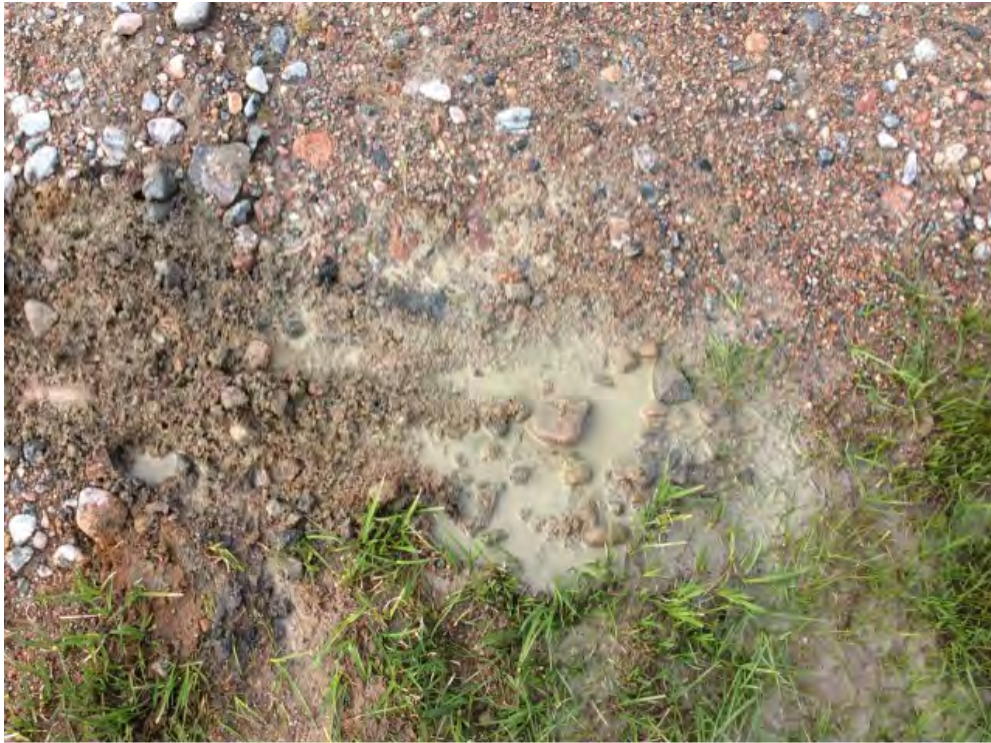
Photo 75: Lower Site Landfill South- Soil Sample C5-4-After Backfilling (CAM5_Photo134.jpg)

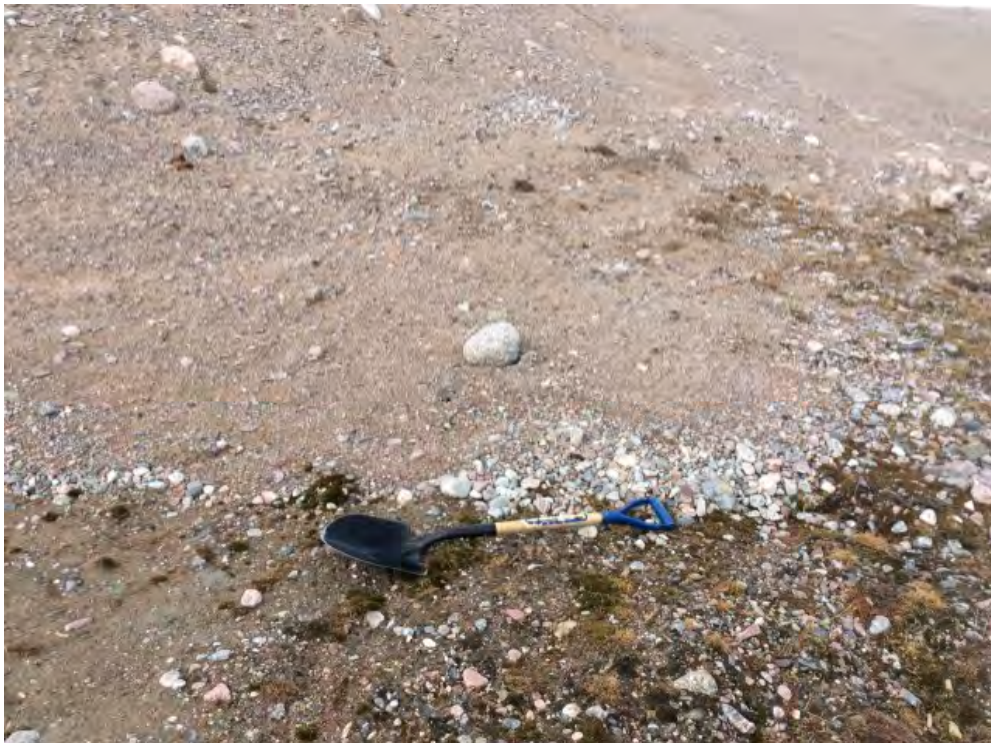
Photo 76: Lower Site Landfill South- Soil Sample C5-5-Before Excavation (CAM5_Photo129.jpg)

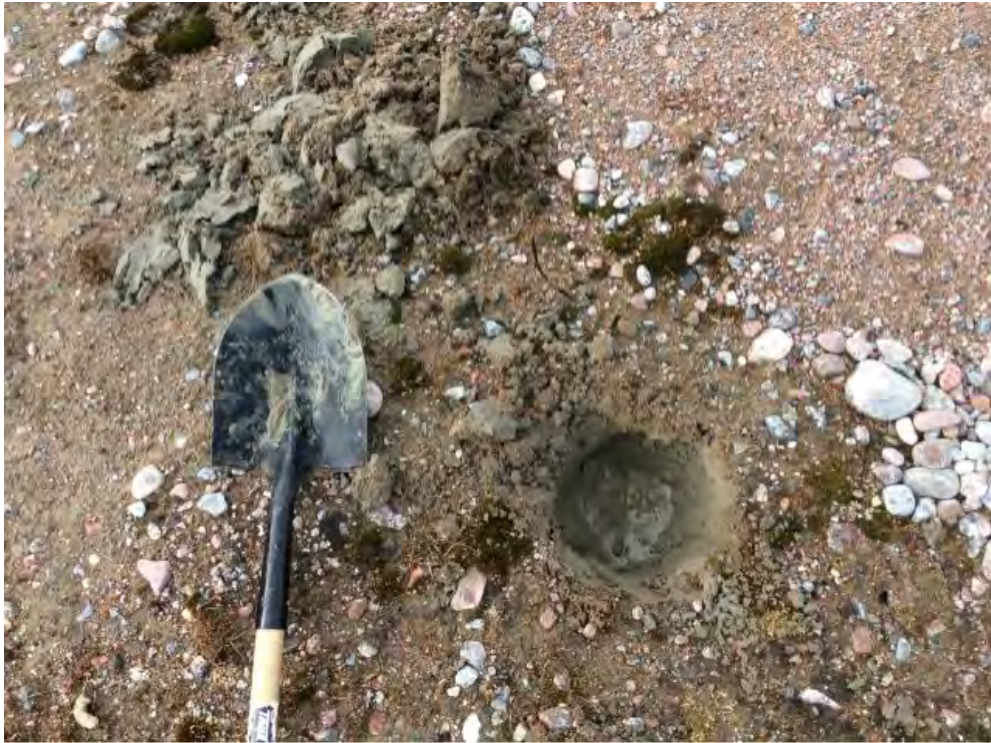
Photo 77: Lower Site Landfill South- Soil Sample C5-5-After Excavation (CAM5_Photo130.jpg)

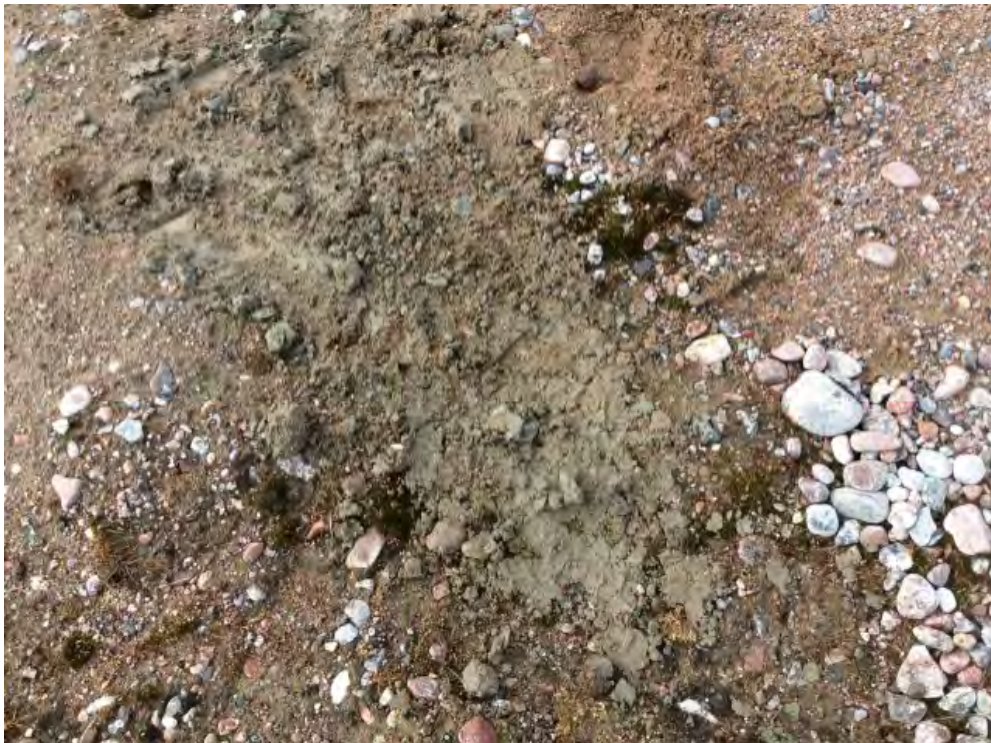
Photo 78: Lower Site Landfill South- Soil Sample C5-5-After Backfilling (CAM5_Photo131.jpg)

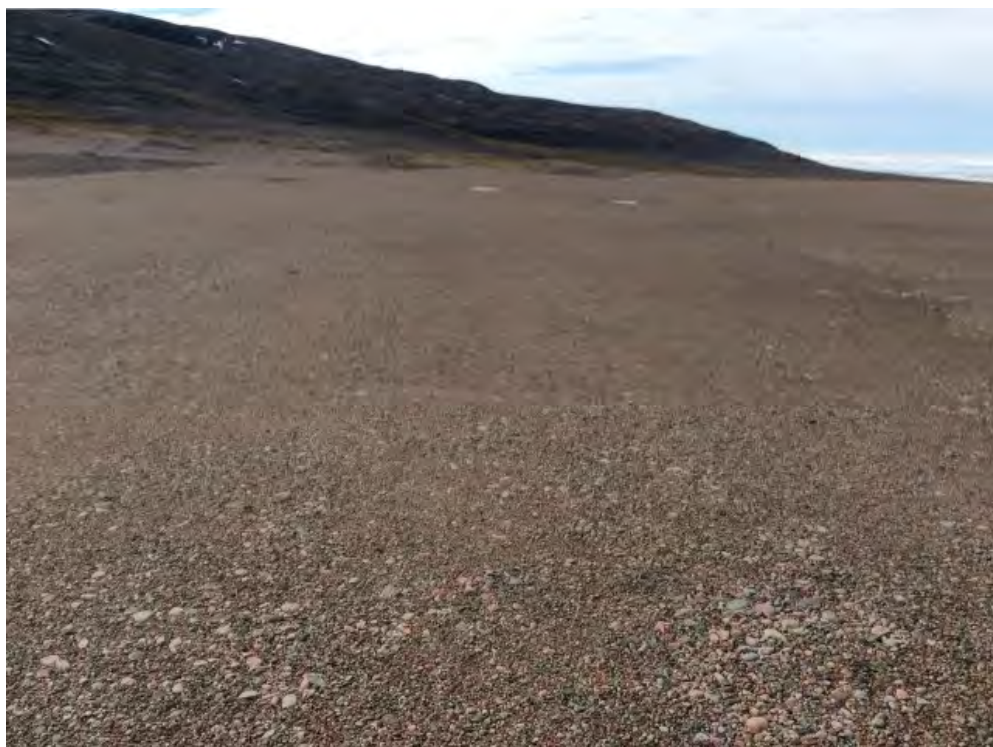
Photo 79: Non-Haz Waste Landfill- Cover surface, facing west (CAM5_Photo167.jpg)

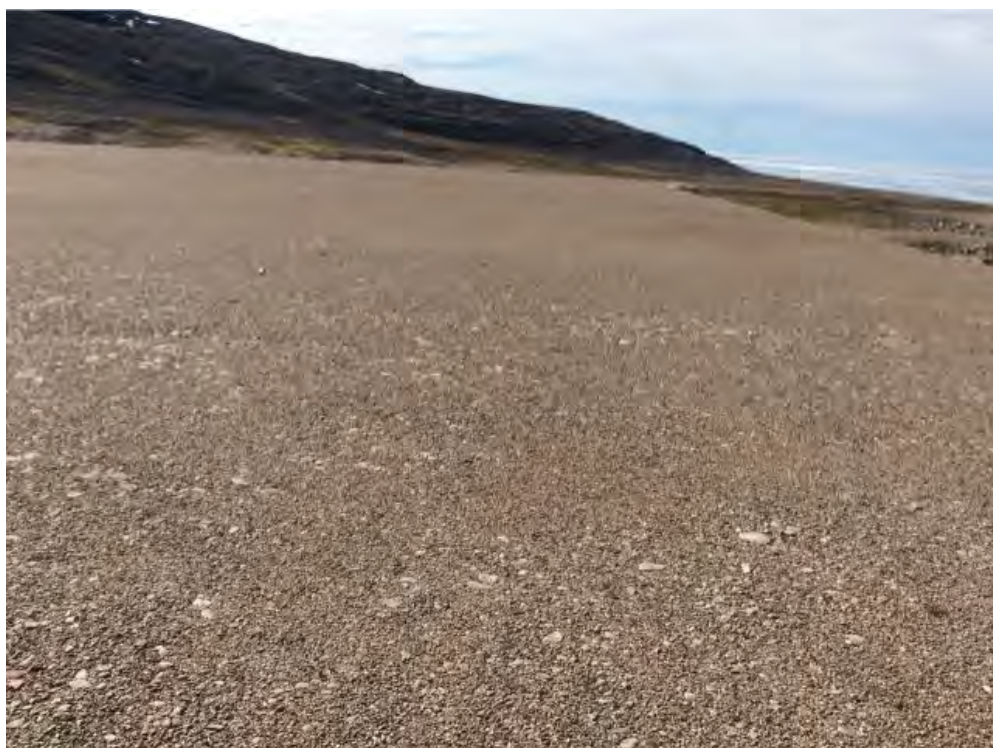
Photo 80: Non-Haz Waste Landfill- Cover surface, facing west (CAM5_Photo168.jpg)

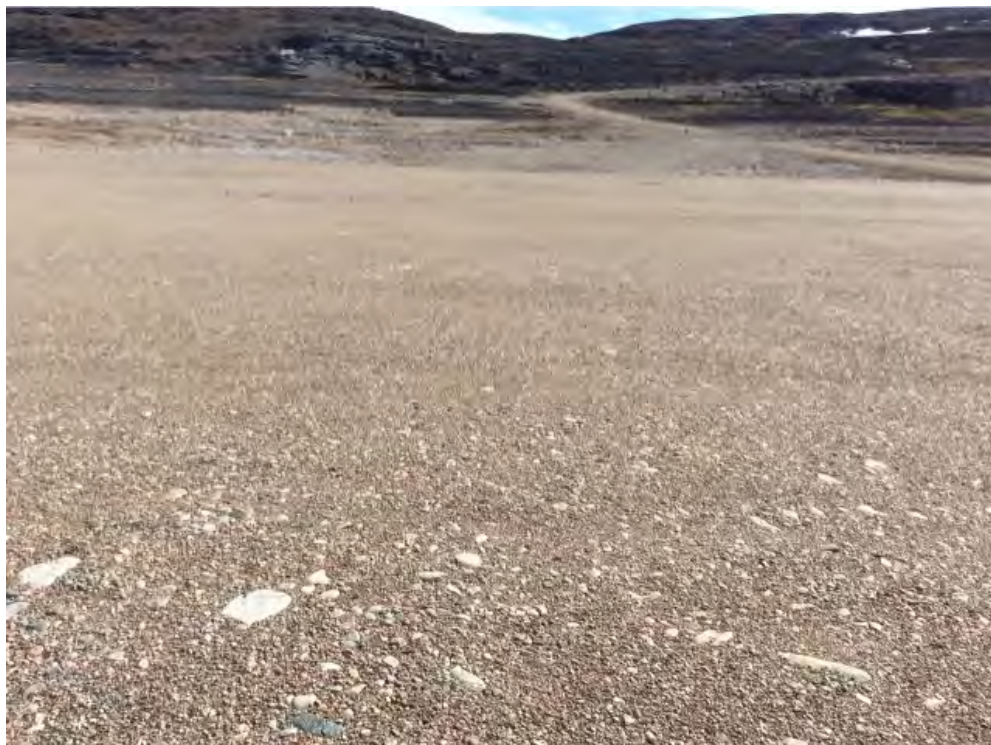
Photo 81: *Non-Haz Waste Landfill- Cover surface, facing southeast (CAM5_Photo170.jpg)*

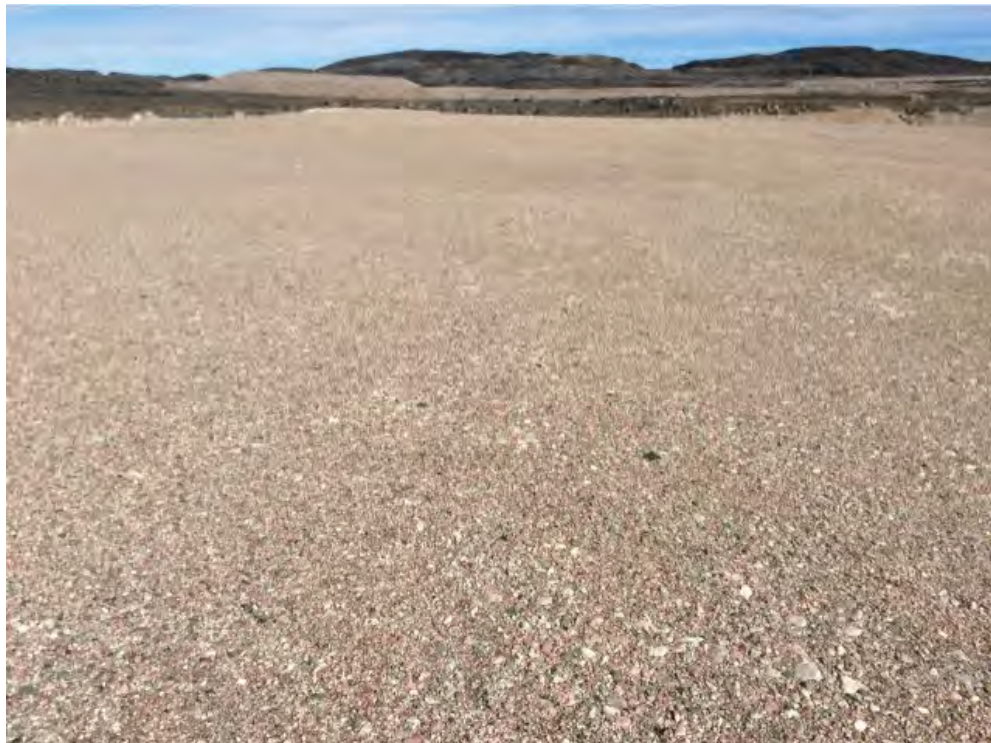
Photo 82: *Non-Haz Waste Landfill- Cover surface, facing northeast (CAM5_Photo173.jpg)*

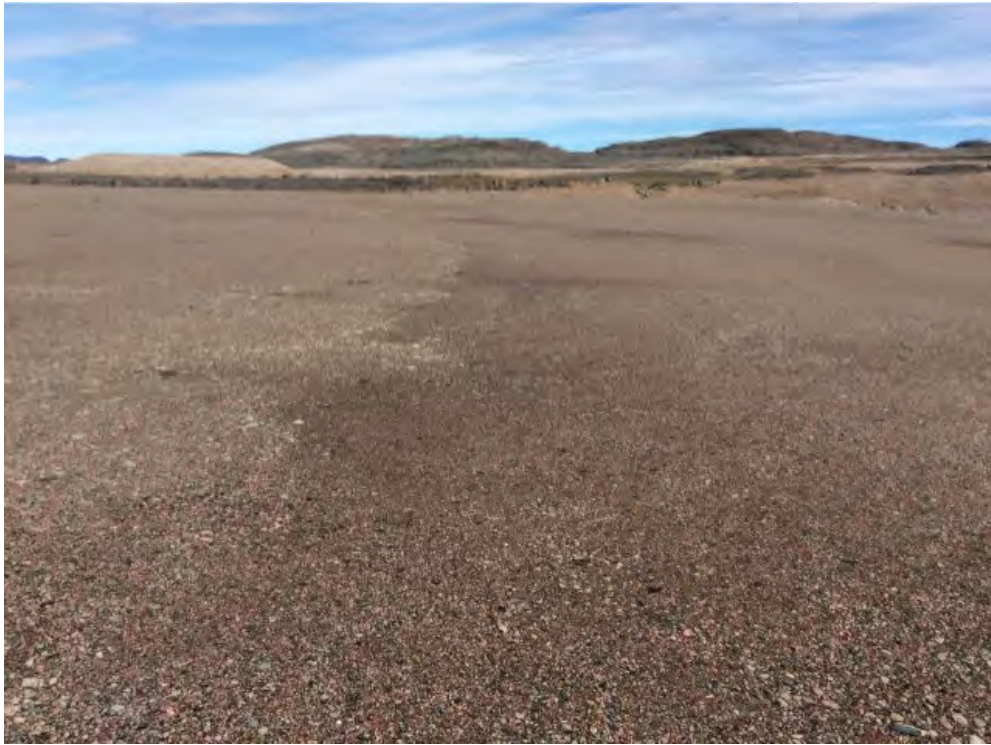
Photo 83: Non-Haz Waste Landfill- Cover surface, facing northeast (CAM5_Photo174.jpg)

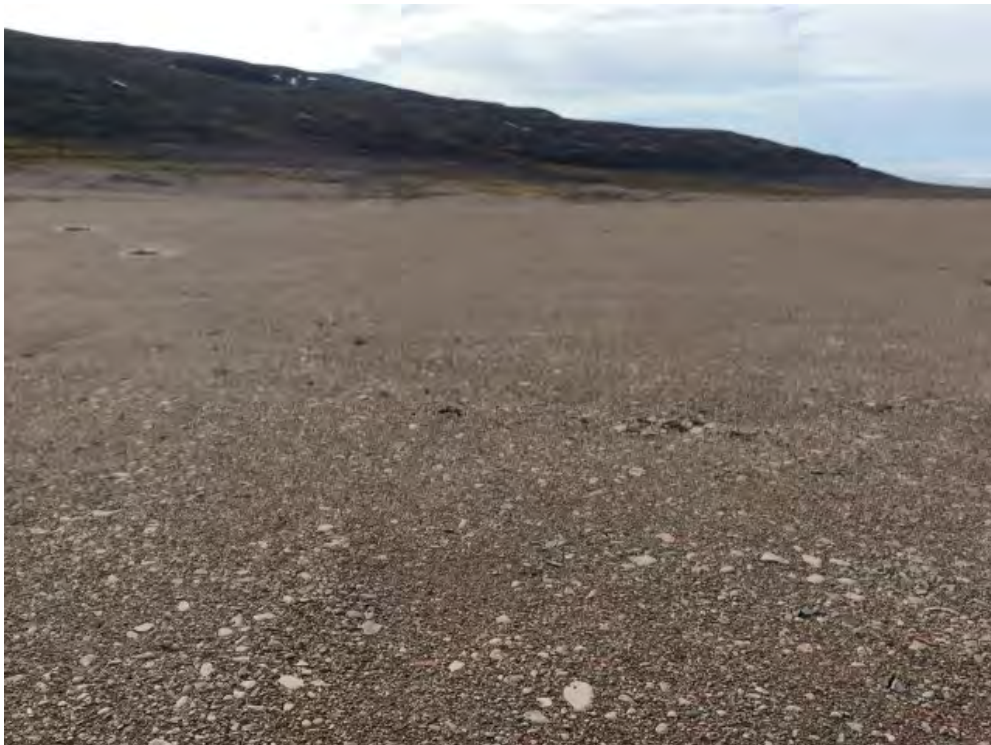
Photo 84: Non-Haz Waste Landfill- Cover surface, facing southwest (CAM5_Photo175.jpg)

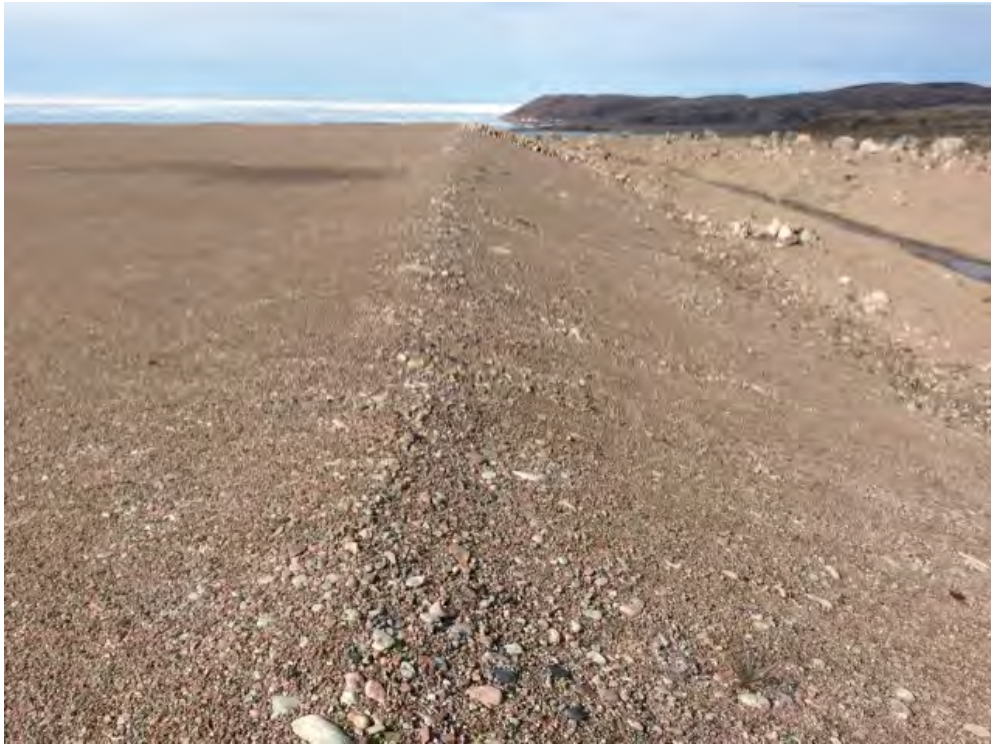
Photo 85: *Non-Haz Waste Landfill- East crest and slope, facing northwest (CAM5_Photo165.jpg)*

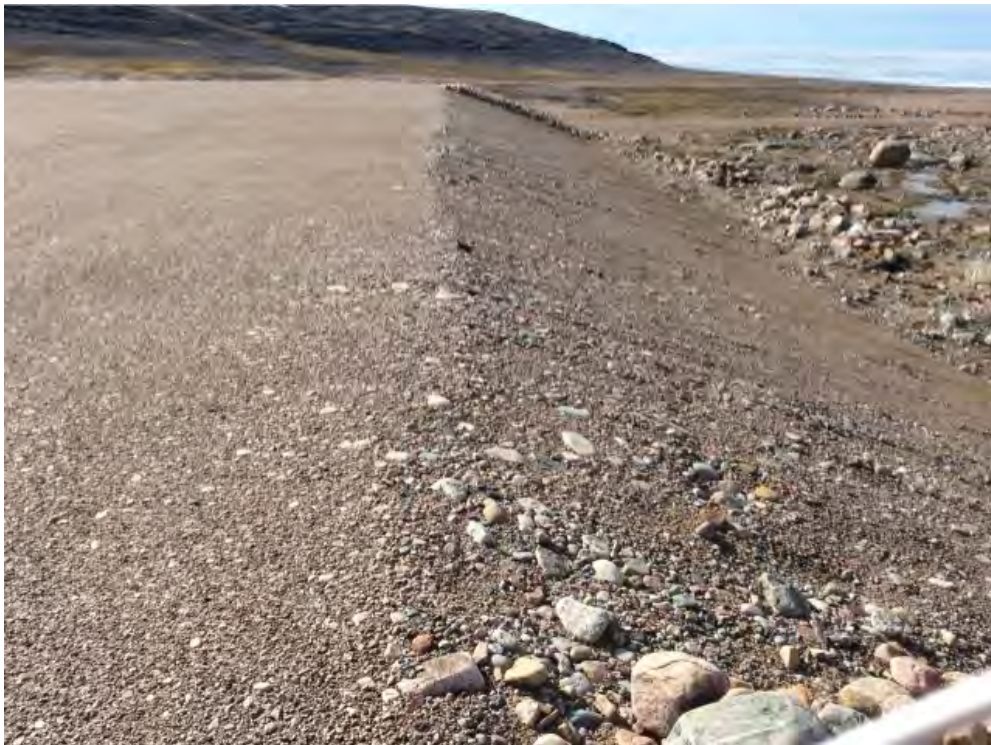
Photo 86: *Non-Haz Waste Landfill- North crest and slope, facing southwest (CAM5_Photo169.jpg)*

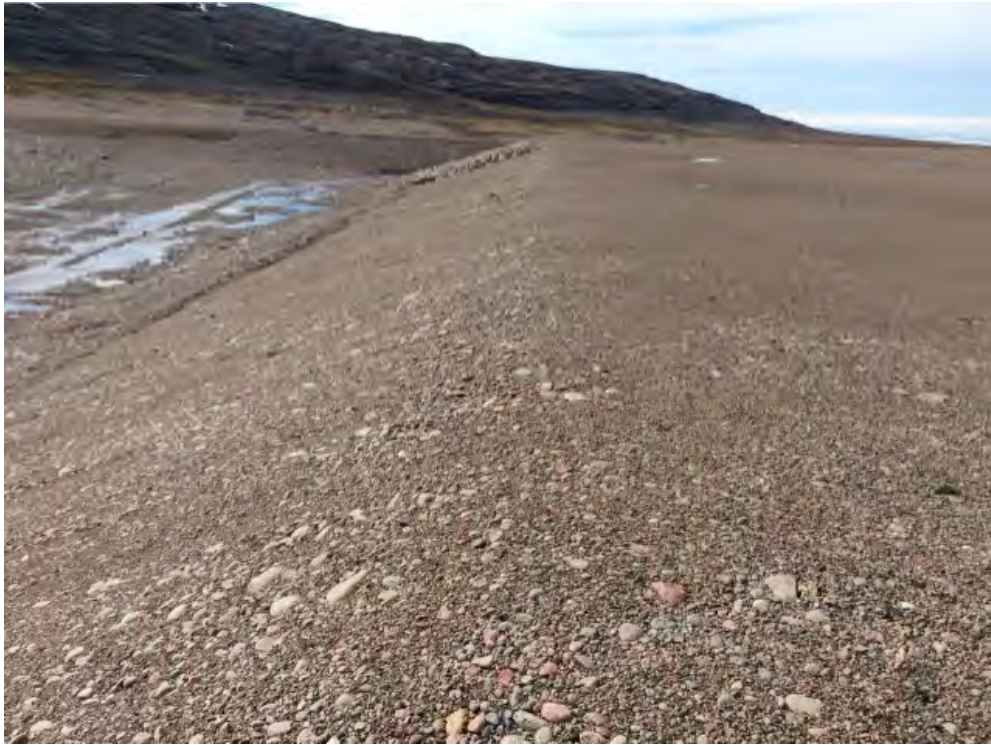
Photo 87: Non-Haz Waste Landfill- South crest and slope, facing southwest (CAM5_Photo166.jpg)

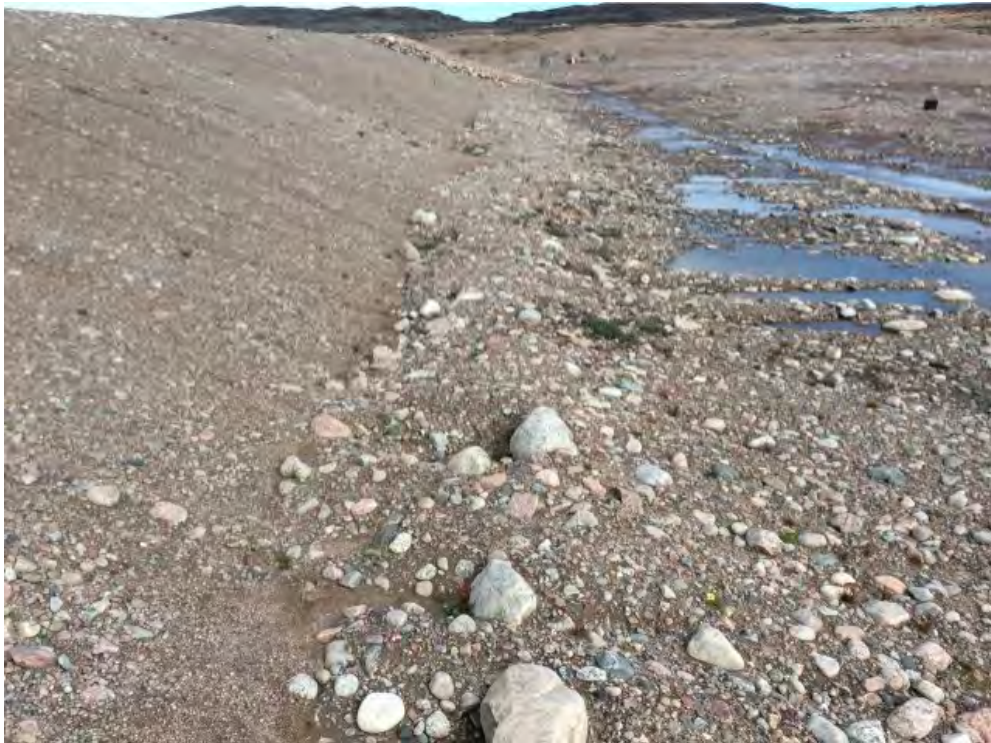
Photo 88: Non-Haz Waste Landfill- South toe, facing northeast (CAM5_Photo176.jpg)

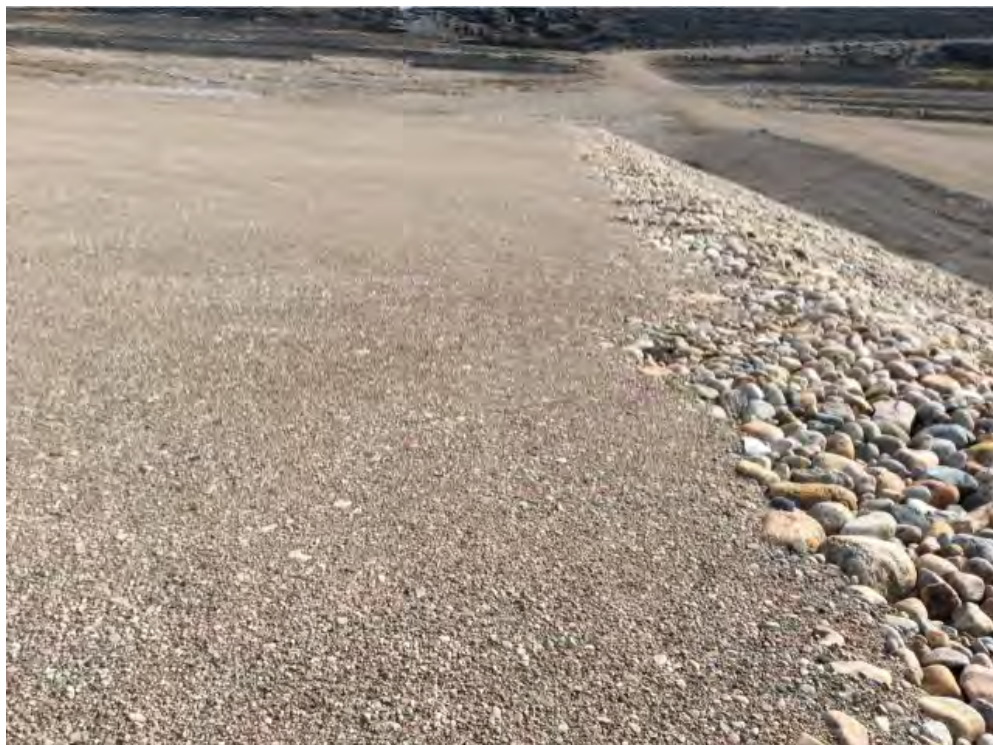
Photo 89: Non-Haz Waste Landfill- West crest, facing southeast (CAM5_Photo171.jpg)

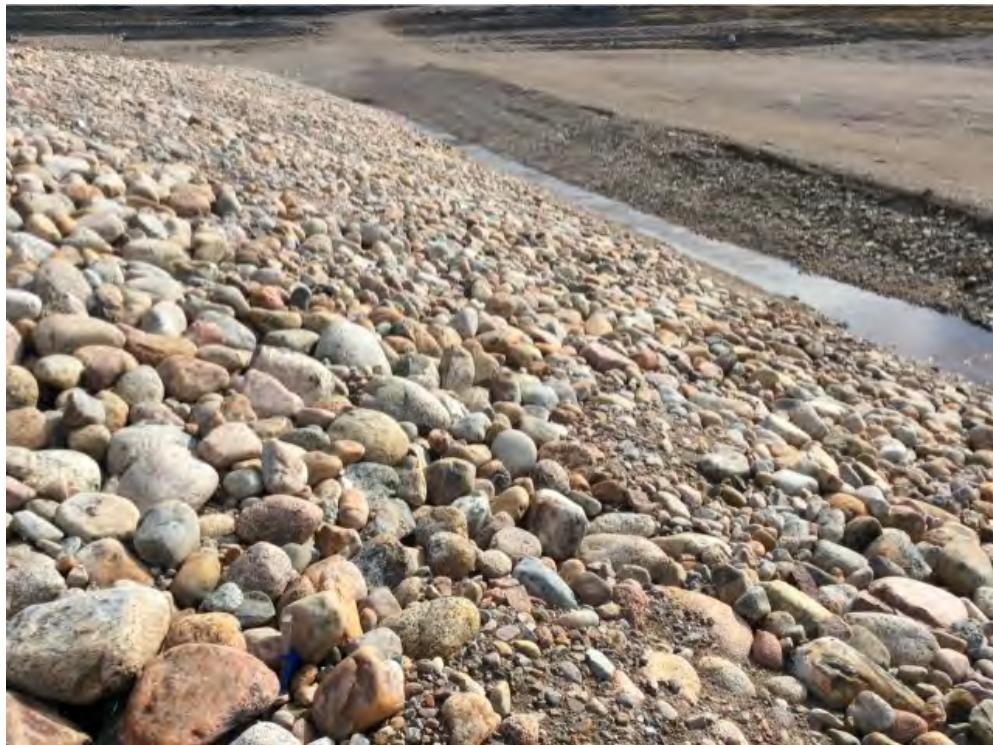
Photo 90: Non-Haz Waste Landfill- West slope and toe (Ephemeral stream along toe – Feature J), facing southeast (CAM5_Photo172.jpg)

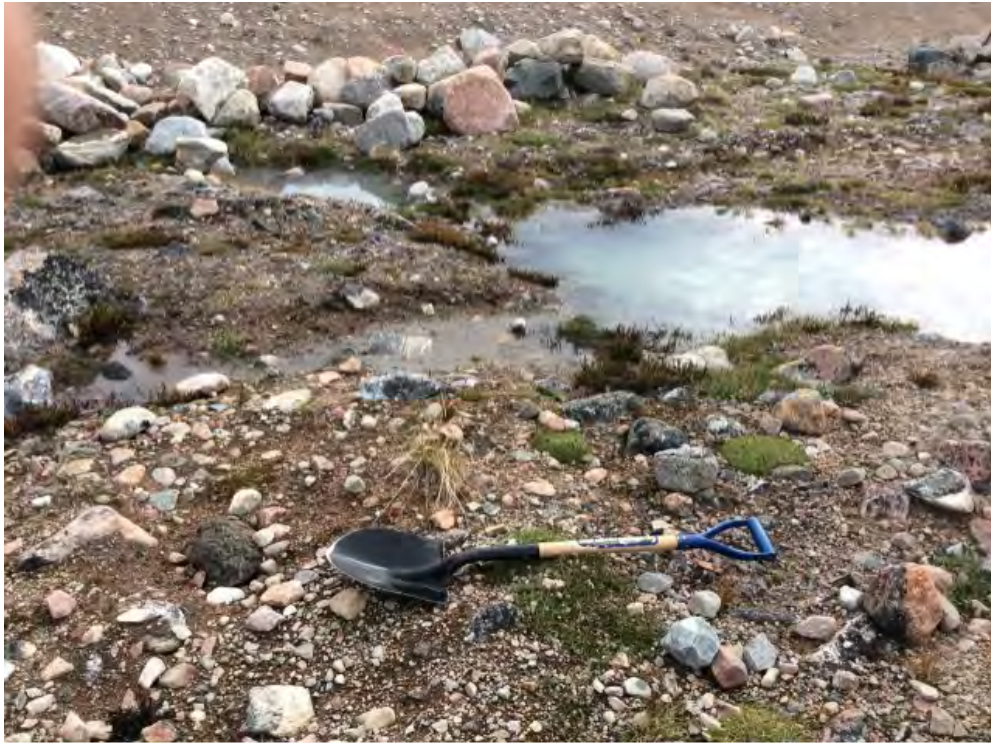
Photo 117: Non-Hazardous Waste Landfill- Soil Sample MW-09-Before Excavation (CAM5_Photo119.jpg)

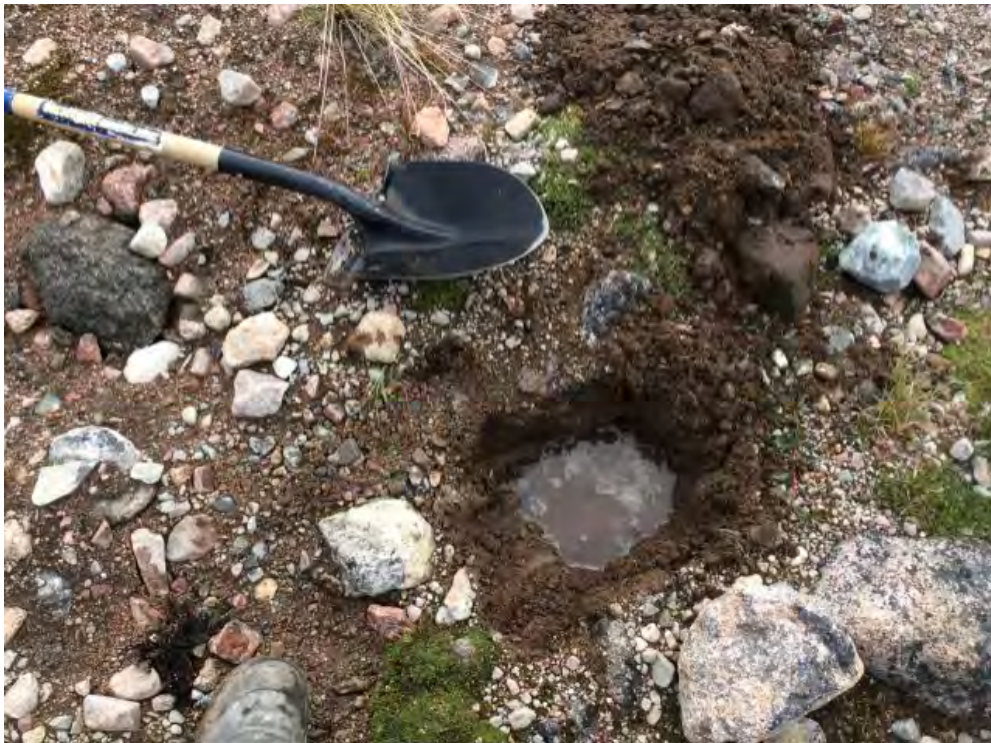
Photo 118: Non-Hazardous Waste Landfill- Soil Sample MW-09-After Excavation (CAM5_Photo120.jpg)

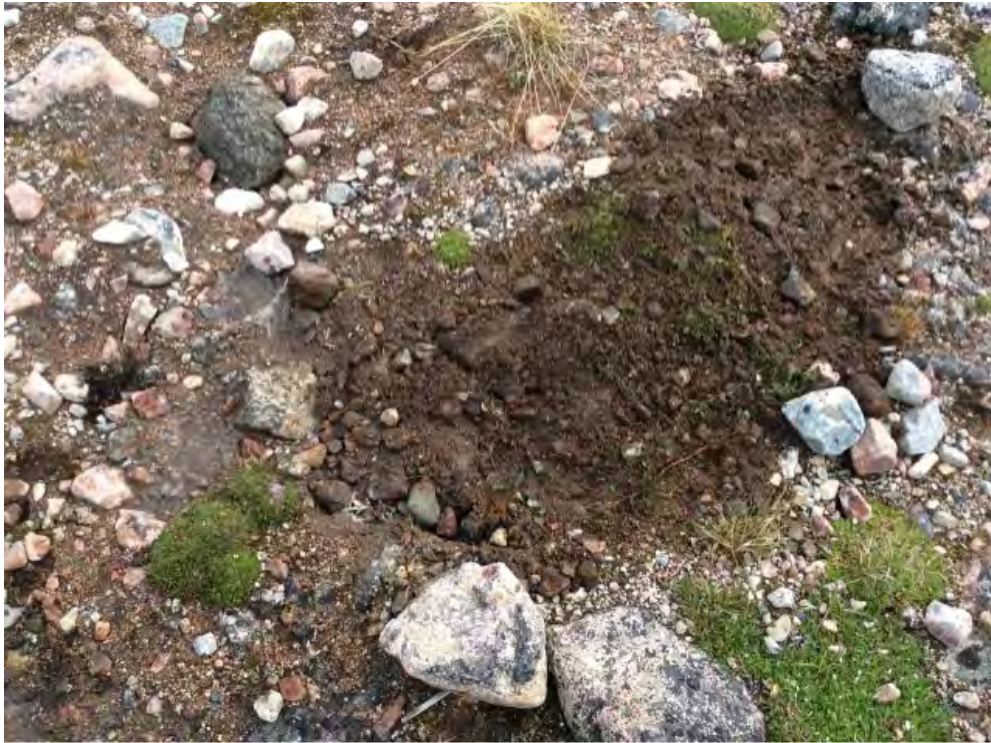
Photo 119: Non-Hazardous Waste Landfill- Soil Sample MW-09-After Backfilling (CAM5_Photo121.jpg)

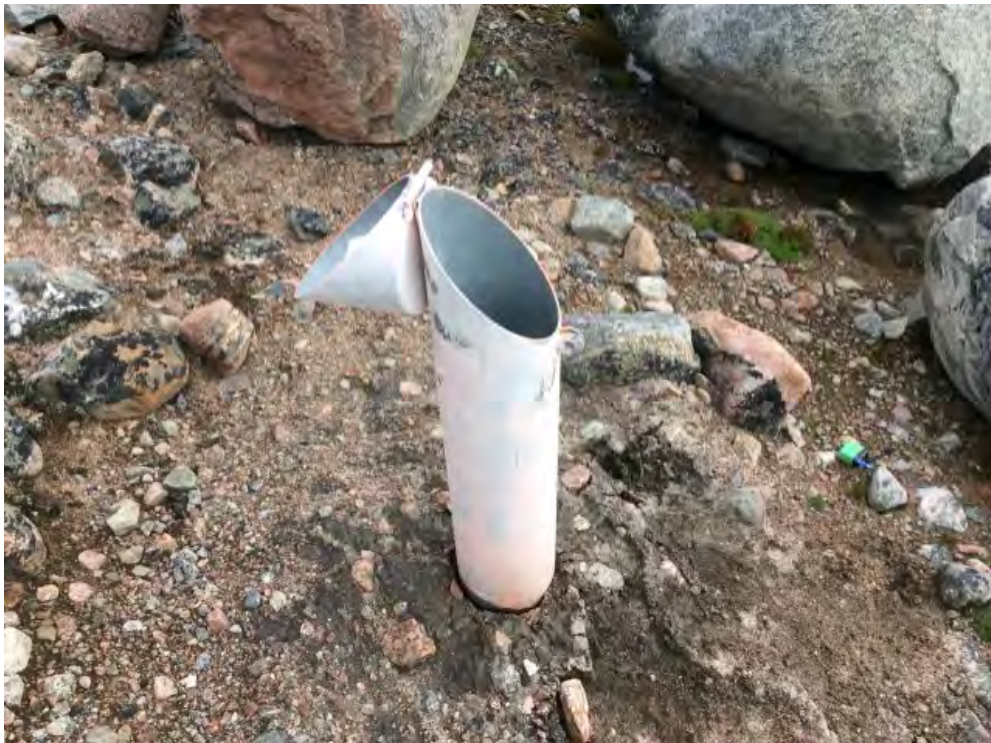
Photo 120: Non-Hazardous Waste Landfill- Water Sample MW-09 (CAM5_Photo122.jpg)

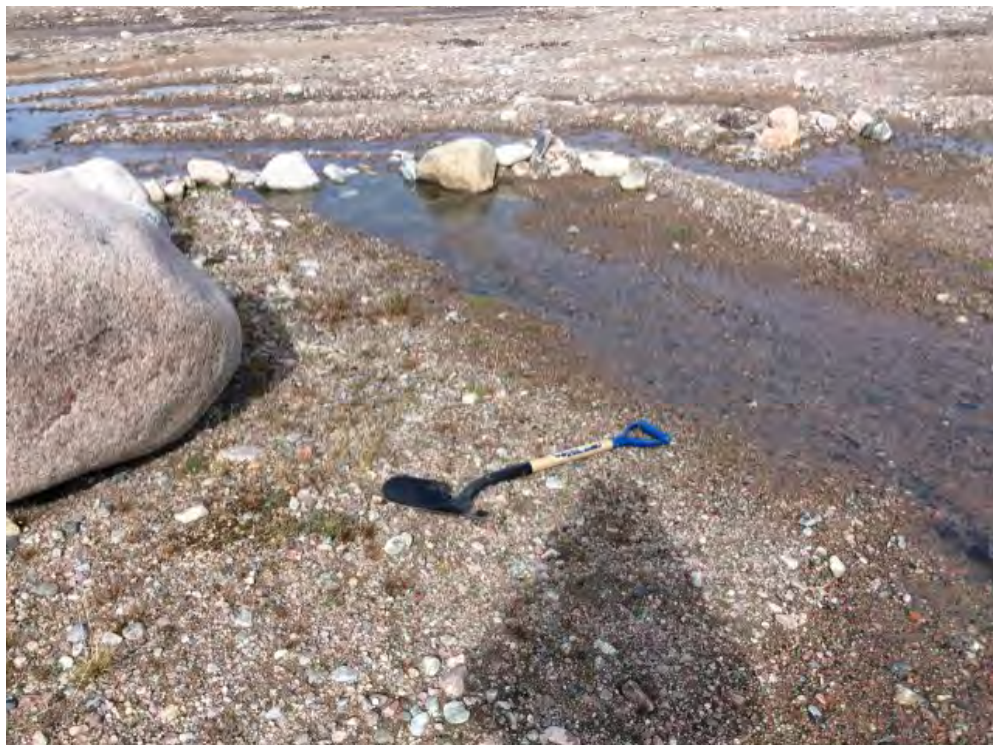
Photo 121: Non-Hazardous Waste Landfill- Soil Sample MW-11-Before Excavation (CAM5_Photo111.jpg)

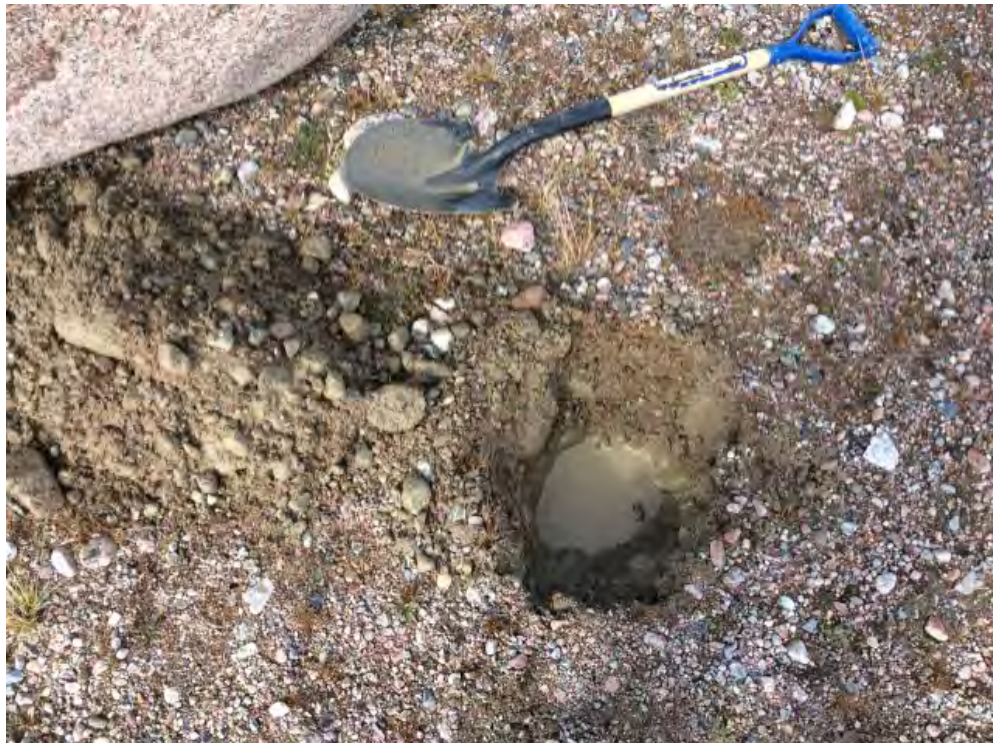
Photo 122: Non-Hazardous Waste Landfill- Soil Sample MW-11-After Excavation (CAM5_Photo112.jpg)

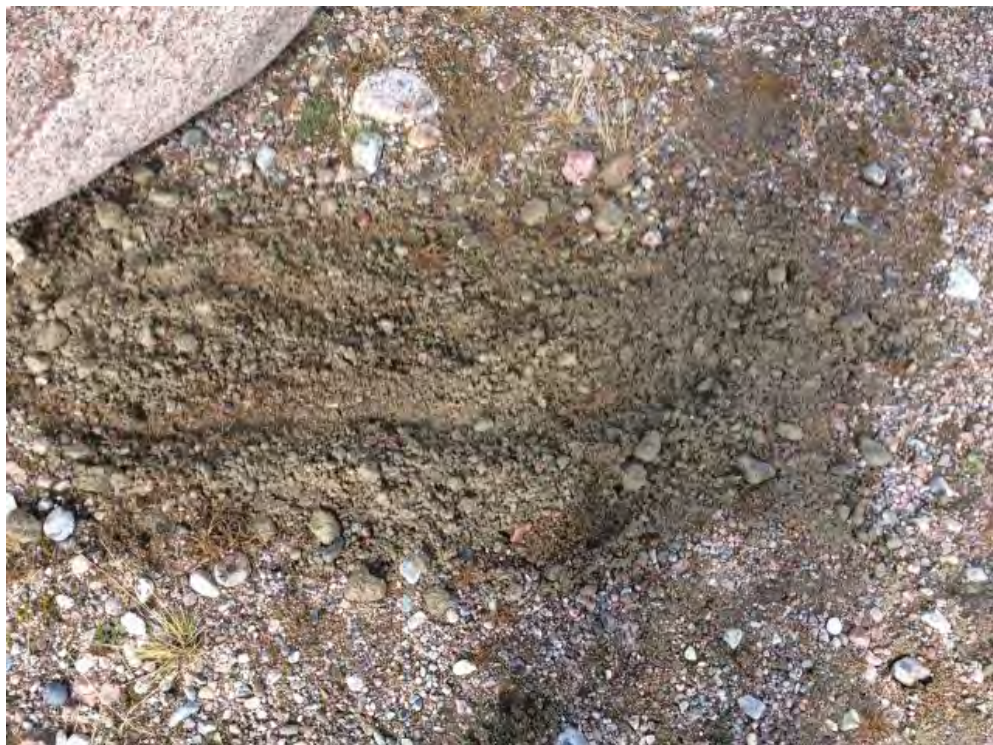
Photo 123: Non-Hazardous Waste Landfill- Soil Sample MW-11-After Backfilling (CAM5_Photo113.jpg)

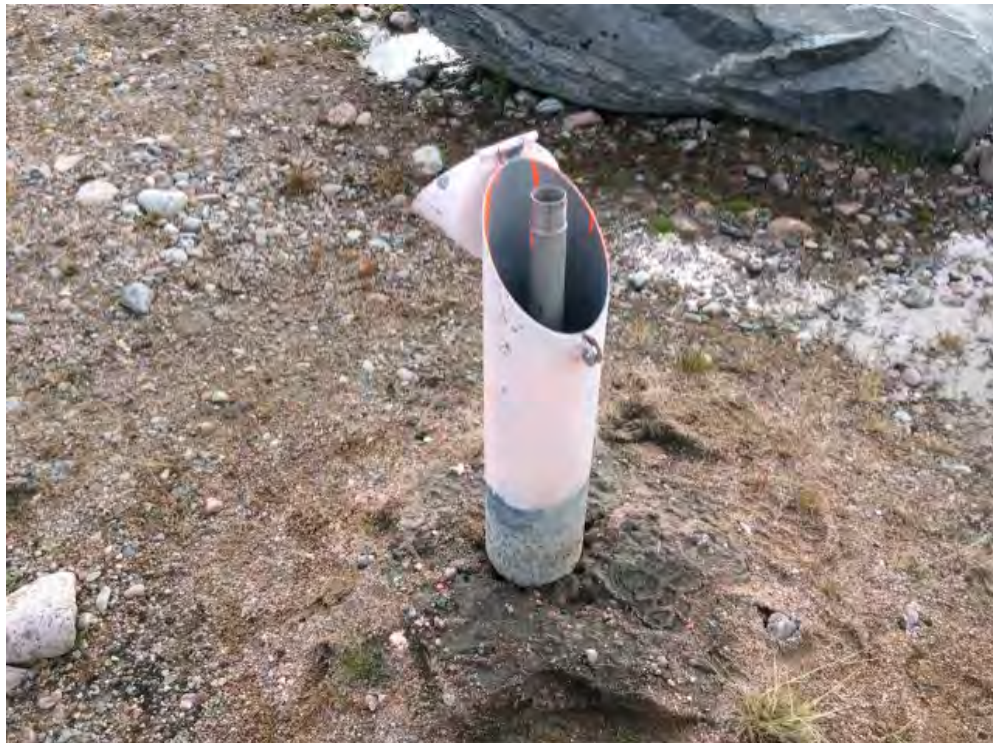
Photo 124: Non-Hazardous Waste Landfill- Water Sample MW-11 (CAM5_Photo114.jpg)

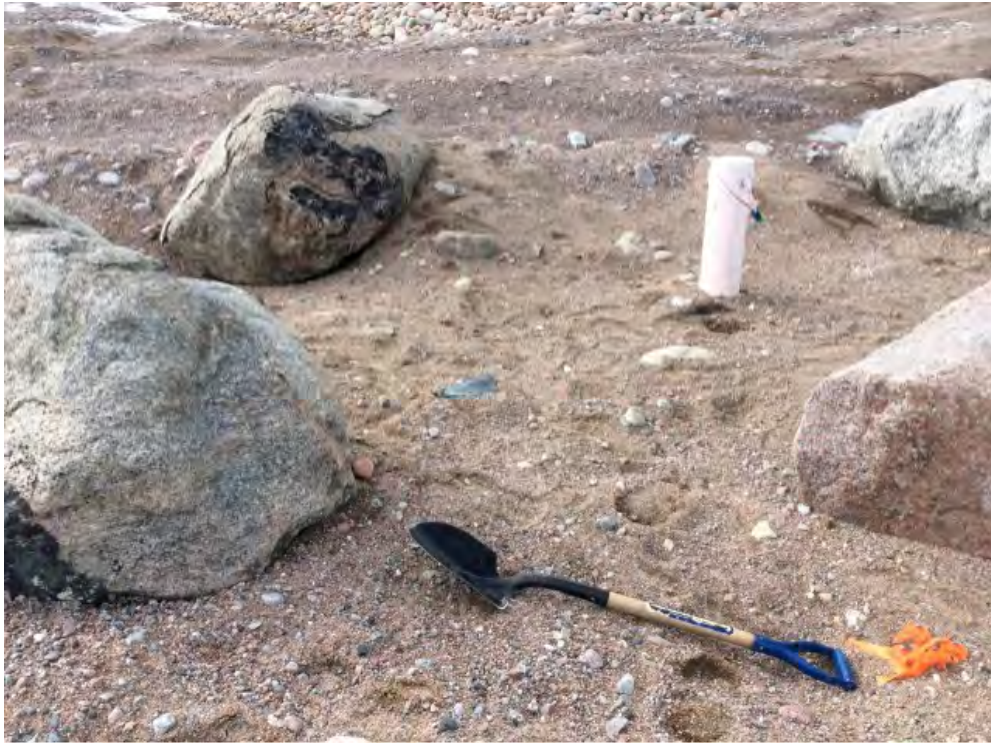
Photo 125: Non-Hazardous Waste Landfill- Soil Sample MW-12-Before Excavation (CAM5_Photo115.jpg)

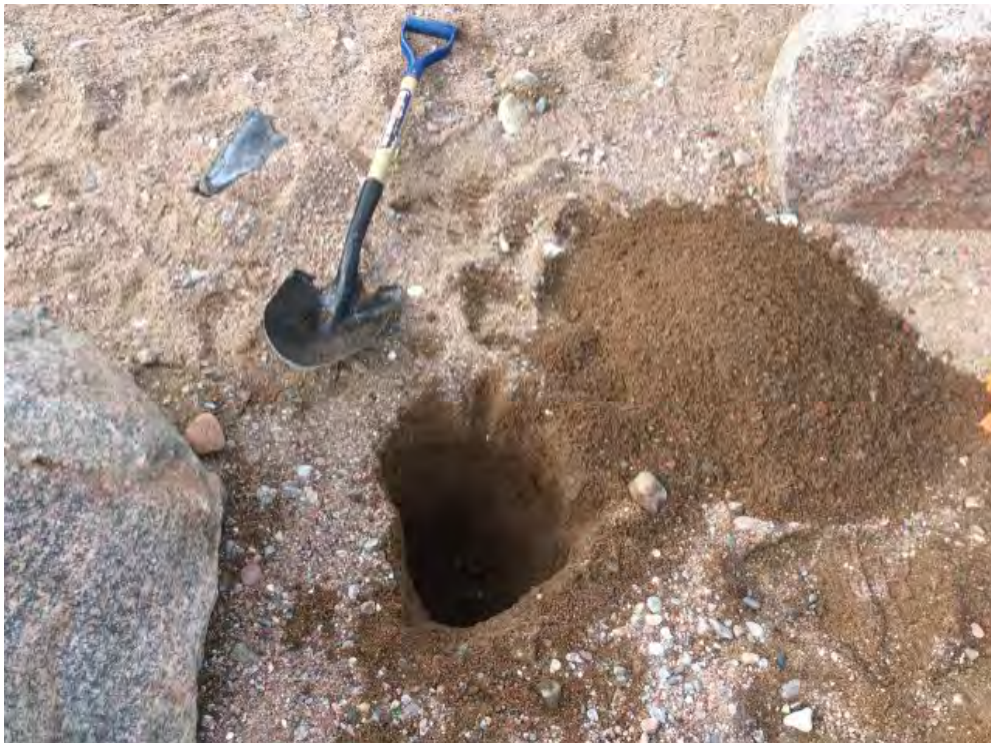
Photo 126: Non-Hazardous Waste Landfill- Soil Sample MW-12-After Excavation (CAM5_Photo116.jpg)

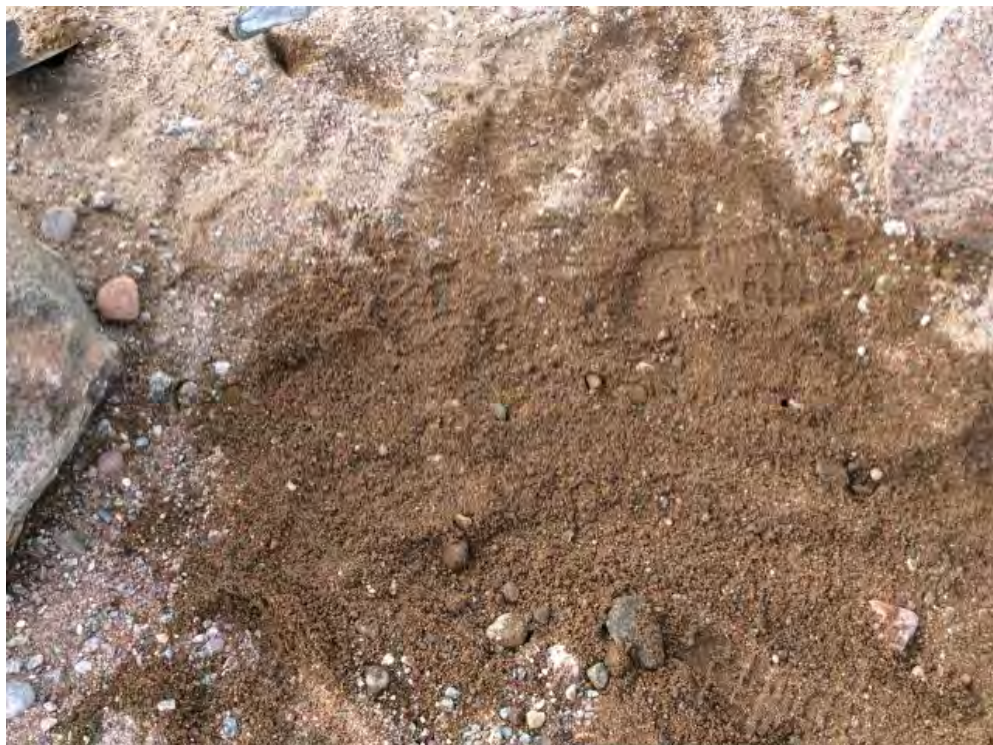
Photo 127: Non-Hazardous Waste Landfill- Soil Sample MW-12-After Backfilling (CAM5_Photo117.jpg)

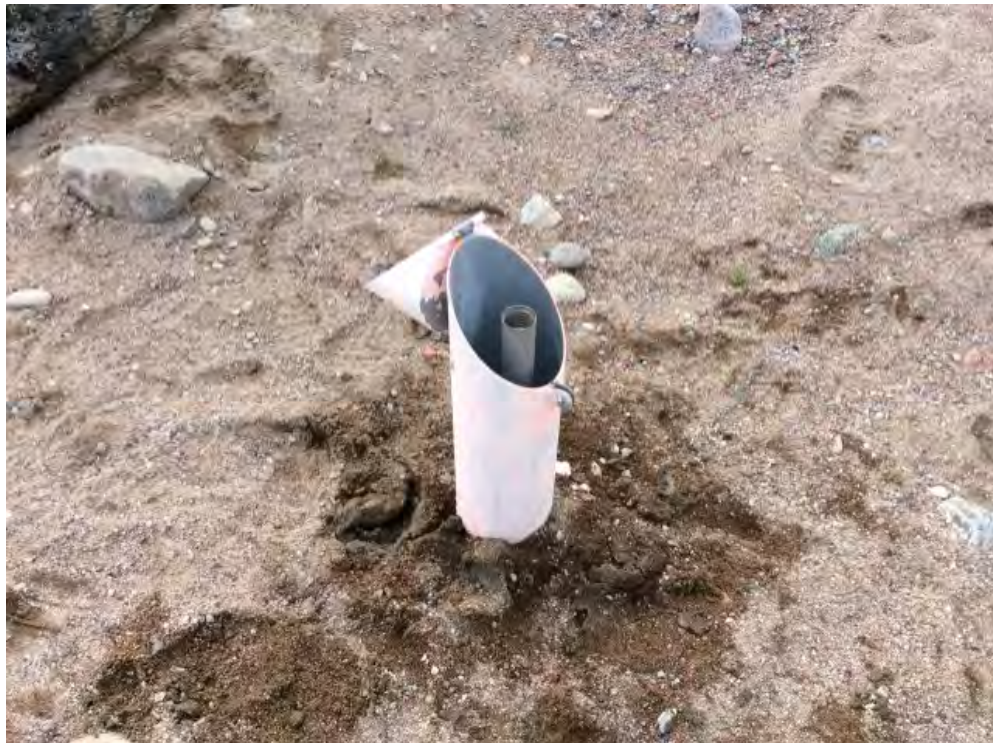
Photo 128: Non-Hazardous Waste Landfill- Water Sample MW-12 (CAM5_Photo118.jpg)

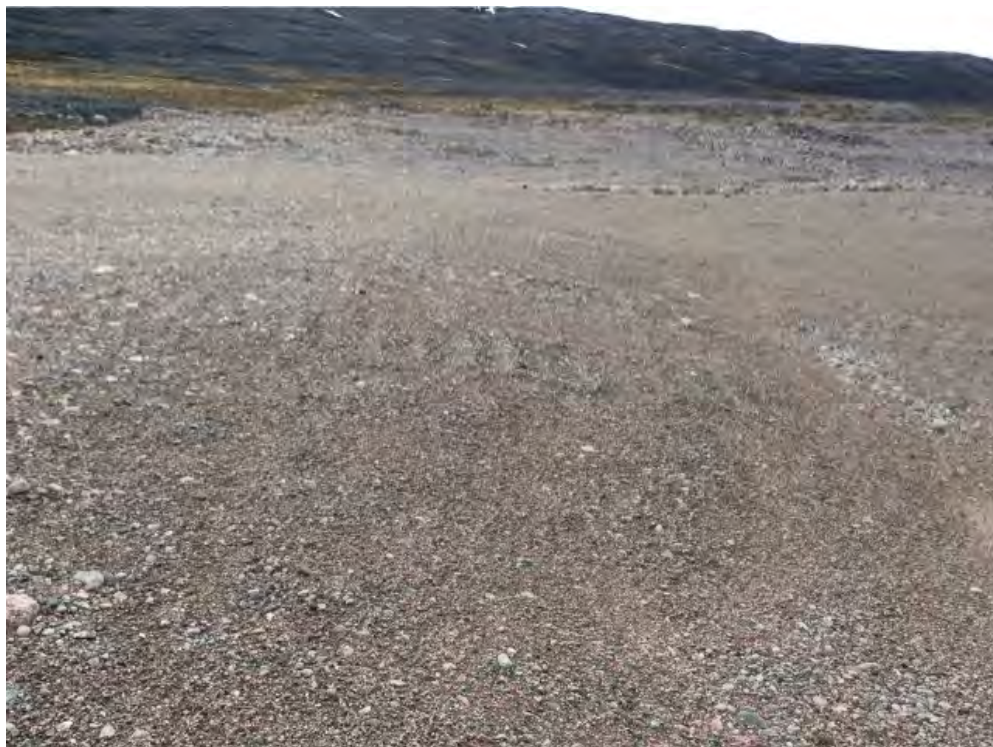
Photo 129: *USAF & Asbestos Landfill- Cover surface, facing west (CAM5_Photo179.jpg)*
