QIKIQ15 BAFFIN REGION DEW LINE SITE MONITORING

2017 CAM-5 Monitoring Report

Report Number: 1530908-3000-R3-V4

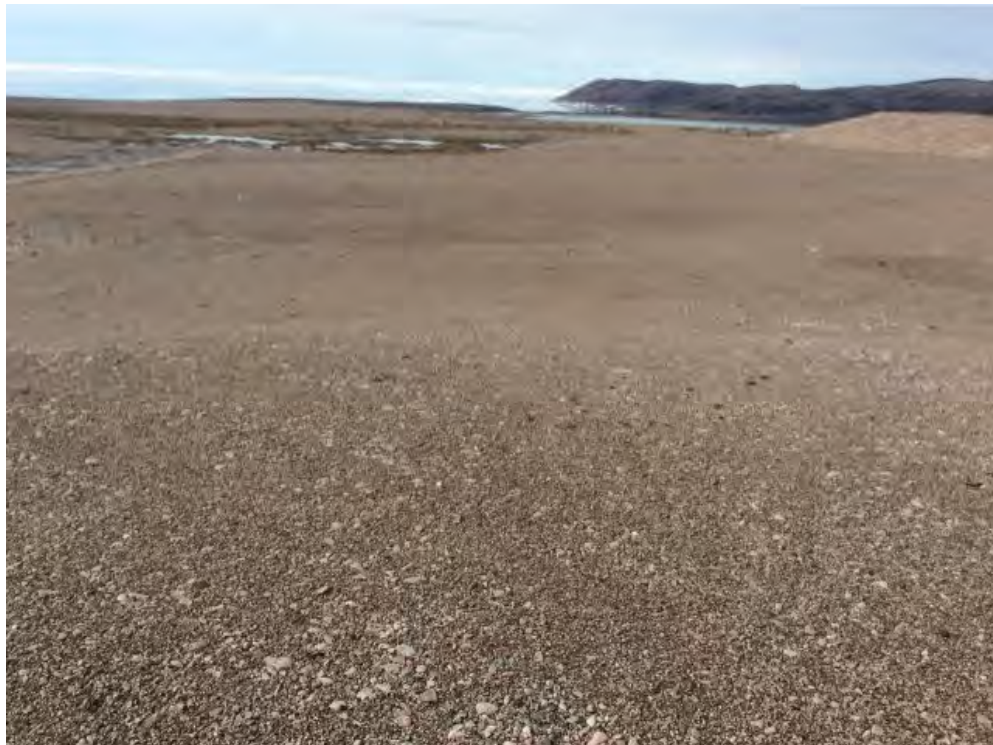
Photo 130: *USAF & Asbestos Landfill- Cover surface, facing northwest (CAM5_Photo180.jpg)*

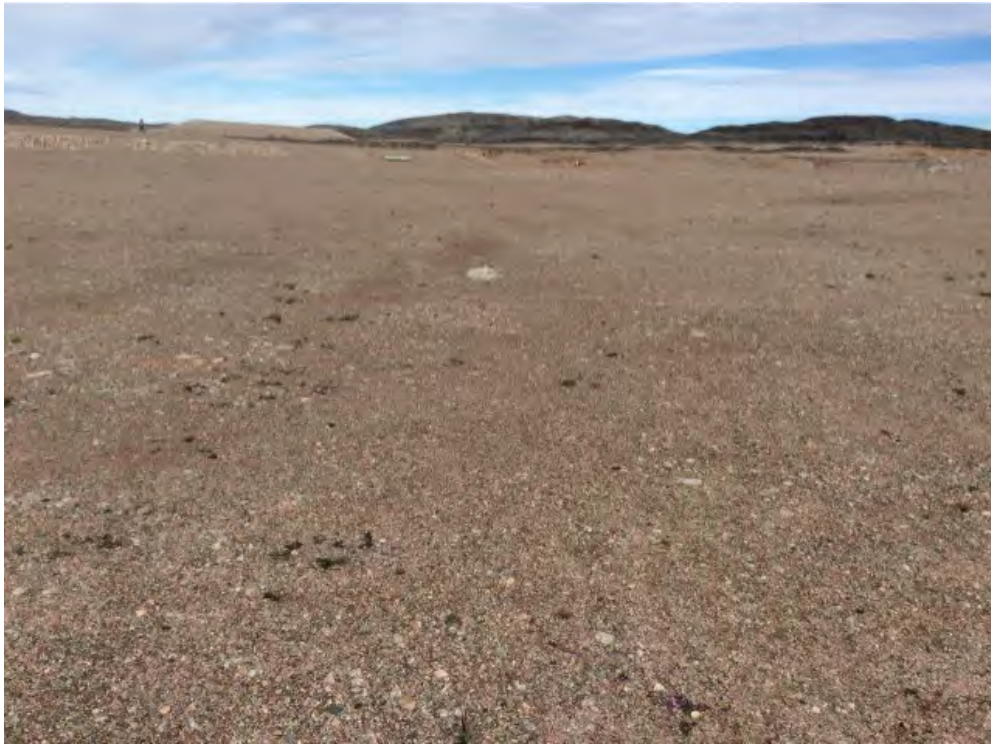
Photo 131: USAF & Asbestos Landfill- Cover surface, facing northeast (CAM5_Photo183.jpg)

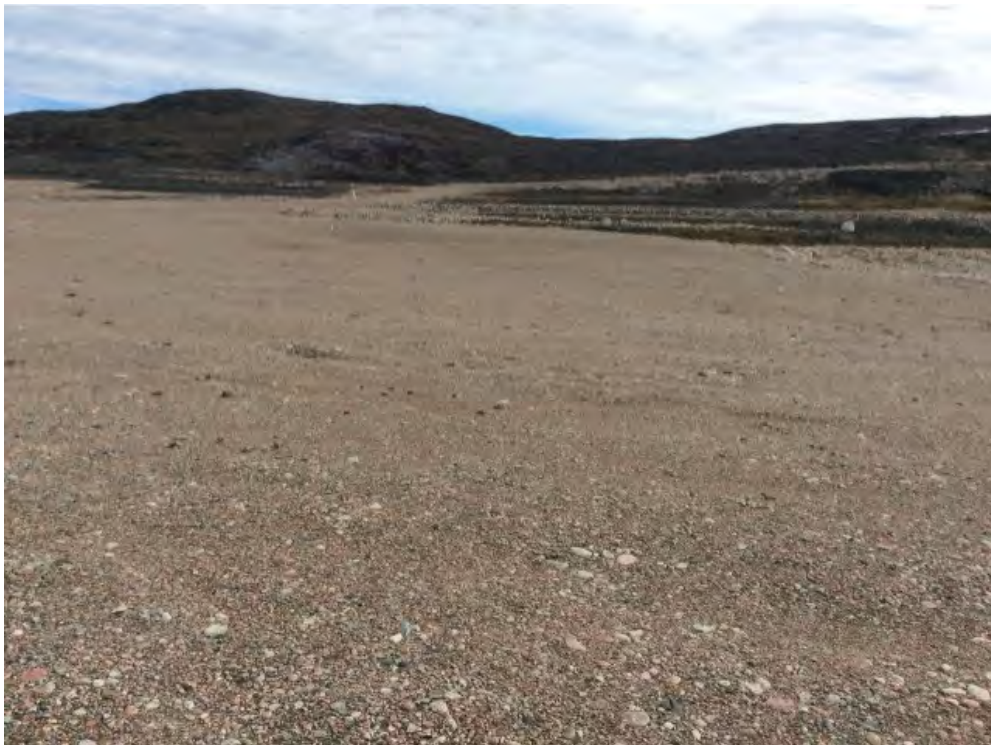
Photo 132: USAF & Asbestos Landfill- Cover surface, facing southeast (CAM5_Photo184.jpg)

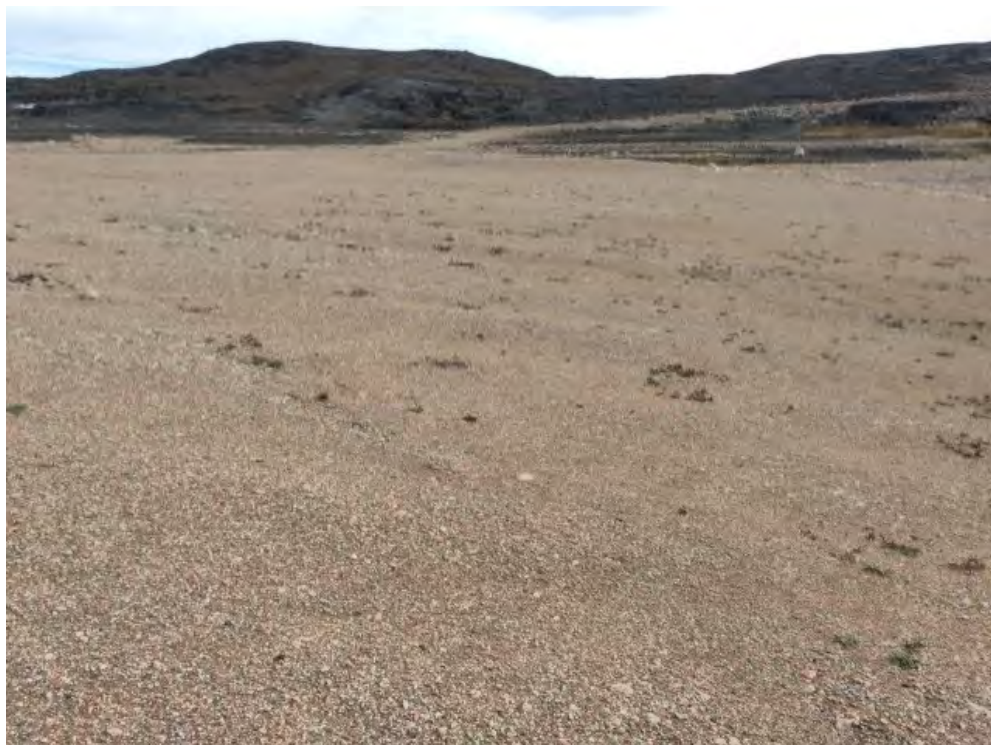
Photo 133: USAF & Asbestos Landfill- Cover surface, facing southeast (CAM5_Photo187.jpg)

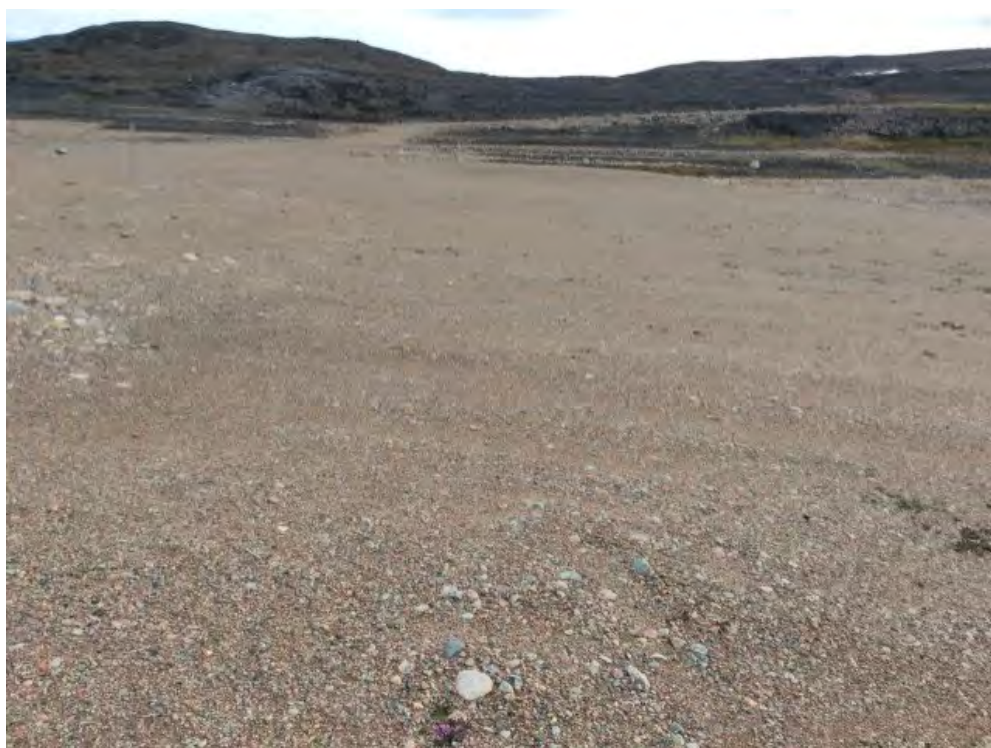
Photo 134: USAF & Asbestos Landfill- Cover surface, facing southeast (CAM5_Photo188.jpg)

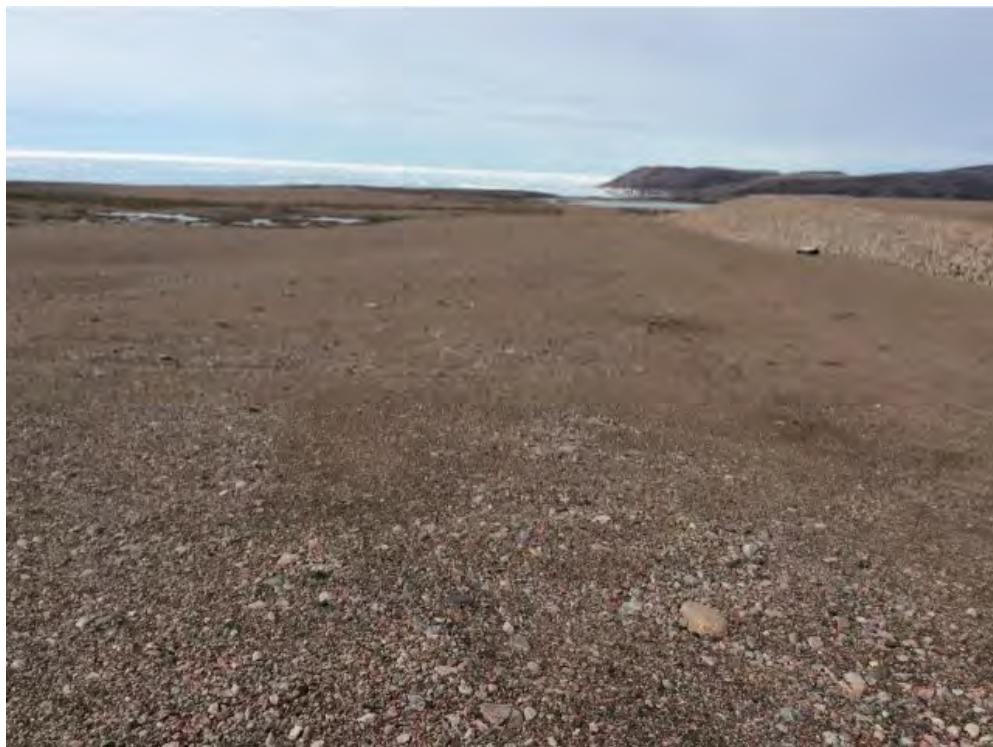
Photo 135: *USAF & Asbestos Landfill- East crest, facing northwest (CAM5_Photo177.jpg)*

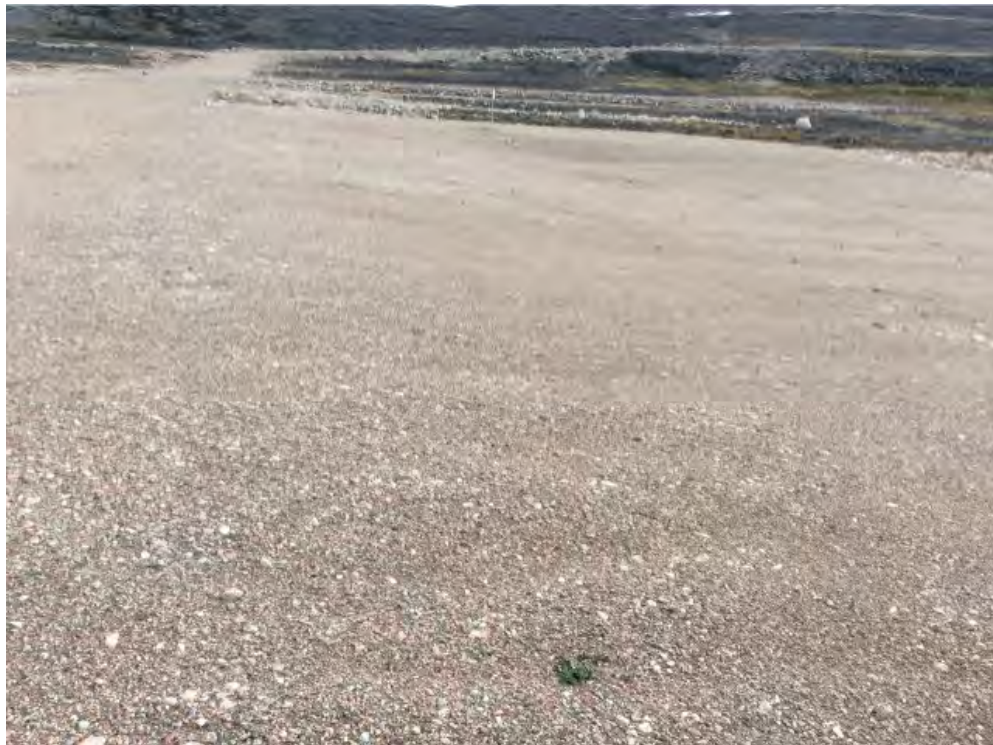
Photo 136: *USAF & Asbestos Landfill- East crest, facing southeast (CAM5_Photo185.jpg)*

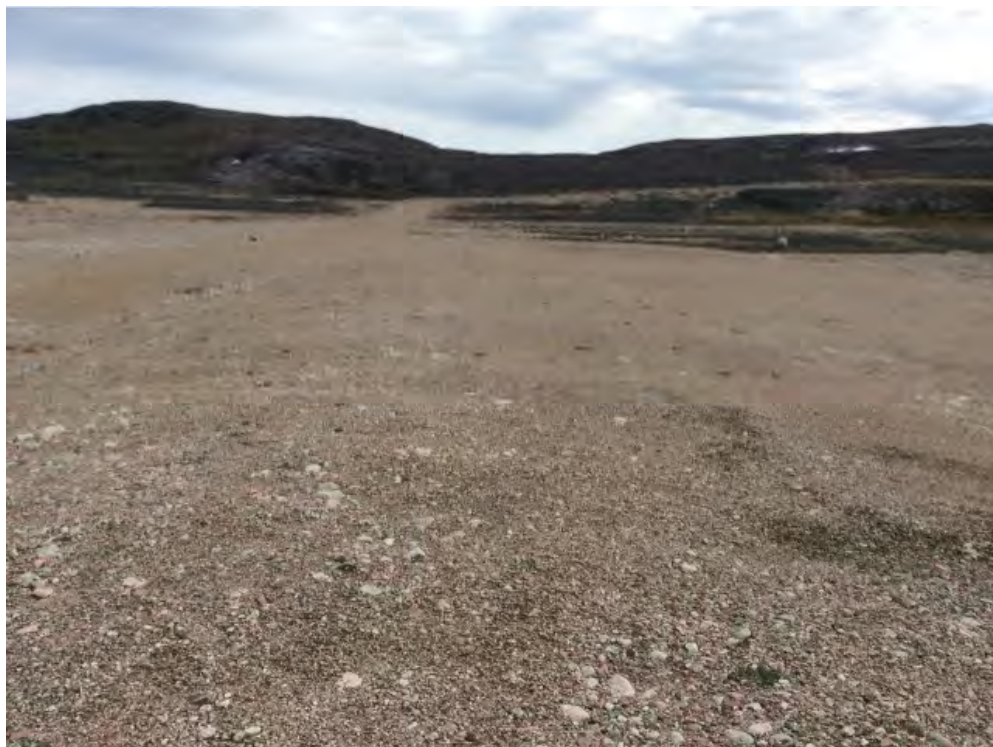
Photo 137: *USAF & Asbestos Landfill- East crest, facing southeast (CAM5_Photo189.jpg)*

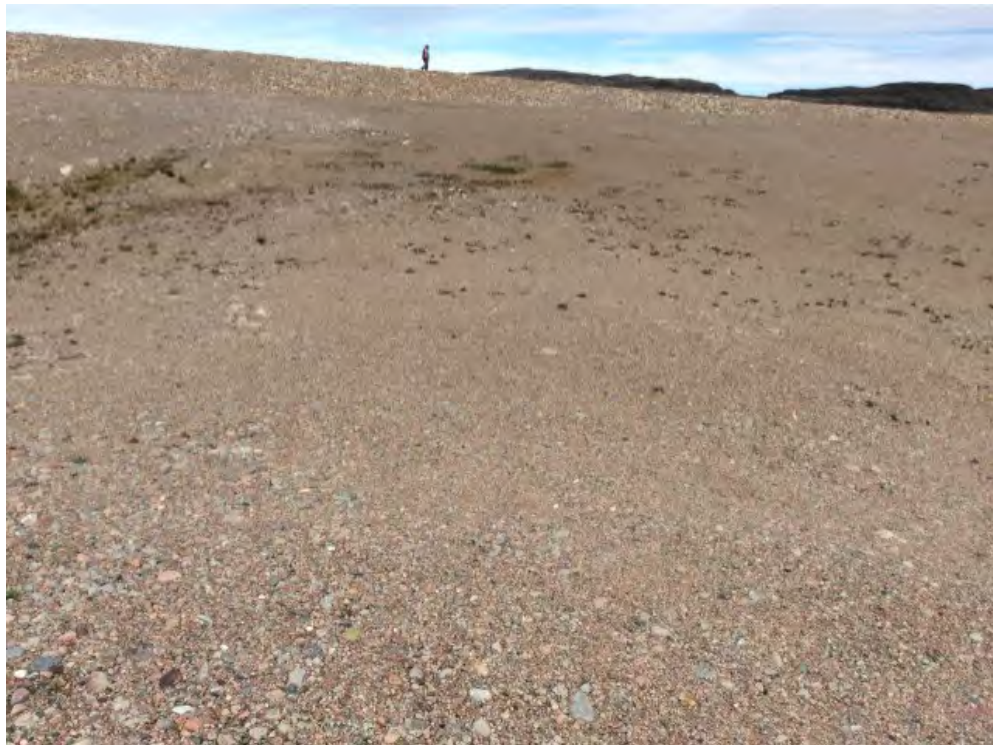
Photo 138: *USAF & Asbestos Landfill- North crest, facing northeast (CAM5_Photo186.jpg)*

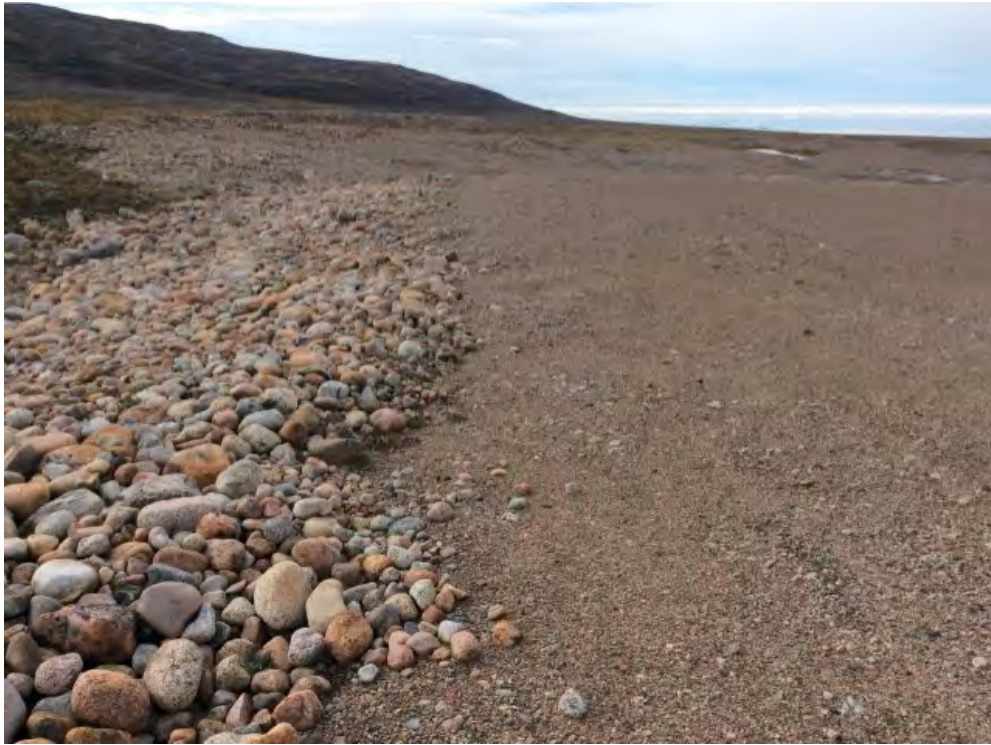
Photo 139: USAF & Asbestos Landfill- South crest, facing west (CAM5_Photo178.jpg)

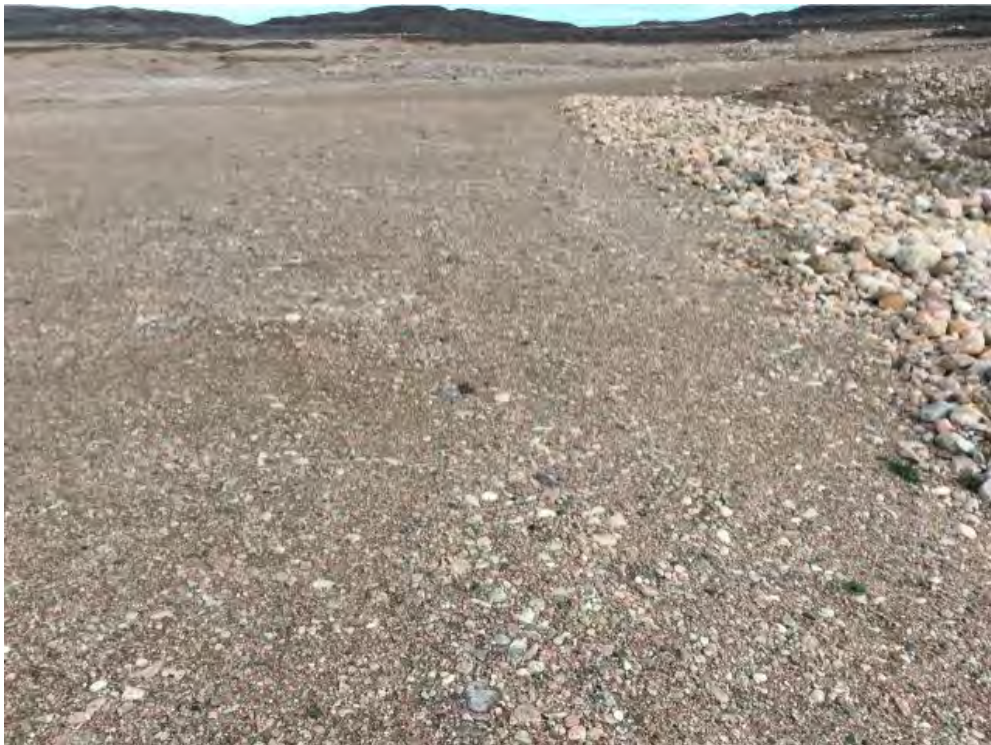
Photo 140: USAF & Asbestos Landfill- South crest, facing east (CAM5_Photo182.jpg)

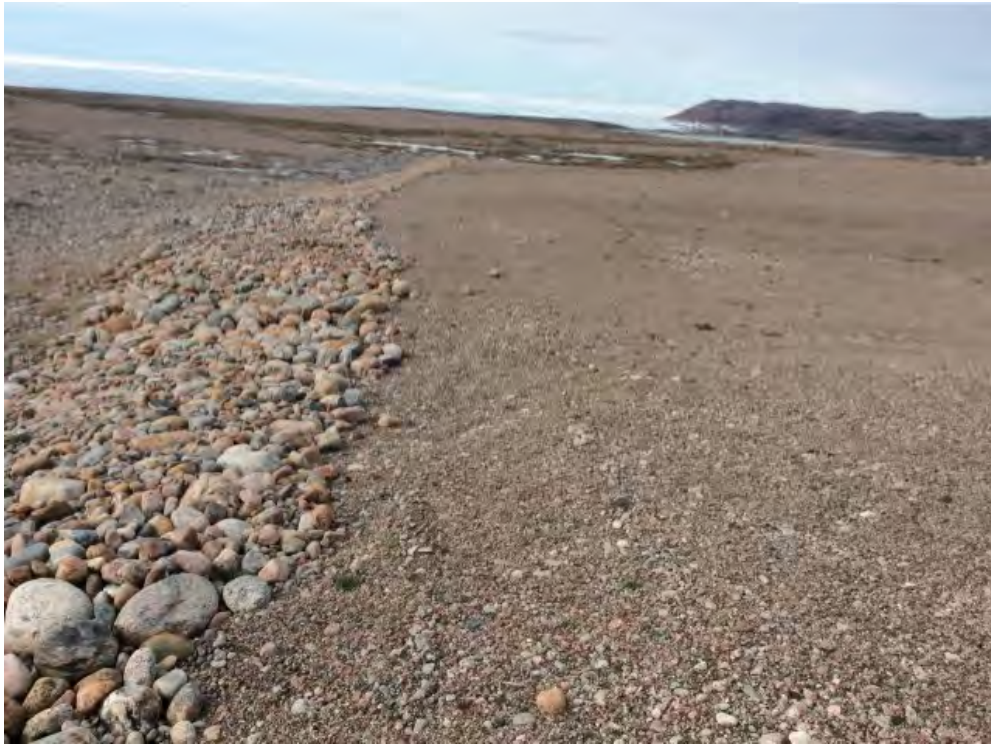
Photo 141: USAF & Asbestos Landfill- West crest, facing northwest (CAM5_Photo181.jpg)

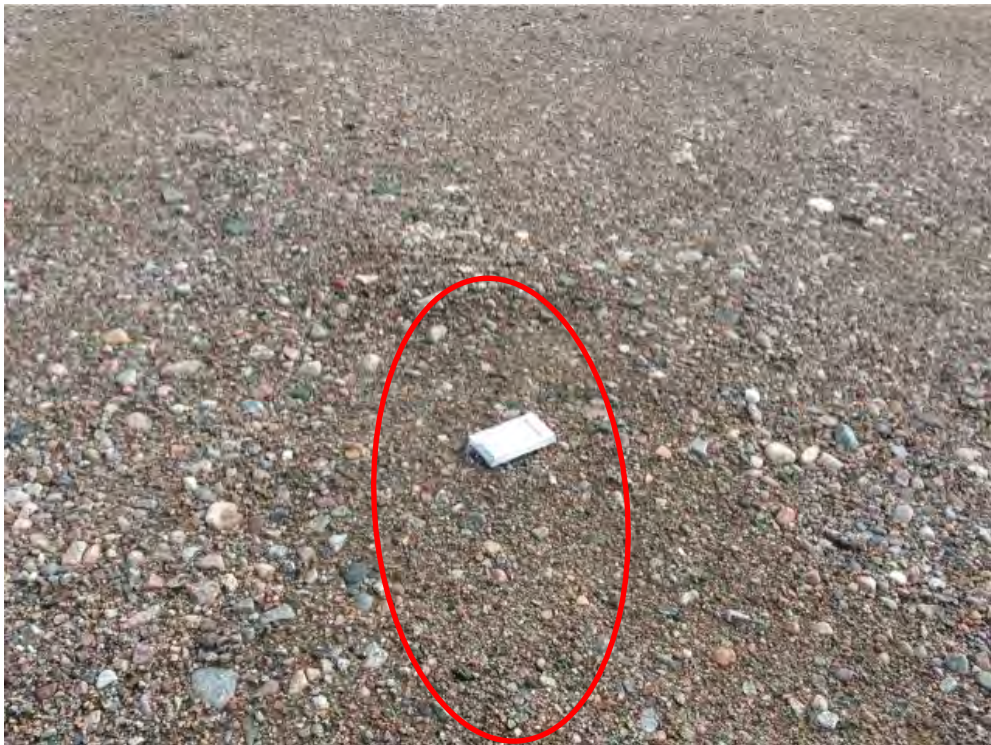
Photo 142: USAF & Asbestos Landfill- Southeast crest surface, Feature A-Linear depression, facing southeast (Acceptable) (CAM5_Photo38.jpg)

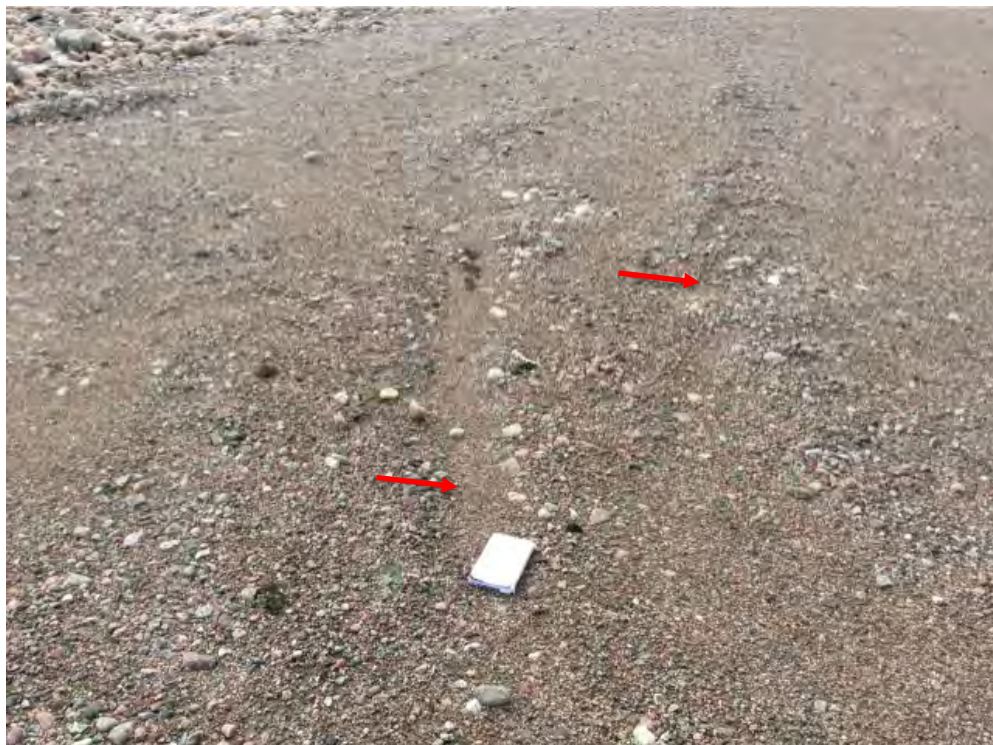
Photo 145: USAF & Asbestos Landfill- Southeast crest surface, Feature E-Vehicle rutting with minor erosion, facing northwest (Acceptable) (CAM5_Photo37.jpg)

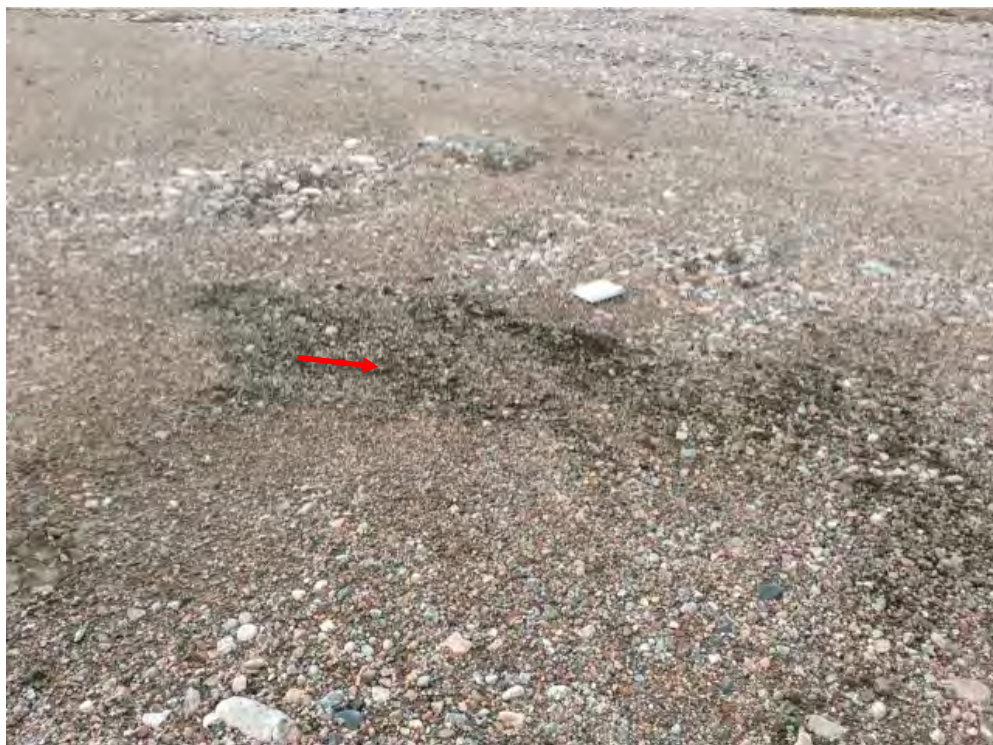
Photo 146: USAF & Asbestos Landfill- Northeast crest surface, Feature F-Bentonite or cement on surface, facing west (Acceptable) (CAM5_Photo50.jpg)

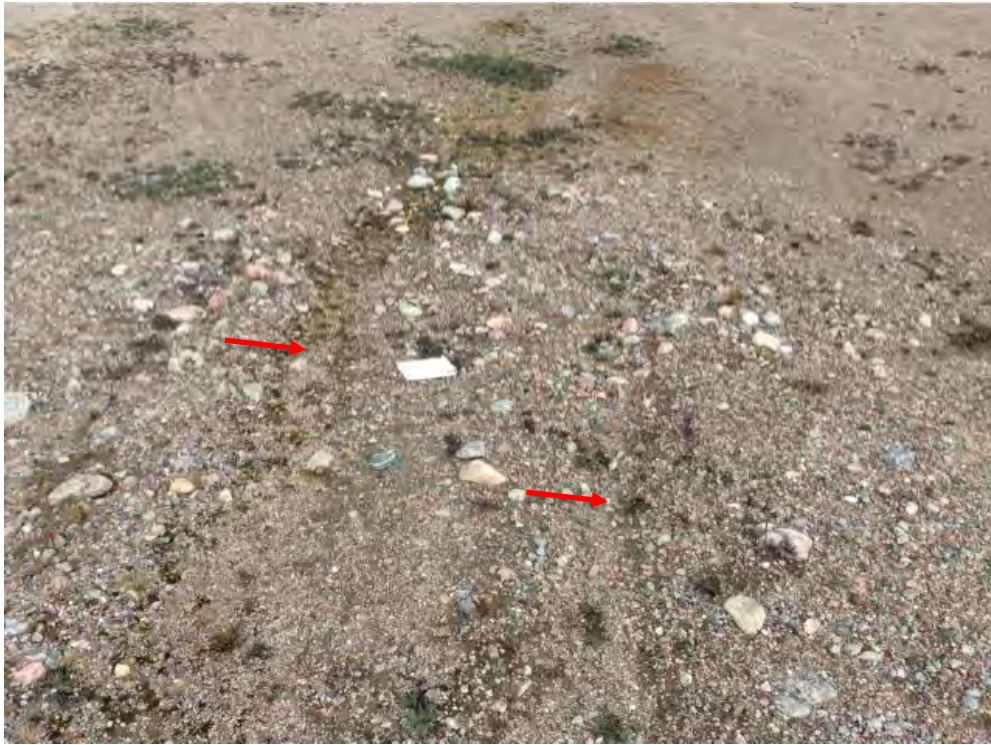
Photo 147: USAF & Asbestos Landfill- North crest surface, Feature G-Rough area with minor settlement, facing northeast (Acceptable) (CAM5_Photo48.jpg)

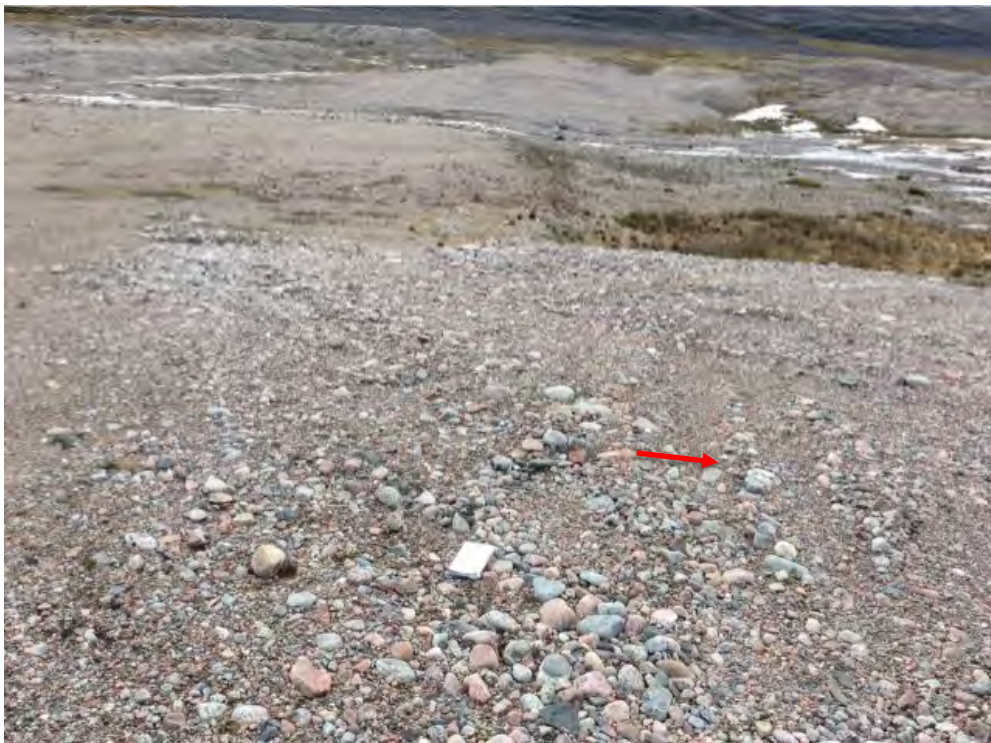
Photo 148: USAF & Asbestos Landfill- Northwest slope, Feature I-Rough area with minor erosion, facing southwest (Acceptable) (CAM5_Photo51.jpg)

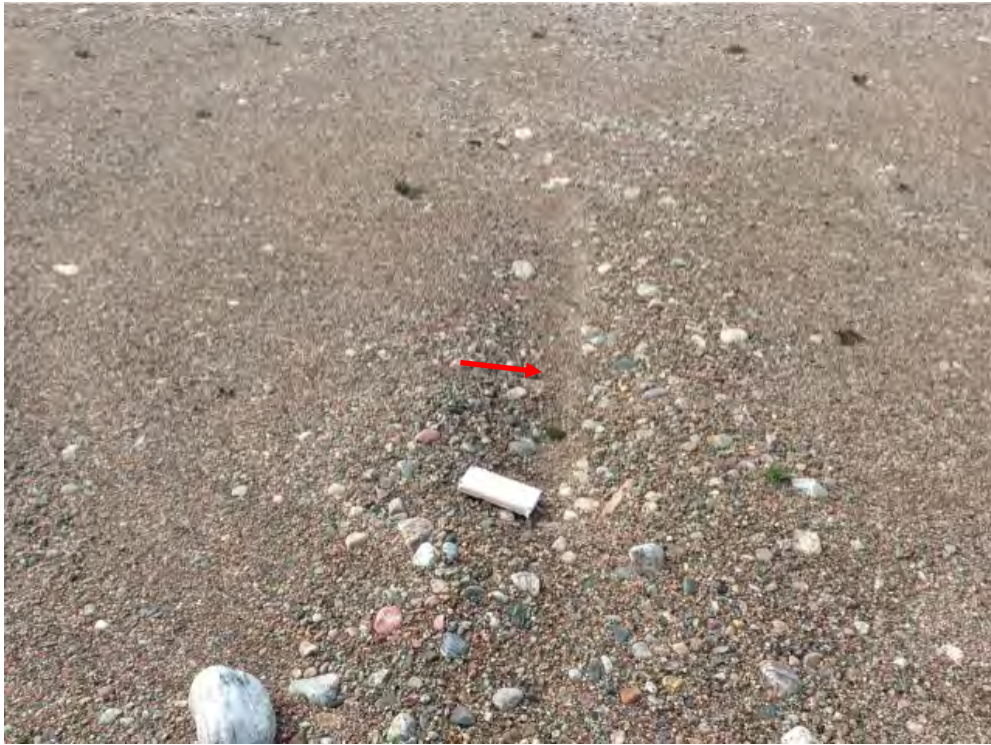
Photo 149: USAF & Asbestos Landfill- Southeast crest surface, Feature K-Linear depression, facing north (Acceptable) (CAM5_Photo39.jpg)

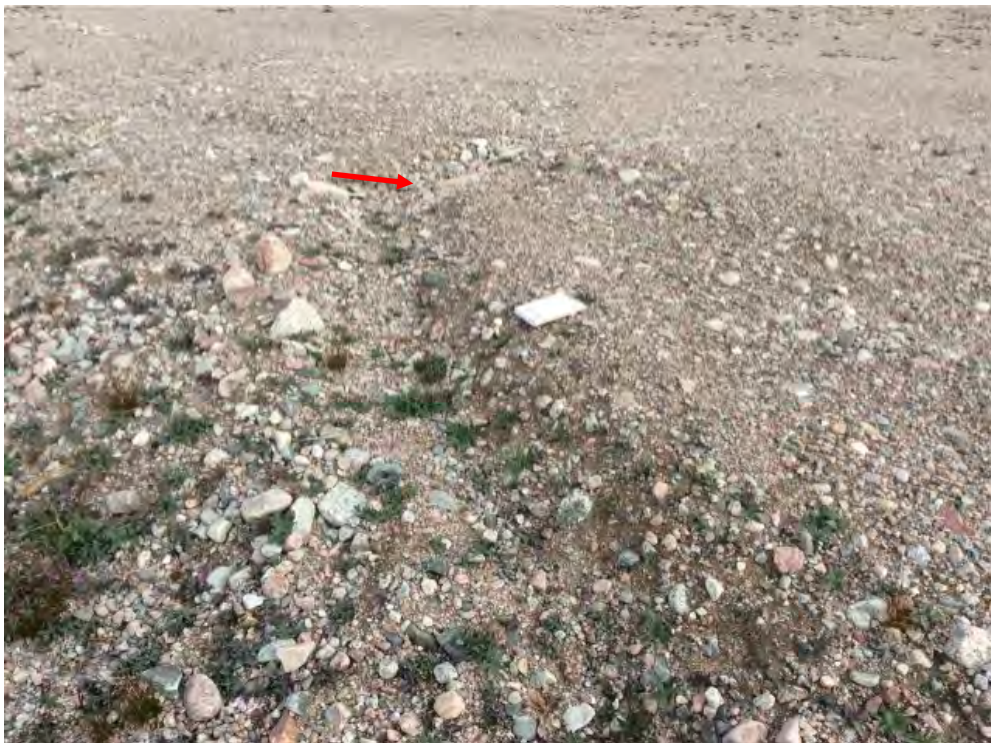
Photo 150: USAF & Asbestos Landfill- Northwest slope, Feature L-Minor erosion channel, facing east (Acceptable) (CAM5_Photo46.jpg)

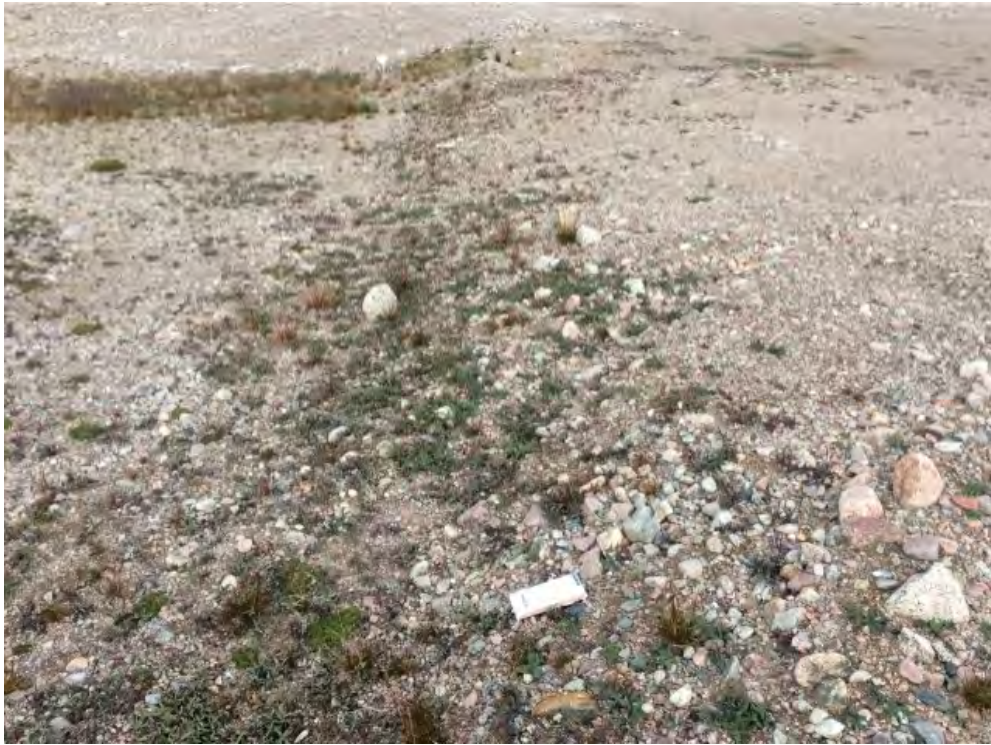
Photo 151: *USAF & Asbestos Landfill- North slope, Feature M-Sparse vegetation, facing northeast (Acceptable)*
(CAM5_Photo47.jpg)

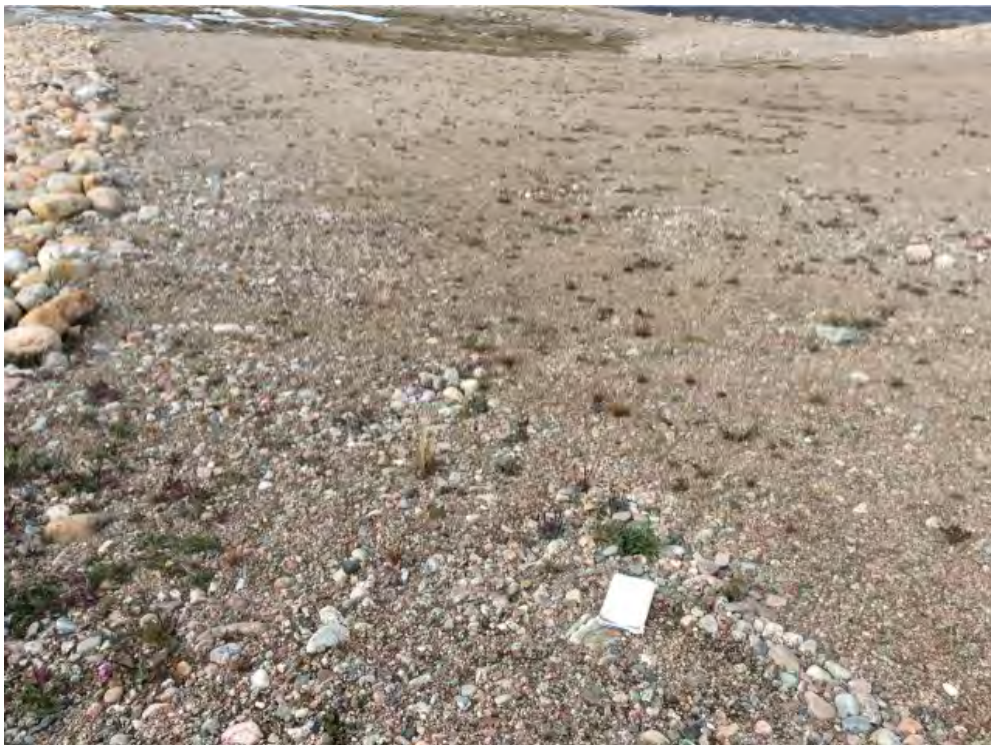
Photo 152: *USAF & Asbestos Landfill- West crest, Feature M-Sparse vegetation, facing north (Acceptable)*
(CAM5_Photo42.jpg)

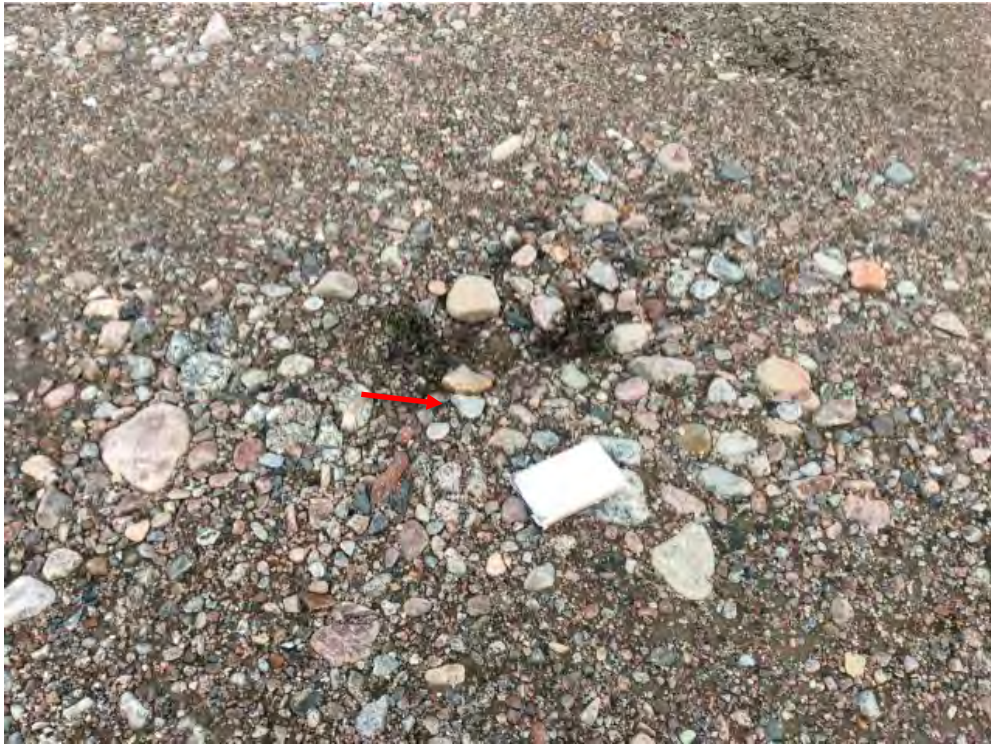
Photo 153: USAF & Asbestos Landfill- Northeast crest surface, Feature N-Minor settlement, facing south (Acceptable) (CAM5_Photo49.jpg)

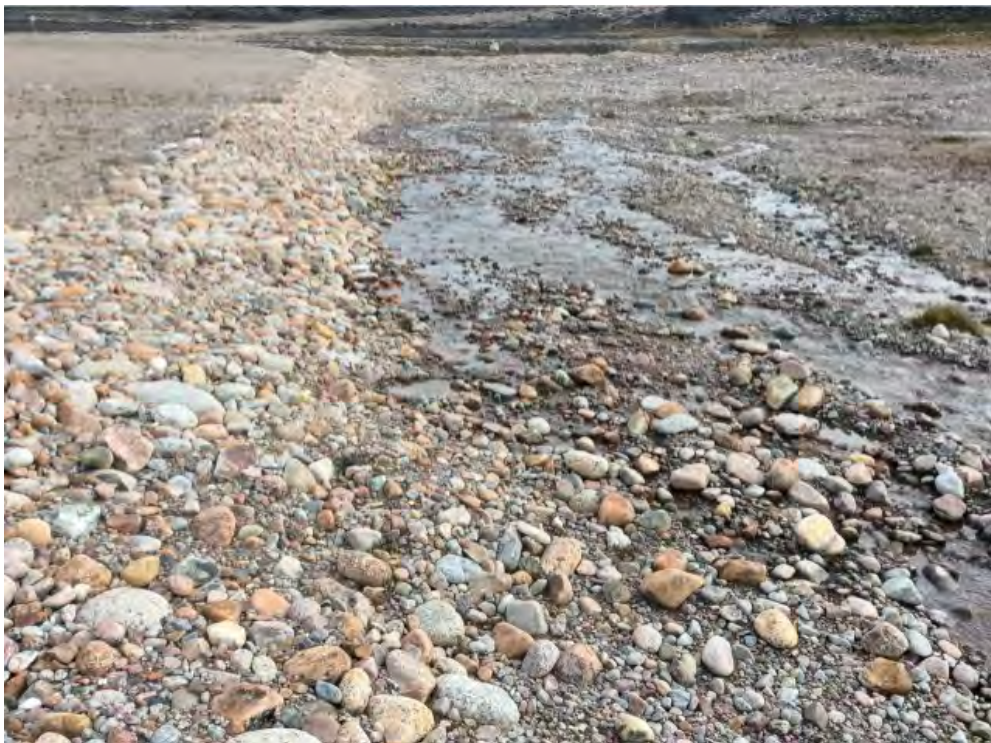
Photo 154: USAF & Asbestos Landfill- West toe, Feature O-Ponded water along toe, facing southeast (Acceptable) facing south (CAM5_Photo45.jpg)

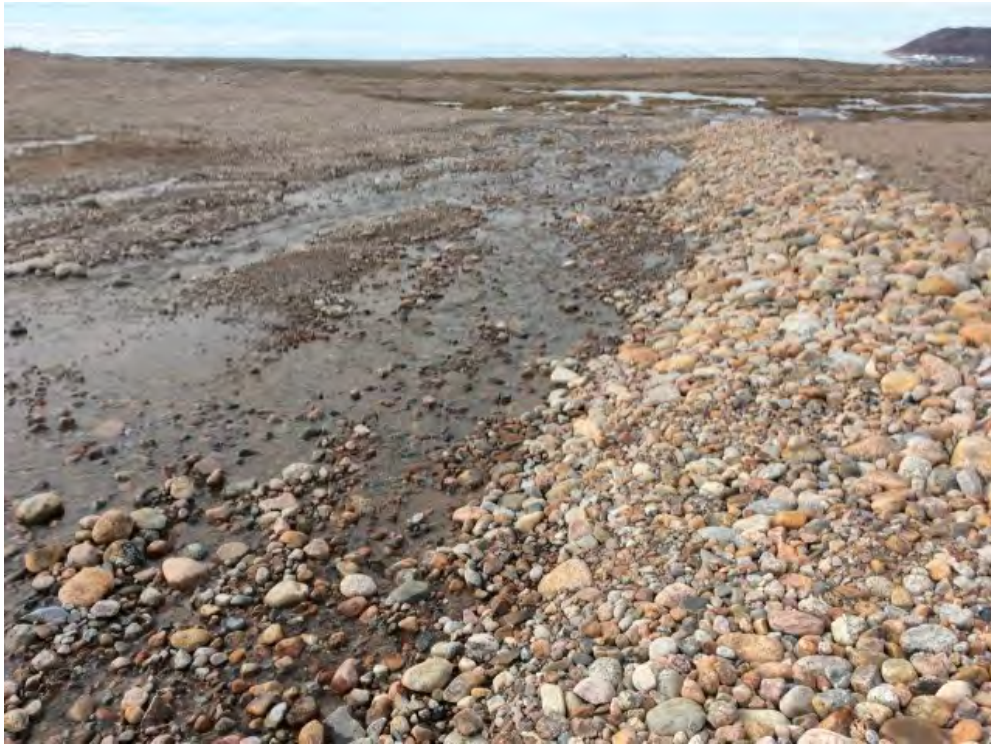
Photo 155: USAF & Asbestos Landfill- West toe, Feature O-Ponded and running water, facing northwest (CAM5_Photo43.jpg)

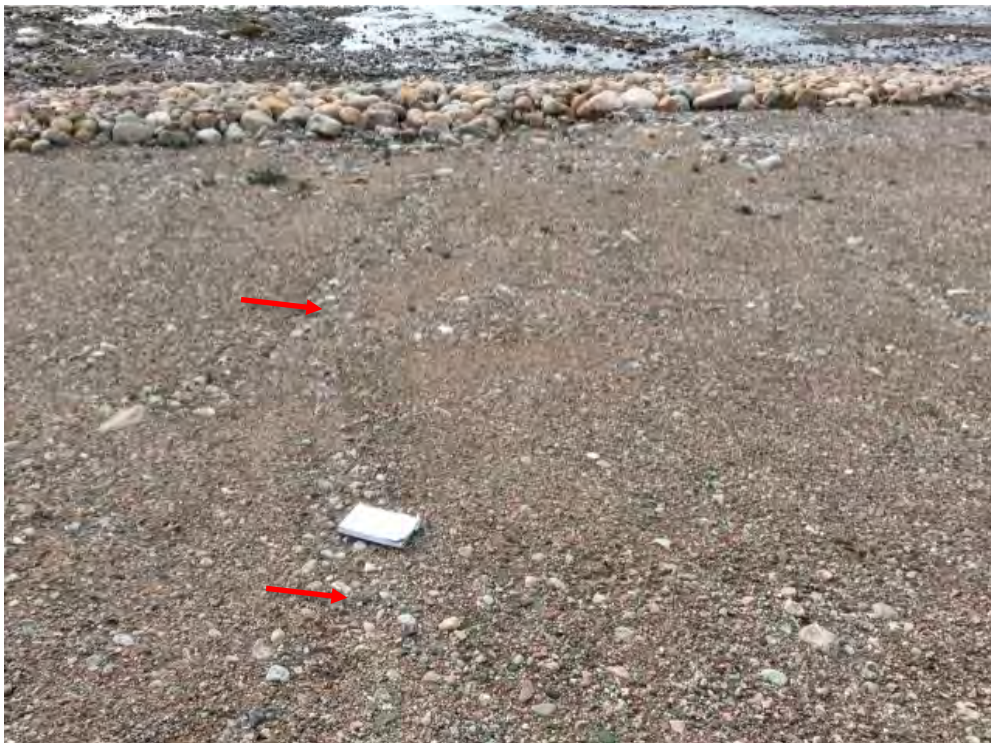
Photo 156: USAF & Asbestos Landfill- West crest, Feature P -Self armouring erosion, facing southwest (CAM5_Photo41.jpg)

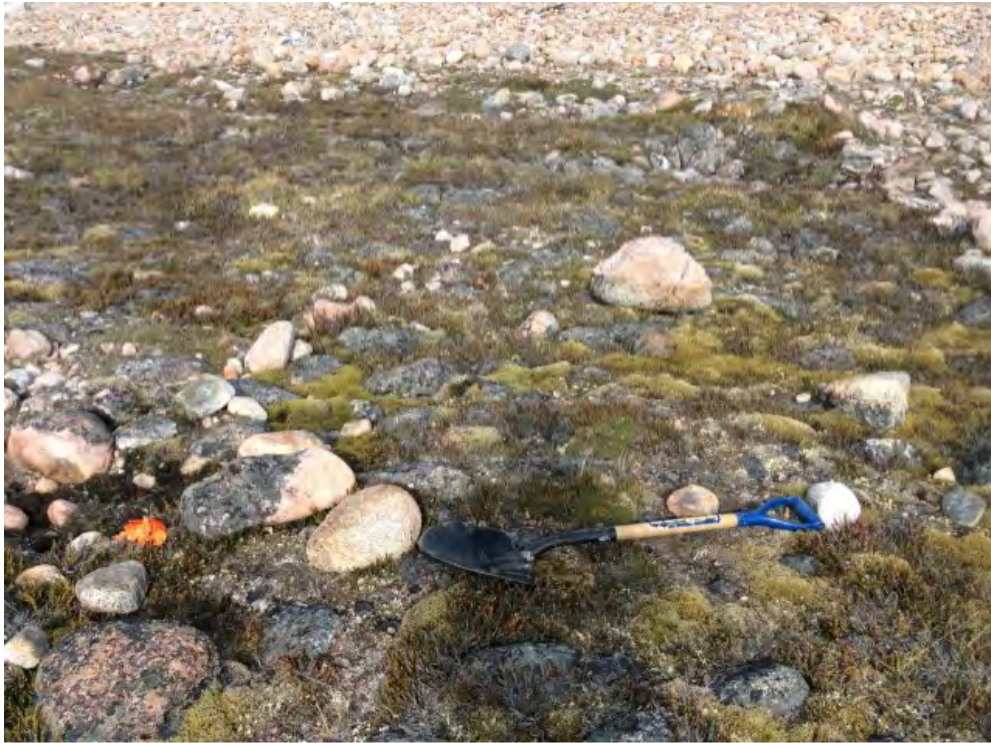
Photo 157: USAF & Asbestos Landfill- Soil Sample C5-6-Before Excavation (CAM5_Photo138.jpg)

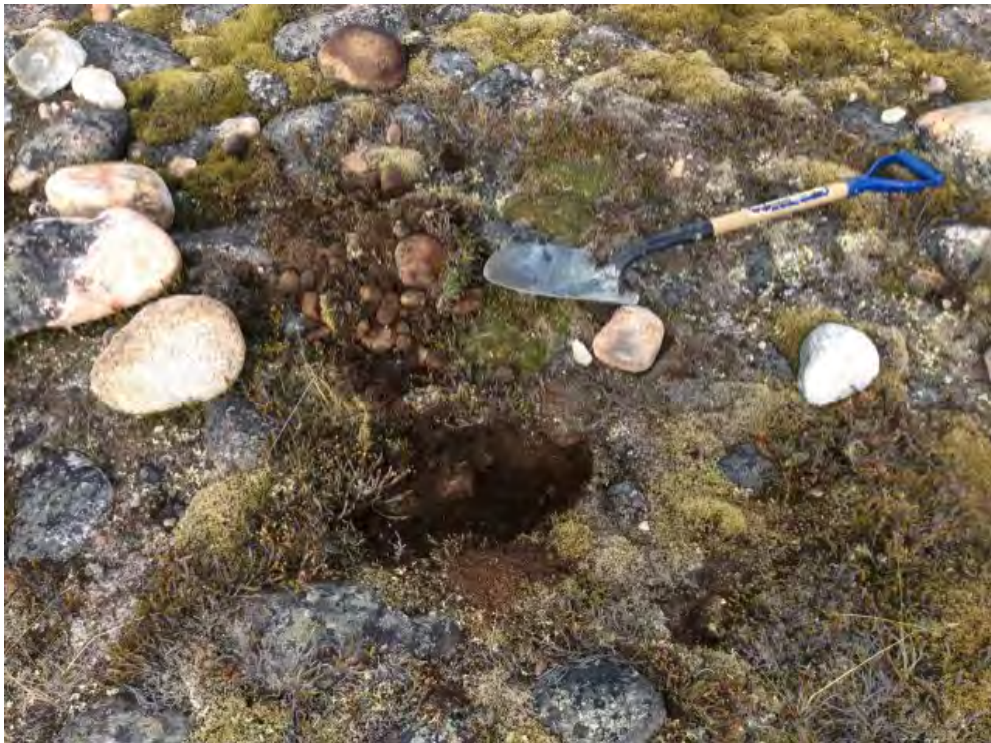
Photo 158: USAF & Asbestos Landfill- Soil Sample C5-6-After Excavation (CAM5_Photo139.jpg)

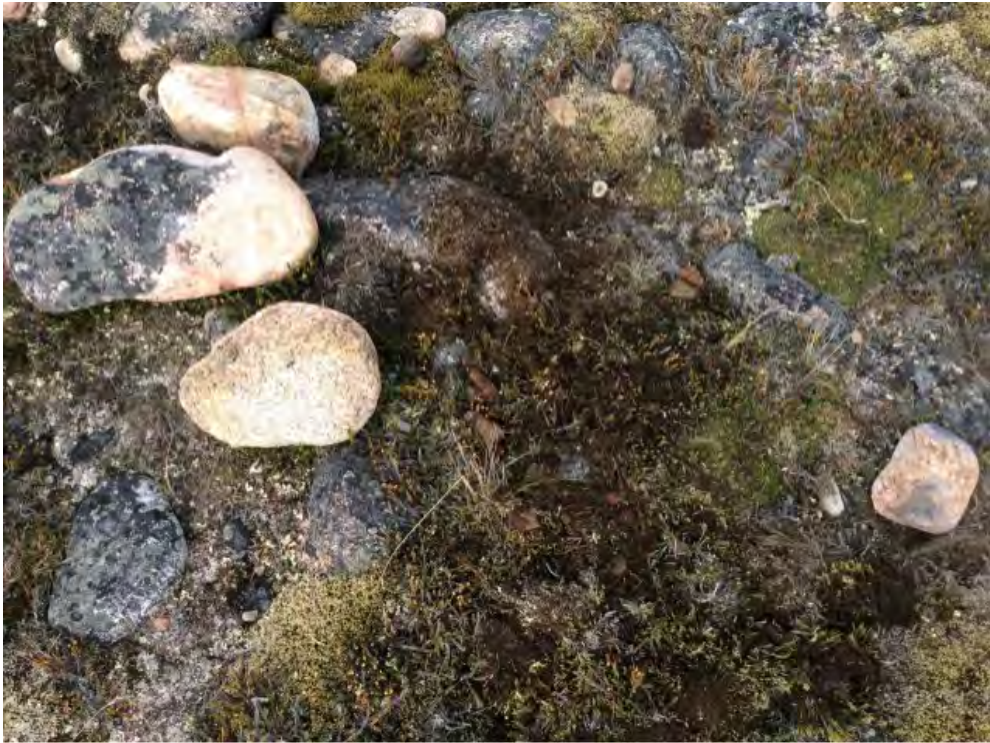
Photo 159: *USAF & Asbestos Landfill- Soil Sample C5-6-After Backfilling (CAM5_Photo140.jpg)*

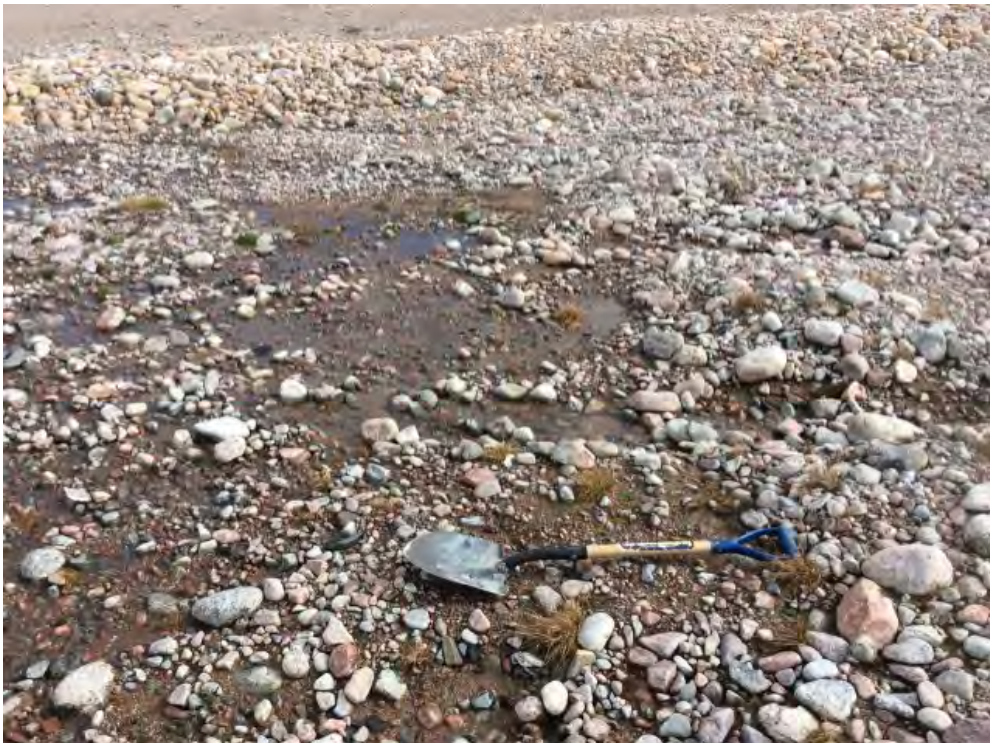
Photo 160: *USAF & Asbestos Landfill- Soil Sample C5-7-Before Excavation (CAM5_Photo141.jpg)*

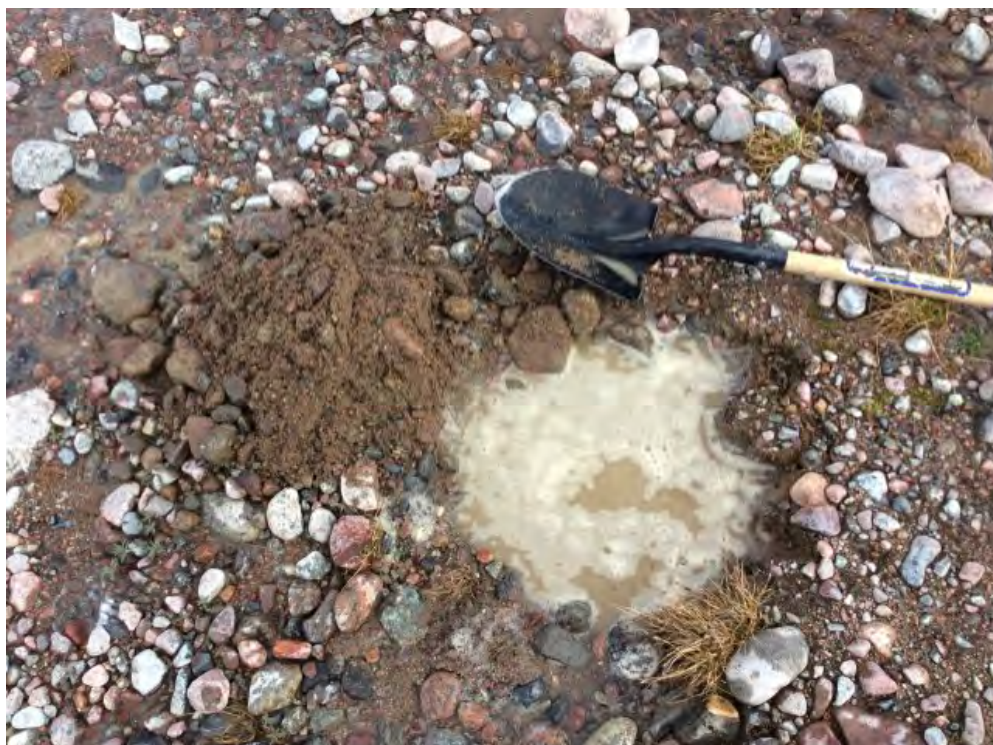
Photo 161: *USAF & Asbestos Landfill- Soil Sample C5-7-After Excavation (CAM5_Photo142.jpg)*
