QIKIQ15 BAFFIN REGION DEW LINE SITE MONITORING

2017 CAM-5 Monitoring Report

Report Number: 1530908-3000-R3-V4

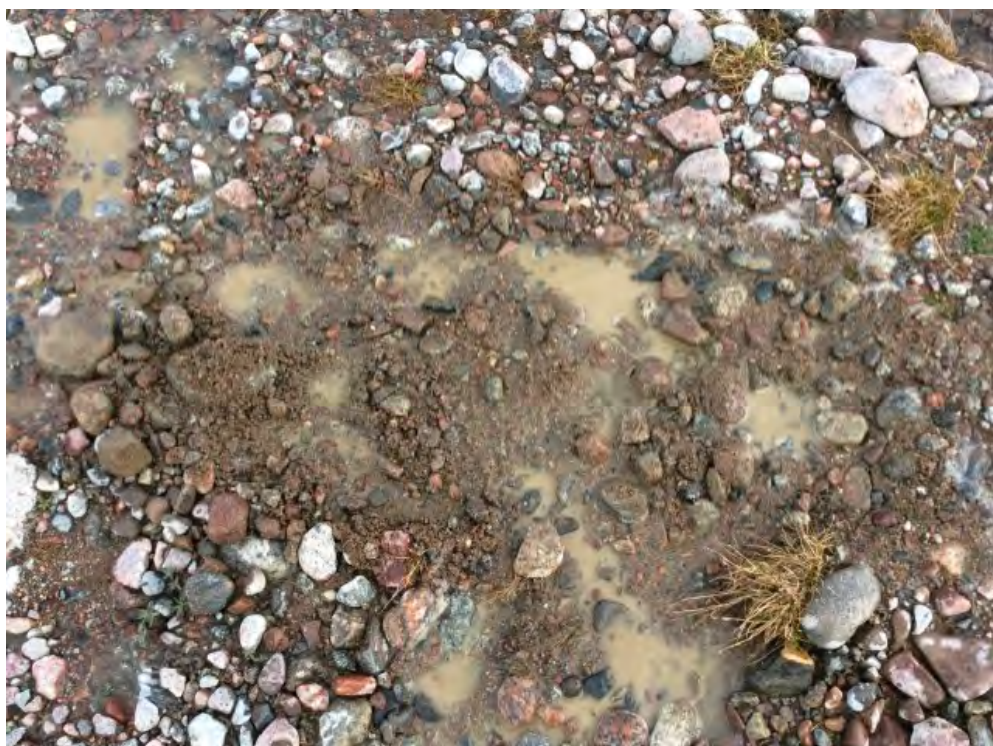
Photo 162: *USAF & Asbestos Landfill- Soil Sample C5-7-After Backfilling (CAM5_Photo143.jpg)*

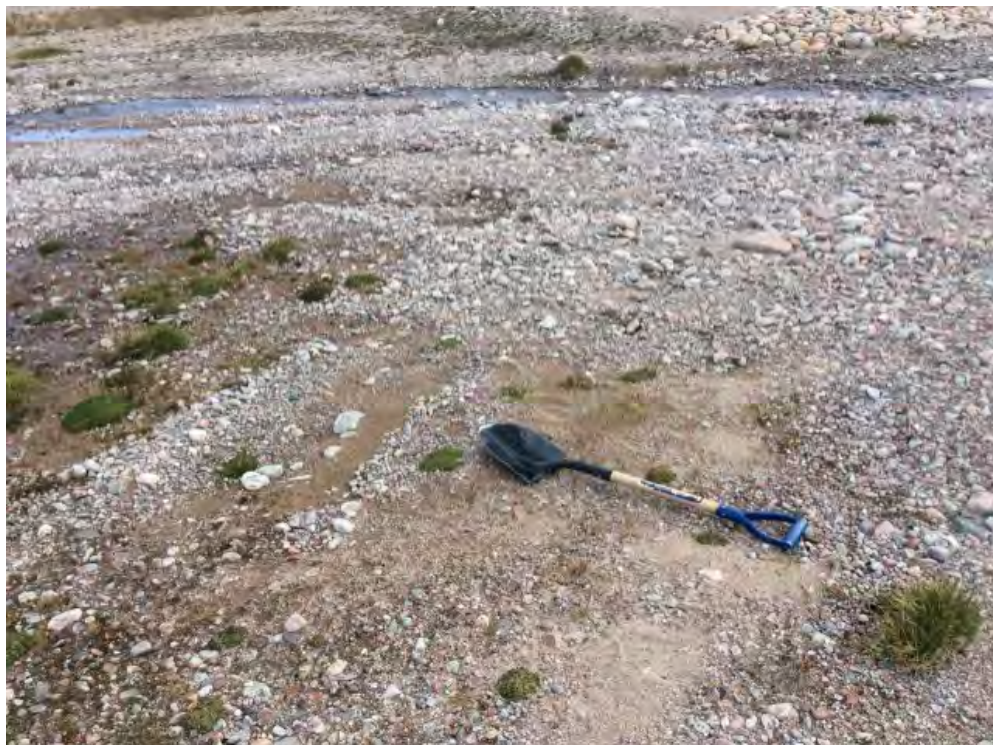
Photo 163: *USAF & Asbestos Landfill- Soil Sample C5-8-Before Excavation (CAM5_Photo144.jpg)*

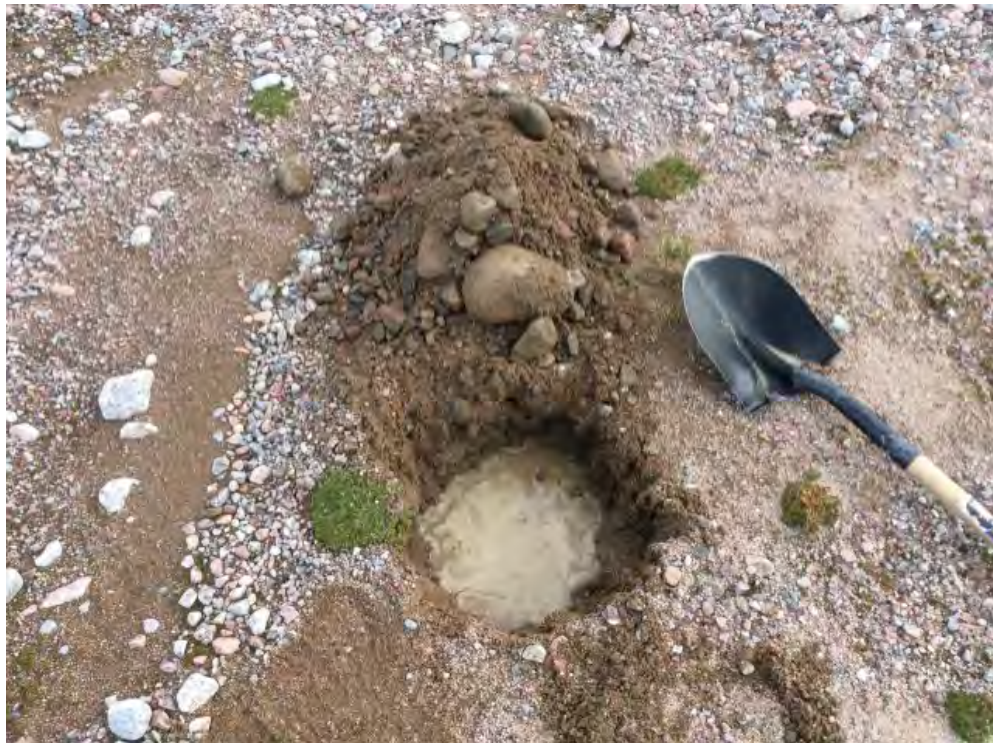
Photo 164: *USAF & Asbestos Landfill- Soil Sample C5-8-After Excavation (CAM5_Photo145.jpg)*

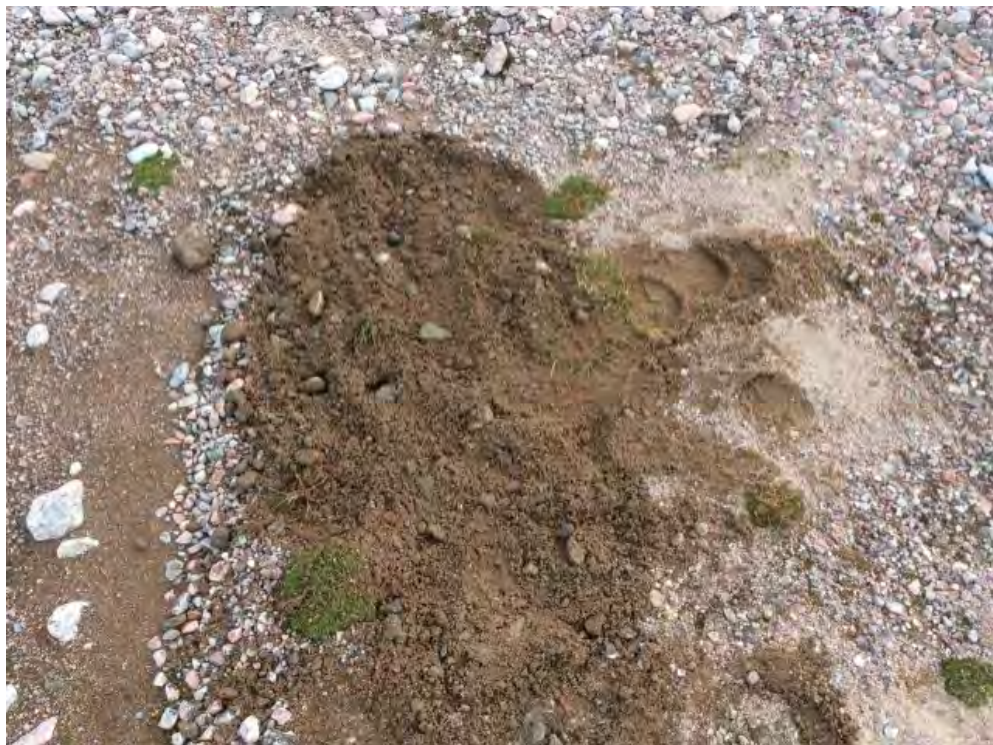
Photo 165: *USAF & Asbestos Landfill- Soil Sample C5-8-After Backfilling (CAM5_Photo146.jpg)*

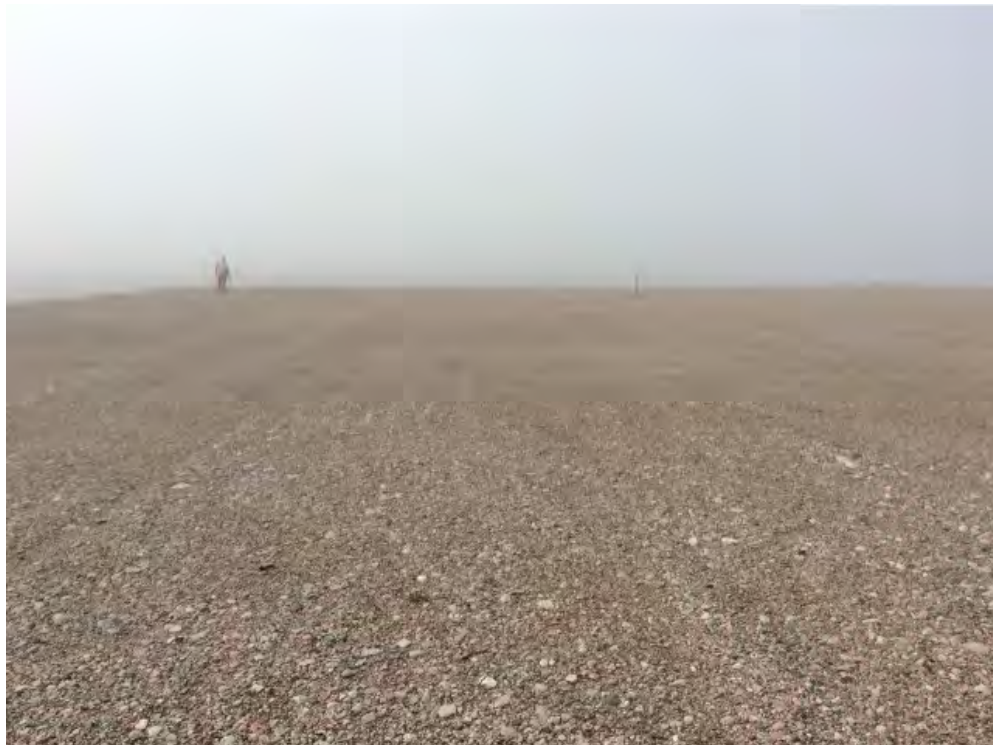
Photo 166: *Tier II Disposal Facility- Cover surface, facing southwest (CAM5_Photo150.jpg)*

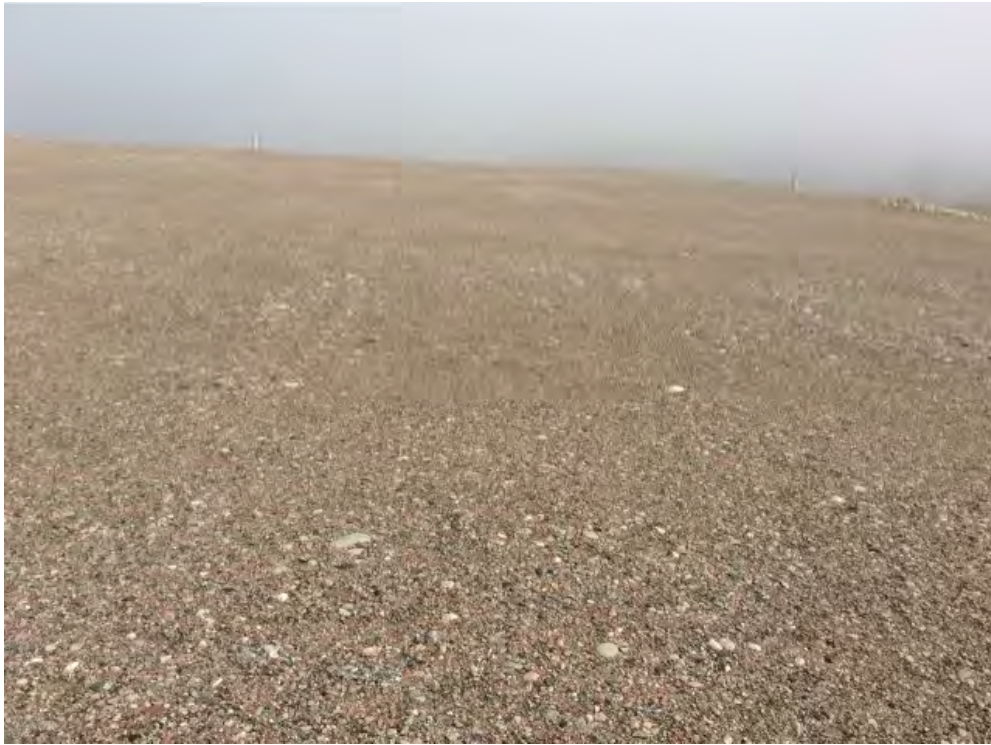
Photo 167: Tier II Disposal Facility- Cover surface, facing northeast (CAM5_Photo154.jpg)

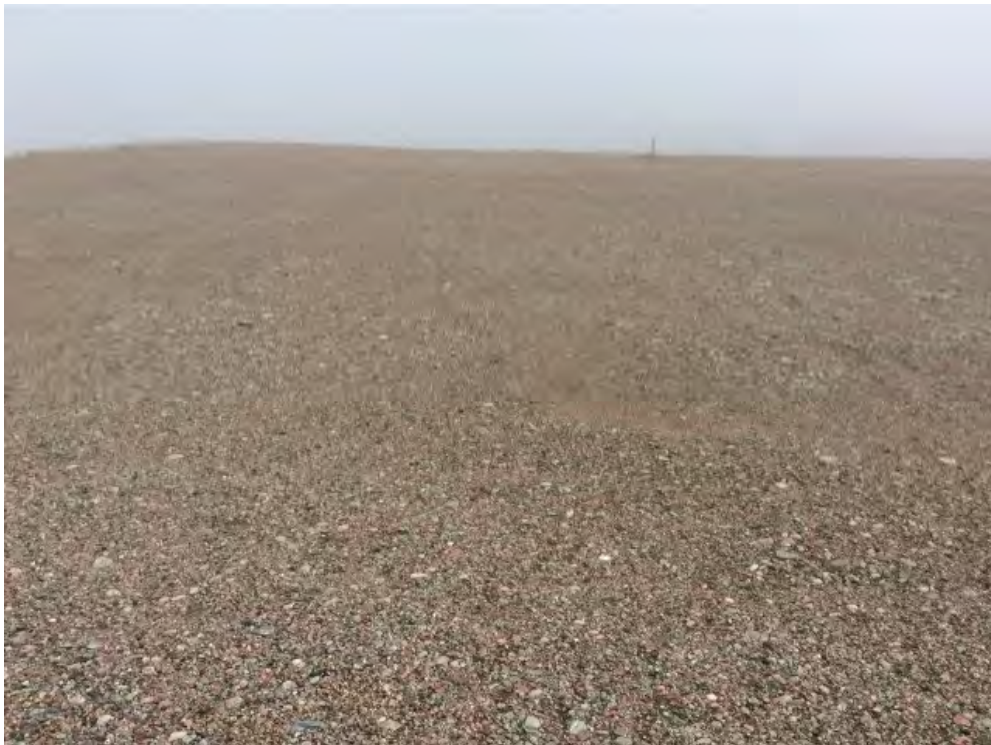
Photo 168: Tier II Disposal Facility- Cover surface, facing northeast (CAM5_Photo157.jpg)

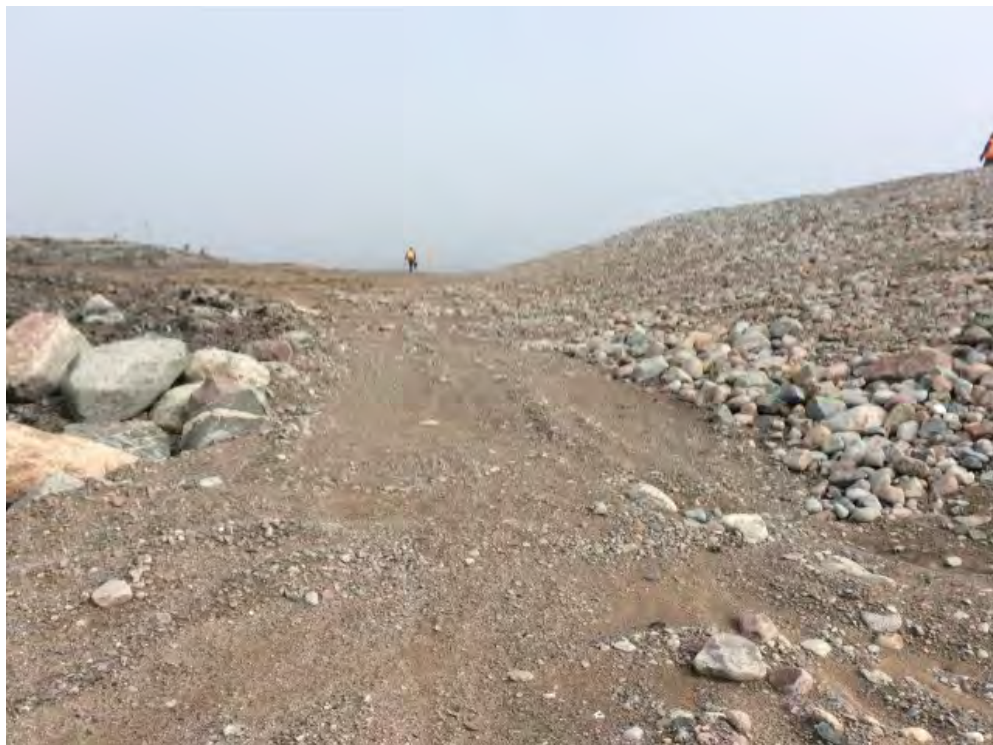
Photo 169: Tier II Disposal Facility- Northwest toe, facing northeast (CAM5_Photo159.jpg)

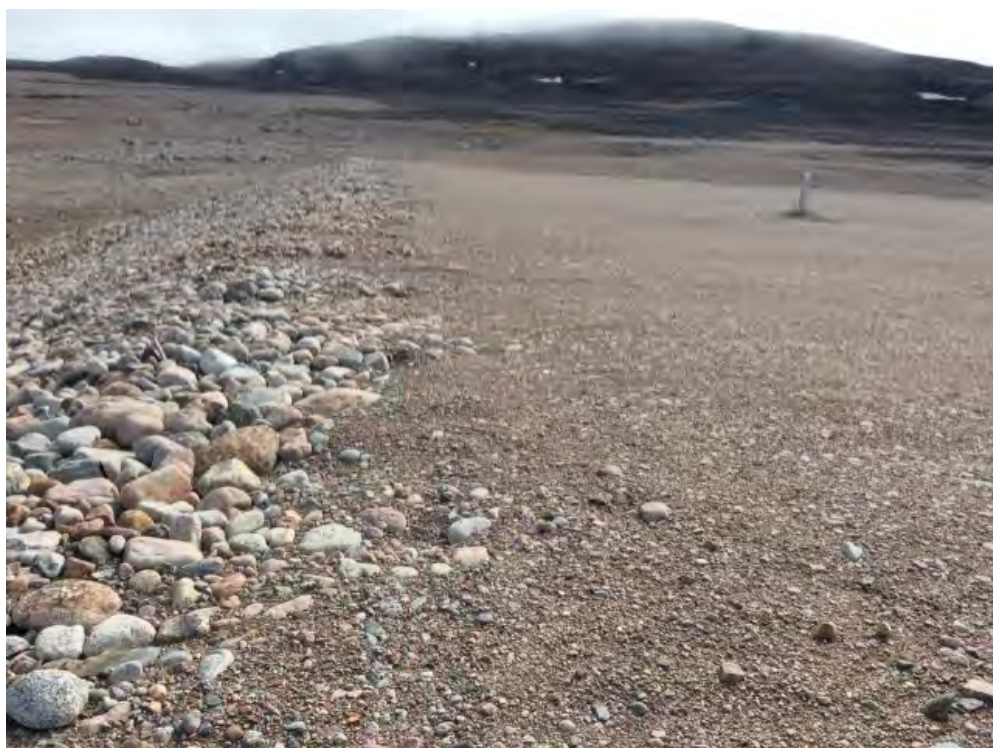
Photo 170: Tier II Disposal Facility- Northeast crest, facing southeast (CAM5_Photo160.jpg)

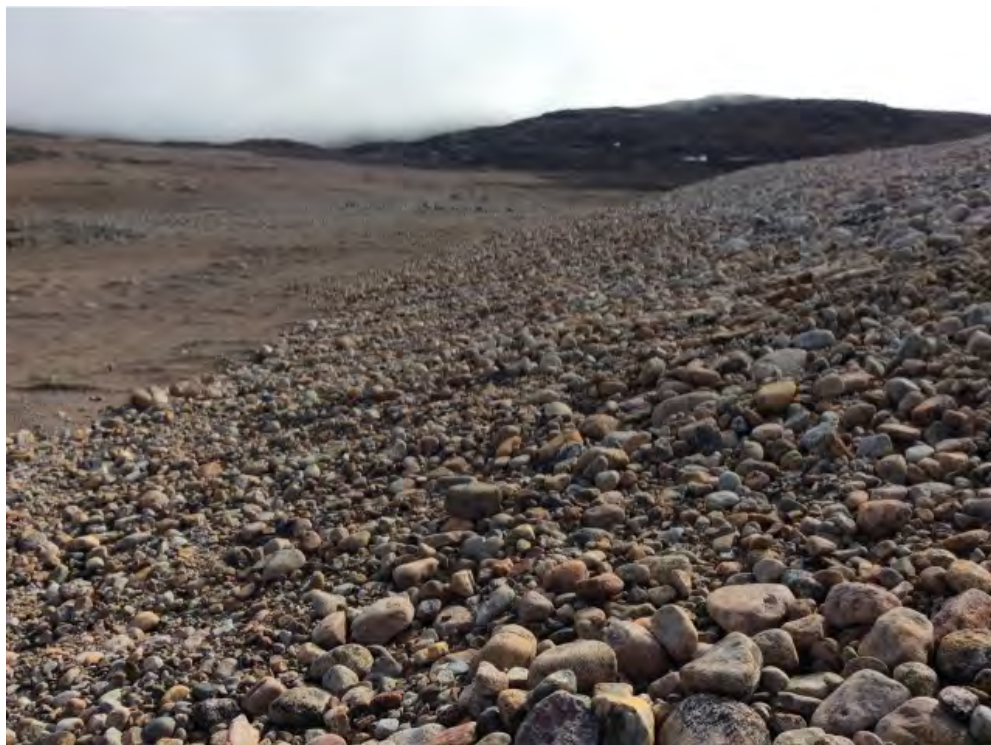
Photo 171: Tier II Disposal Facility- Northeast slope and toe, facing southeast (CAM5_Photo162.jpg)

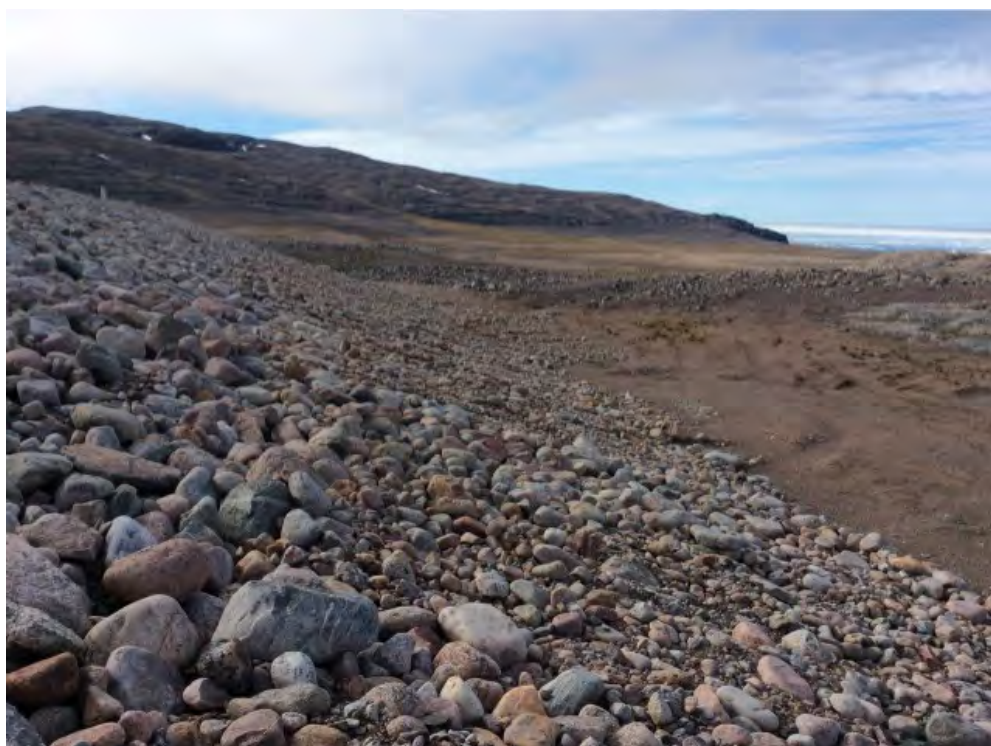
Photo 172: Tier II Disposal Facility- Northwest slope and toe, facing southwest (CAM5_Photo161.jpg)

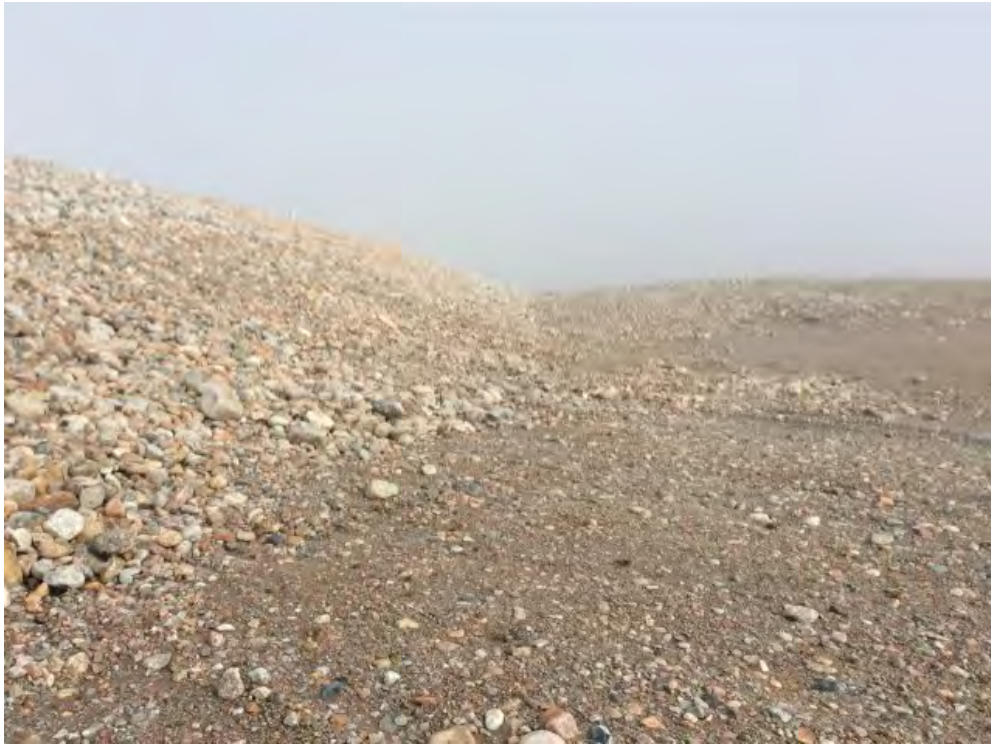
Photo 173: Tier II Disposal Facility- South east toe, facing northeast (CAM5_Photo153.jpg)

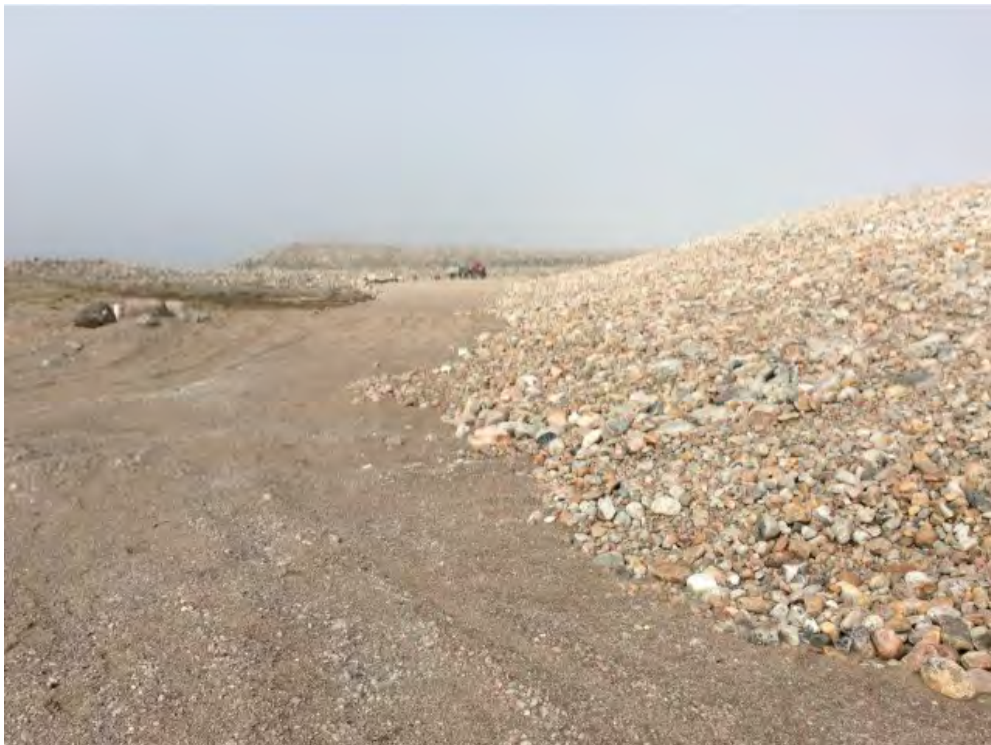
Photo 174: Tier II Disposal Facility- South west toe, facing northwest (CAM5_Photo152.jpg)

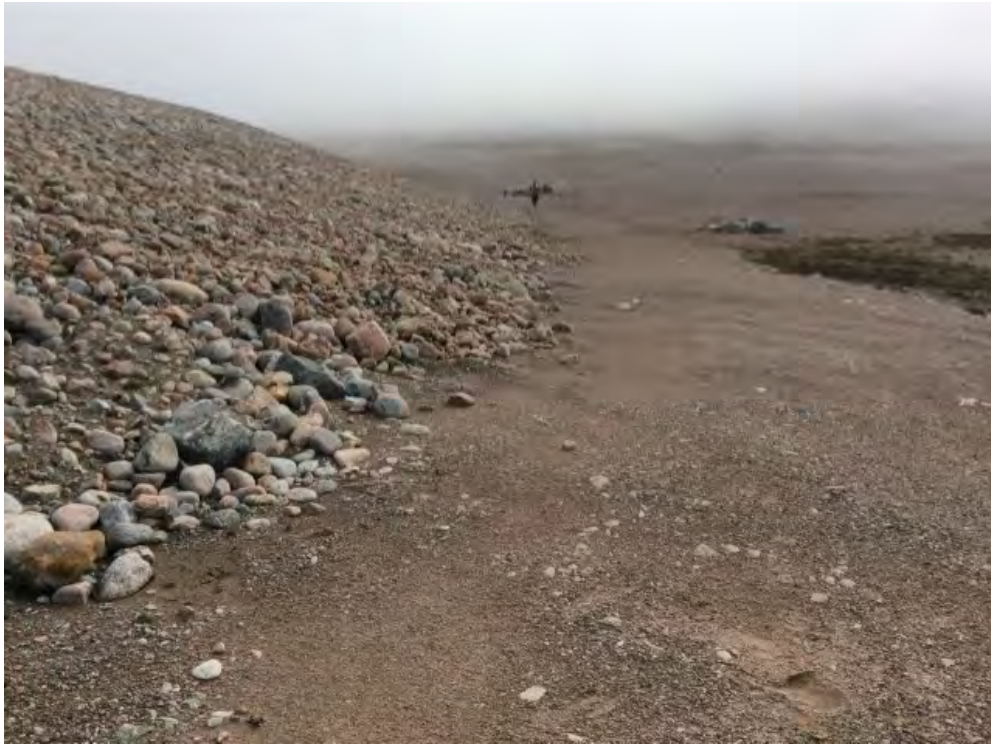
Photo 175: Tier II Disposal Facility- South west toe, facing southeast (CAM5_Photo158.jpg)

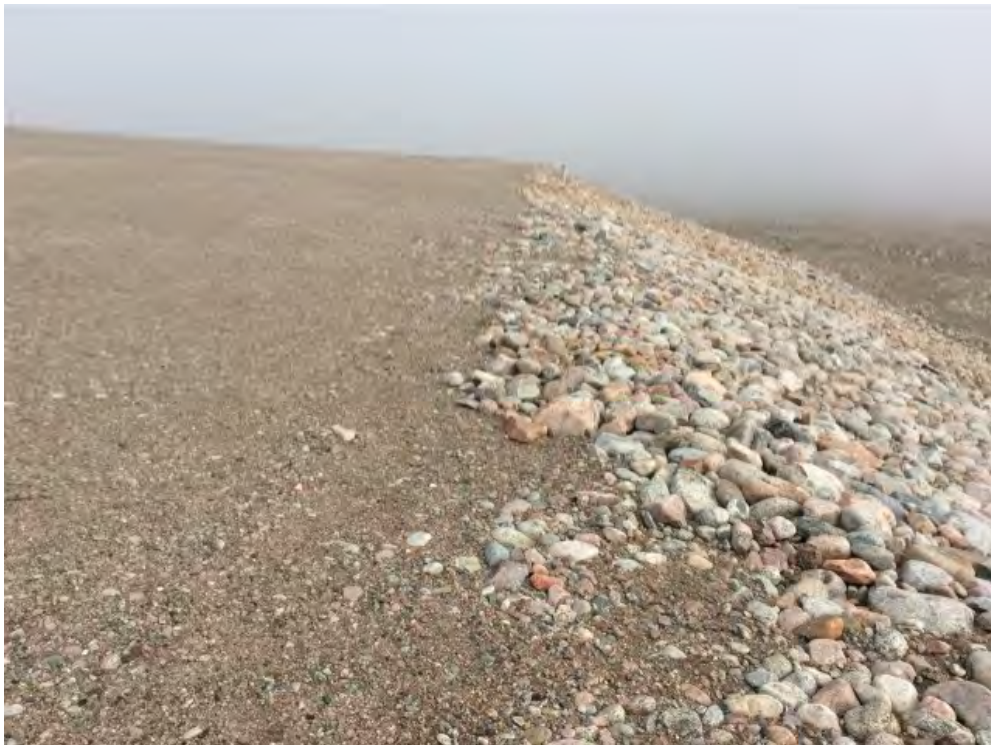
Photo 176: Tier II Disposal Facility- Southeast crest, facing northeast (CAM5_Photo156.jpg)

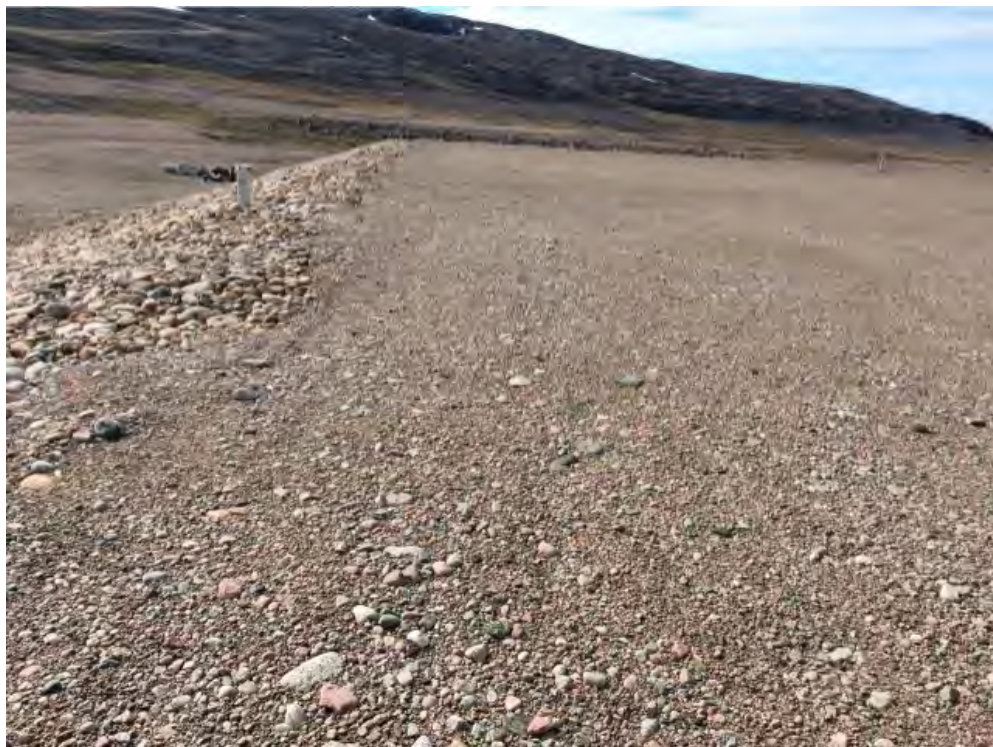
Photo 177: Tier II Disposal Facility- Southeast crest, facing southwest (CAM5_Photo163.jpg)

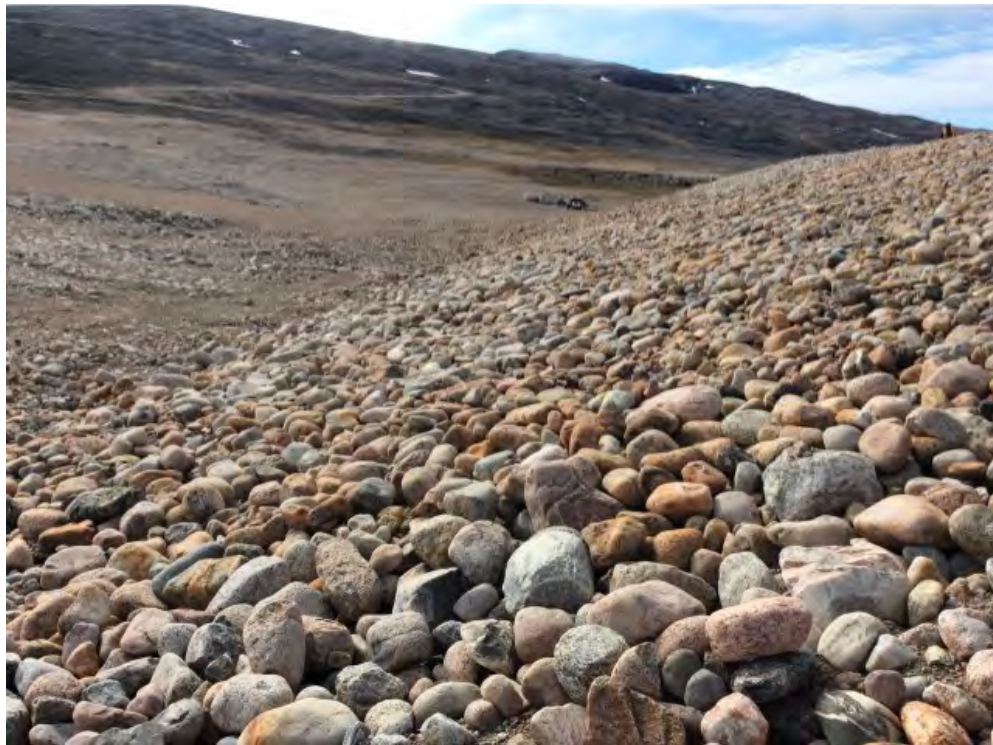
Photo 178: Tier II Disposal Facility- Southeast slope and toe, facing southwest (CAM5_Photo164.jpg)

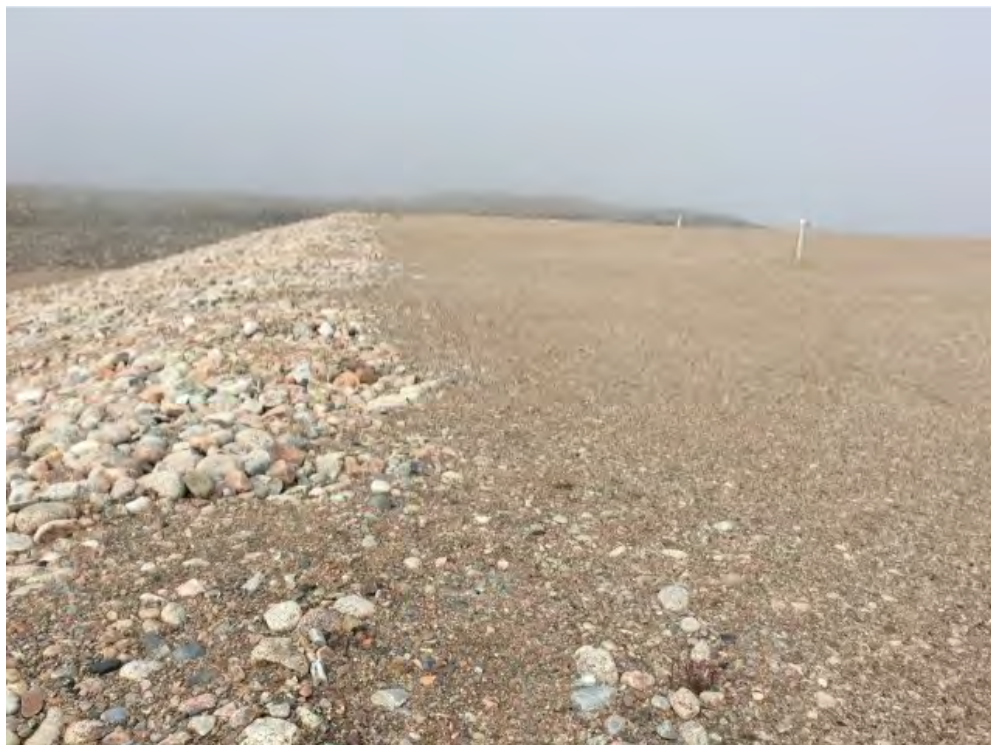
Photo 179: Tier II Disposal Facility- Southwest crest, facing northwest (CAM5_Photo155.jpg)

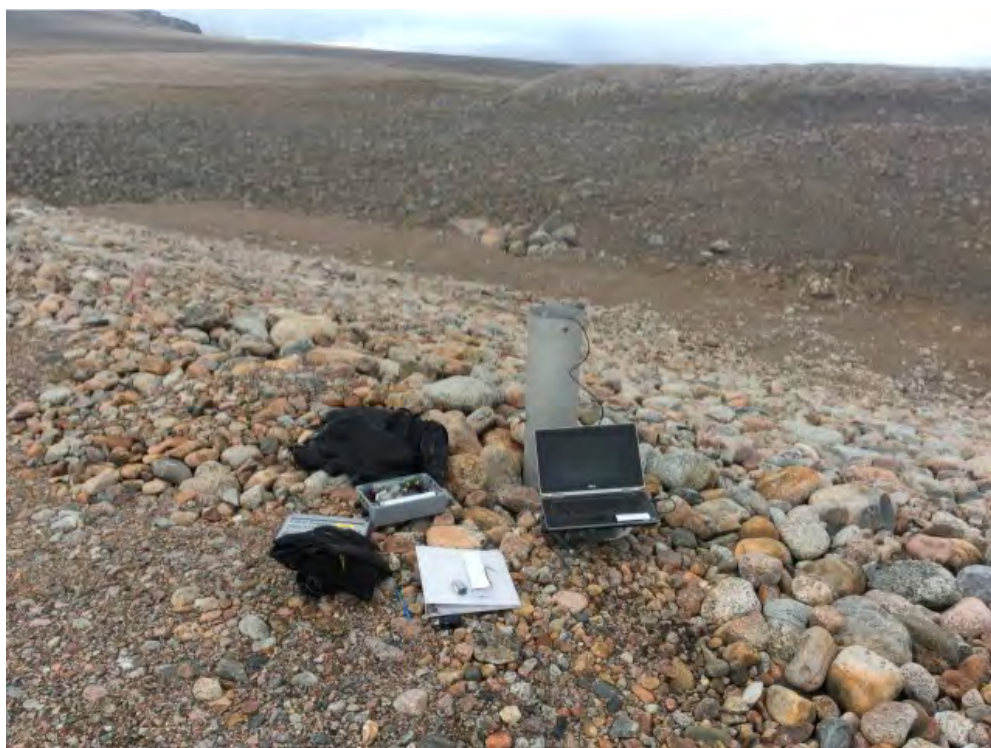
Photo 180: Tier II Disposal Facility- VT1, facing northwest (CAM5_Photo148.jpg)

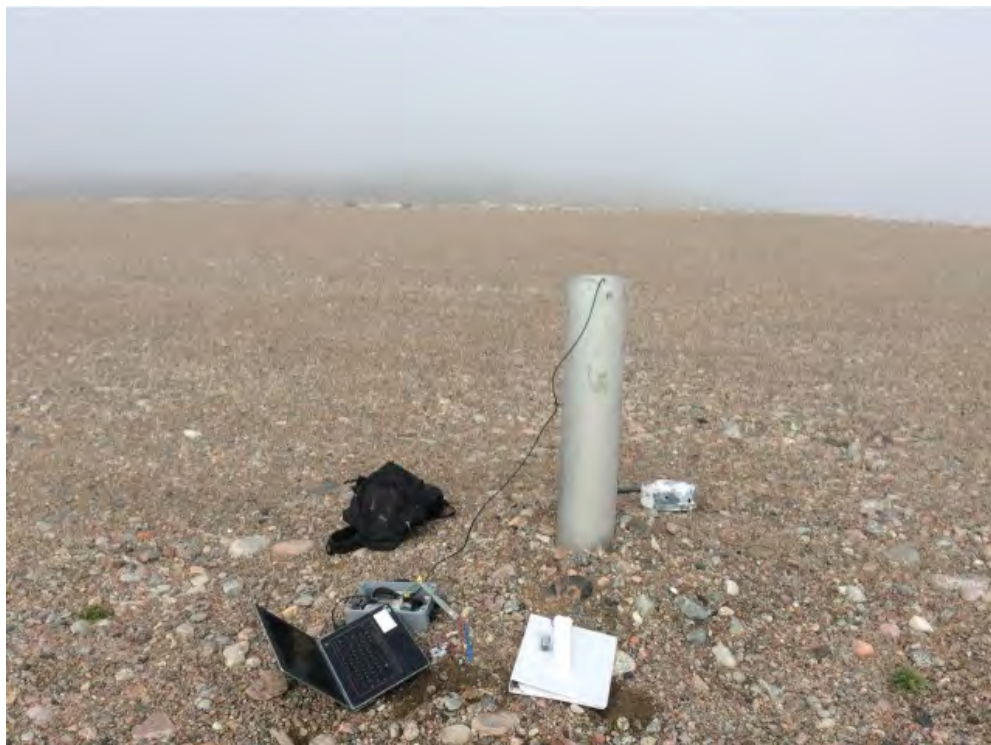
Photo 181: Tier II Disposal Facility- VT2, facing northwest (CAM5_Photo149.jpg)

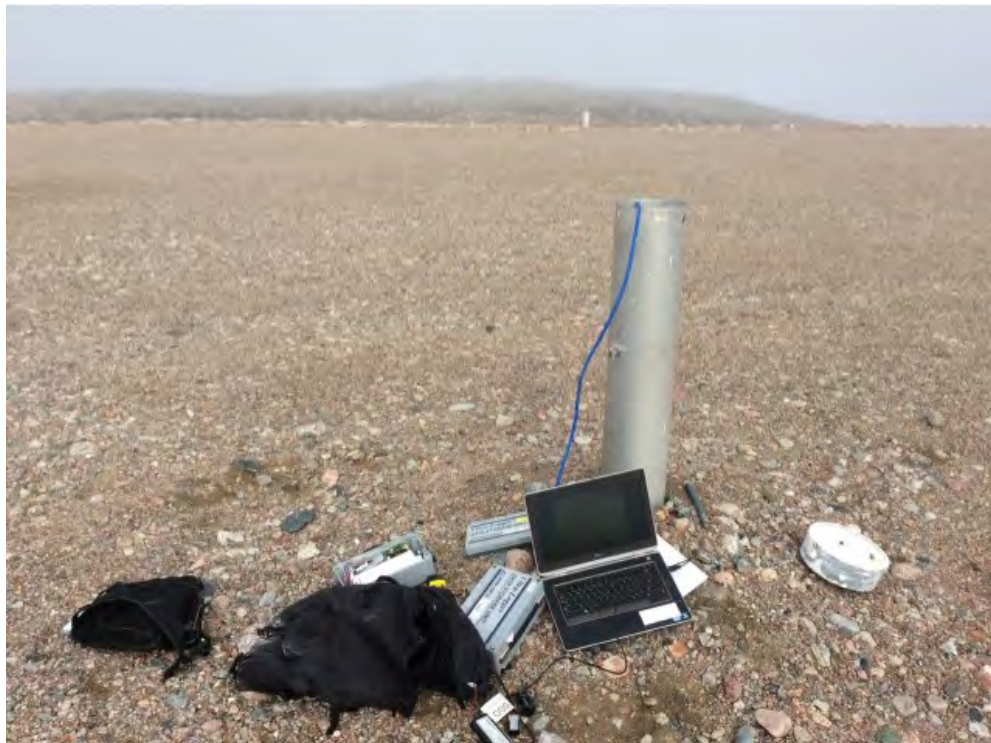
Photo 182: Tier II Disposal Facility- VT3, facing north (CAM5_Photo147.jpg)

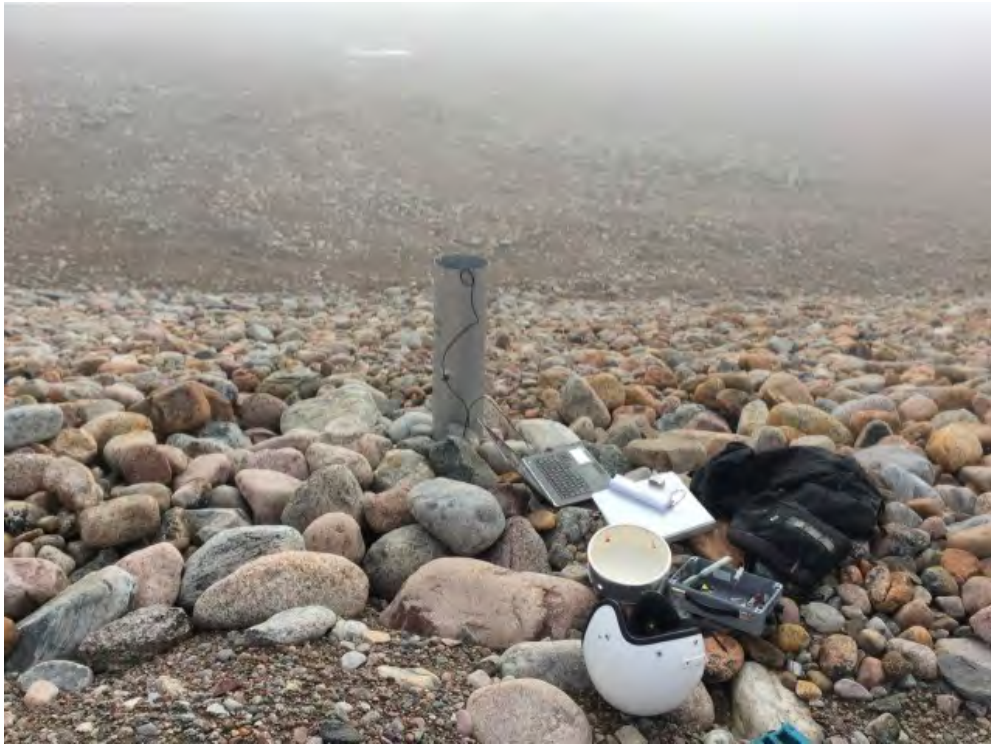
Photo 183: Tier II Disposal Facility- VT4, facing southeast (CAM5_Photo151.jpg)

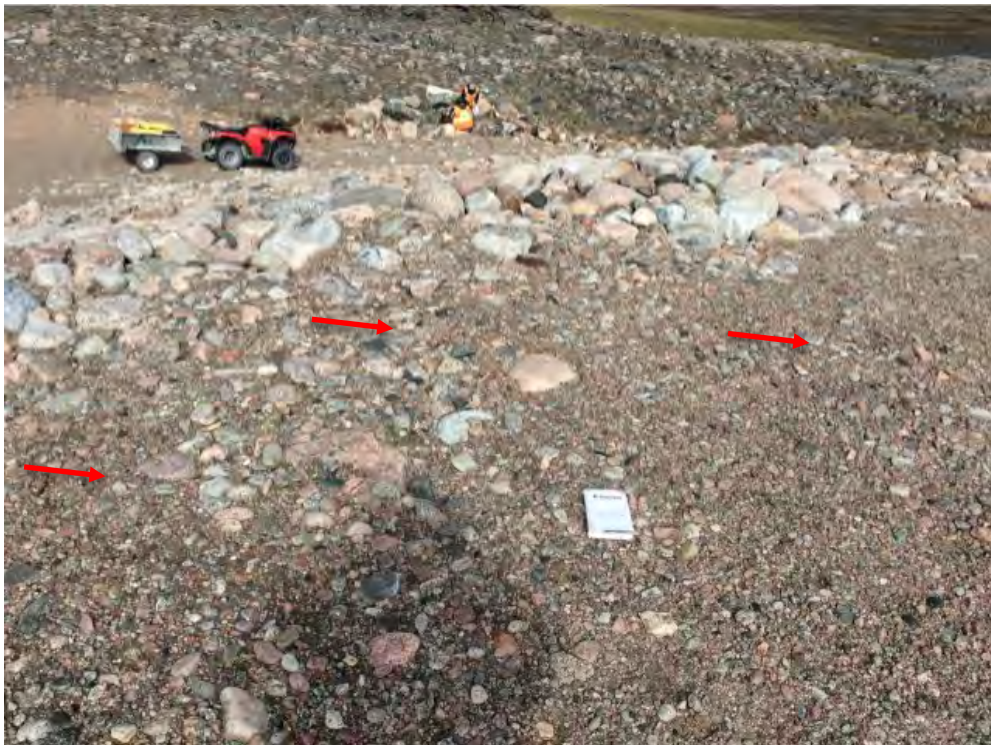
Photo 184: Tier II Disposal Facility- Northeast crest surface, Feature A-Minor depressions, facing north (Acceptable) (CAM5_Photo10.jpg)

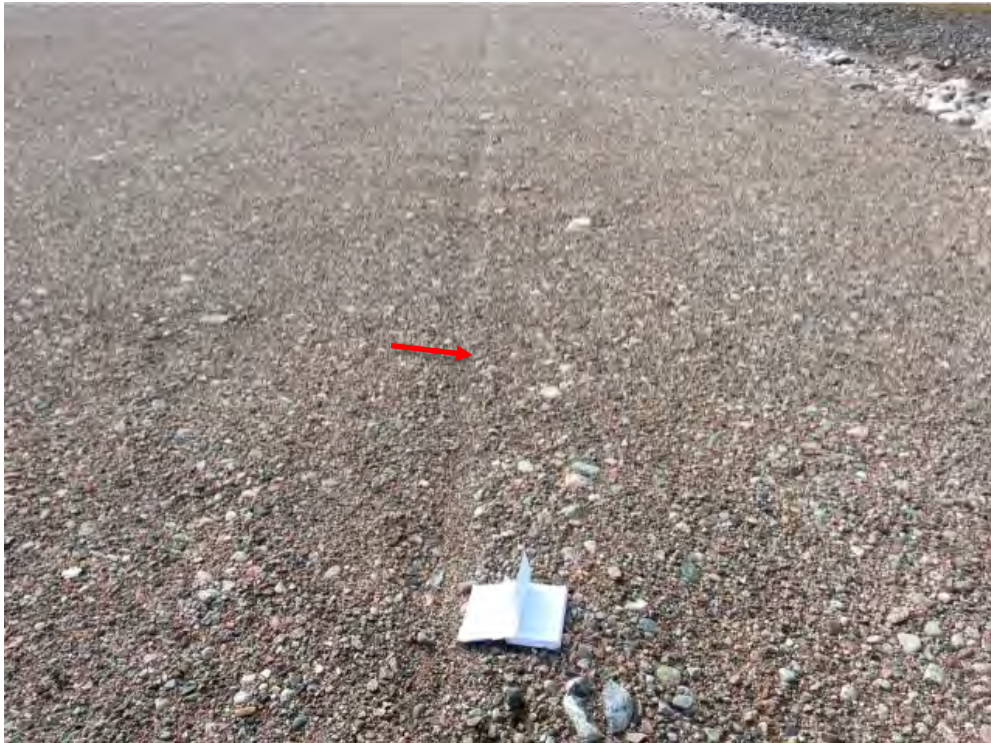
Photo 187: Tier II Disposal Facility- Northeast crest surface, Feature E-Minor erosion channel, facing southwest (Acceptable) (CAM5_Photo9.jpg)

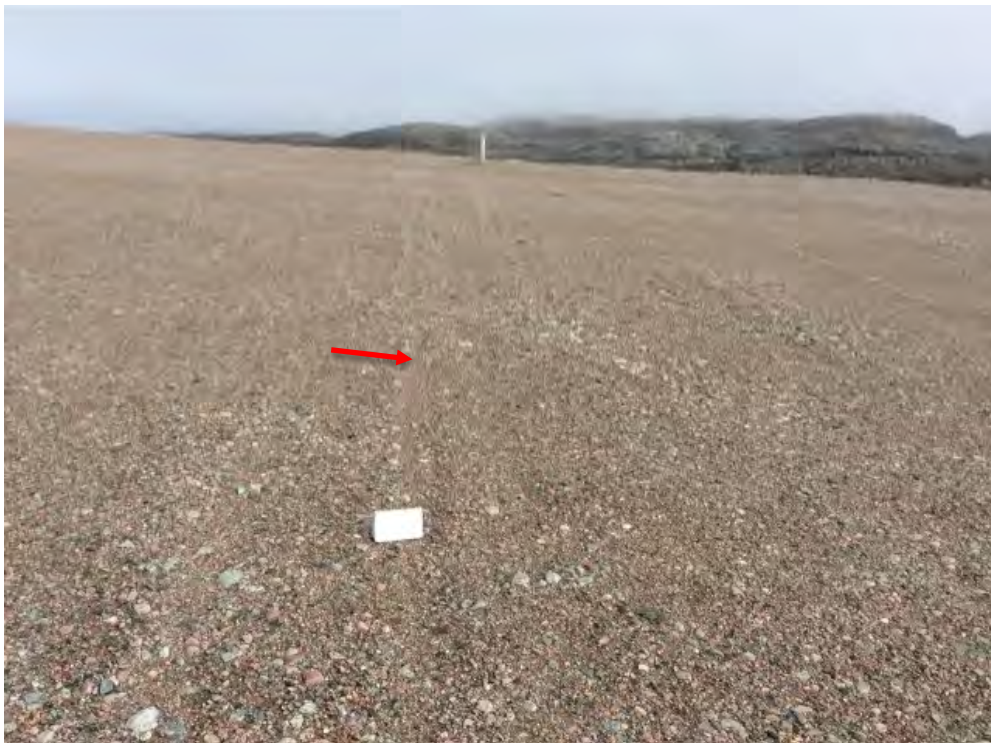
Photo 188: Tier II Disposal Facility- Cover surface, Feature E-Minor erosion channel, facing northeast (Acceptable) (CAM5_Photo6.jpg)

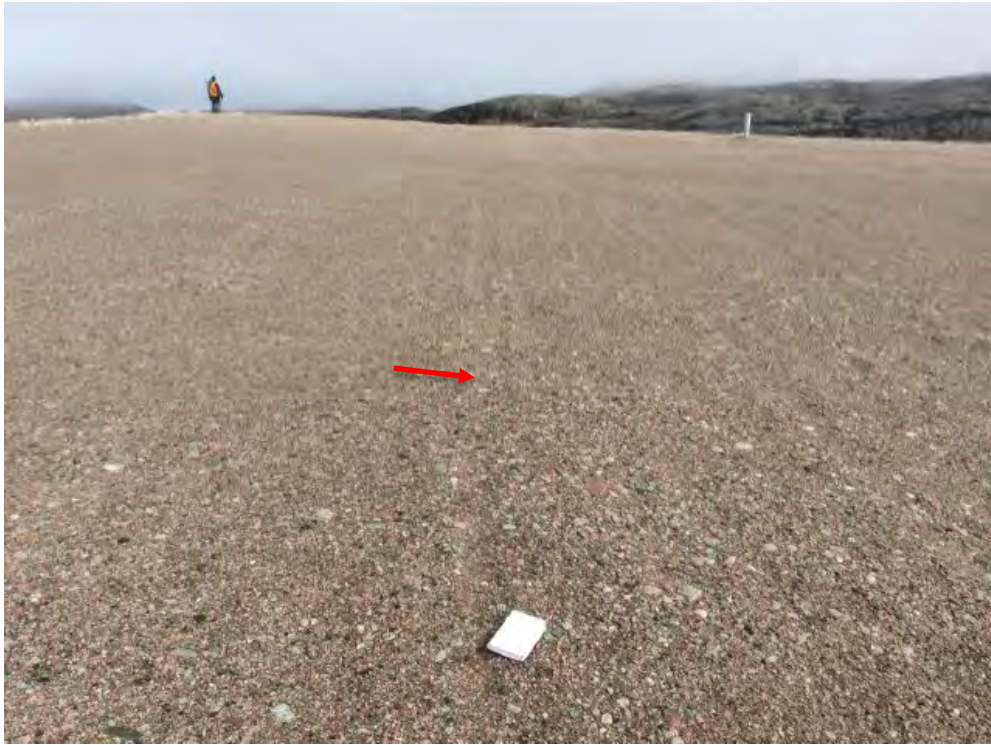
Photo 189: Tier II Disposal Facility- Cover surface, Feature E-Minor erosion channel, facing northeast (Acceptable) (CAM5_Photo5.jpg)

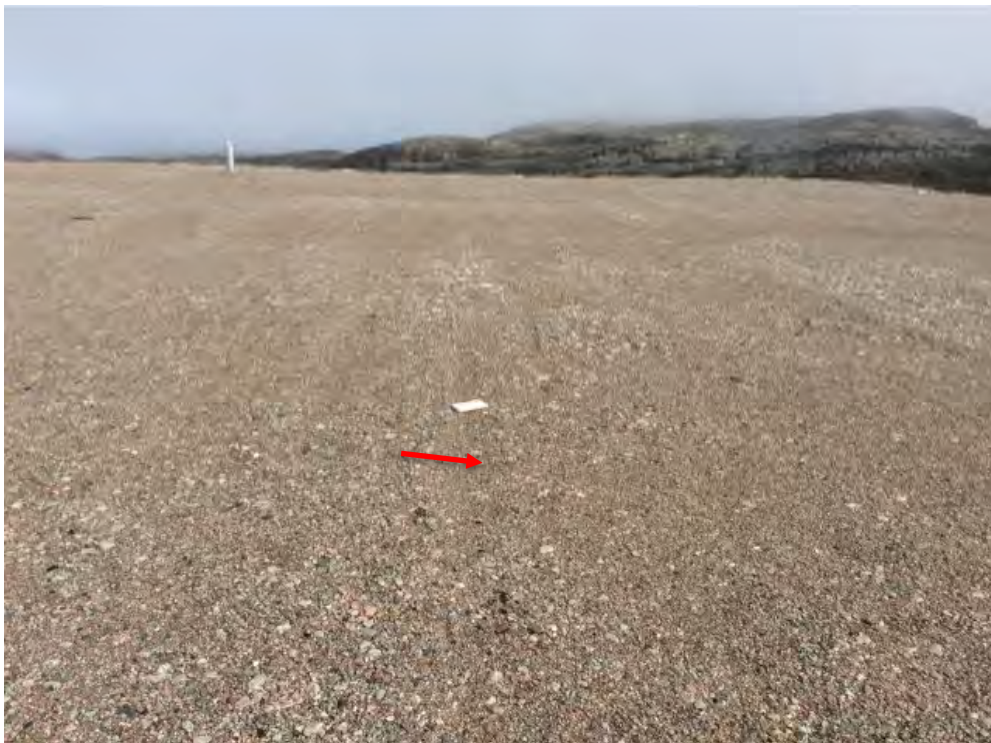
Photo 190: Tier II Disposal Facility- Cover surface, Feature E-Minor erosion channel, facing northeast (Acceptable) (CAM5_Photo7.jpg)

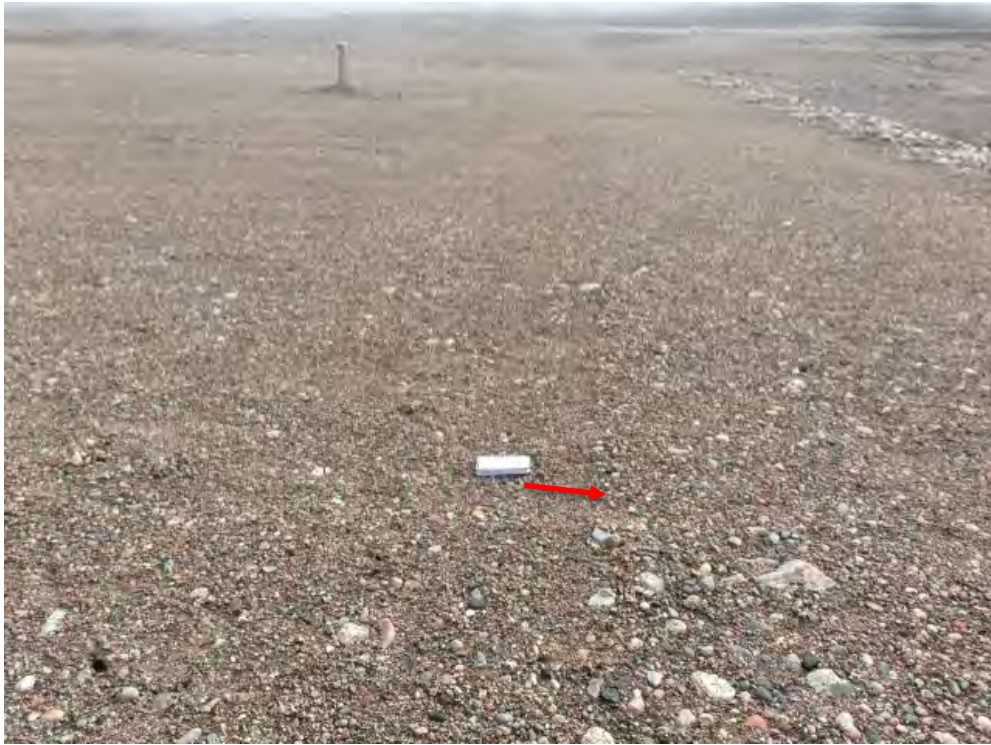
Photo 191: Tier II Disposal Facility- Cover surface, Feature F-Minor erosion channel, facing southeast (Acceptable) (CAM5_Photo4.jpg)

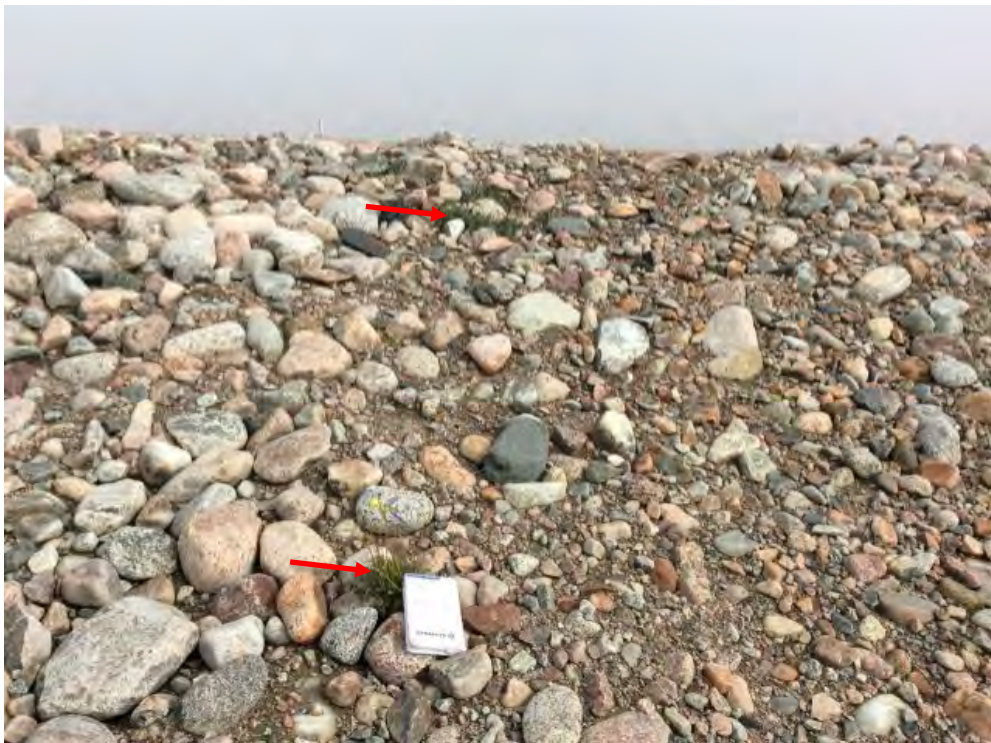
Photo 192: Tier II Disposal Facility- West slope, Feature G-Sparse vegetation, facing northeast (Acceptable) (CAM5_Photo1.jpg)

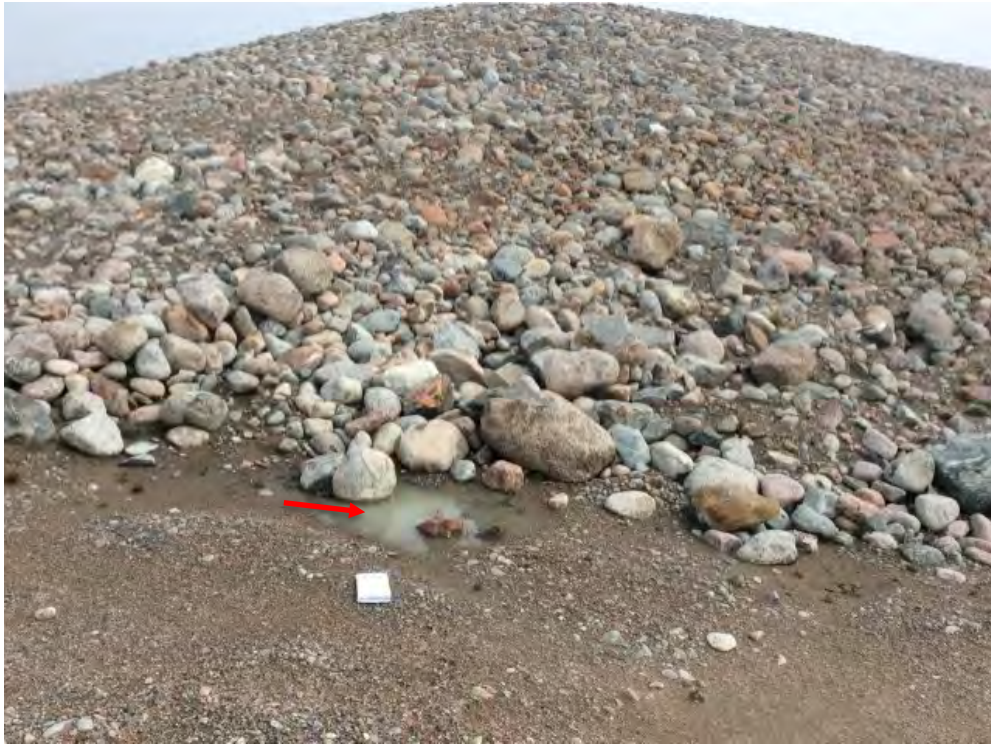
Photo 193: Tier II Disposal Facility- West toe corner, Feature H-Small ponded water, facing east (Acceptable) (CAM5_Photo2.jpg)
