BAF-5 Resolution Island

Maintenance Assessment Report (AECOM, 2014)

Public Works and Government Services Canada

BAF-5, Resolution Island Maintenance Assessment Report

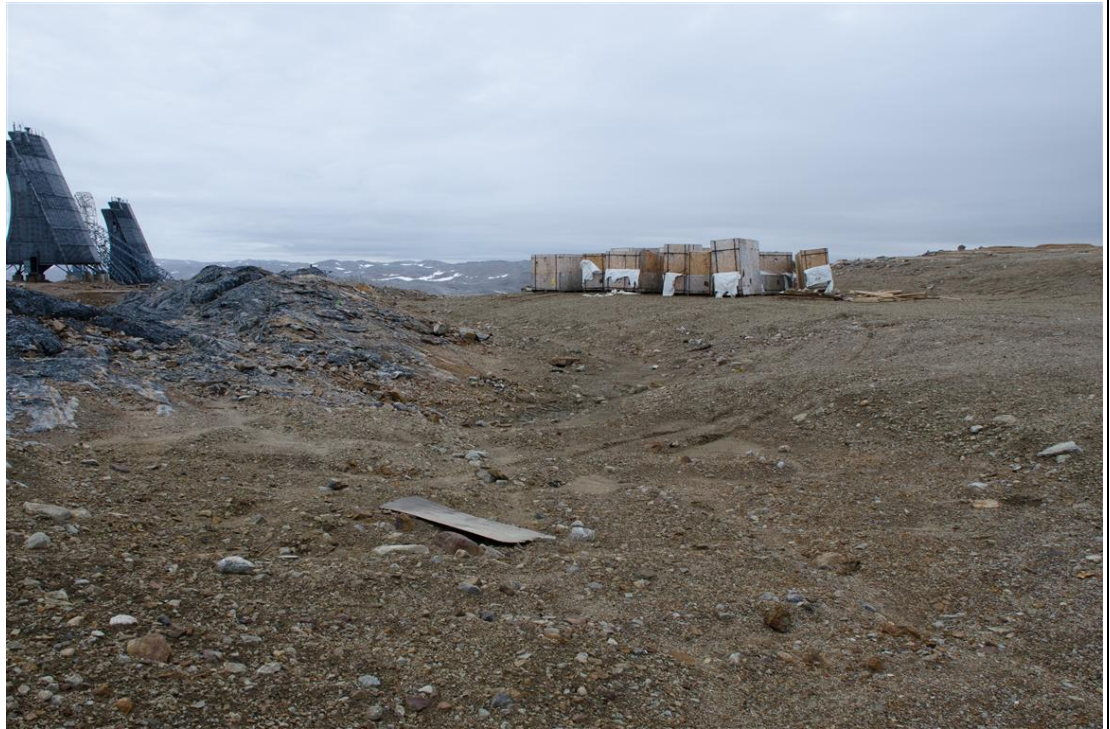
Looking west along the south toe of the landfill, taken from south of the landfill toe. Wood crates containing metallic items, likely associated with SRR facility upgrades, are being stored on the surface of the Camp Landfill.

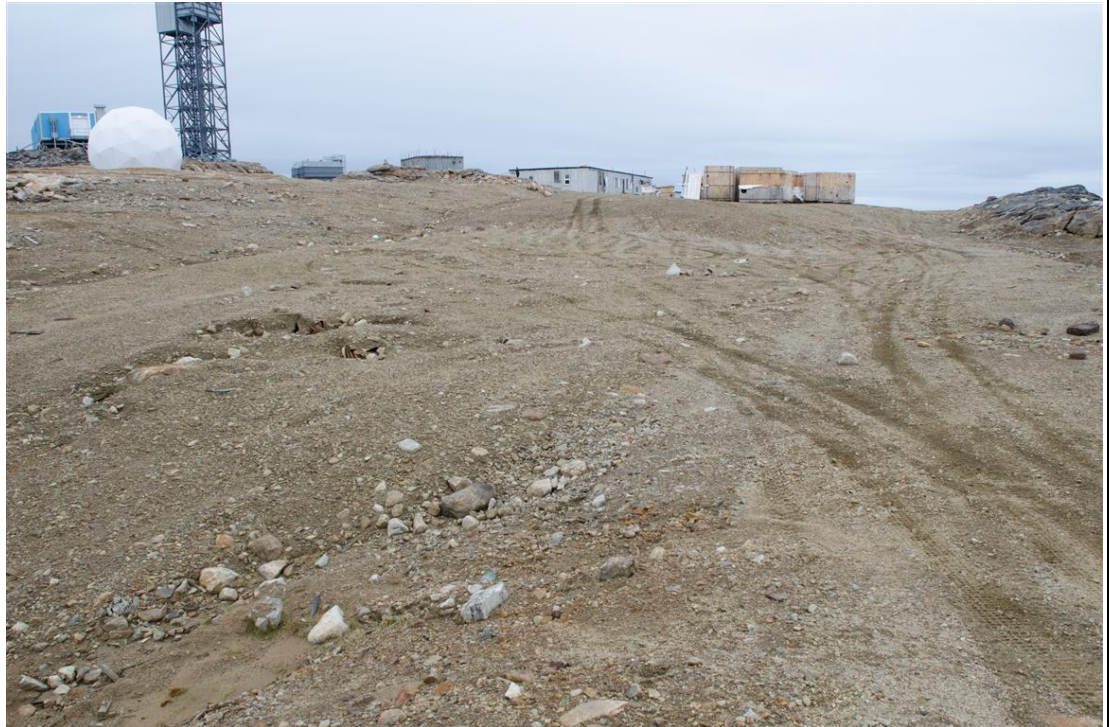
Looking northeast at west portion of landfill with sinkhole area in foreground, taken near the southwest landfill toe

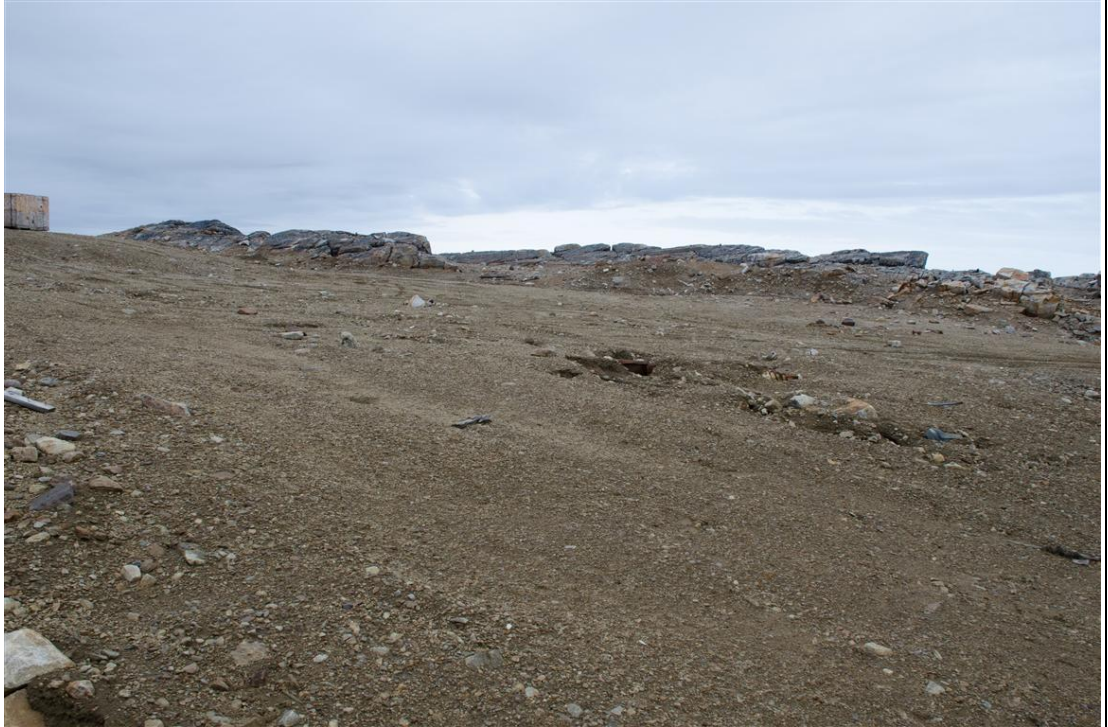
Looking southeast across landfill with sinkhole in foreground, taken near the northwest landfill toe.

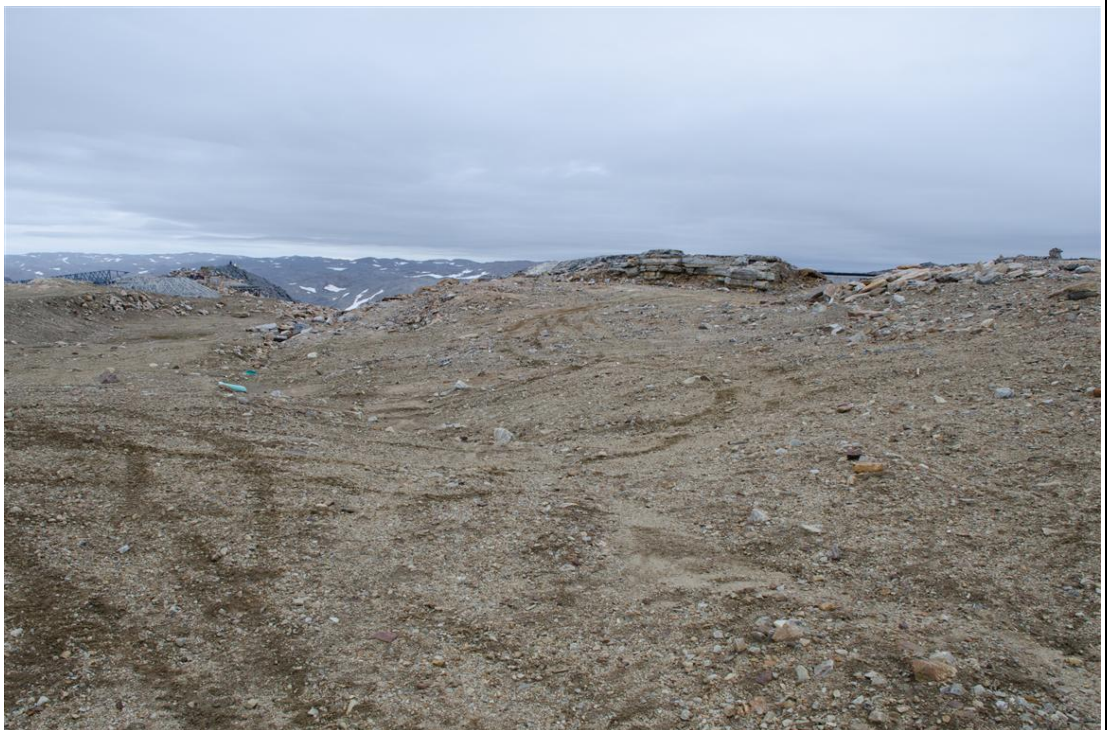
Looking southwest across landfill where drainage channel forms, taken from north side of landfill surface.

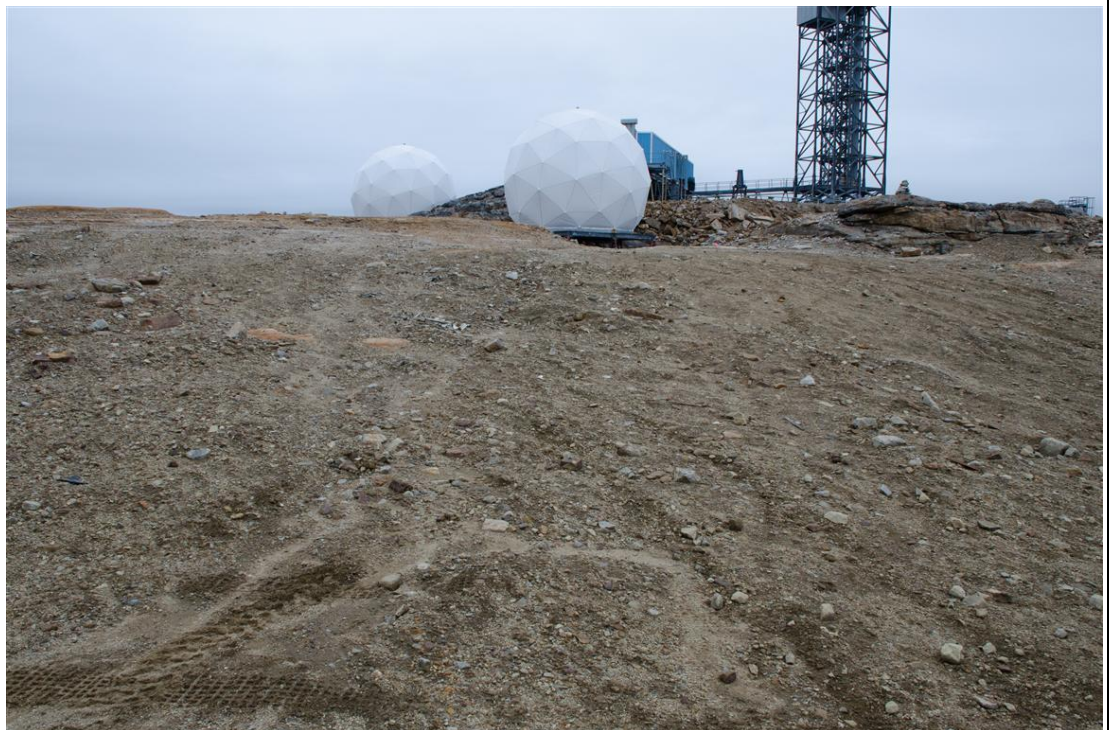
Looking north towards surface north of landfill area, taken from north side of landfill surface.

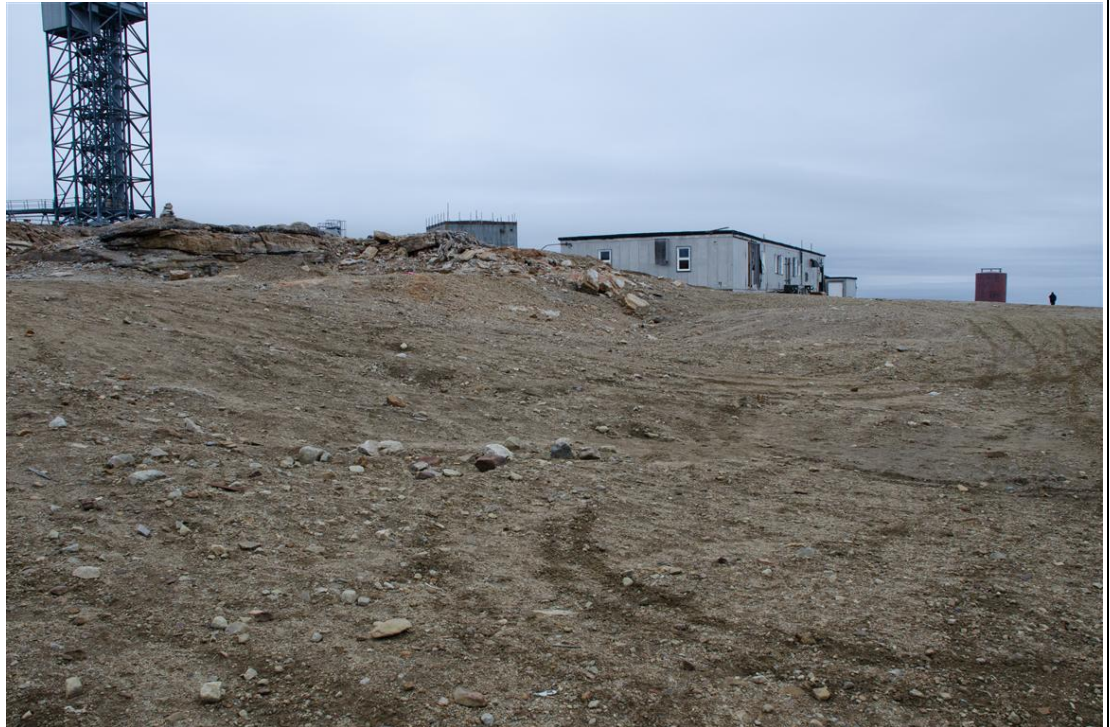
Looking east towards surface north of landfill area, taken from north side of landfill surface.

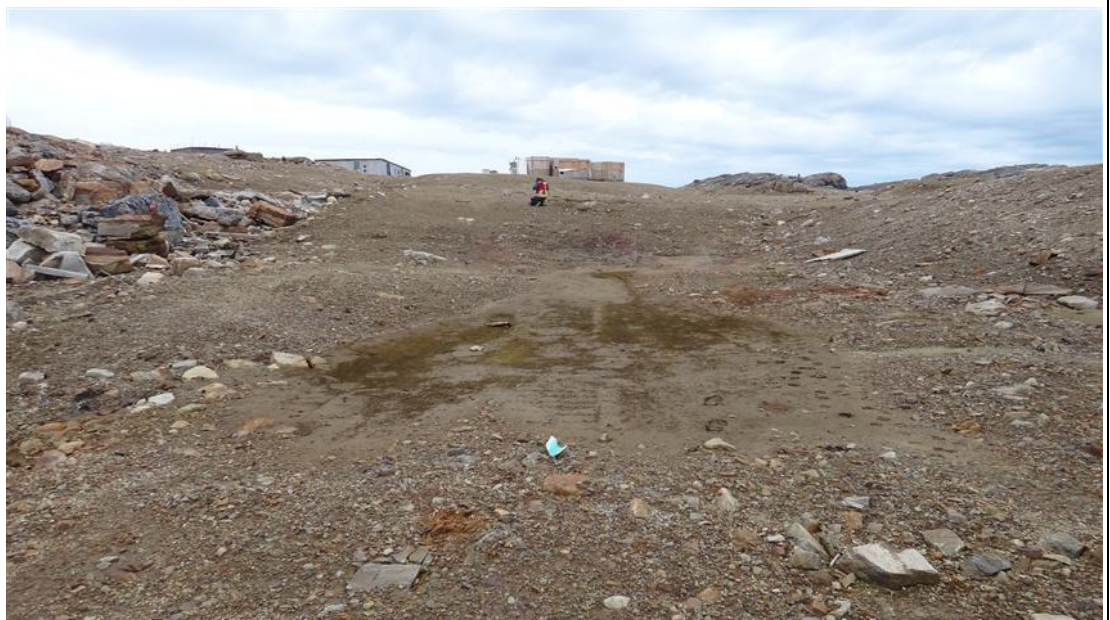
Looking east across the Camp Landfill, taken west of the landfill.

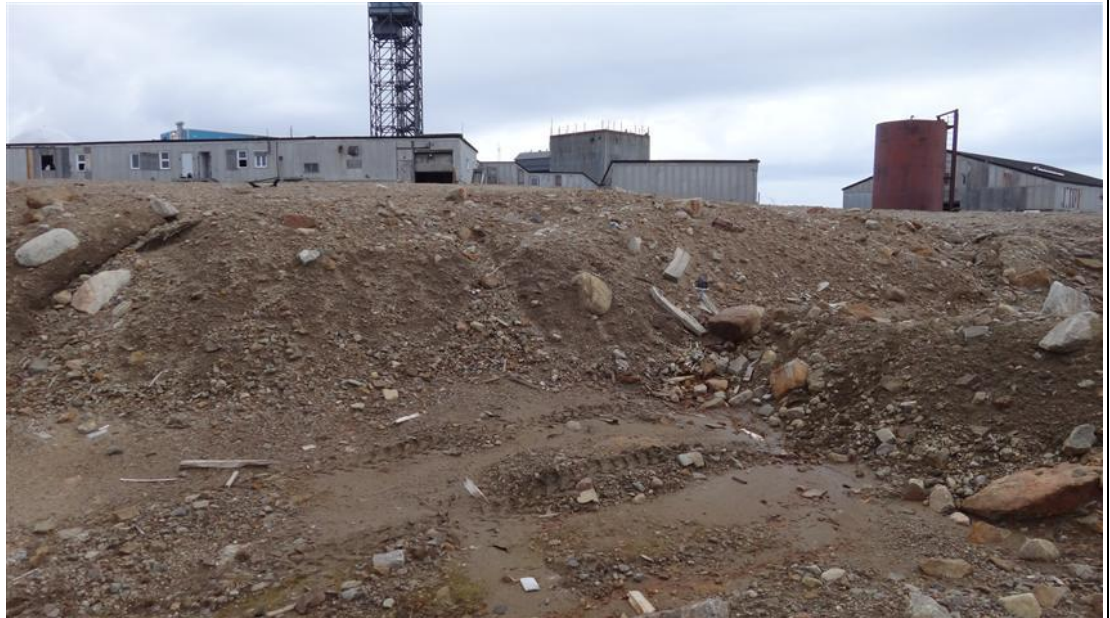
Looking north at south toe of east portion of the Camp Landfill.

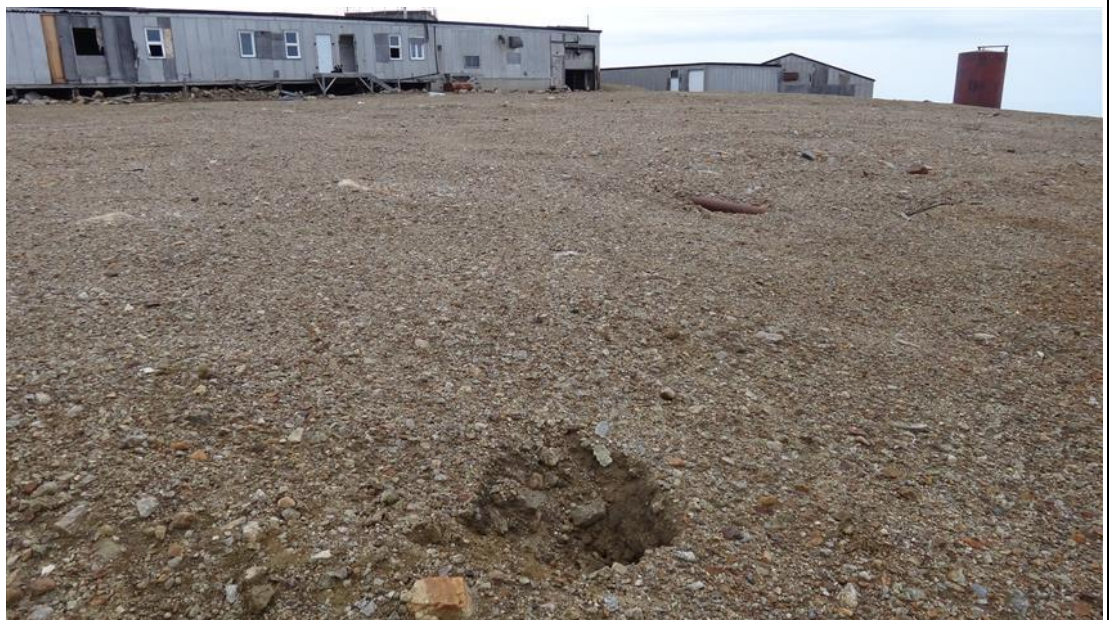
Looking northeast across east portion of Camp Landfill cap. Sinkhole visible in foreground.

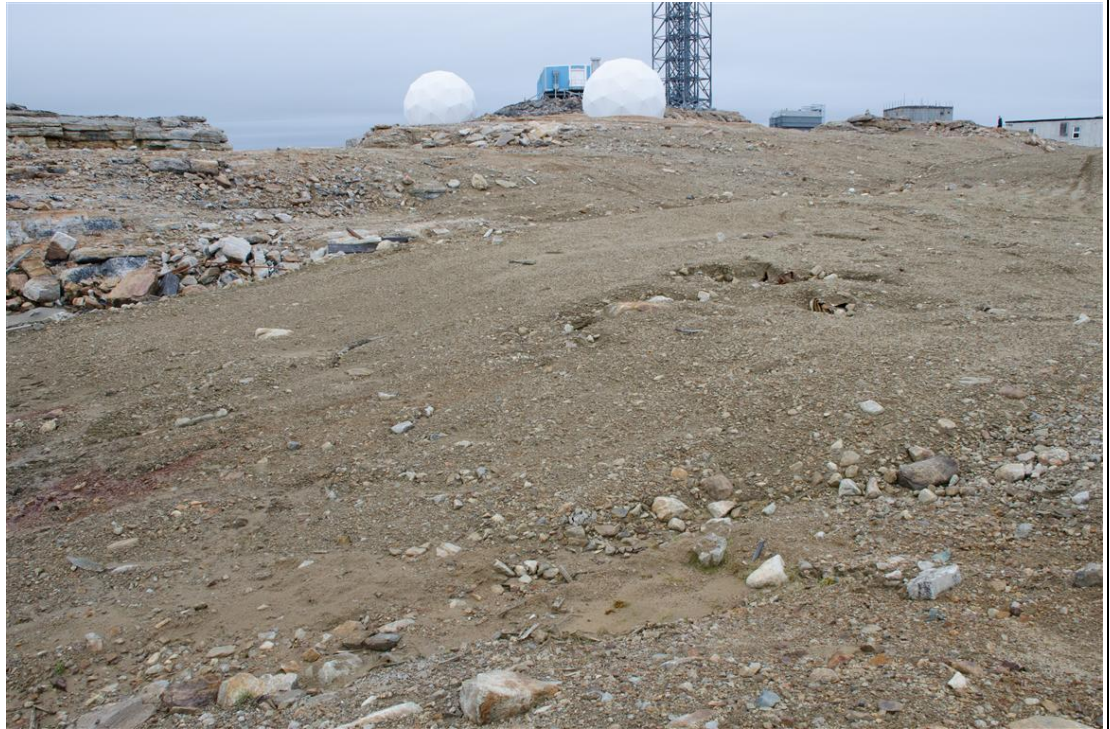
Looking northeast at west landfill lobe with sinkhole area in foreground, taken near the southwest landfill toe.

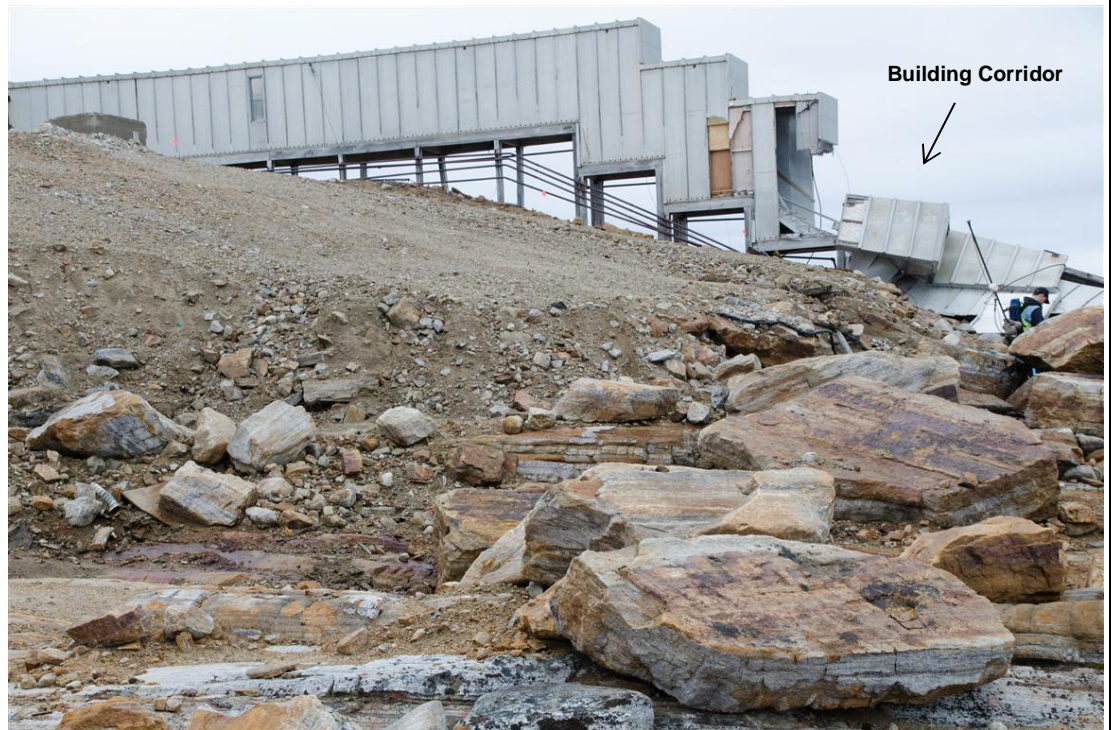
Looking north at lower lobe of PCL Dump

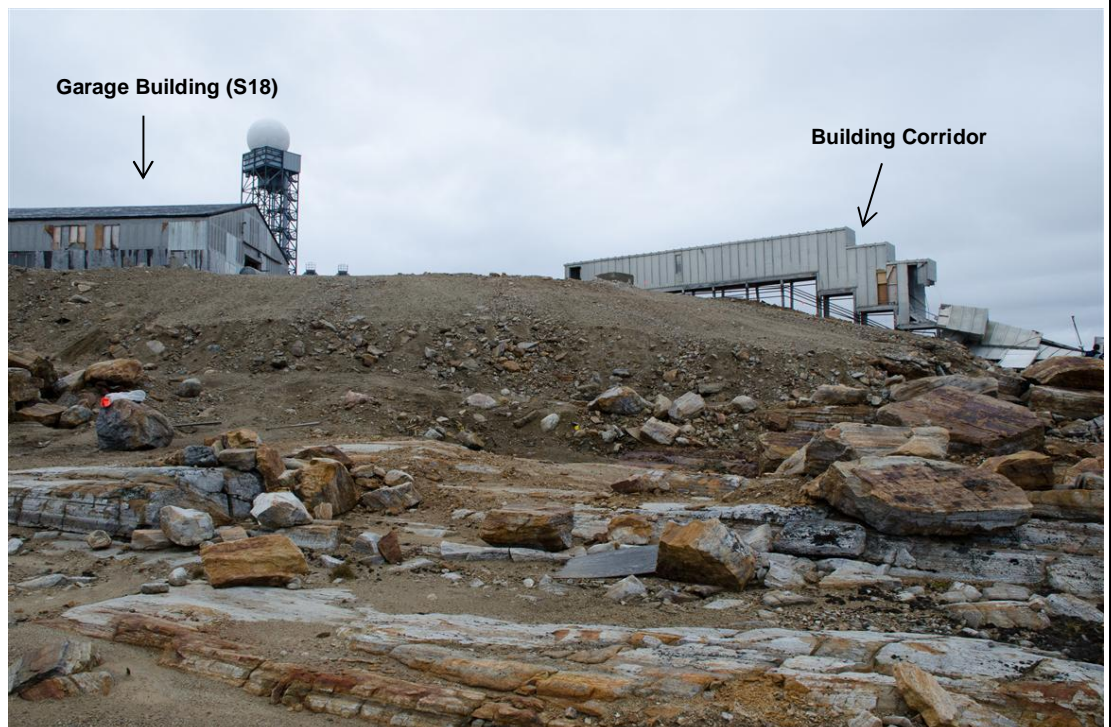
Looking northwest at PCL Dump, taken from the main drainage path

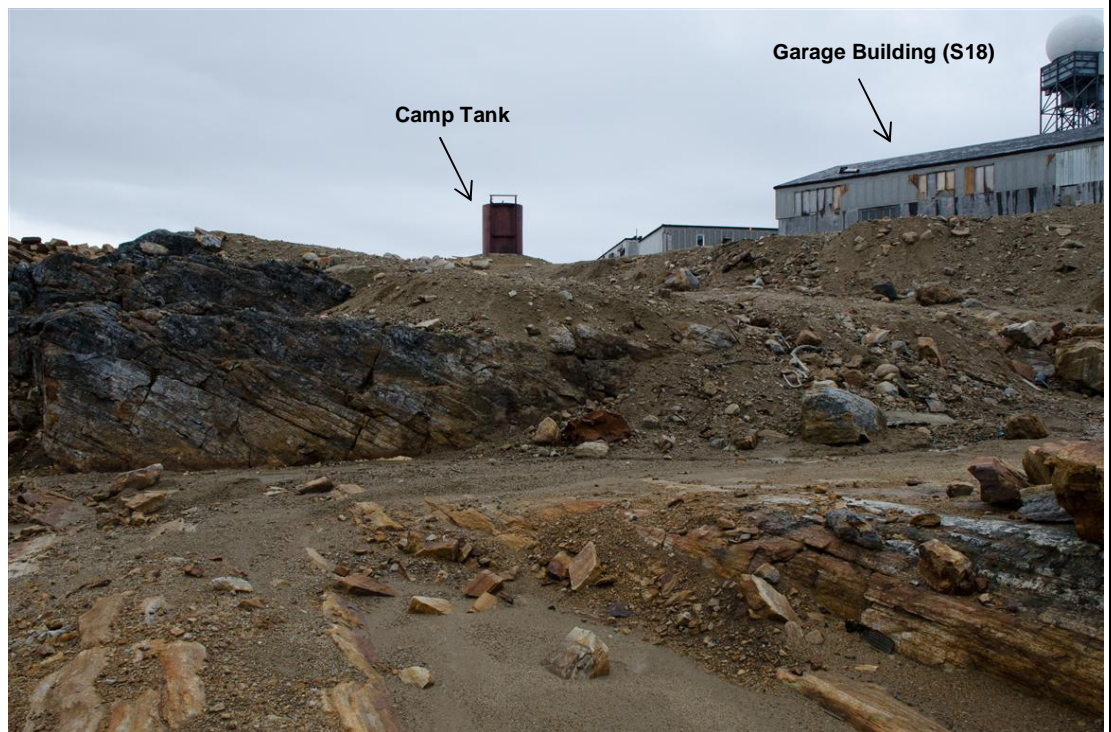
Looking west at south section of the PCL Dump (lower lobe), taken from the main drainage path

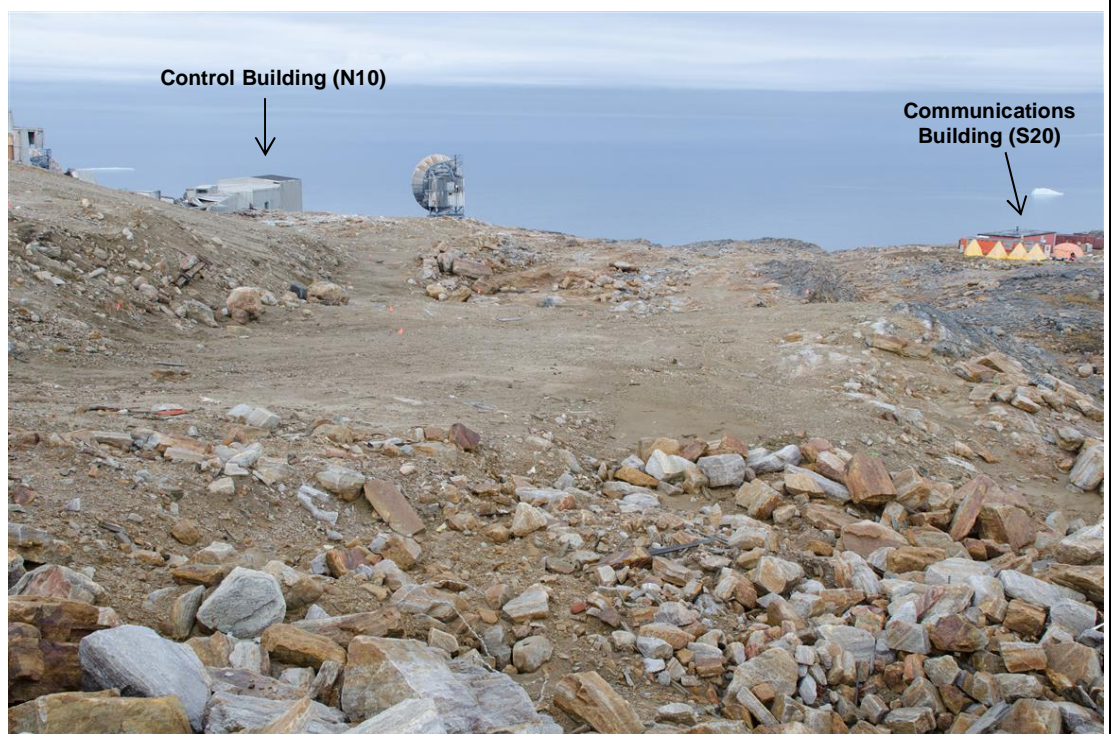
Looking northeast at south section (lower lobe) of PCL Dump, taken from south of dump after anomaly flagging

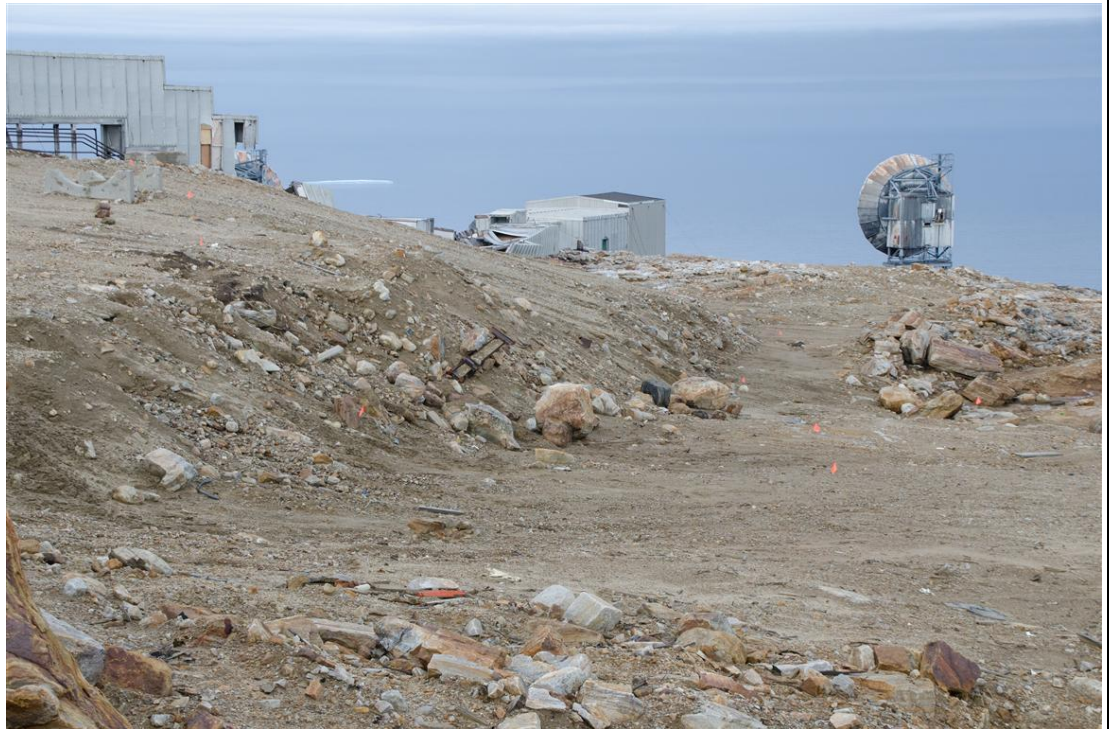
Looking north at sloped section of PCL Dump, taken from south section (lower lobe) after anomaly flagging

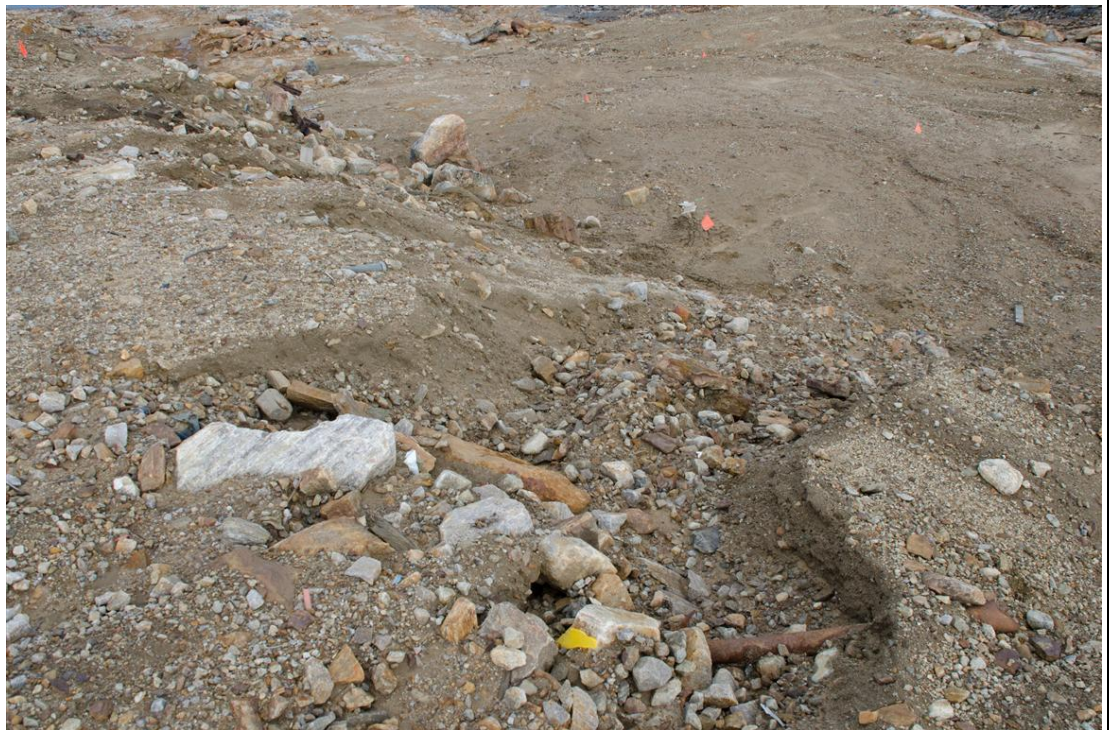
Looking down at eroded section of PCL Dump, taken from upslope

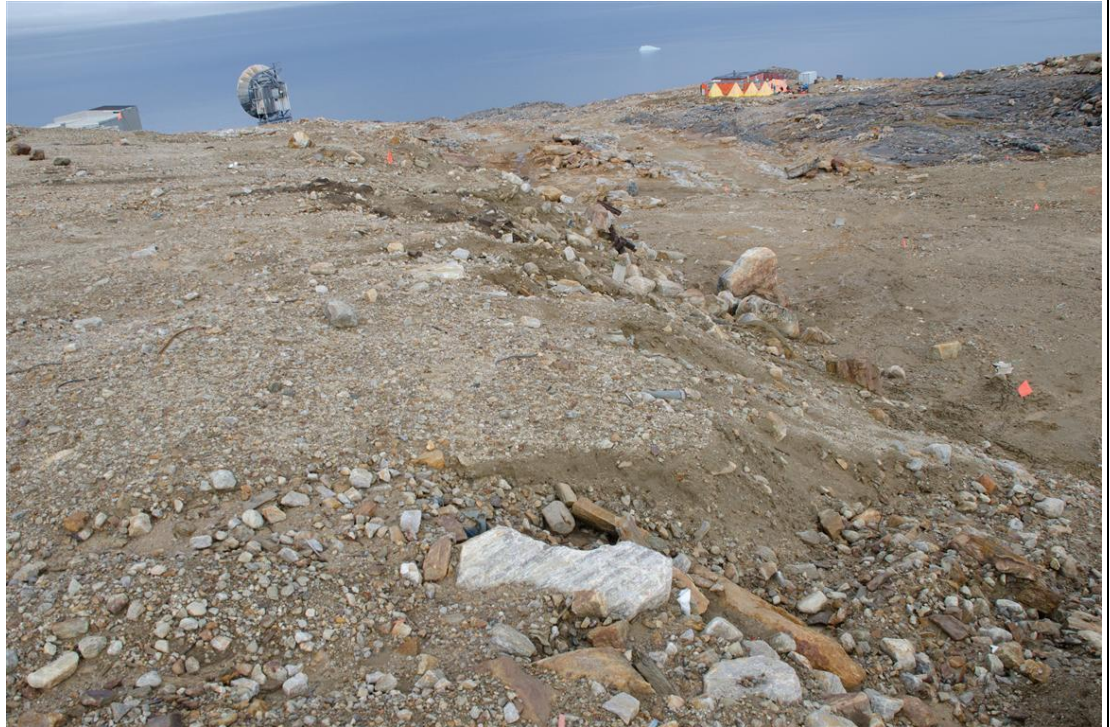
Looking northeast at erosion channels, taken from upslope

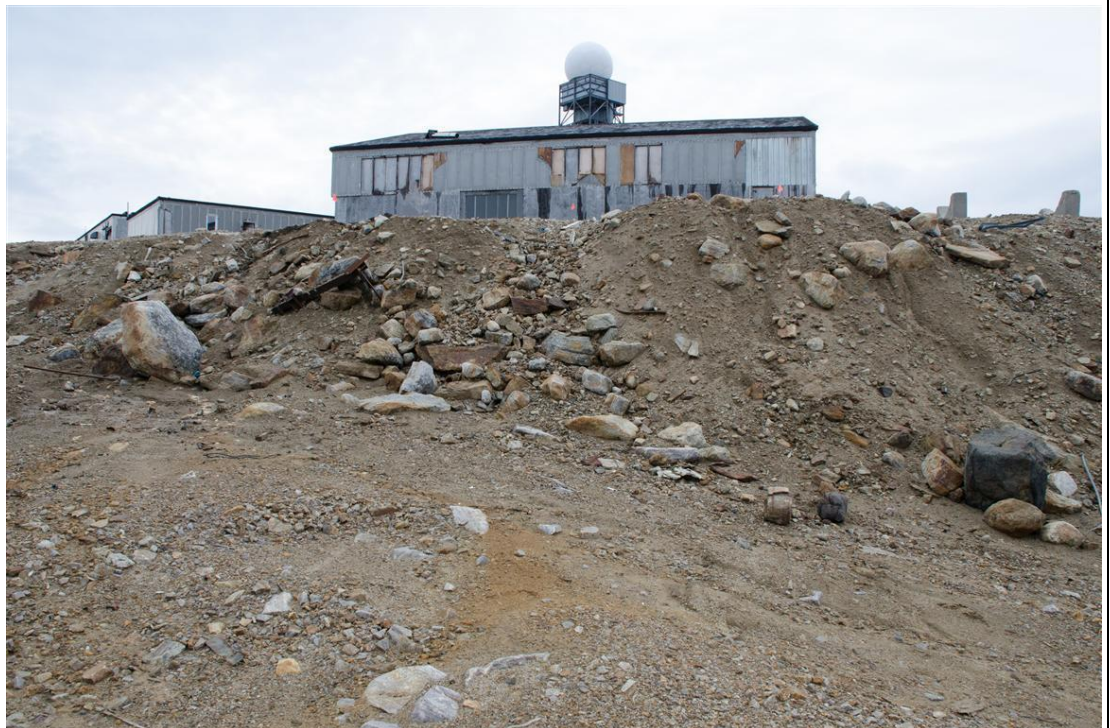
Looking northwest at erosion channels on sloped section of PCL Dump, taken from downslope

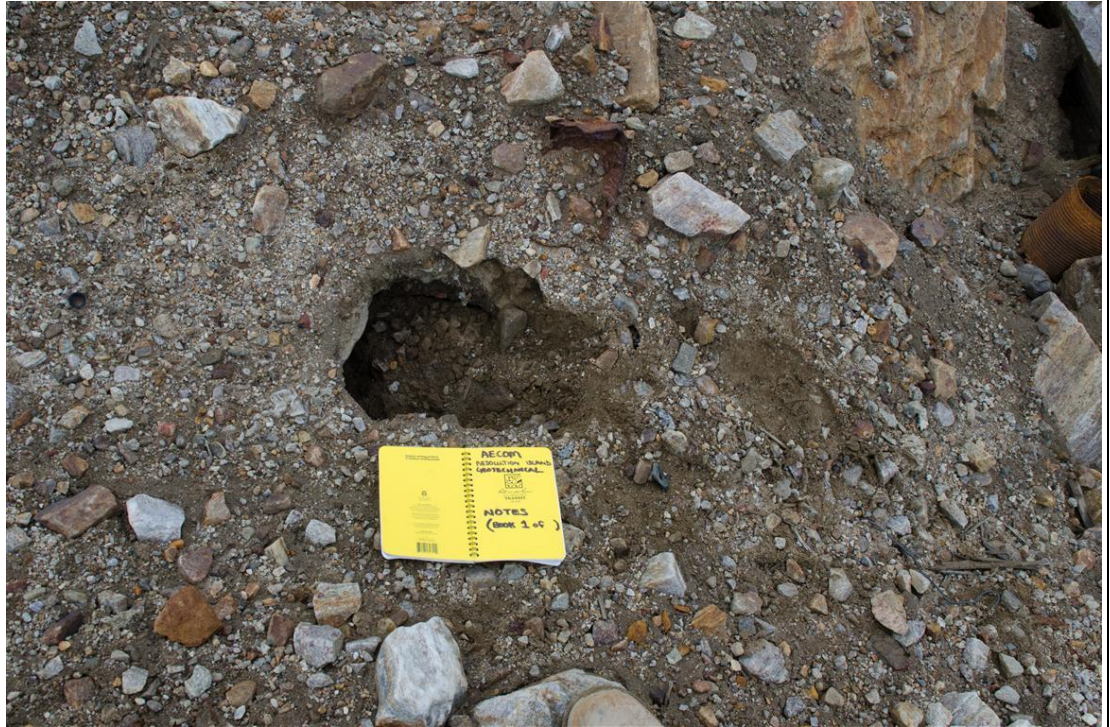
Sinkhole at lower section
of PCL Dump

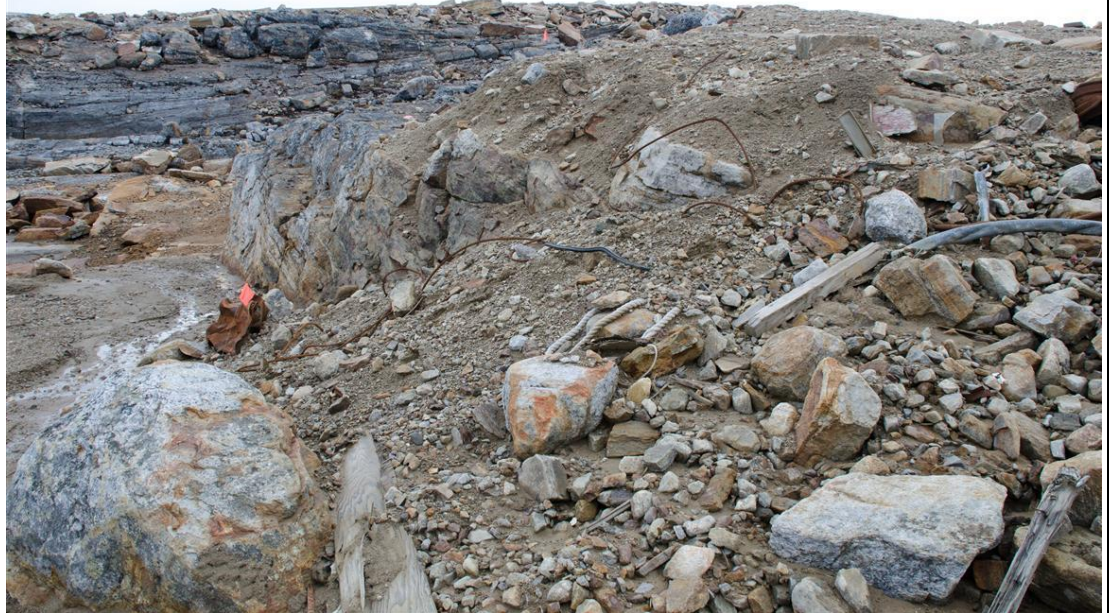
Looking south at
exposed debris on lower
section of PCL Dump

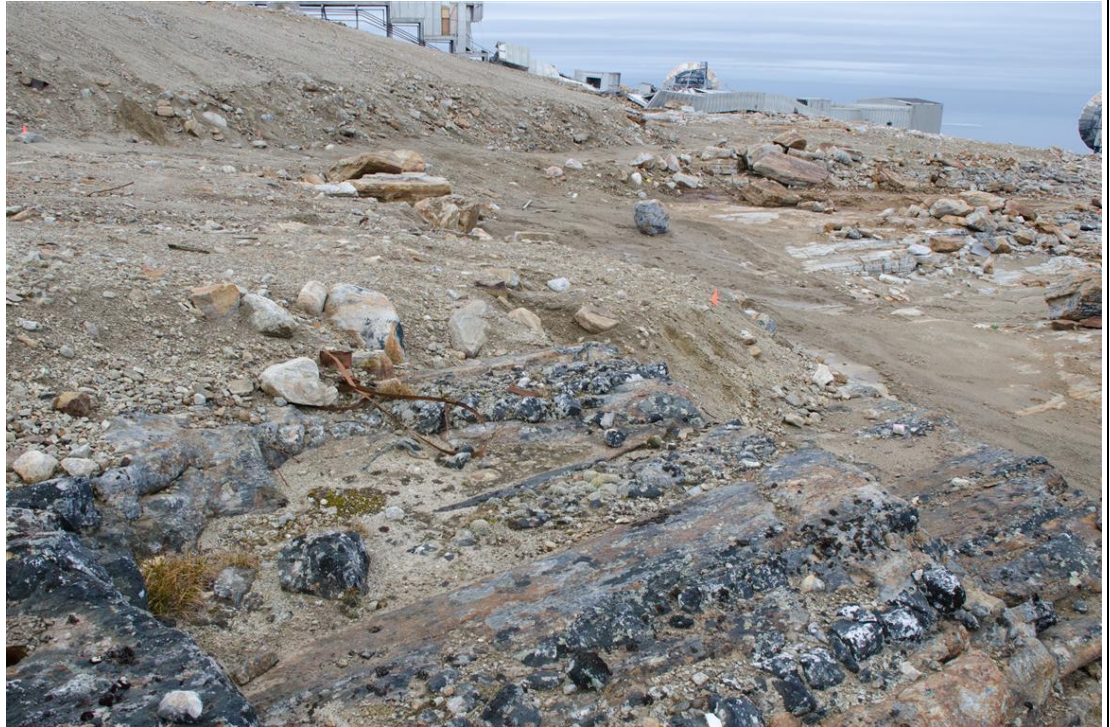
Looking north where soil meets bedrock, taken on lower section of PCL Dump

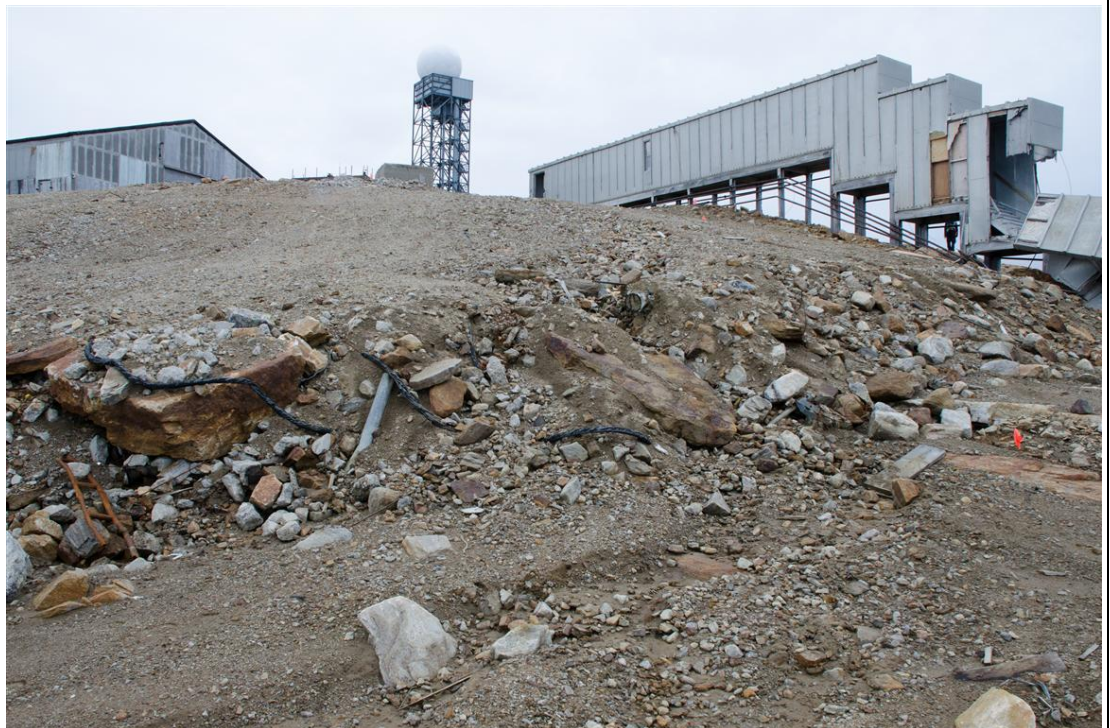
Looking northwest at exposed slope and debris, taken below slope of north section

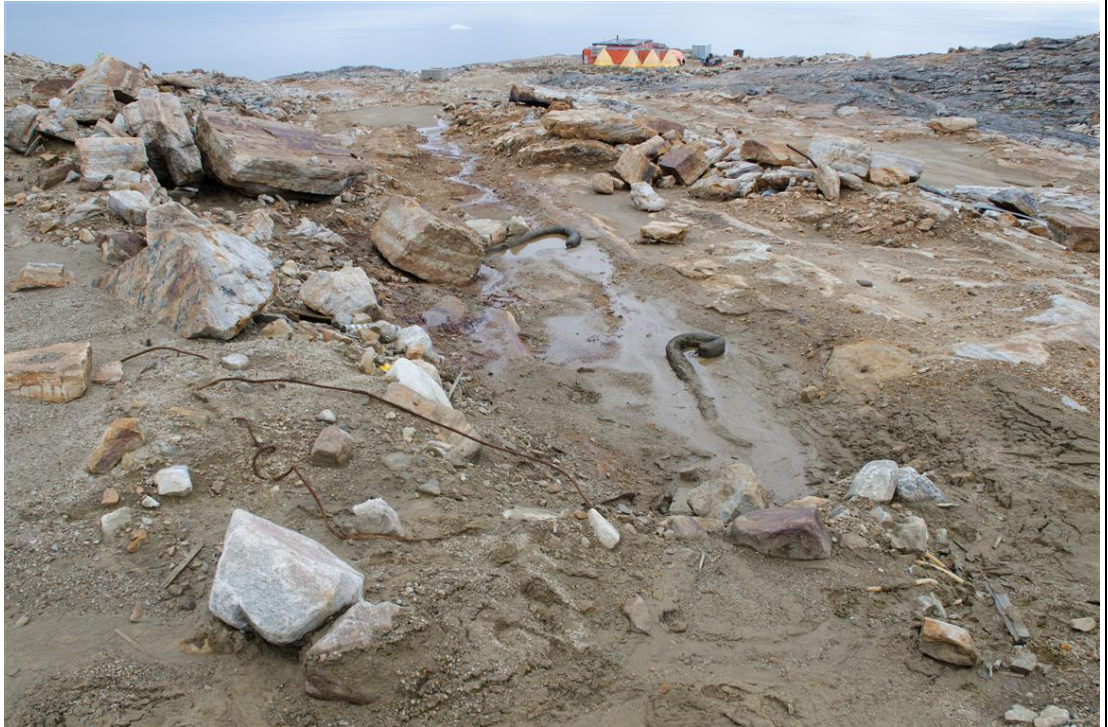
Looking east at downstream drainage, taken on lower section

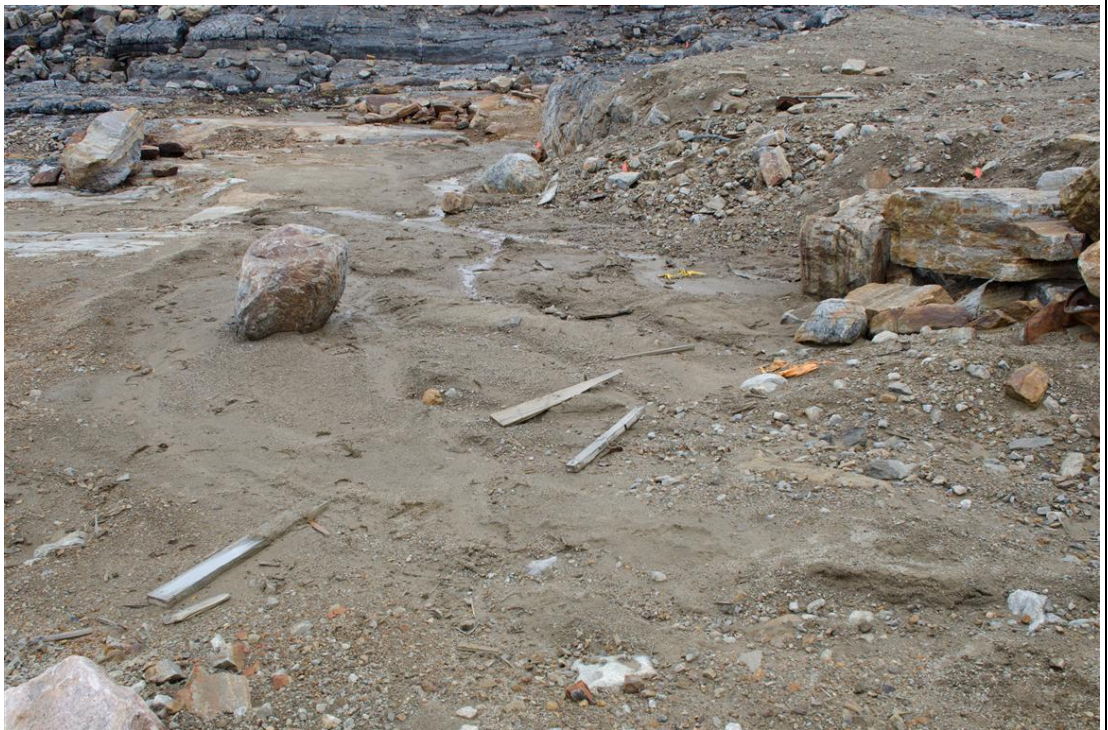
Looking south at exposed debris, taken below slope of north section

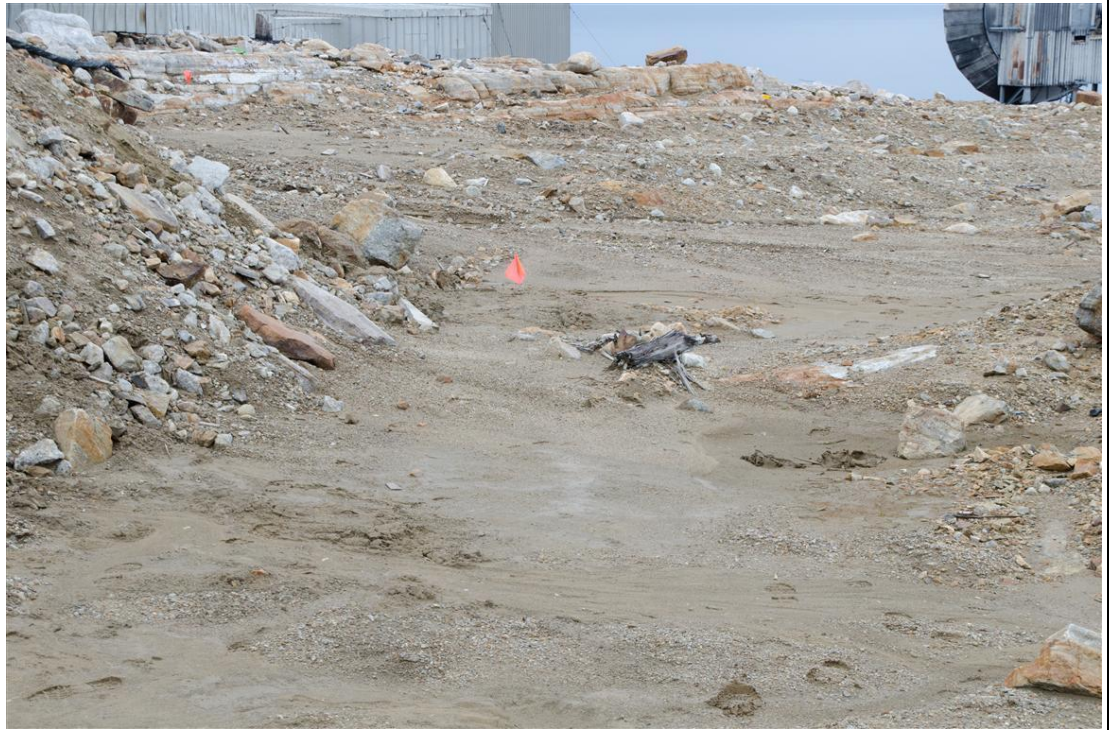
Looking north along exposed slope, taken below slope of north section

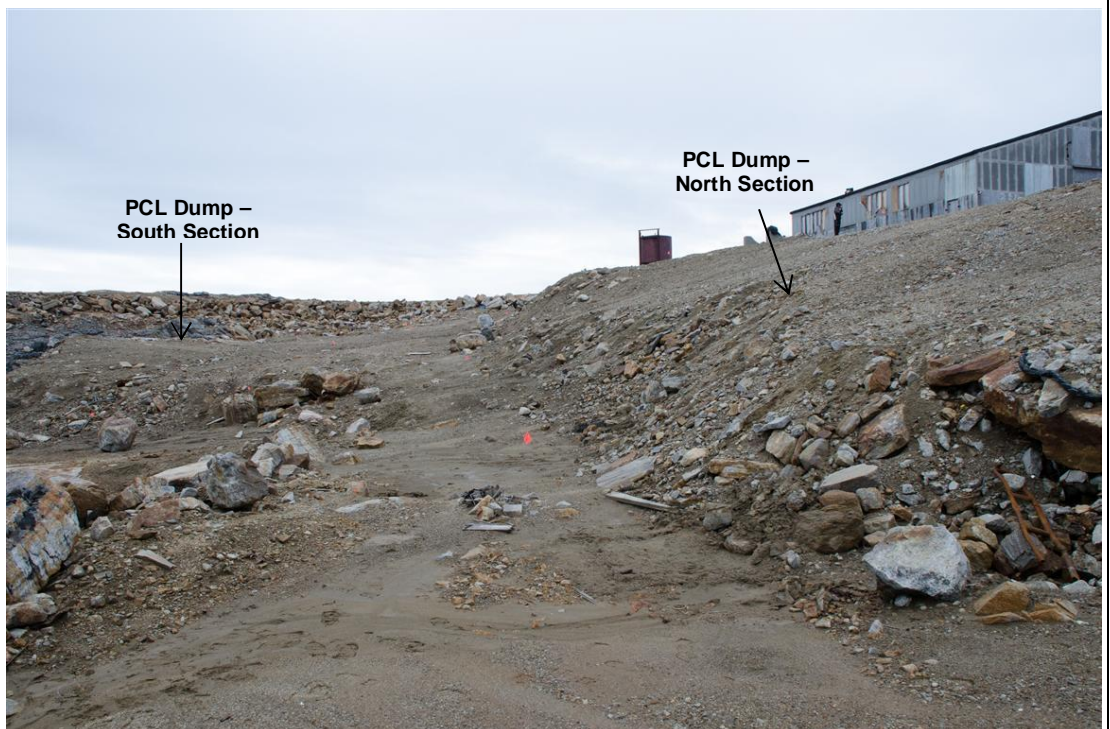
Looking southwest at access road, exposed slope and debris associated with the PCL Dump. Photo taken below slope of the north section

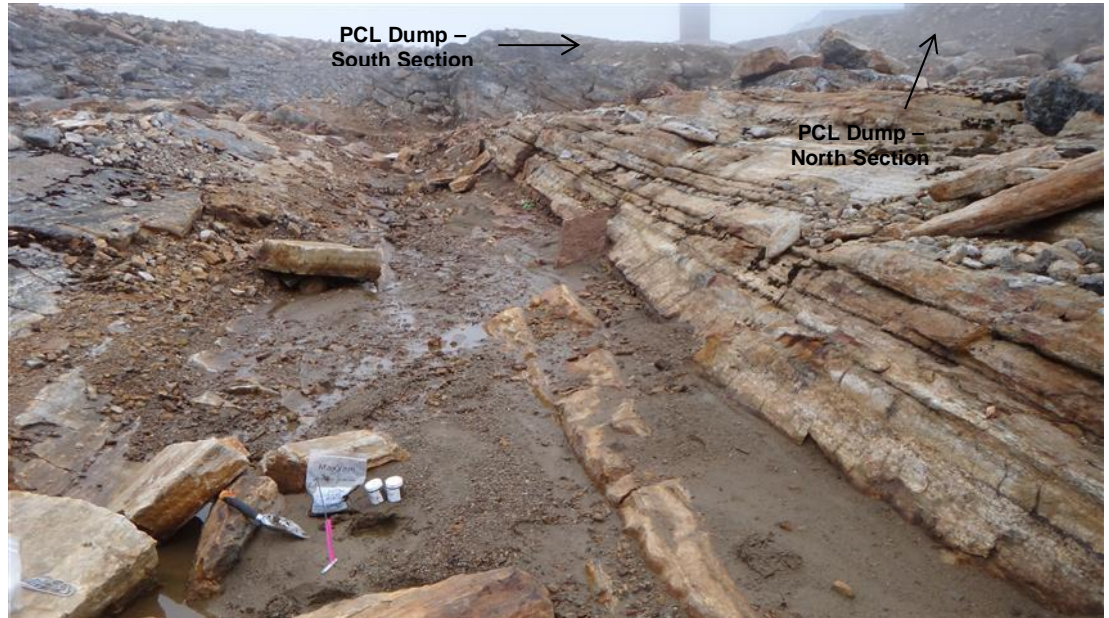
Soil sample collected from main drainage channel. Low volume of soil present in channel is indicative of previous excavation activities.

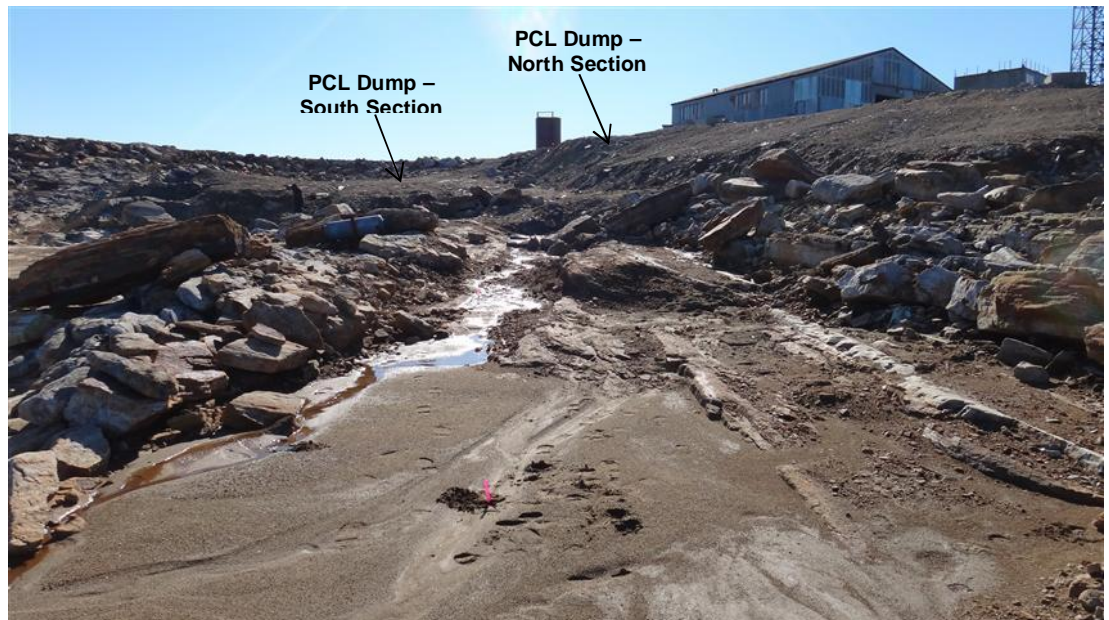
Looking west along drainage channel

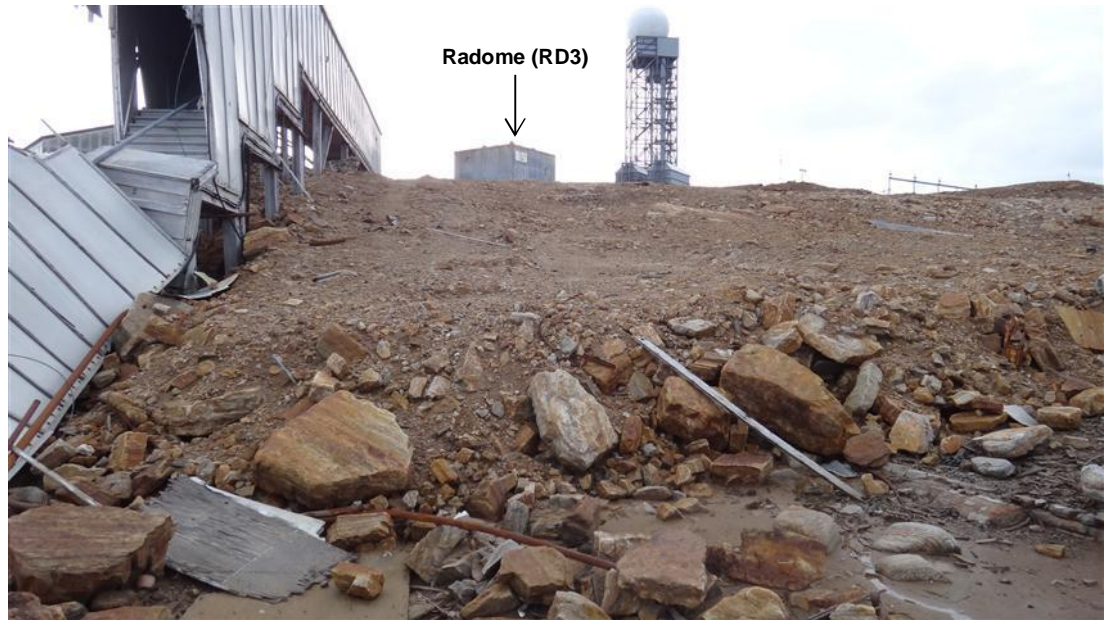
Looking west at toe of south-most portion of North Slope Dump
