BAF-5 Resolution Island

Maintenance Assessment Report (AECOM, 2014)

Public Works and Government Services Canada

BAF-5, Resolution Island Maintenance Assessment Report

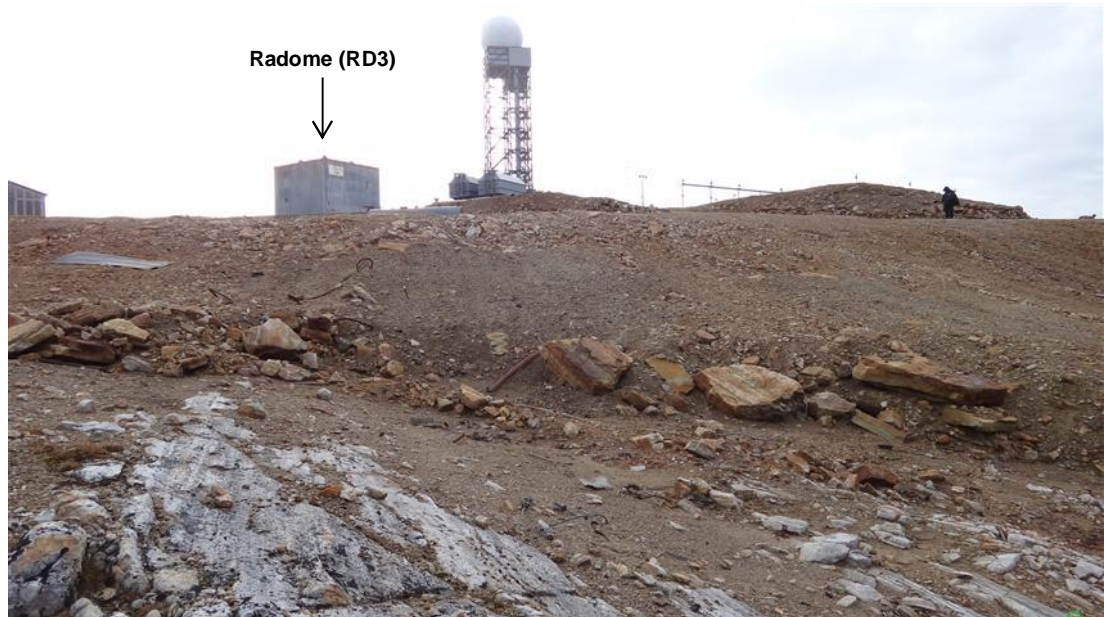
Looking west at toe of southern portion of North Slope Dump

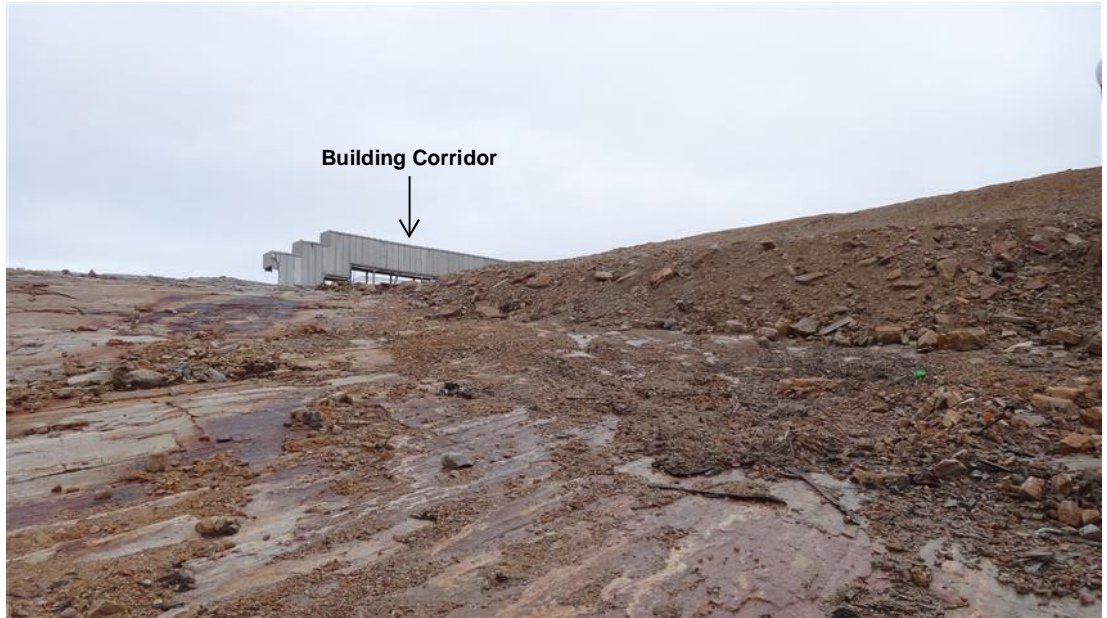
Looking south along toe of southern portion of North Slope Dump.
Taken from the same location as Photo No. 3

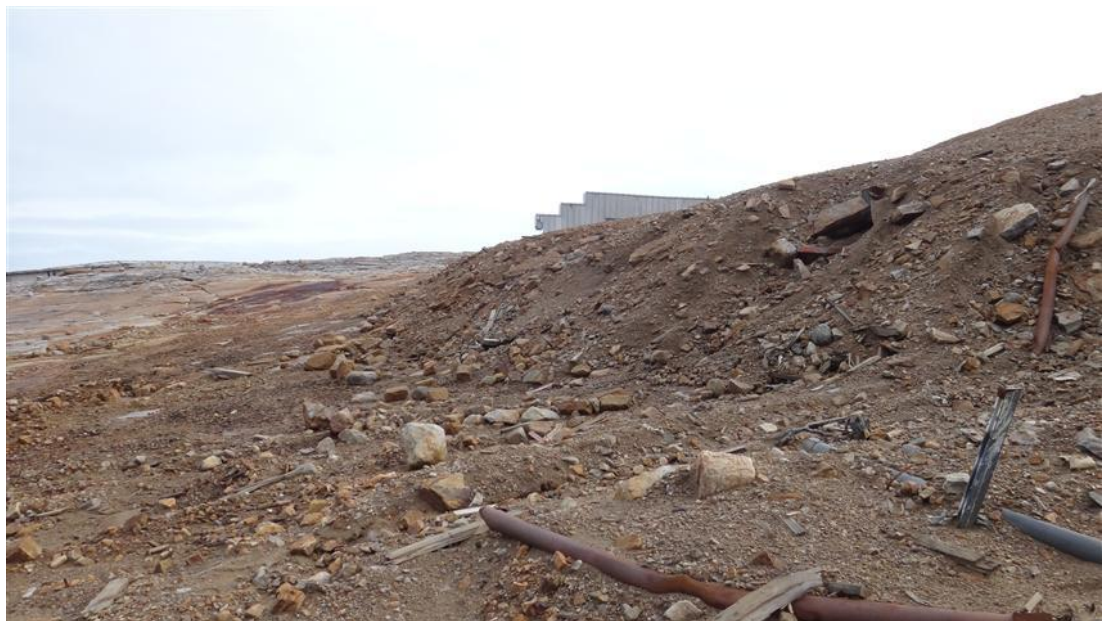
Looking south along toe of North Slope Dump.
Miscellaneous metal debris visible

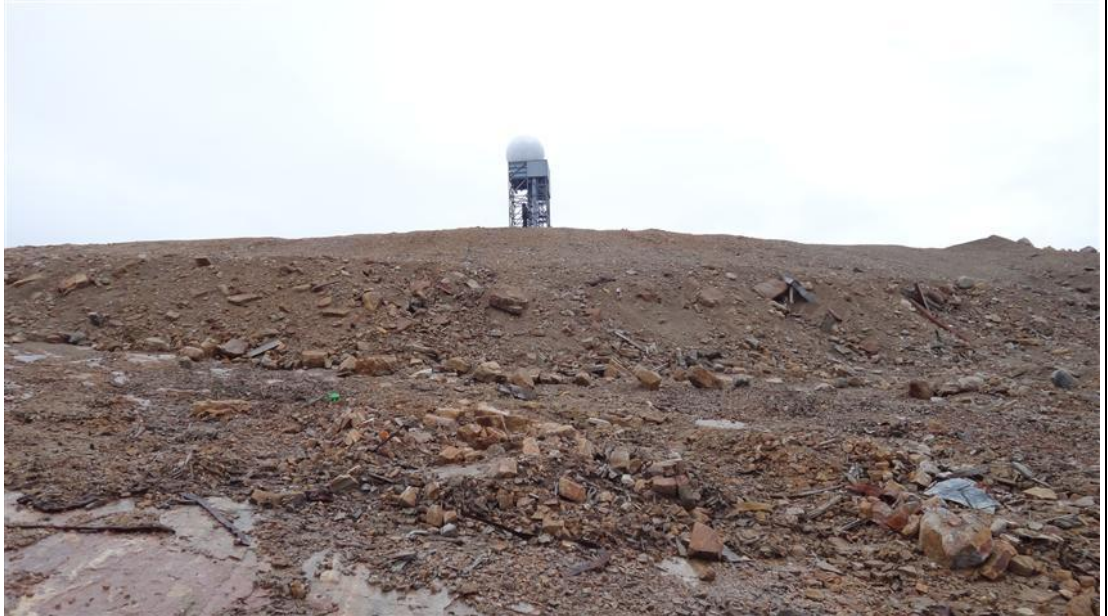
Looking west at toe of central portion of North Slope Dump

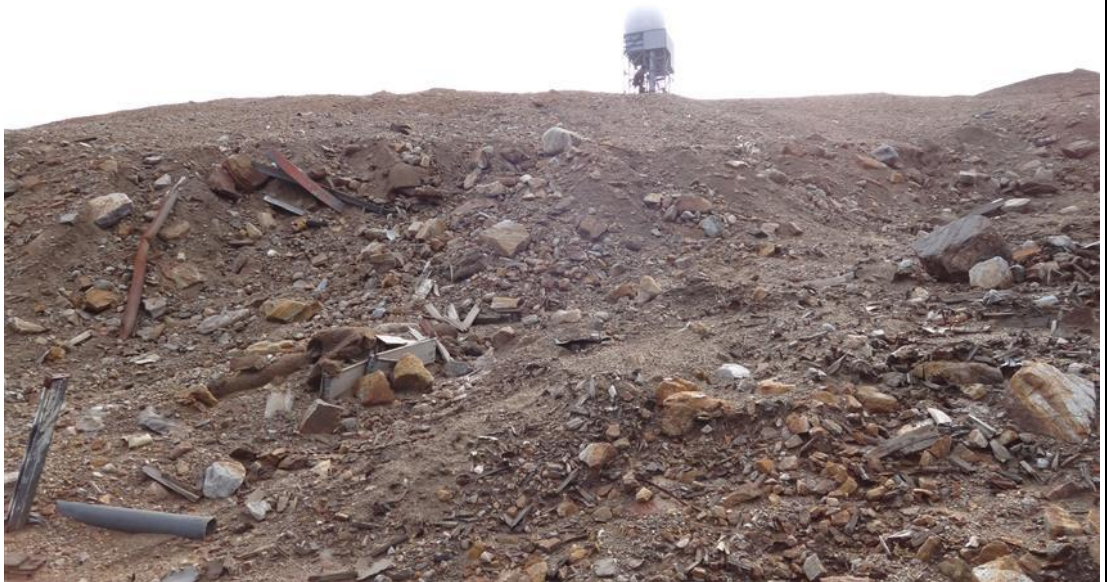
Looking southwest at toe of central portion of North Slope Dump. Miscellaneous metal and wood debris is visible in foreground

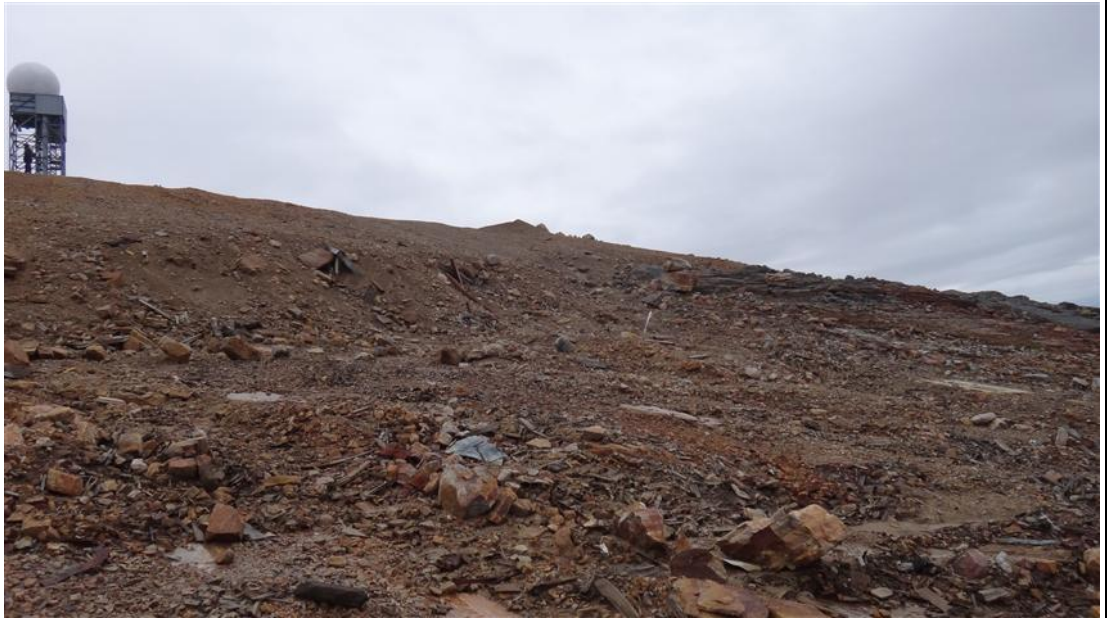
Looking northwest at toe of northern section of North Slope Dump

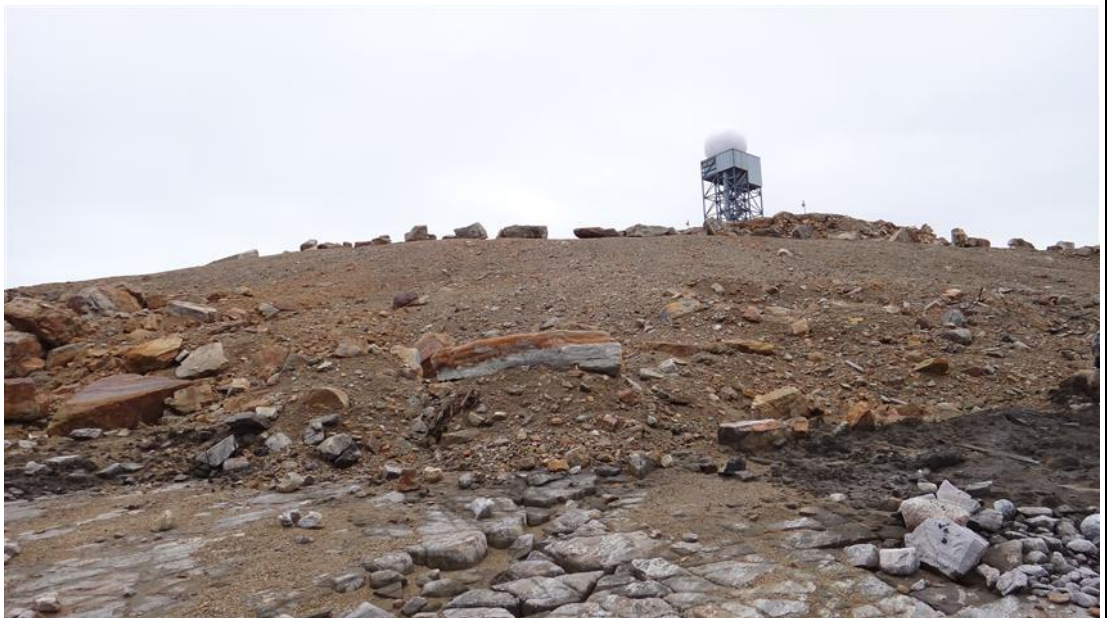
Looking southwest at northern section of North Slope Dump

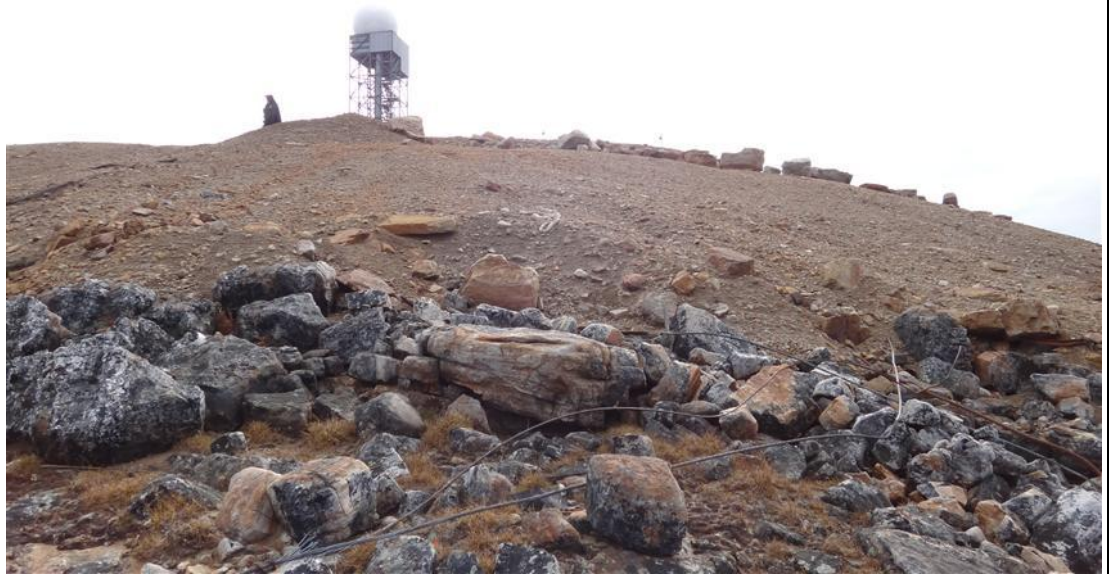
Looking northwest at
northern section of North
Slope Dump

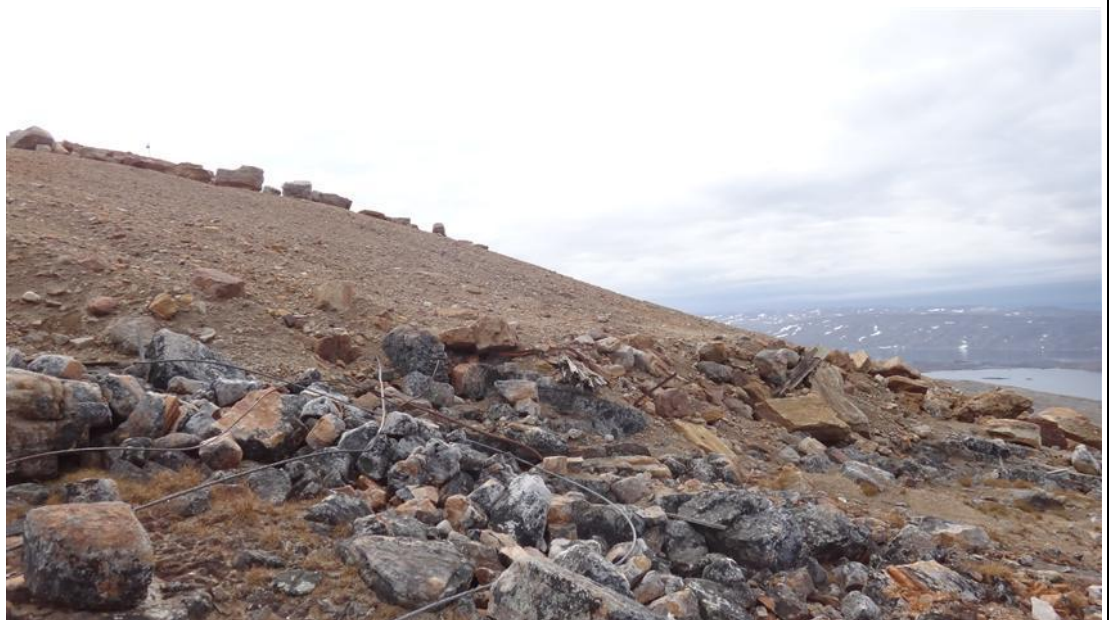
Looking northwest
along northern portion of
North Slope Dump

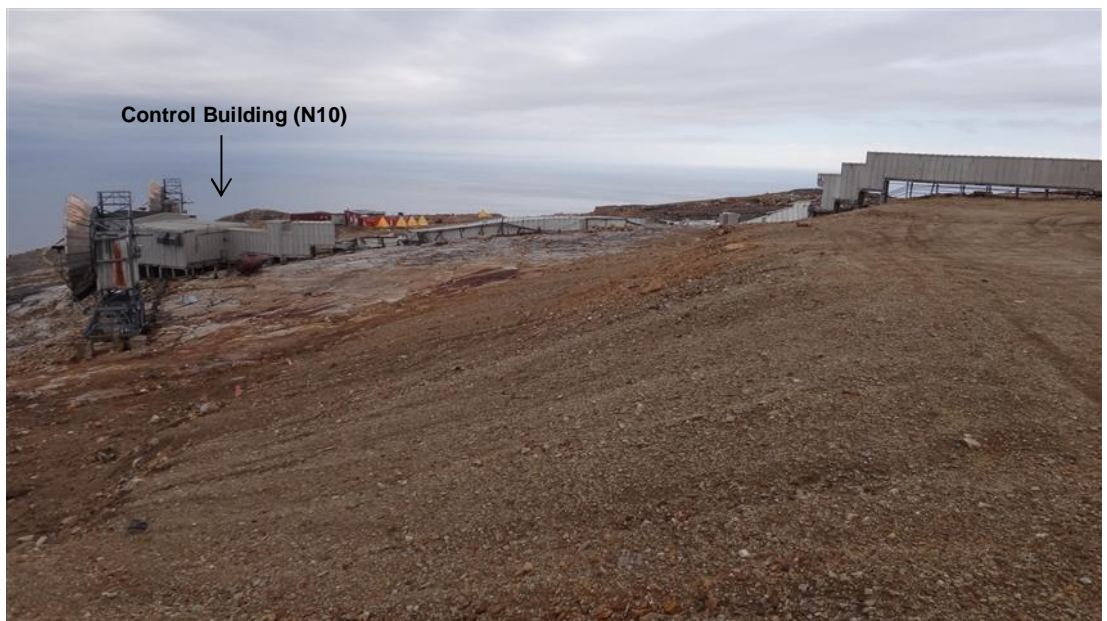
Looking south along top of slope, taken from central section of North Slope Dump

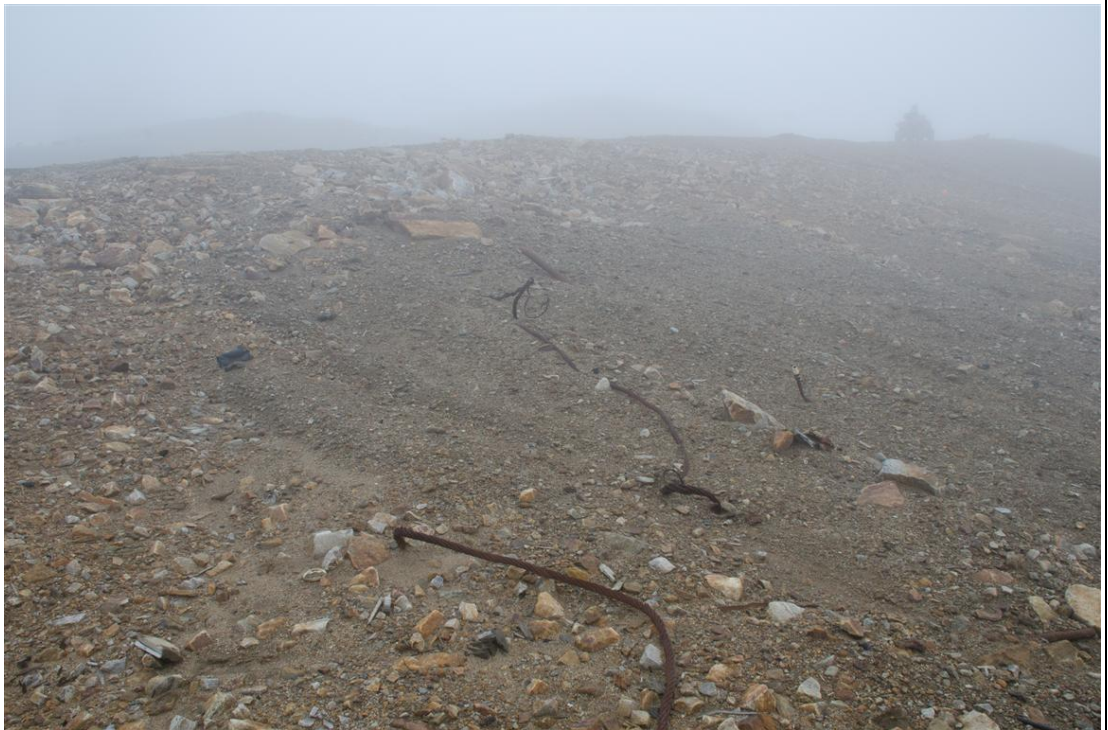
Looking north along crest of south section of dump at partially buried metal cable (near WP#64)

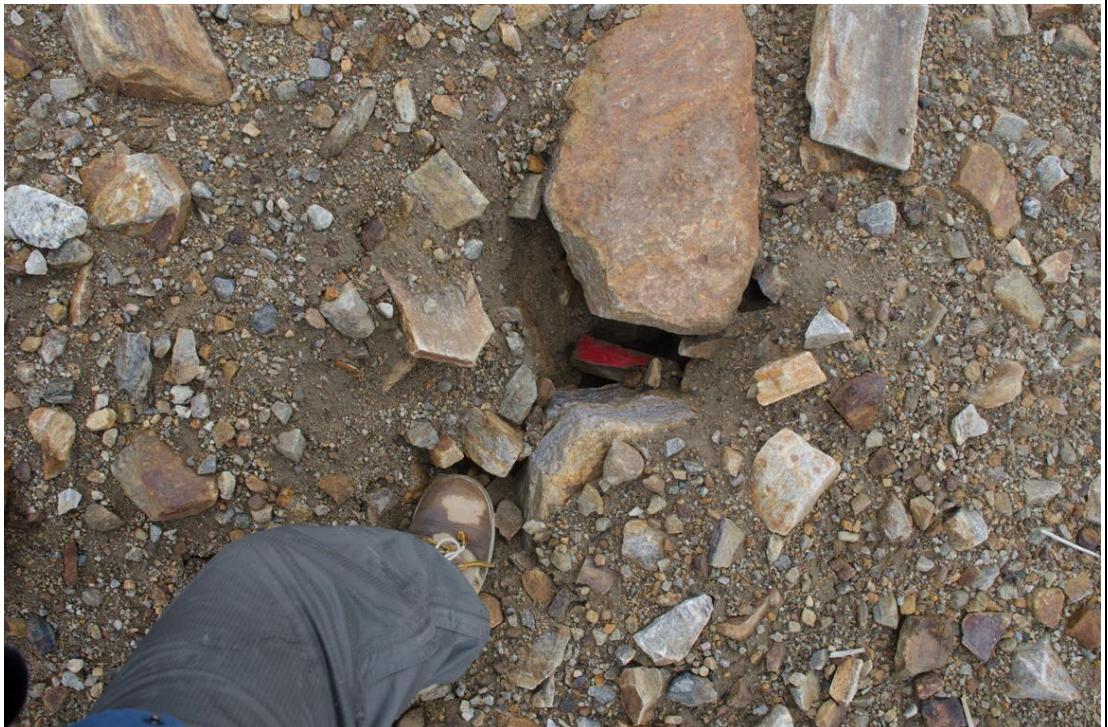
Sinkhole in south section of North Slope Dump (WP#068)

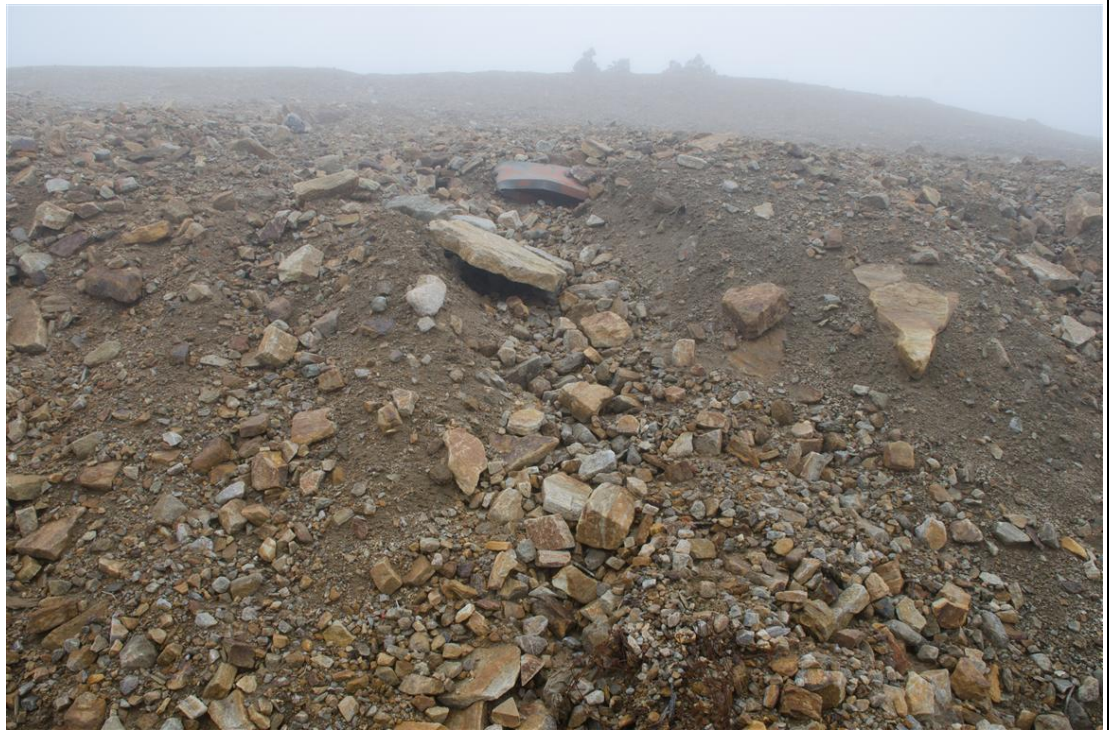
Erosion channels in central section of North Slope Dump (WP#074)

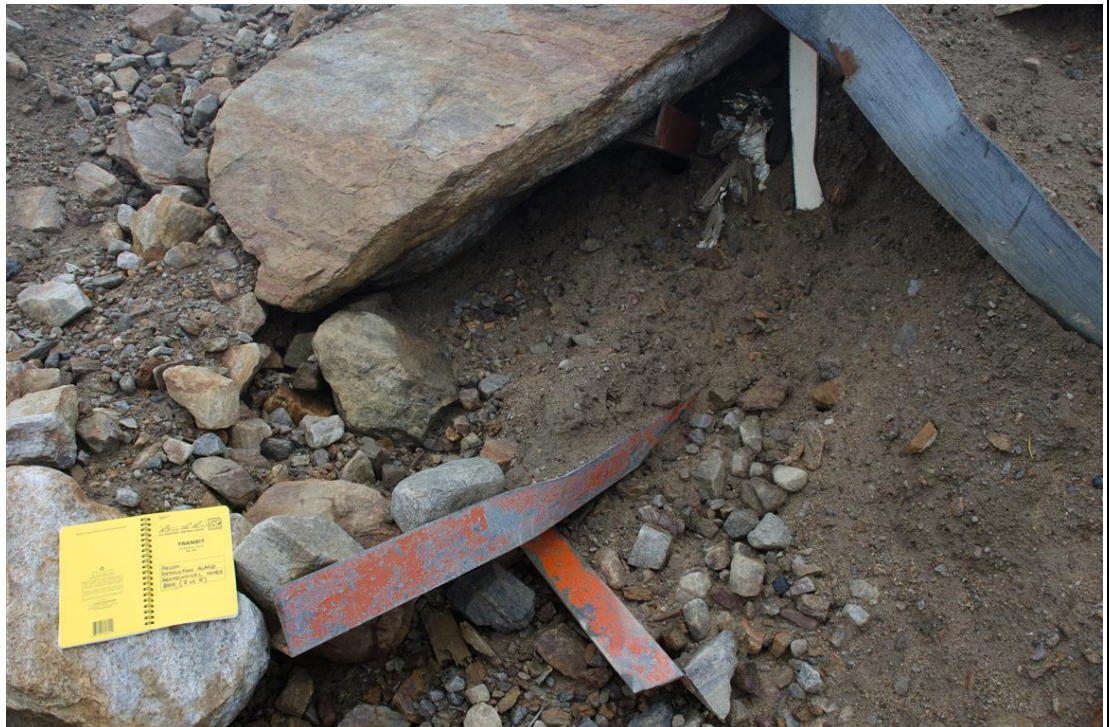
Evidence of erosion in central section of North Slope Dump (WP#076)

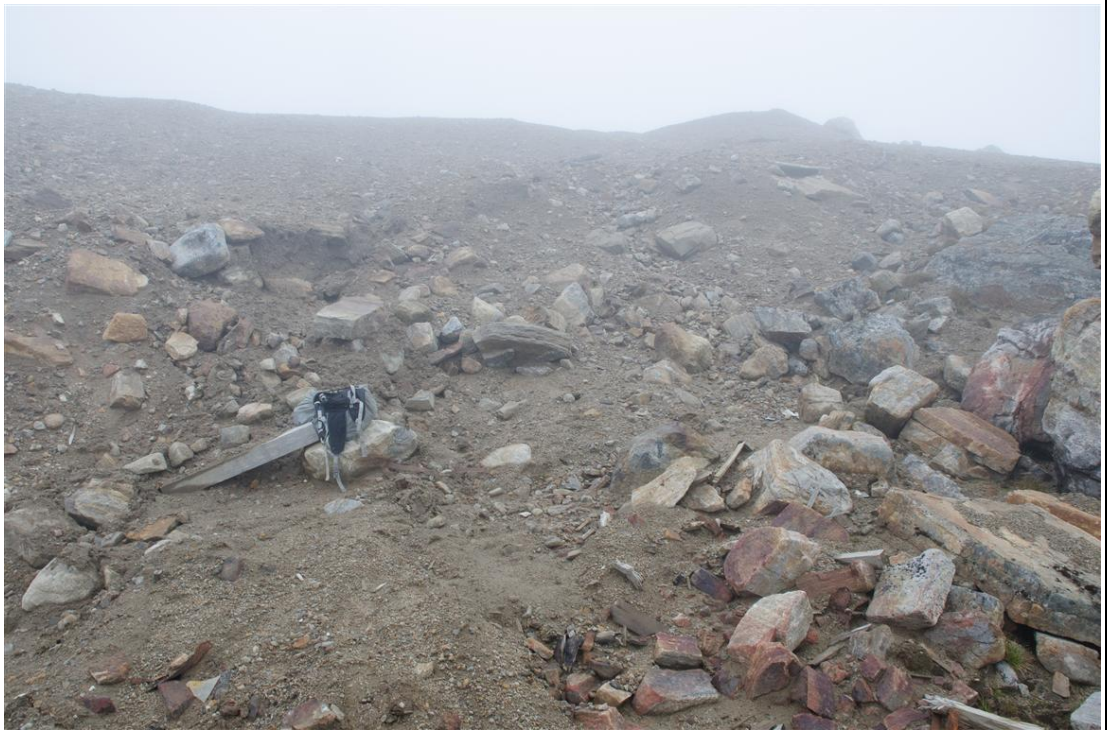
Multiple erosion channels in central section of North Slope Dump (between WP#079 and WP#080)

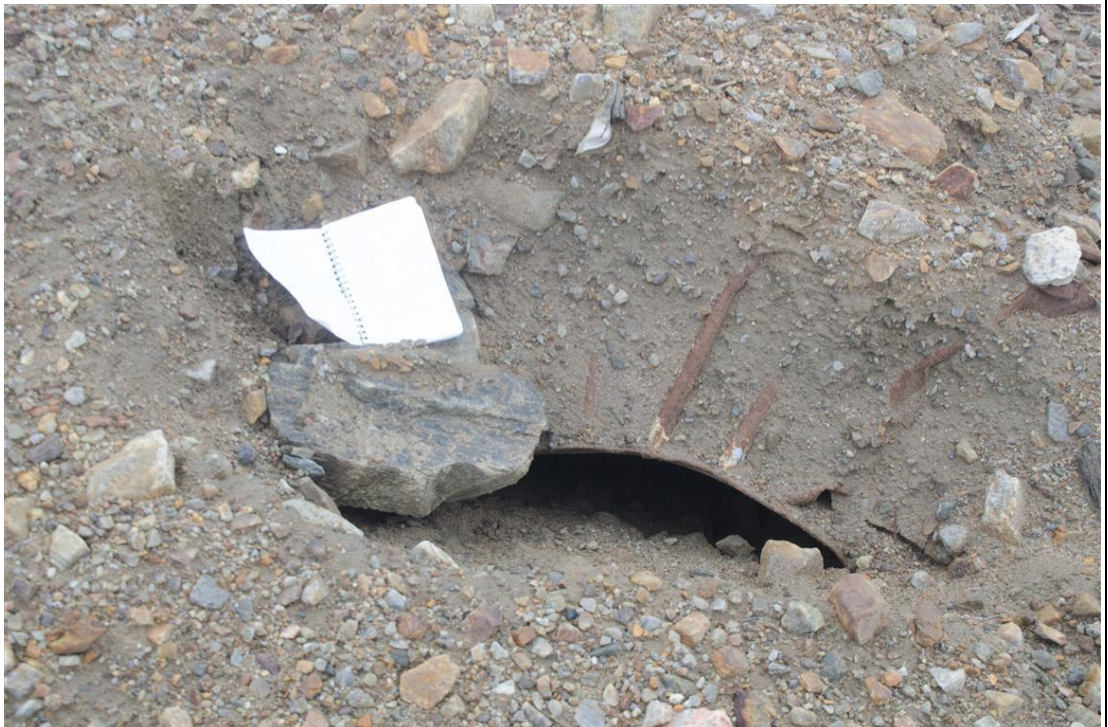
Large sinkhole near boulder on surface of central section of North Slope Dump (WP#084)

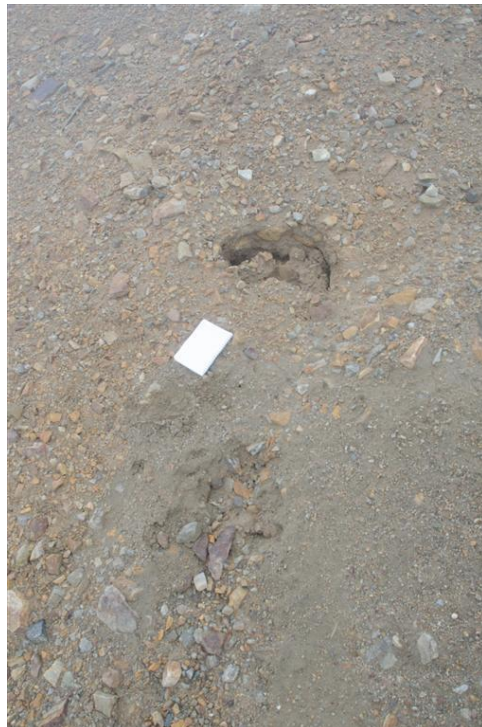
Photo No.
22

Sinkhole in north section
of North Slope Dump
(WP#118)

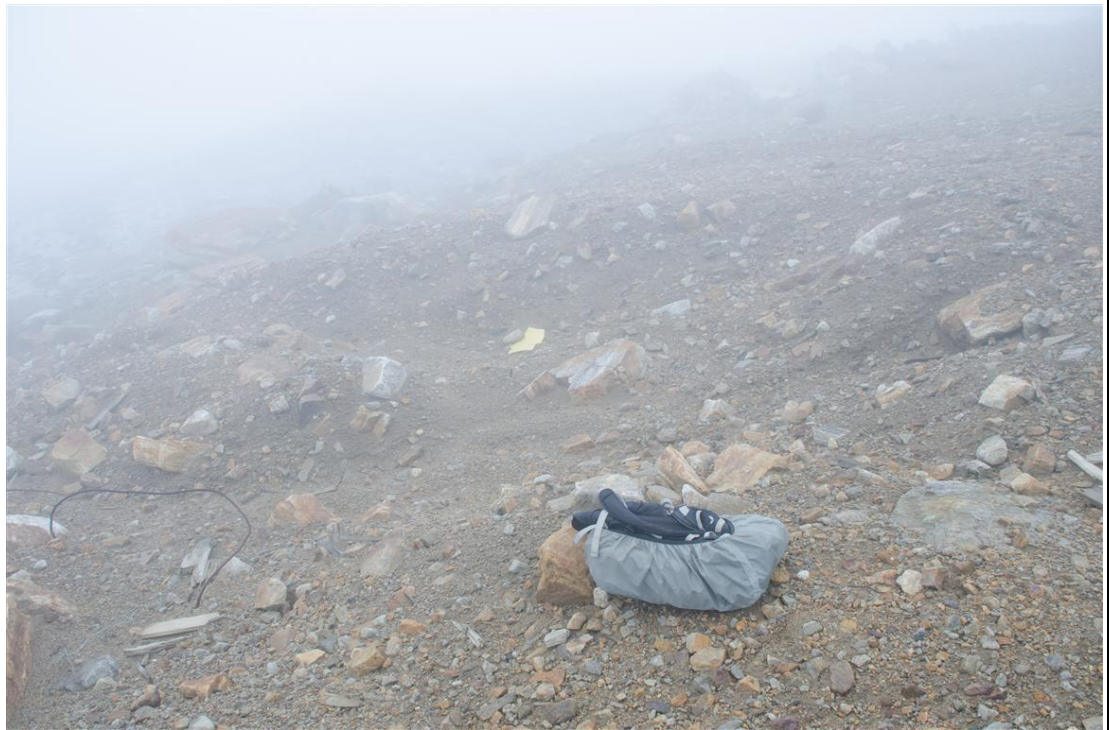
Large settlement area in north section of North Slope Dump (WP#119 to WP#120)

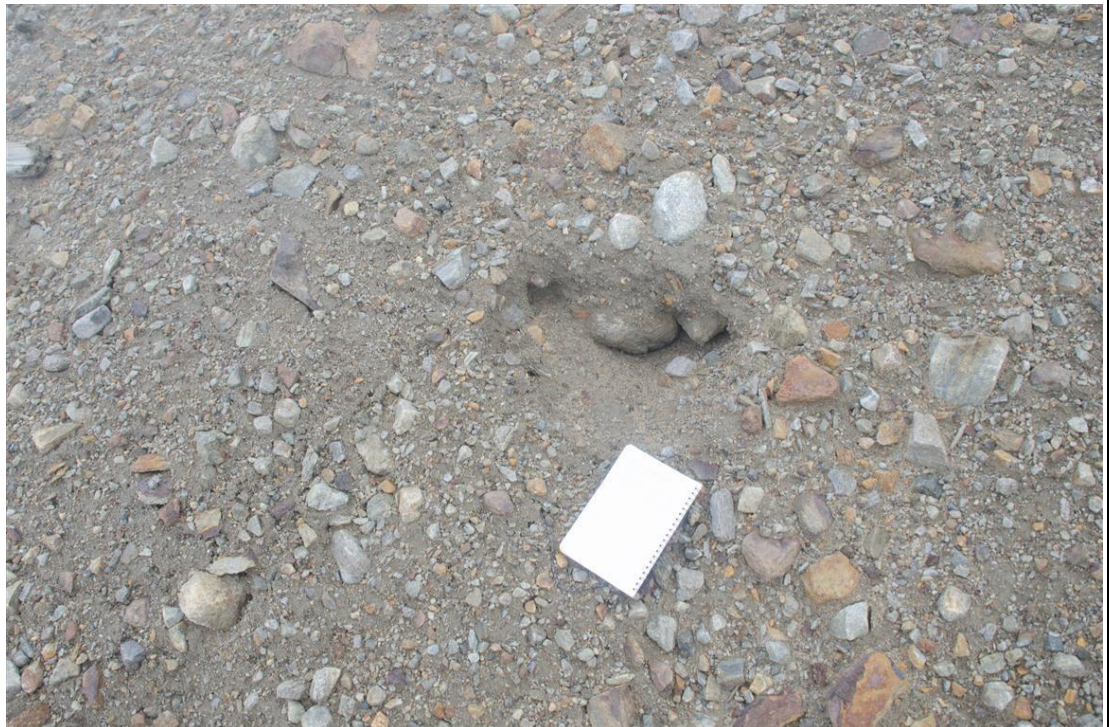
Photo No.
24

Large sinkhole in north section of North Slope Dump (WP#12)

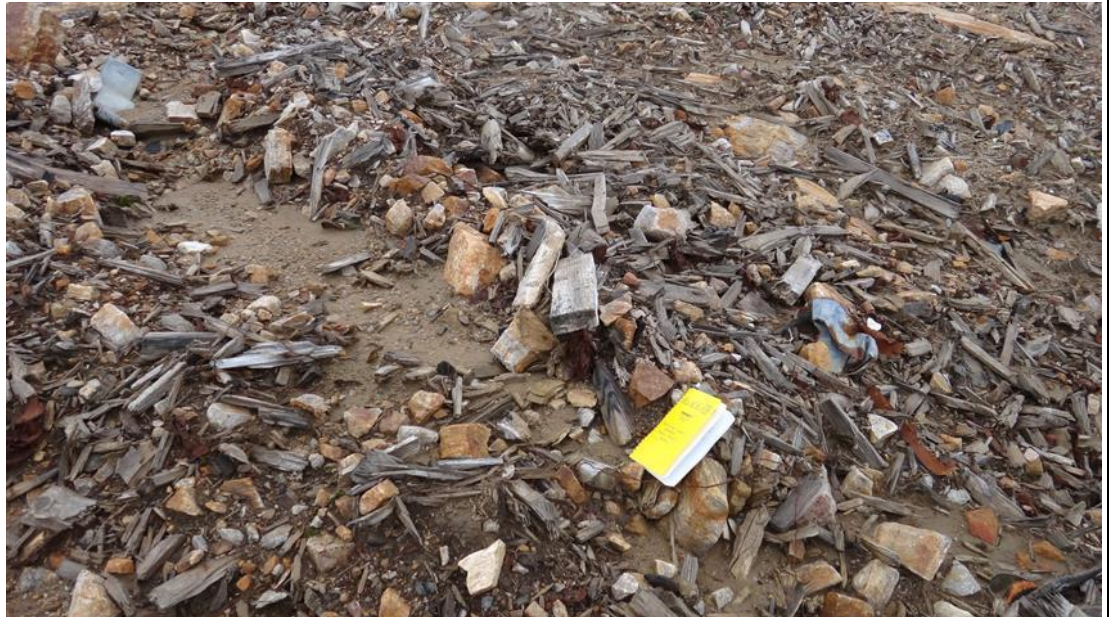
Area of small pieces of wood debris located downslope of central portion of North Slope Dump

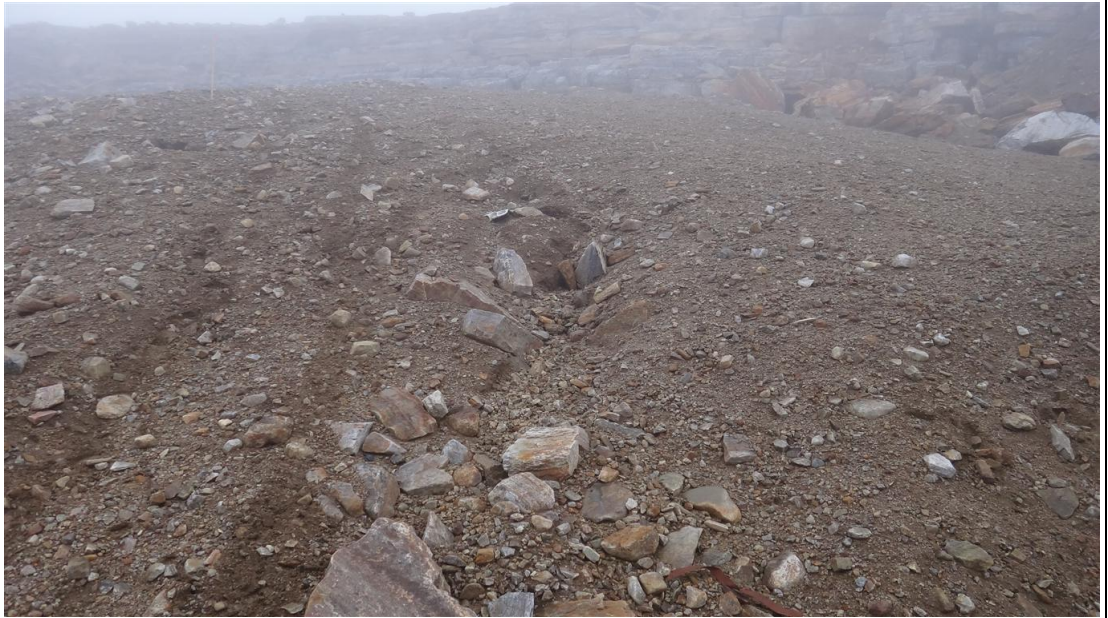
Looking south at erosional feature on "ramp" portion of the SRR Construction Landfill.

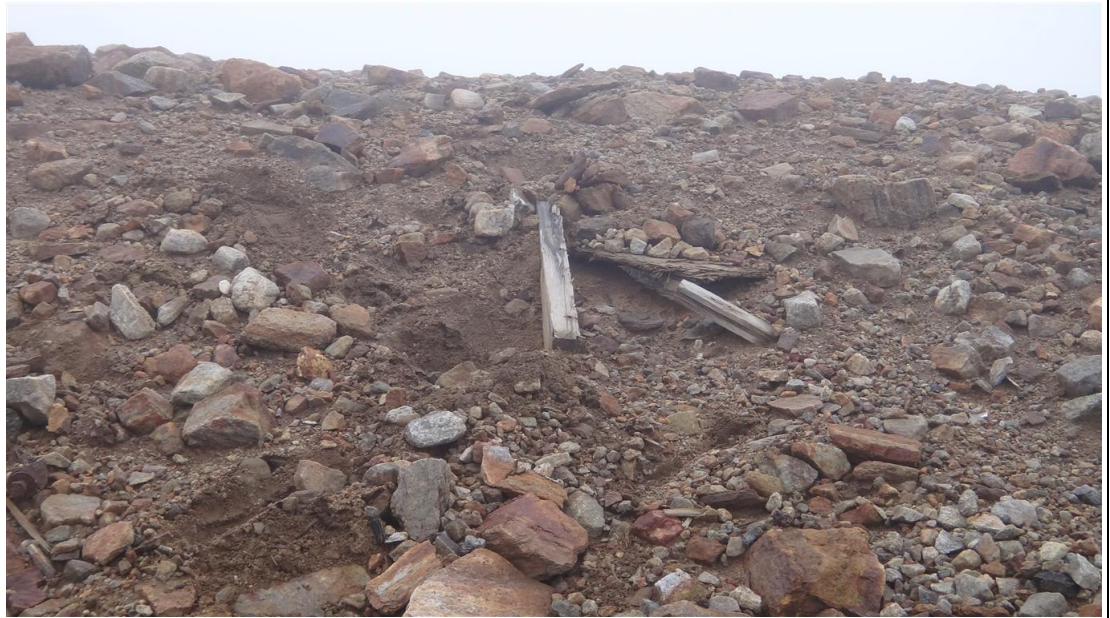
Example of partially buried wood debris in the landfill cover.

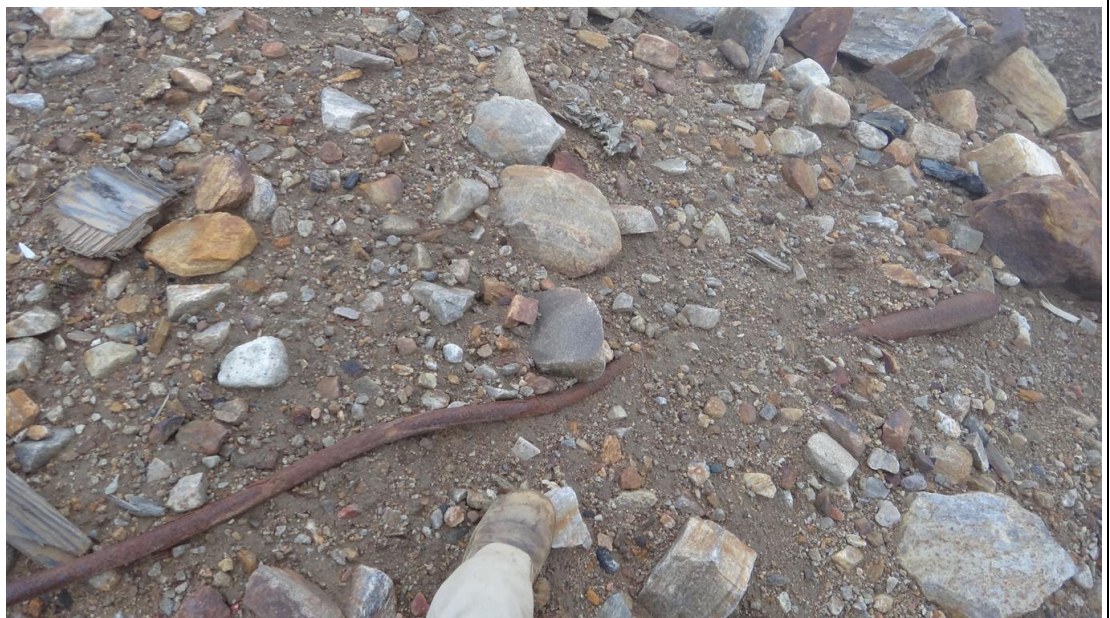
Photo No.
10

Example of partially buried metal debris in the landfill cover.

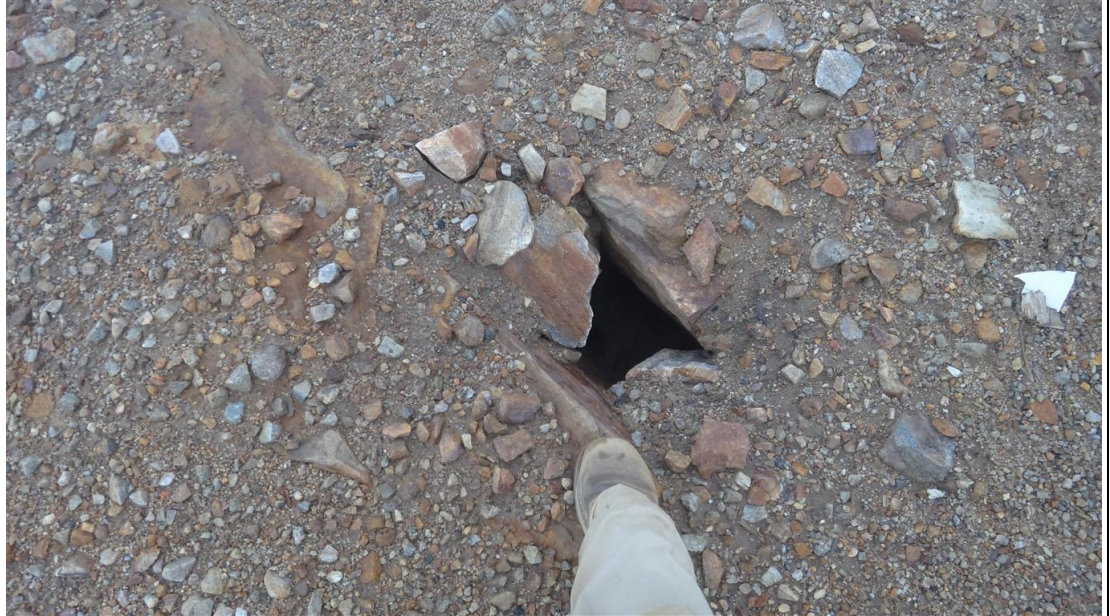
Sinkhole on landfill surface indicates presence of large void spaces due to uncompacted debris

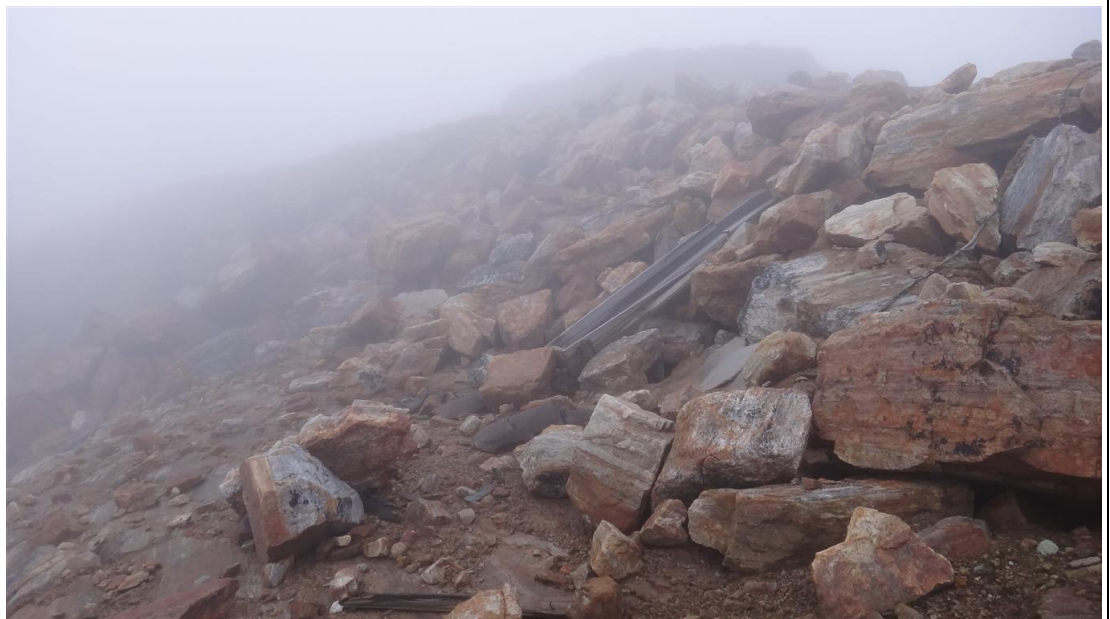
Photo No.
12

Looking east at surficial debris on landfill slope.

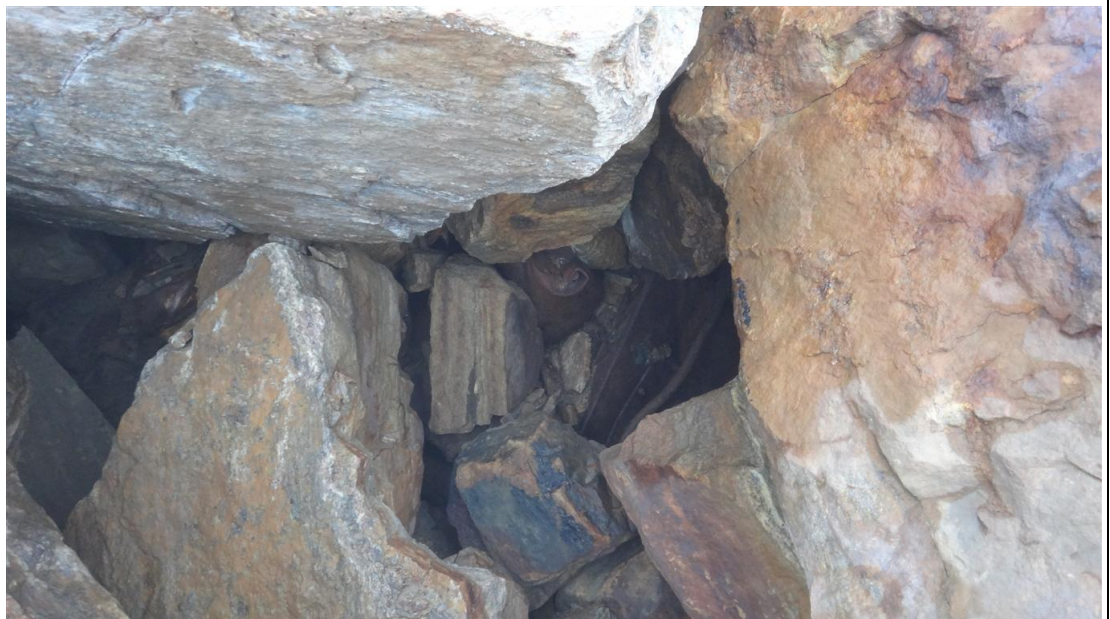
Photo No.
14

Example of void spaces
within the SRR
Construction Landfill.
Large pieces of metal
debris are evident
throughout.

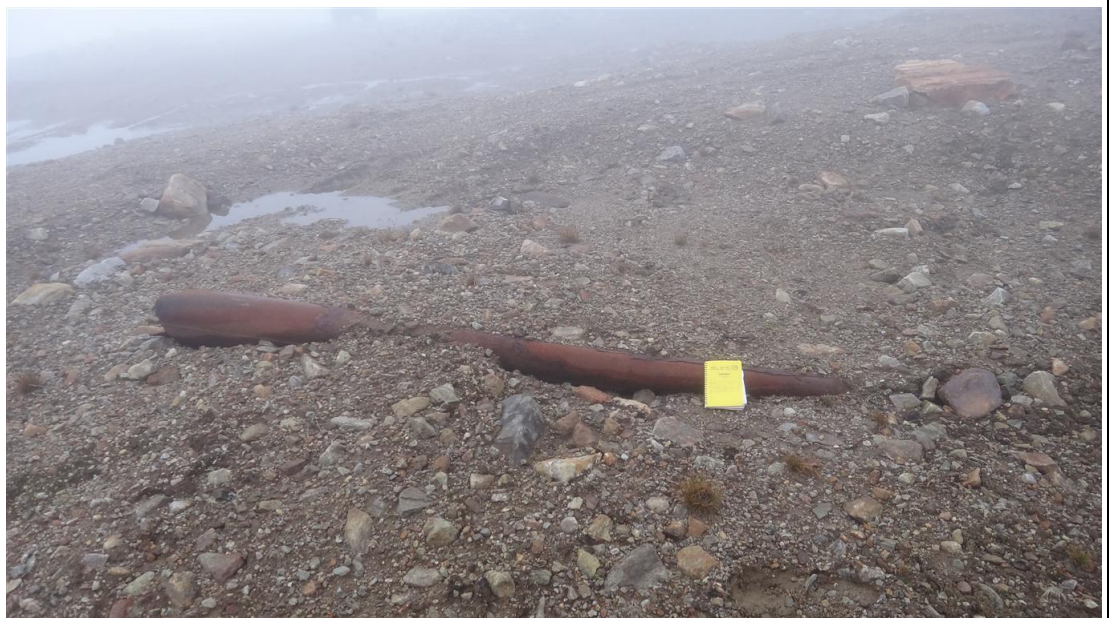
Photo No.
16

Looking east at partially buried pipe near base of landfill slope.

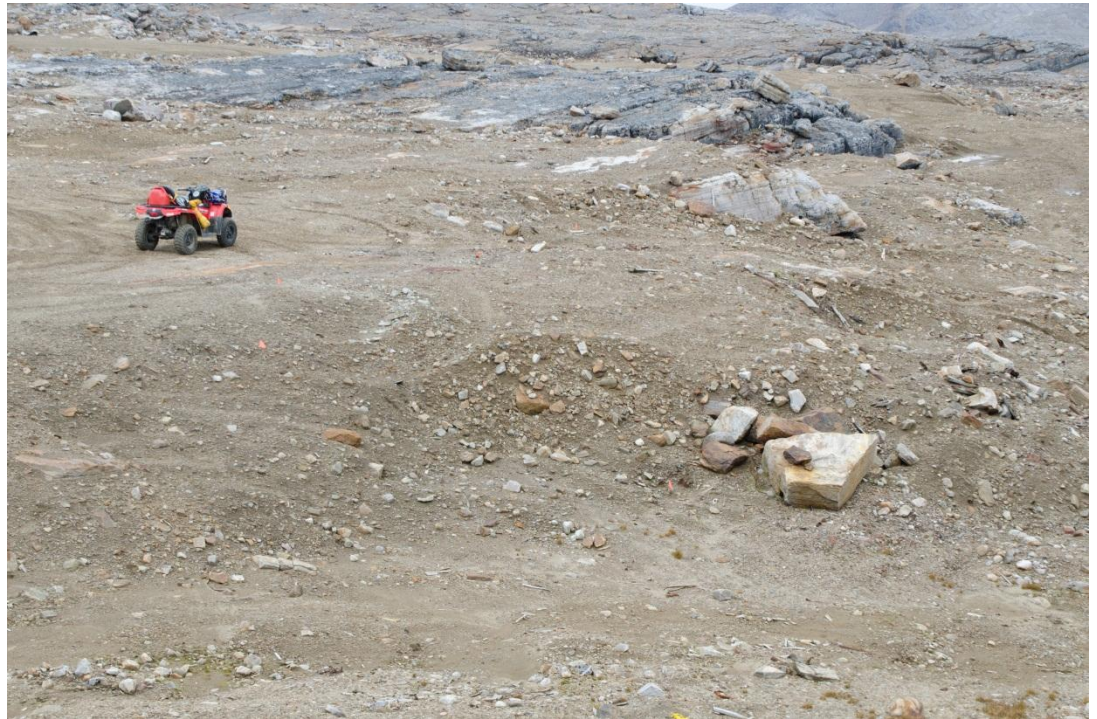
Looking northeast at primary anomaly at the East Lobe of the Maintenance Dump (MD-Upper).

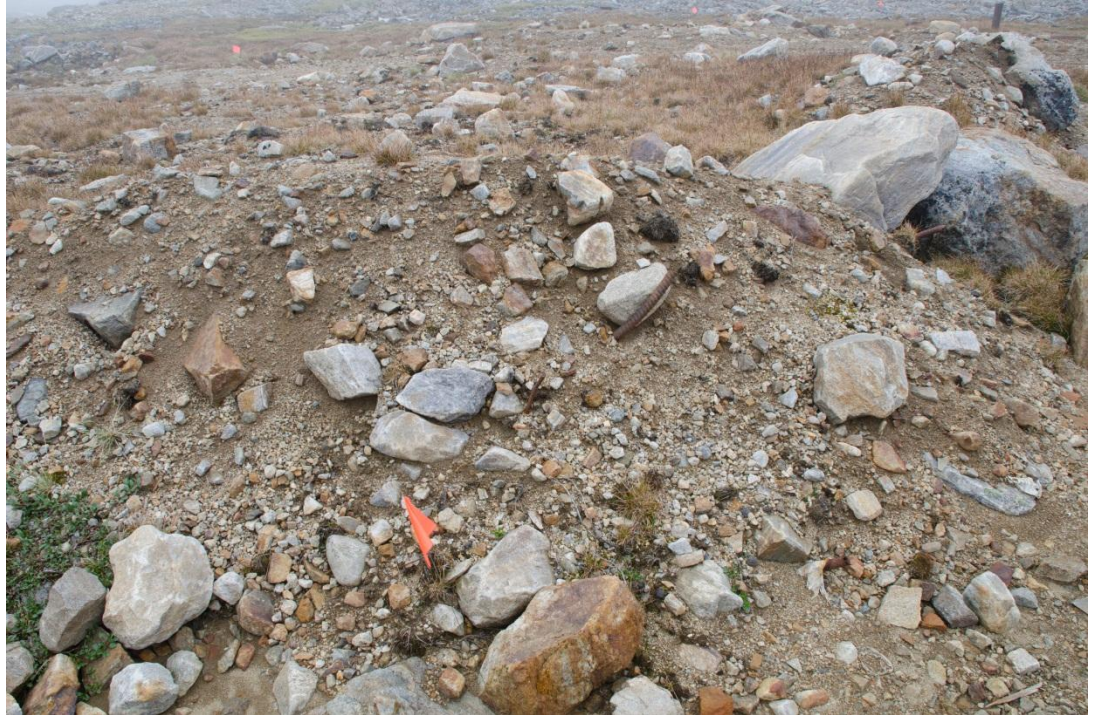
Exposed debris and non-compacted slope of West Lobe.

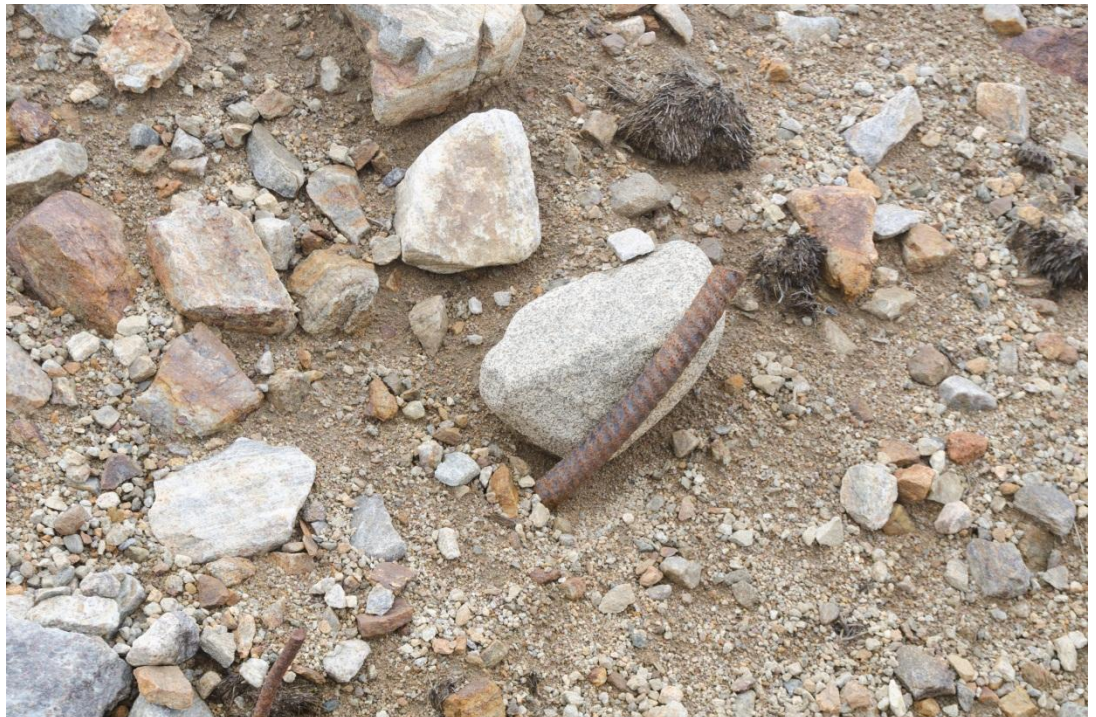
Photo No. 12
Date: 20/08/2013

Exposed debris at the West Lobe.

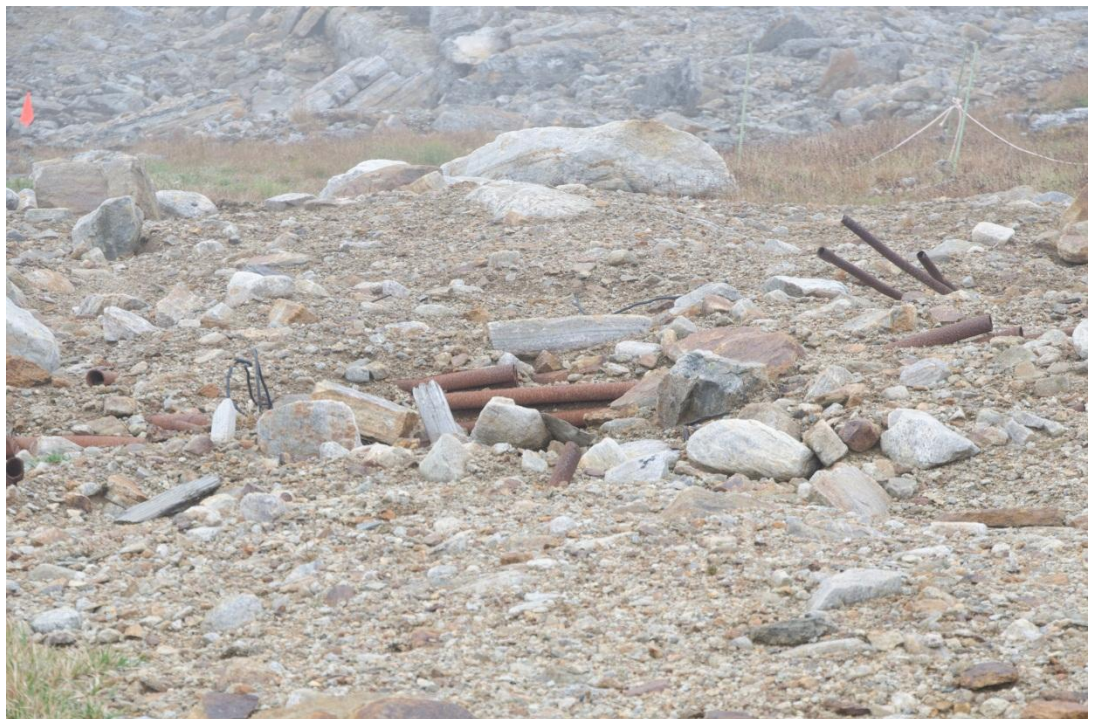
Photo No.
16

Looking north at exposed debris associated with West Lobe of Maintenance Dump, taken from south of West Lobe.
