BAF-5 Resolution Island

Maintenance Assessment Report (AECOM, 2014)

Public Works and Government Services Canada

BAF-5, Resolution Island Maintenance Assessment Report

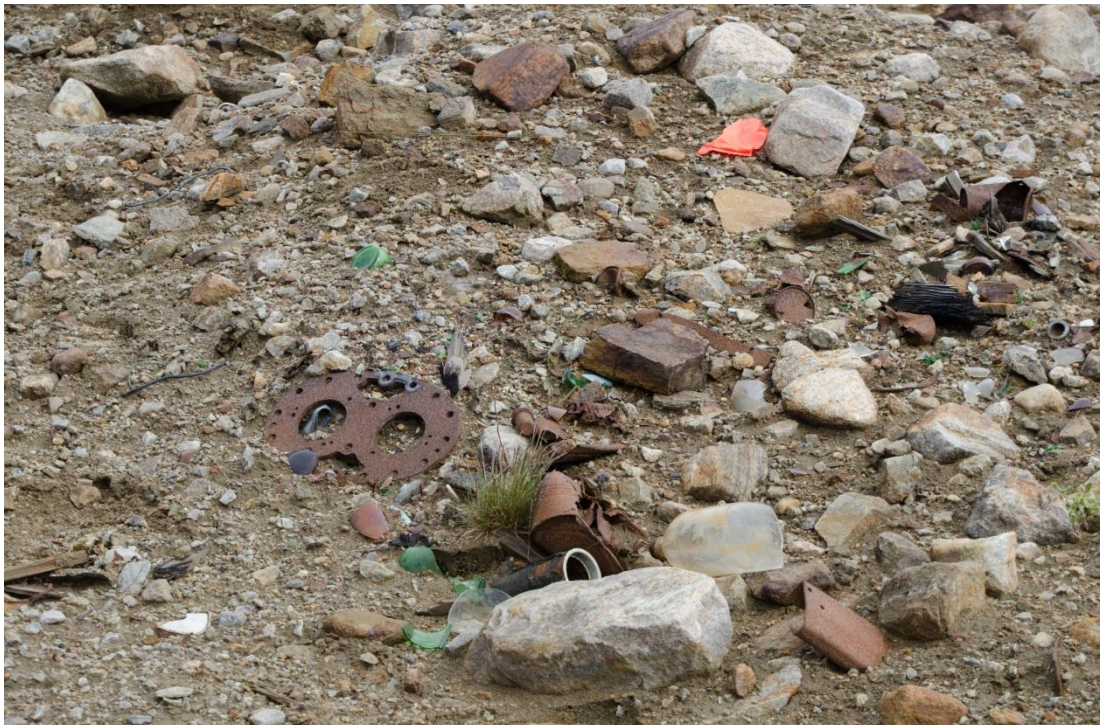
Photo No.
2

Exposed debris on the surface of the south lobe of the Airstrip Landfill.

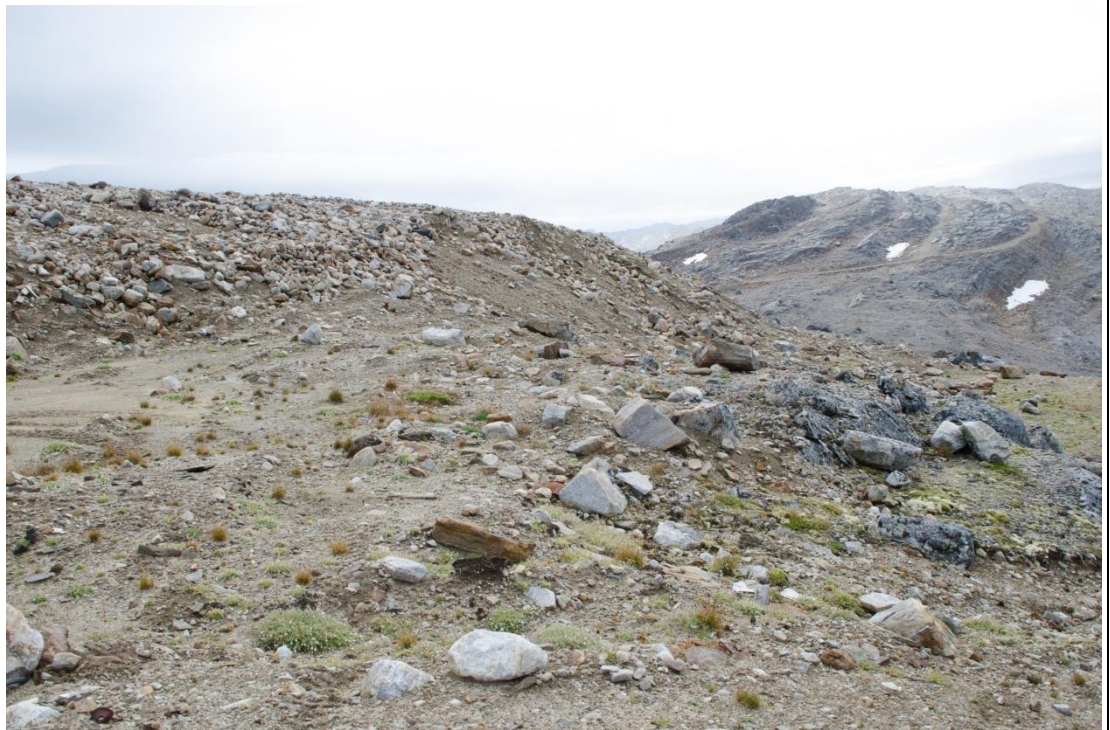
Photo No.
12

Looking west at steep north toe of Airstrip Landfill.

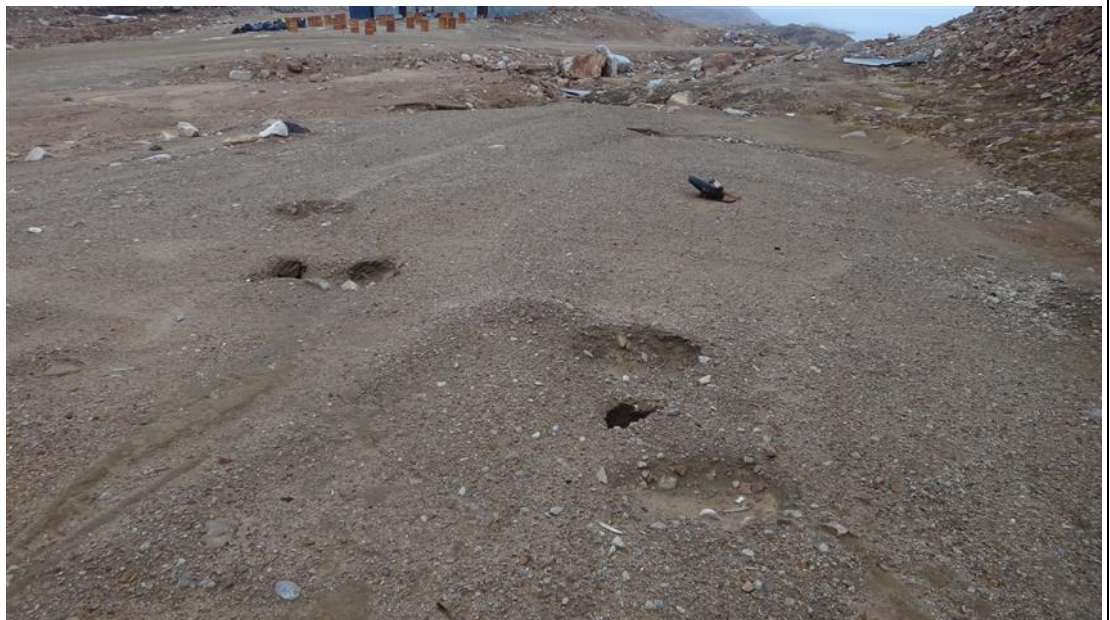
Photo No.
4

Looking east at several sinkholes on the eastern portion of the landfill cap

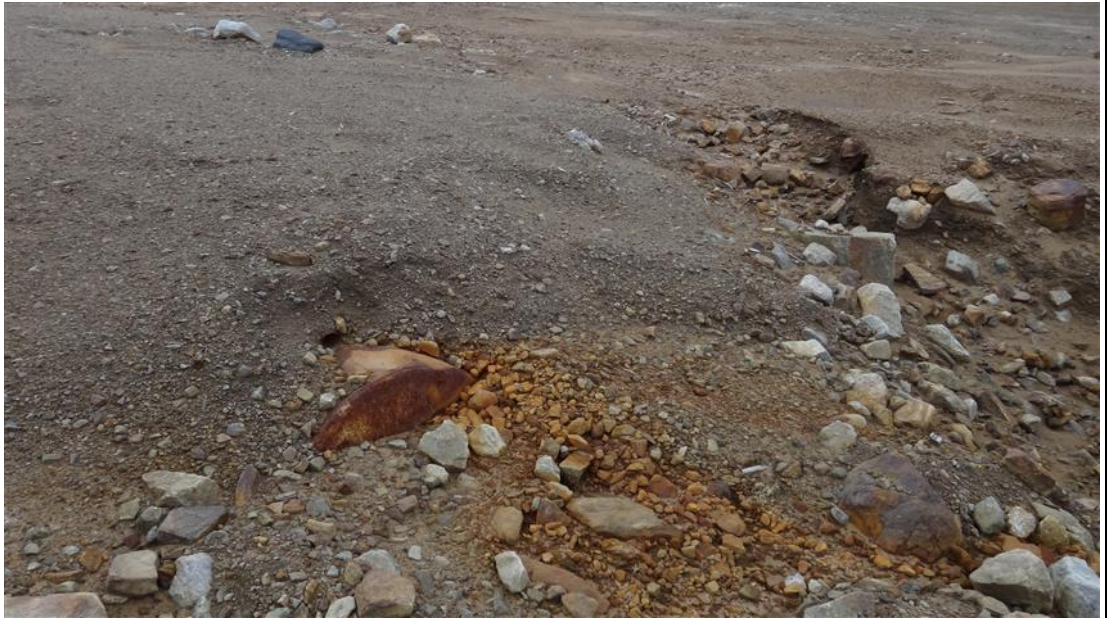
Partially exposed drum
at the eastern toe of the
landfill

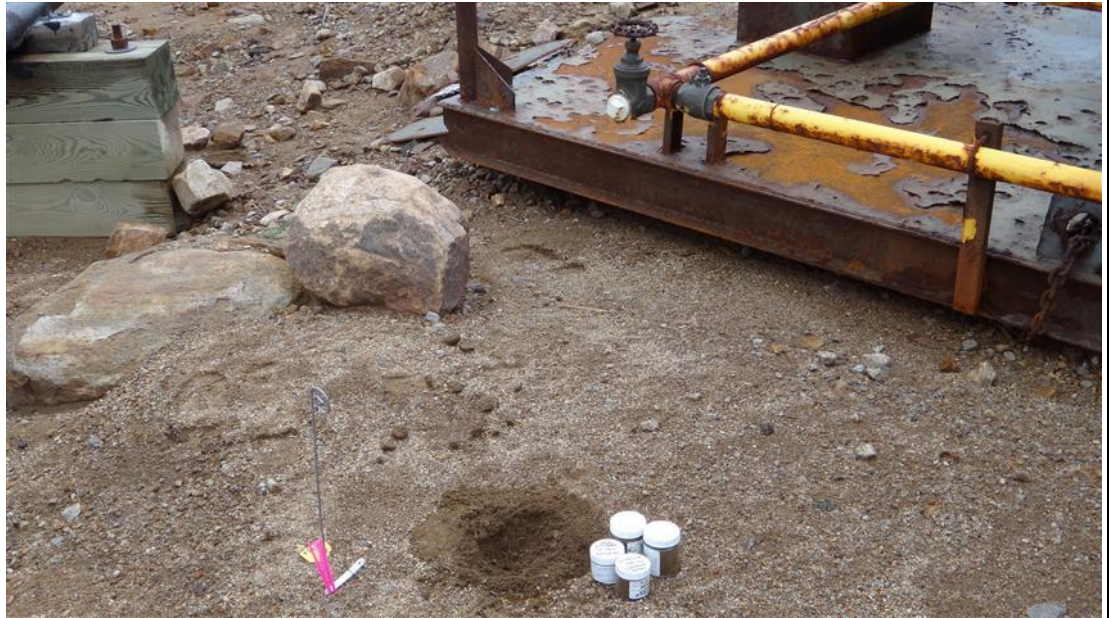
Sample 13-262 collected at same location as ESG sample tag #29704 located near valve on southeast corner of tank #1 (east-most tank).

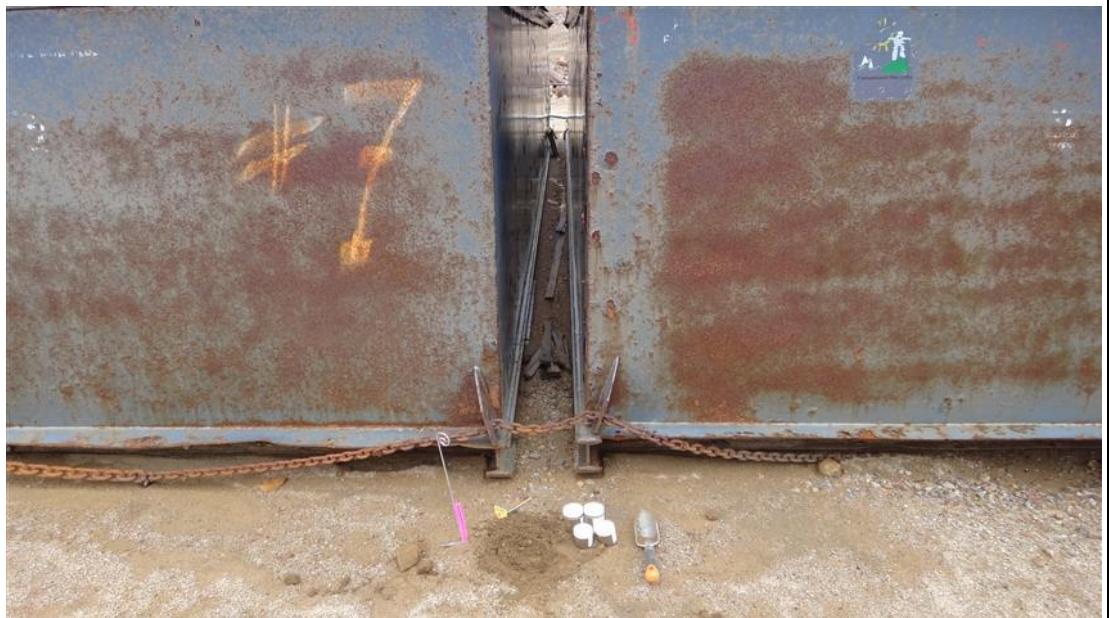
Photo No.
8

Sample 13-263 collected at same location as ESG sample tag #29702 in between tank #7 and tank #8 (west-most tank)

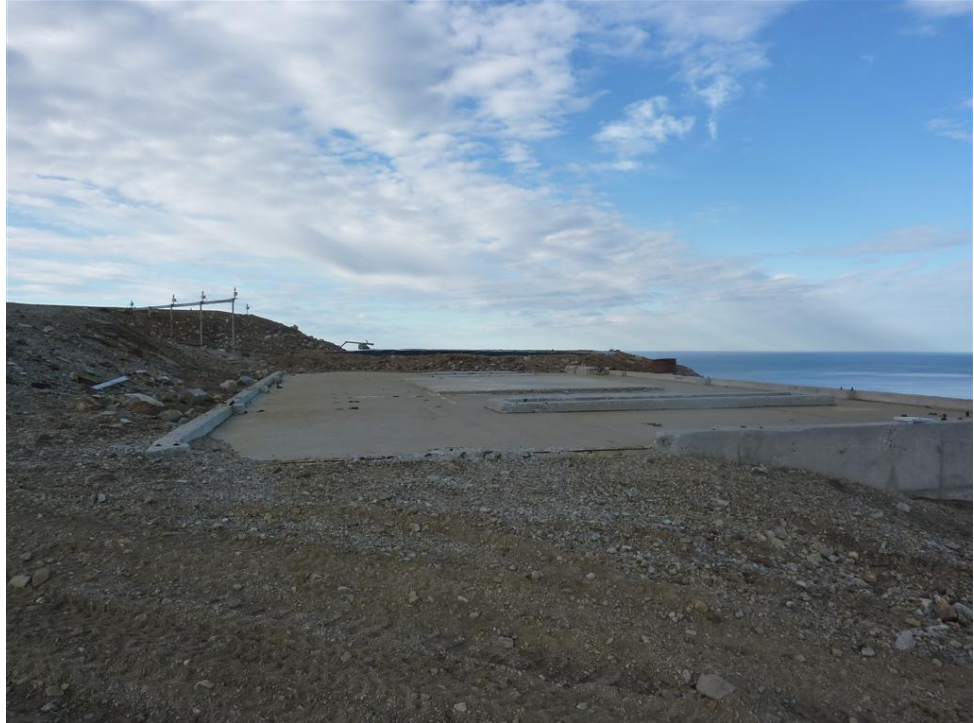
Photo No.
12

Concrete foundation located north of Radome Building (RD3).

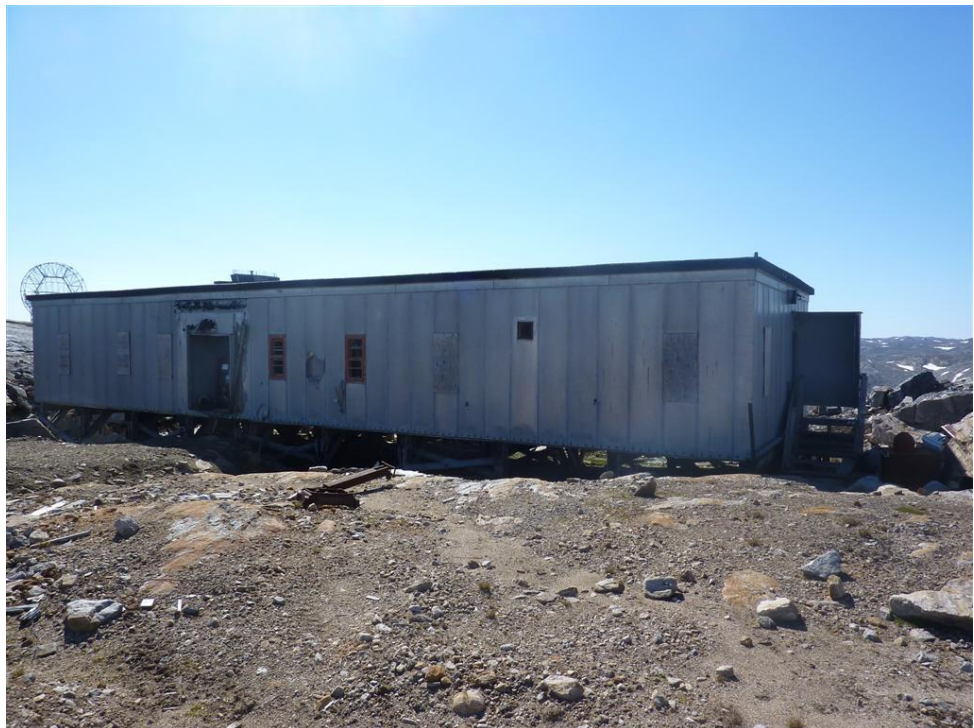
Looking west at building S9 of the Officer's Quarters and Mess.

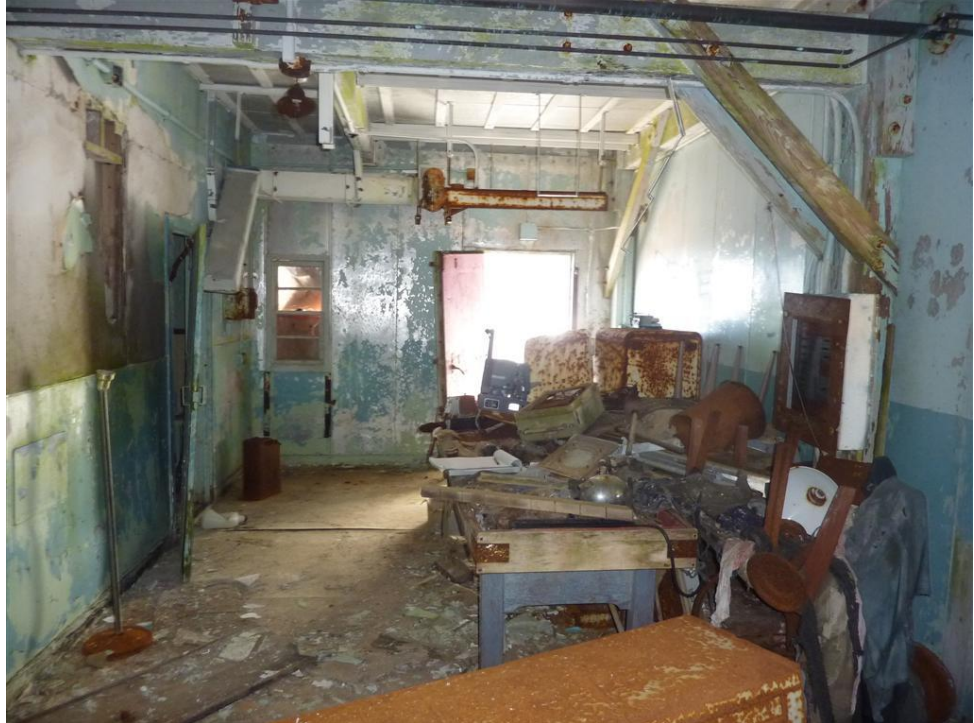
Photo No.
14

Interior of building S9.

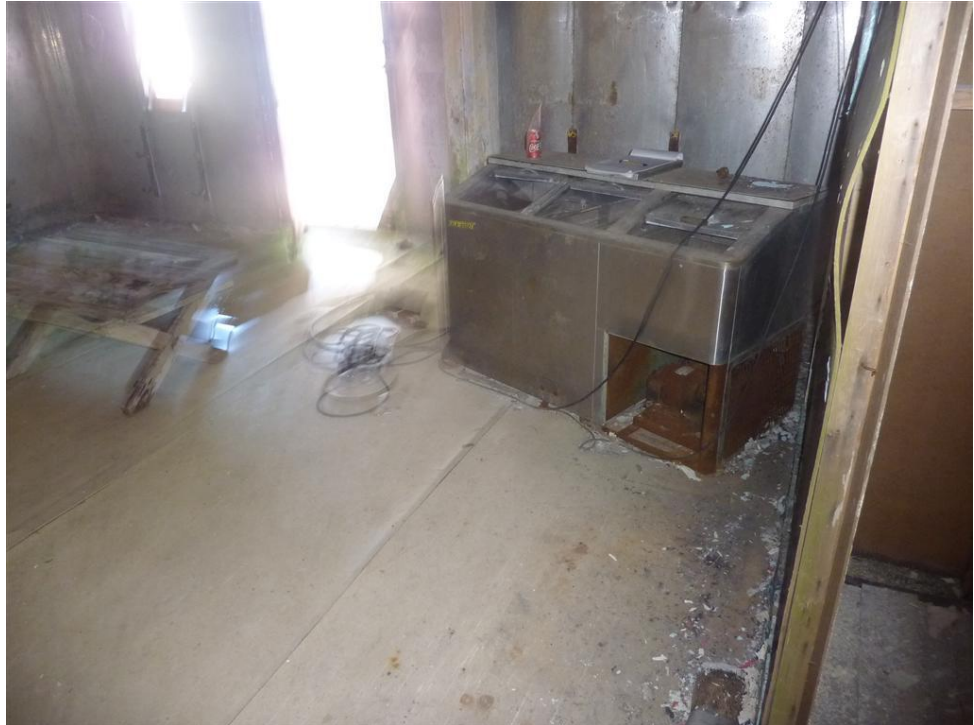
Photo No.
16

Interior of building S9.

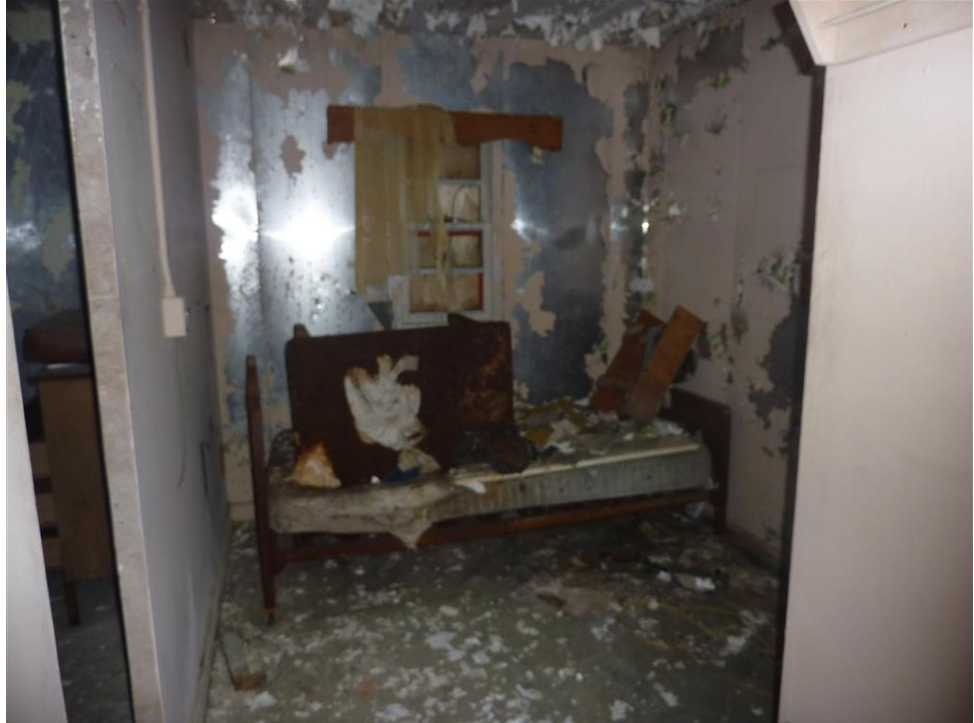
Photo No.
20

Interior of building S10.

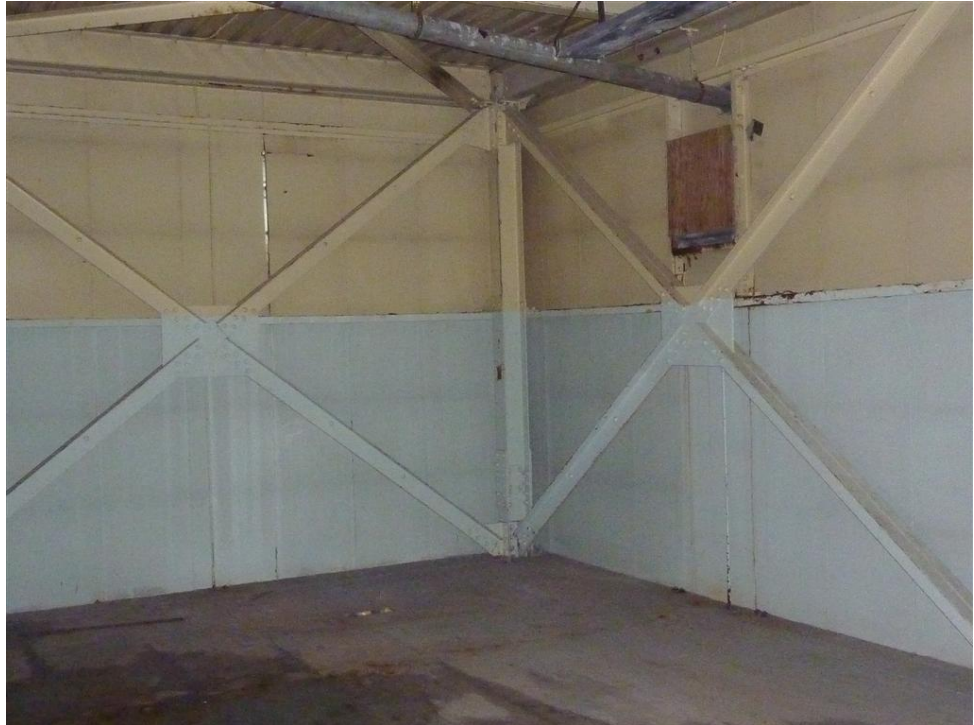
Photo No.
22

Interior of the Radome Building (RD3).

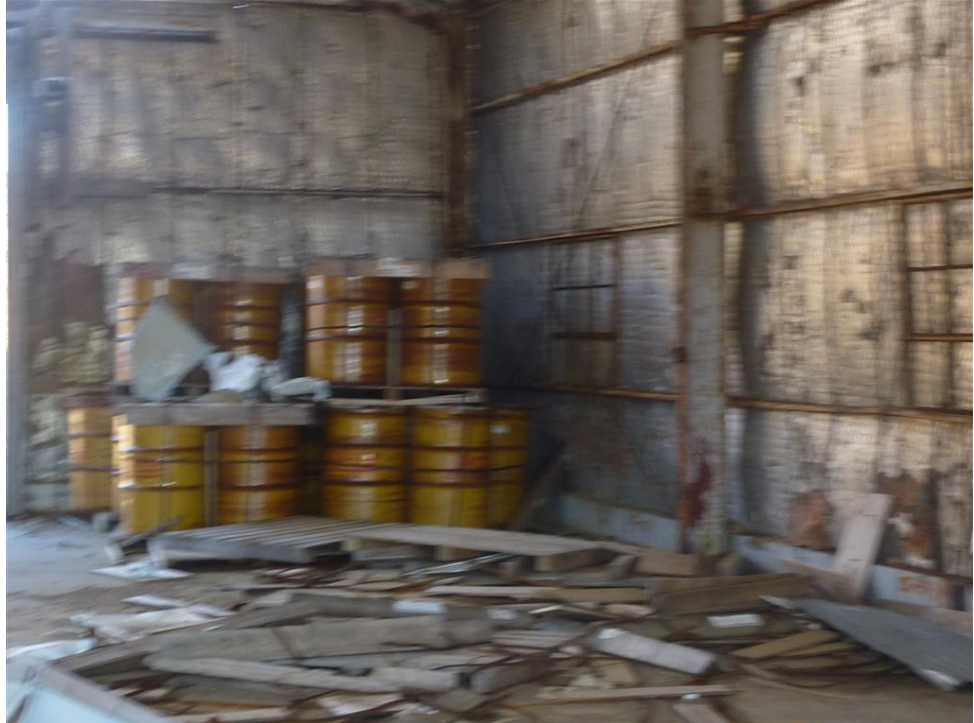
Photo No.
32

Empty drums stored on pallets in the southeast corner of the Beach Warehouse (B2).

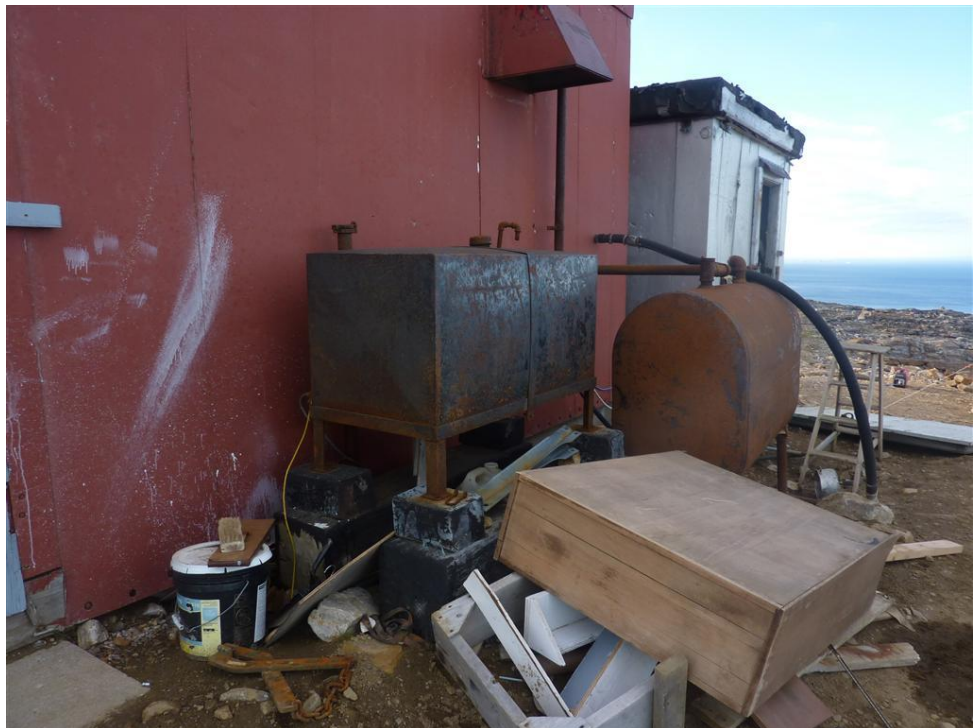
Fuel tanks located
adjacent to east side of
Monitoring Camp (S20).

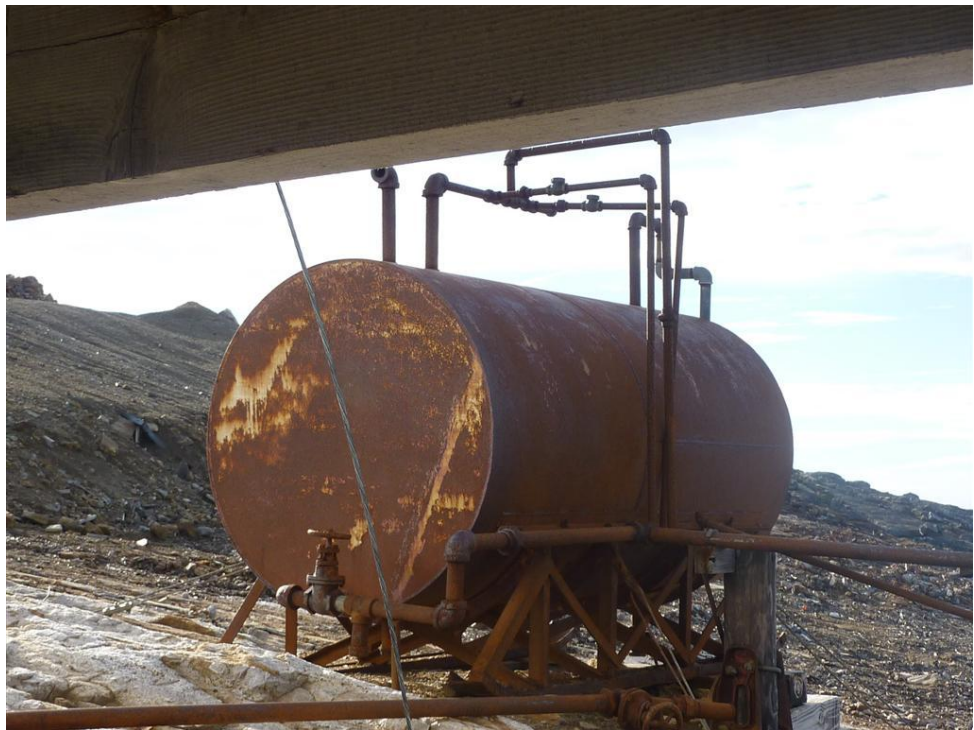
Looking northwest at
fuel tank near Building
N10. North Slope Dump
visible in background.

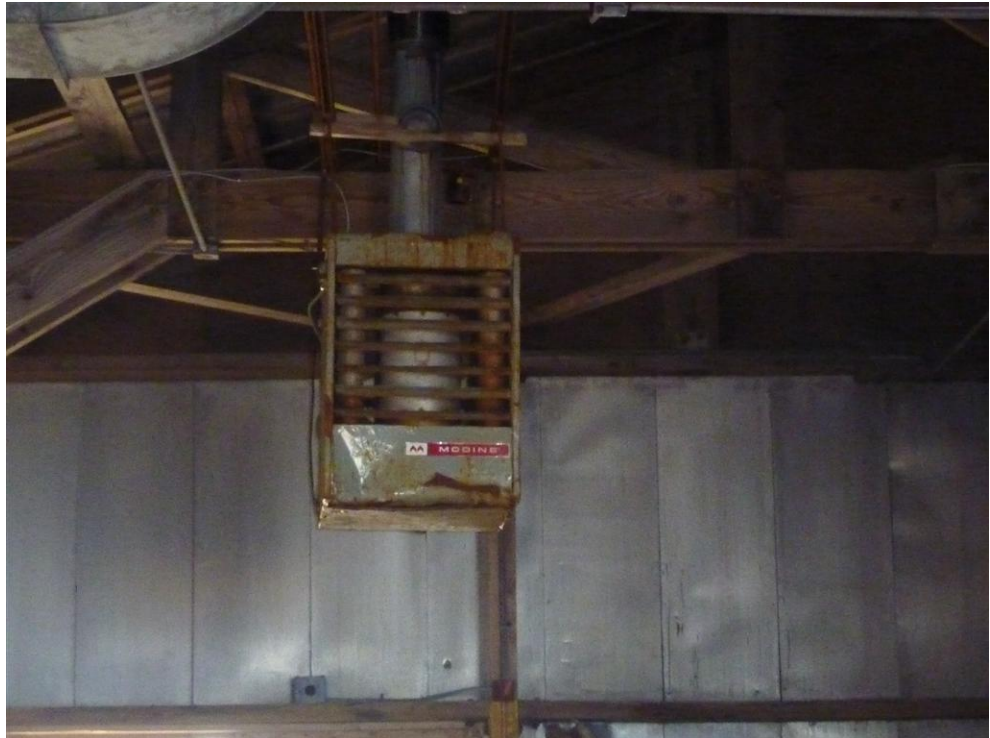
Photo No.
50

Overhead furnace unit in
Garage Building (S18).

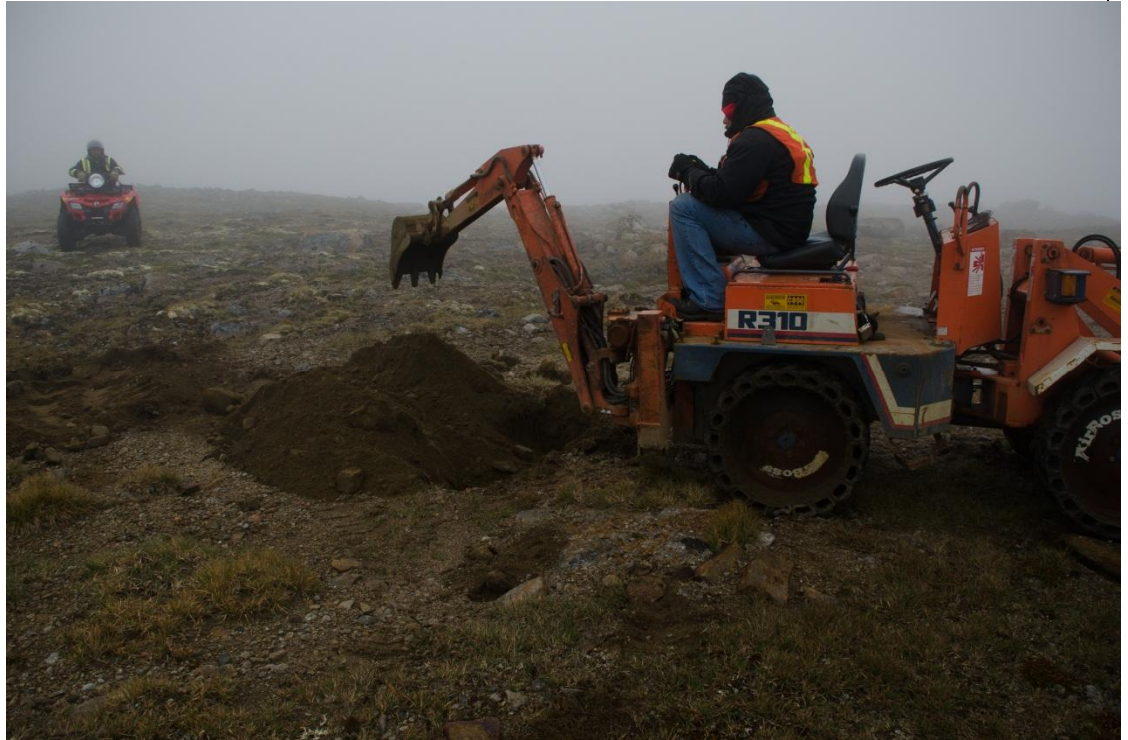
Lower Airstrip Borrow
Area 4 – Testpitting at
Lower Airstrip Borrow
Area 3.

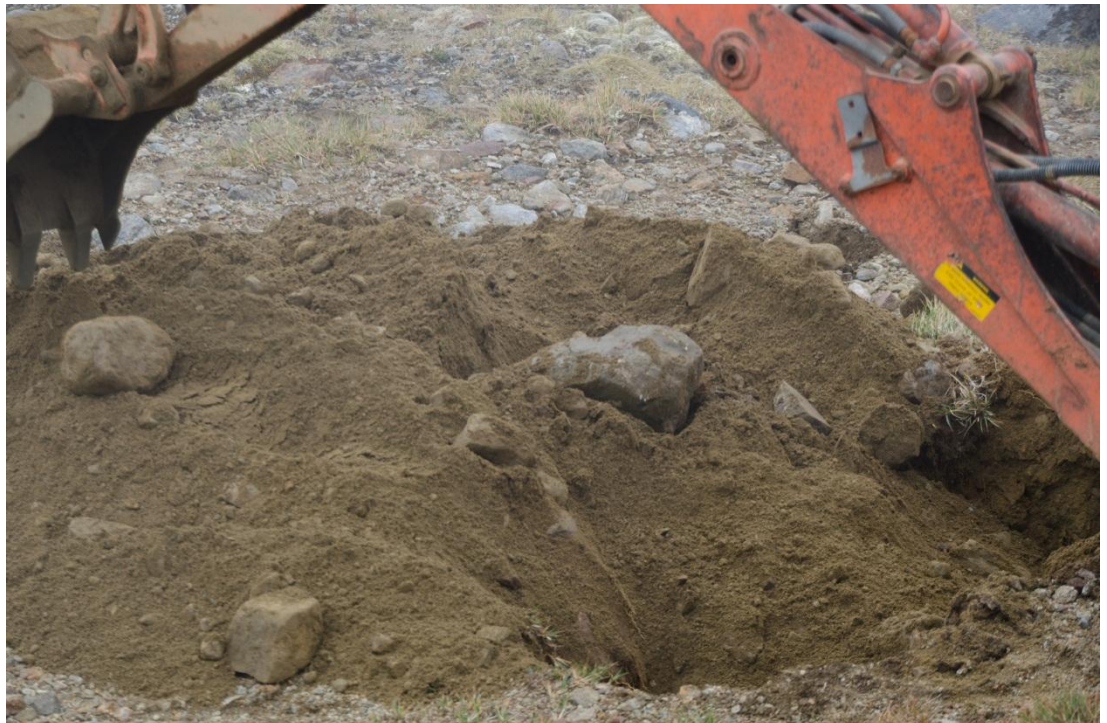
Photo No.
2

Lower Airstrip Borrow
Area 4 – Example of
granular material
investigated at Lower
Airstrip Borrow Area 4
(TP13-13).

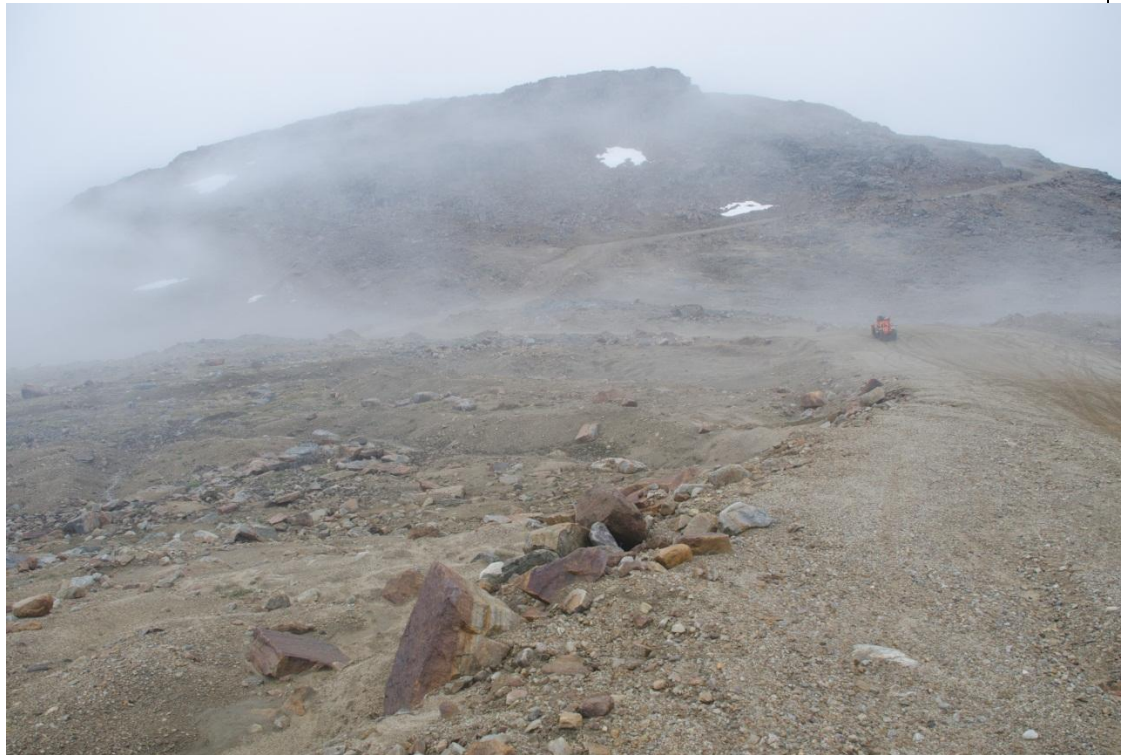
Lower Airstrip Borrow Area 4 – Overview of Lower Airstrip Borrow Area 4, looking west. Photo taken from the northeast corner of borrow area, on the road

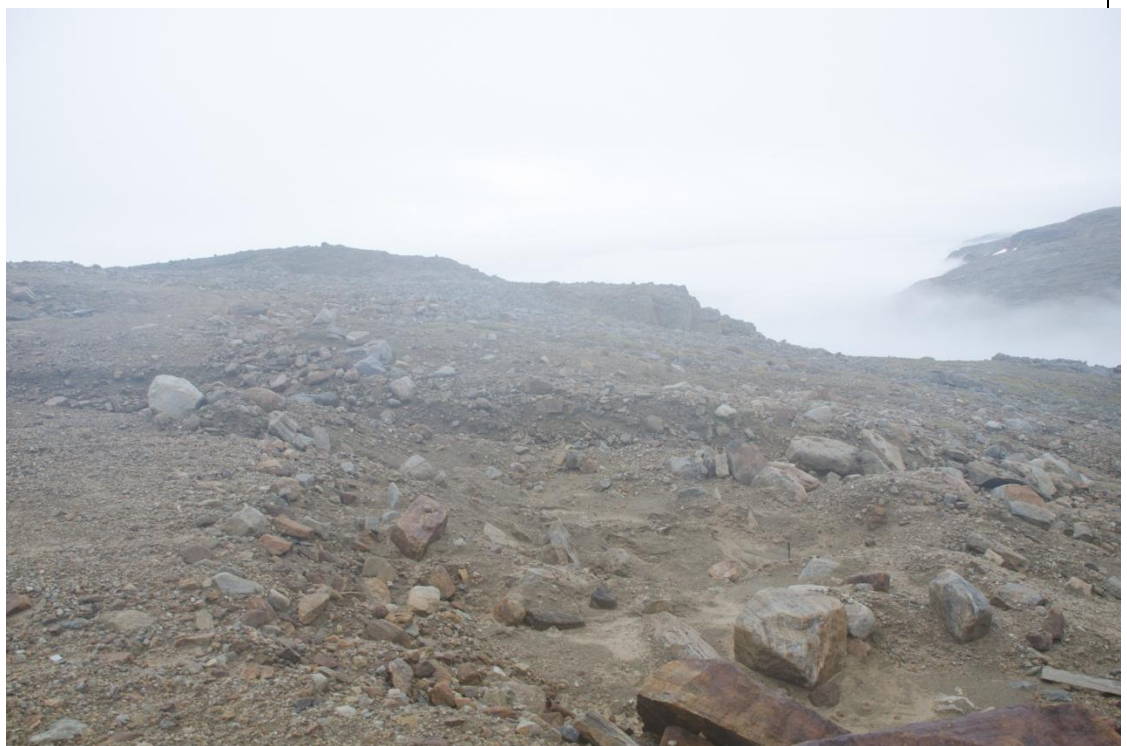
Photo No.
4

Lower Airstrip Borrow Area 4 – Overview of Lower Airstrip Borrow Area 4, looking south. Photo taken from the northeast corner of borrow area, on the road.

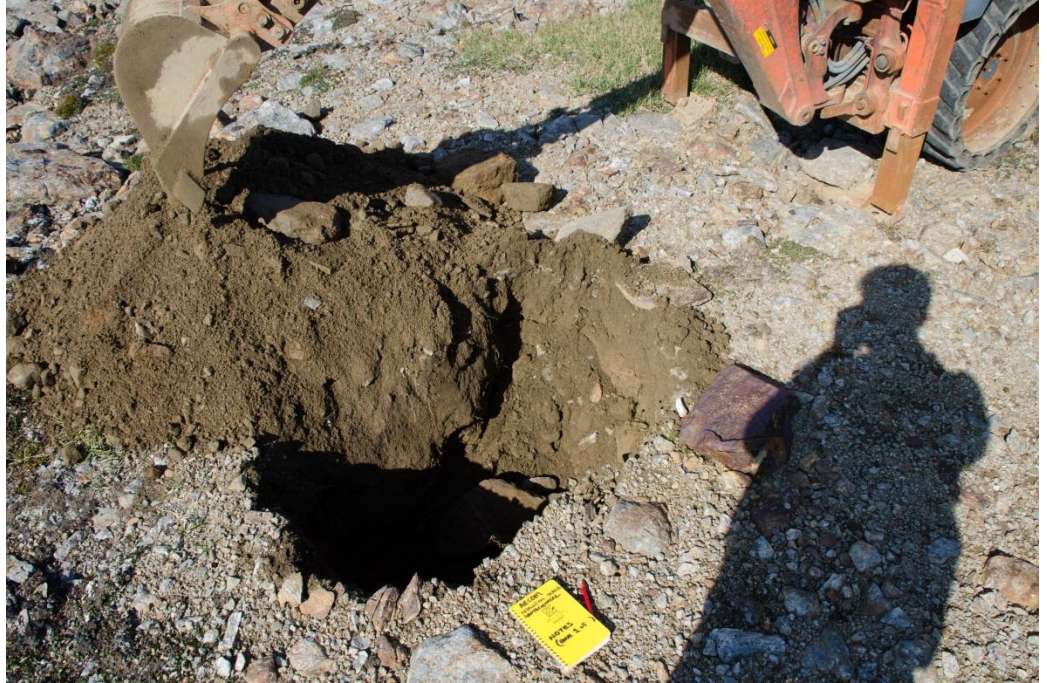
Lower Airstrip Borrow
Area 3 – Example of
material encountered in
Lower Airstrip Borrow
Area 3

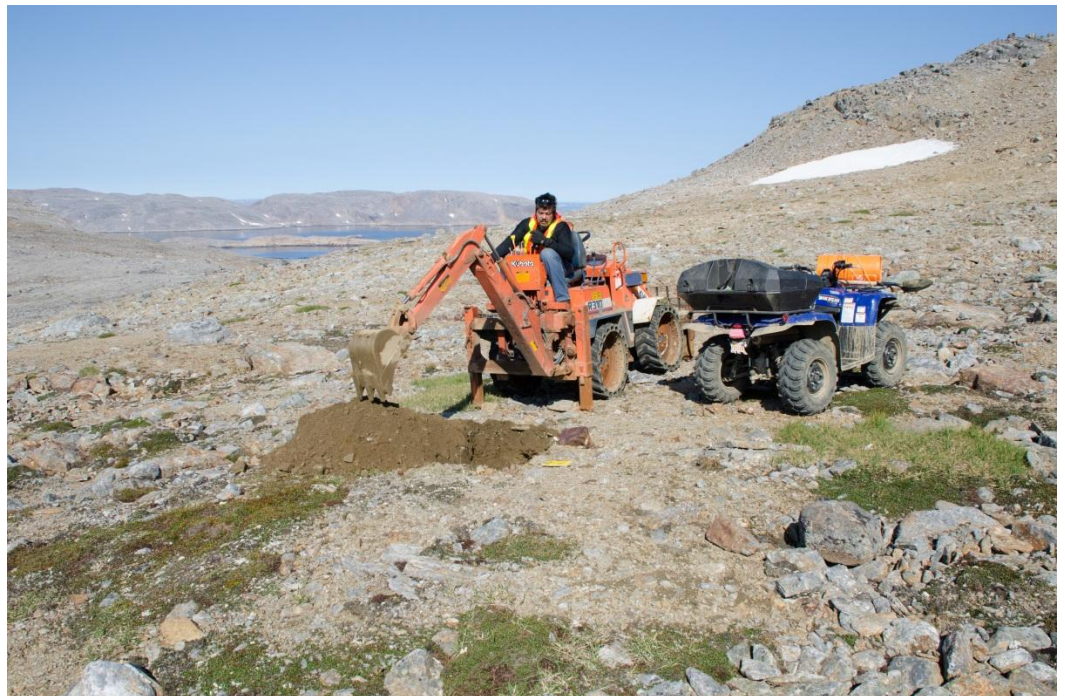
Photo No.
18

Lower Airstrip Borrow
Area 3 – Testpitting in
Lower Airstrip Borrow
Area 3

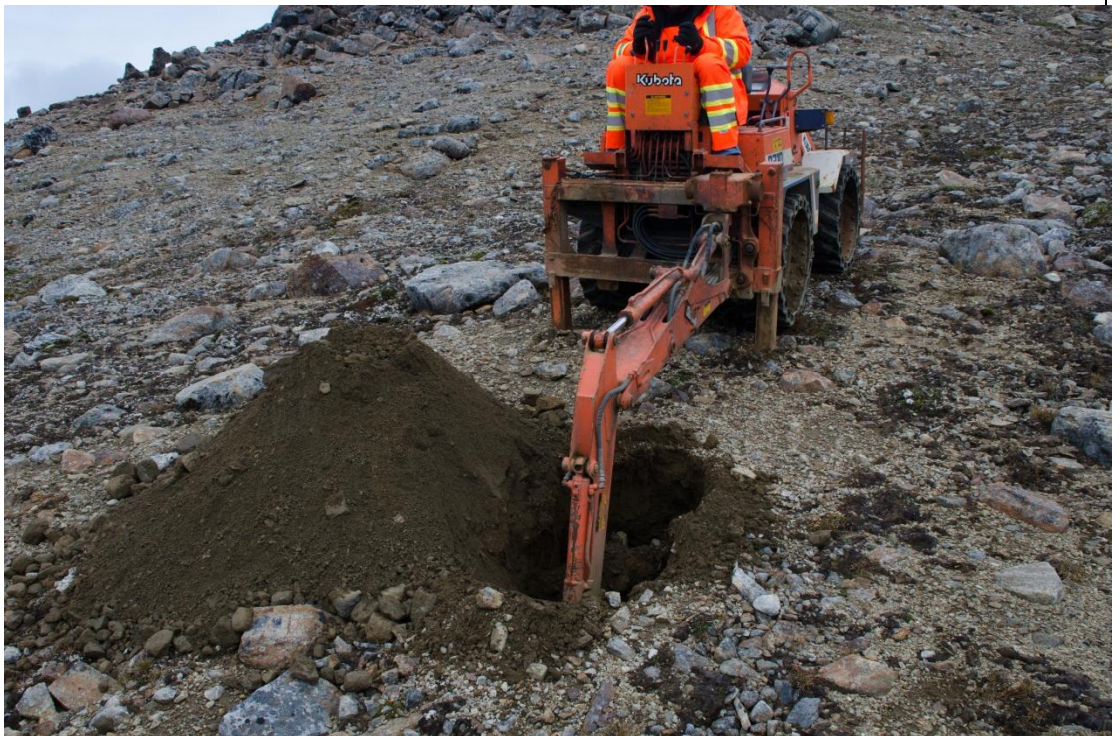
Photo No.
26

Lower Airstrip Borrow Area 5 – Testpitting in borrow area (TP13-18).

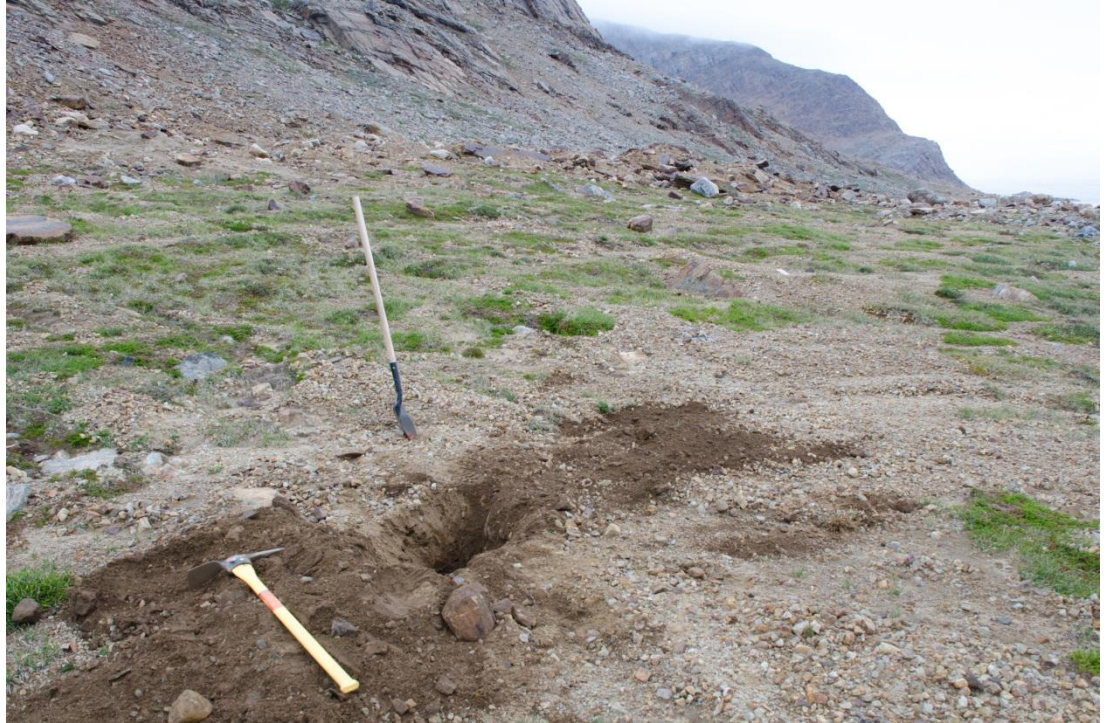
Upper Beach Borrow Area – Testpitting in Upper Beach Borrow Area. Photo taken looking east.

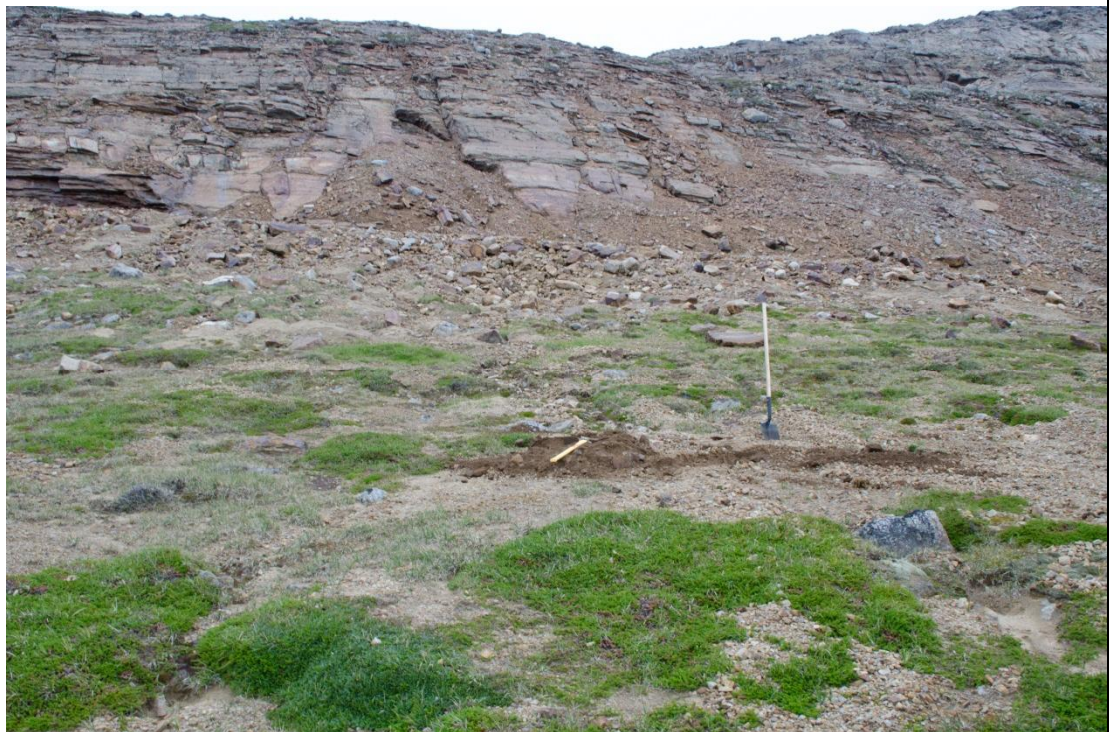
Photo No.
28

Upper Beach Borrow Area – Testpitting in Upper Beach Borrow Area. Photo taken looking north.

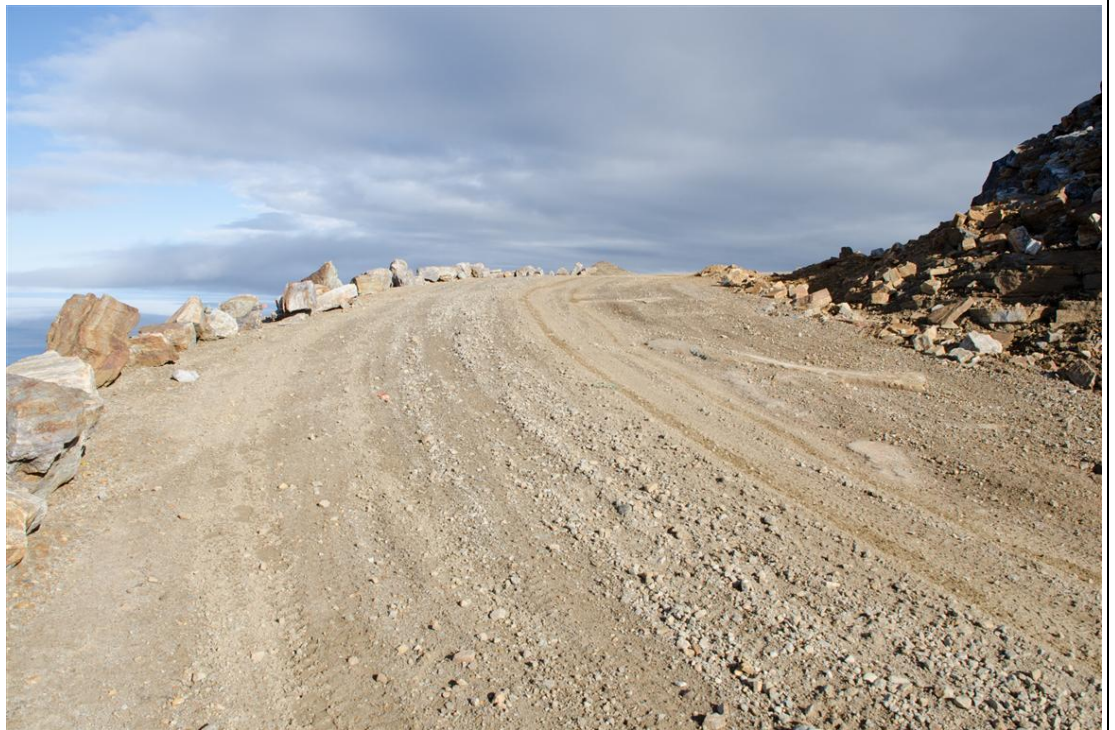
Road Section 1: Looking northeast at exposed bedrock on road between Station Area and Maintenance Area.

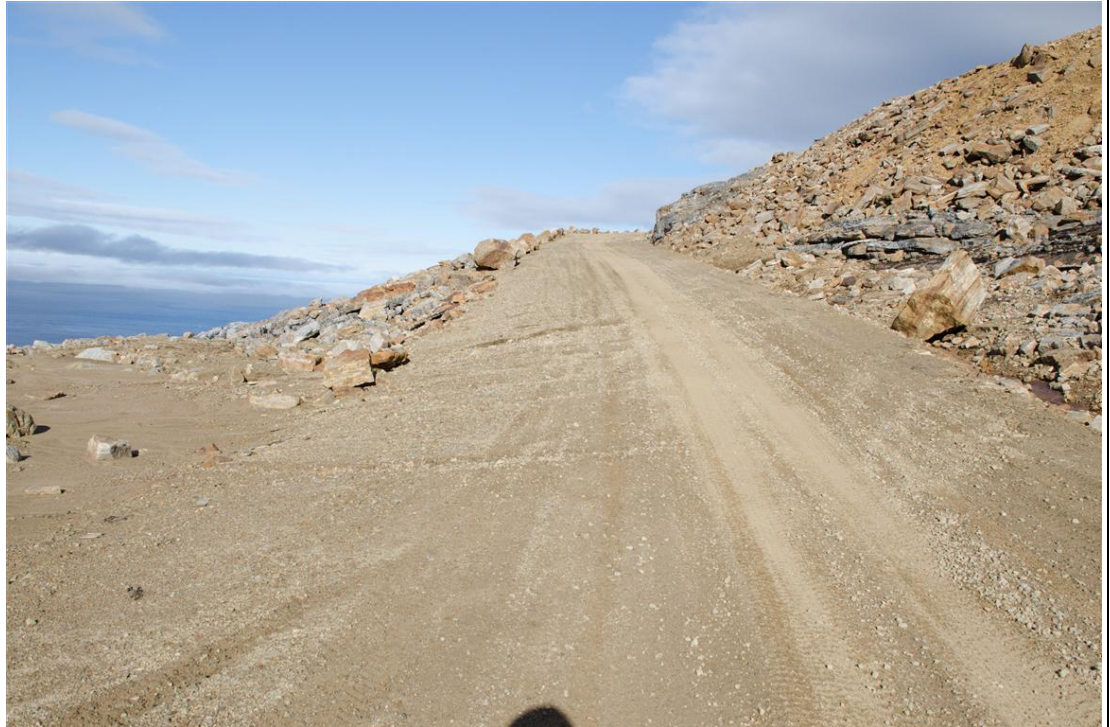
Road Section 1:
Example of minor
drainage channels on
the section of road
between the Station
Area and Maintenance
Area. Photo taken
looking east.

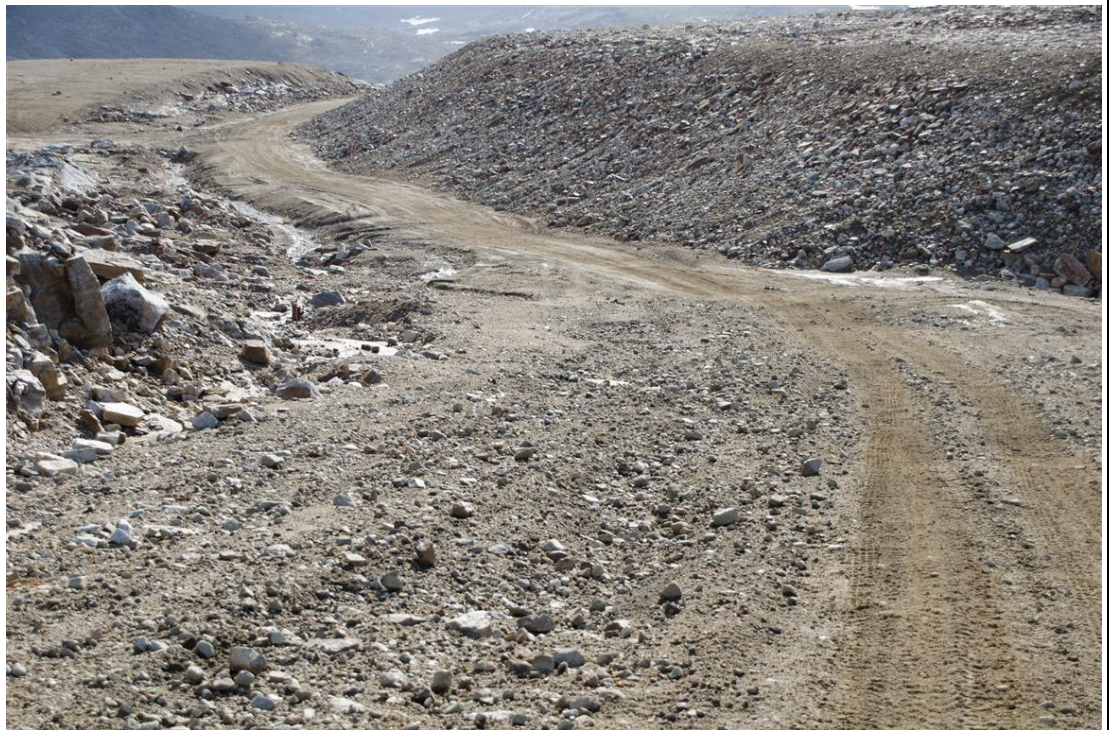
Road Section 1: Looking
northwest at erosion
channels on south side
of road passing the
Maintenance Area. This
portion of road can only
accommodate one-way
traffic. The Tier II
Disposal Facility is
visible on photo right.
The Former Landfarm is
visible on photo left.

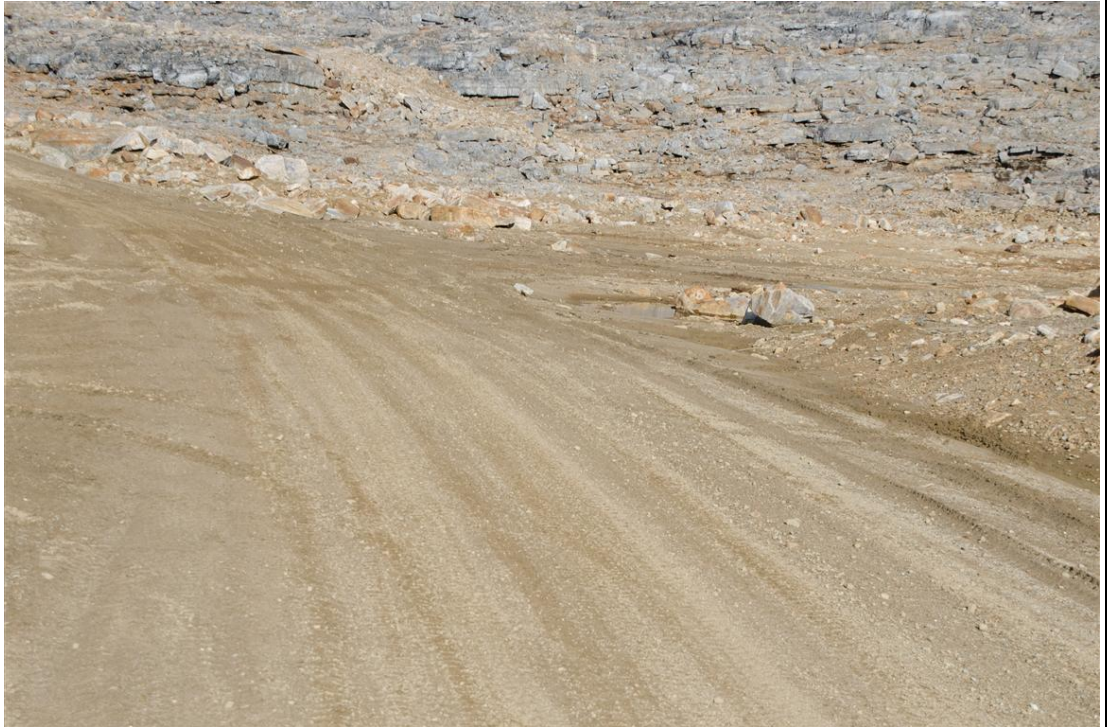
Road Section 1: Looking northwest at poor drainage near west end of Tier II Disposal Facility. Additional fill or improvement of drainage ditch required.
