BAF-5 Resolution Island

Maintenance Assessment Report (AECOM, 2014)

Public Works and Government Services Canada

BAF-5, Resolution Island Maintenance Assessment Report

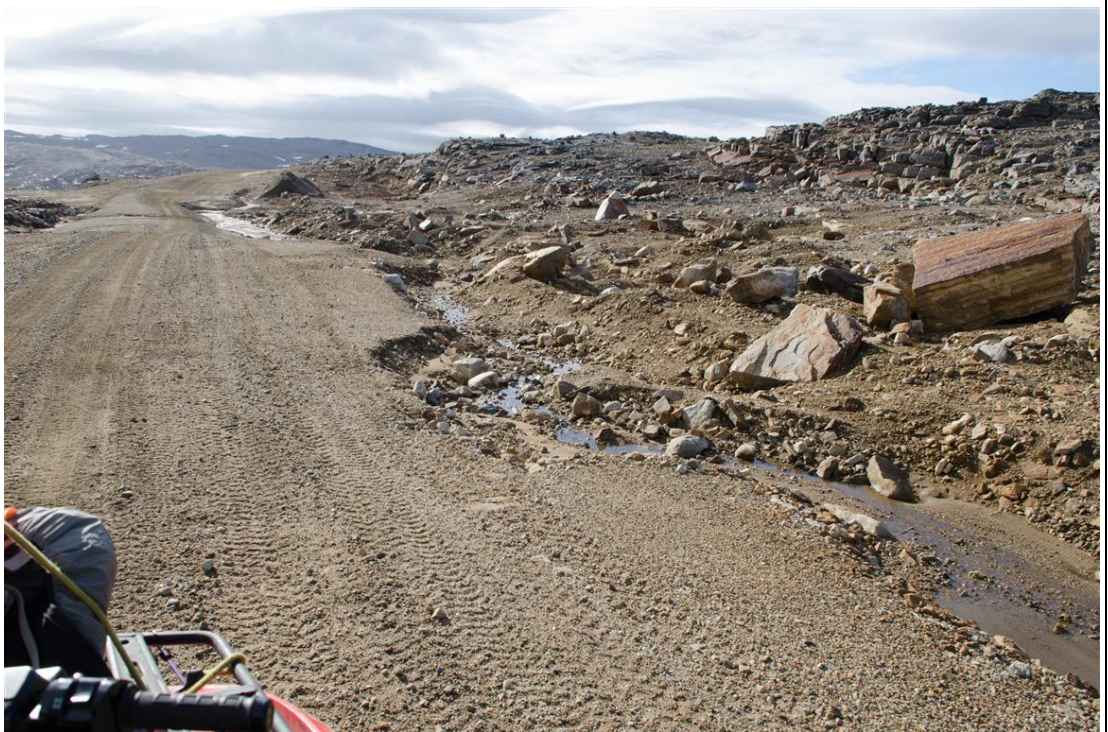
Road Section 1: Looking northwest at minor washout on north side of road at west end of Tier II Disposal Facility.

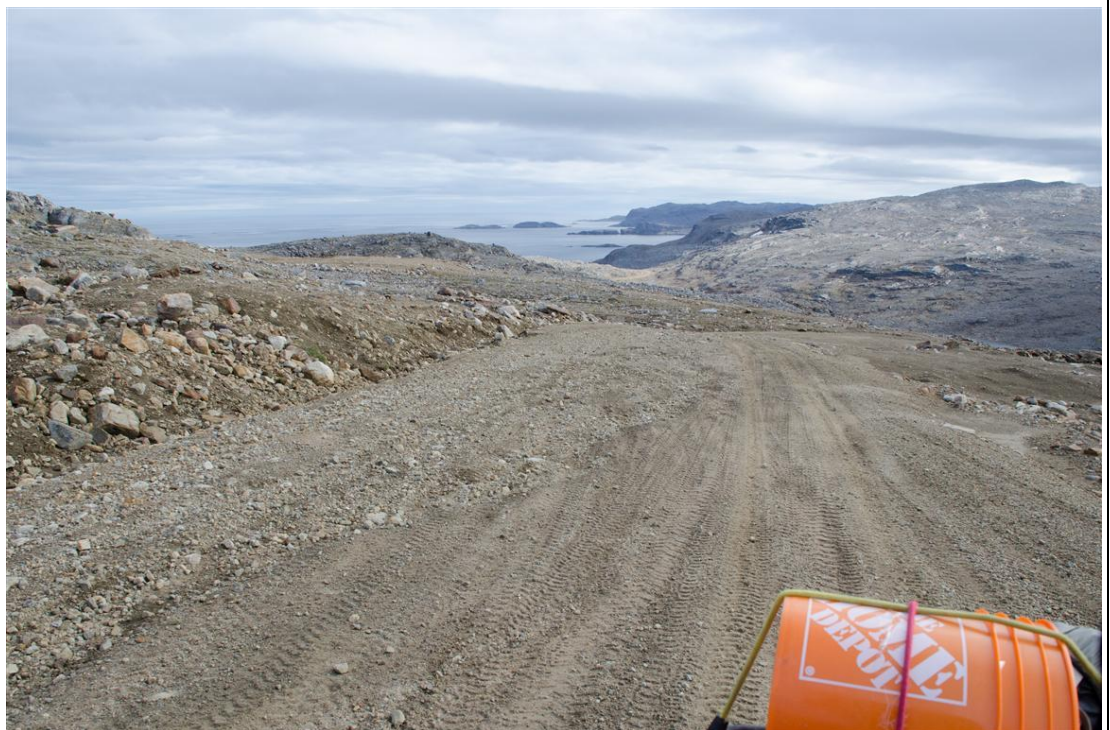
Road Section 2: Looking southwest at example on minor erosion channels/rills in Road Section 2.

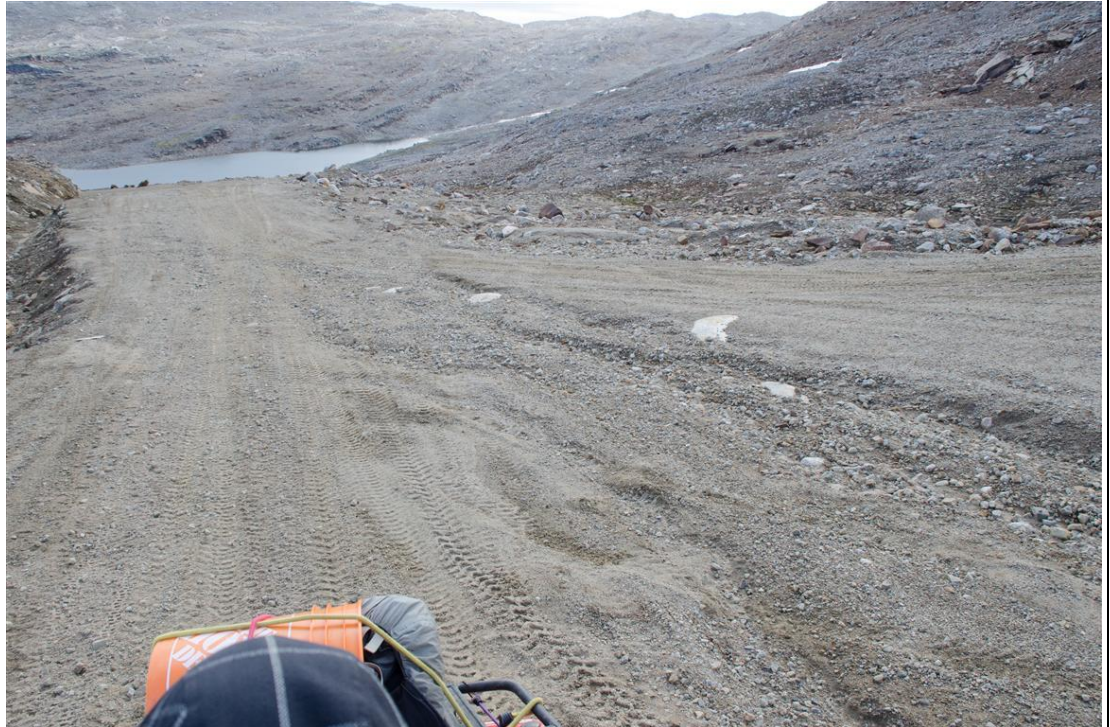
Photo No.
14

Road Section 2: Looking southwest at erosion channels/rills in road near the Radio Hill access (to the Remote Antenna Building). Some grading required.

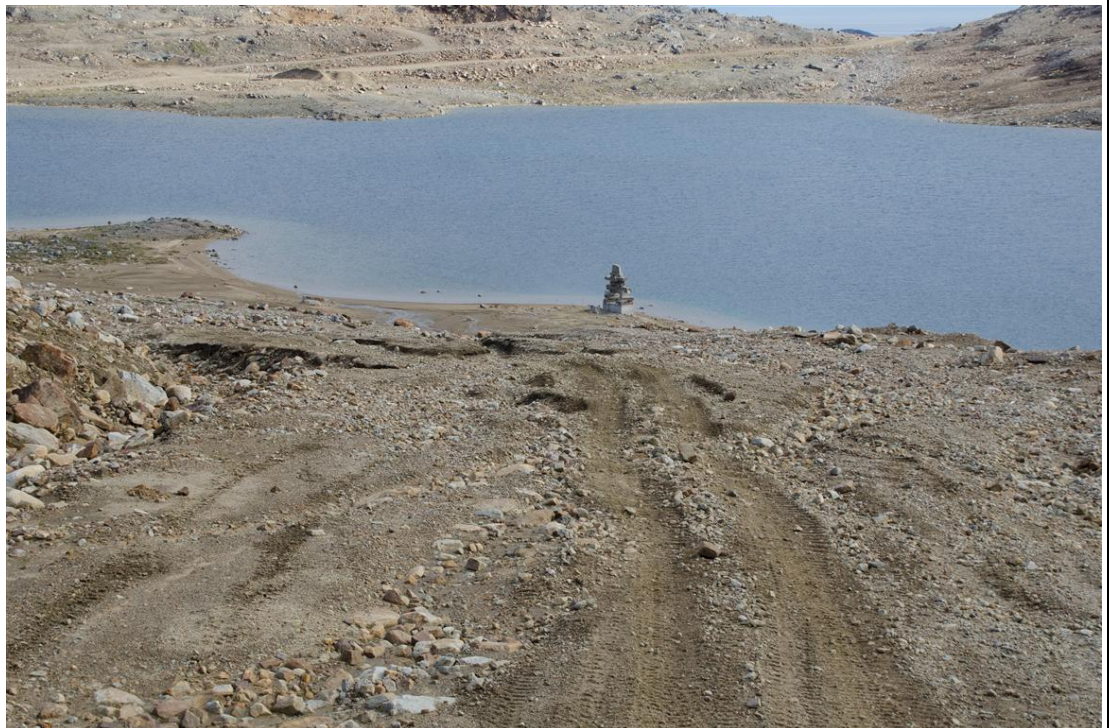
Road Section 2: Looking southwest at deep channels (~15 to 20 cm deep) near Freshwater Lake. East ditch is also eroded significantly. This section of road is likely passable with a pickup truck but will require additional fill and grading prior to future maintenance activities.

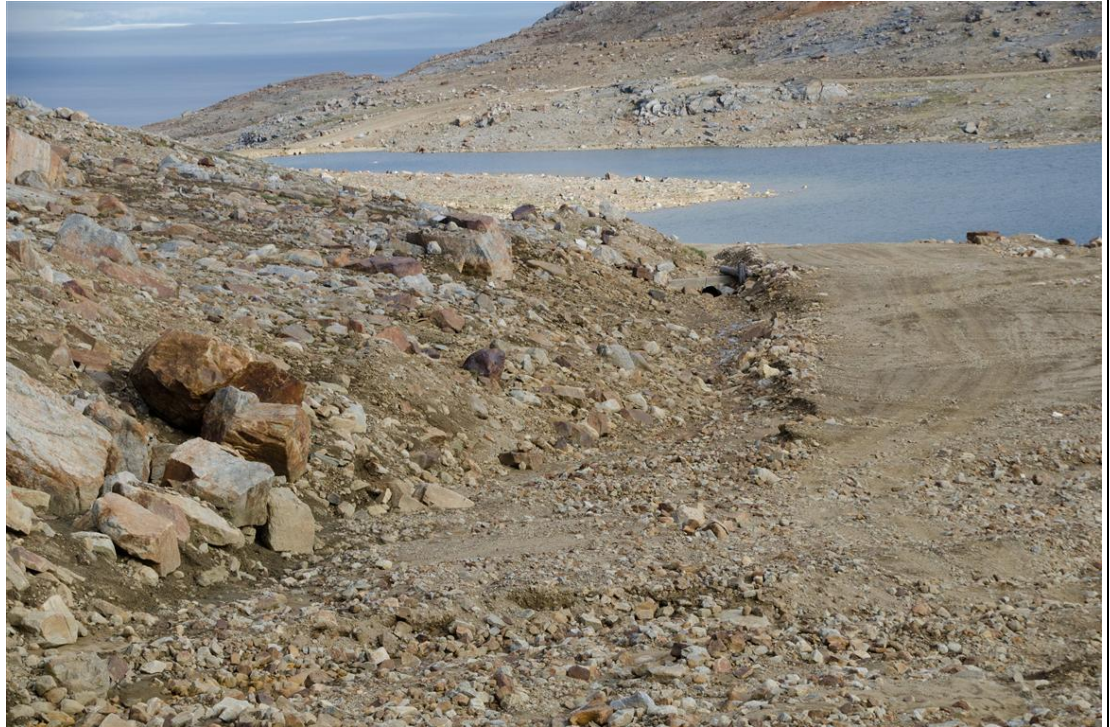
Photo No.
16

Road Section 2: Looking southwest at location where ditch silted up, resulting in a washout of the road.

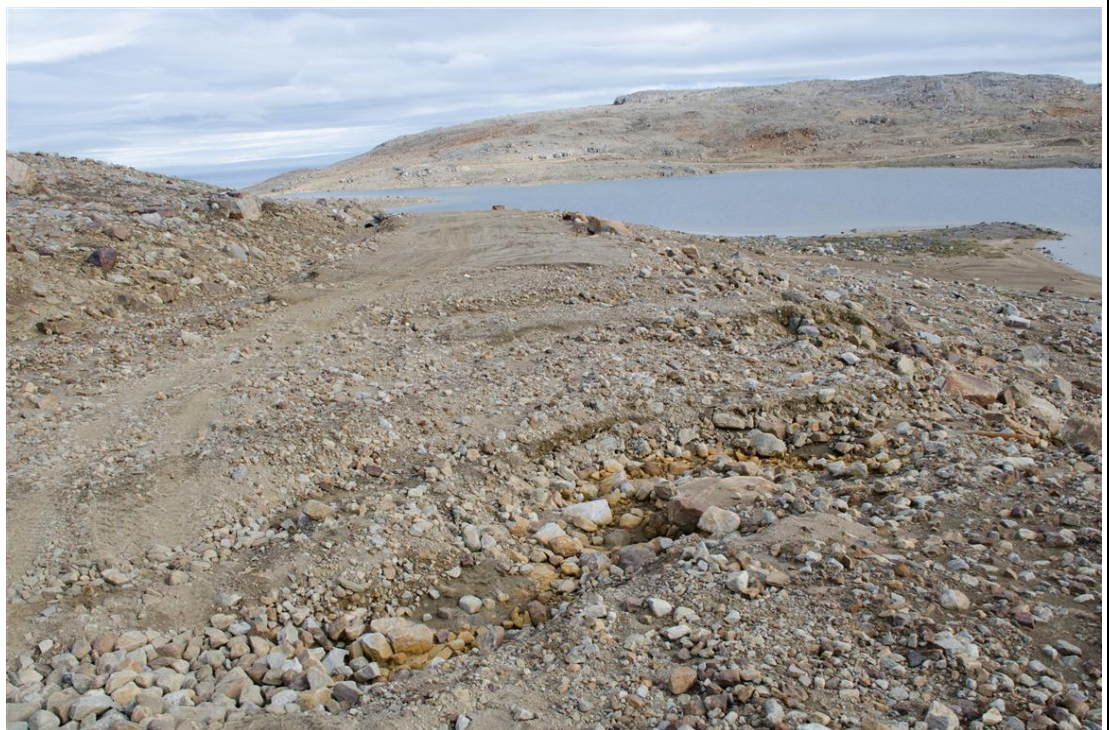
Road Section 2: Looking south at erosion of the ditch on the west side of the road. Approximately 30 to 50 cm of fill is required in this 30 m portion of road.

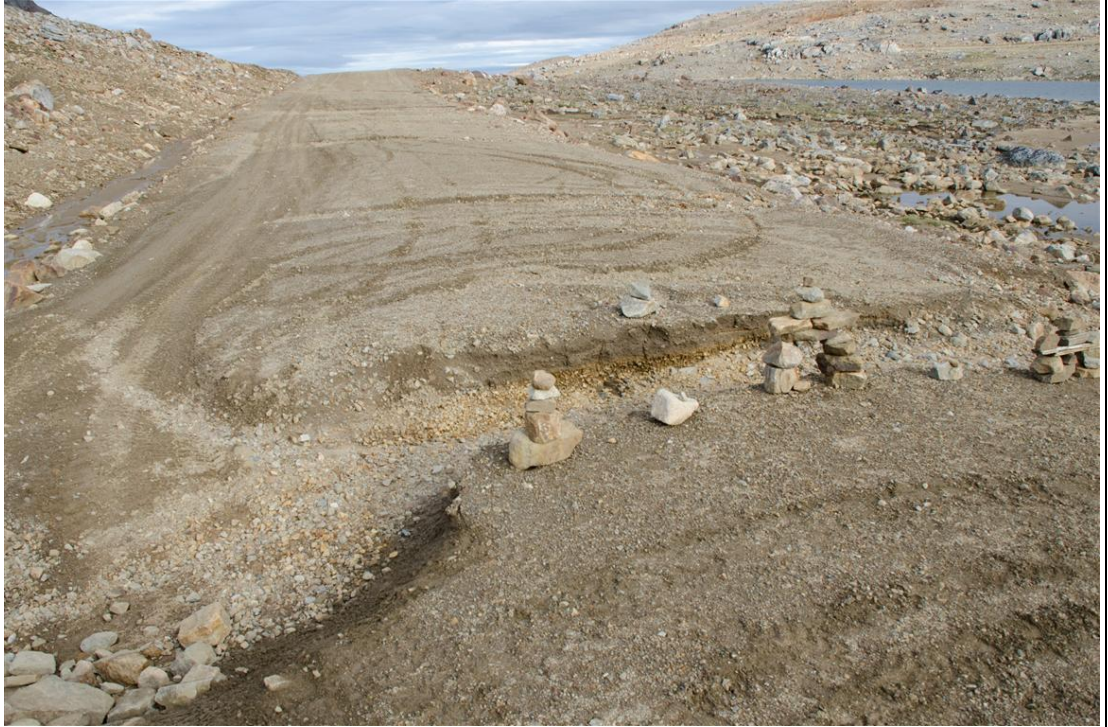
Photo No. 18
Date: 23/08/2013

Road Section 2: Looking south at example of typical washout in the road passing Freshwater Lake. Multiple washouts are present in this section of road. In the lowest portions, it appears as though water crosses the road during high flows. A culvert could be considered in some locations.

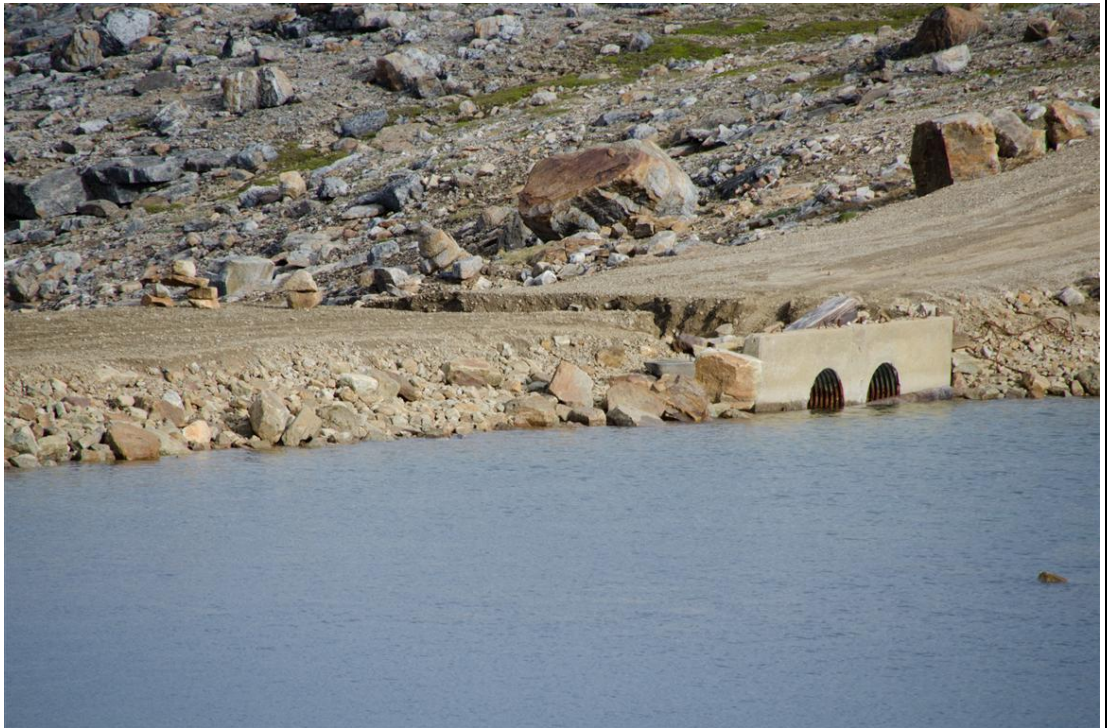
Road Section 2: Looking southeast at the largest of the road washouts in the road network. The original two culverts in this location are collapsed and segmented. Construction of two new culverts will likely be required to facilitate future maintenance activities.

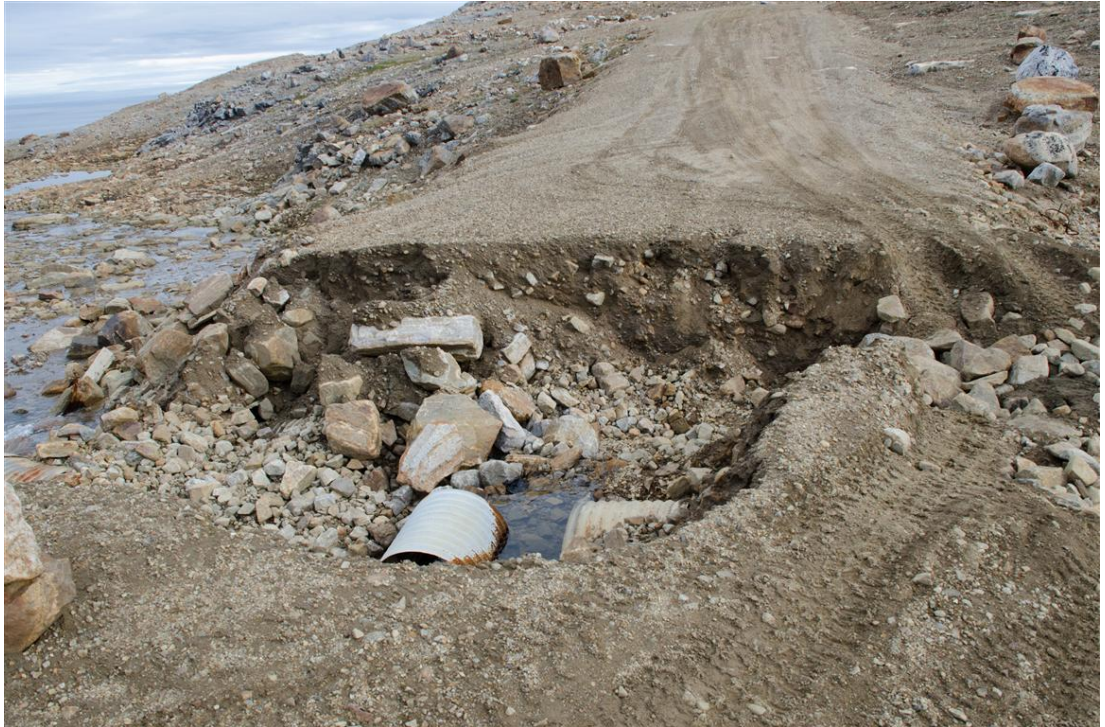
Photo No.
20

Road Section 2: Looking south at east portion of the large road washout identified in Photo 18. Freshwater Lake is on photo right.

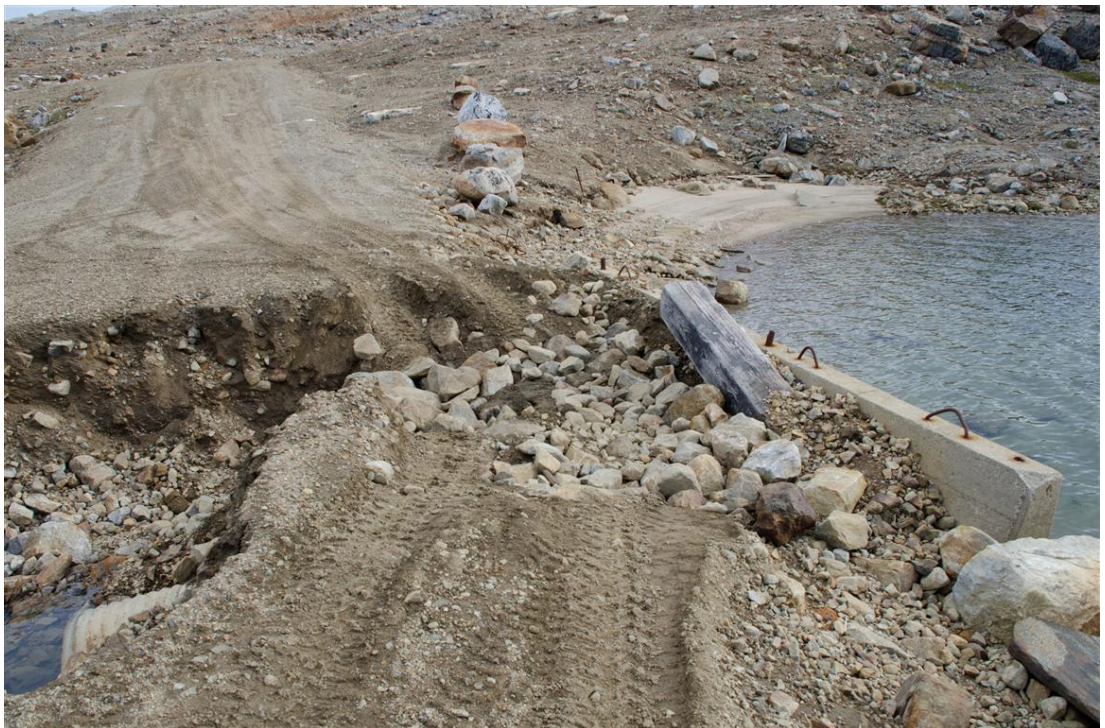
Road Section 2: Looking south at west portion of the large road washout identified in Photo 18. Freshwater Lake is on photo right.

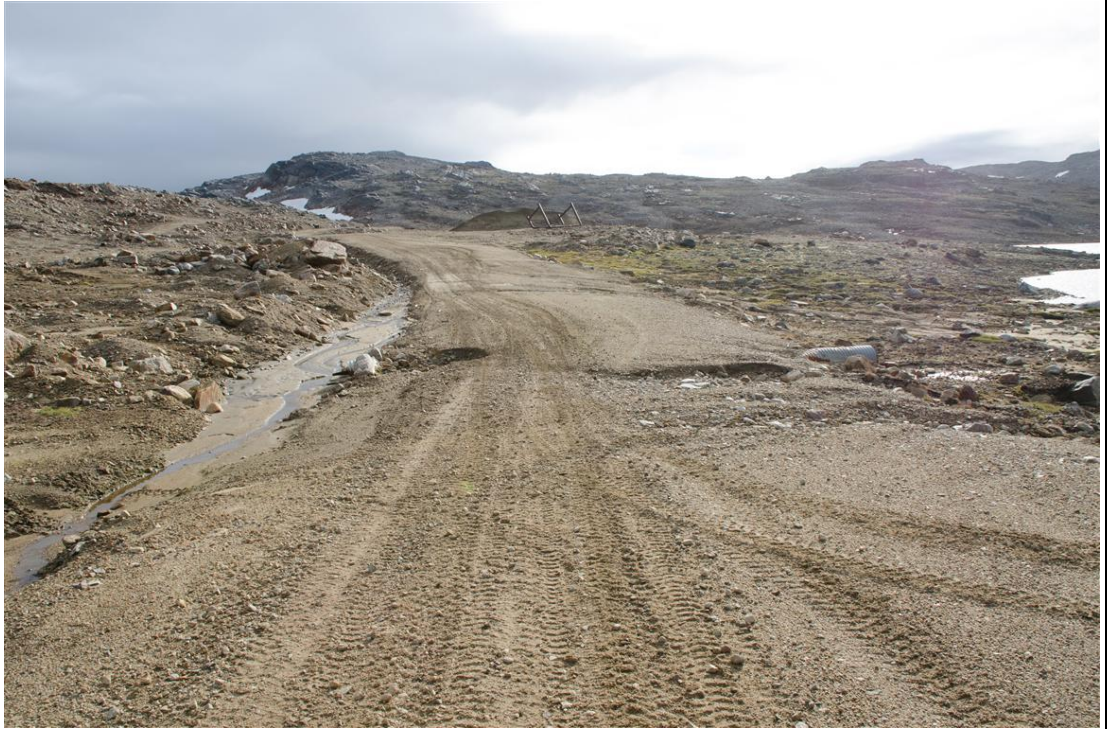
Photo No.
22

Road Section 3: Looking southeast at minor washout due to culvert collapse. Freshwater Lake is on photo right.

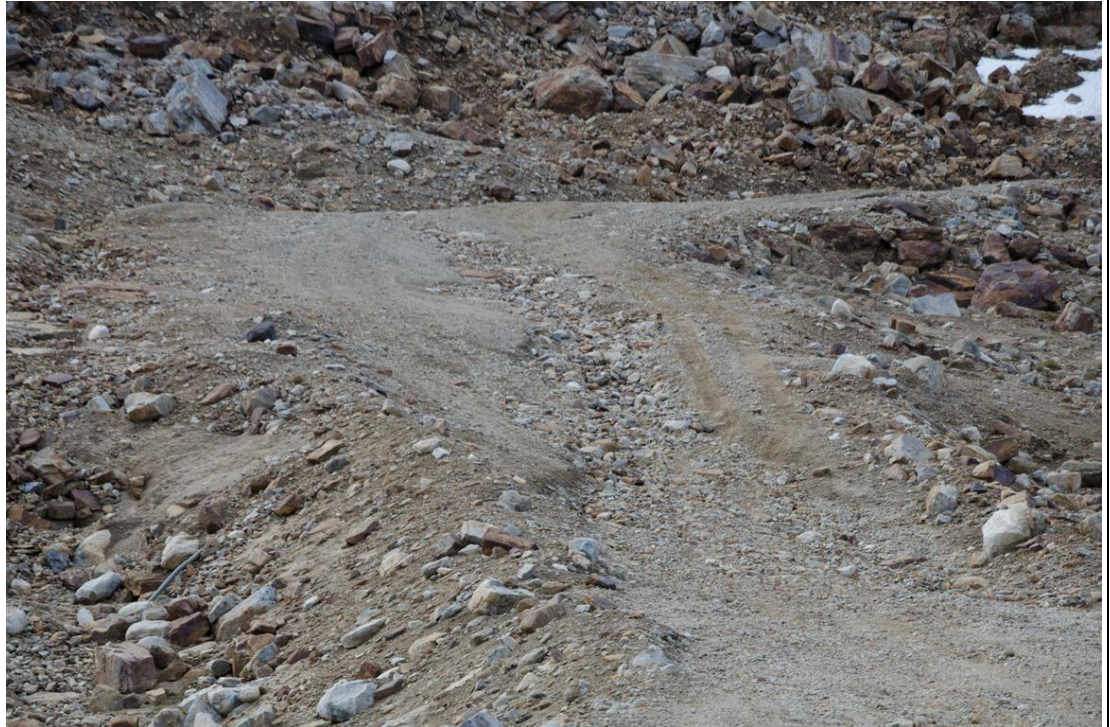
Photo No.
26

Road Section 4: Looking north at large drainage channel in the middle of the Radio Hill Access road.

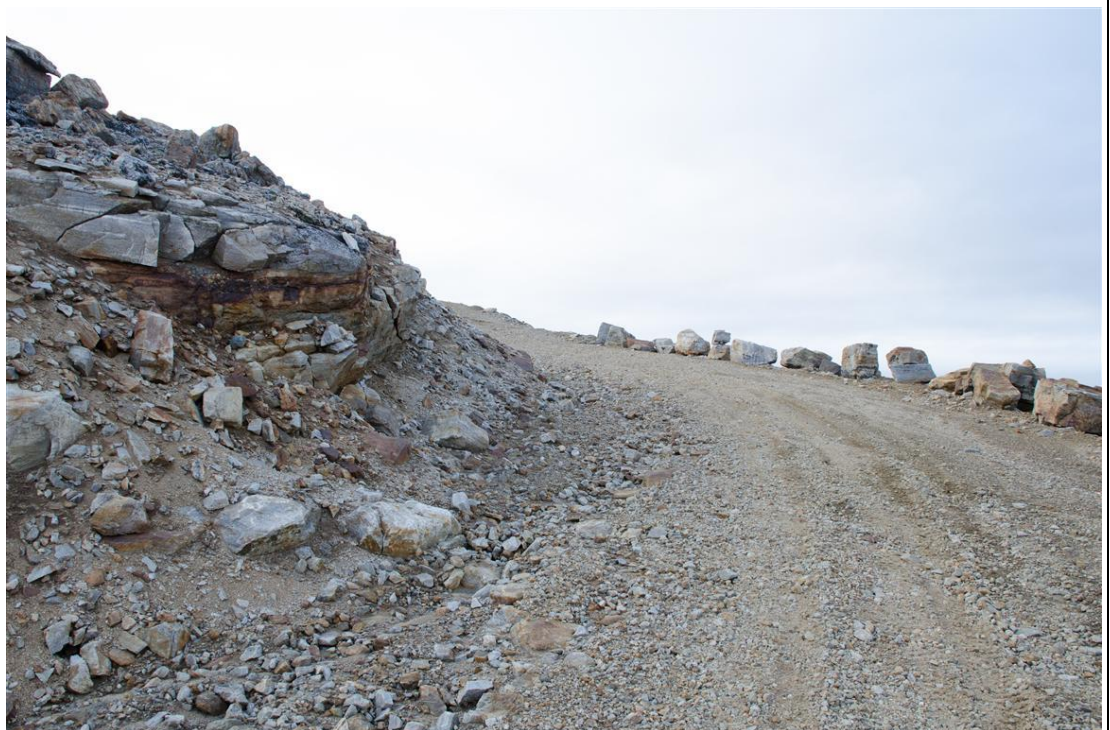
Road Section 4: Looking northeast along road. Drainage ditch (photo left) has silted up in the steep section of road, causing multiple drainage channels throughout the road to the top of the hill.
