WOLFDEN RESOURCES INC.

2006 GEOTECHNICAL INVESTIGATION PROGRAM

HIGH LAKE PROJECT, NU

PROJECT NO.: 0385-003-15
DATE: MARCH 26, 2007

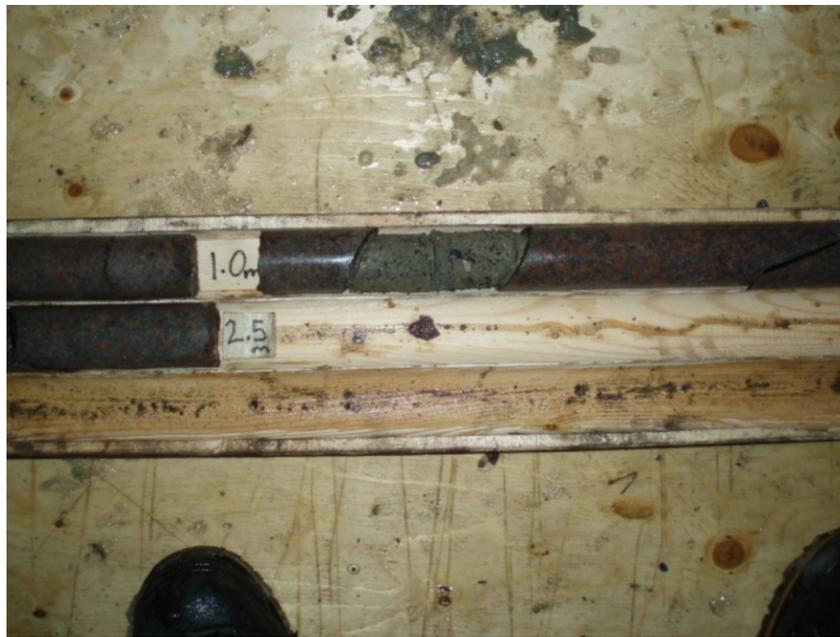
Example of till cored between 1.0 and 1.2 m at BGC06-02.

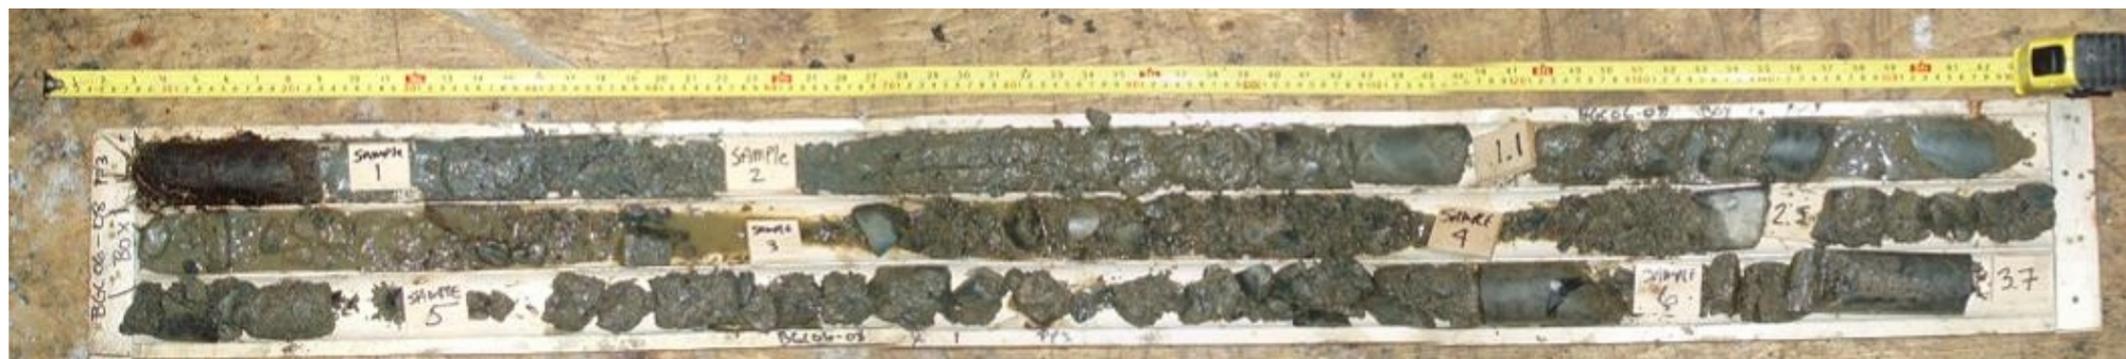
Example of till with excess ice melted between 0 and 3.1 m at BGC06-08. Ice content was determined to range between 3% and 35%.

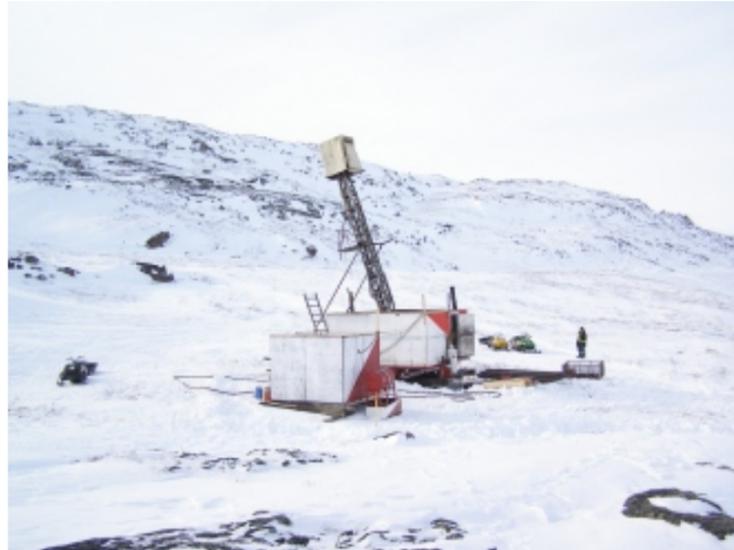
Looking north along the Kennarctic River Valley. Drill rig centered over BGC06-04.

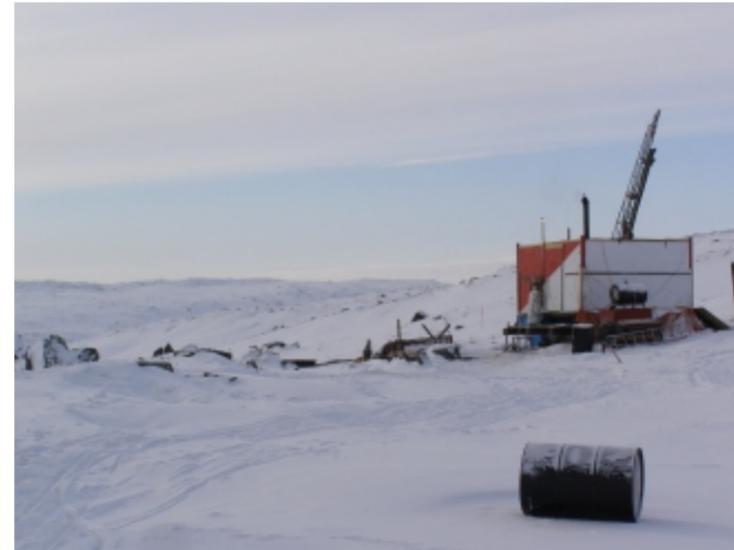
Drill rig set-up over BGC06-06 at the East Dam.

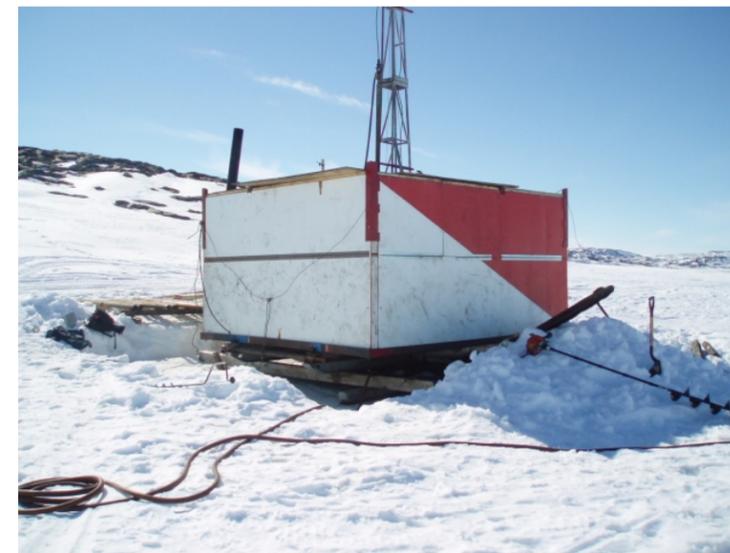
Drill rig located on the ice at DS-BGC06-01. Note the depth of the snow drifts along the shoreline.

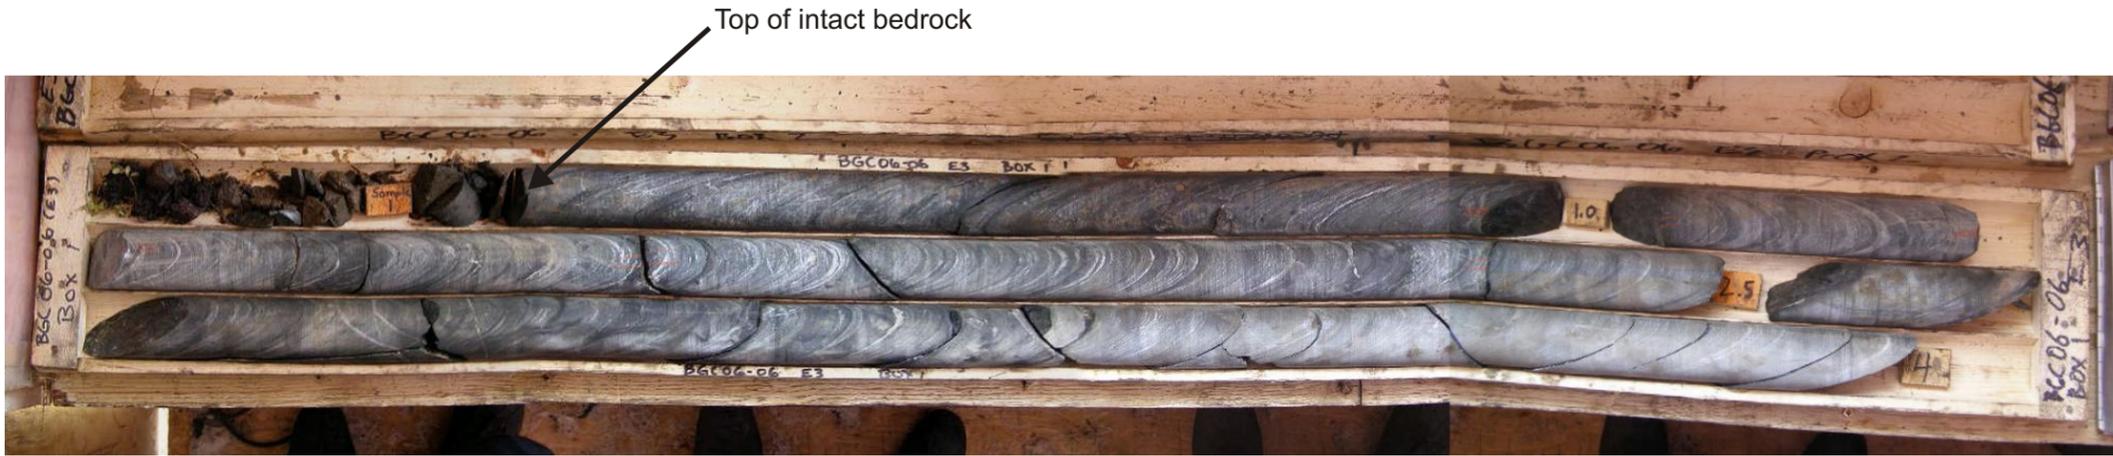
BGC06-06 East Dam, Box 1, Depth 0-4.0 m.

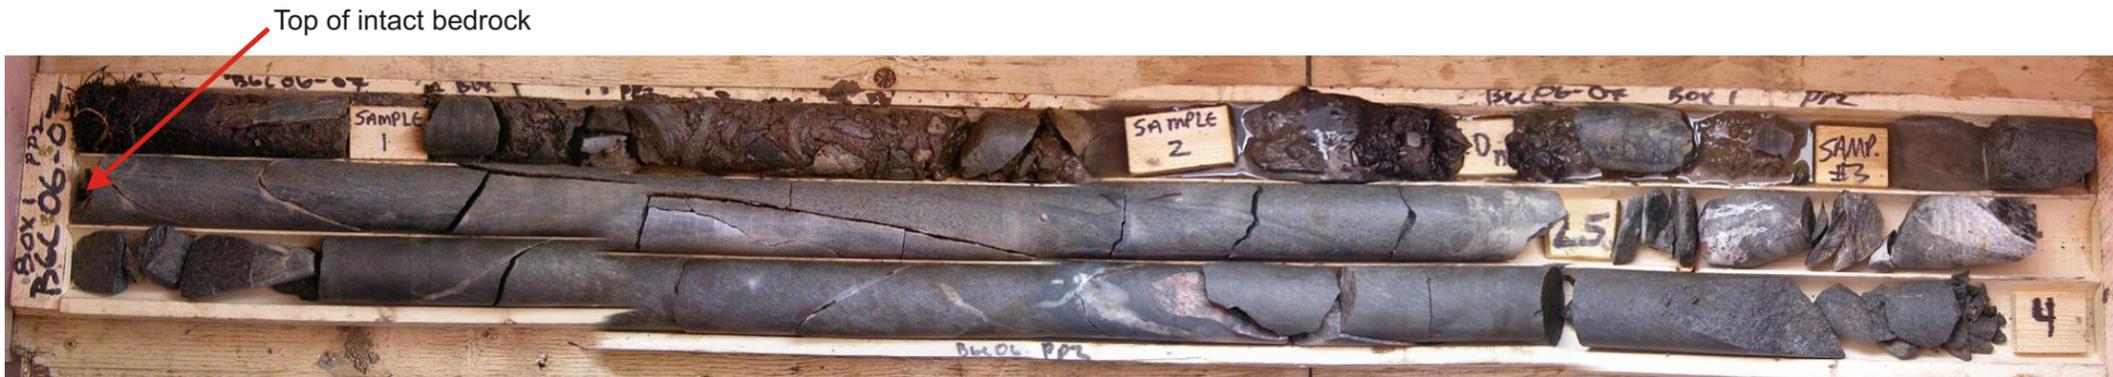
BGC06-07 Polishing Pond, Box 1, depth 0-4.0 m.

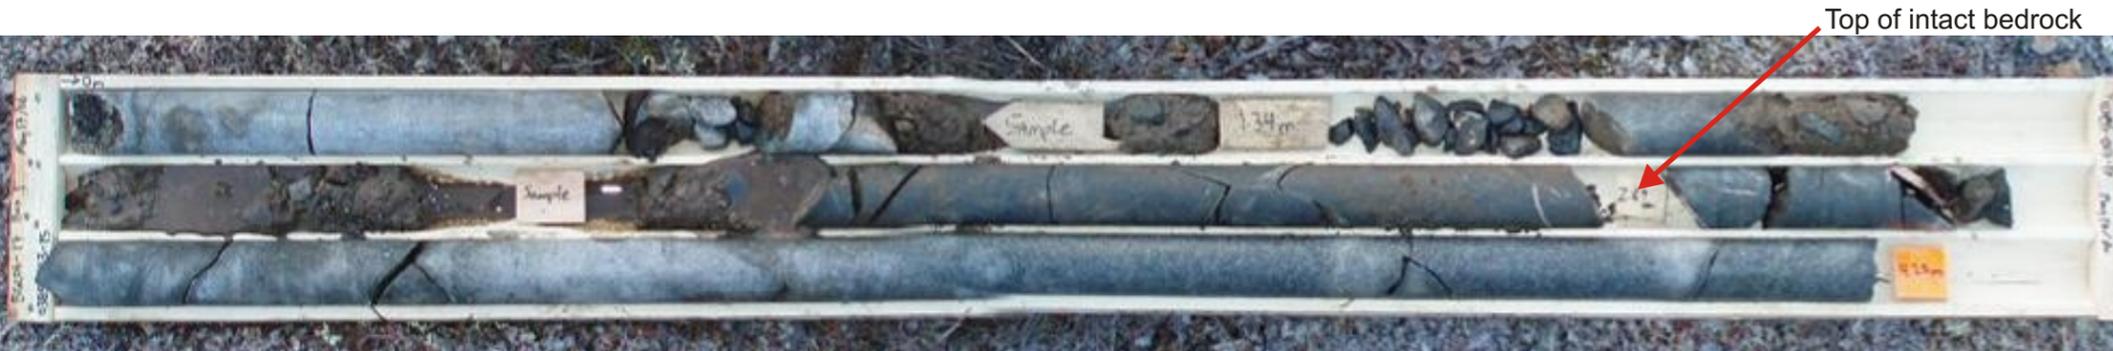
BGC06-17 Water Dam, Box 1, Depth 0-4.3 m.

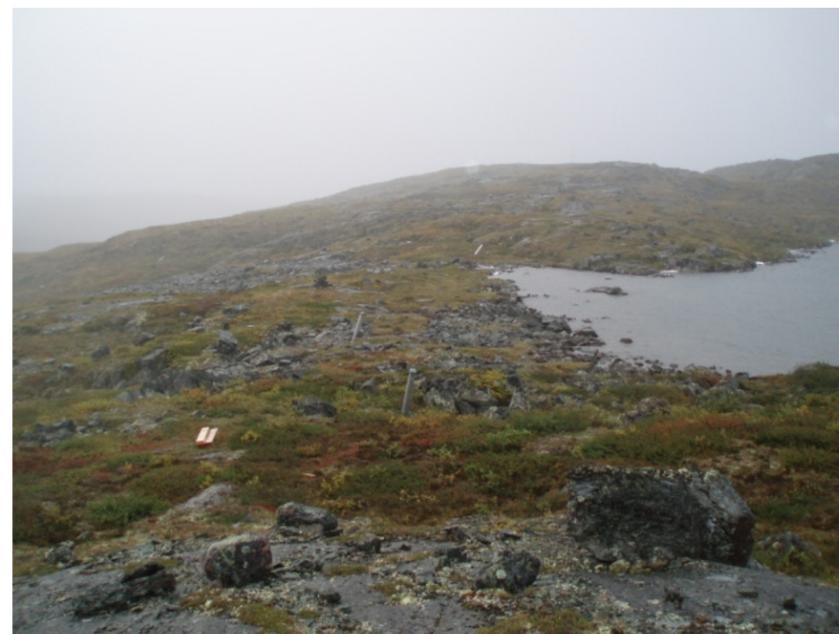
Looking south from left abutment along the proposed dam centreline.

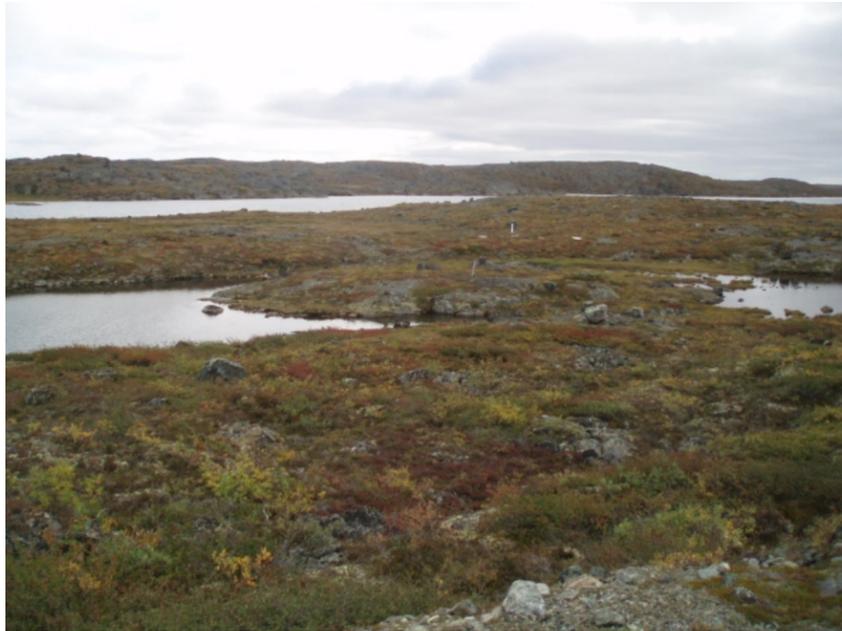
View of the proposed Northwest Dam centreline.

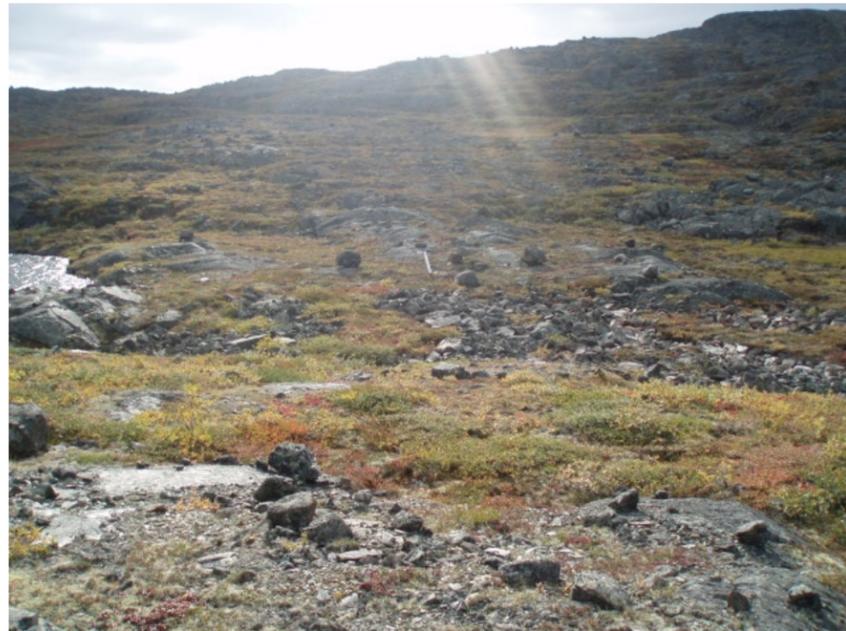
View looking south along proposed dam centreline from the right abutment area.

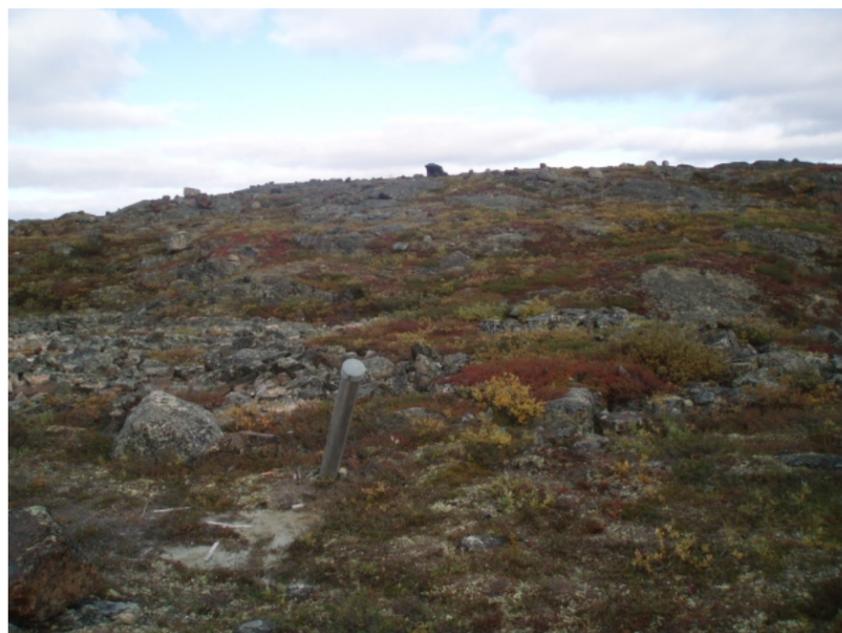
View of the left abutment area and meltwater channel near BGC06-16.

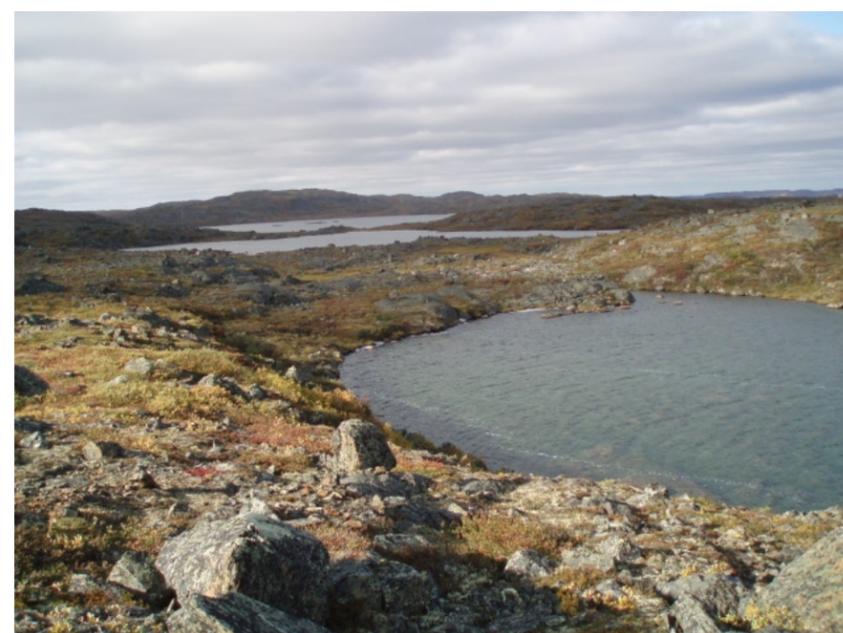
View of the Northwest Channel area looking northwest.

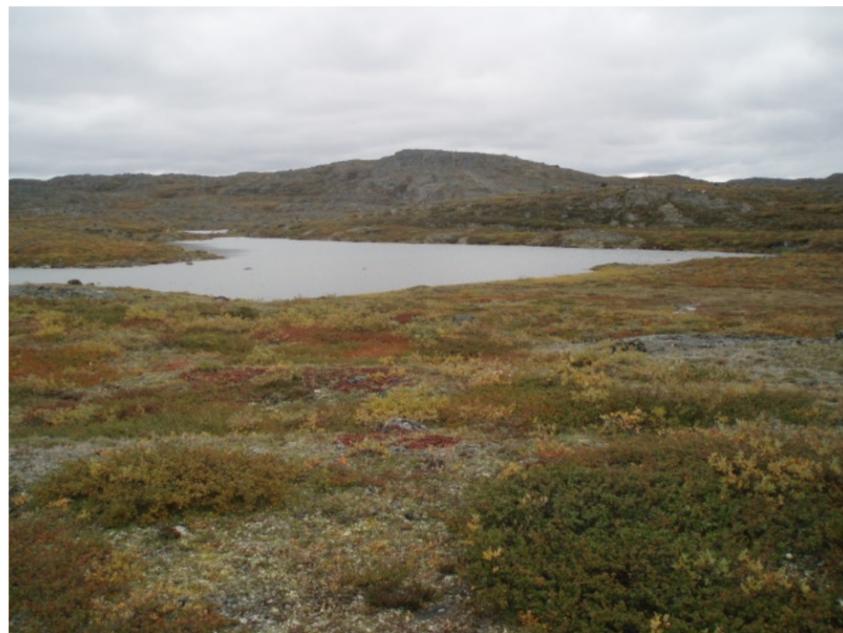
Looking southwest along the left dike alignment of the Northeast Dam.

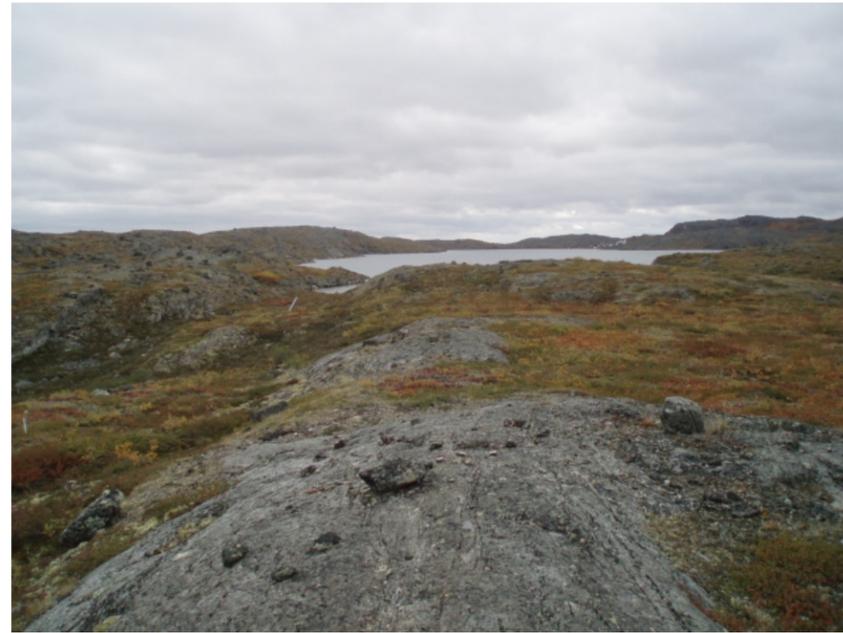
Looking southeast to BGC06-11 and a meltwater channel from the apex area of the Northeast Dam.

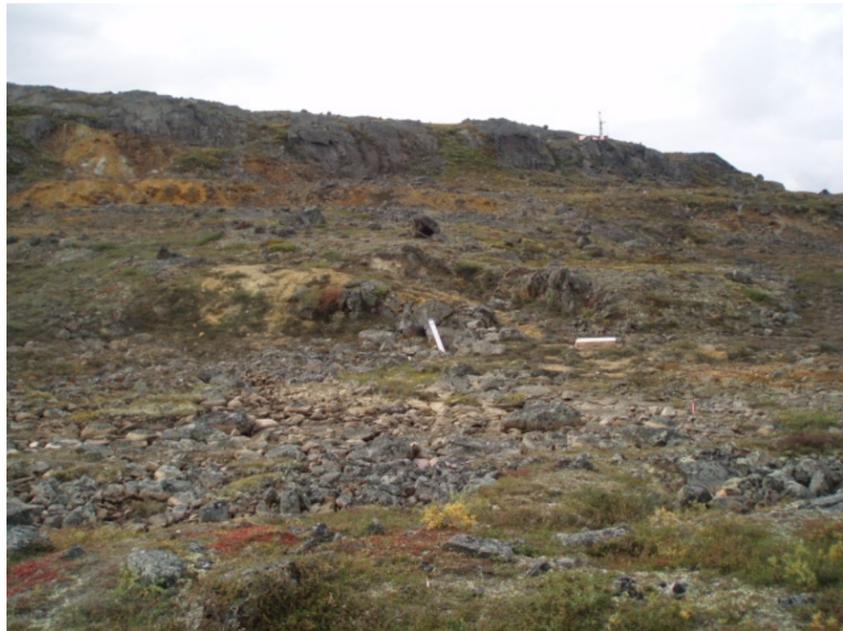
Looking west to the D Zone from the vicinity of BGC06-19.

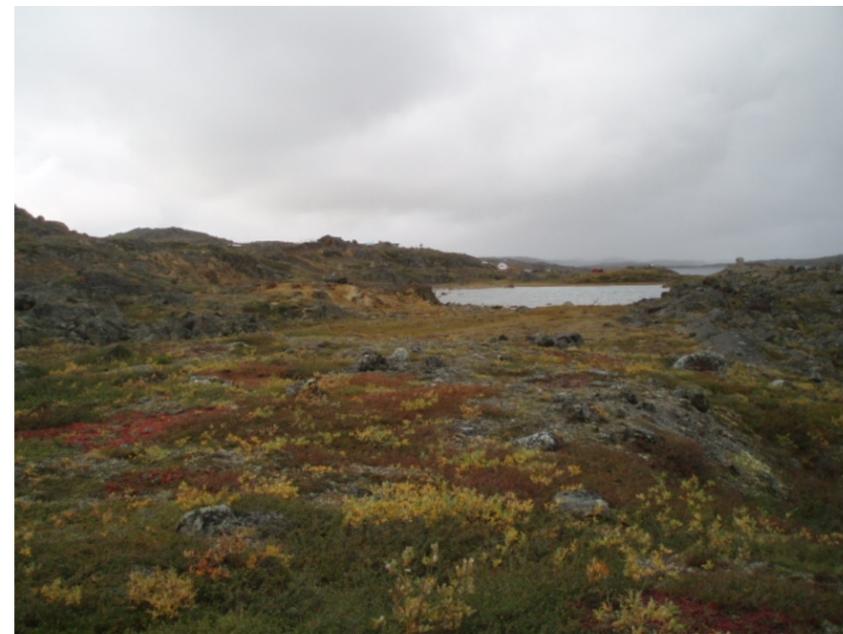
Looking north to High Lake camp along the felsenmeer and fluvial channel.

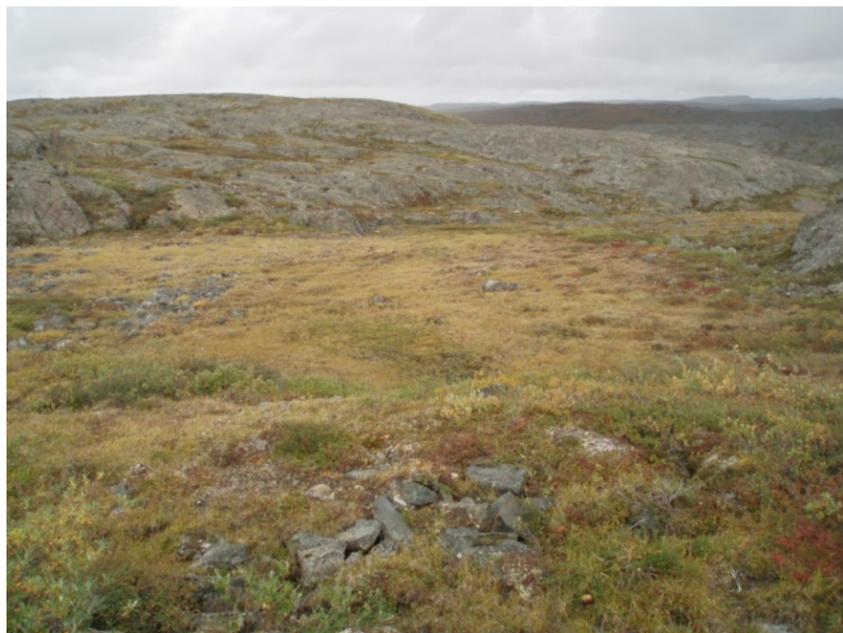
Looking east along the potential spillway channel from Contact Lake. Note the organic covered felsenmeer.

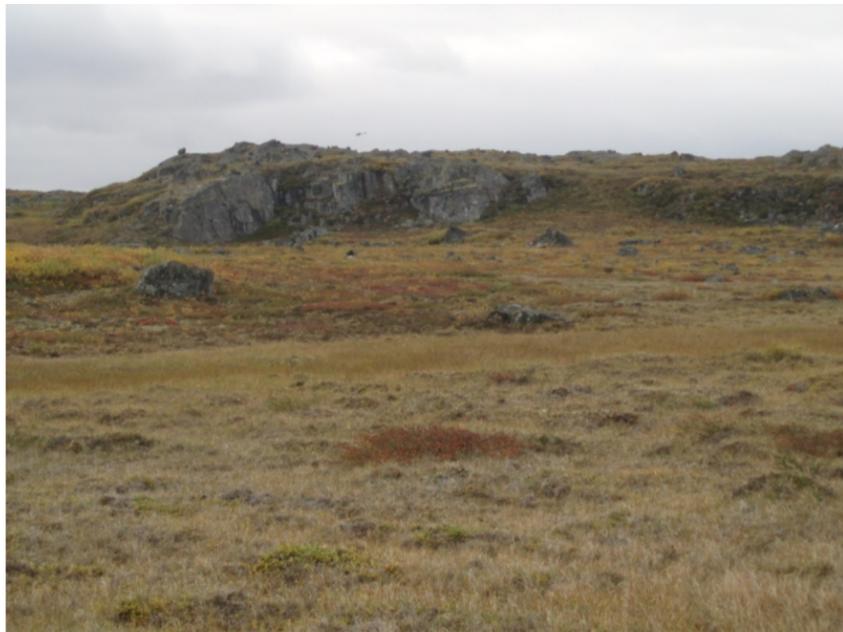
Looking south to the solifluction lobe in the vicinity of the right abutment.

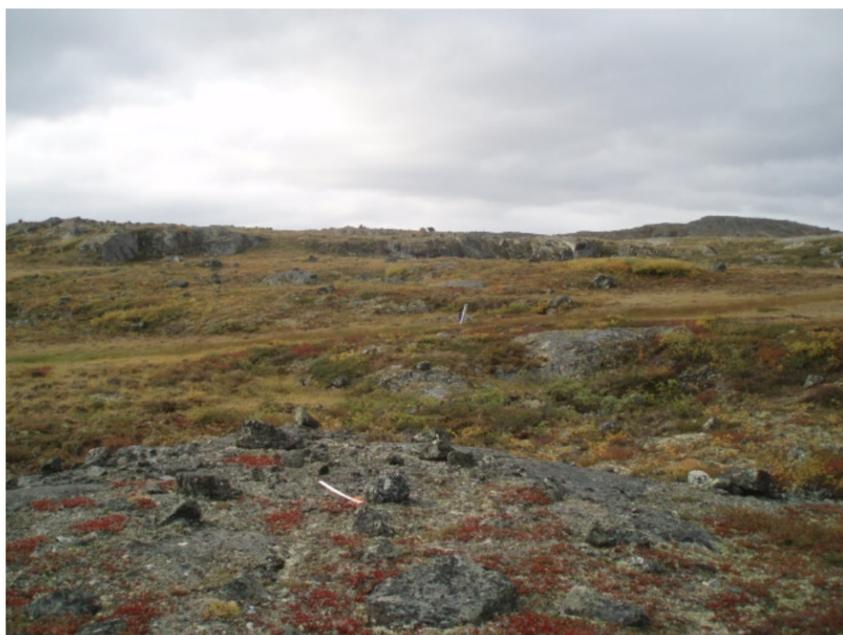
Looking south to BGC06-08, from the right abutment area along the proposed centreline of the Polishing Pond Dam.

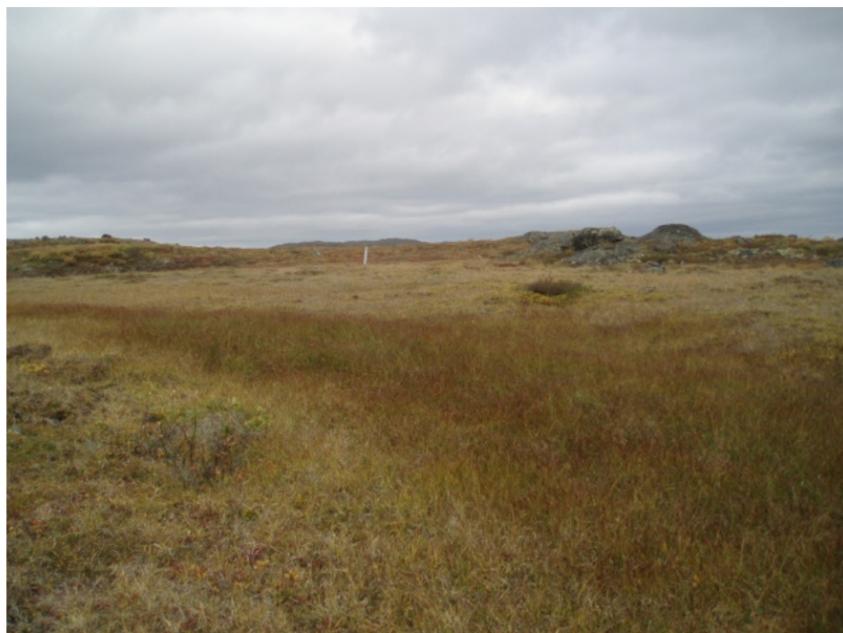
Looking northwest to BGC06-07 from BGC06-08 along the Polishing Pond Dam centreline.
