**APPENDIX E.7**  
**INSPECTION REPORTS**

**APPENDIX E.7.1**  
**AANDC INSPECTION REPORTS AND BAFFINLAND RESPONSE**

**RE: Water Licence Inspection Report – Mary River Project – Mary River Camp and Milne Inlet Camp May 4&5 2013.**

# May 2013 Water License Inspection

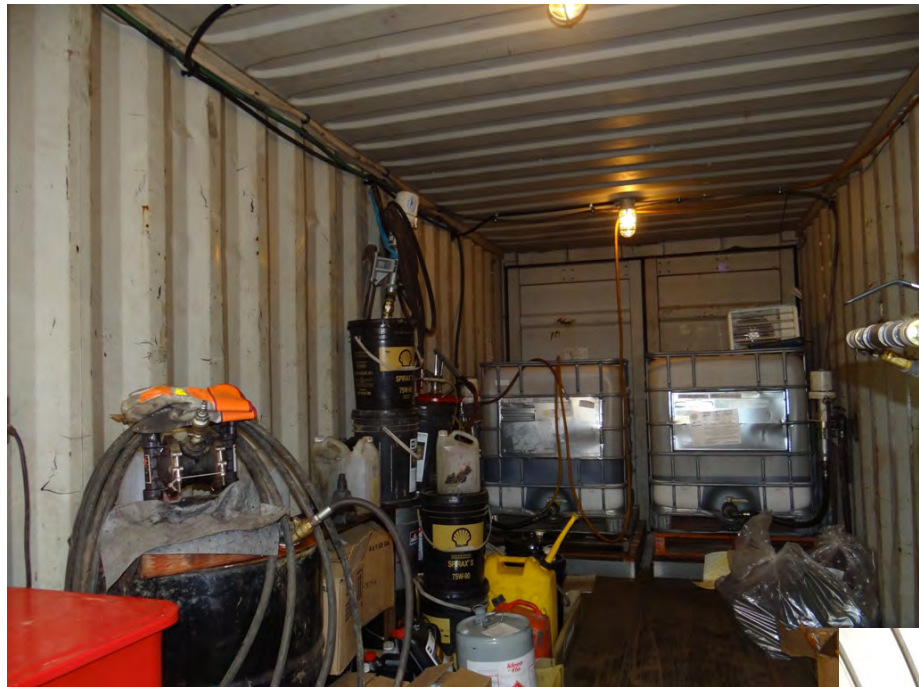
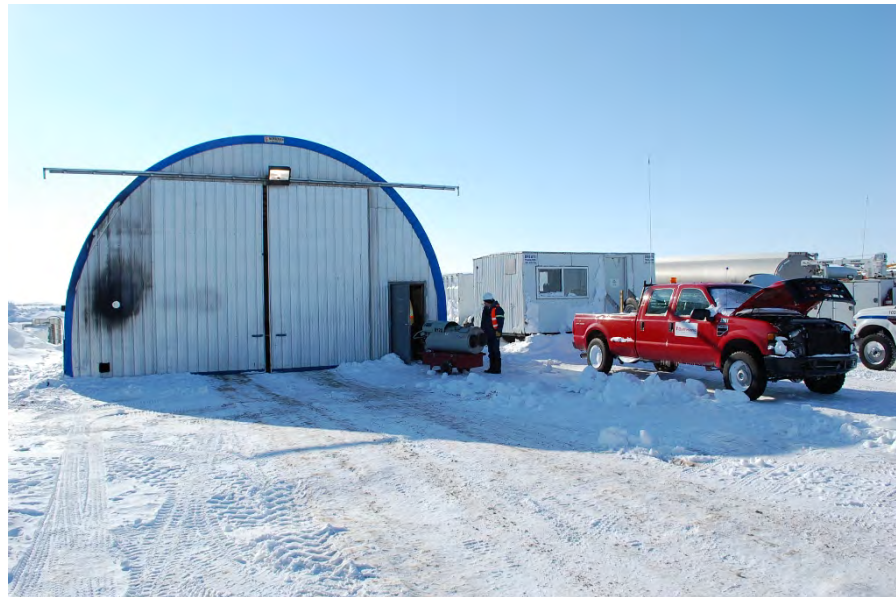
**Mary River Solid Waste  
Management Area**

No major instances of Non-compliance were noted at the Mary River Camp (Mine site) Facilities. The Licensee is reminded that the policing and management of the solid waste facility is to be maintained as a high priority. During the Inspection a battery and other wildlife attractants were identified within the facility.

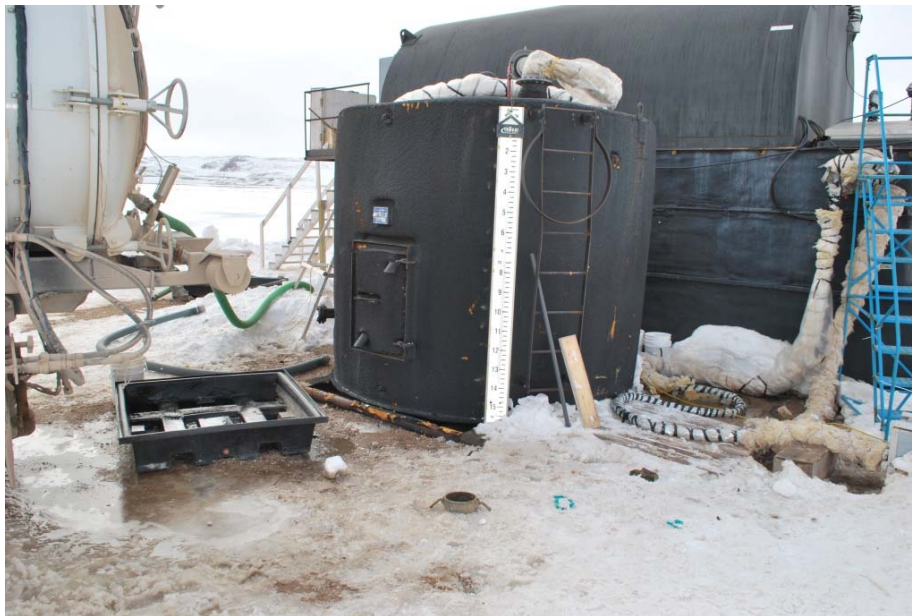
As mentioned above, the spill was noticed and all RBC pumps were promptly turned off and the leaking access port was capped (see Photo 1). Due to the impermeability of the frozen ground around the RBC, nearly all of the spilled effluent was collected using a vacuum truck and transported to PWSP #1 at the Mary River Site (see Photos 2 & 3) for secure disposal.

**Photo 1** – Milne RBC after Access Port was Capped

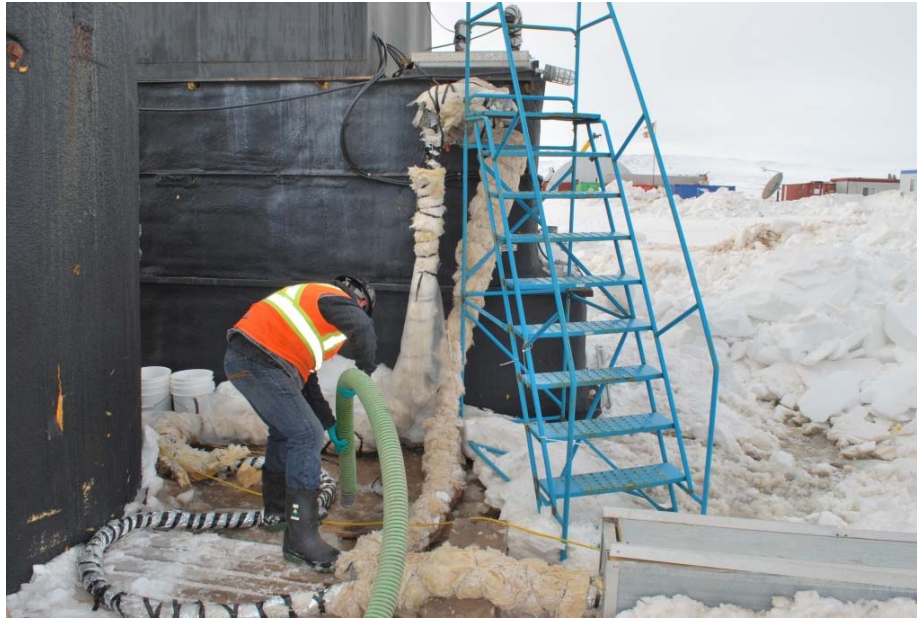
**Photo 2 – Collecting Spilled Effluent with Vacuum Truck**

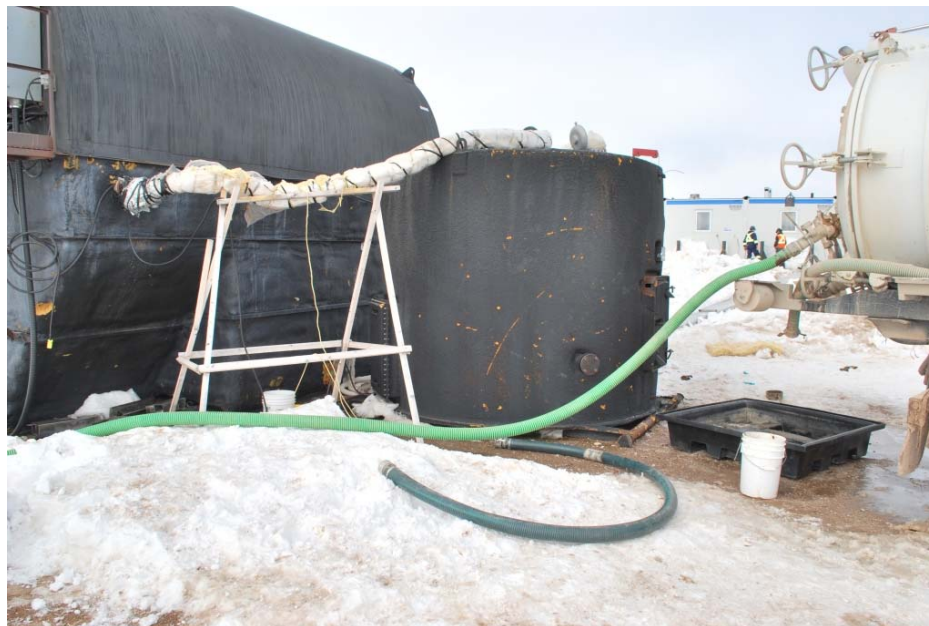
**Photo 3 – Milne RBC after Cleanup**

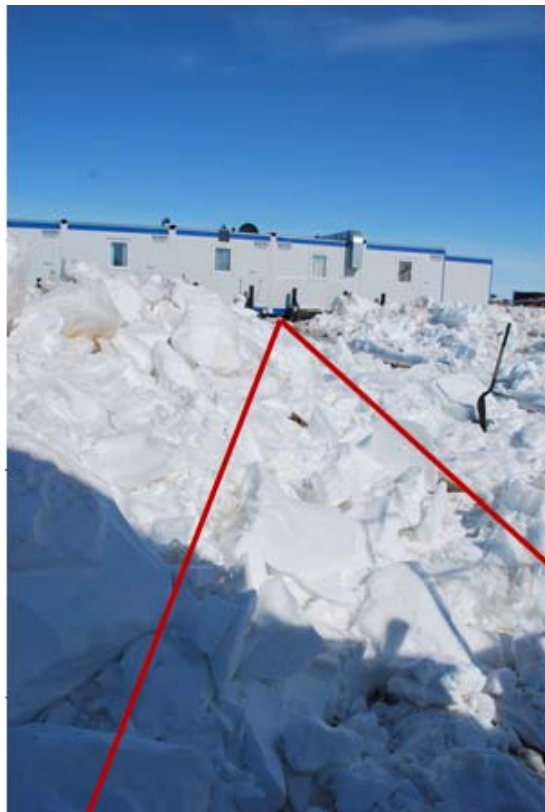
The migration route of the spill was identified using the known slope of the ground (see Photo 1). Impacted ice and snow were excavated where possible and trucked to the PWSP No. 1 at the Mary River Mine Site (a lined and engineered containment pond), where it will melt out in the spring. Refer to Photos 3 and 4 for a record of the clean-up activities. All piping has since been inspected and no further leaks detected.

**Photo 1** –Spill Migration Route (looking North)

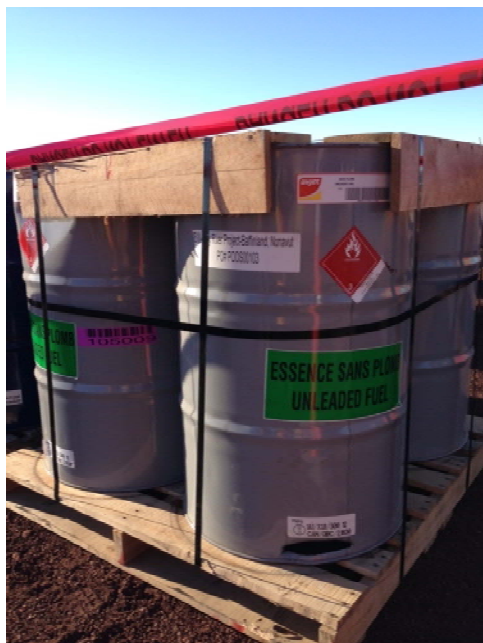
Figure 1. Punctured Drum

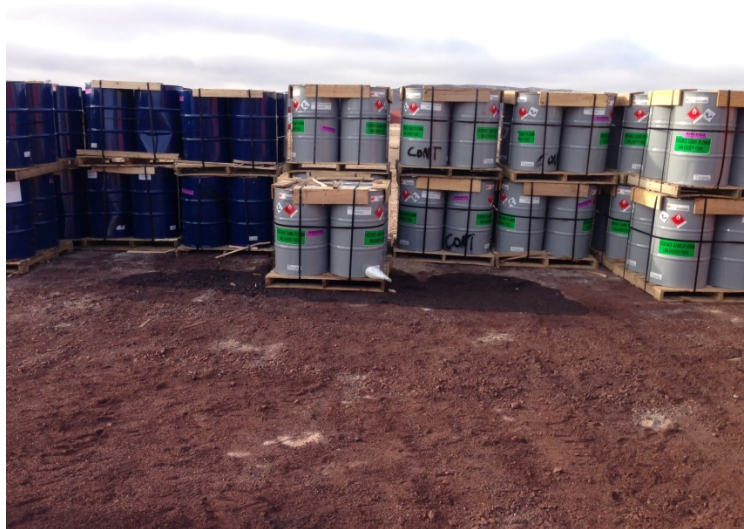
Figure 2. Spill Before Clean-Up

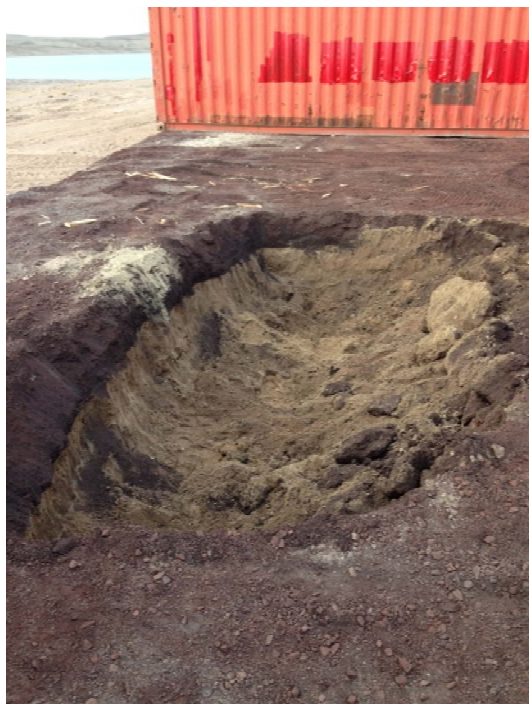
Figure 3. Excavated Area

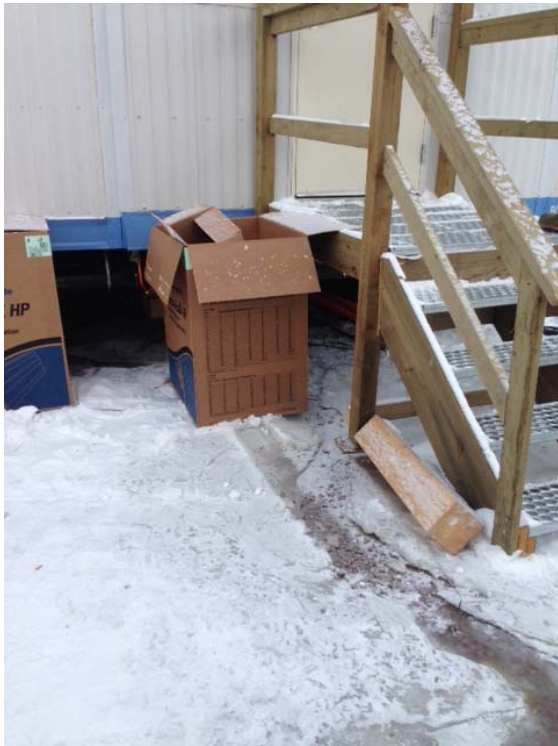
13 10 29 Sewage Spill Under Camp

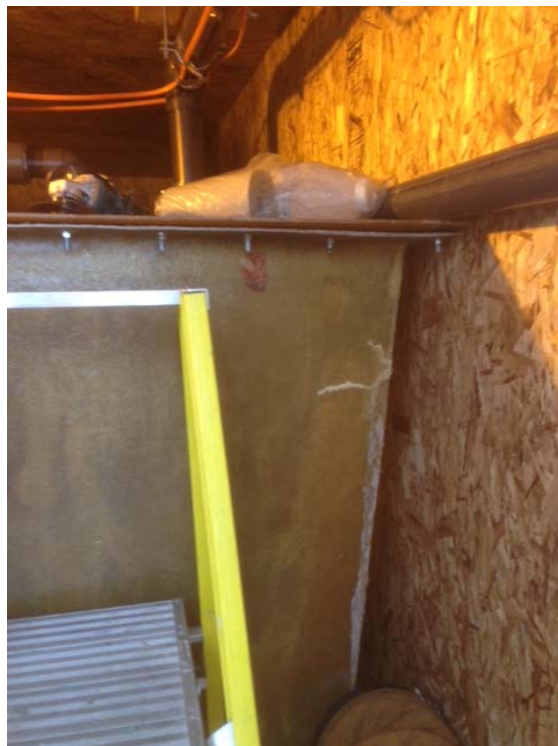
13 10 29 Tank Breach

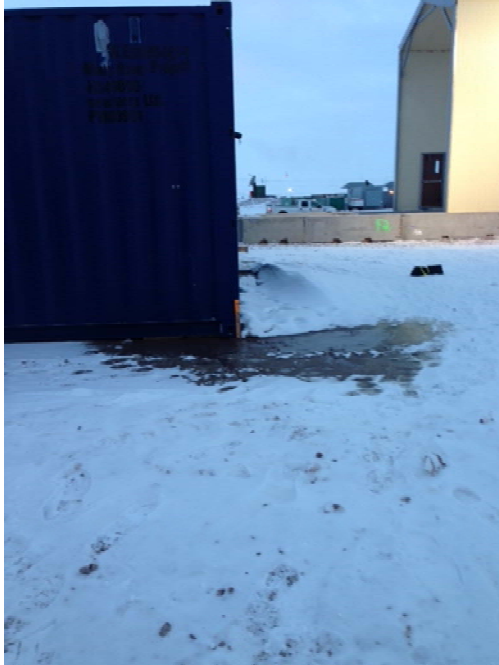
Figure 1. Sewage spill at Sewage treatment plant

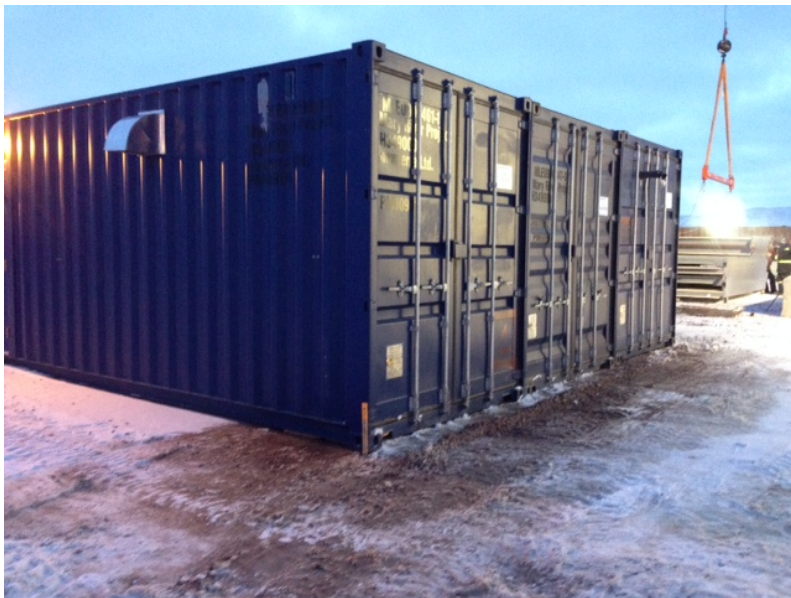
Figure 2. Sewage spill cleaned-up

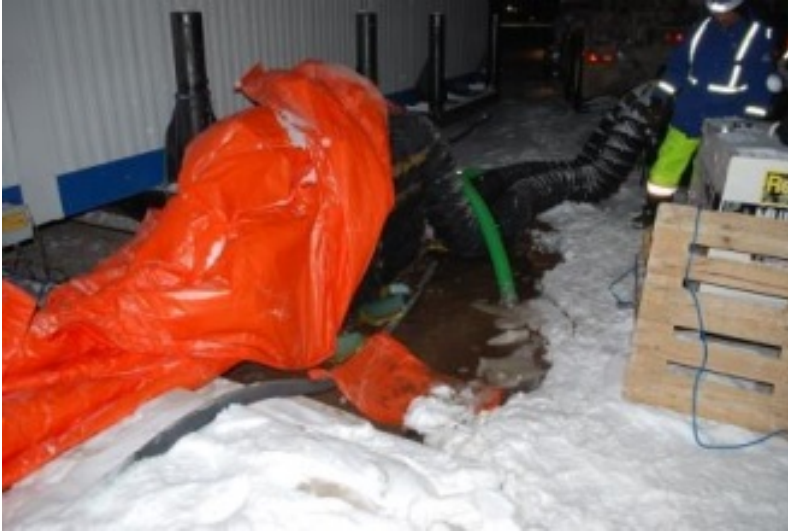
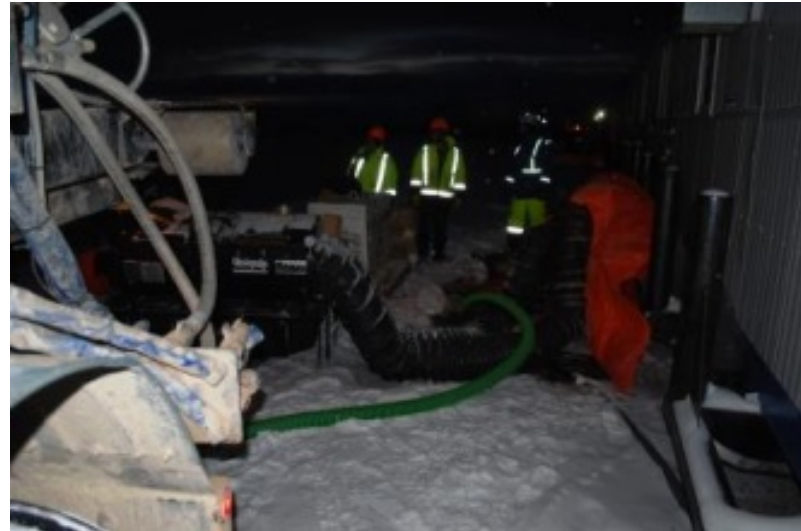
13 11 08 - Milne Port - SE Lift Station Shanco - 700 Liters

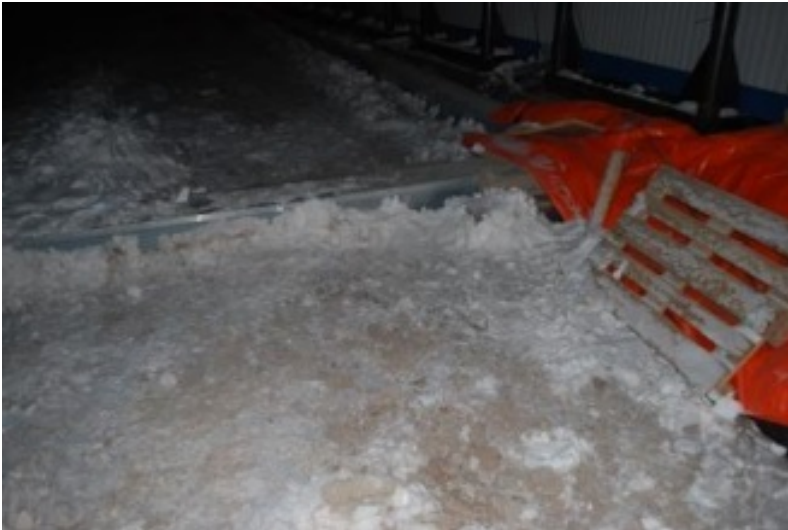
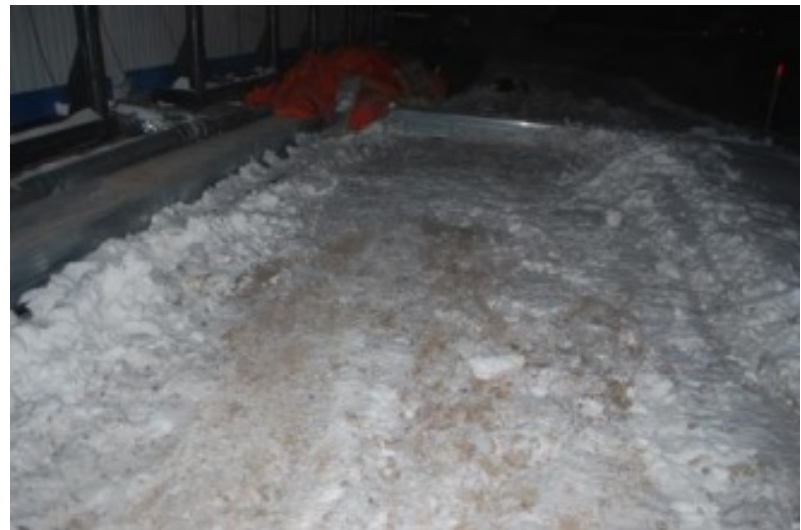
13 11 11 - Milne Port - SE Lift Station Shanco - After Clean Up
