2015 QIA and NWB Annual Report

APPENDIX D AS BUILT REPORTS

APPENDIX D.1 CONSTRUCTION SUMMARY REPORTS

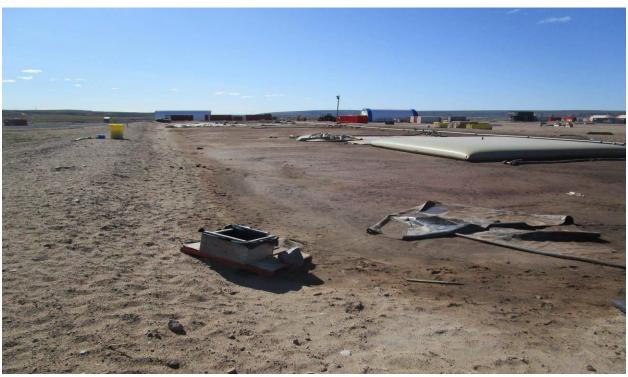
Bulk Fuel Storage Facility showing one former fuel bladder in use.

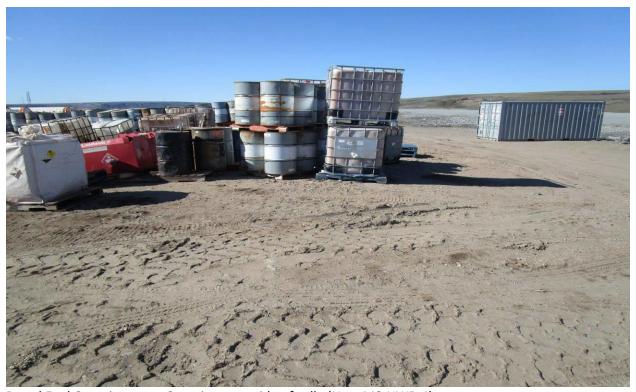
Barrel Fuel Containment – Containers outside of cell. (Now MS-HWB-4)

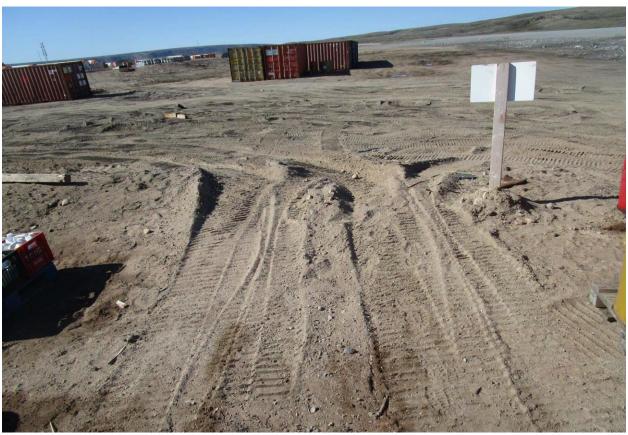
The north dyke in the north cell has had a track fork lift travel over the berm at the east end. It was recommended that signage be placed to prevent this before damage occurs to the liner.

Barrel Fuel Containment – Shows travel over side dyke of cell. (Now MP-HWB-3)

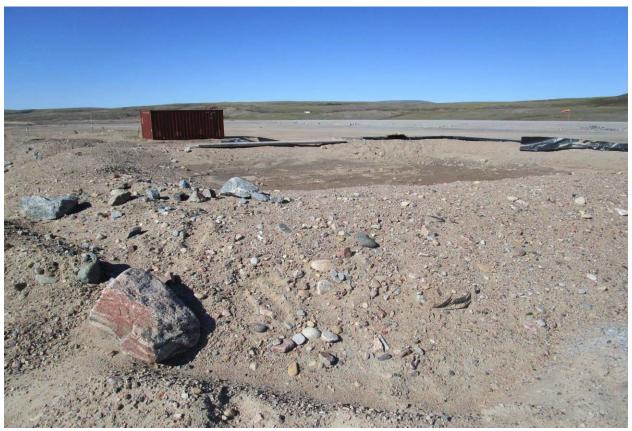
Jet Fuel and Pumping Containment – Now empty.

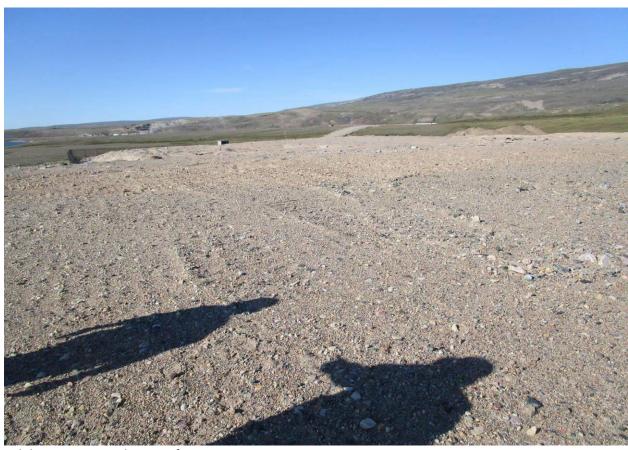
Solid Waste Disposal – Top of cover.

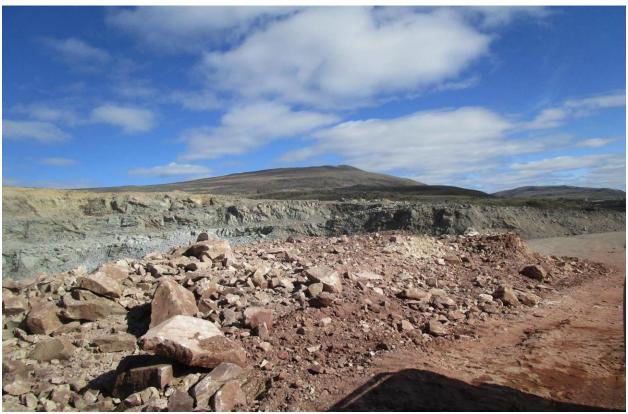
Mary River Quarry.

At the time of the inspection, the quarry was being actively mined. Overburden from the top surface of the quarry was being cleaned and pushed as thawing permits, to serve as long term protection against moving aggregate and to promote long term stability. There were a number of cobbles and larger boulders above the upper bench of the quarry that may be unstable and potentially hazardous. It was recommended that at the time of closure, the quarry shall be closed in a manner as set out to maintain long term stability.

<u>Baffinland Action</u>: The quarry is still active and the unstable area noted in the inspection had already been identified and measures are planned for stabilizing. The QMR2 Quarry Management Plan and Interim Closure and Reclamation Plan include requirements to ensure for long term stability at the time of closure.

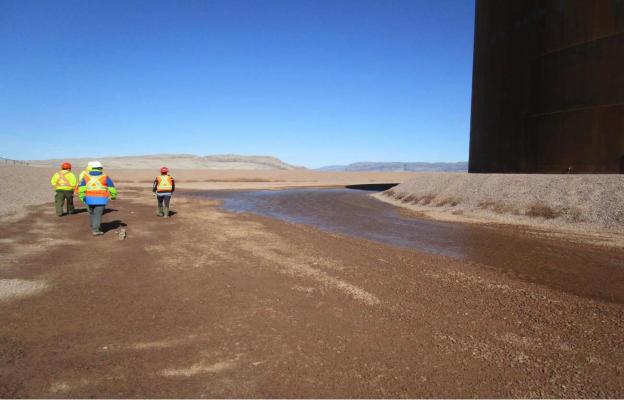
Fuel Tank Farm Containment.

It was noted that the sump placed in the facility was located at the high end of the containment. There was water observed ponding in the low end of the containment. It was recommended that the sump be relocated to the low point at the north end of the containment or an addition sump be installed.

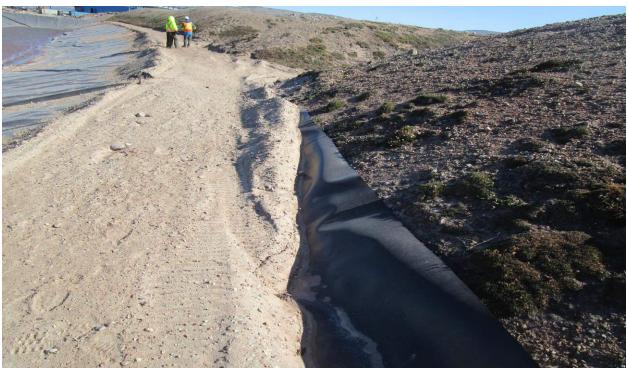
West Settling Pond – "Tuck-in" liner this location.

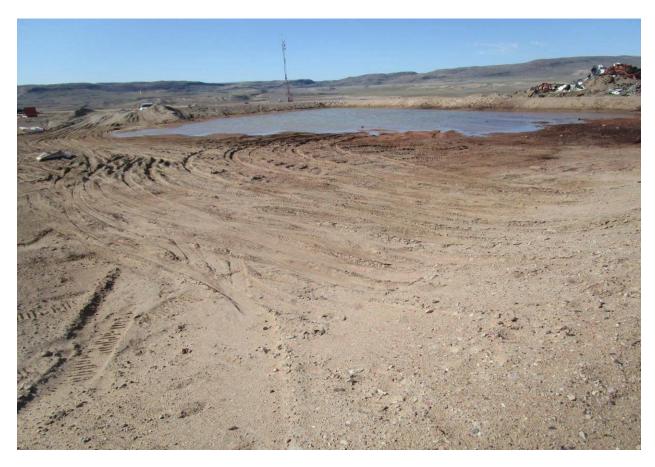
Contaminated Snow Melt Containment.

There were concerns noted regarding the stability of the liners. It was recommended that more soil ballast on the south edge be applied and possibly tire ballast over the liner which appears subject to impacts from wind. Used tires were suggested for this purpose.

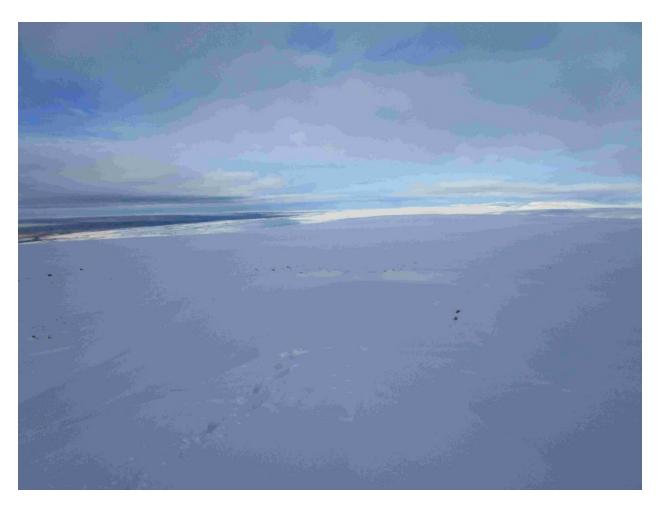
Mary River Quarry Bench Undermining

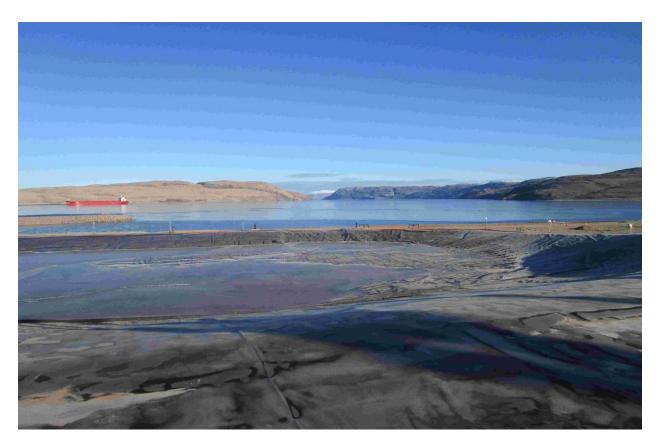
Indicates Movement in Anchorage at Sediment Pond East
