## **Appendix A      Photolog from 2023 Visit – Goose**

Back River Project

2023 Annual Geotechnical Inspection

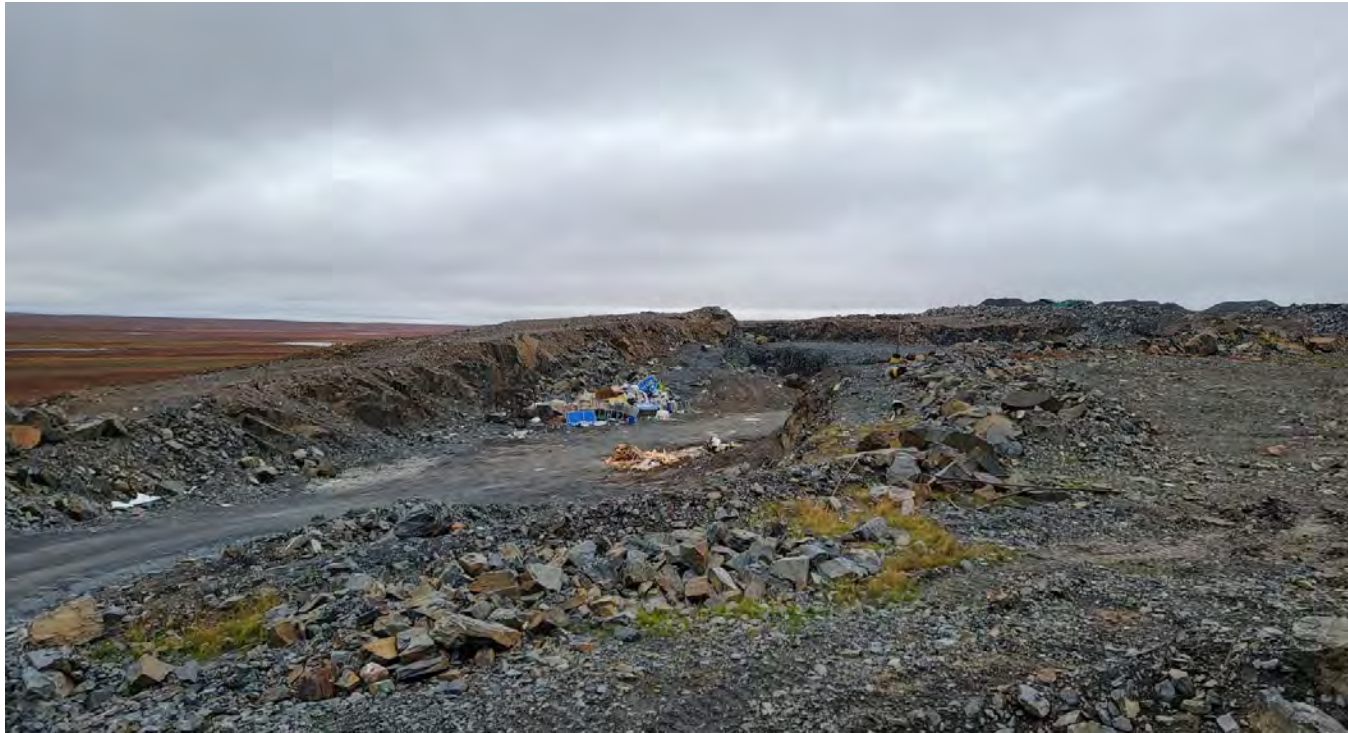
**G-1.** – Access road to Goose Quarry looking south

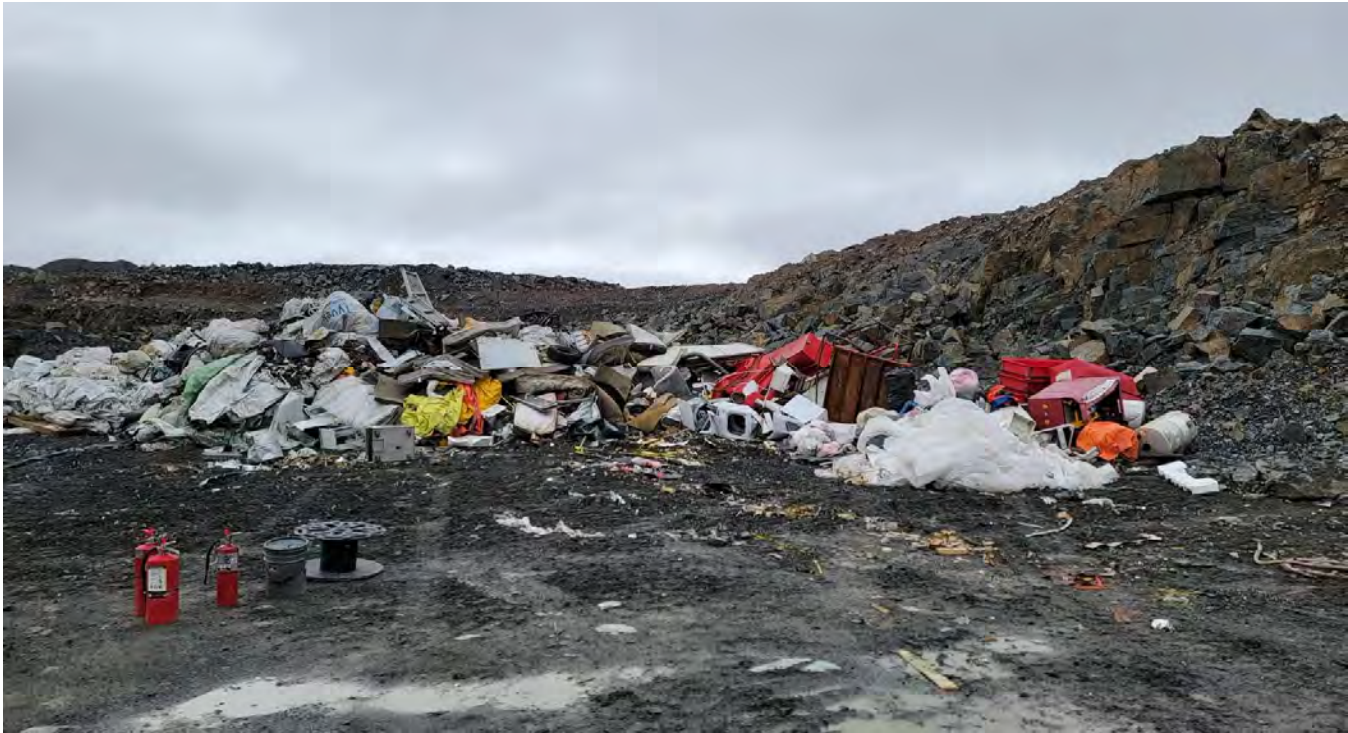
**G-2.** – A quarry is currently being used as a temporary disposal area for refuse, looking west

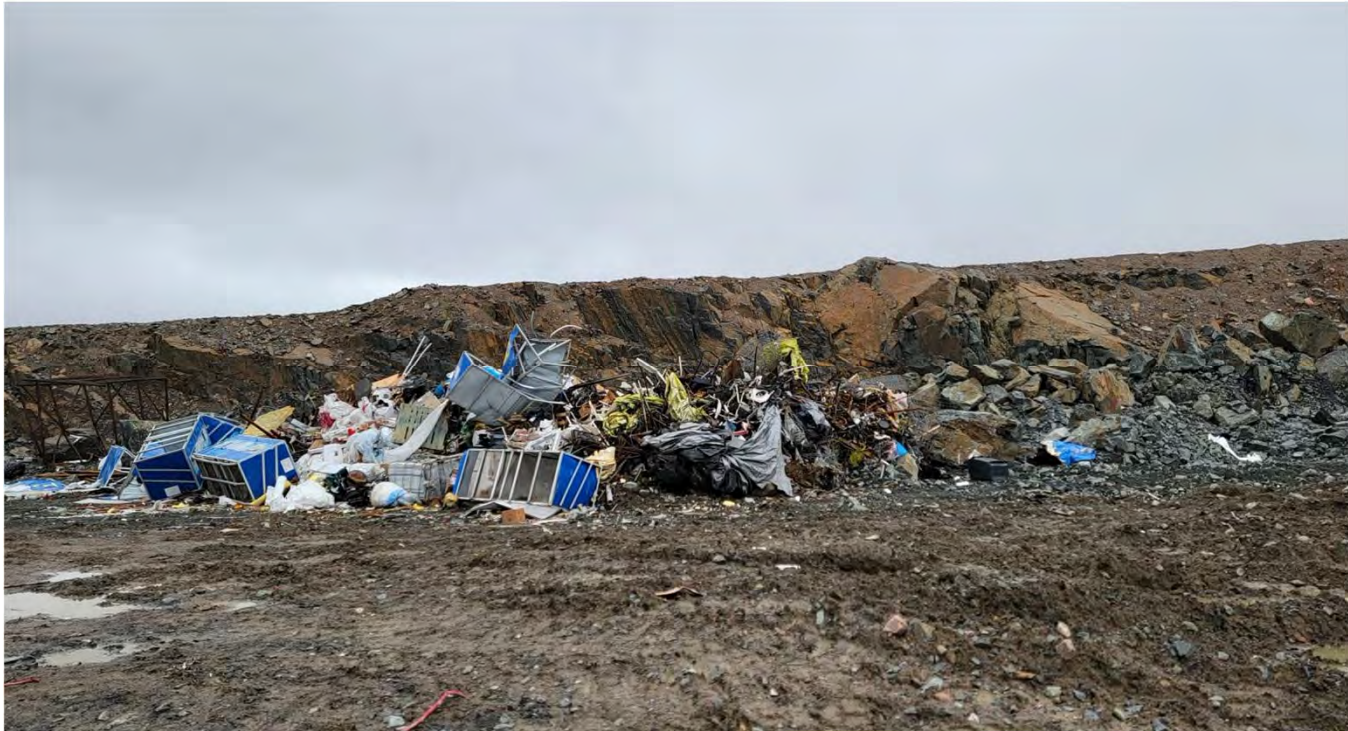
**G-3.** – A pile of refuse at the toe of the eastern wall

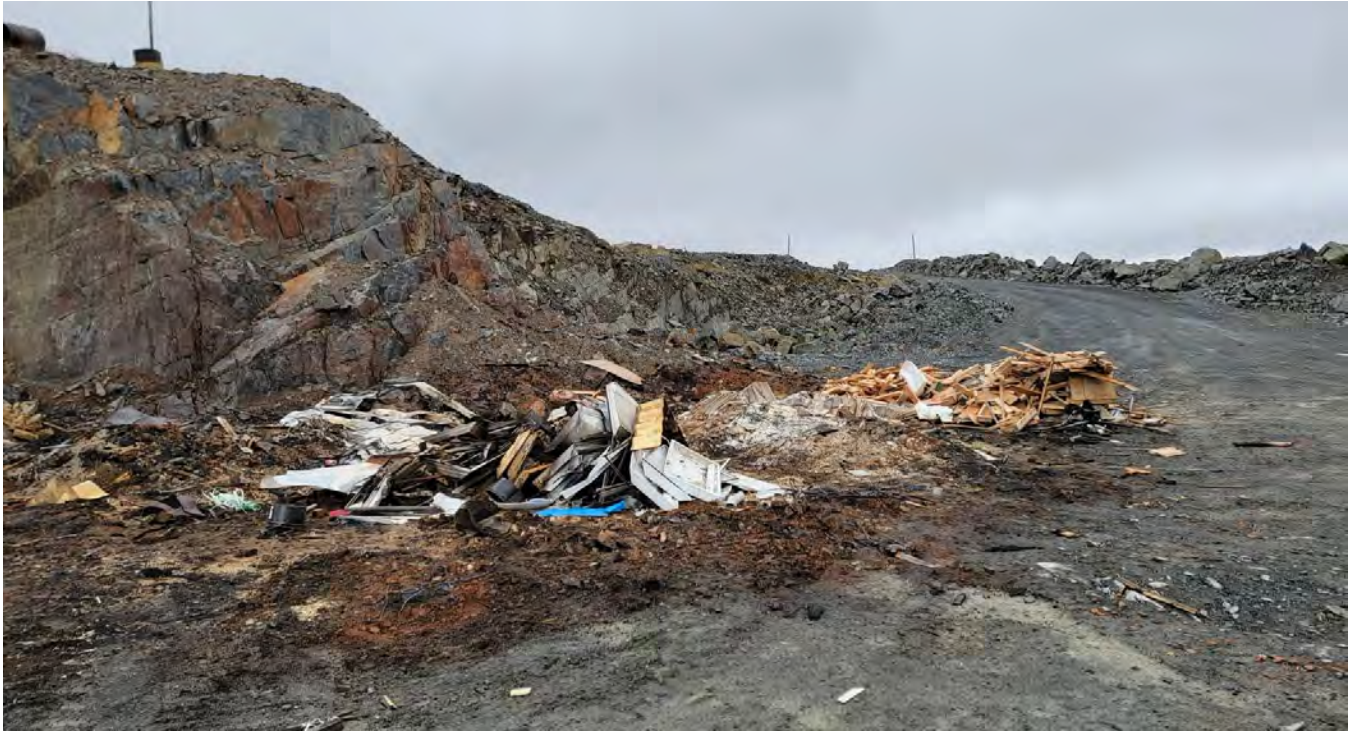
**G-4.** – A pile of refuse at the center of the base

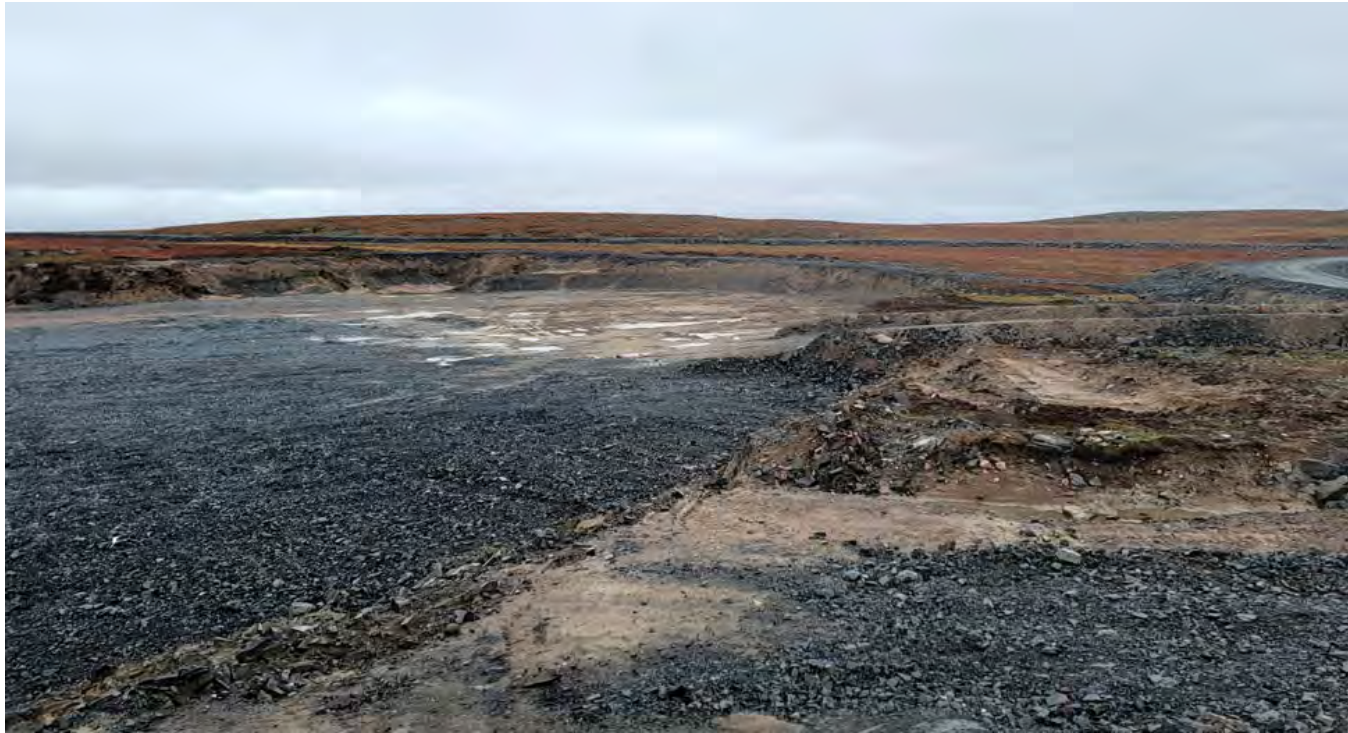
G-8. - Echo Pit, looking SE

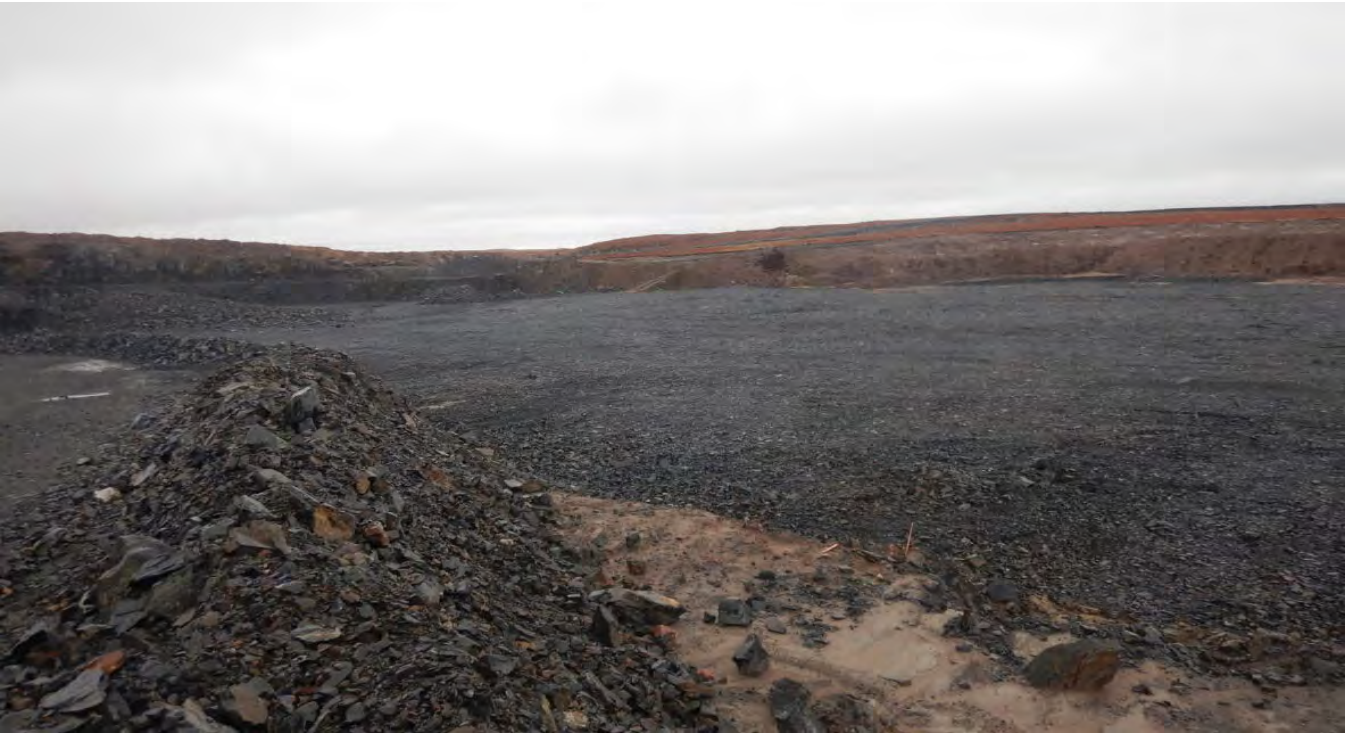
G-9. – Echo Pit base, looking SW

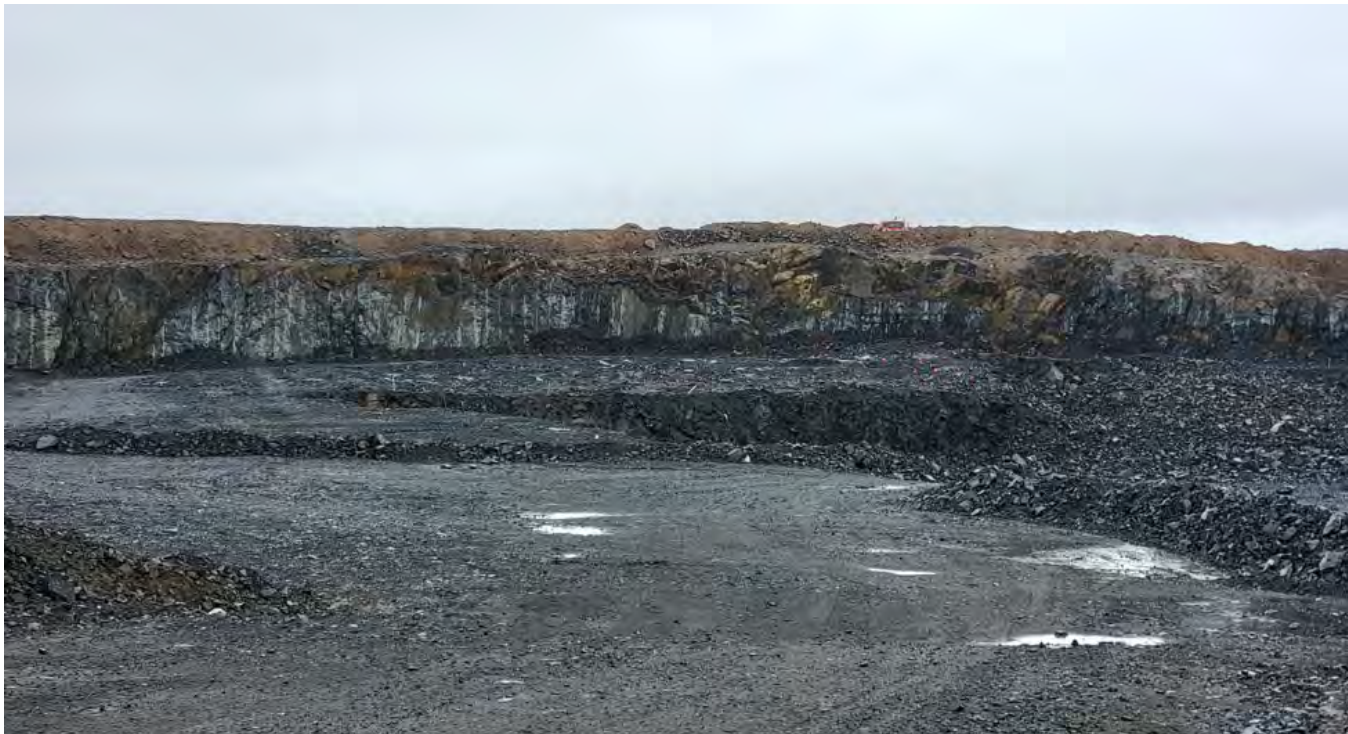
G-10. – Eastern wall of the pit

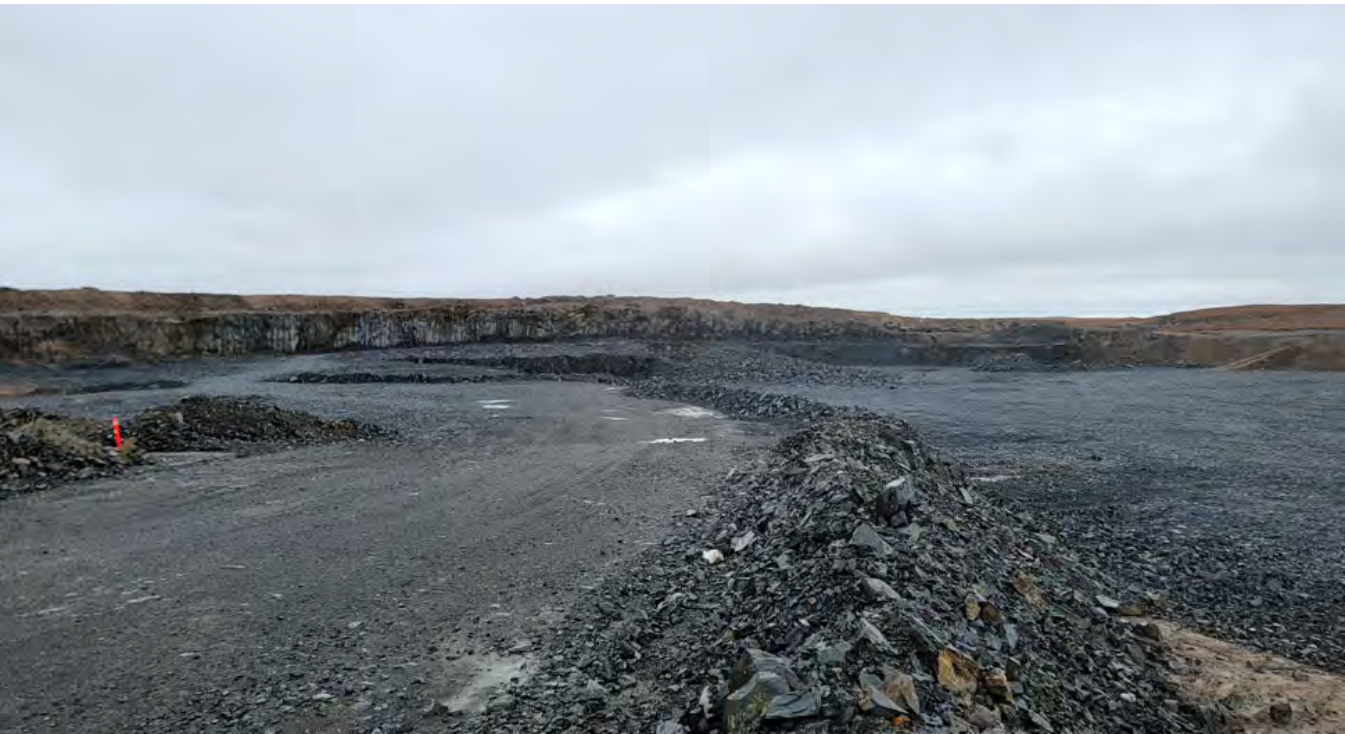
G-11.- Southern wall of the pit

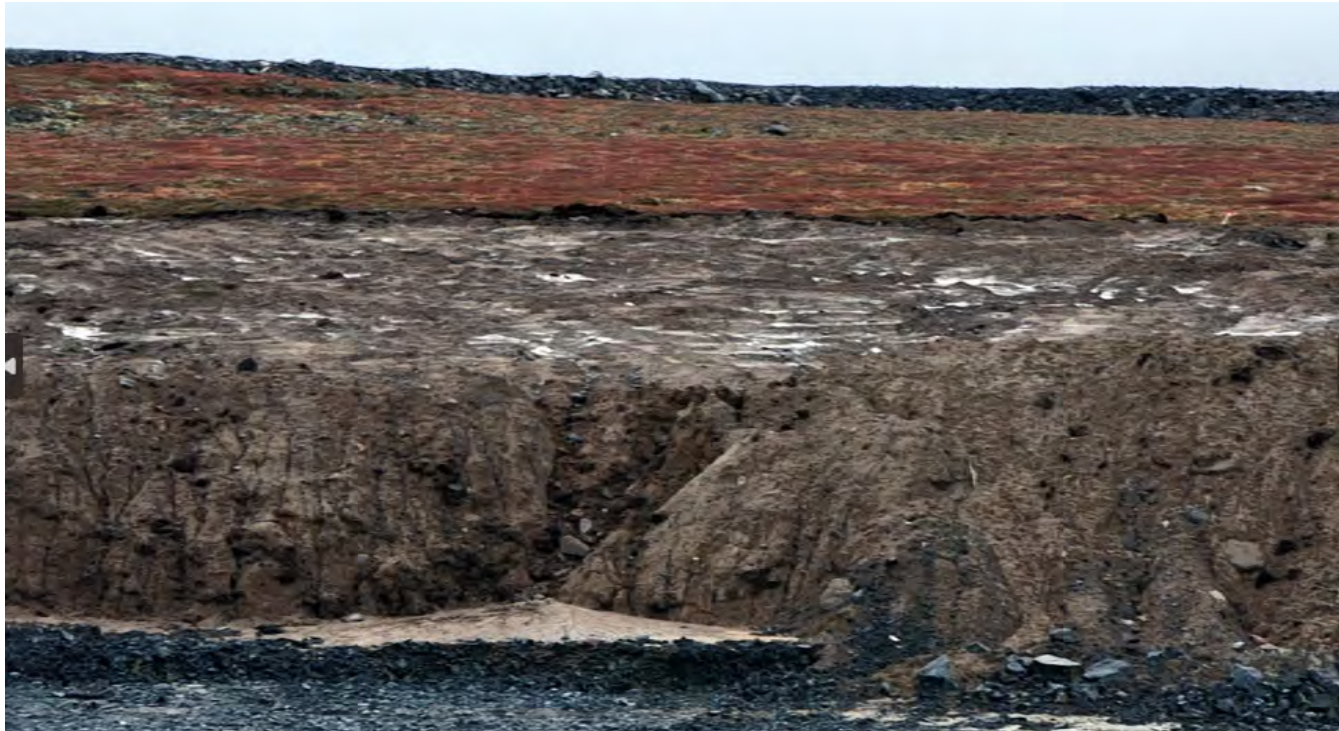
G-14. Erosion gullies at the SSW wall of Echo Pit

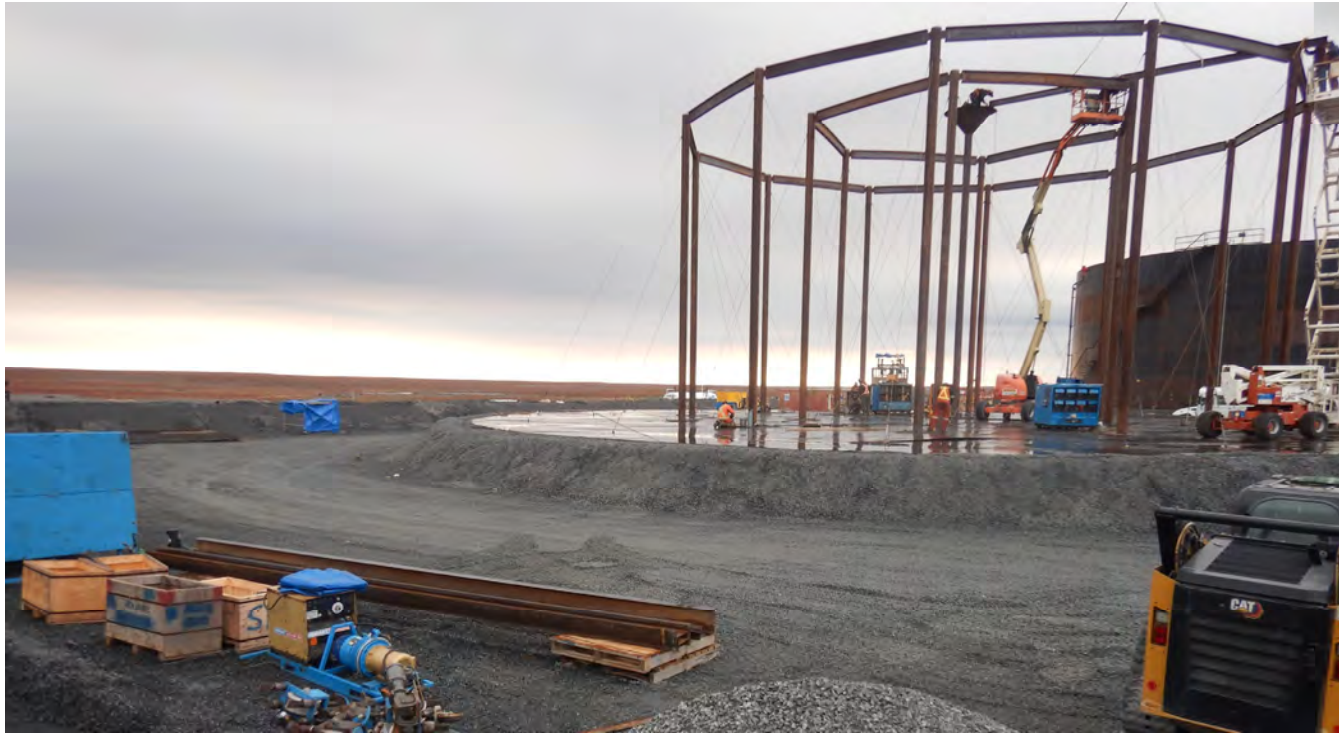
G-33. – Pedestal of Tank #2, looking west

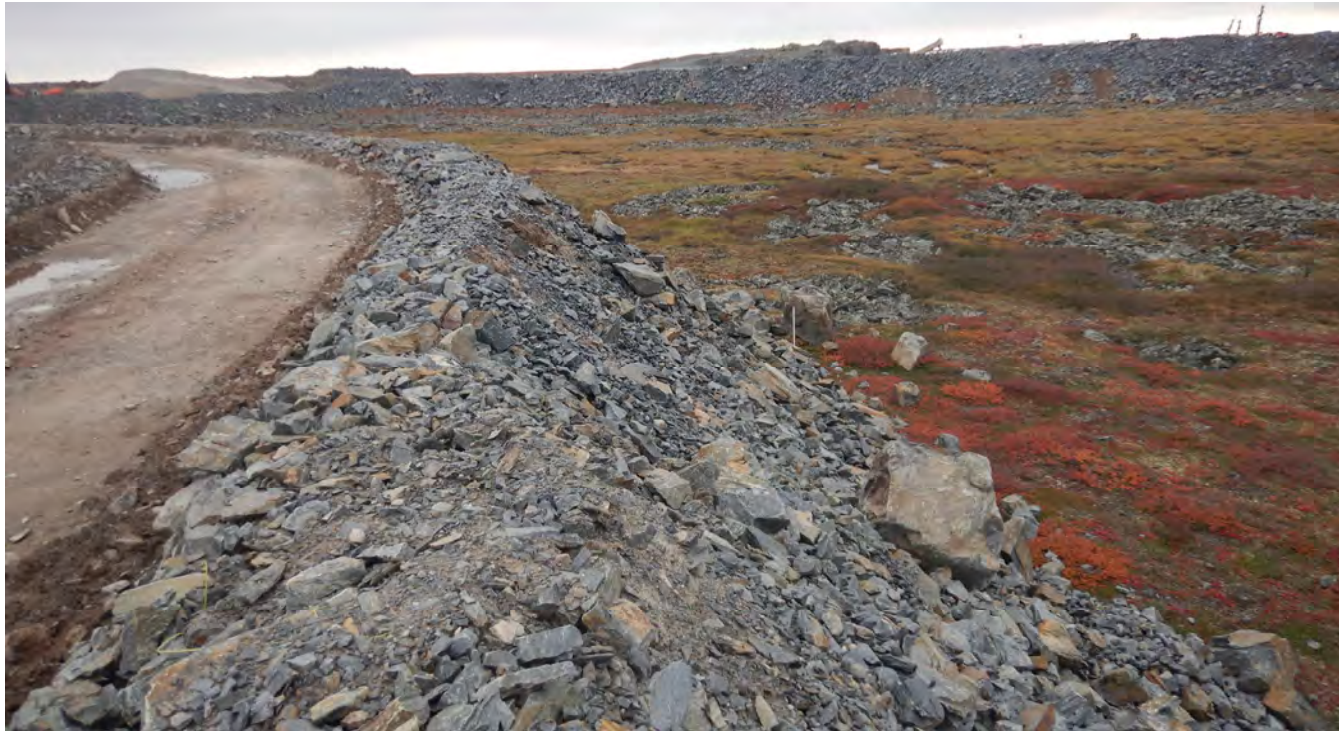
G-43. - Berm of the CWP. Western slope. Photo was taken looking W

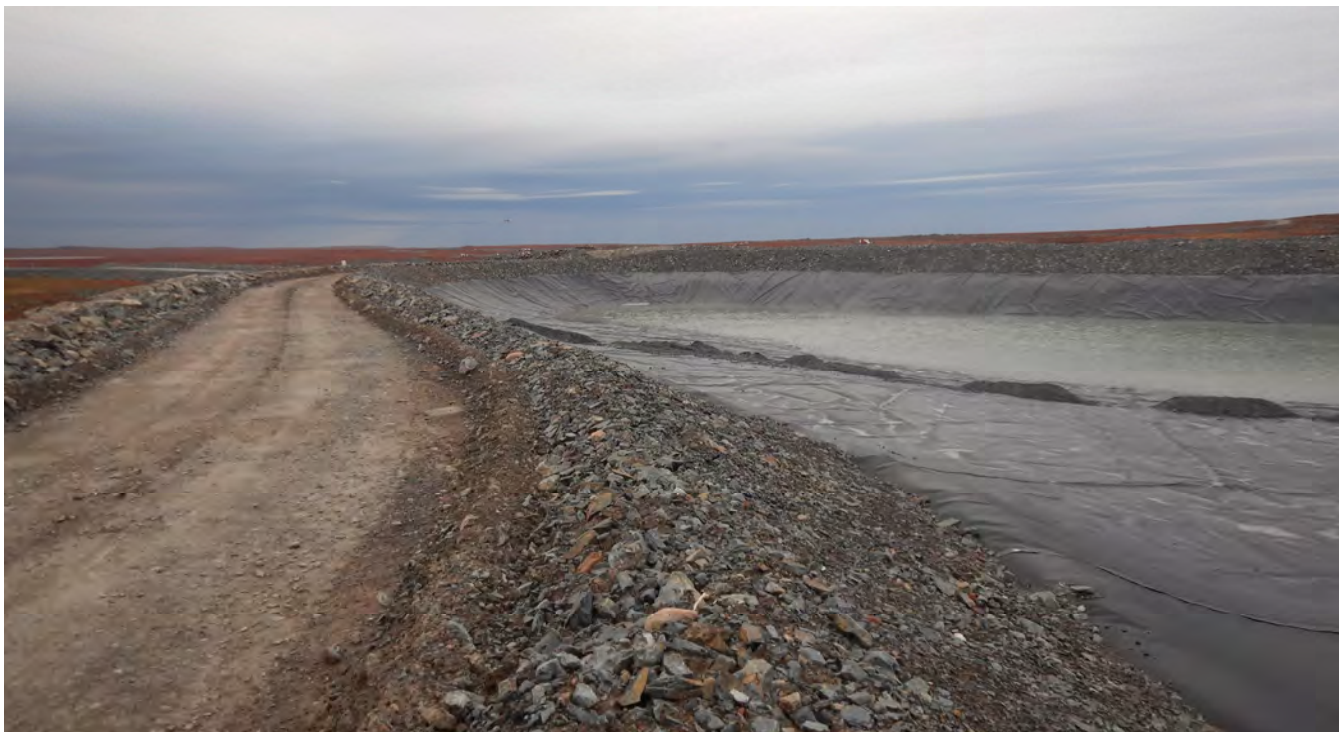
G-45 . Berm of the CWP. Eastern slope. Photo was taken looking E

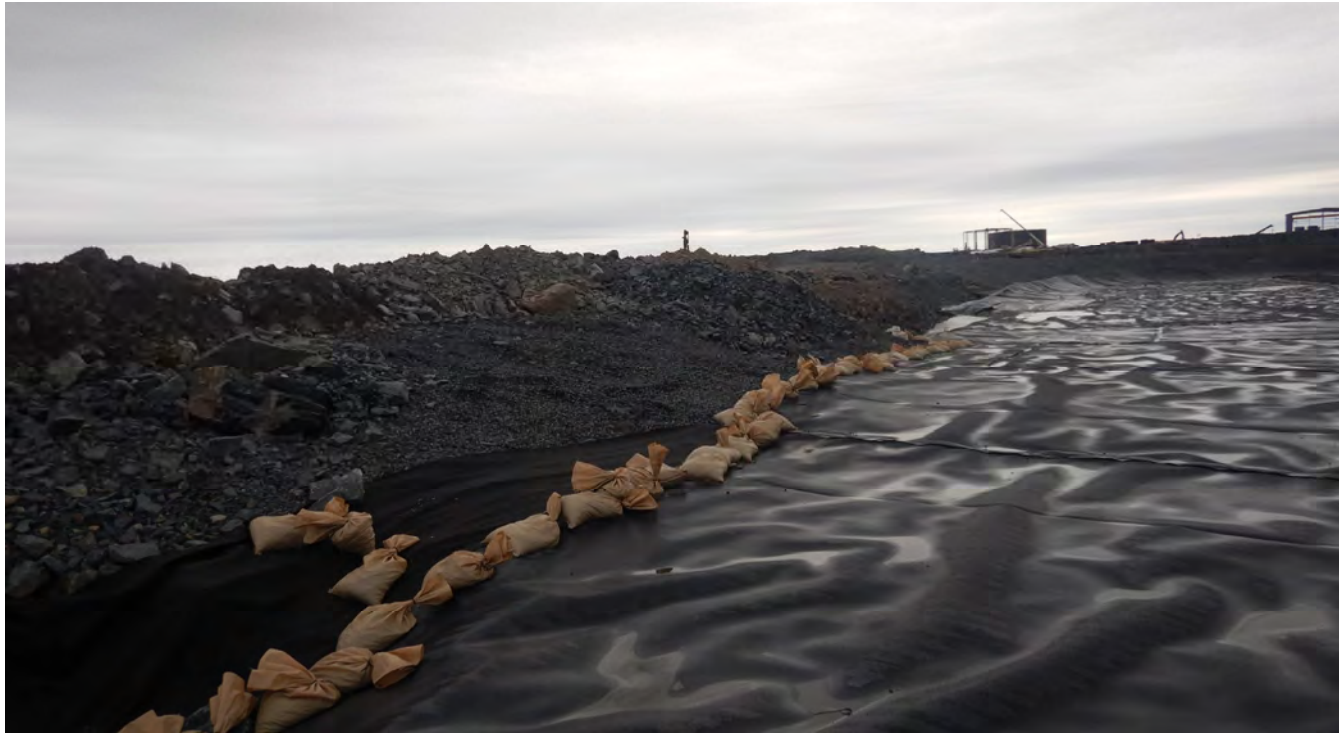
G-47 – Eastern berm of Camp Pas CWP, looking SW

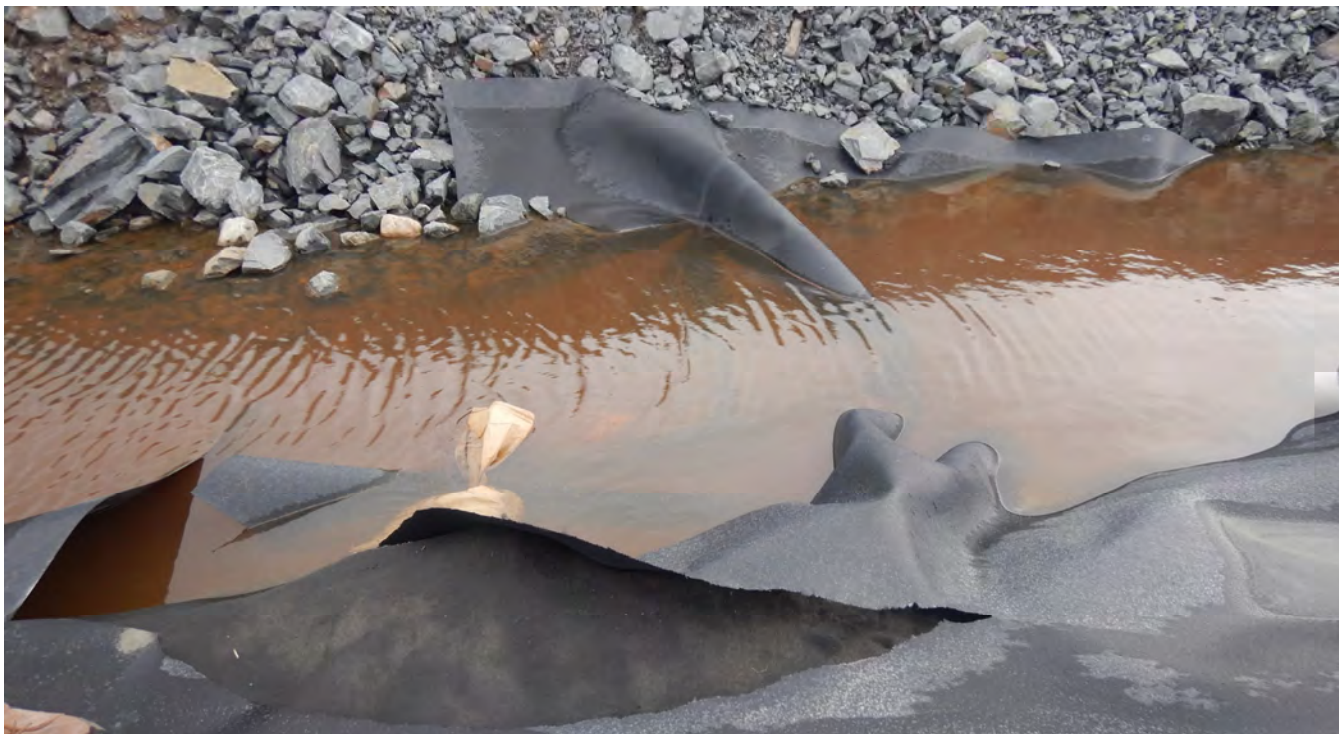
G-49. – HDPE liner is not anchored to the berm

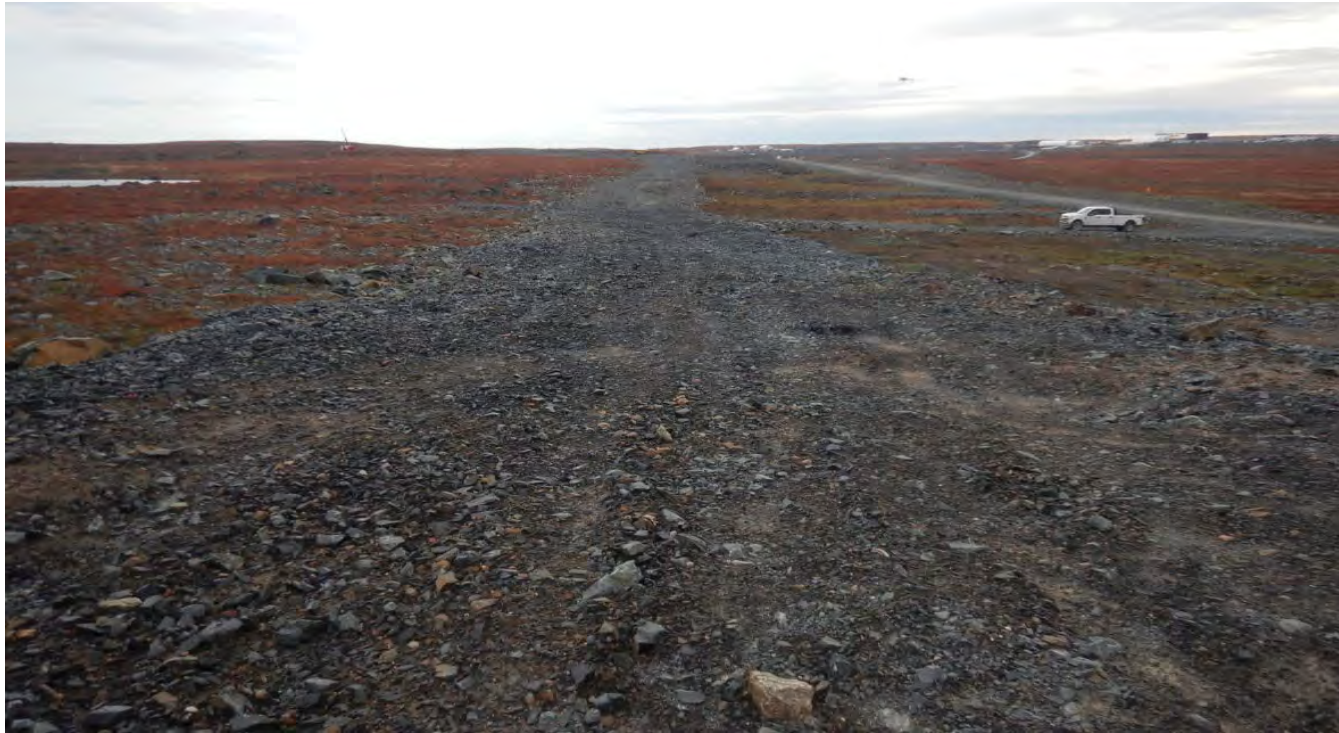
G-51. - A temporary access road at the upstream side of the key trench was built in Jan 2023, looking SE (approx. between Sta 0+50 and 0+150)

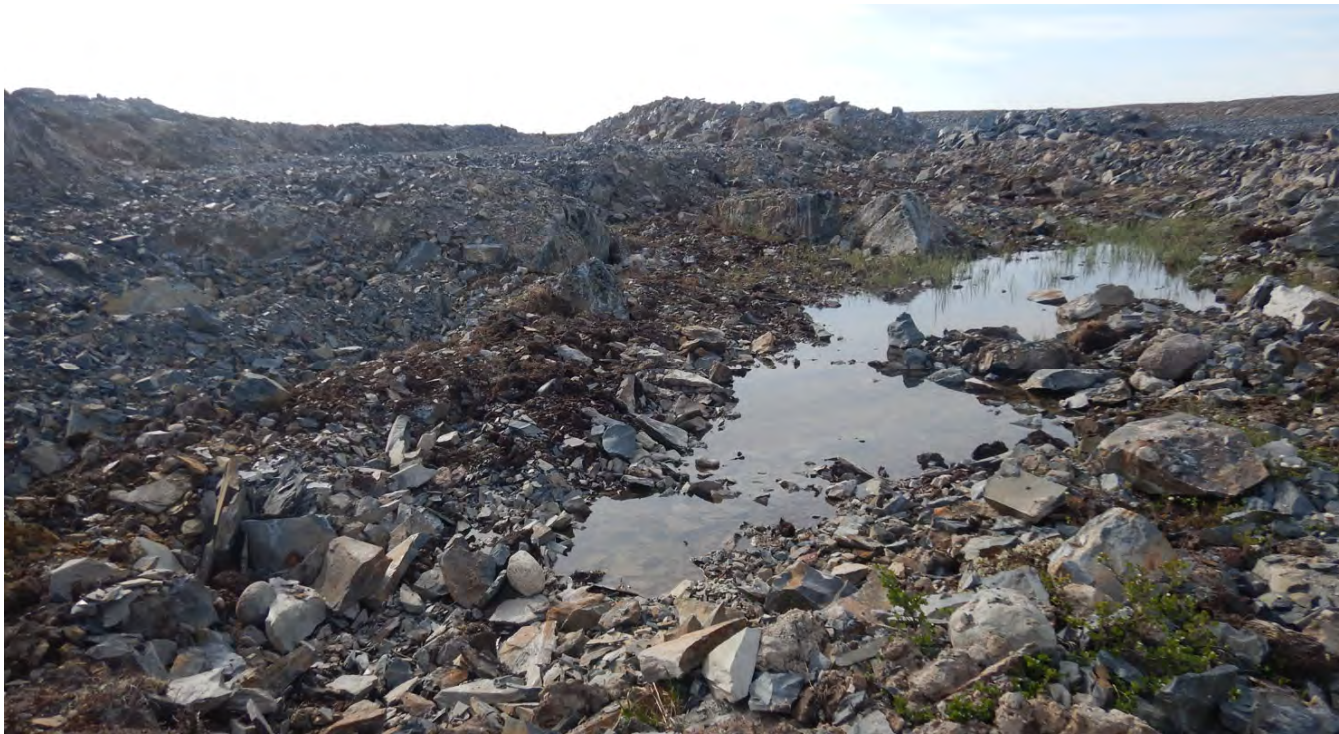
G-53.- Ponding water at the upstream side of the key trench approx.at Sta 0+250

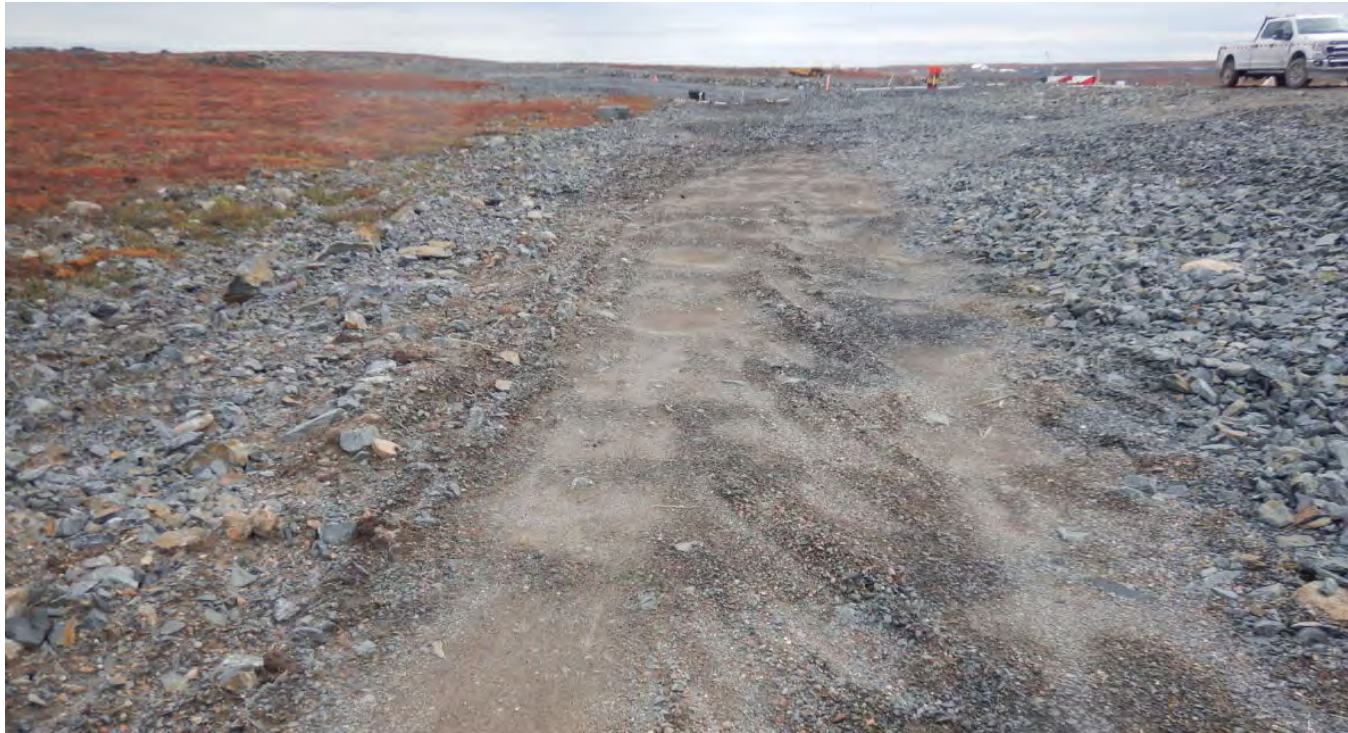
G-55. - Temporary Road along the upstream side of the key trench approx. at Sta 0+400

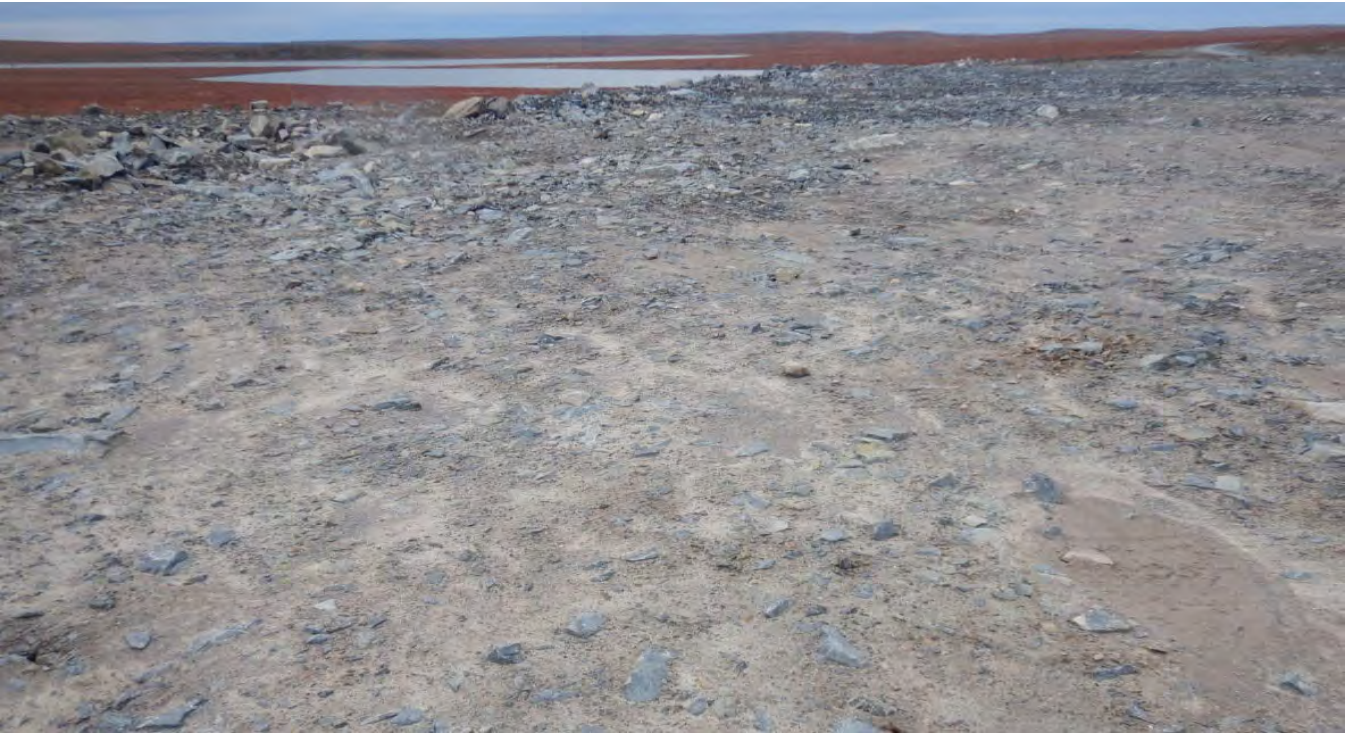
G-56. – Key trench winter cover approx. at Sta 0+410. Note the high overburden content in the ROQ/ROM

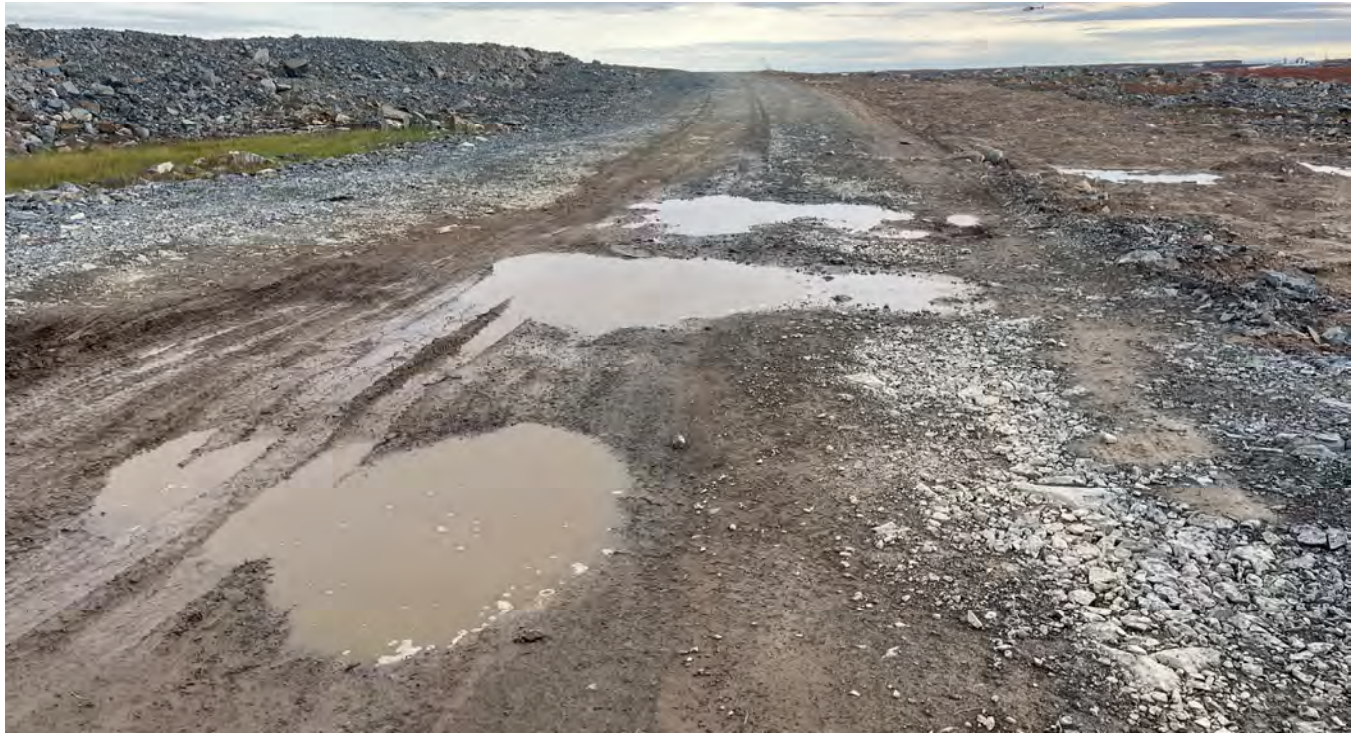
G-72. - Road embankment undulation

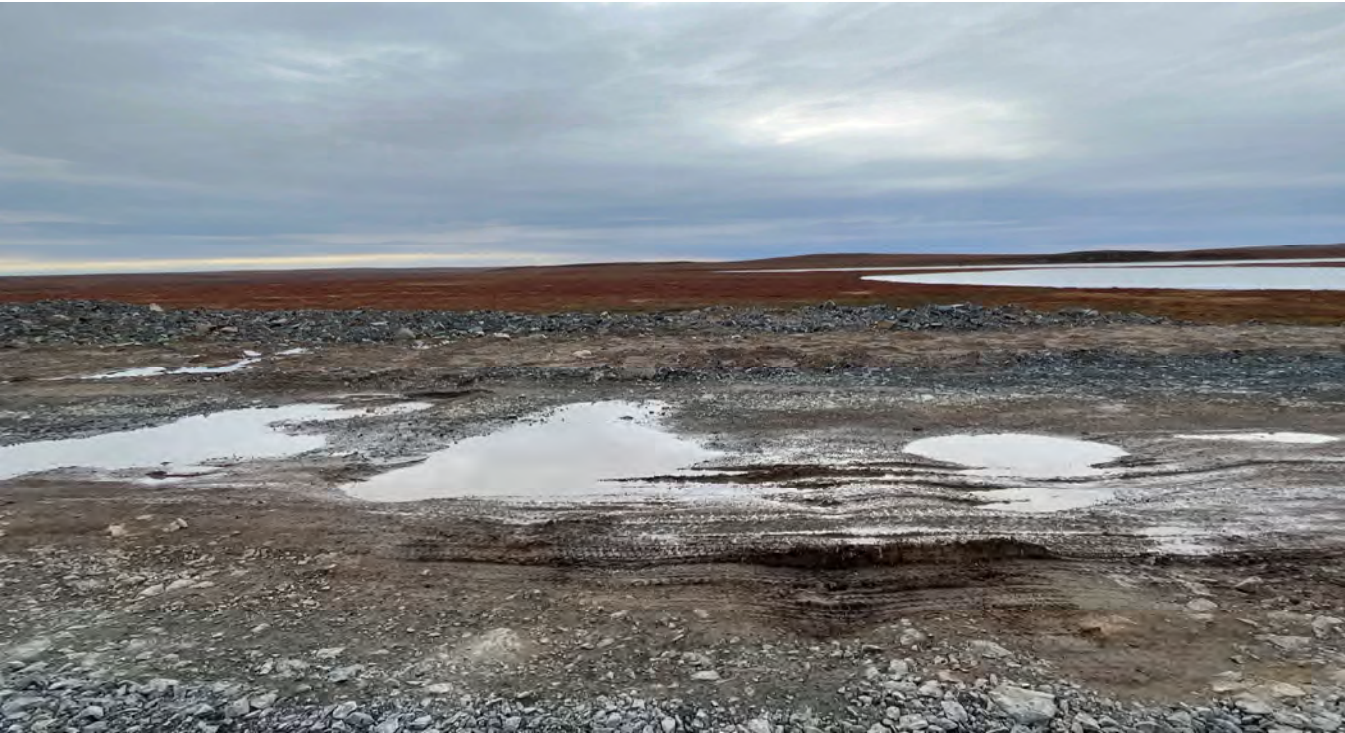
G-73. - Road embankment undulation

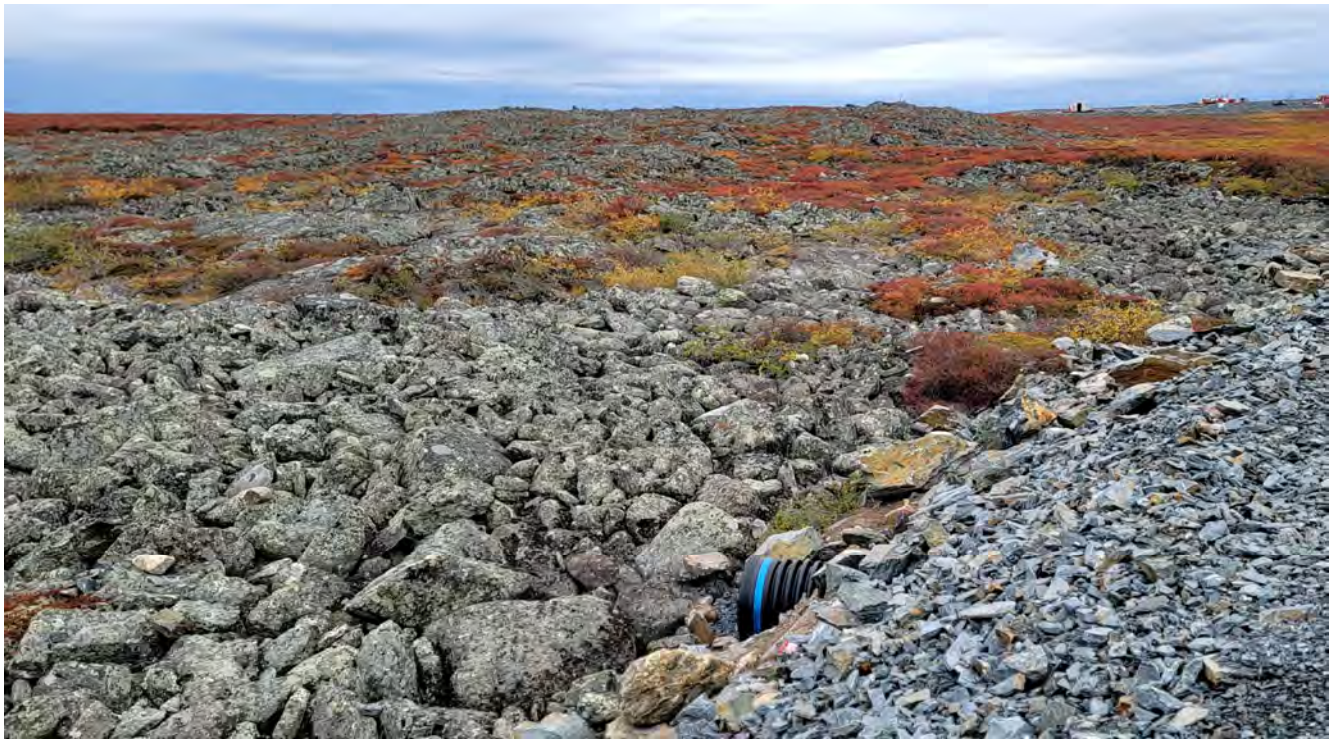
G-76. - Culvert. Inlet

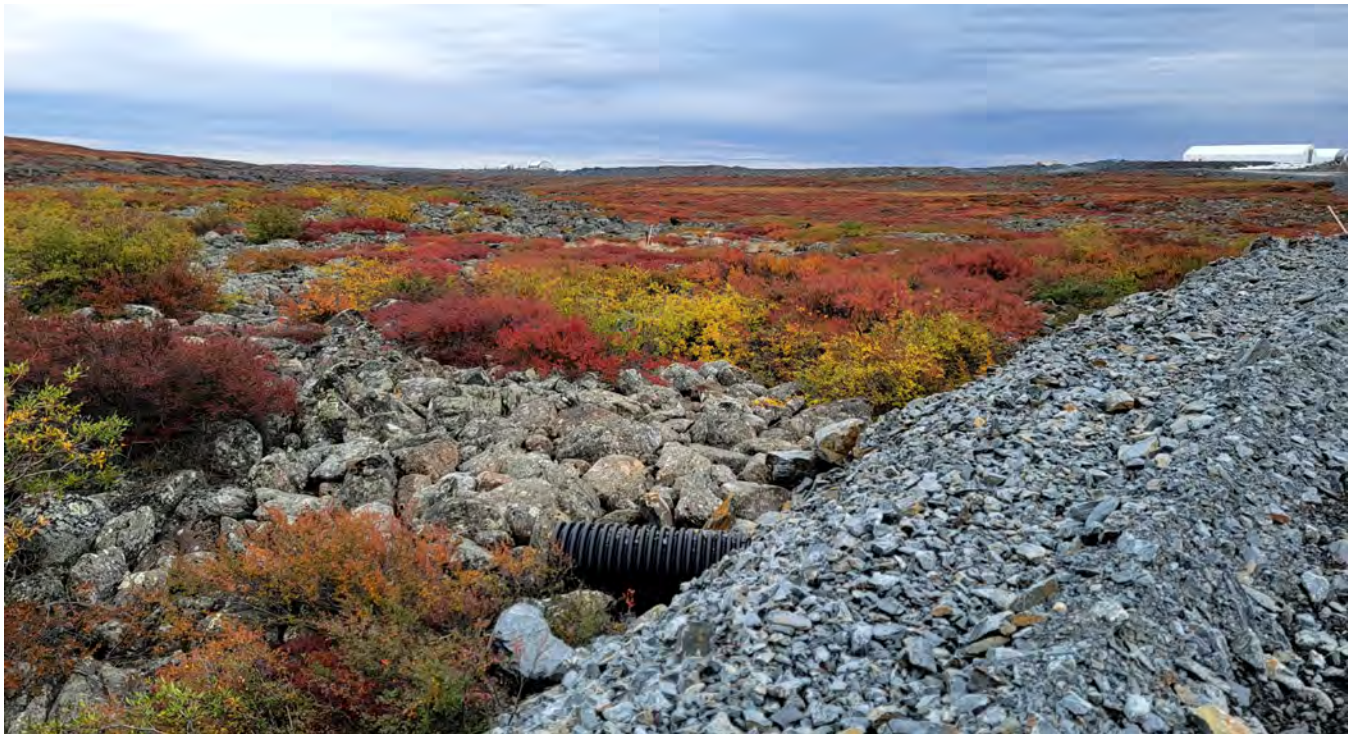
G-78. - Culvert. Inlet

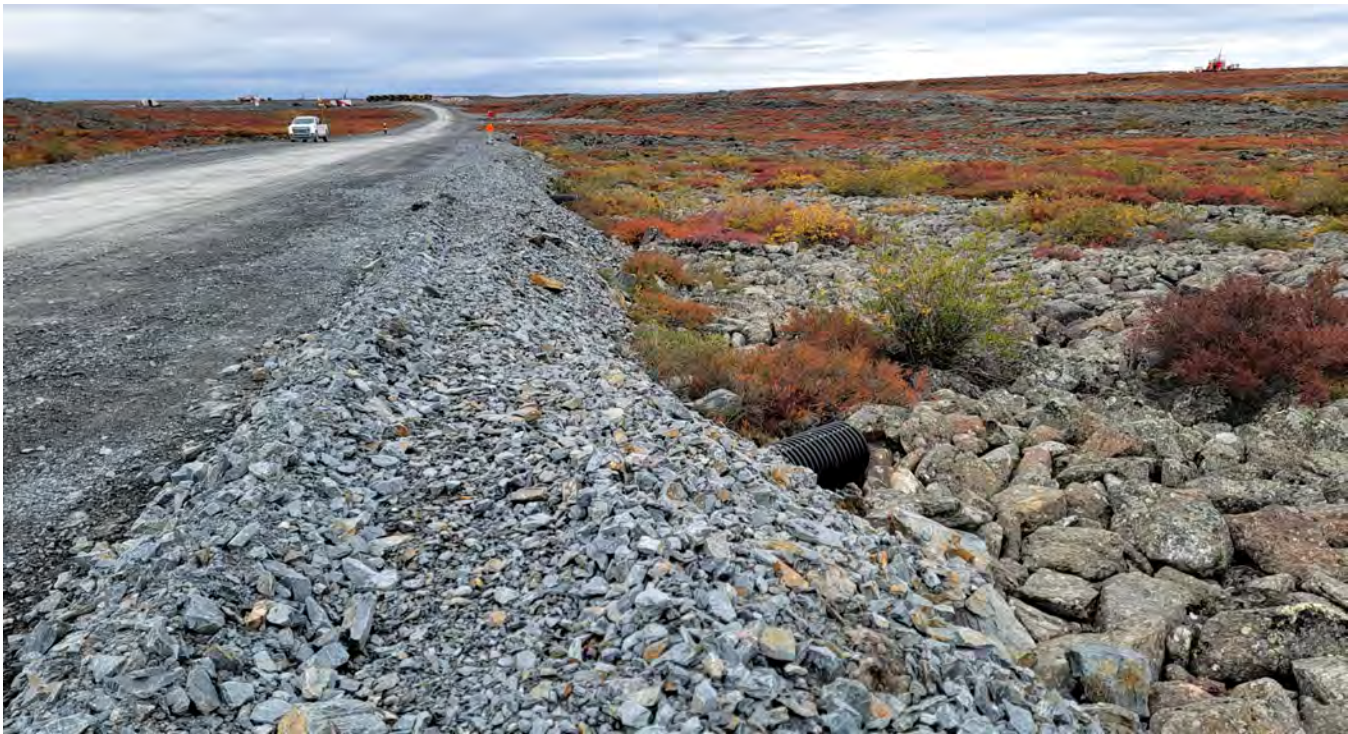
G-79. - Culvert. Outlet
