## **Appendix A      Photolog from 2023 Visit – Goose**

Back River Project

2023 Annual Geotechnical Inspection

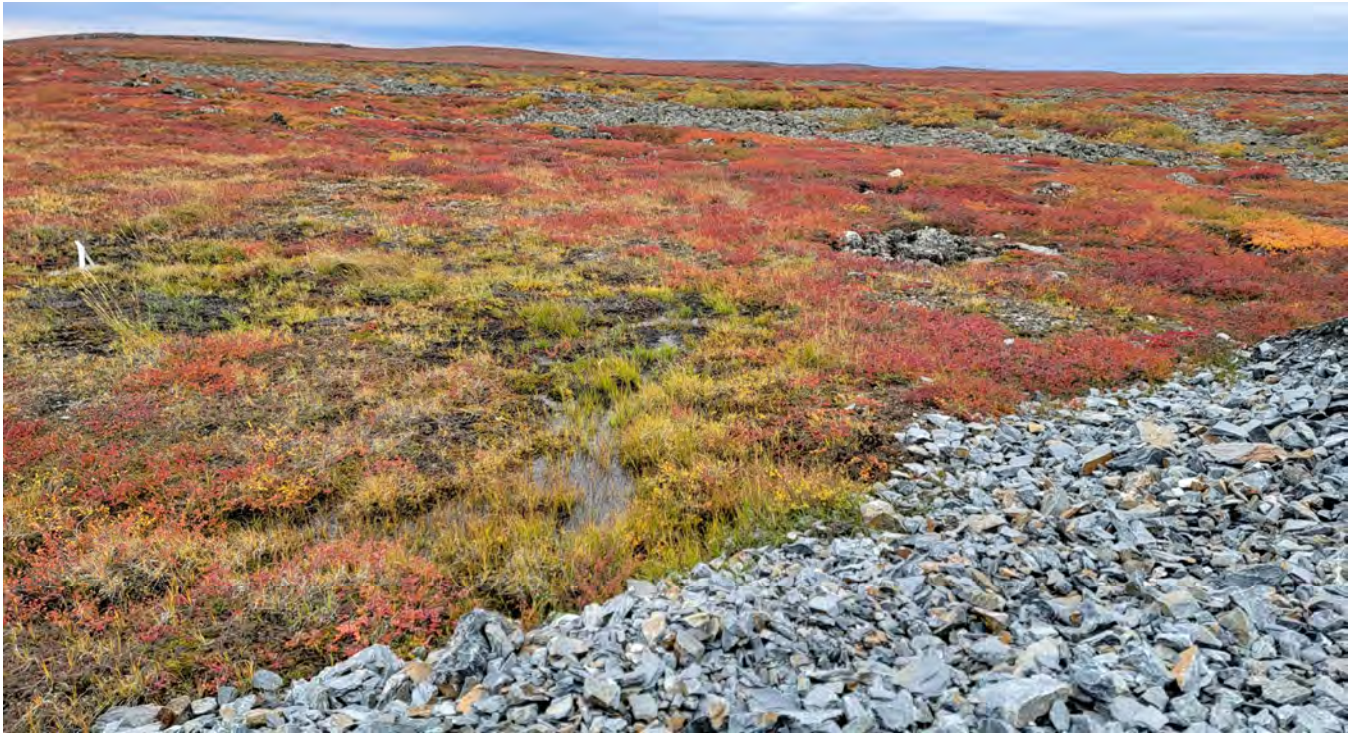
G-87. – Ponding waters at the eastern side of the road

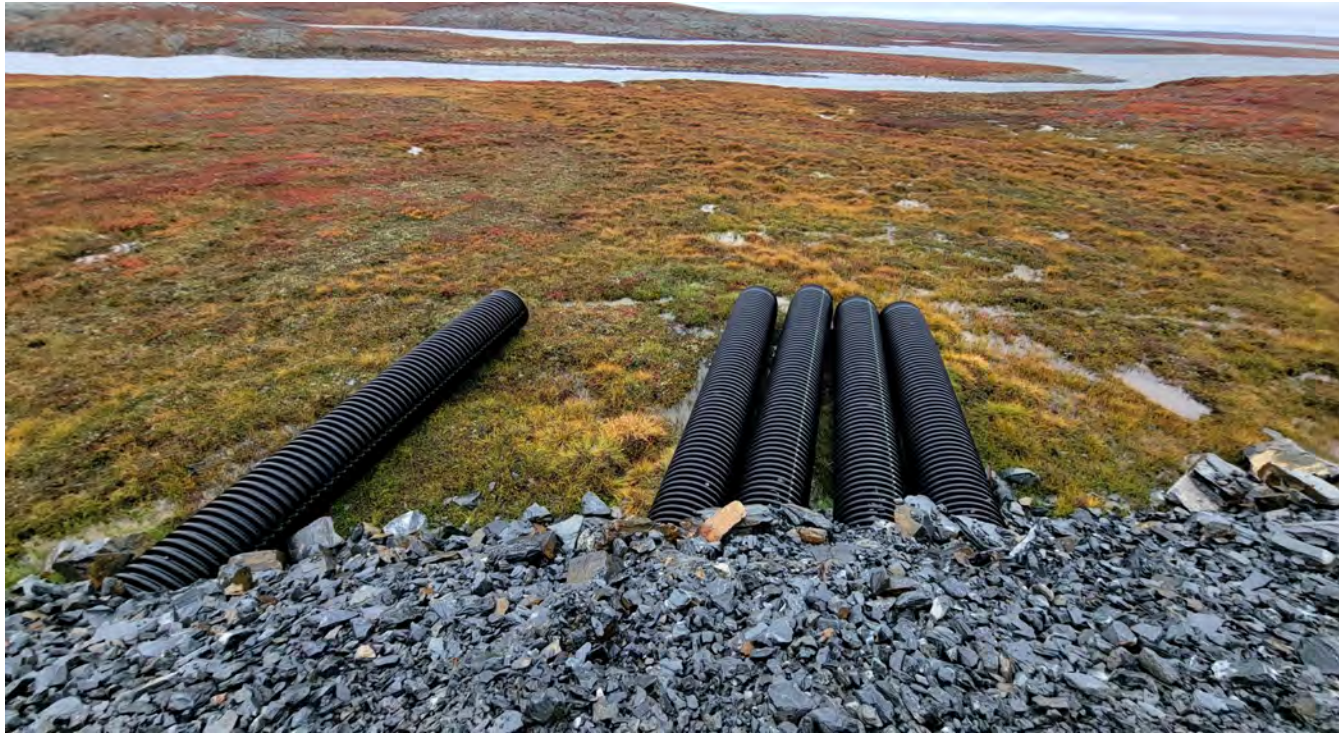
G-89. – Culvert: Outlet. Note some ponding water at the toe of the road

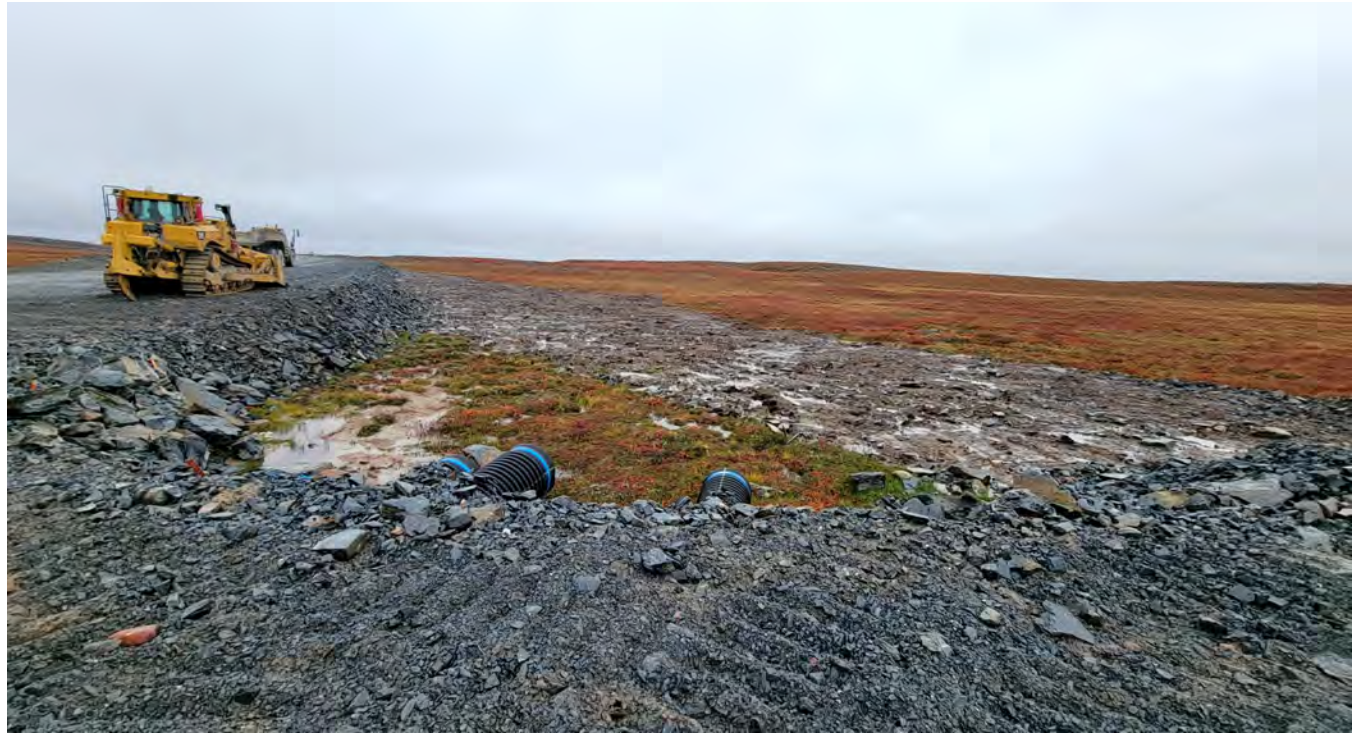
G-90. – Culvert: Inlet

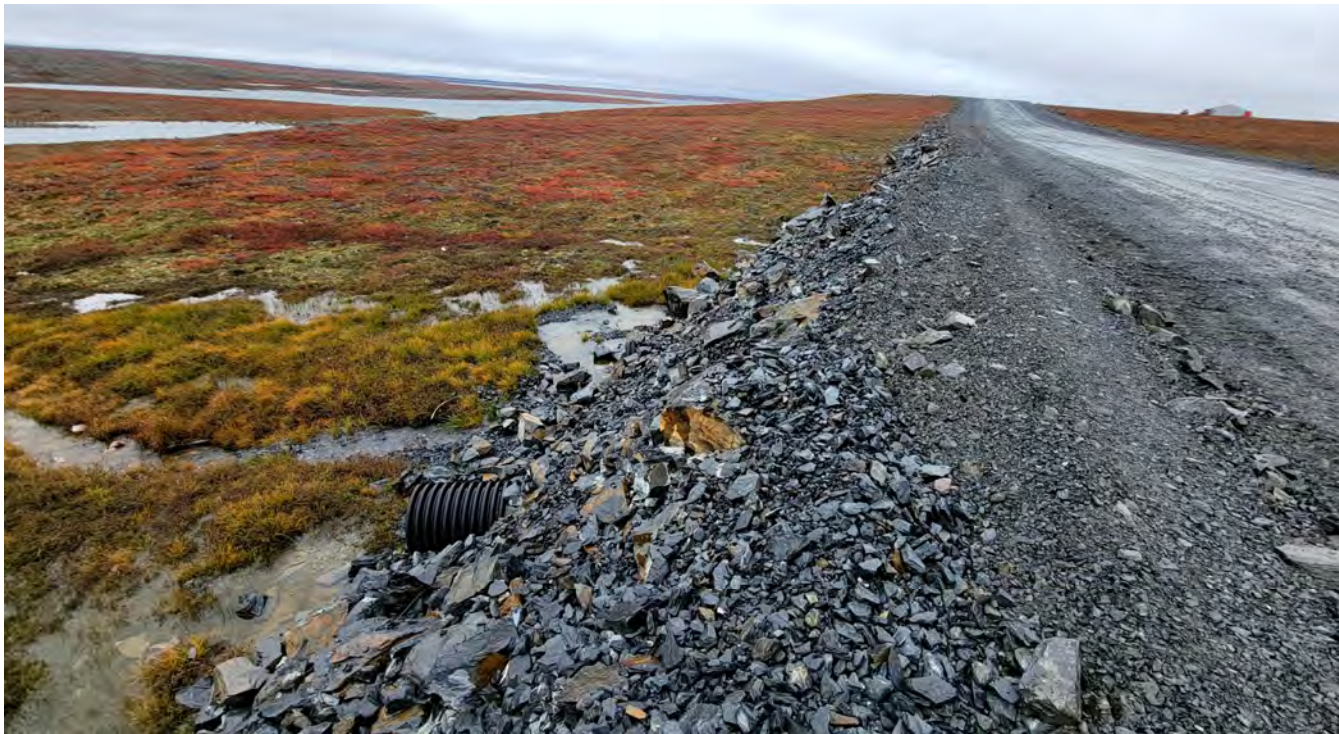
G-91. – Culvert: Inlet. Note some ponding water at the toe of the road

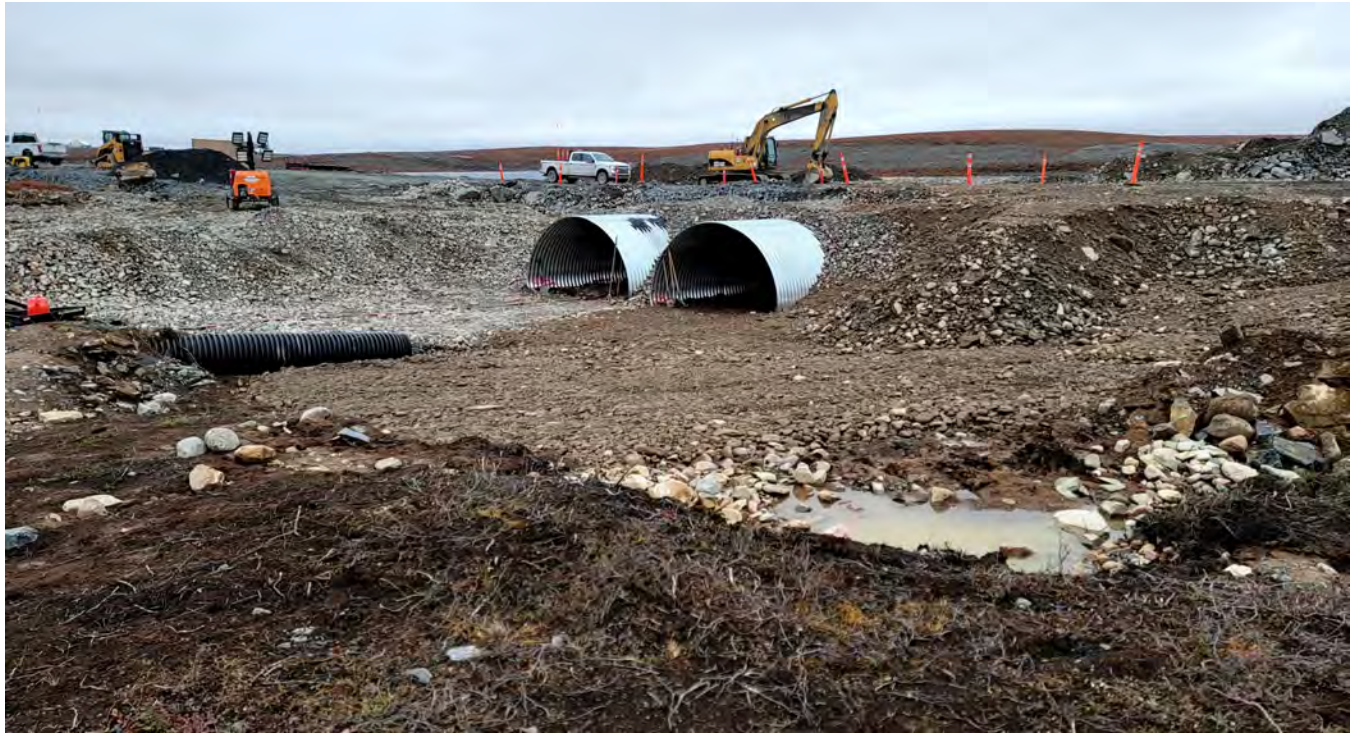
G-93 – Culverts: Outlet

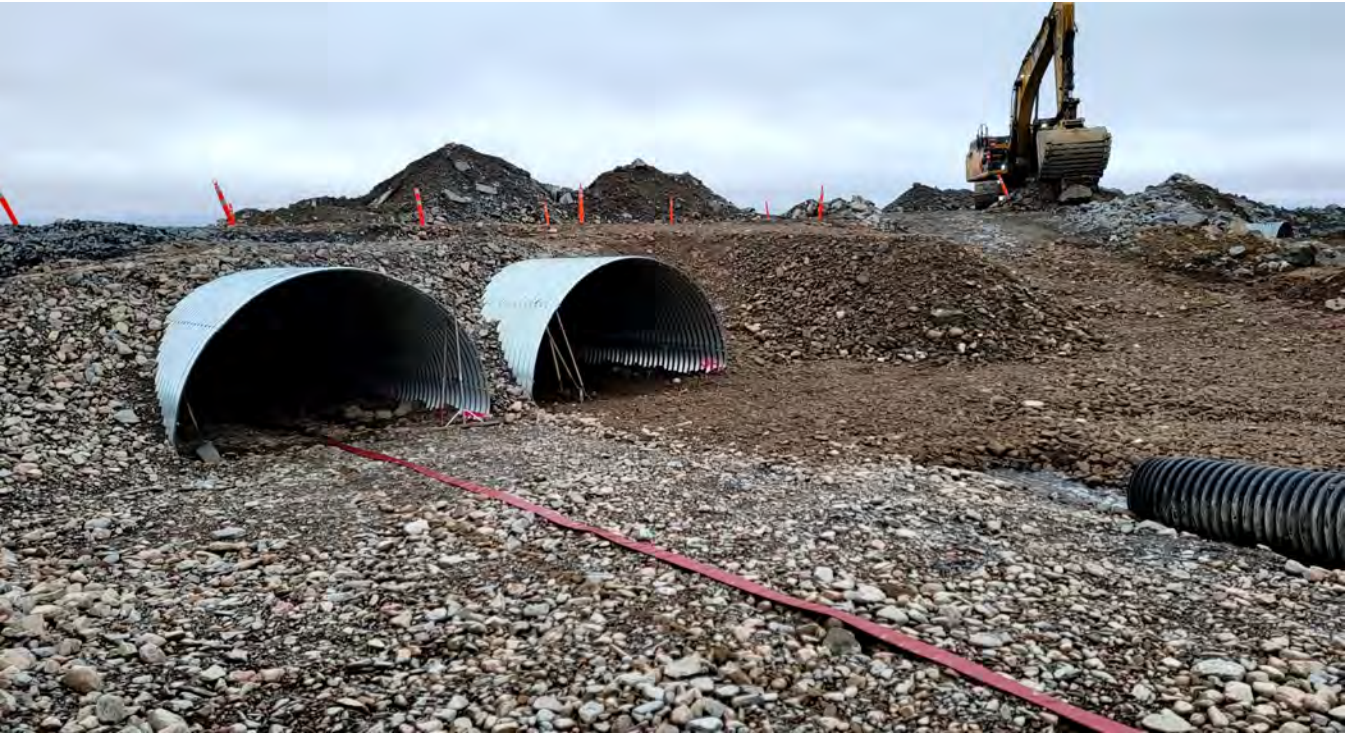
G-94. – Culverts: Inlet

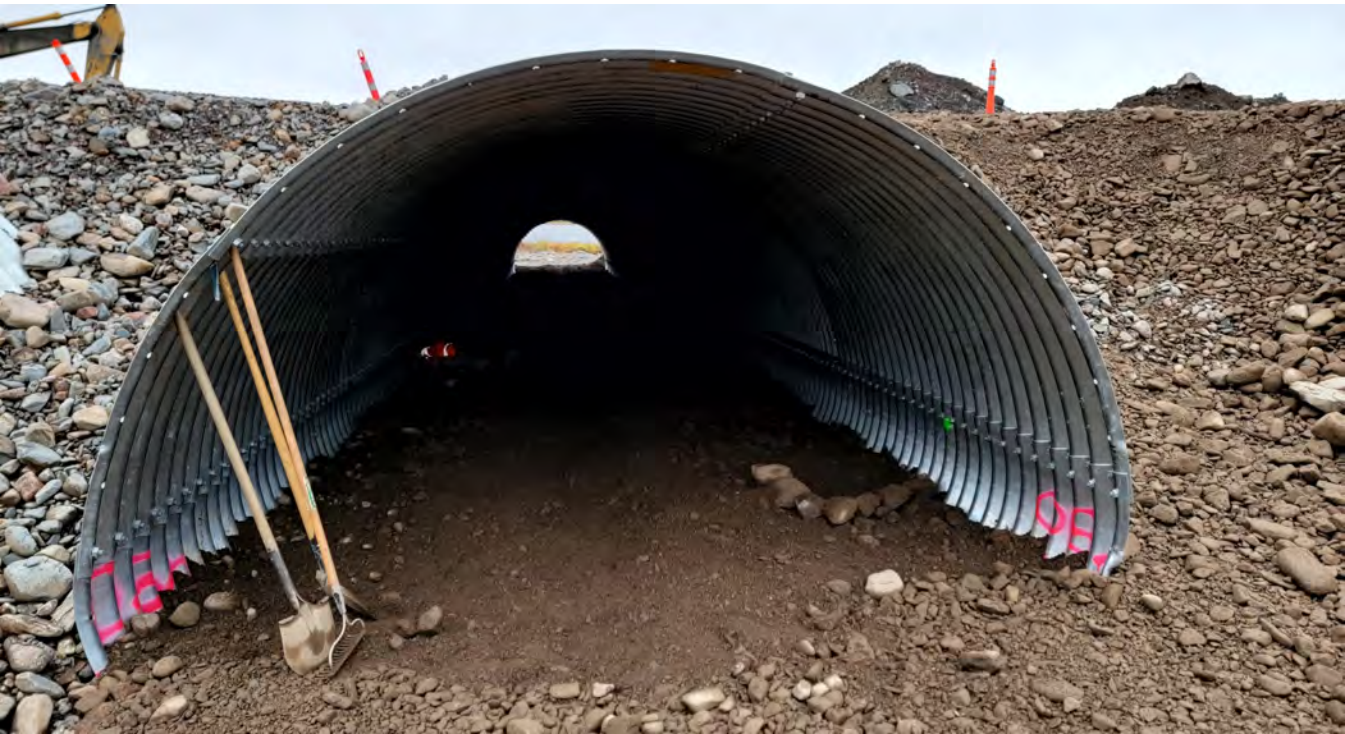
G-96. Base of the culvert #2
