Goose & MLA Project Sites – 2024 Annual Geotechnical Inspection

Back River Project, Nunavut, Canada
B2Gold Corp.

SRK Consulting (Canada) Inc. ■ CAPR003105 ■ April 2025

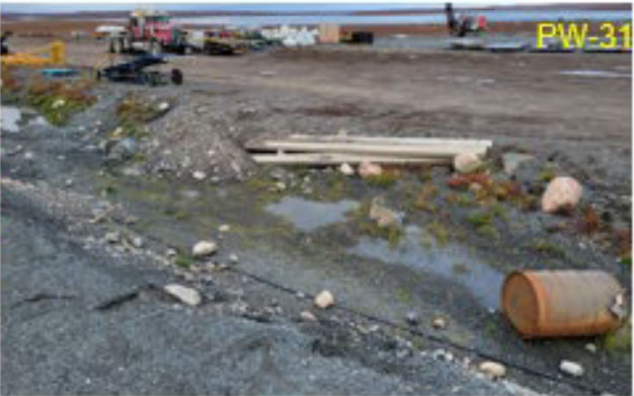
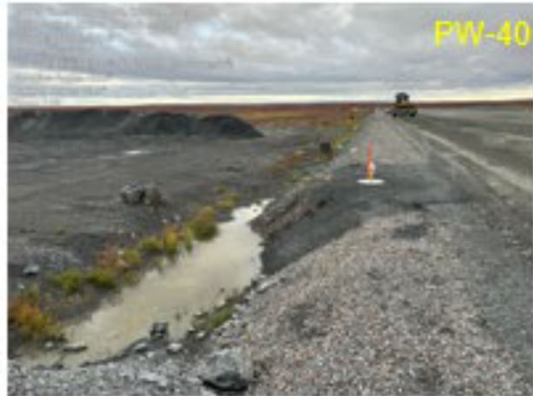
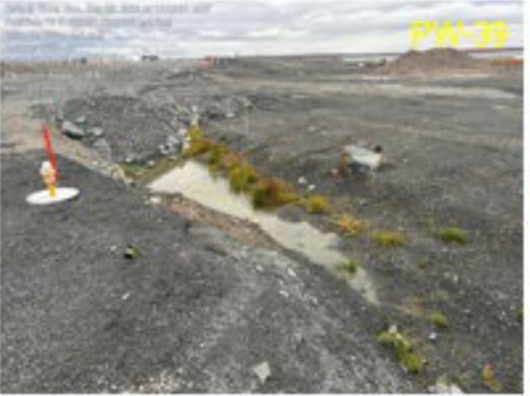
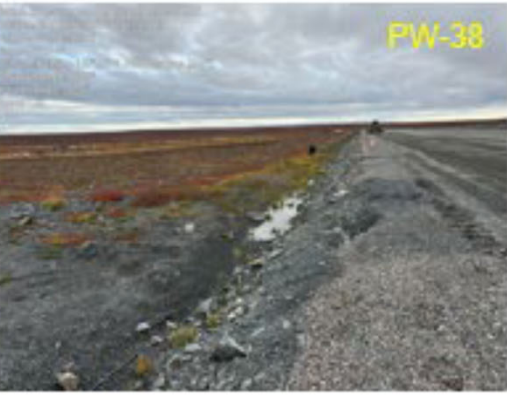
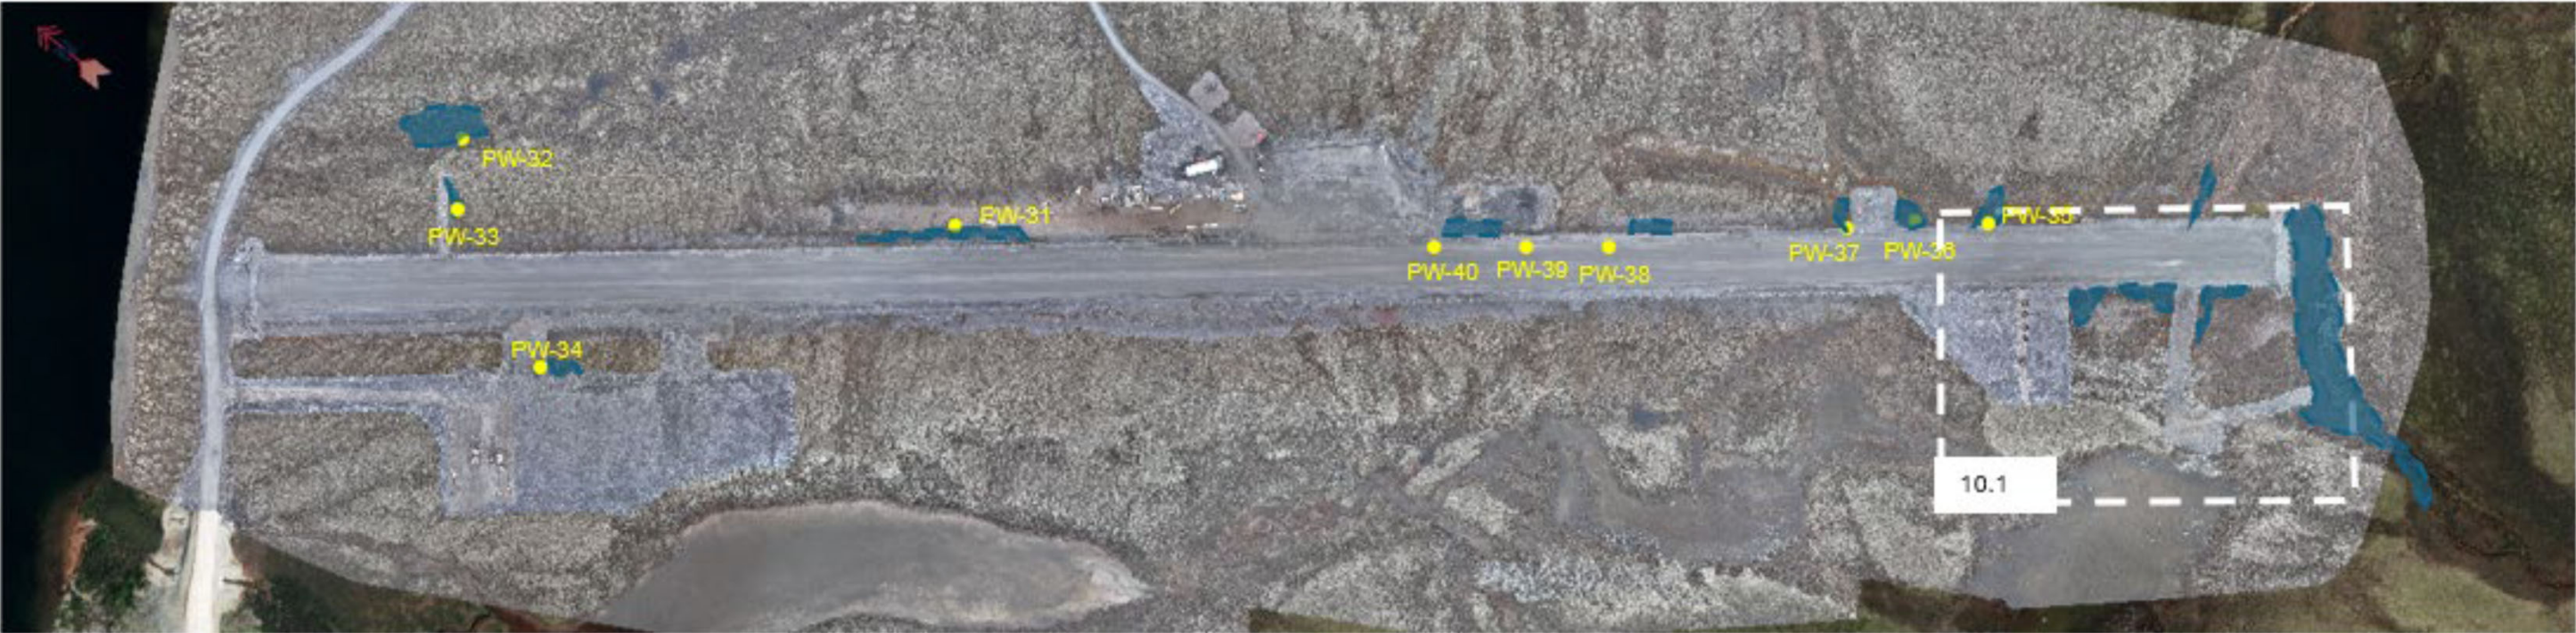
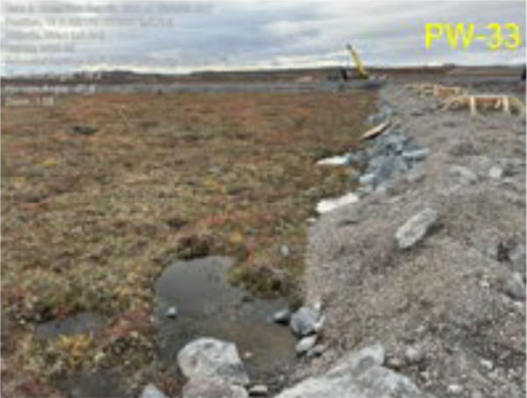
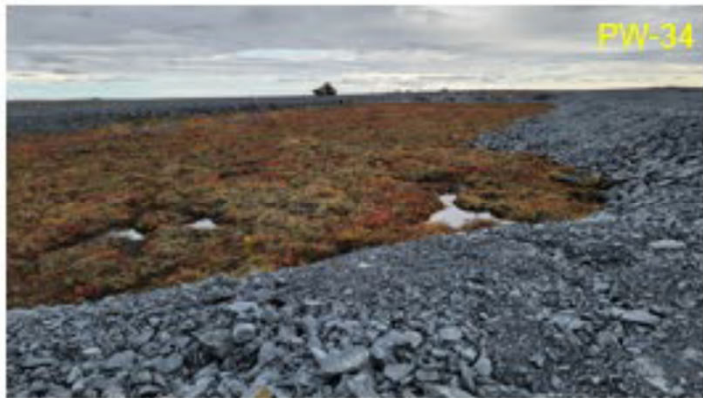
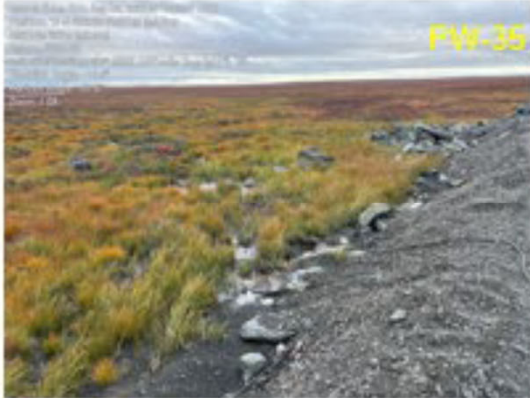
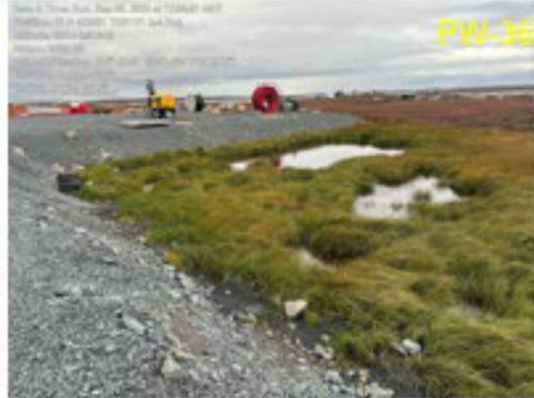
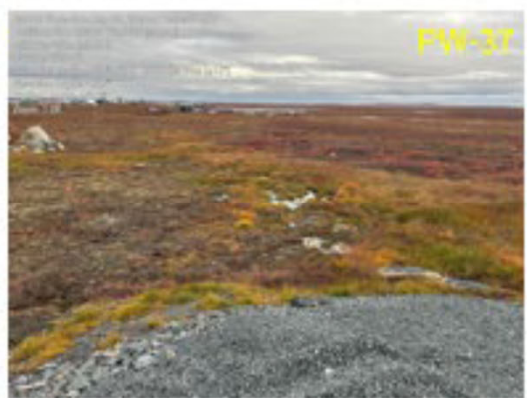
Job No: CAPR003105 Filename: BackRiver_MLA&Goose_2024AGI_Figures..pdf	  Back River Project	2024 Annual Geotechnical Inspection		
		Goose Airstrip – Ponding Water		
		Date: 2025-03-11	Approved: JBK	Figure: 4

- The Goose Phase 1 airstrip extension to the South was completed in October 2023. As this airstrip extends to the south, it intersects some more notable surface water flow pathways /ephemeral streams (Figures 4 and 5, Appendix D). It should be noted that the most southern stream remains mostly undisturbed to allow water movement. The airstrip terminates to the North of most southern stream. Site has confirmed the airstrip will not be extended until upstream diversion infrastructure is built first.

Ponding water and bodies of water near pads.

- B2Gold should take extra care to consider the location of existing surface water flow paths in the infrastructure plans and earthwork constructions (Figures 4, 5, 6, 13, 14, 15, and 16).

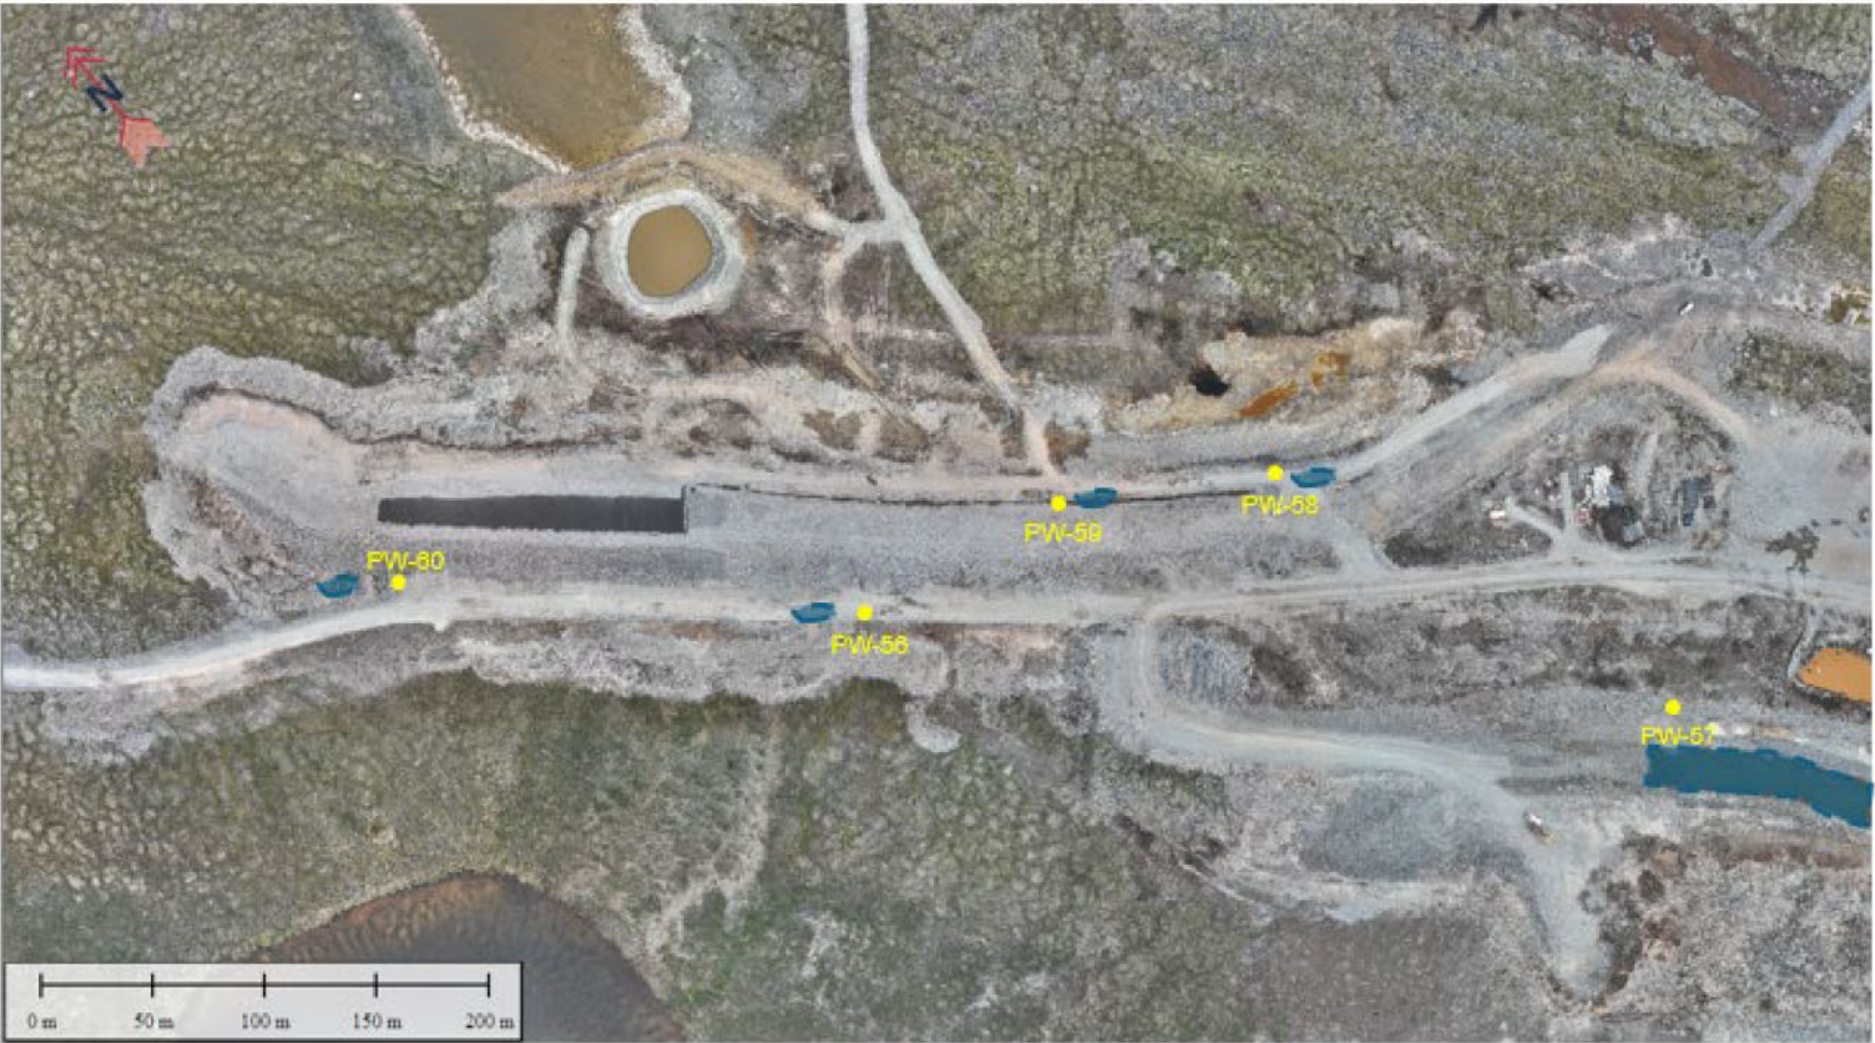
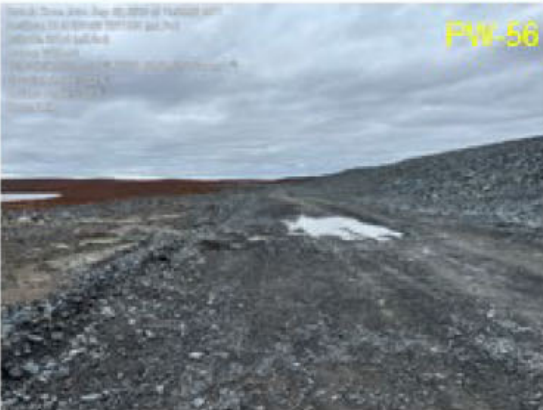
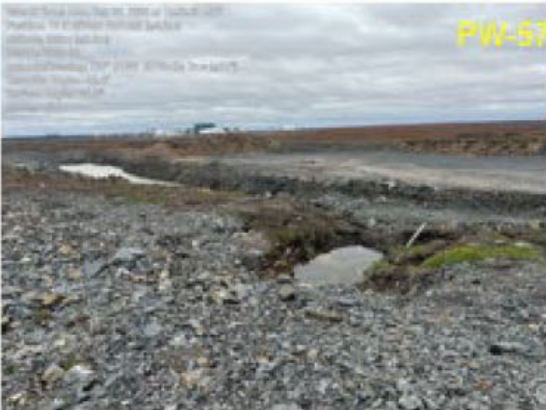
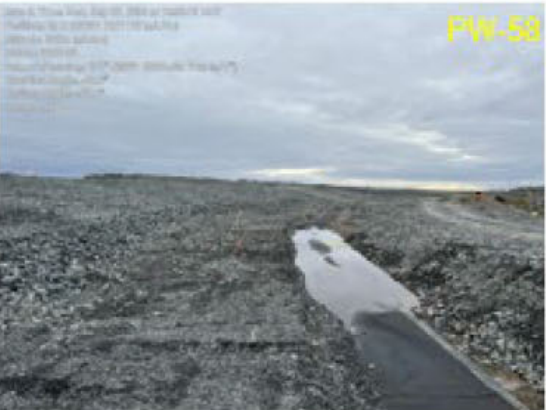
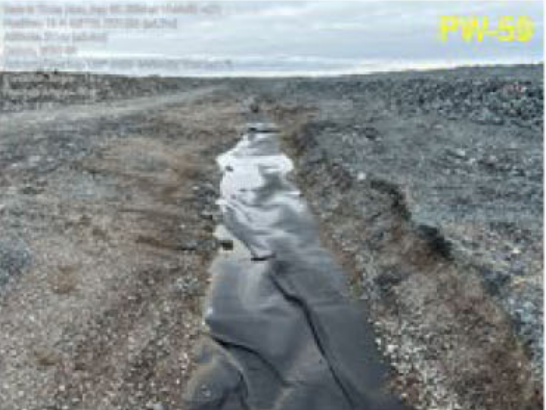
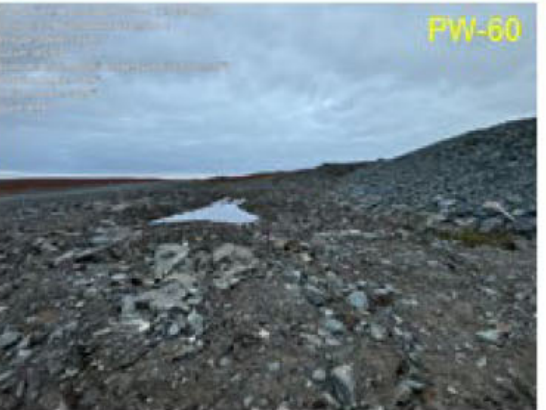
Job No: CAPR003105 Filename: BackRiver_MLA&Goose_2024AGI_Figures..pdf	  Back River Project	2024 Annual Geotechnical Inspection		
		Primary Pond Dam – Ponding Water		
		Date: 2025-03-11	Approved: JBK	Figure: 6

Ponding water and bodies of water near pads.

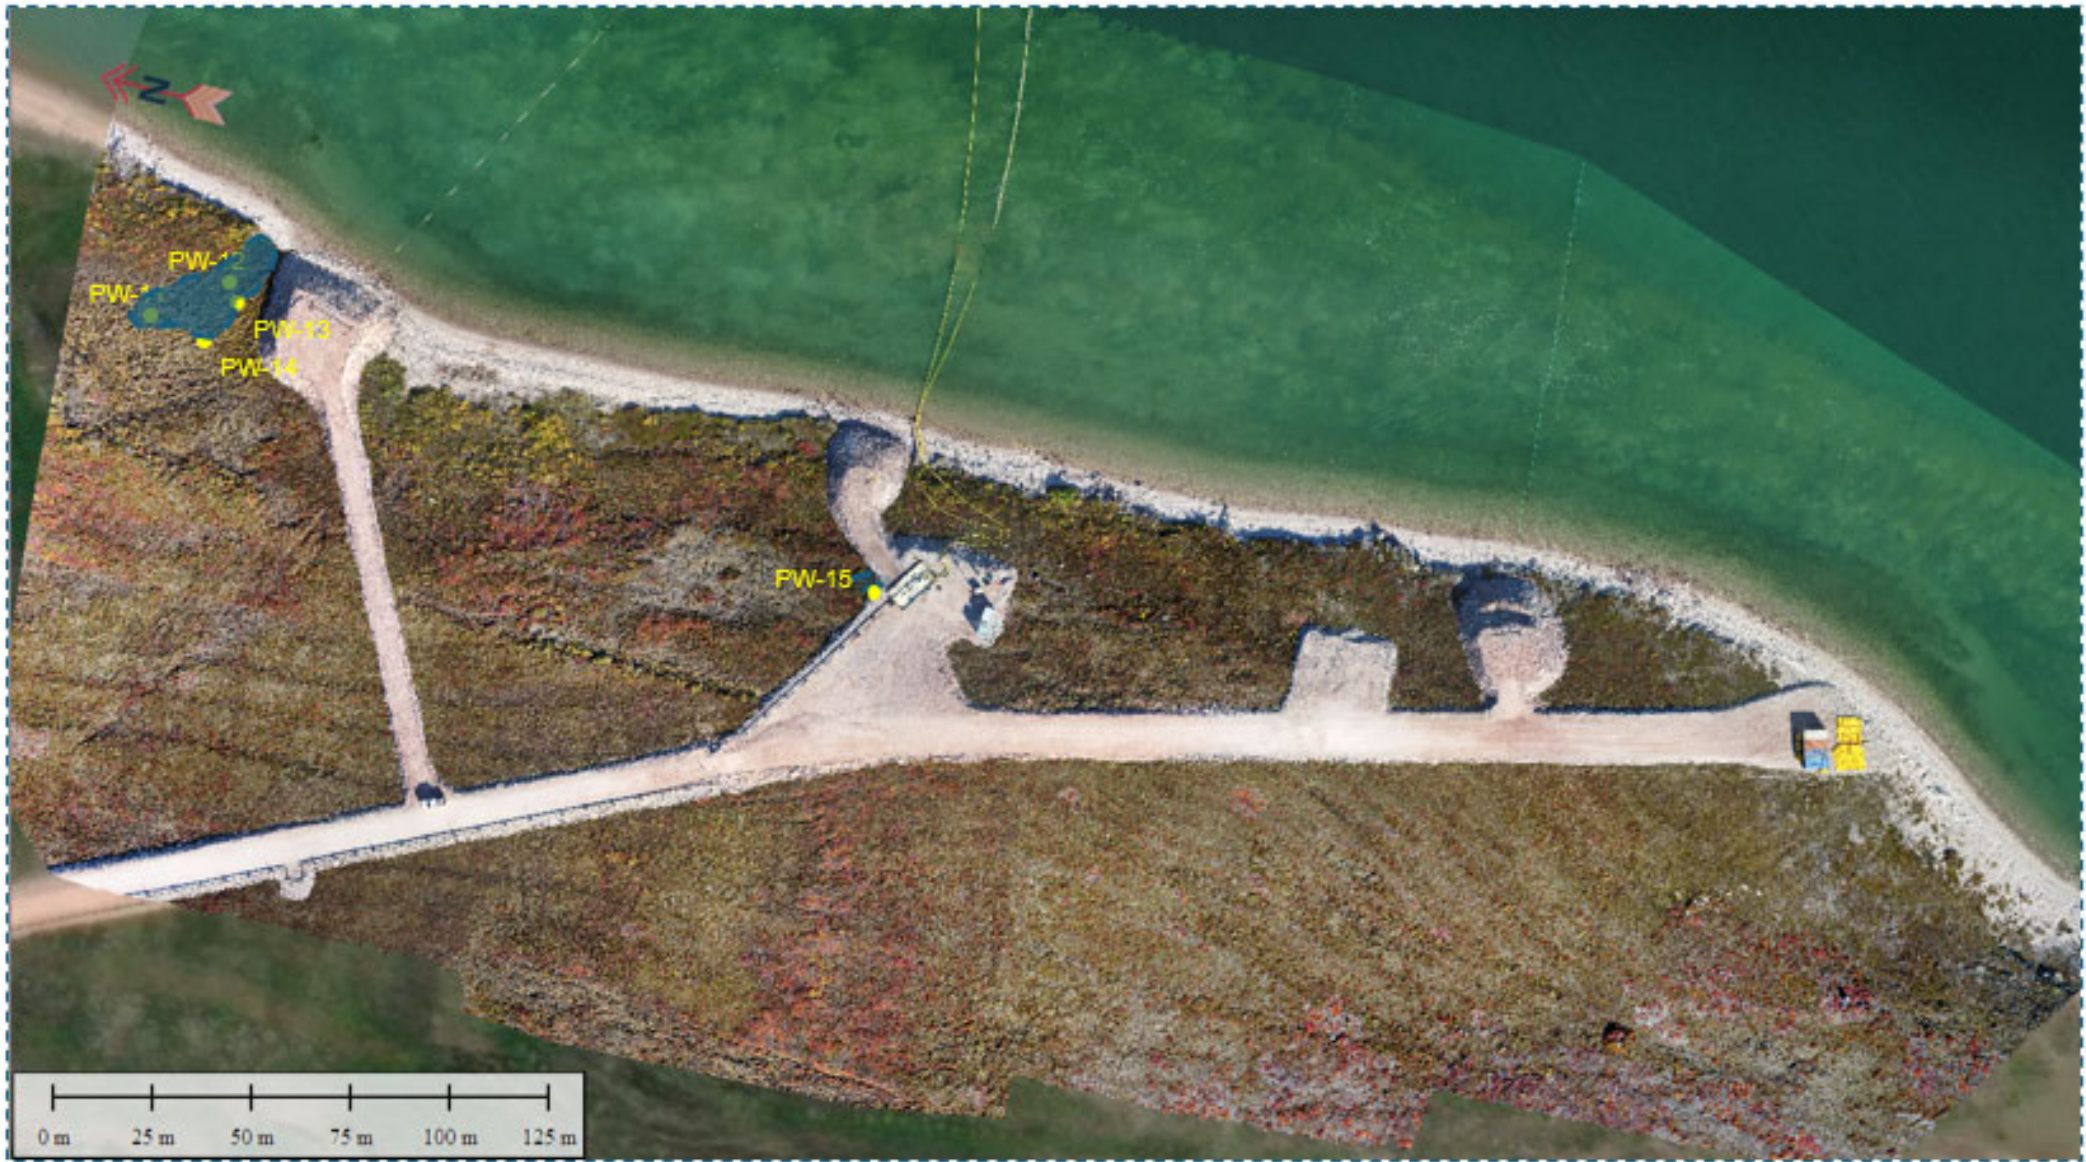
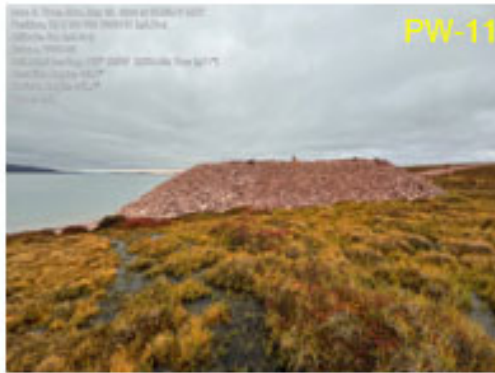
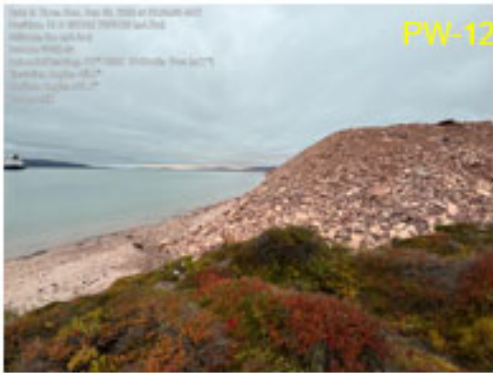
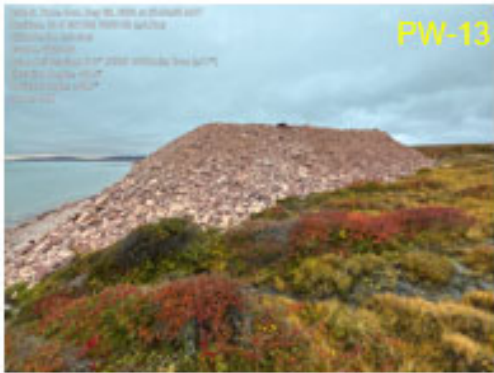
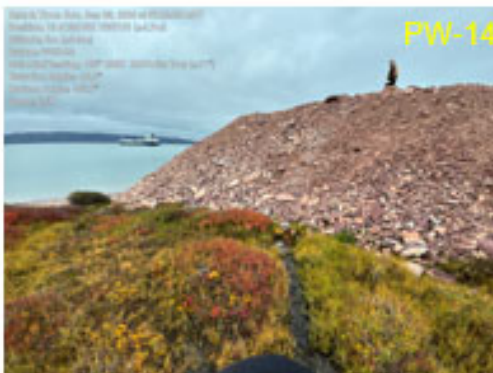
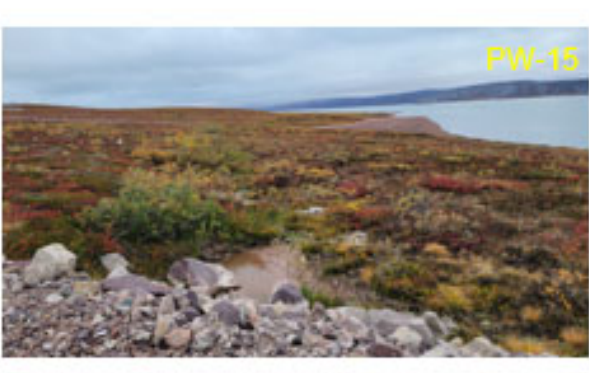
Ponding water and bodies of water near pads.

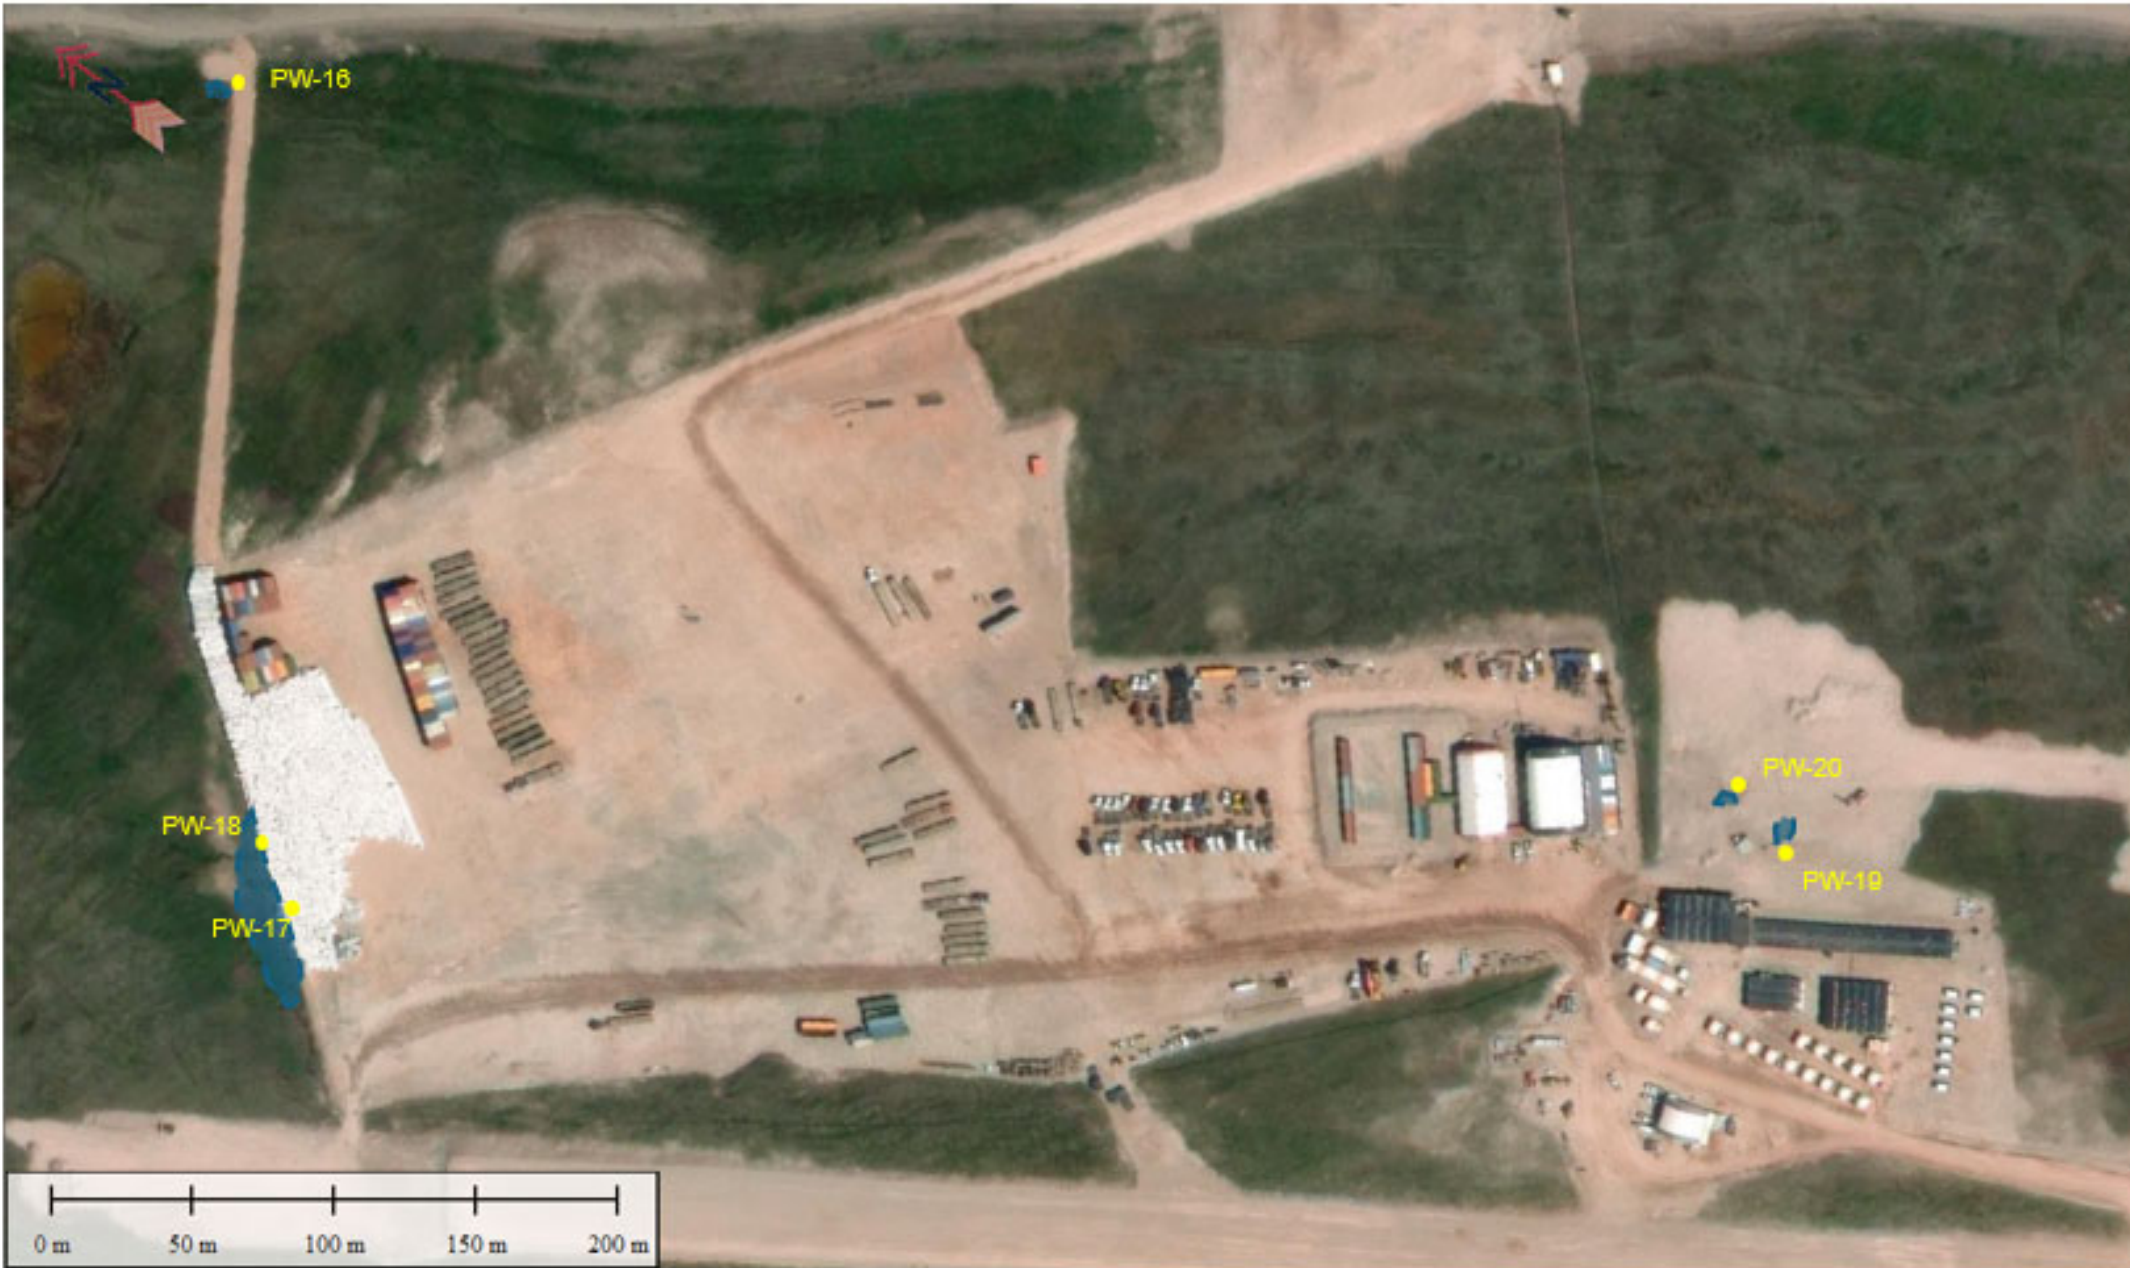
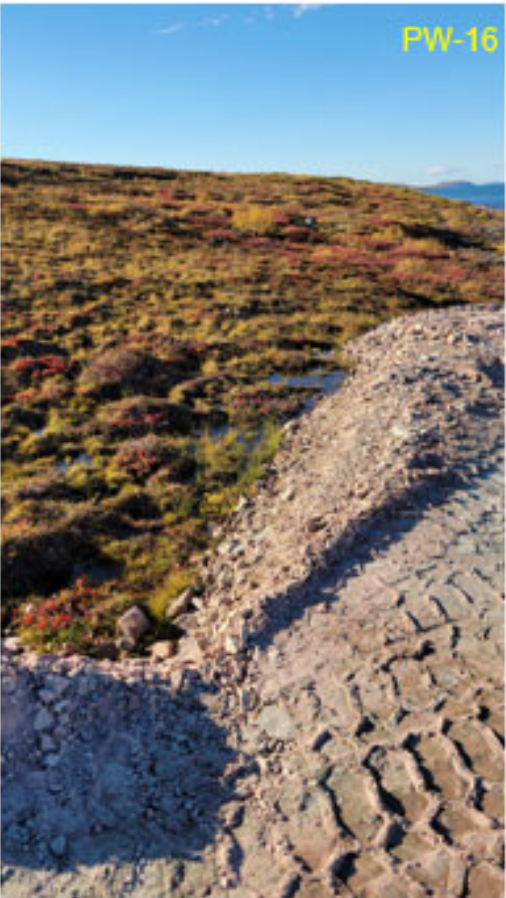
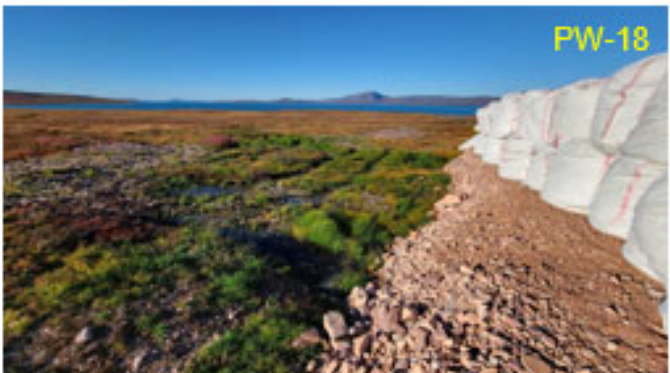
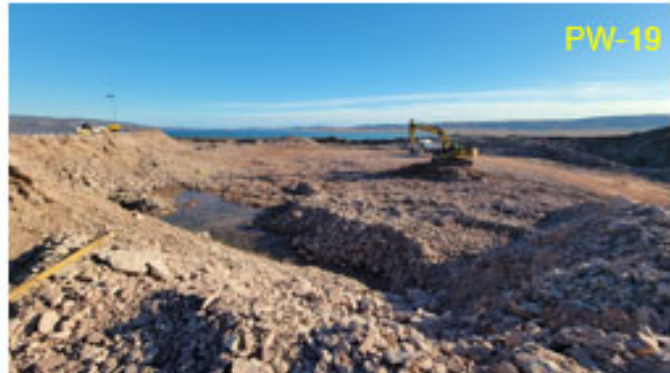
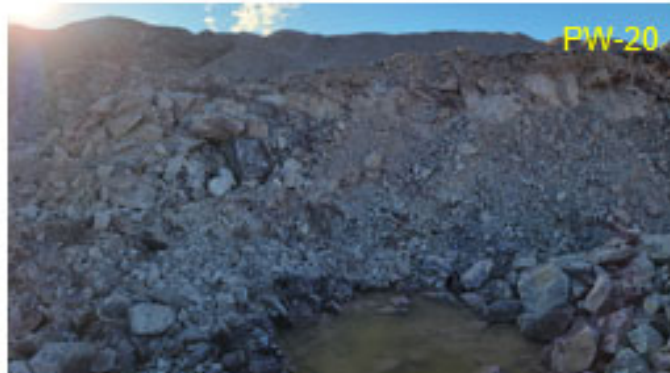
Ponding water and bodies of water near pads.

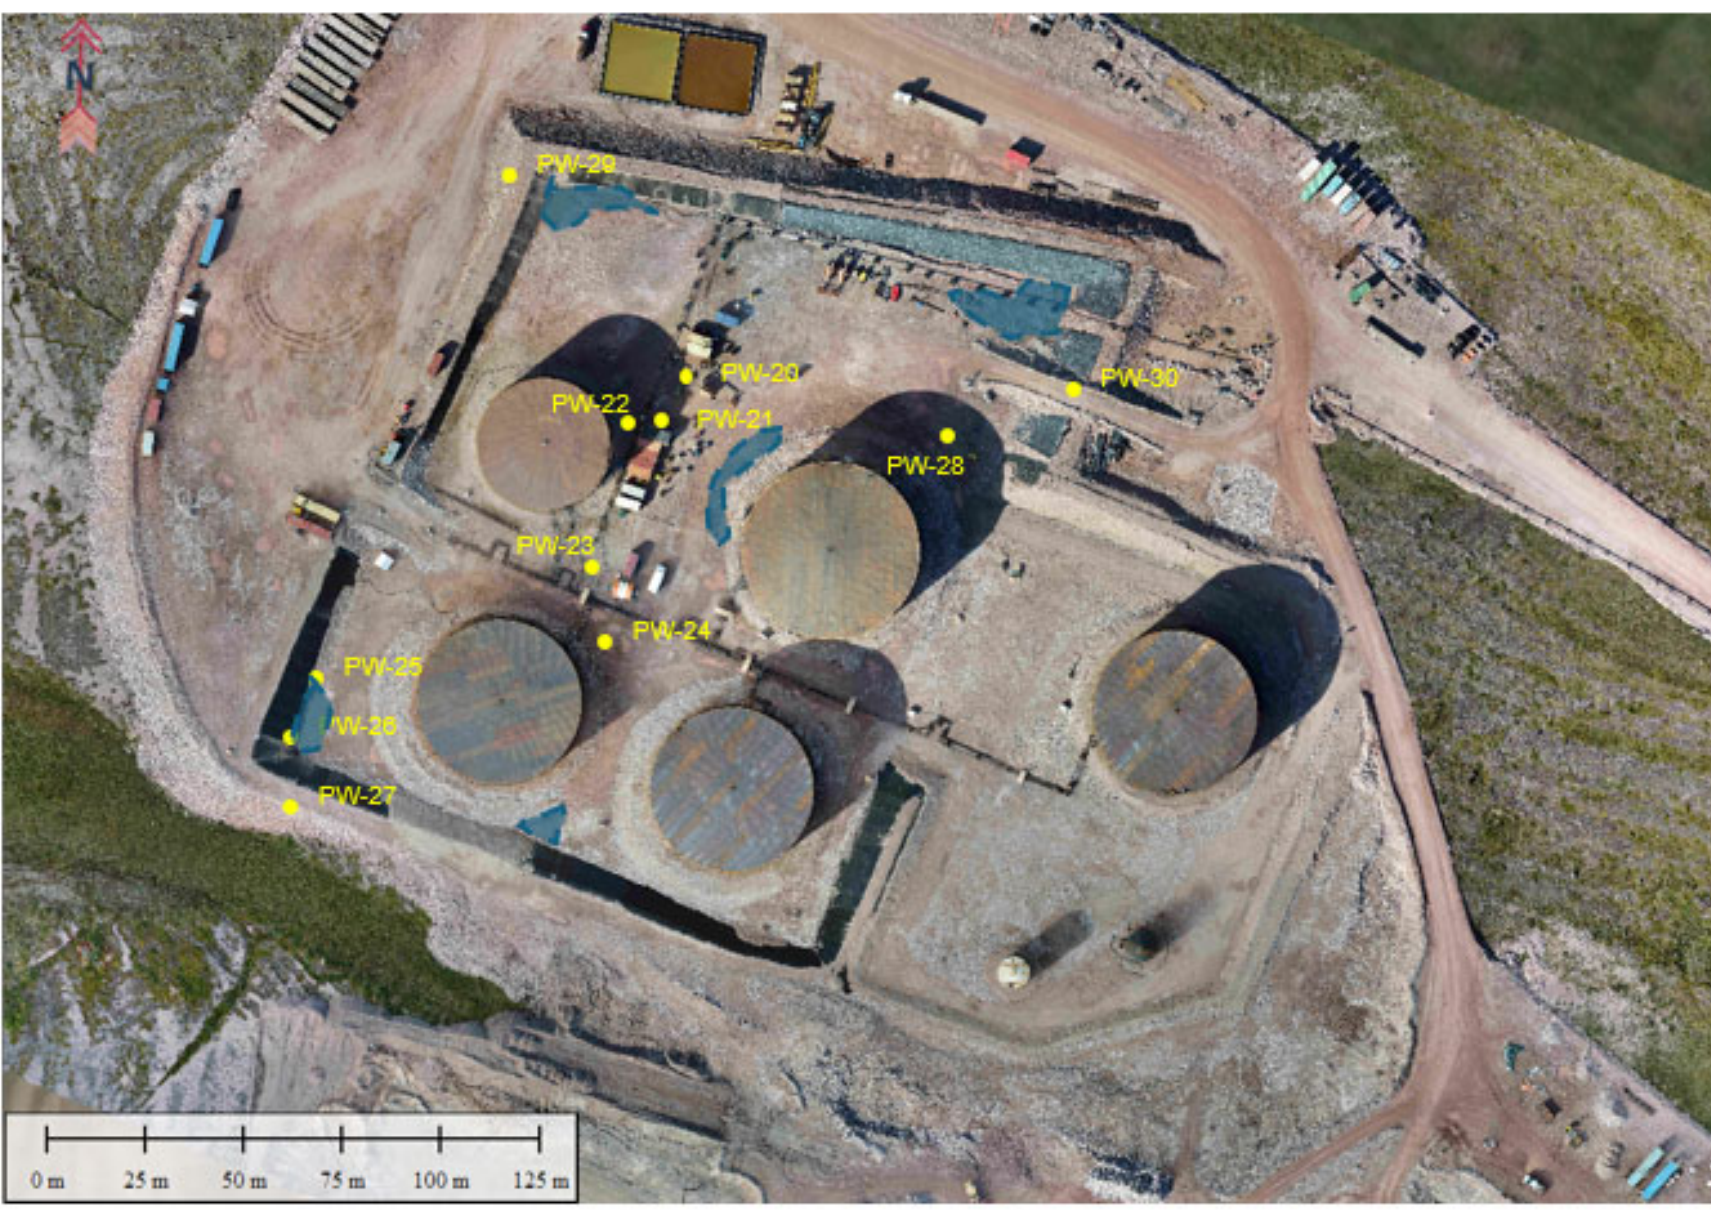
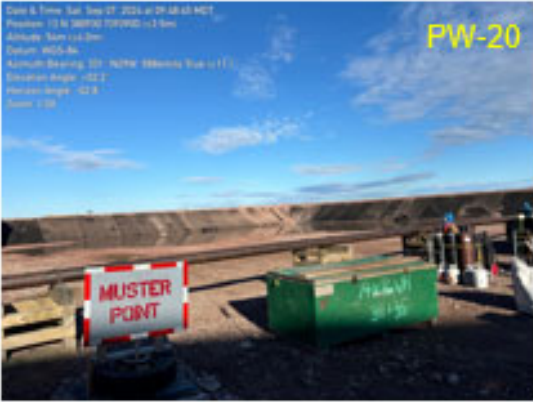
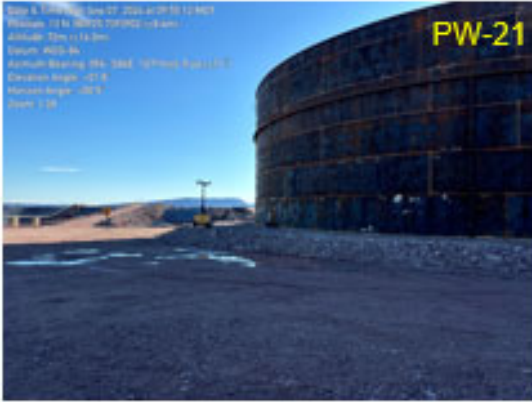
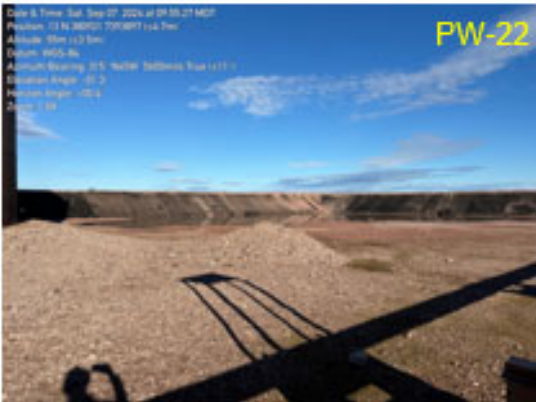
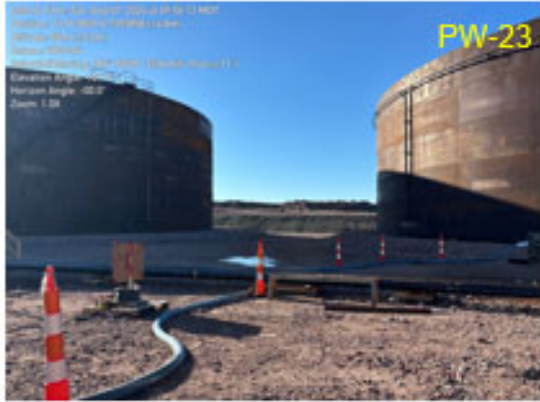
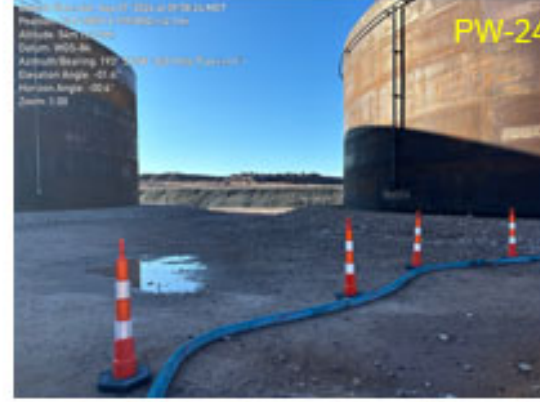
**MLA Lower Laydown and Camp Pad
– Ponding Water**

Ponding water and bodies of water near pads.

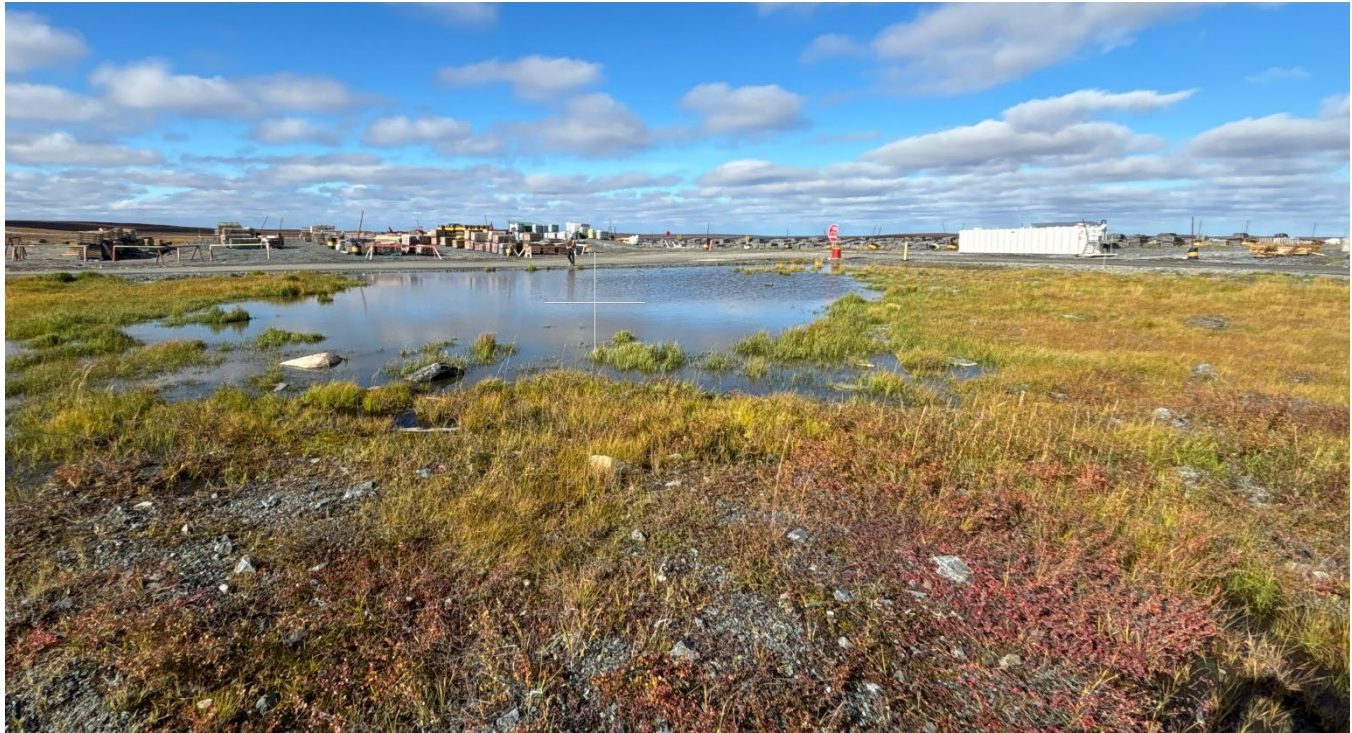
G-1: Exploration camp, looking north towards core area – Note ponding water

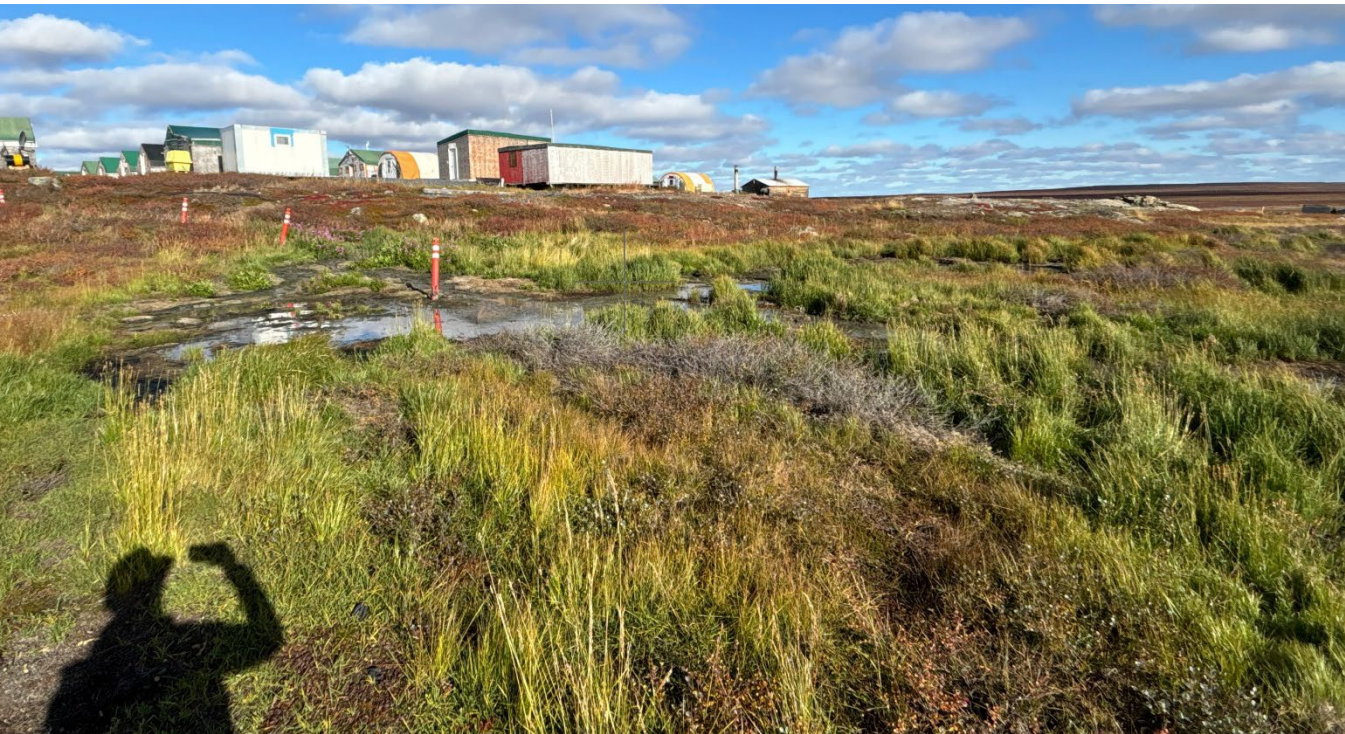
G-8: Camp pad area, facing west – Note ponding water

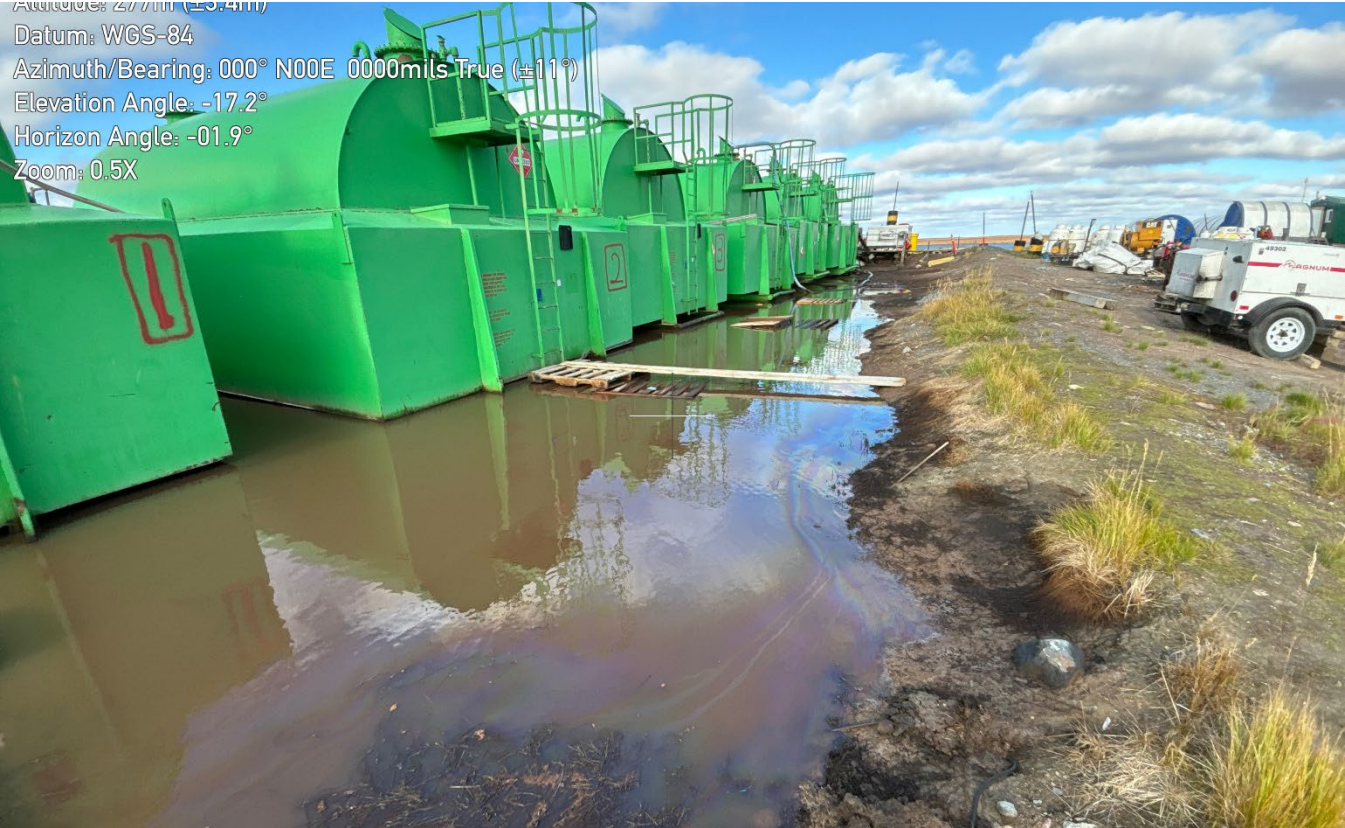
G-10: Fuel tank containment. Ponding Water

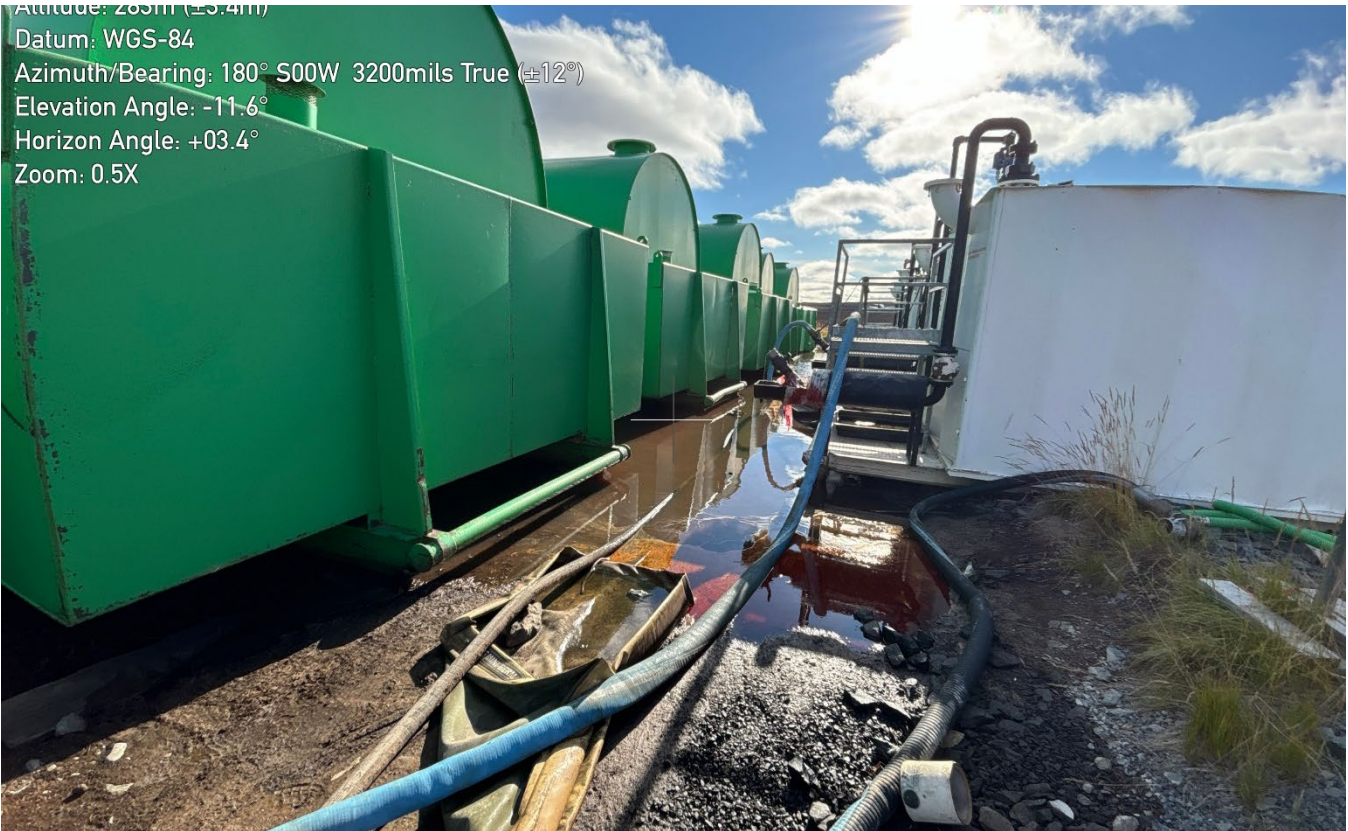
G-11: Fuel tank containment. Ponding water

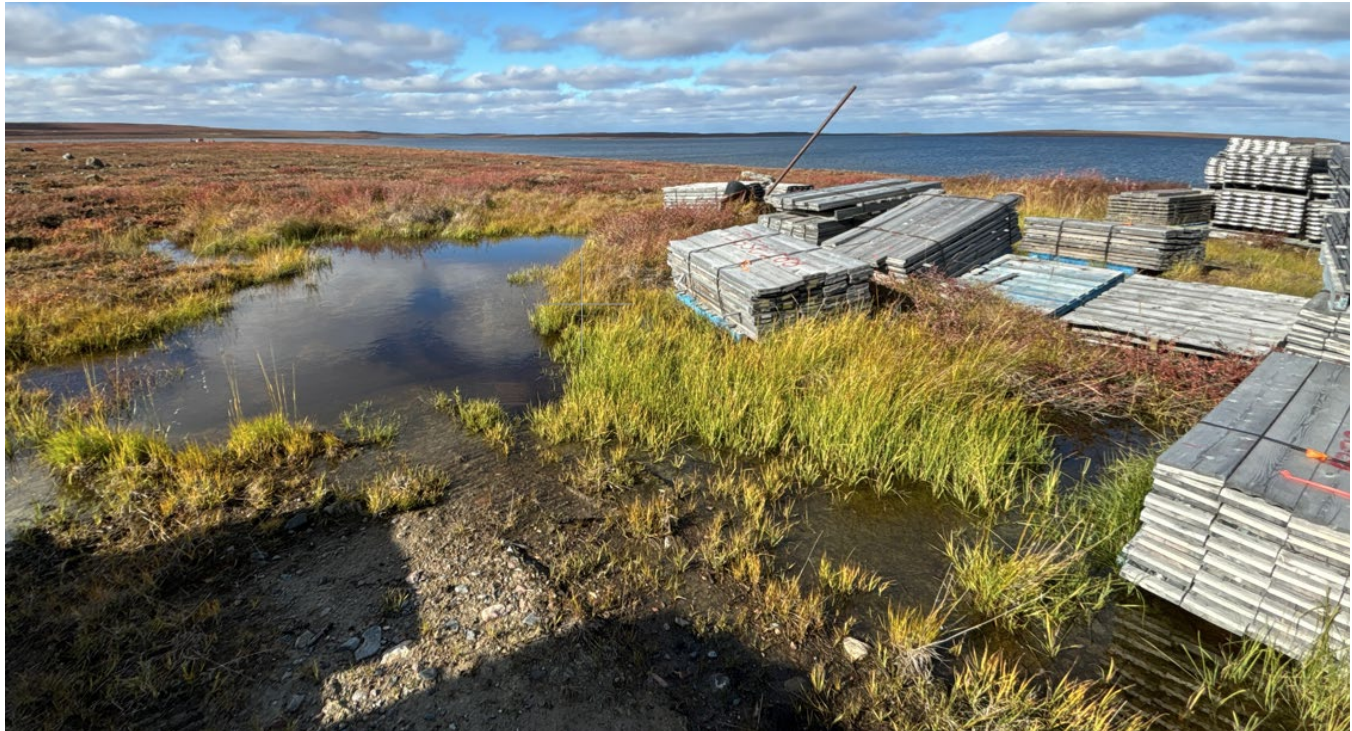
G-12: North of core storage, facing north – Note ponding water and disturbed tundra
