Goose & MLA Project Sites – 2024 Annual Geotechnical Inspection

Back River Project, Nunavut, Canada
B2Gold Corp.

SRK Consulting (Canada) Inc. ■ CAPR003105 ■ April 2025

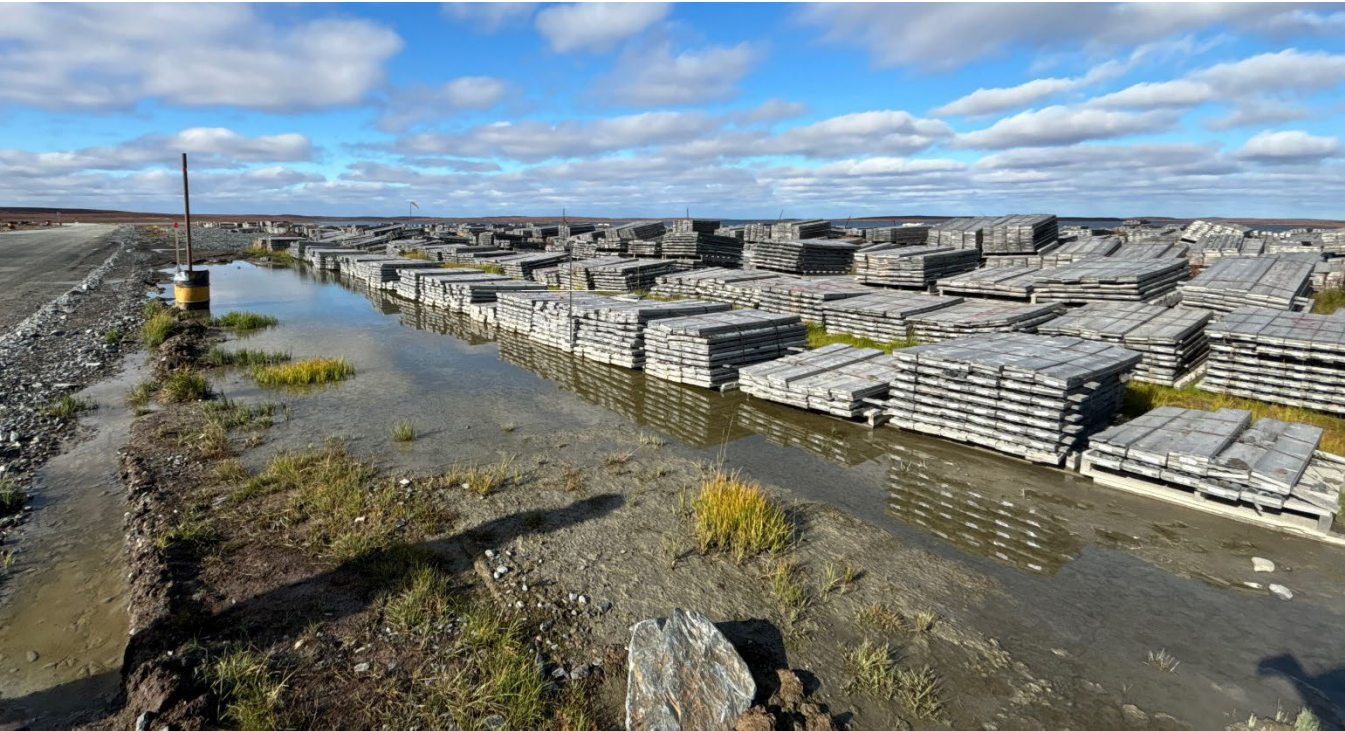
G-13: South edge core storage – Note ponding water

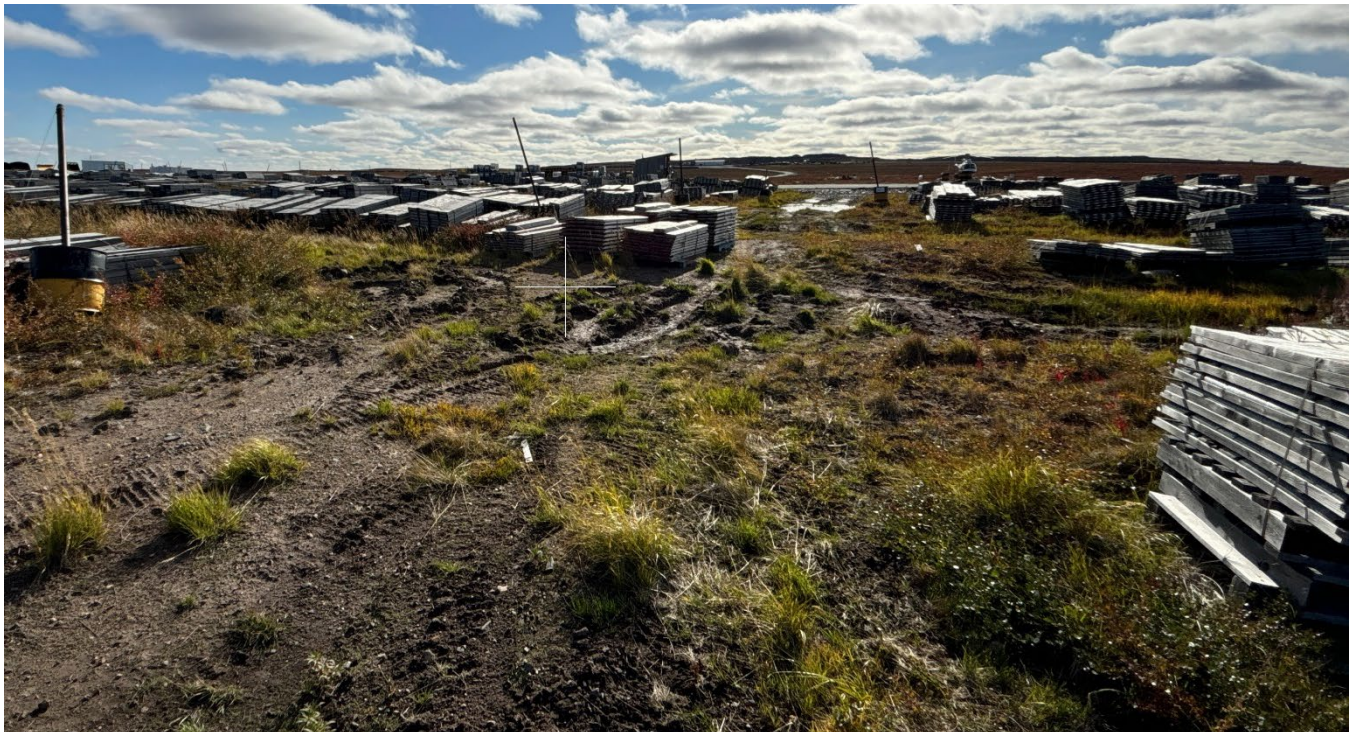
G-14: Core boxes stored on degraded tundra

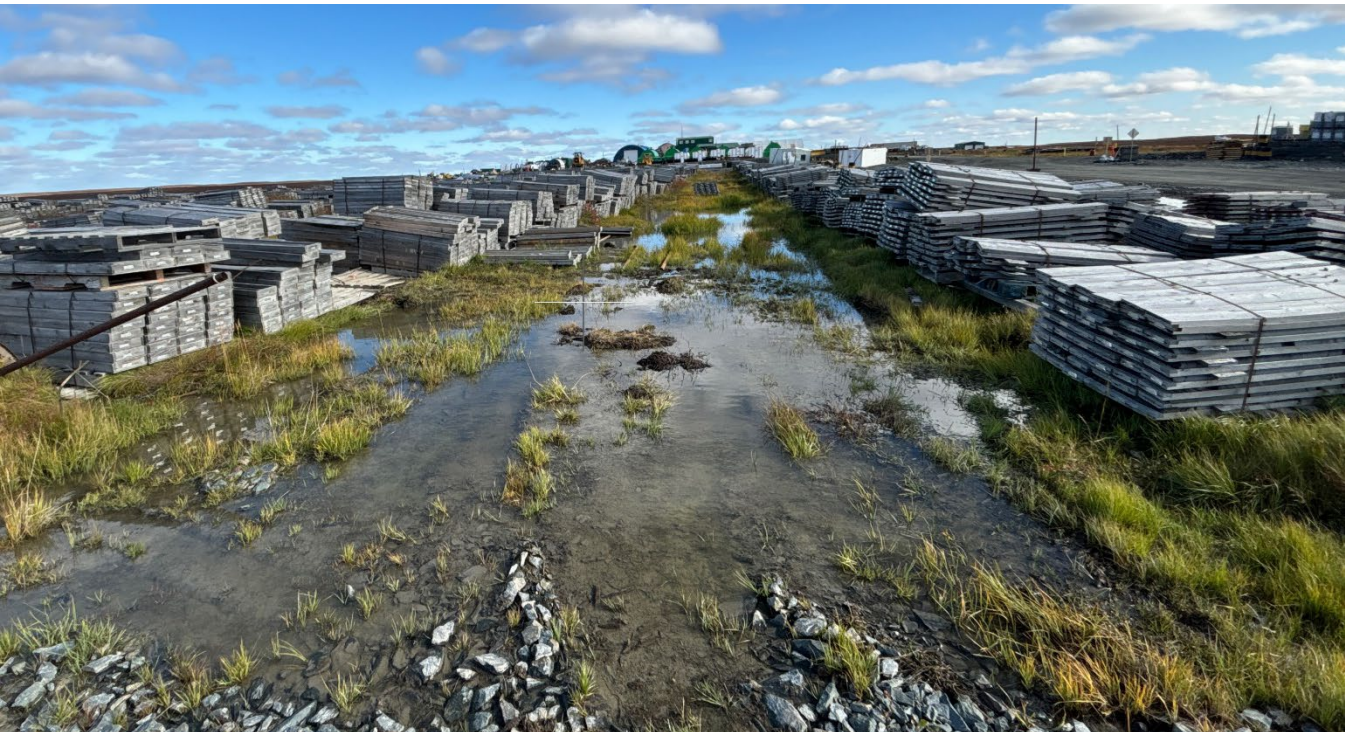
G-15: Ponding water

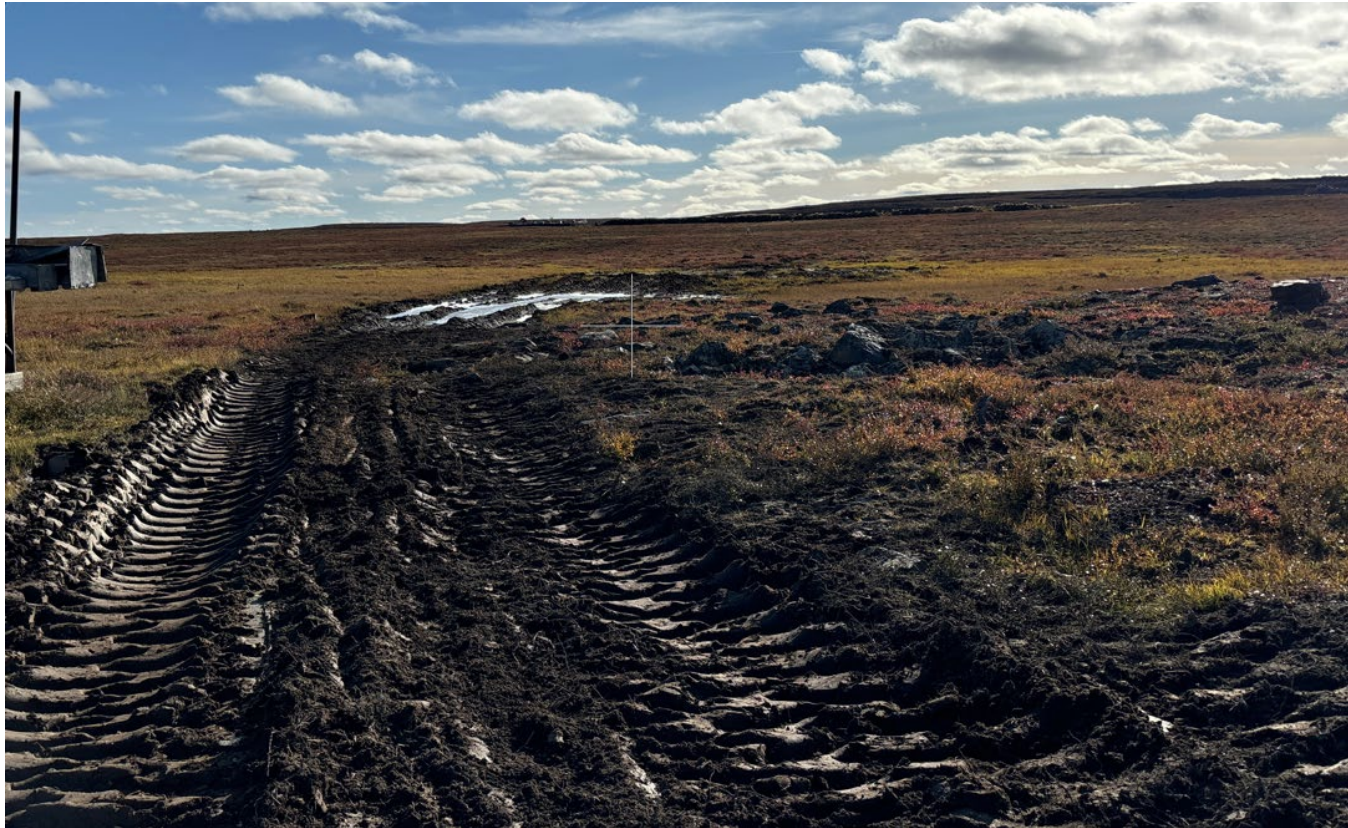
G-16: Footprint area, facing south – Note disturbed tundra and ponding waters within the future Main Pit footprint

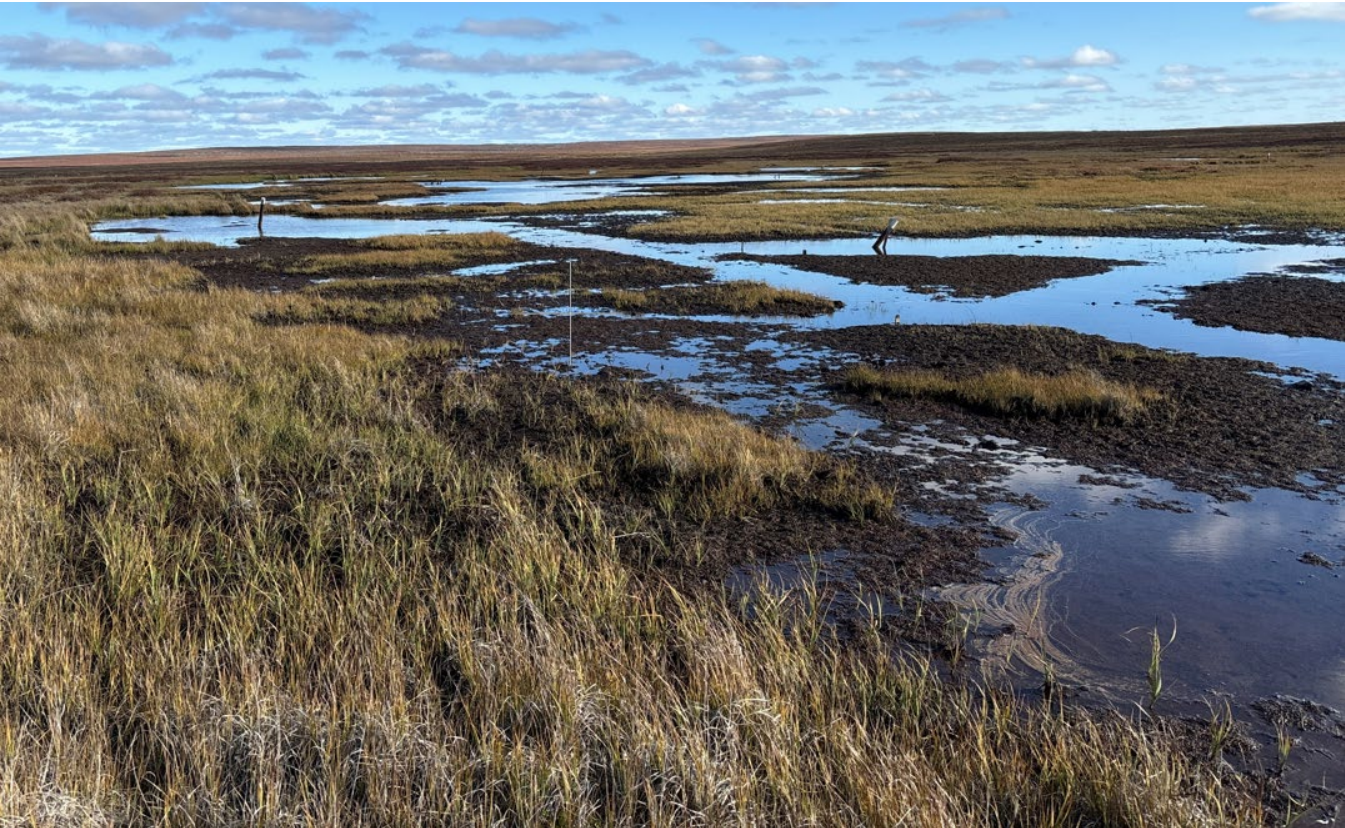
G-17: Ponding water, facing SE

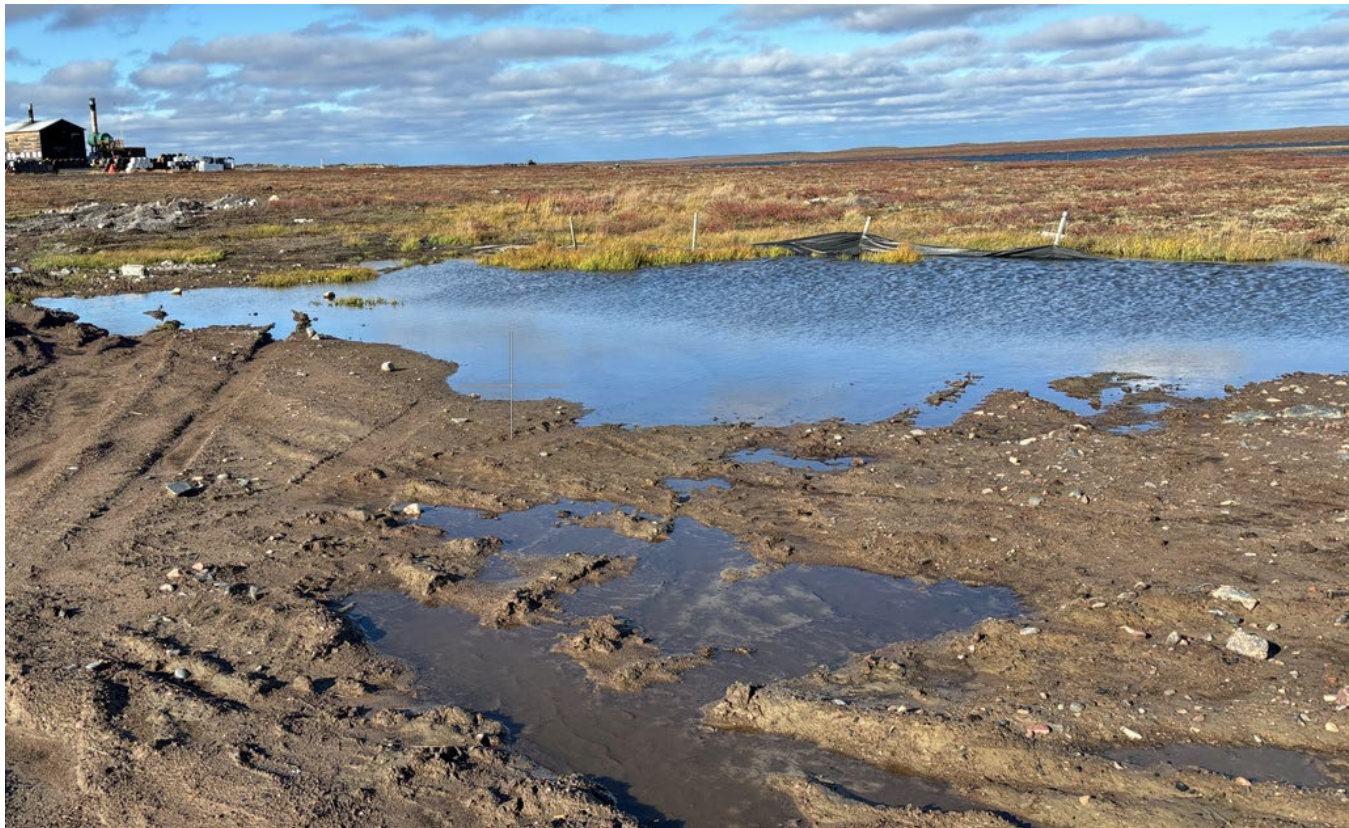
G-18: Ponding water, facing south

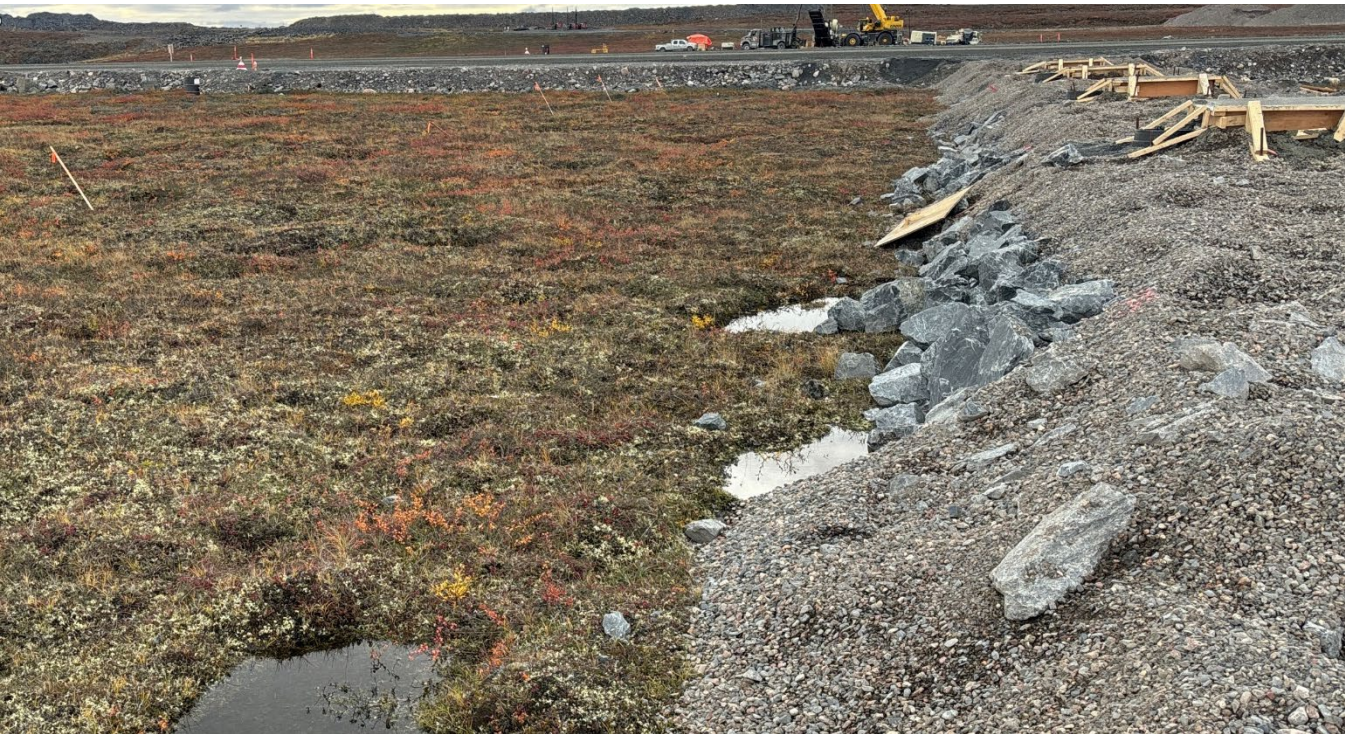
G-22: Note ponding water

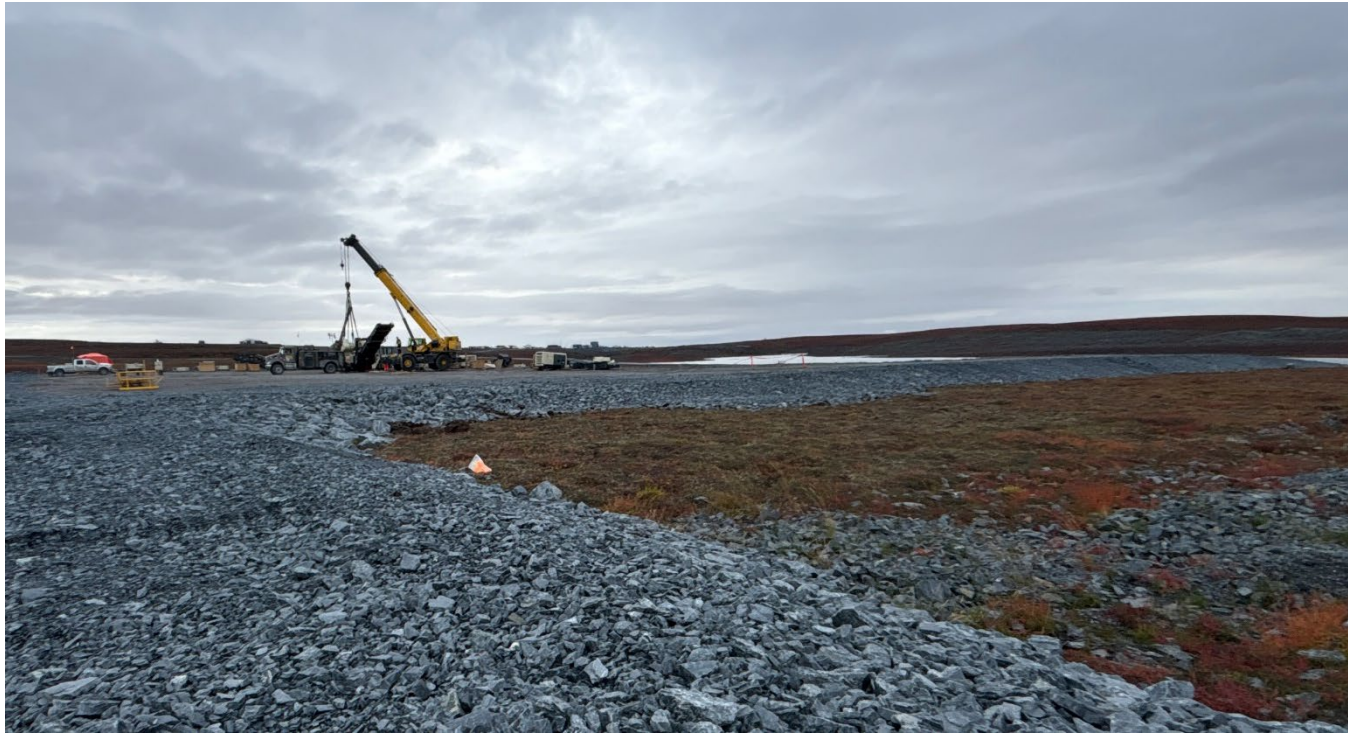
G-31: Western side of airstrip. NW Apron, facing west

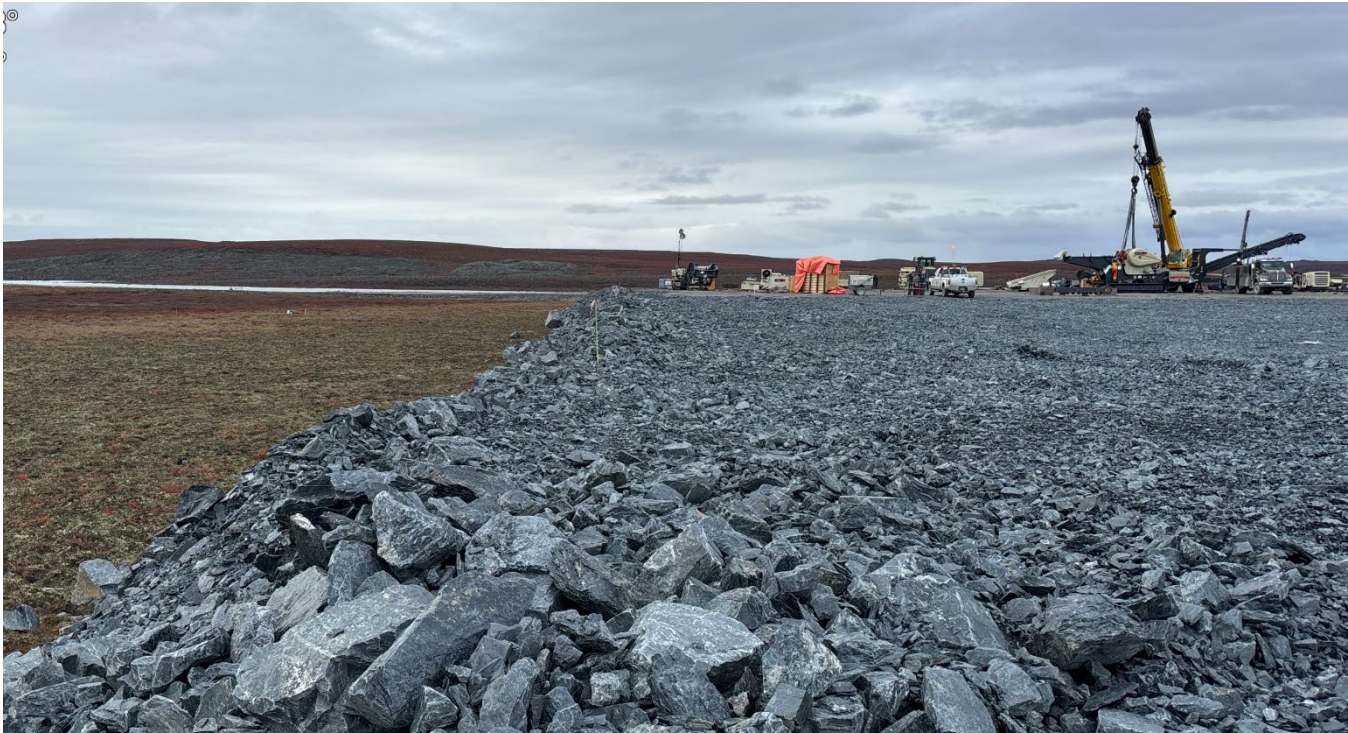
G-32: NW Apron, facing NE – Note thickness of pad less than 0.6m

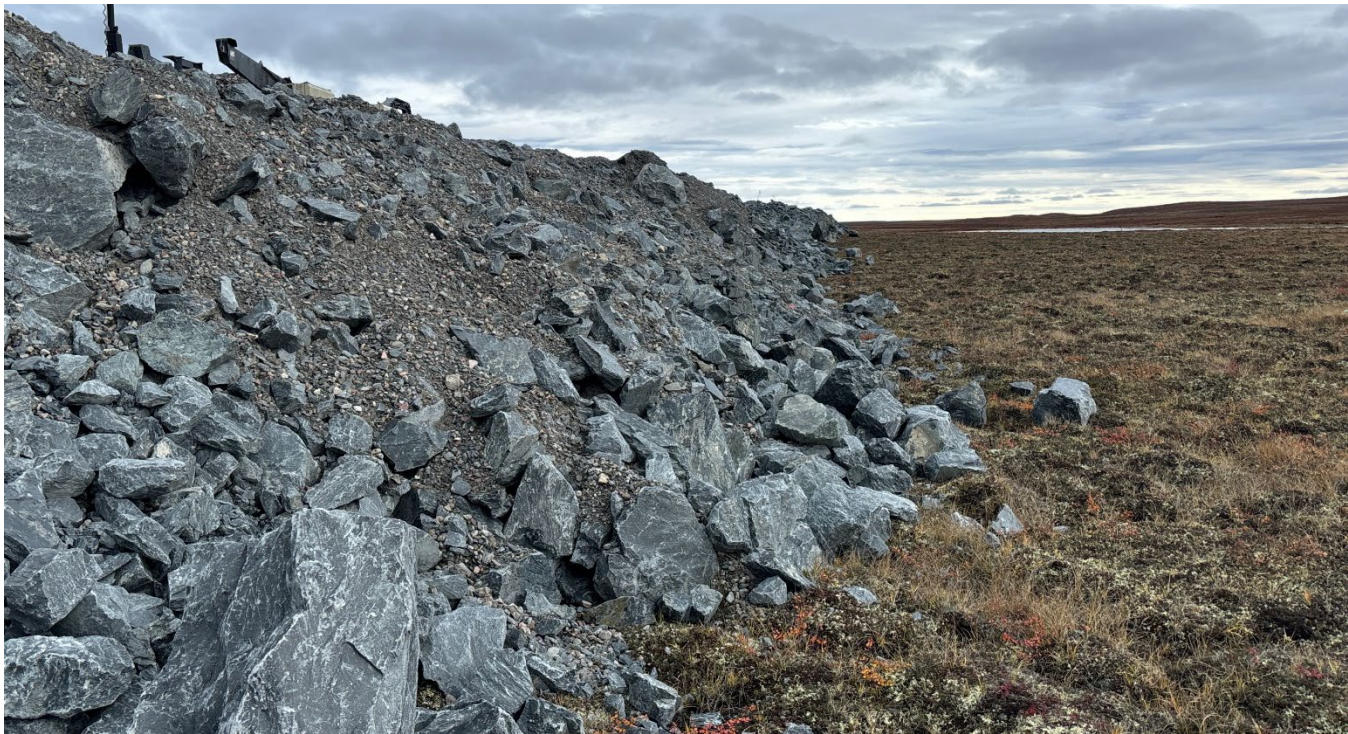
G-33: NW apron northern slope, facing SE – Note oversteepend slope

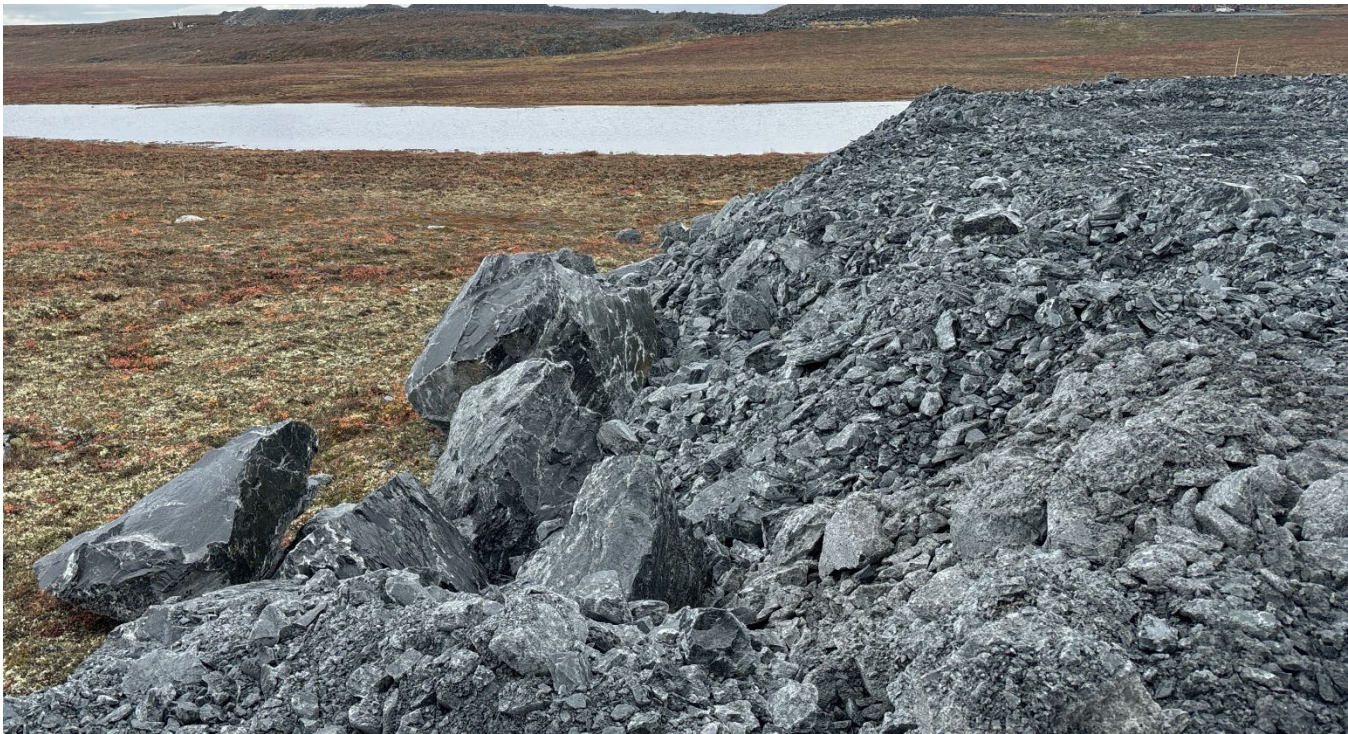
G-34: South end of NW apron, facing SW – Note irregular slope face

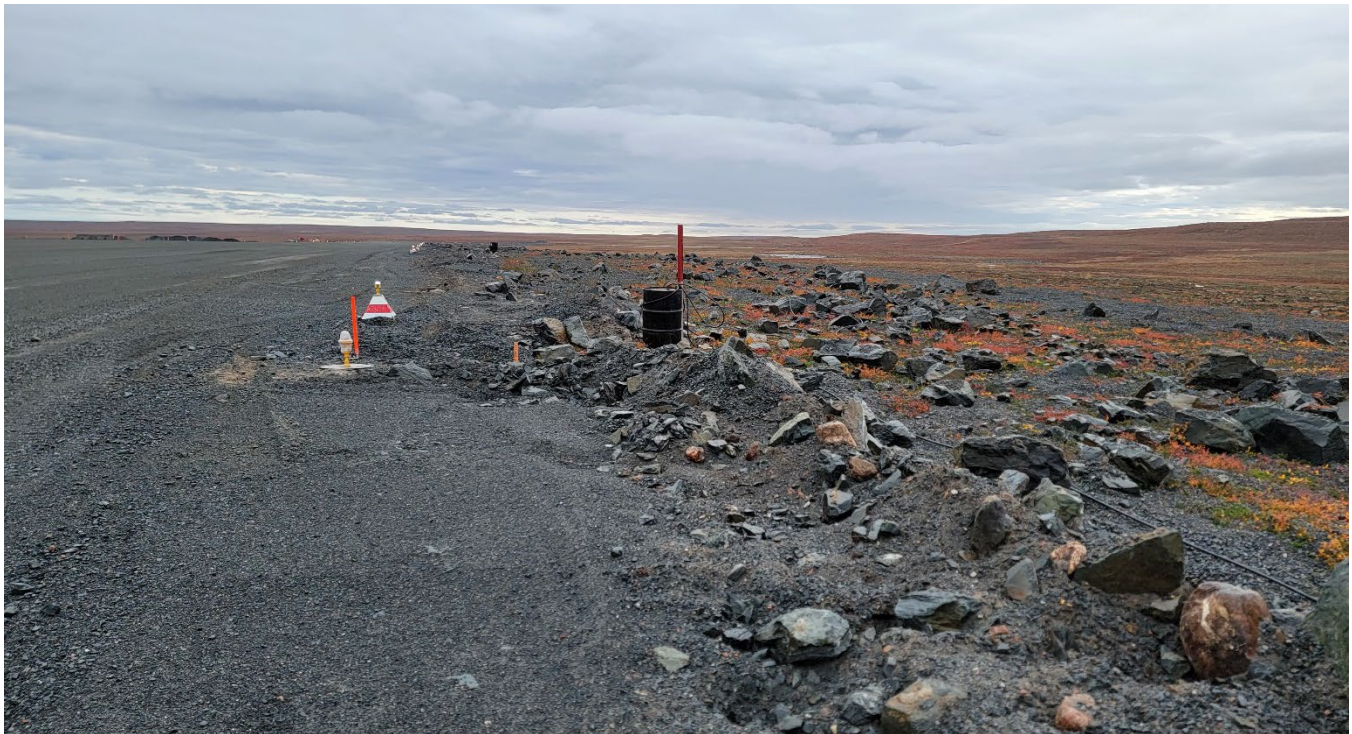
G-37: SW side of airstrip, facing SW – Note no distinct edge of runway

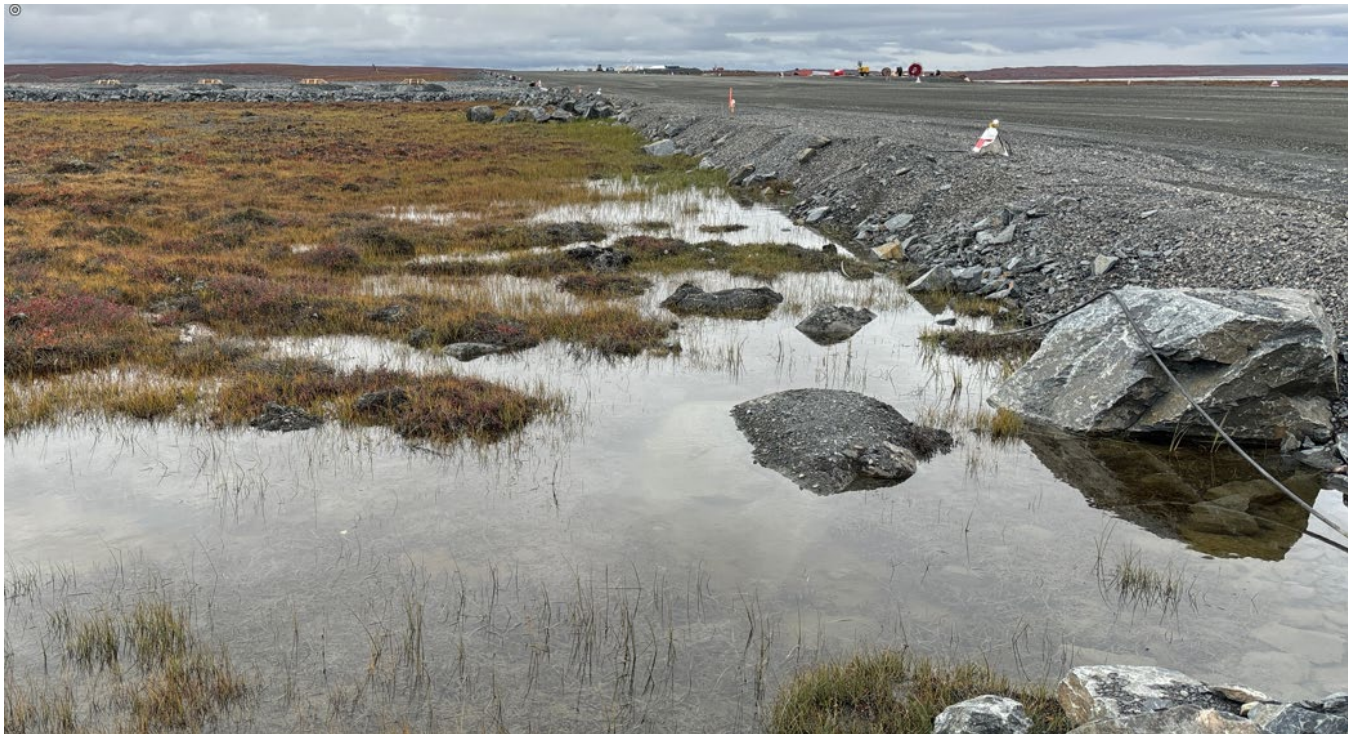
G-41: Toe of airstrip, looking NW – Note ponding water

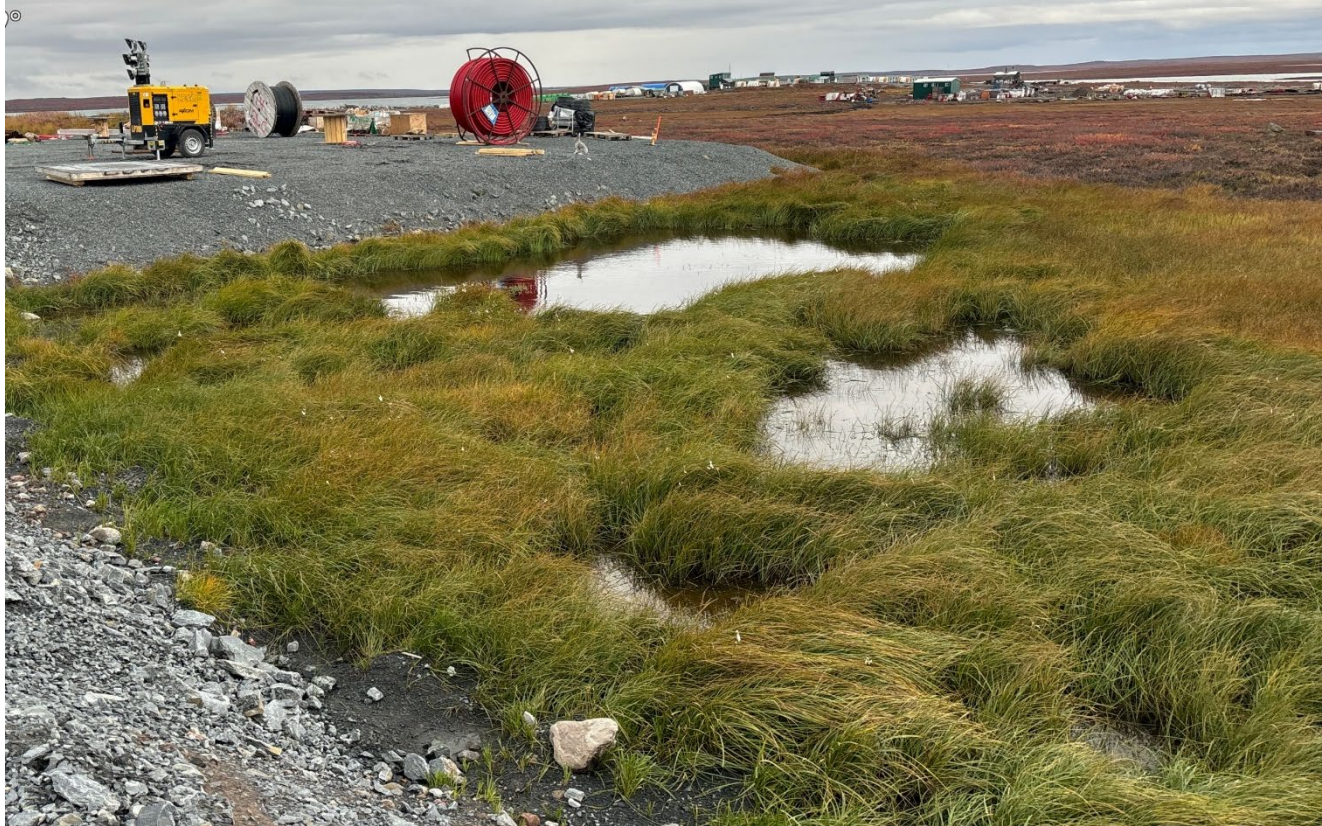
G-46: East laydown area, facing NW – Note ponding water

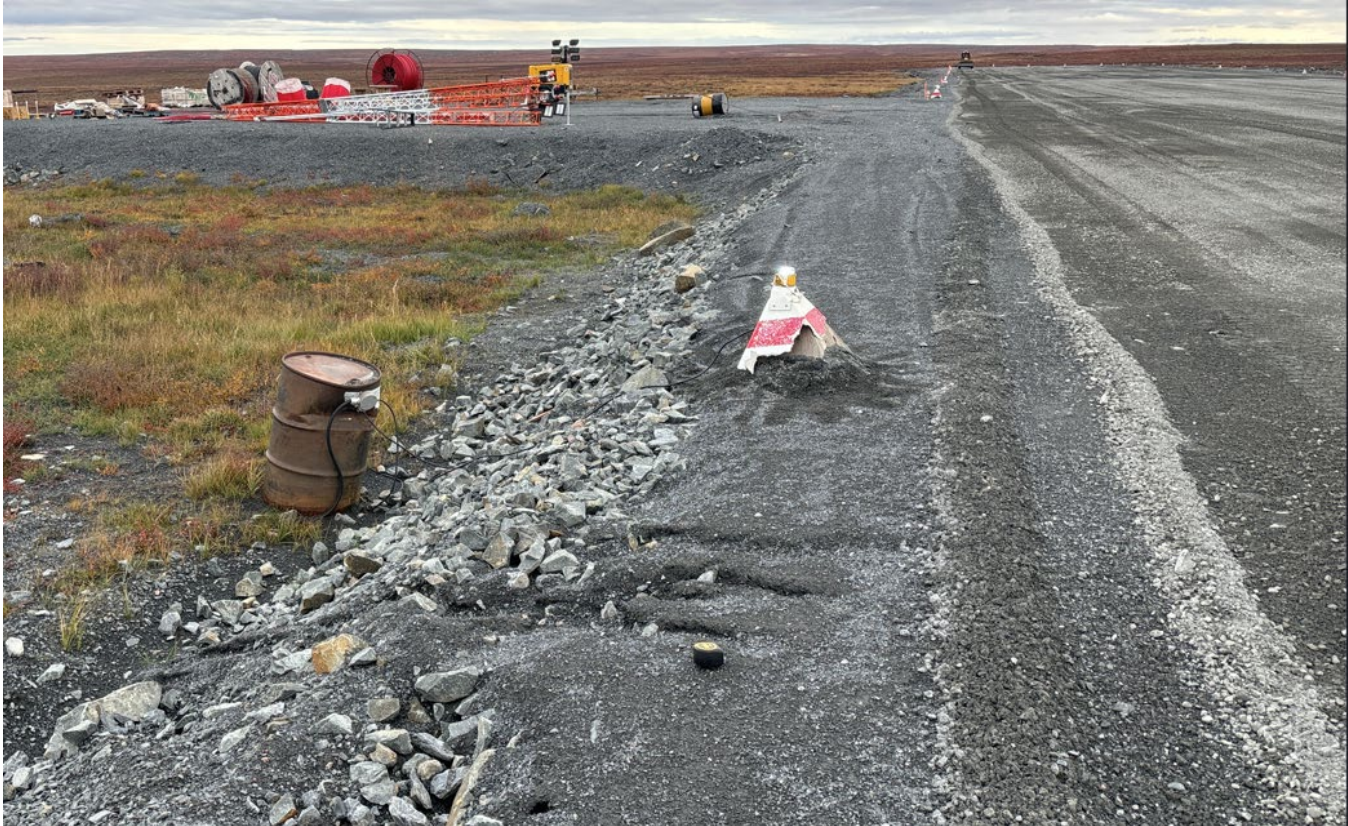
G-47: Eastern laydown area, facing SE – Note erosion pathways

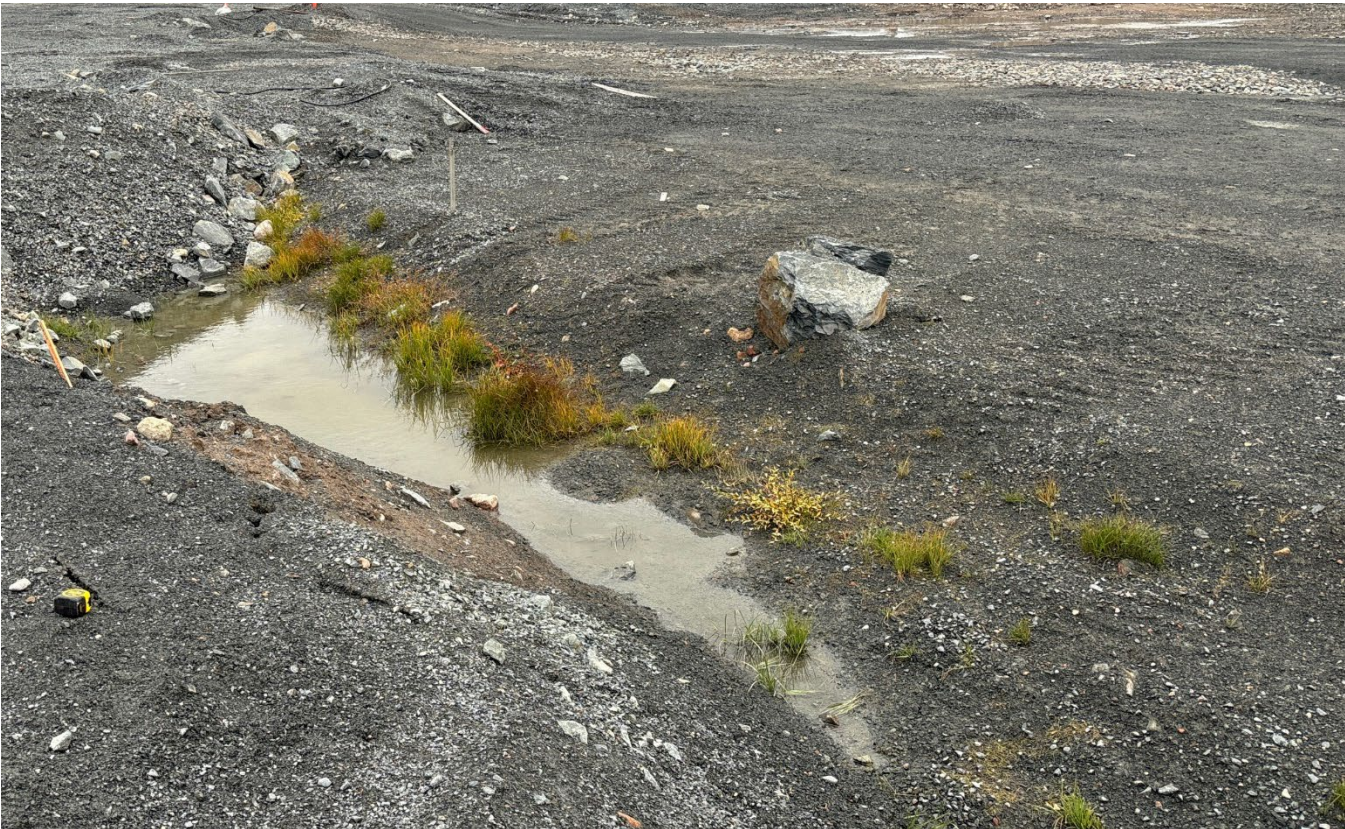
G-48: Beginning of apron, facing NW – Note ponding water

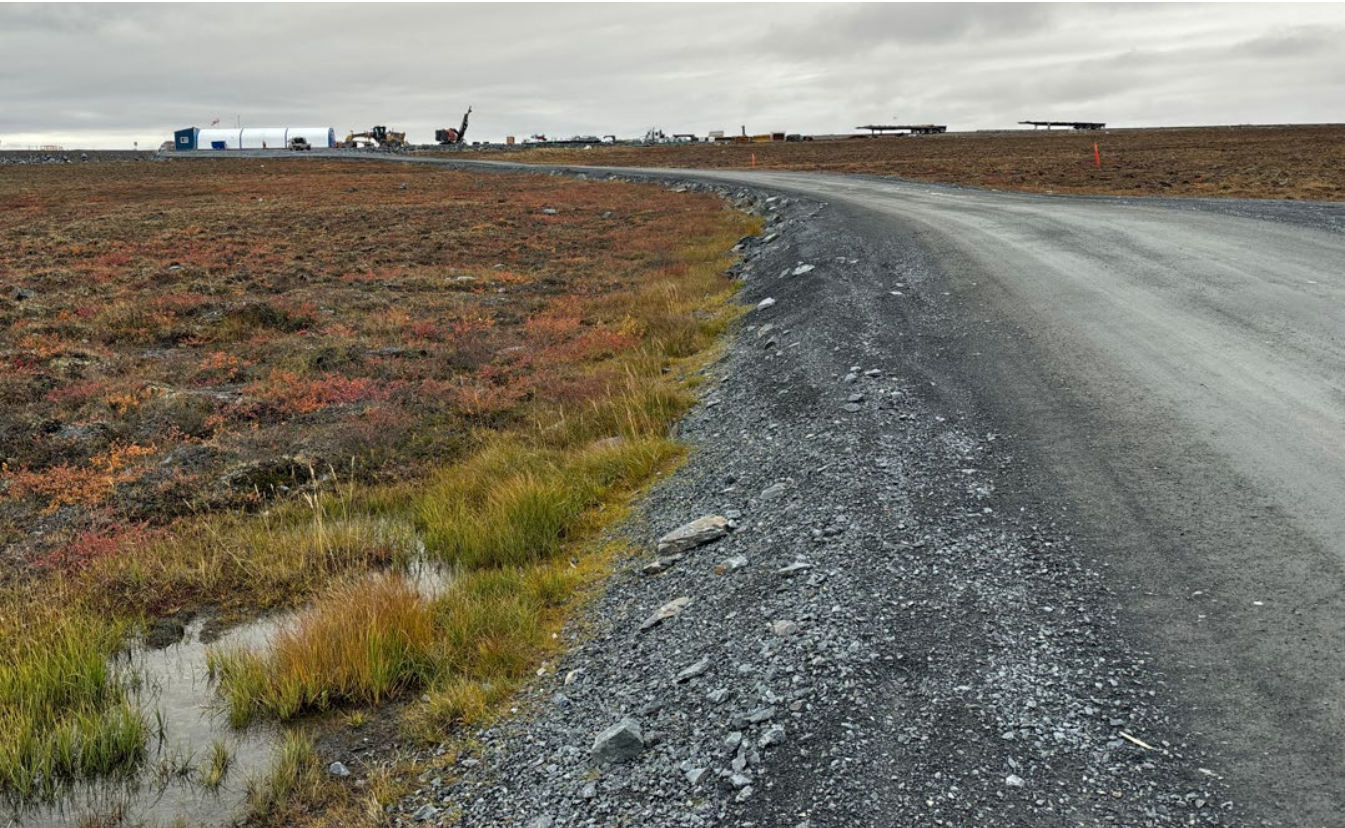
G-60: Ponding water at the toe of the access road, facing exploration camp

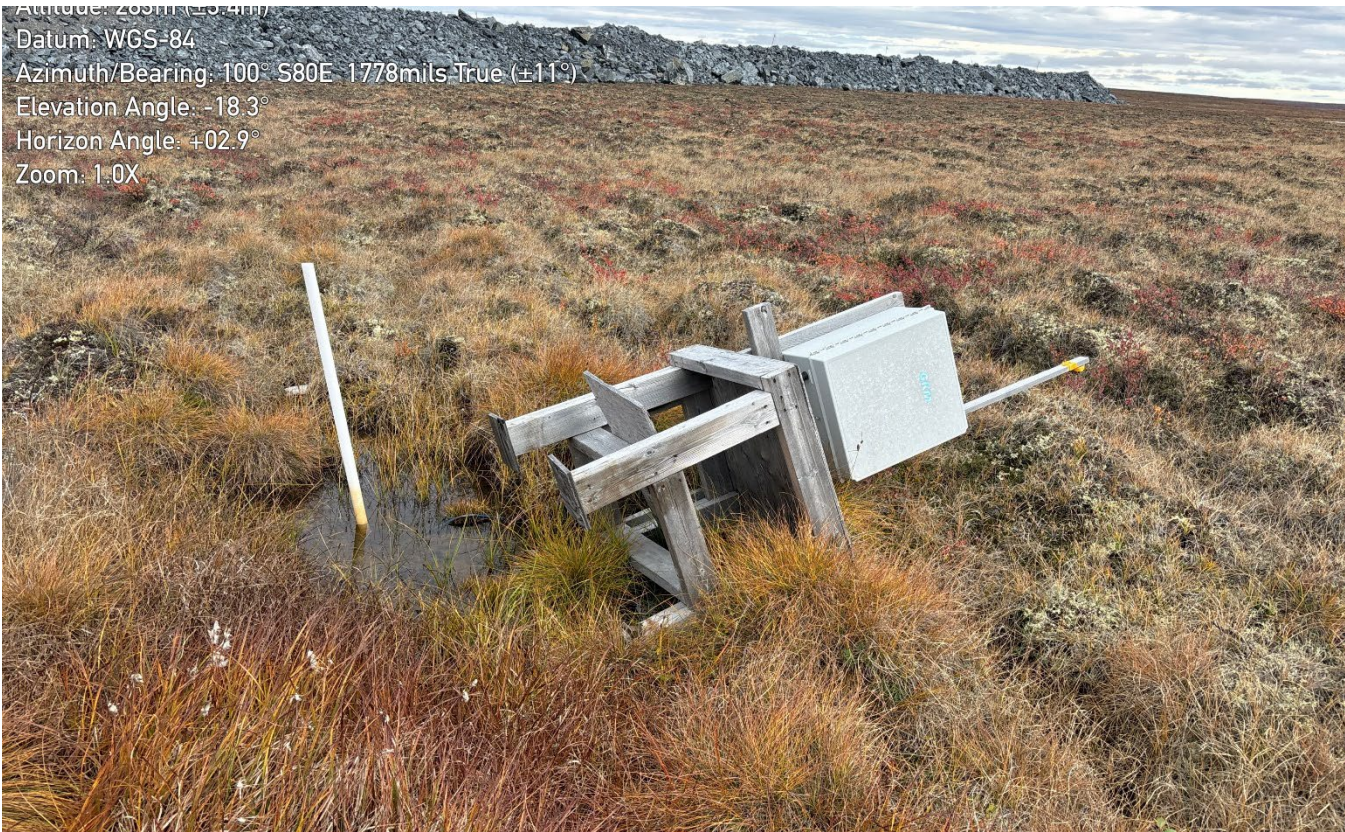
G-62a: Fallen datalogger

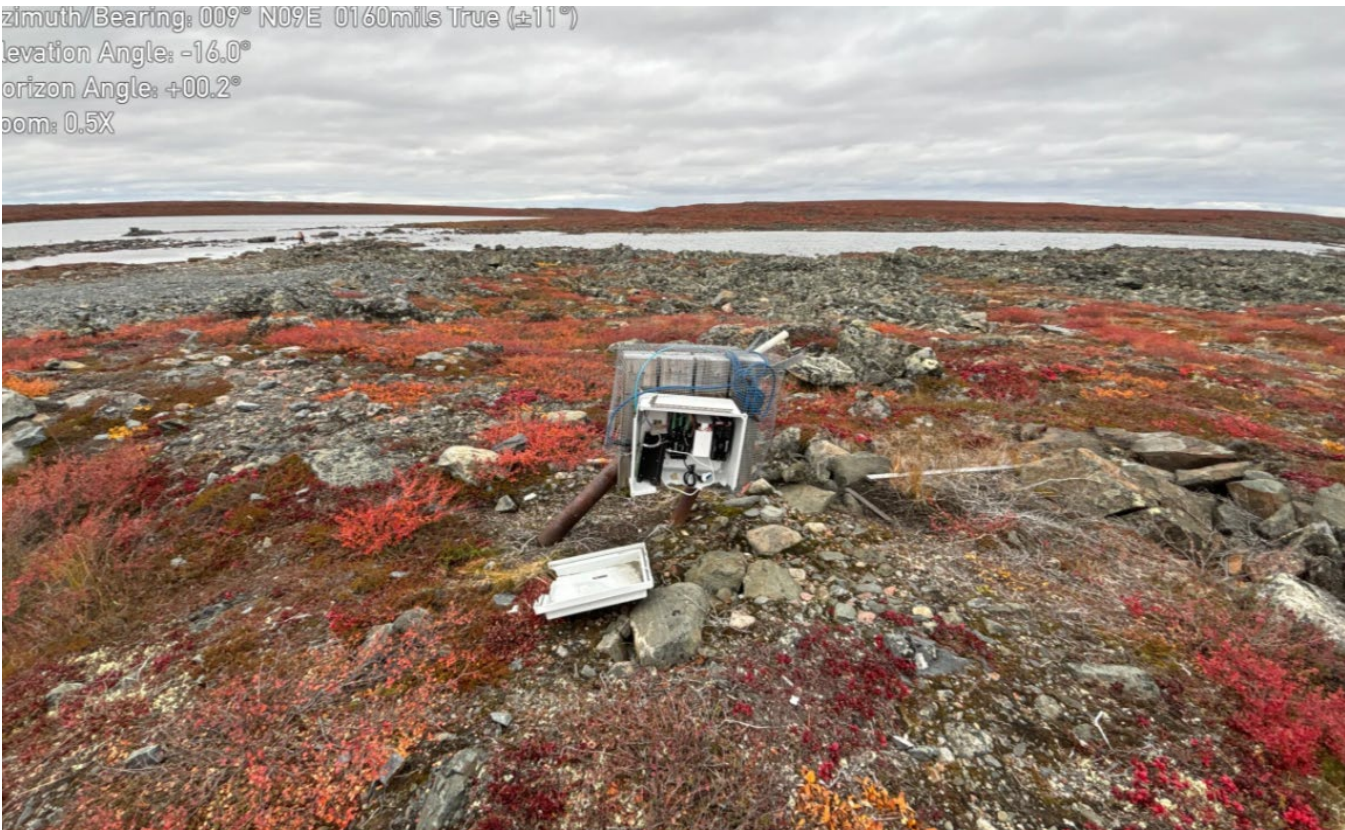
G-64a: Fallen datalogger

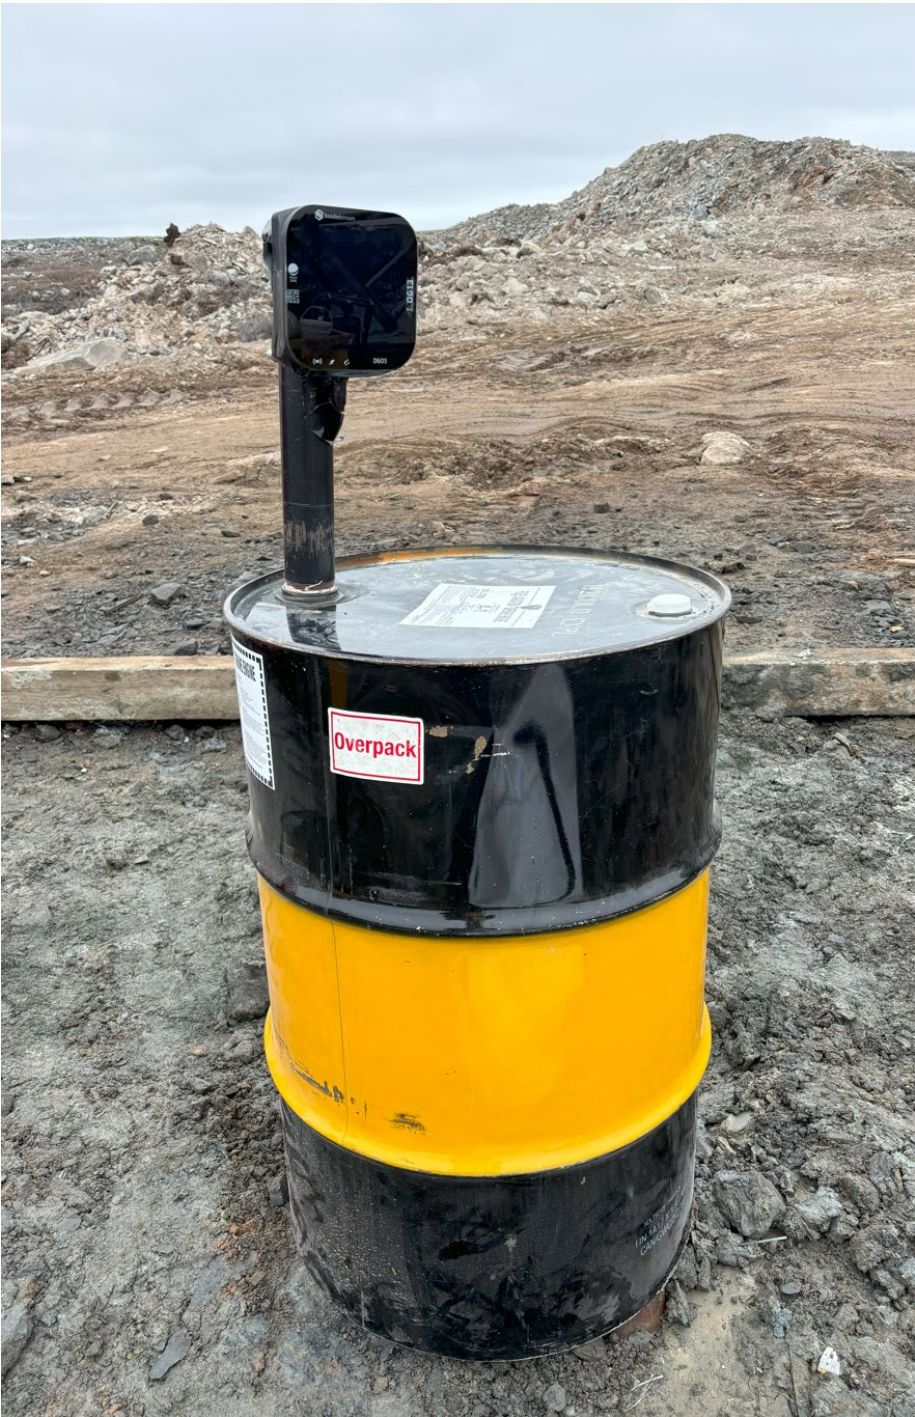
G-64e: Camp Pad. SRK-23-CPI-DH2

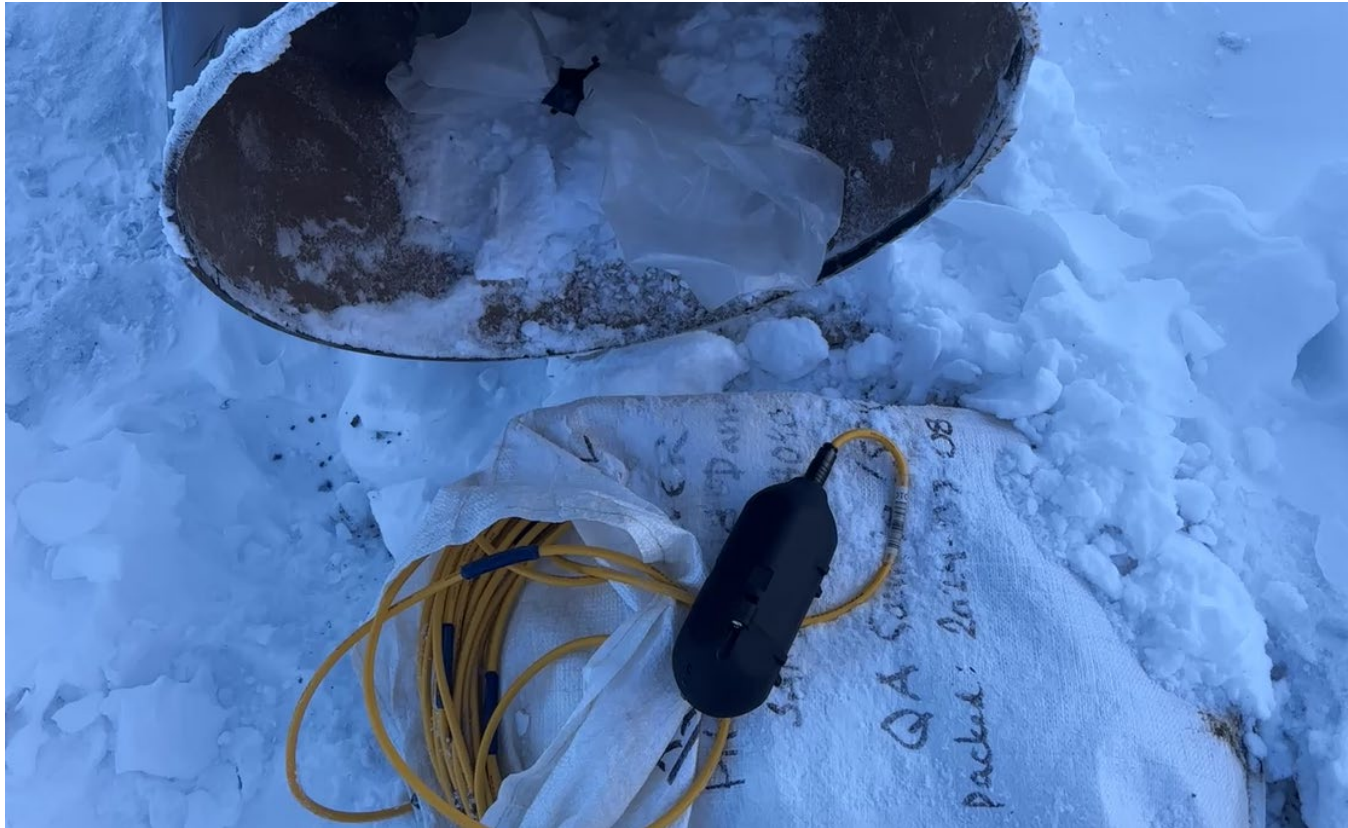
G-64f: Umwelt Underground Mine. 24-GSE-678B
