Goose & MLA Project Sites – 2024 Annual Geotechnical Inspection

Back River Project, Nunavut, Canada
B2Gold Corp.

SRK Consulting (Canada) Inc. ■ CAPR003105 ■ April 2025

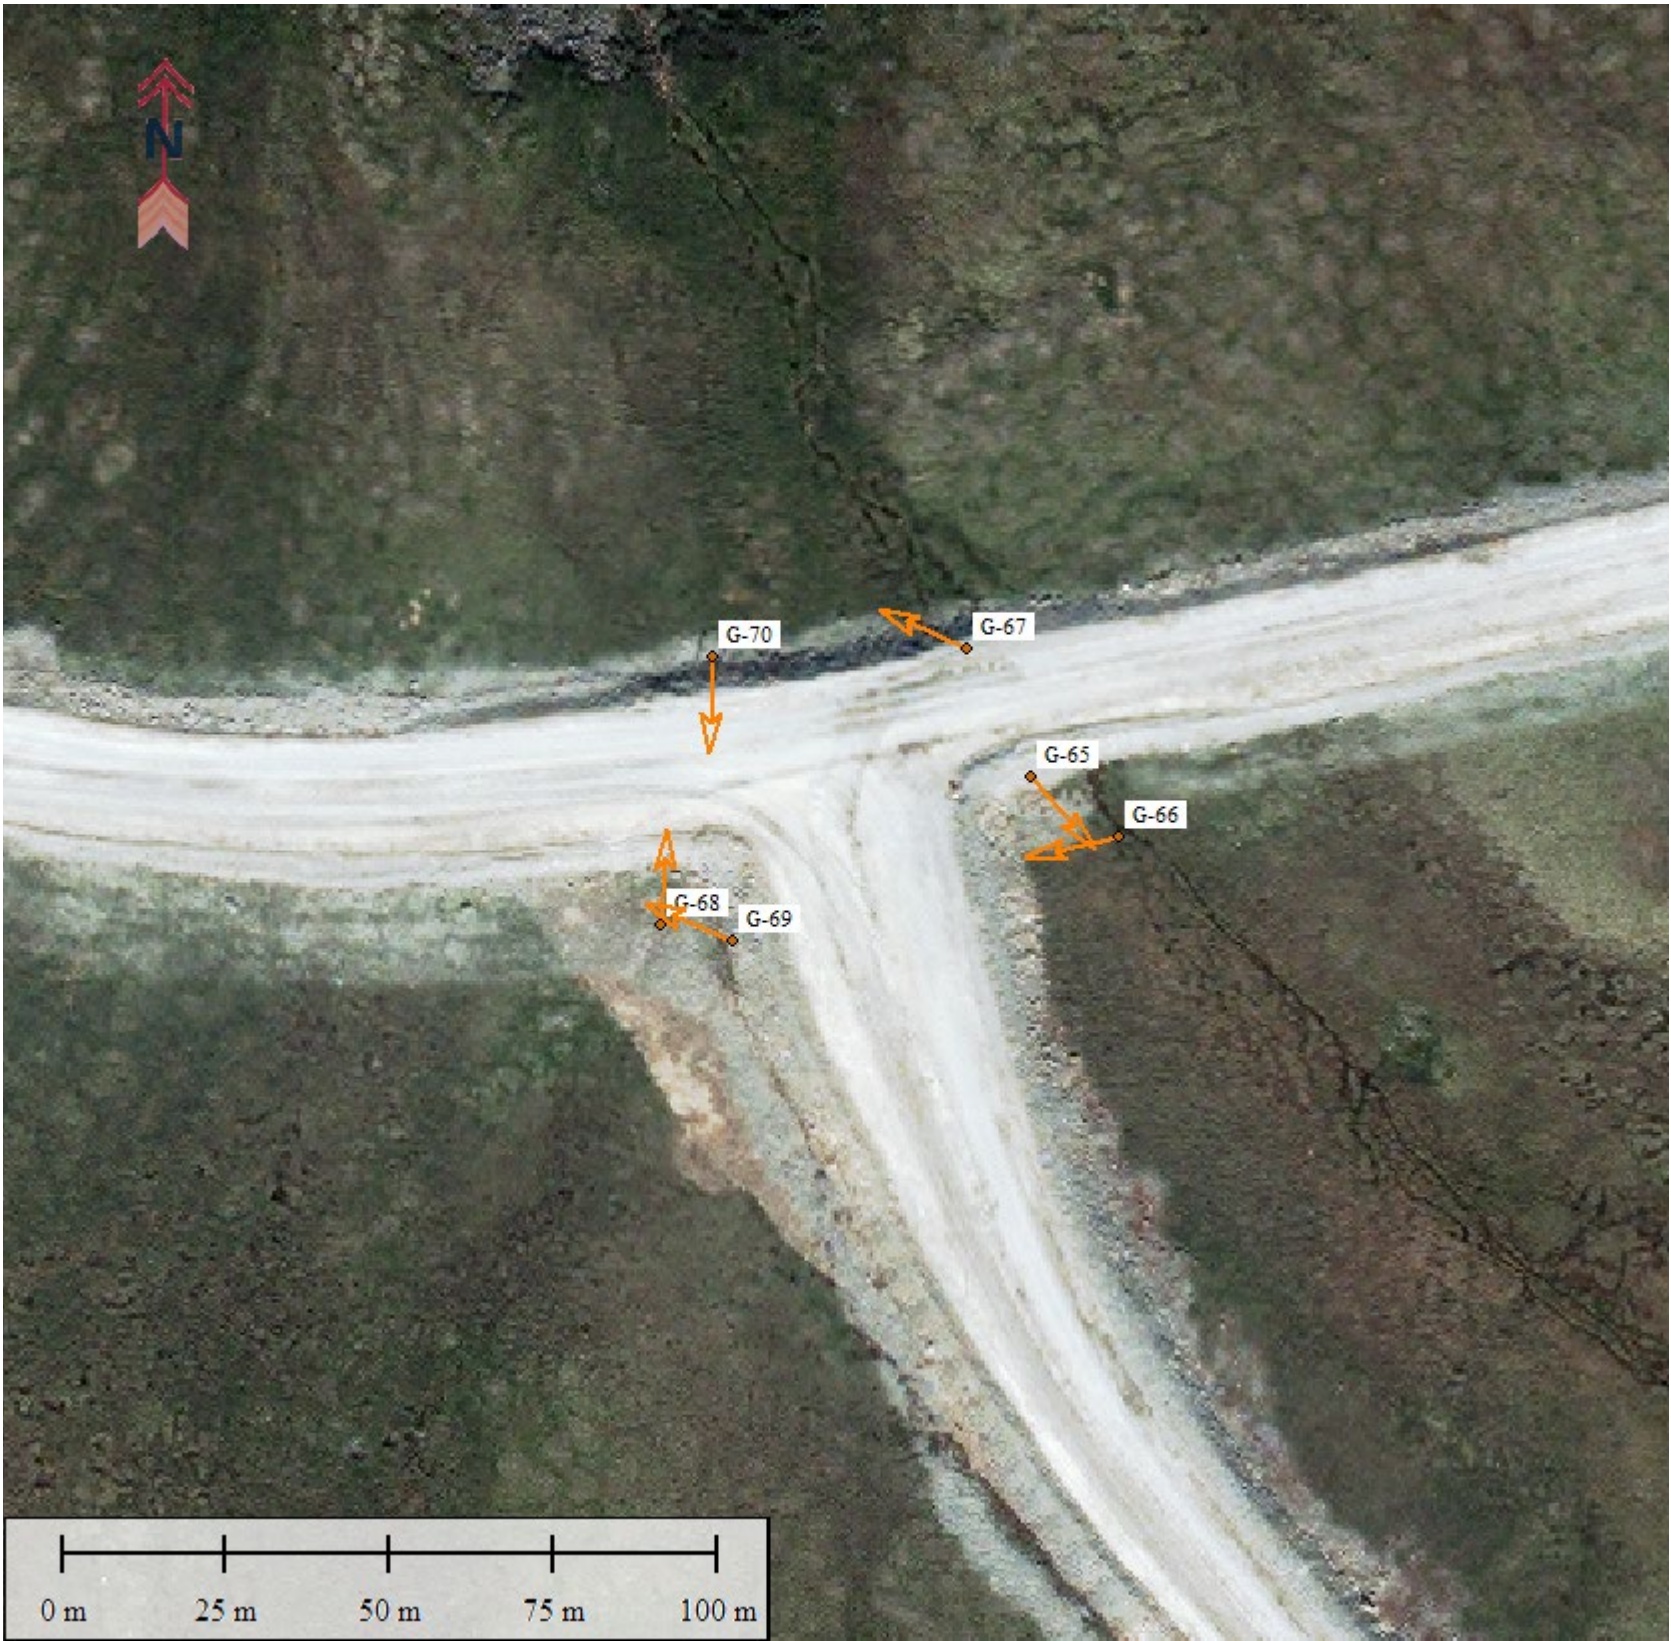
G-64h: Primary Pond Dam. PP-HTC-640-LN

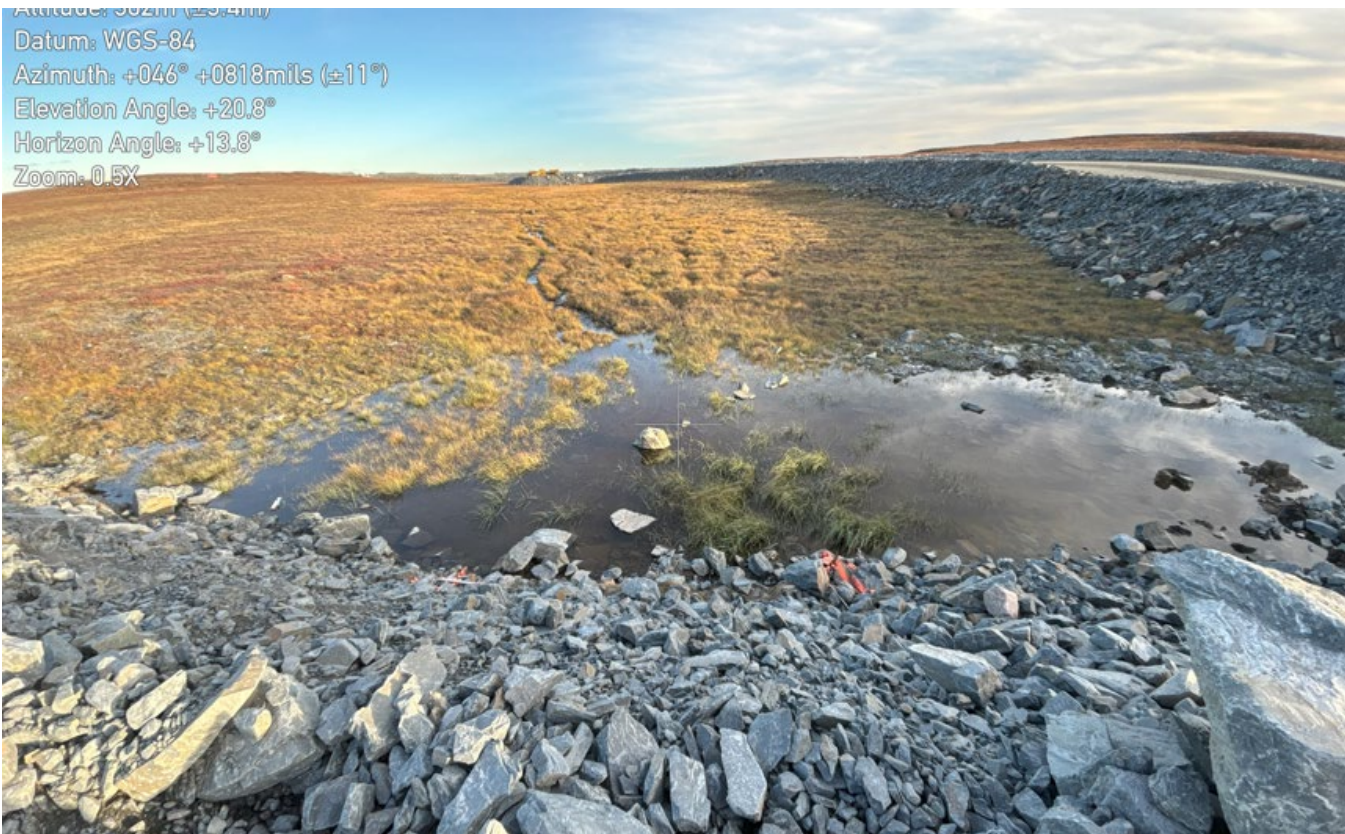
G-65: Eastern Side of Echo Pit Access Road Looking South – Note Culverts are Blocked. Ponding Water

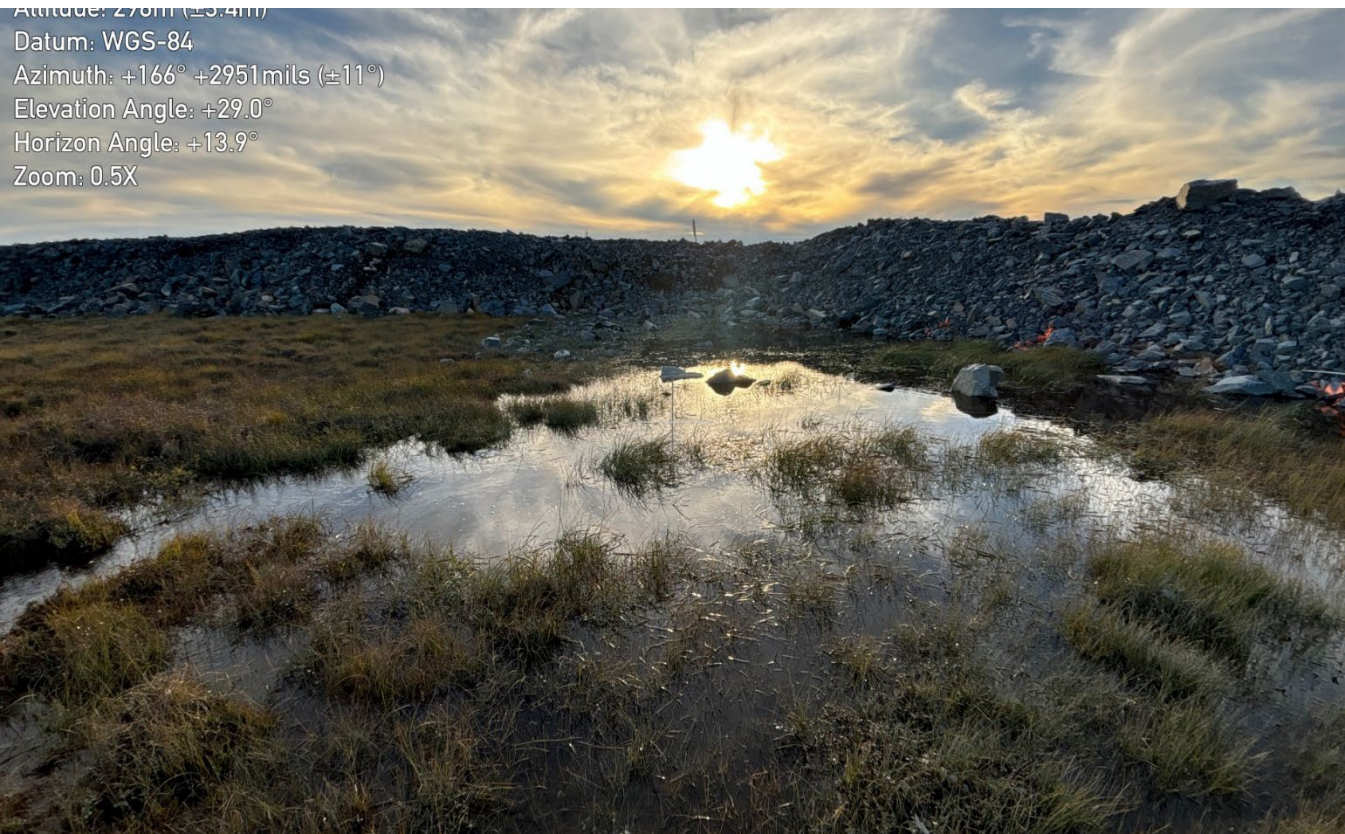
G-66: Eastern Side of Echo Pit Access Road looking West – Note Culverts are blocked

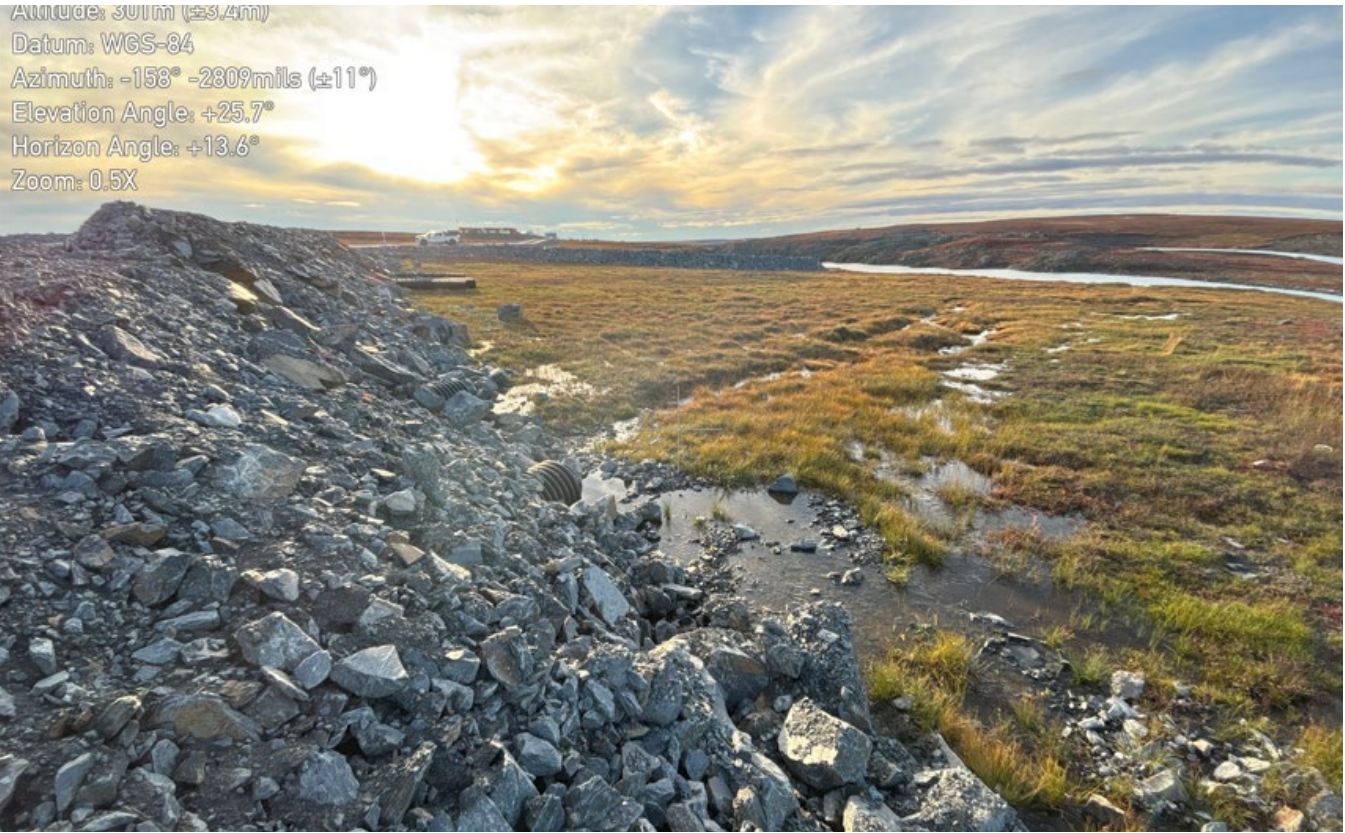
G-67: Northern Side of Echo Pit Haul Road – Note Ponding Water

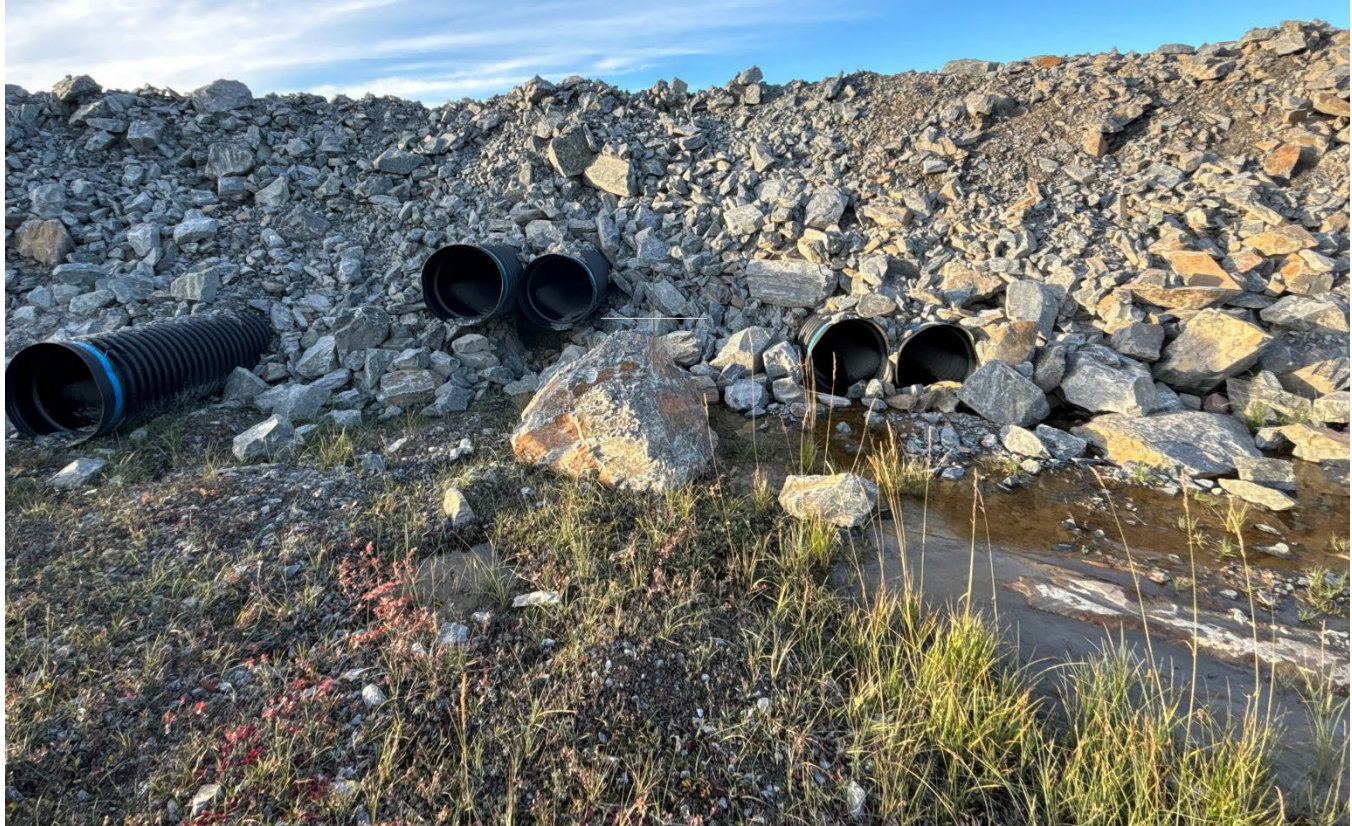
G-68: Southern Side of Echo Pit Haul Road – Note two Culverts are elevated approx. 0.5m from toe of embankment. Culverts partially blocked

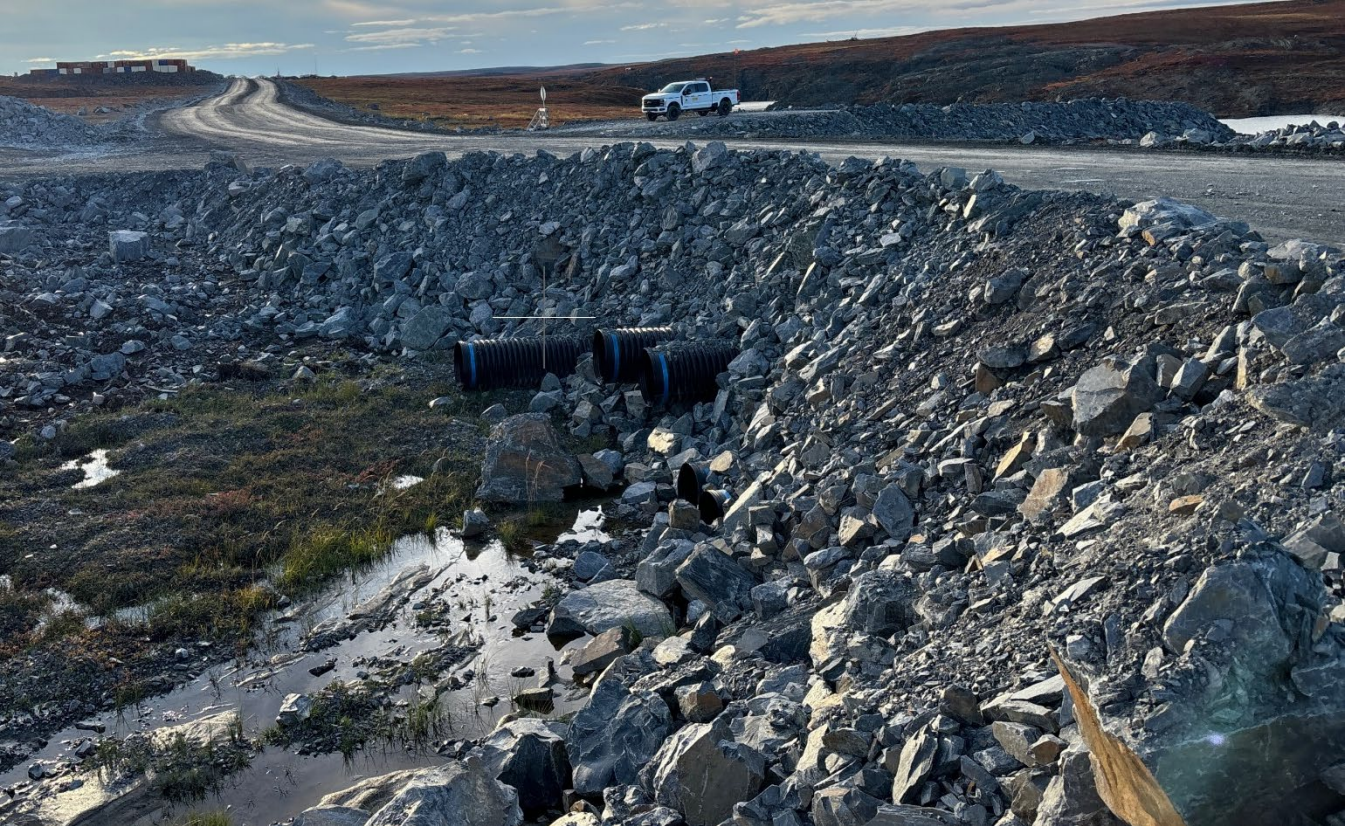
G-69: Haul road slope, facing west to crossing culverts

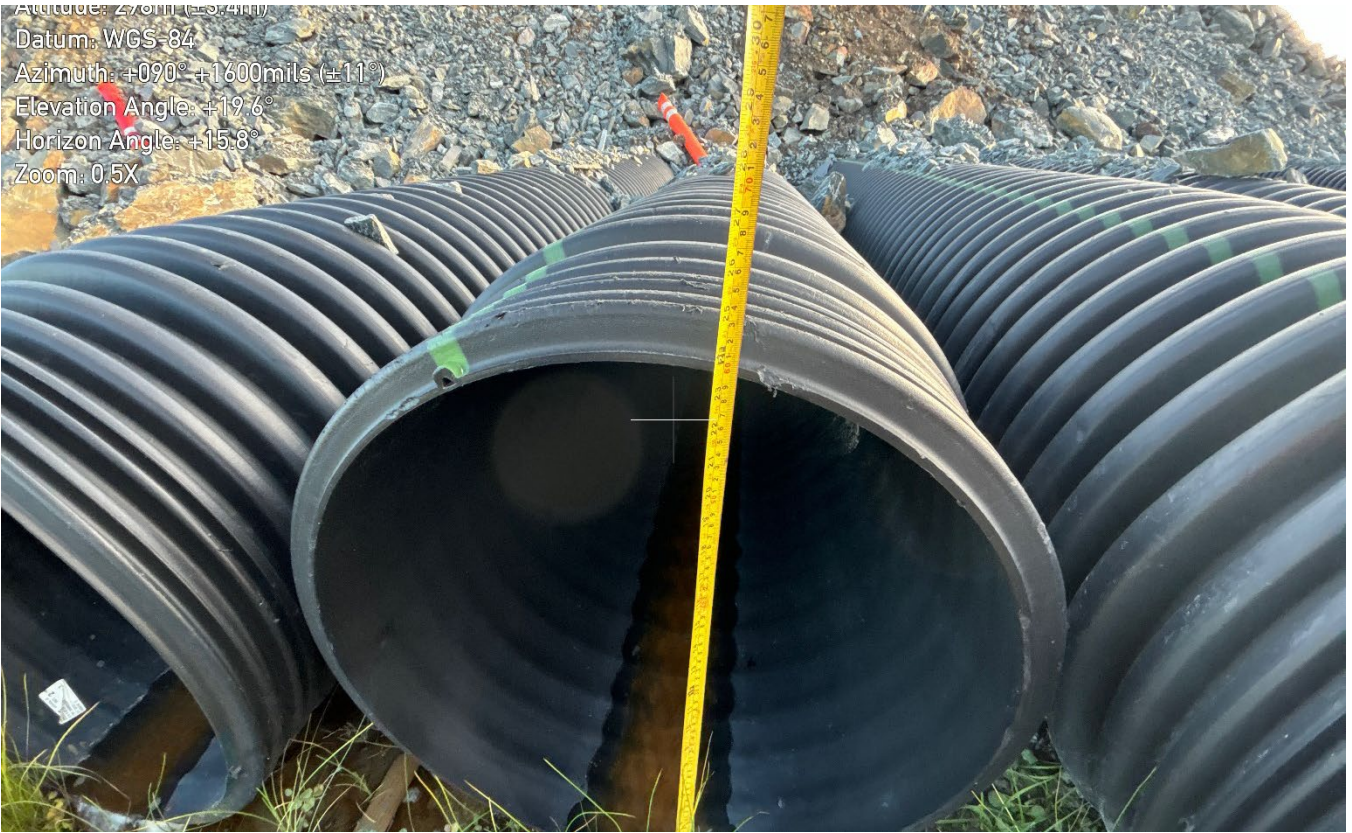
G-70: Culvert size

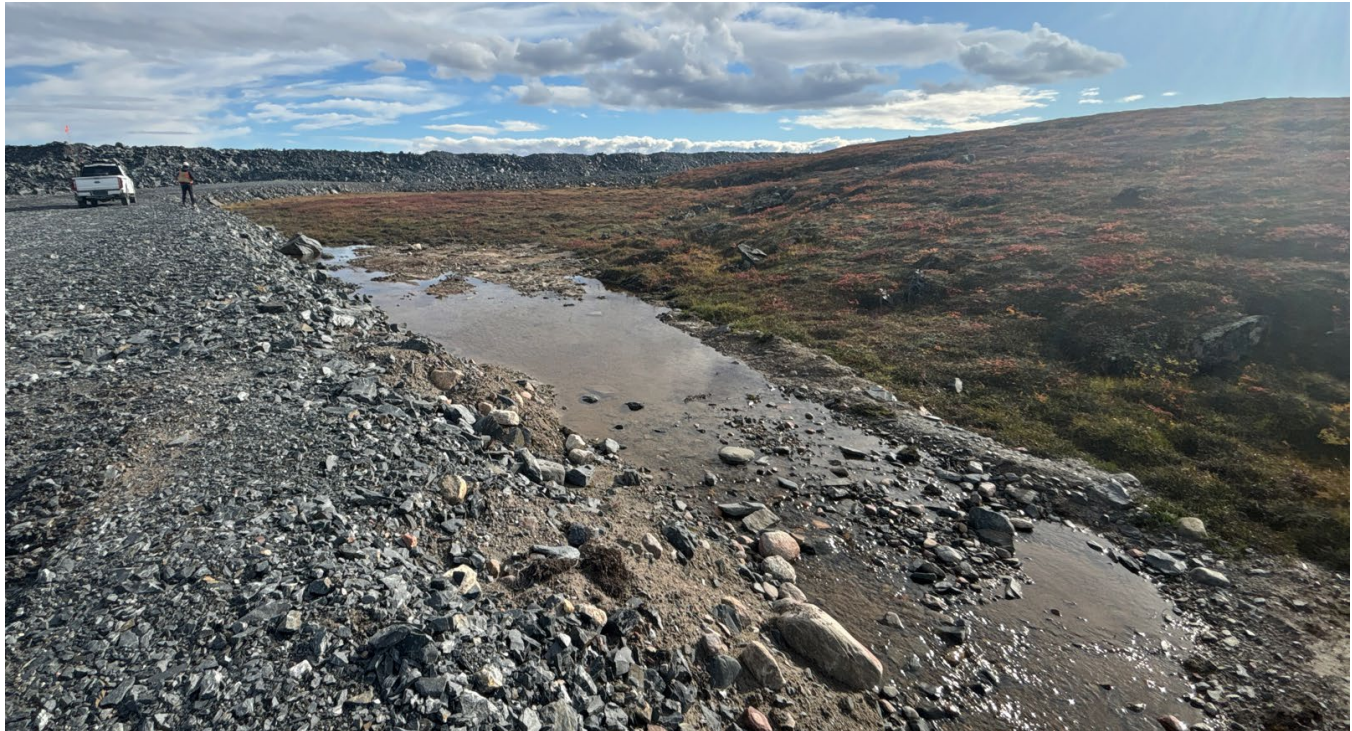
G-71: Beginning of diversion, facing south

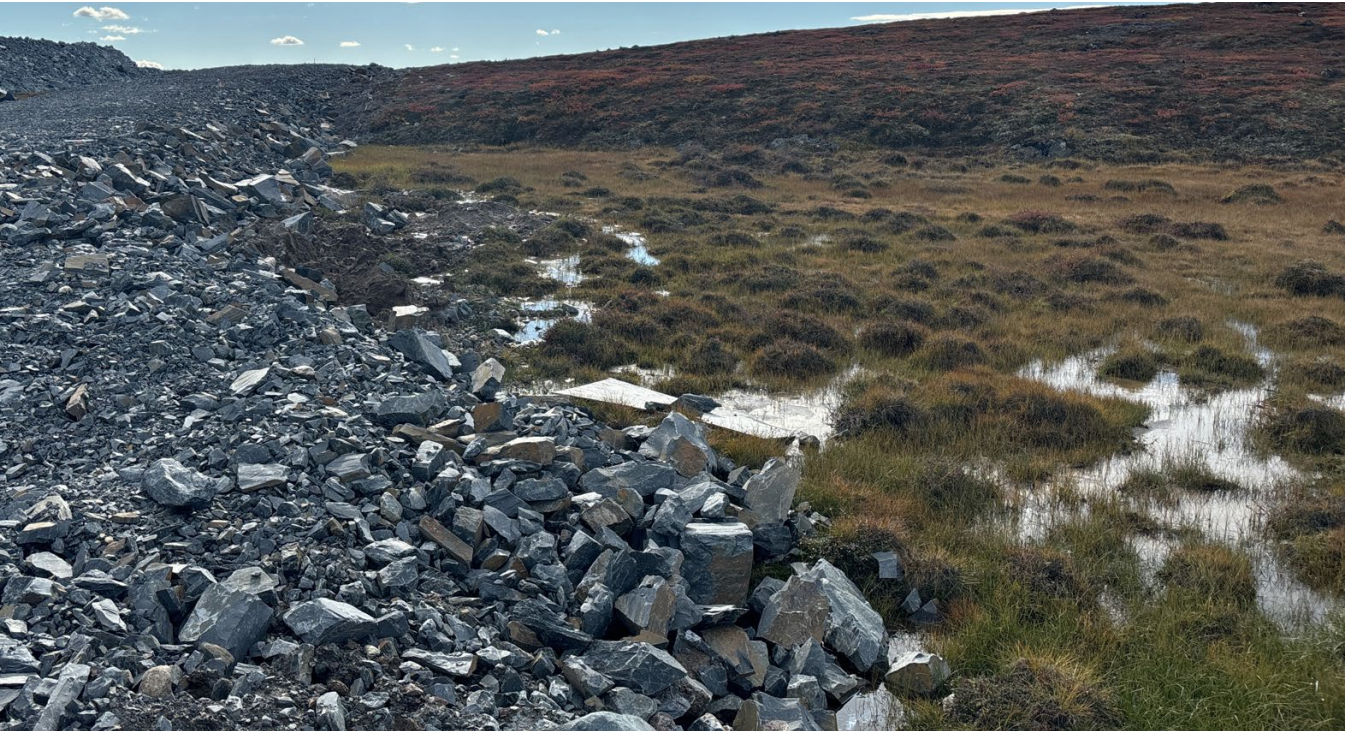
G-72: Diversion, facing west – Note thickness less than 1m

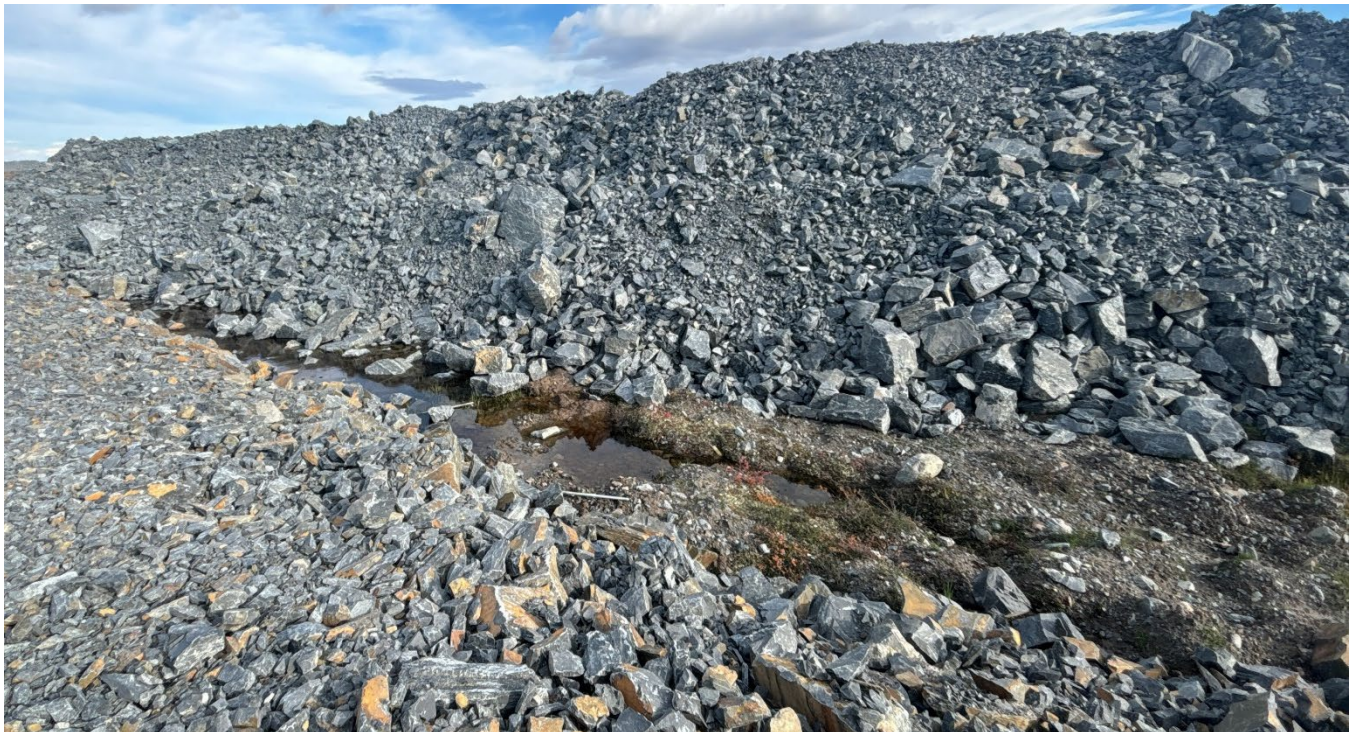
G-73: Diversion, facing west – Note that dump is built on overburden rich sections at the toe

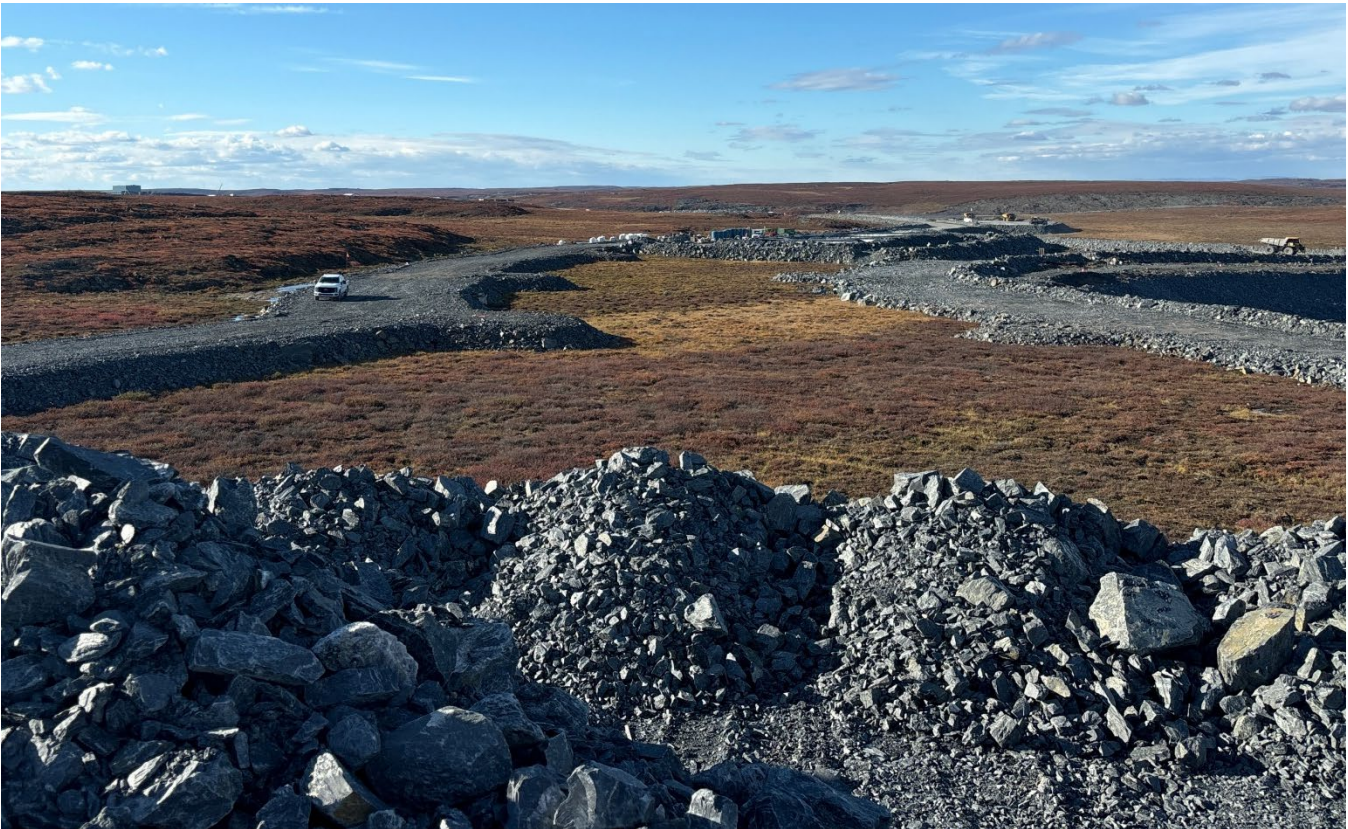
G-77: View from echo pit dump towards diversion

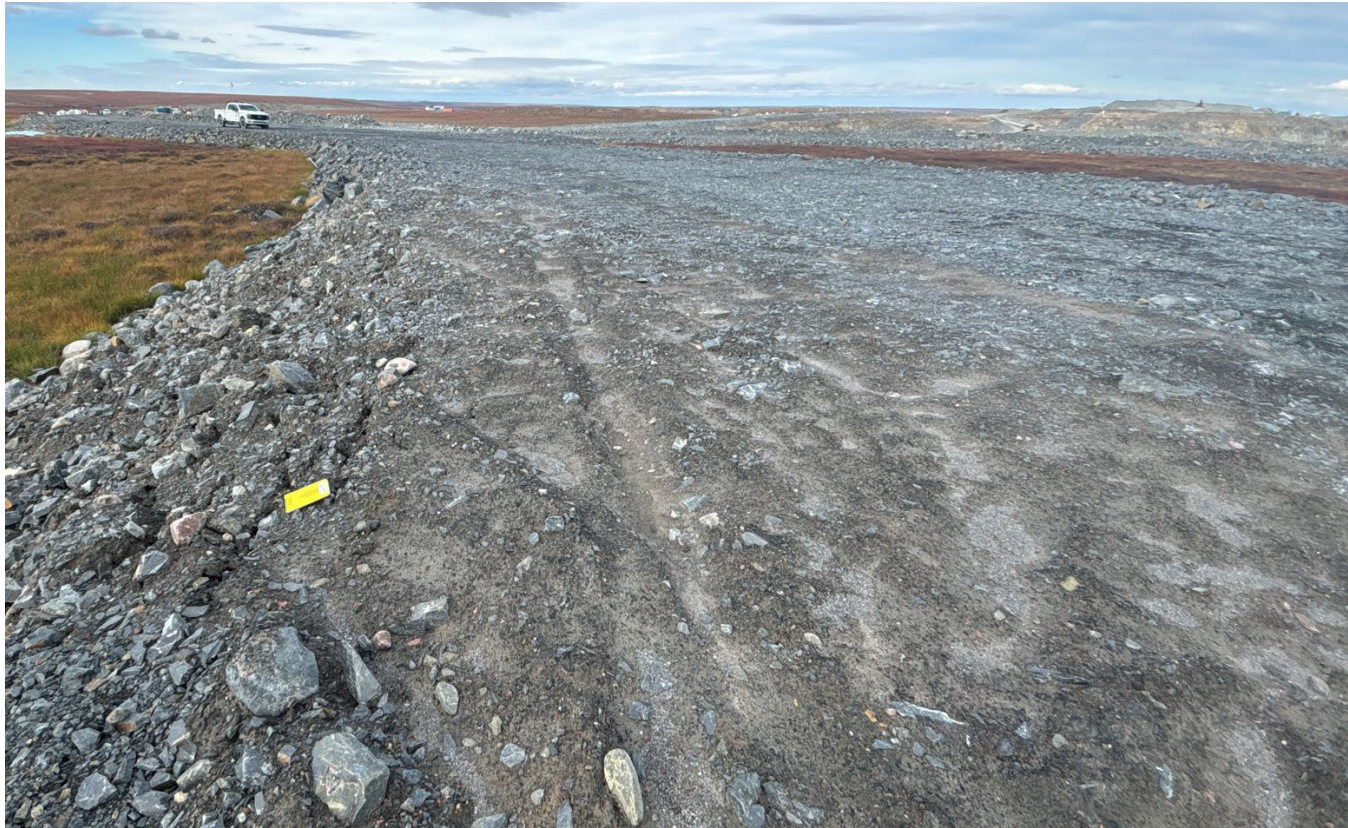
G-78: Diversion, facing north – Note thickness below 1m

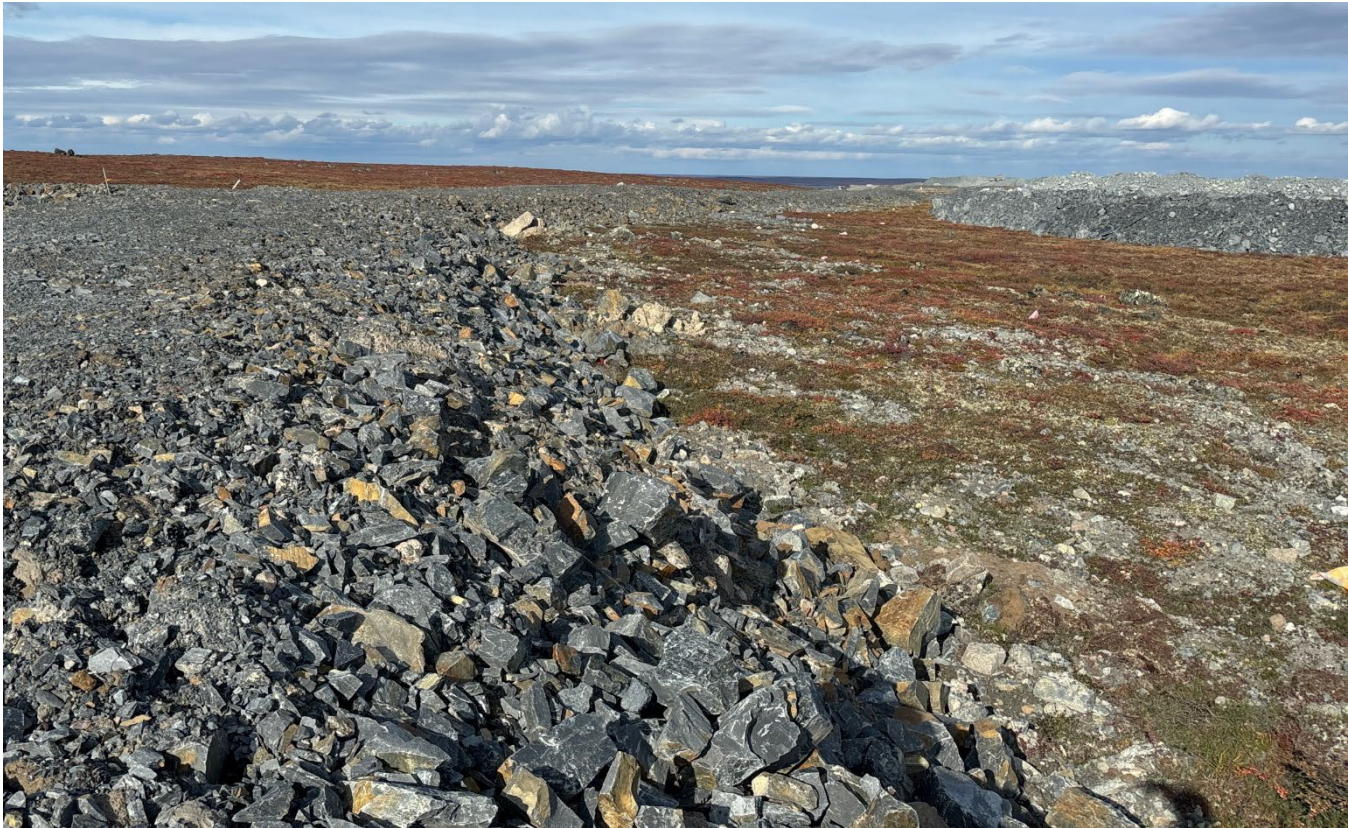
G-79: Westerly end, facing north – Note thickness below 1m

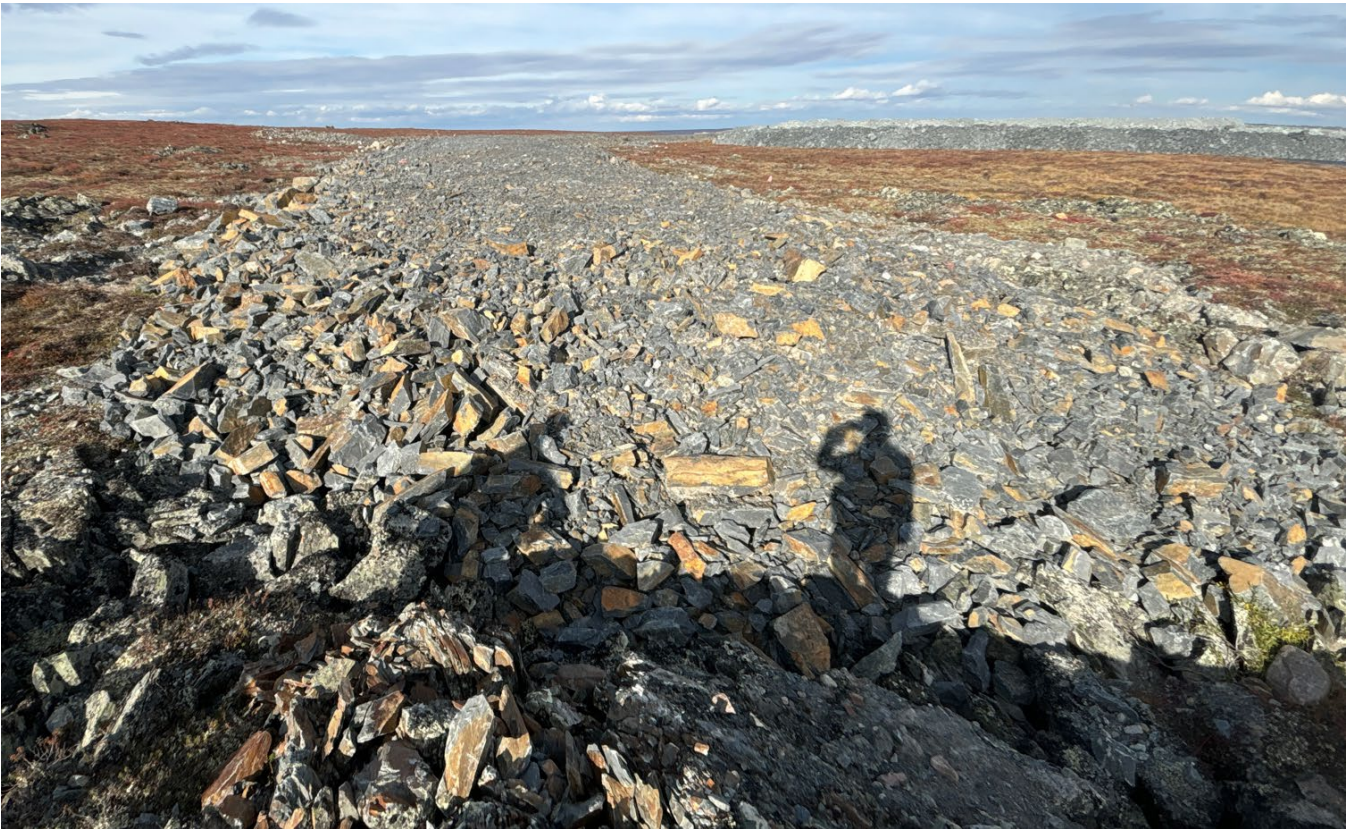
G-80: Westerly end of diversion – Note thickness below 1m

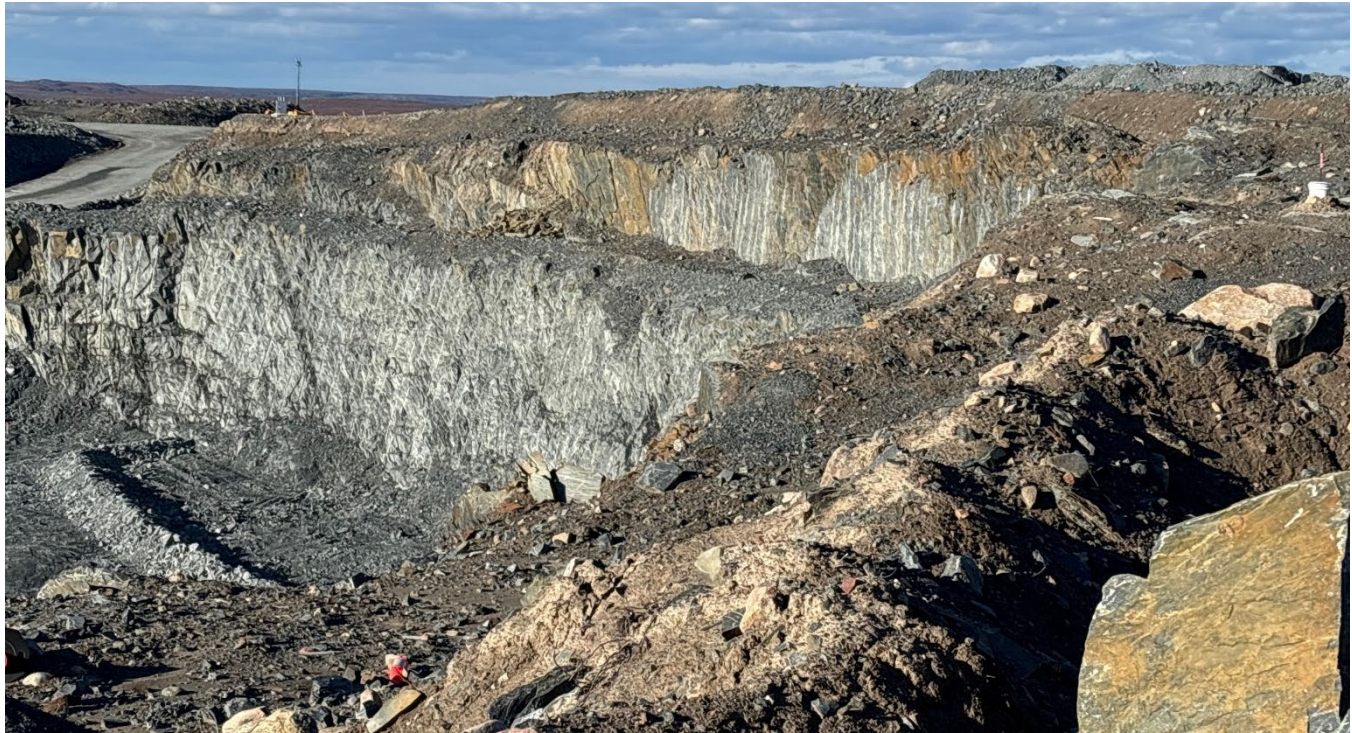
G-81: Eastern highwall, facing north

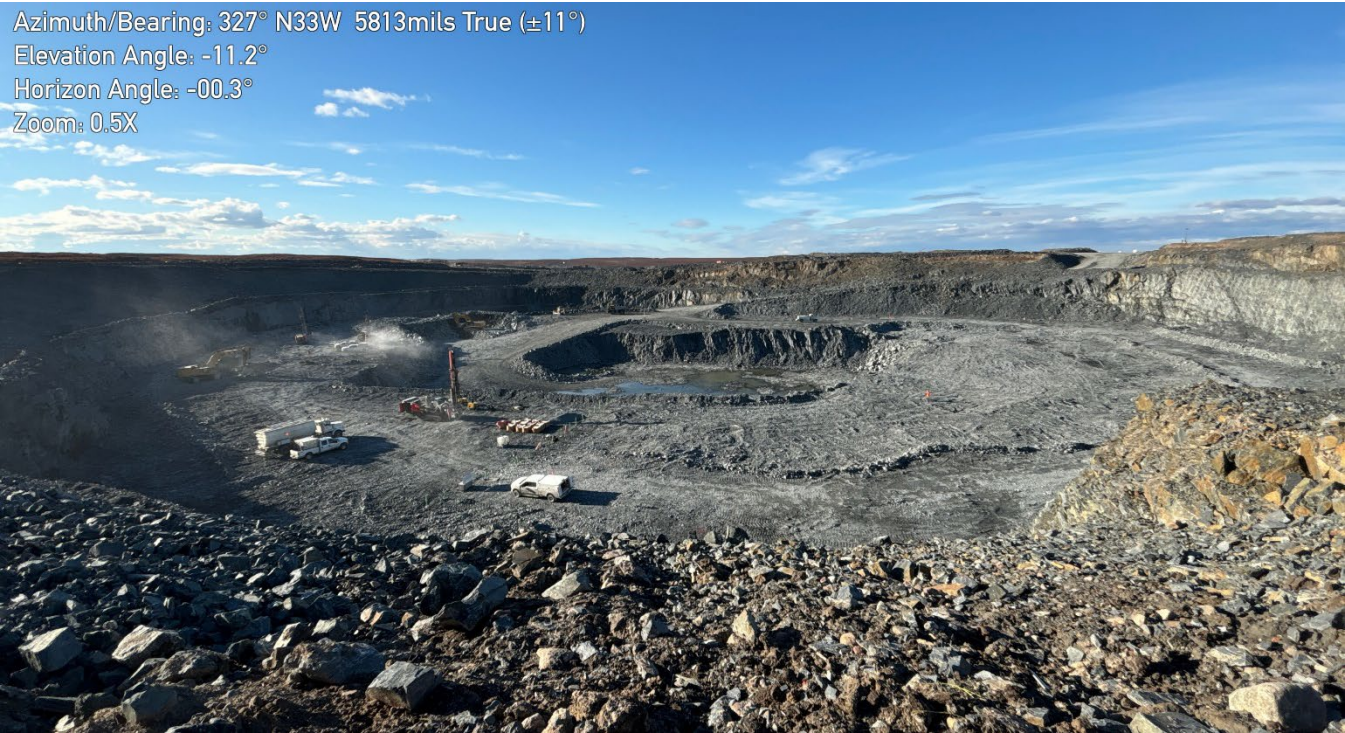
G-82: General view, facing north

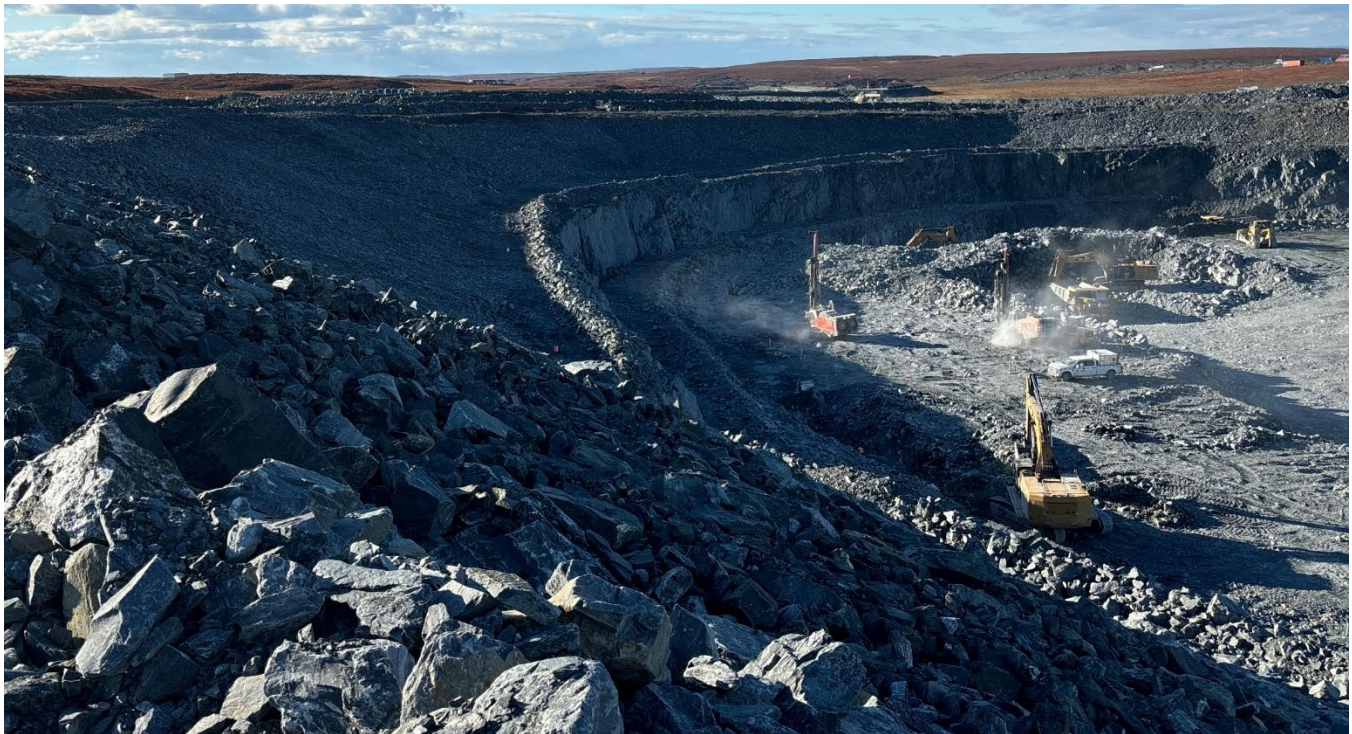
G-83: Western wall, facing NW

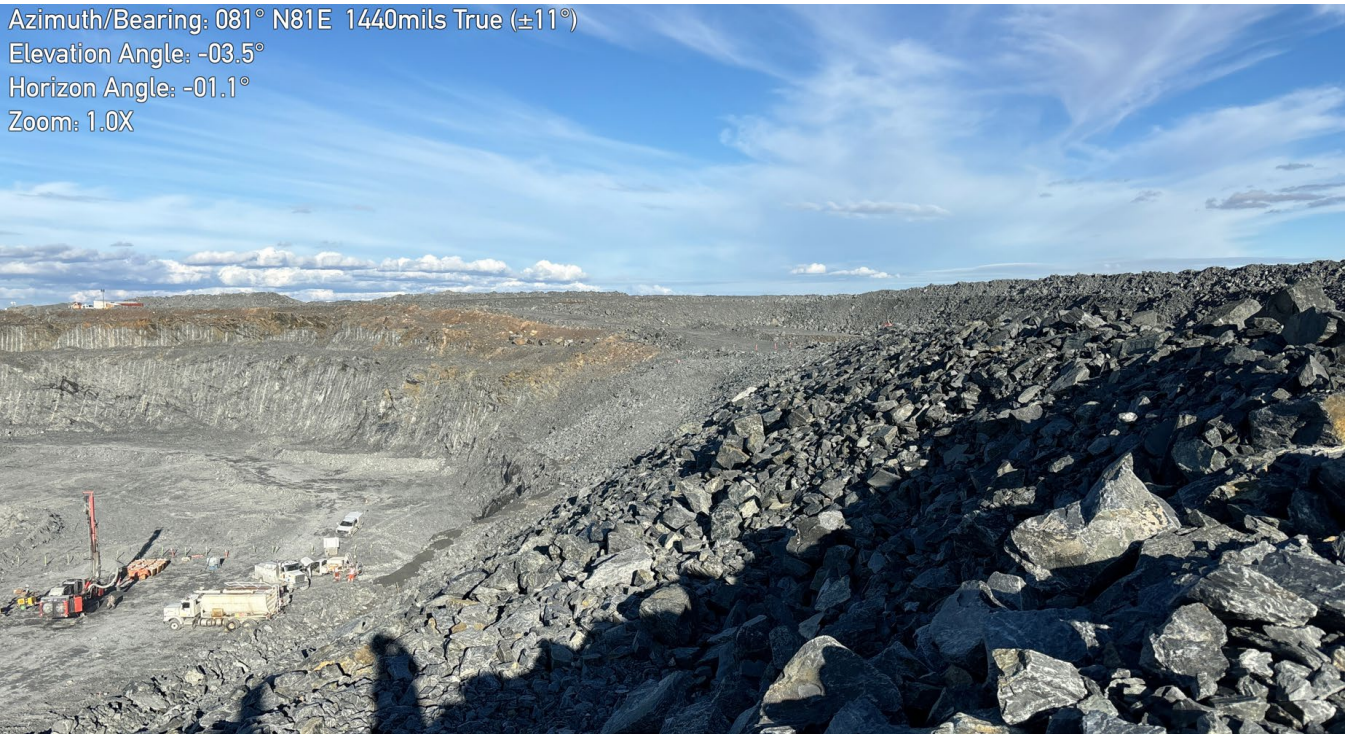
G-84: Southern wall, facing east

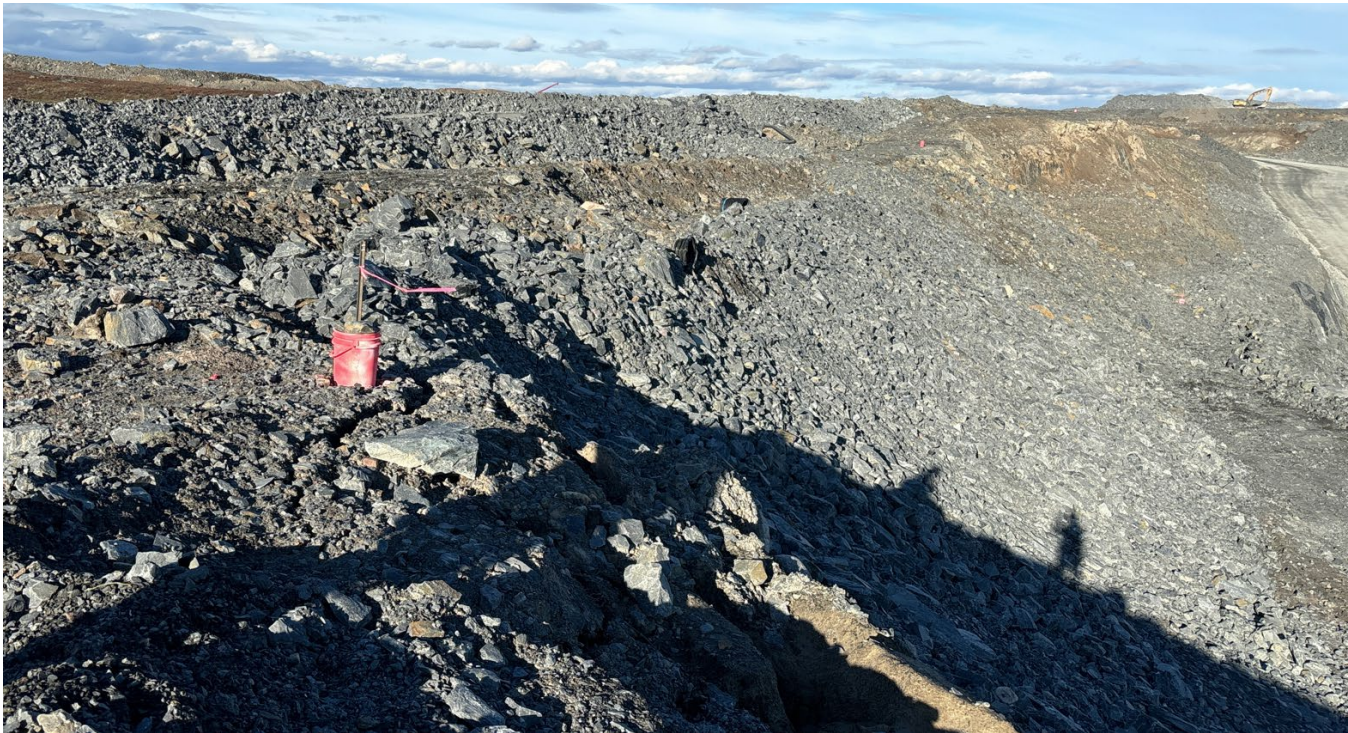
G-86: Northern wall, facing NE – Note

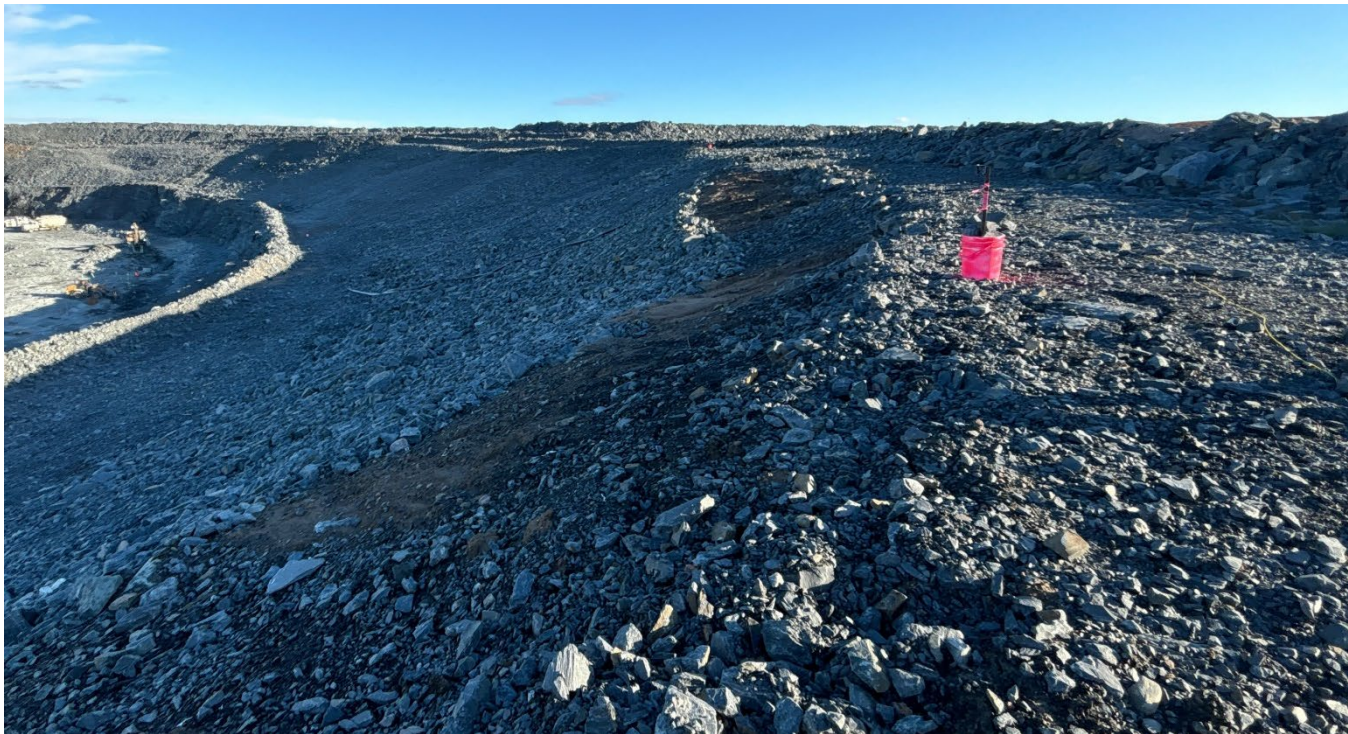
G-87: Crest of western wall, facing south
