Goose & MLA Project Sites – 2024 Annual Geotechnical Inspection

Back River Project, Nunavut, Canada
B2Gold Corp.

SRK Consulting (Canada) Inc. ■ CAPR003105 ■ April 2025

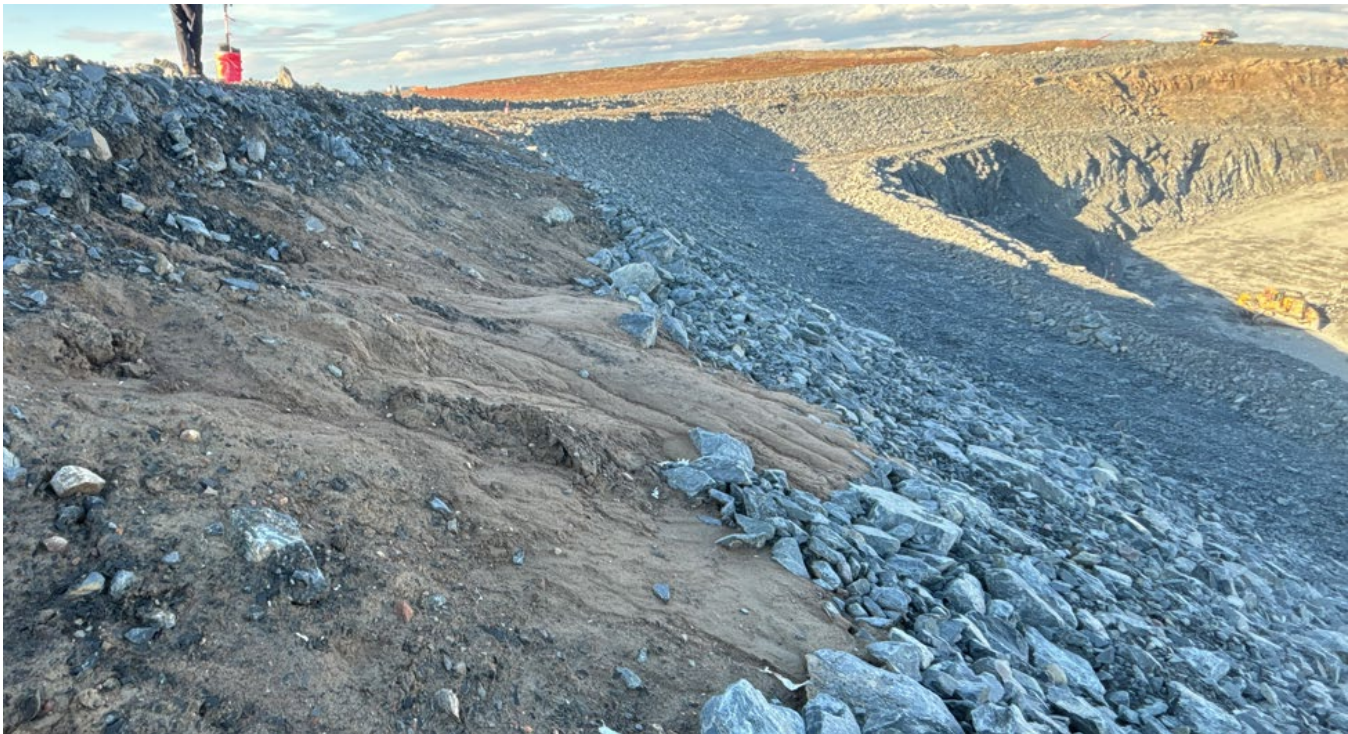
G-88: Crest of western wall, facing north – Note thermal erosion and erosion gulleys

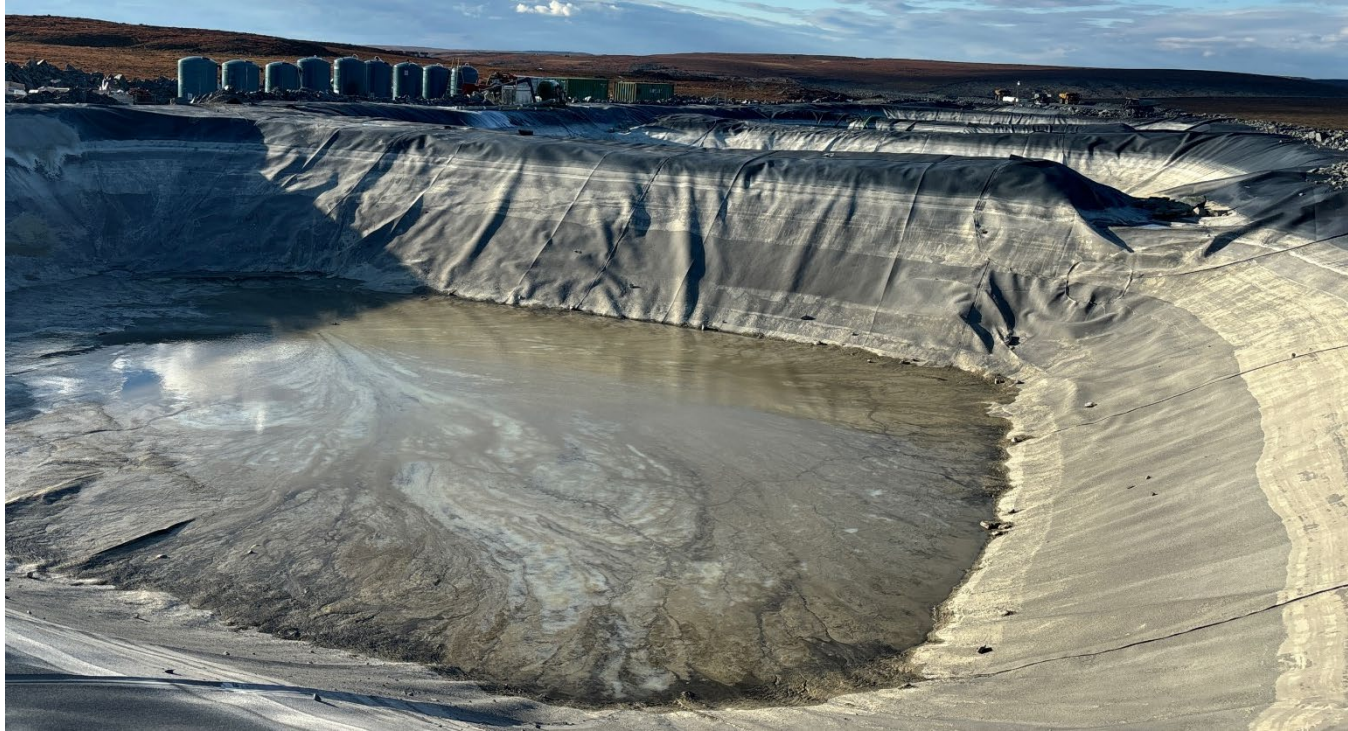
G-89: Treatment pond

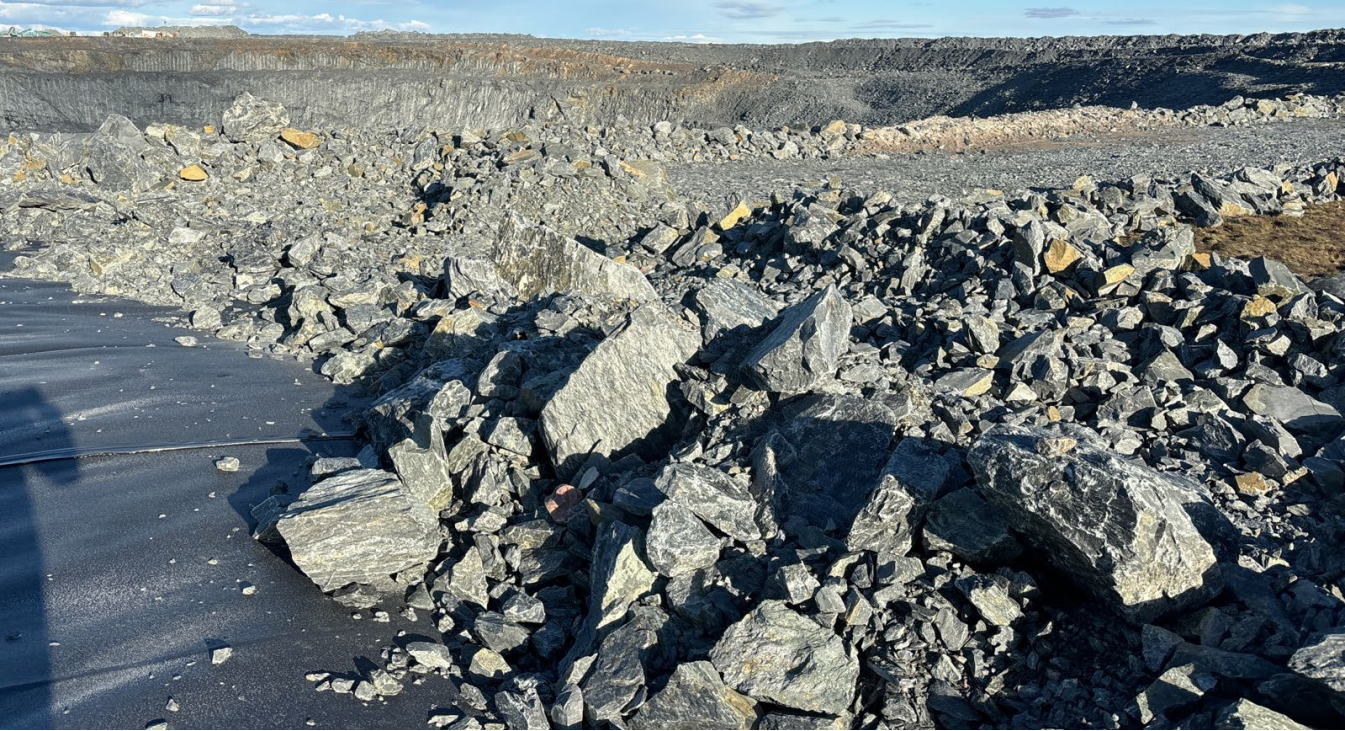
G-90: Pond tie-in – Inappropriate over-liner material (4" plus blasted rock)

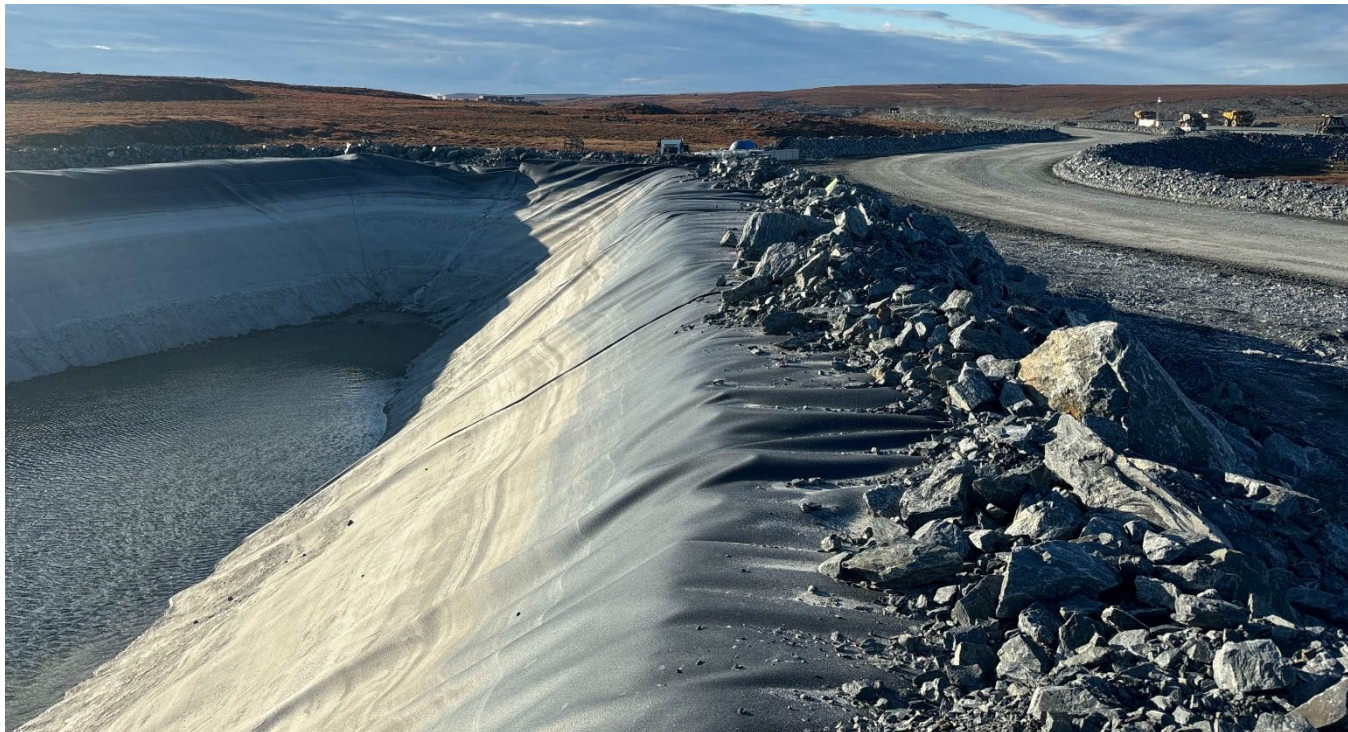
G-91: Pond Slopes are oversteepend and no spillway present

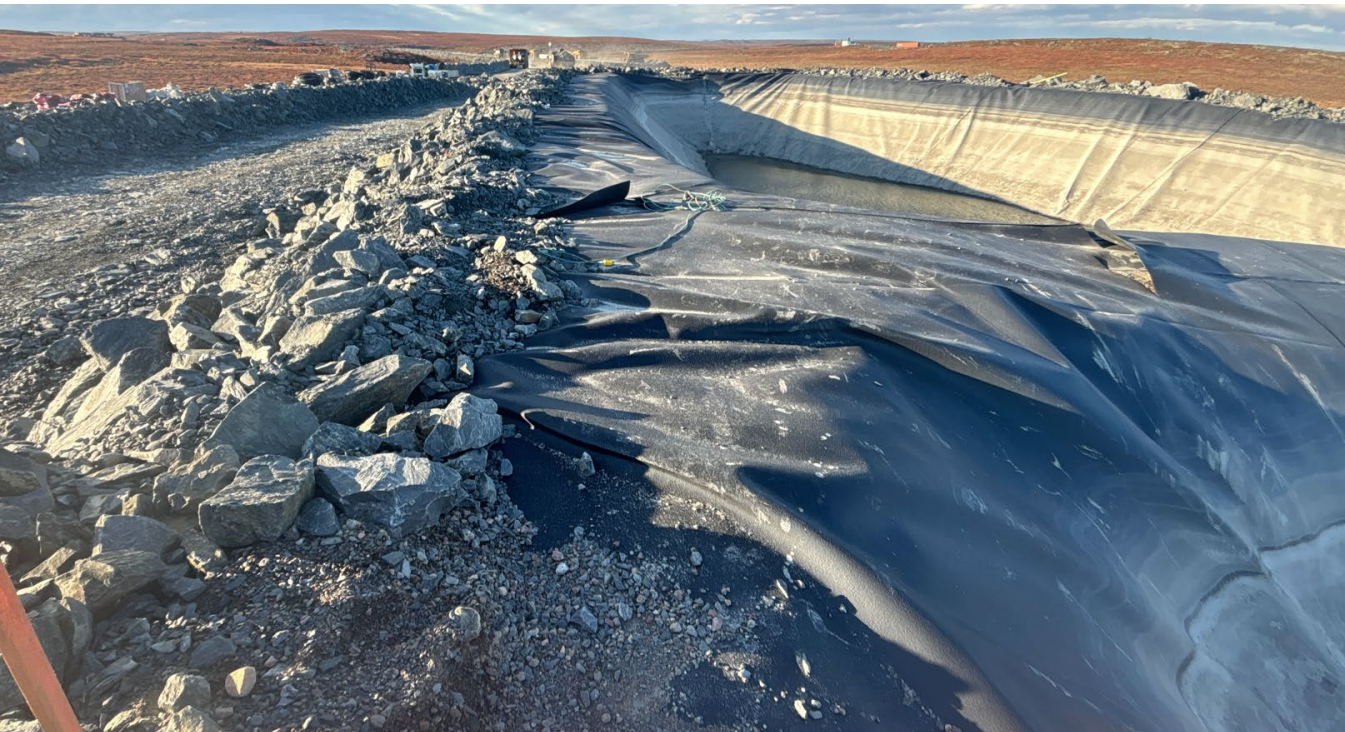
G-92: Pond tie-in – Inappropriate over-liner material (4" plus blasted rock) and no spillway present

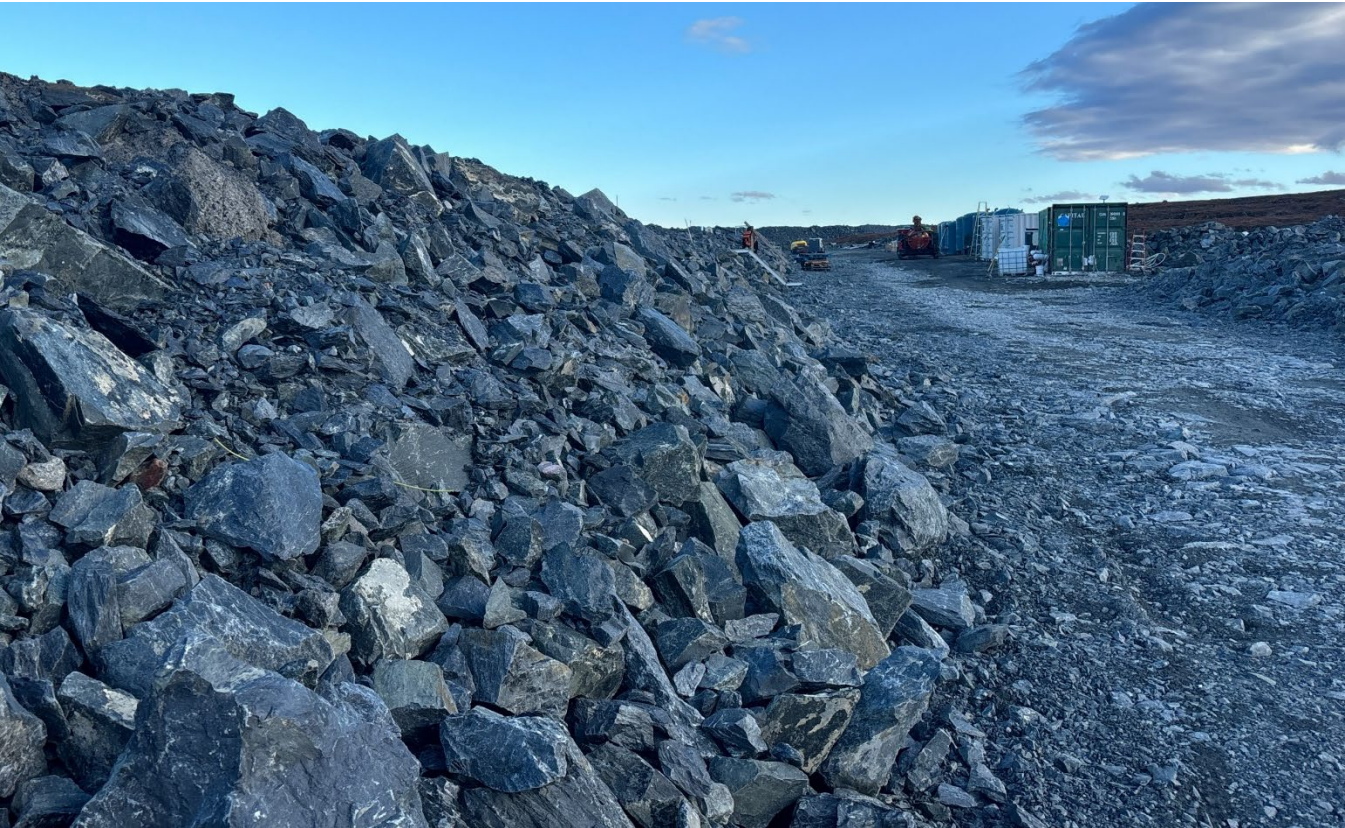
G-97: Northern most treatment pond slope – Note pond slope is oversteepended

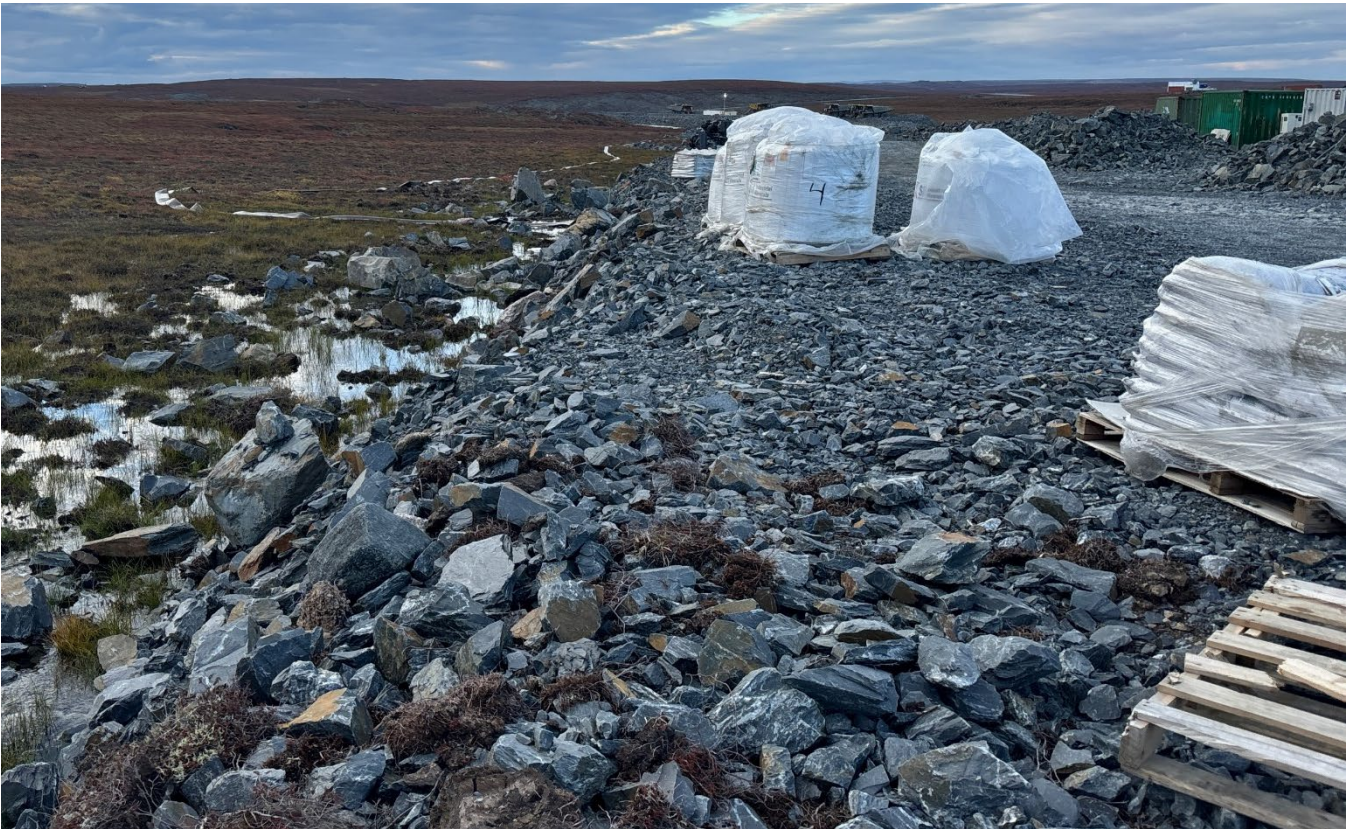
G-98: Eastern side of treatment area – Note ponding water

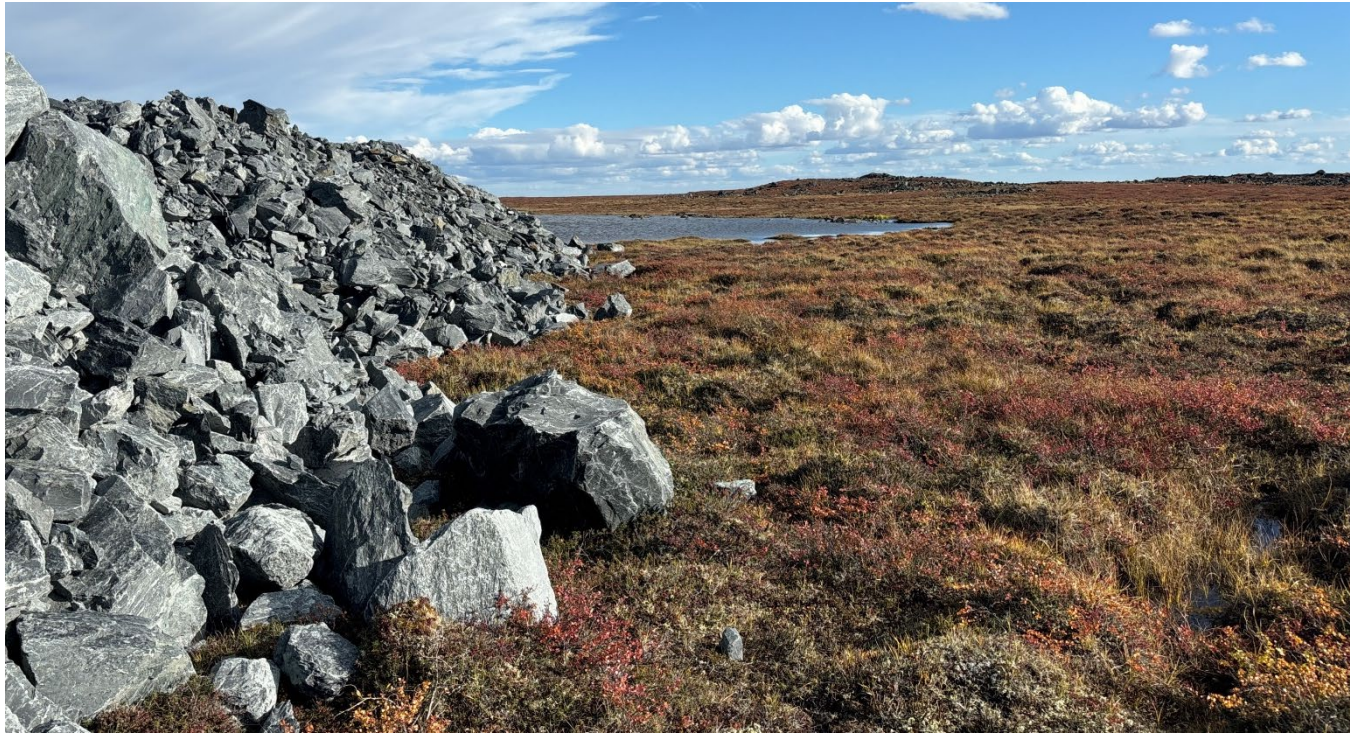
G-99: Southern end of WRSA, facing SE – Note oversteepened slopes

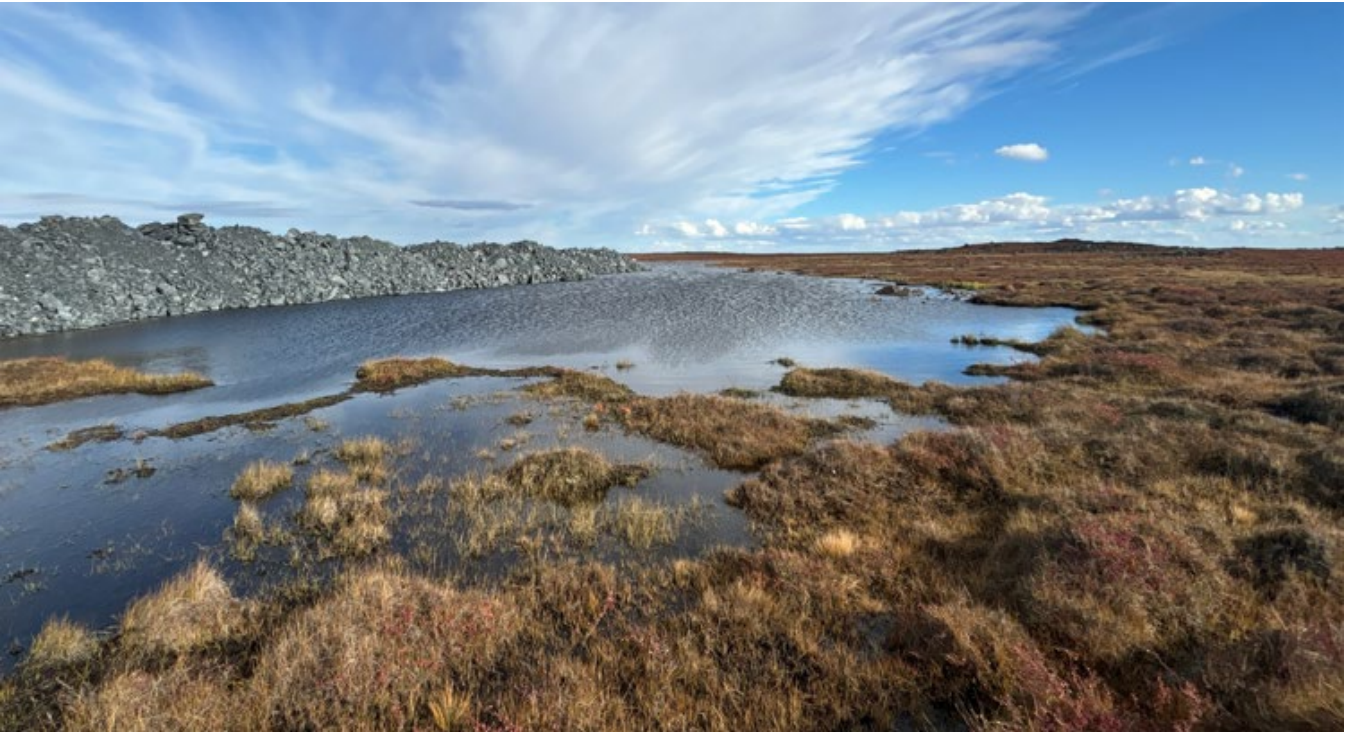
G-100: Southern end of WRSA, facing east – Note waste rock dumping in lake pond

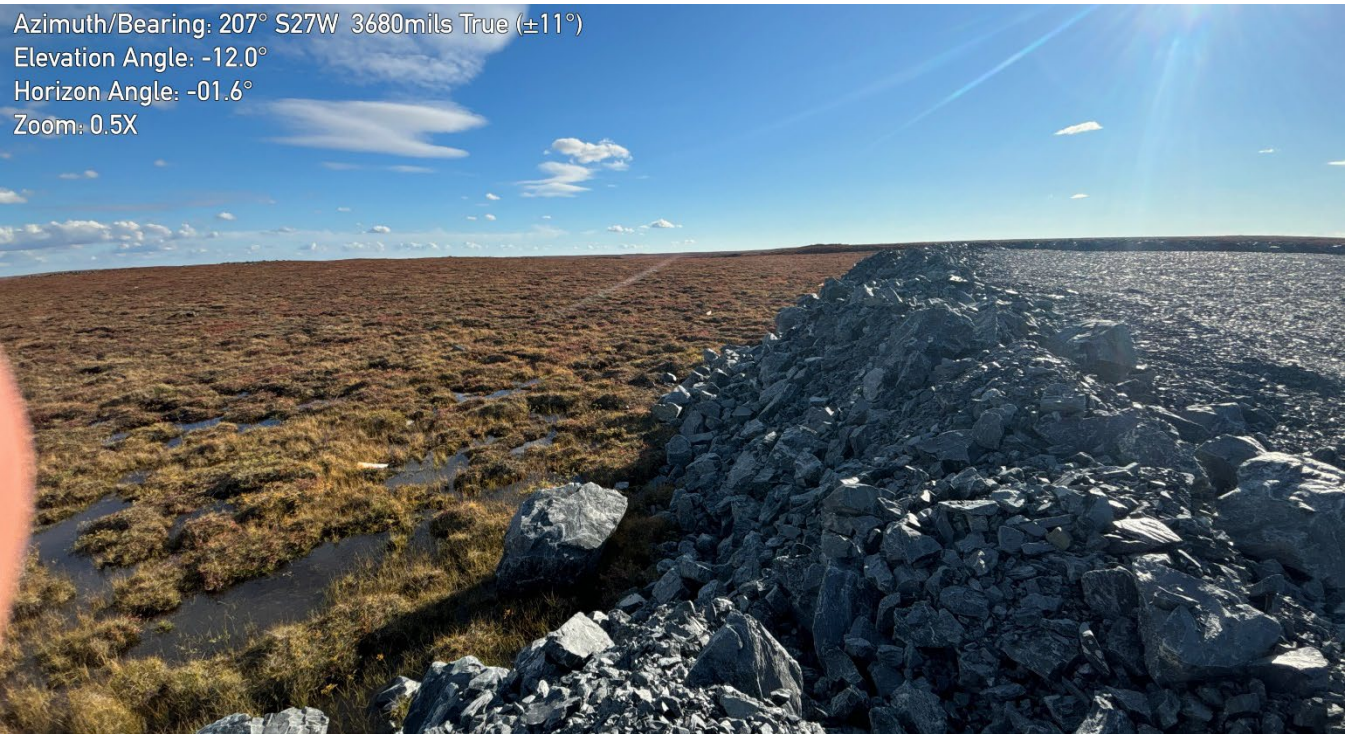
G-102: General view, southern slope, facing SW – Note lack of safety berm and irregular slope face

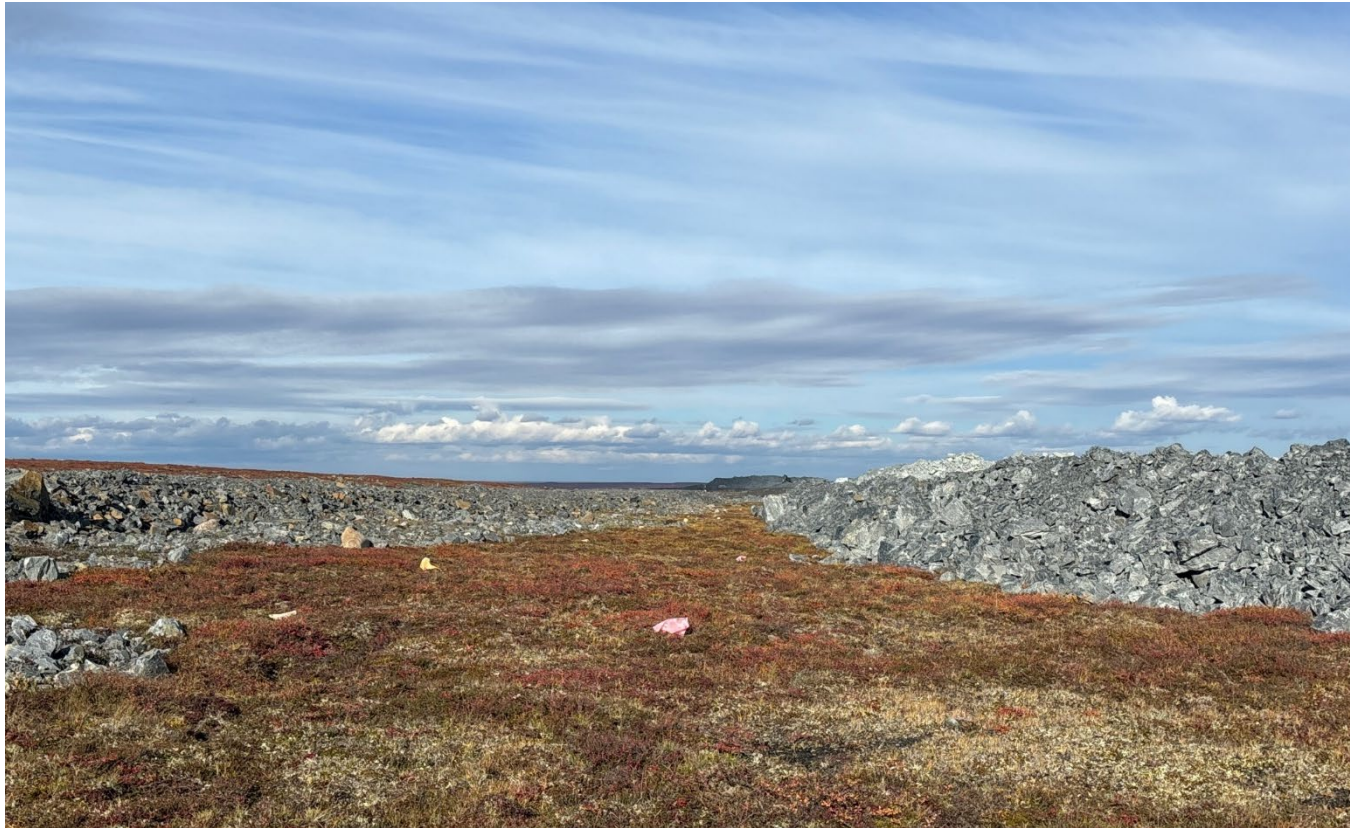
G-103: Diversion berm (left), WRSA (right), facing NE – Note WRSA too close to diversion berm

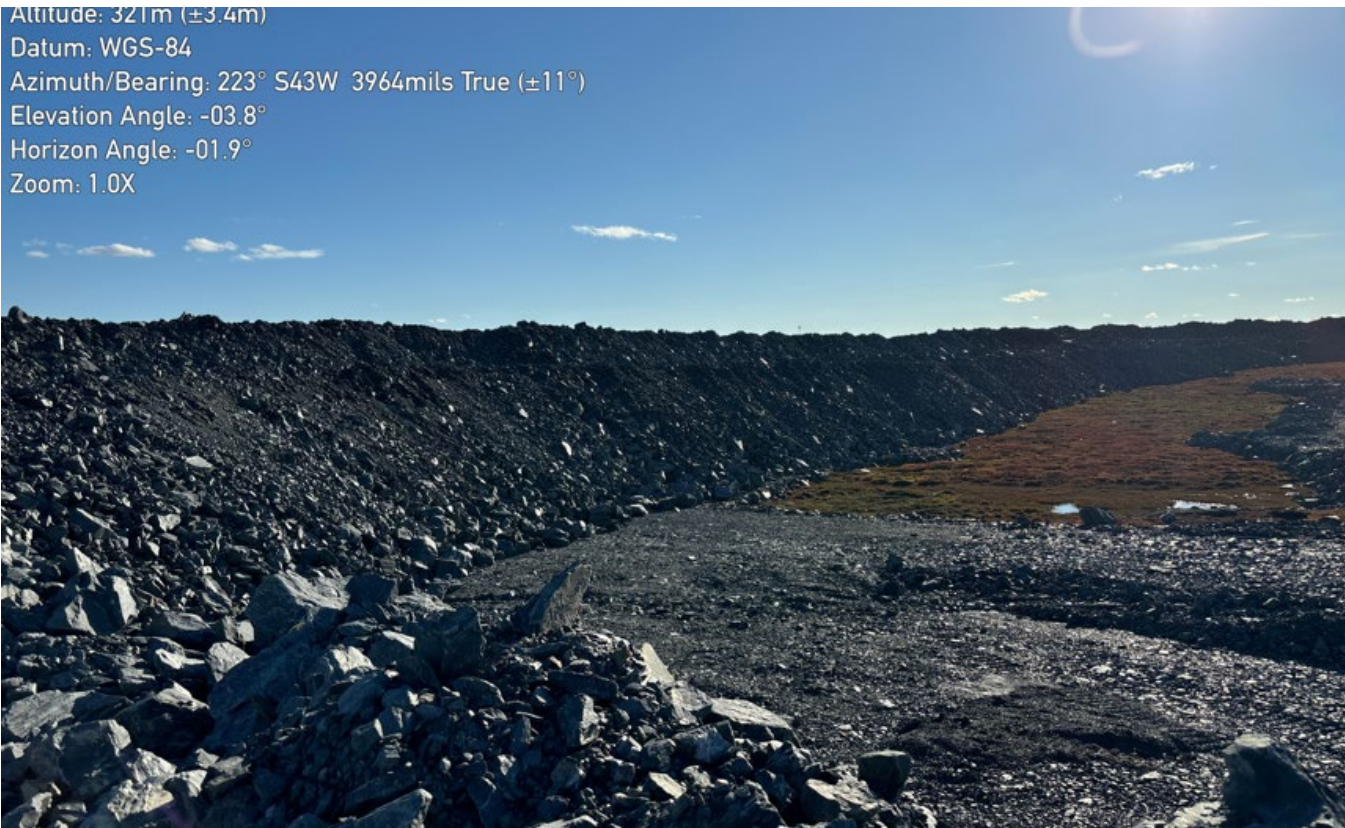
G-104: Northern face of WRSA, facing SW – Note oversteepened slopes

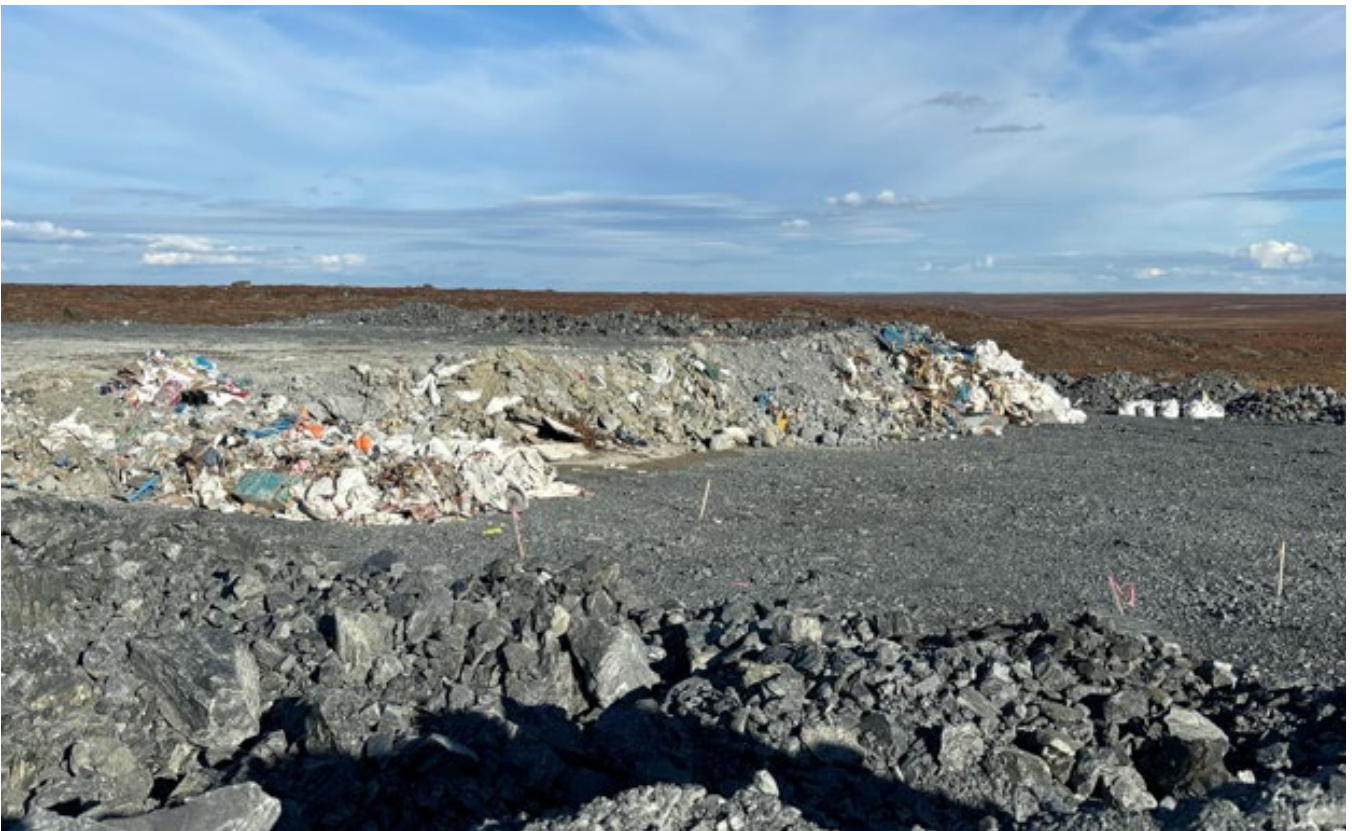
G-105: Eastern side of WRSA – Note garbage near edge

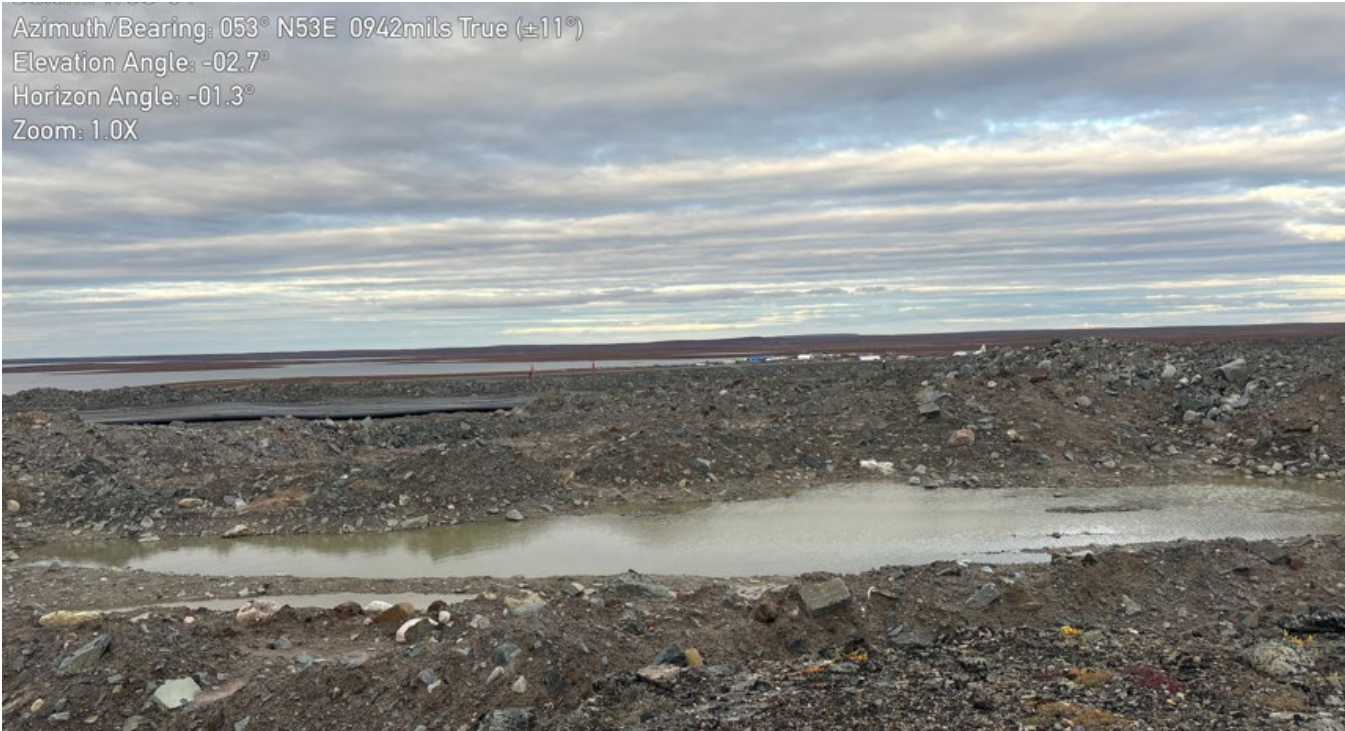
G-110: Western edge of stockpile, facing east – Note ponding water

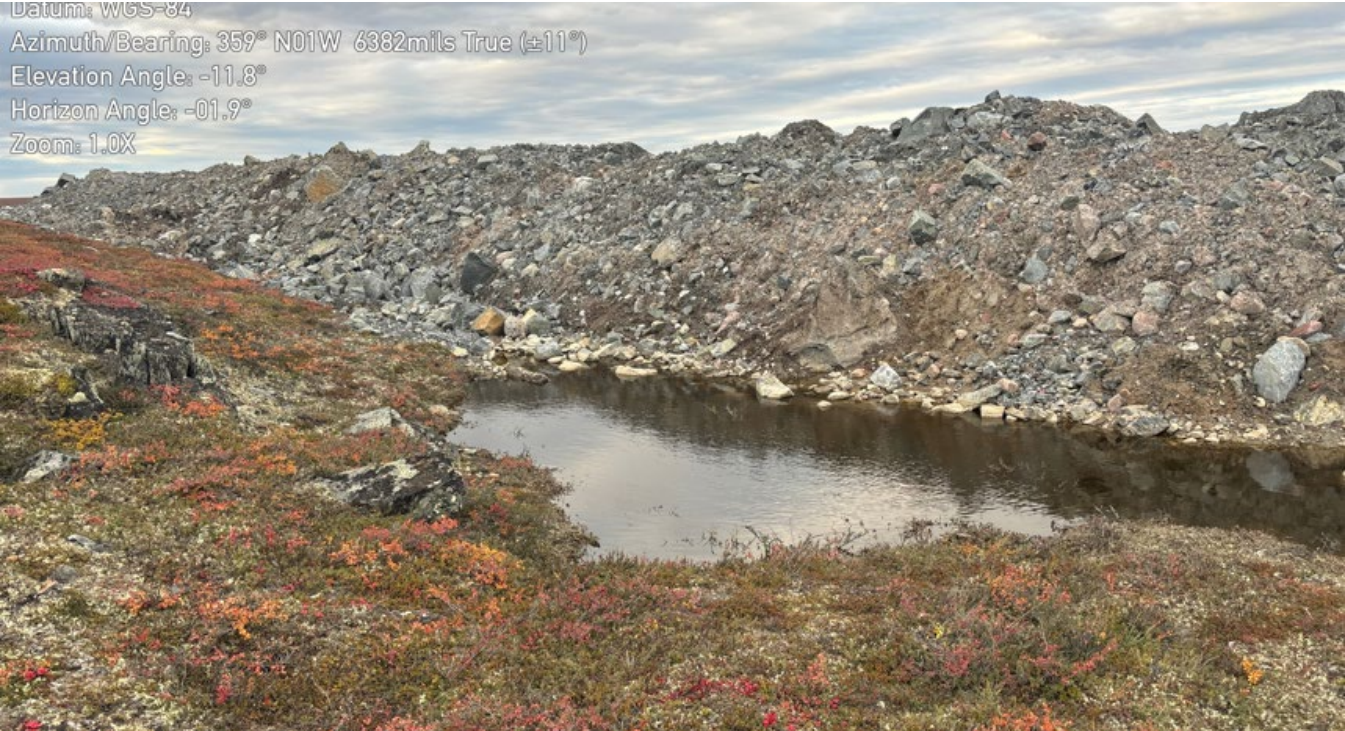
G-111: Western edge of stockpile, facing north – Note ponding water

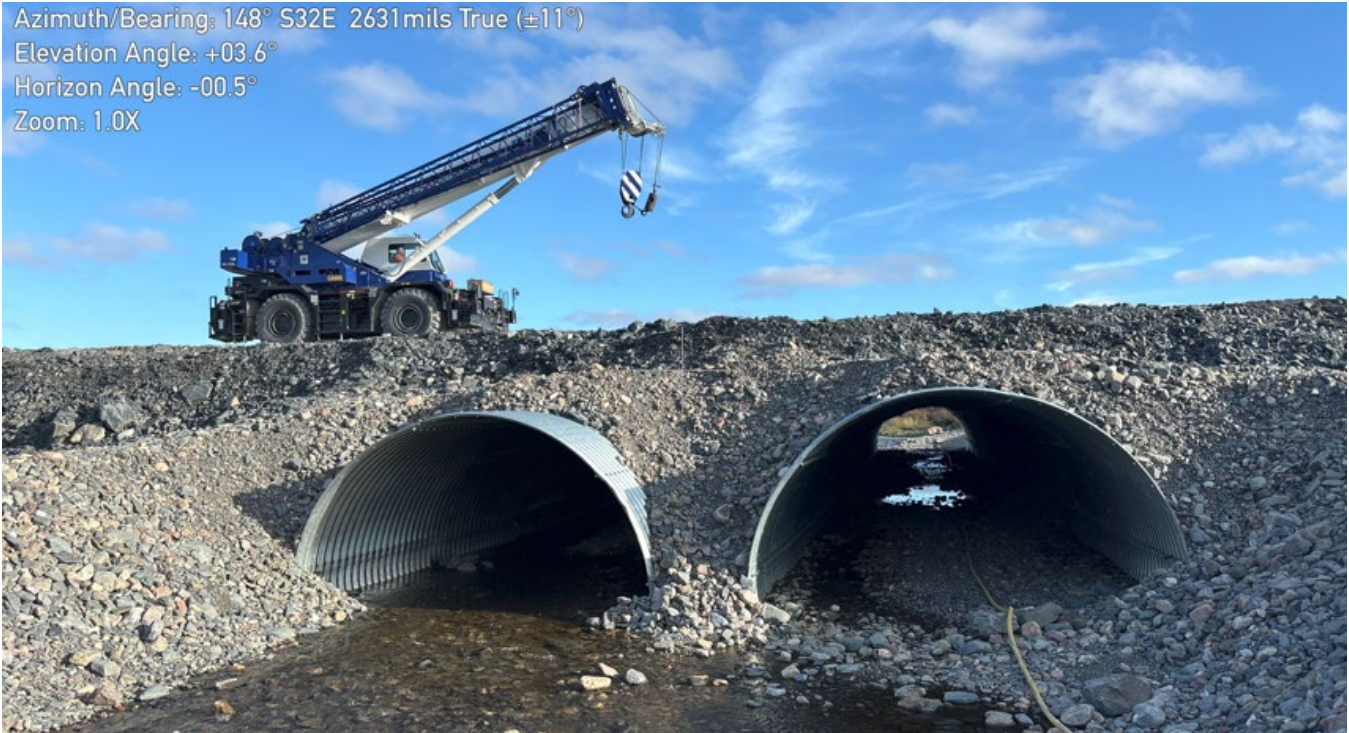
G-118: Gander Crossing Large Culverts, facing South - Note Flow into Arches

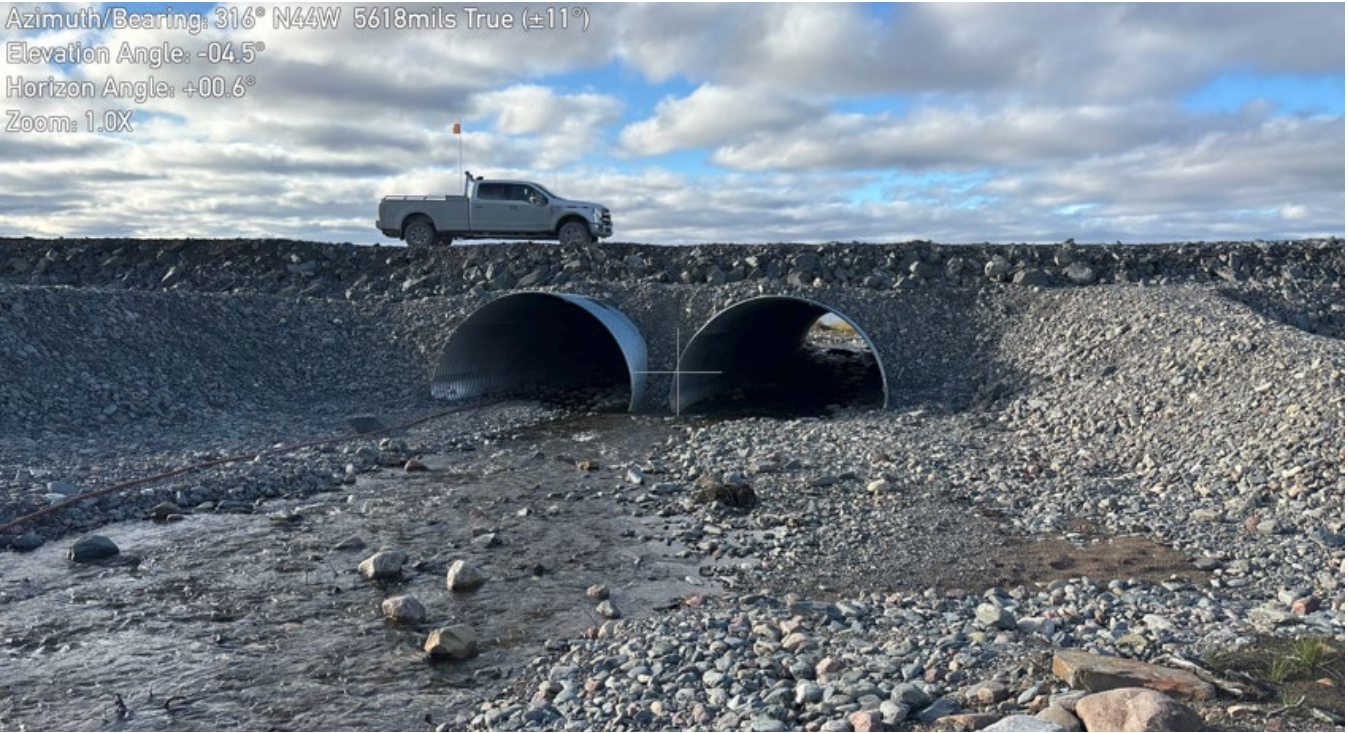
G-119: Gander Crossing Culverts, facing north – Monitoring Suggestion

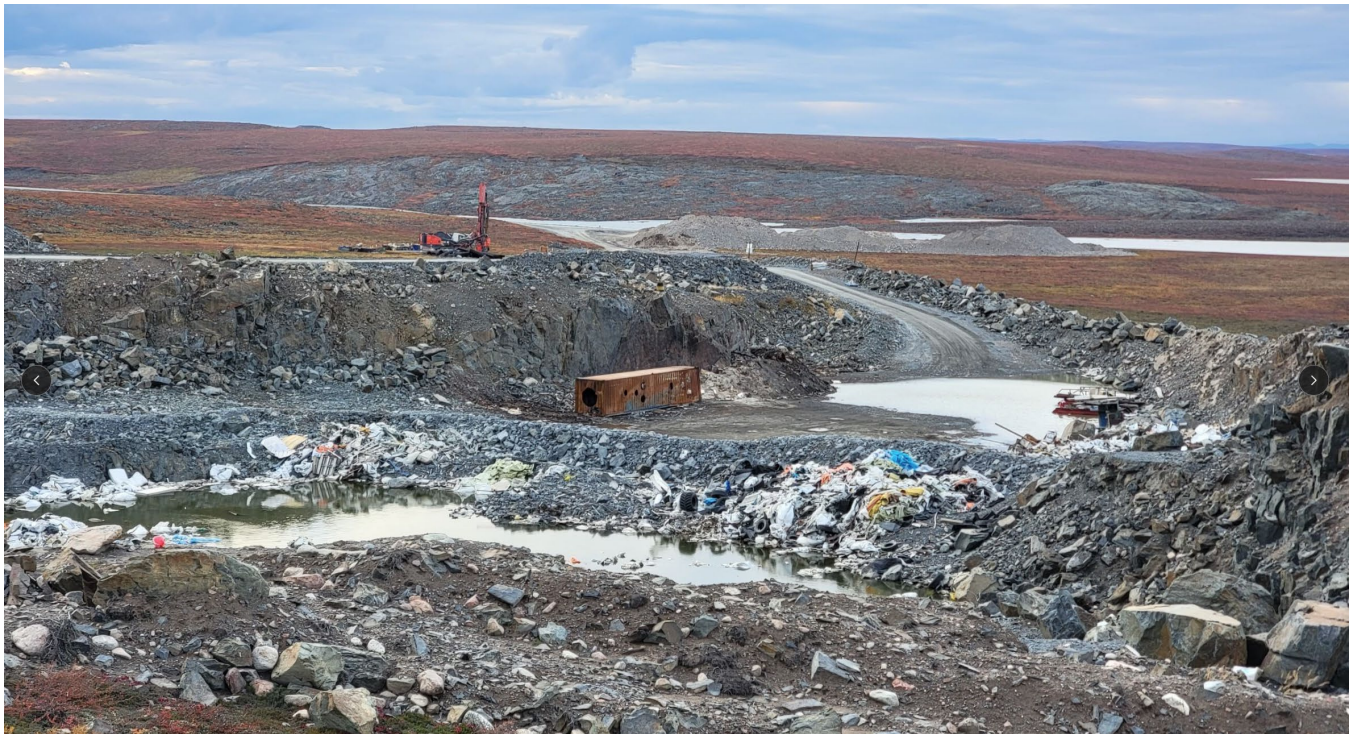
G-136: Goose Quarry, facing NW – Note ponded water and waste tipped on boundary of tip area

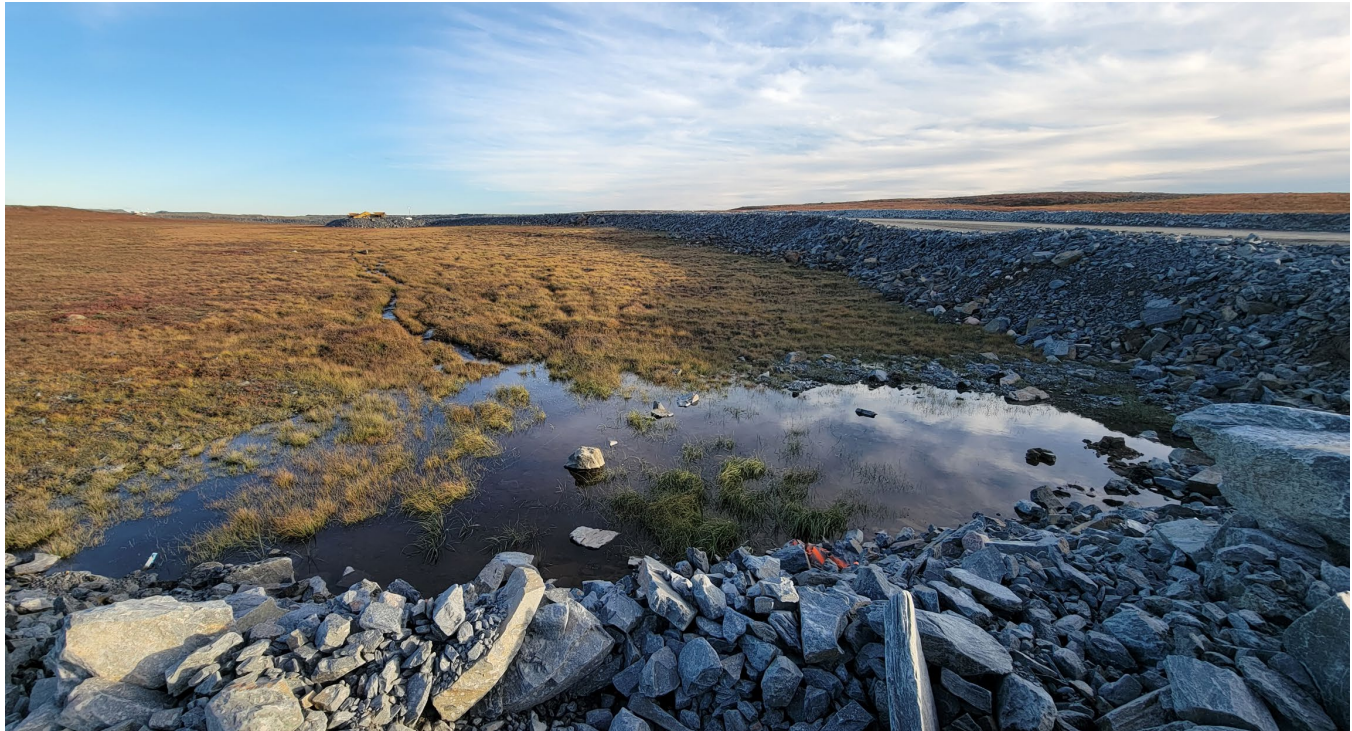
G-141: Echo haul road. Eastern side, facing south – Note ponding water

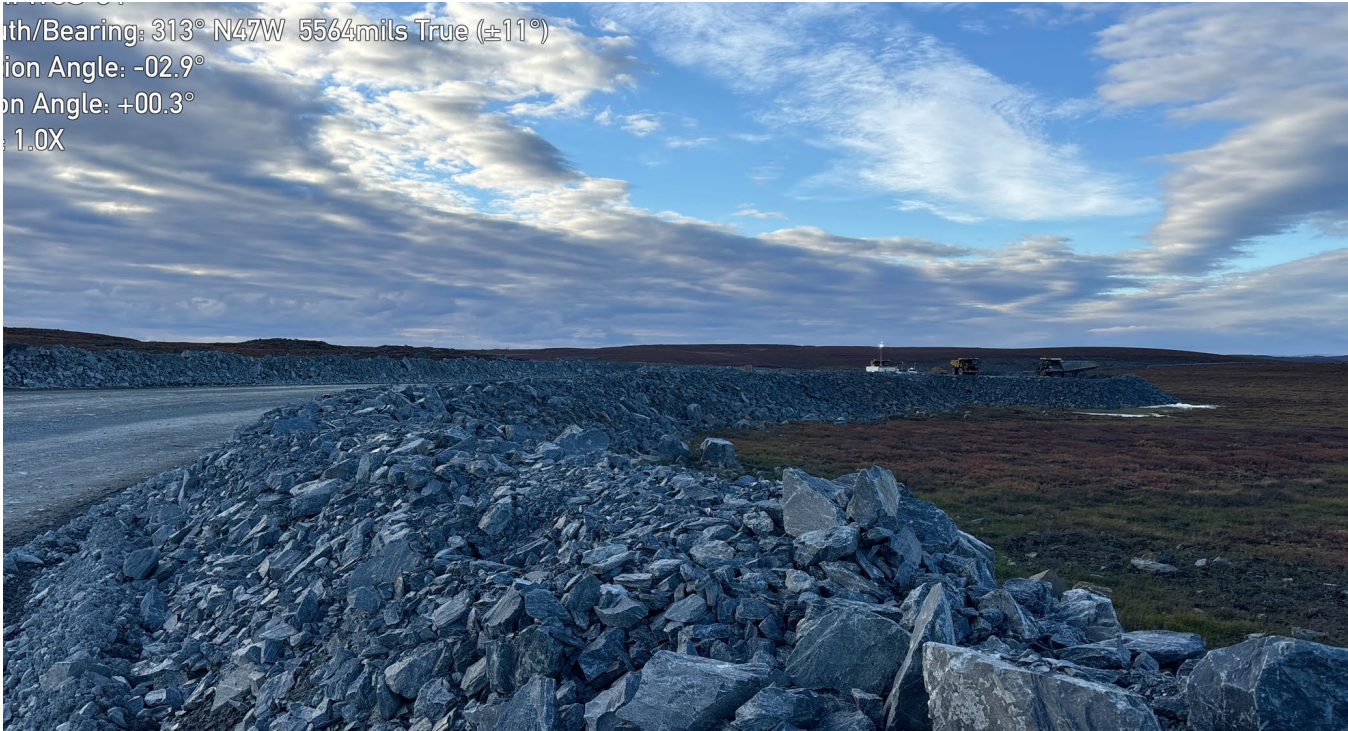
G-142: Echo haul road. Eastern side, facing northwest

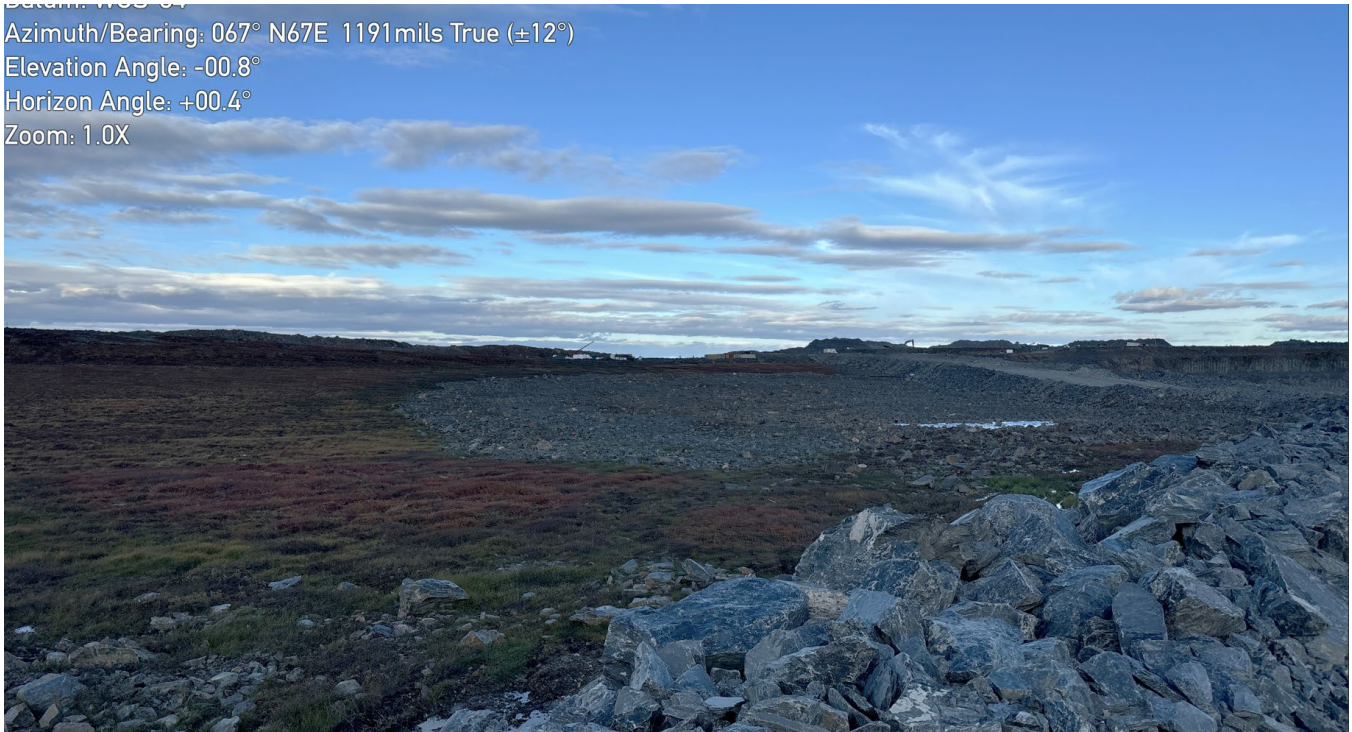
G-143: Echo haul road along the northern wall of Echo Pit, facing east – Note a pile of bulk material at the toe

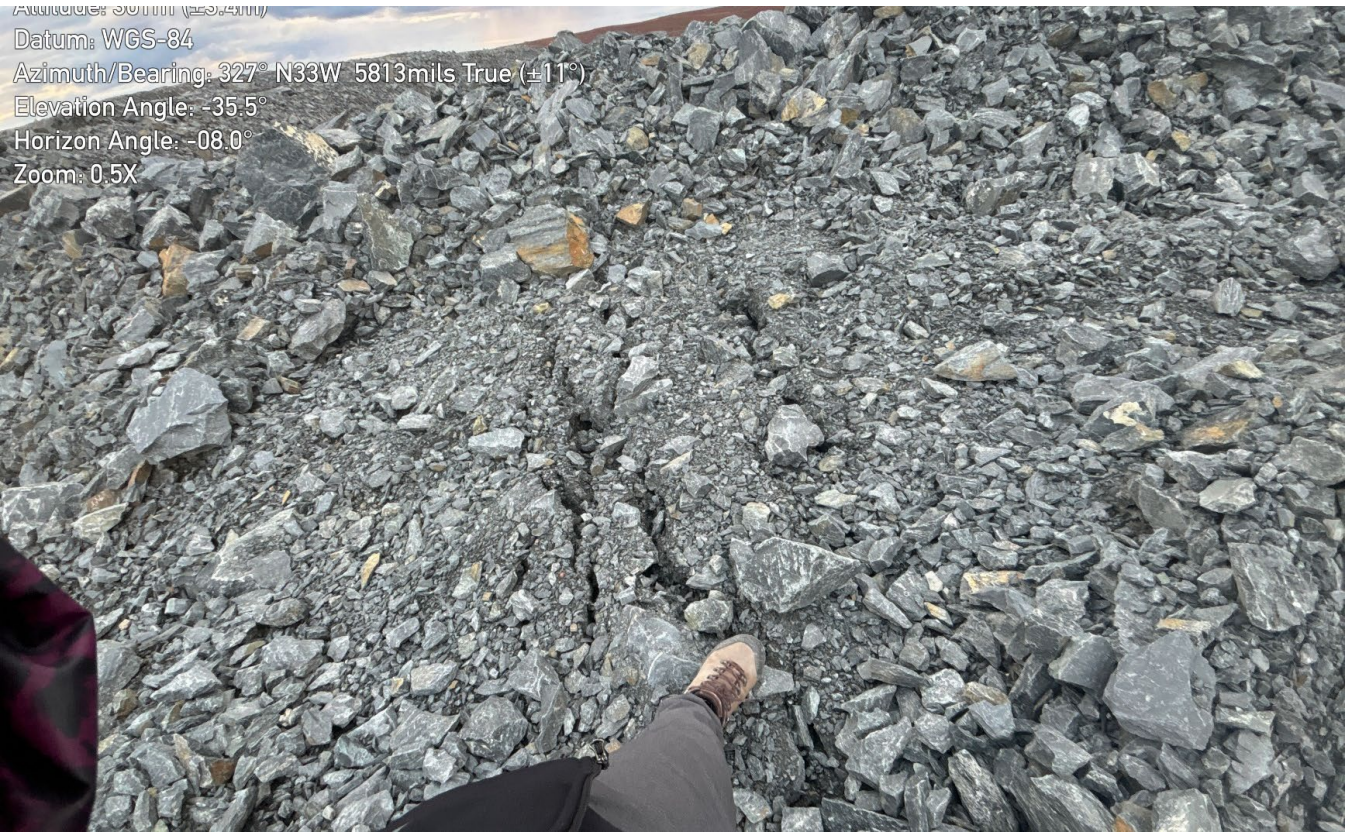
G-145: Mining Equipment Laydown area pad, facing south
