Goose & MLA Project Sites – 2024 Annual Geotechnical Inspection

Back River Project, Nunavut, Canada
B2Gold Corp.

SRK Consulting (Canada) Inc. ■ CAPR003105 ■ April 2025

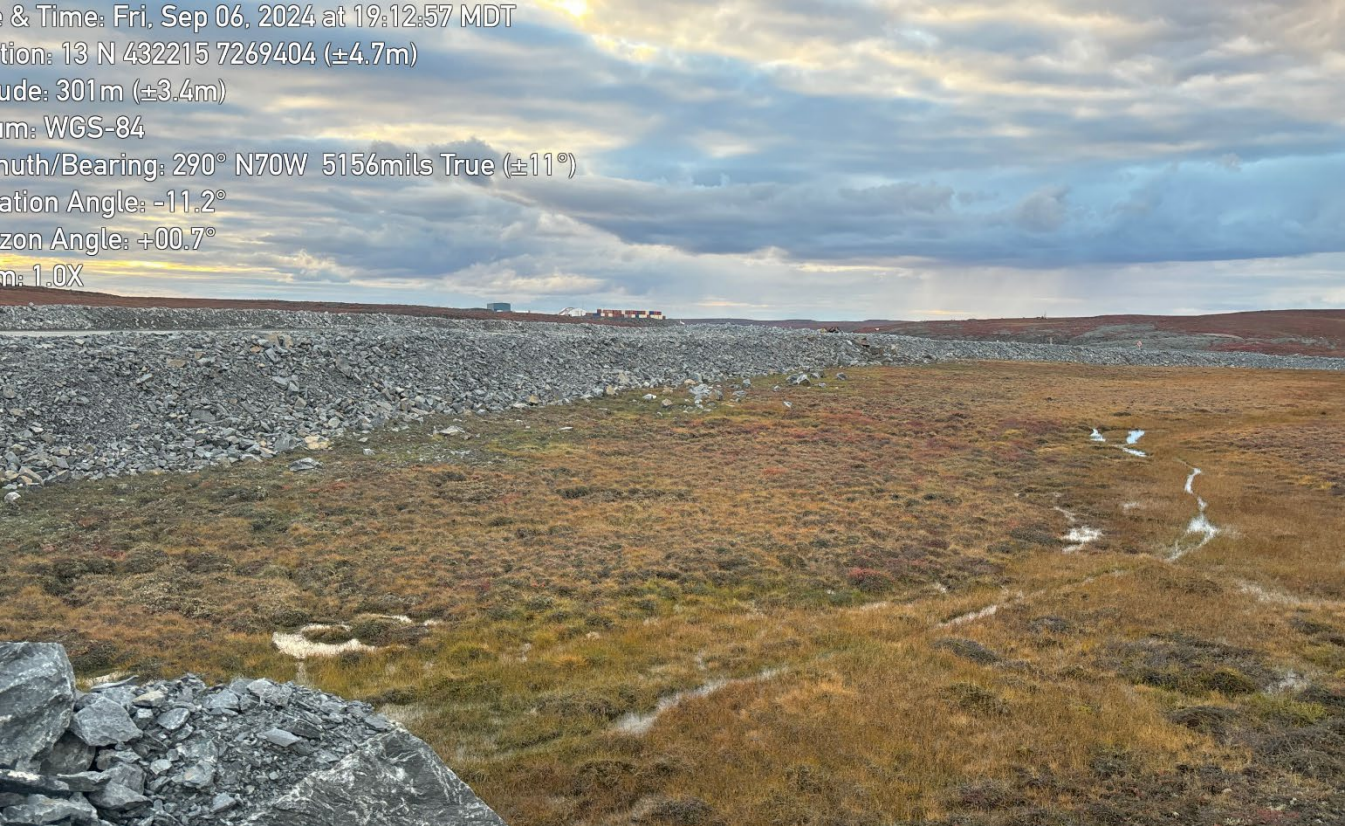
G-146: Echo Haul Road. Eastern Side, facing north – Note flow paths.

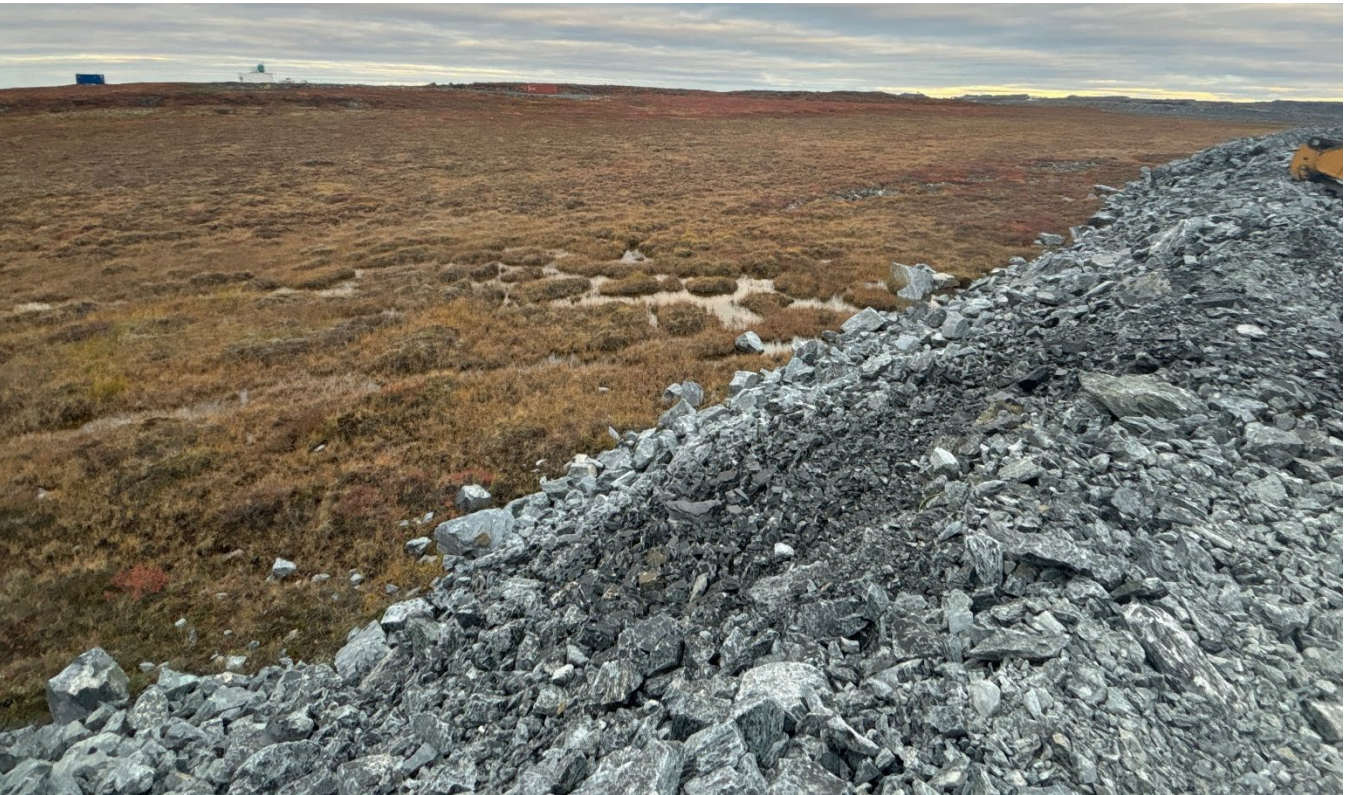
G-147: Mining Equipment Laydown. Berm. Eastern slope, facing north – Note flow paths

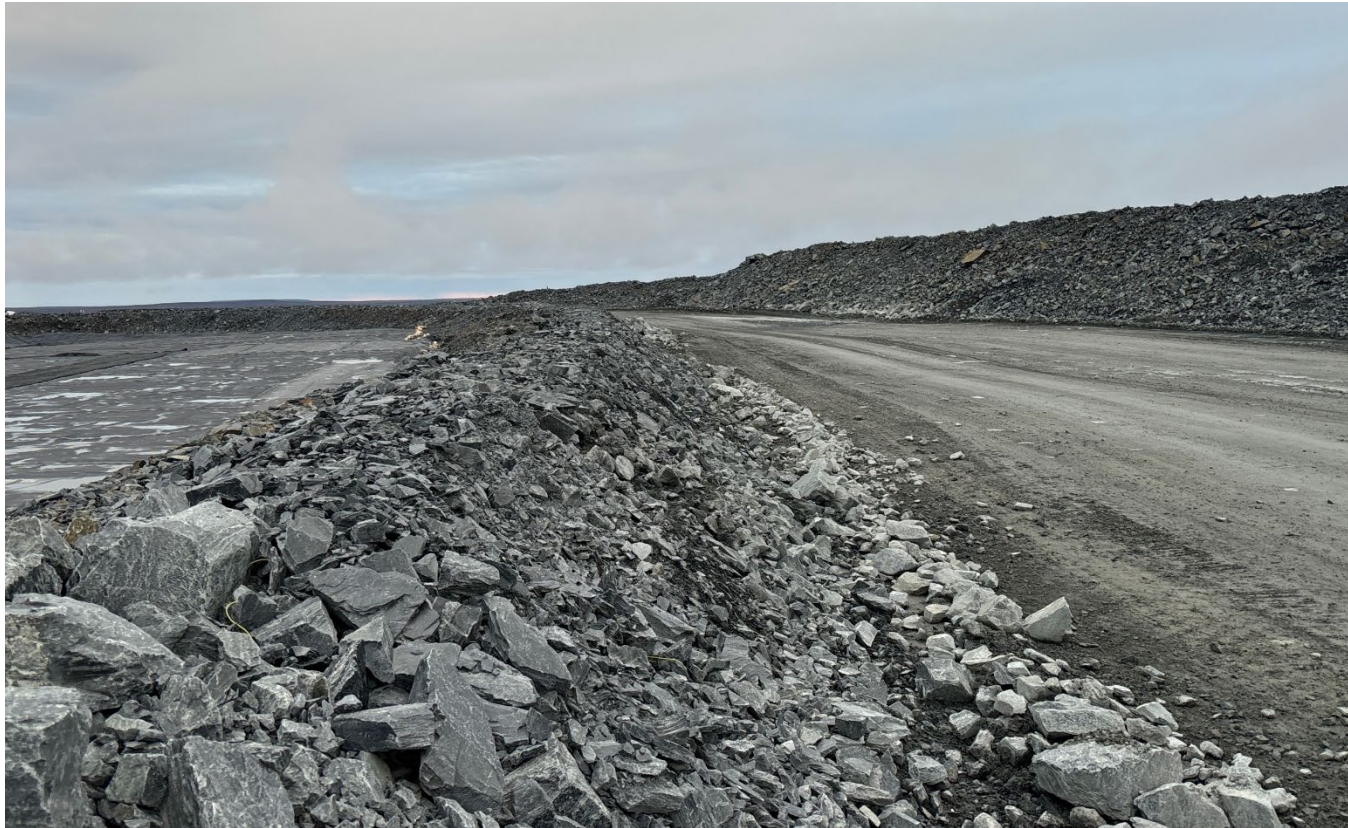
G-148: CWP safety berm, facing east

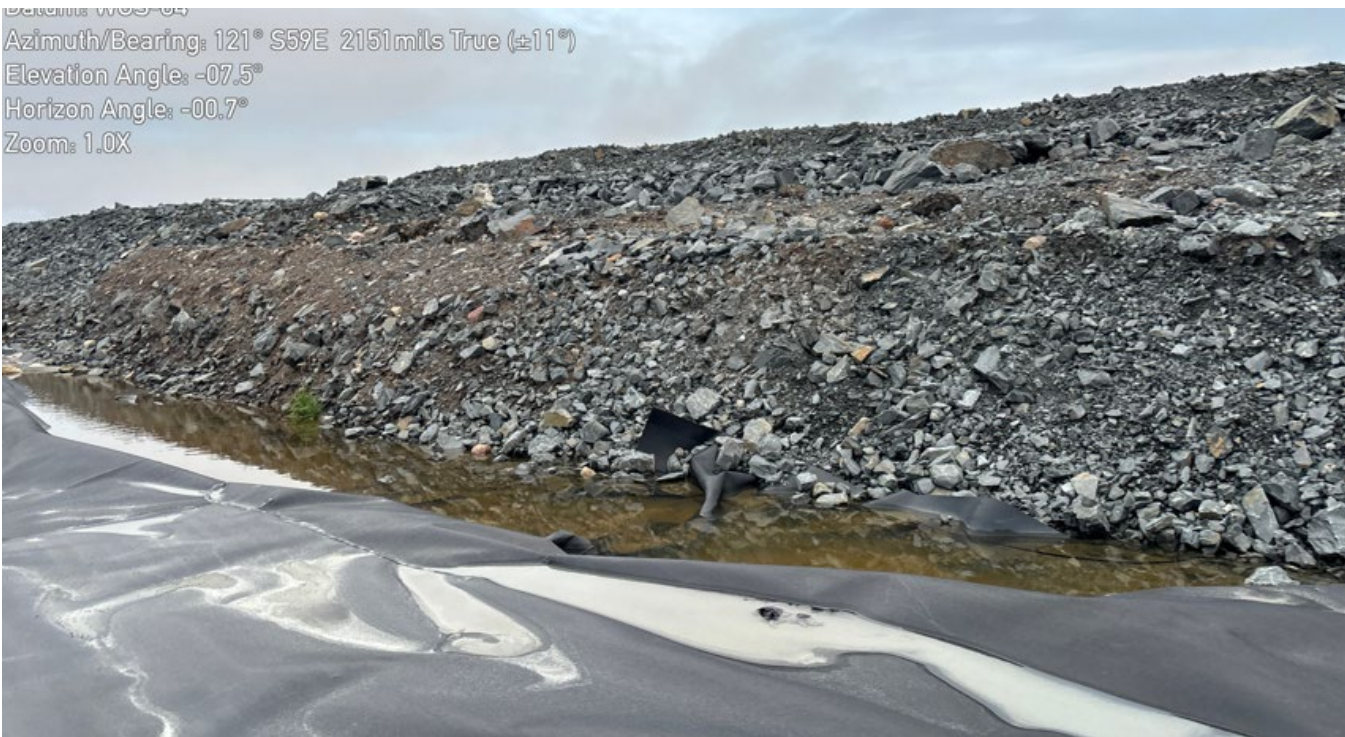
G-151: Typical slope

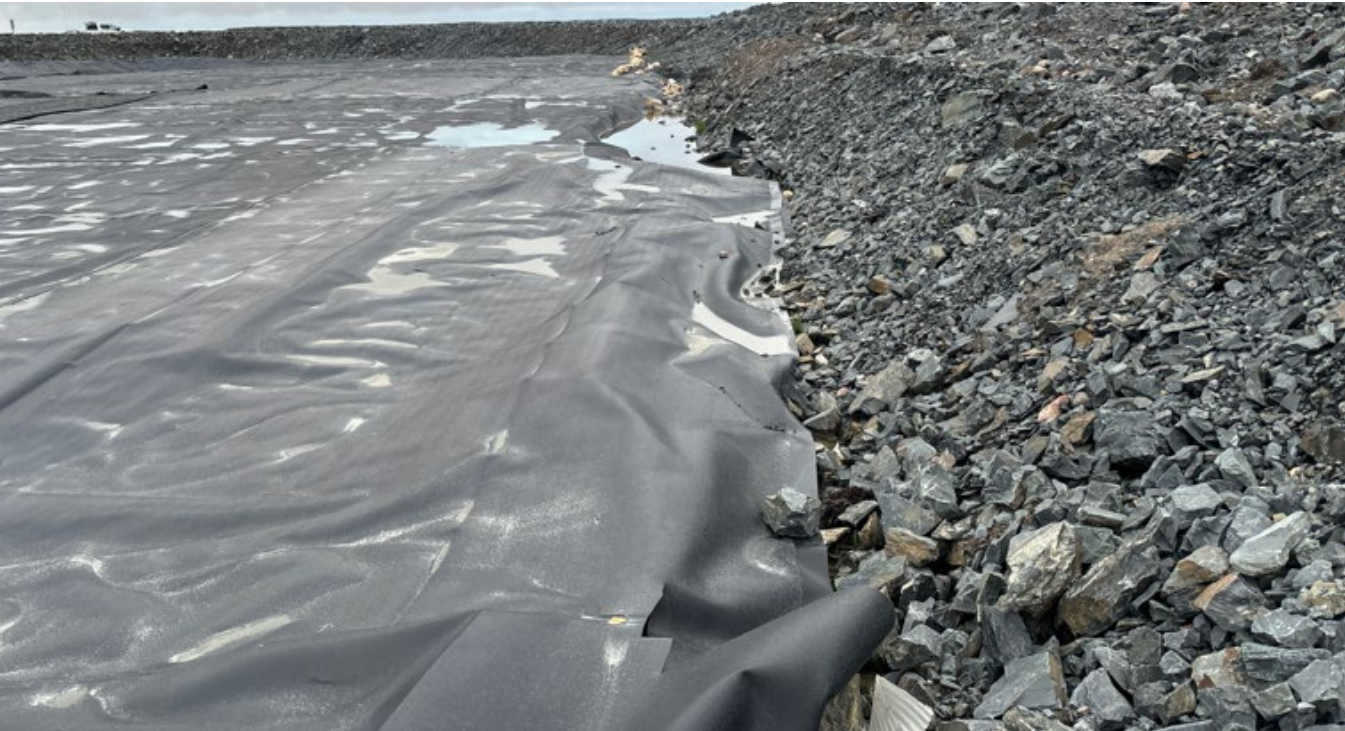
G-152: Western slope, facing east – Note no liner tie-in and varying crest of liner

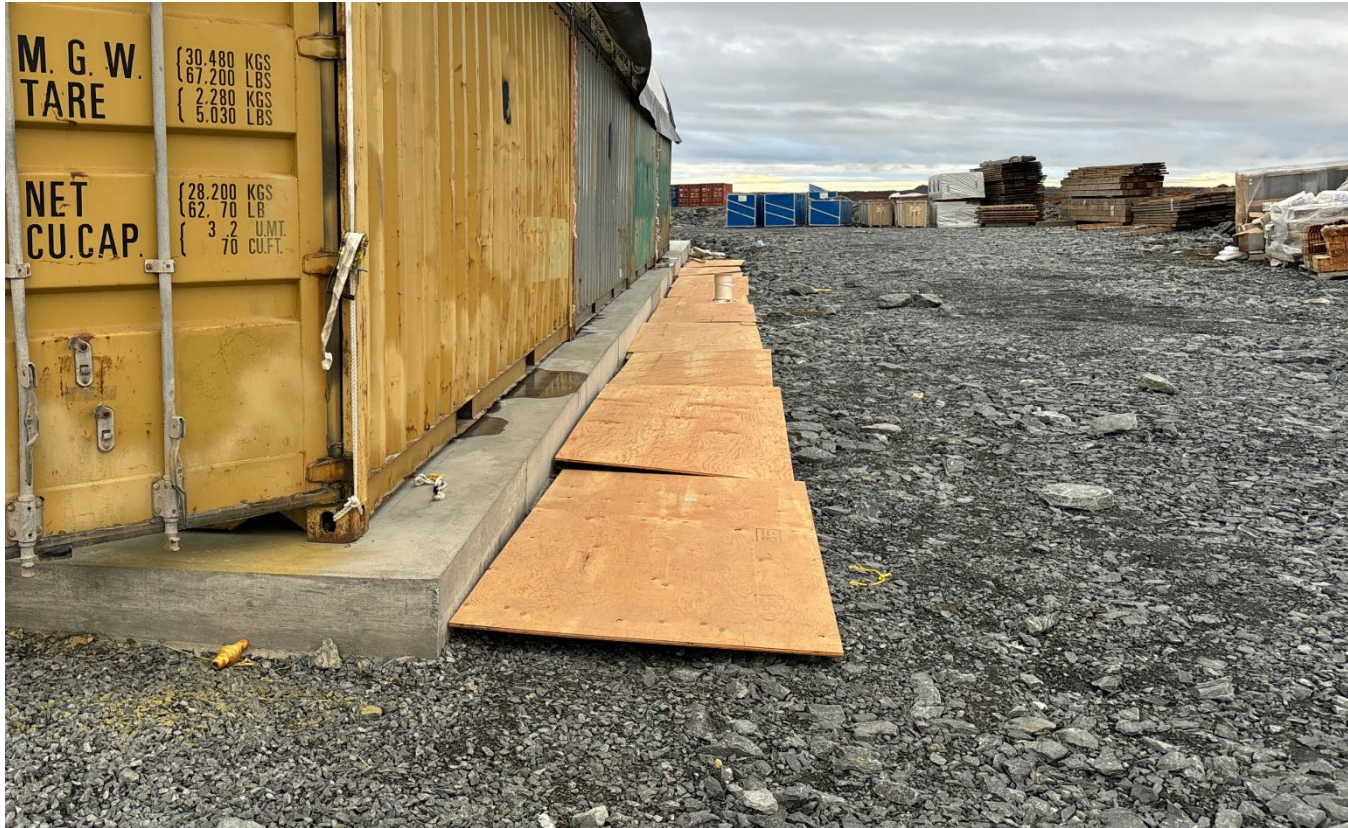
G-166: Eastern side typical storage area, facing west

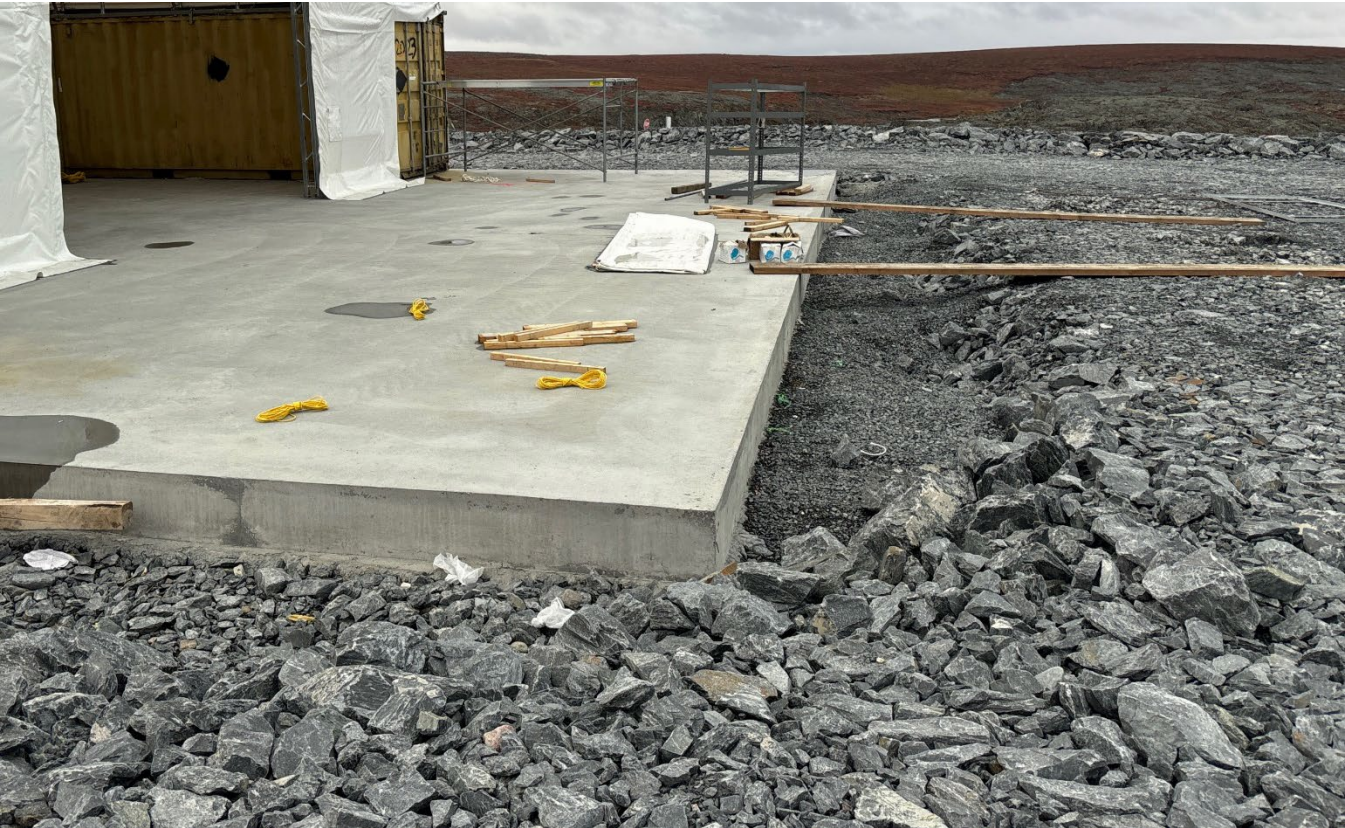
G-167: Concrete slab construction

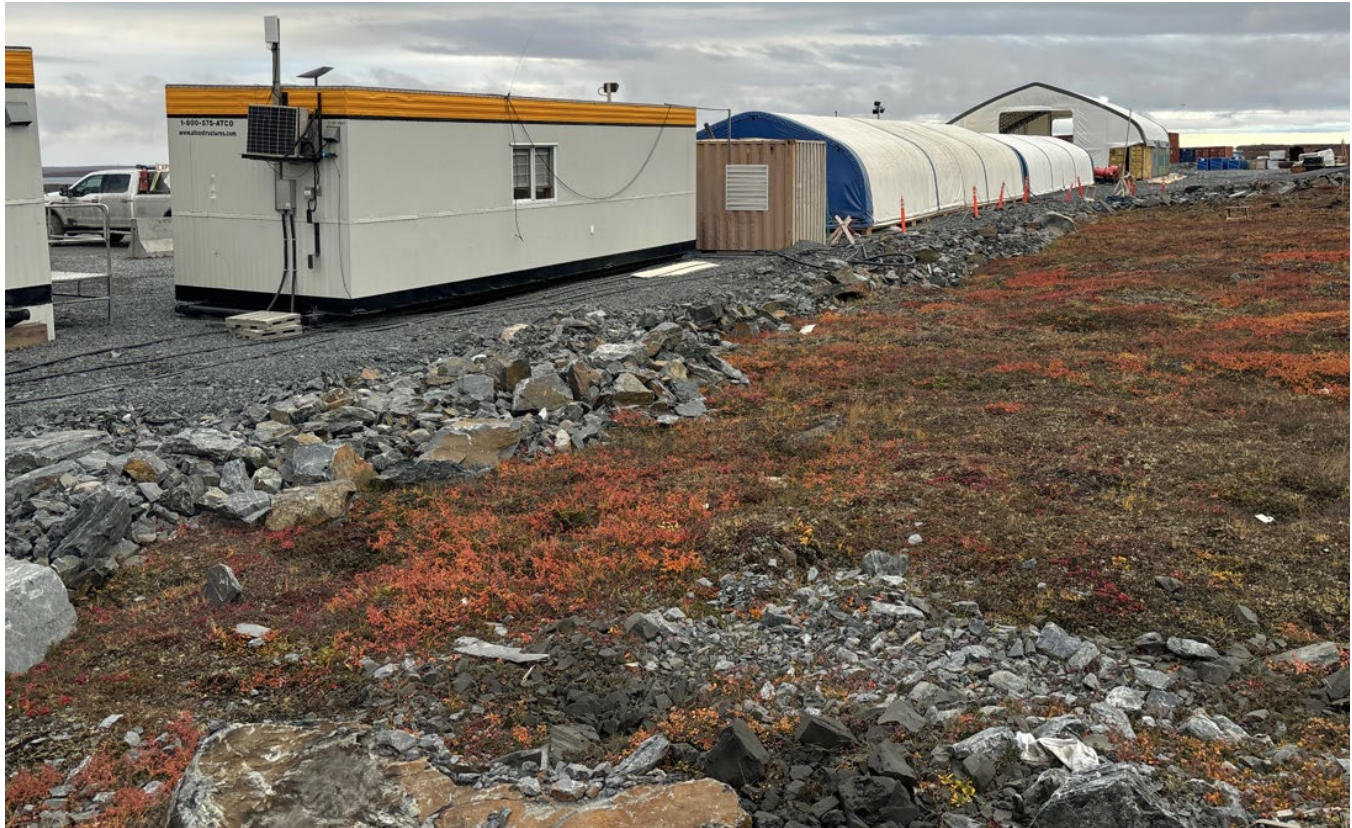
G-169: Typical pad thickness

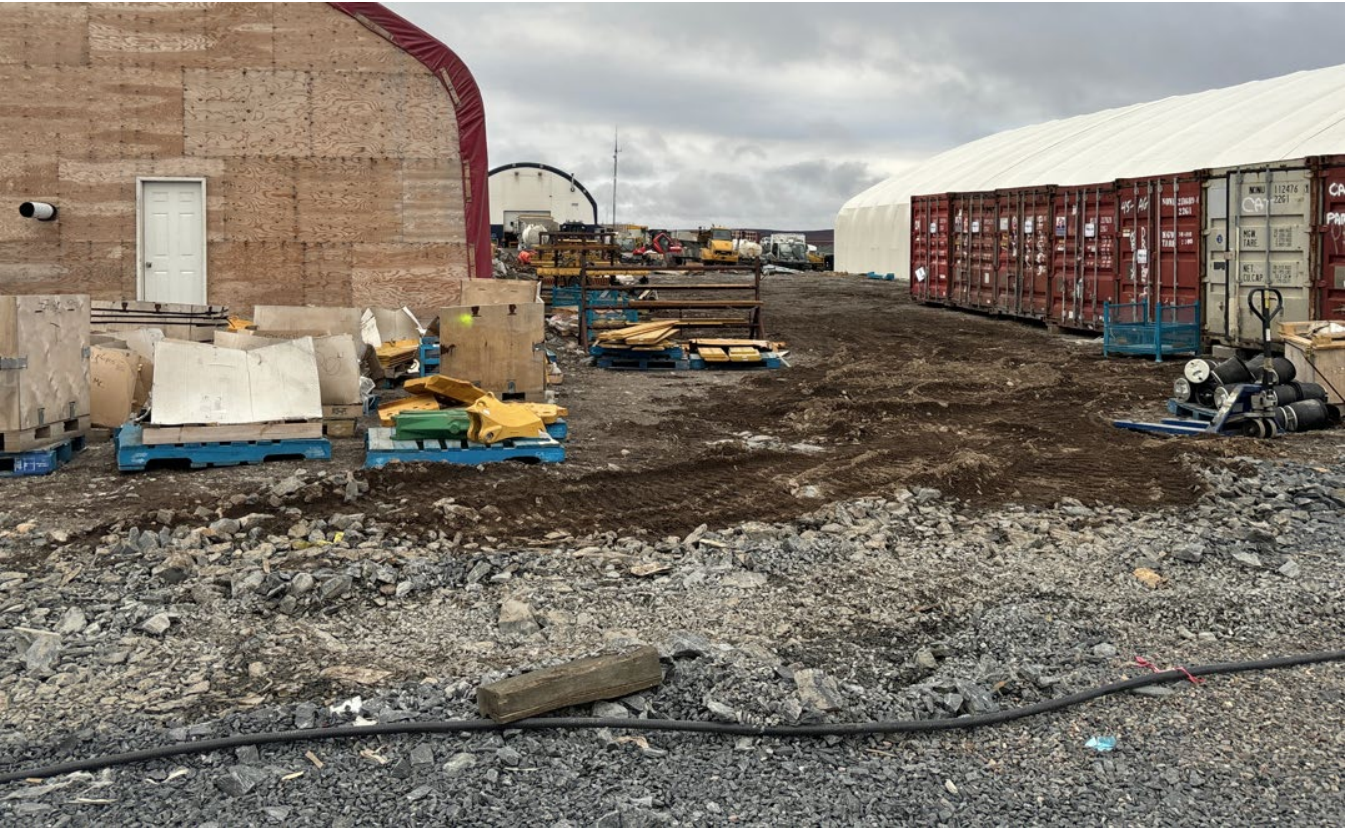
G-170: Centre of Ops pad – Note maintenance buildings are on exposed tundra

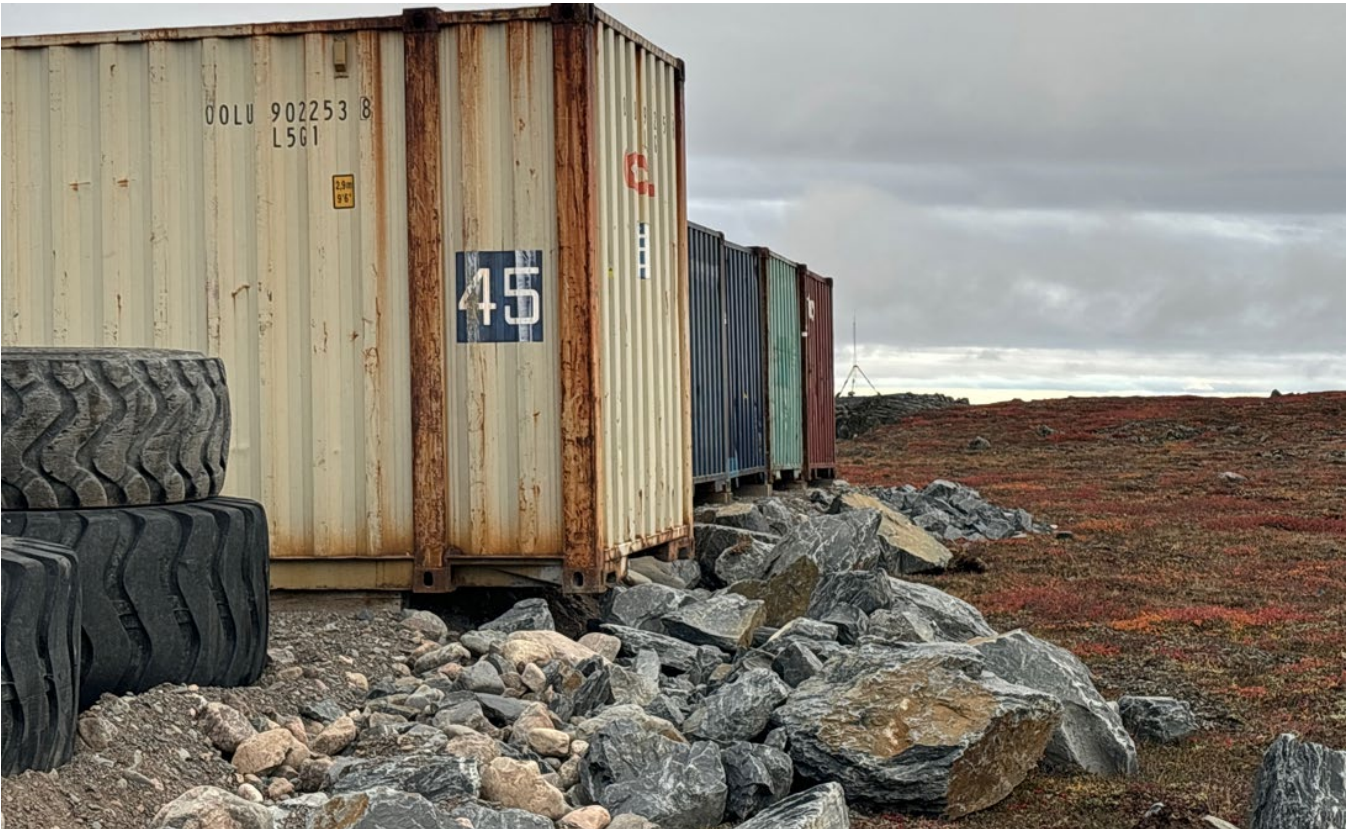
G-171: Western side of pad – Note Seacans and materials close to pad edge. Pad less than 0.5m in some areas

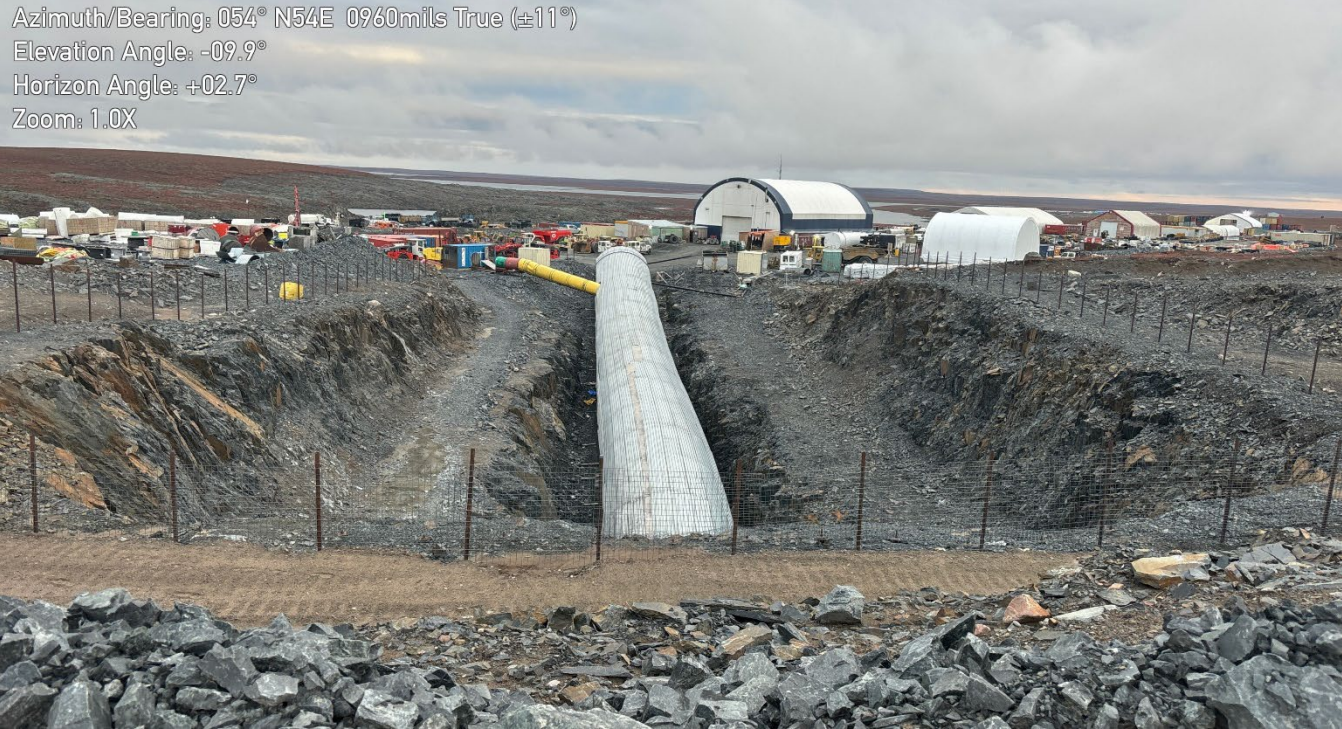
G-175: Underground portal entrance, facing NW

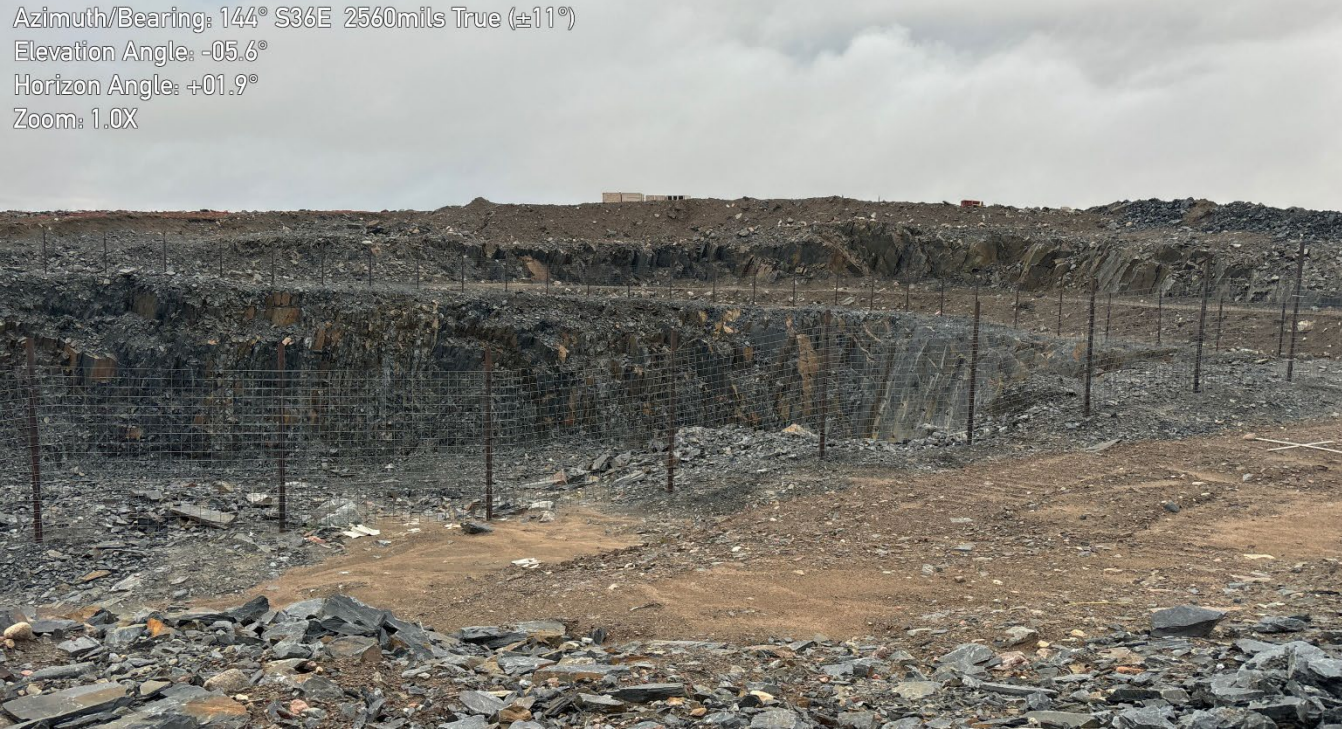
G-176: Portal entrance walls and safety fence, facing SW

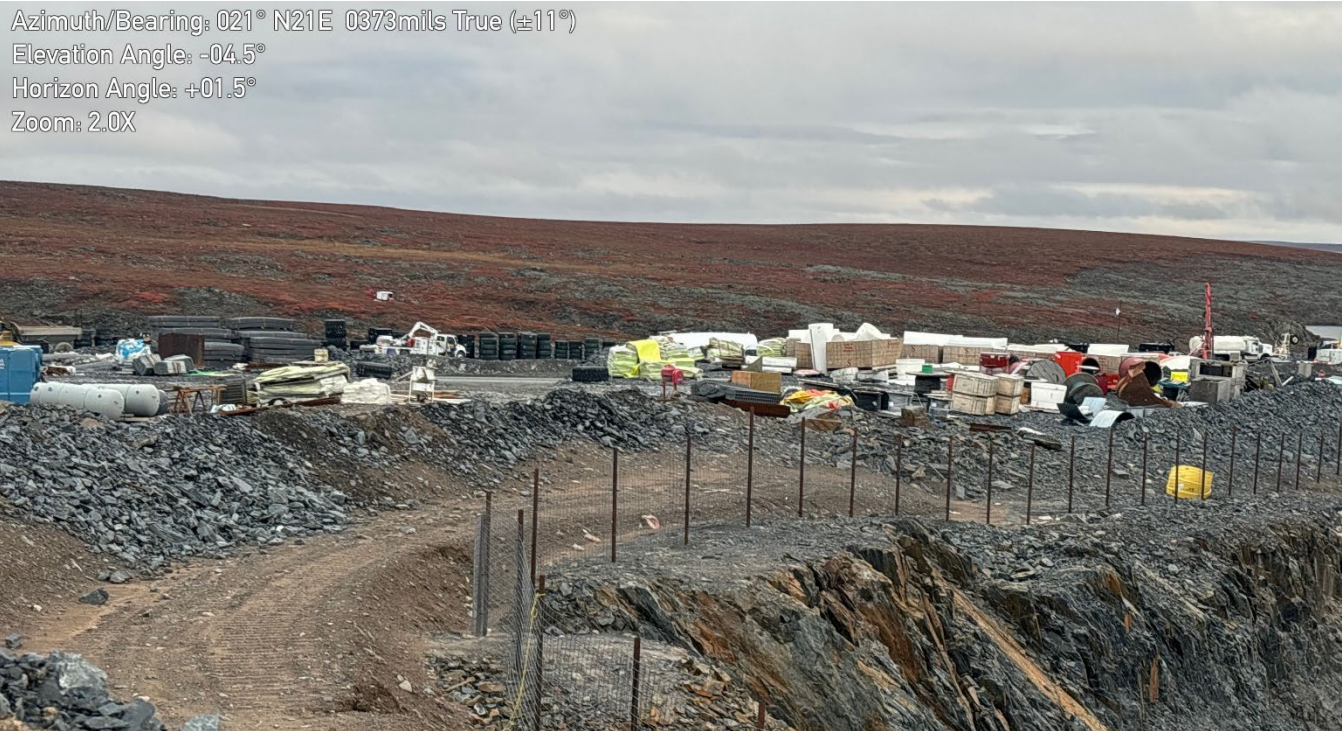
G-177: Portal wall crest and laydown area, facing NW

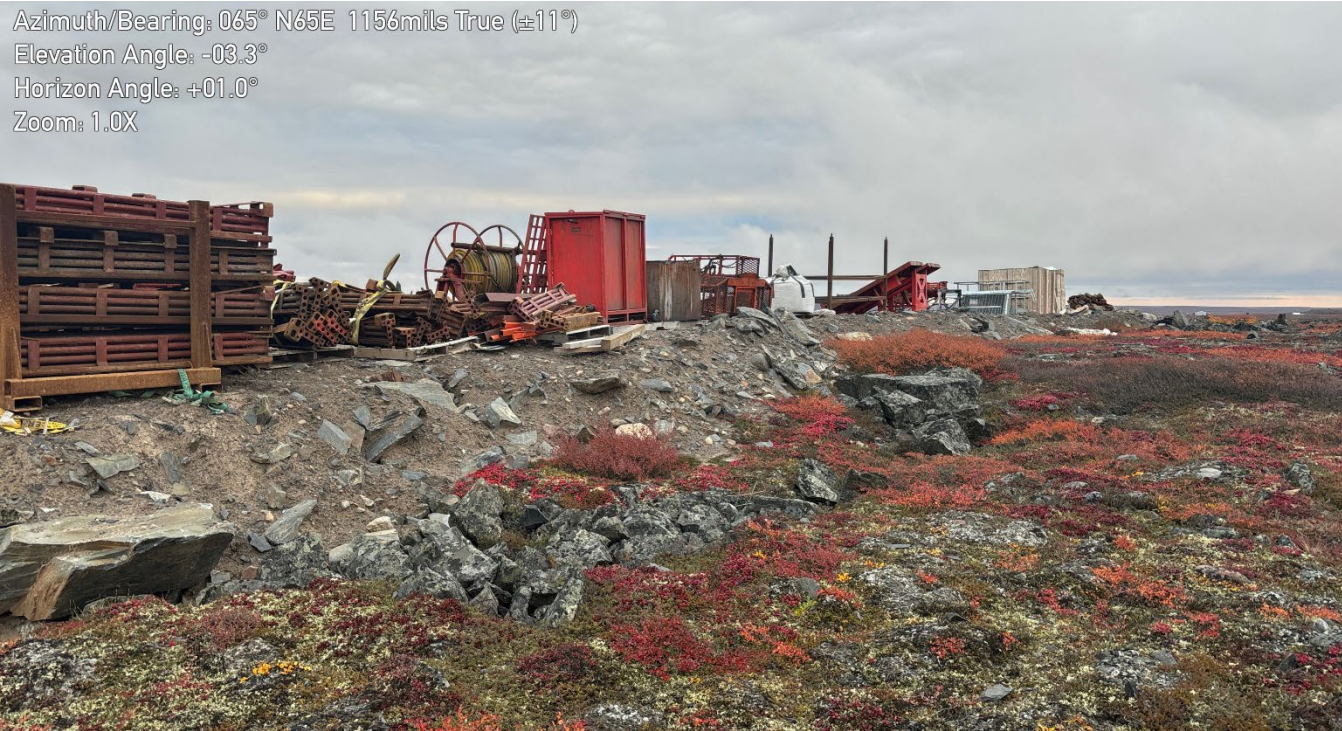
G-178: Western most laydown area, facing NW – Note equipment to close to pad edge

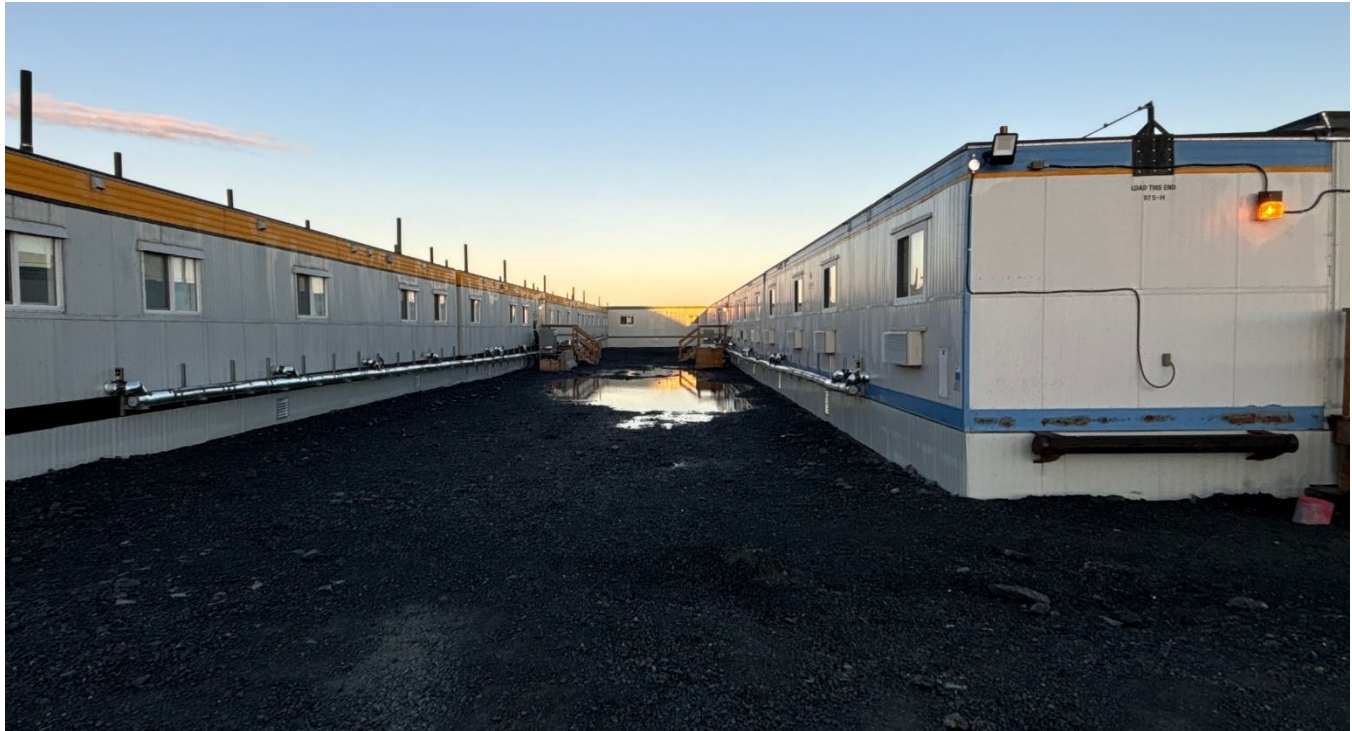
G-179: Camp area, facing west – Note ponding water

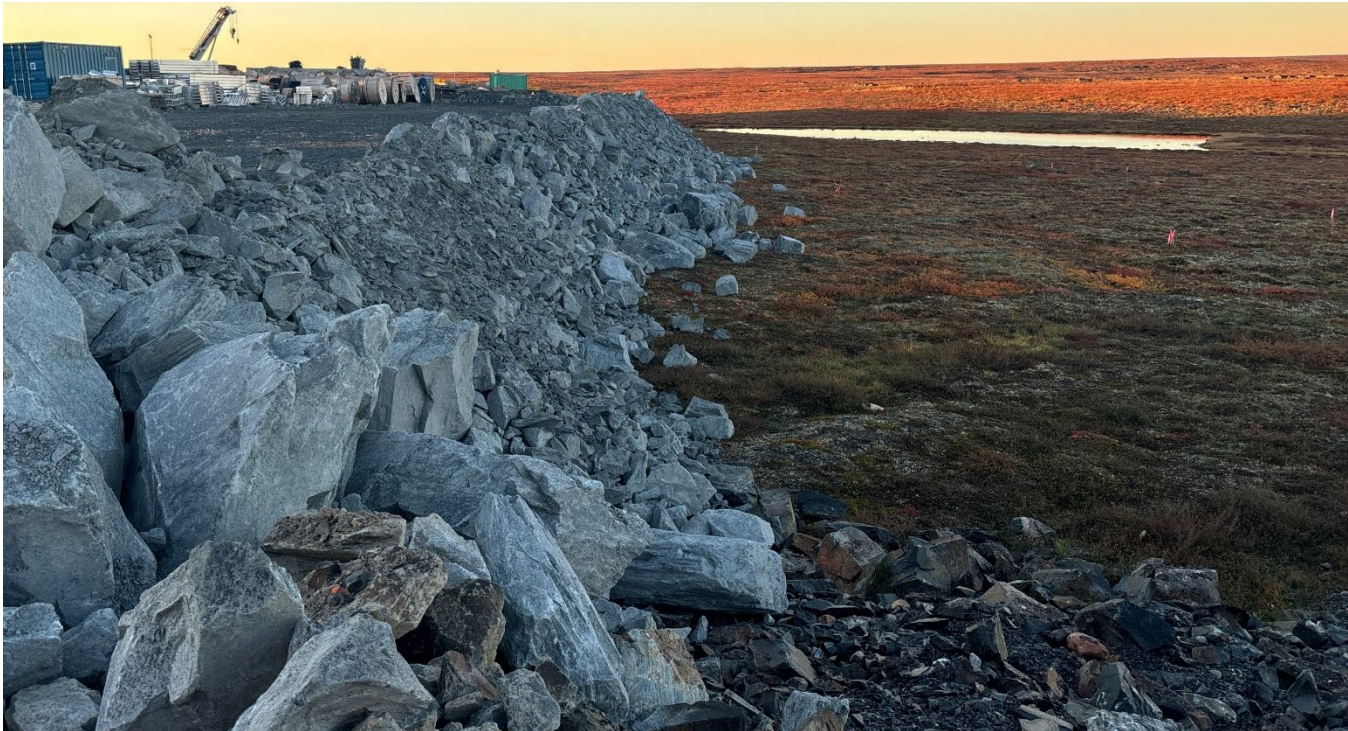
G-180: South facing slope – Note oversteepened, rockfall evident

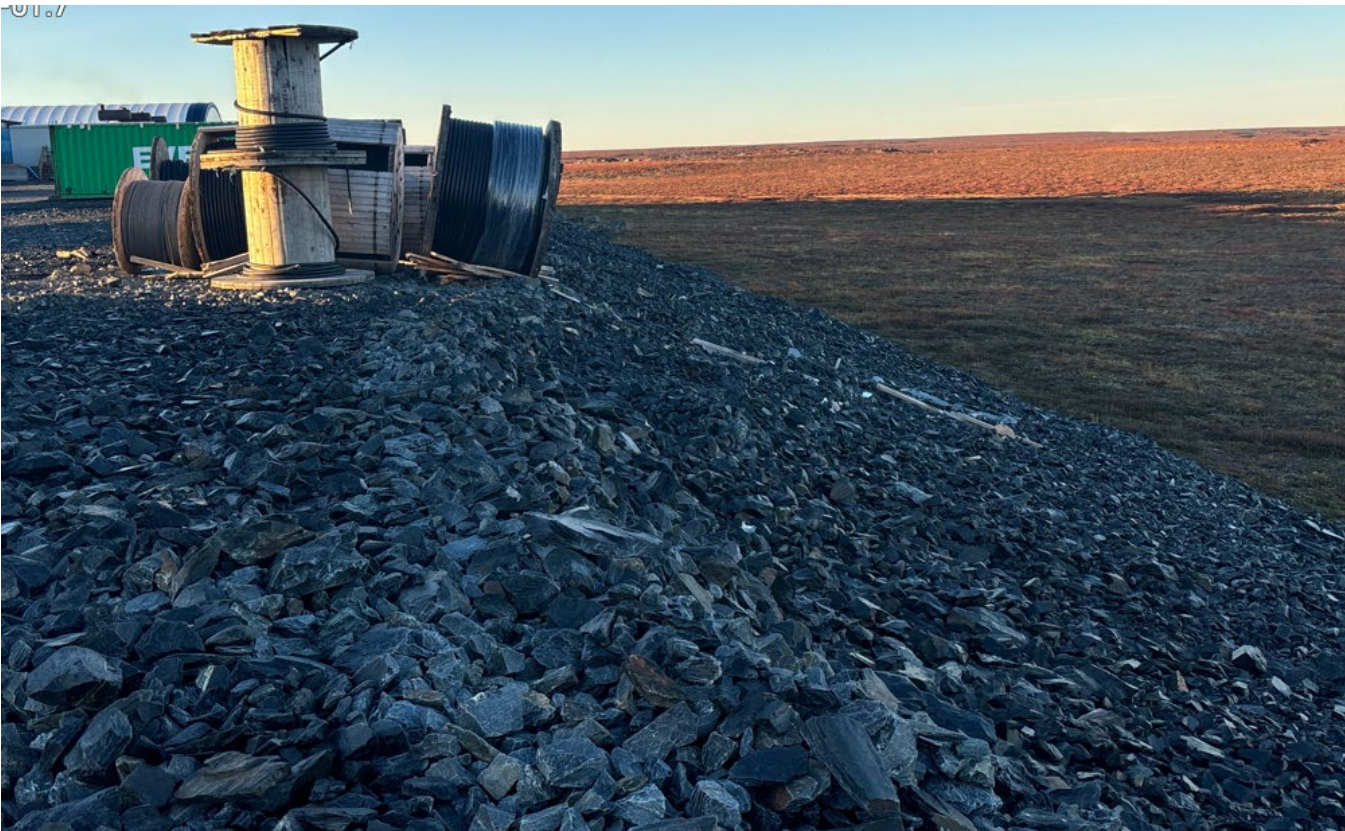
G-185: Western side of pad – Note coils to close to edge

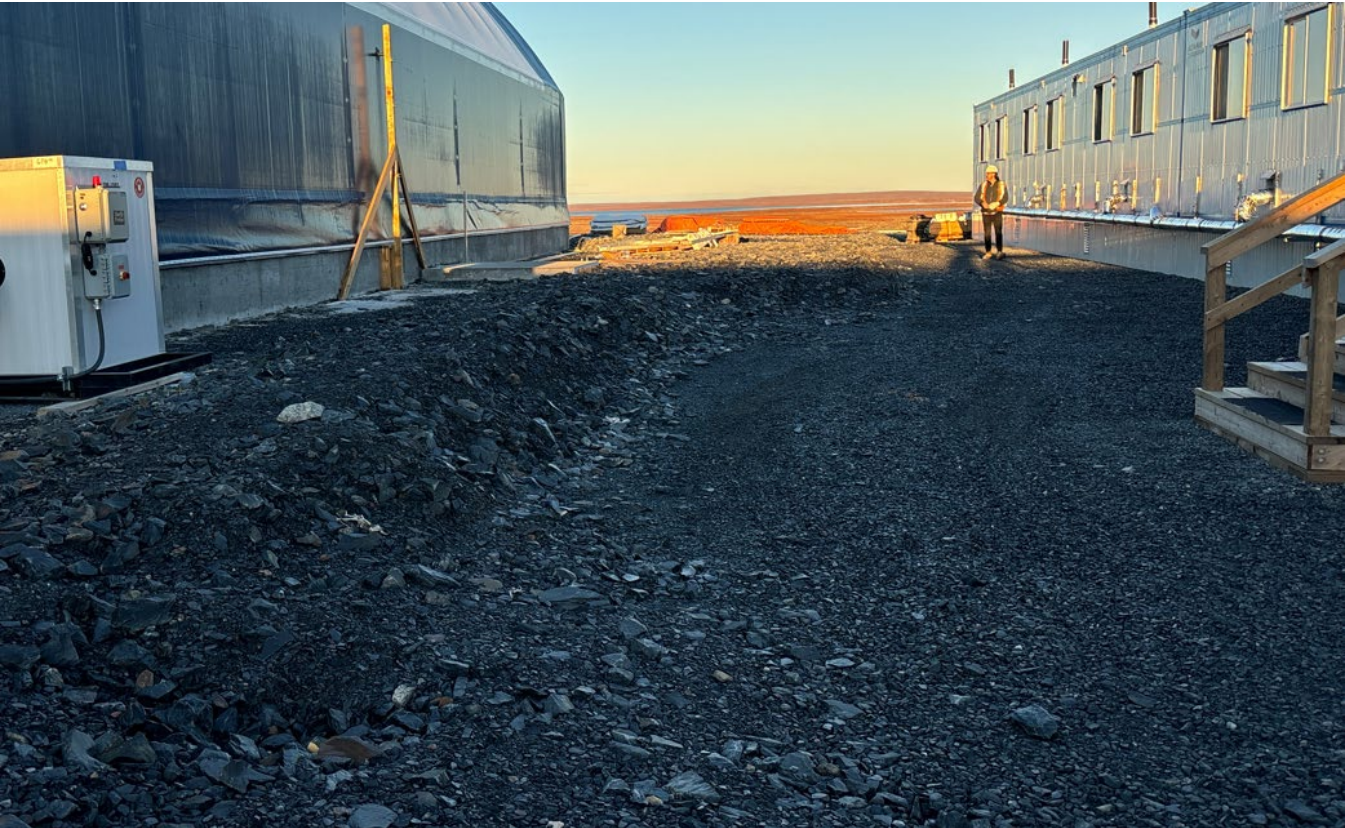
G-187: Typical pad thickness

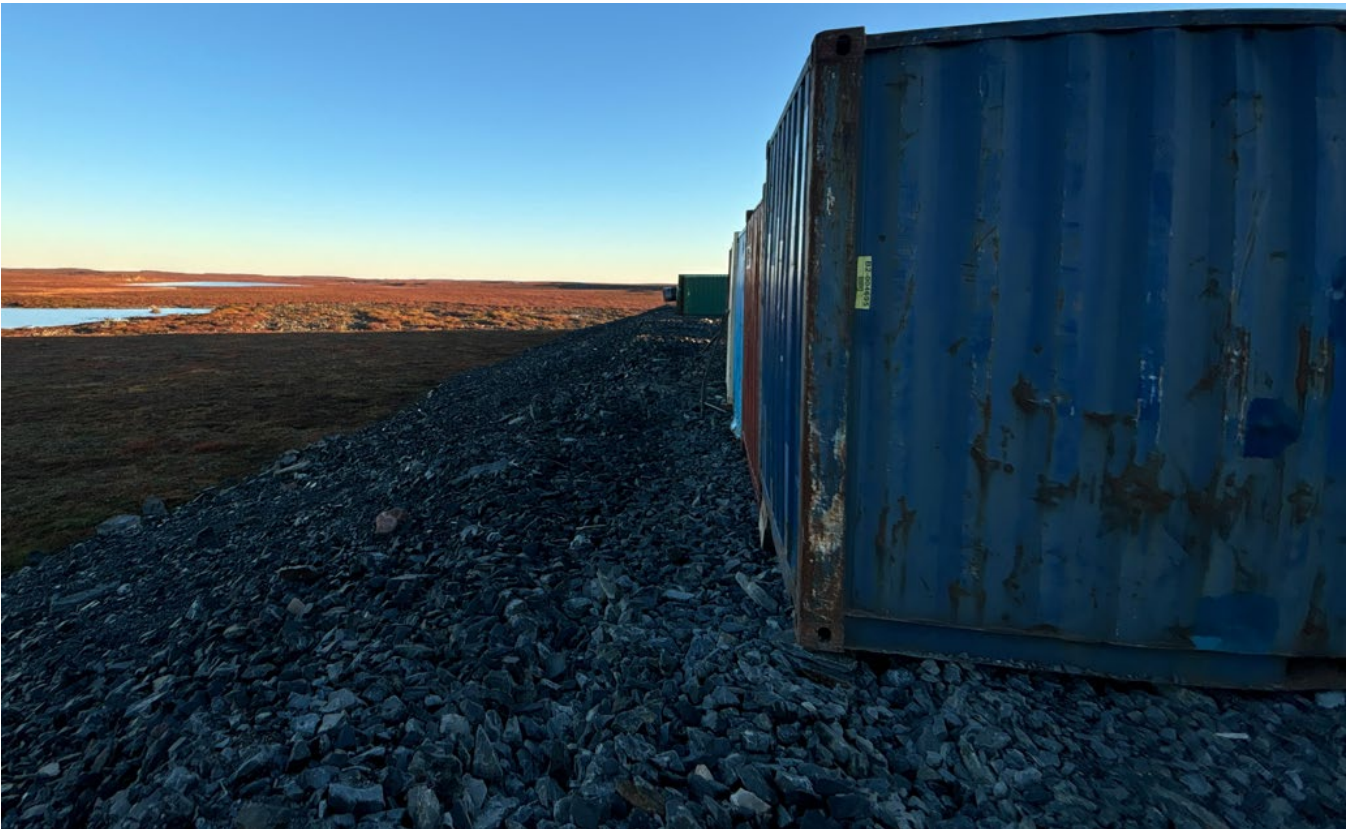
G-188: Western slope – Note seacans close to edge

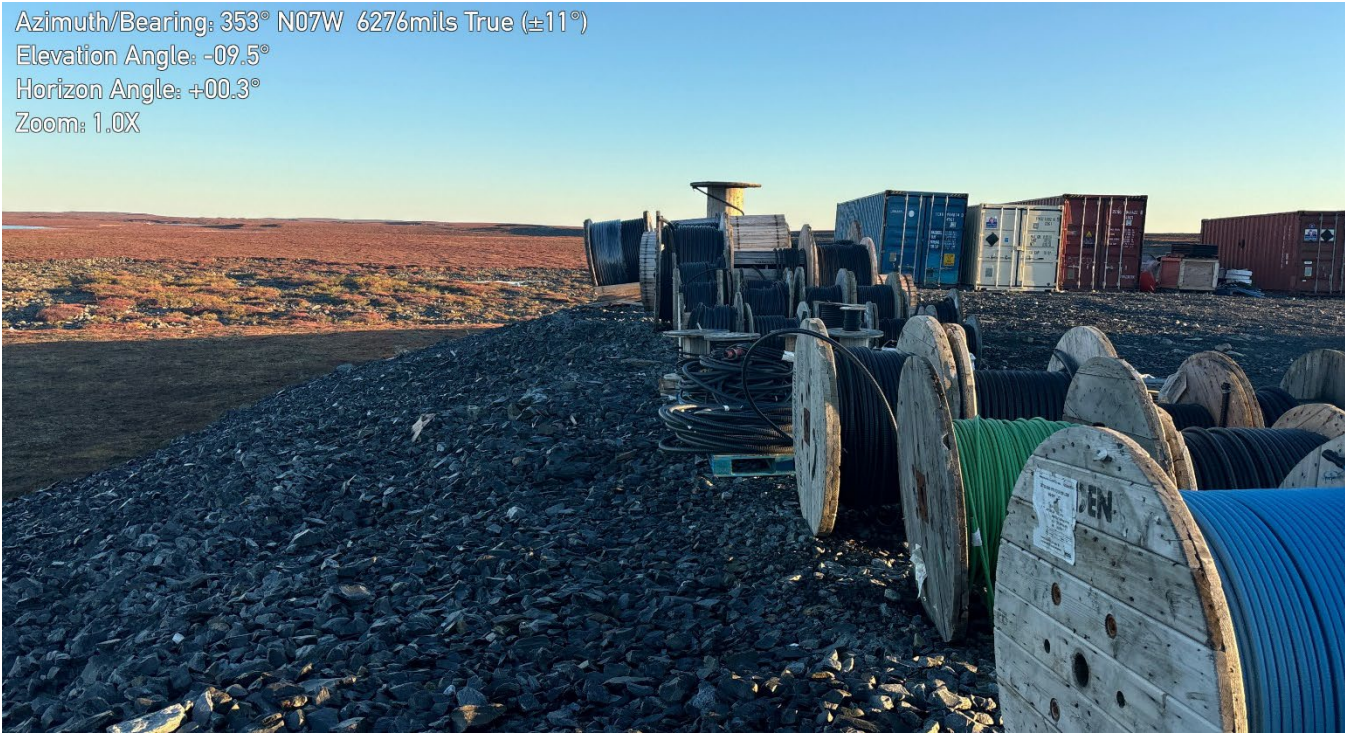
G-189: Western slope, facing north – Note equipment close to edge

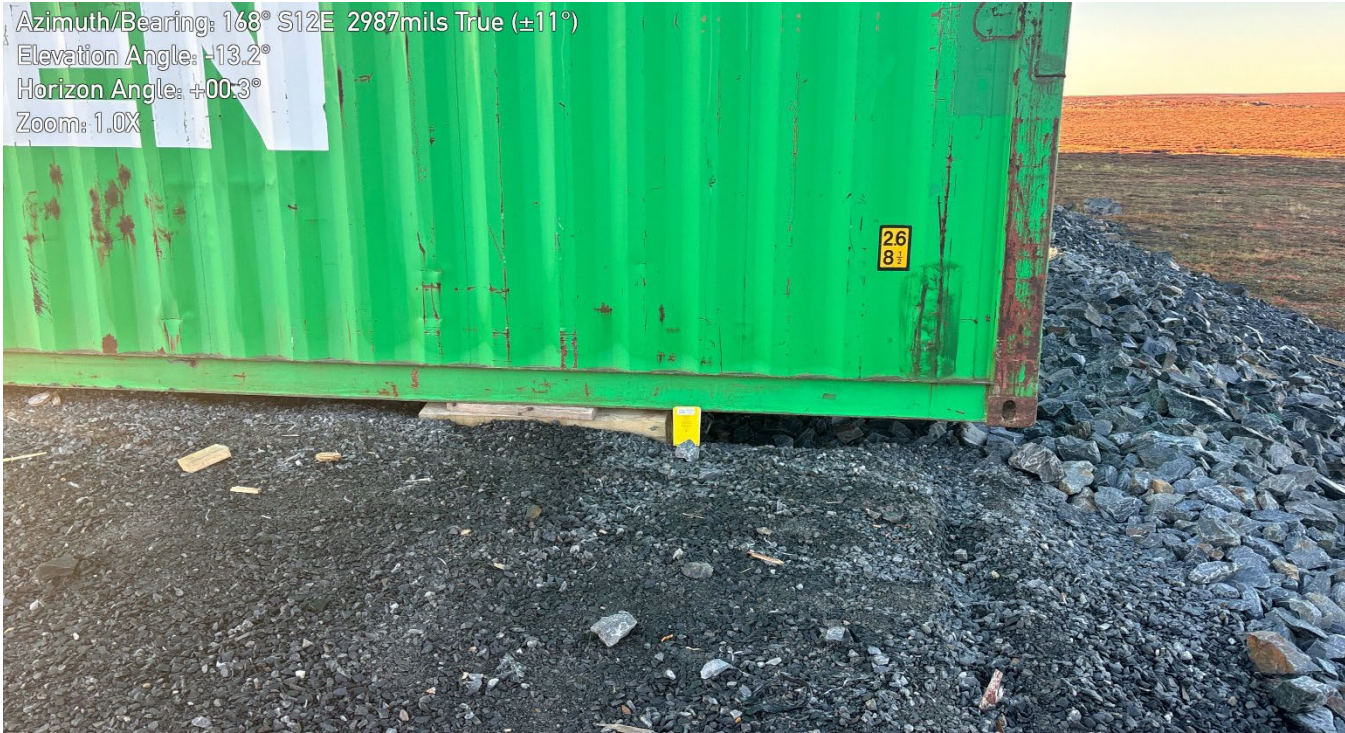
G-190: Western slope seacan – Note gap beneath seacan
