Goose & MLA Project Sites – 2024 Annual Geotechnical Inspection

Back River Project, Nunavut, Canada
B2Gold Corp.

SRK Consulting (Canada) Inc. ■ CAPR003105 ■ April 2025

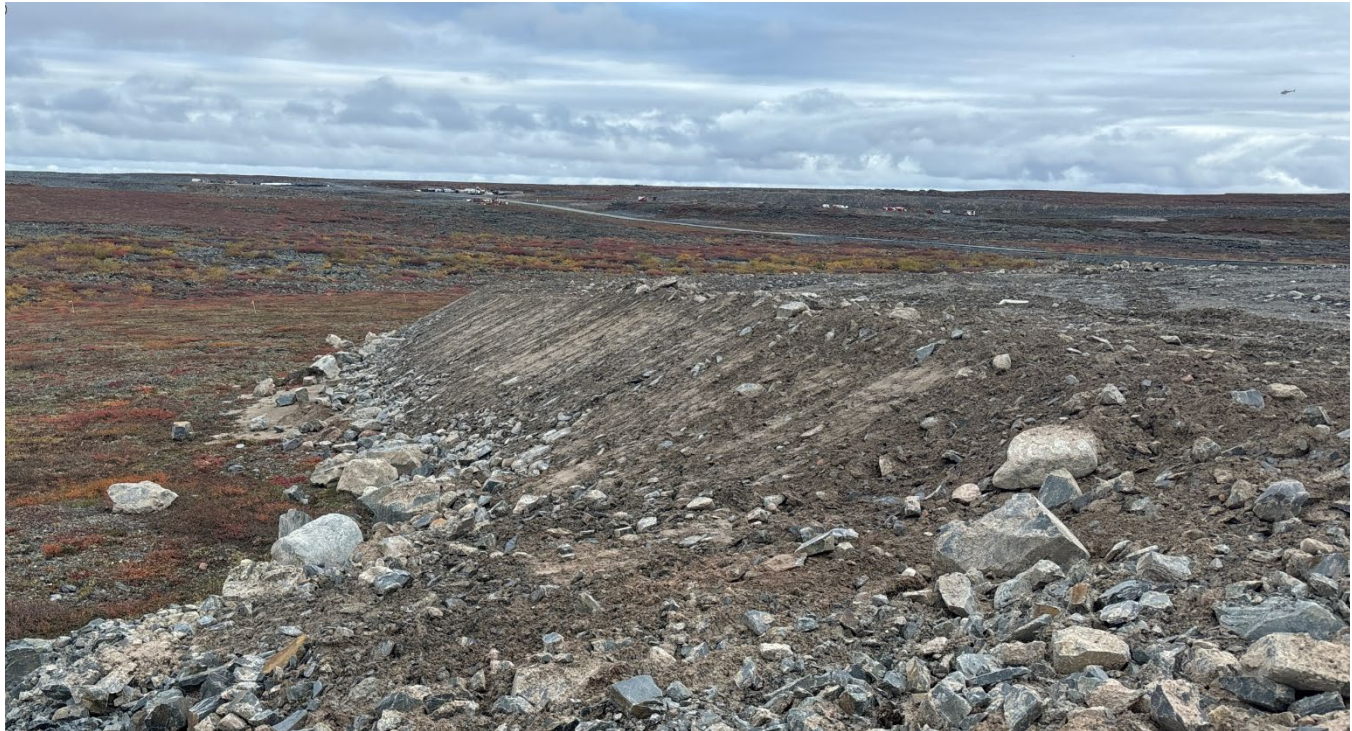
G-193: Western end of extension – Note slopes are prone to significant settlement. Looking north

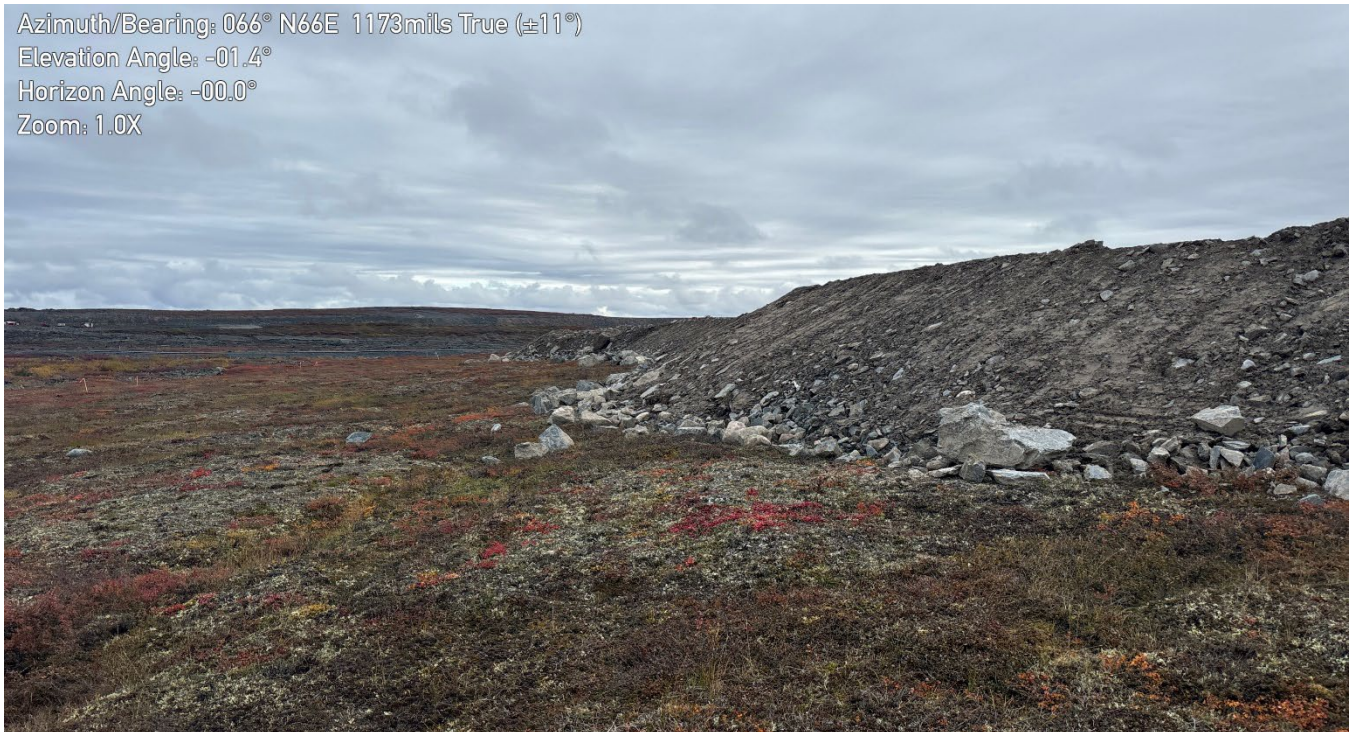
G-195: Looking East – Note oversteepened slopes

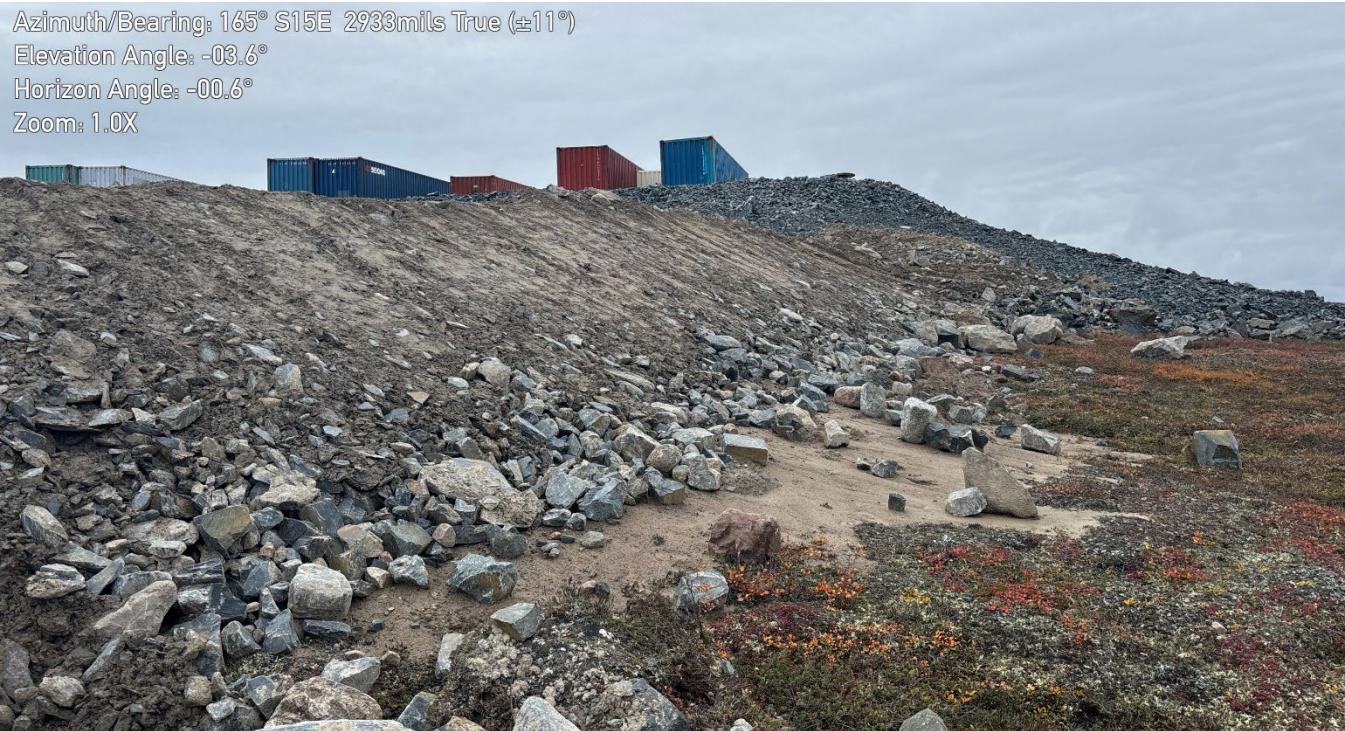
G-194: Camp Pad. Western slope – Note oversteepened slopes

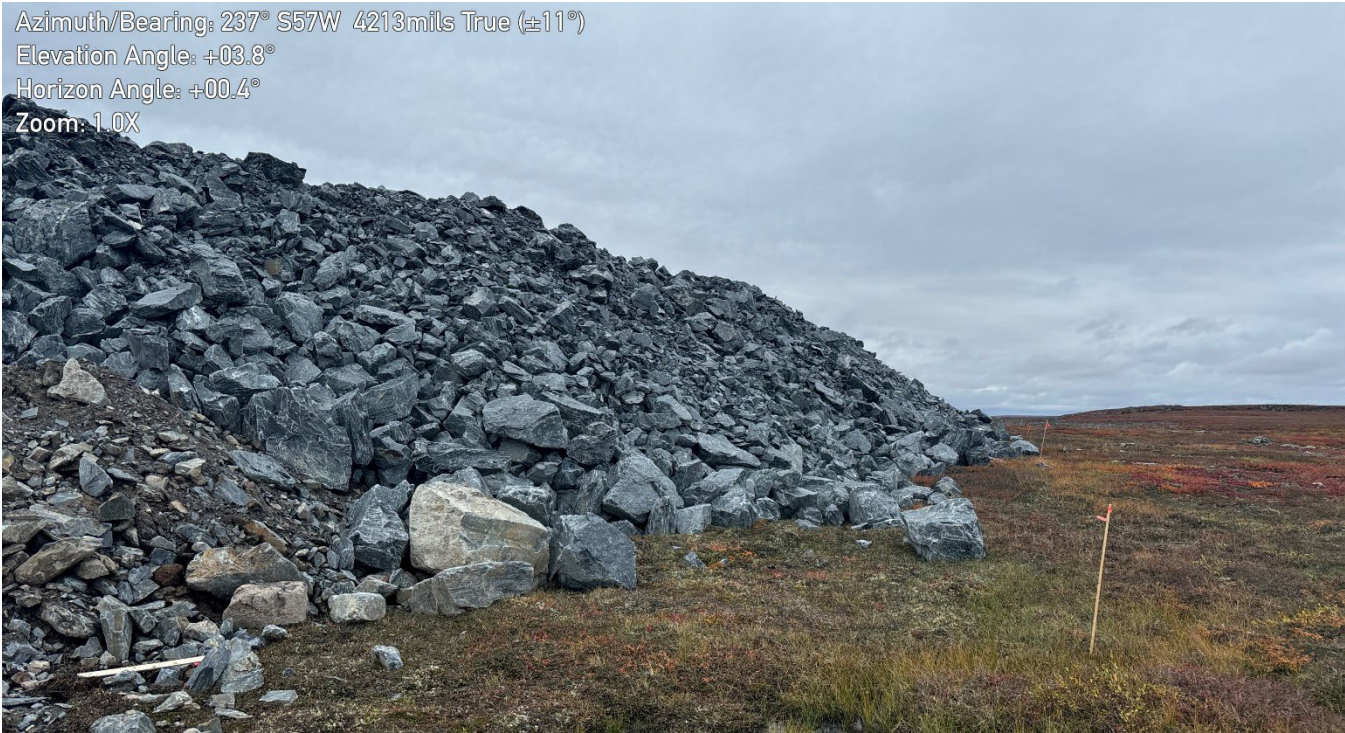
G-197: Pad extension looking west – Note oversteepened slopes

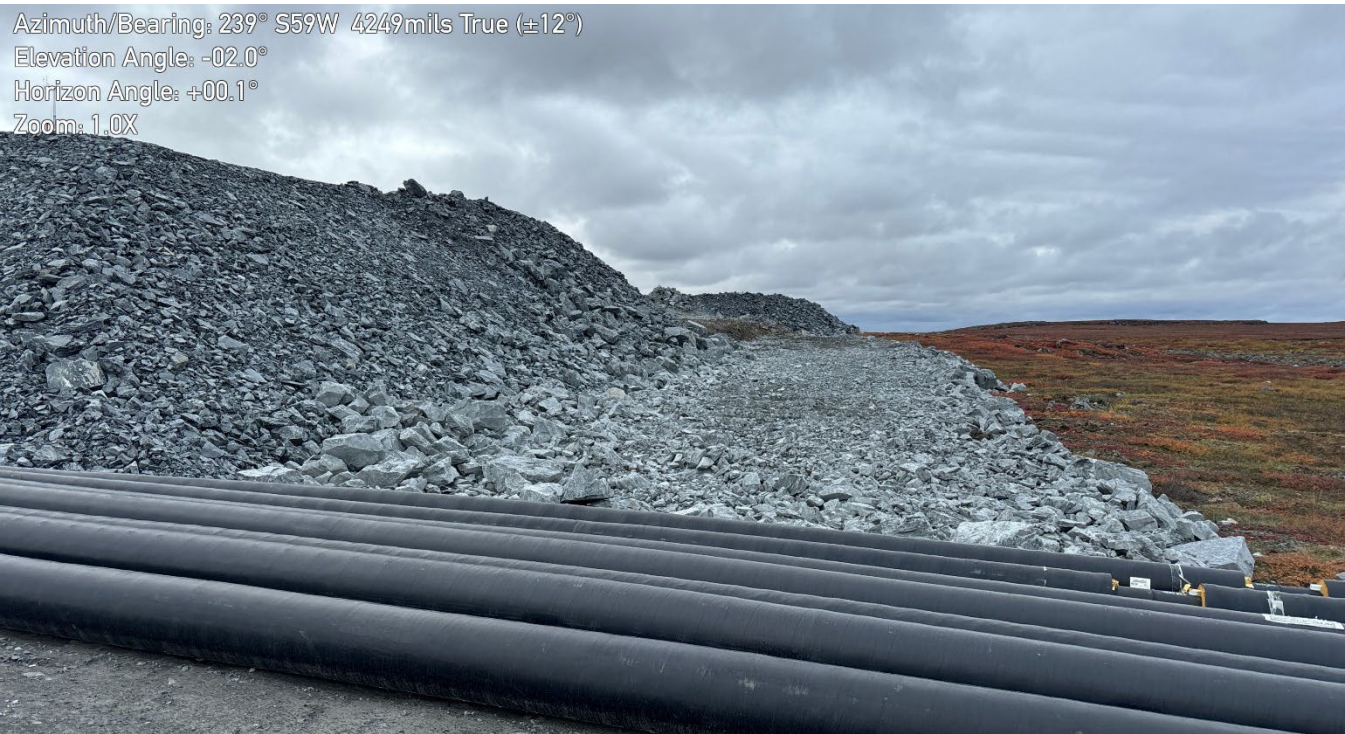
G-200: Extension from all-weather road. Facing west – Note oversteepend slopes

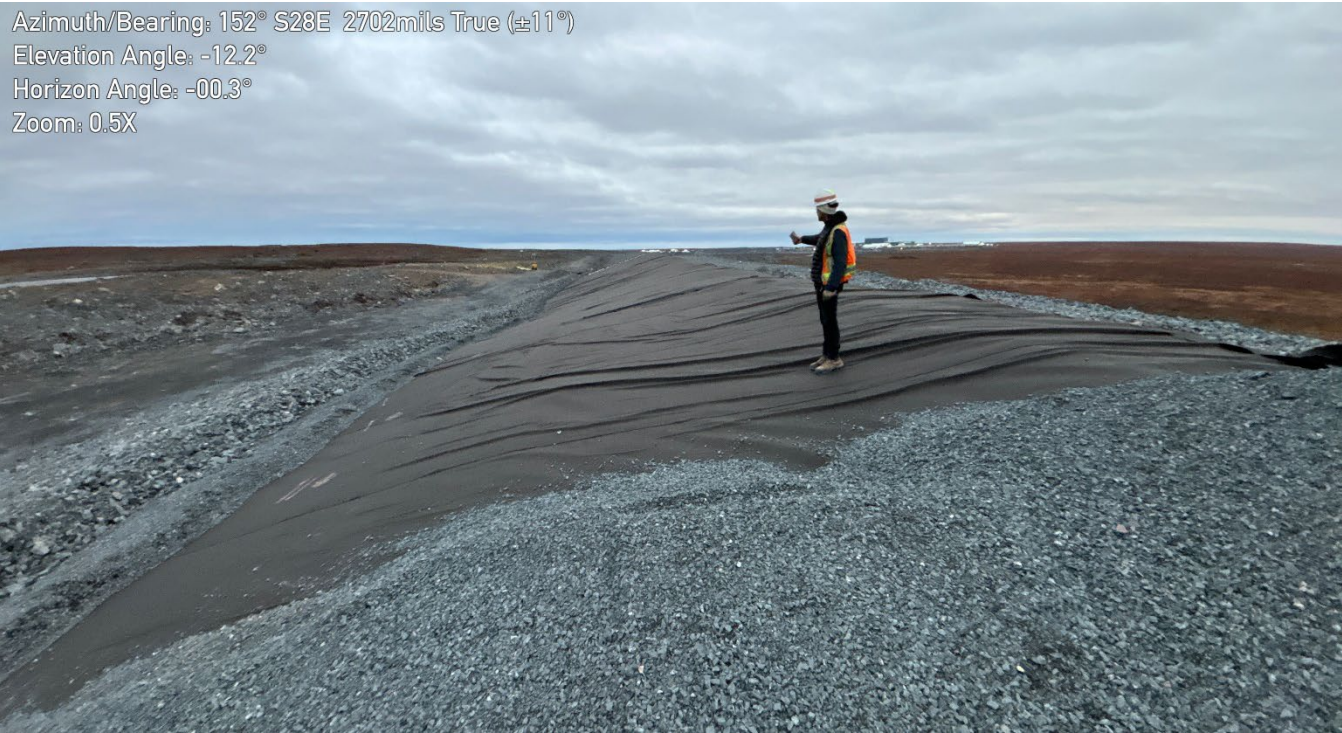
G-219: Upstream face. Previous liner fix. Looking SE (between Sta 0+150 and 0+200)

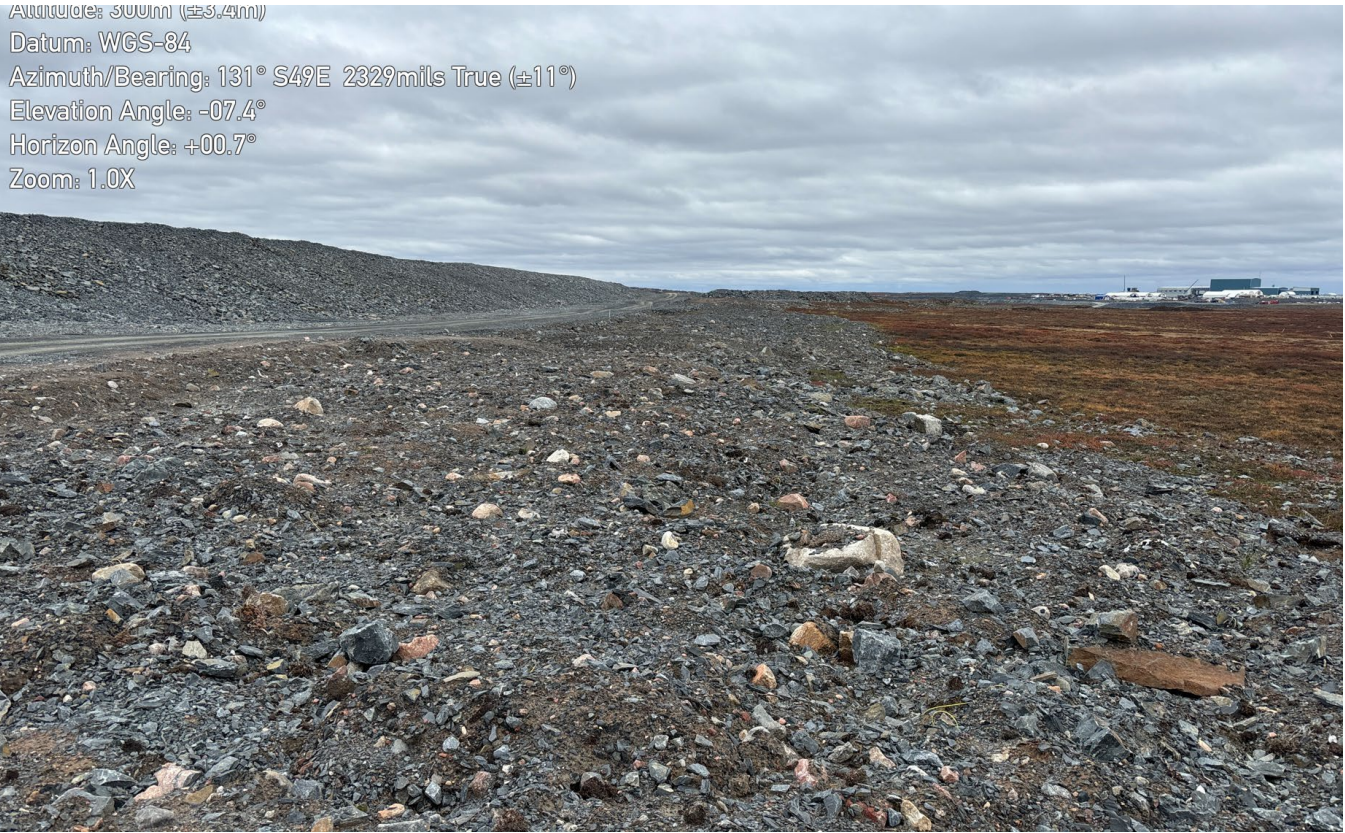
G-225: Downstream to be cleaned up. Facing SE

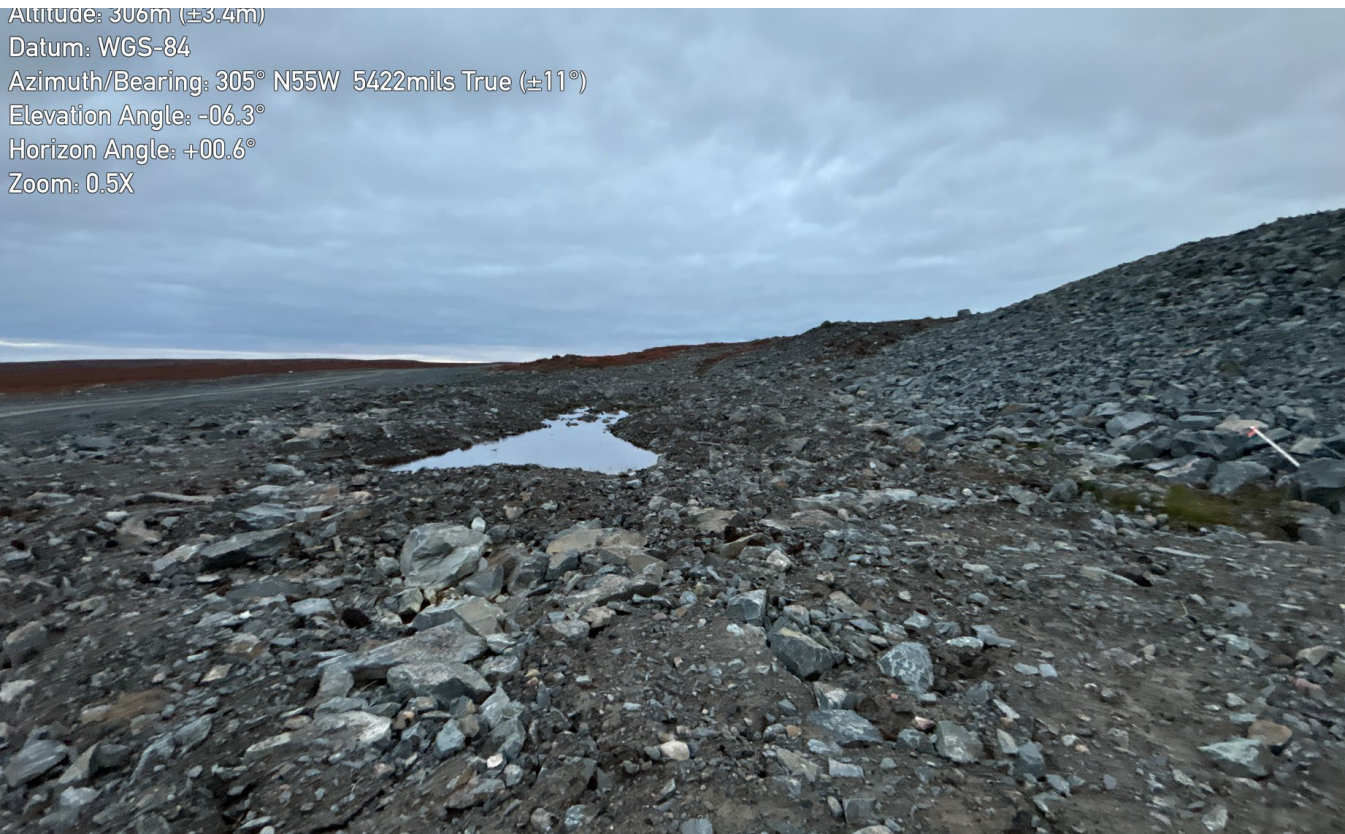
G-226: NW end, facing NW – Note downstream ponding

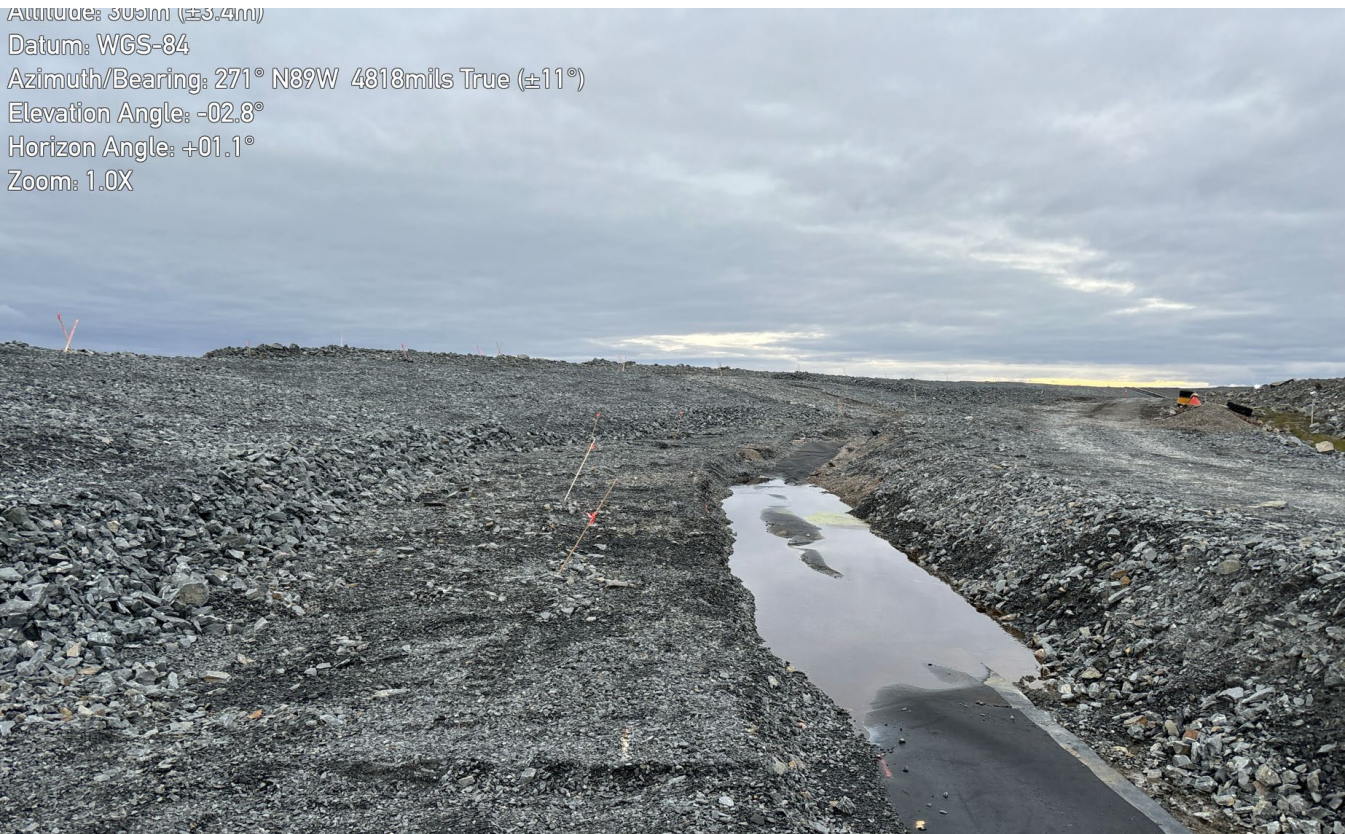
G-227: SE end, facing west – Note ponding water over liner

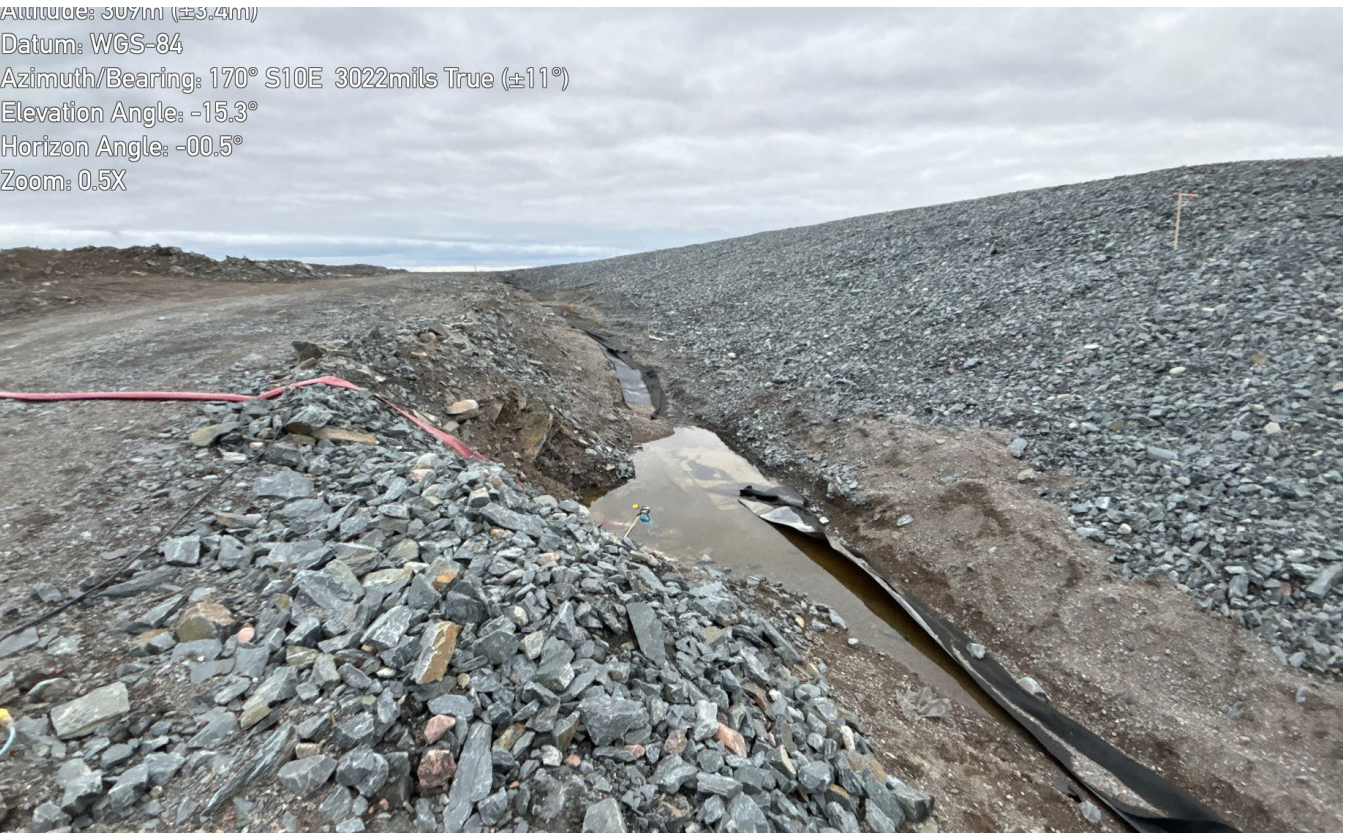
G-228: ponding water over liner at toe (between Sta 0+400 and Sta 0+450)

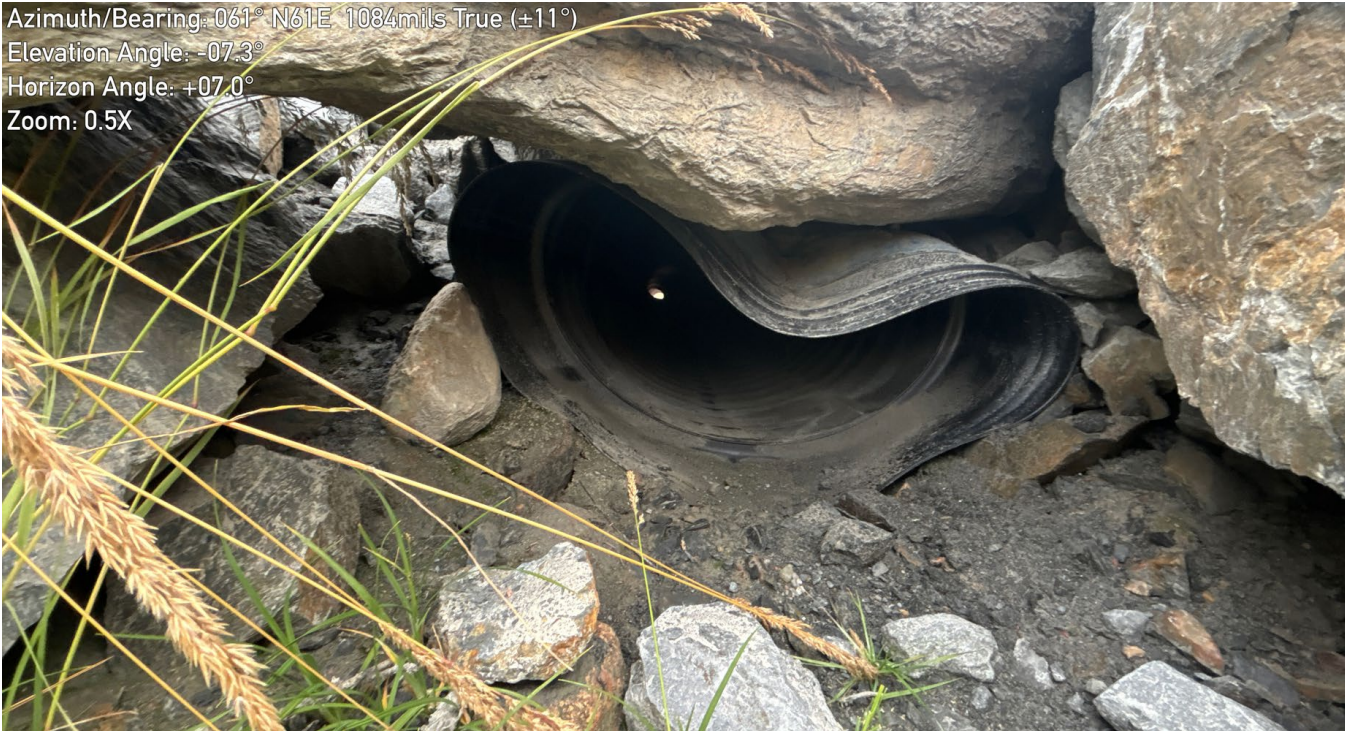
G-229: Goose Neck Crossing Culvert – Note No Fine Material around Culvert

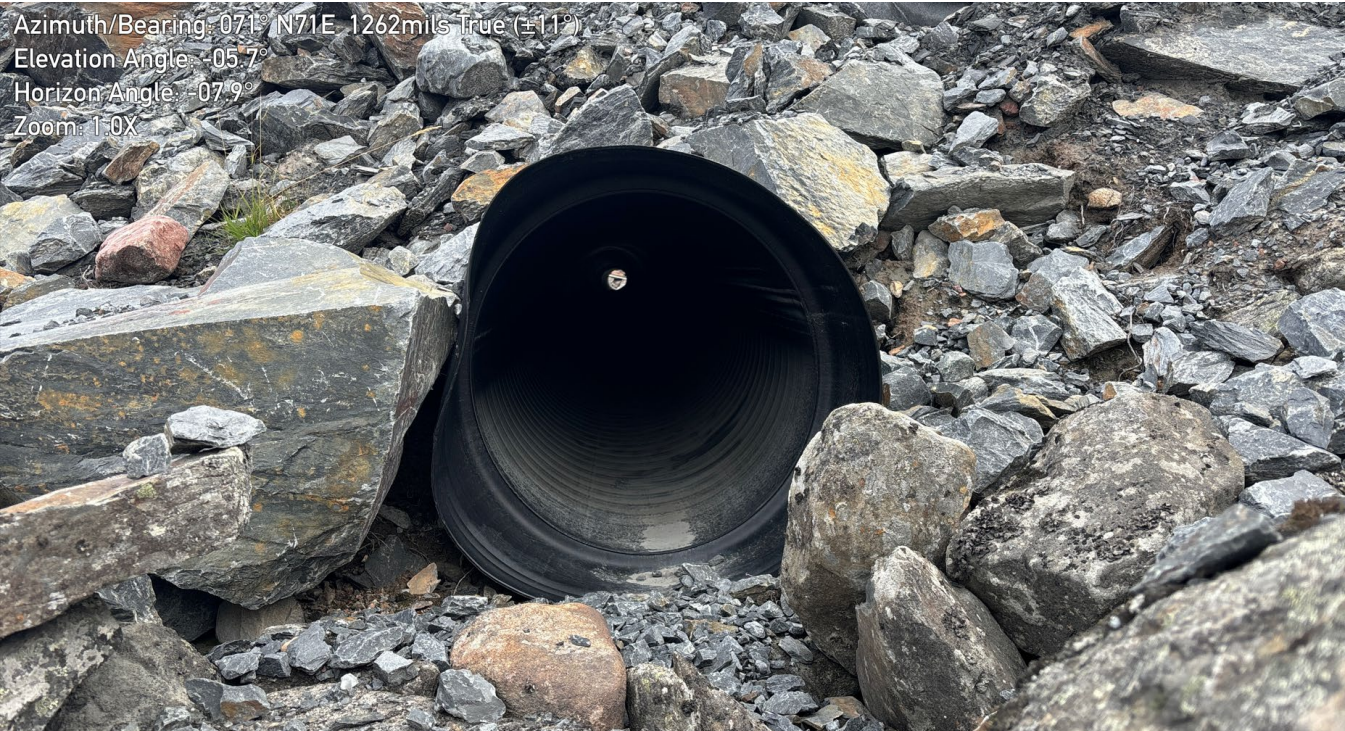
G-230: Toe of Crossing looking East – Note location of culverts do not match design location. Sizing insufficient for storm event (additional Culverts required)

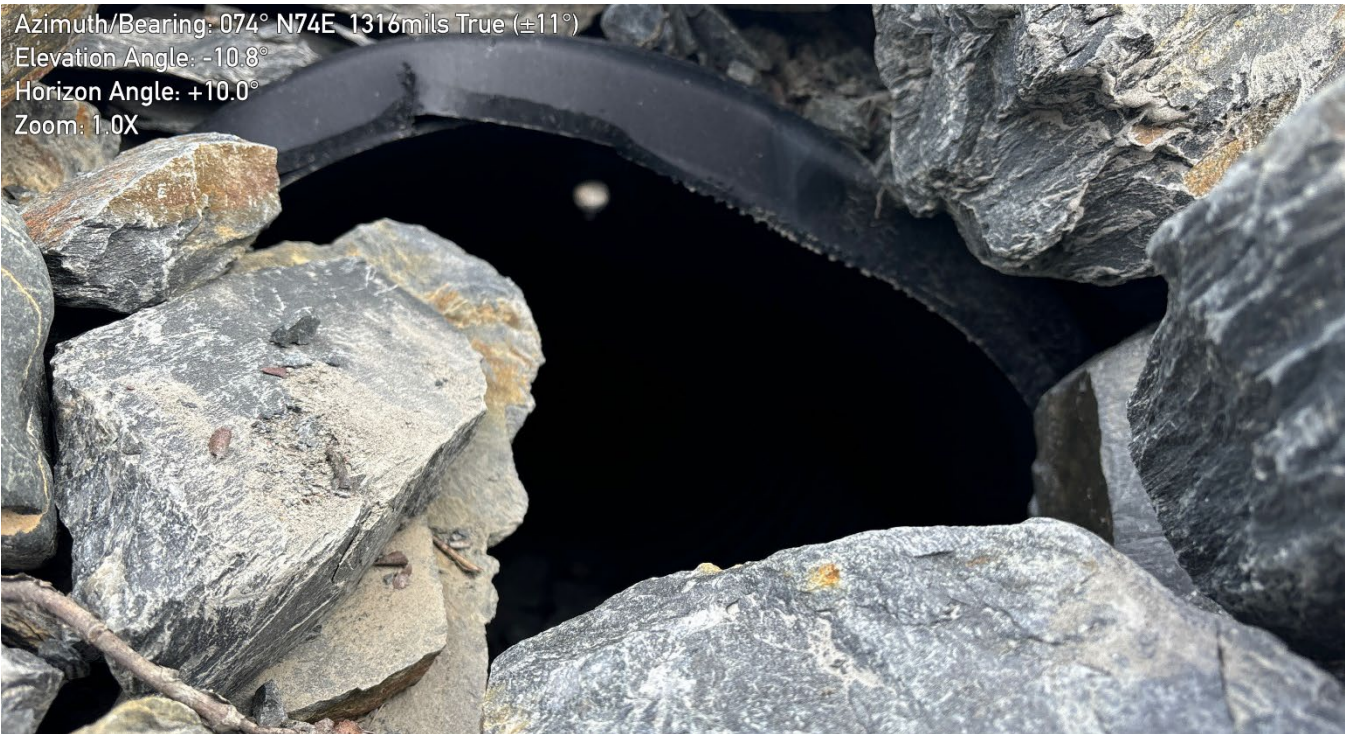
G-231: Culvert inlet partially blocked

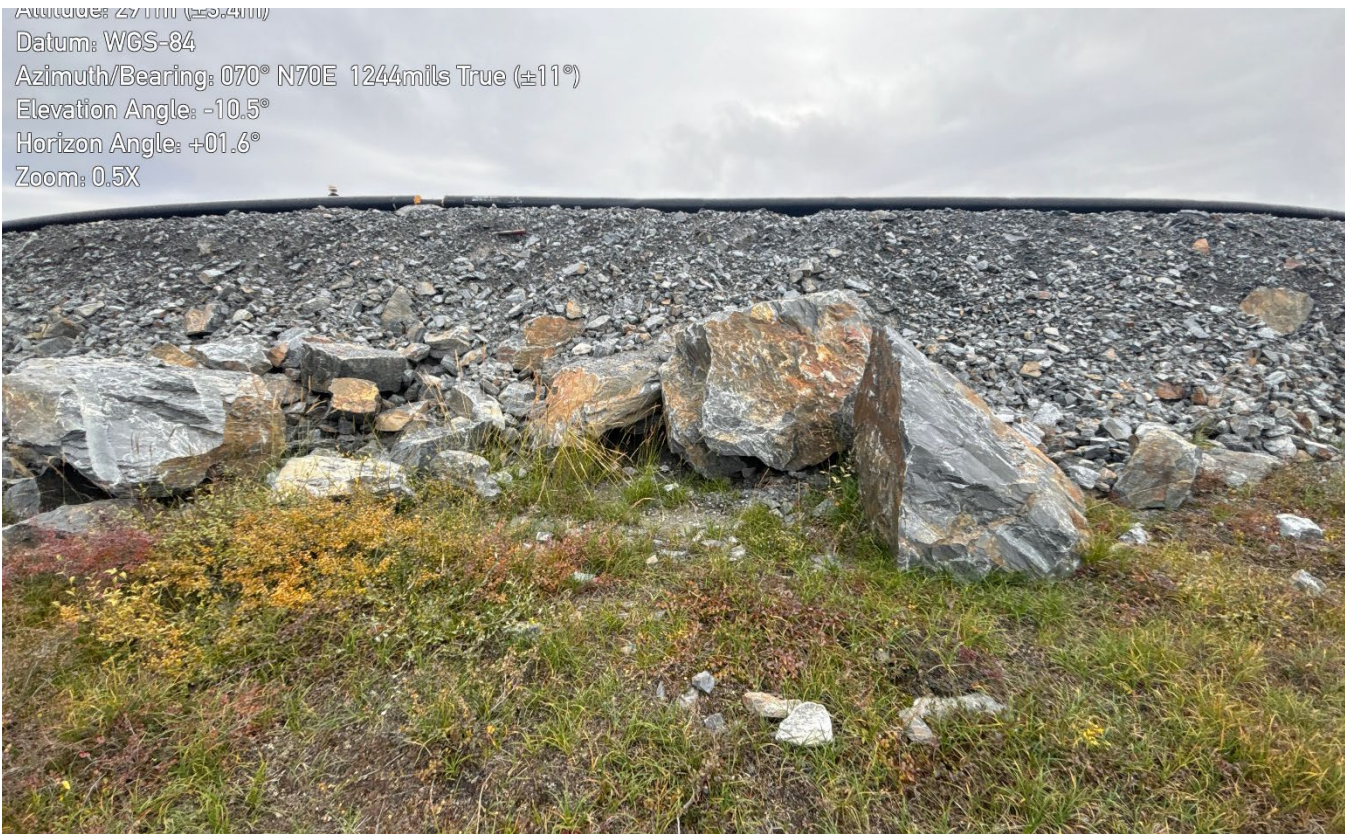
G-233: Thick blasted rock left from Umwelt pit after exploration

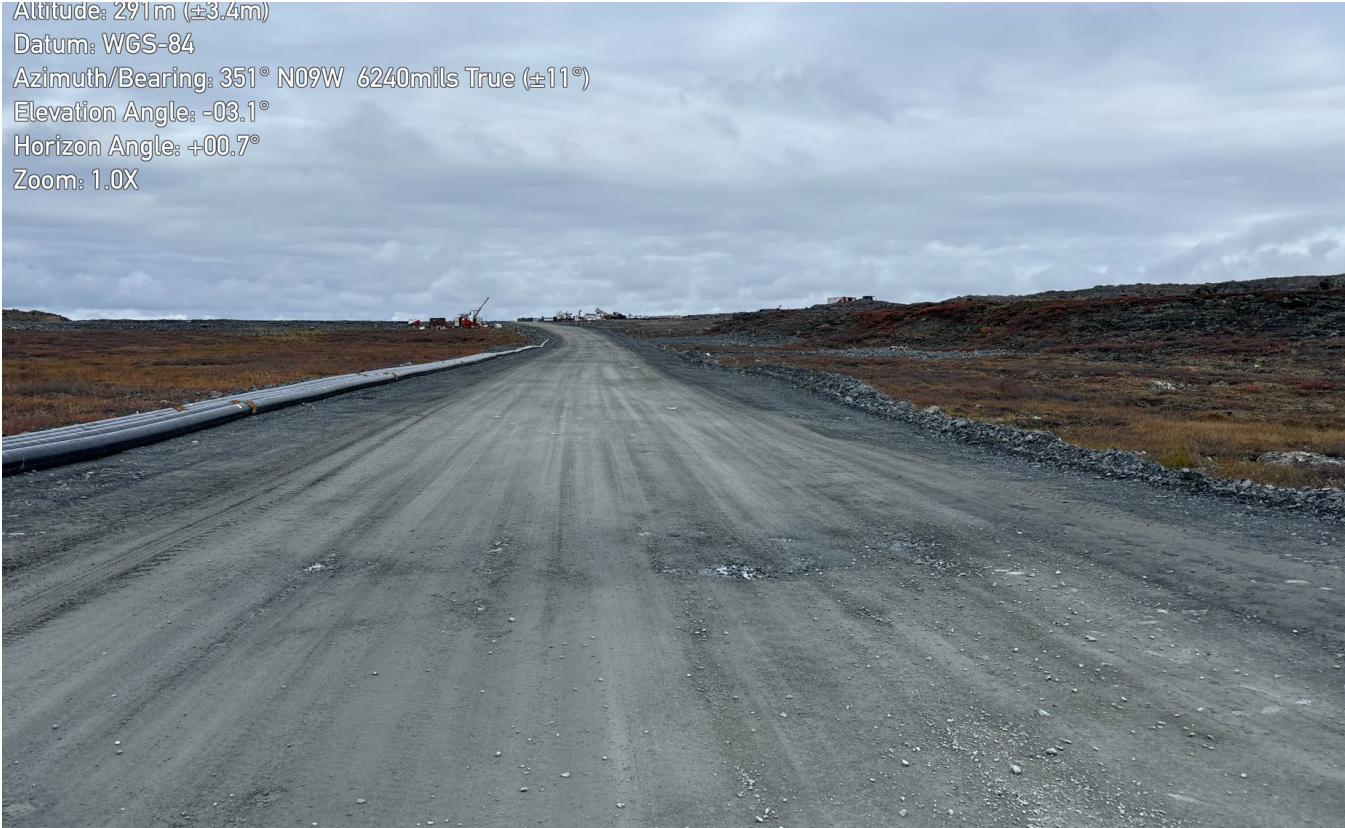
G-236: Haul Road Looking North – Note Road is underbuilt

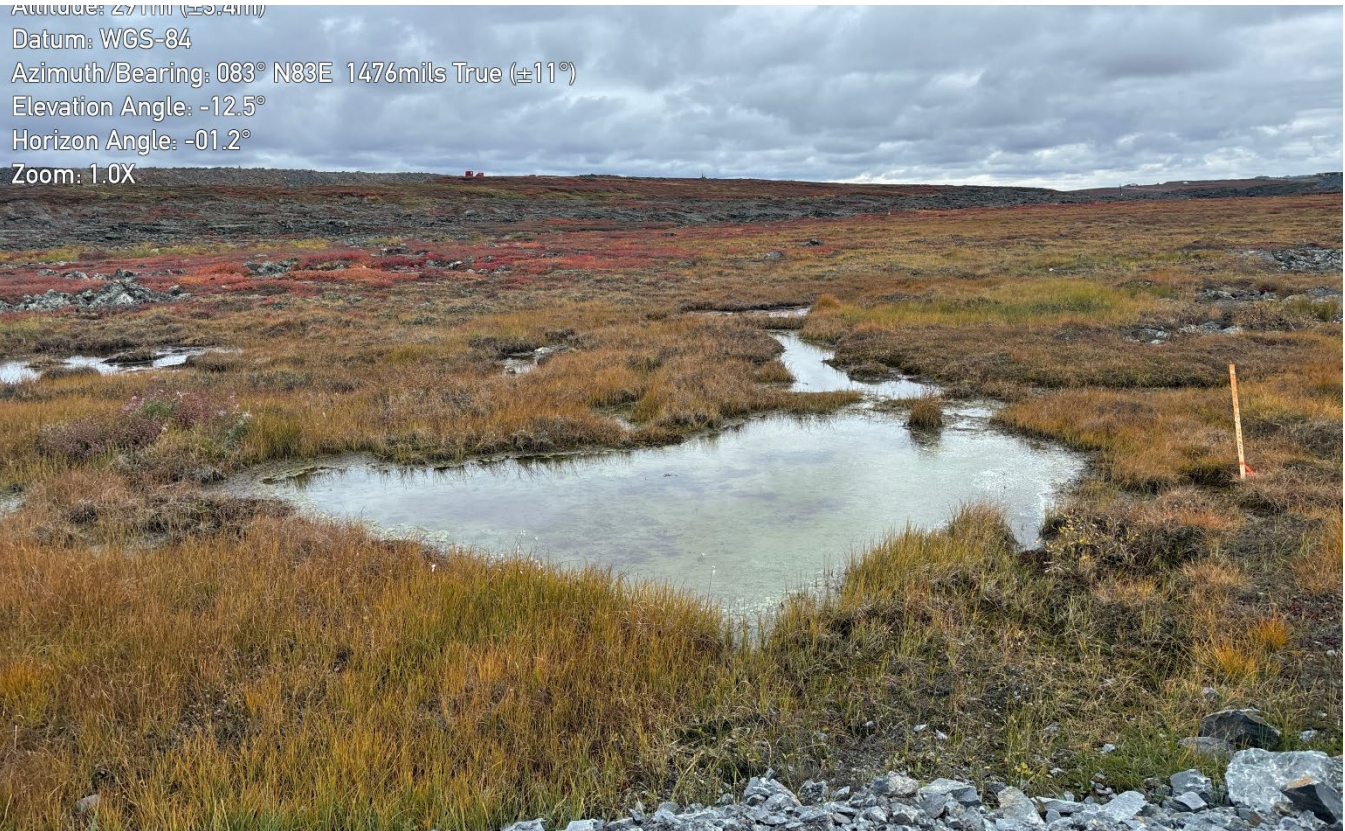
G-238: Southern end of crossing, facing east – Note ponding water

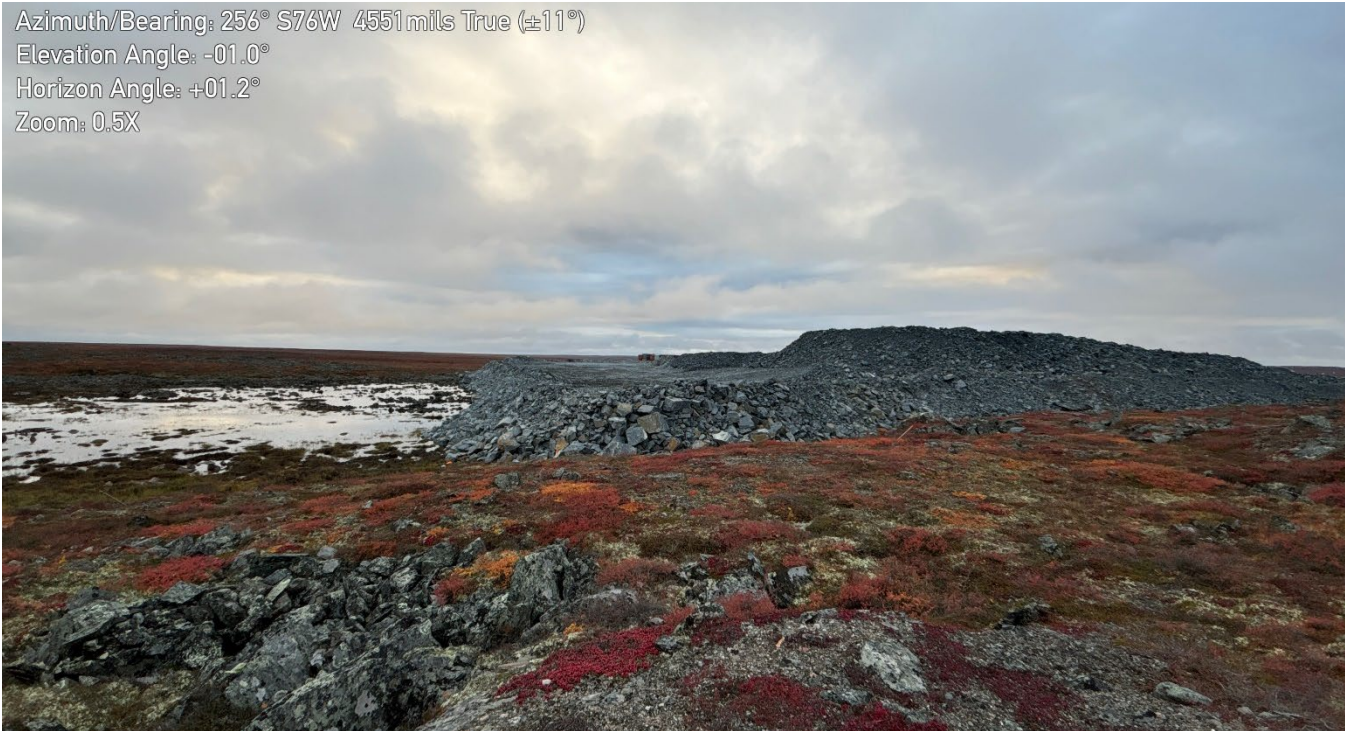
G-239: General view from SSE, facing SW – Previous Note ponding water

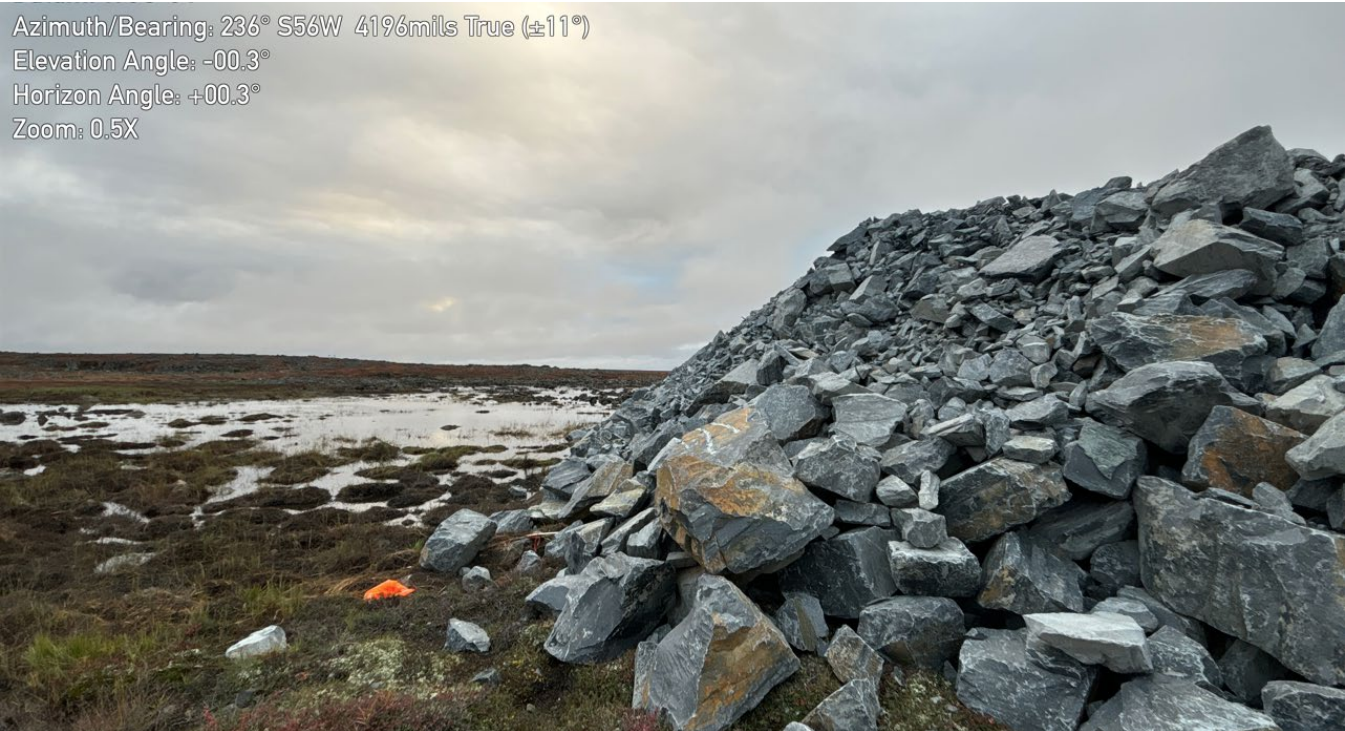
G-240: Eastern slope - Oversteepened

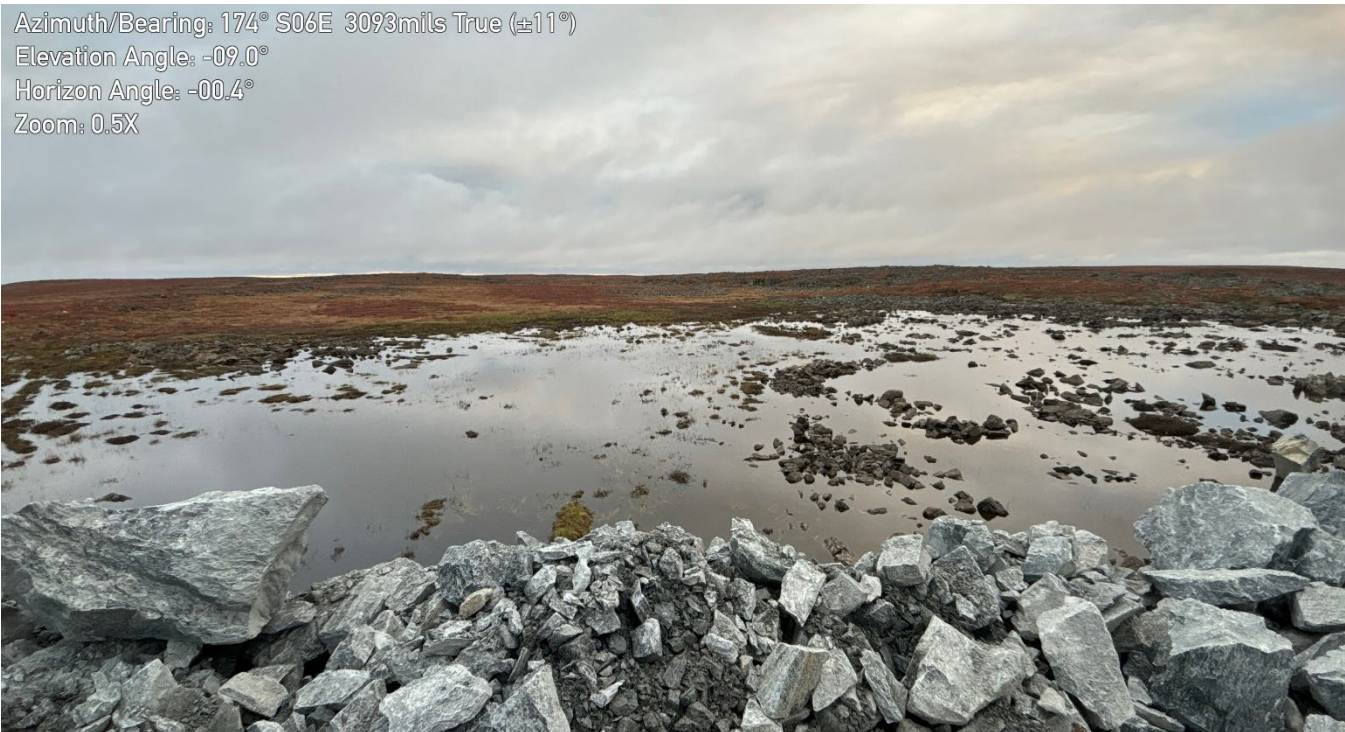
G-241: Southern slope – Note previous ponding water

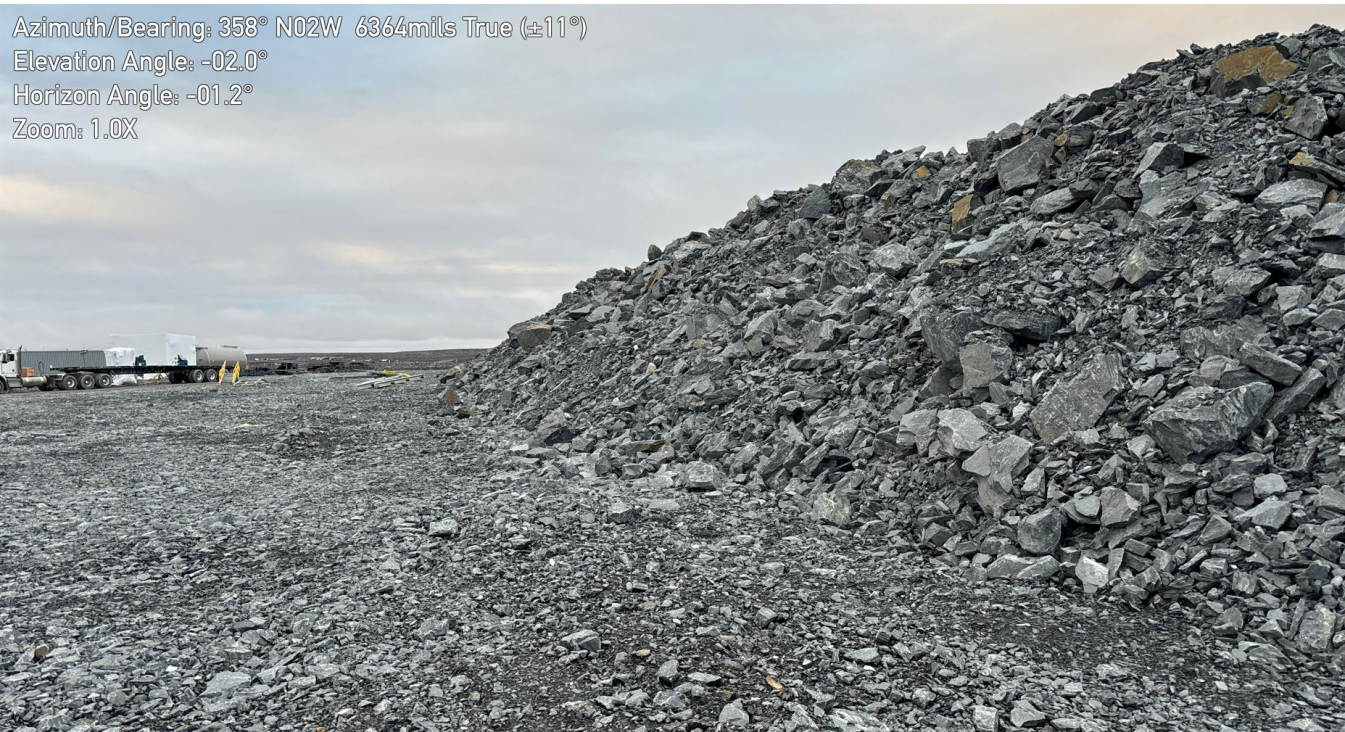
G-242: Western slope – Oversteepened

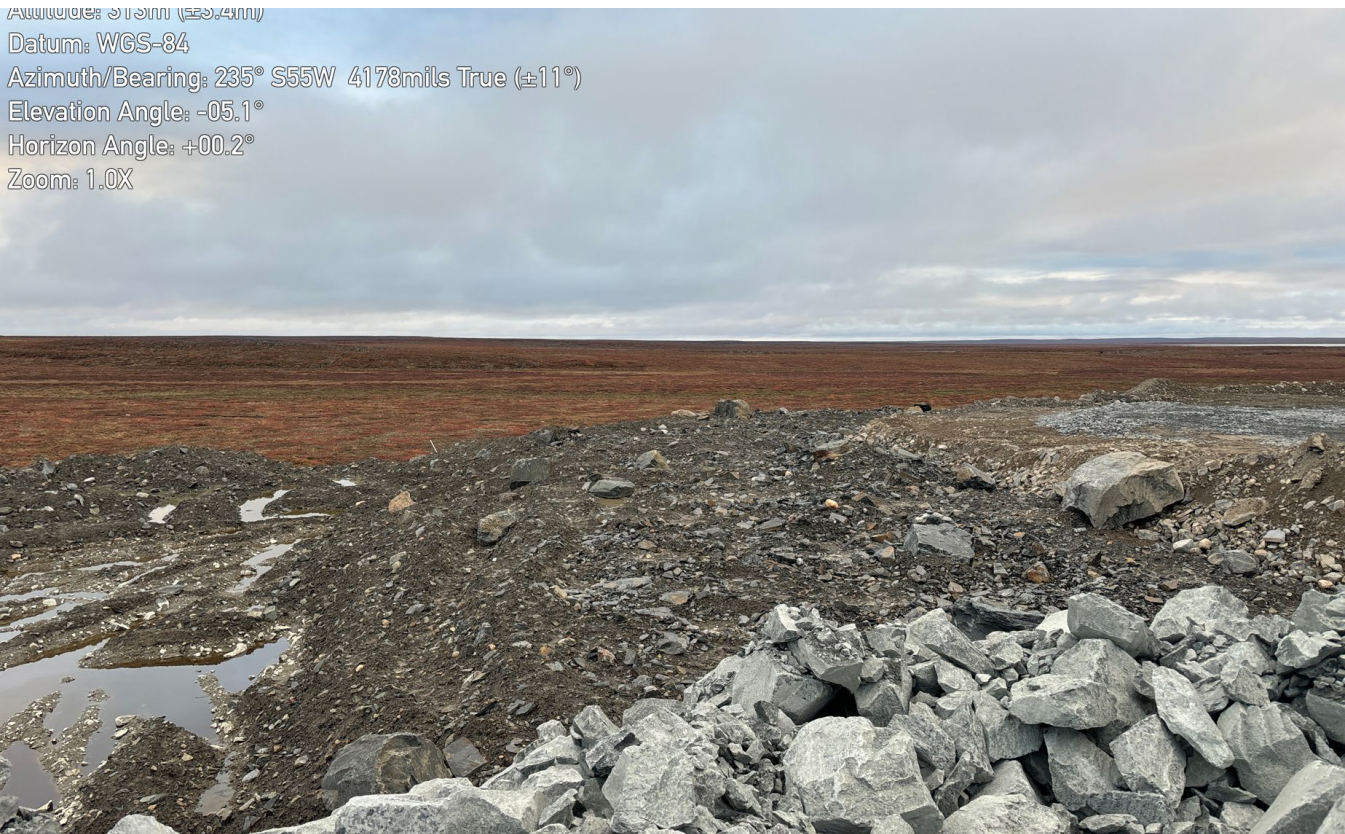
G-244: South of seacan layer – 1.5m overburden lift?

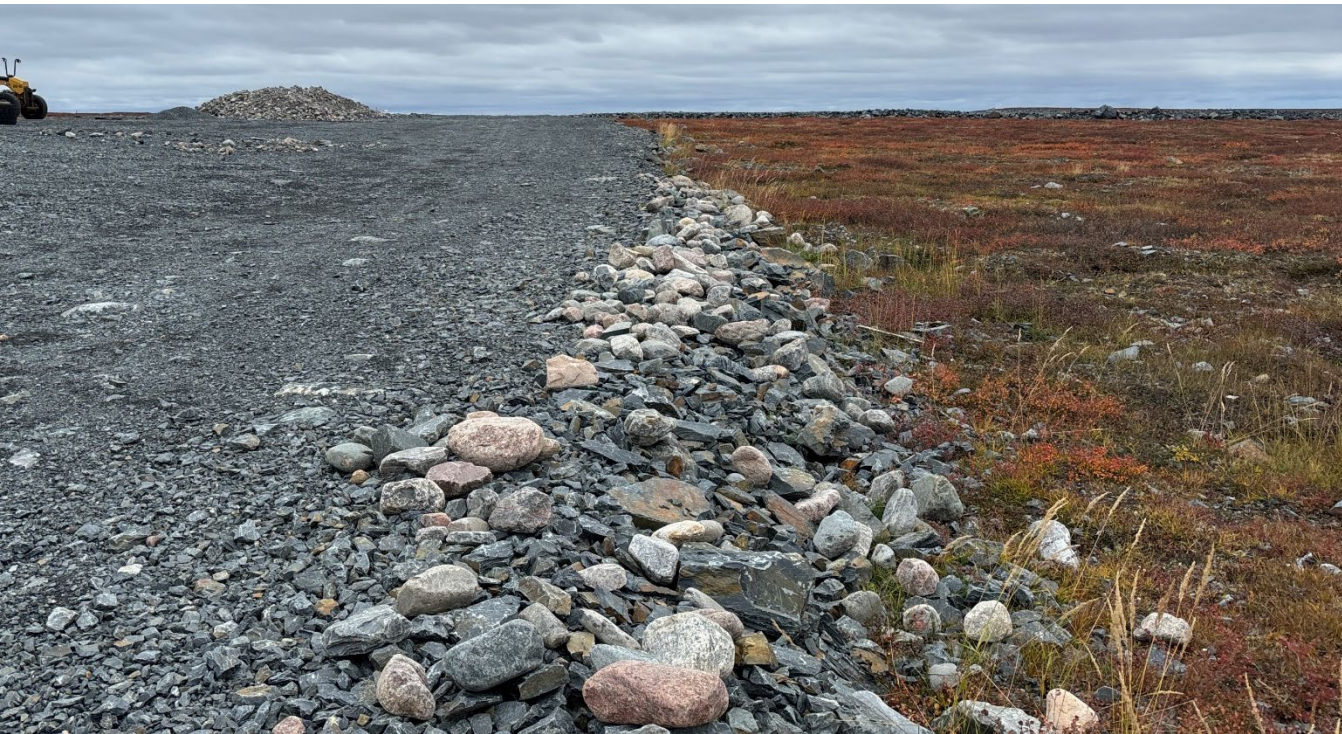
G-256: Edge of road opposite camp pad – Note thickness
