Goose & MLA Project Sites – 2024 Annual Geotechnical Inspection

Back River Project, Nunavut, Canada
B2Gold Corp.

SRK Consulting (Canada) Inc. ■ CAPR003105 ■ April 2025

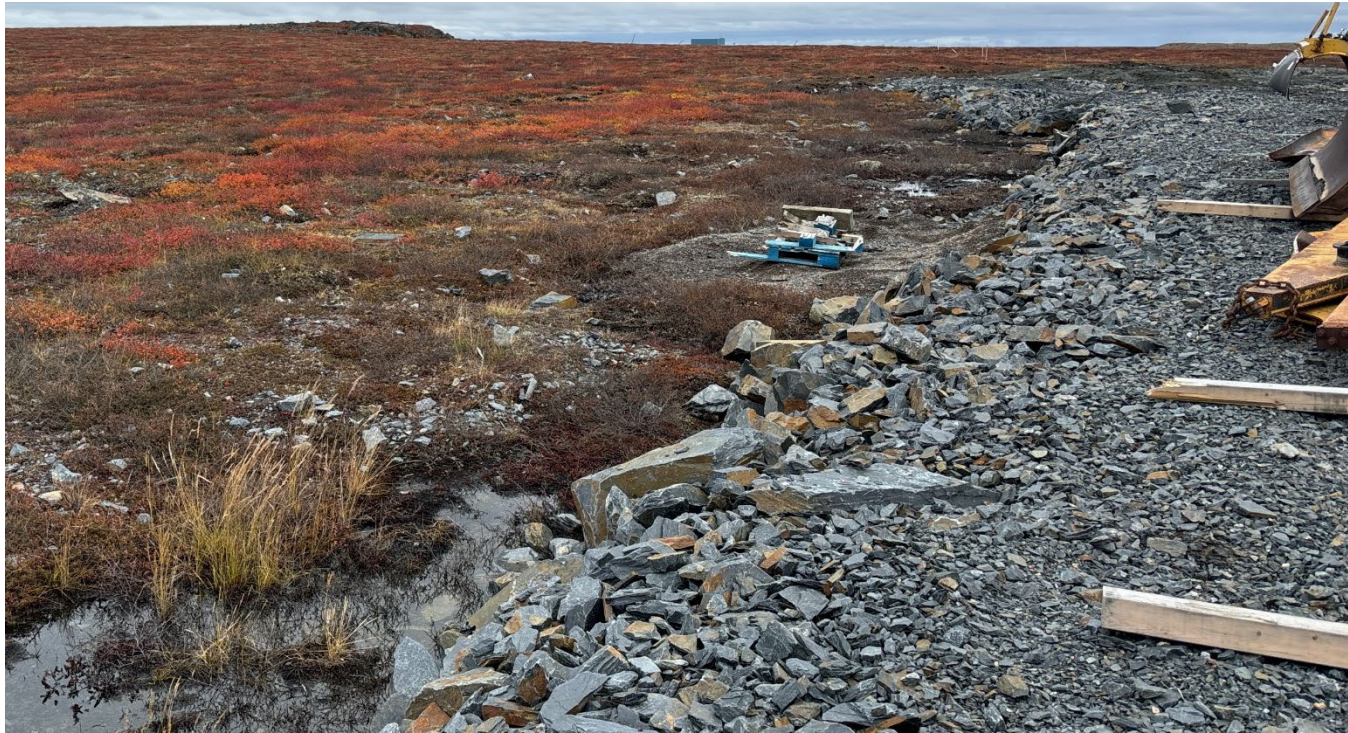
G-257: Edge of camp pad – Note ponding water

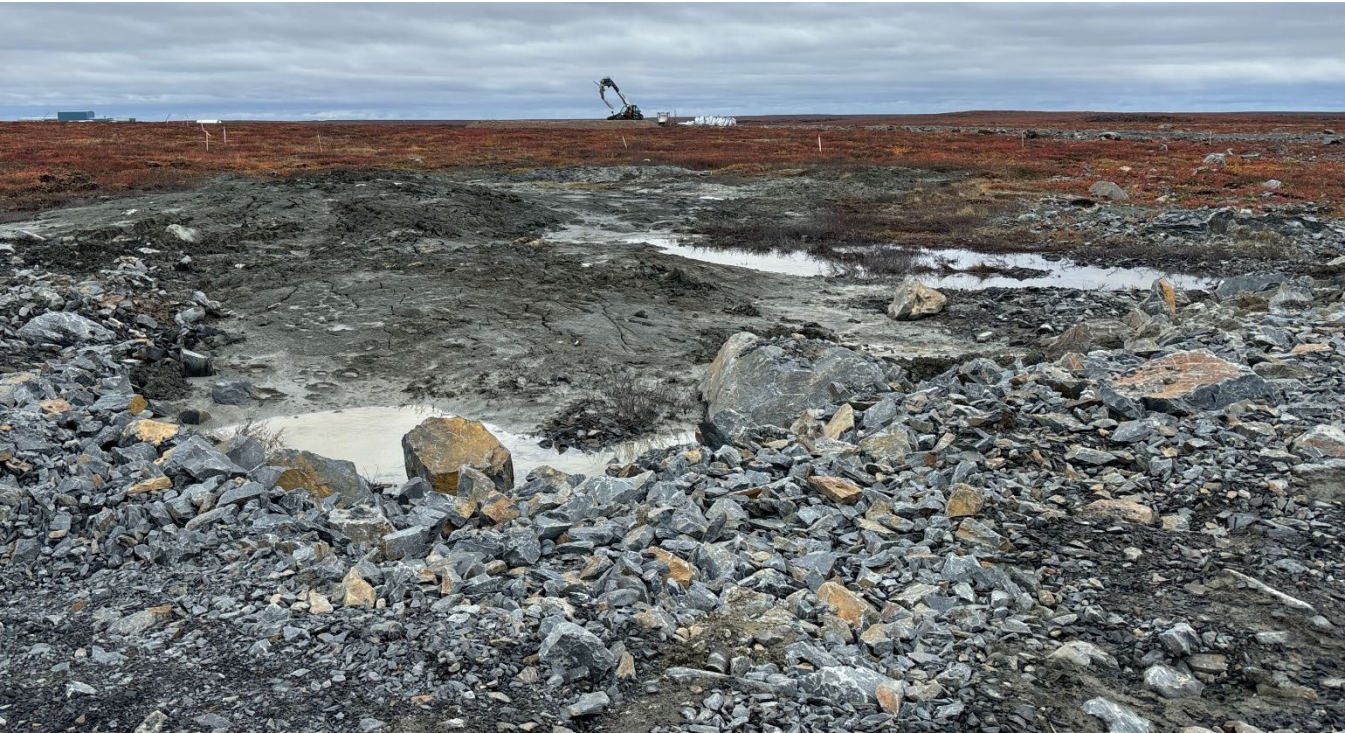
G-258: Camp pad – Note Erosion, ponding and lack of aggregate material

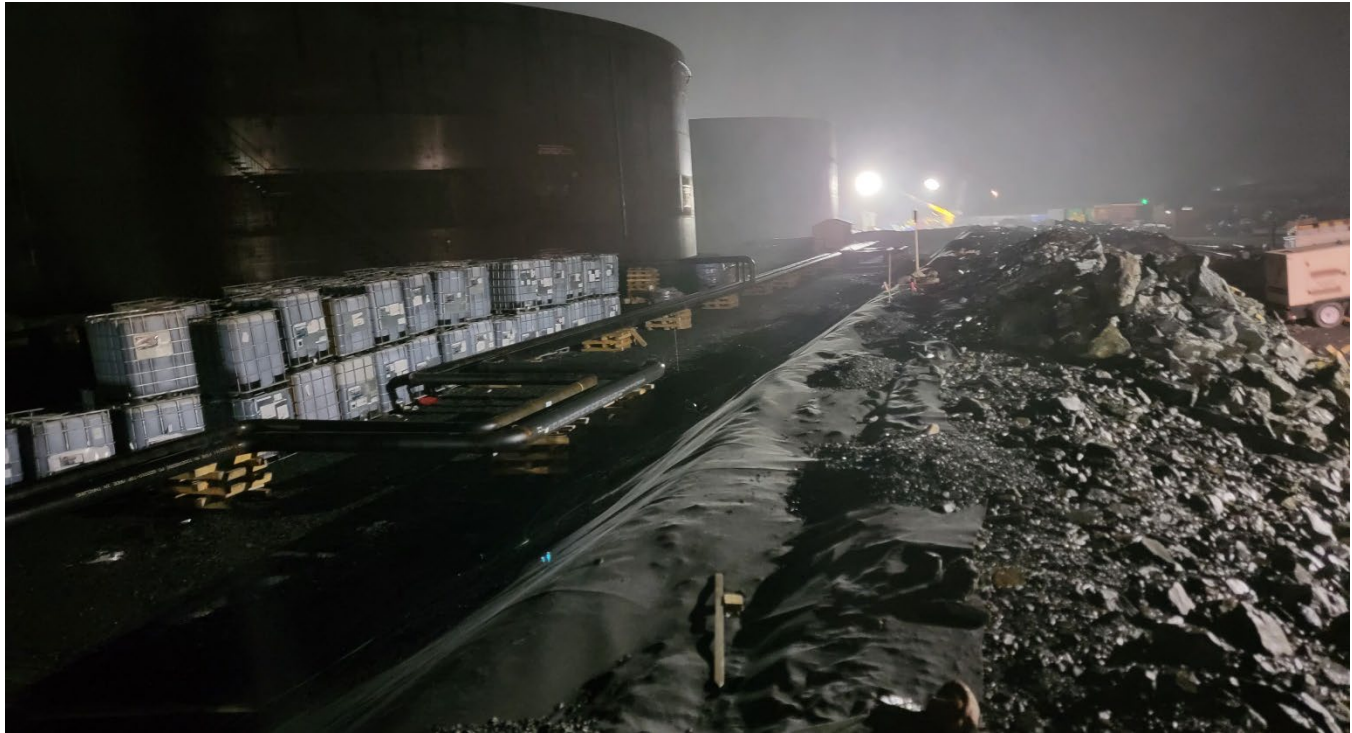
G-261 - General view facing east

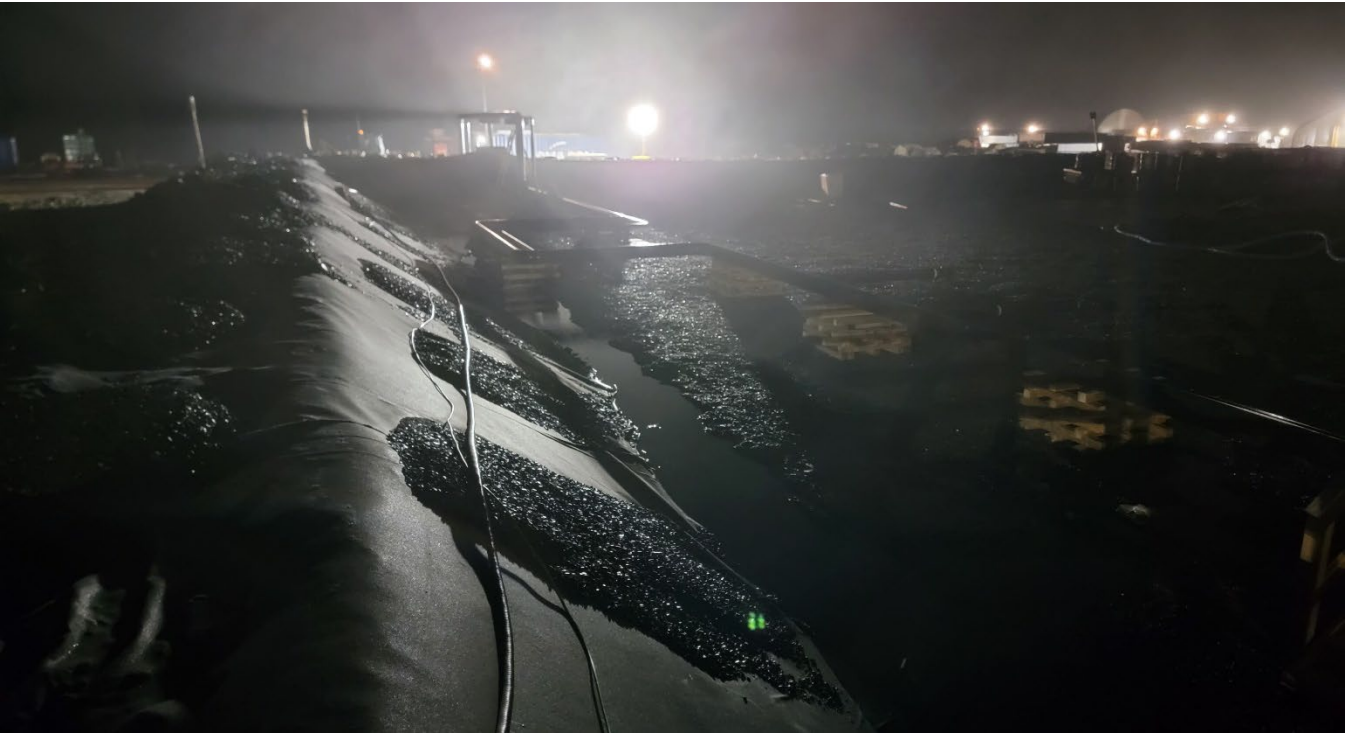
G-262 - General view of the southern berm, facing west

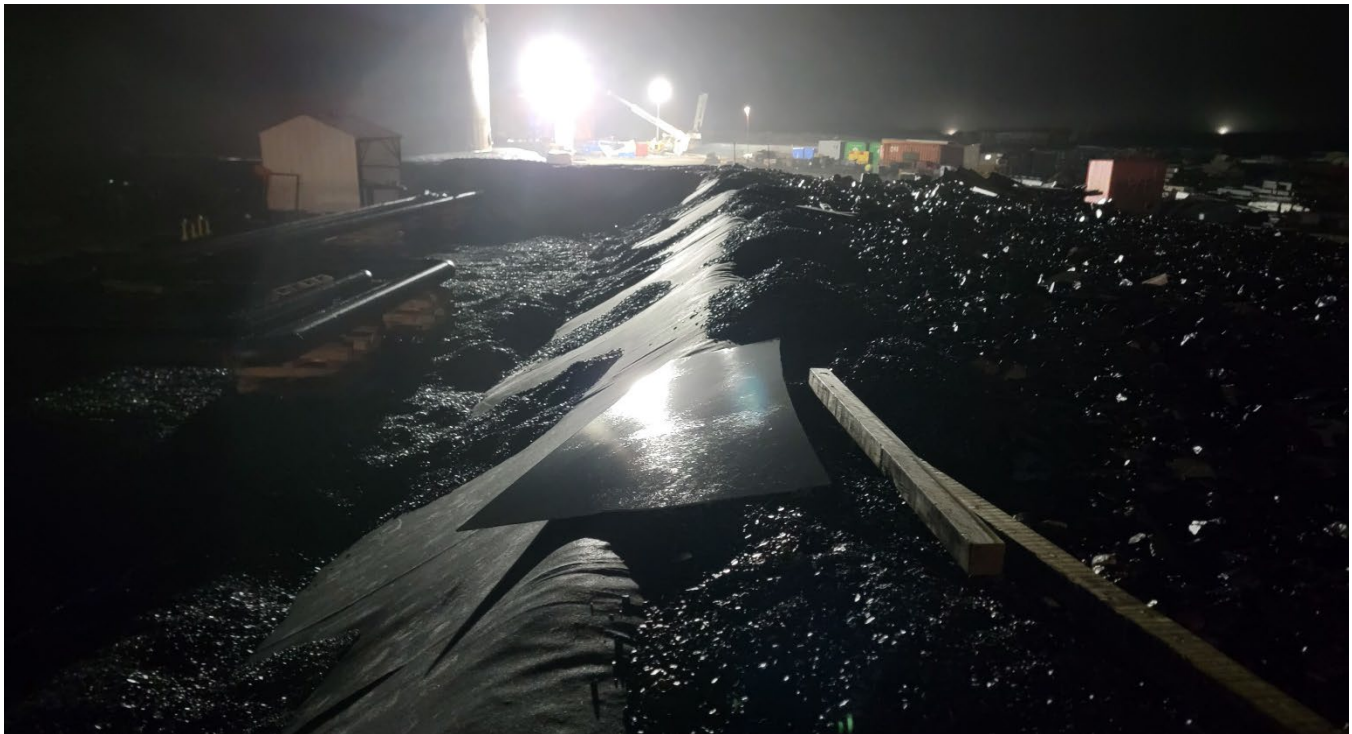
G-263 – General view of the western berm, facing south

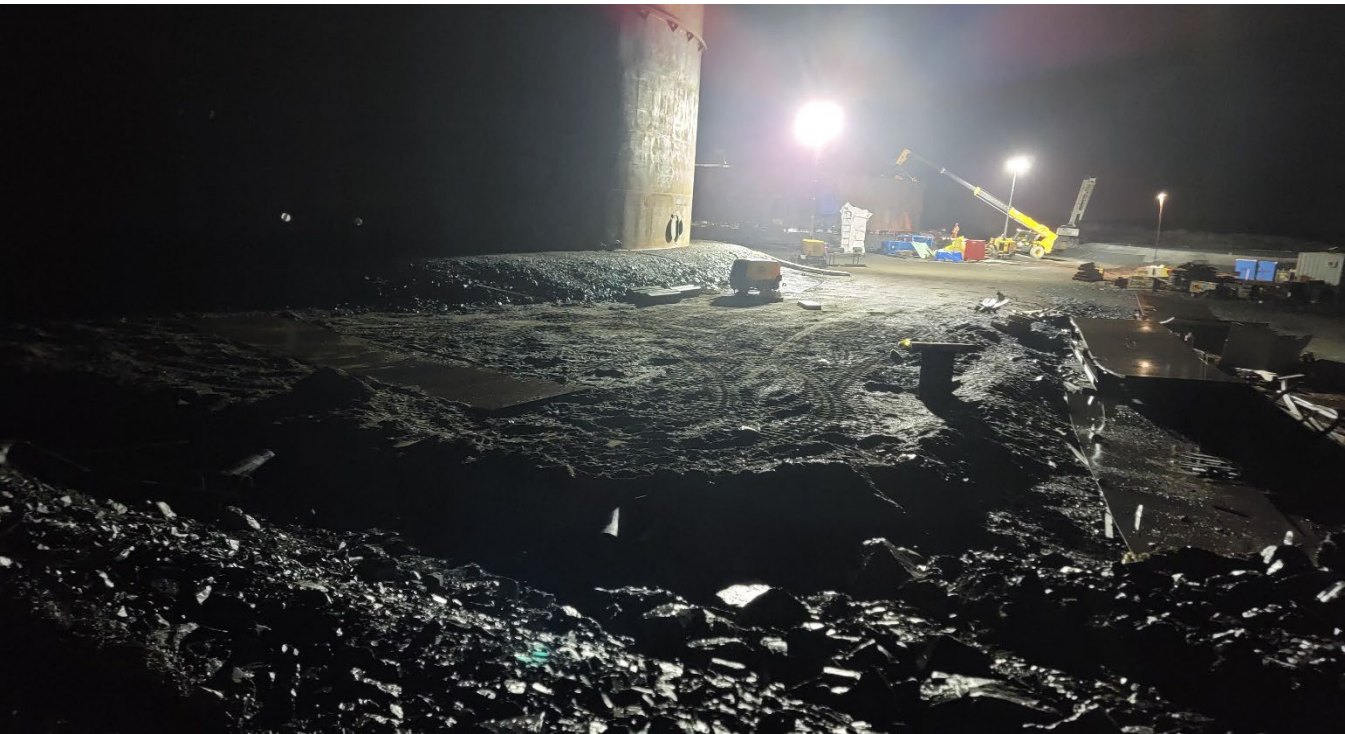
G-264 – General view of the Phase 2 base condition. Construction is in progress

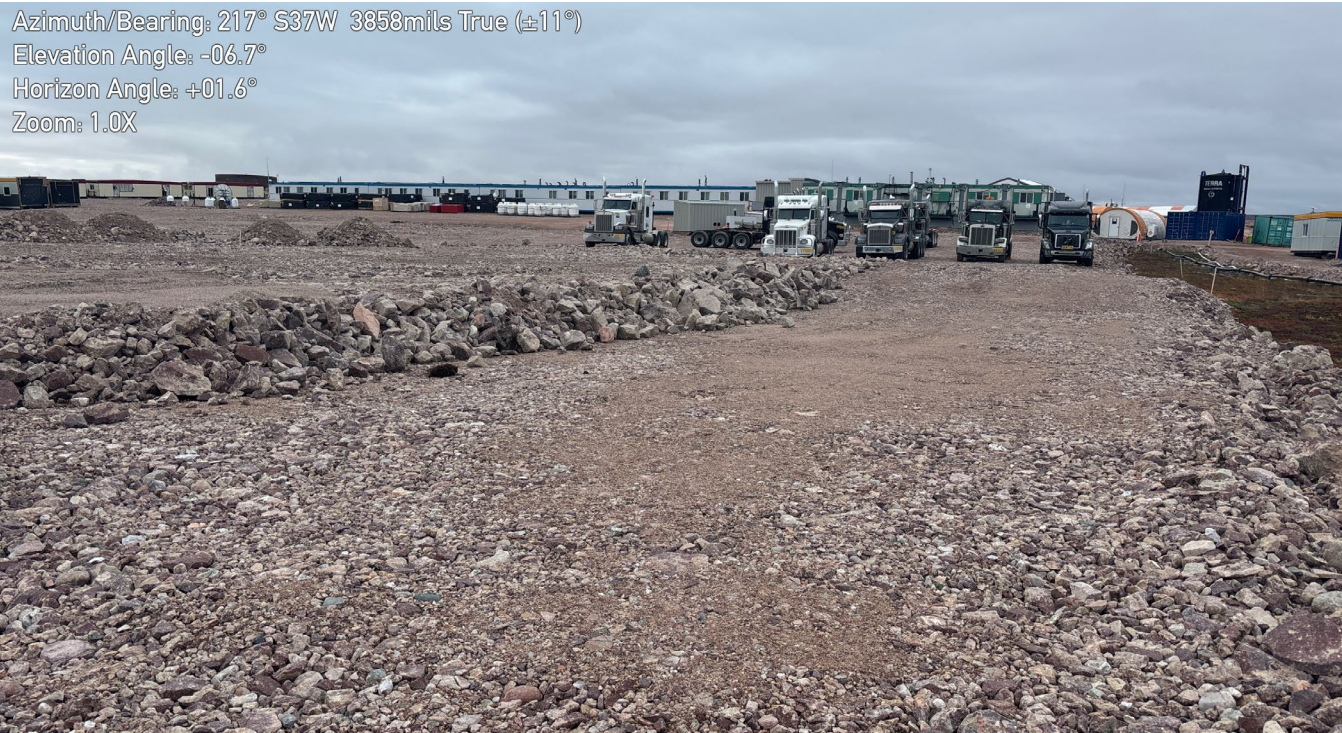
M-1: North end of pad – Note fill material is placed in lifts

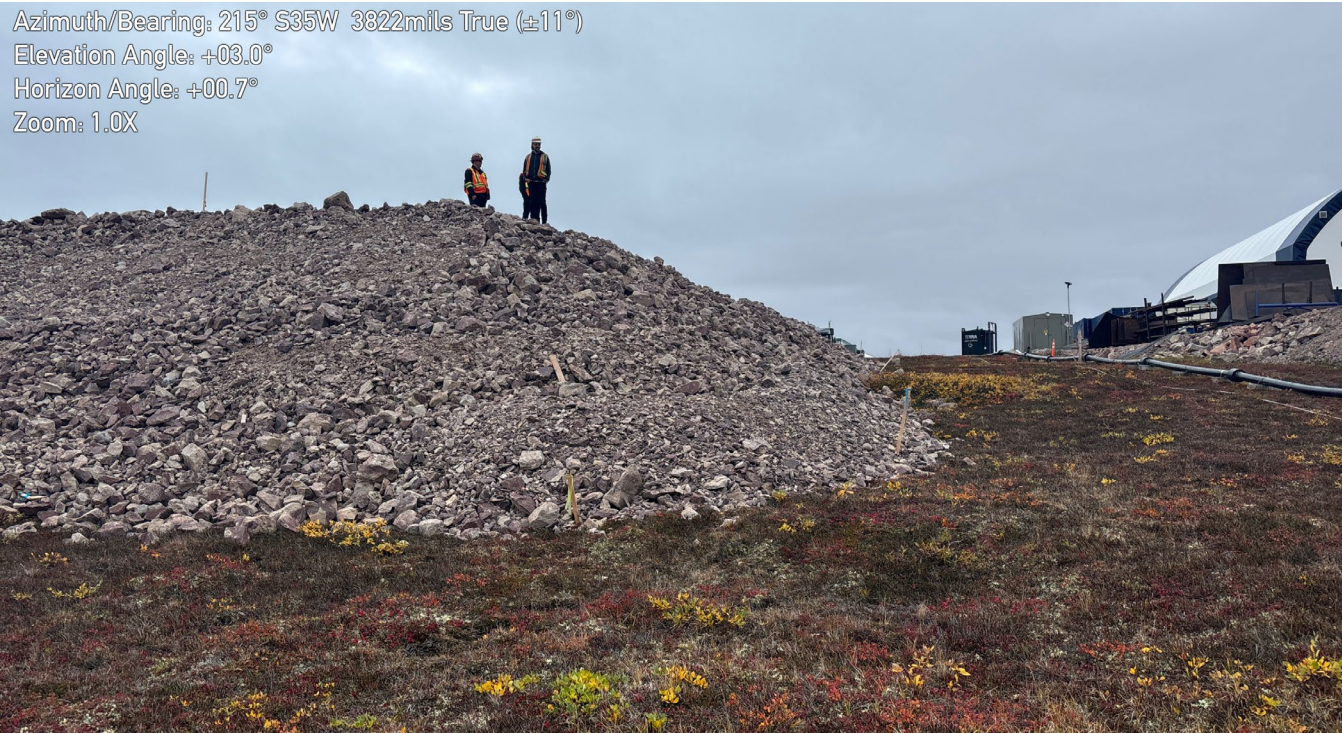
M-2: North slope – Note fill slopes are too steep

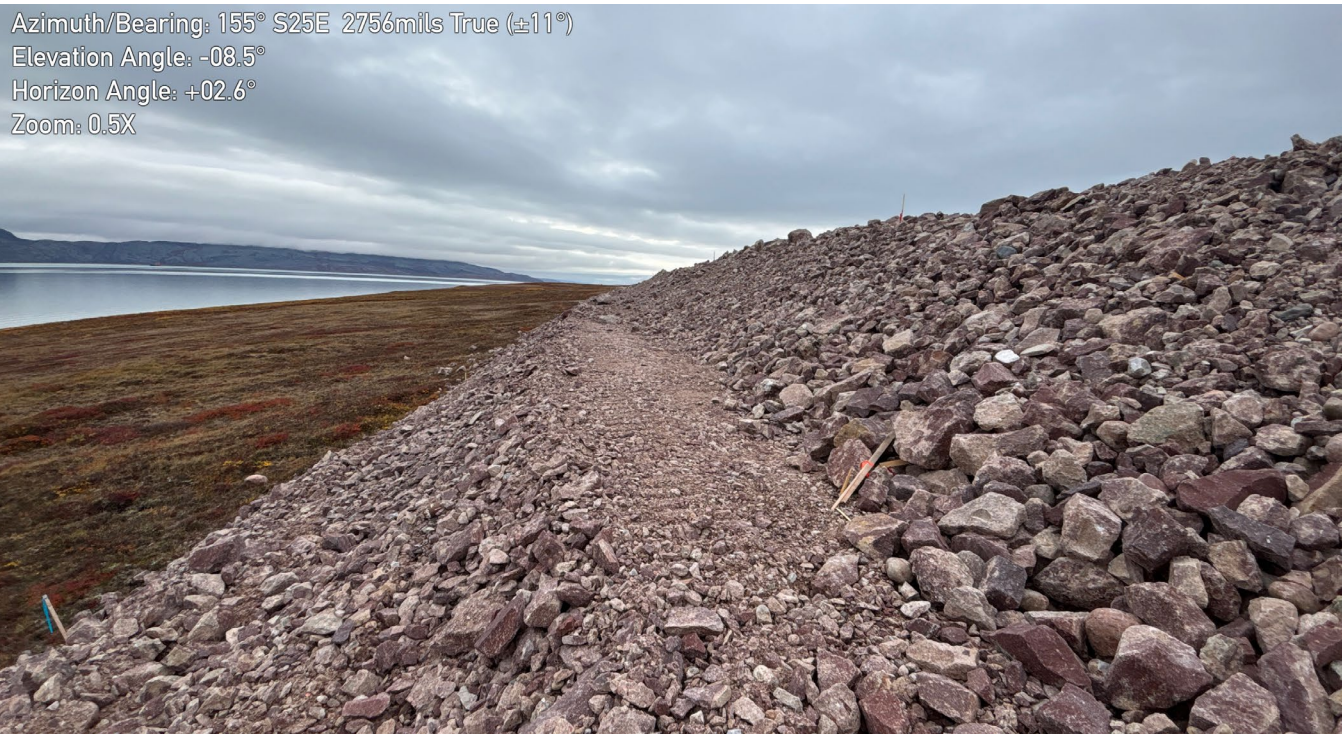
M-3: NE slope bench – Note fill material is placed in lifts

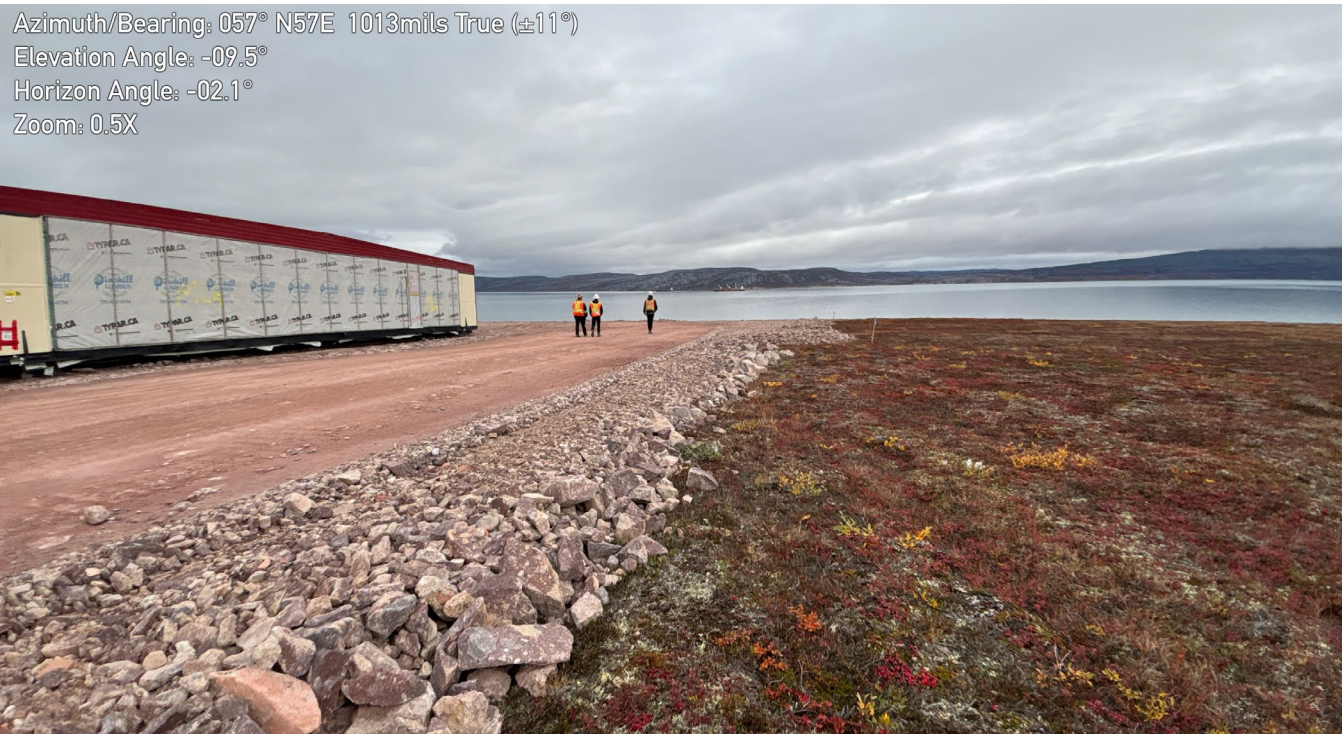
M-4: Access road under construction – Note fill is too thin

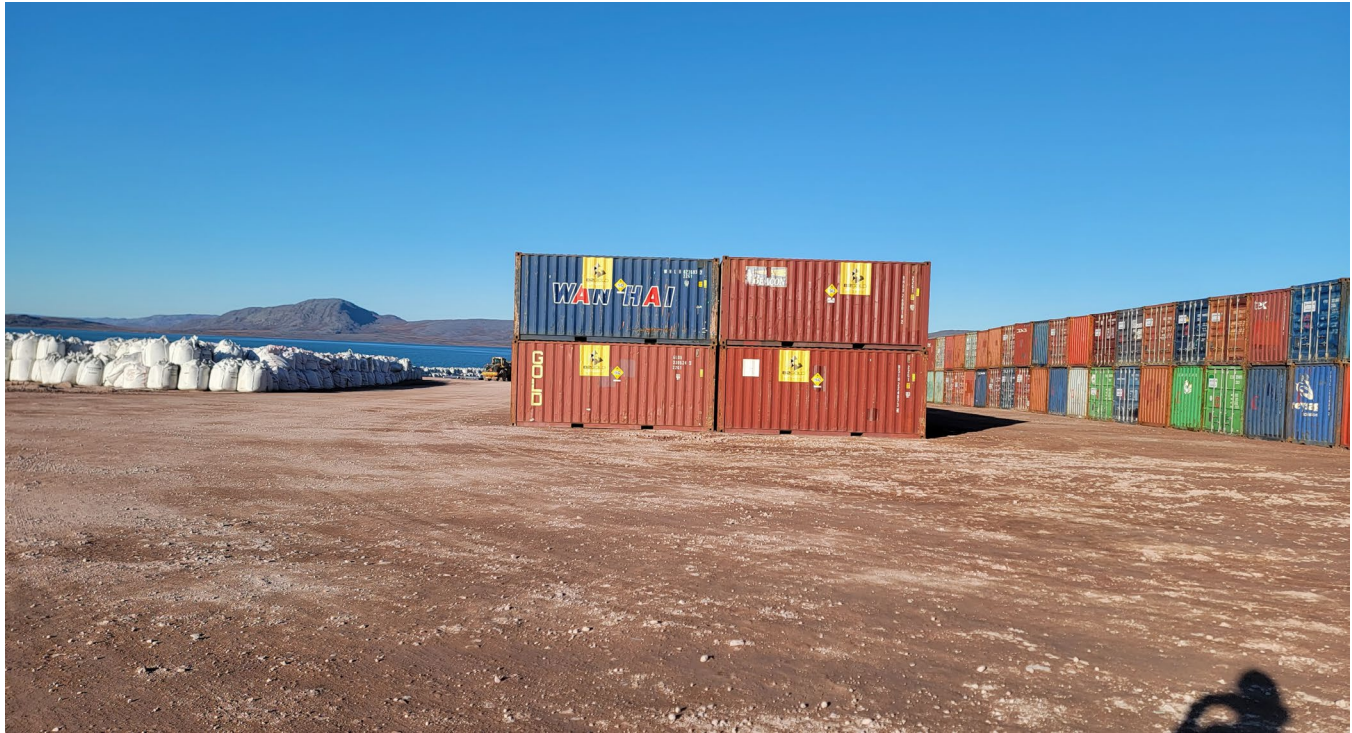
M-5: General Laydown pad condition, facing NE

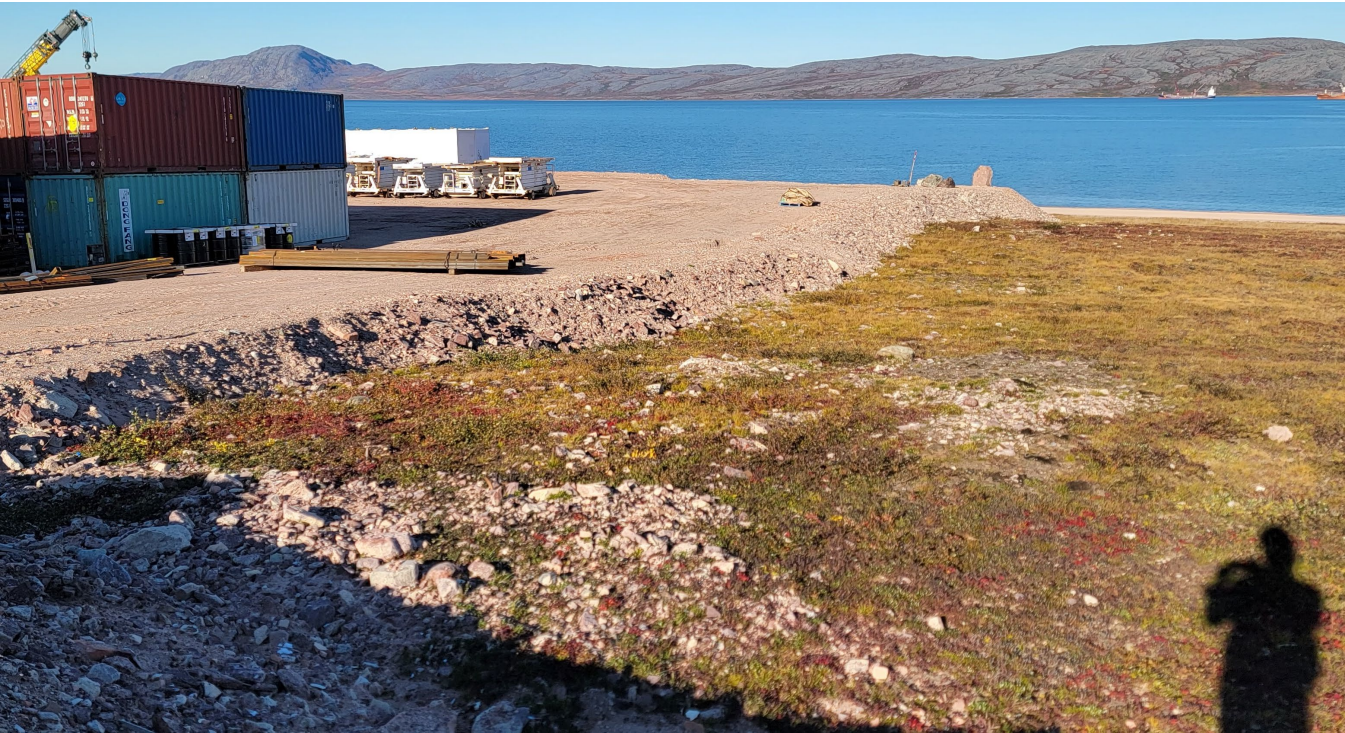
M-6: Typical Laydown pad thickness, facing NE

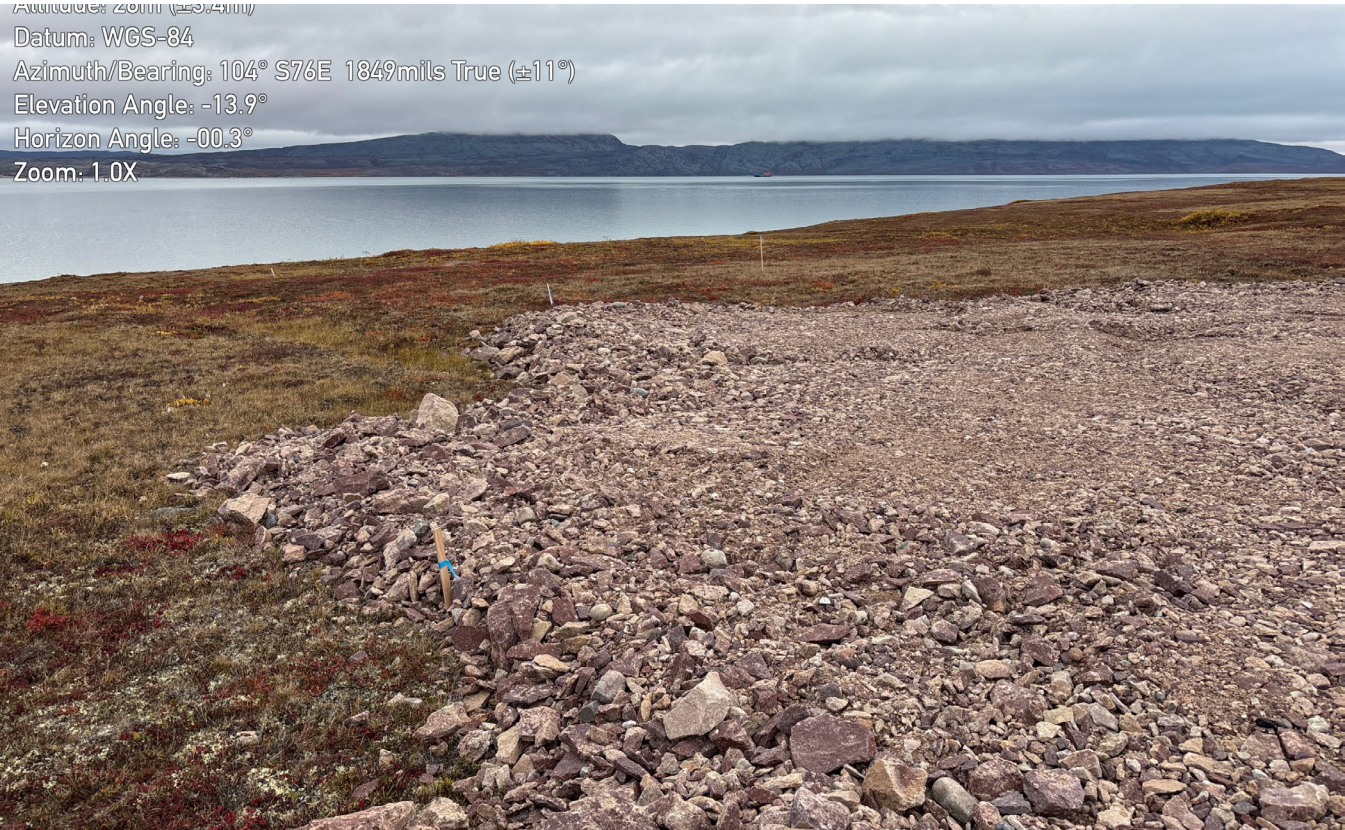
M-9: SE end of pad – Note fill is too thin

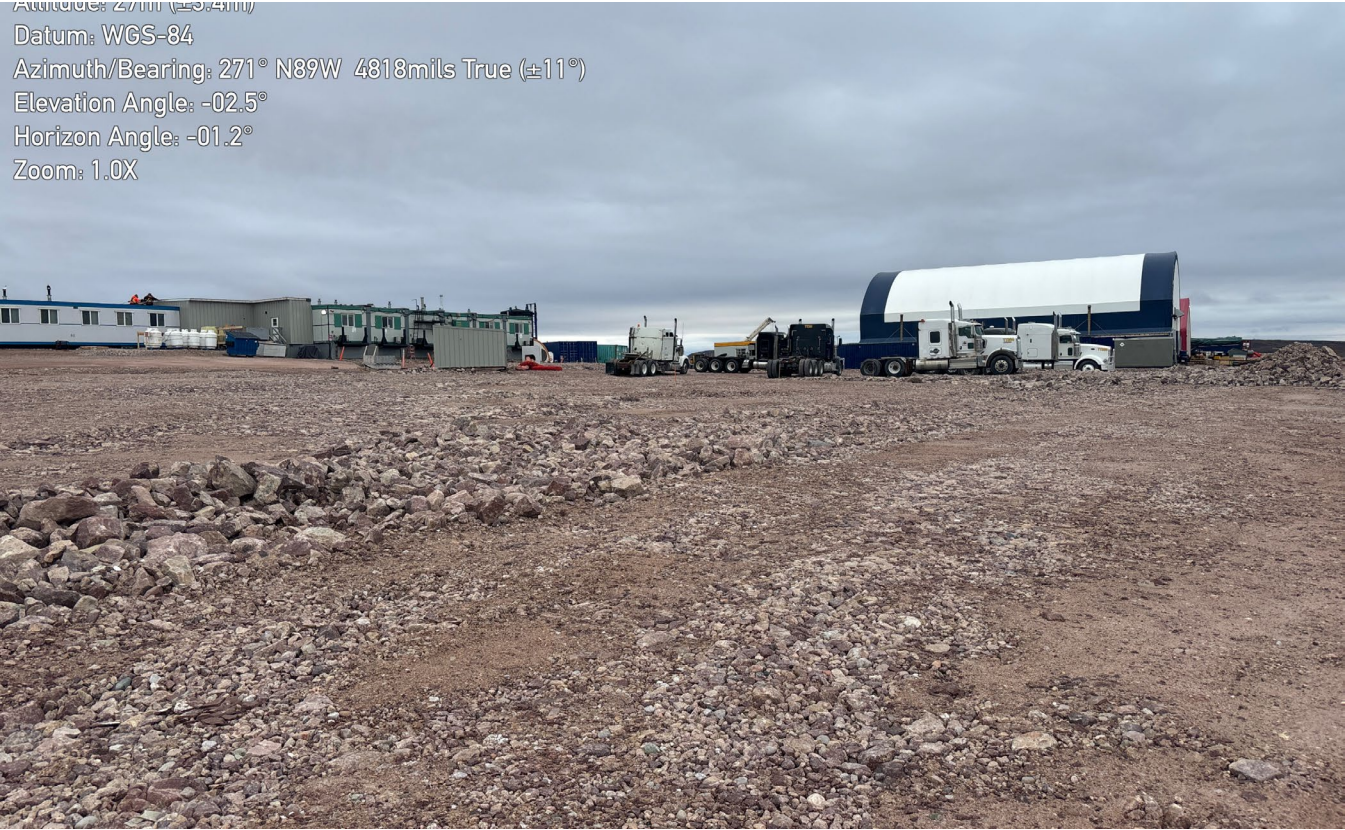
M-10: West side of extension - Note that fill material lacks proper compaction

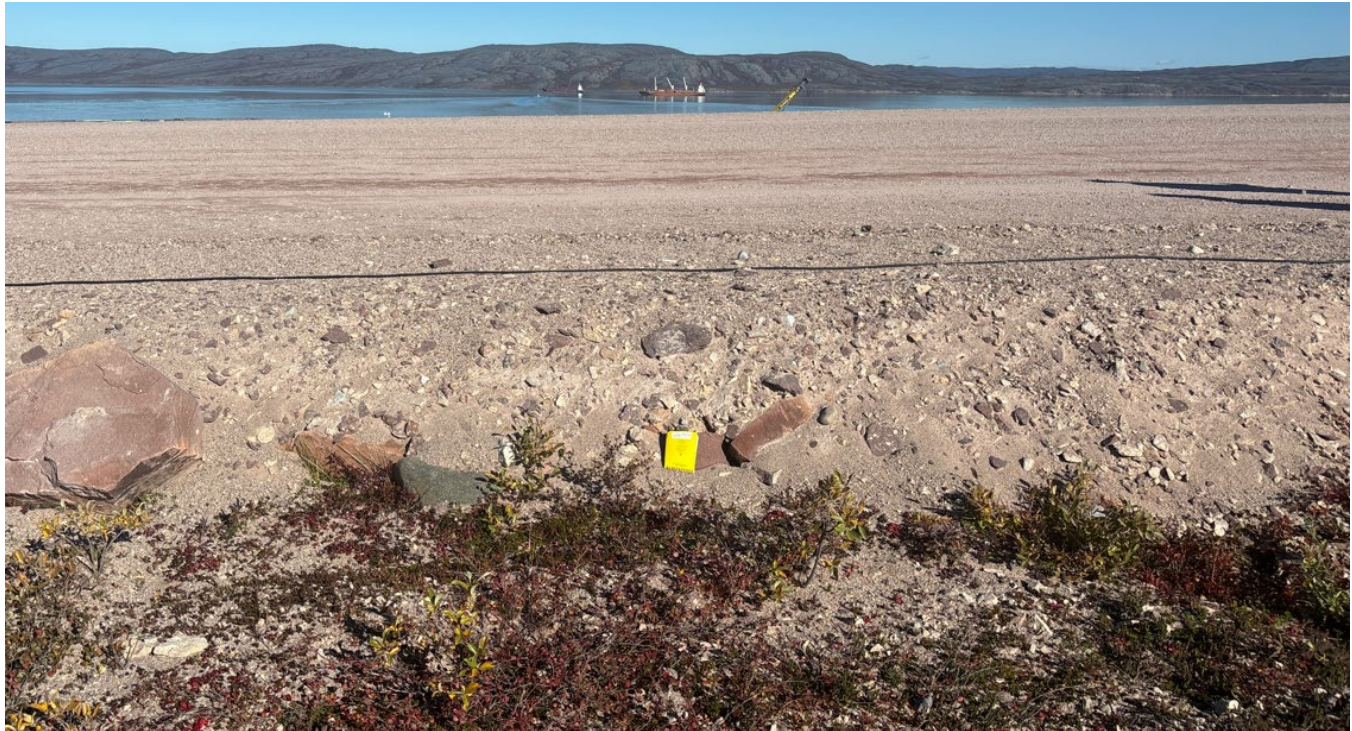
M-12: Airstrip, western side, facing East – Typical thickness of the embankment - some sections are too thin

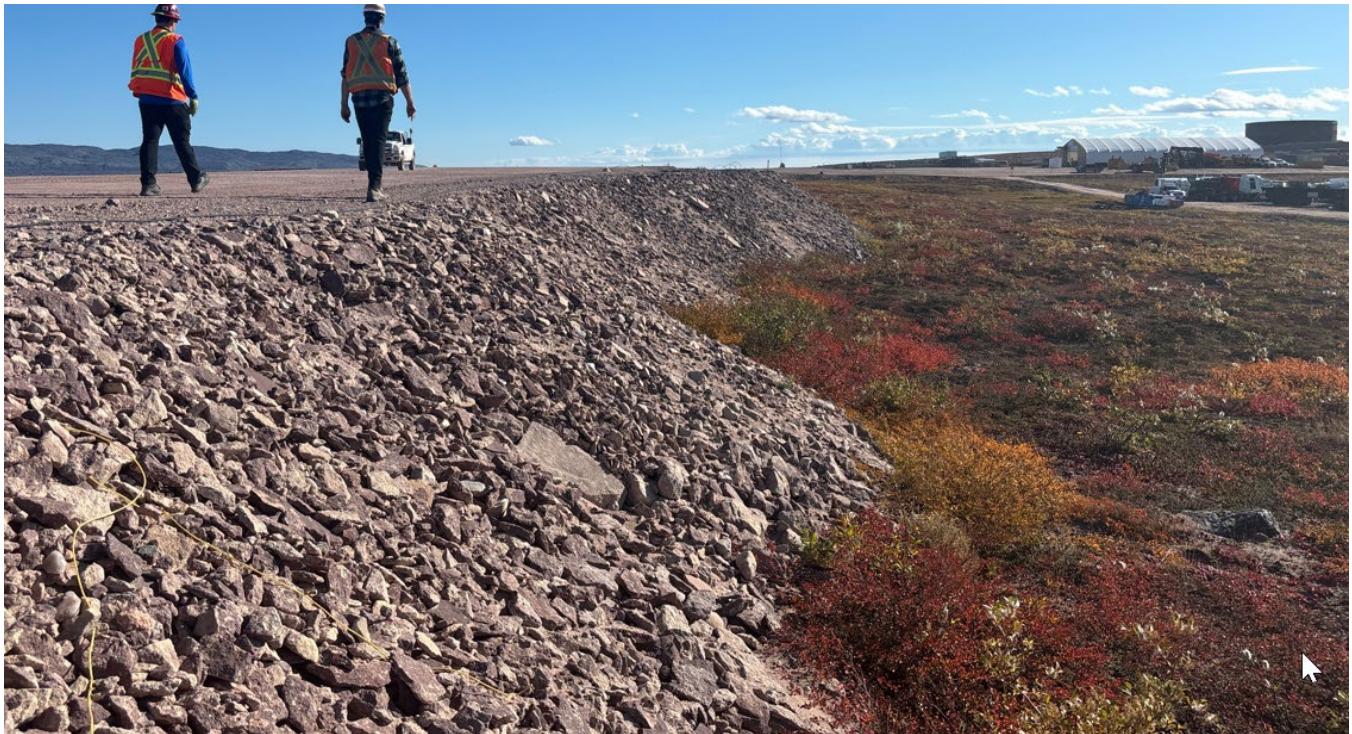
M-14: Airstrip, western side – Typical slope of the embankment - some sections are too steep

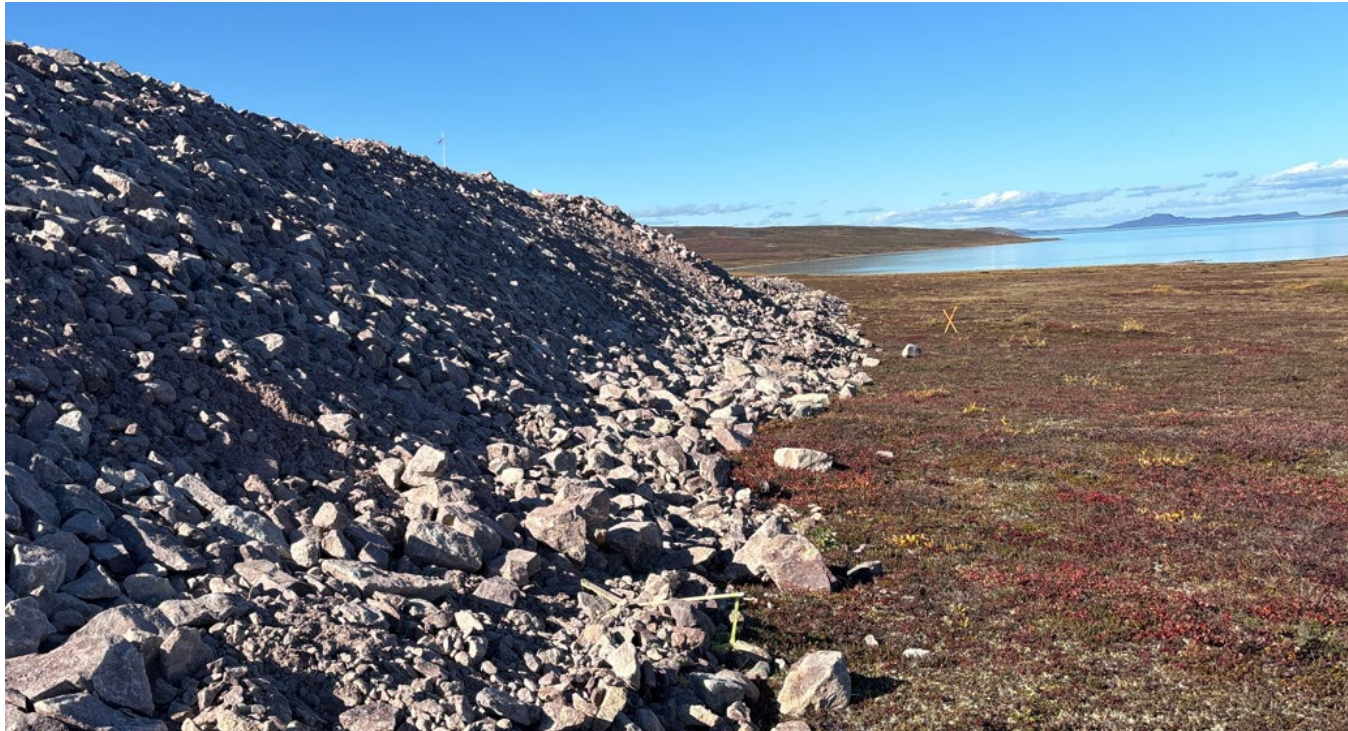
M-16: Airstrip extension, northern end – Slopes are too steep

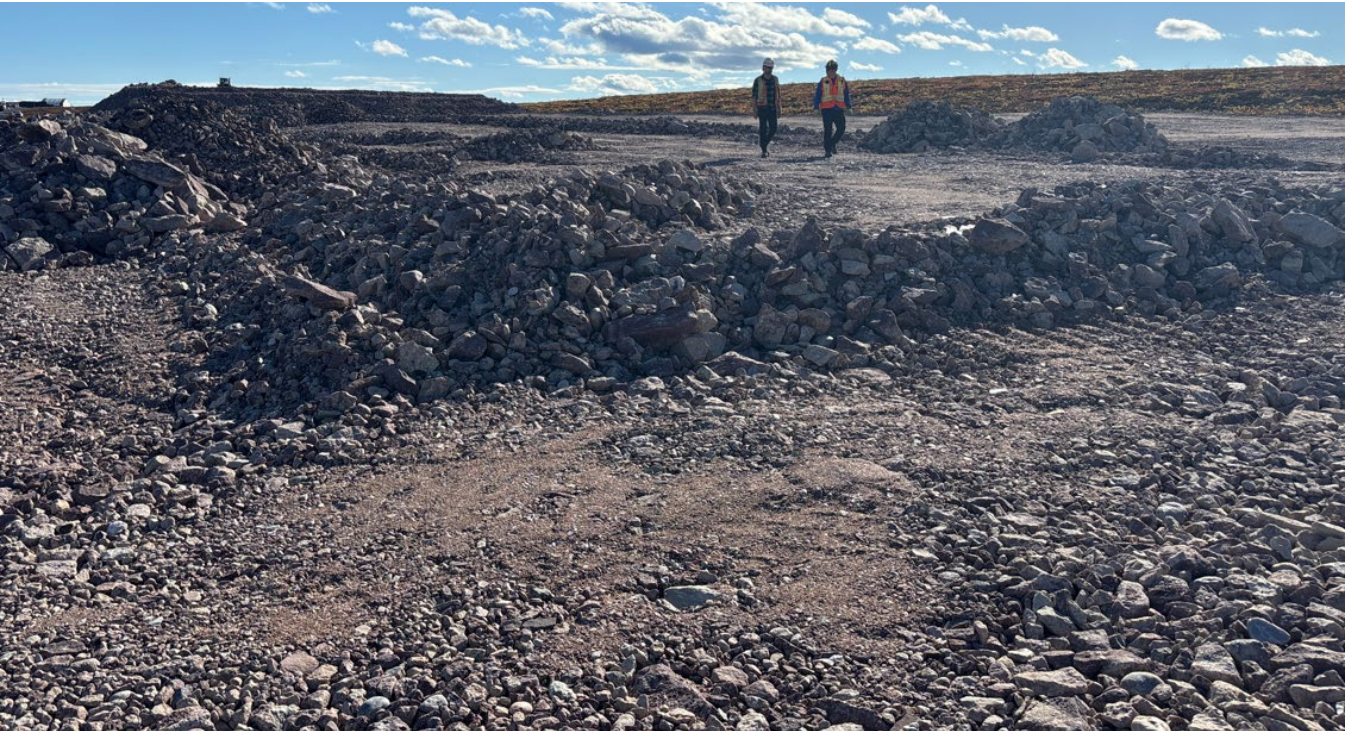
M-17: Airstrip extension, northern end – fill material is placed in 0.8m lifts

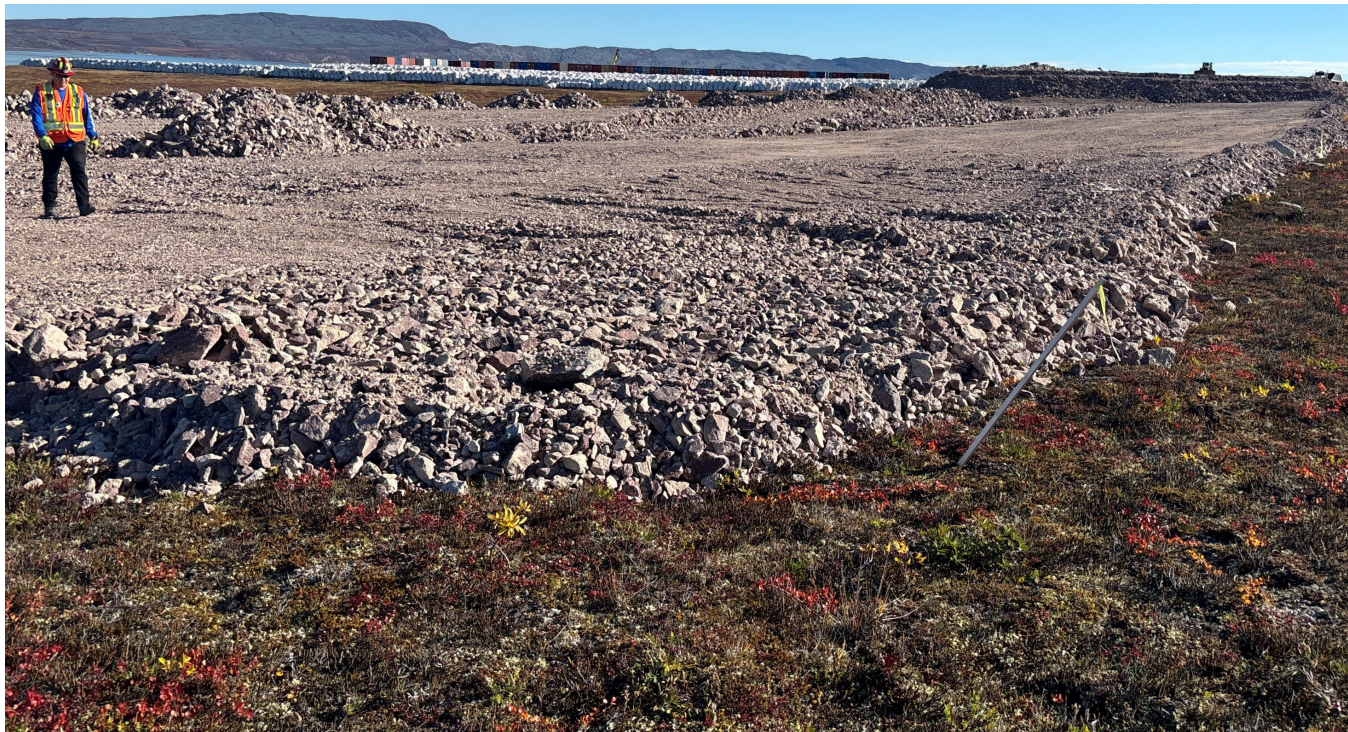
M-18: Northernmost end of airstrip extension – 0.8m lifts

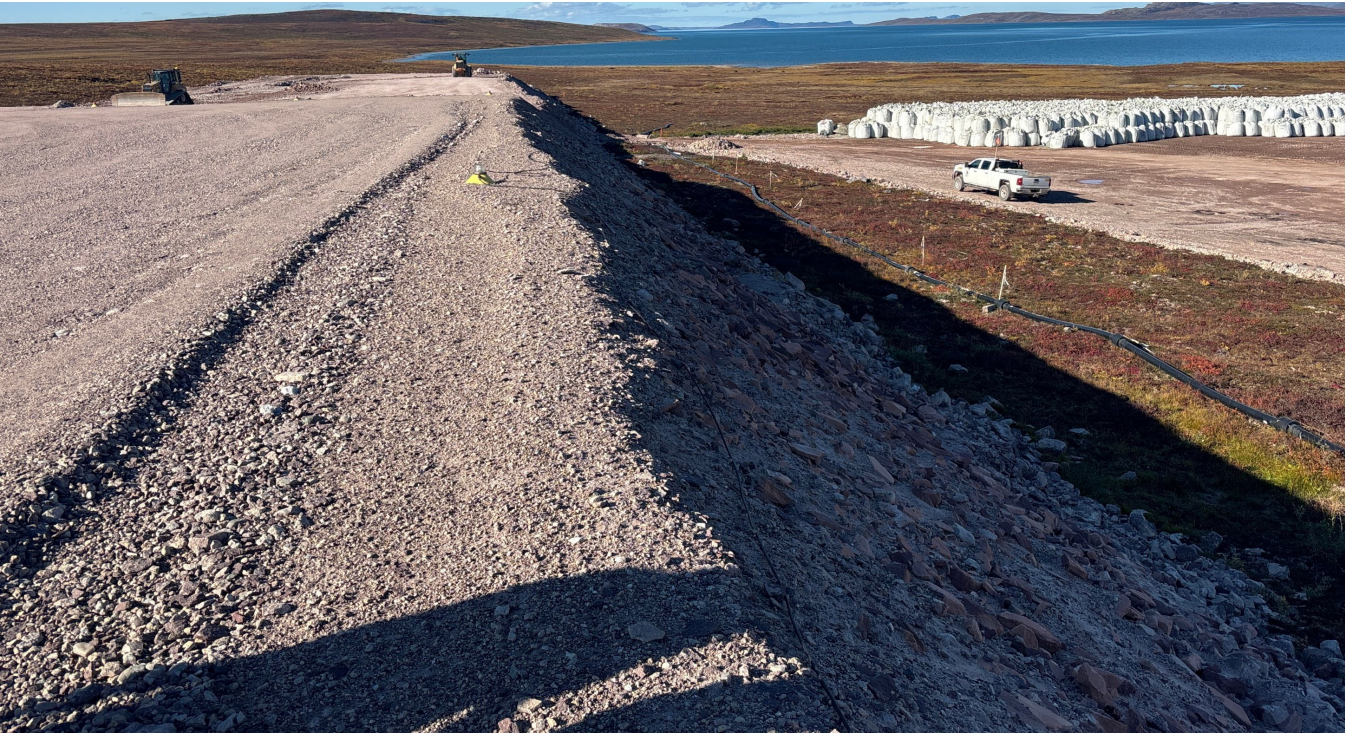
M-21: Eastern side of airstrip, facing NW

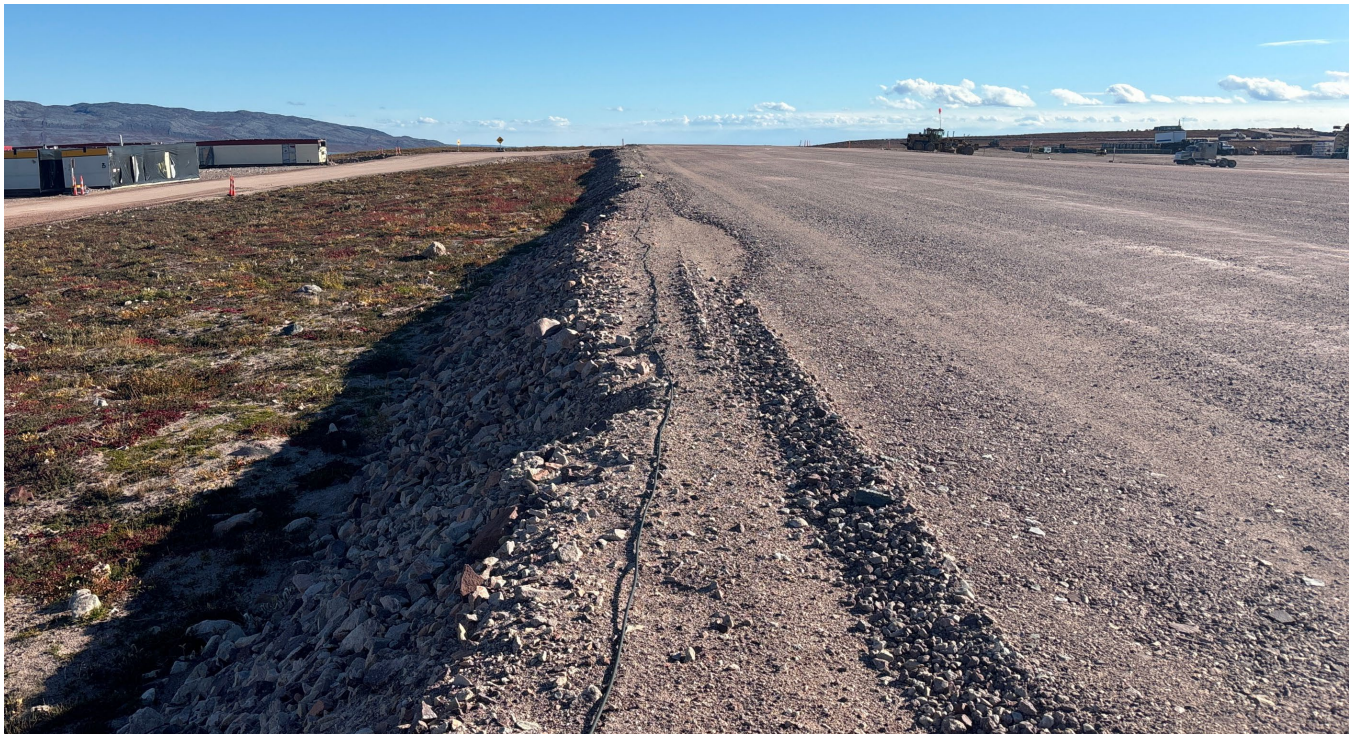
M-22: Eastern side of airstrip, facing SE

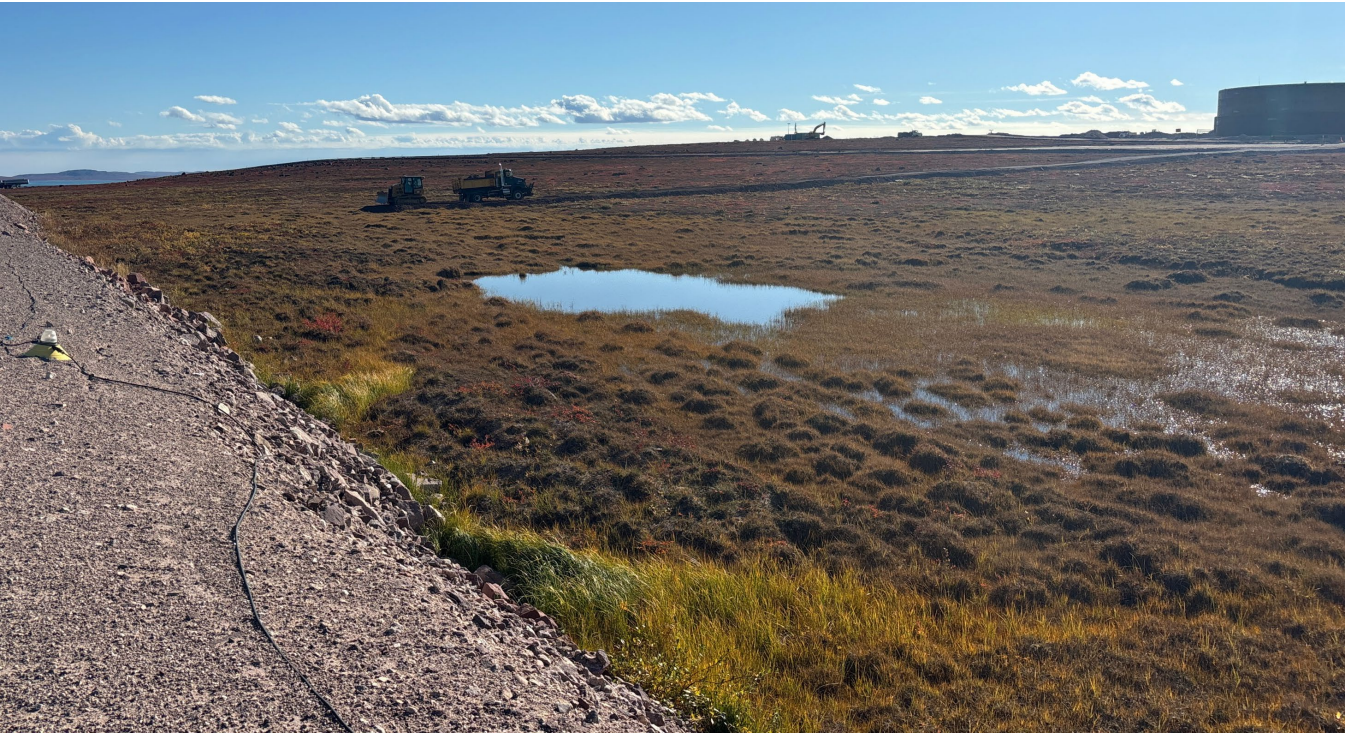
M-25: South end – Note Ponding water at the toe of the embankment

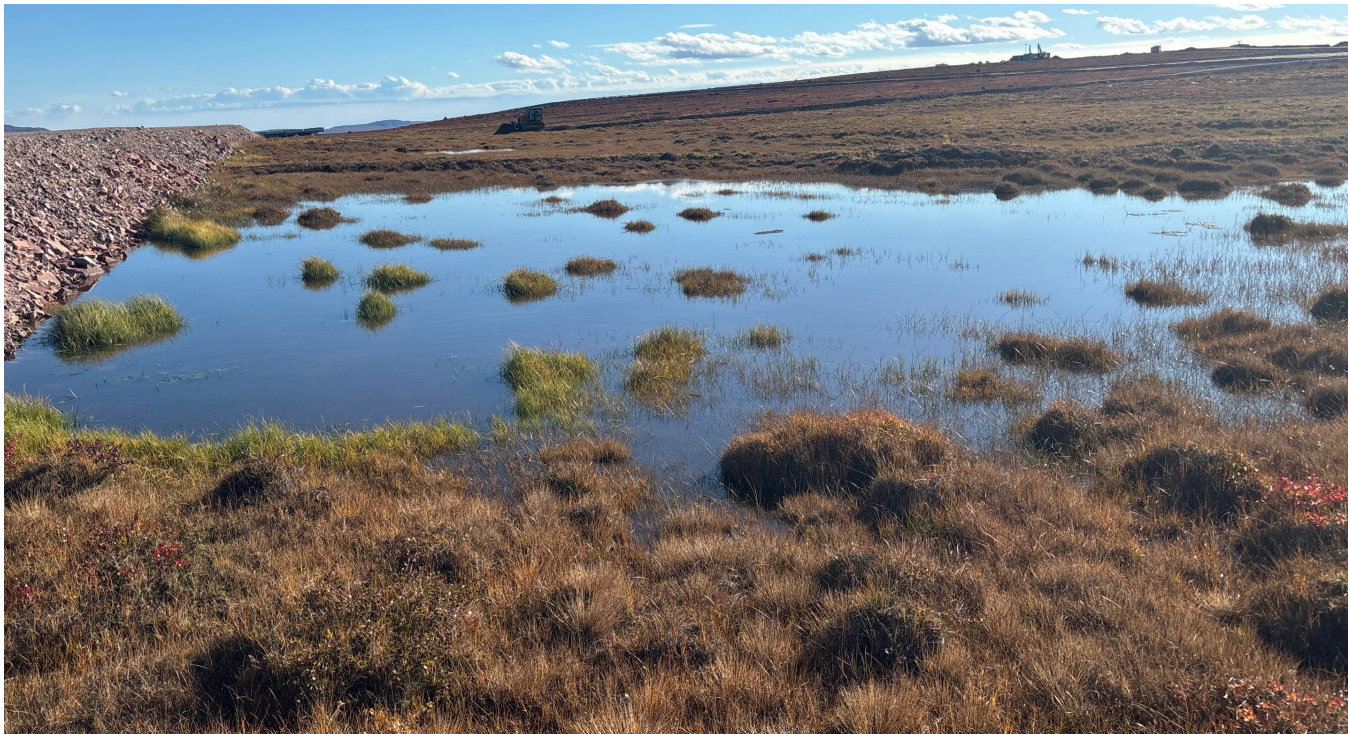
M-26: South end – Note ponding water at the toe of the embankment
